Revised Appendix Q

Existing Building Evaluation

Los Angeles County Museum of Art Building Evaluation

September 16, 2014

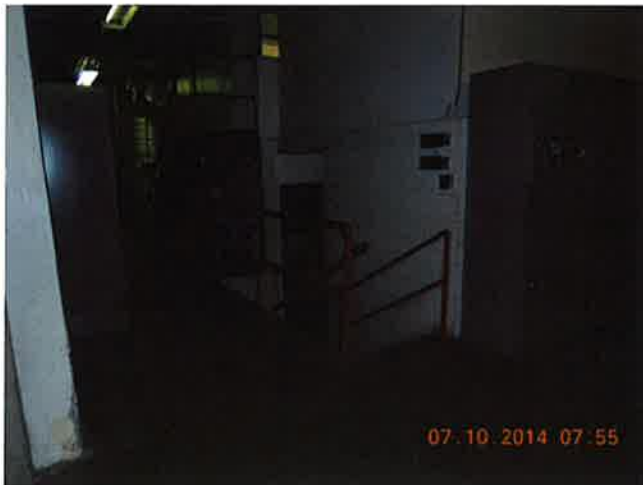
A-010

Several mechanical pipes penetrate through fire rated walls without the proper fire caulking.

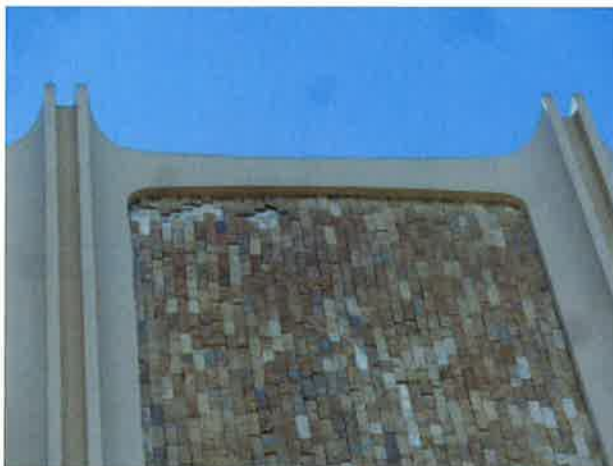
Deteriorated Column Enclosure A-013

Marble cladding is falling off of building.

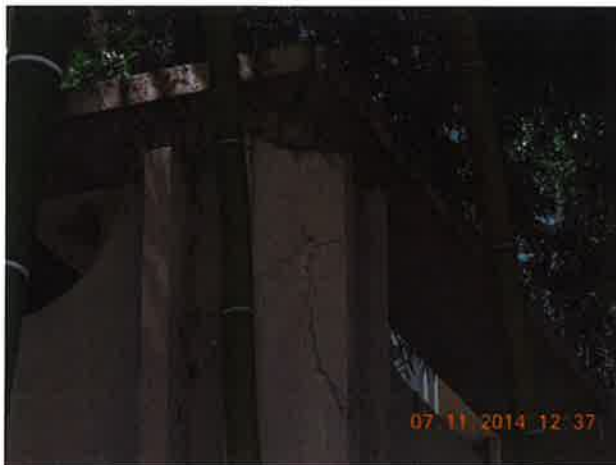
Balcony Cement Plaster – cracking A-023

There are cracks on the balcony cement plaster soffits.

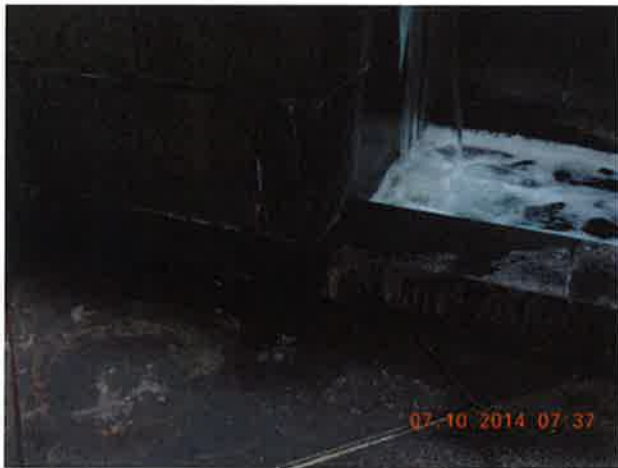
Water Fountain A-025

Water fountain marble tiles have developed extensive efflorescence stain marks all around.

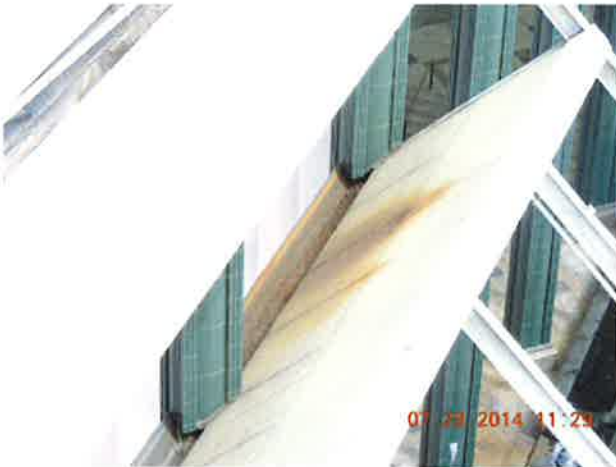
Skylight panels

Wilshire Boulevard main entrance metal canopy with translucent Kalwall panels are in poor condition and need extensive maintenance.

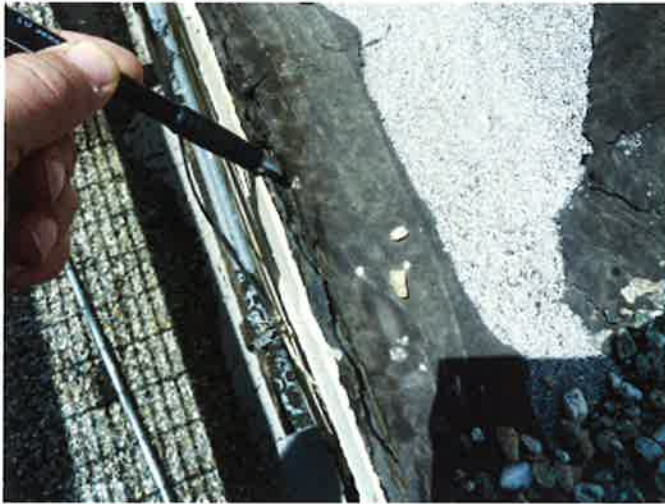
Roofing

Degraded sealant at flashings, degraded sealant at surface mounted counter flashing, roof cement repairs at base flashings

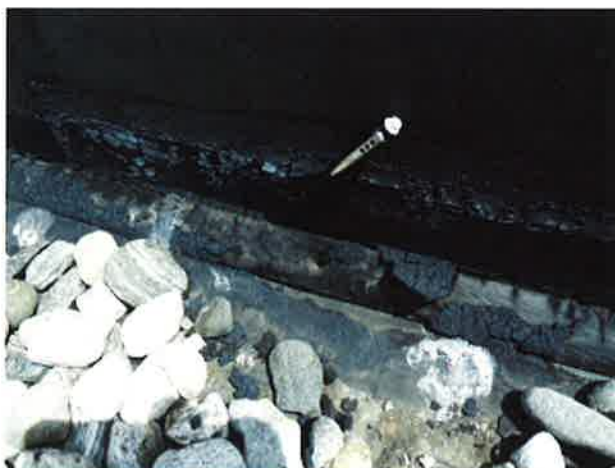
Degraded sealant at flashings, degraded sealant at surface mounted counter flashing, roof cement repairs at base flashings

Roofing should be replaced on all buildings in the near term.

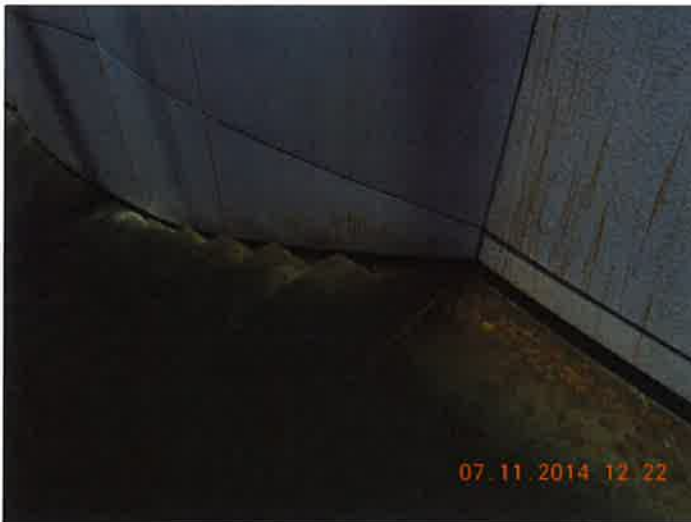
Wall Cladding

There are numerous areas of rust, particularly at the top of the panels where there is a flat eyebrow panel that caps the top of the porcelain panels.

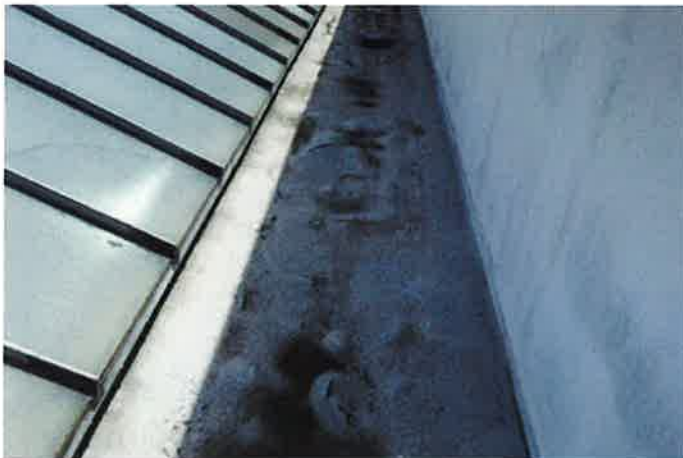
Skylight – gutter well

This picture shows the deterioration of the skylight gutter wells.

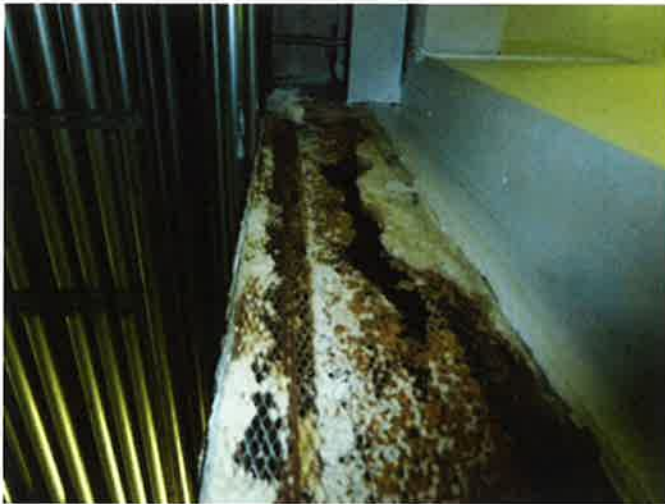
Water Damage in lower levels

This picture shows the water damage in the lower levels due to the water leaking from the plaza level.

The waterproofing system of plaza is a cold-tar patch membrane and is outdated and no longer used as construction methods and beyond the end of expected useful life.

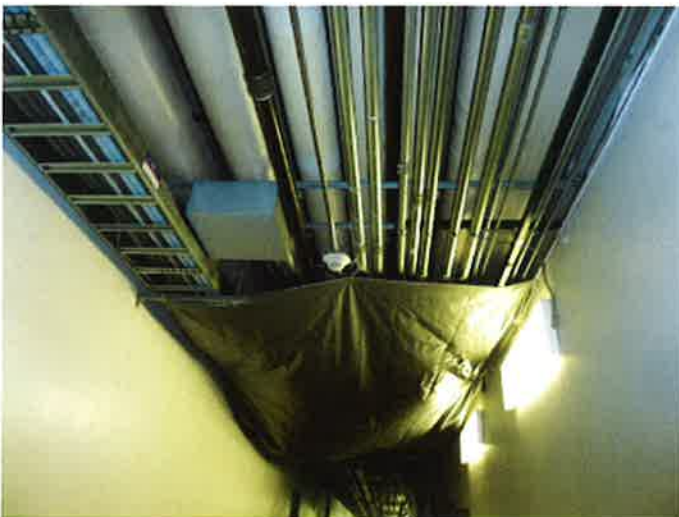
Plaza Level – Leaking Water

This picture shows plastic tarps used to collect the intruding water.

Water leaks to lower level areas from the plaza are reported to be a continuing problem.

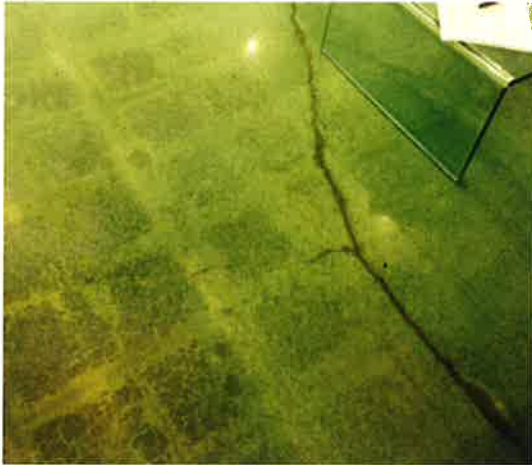
Footing Cracks

Several cracks were observed in the mat foundation of the Ahmanson Building.

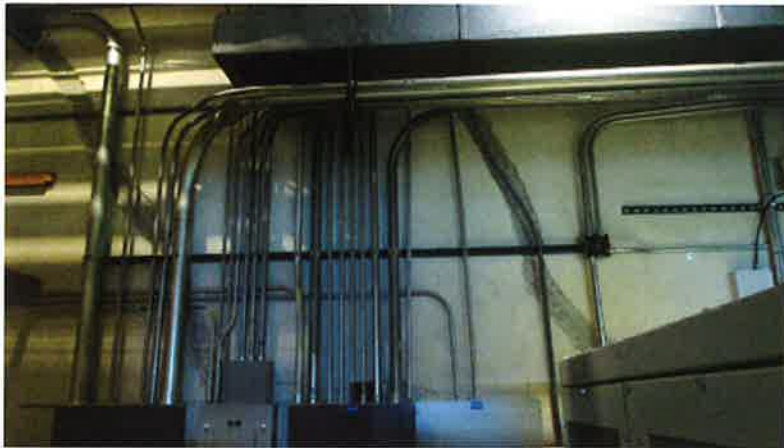
Major Seismic Crack & Repair

Seismic cracks observed in the walls adjacent to the Transformer Room of the Ahmanson Building.

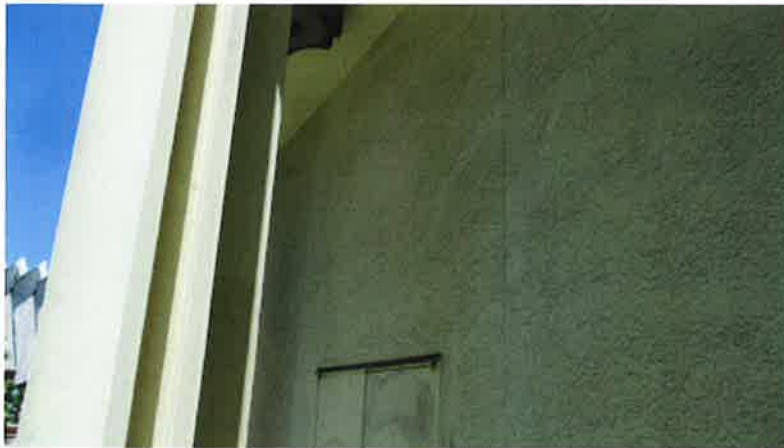
Shear Wall Crack Repair (Lvl 2)

Several diagonal cracks and repairs were observed in the walls at the corner of the Ahmanson building 2nd floor.

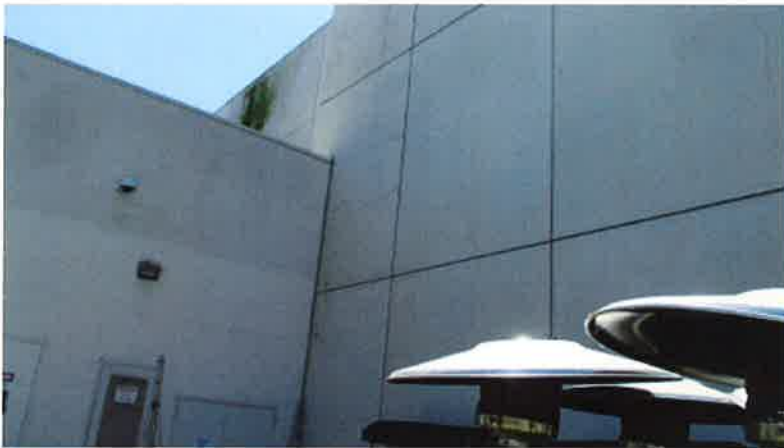
External Shell Cracks

Several cracks in the external shell of the Ahmanson extension were observed at the 2nd floor.

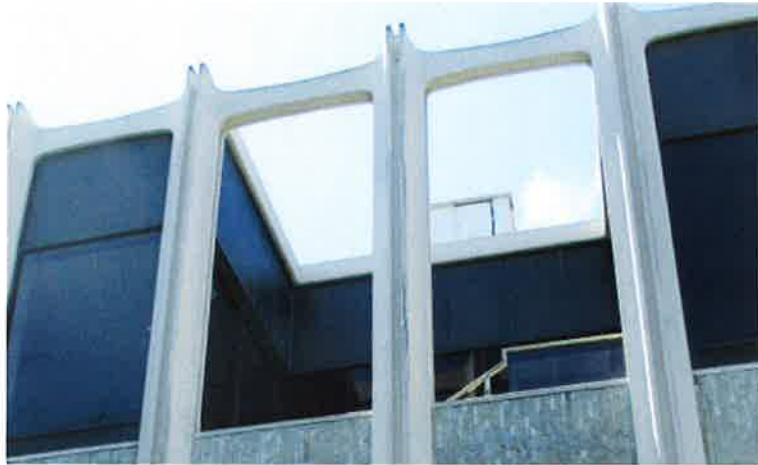
Cracked Column

Columns show signs of cracking

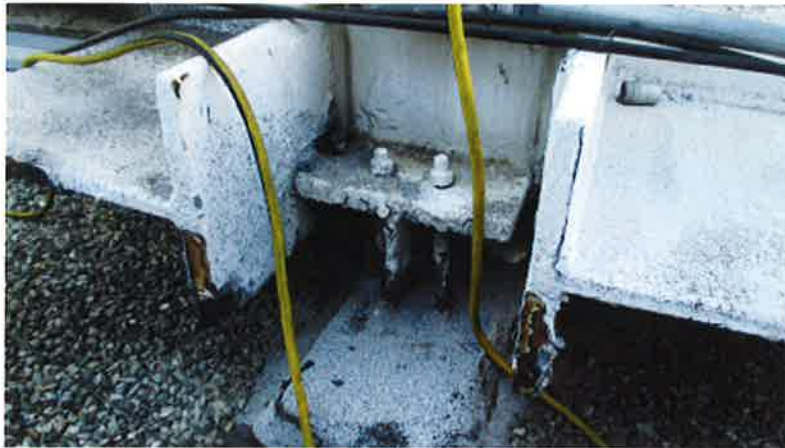
Displaced Canopy Connection

Bent / displaced bolts were observed at the canopy connection at the roof of the Hammer building.

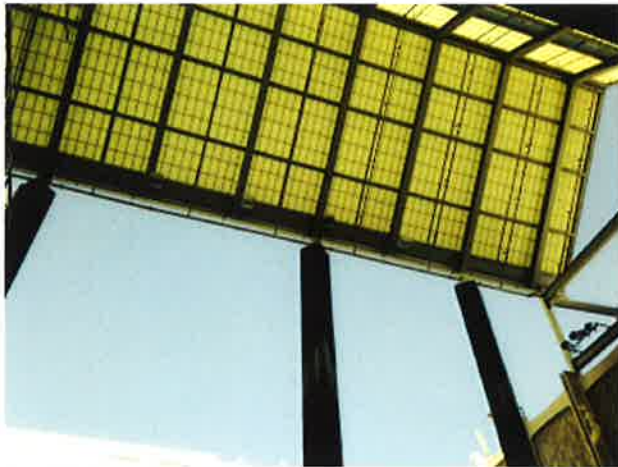
Partial Column Support

Heavily clad, 40 ft columns were observed supporting the canopy.

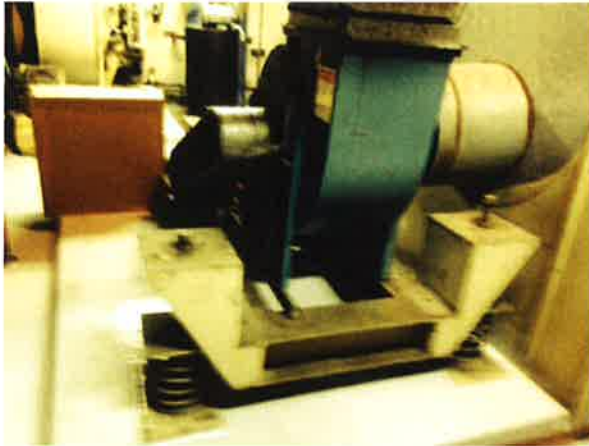
Unrestrained Mechanical Equipment

Several isolated equipment was observed without lateral restrains.

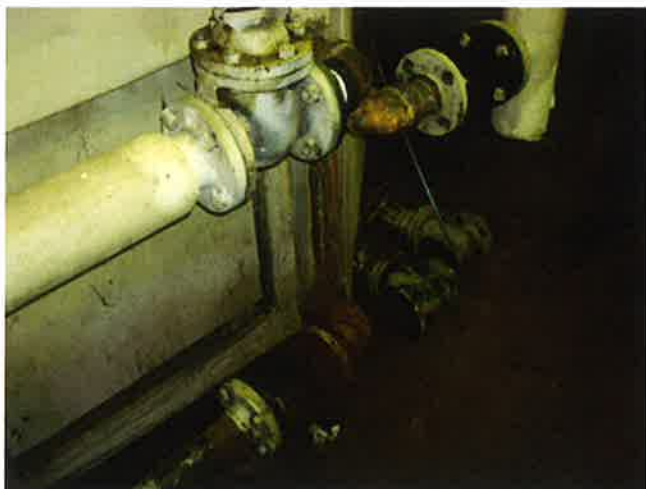
HHW piping disconnect

This picture shows the HHW piping in poor condition and is disconnected from the steam humidifier unit.

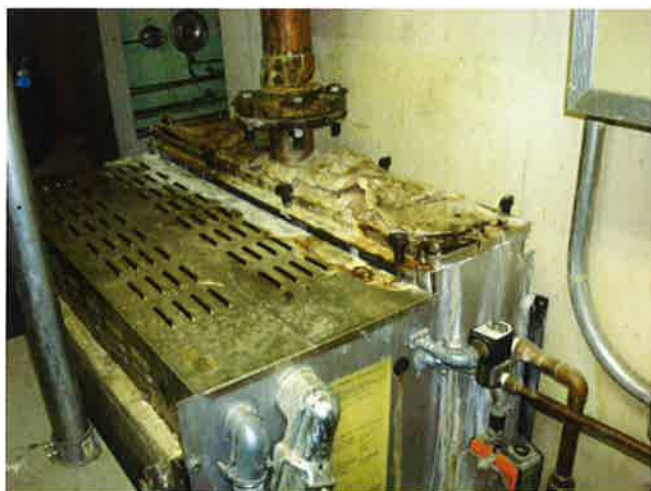
HHW Piping

This picture shows a steam humidifier that is shut off and non-operational.

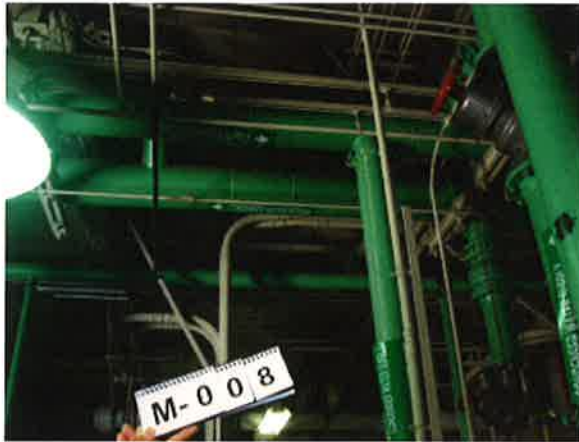
Condensate piping M-008

Condensate Water supply and return piping is in fair condition

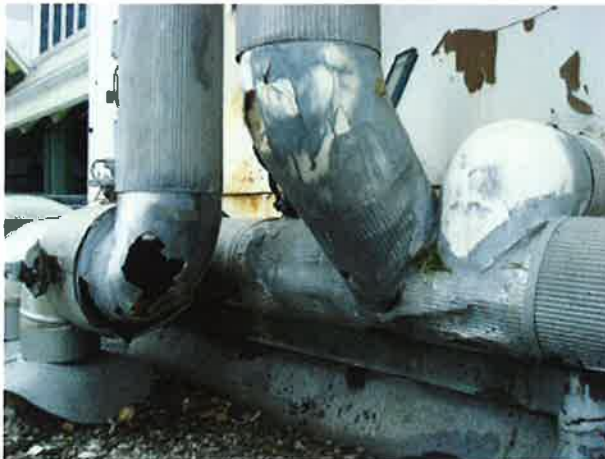
CHW piping - insulation M-009

Chilled water distribution piping: Insulation is in poor condition

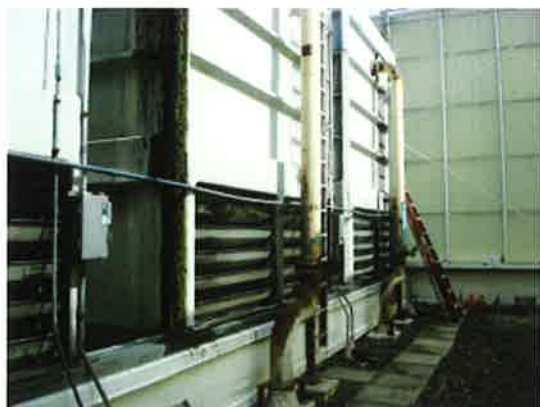
Cooling Tower

These cooling towers are in poor condition

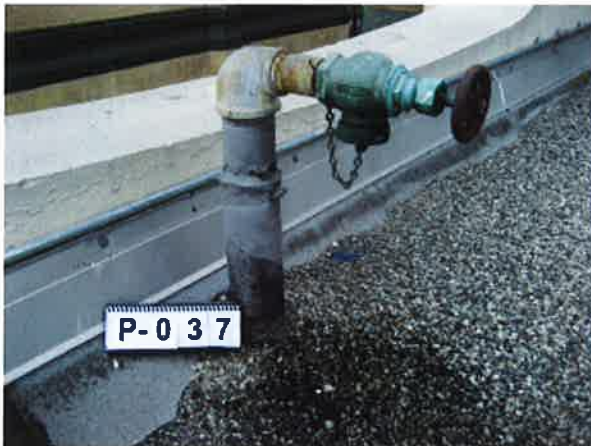
Leaking wet standpipe

Water is leaking from this wet standpipe fire hose connection on Building C.
