Winchester Ranch

Tree Assessment

September 12, 2018

Winchester Ranch
San Jose CA

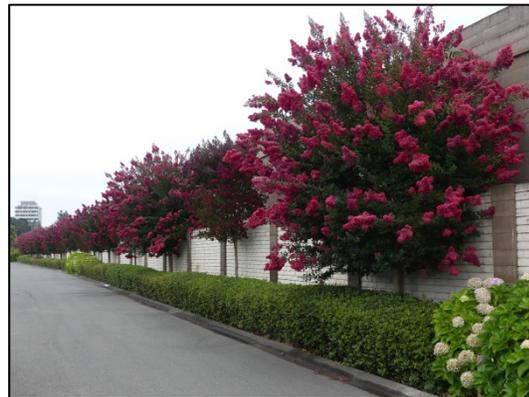
Crape myrtle was the most frequently occurring taxa with 58 trees. This small flowering tree was present throughout the site, particularly along the south property bordering I-280 (Photo 1). Trees were young and semi-mature in development with trunk diameters between 2- and 7-inches. Tree condition was generally good (34 trees) with five trees in excellent condition. Eighteen (18) trees were in fair condition due largely to a history of topping and/or lack of irrigation.

Photo 1. Crape myrtles along the south property line.

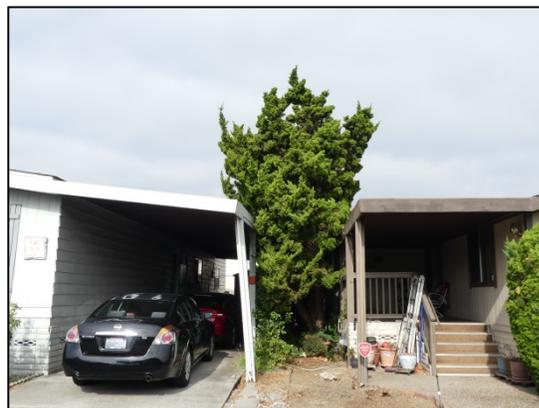
Thirty-two (32) Hollywood junipers were present (Photo 2). This large evergreen shrub was found in unpruned, sheared, and poodle-balled forms. Most trees were mature in development. Tree condition was generally poor and fair. Trees in poor condition were likely to be found located in sites without adequate growing space.

Photo 2. Hollywood junipers with limited growing space.

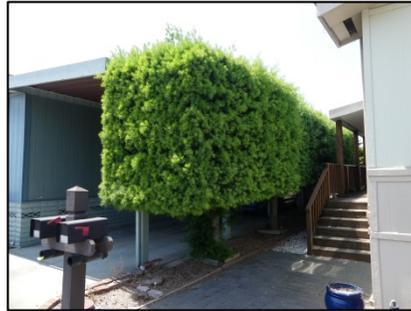
Nineteen (19) fern pines were present (Photo 3). Almost all were located between mobile homes and had been sheared into geometric forms. Trunk diameters varied from 4- to 11-inches. Essentially all trees were in fair condition.

Photo 3. Fern pine sheared into a cube.

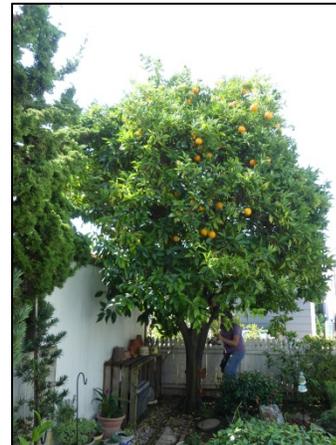
Twenty (20) oranges were present (Photo 4). As with the lemons, trees were often crowded, clipped, and sheared. Trunk diameters ranged from 4-inches to 10-inches. Approximately 70% of oranges had multiple stems. Tree condition was generally fair and good.

Photo 4. Orange tree in small garden area.
