**PHASE I ENVIRONMENTAL
SITE ASSESSMENT**

**CARDEN PROPERTY
HAYWARD, CALIFORNIA**

June 1, 2016

Project No:
4920.003.000

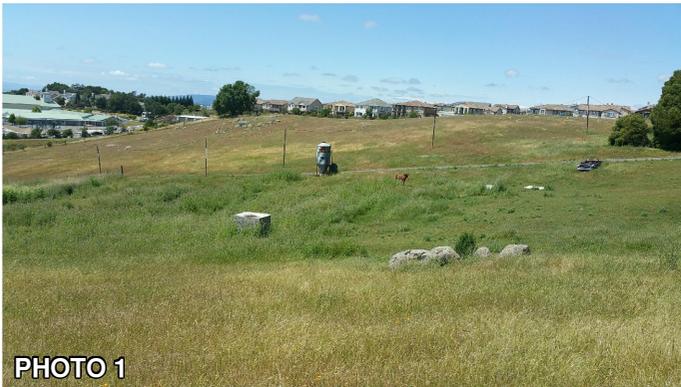
PHOTO 1

VIEW FACING NORTH ON THE SOUTHERN PORTION OF THE PROPERTY

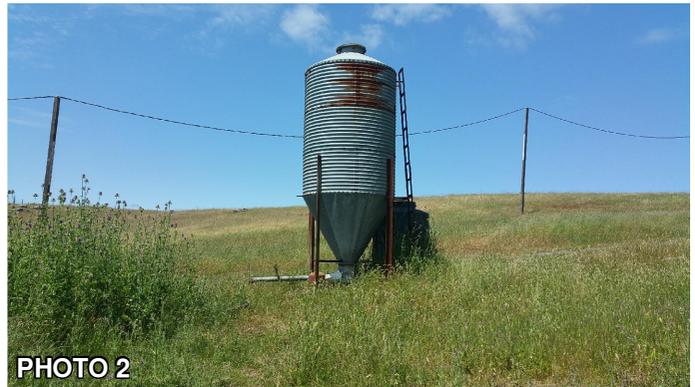
PHOTO 2

SILO ON THE CENTRAL PORTION OF THE PROPERTY NEAR THE FORMER COOPS

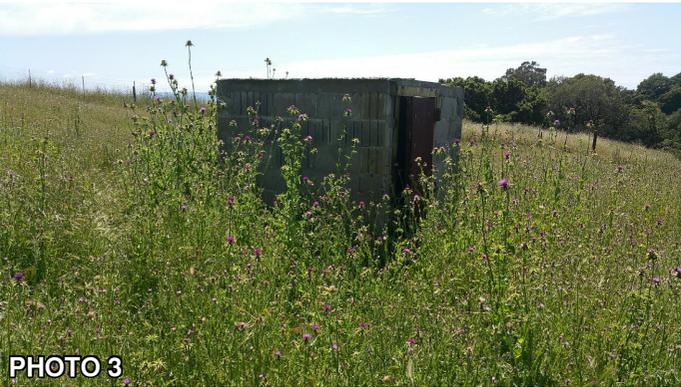
PHOTO 3

A SMALL STRUCTURE WITHIN THE VICINITY OF THE FORMER COOPS

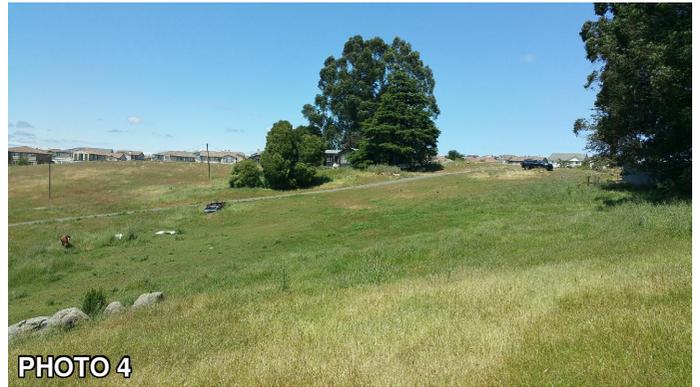
PHOTO 4

VIEW OF THE EASTERN PORTION OF THE PROPERTY

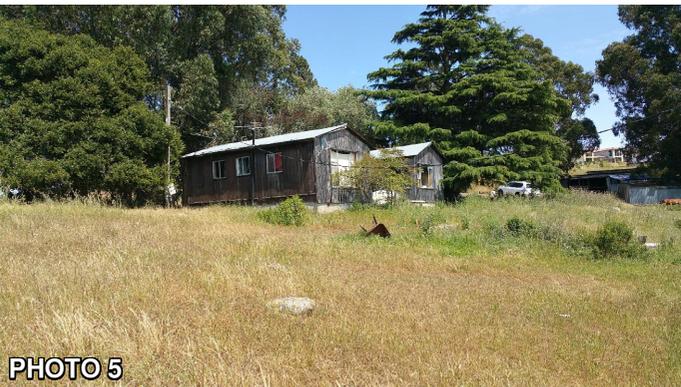
PHOTO 5

An asbestos and lead-based paint survey was not conducted as part of this assessment. Given the age of the structures on the Property, it is conceivable that asbestos-containing material and lead-based paint may be found in the building materials.

VIEW OF THE RESIDENCE LOCATED ON THE EASTERN PORTION OF THE PROPERTY

- Given the age of the structures, it is conceivable that asbestos-containing materials or lead-based paint materials were used in its construction. ENGEO recommends that a Cal-OSHA certified ACBM and lead-based paint contractor be retained to assess the structure prior to any demolition activities.

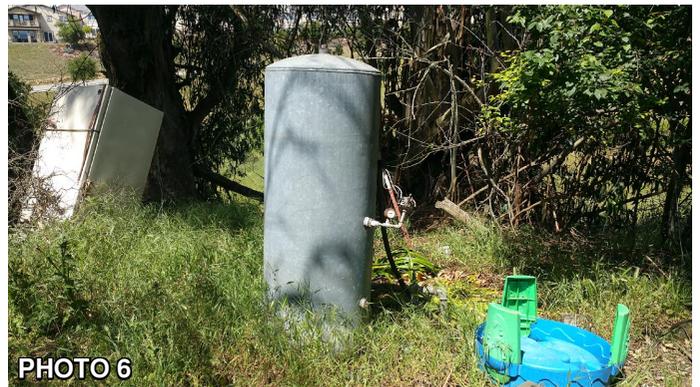
PHOTO 6

Wells. The well house and adjacent sump observed on the Property in 2004 were not identified at the time of the site reconnaissance. What appears to be equipment for water storage and/or a water heater was observed adjacent to the residence on May 23, 2016. ENGEO recommends any wells identified during construction-related activities be properly abandoned under permit.

WATER EQUIPMENT OBSERVED ADJACENT TO THE RESIDENCE

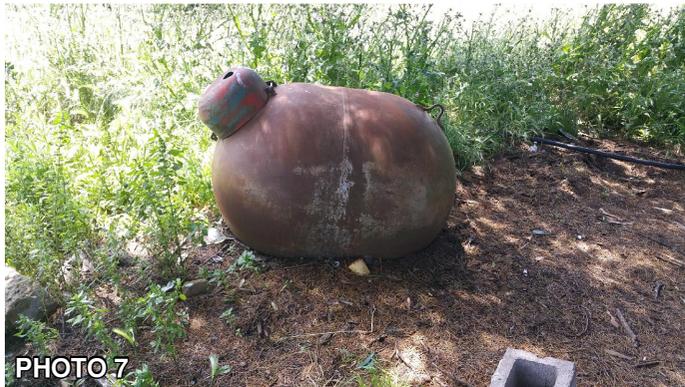
PHOTO 7

Storage Tanks. No evidence of underground storage tanks were observed at the time of the site reconnaissance. A grain silo and plastic above-ground storage tank, likely a water storage tank, were observed on the central portion of the Property, near the former coops. What appears to be either a water heater and/or equipment used to store water was observed adjacent to the residence. Lastly, what appeared to be an old propane tank was observed near the residence.

TANK OBSERVED ON THE PROPERTY

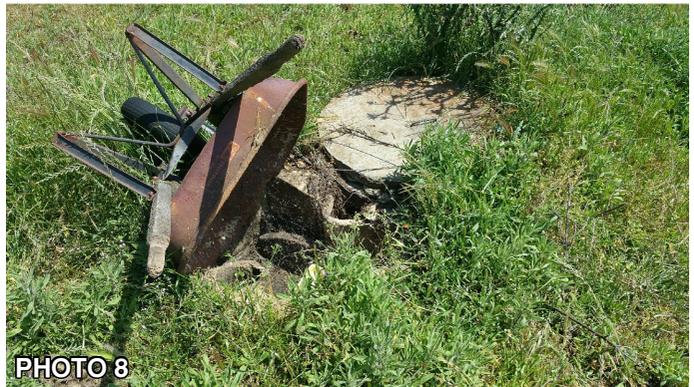
PHOTO 8

SEPTIC OBSERVED ADJACENT TO THE RESIDENCE

Septic Systems. Evidence of a septic system was observed west of the residence at the time of the site reconnaissance. ENGEO recommends that the septic system be properly abandoned under permit prior to any grading activities.

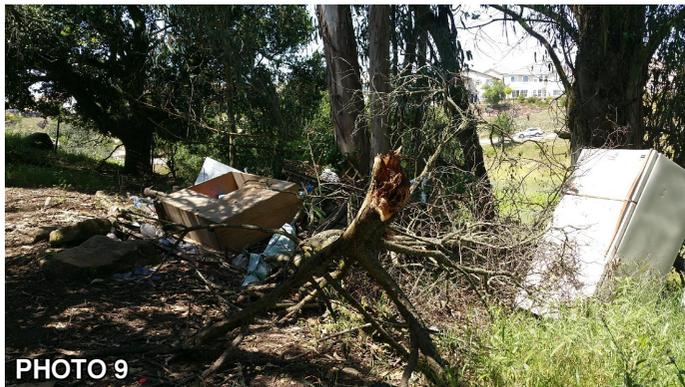
PHOTO 9

Solid Waste/Debris. Solid waste and debris, including, but not limited to: a refrigerator, bathtubs, wood, and two abandoned vehicles were observed on the Property at the time of the site reconnaissance.

TRASH AND DEBRIS OBSERVED NEAR THE RESIDENCE

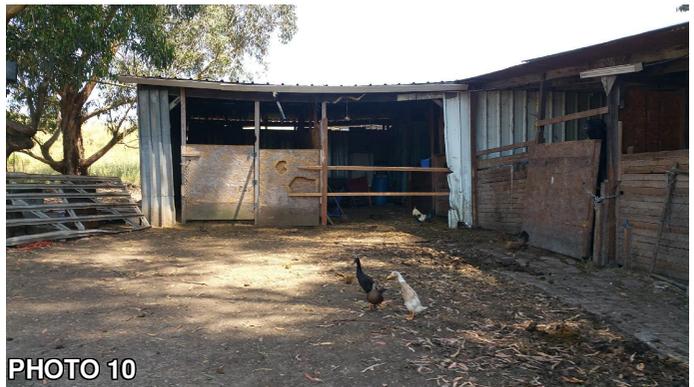
PHOTO 10

Stained Soil/Pavement. No stained soil or pavement was observed within the Property at the time of our reconnaissance; however, the flooring/ground of the outbuildings were not visible due to the amount of waste, debris and other equipment stored within. If a significant amount of stained soil is observed during the removal of solid waste and debris, ENGEO recommends contacting an environmental professional and properly disposing of the impacted material.

VIEW OF OUTBUILDINGS
(INCLUDING STORAGE SHEDS AND STABLES)

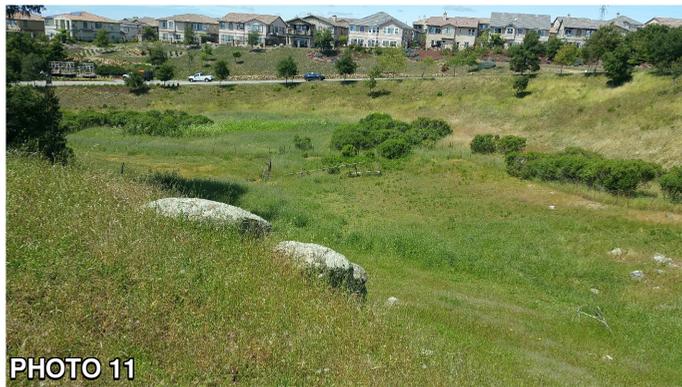
PHOTO 11

VIEW OF THE NORTHEASTERN PORTION OF THE PROPERTY
