**PHASE I  
ENVIRONMENTAL SITE ASSESSMENT \***

**Undeveloped Property  
8600 Prospect Avenue  
Santee, California**

Project C415-01

September 28, 2016

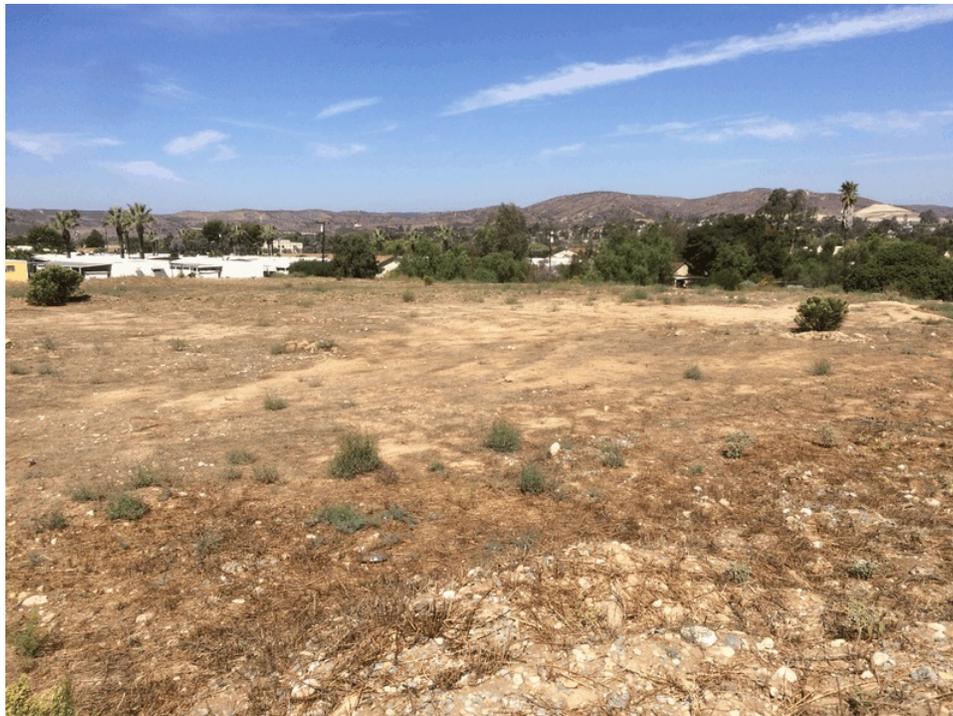
The reported 3.54-acre undeveloped Property is mostly overgrown with grasses and weeds. A roughly graded area was observed in the approximate center of the Property. This area did not appear to have been graded recently. Stockpiled soil was located in the southeast portion of the Property, near Prospect Avenue. Concrete conduits and what appeared to three storm drains were observed near the northwestern Property corner. Refer to Figure 2 and Photographs 1 through 10 in Section 7.0 - Property Photographs (E 1527-13, Section 9).

Photograph 8: View of the central, roughly graded portion of the Property, looking northwestward

The Property appeared to have been used as a plant nursery from before 1953 to approximately the late 1960s. This past use does not represent a significant environmental concern. Although small underground storage tanks/aboveground storage tanks (USTs/ASTs) for storing oil and/or diesel fuel are generally characteristic of past nursery use, CERES did not find documentation that would suggest these features were present at the Property. Also, an historical aerial image indicated that substantial grading/reworking of the Property had occurred in 2003 (presumably for an intended development by Saint George Antiochian Orthodox Church). This activity would have likely unearthed such features. It is CERES' opinion that minor releases of hazardous materials/wastes that may have occurred during the past use of the Property as a nursery, if any, likely represent a dispersed and *de minimis* condition to the Property subsurface. If "hot spots" are found during future construction grading activities, mitigation should not be a costly endeavor.

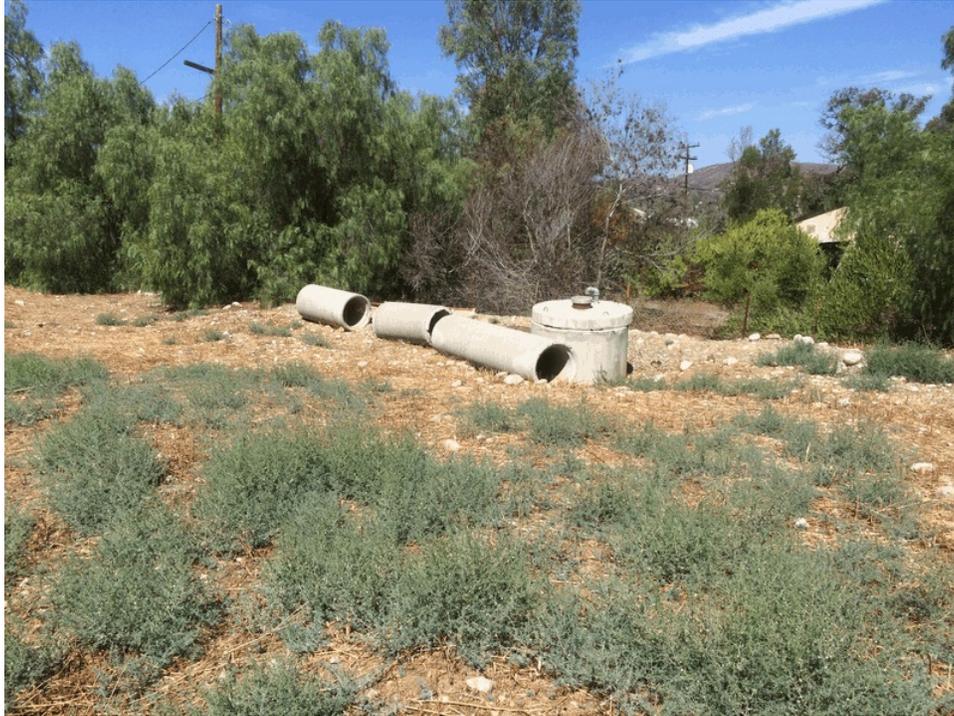
Photograph 9: View of concrete conduits near the northwestern Property corner

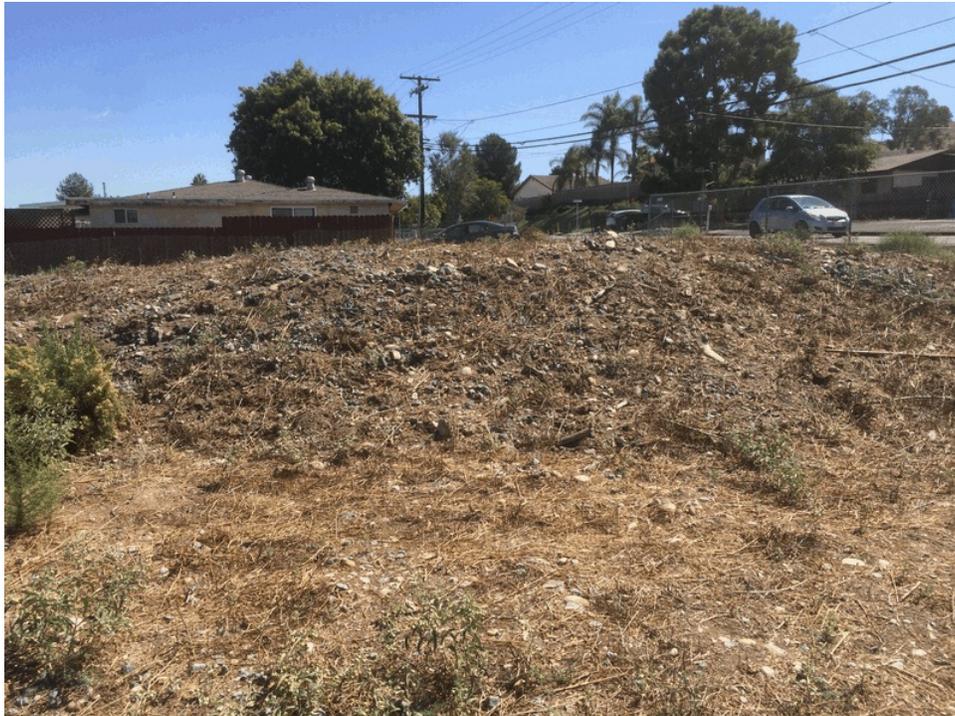
Photograph 10: View of stockpiled soil near Prospect Avenue
