# Tree Survey and Arborist Report

THE TERRACES AT WALNUT  
CITY OF WALNUT, CA

Revised December 20, 2017

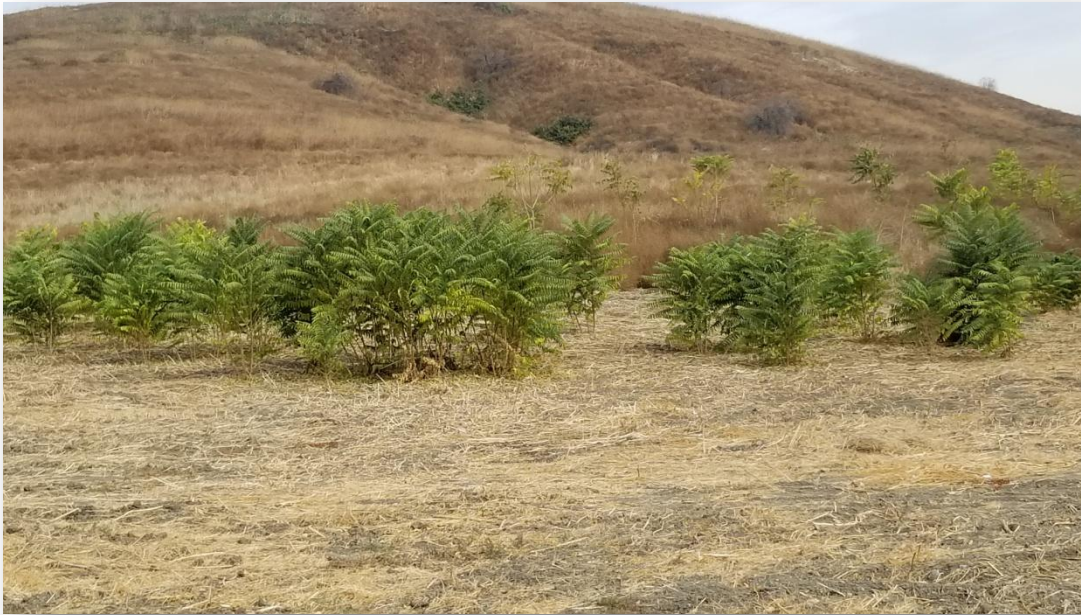
Plate 1. This is a northwestern view across the southeastern portion of the property showing a stand of volunteer tree of heaven sprouters.

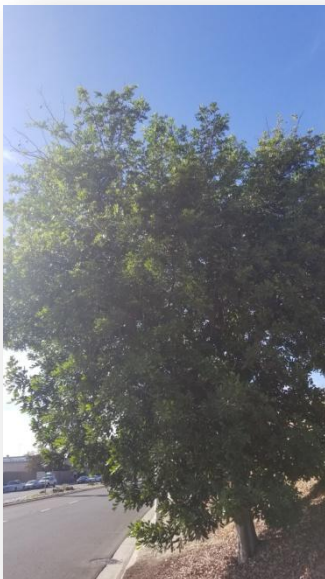
Plate 2. This a view of a carrotwood tree encroaching in southbound lanes of Valley Blvd (tree #57).

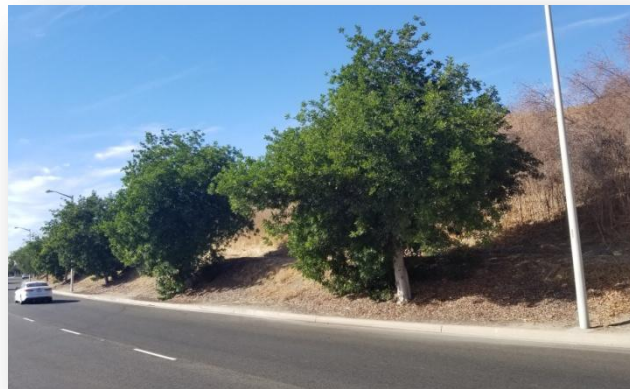
Plate 3. This is a view from the median of Valley Blvd at carrotwood trees lining the street.

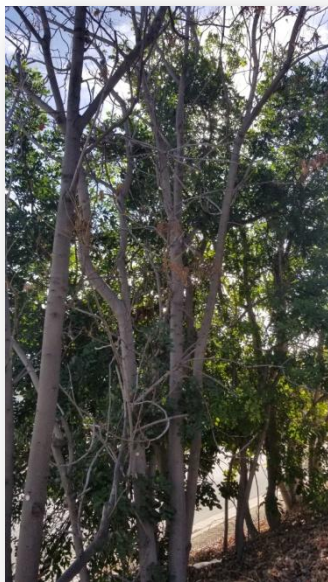
Plate 4. This a view of densely sprouting trees of heaven creating intermingling canopies (tree #88).

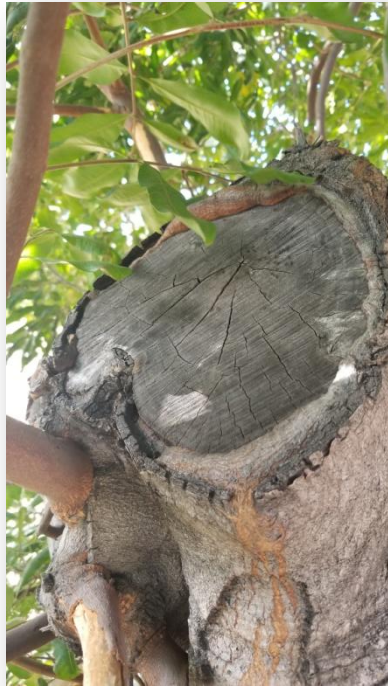
Plate 5. This is a view of a primary branch cut with resultant water sprouting (tree #58).

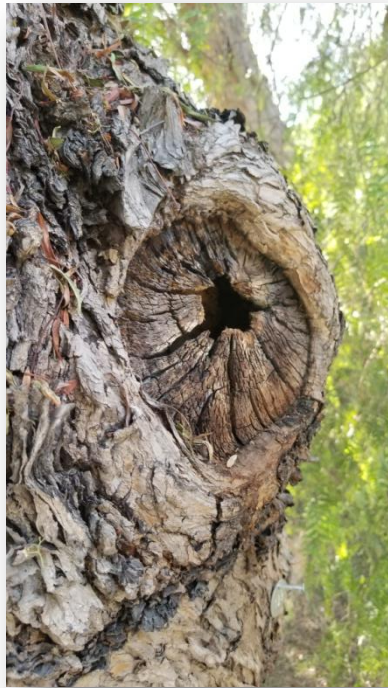
Plate 6. This is a view of internal stem decay stemming from an unclosed branch cut (tree #129).

128	Peruvian Pepper	2	2	2	3	9	10	5	5	5	2	2	2	Remove
	Sprout system, poor primary Stem designation							5		5				
								5	5	5				
129	Peruvian Pepper	32				32	45	10	15	20	3	3	3-4	Remove
	Large unclosed branch cut, likely internal decay, competing canopy							5		15				
								25	20	25				
130	Elderberry	8	8	10	10	36	18	8	10	8	3-4	3	3	Remove
	decreased living mass, borer							8		8				
								8	8	8				
131	Elderberry	8	24			32	15	8	8	8	3	2	3	Remove
	Decay in stem, increased canopy dead wood							8		8				
								8	8	8				
132	Elderberry	8	8	8	10	34	15	15	15	15	3	2	3	Remove
	Decay in stem, canopy dead wood							15		14				
								14	14	14				
133	Elderberry	4	4	4	16	28	17	15	15	15	3-4	2	2-3	Remove
	Fire damaged, poor aesthetics							15		15				
								15	15	15				
134	Elderberry	12	8	5	50	75	18	10	10	10	3-4	2	2-3	Remove
	Fire damaged, poor aesthetics							10		10				
								10	10	10				
135	Elderberry	15	10			25	18	8	10	8	3	2	3-4	Remove

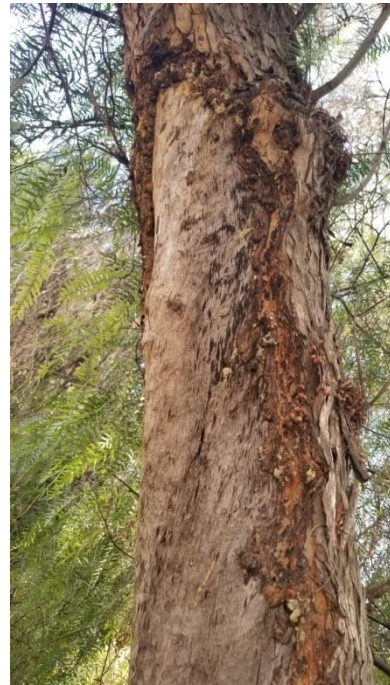
Plate 7. This is a view of a large patch of decay with internal, xylem tissue exposed (tree # 107).

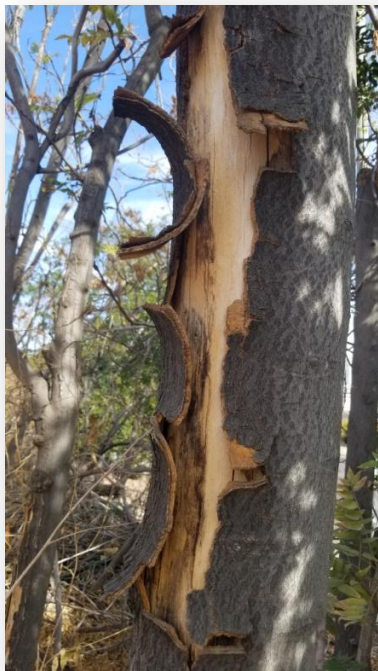
Plate 8. This is a view of excessive bark shedding stemming from a possible infection (tree # 90)

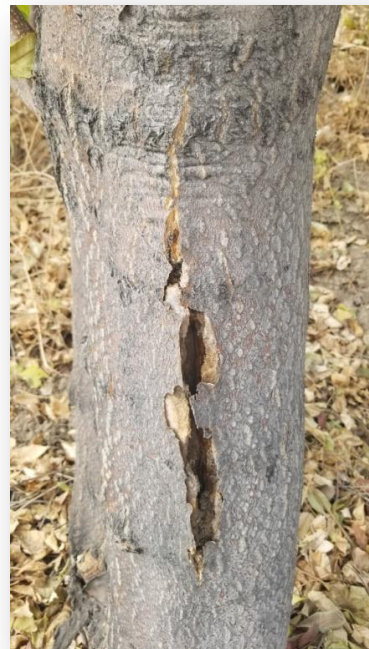
Plate 9. This is a view of a lateral crack in the bark from a likely incision (tree # 28)

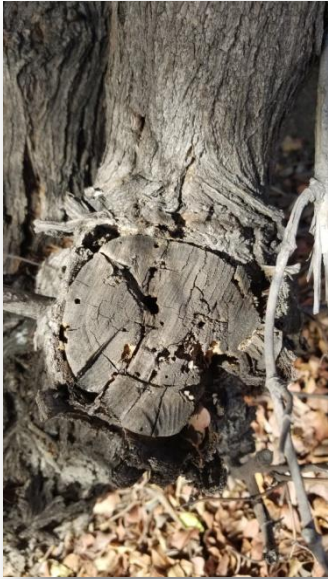
Plate 10. This is a view of termite-infested deadwood from a previous branch cut (tree #48).

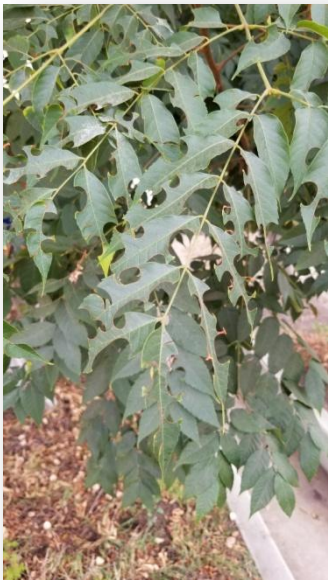
Figure 12. This is a view of significant herbivory damage on a tree of heaven from a local pest (tree #8).

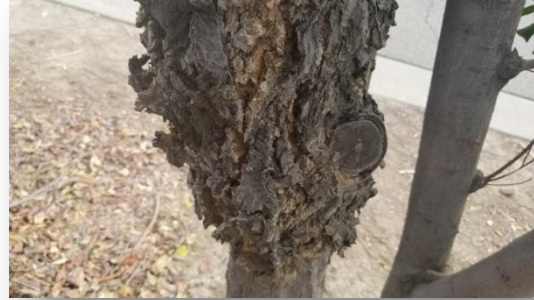
Plate 11. This is a view of a possible fungal canker on tree #30.

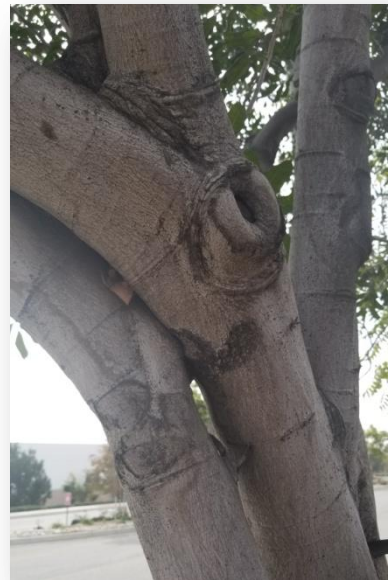
Plate 13. This is a view of crowded interior canopy branches (tree #34).

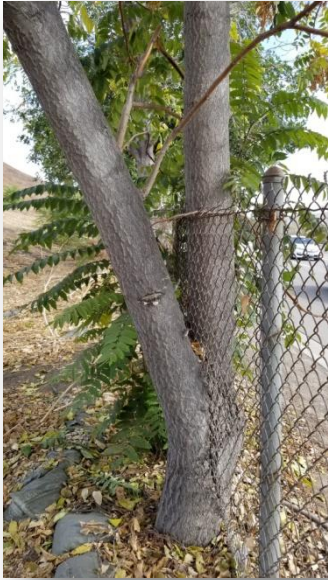
Plate 14. This is a view of a tree of heaven bifurcated by and compartmentalizing a chain link fence (tree #14).

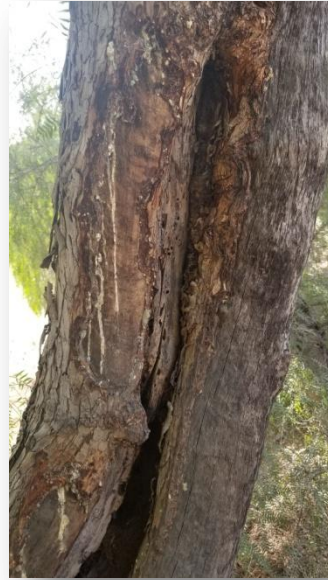
Plate 16 This is a view of severe internal stem decay posing a substantial hazard (tree #112).

20	12	10				
112	Peruvian Pepper	13	16			29	25	15	15	10	3	3	4	Remove
	Increased stem decay, rubbing branch							20		10				
								30	30	15				
113	Peruvian Pepper	11				11	10	6	5	3	3-4	3	3-4	Remove
	Holes (burrows) at root base, topped, heave risk							10		5				
								10	10	4				
114	Peruvian Pepper	11.5	11			22.5	20	15	20	6	2	3	3-4	Remove
	Decent canopy, large branch cut, health fair, part of a two-stem system, other stem must be removed							10		5				
								20	25	18				
115	Peruvian Pepper	19				19	25	8	15	15	2-3	3	2-3	Remove
	Poor prognosis, unbalanced canopy, large cut likely won't heal, likely internal decay							10		10				
								15	25	20				
116	Peruvian Pepper	11				11	20	20	14	10	3	3	3-4	Remove
	Horse damage, poor canopy							5		5				
								5	4	5				
117	Peruvian Pepper	14	10			24	20	15	10	2	3	3	3-4	Remove
	Horse damage, increased decay on primary Limb, internal decay							20		3

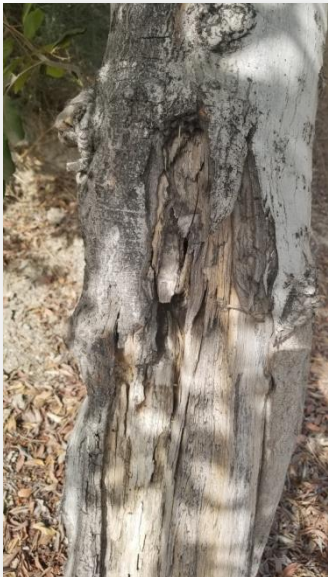
Plate 17. This is a view of possible mechanical damage and subsequent stem decay (tree #39).

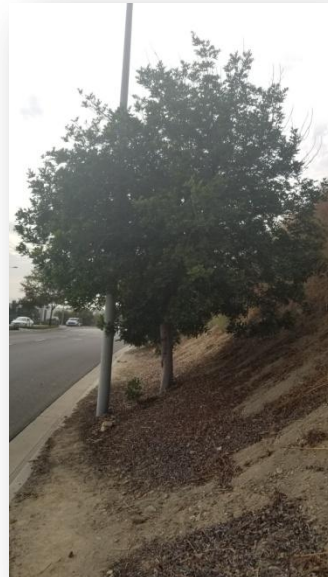
Plate 18. This is a view of tree # 43 planted too close to a utility pole creating a potential hazard.
