Tree Survey and Arborist Report

THE TERRACES AT WALNUT OFFSITE (LOTS 17 & 18)
CITY OF WALNUT, CA

Golden State Land & Tree Assessment
George J Wirtes, MS, ISA Certified Arborist

May 11, 2018

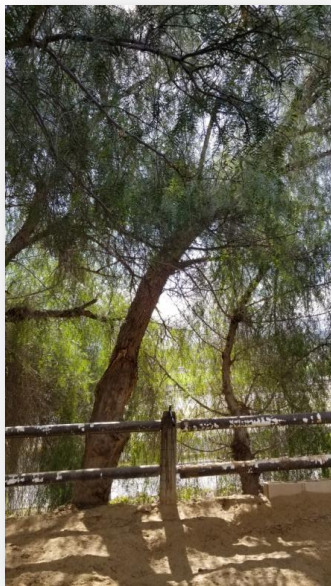
Plate 1. This a view of densely planted trees in which the competing canopies have resulted in poor canopy development and offset tree mass (tree #349).

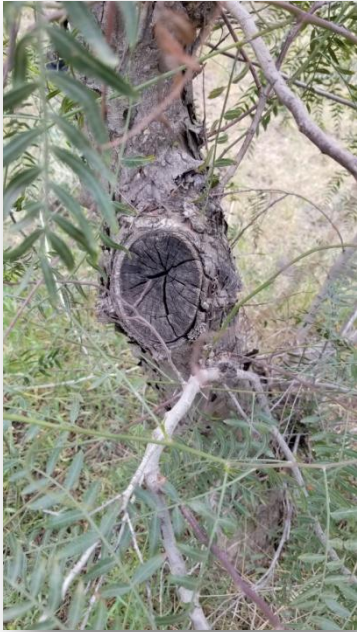
Plate 2. This is a view of an improper flushcut pruning where the branch collar was cut impacting wound closure (tree # 388).

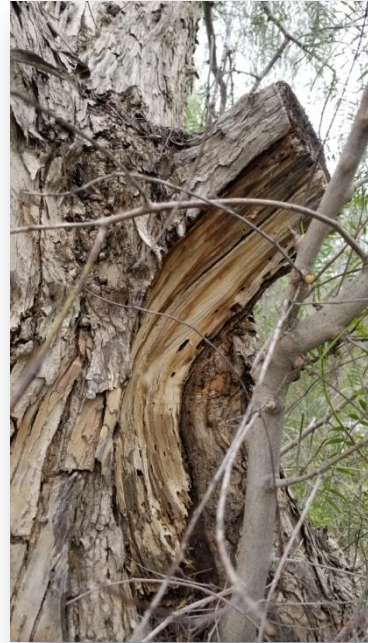
Plate 3. This is a view of an improper pruning cut where the partially cut branch ripped open the underside bark and cambial layer (tree # 408).

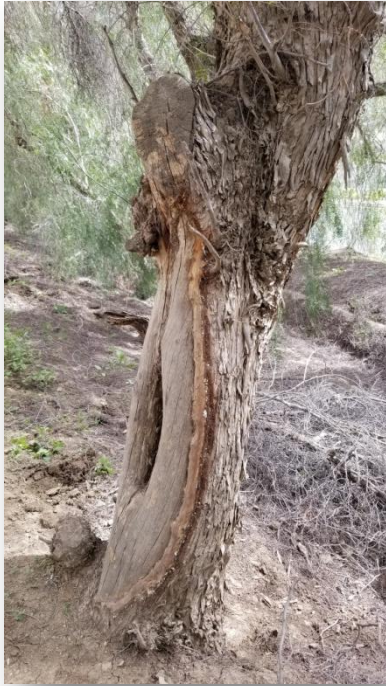
Plate 4. This is a view of a large canker within a stem of a tree (tree #351).

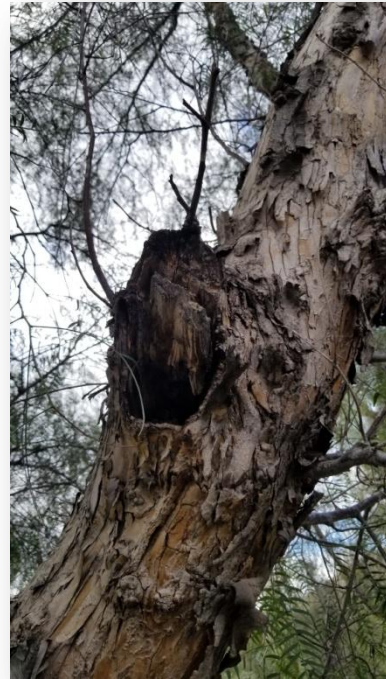
Plate 5. This is a view of internal decay stemming from an unclosed branch cut (tree # 372).

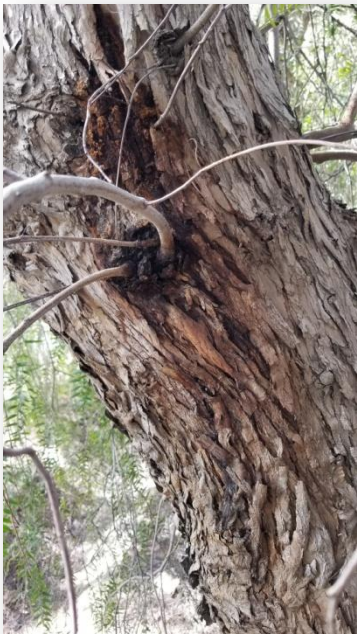
Plate 6. This is a view of an exuding canker from a localized infection (tree # 360).

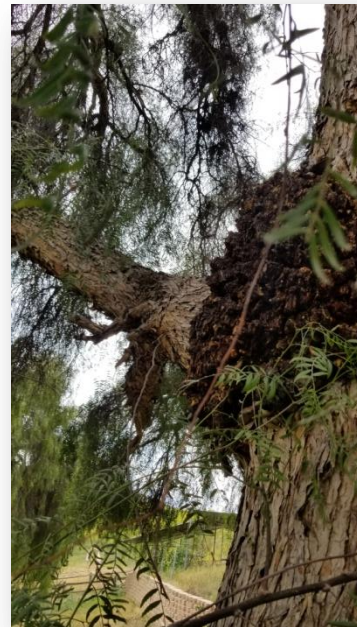
Plate 7. This is a view of possible infected tissue (tree # 417).

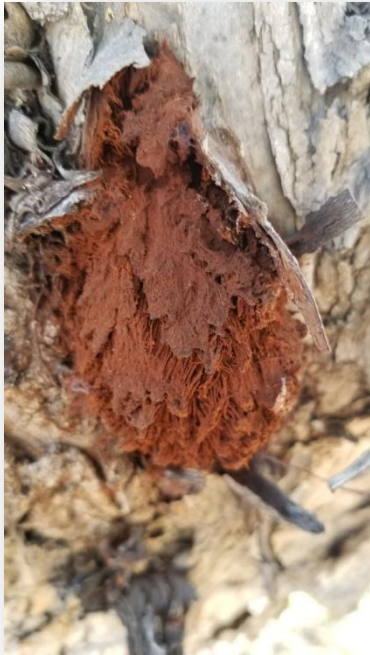
Plate 8. This is a view of localized fungal mass resident on decayed tissue (tree #463).

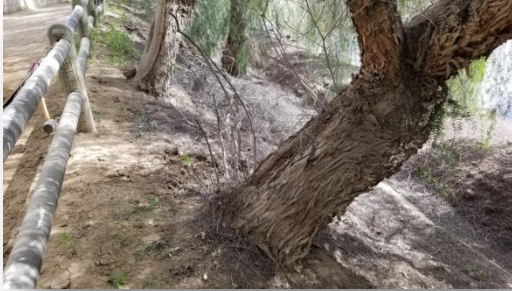
Because of localized conditions, several trees within the site pose a significant threat of failure. These trees may show signs of stem cracking, significant lean, or serious decay. Trees showing indication for immediate removal include the following individuals:

Plate 9. This is a view of a significant lean of a tree stem (tree #350).

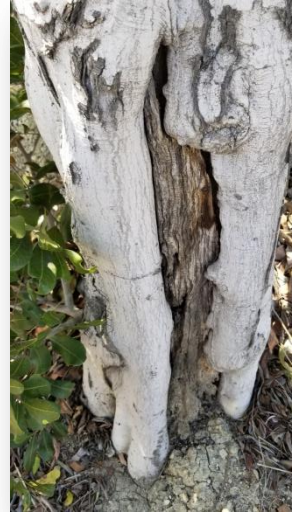
Plate 10. This is a view of severe internal stem/flare decay posing a hazard of tree failure (tree #299).
