Storm Drainage Maintenance Plan

City of Monterey

Storm Drainage Maintenance Plan (SDMP)

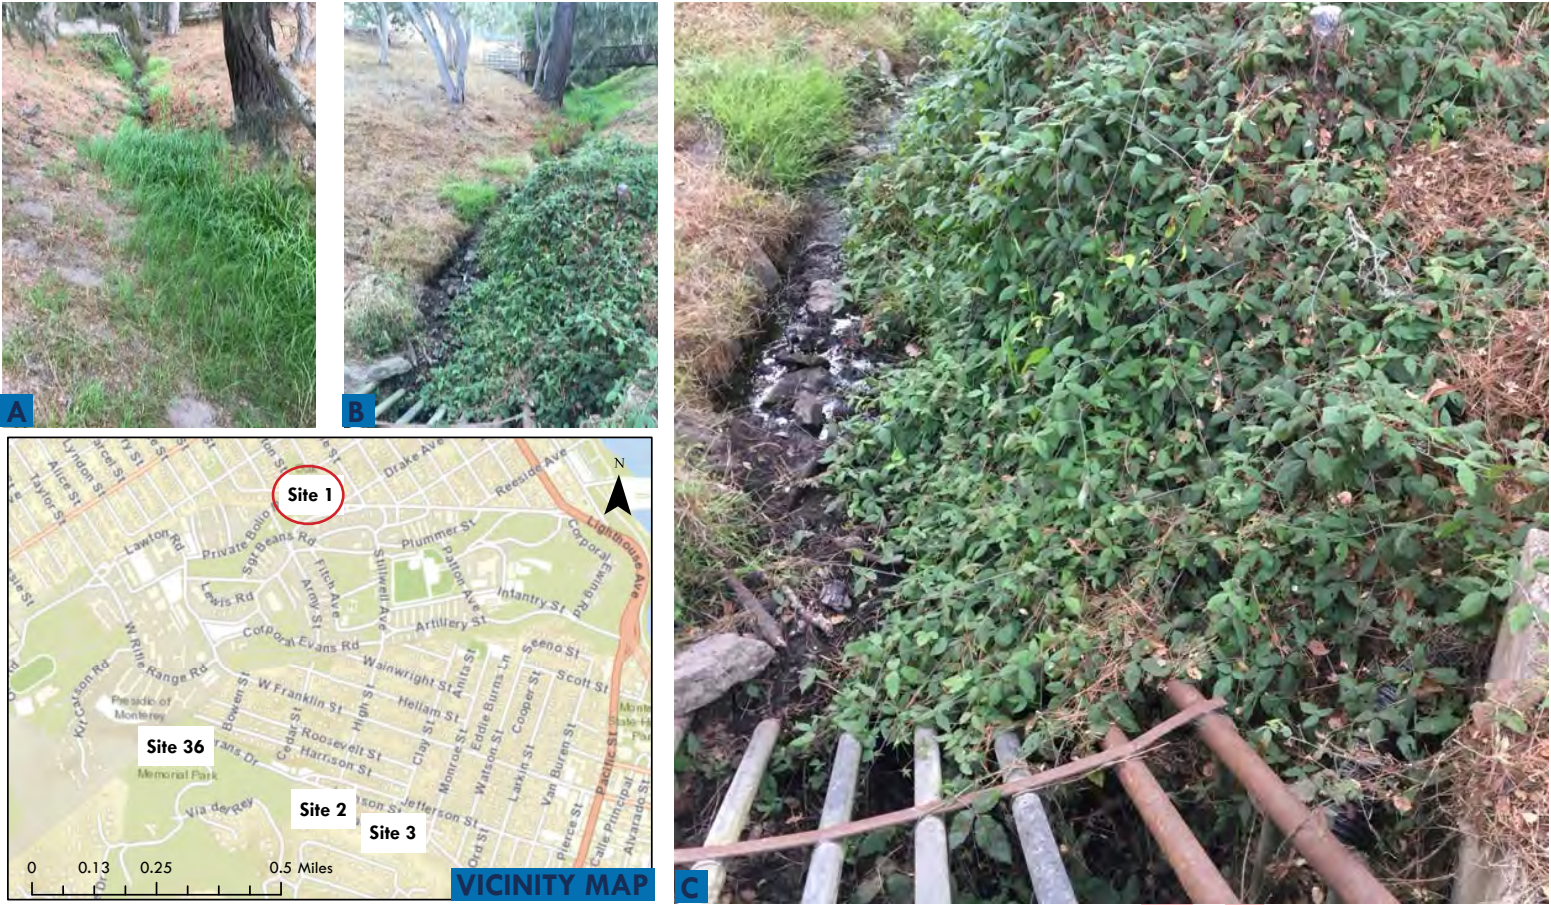
Inspected on September 11, 2017. Site includes an earthen channel flowing through Oak Newton Park. The channel is approximately 2-3-ft wide at its base, extending up to an open channel width of approximately 8-ft, with outlet through a trash rack and culvert. Vegetation is mostly grass with some trees with 60% vegetative cover observed on banks. Some rock and accumulated sediment was observed along the channel bottom. The adjacent land use includes park land, the Presidio of Monterey, single family residences, and roadways. There were no significant fallen trees or tree limbs and none of the existing infrastructure is known to be undersized. No flood or erosion threats were observed. Vegetation around the culvert inlet was short, allowing adequate access and visibility.

The growth of vegetation in the inlet channels was not preventing access to evaluate condition and maintain facilities nor is it currently reducing the capacity of the system. Sediment accumulation in the channel and vegetation accumulation on the trash rack are maintenance concerns.

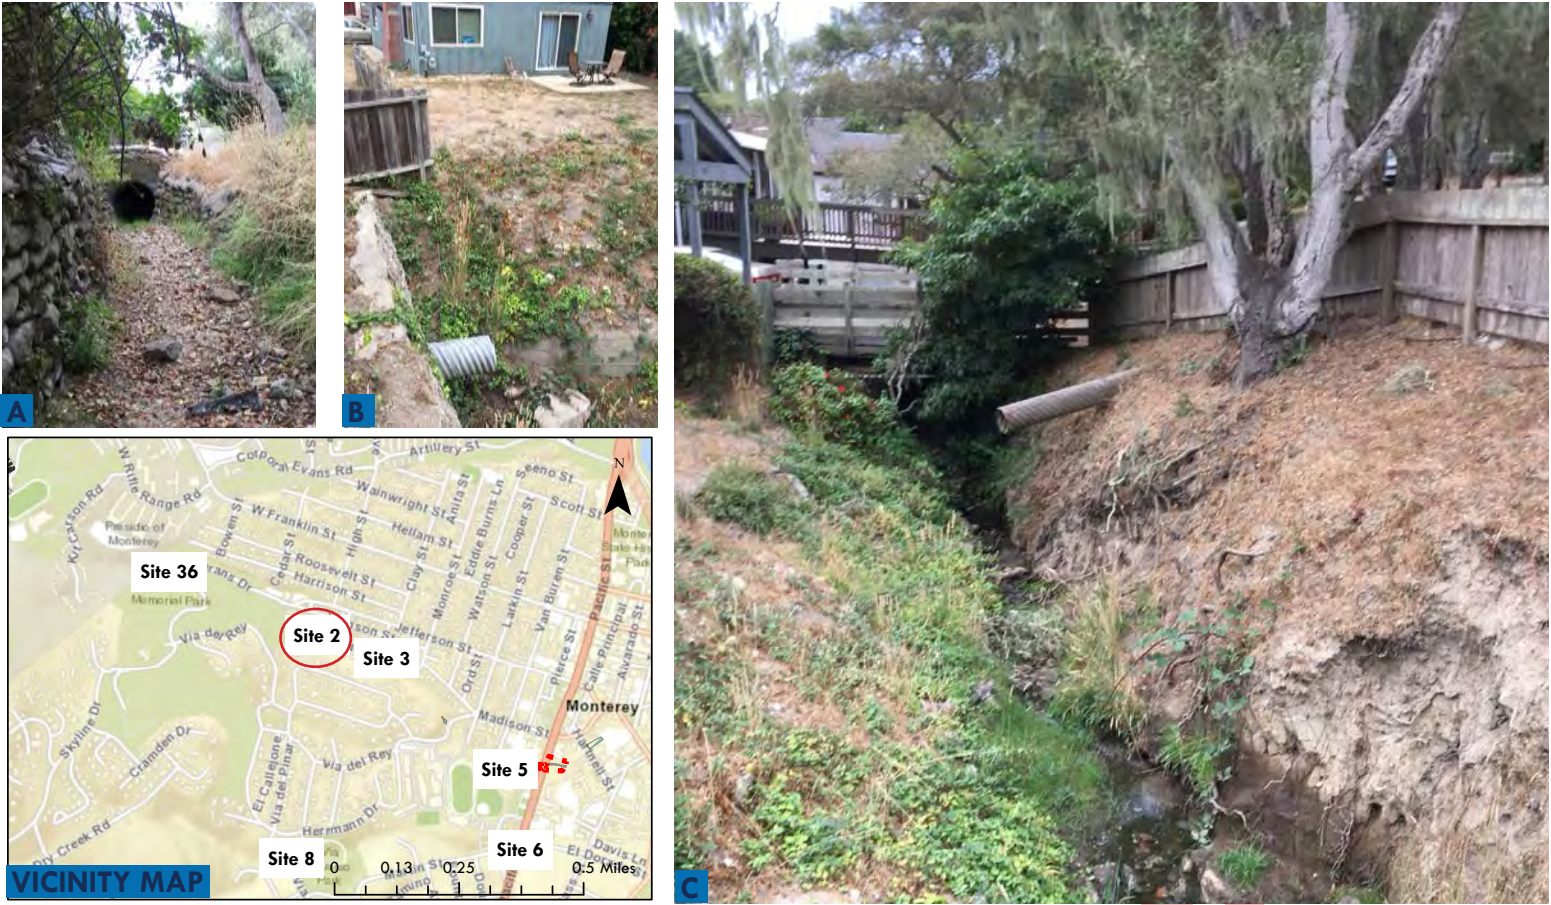
Inspected on September 13, 2017. Site includes an earthen channel flowing through undeveloped land, and between residential properties and Madison Street. The channel is approximately 5-ft wide at its base, with near vertical banks extending up to an open channel width of approximately 5-ft. Vegetation is mostly grass with 80% vegetative cover observed on banks. Erosion was observed on the downstream right channel bank (photo C) where the channel passes through the backyard of a residential property. No significant rock or accumulated sediment was observed along the channel bottom. Within the limit of work, there were no significant fallen trees or tree limbs and none of the existing infrastructure is known to be undersized. Vegetation around the culvert inlet was short, allowing adequate access and visibility.

Flooding is a risk, and has occurred in the past at this sight because of the proximity of the channel to the road and private residences. The growth of vegetation in the inlet channels was not preventing access to evaluate condition and maintain facilities nor is it currently reducing the capacity of the system. Sediment accumulation in the channel and vegetation accumulation in the channel are maintenance concerns.

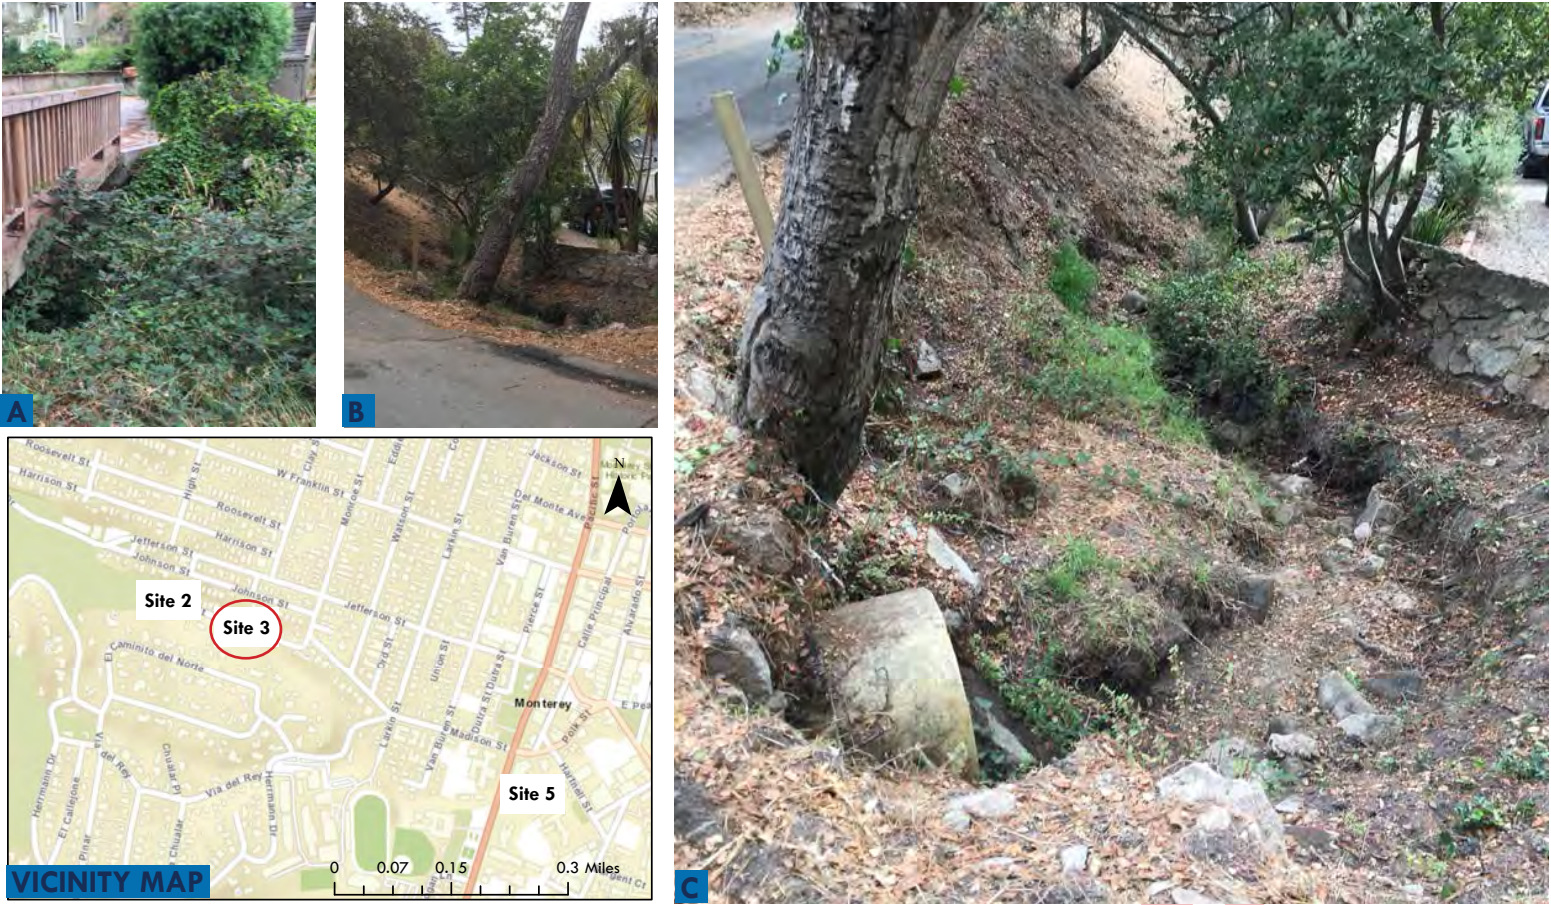
CROSS STREETS: Madison Street
CITY DRAINAGE BASIN: Hartnell Drainage

Inspected on September 13, 2017. Site includes an earthen channel flowing between residential properties and Madison Street. The channel is approximately 4-ft wide at its base, with near vertical banks extending up to an open channel width of approximately 8-ft. Vegetation is mostly grass and berries with more than 80% vegetative cover upstream of Madison Street where the channel is overgrown with brambles and approximately 30% downstream of Madison Street. No significant rock or accumulated sediment was observed along the channel bottom. Within the limit of work, there were no significant fallen trees or tree limbs and none of the existing infrastructure is known to be undersized. Vegetation around the culvert outlet was short, allowing adequate access and visibility; the inlet was obstructed by overgrown vegetation.

The growth of vegetation in the channel is a maintenance concern, along with the close proximity of the channel to residential structures. The loose condition of the channel and bank material will potentially limit access and the types of tools used to perform maintenance activities.

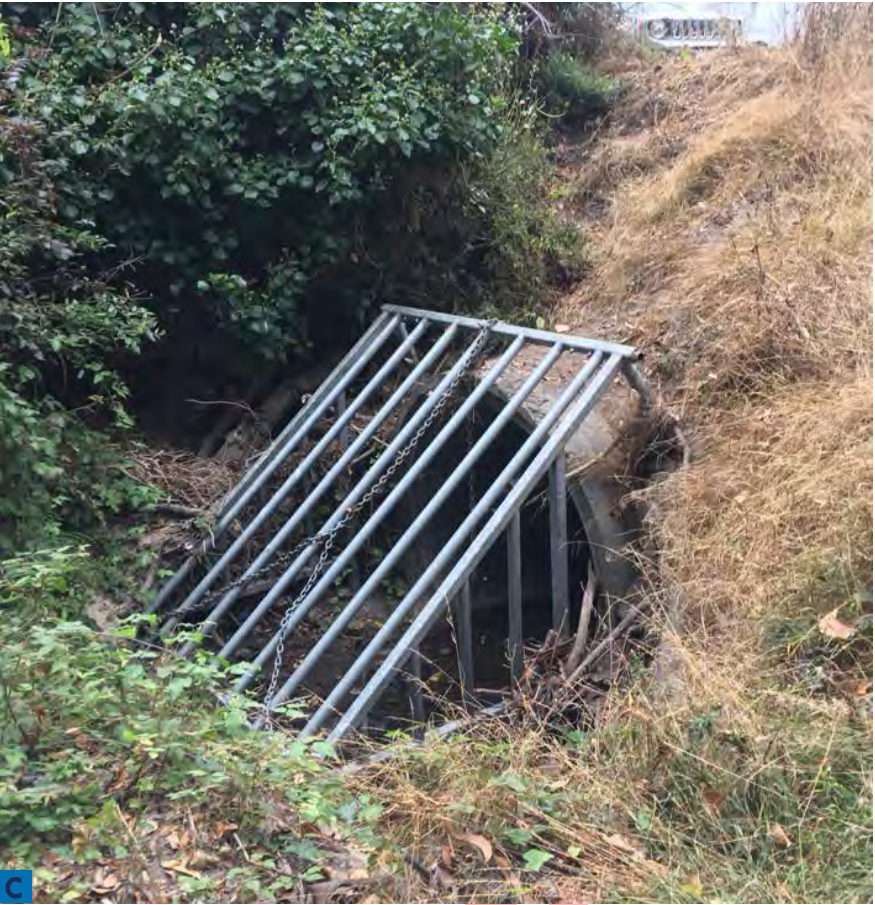
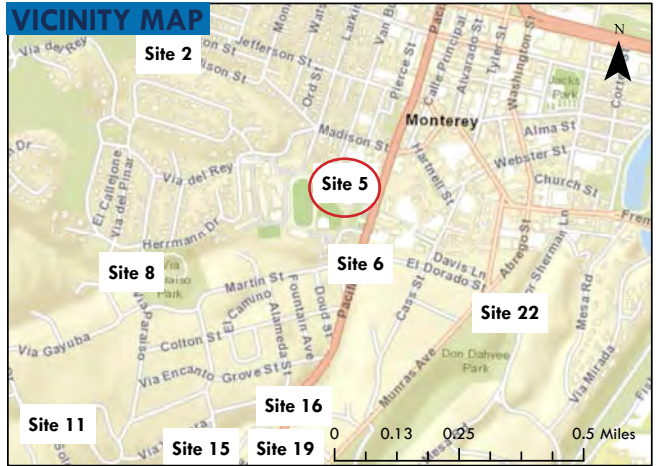
Inspected on September 13, 2017. Site includes an earthen channel flowing west to east between Van Buren Street and Pacific Street. The western most section proposed for maintenance activities is accessed from the Police Station Parking lot; the eastern most section, east of Pacific Street is accessed through the library parking lot. A trash rack is located across the culvert inlet (Photo C) with evidence of sediment and debris accumulation. The channel is approximately 5-ft wide at its base, with near vertical banks extending up to a bankfull channel width of approximately 6-ft. Vegetation includes trees and low brush with 75% vegetative cover observed on banks. East of Pacific Street the channel is incised and approximately 15 feet lower than the parking lot elevation. Within the limit of work, there were no significant fallen trees or tree limbs and none of the existing infrastructure is known to be undersized.

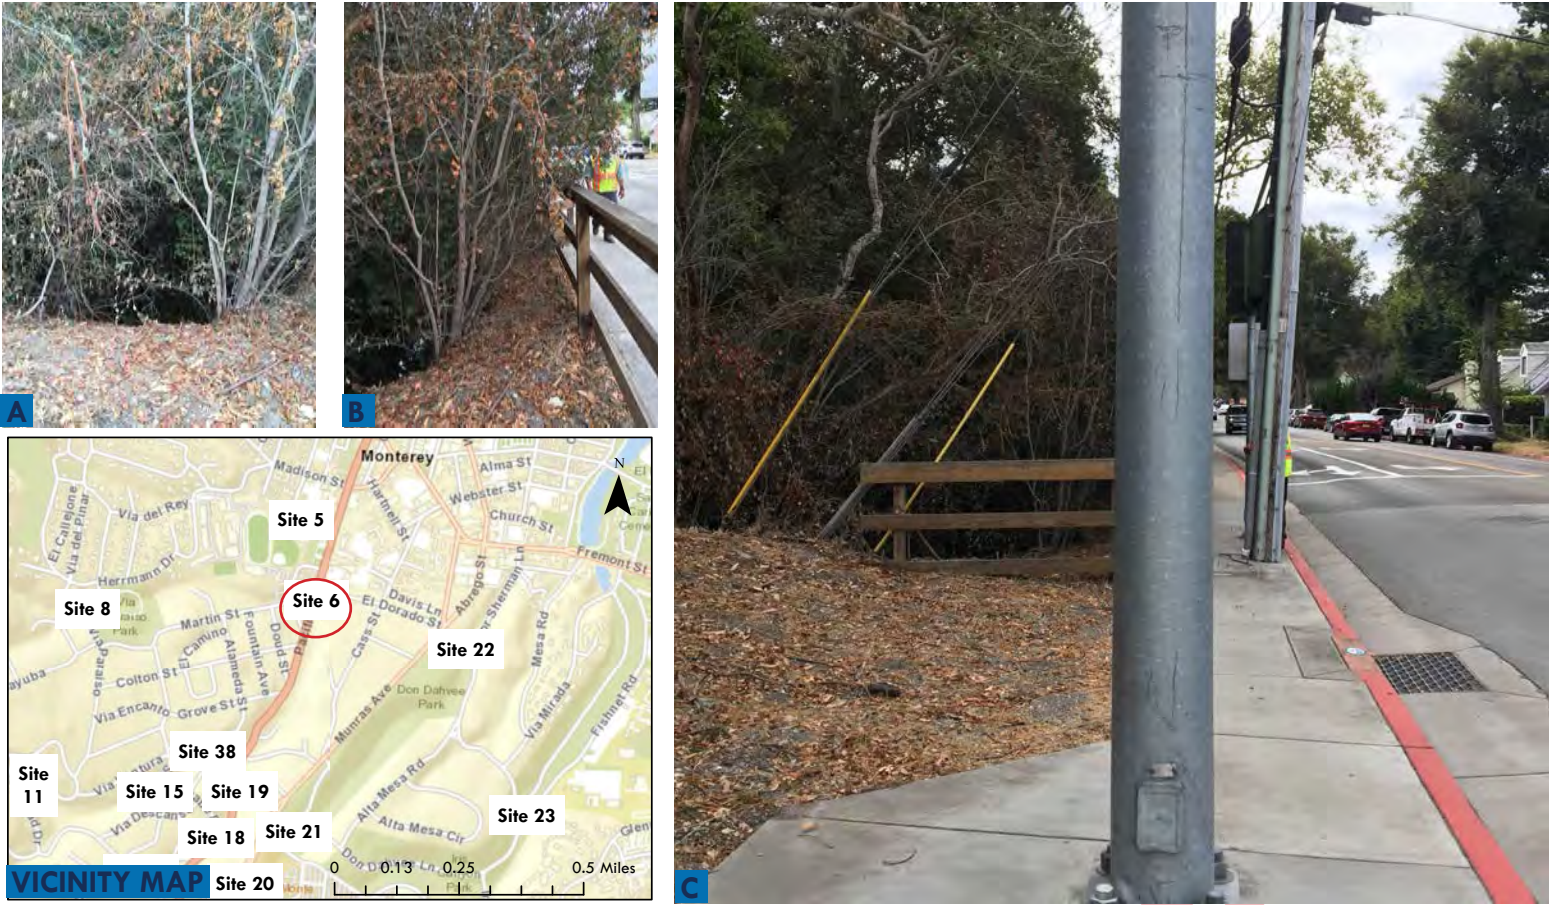
Inspected on September 13, 2017. Site includes an earthen channel flowing parallel to Pacific Street. The channel is approximately 5-ft wide at its base, with near vertical banks extending up to an open channel width of approximately 8-ft. Vegetation is mostly trees and brush with over 80% vegetative cover observed on banks. No significant rock or accumulated sediment was observed along the channel bottom. Within the limit of work, there were no significant fallen trees or tree limbs and none of the existing infrastructure is known to be undersized. Vegetation around the culvert inlet was dense, limiting access and visibility.

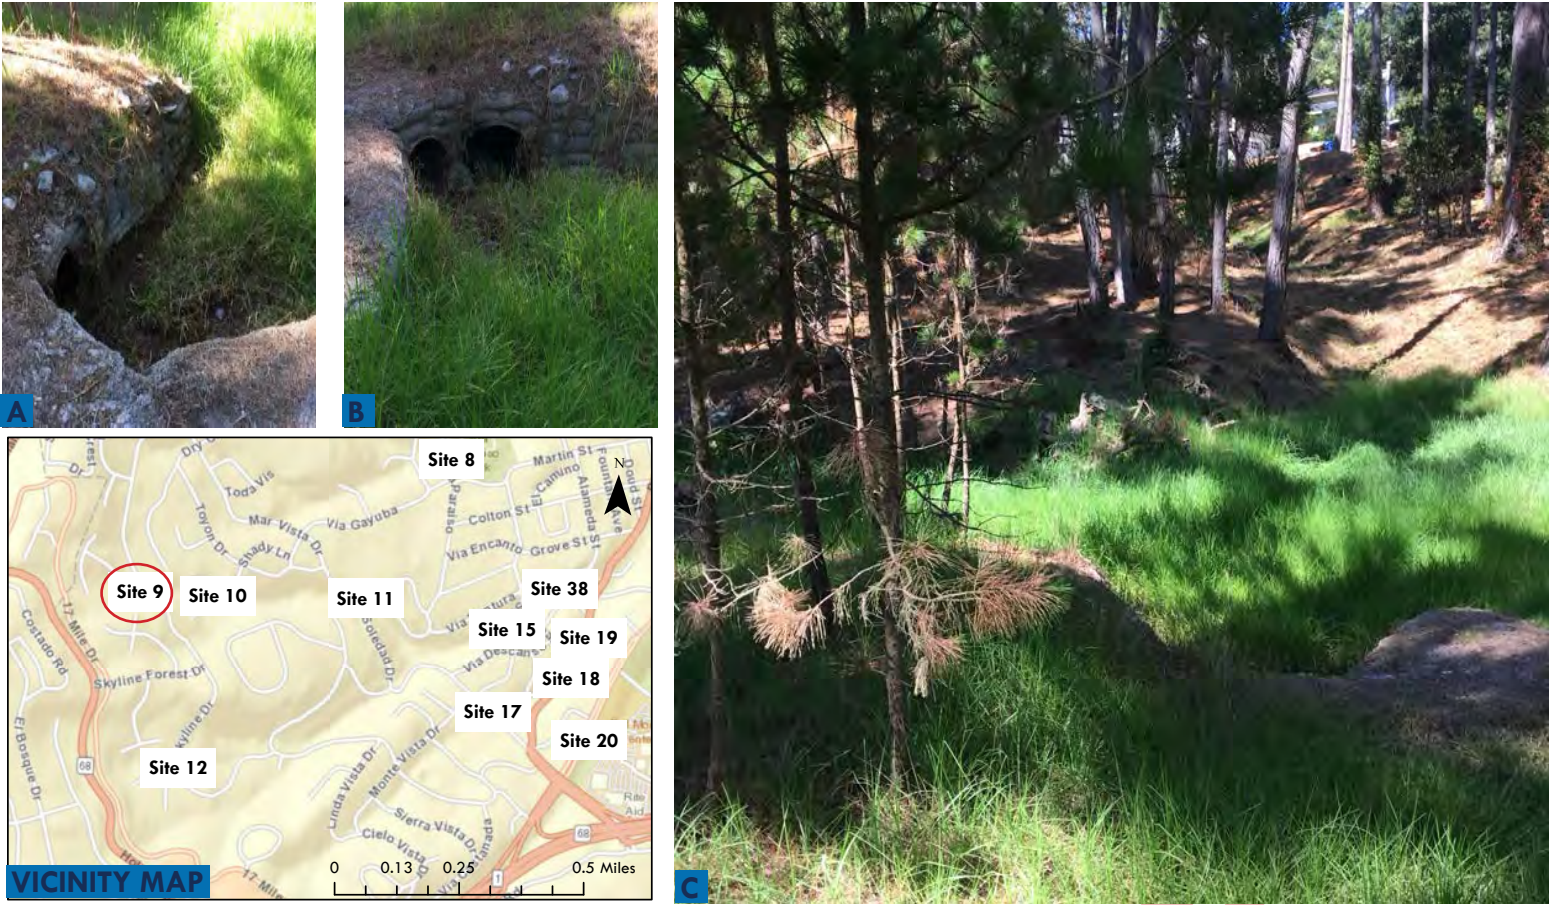
Inspected on September 11, 2017. Site includes an earthen channel flowing in a gully between residential developments and roadways. A series of log drop structures have been installed in the upper (western) portion of the channel. Maintenance of those structures is not included in the annual maintenance SDMP limit of work, which is focused on the sediment basin at the base of the structures and upstream of Skyline Drive. The basin is approximately 30-ft wide at its base, with outlet through a 21-inch culvert beneath Skyline Drive. Vegetation is light brush and weeds with some trees. Accumulated vegetation and sediment was observed along the channel bottom and in front of the culvert. There were no significant fallen trees or tree limbs and the existing culvert beneath Skyline is considered to be undersized resulting in a backwater effect and localized flooding.

The growth of vegetation in the basin was not preventing access to evaluate condition and maintain facilities. Sediment and vegetation accumulation in the basin are maintenance concerns.

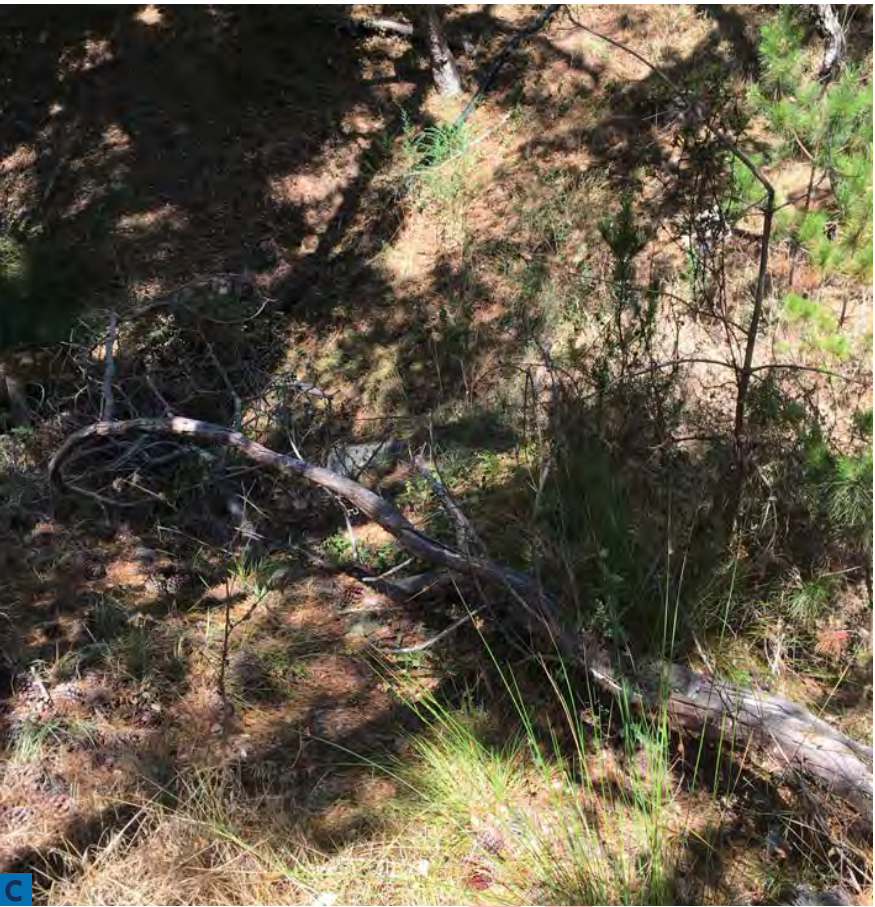
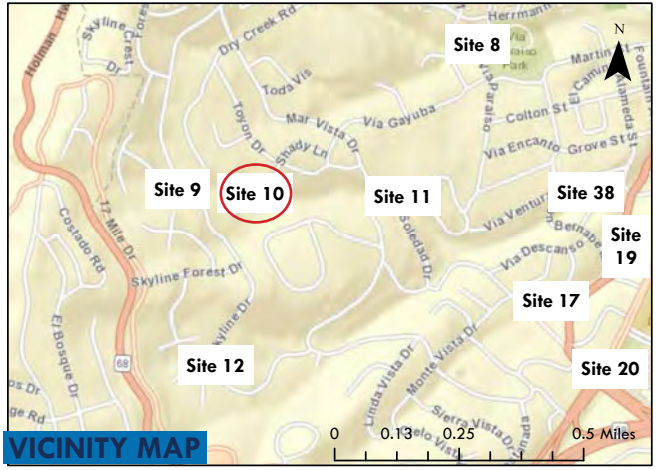
Inspected on September 11, 2017. Site includes an earthen channel flowing in a gully between single family residences and roadways. A series of log drop structures have been installed in the upper (western) portion of the channel. Annual maintenance activities are expected to include the bottom two structures, a distance of approximately 40-ft upstream of the culvert inlet under Crandell Road. The channel is approximately 2-3-ft wide at its base, extending up to an open channel width of approximately 10-ft. Vegetation is mostly grass, weeds, poison oak with trees and approximately 30% vegetative cover observed on banks. Accumulated vegetation, rock, and sediment was observed along the channel bottom and in front of the culvert. Fallen trees and tree limbs in and around the channel were observed. None of the existing infrastructure is known to be undersized.

The growth of vegetation in the channel was not preventing access to evaluate the facility condition. Some young pine trees are located in the access path and will need to be removed to allow maintenance activities to occur. Sediment, loose rock from the upstream armoring, and vegetation accumulation in the channel are maintenance concerns.

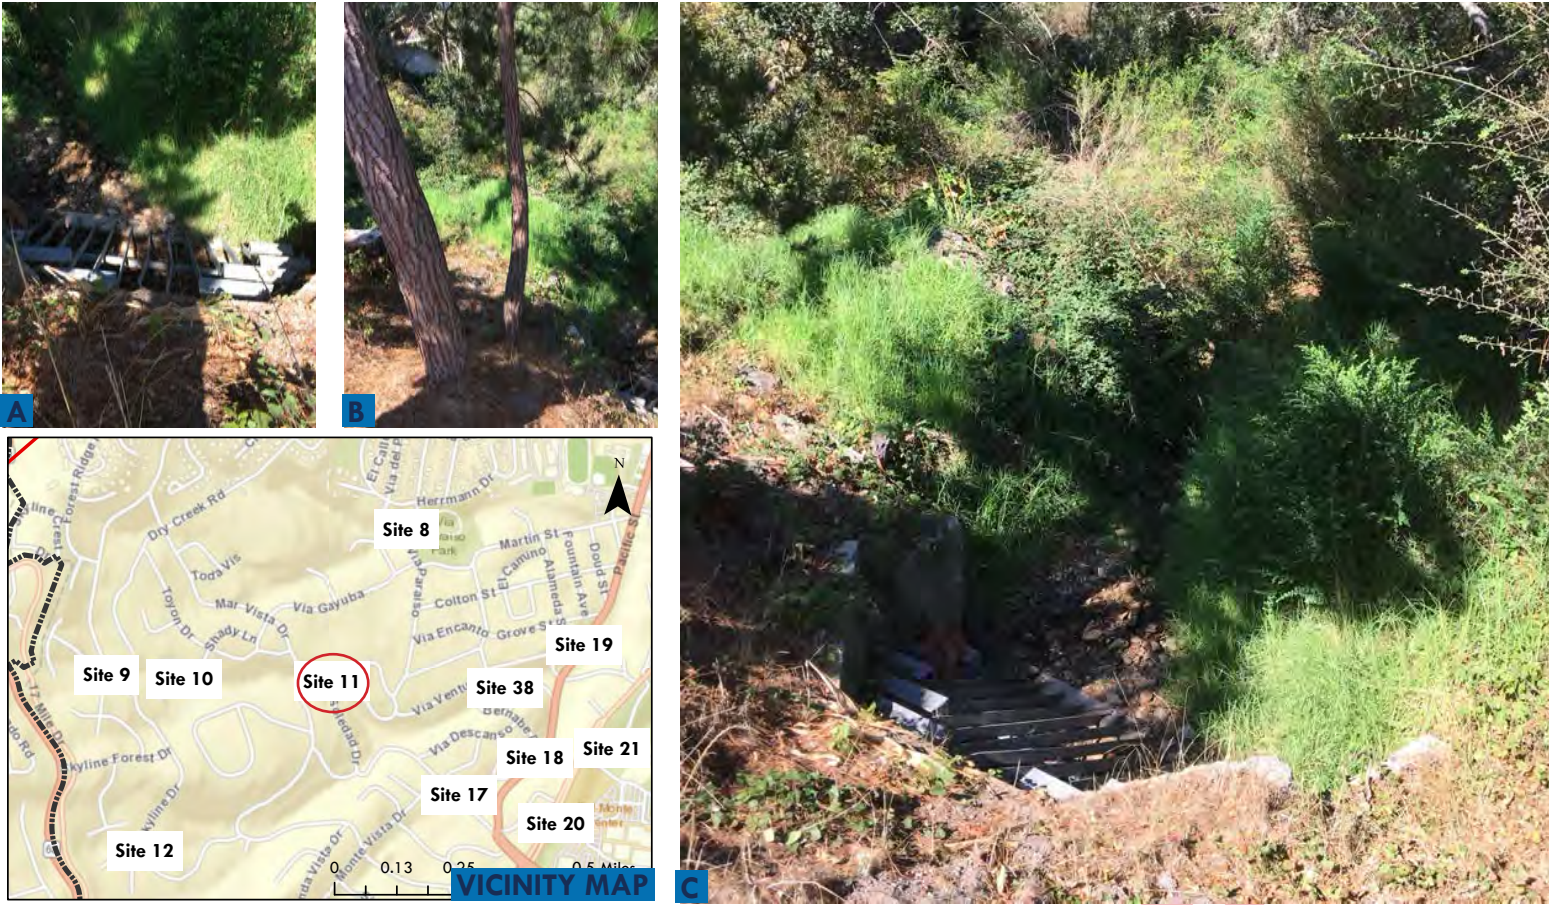
Inspected on September 11, 2017. Site includes an earthen channel near Mar Vista Drive. The channel is approximately 2-ft wide at its base, extending up to an open channel width of approximately 8-ft, with outlet through a trash rack and culvert. Vegetation is mostly dense brush with some trees with 95% vegetative cover observed on banks. Some rock and accumulated sediment was observed along the channel bottom. The adjacent land use includes single family residences and roadways. There were no significant fallen trees or tree limbs and none of the existing infrastructure is known to be undersized. No flood or erosion threats were observed. Vegetation around the culvert inlet was short, allowing adequate access and visibility.

The growth of vegetation in the inlet channels was not preventing access to evaluate condition and maintain facilities nor is it currently reducing the capacity of the system. Sediment accumulation in the channel and vegetation accumulation on the trash rack are maintenance concerns.

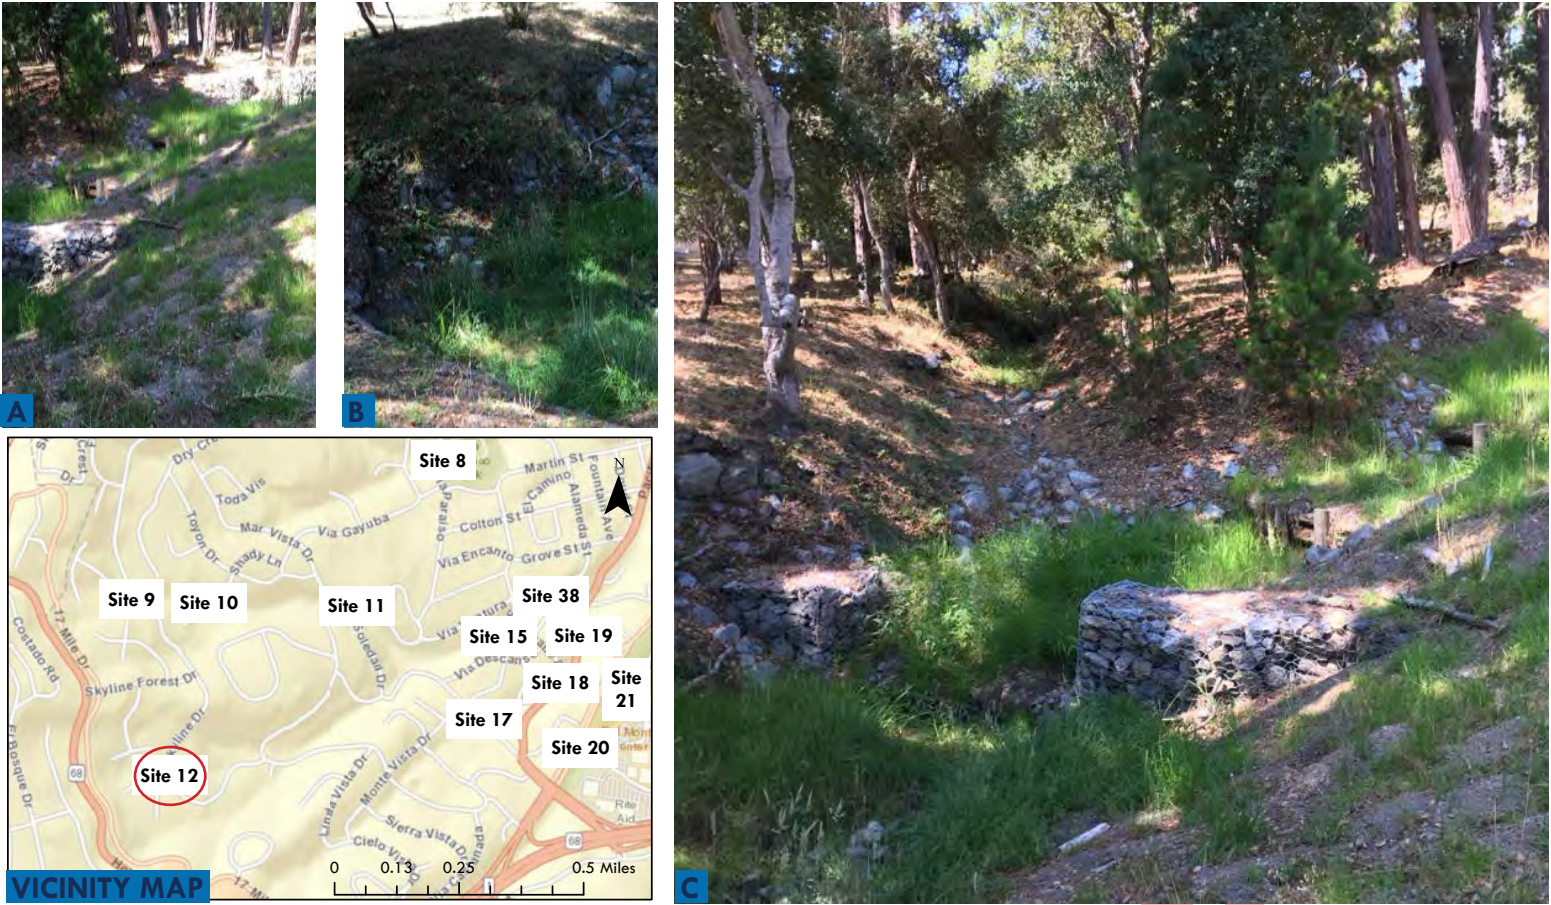
CROSS STREETS: Skyline Drive and Shepards Place
CITY DRAINAGE BASIN: Hartnell Drainage

Inspected on September 11, 2017. Site includes earthen channels flowing between single family residences and roadways. A series of drop structures have been installed in the upper (northern) portion of the channel. Annual maintenance activites are expected to include all the structures upstream of the culvert inlet under Skyline Drive. The channel is approximately 2-3-ft wide at its base, extending up to an open channel width of approximately 10-ft. Vegetation is mostly grass and brambles with trees and approximately 50% vegetative cover on banks. Accumulated vegetation, rock, and sediment was observed along the channel bottom and in front of the culvert. Fallen trees and/or tree limbs were observed above the channel banks. None of the existing infrastructure is known to be undersized. No flood or erosion threats were observed.

The growth of vegetation in the inlet channels was not preventing access to evaluate condition and maintain facilities. Sediment and vegetation accumulation between the drop structures and upstream of the culvert are potentially reducing the capacity of the system. Sediment accumulation in the channel and vegetation accumulation on the trash rack are maintenance concerns.

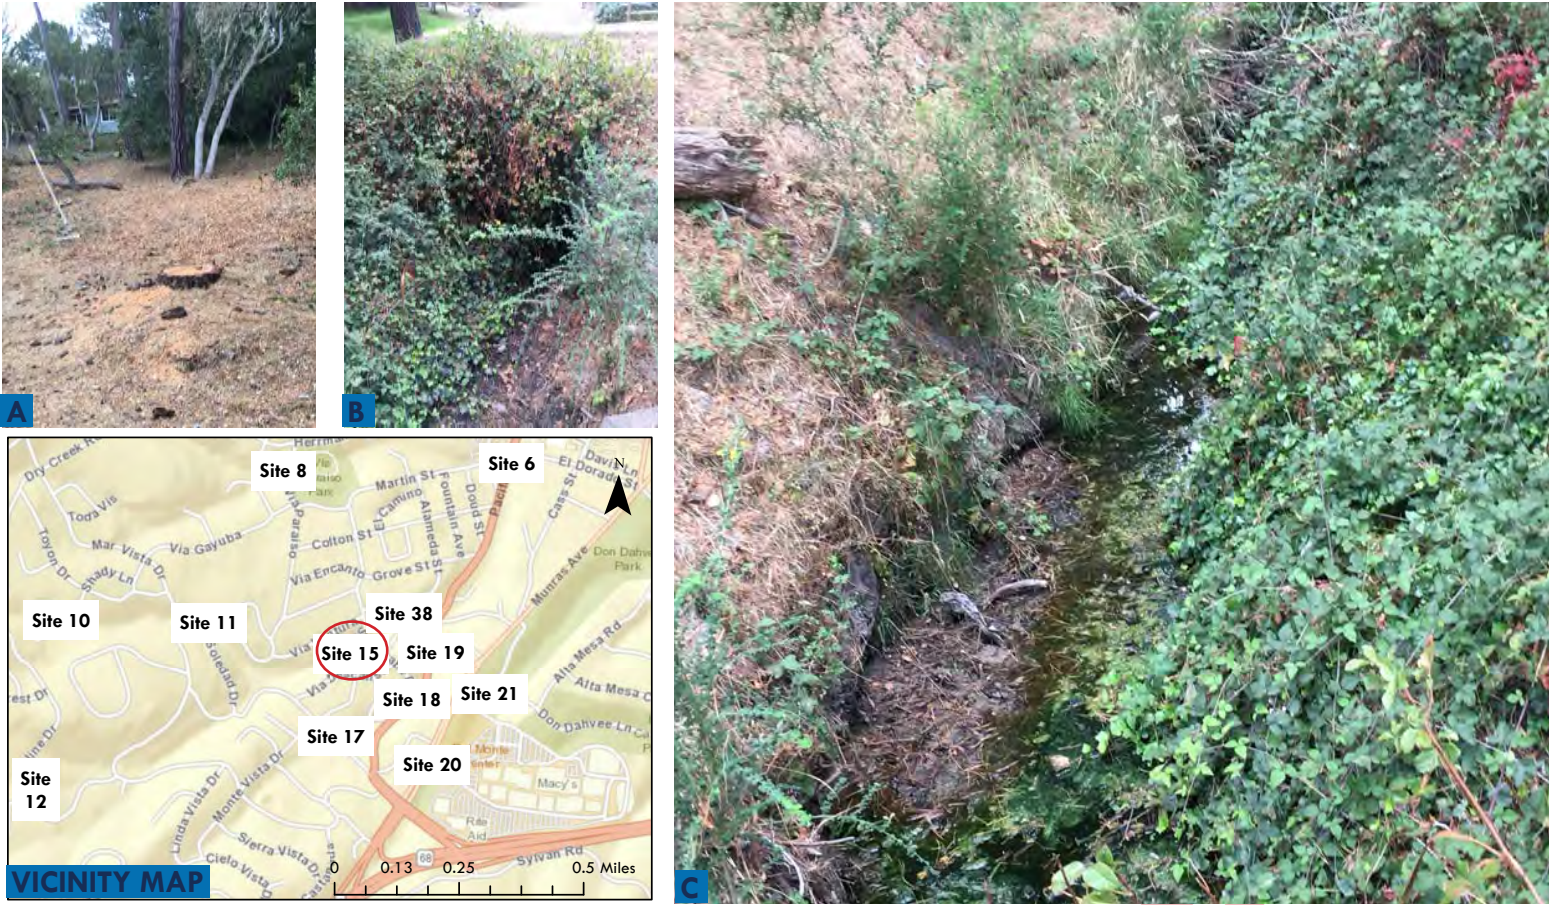
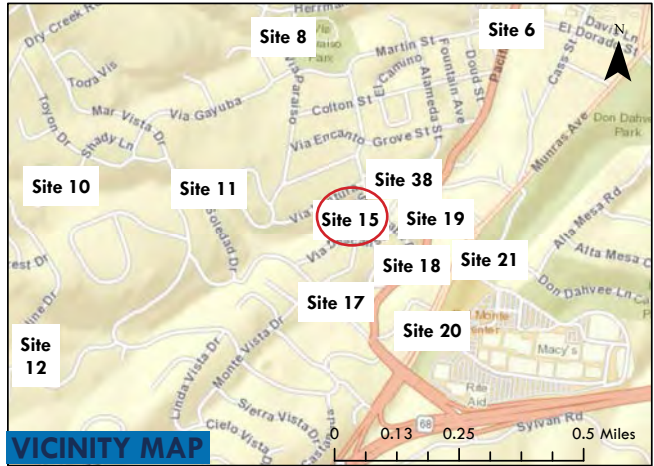
CROSS STREETS: San Bernabe Drive near
CITY DRAINAGE BASIN: Hartnell Drainage

Inspected on September 11, 2017. Site includes an earthen channel flowing through undeveloped land and between residential properties towards San Bernabe Drive. The channel is approximately 2-ft wide at its base extending up to an open channel width of approximately 5-ft. Vegetation is mostly light brush with weeds with 100% vegetative cover observed on banks. No significant rock or accumulated sediment was observed along the channel bottom. Within the limit of work, there were no significant fallen trees or tree limbs and none of the existing infrastructure is known to be undersized. Vegetation around the culvert inlet was limiting access and visibility.

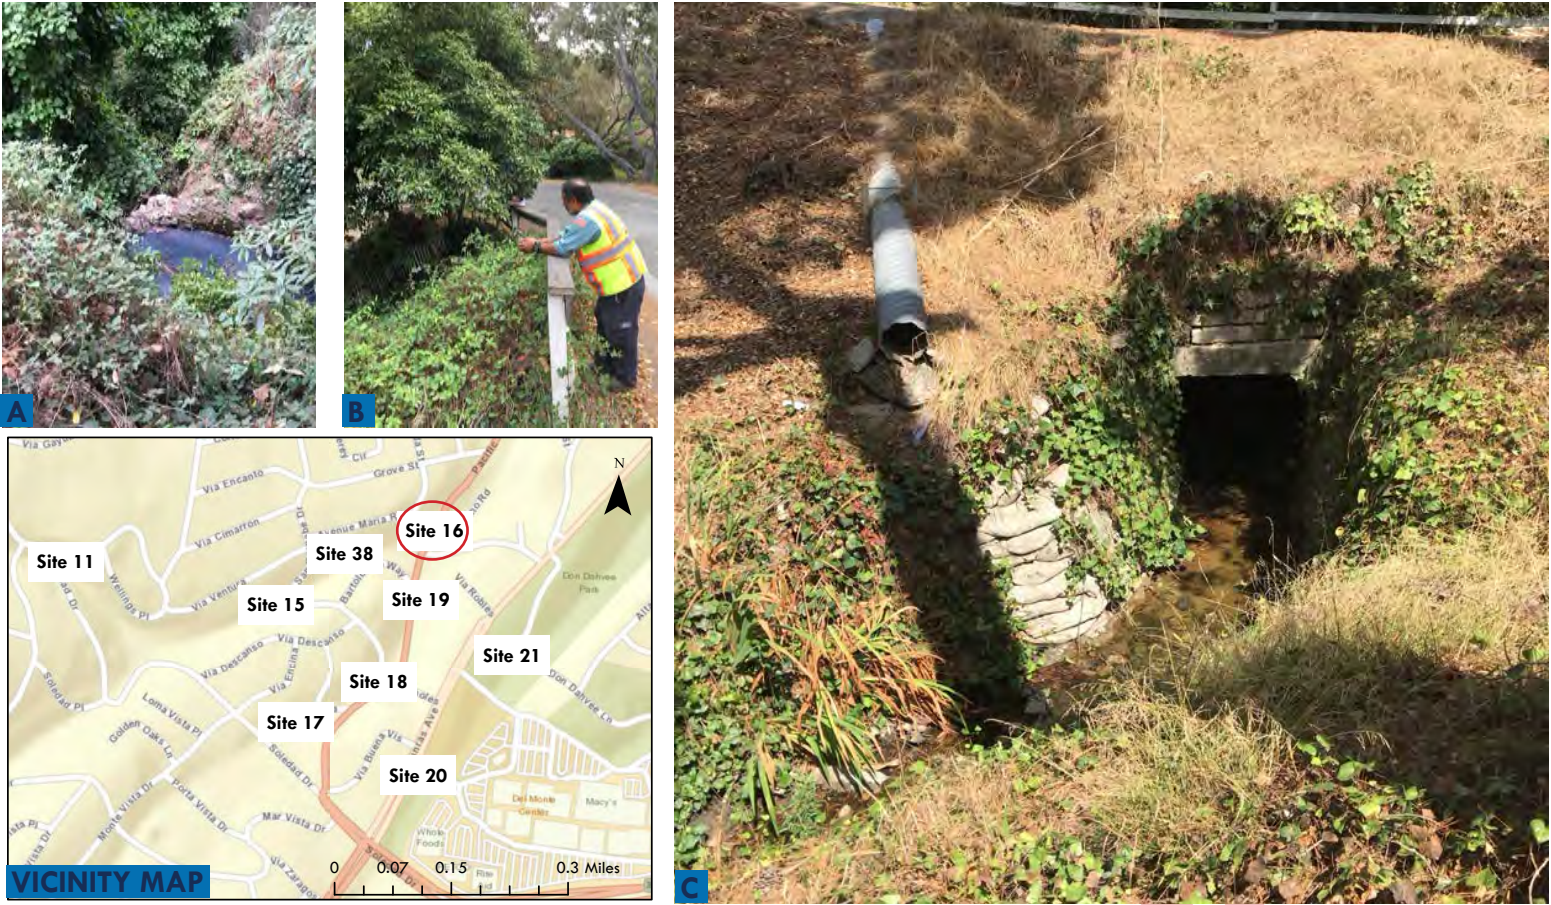
CROSS STREETS: Ave Marie Rd and Alameda Street
CITY DRAINAGE BASIN: Hartnell Drainage

Inspected on September 11, 2017. Site includes an earthen channel flowing between homes in a residential neighborhood. The channel is approximately 2-3-ft wide at its base, extending up to an open channel width of approximately 7-ft, with outlet through a box culvert beneath Alameda Street. Vegetation is mostly ivy and brambles, with some trees and 90% vegetative cover on banks. Some rock and accumulated sediment was observed along the channel bottom. There were no significant fallen trees or tree limbs and none of the existing infrastructure is known to be undersized. No flood or erosion threats were observed. Vegetation around the culvert inlet was short, allowing adequate access and visibility, whereas vegetation on the downstream side was preventing access and evaluation of the facility.

The growth of vegetation in the inlet channels was not preventing access to evaluate condition and maintain facilities nor is it currently reducing the capacity of the system. In the downstream section ivy and high vegetation is limiting visibility and access to maintain the conveyance capacity in the channel. Sediment, rock, and vegetation accumulation in the channel are maintenance concerns.

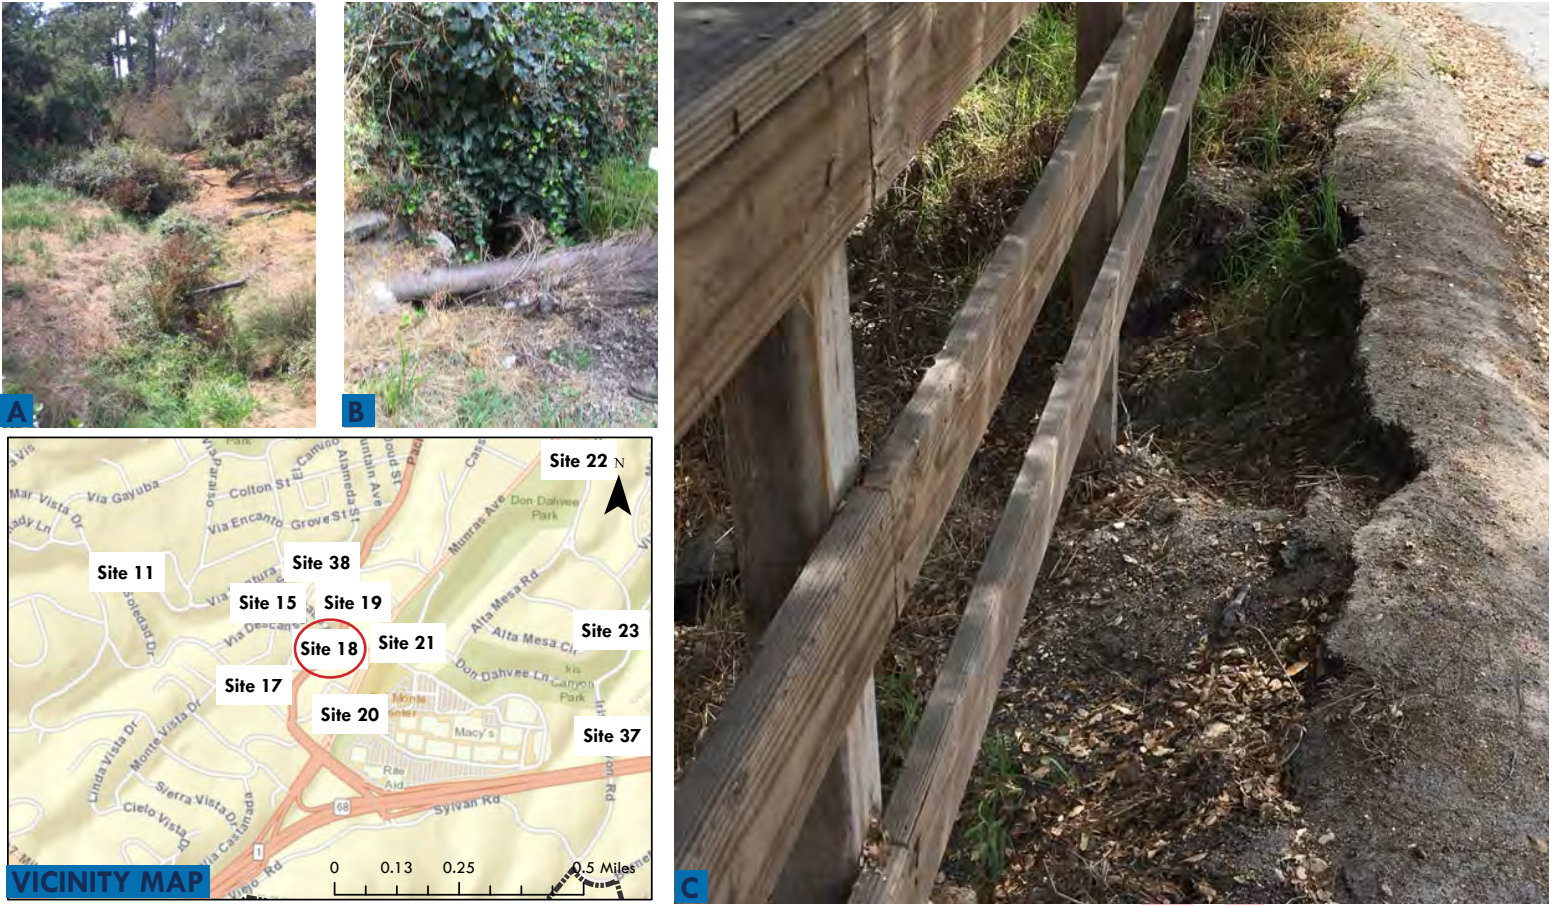
CROSS STREETS: San Bernabe Street & Pacific Street
CITY DRAINAGE BASIN: Hartnell Drainage

Inspected on September 11, 2017. Site includes an earthen channel flowing and between residential properties and Pacific Street. The channel is approximately 1-ft wide at its base, extending up to an open channel width of approximately 5-ft. Vegetation is mostly grass and light brush on the upstream side and oak treres along the downstream channel banks; 80% vegetative cover was observed on the banks. Upstream of San Bernabe Drive, accumulated sediment was observed along the channel bottom and ivy is blocking the inlet to the culvert beneath the road (Photo B). Within the limit of work, there were no significant fallen trees or tree limbs. The 24” diameter culvert beneath San Bernabe is known to be undersized and likely the source of occasional flooding over the road. Erosion was observed in the downstream channel and along a fenceline at the top of the drownstream channel (Photo C).

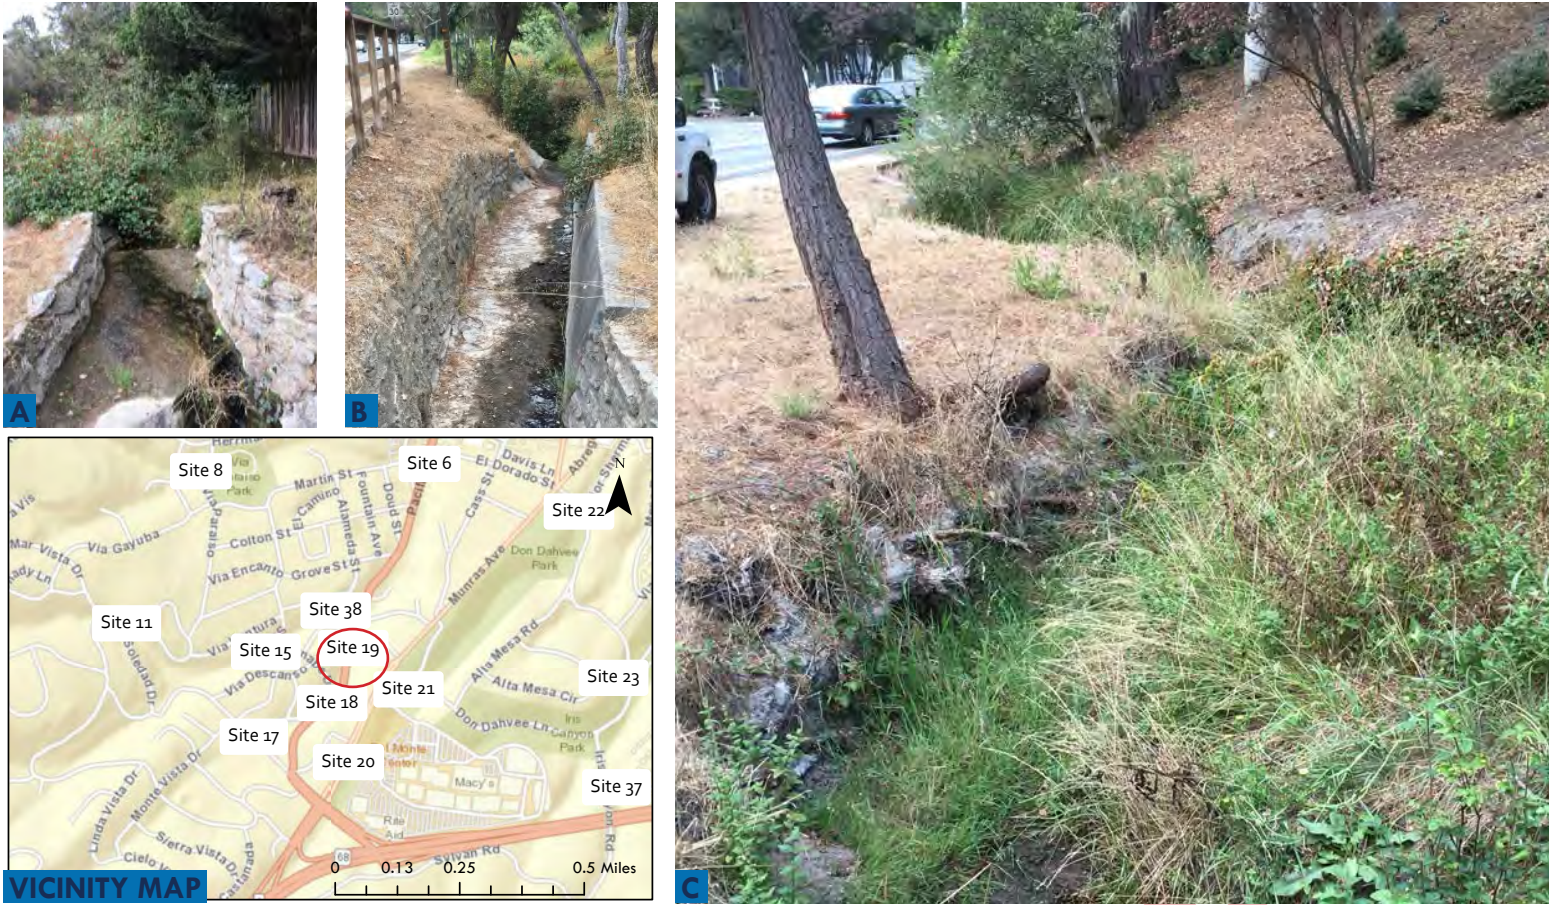
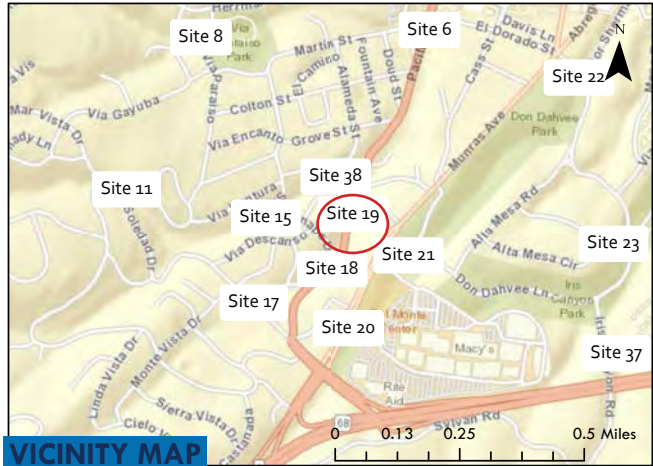
CROSS STREETS: Pacific Street
CITY DRAINAGE BASIN: Hartnell Drainage

Inspected on September 11, 2017. Site includes amostly straight earthen channel flowing south to north between homes in a residential neighborhood and Pacific Street. The channel is approximately 1-2-ft wide at its base, extending up to an open channel width of approximately 5-ft. Vegetation is mostly dense brush with some trees and 90% vegetative cover on banks. Some rock and accumulated sediment, along with vegetation growth, was observed along the channel bottom. There were no significant fallen trees or tree limbs and none of the existing infrastructure is known to be undersized. The growth of vegetation in the channel is reducing conveyance capacity and has resulted in channel overtopping and flood conditions along Pacific Street.
