Storm Drainage Maintenance Plan

City of Monterey

Storm Drainage Maintenance Plan (SDMP)

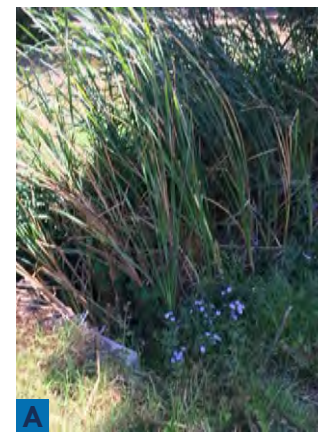
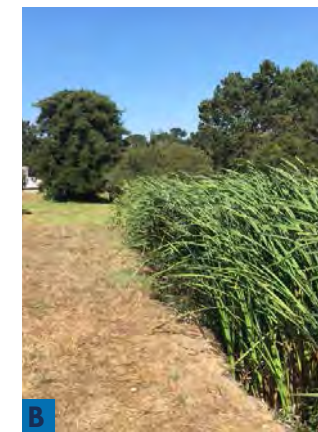
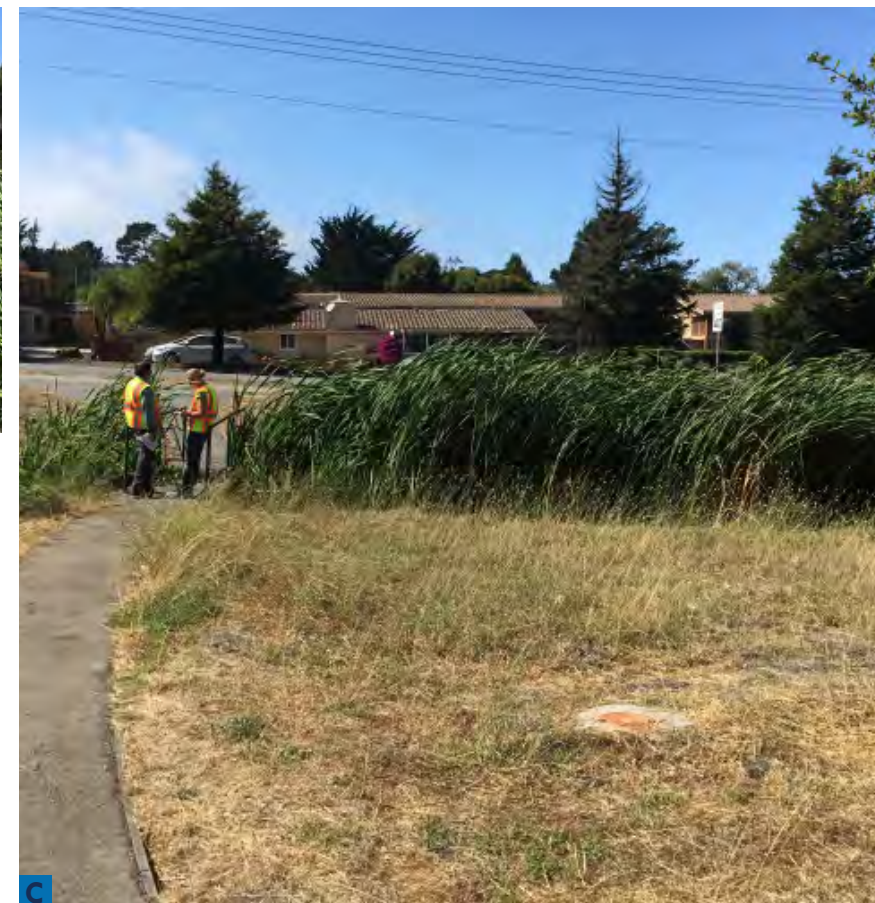
CROSS STREETS: Munras and Soledad Drive
CITY DRAINAGE BASIN: EL ESTERO DRAINAGE

Inspected on September 12, 2017. The adjacent land use includes the Del Monte Shopping Center and roadways. Vegetation is 6-8-ft tall with approximately 70% vegetation cover within the channel. The open channel width is approximately 10-ft, the banks are 4-ft high and near vertical. Some erosion was observed on the channel banks associated with channel incision. A pedestrian bridge crosses the channel between the Shopping Center and Munras Avenue. None of the existing infrastructure is known to be undersized and water has never been reported above the channel banks. The Shopping Center regularly mows the grass on the channel floodplain.

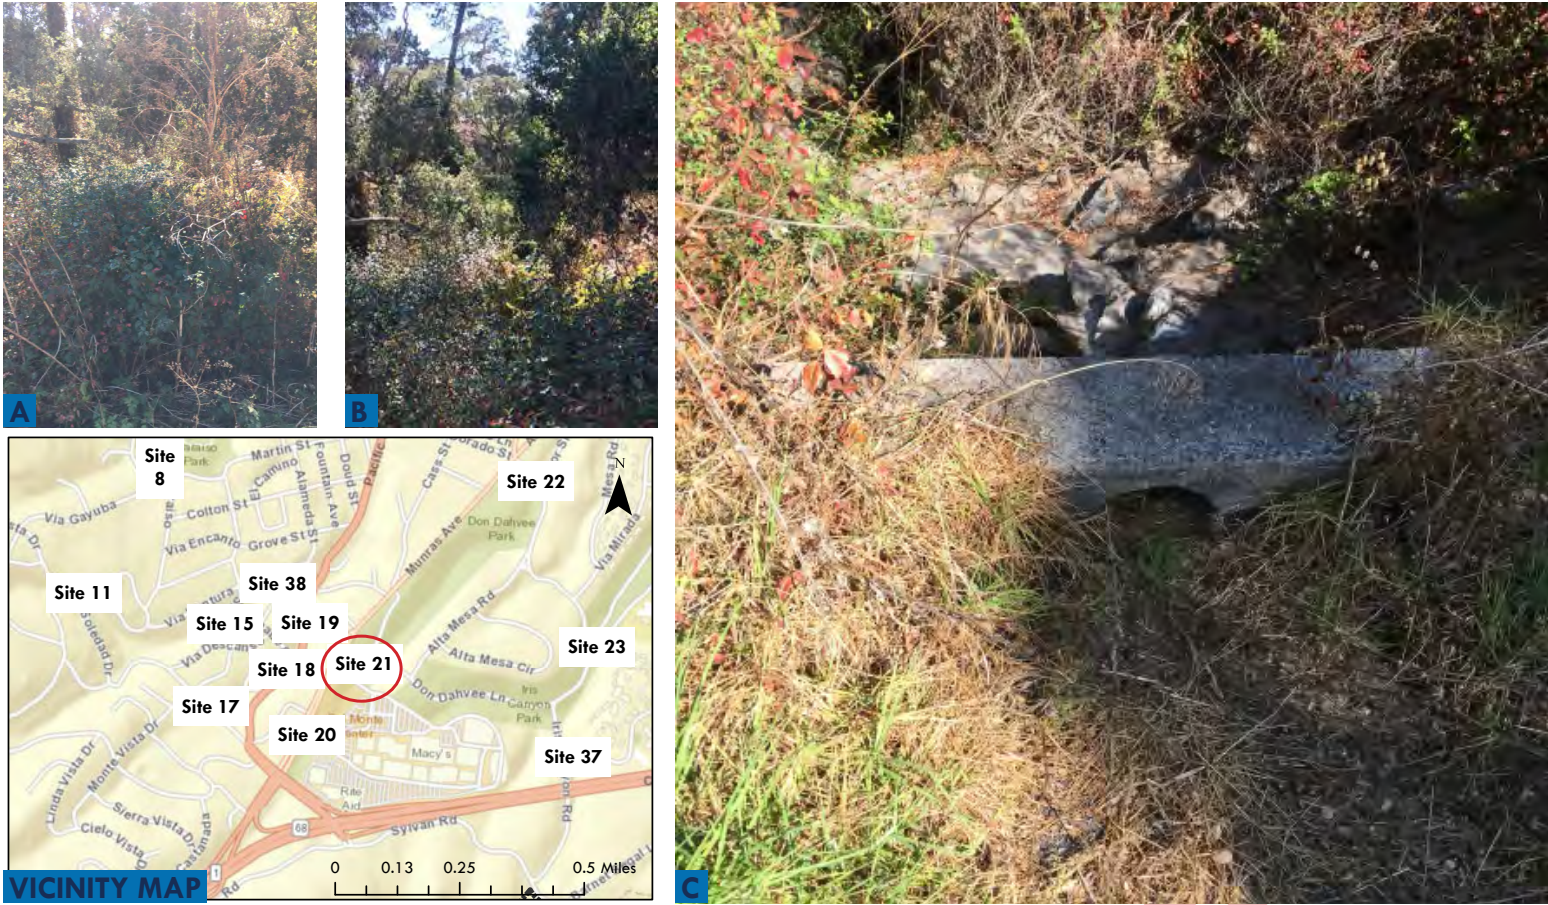
Inspected on September 12, 2017. The adjacent land use includes open space (Don Dahvee Park), roadways, and single family residences. Vegetation is 3-6-ft tall with approximately 90% vegetation cover on the banks. The dense brush on the upstream side especially, prevented inspection of existing infrastructure. There was a 24" diameter tree down across the upstream channel. None of the existing infrastructure is known to be undersized. No flood or erosion threats were observed though vegetation on the northern site obscured an evaluation of the facility condition. The downstream channel has a steep drop from the culvert outlet and roadway into a rock spillway (Photo C).

The growth of vegetation in the vicinity of the culvert inlet is preventing access to evaluate condition and maintain facilities. Sediment accumulation does not appear to be as significant of a maintenance concern compared to overgrown vegetation.

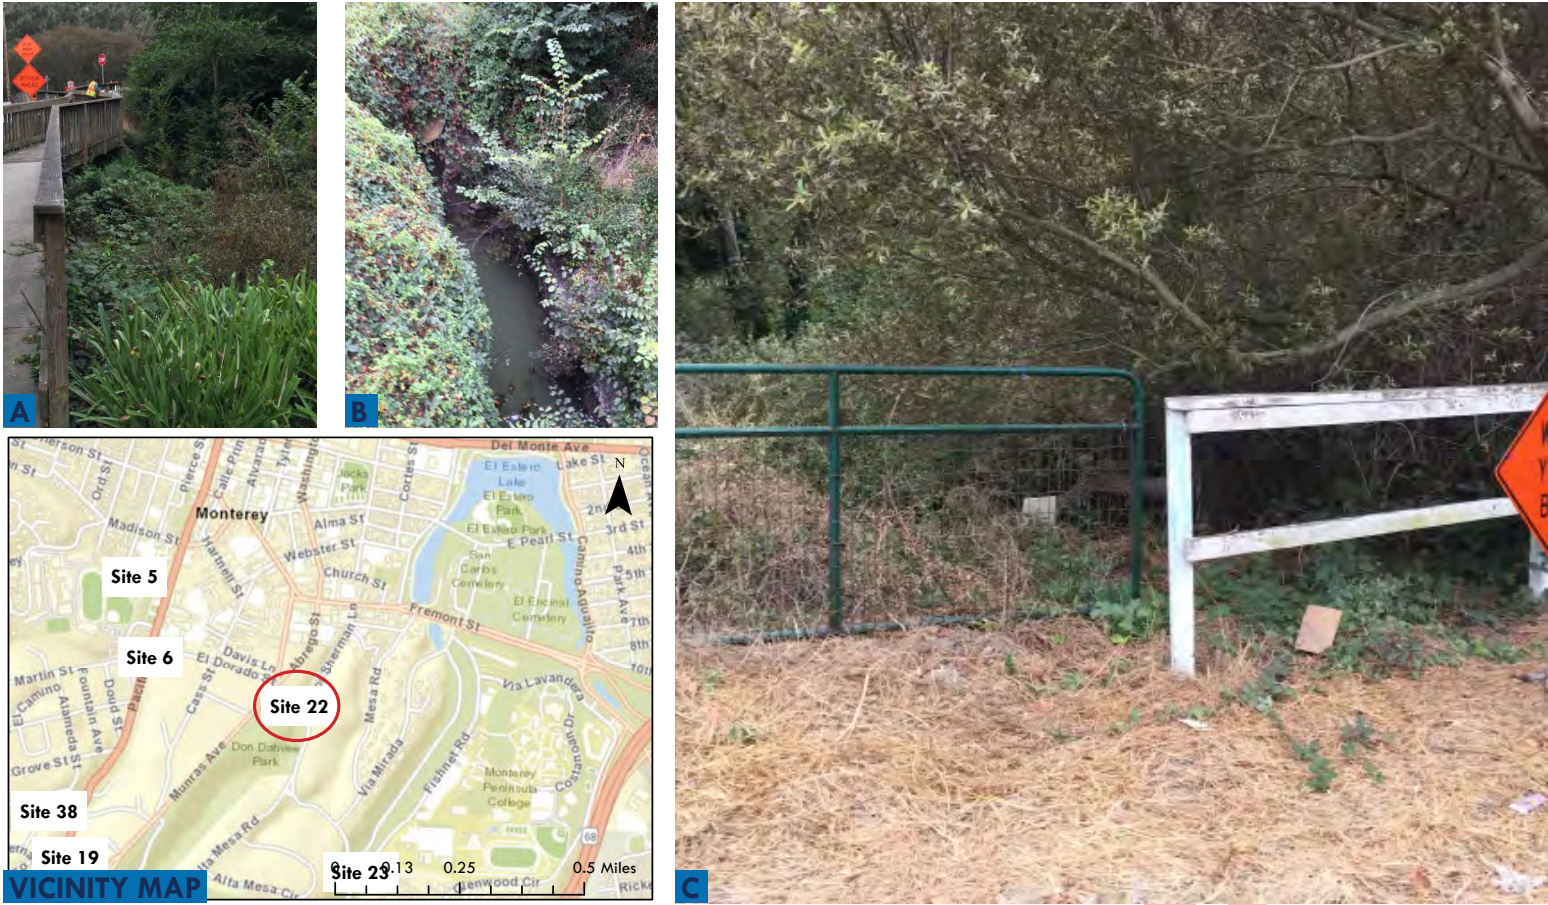
Inspected on September 13, 2017. The channel bankfull width is approximately 12-ft upstream of El Dorado Street and a trash rack on the upstream culvert inlet was clear of debris though an 8-ft long 18-inch diameter downed tree was crossing the channel upstream of the trash rack. The downstream channel section has incised approximately 5-ft below the invert of the culvert outlet and bank erosion was observed. Dense brush and trees were established along the channel banks in both the upstream and downstream sections. The adjacent land use includes professional buildings, Don Dahvee Park, single family residences, and roadways. None of the existing infrastructure is known to be undersized and no flood threats were observed. Vegetation around the culvert inlet was short, allowing adequate access and visibility, though on the downstream side overgrown vegetation limited visibility of the culvert outlets.

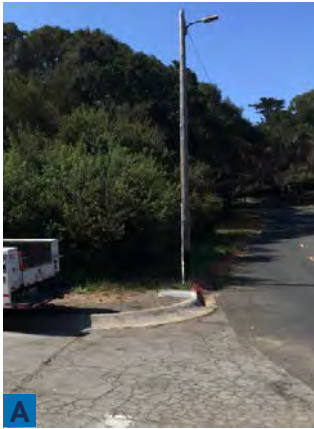
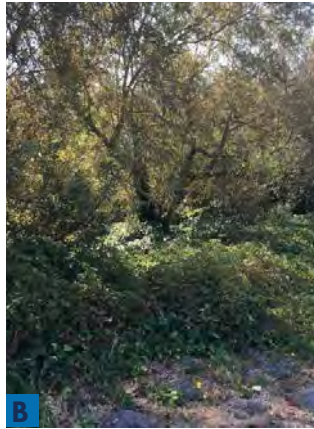
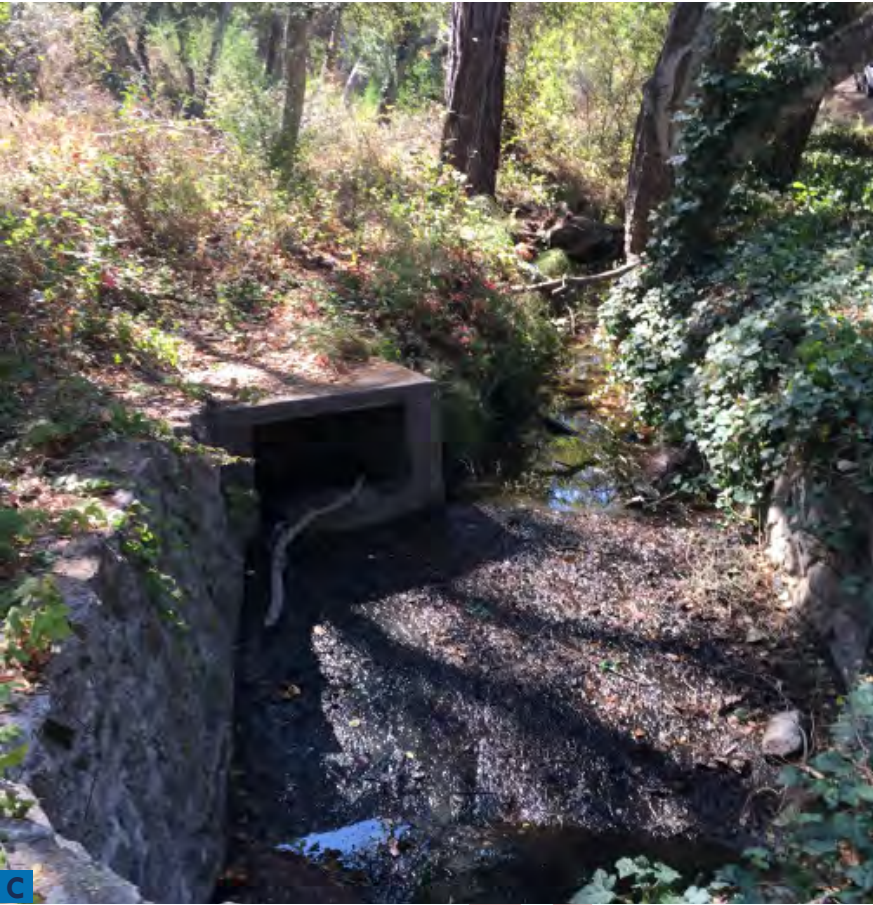
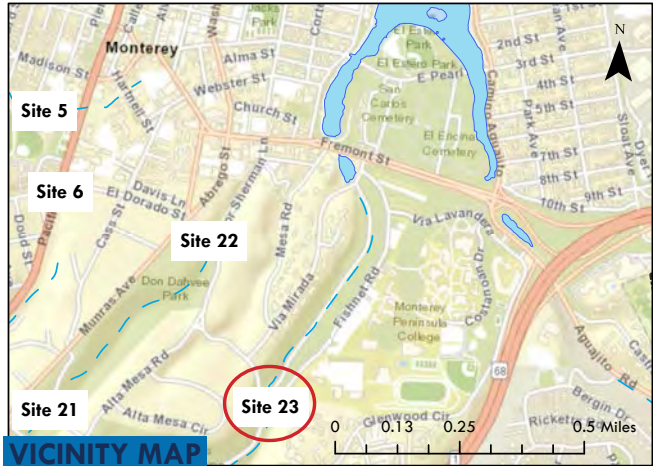
CROSS STREETS: El Dorado Street and Via Mirada
CITY DRAINAGE BASIN: EL ESTERO DRAINAGE

Inspected on September 12, 2017. Site consists of a northern and southern portion; the southern begins at Iris Canyon Road and El Dorado/Fishnet Road and the northern portion drains into Lagunita Mirada (Site 24). The adjacent land use includes open space (Iris Greenbelt), Monterey Peninsula College, and single family residences. Vegetation is 10-12-ft tall on the banks and 6-8-ft tall in the channel with approximately 90% vegetation cover on the banks. At the southern site the vegetation includes mature trees and low lying brush with approximately 90% vegetation cover on the banks. At both sites, there were no significant fallen trees or tree limbs and none of the existing infrastructure is known to be undersized. No flood or erosion threats were observed though vegetation on the northern site obscured an evaluation of the facility condition.

At the northern site there are two culvert crossings at Iris Canyon Road and Via Mirada that require annual maintenance. At the southern site, a culvert inlet on the upstream side of El Dorado/Fishnet Road requires annual maintenance. The growth of vegetation in the vicinity of the culvert inlets is preventing access to evaluate condition and maintain facilities and is reducing the capacity of the system. Sediment accumulation does not appear to be as significant of a maintenance concern at either location, compared to overgrown vegetation.

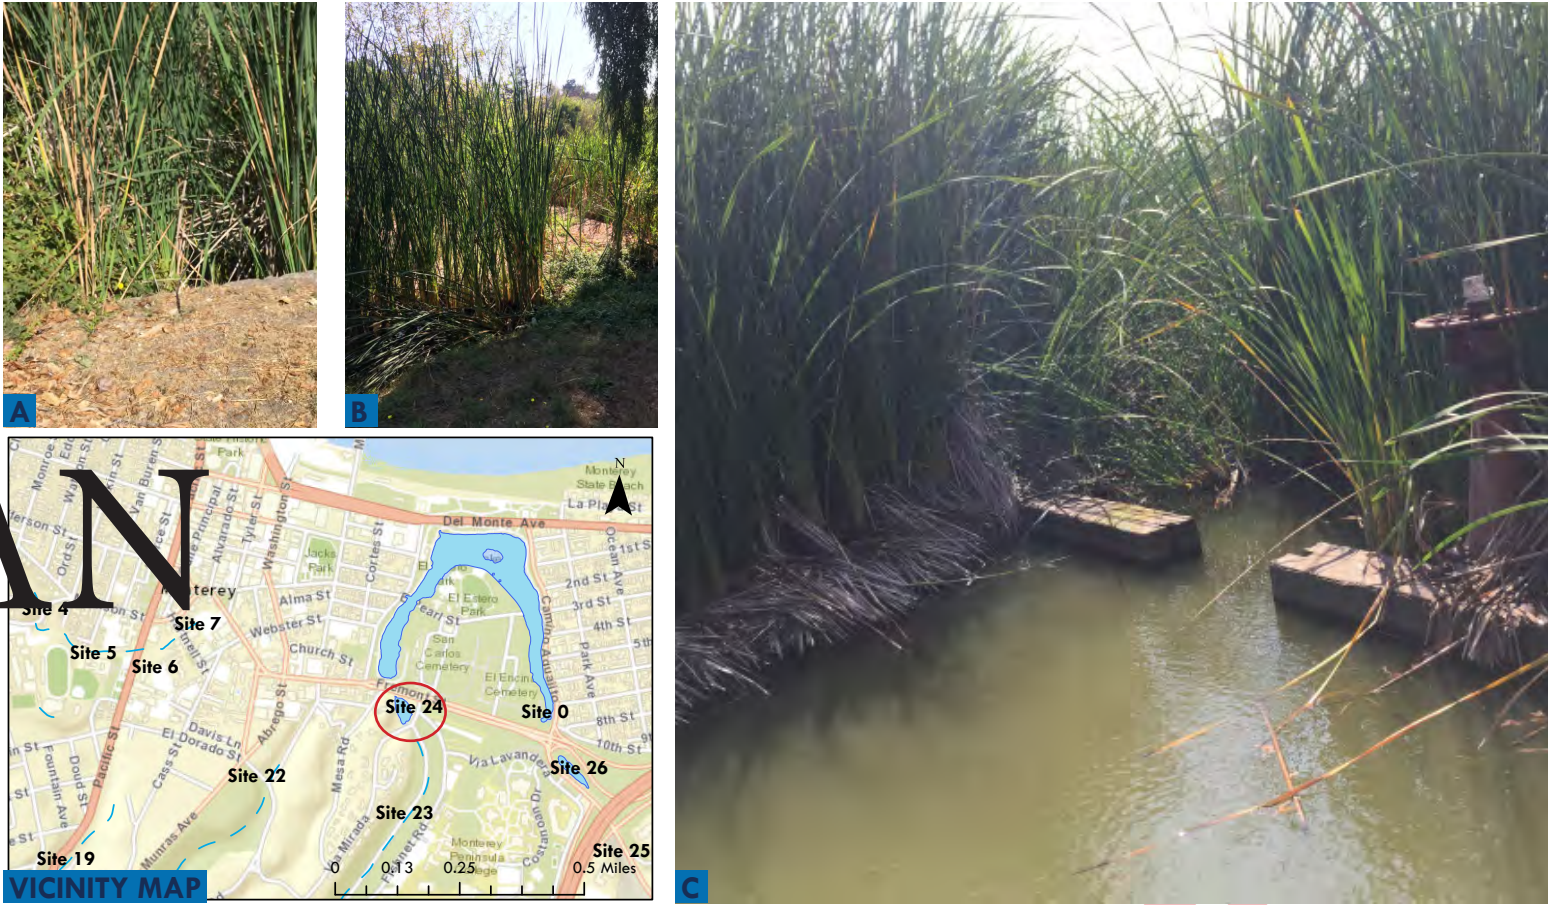
CROSS STREETS: Fremont Street and Fishnet Road
CITY DRAINAGE BASIN: EL ESTERO DRAINAGE

Inspected on September 12, 2017. Dense vegetation, 8-12-ft in height, extends from the pond perimeter towards the center of the pond, becoming less dense towards with distance from the pond bank. Light brush and weeds provides 90% coverage along the pond banks. The adjacent land use is predominantly roadways, park land, and a museum (Monterey Museum of Art - La Mirada). Accumulated woody debris and significant sediment build-up were observed along the western pond bank. The existing infrastructure is not known to be undersized, though localized flooding has occurred adjacent to the culvert inlets that are blocked with sediment. No erosion threats were observed, though visibility was limited due to the extent and density of vegetation. Vegetation around the pond inlets and outlet was dense and overgrown, preventing adequate access and visibility to maintain the structure.

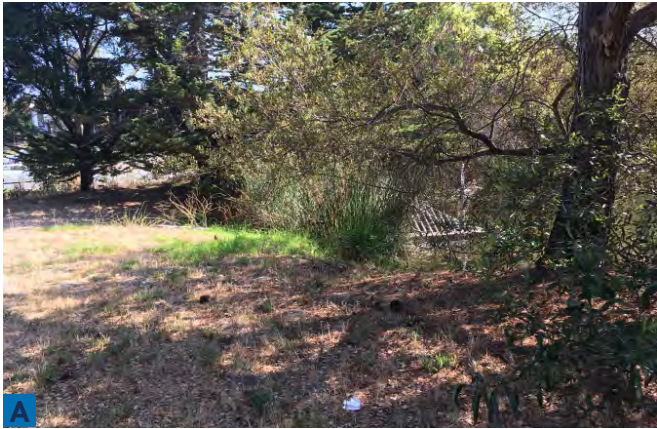
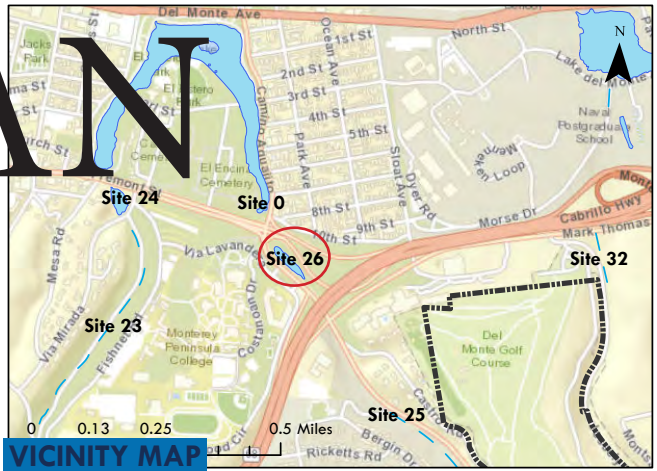
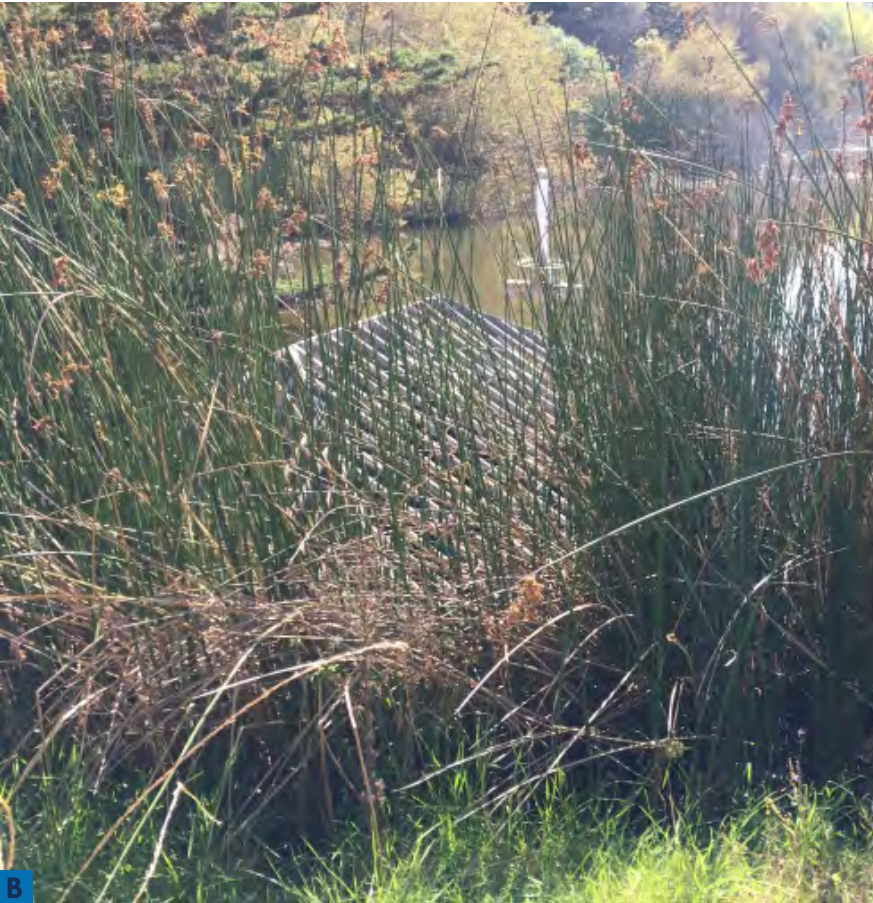
Inspected on September 12, 2017. Dense vegetation, 10-12-ft in height, extends from the pond perimeter towards the center of the pond, becoming less dense towards with distance from the pond bank. Light brush and weeds provides 100% coverage along the pond banks. The adjacent land use is predominantly roadways and medians. No significant fallen trees or tree limbs were observed and none of the existing infrastructure is known to be undersized. No flood or erosion threats were observed, though visibility was limited due to the extent and density of vegetation. Vegetation around the pond outlet and trash rack was dense and overgrown, preventing adequate access and visibility to maintain the structure.

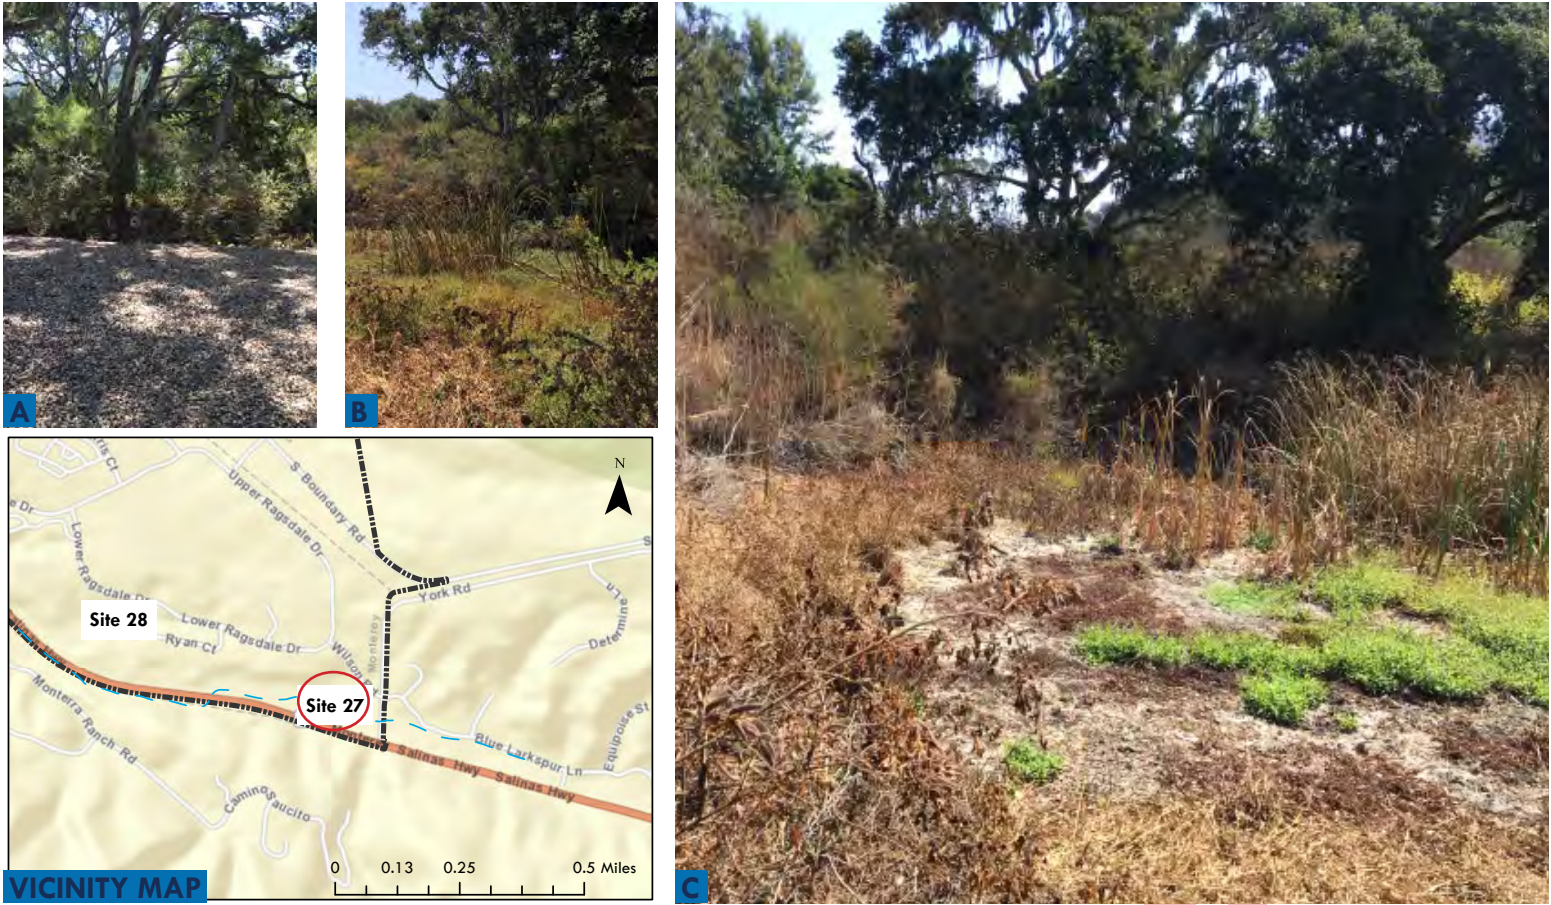
Inspected on September 12, 2017. Site vegetation is light density brush and weeds with 3-4 ft tall shrub and grasses (french broom) in the basin bottom and banks with approximately 60% vegetation cover on the banks. The adjacent land use includes Highway 68 and the Ryan Ranch Industrial Park and the area is zoned as Industrial in the City's General Plan. The area in the immediate vicinity of the detention basin is a parking lot for medical offices. There were no significant fallen trees or tree limbs and none of the existing basin infrastructure is known to be undersized. No flood or erosion threats were observed. A 5 to 8-ft wide channel drains to the basin from the west.

Capacity and function of the basin is reduced by the presence of vegetation and accrual of sediment. Access to the basin is limited due to vegetation that has grown up on the banks and within the 10-ft perimeter path that was previously used to access the basin. An existing overflow standpipe in the basin was not located due to overgrowth. Vegetation is generally obscuring visibility to determine facility condition.

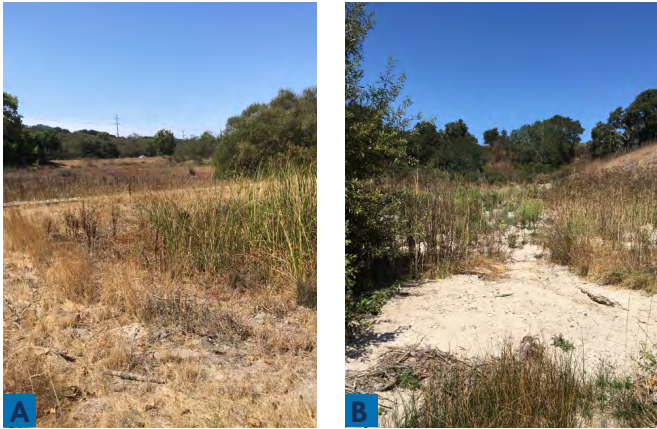
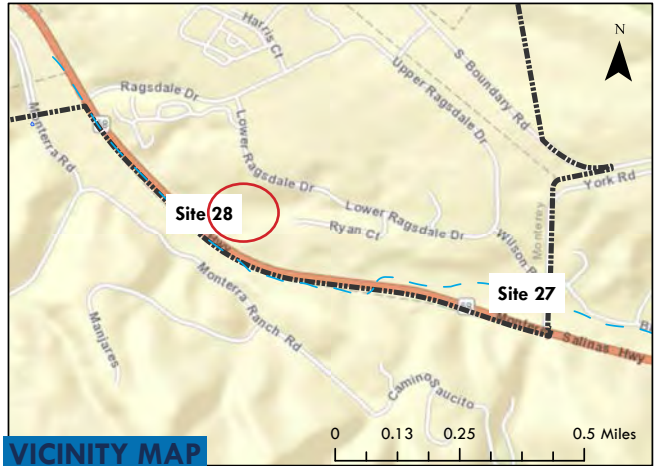
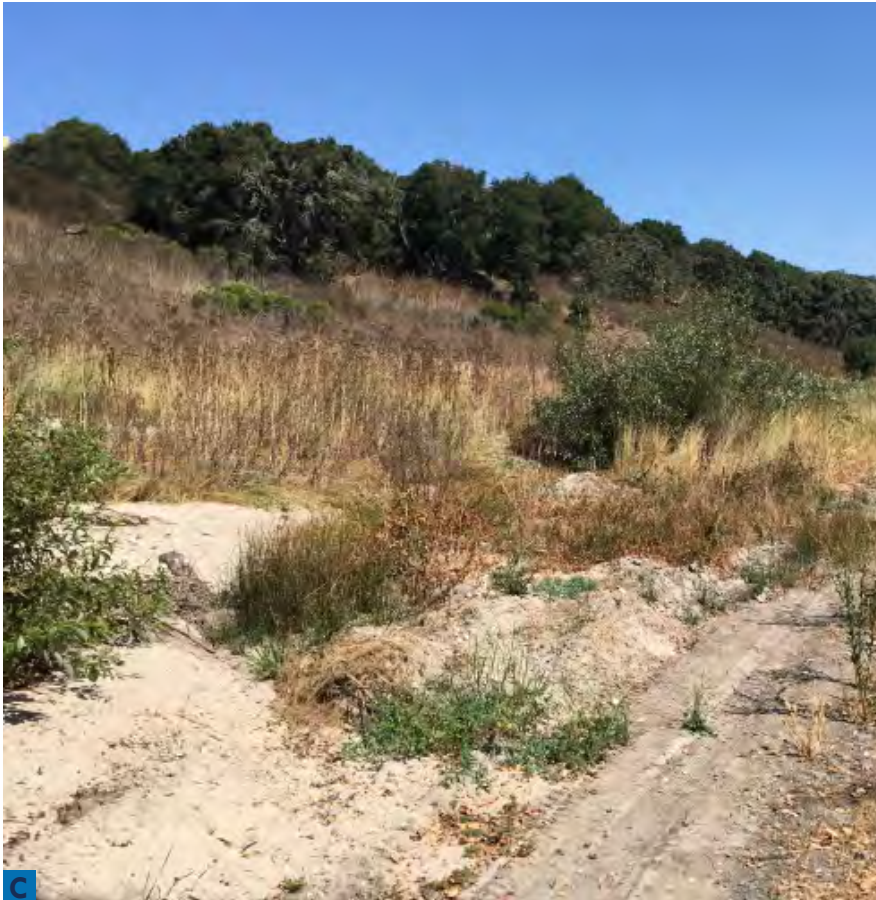
CROSS STREETS: Monterey Salinas Highway (Highway 68)
CITY DRAINAGE BASIN: Laguna Grande

Inspected on September 12, 2017. Site vegetation is light density brush and weeds with 10-12 ft tall willows with approximately 60% vegetation cover on the banks. The adjacent land use includes Highway 68 and the Ryan Ranch Industrial Park and the area is zoned as Industrial in the City’s General Plan. The area in the immediate vicinity of basin is open space. There were no significant fallen trees or tree limbs and none of the existing basin infrastructure is known to be undersized. Areas of sedimentation and erosion were observed related to a slope failure/landslide on the north/north-east slope above the Basin.

Capacity and function of the basin is reduced by the presence of vegetation and accrual of sediment. The sediment and debris from the slope failure has overwhelmed the Basin and the incoming drainage channel that enters from the east. As a result of the channel being choked with sediment from the slope failure, storm flows will be forced into the adjacent sewer easement road; potentially causing erosion along the roadway and risking exposure of the sewer line. The Study Area does not include the extents of the slope failure, and the proposed maintenance activities described in the project description do not include restoration of the flow path/drainage channel into the siltation basin.

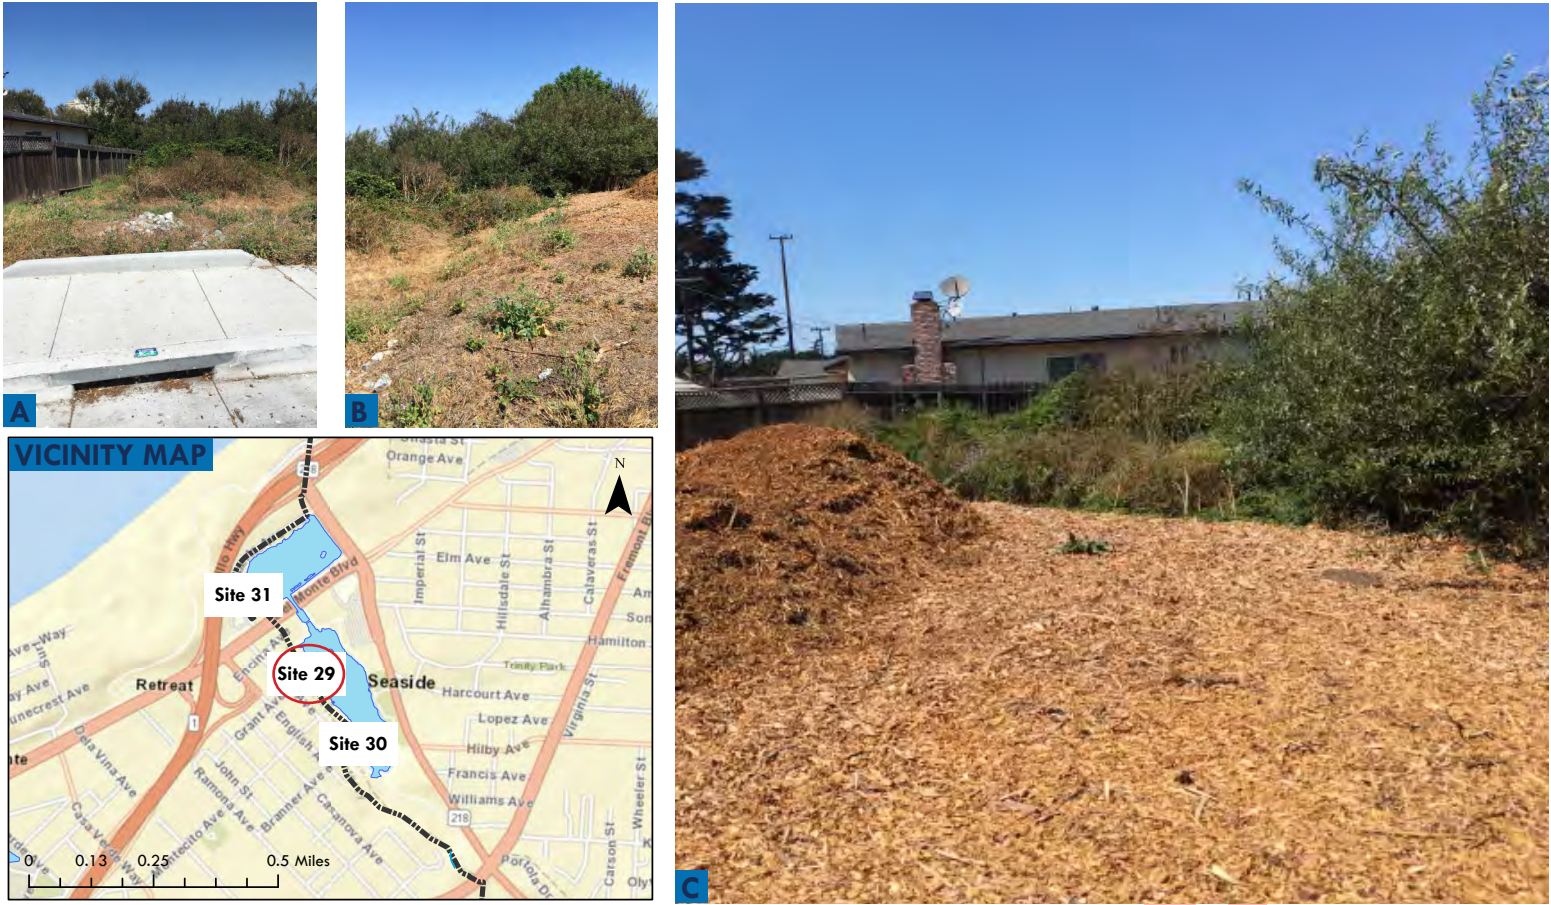
Inspected on September 12, 2017. Site includes a low density stormwater swale that drains from east to west towards dense riparian vegetation extending around the border of Laguna Grande. Vegetation in the stormwater swale is approximately 2-ft tall, whereas the riparian vegation is 8-10-ft tall willow. In both cases approximately 60% vegetation cover on the banks was observed. The adjacent land use includes single family residences and public park land. There were no significant fallen trees or tree limbs and none of the existing infrastructure is known to be undersized. No flood or erosion threats were observed. Vegetation around the inlet to the stormwater swale was short, allowing access and visibility to the storm water inlet and channel.

The growth of vegetation in the inlet channel was not preventing access to evaluate condition and maintain facilities nor is it currently reducing the capacity of the system. Sediment accumulation does not appear to be as significant of a maintenance concern compared to overgrown vegetation. The observed condition is how the City proposes to maintain the swale in future as part of the annual maintenance practices.

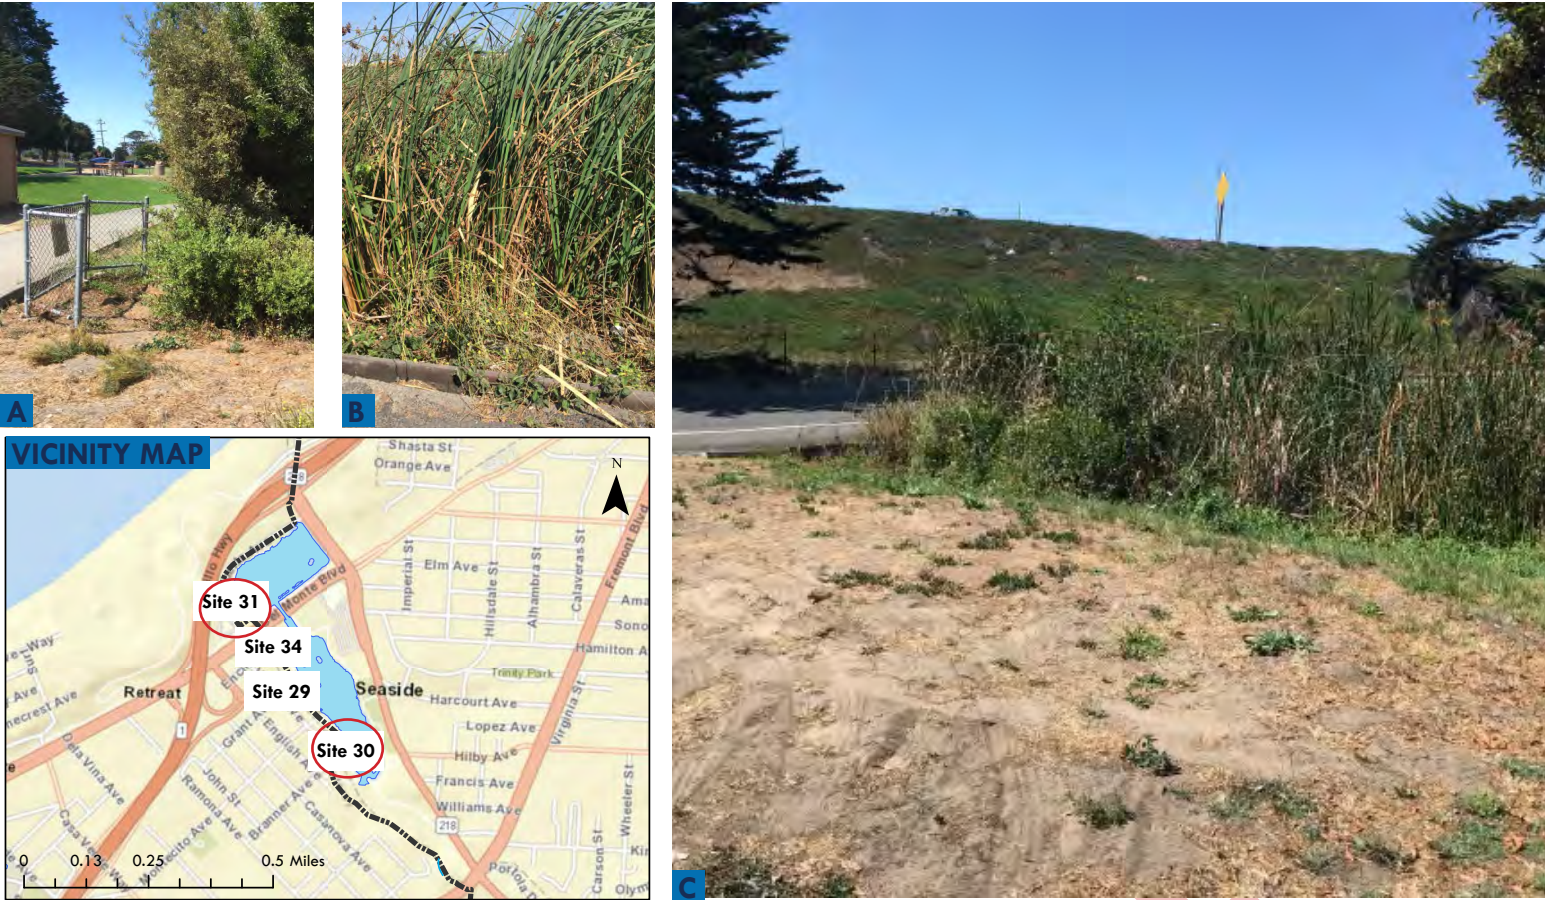
CROSS STREETS: Roberts Avenue and Del Monte Avenue
CITY DRAINAGE BASIN: Laguna Grande

Inspected on September 12, 2017. Site consists of a northern and southern portion; the southern portion drains into Laguna Grande and the northern portion drains into Roberts Lake. At the northern site vegetation is dense along the perimeter of the basin, with 6-8 ft tall wetland plants with approximately 100% vegetation cover on the banks. The adjacent land use includes highway, roaway, and a hotel. At the southern site the vegetation is dense, with 6-8 feet tall willows and ivy at the inlet with approximately 100% vegetation cover on the banks. The adjacent land use includes single family residences and public park land. At both sites, there were no significant fallen trees or tree limbs and none of the existing basin infrastructure is known to be undersized. No flood or erosion threats were observed. The pond inlet and channel are overgrown with vegetation which obscured an evaluation of the facility condition.

The growth of vegetation in the inlet channels is preventing access to evaluate condition and maintain facilities and is reducing the capacity of the system. Sediment accumulation does not appear to be as significant of a maintenance concern at either location, compared to overgrown vegetation.

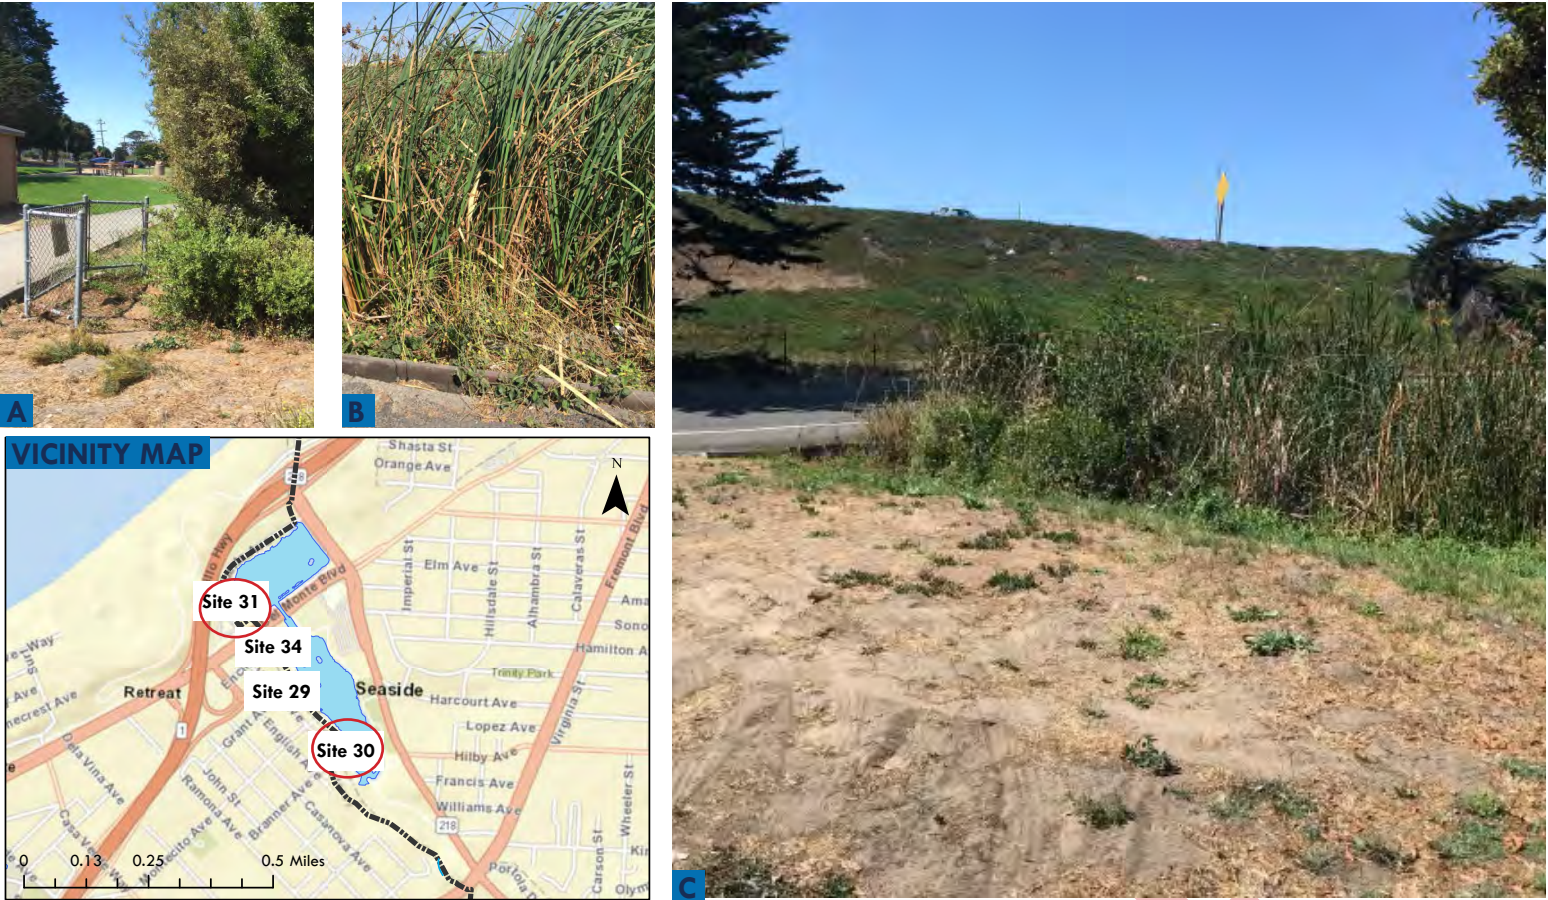
CROSS STREETS: Roberts Avenue and Del Monte Avenue
CITY DRAINAGE BASIN: Laguna Grande

Inspected on September 12, 2017. Site consists of a northern and southern portion; the southern portion drains into Laguna Grande and the northern portion drains into Roberts Lake. At the northern site vegetation is dense along the perimeter of the basin, with 6-8 ft tall wetland plants with approximately 100% vegetation cover on the banks. The adjacent land use includes highway, roadway, and a hotel. At the southern site the vegetation is dense, with 6-8 feet tall willows and ivy at the inlet with approximately 100% vegetation cover on the banks. The adjacent land use includes single family residences and public park land. At both sites, there were no significant fallen trees or tree limbs and none of the existing basin infrastructure is known to be undersized. No flood or erosion threats were observed. The pond inlet and channel are overgrown with vegetation which obscured an evaluation of the facility condition.

The growth of vegetation in the inlet channels is preventing access to evaluate condition and maintain facilities and is reducing the capacity of the system. Sediment accumulation does not appear to be as significant of a maintenance concern at either location, compared to overgrown vegetation.

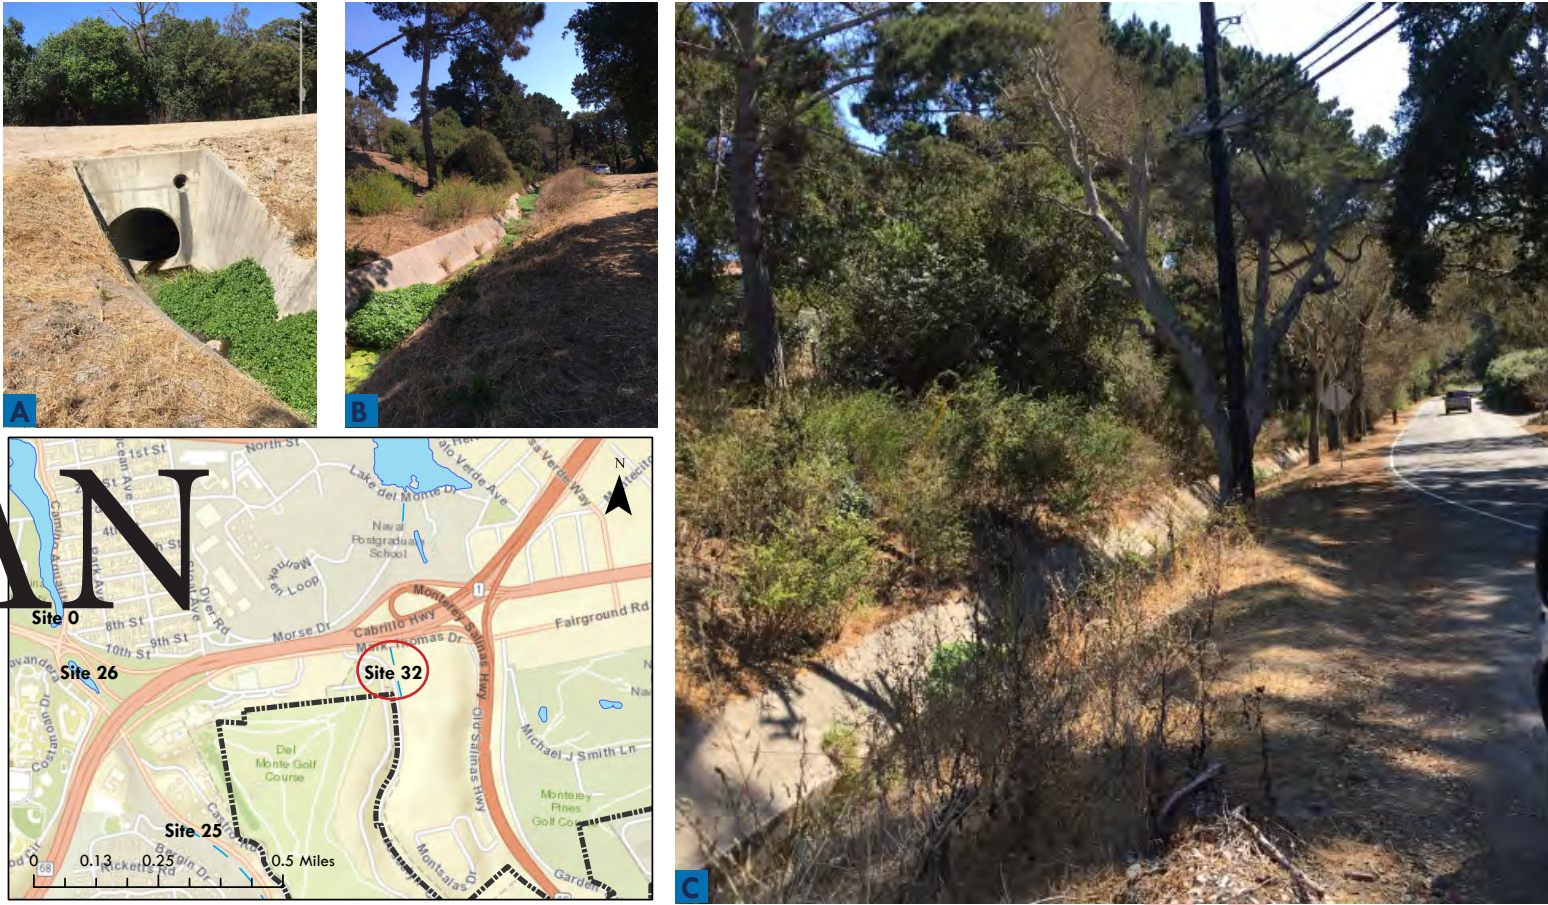
CROSS STREETS: Oak Crest Drive and Sylvan Drive
CITY DRAINAGE BASIN: DEL MONTE LAKE (NPS)

Inspected on September 12, 2017. Site includes a concrete lined conveyance channel approximately 2-ft wide at its base, extending up to an open channel width of approximately 8-ft, with outlet through a 60-inch RCP culvert beneath Mark Thomas Drive. Low lying aquatic vegetation had established in accumulated sediment along the channel bottom. The concrete sides slopes were generally bare of vegetation. The adjacent land use includes a private school (Santa Catalina School), single family residences, golf course (Del Monte Golf Course), and roadways. There were no significant fallen trees or tree limbs and none of the existing infrastructure is known to be undersized. No flood or erosion threats were observed. Vegetation around the culvert inlet was short, allowing adequate access and visibility.

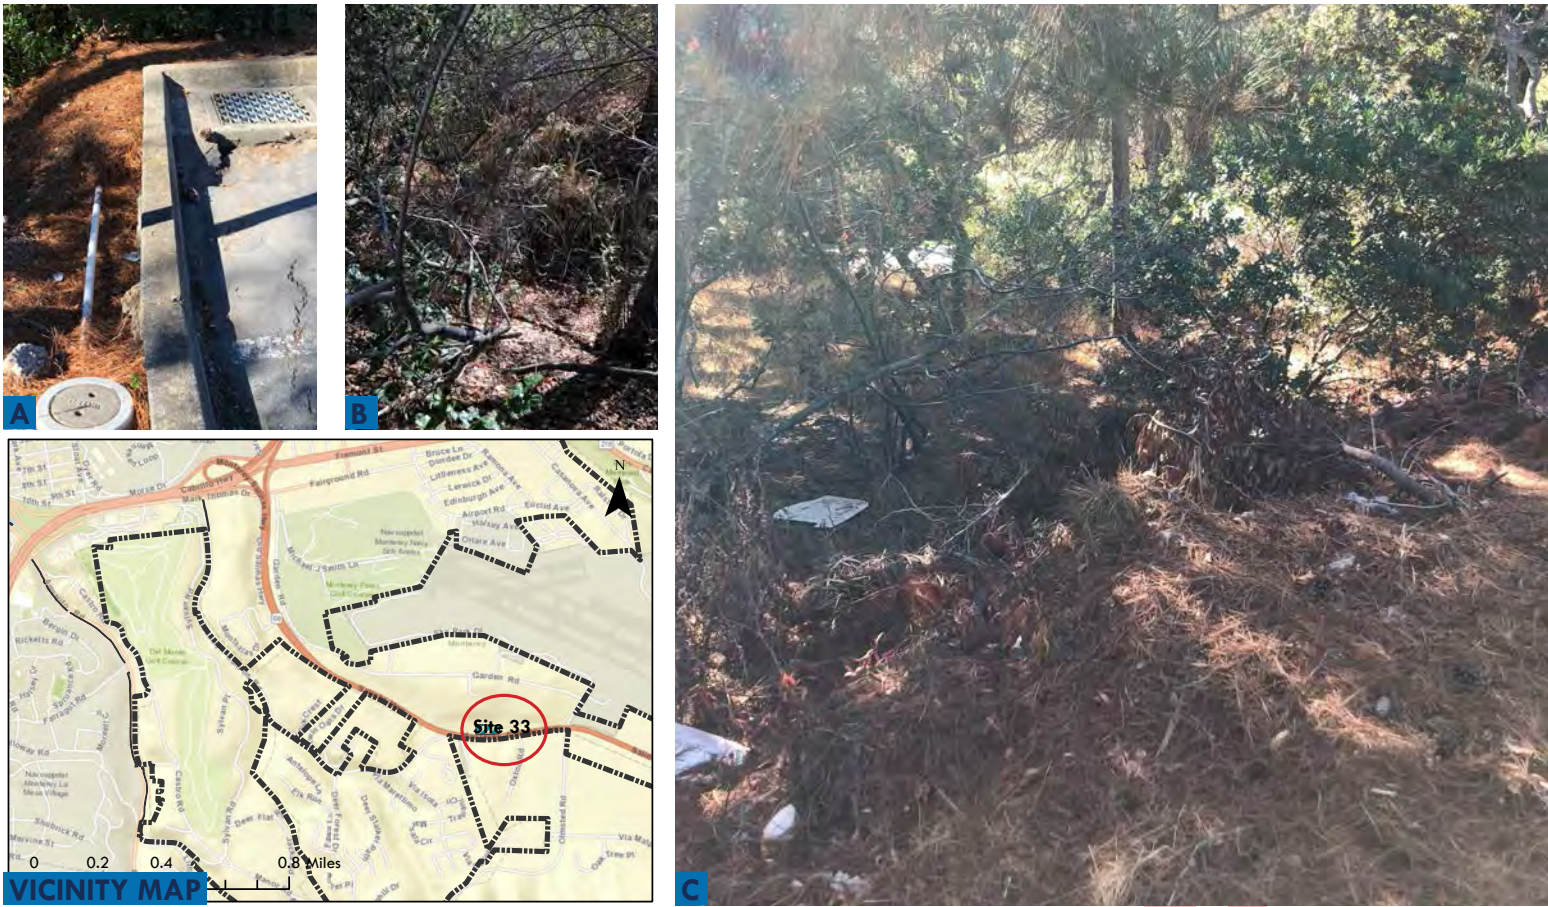
CROSS STREETS: Garden Court and Highway 68
CITY DRAINAGE BASIN: DEL MONTE LAKE

Inspected on November 7, 2017. The basin is located to the south of a commercial building complex and receives drainage from the developed areas. Overflow from the basin is to a drainage swale parallel to Highway 68 directly south and parallel to the basin. The basin berm and bottom are covered in dense brush and trees with approximately 90% coverage, and vegetation ranges in height from 10-20 feet tall. Fallen tree trunks and limbs were identified throughout the proposed maintenance area. An 8" CMP outflow to Highway 68 was identified, along with a 4" PVC inlet to a catchbasin box. Visibility to existing inlets and outlets was obstructed by overgrown vegetation. Vegetation around the culvert inlet was short, allowing adequate access and visibility, though on the downstream side overgrown vegetation limited visibility of the culvert outlets.
