Storm Drainage Maintenance Plan

City of Monterey

Storm Drainage Maintenance Plan (SDMP)

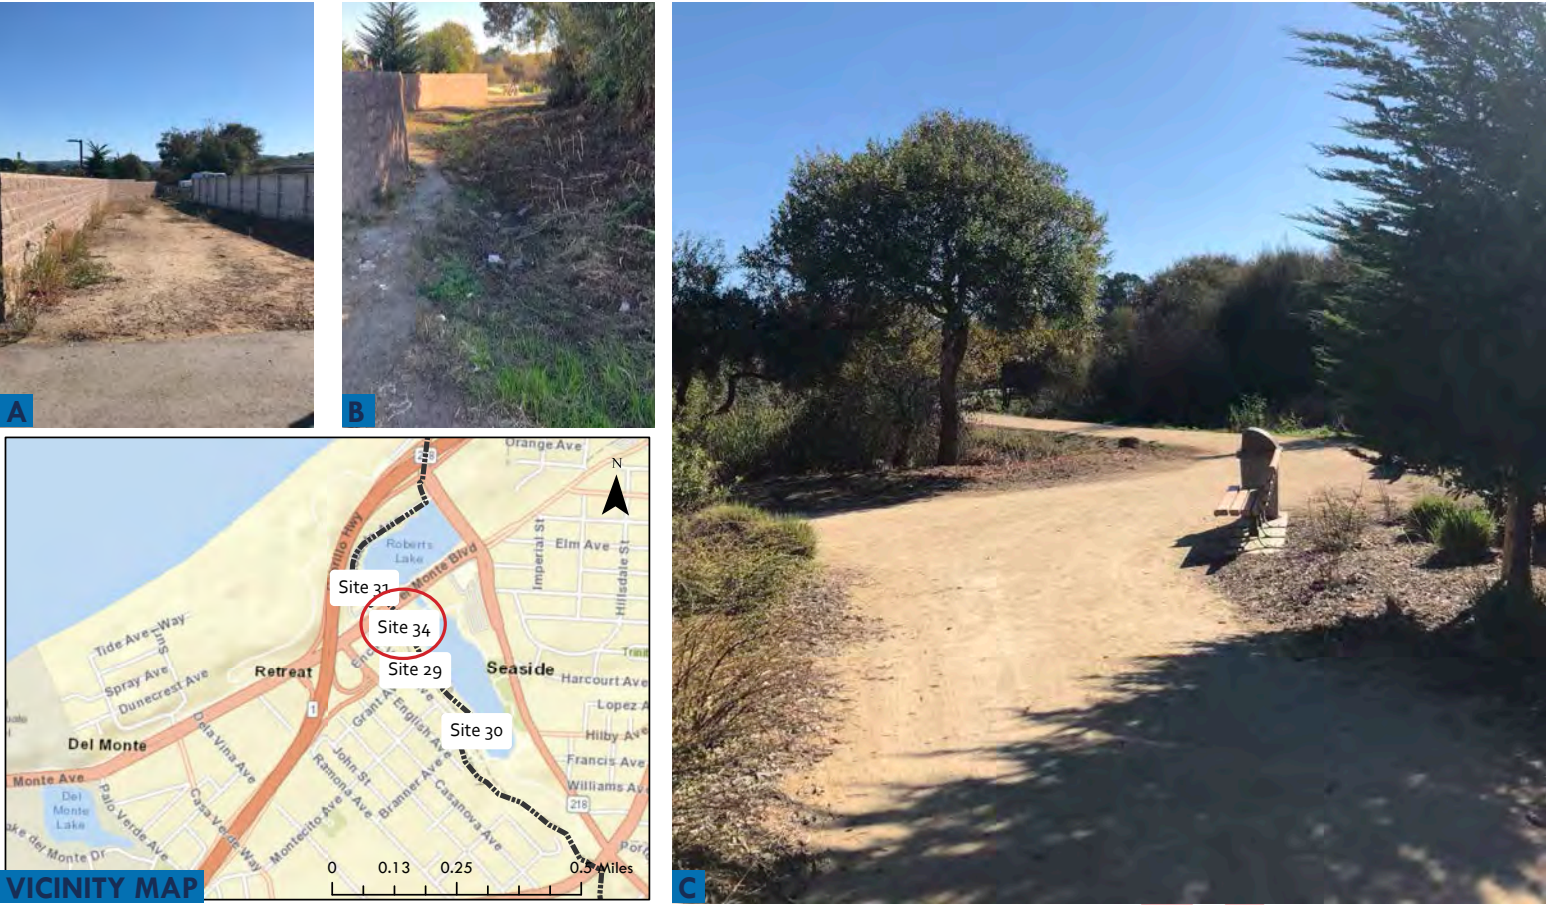
CROSS STREETS: Del Monte Boulevard and Encina Avenue
CITY DRAINAGE BASIN: LAGUNA GRANDE

Inspected on November 7, 2017. The proposed maintenance area includes a grass swale that drains northwest to southeast between commercial and residential properties toward a trail and eventual outlet into Laguna Grande Lake. Vegetation in the stormwater swale is mowed grass, whereas the riparian vegetation includes mature trees and shrubs. In both cases approximately 60% vegetation cover on the banks was observed. The adjacent land use includes single family residences and public park land. There were no significant fallen trees or tree limbs and none of the existing infrastructure is known to be undersized. No flood or erosion threats were observed.

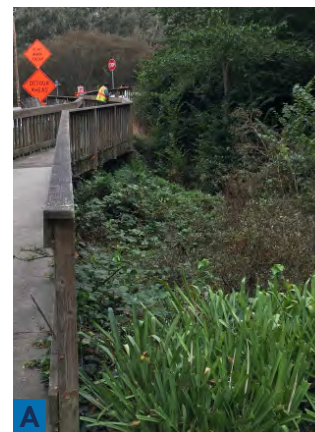
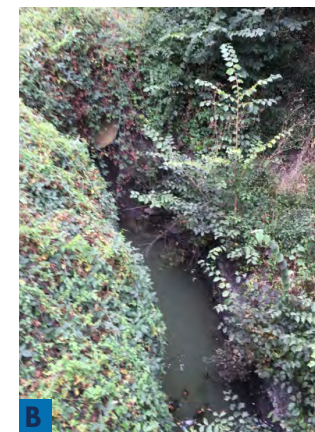
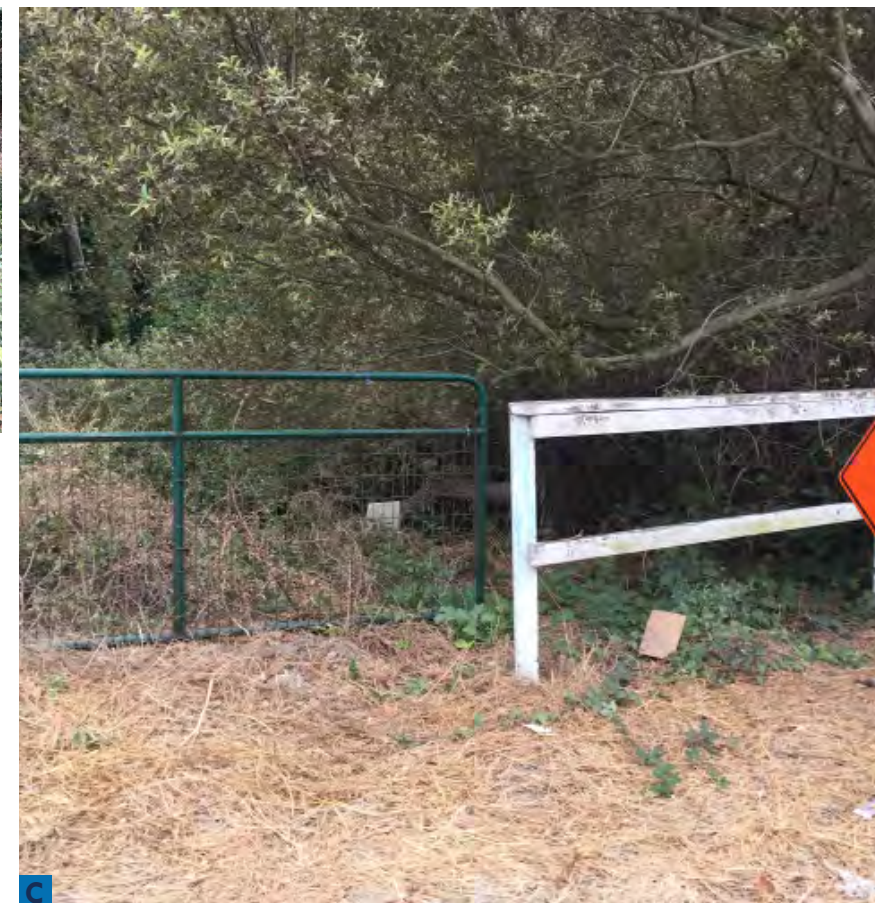
CROSS STREETS: El Dorado Street and Major Sherman Lane
CITY DRAINAGE BASIN: HARTNELL DRAINAGE

Inspected on September 13, 2017. The channel bankfull width is approximately 12-ft upstream of El Dorado Street and a trash rack on the upstream culvert inlet was clear of debris though an 8-ft long 18-inch diameter downed tree was crossing the channel upstream of the trash rack. The downstream channel section has incised approximately 5-ft below the invert of the culvert outlet and bank erosion was observed. Dense brush and trees were established along the channel banks in both the upstream and downstream sections. The adjacent land use includes professional buildings, Don Dahvee Park, single family residences, and roadways. None of the existing infrastructure is known to be undersized and no flood threats were observed. Vegetation around the culvert inlet was short, allowing adequate access and visibility, though on the downstream side overgrown vegetation limited visibility of the culvert outlets.

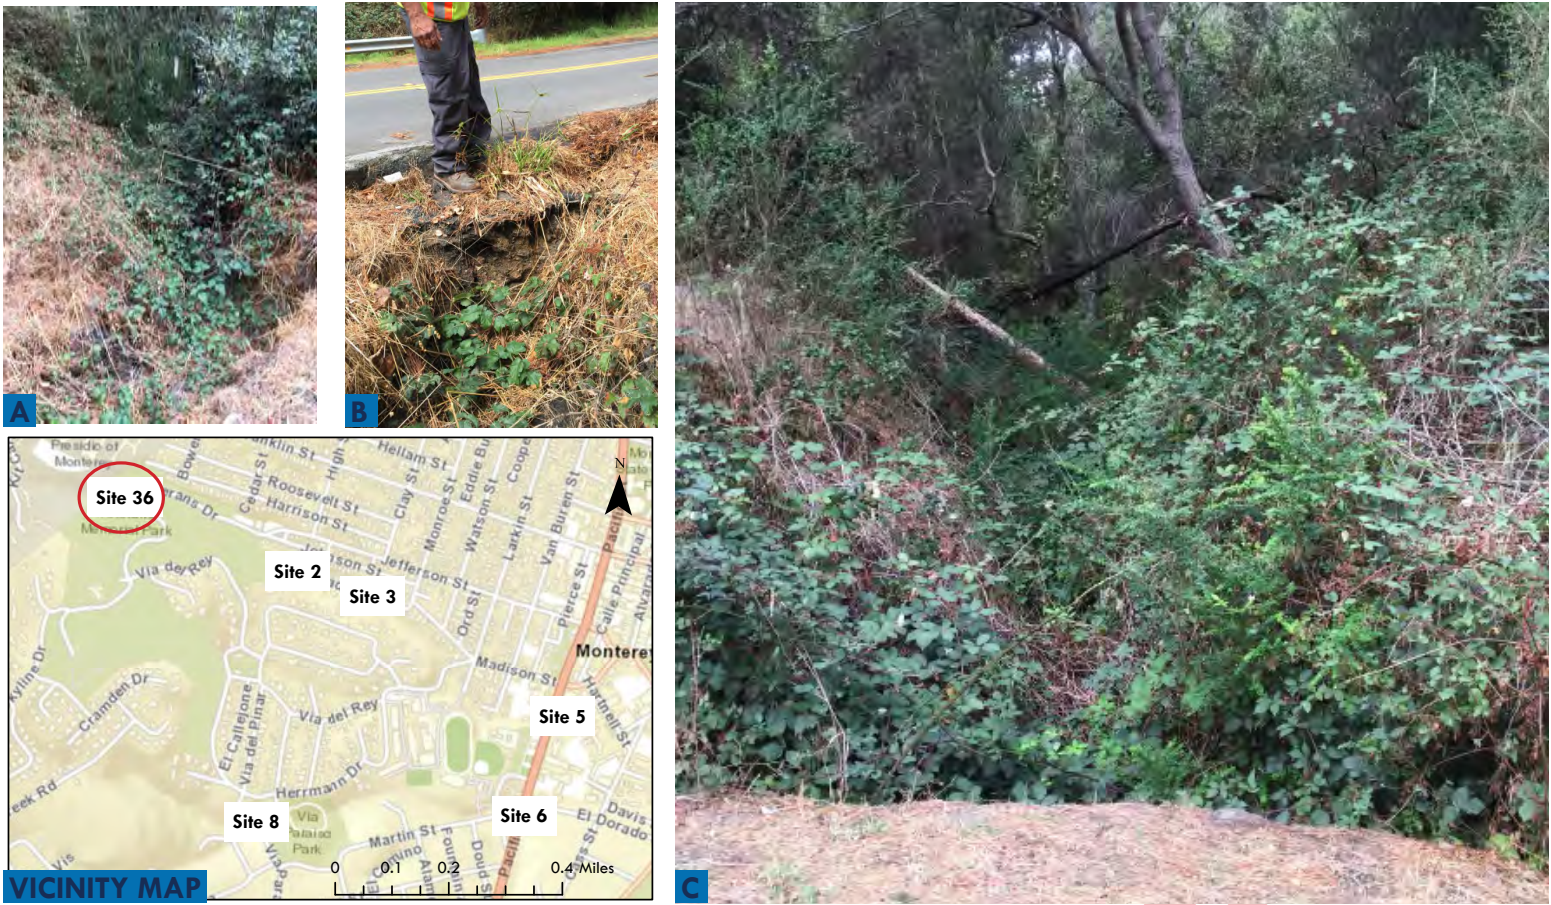
CROSS STREETS: Veterans Memorial Park Drive in Memorial Park
CITY DRAINAGE BASIN: HARTNELL DRAINAGE

Inspected on September 13, 2017. The adjacent land use includes open space (Veterans Memorial Park), roadways, and the Presidio of Monterey. Vegetation is 10-ft tall with approximately 90% vegetation cover on the banks. The dense brush on the upstream (Photo C) and downstream side (Photo A) prevented inspection of existing infrastructure. There were two approximately 24” diameter trees down across the upstream channel. None of the existing infrastructure is known to be undersized. Erosion was observed where surface runoff from Veterans Memorial Park Drive enters the downstream channel (Photo B).

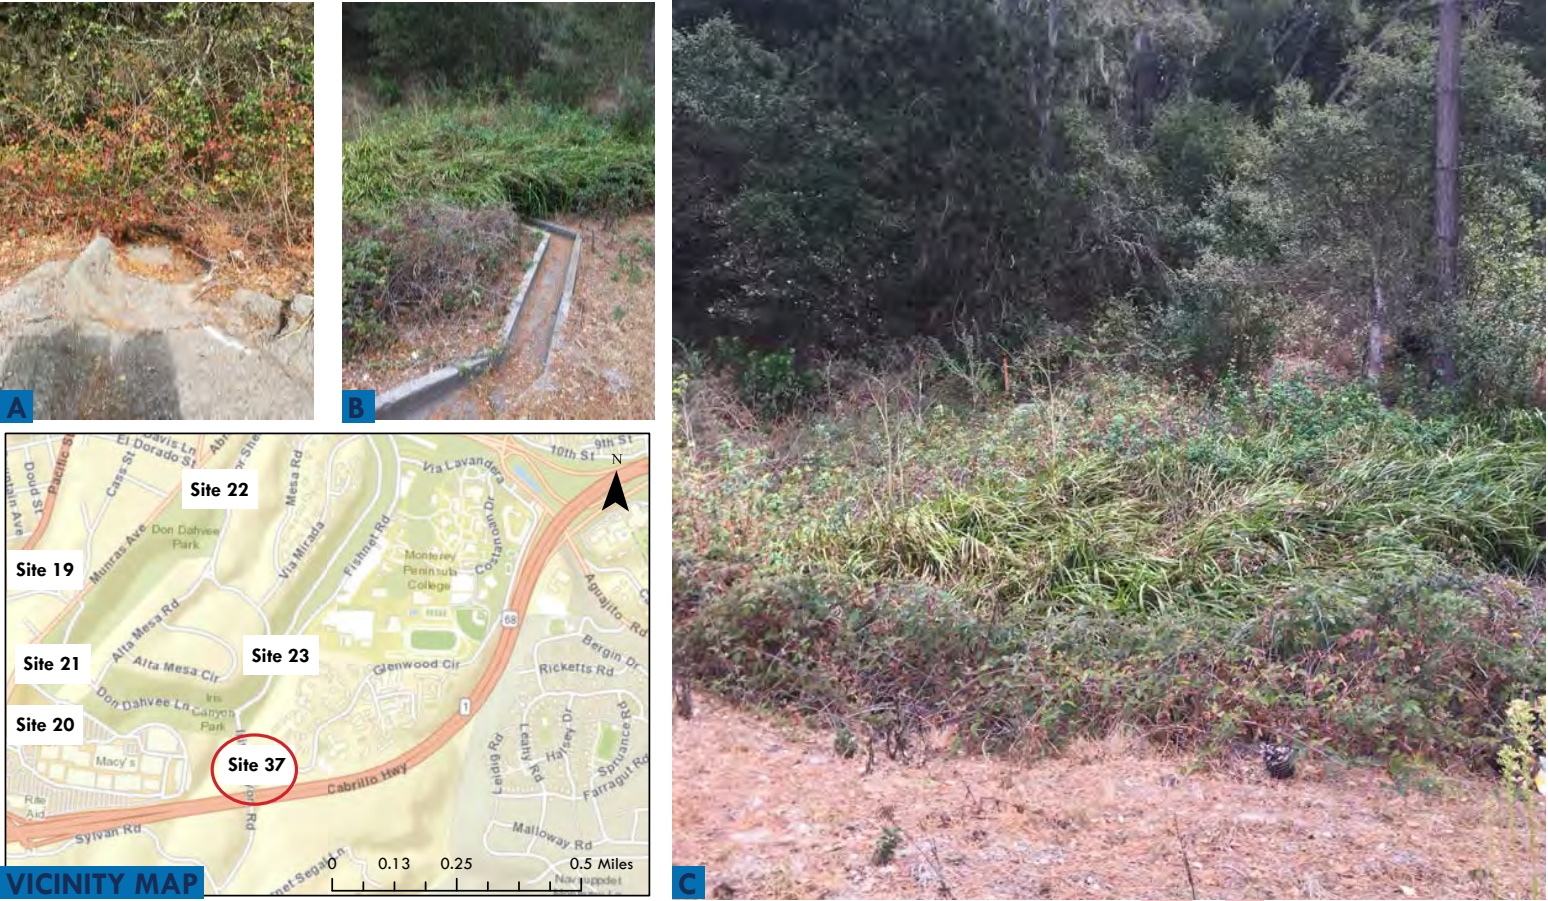
Inspected on September 13, 2017. Site includes an earthen channel flowing between open space, roadways, and multi-family apartments. Vegetation and accumulated sediment prevented access and evaluation of the channel and associated conveyance infrastructure. Vegetation is berries, pampas grass, and poison oak with 90% vegetative cover observed on banks. No significant fallen trees or tree limbs were observed and none of the existing infrastructure is known to be undersized. Vegetation in the vicinity of Glenwood Circle was dense and overgrown, preventing adequate access and visibility to maintain the structures.

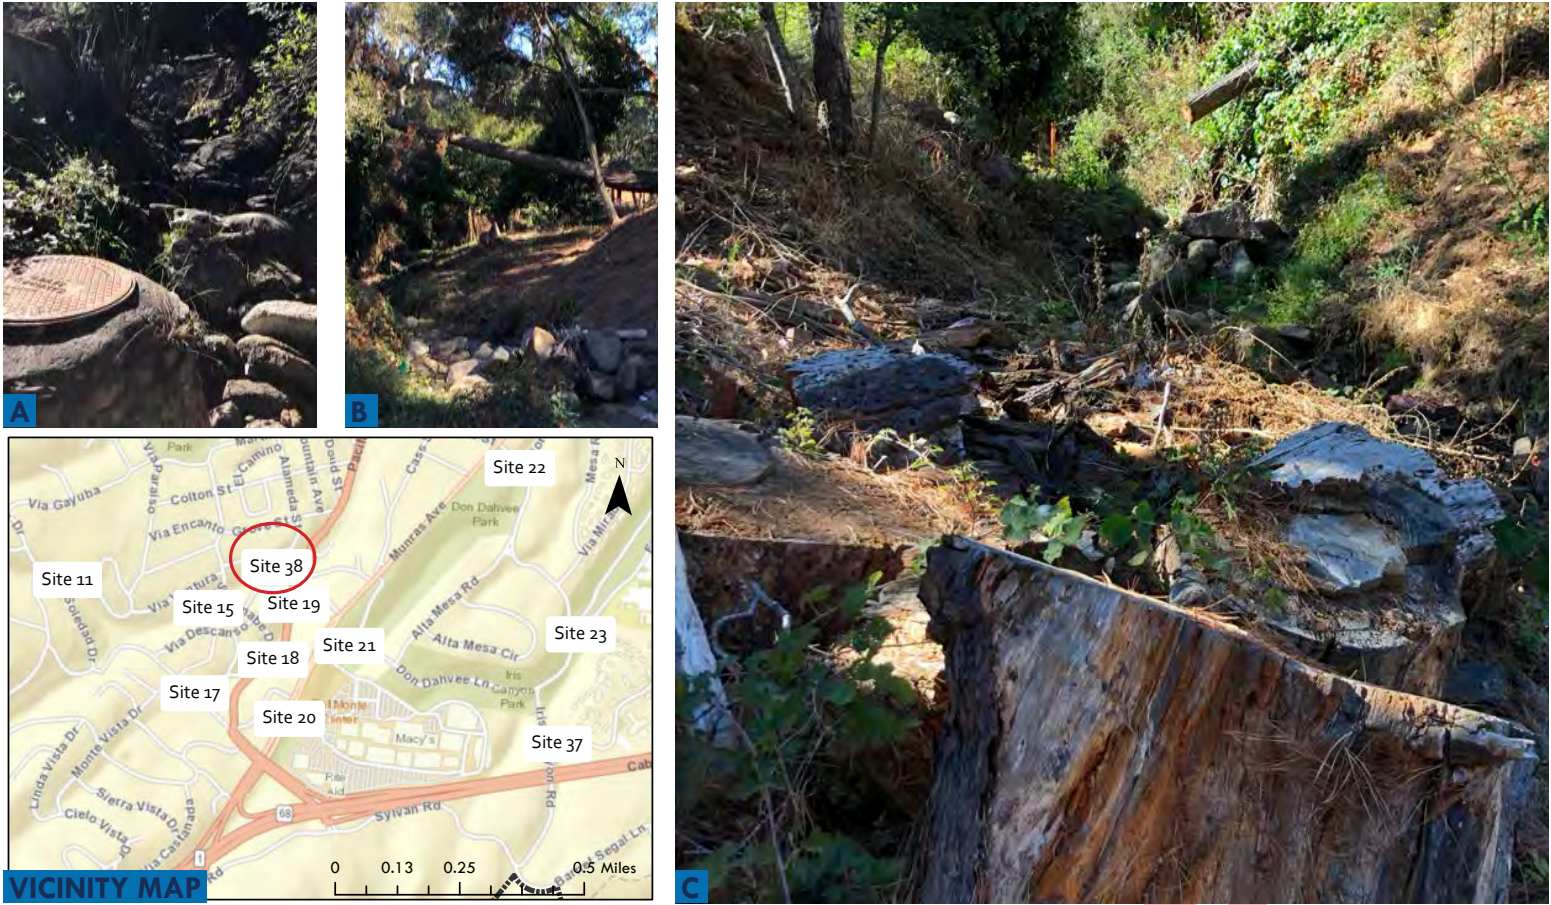
CROSS STREETS: San Bernabe Drive to Alameda Avenue
CITY DRAINAGE BASIN: HARTNELL DRAINAGE

Inspected on November 7, 2017. Site includes an earthen channel flowing between residential properties along a sewer easement (photo A) from San Bernabe Drive northeast towards Alameda Street. The channel is approximately 2-3-ft wide at its base, extending up to an open channel width of approximately 7-ft, with outlet through a box culvert beneath Alameda Street (see Site 16 description). Vegetation is mostly ivy and brambles, with some trees and 90% vegetative cover on banks. Some rock and accumulated sediment was observed along the channel bottom. There were two fallen trees identified at the time of survey (24" and 36" DBH, photo B) crossing the stream channel. Locations were observed where erosion was occurring, bank material was loose, and vegetation loss had occurred.
