**SCHMIDIG/LAM PROPERTY**  
LIVERMORE, CALIFORNIA

**PRELIMINARY GEOTECHNICAL EXPLORATION**

**PREPARED BY**  
ENGEO Incorporated

June 13, 2017

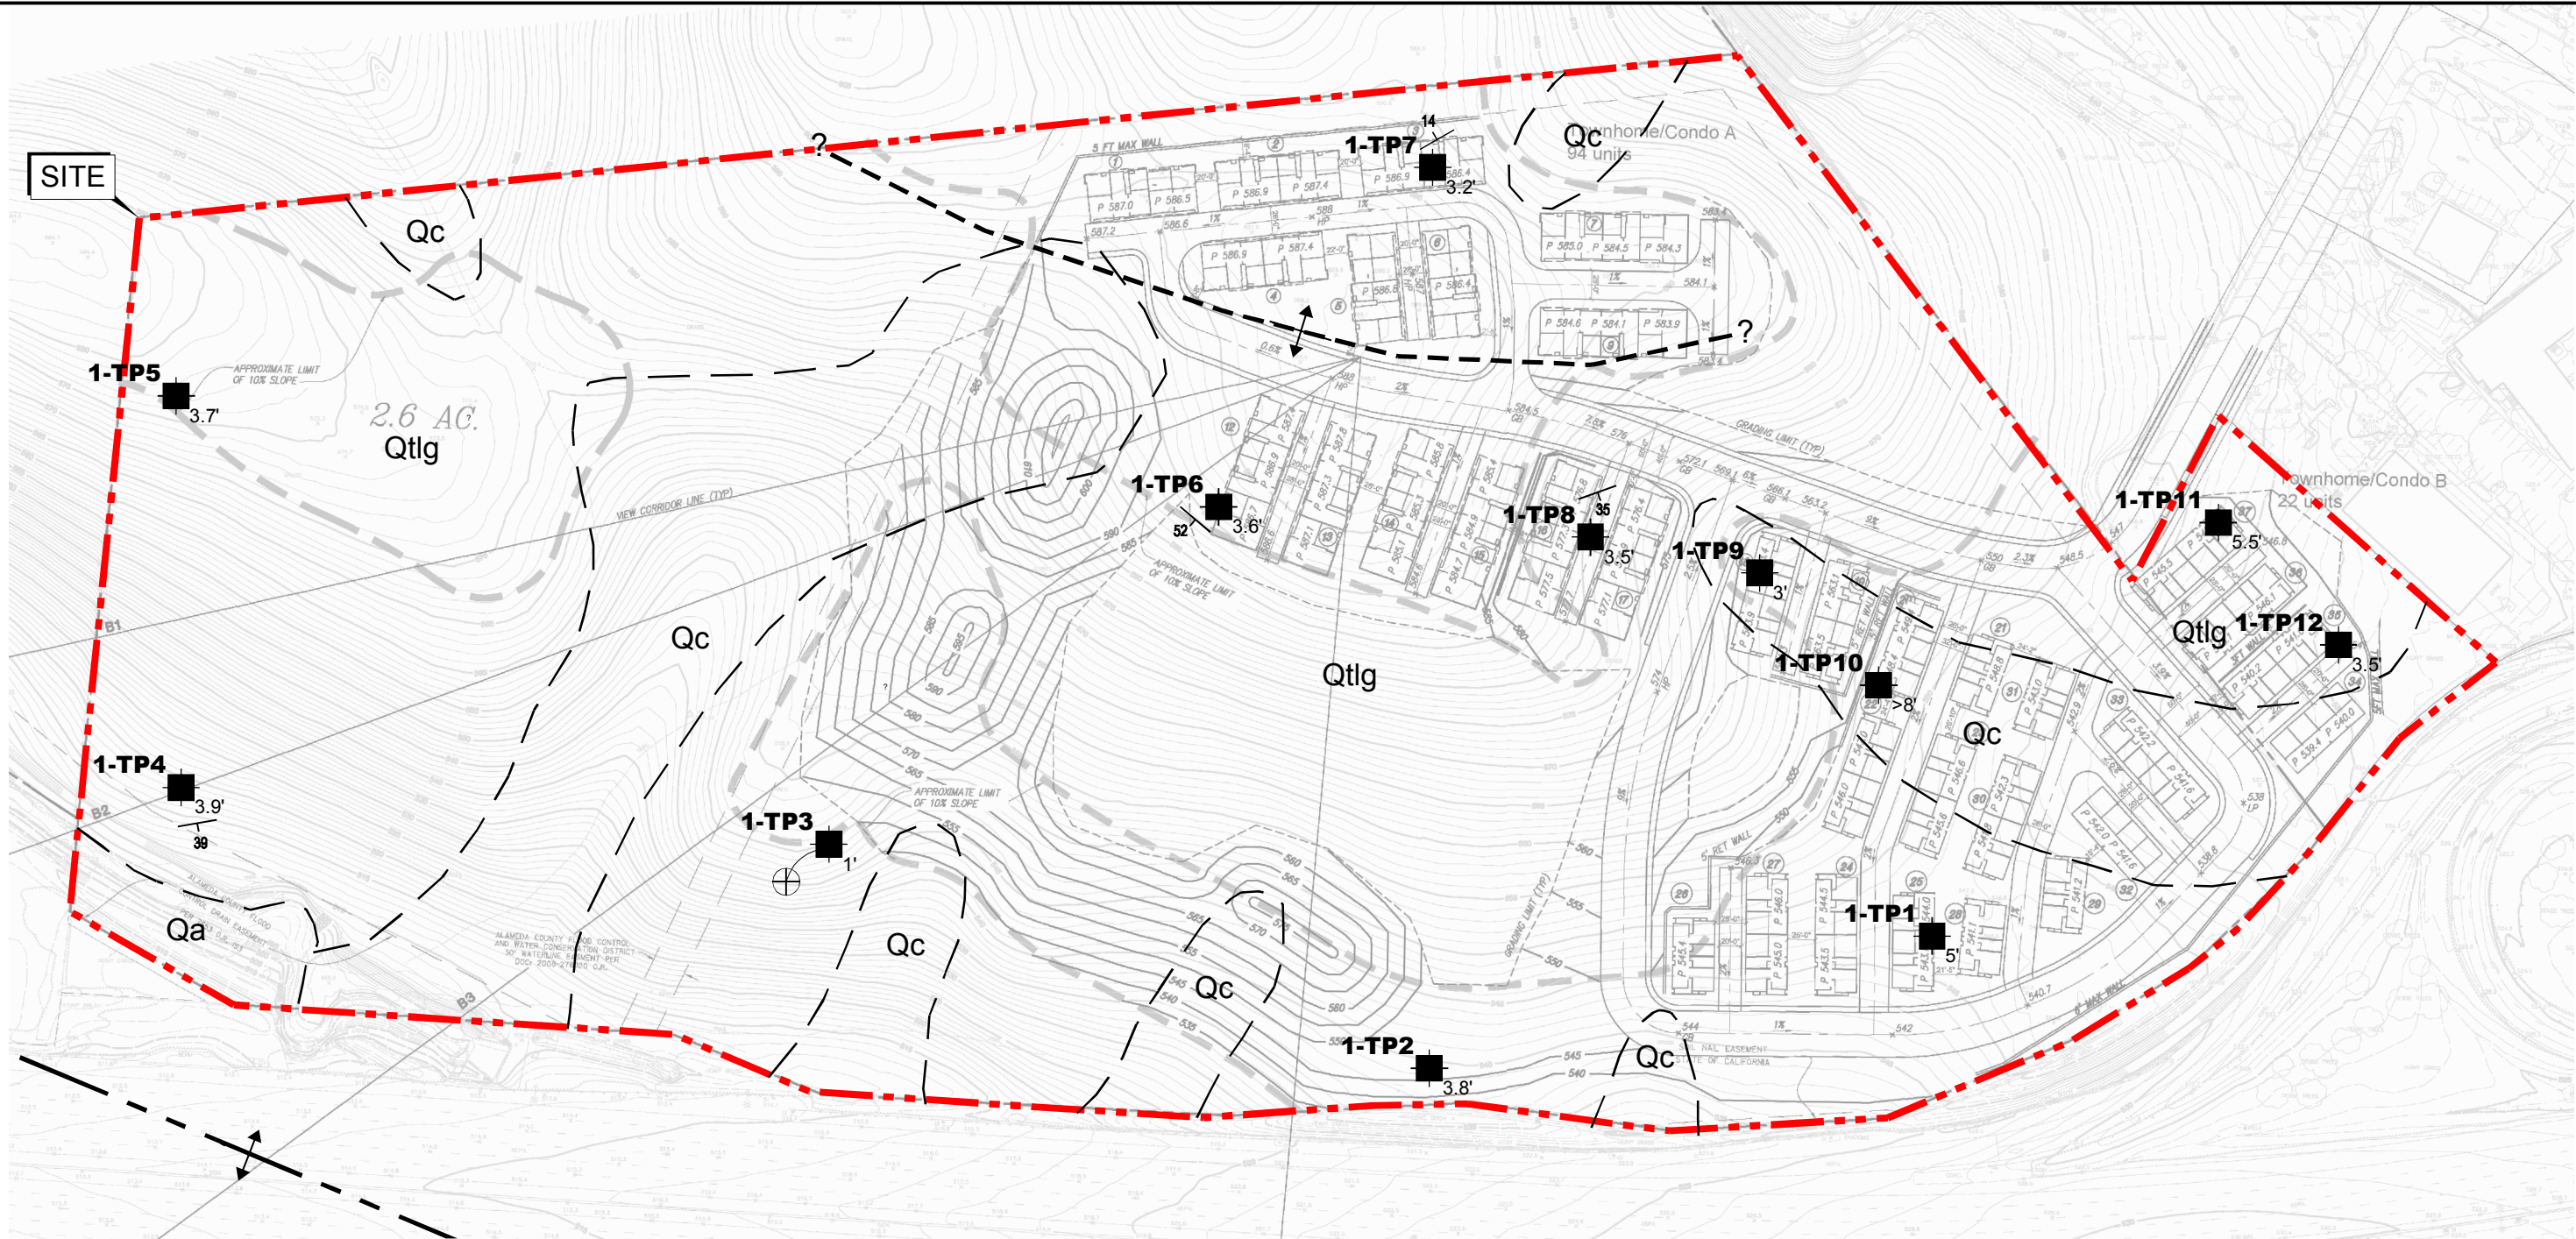
We observed excavation of twelve test pits at the locations shown on the Site Plan, Figure 2. An ENGEO geologist observed the test pit excavation and logged the subsurface conditions at each location. We retained a backhoe with a 28-inch-wide bucket to excavate the test pits and logged the type, location, and uniformity of the underlying soil and rock. The maximum depth of the test pits was 8 feet.

Consult the Site Plan and test pit logs for specific subsurface conditions at each location. We include our test pit logs in Appendix A. The logs graphically depict the subsurface conditions encountered at the time of the exploration. The depths of surficial soils or colluvium overlying bedrock are indicated at each test pit location on Figure 2.

Bedding was observed in our test pits in the Livermore Gravels, striking from approximately N70W to approximately N40E and dipping from approximately 70 degrees to the southwest to 14

degrees west (Figure 2). The bedding observed was generally consistent with Barlock (1988), who mapped an anticline to the southwest of the site. During our field mapping and test pit logging, we mapped a possible antiform near the northern portion of the site, based on the change in bedding orientation in TP-7.
