B.F. Sisk Dam Safety of Dam Modification Project Environmental Impact Statement / Environmental Impact Report

Appendix I: Biological Resources Appendix

B.F. SISK SAFETY OF DAMS MODIFICATION PROJECT

Biological Survey Report

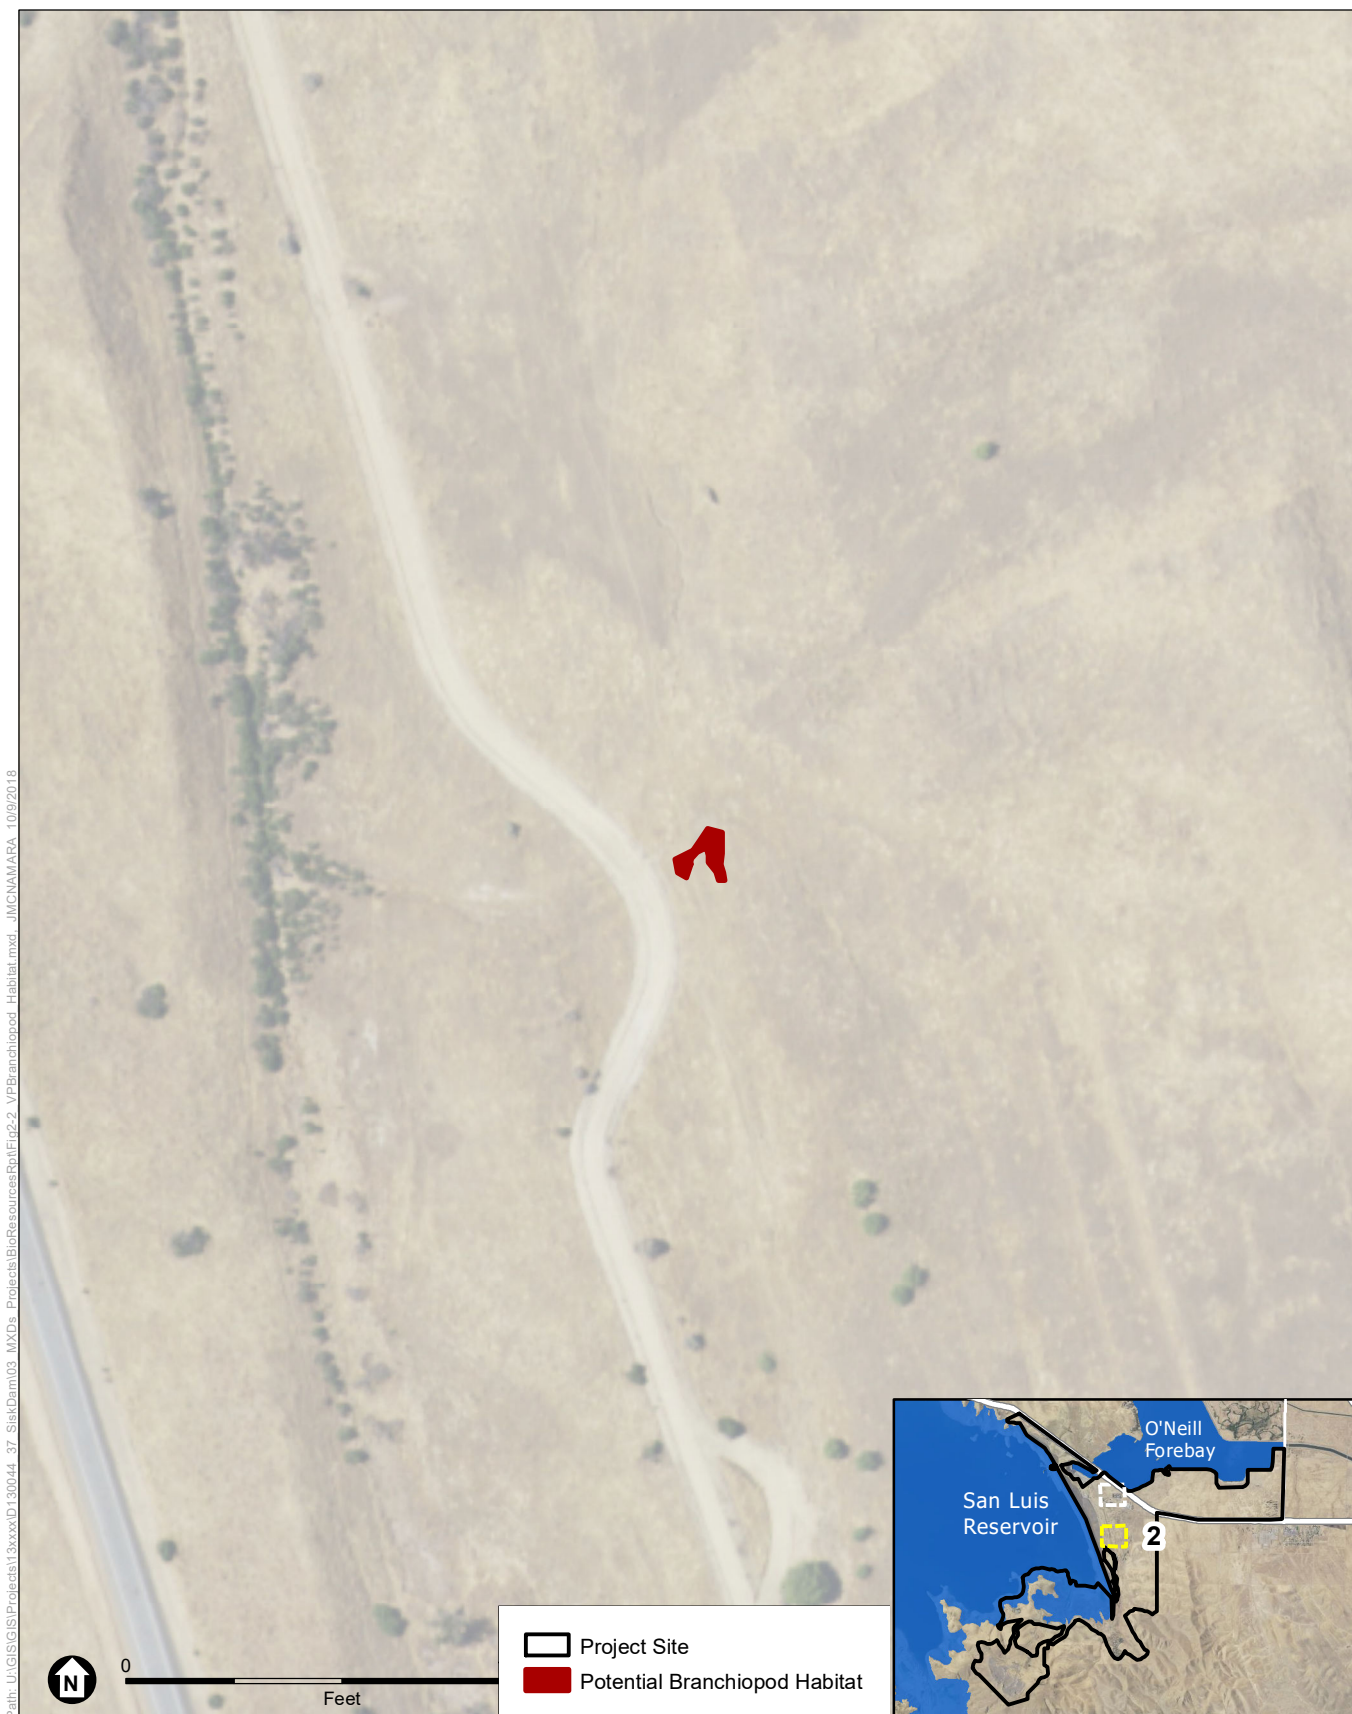
Figure 2-2

Location of Potential Vernal Pool Branchiopod Habitat

Potential listed branchiopod habitat was identified in two general areas comprised of seven small pools north of the California Department of Water Resources (DWR) maintenance yard, and one area below B.F. Sisk Dam (see **Figures 2-2** and **2-3**). Each of these features is considered to provide potential habitat based on observed hydrologic indicators and ponding depth, the absence of flow-through water, alkali conditions, algal matting, the presence of aquatic invertebrates. Based on these indicators, each of the four observed features that were characterized as potential habitat during this dry season assessment are estimated to pond greater than 3 to 6 weeks out of the year, which is sufficient to support the life cycle of vernal pool fairy shrimp and vernal pool tadpole shrimp.

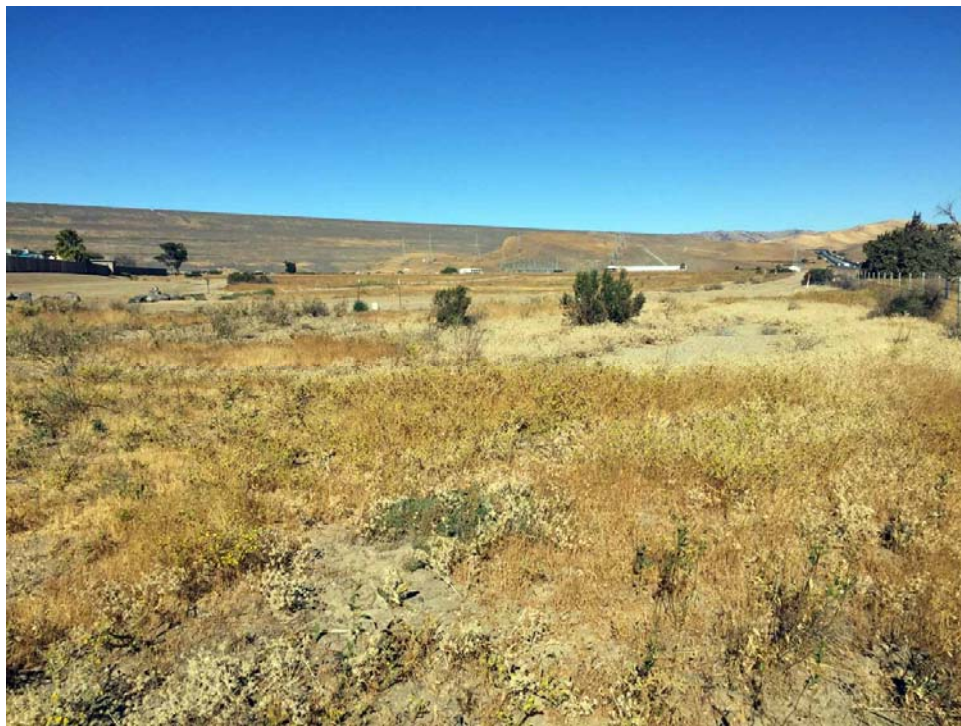
Seasonal Pools North of the DWR Maintenance Yard may Support Large Branchiopods; Algae Mats, Soil Cracking and Ostracod Shells are Present
Photo date: September 12, 2018

pools (**Figure 2-5**). These indicators show adequate ponding capacity to support vernal pool fairy shrimp maturation.

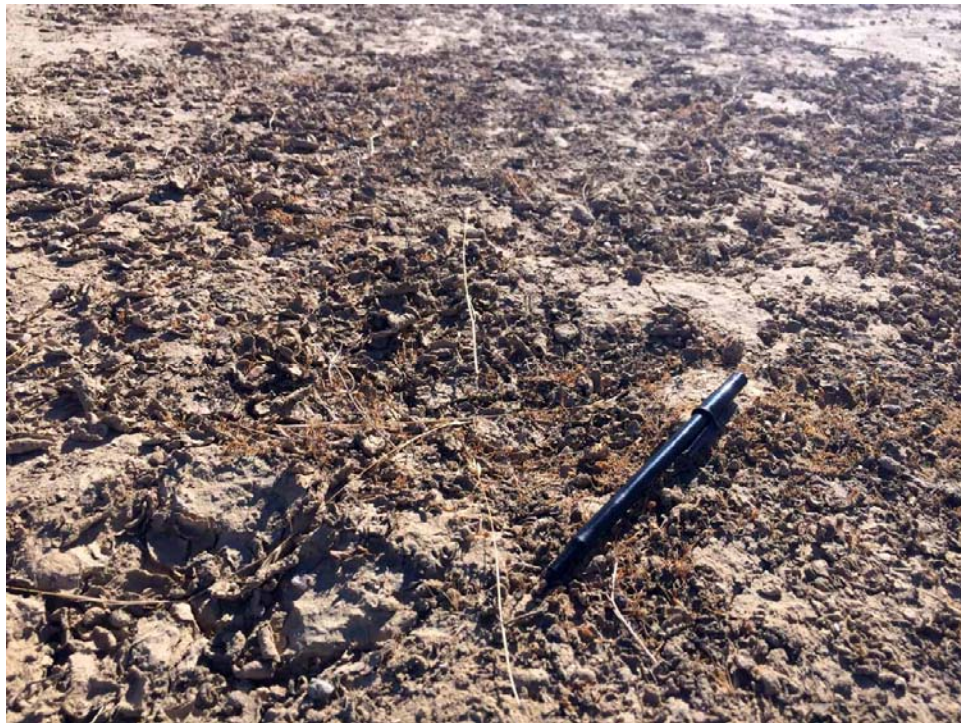
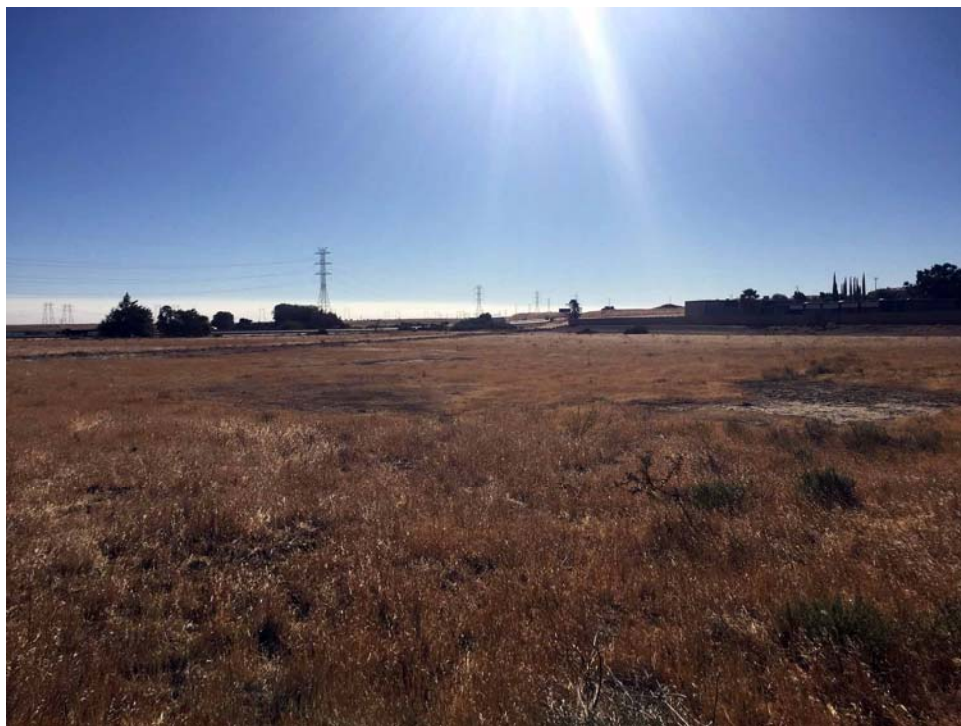
Figure 2-5
Detail of Pools North of the DWR Maintenance Yard, showing Algae Growth (Top);
and Two Pools in the Vicinity (Bottom)
Photo date: September 12, 2018

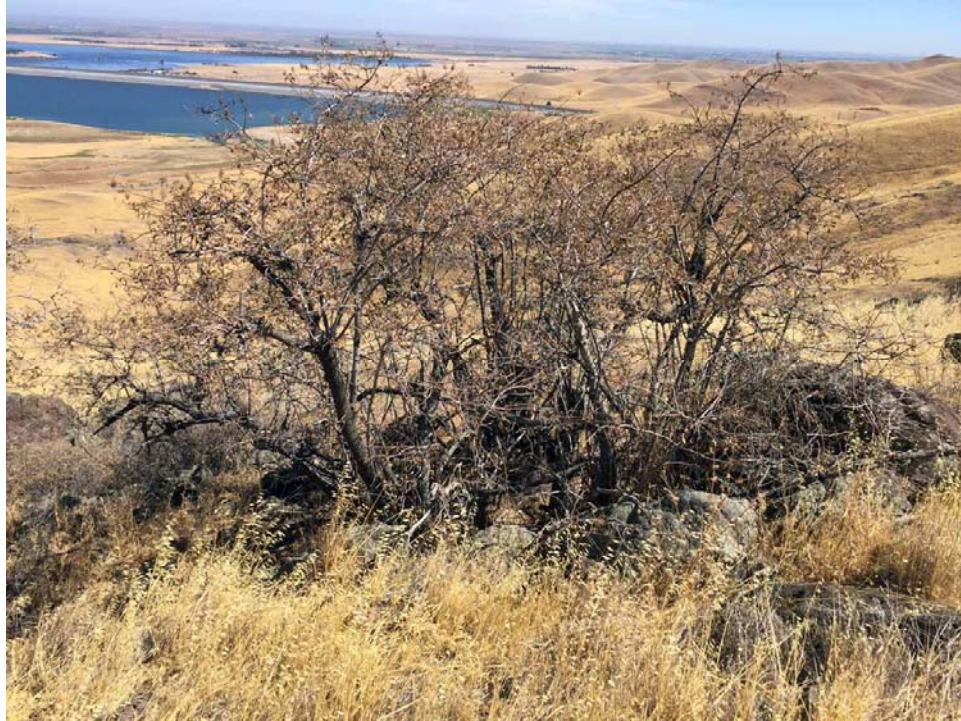
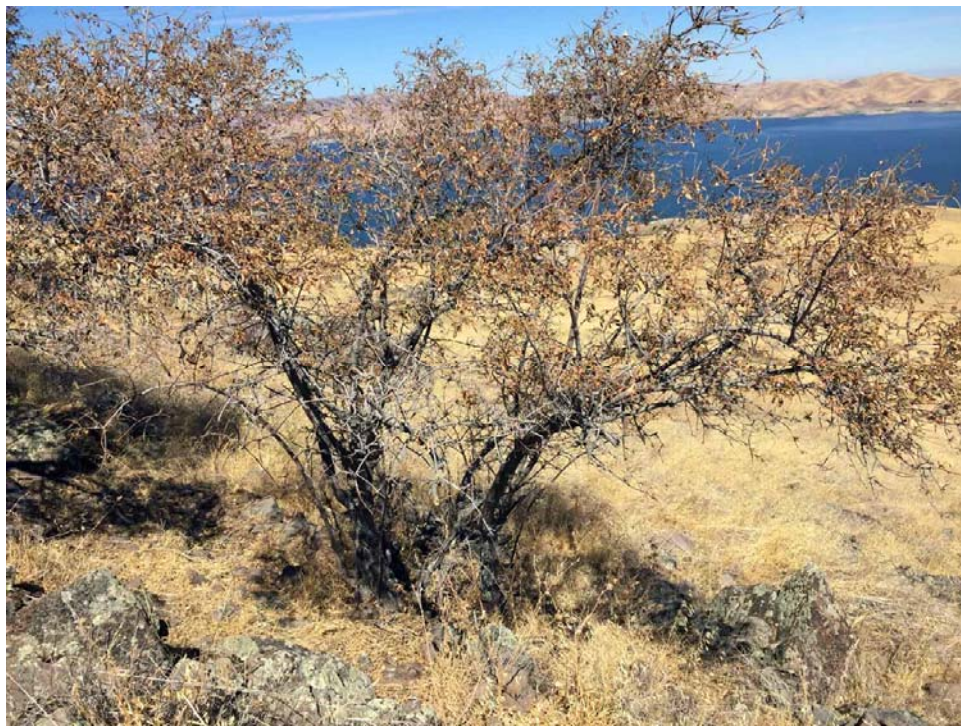
Figure 3-2
Location of Elderberry Shrubs
in the B.F. Sisk Dam Project Study Area

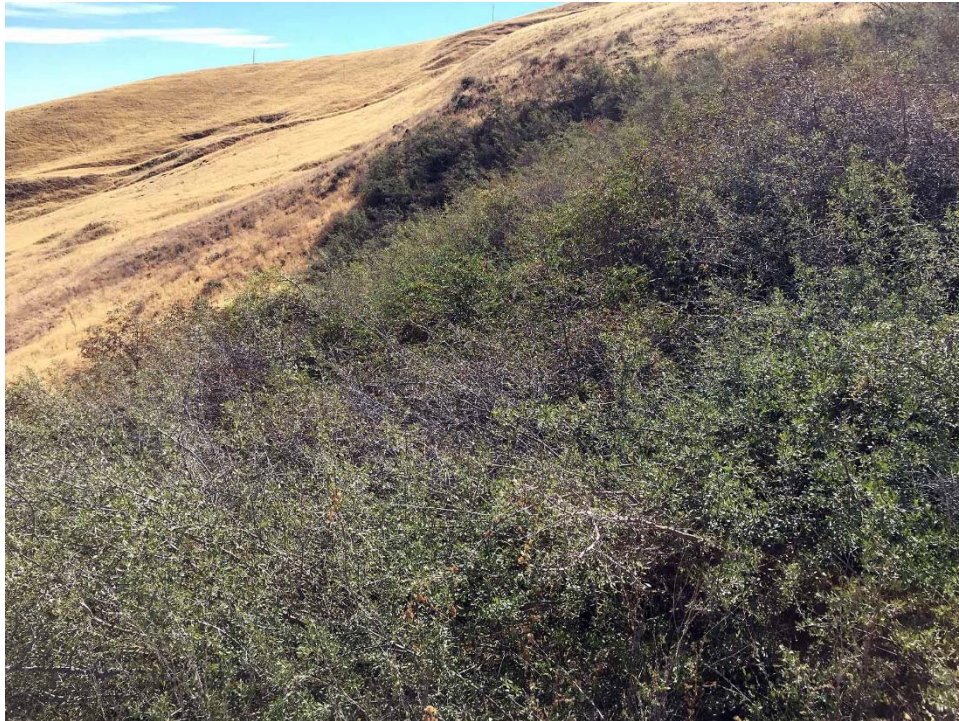
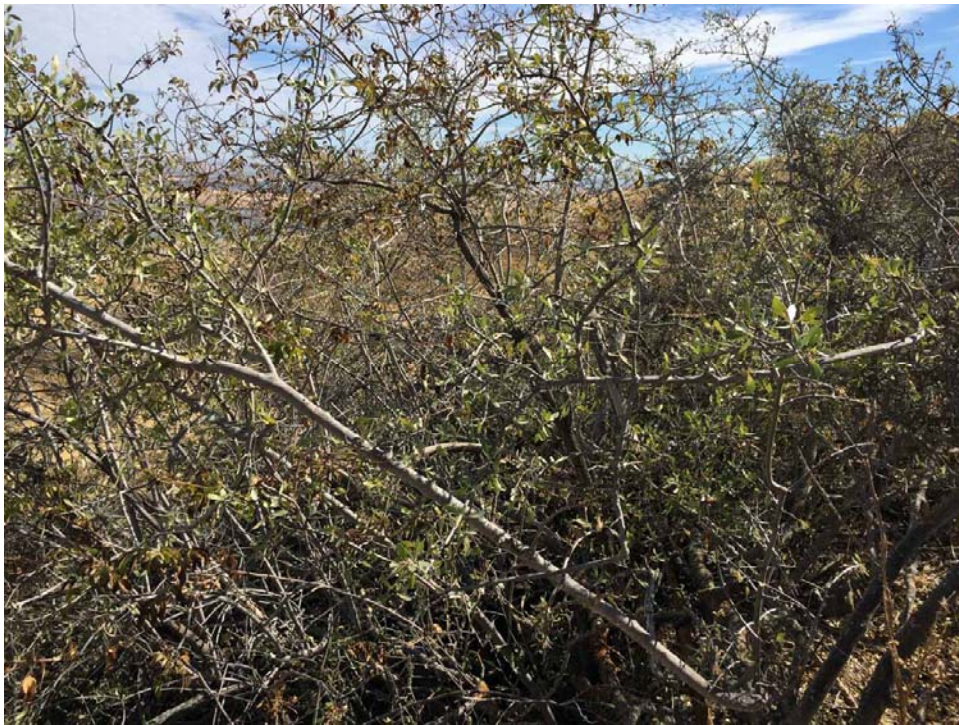
B.F. Sisk Safety of Dams Modification Project. 130314.04
Figure 3-3
Individual and Clumped Elderberry Shrubs were Identified in Poor to Moderate Health
near the Basalt Quarry Area
Photo date: September 13, 2018

The site assessment found 40 elderberry shrubs in the study area with stems greater than 1-inch diameter, principally located near the Basalt Quarry area. However, no evidence of VELB presence such as larval exit holes or adult beetles were observed on any of the generally poor-to-fair health elderberry shrubs. The VELB is considered to have a low potential to occur on inspected plants and a low to moderate potential to occur on approximately 5 to 10 inaccessible elderberry shrubs. These findings are summarized in **Table 3-1**, below.

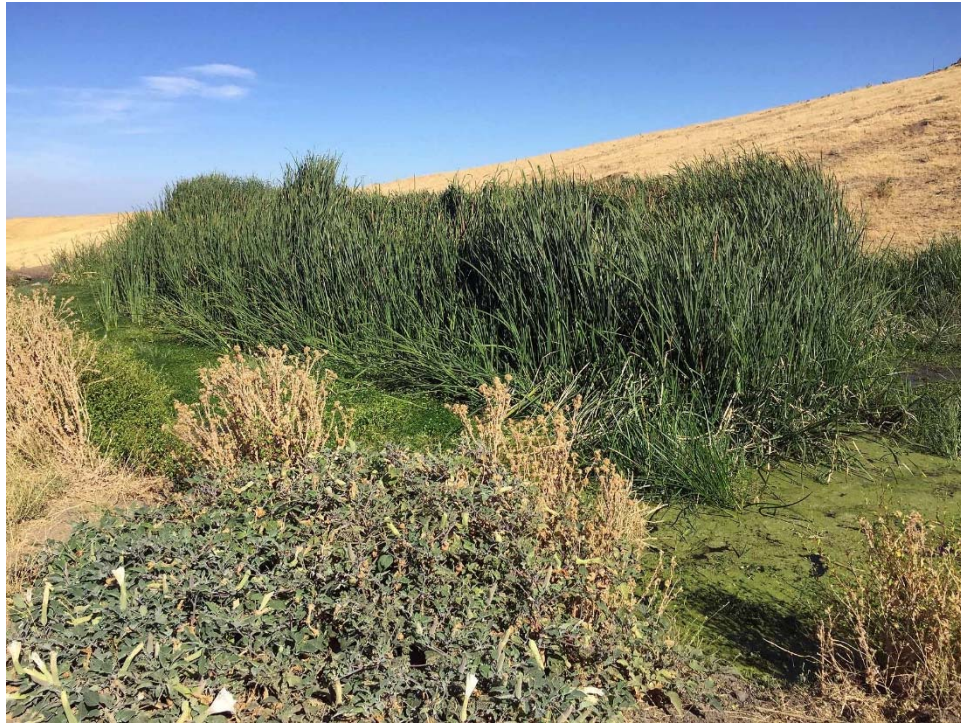
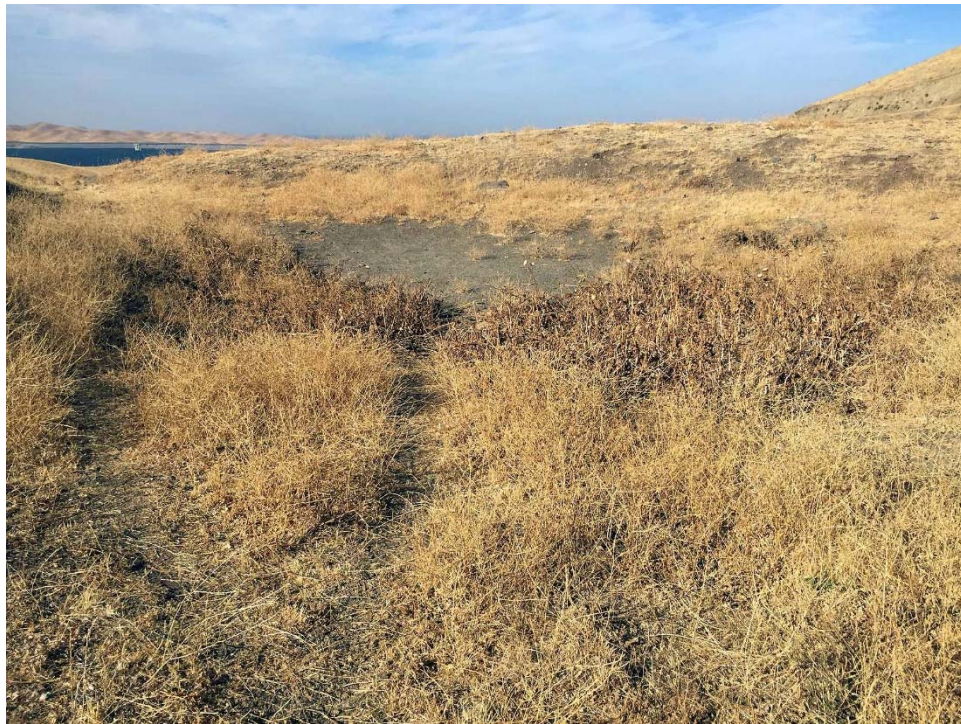
Figure 4-2
Location of Potential California Tiger Salamander Habitat
within 2 miles of the B.F. Sisk Dam Study Area

Two potential aquatic breeding sites for California tiger salamander were identified in the study area (**Figures 4-2 and 4-3**), and two such features were identified outside of the study area, southeast of the Basalt Quarry and Basalt Campground area (**Figure 4-4**; also see **Figure 5-4**). The first two sites are within B.F. Sisk Safety of Dams Modification Project area and the other two are within the typical movement range of the California tiger salamander. Three of the features directly reviewed, and the fourth off-site area is considered to provide potential breeding habitat based on a review of aerial photographs and review using binoculars from approximately 0.25-mile. These sites are further described in **Table 4-1**.

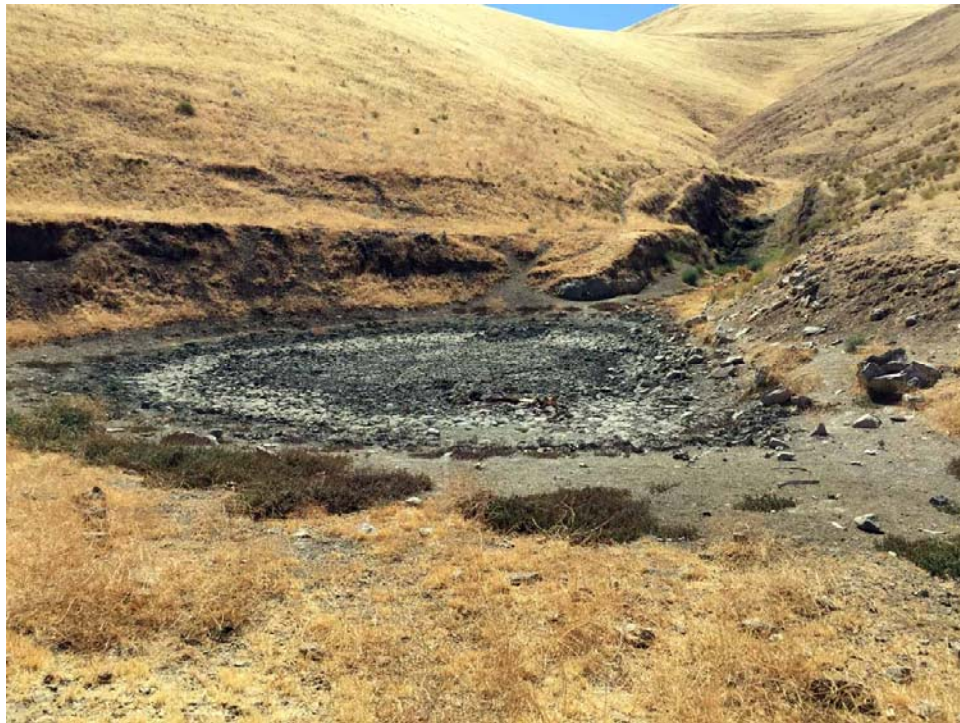
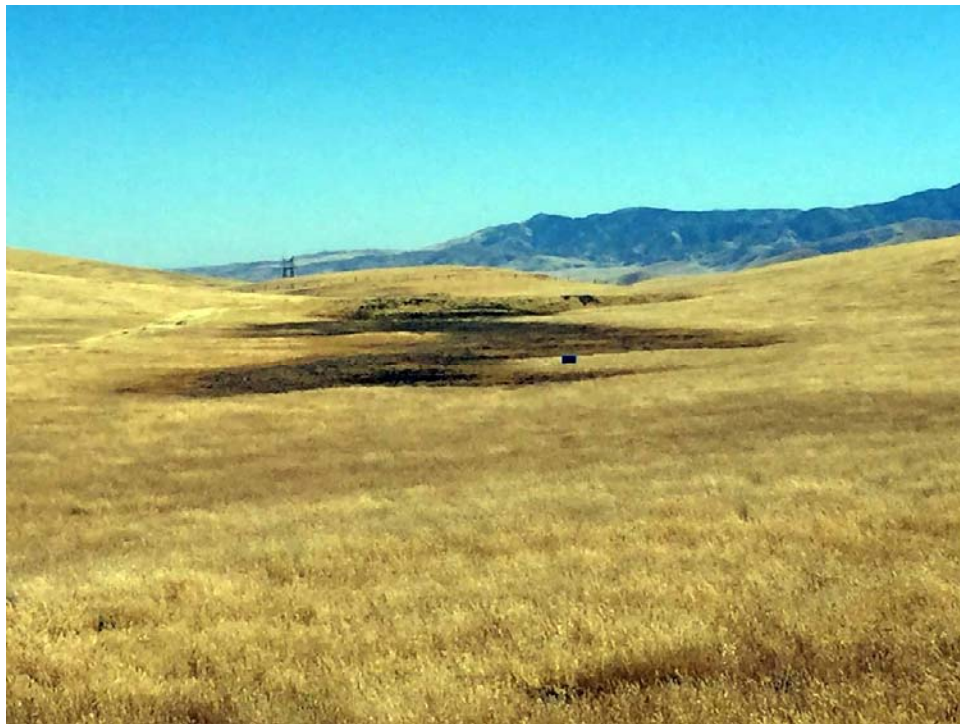
B.F. Sisk Safety of Dams Modification Project. 130314.04
Figure 4-3
Potential California Tiger Salamander Breeding Habitat at Willow Spring Pond (top)
and “Basalt Quarry Pond” (bottom)
Photo date: September 13, 2018

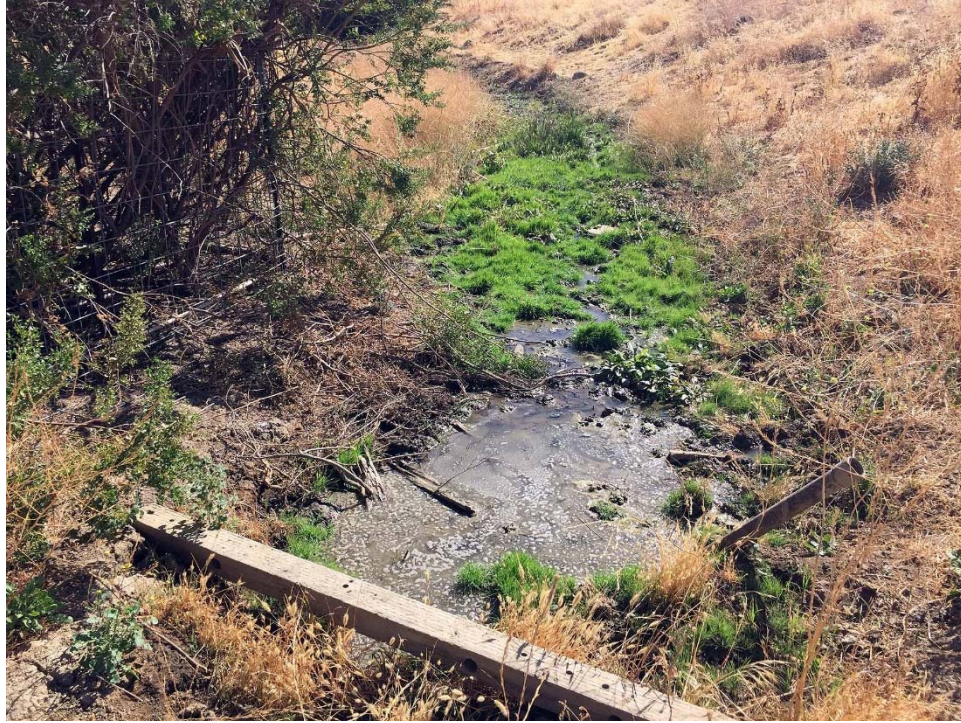
Figure 5-1

Location of Known and Potential California Red-legged Frog Habitat within 2 miles of the B.F. Sisk Dam Study Area

In addition, potential habitat for this species was identified during daytime surveys in a spring-fed stock pond located approximately 0.63-mile northwest of the Basalt Hill summit (see Figures 5-1 and 5-3). This seasonal pond is fed by a perennial spring. It is believed that the pond may serve as a suitable California red-legged frog breeding site, drying by mid-summer. The adjacent spring provides year-round non-breeding aquatic habitat that, in combination with the pond and regionally-occurring California red-legged frog populations, could support a breeding population. This pond is located outside of the B.F. Sisk Safety of Dams Modification Project area, on grazing land owned by Reclamation.

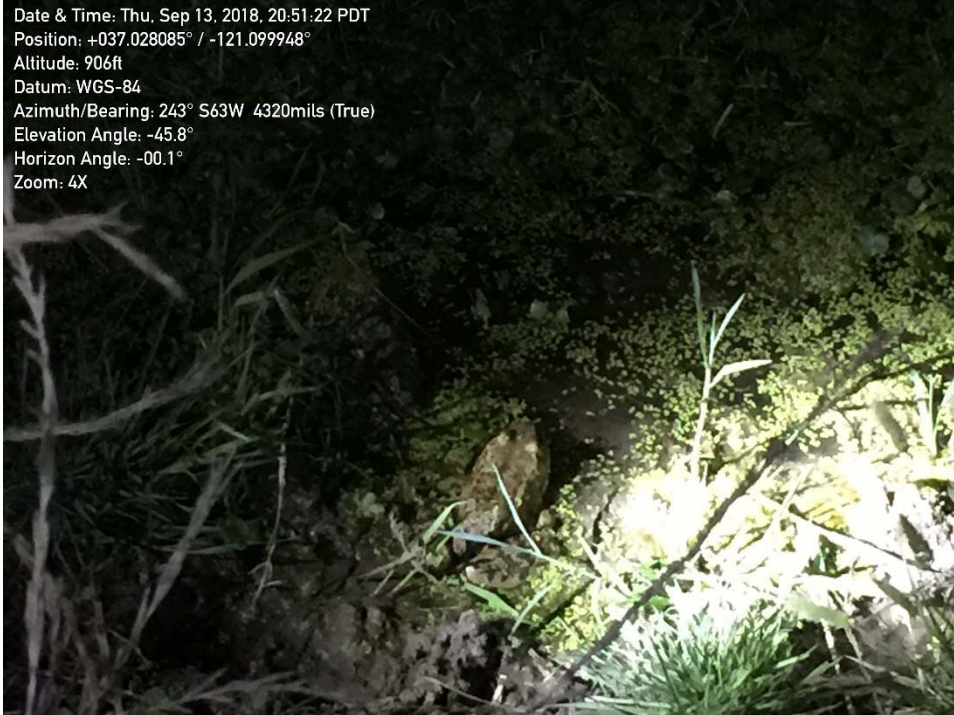
Figure 5-2

Surveyed Habitat in the Study Area included Two Spring-fed Drainages: Domengine Spring near Basalt Campground (top) and Willow Spring Pond (bottom).
Photo date: September 12, 2018

Based on the desktop review and daytime review of field sites, nighttime surveys were performed at two high quality perennial aquatic sites: Willow Spring and Domengine Spring. A California red-legged frog breeding population was identified during surveys at the Willow Spring stock pond (37.02791N, -121.10020W) (**Figures 5-1, 5-2, and 5-3**). One adult and eight subadult California red-legged frogs were identified in the pond during the night survey. Details for this occurrence are provided in the CNDDDB reporting form in **Appendix A**.

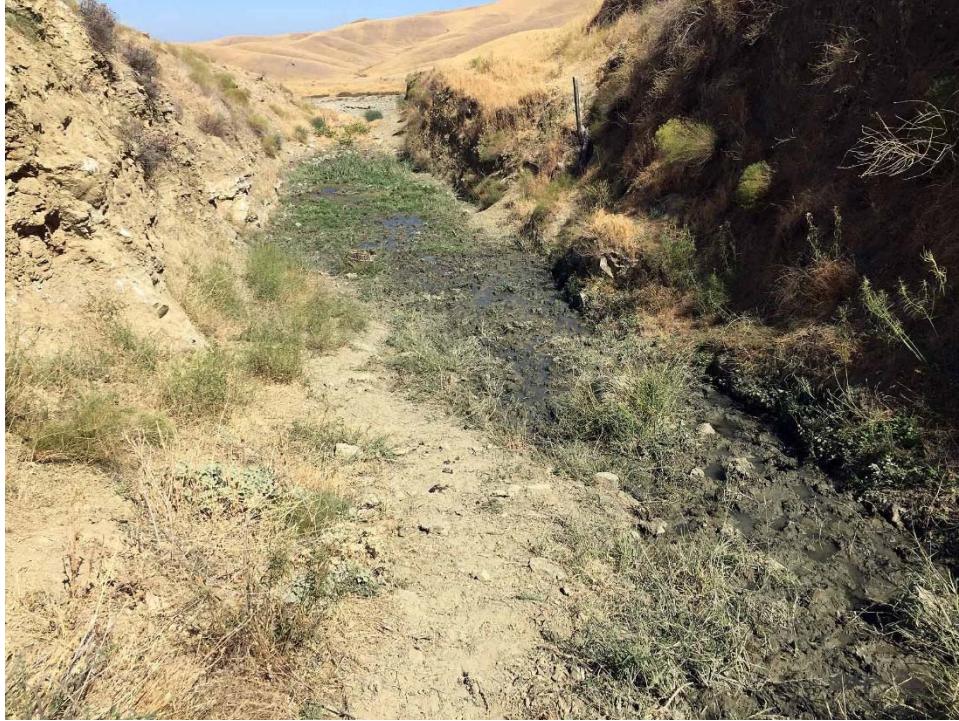
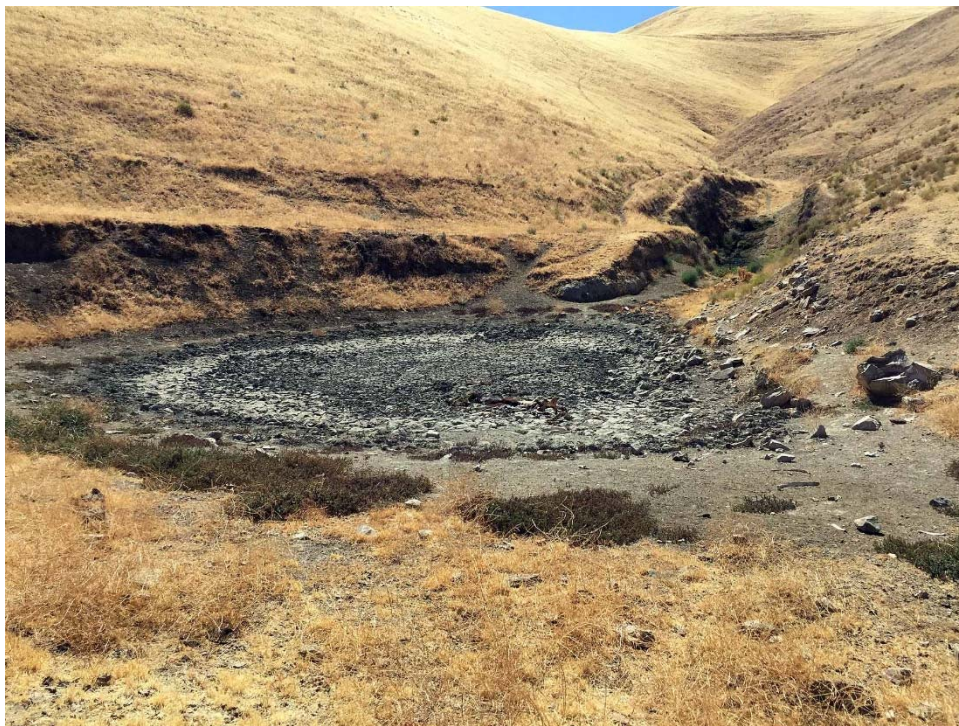
B.F. Sisk Safety of Dams Modification Project. 130314.04
Figure 5-3

A Breeding Population of California Red-legged Frogs was Detected at the Willow Spring Pond. Photos show an Adult Frog (top) and Subadult Frog (bottom).
 Photo date: September 13, 2018

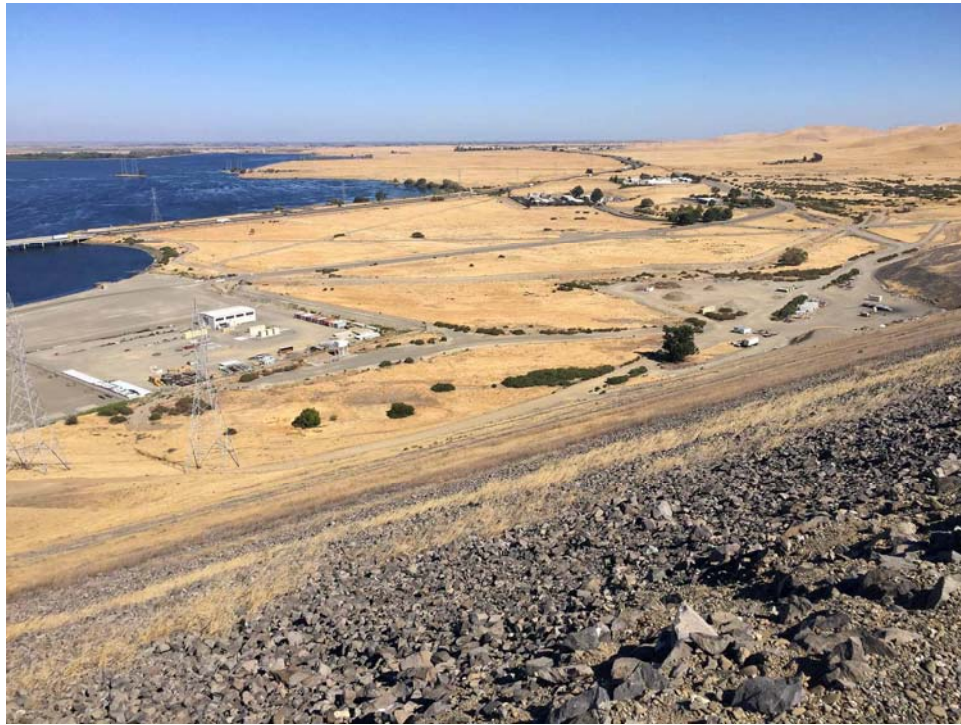
Much of the Study Area Supports Annual Grasslands that are Suitable for Burrowing Owl Nesting; seen from atop B.F. Sisk Dam looking toward O'Neill Forebay (top) and in Greater Detail (bottom). Photo date: September 12, 2018

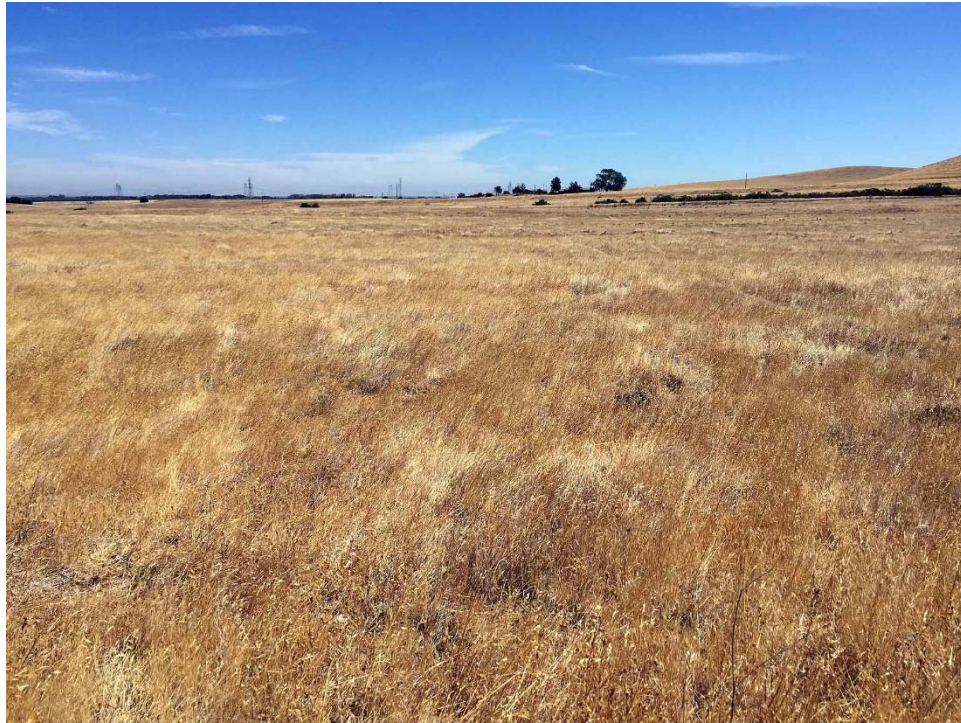
Figure 6-2
Location of Potential Burrowing Owl and Swainson's Hawk
Habitat in the B.F. Sisk Dam Project Study Area

Potential burrowing owl nesting and foraging habitat was identified in grasslands throughout the study area; however, no evidence of burrowing owl presence was noted during transect surveys within the highest quality habitat areas. Based on the field review, the distribution of potential burrowing owl nesting habitat is shown in **Figure 6-2**.

While Swainson's hawk nesting was not observed in the study area, eucalyptus, cottonwoods and other trees provide potential nesting habitat. Grasslands throughout the study area provide potential foraging habitat. The distribution of potential Swainson's hawk nesting and foraging habitat is also shown in Figure 6-2.

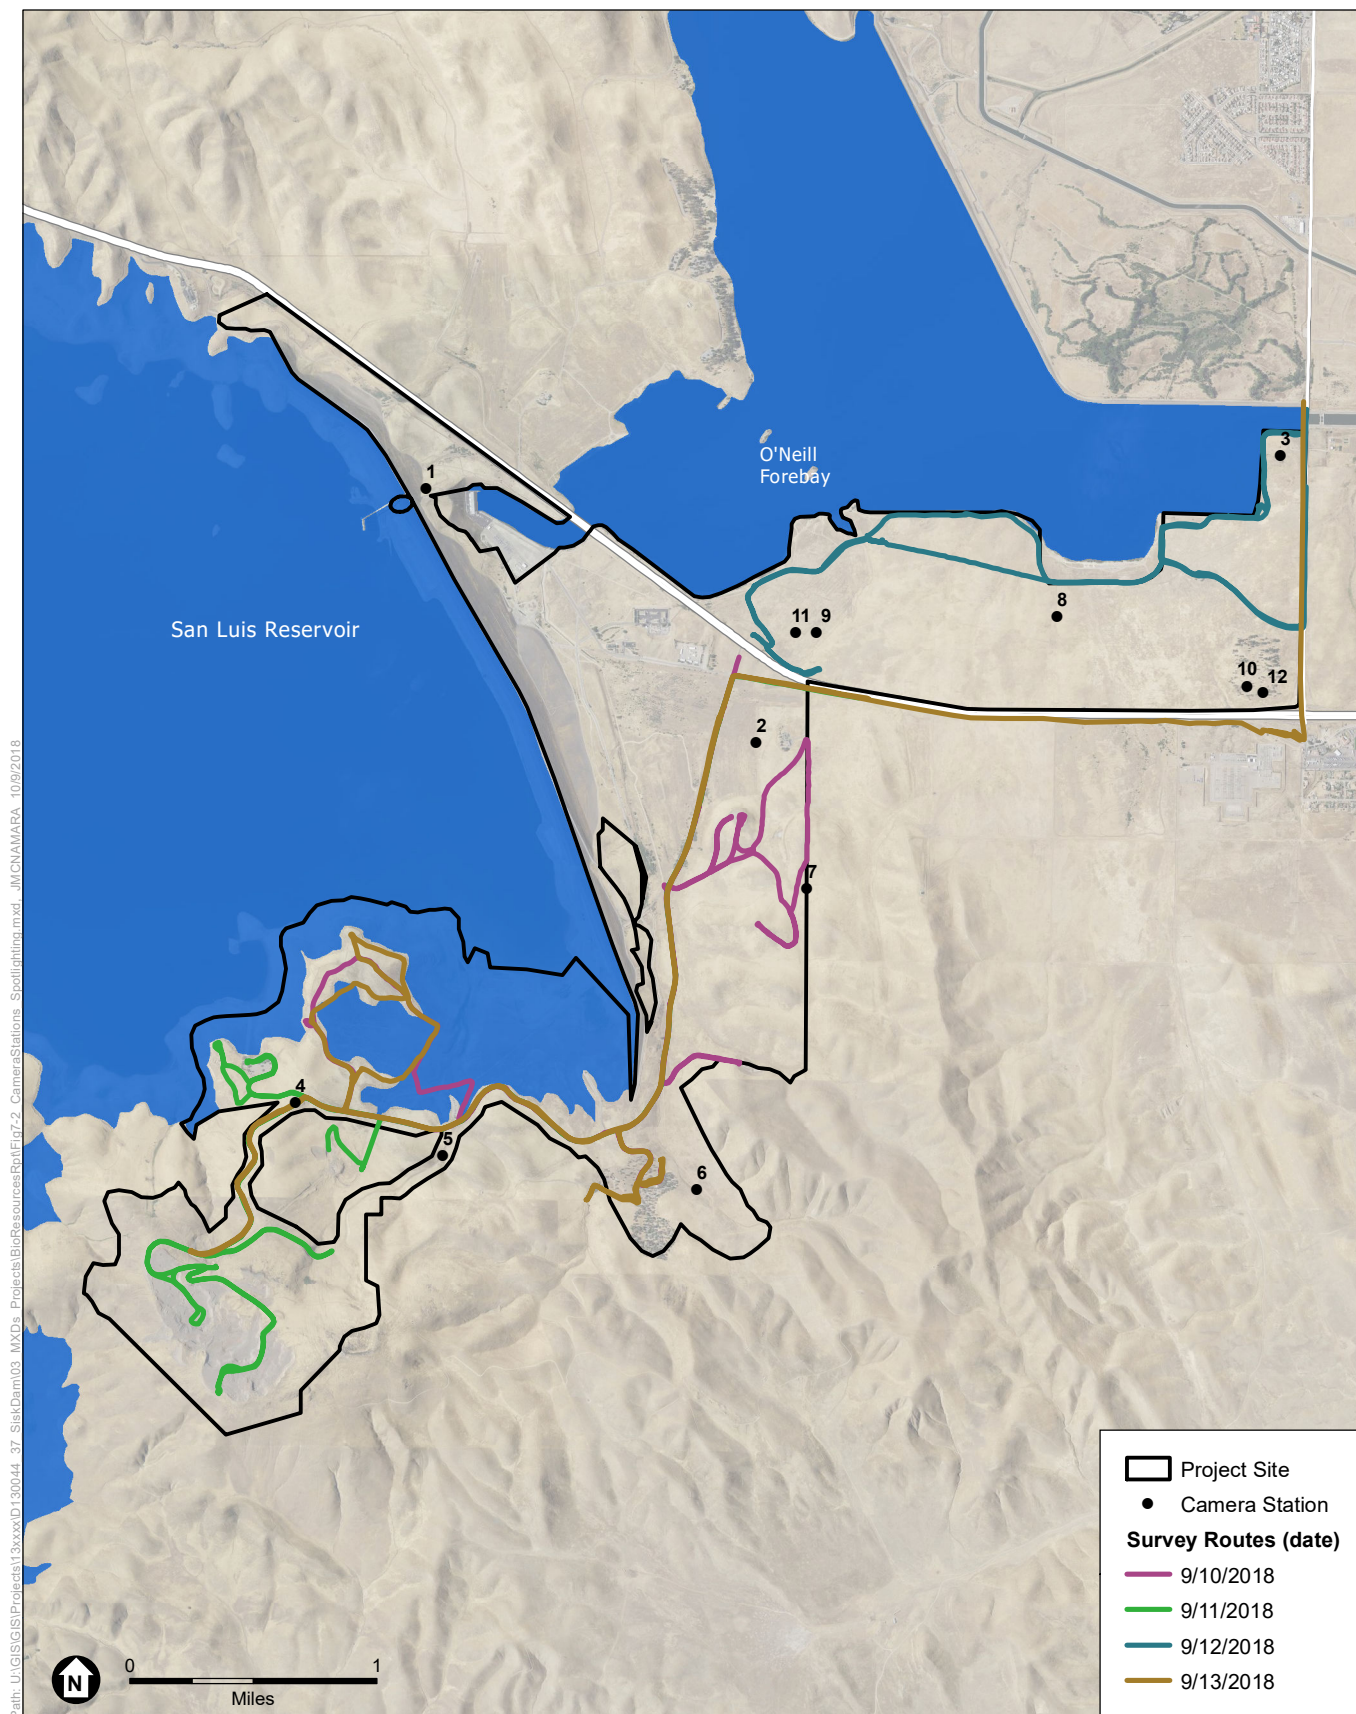
Figure 7-1
Occurrences of American Badger and San Joaquin Kit Fox
within 10 miles of the B.F. Sisk Dam Project Study Area

At least 24 San Joaquin kit fox sightings area reported within 10 miles of the study area (CDFW, 2018), including multi-year observations of numerous individuals. Within 0.75 to 5.5 miles to the south of the study area, a single CNDDDB occurrence includes sightings of 185 individuals between 1984 to 2005 (**Figure 7-1**). The next nearest sighting to the south describes 291 individuals observed from 1972 to 2003 (CDFW, 2018). Most of the recently documented kit fox sightings are pre-2005, and occur south and southeast of the study area, with scattered occurrences to the northeast (Figure 7-1).

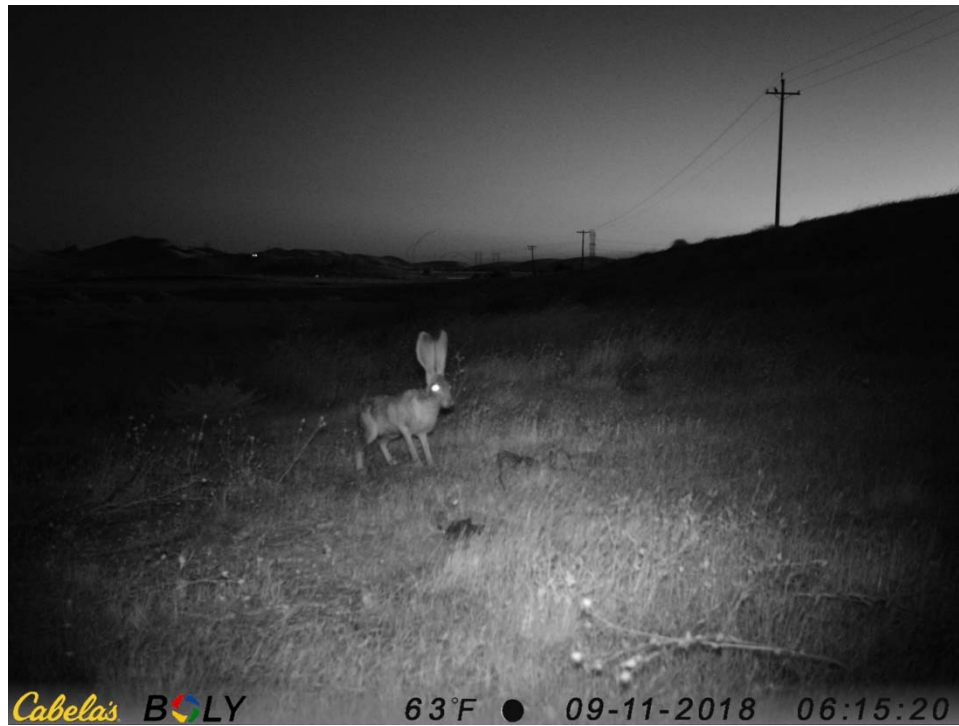
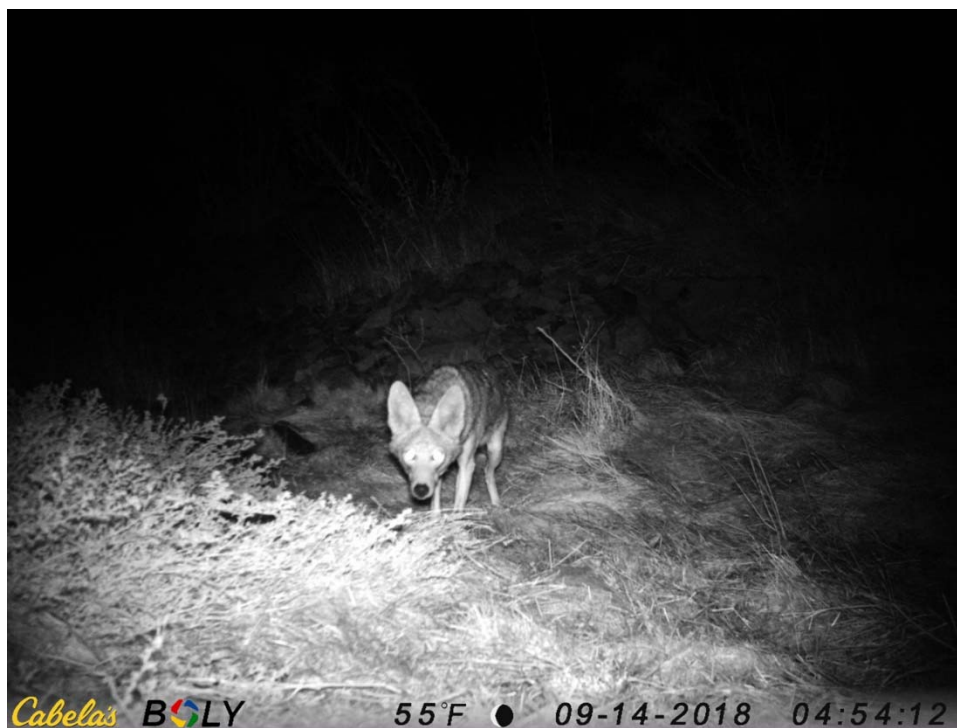
One Station Examined Wildlife Movement across the B.F. Sisk Dam (top); as Noted in the NSR (2010c) Report, Potential Kit Fox Dens occur Throughout the Study Area.

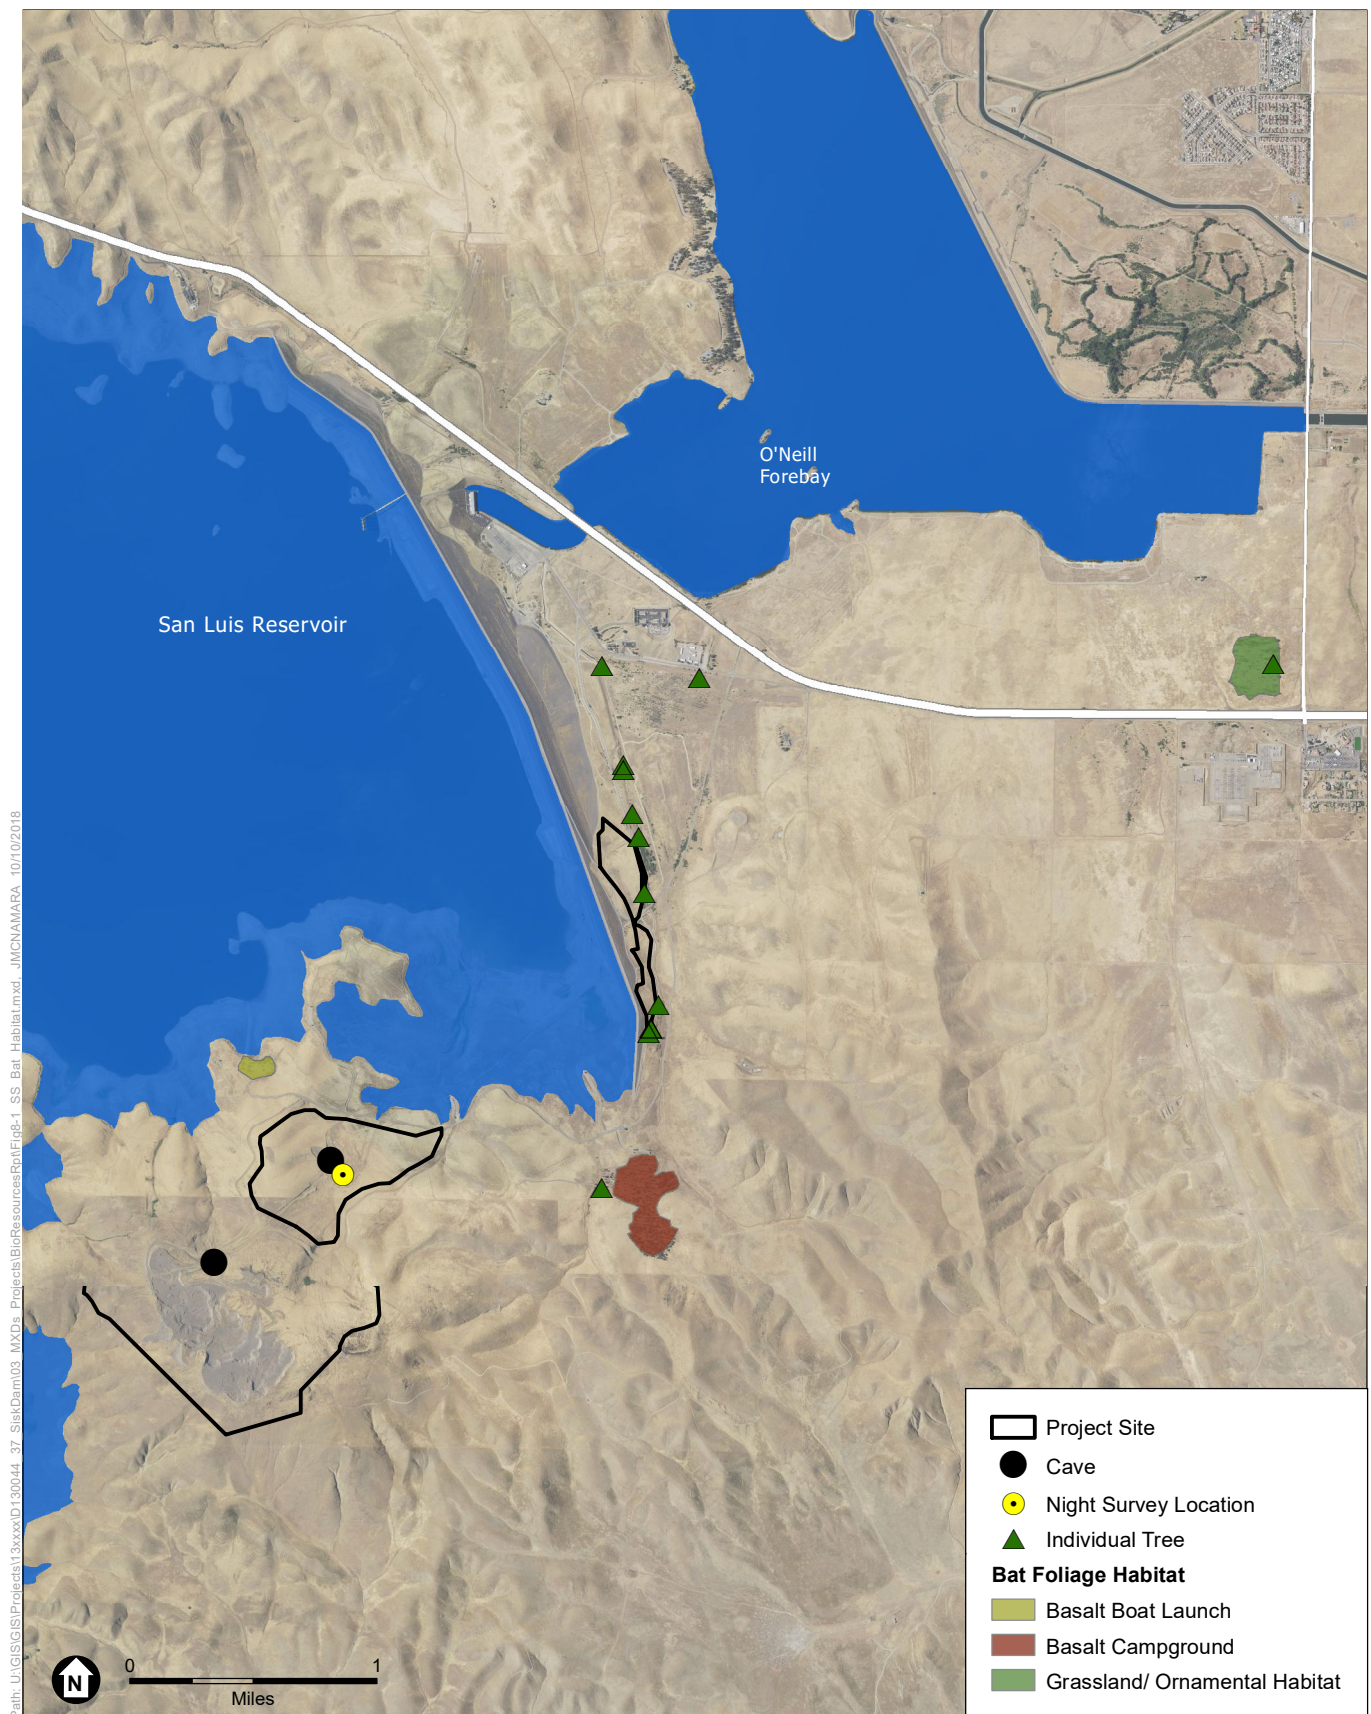
Figure 8-1
Location of Special-status Bat Habitat in the Study Area

The assessment found potential tree roosting habitat for the western red bat (*Lasiurus blossevillei*) in day use areas and other locations in the study area, as shown in Figure 8-1. Yuma myotis (*Myotis yumanensis*) and Mexican free-tailed bat (*Tadarida brasiliensis*) roosting was verified in a cavernous concrete structure near the Basalt Quarry, though the structure itself will not be subject to direct project impacts. Potential roosting by Yuma myotis and Mexican free-tailed bat are suspected at a second, similar concrete structure within the study area near the quarry. This location of all features discussed in this chapter is shown in Figure 8-1.

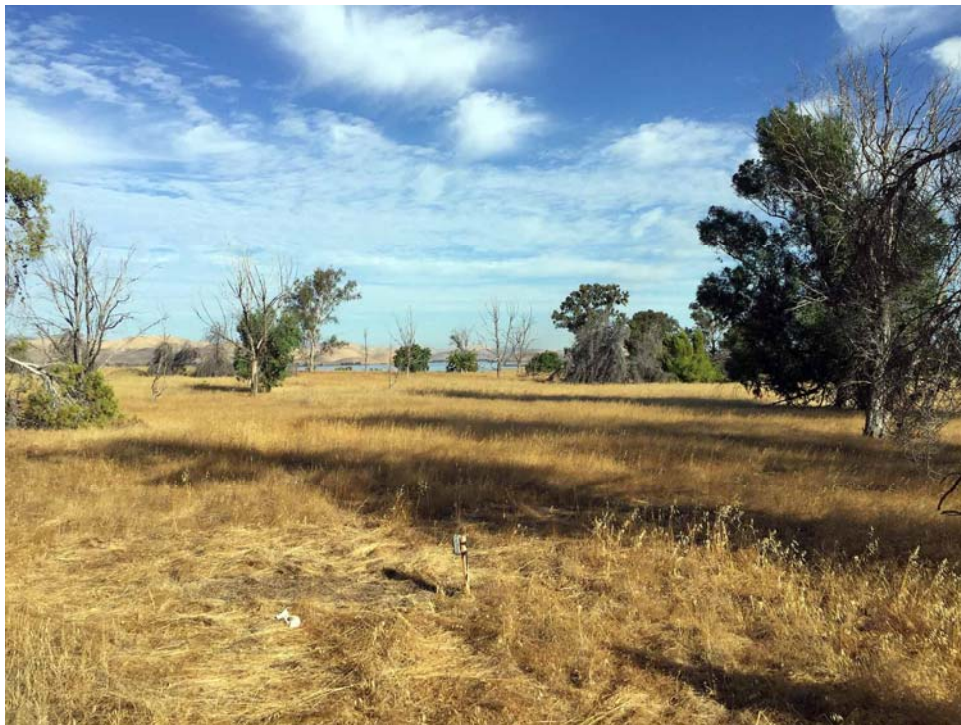
Two Cavernous Features in the Basalt Quarry Area Support Bat Roosts. Monitoring at the Tunnel (top) Confirmed Yuma Myotis and Mexican Free-tailed Bat Roosting.

The Wildlife Acoustics EM3+ bat detector survey was performed at a single man-made cave for a single night survey. The meter identified a total of 951 bat call files and identified three species with 99% to 100% likelihood of presence.
