B.F. Sisk Dam Safety of Dam Modification Project Environmental Impact Statement / Environmental Impact Report

Appendix I: Biological Resources Appendix

B.F. SISK SAFETY OF DAMS MODIFICATION PROJECT

Biological Survey Report

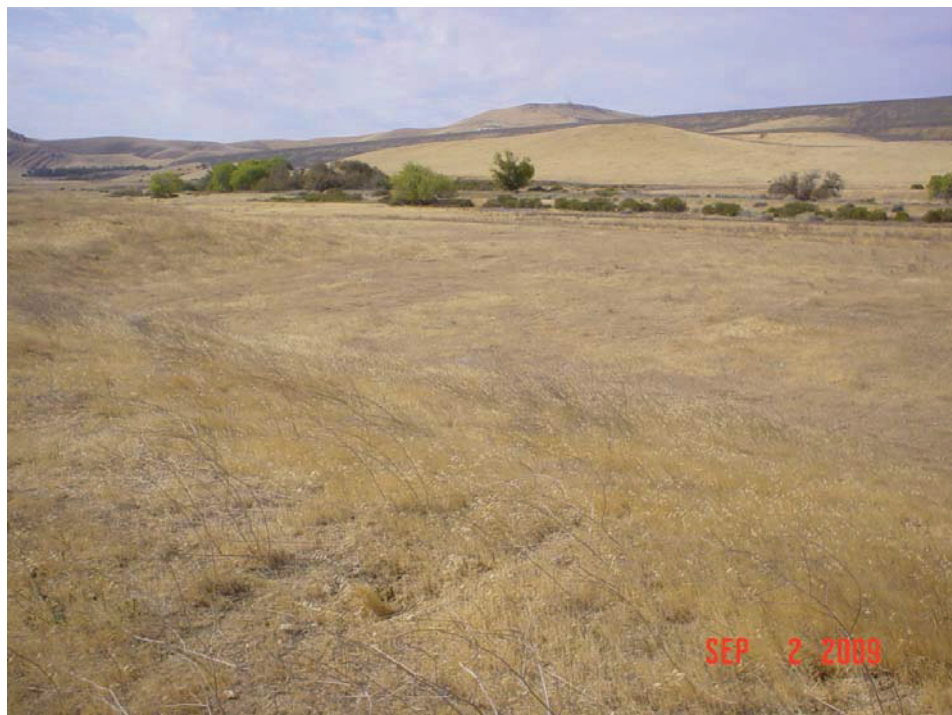
Photograph 1. Cover photograph. Looking southwest from the eastern edge of the study area, south of State Route 152 and Gonzaga Road. Visible in the photograph is the dam, the seep wetlands at the base of the dam, and Basalt Hill Road.

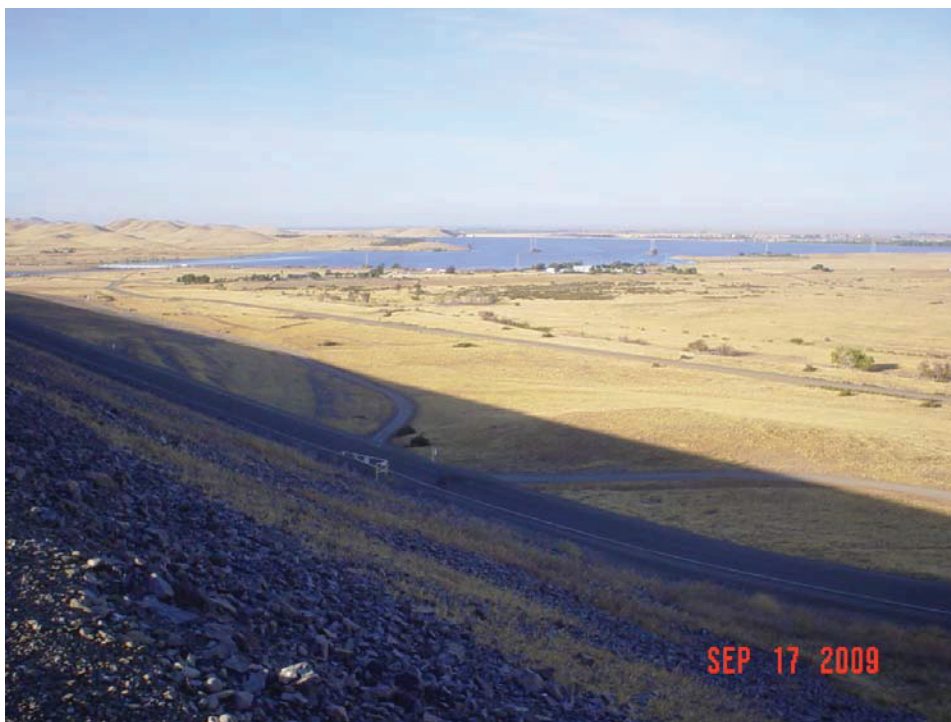
Photograph 2. To provide a sense of scale, this view is from the top of the dam looking northeast. The seep wetlands described in the photographs that follow can be seen as the narrow string of trees and darker vegetation just beyond the straight gravel road in the sunny portion of the photograph.

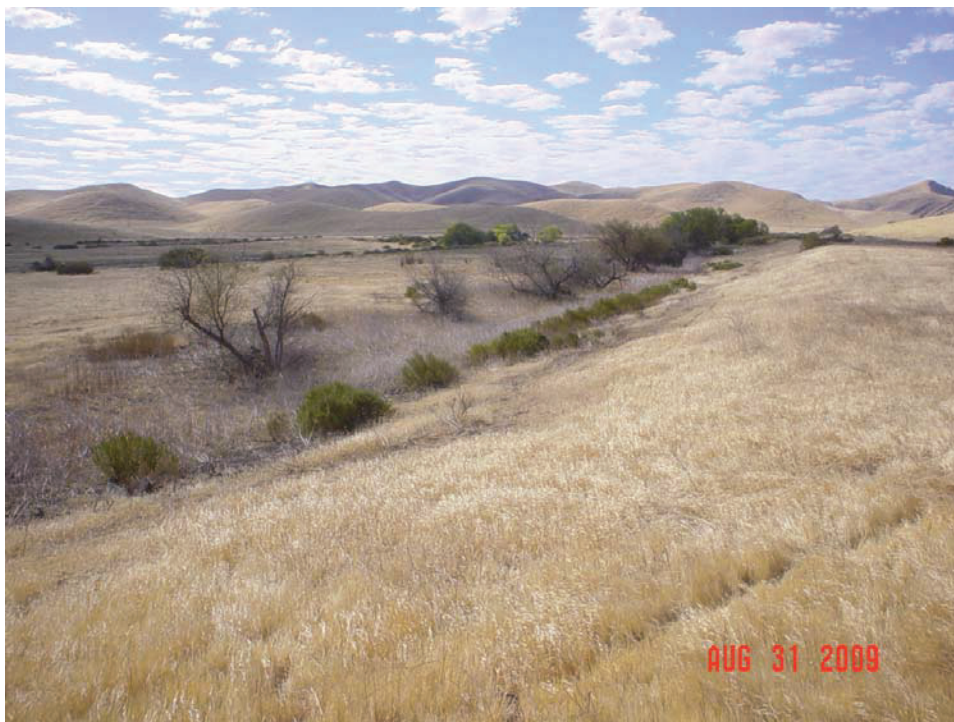
Photograph 4. Looking southeast at the north end of FEW9, another seep wetland in the complex mentioned in Photograph 3. The photograph is taken from a low bench near the eastern foot of the dam.

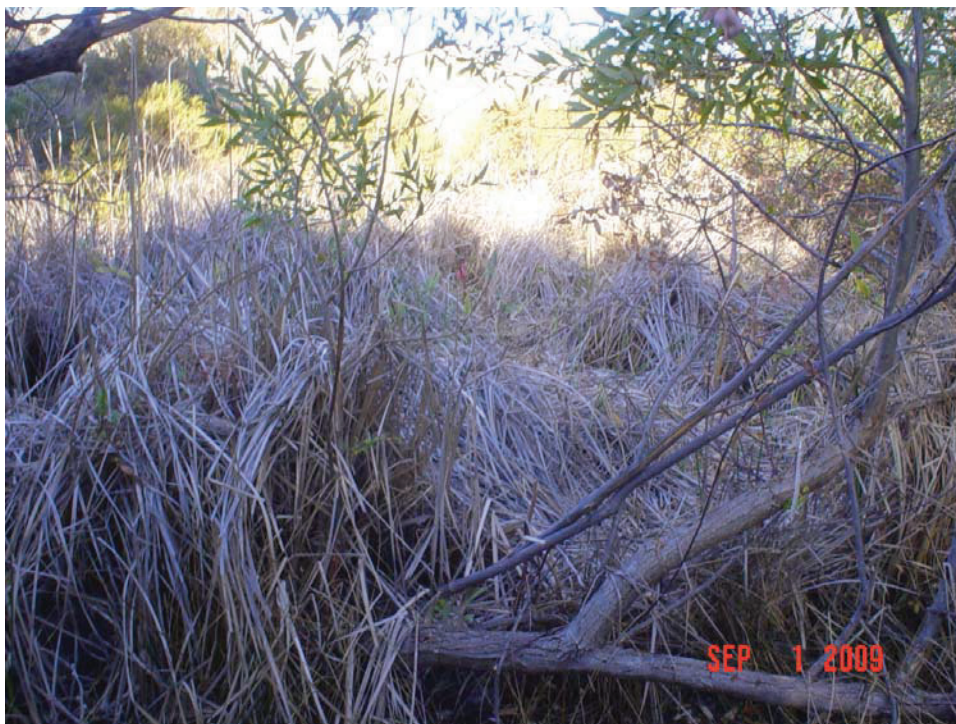
Photograph 5. Data point 5 located on the western edge of FEW9. The data point is located at the base of a small rise at the abrupt upland boundary to the wetland feature. Note the dense cattail understory and red willow overstory.

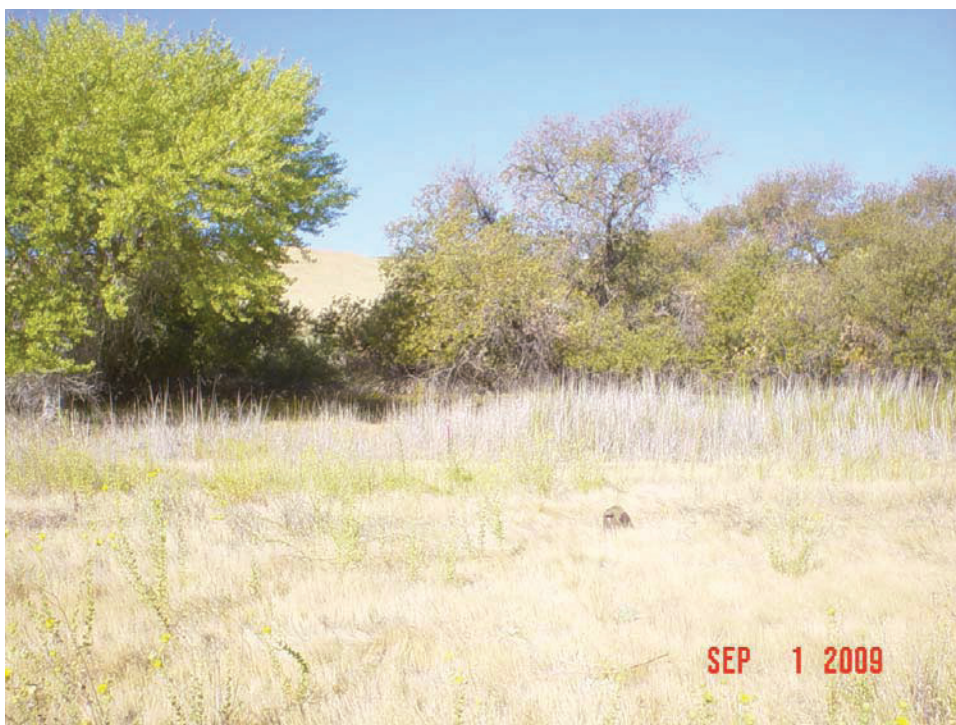
Photograph 6. Looking west at FEW9, data points 6 (shovel in background) and 7 (backpack) document the eastern edge of the FEW9 feature. The data points are located south of the point Photograph 4 was taken from (see Figure 4c).

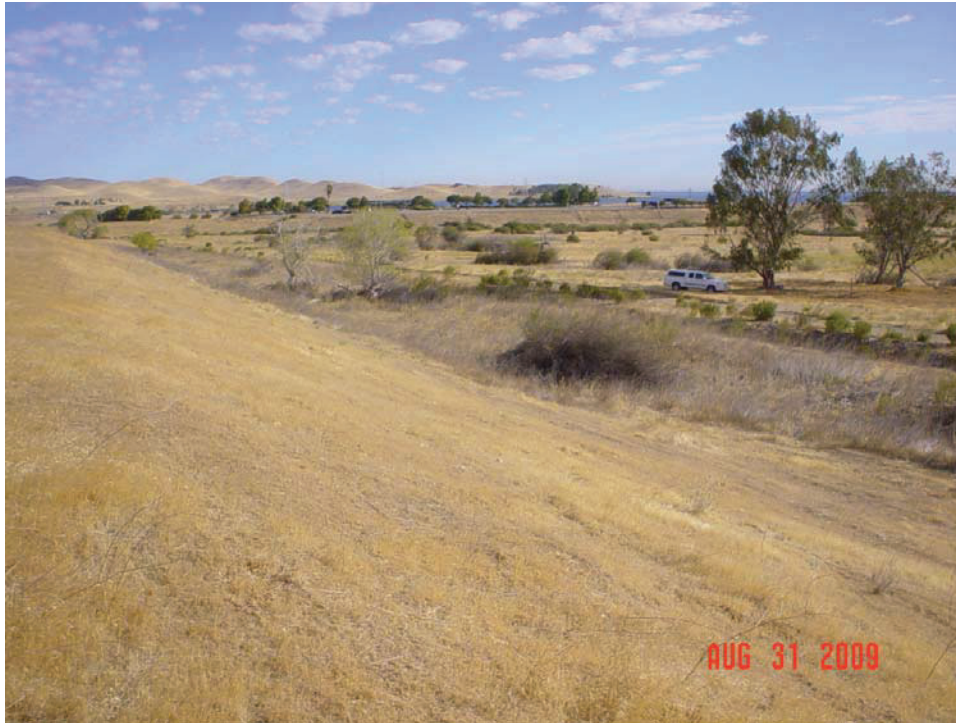
Photograph 7. Looking northeast from approximately 0.1 mile north of the point Photograph 4 was taken from. The darker vegetation between the toe of the slope and the pickup truck is the wetland feature (SW4) associated with the conveyance of dam seepage. Data points 1 and 2 are located just out of the photograph to the right.

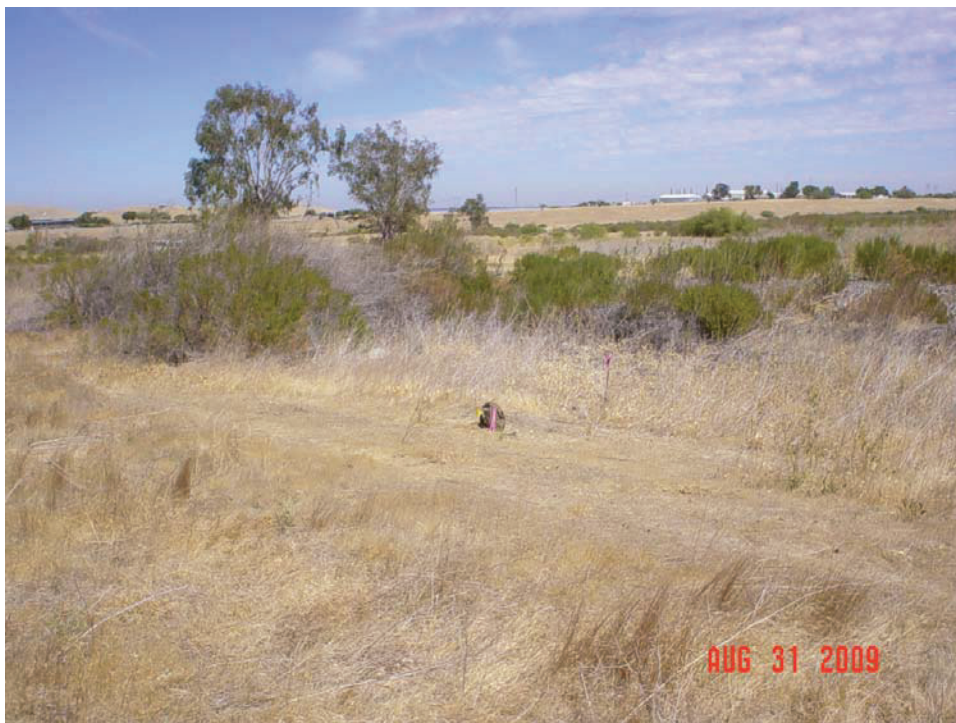
Photograph 8. Data points 1 (shovel) and 2 (backpack) document the seasonal wetland (SW4) and adjacent upland, respectively.

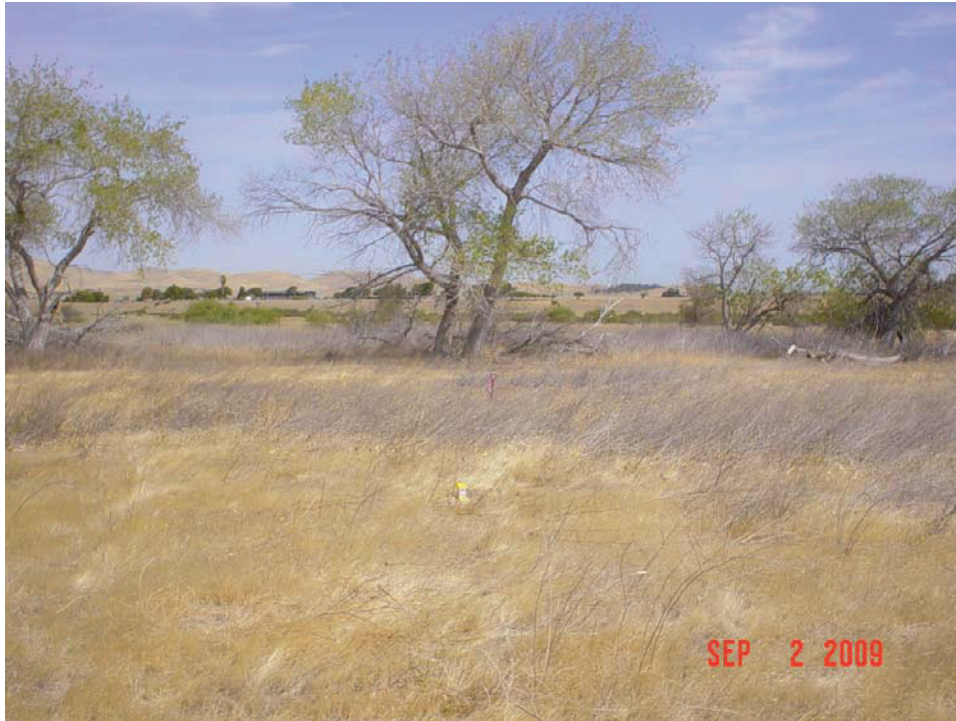
Photograph 9. Data points 21 and 22 document the seasonal wetland (SW6) and adjacent upland, respectively, that occurs at the northern boundary of the central portion of the study area (see Figure 4c). The feature extends beyond the boundaries of the study area and functions as a collection area for runoff of precipitation and dam seepage that occurs east of the dam. SW4, SW6, and SW20 are part of the same large seasonal wetland.

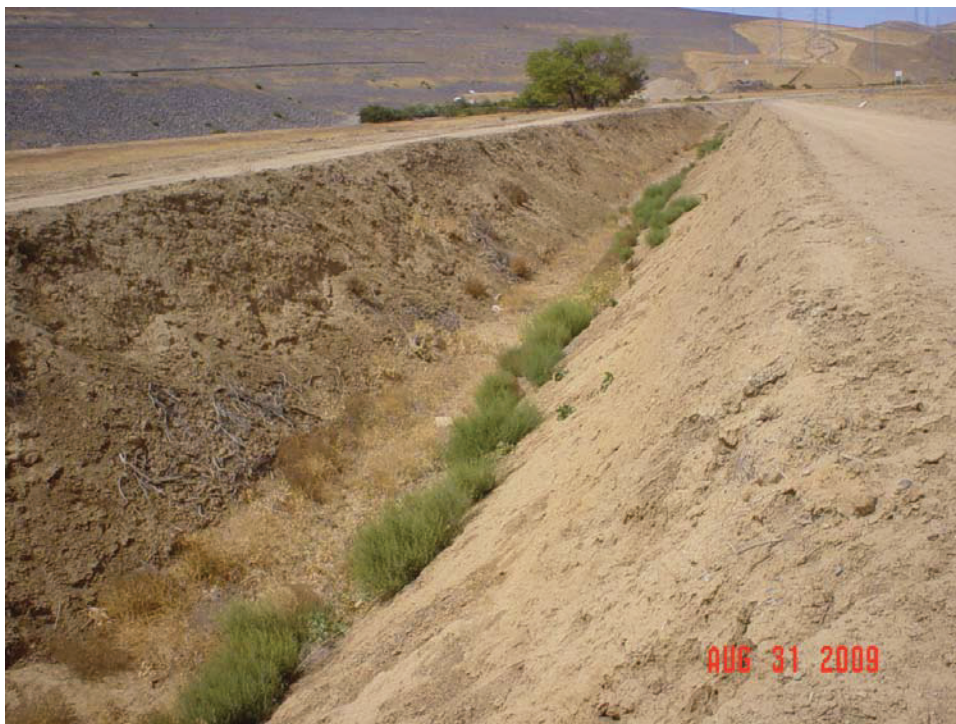
Photograph 10. Looking northwest at D8. This ditch is the main outflow conveyance feature of the seepage collected in the wetlands and ditch features pictured above. This ditch flows north to O'Neill Forebay. The channel width at this point is estimated at 8 feet, based on weak indicators of an ordinary high water mark.

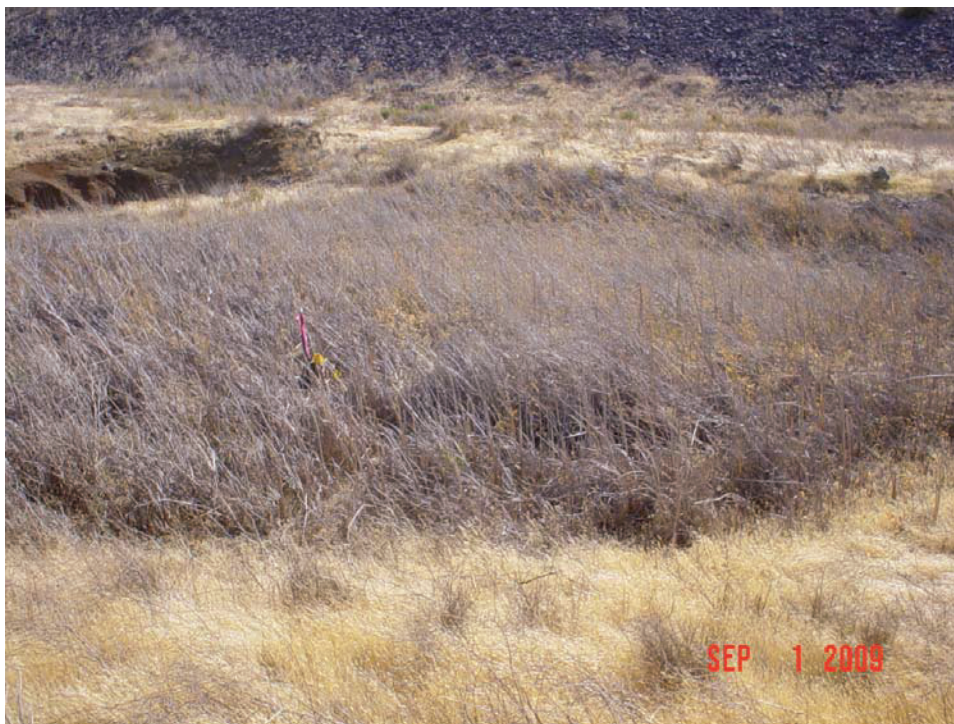
Photograph 11. Data point 15 (shovel) documents a small fresh emergent wetland (FEW4) located on the north side of the dam in the north western portion of the study area. This feature is also a seep wetland and a number of ditches (e.g., D12) help to convey these waters to the O'Neal Forebay.

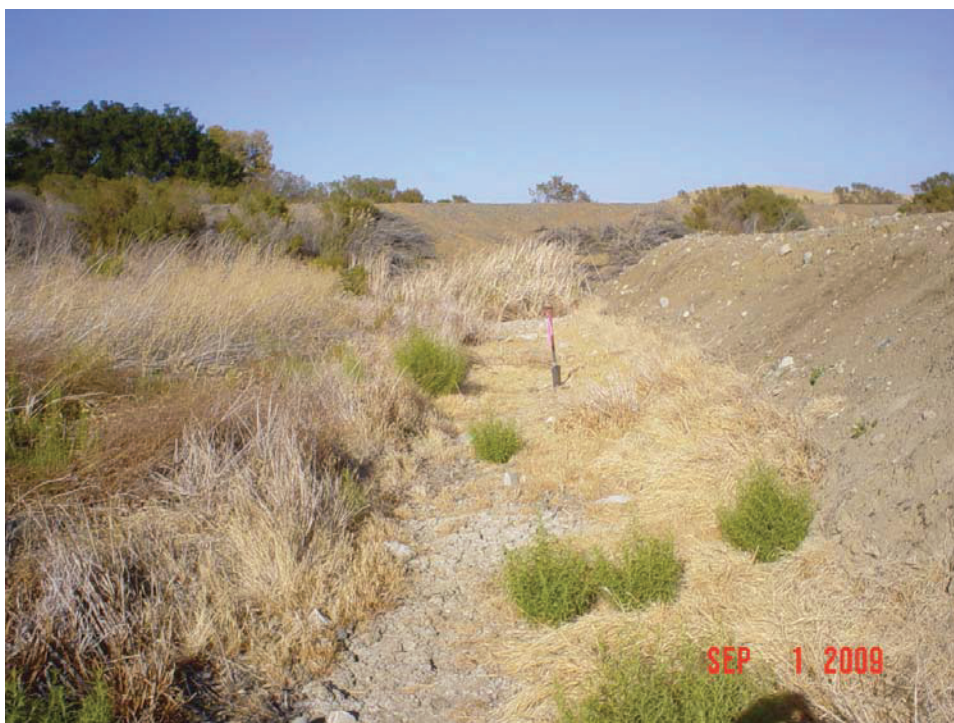
Photograph 12. Data point 16 documents a ditch (D10) that conveys seepage waters toward O'Neill Forebay on the north side of the dam.

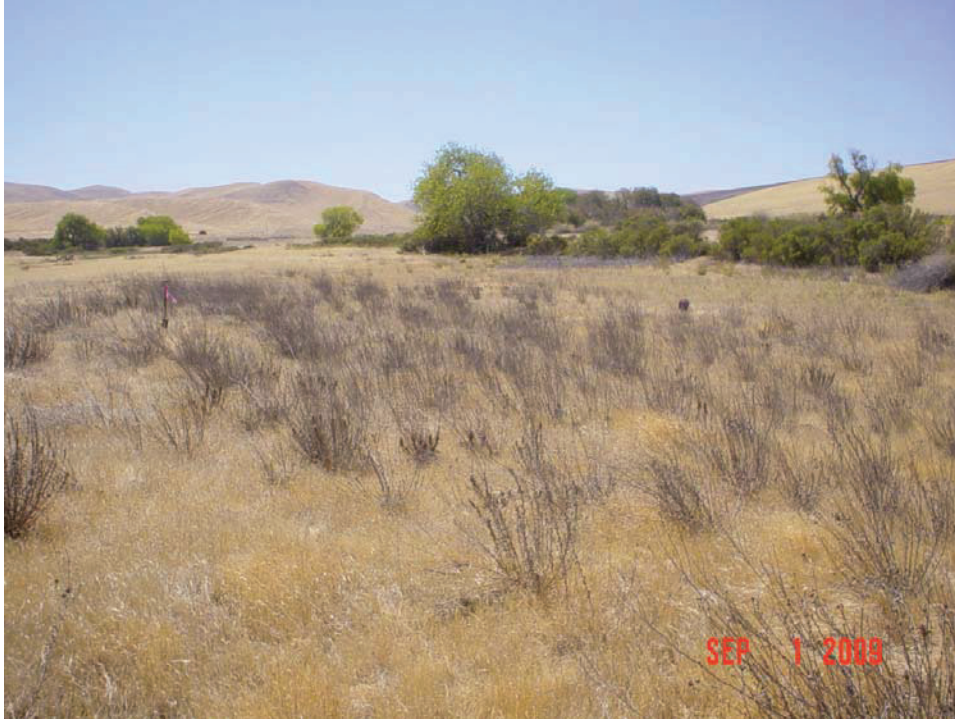
Photograph 13. A number of seasonal wetlands occur east of the dam. This photograph of SW32 shows the feature's close proximity to FEW9. Data point 11 (backpack) documents the feature, and data point 10 (shovel) documents the adjacent uplands.

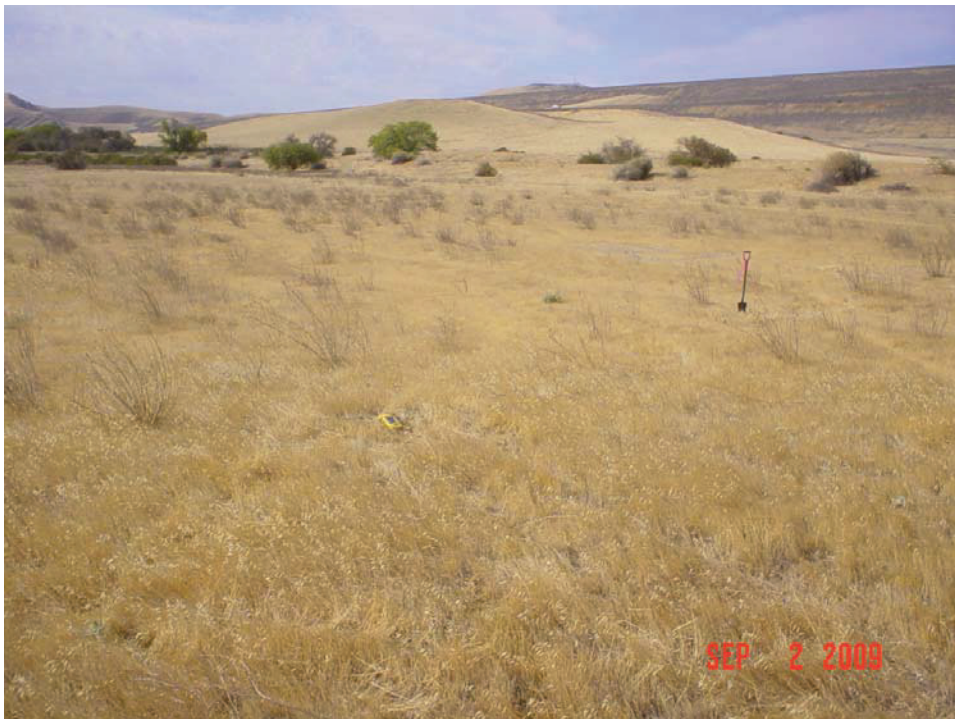
Photograph 14. Data points 19 (shovel) and 20 (GPS unit) document the boundaries of SW22. As is evident in the photograph, the boundary is very subtle. In this case, hydric soil indicators were observed at both points, but the vegetation and hydrology indicators were missing from the upland point.

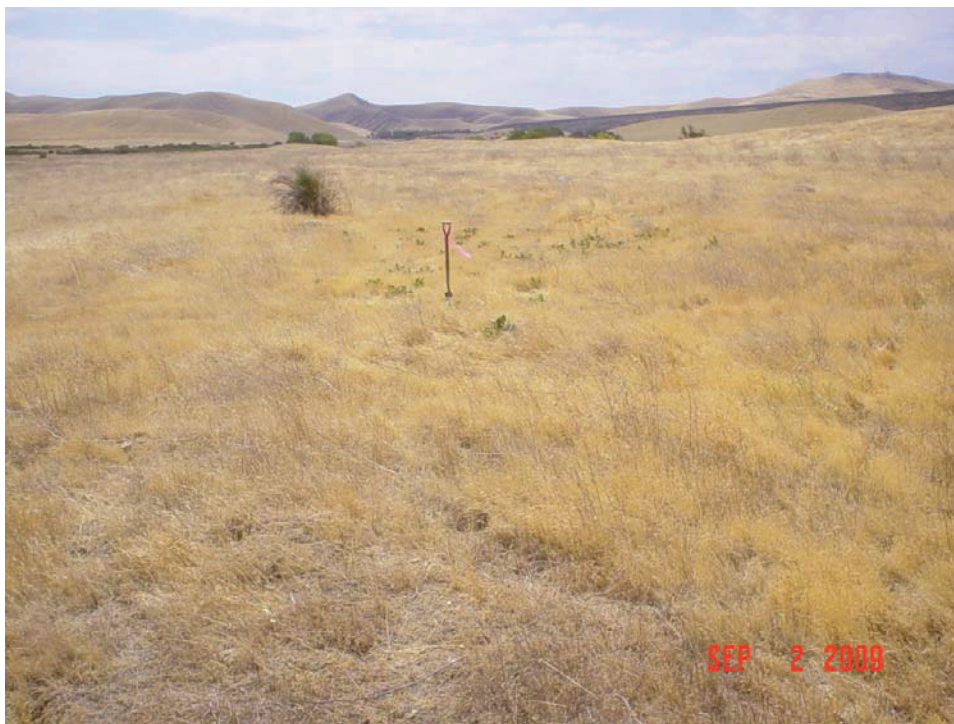
Photograph 15. Data point 23 documents another small seasonal wetland (SW24). Each of the seasonal wetland features that occur east of the dam are depressional, and the three wetland parameters are evident, but it is not certain whether dam seepage plays a role in their hydration. As depressional features, they may only be hydrated during winter precipitation events.

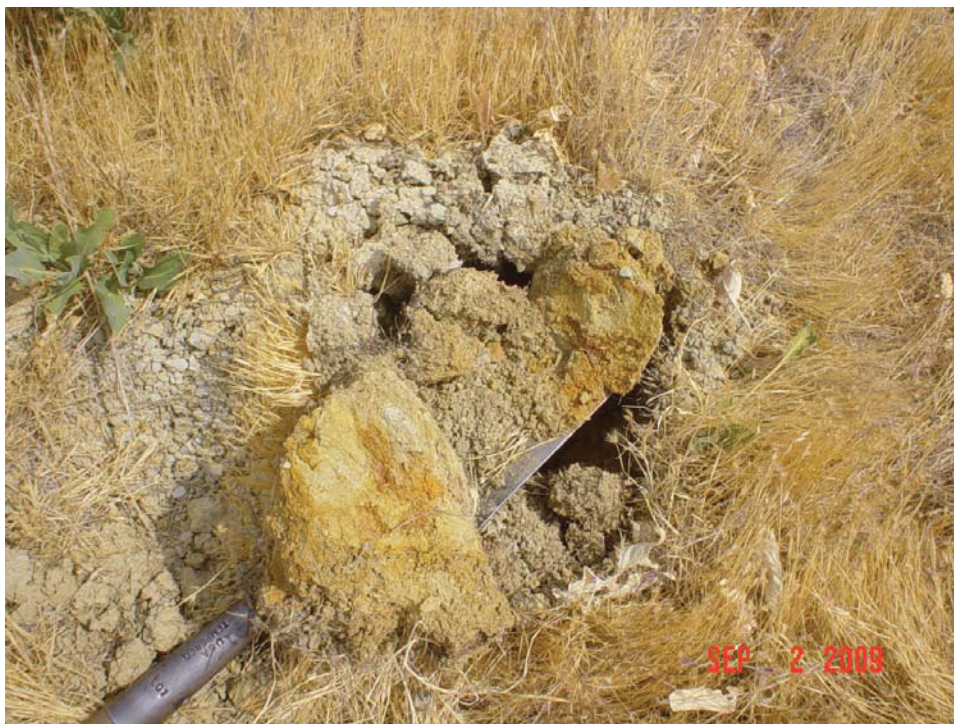
Photograph 16. The soils at data point 23 show the prominent redox features.

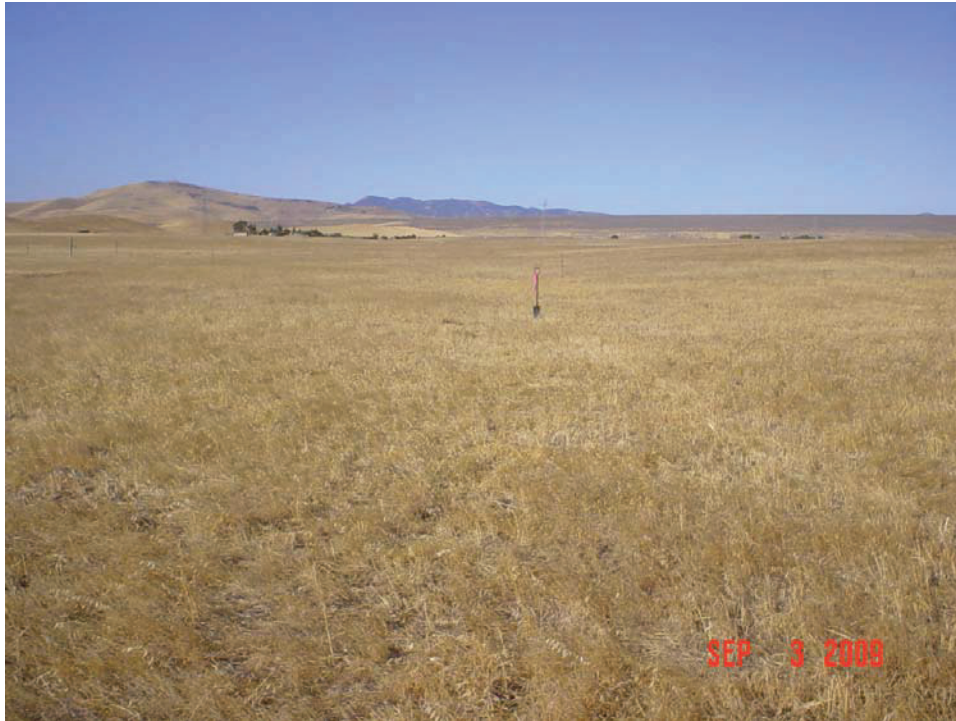
Photograph 17. Data point 28 (shovel) documents upland conditions in a suspect wetland located north of State Route 152. The aerial photograph of the study area shows a drainage-like feature here. This data point was installed at the low point of the feature, but no wetland parameters were met.

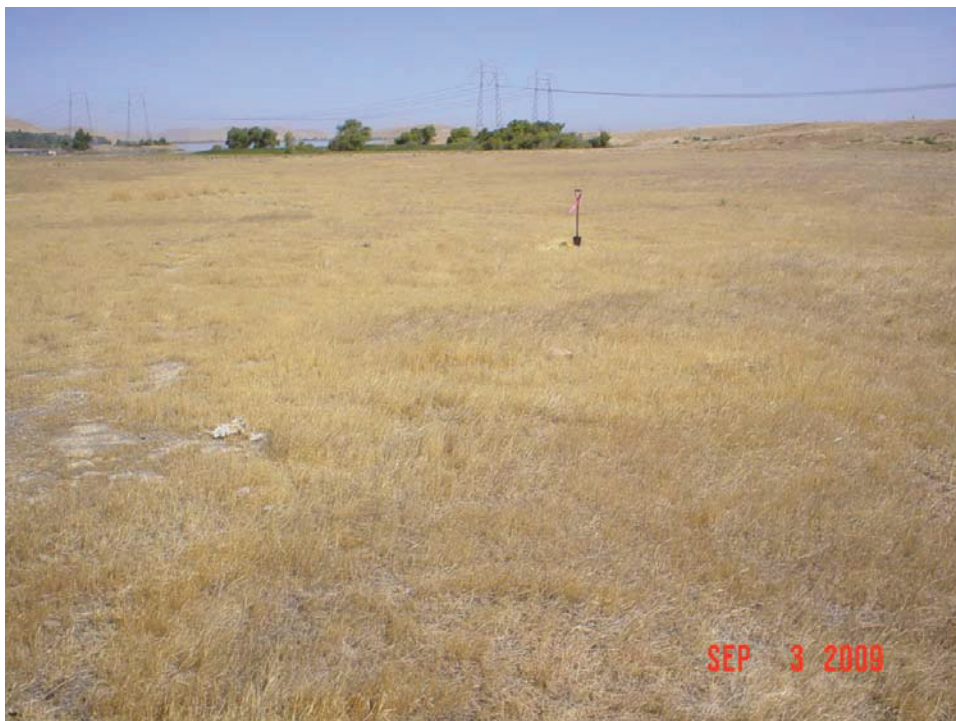
Photograph 18. Data point 31 documents the seasonal wetland (SW19) that occurs in a very shallow depression in the portion of the study area north of State Route 152. The indicators are weak, but sufficient for the feature to be considered a wetland.

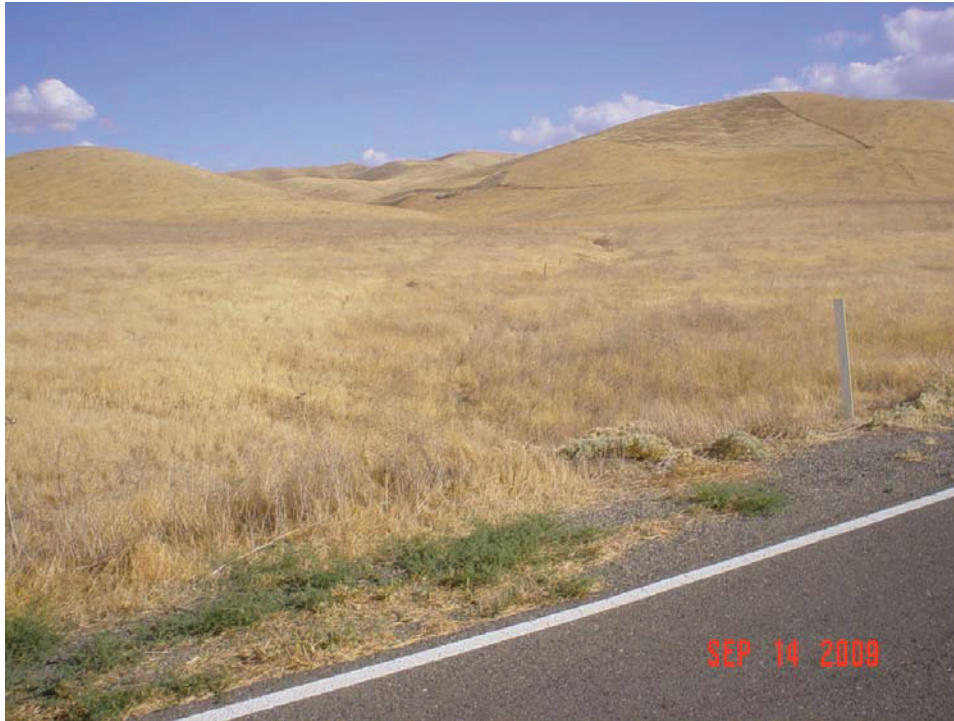
Photograph 19. Several ephemeral drainages exit the hills surrounding the study area. Here, DP 43 documents this 2-foot wide ephemeral drainage (ED5). Although annual upland vegetation has colonized the feature, and the soils are not hydric, the bed and bank feature with evidence of scour and deposition qualifies as an “other waters” of the United States.

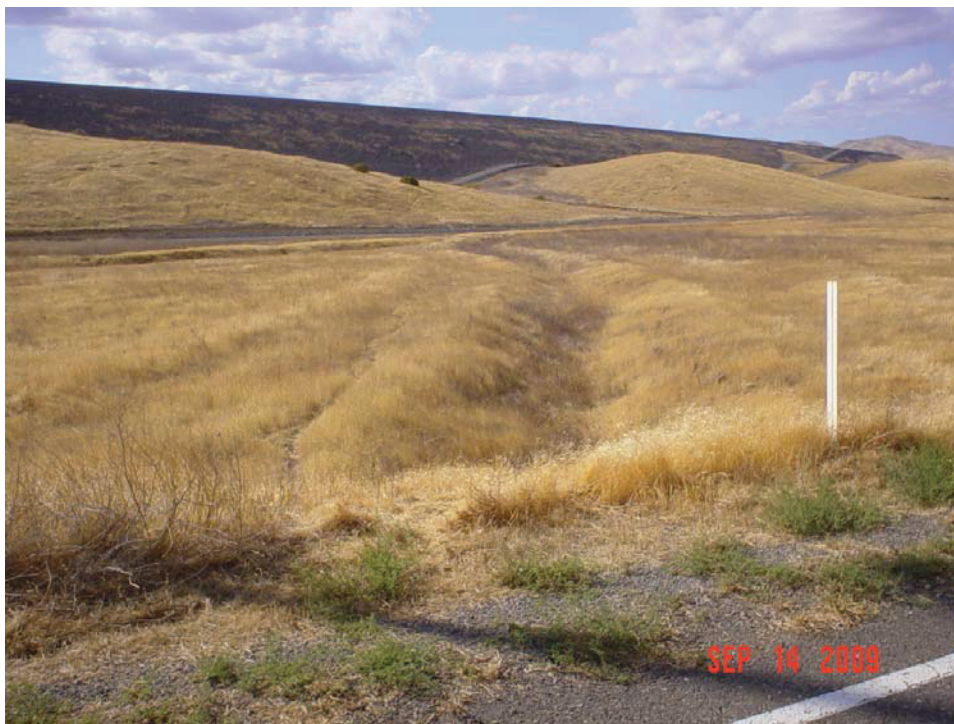
Photograph 20. The incised channel of ED5 is more pronounced on the west side of Basalt Hill Road.

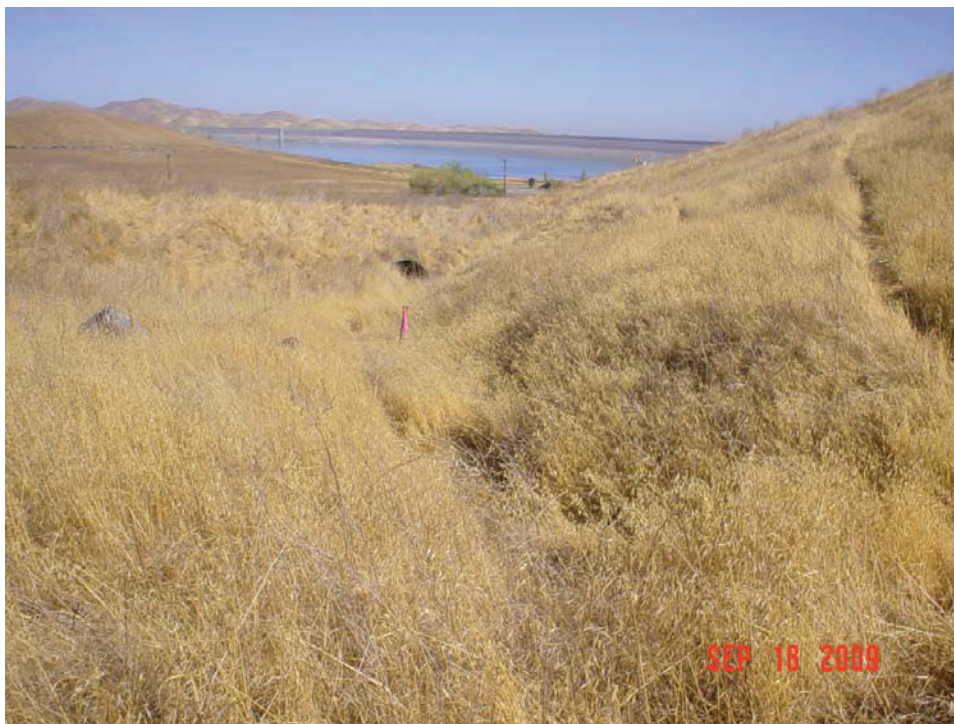
Photograph 21. Data point 47 documents another small ephemeral drainage (ED3). Similar to ED5, upland vegetation has colonized this drainage, but strong evidence of scour and deposition, and a pronounced bed and bank qualify this feature as an “other waters”.

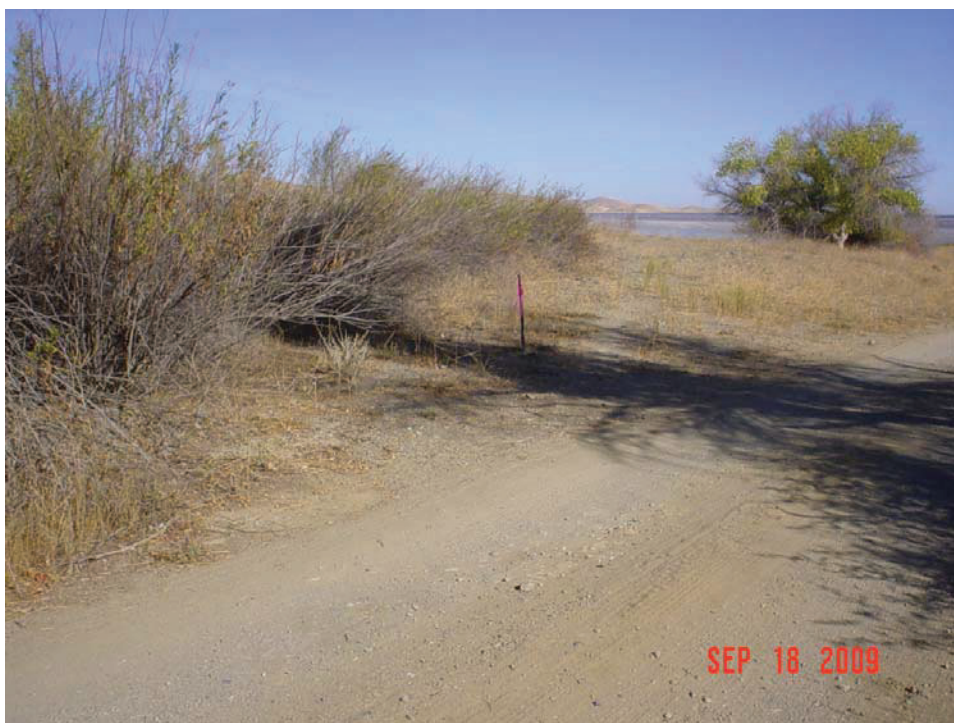
Photograph 22. Data point 46 documents the San Luis Reservoir below the full pool elevation. The dam can be seen in the background, and a temporary road in the foreground. Scattered debris has been trapped within the stems of the shrub (seep willow) growing along the upper water mark and other indicators help to define the “bathtub ring” at full pool elevation.

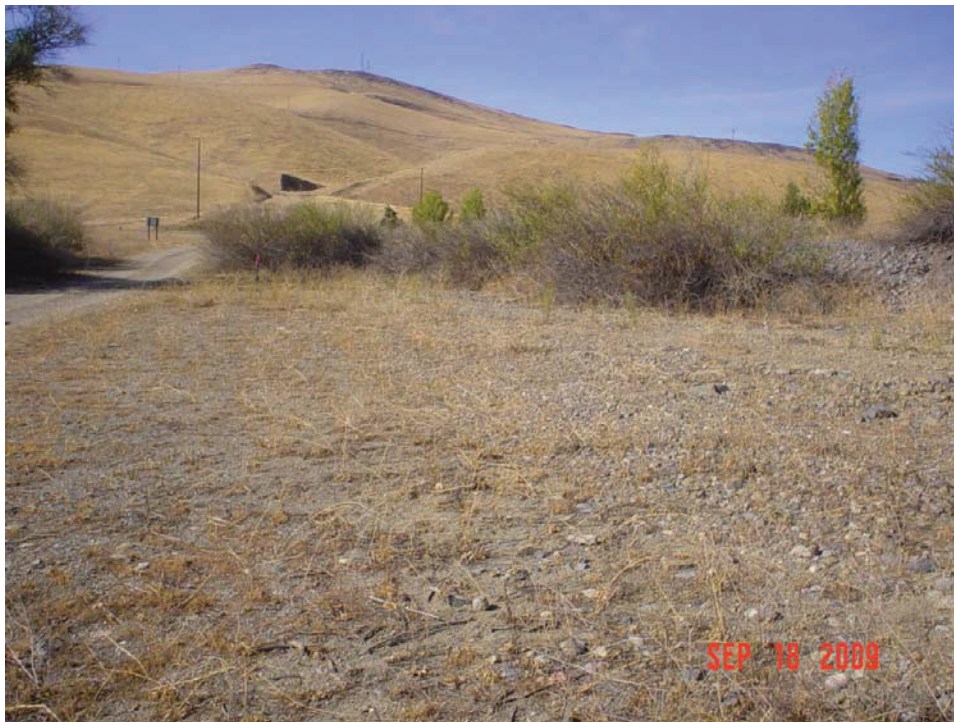
Photograph 23. Another view of the lake bottom documented by data point 46 (shovel in background).

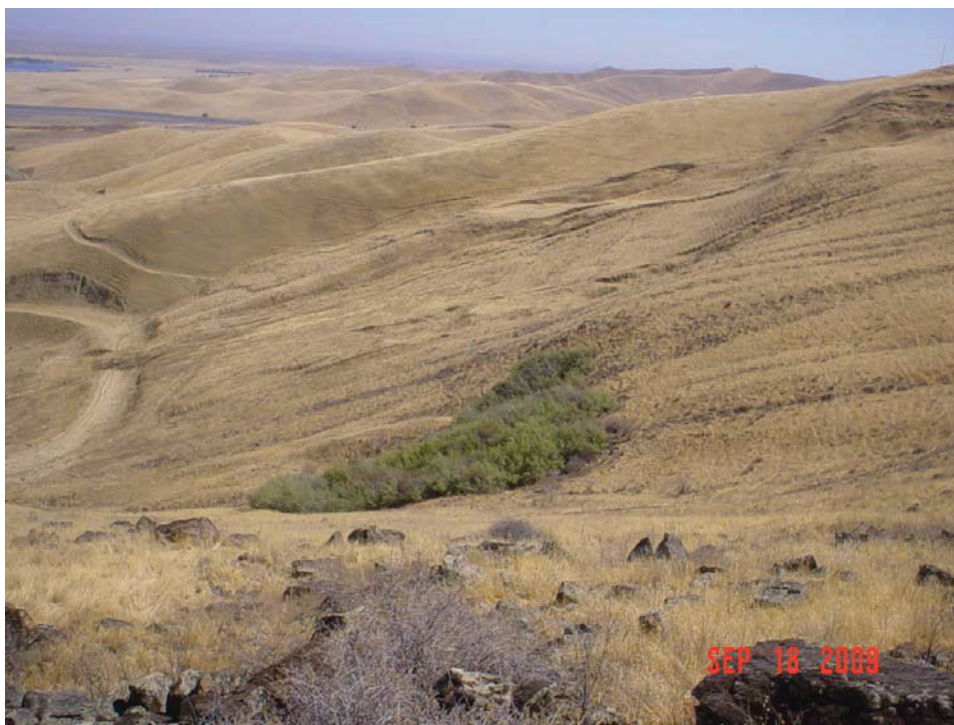
Photograph 24. This photograph shows the single “mixed chaparral” stand of silver buffaloberry. The species is not a wetland indicator, but there is a small ephemeral drainage leading from it. Data point 48 documents that the three wetland parameters were met within the stand. Also visible in the photograph is the “mud slide area” depicted on Figure 4e. Although small rivulets are visible within the mud slide, they are a remnant of the slide and are not considered waters.

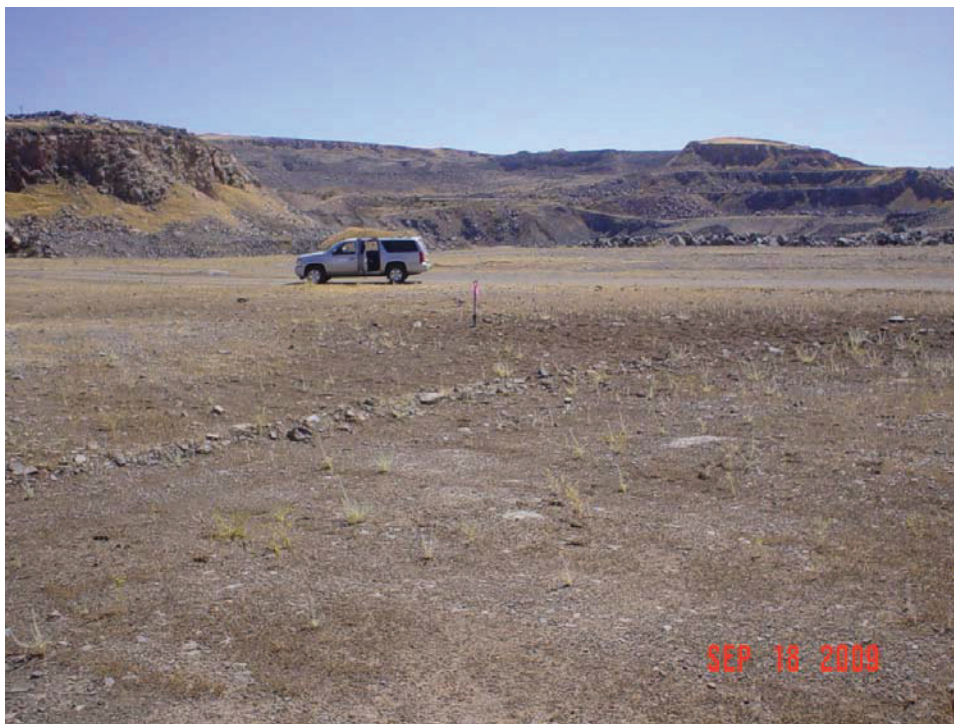
Photograph 25. Data point 49 documents that the small “puddles” that have formed within the quarry on top of Basalt Hill are not wetlands. The features are almost devoid of vegetation, the soil layer is very thin on top of rock, with no hydric soil indicators. Only the wetland hydrology parameter is met (see data sheet 49).

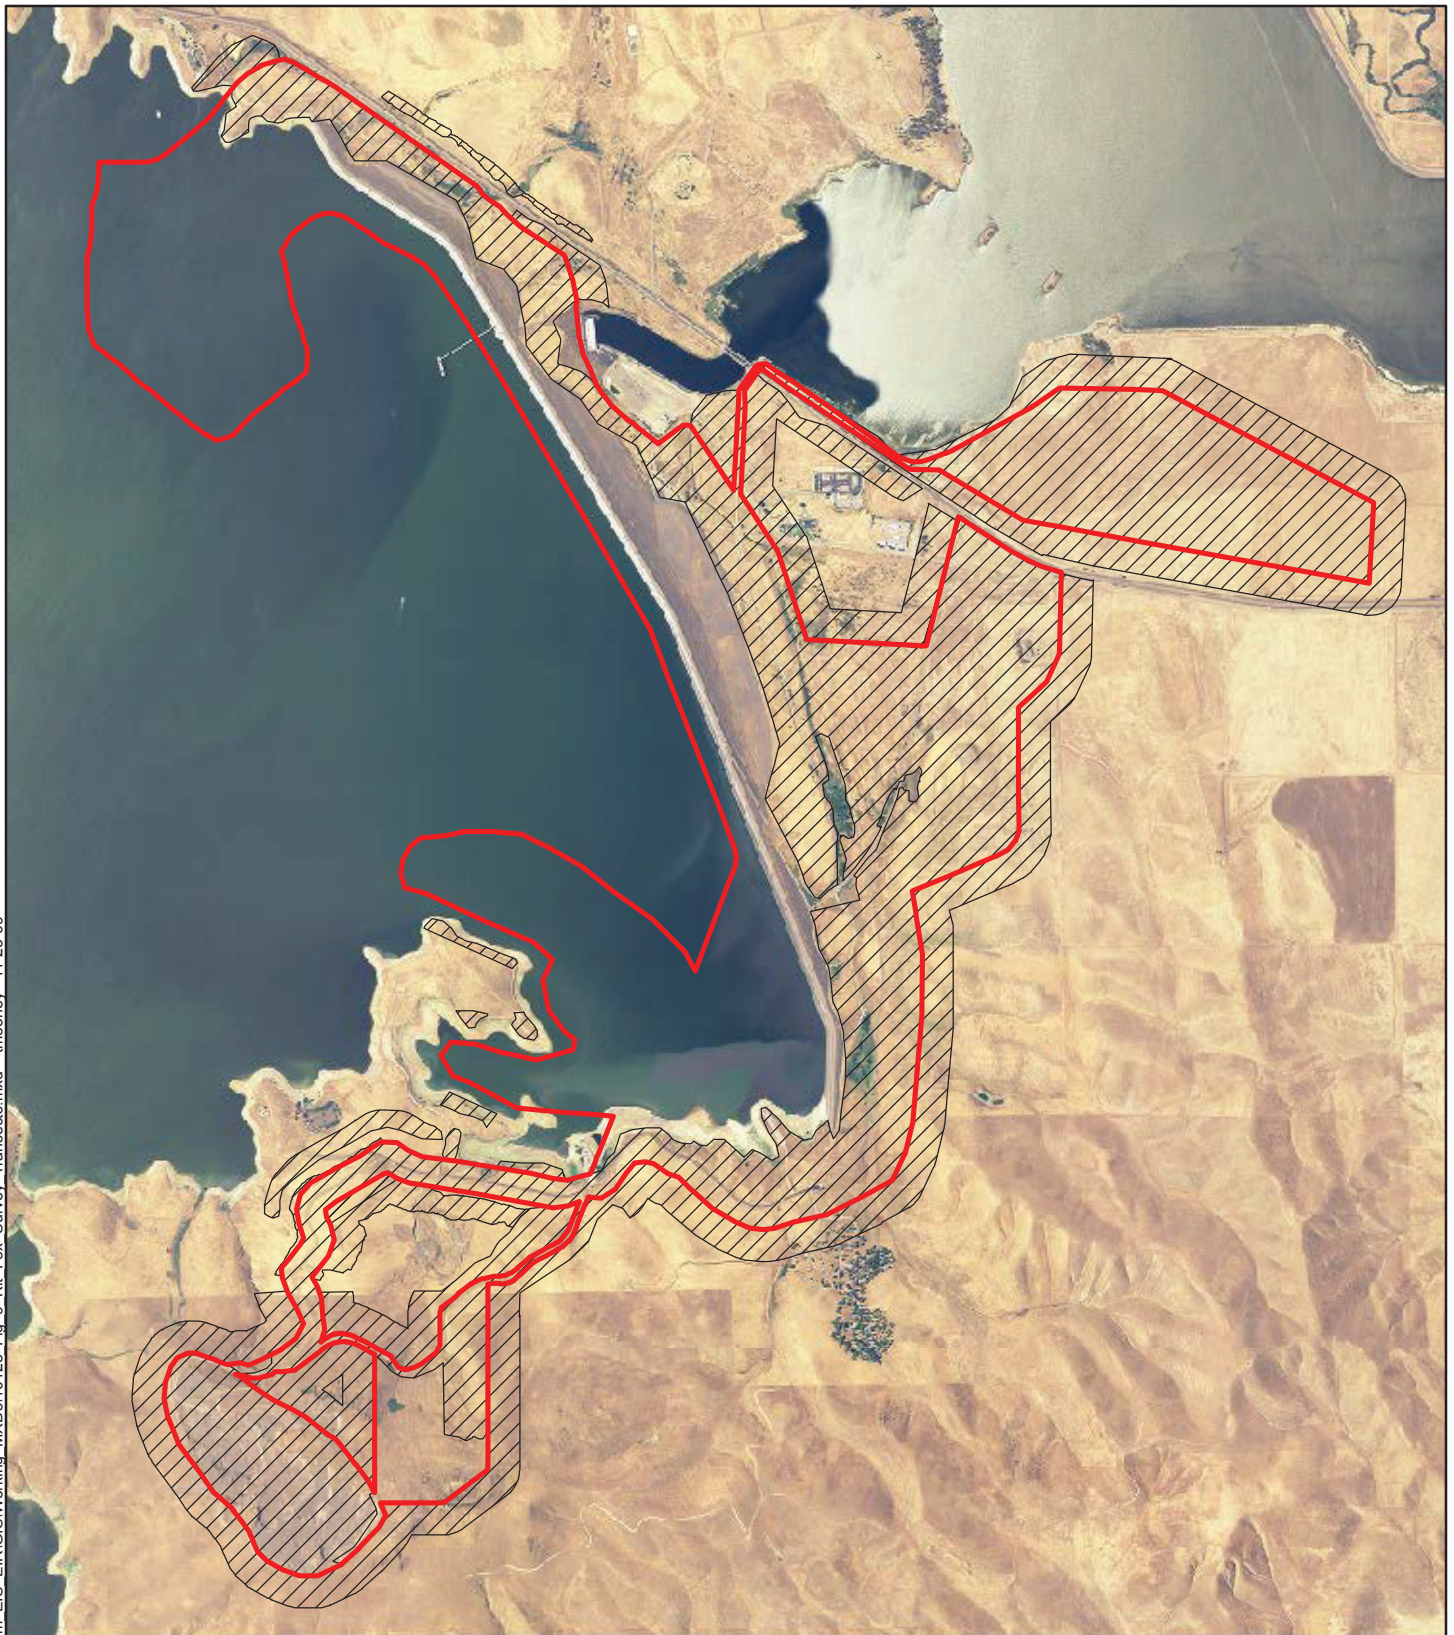
G:\Projects\10128_Sisk Dam EIS EIR\GIS\Working_MXD\10128_Fig 9 Kit Fox Survey Transects.mxd tmooney 11-25-09

Portions of the project site that met any of the following three conditions were eliminated from consideration as potential San Joaquin kit fox: (1) area was within the lake inundation scar; (2) area consisted of steep, rocky slopes; or (3) area was covered by dense shrub or forb habitat typically associated with inundated or saturated soils (see Figure 9).
