B.F. Sisk Dam Safety of Dam Modification Project Environmental Impact Statement / Environmental Impact Report

Appendix I: Biological Resources Appendix

B.F. SISK SAFETY OF DAMS MODIFICATION PROJECT

Biological Survey Report

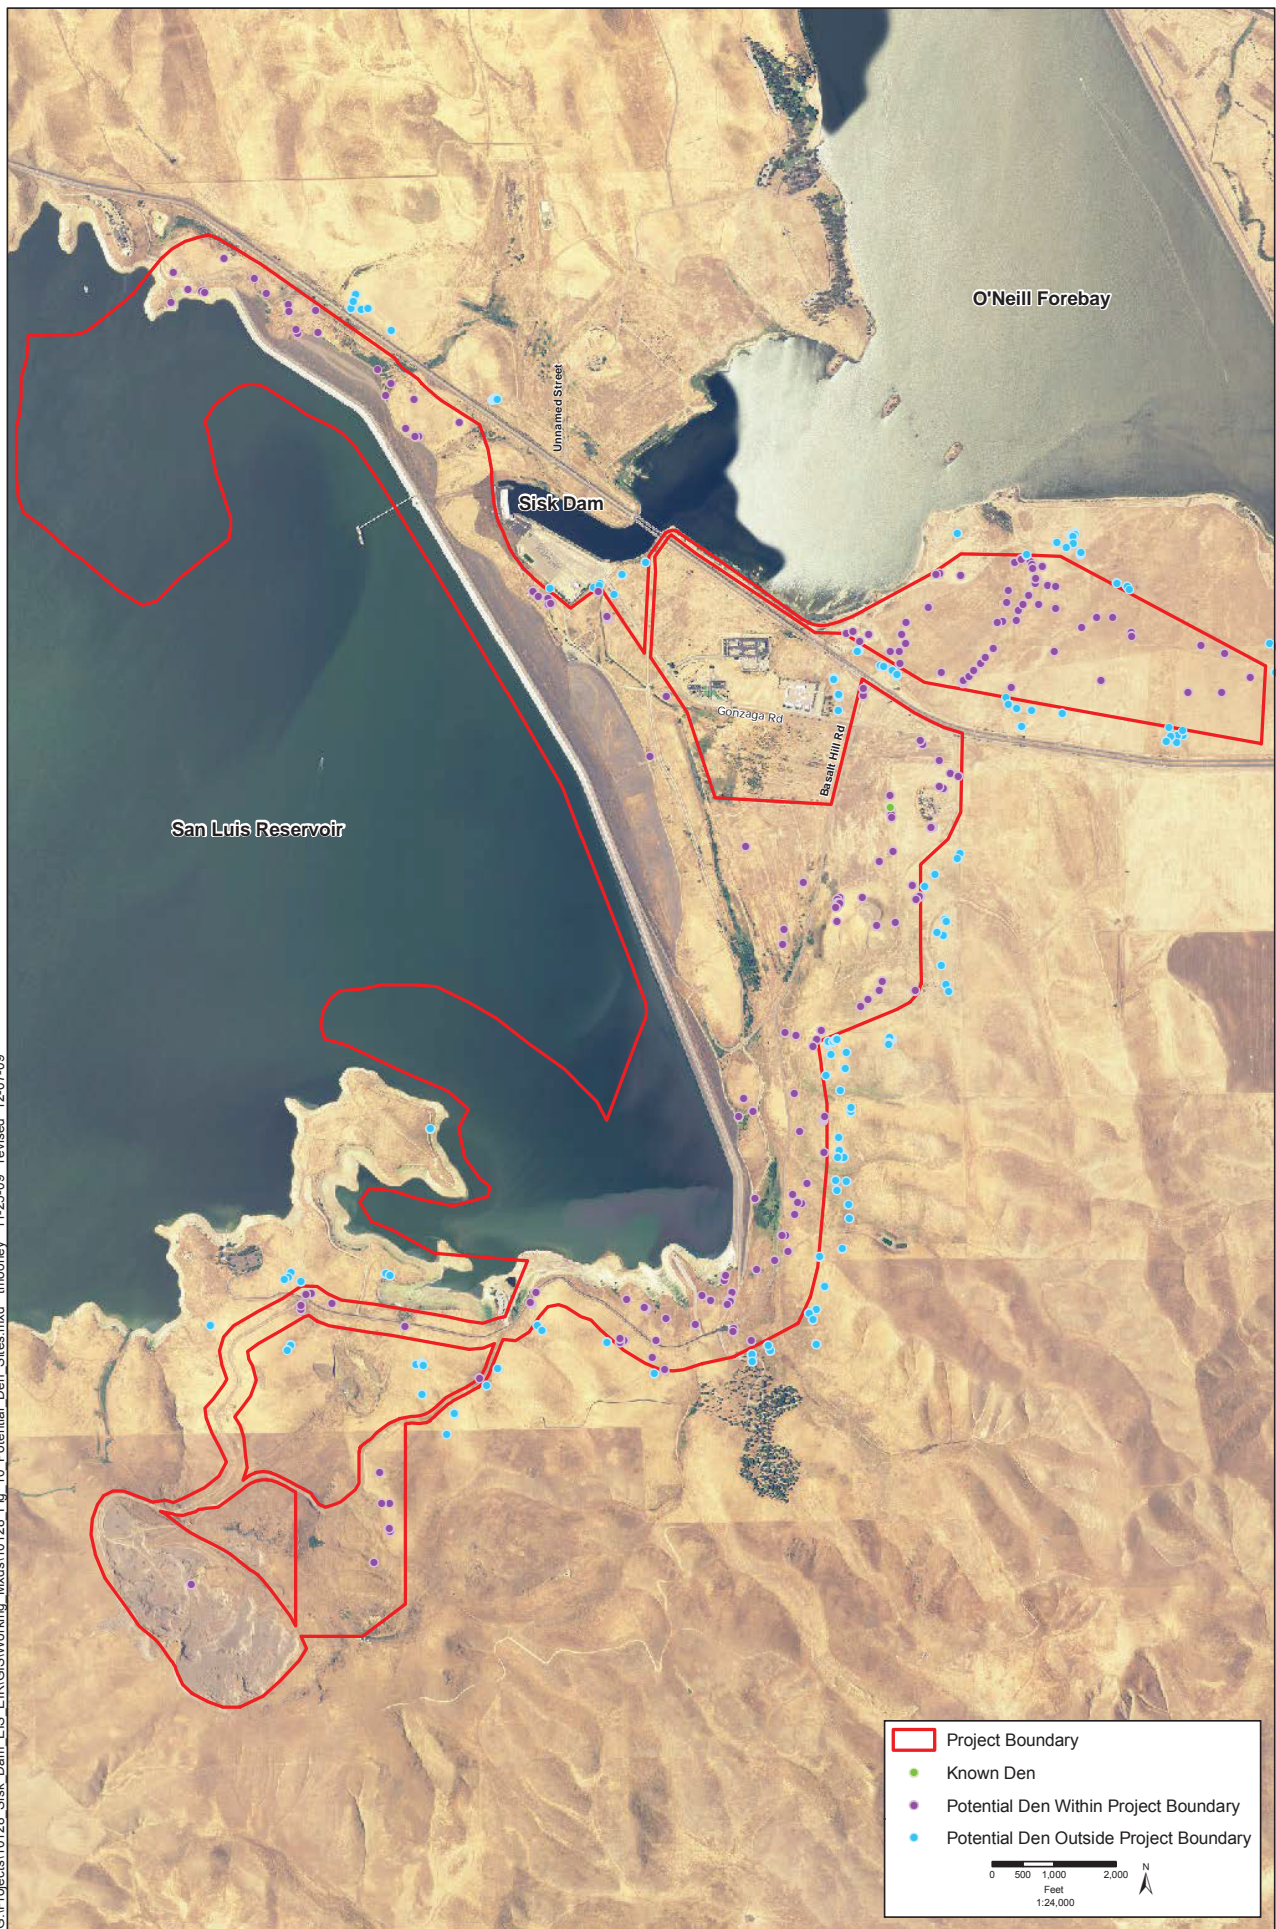
G:\Projects\10128_Sisk Dam EIS\ERGIS\Working_Maps\10128_Fig_10_Potential Den Sites.mxd Imooney 11-25-09 revised 12-07-09

One San Joaquin kit fox den was observed within the project boundary (Figure 10). Kit fox use of the den was concluded based on the presence of a track positively identified as San Joaquin kit fox by senior biologist Mike Bumgardner. Within the project boundary, 194 potential dens were observed. Potential dens include all subterranean holes that had entrances of appropriate dimensions (i.e., approximately 5–8 inches in diameter) and for which available evidence was insufficient to conclude that it was being used or had been used by a kit fox. Approximately 40 percent of the potential dens identified during the survey appeared to have been created by American badgers.

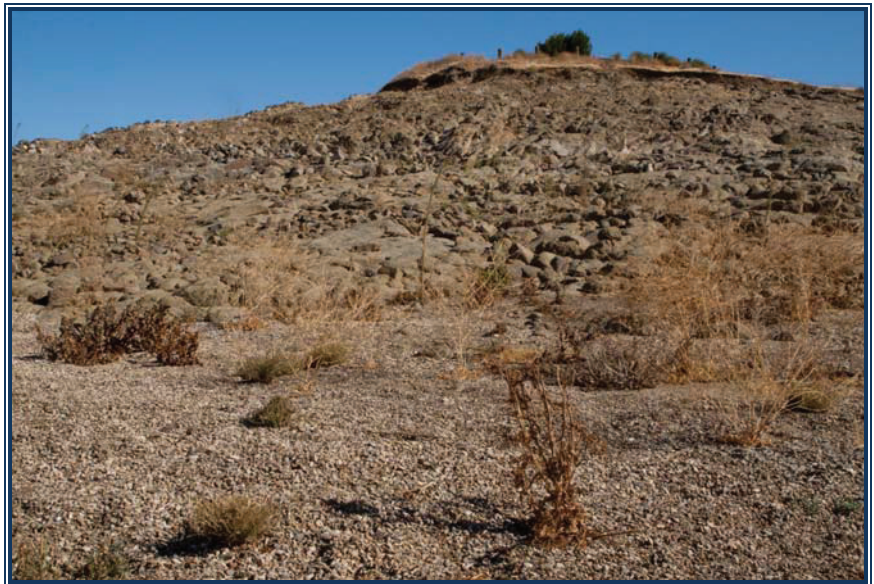
Photograph No. 2 – The photo shows consolidated rock and gravel substrates located within the lake inundation scar. Though now exposed and dry, these substrates, which are unsuitable for San Joaquin kit fox dens, also exhibit no evidence of use by small rodents (e.g., burrows). Substrates of this type are well distributed within the lake inundation scar. This photo is oriented uphill towards the parking lot at the southeastern corner of the lake.

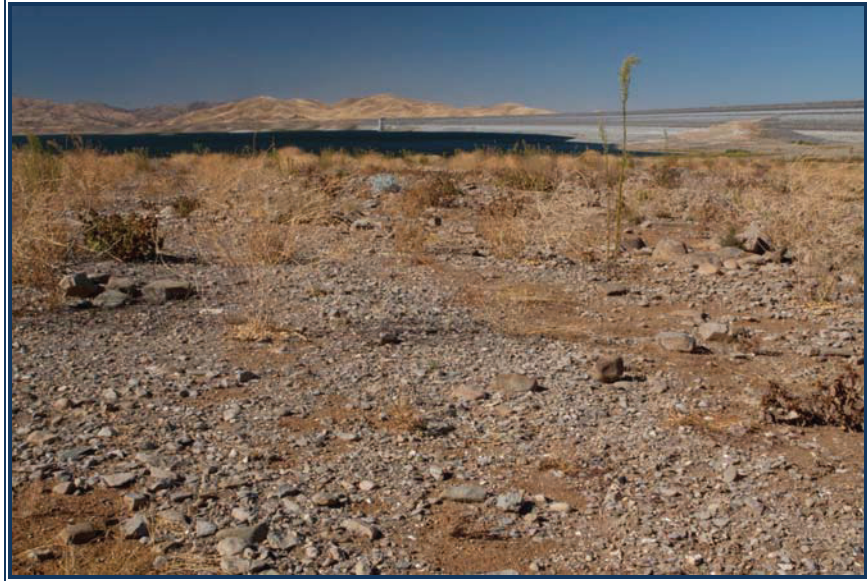
Photograph No. 3 – The photo shows dried sand and gravel substrates located within the lake inundation scar. These substrates are unsuitable for San Joaquin kit fox dens. Though well distributed within the lake inundation scar, they show no evidence of use by small rodents (e.g., burrows). Note that the vegetative cover within these areas is relatively sparse (i.e., low canopy cover).

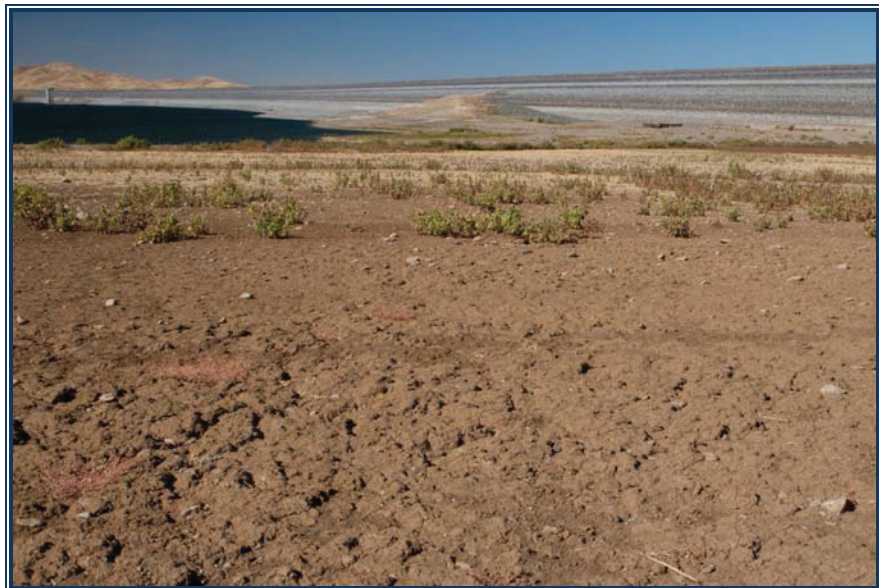
Photograph No. 4 – The photo shows dried silt and mud substrates located within the lake inundation scar. These substrates are unsuitable for San Joaquin kit fox dens. They also show no evidence of use by small rodents (e.g., burrows). Substrates of this type are also well distributed within the lake inundation scar. Similar to the other substrates within the lake inundation scar, these substrates do not support a well-developed canopy of grassland and/or ruderal species.

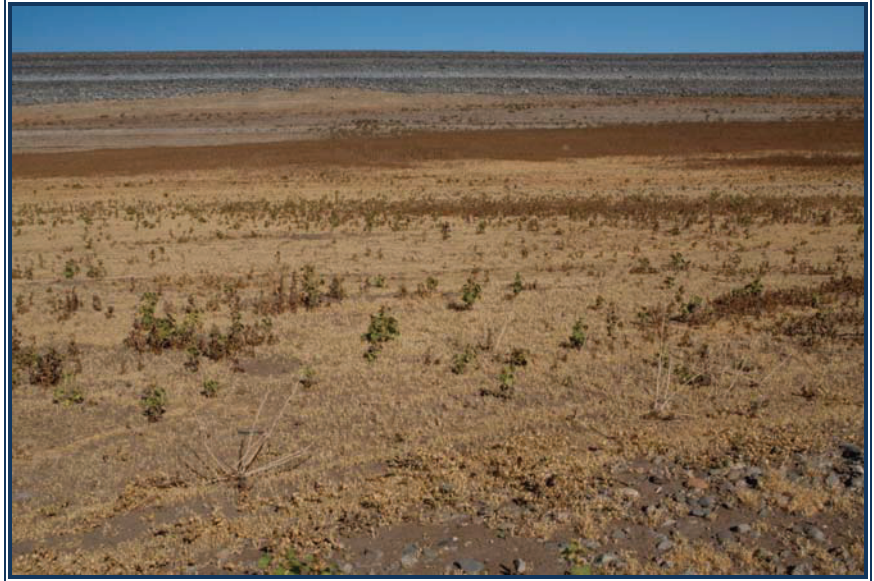
Photograph No. 5 – The photo shows the poorly developed vegetation on muds and silts within the lake inundation scar. Though dry for at least two years, almost all vegetation on the dry lakebed is low in height and density. Furthermore, there has been no colonization by small rodents based on the lack of burrows.

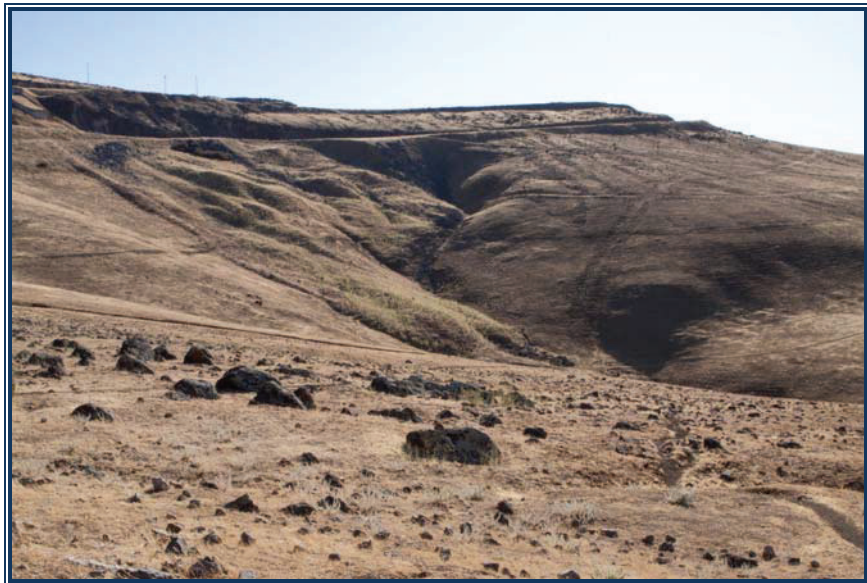
Photograph No. 8 – The photo shows the steep, rocky slopes immediately downslope from the existing rock quarry. The photo is oriented towards the northwest corner of the quarry. The access road that enters the quarry can be seen near the top of slope. The annual grassland on these slopes has been moderately grazed, making the rocky substrate more visible. This habitat is considered unsuitable for San Joaquin kit fox (primarily due to the rocky substrate which is difficult to excavate).

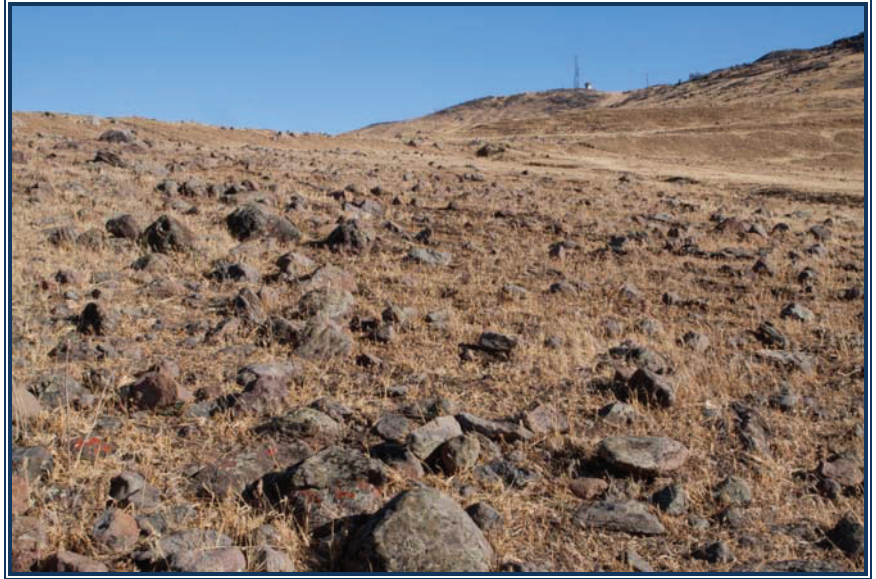
Photograph No. 9 – The photo shows the rocky substrate associated with the slopes located immediately downslope of the existing rock quarry. Such material is difficult for burrowing mammals (including American badger) to excavate. Thus, it was not surprising to find no potential dens in this habitat during the potential den surveys. Annual grasslands that occur on such slopes are not considered to be suitable habitat for San Joaquin kit fox.

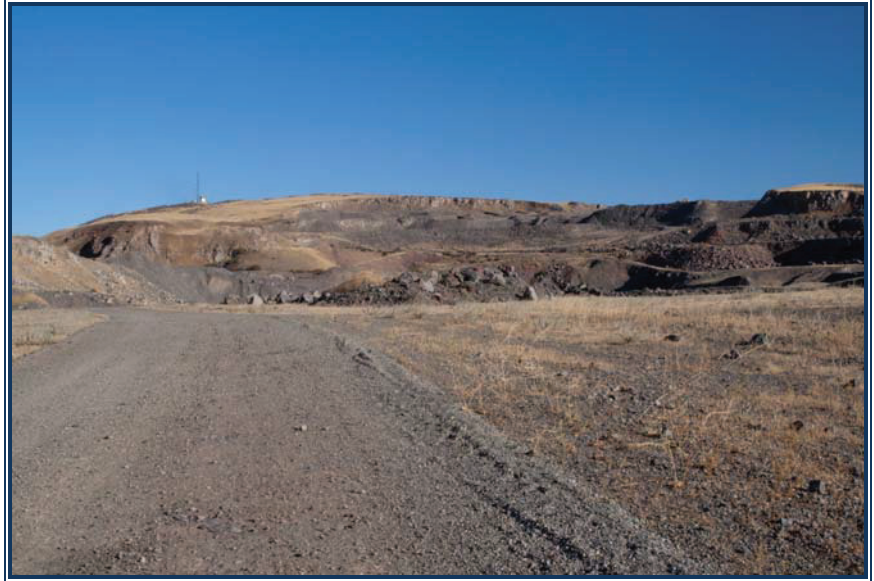
Photograph No. 11 – The photo shows the existing rock quarry from the access road into the site. The quarry consists primarily of flat benches with extremely rocky substrates (similar to desert pavement), scattered rock piles, and mined, rocky slopes. Very few areas with deeper, well developed soils occur within the quarry. Surveys were conducted throughout the entire quarry site and found only one potential den (a marginal burrow beneath a large rock). Areas with similar rocky soils were subsequently considered to be unsuitable for the San Joaquin kit fox without completing 100 percent surface coverage surveys for potential kit fox dens.

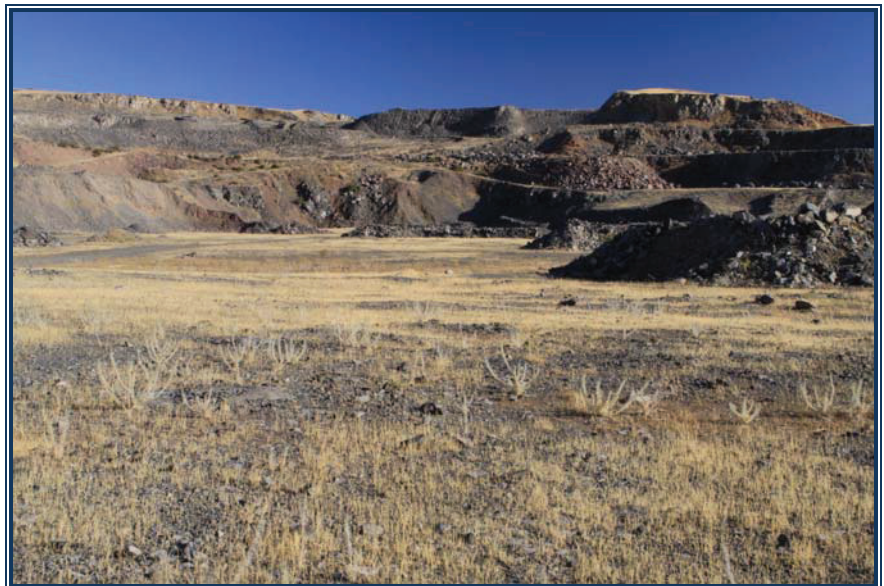
Photograph No. 12 – The photo further shows that the habitat is unsuitable for San Joaquin kit fox. The rocky substrates preclude burrowing activity by mammalian species (including small rodents). Therefore, the habitat does not provide a suitable prey base or escape refugia for the San Joaquin kit fox.

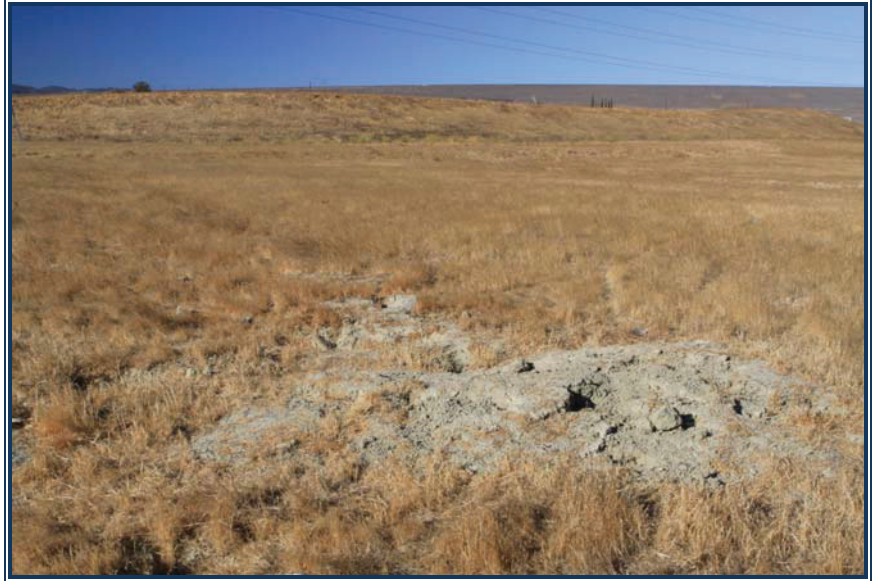
Photograph No. 15 – The photo shows the most suitable habitat for San Joaquin kit fox within the project site. This area, located east of SR 152, supports a low, sparse cover of annual grassland. Furthermore, the area supports some of the highest California ground squirrel densities observed in the study area. This latter species creates most of the burrows that are later modified as dens for kit fox. The photo is oriented to the west towards SR 152 and the dam.

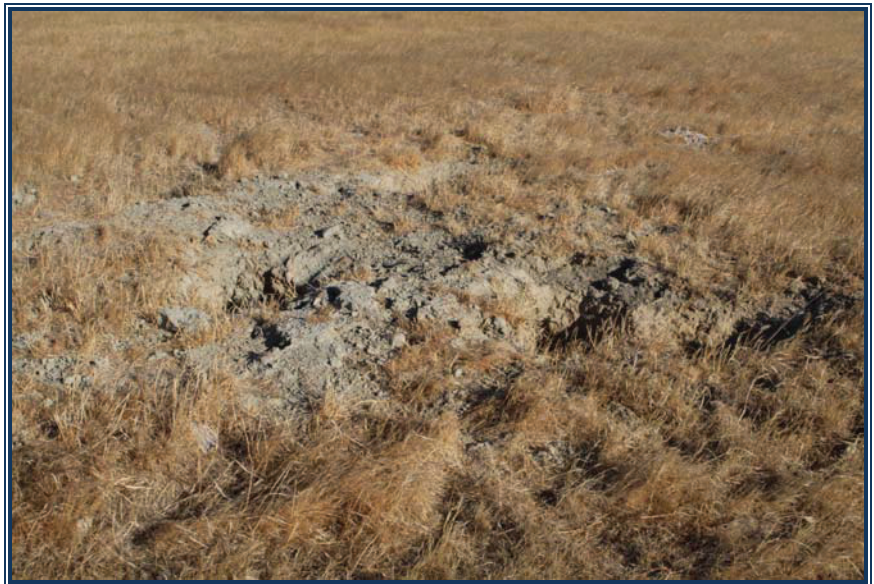
Photograph No. 16 – The photo further illustrates the low height and density of the annual grassland located east of SR 152. It also shows how easily potential escape refugia can be seen in the shorter grass landscape. Each of these factors is important to kit fox since they facilitate avoidance of and escape from potential predators (e.g., coyote).

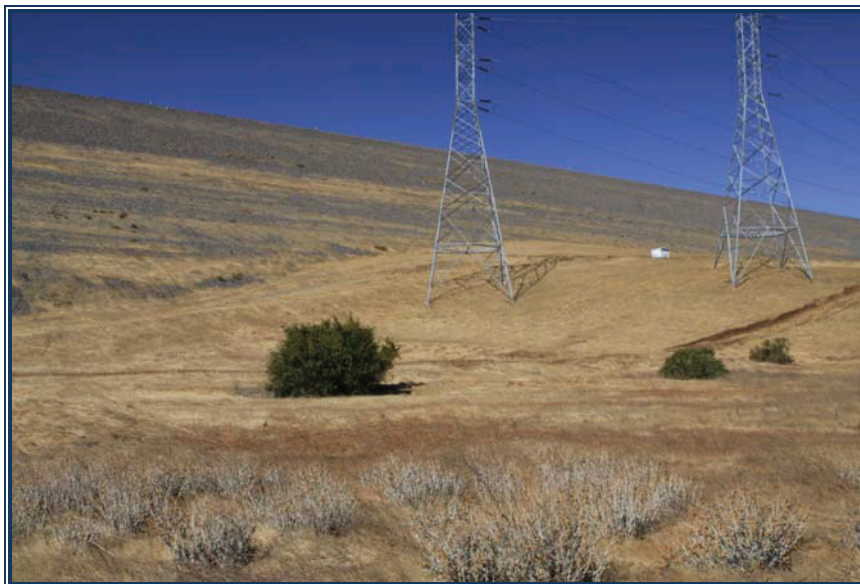
Photograph No. 17 – The photo shows annual grassland near the base of the dam that is suitable habitat for San Joaquin kit fox. The photo also shows the rock fill face of the dam, which is not suitable habitat for kit fox.

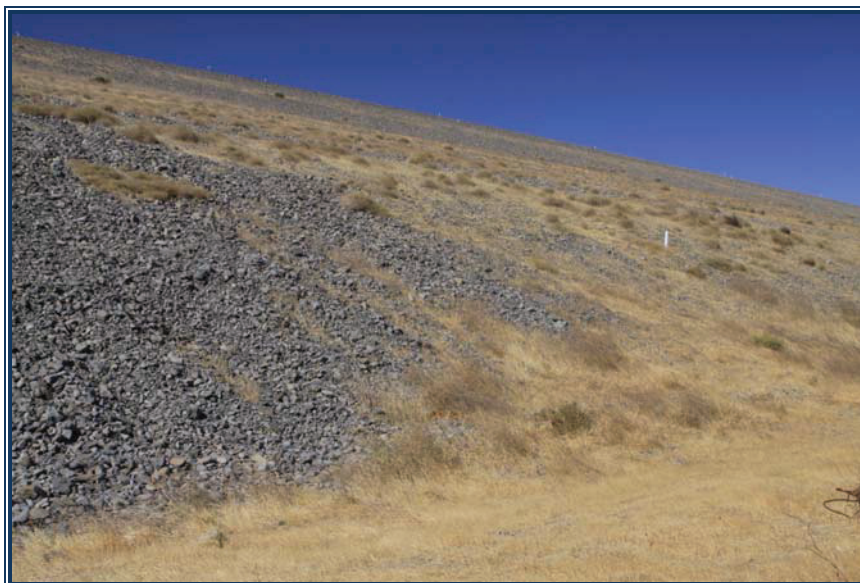
Photograph No. 18 – The photo shows a closer view of the rock fill associated with the dam. At a distance the face appears to be covered in sparse annual grassland. However, in this closer view it can be seen that the vegetative cover is sparse and patchy. Furthermore, there are no opportunities for escape refugia (i.e., potential dens) for kit fox due to the rocky substrates.

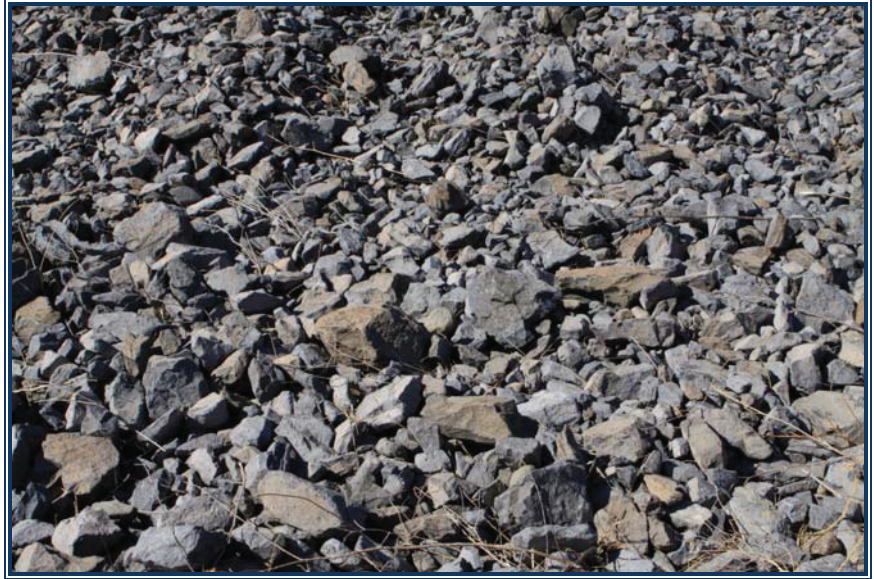
Photograph No. 19 – The photo further illustrates the rocky conditions that are found on the face of the dam. This substrate precludes any development of potential dens for kit fox.

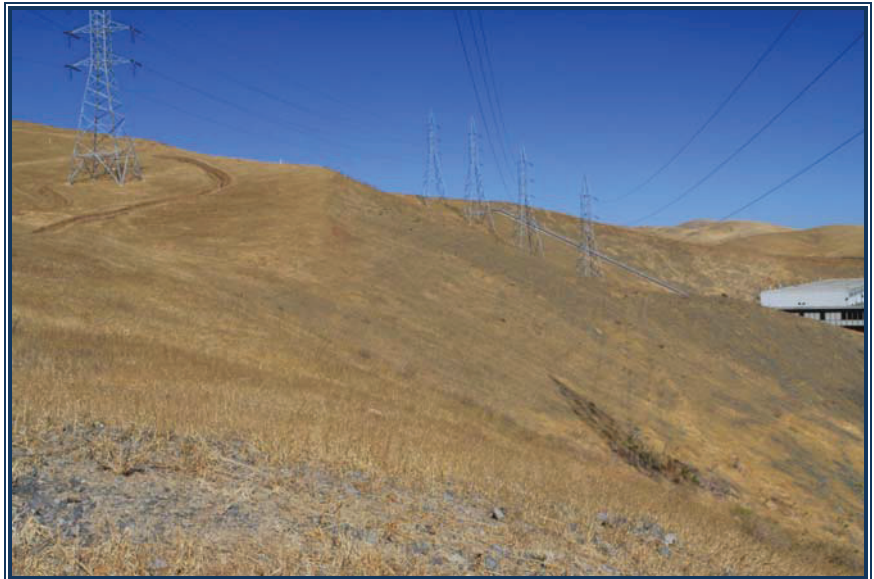
Photograph No. 20 – The photo shows annual grassland on the higher portions of the slope above the dual-purpose pumping-generating plant at O'Neill Forebay that is suitable habitat for San Joaquin kit fox (i.e., flatter terrain with deeper friable soils). However, the steeper slopes in the center and right middle ground views are associated with an extremely rocky substrate. Though animal trails were observed crossing this steep slope, no evidence of potential dens was found on the slope, while potential dens were found in the annual grassland above the steep slope. Again, similar to other portions of the study area, rocky substrates preclude the creation of potential dens for kit fox.

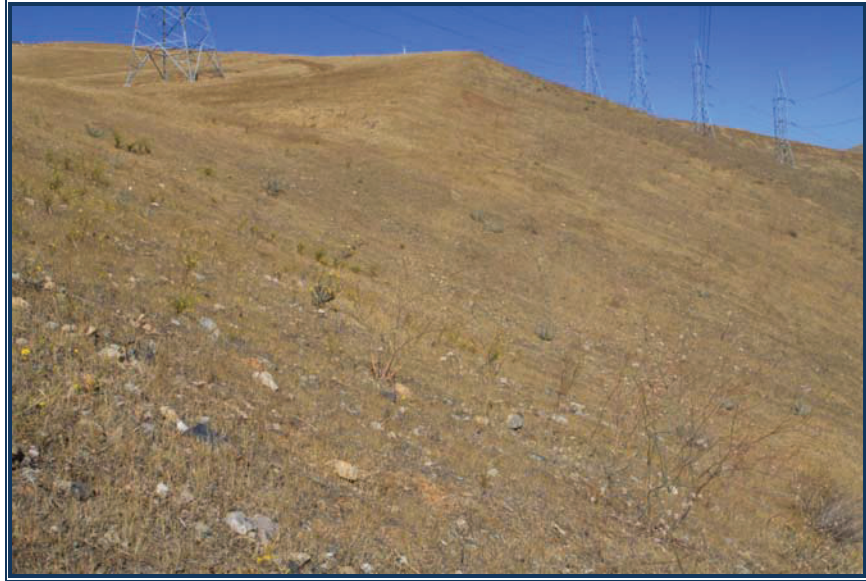
Photograph No. 21 – The photo shows a closer view of the steep, rocky slope above the dual-purpose pumping-generating plant at O’Neill Forebay. Note that no soils excavation (associated with burrowing activity) is apparent on the slope even though the vegetation is sparse and relatively low.

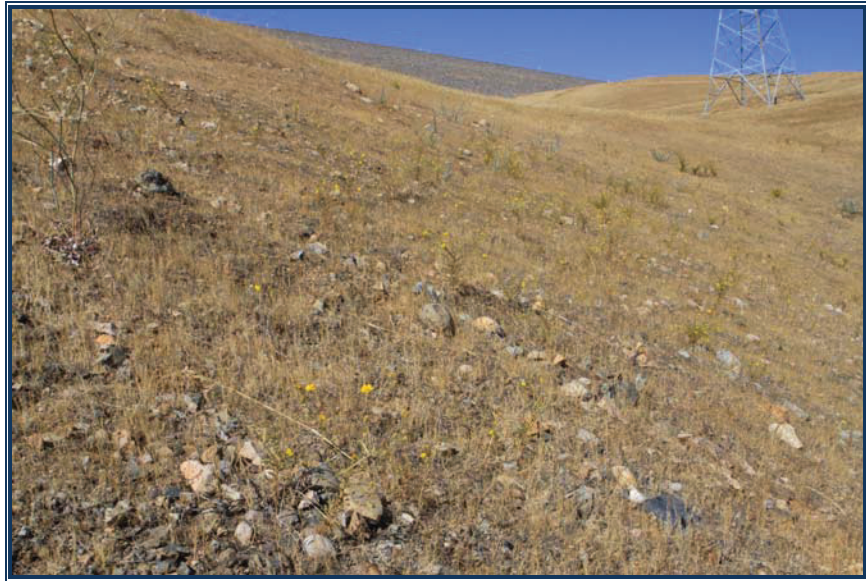
Photograph No. 22 – The photo further shows the rocky substrate above the dual-purpose pumping-generating plant at O’Neill Forebay. In addition, the photo shows the suitable habitat on the upper slopes below the rock fill face of the dam (in the right background view).

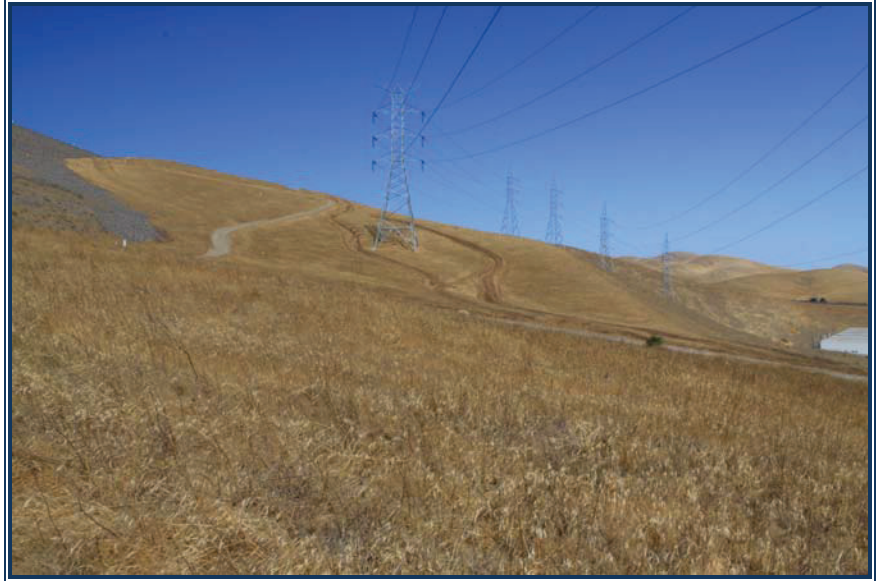
Photograph No. 23 – The photo shows a narrow corridor of suitable habitat for San Joaquin kit fox that is sandwiched between unsuitable habitat for the taxon (i.e., the rock filled face of the dam and steep, rocky slope above the dual-purpose pumping-generating plant at O'Neill Forebay).

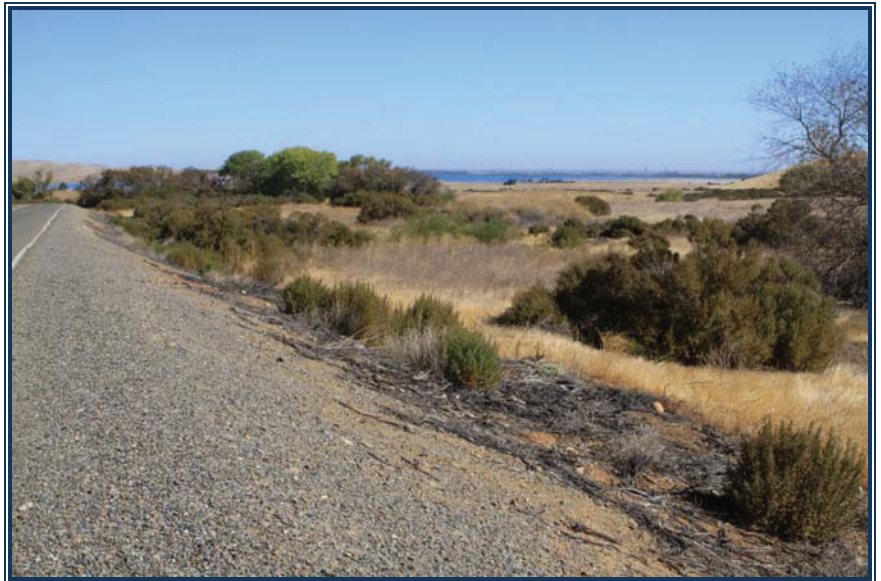
Photograph No. 24 – The photo shows a stand of dense vegetation that includes tall weedy species, *Baccharis* sp., and riparian woodland. This habitat is unsuitable for kit fox due to its height, density, presence of spiny vegetation, and seasonal presence of surface water. As identified in a previous photo, this vegetation is supported by surface runoff from and leakage through the dam. Several stands of this habitat type occur close to and downslope from the dam.

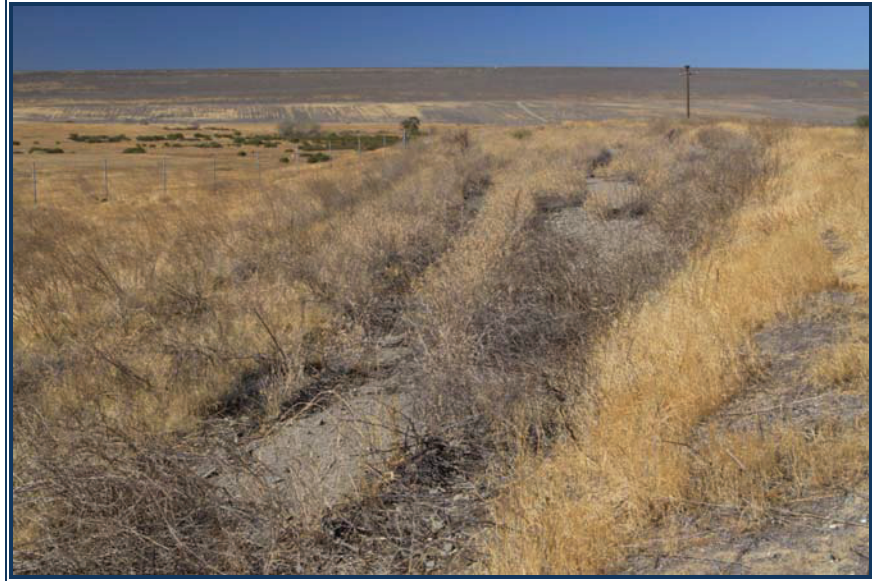
Photograph No. 25 – The photo shows overgrown pavement associated with a short reach of the old highway south of Gonzaga Road. The habitat does not provide suitable conditions for kit fox denning, but may be used as foraging habitat. The dam can be seen in the distance in the background view.

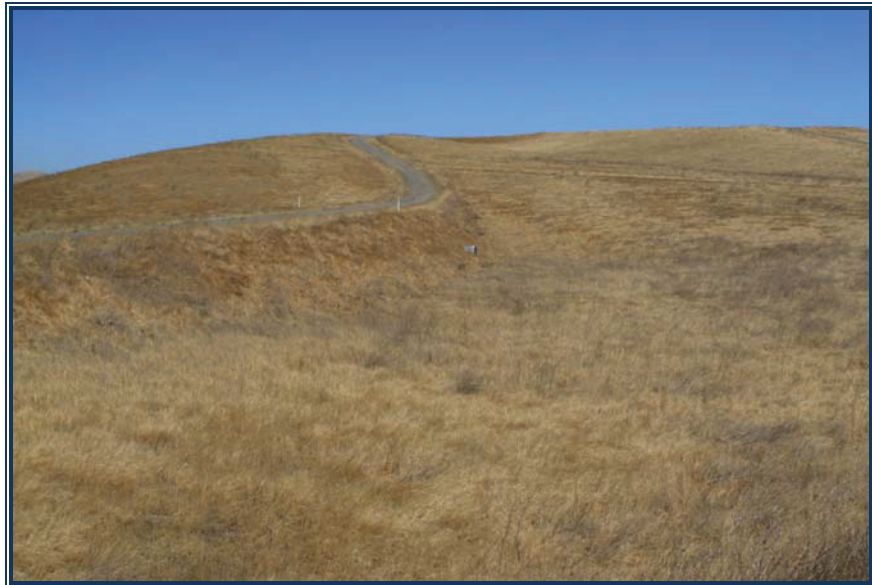
Photograph No. 26 – The photo shows the extensive annual grassland east of Basalt Road in the study area (in the vicinity of Helicopter Hill). As previously noted, this habitat is suitable for kit fox, but has diminished value due to the height and density of the annual grasses. Though potential dens (mostly American badger dens) were found in small numbers throughout this habitat, the locations of these dens are not apparent in the dense, grassland landscape. Thus, potential escape refugia for kit fox would be difficult to find in this landscape.

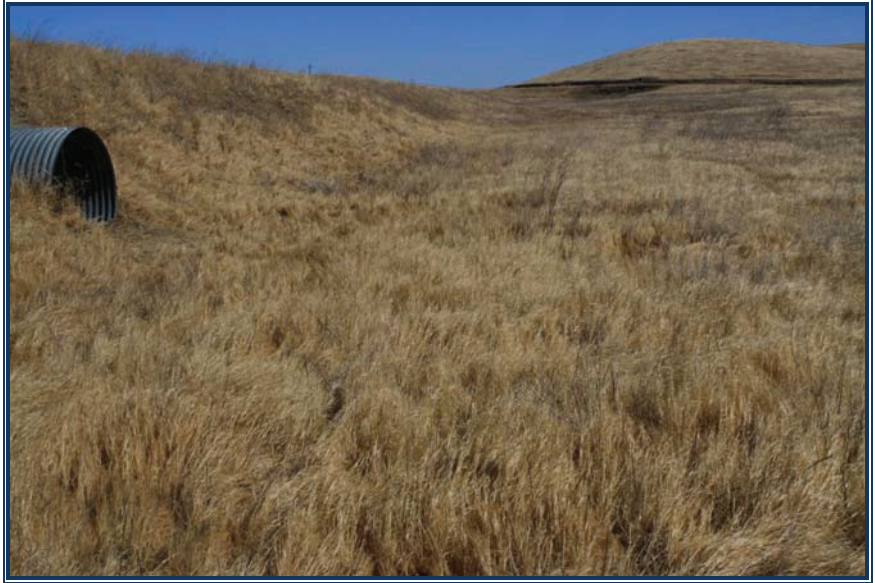
Photograph No. 27 – The photo further shows the dense, annual grassland located east of Basalt Road in the study area.

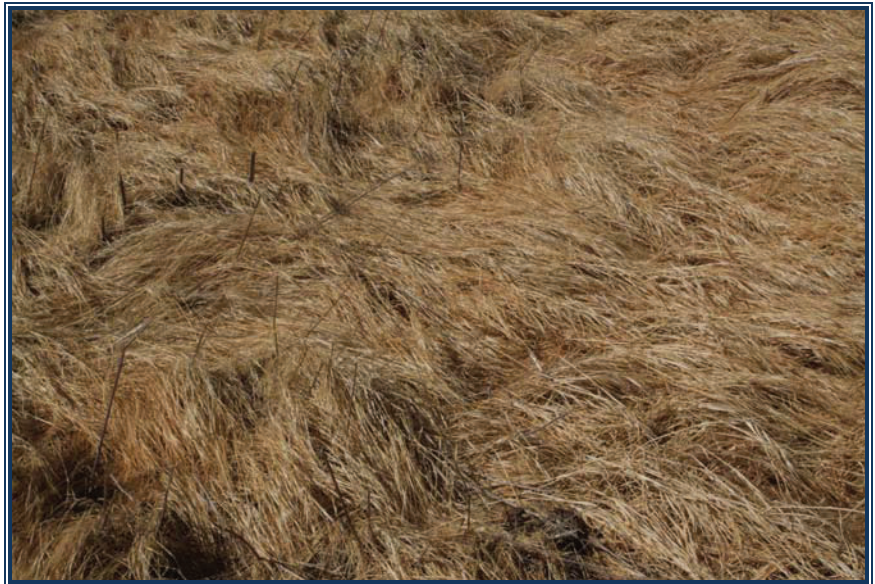
Photograph No. 28 – The photo shows a closer view of the annual grassland east of Basalt Road. Grass canopy density of this type typically occurs where fire and grazing has been precluded. The density of this grassland diminishes the value to kit fox for a variety of reasons (e.g., increased difficulties associated with movement, detection of prey species, and finding escape refugia).

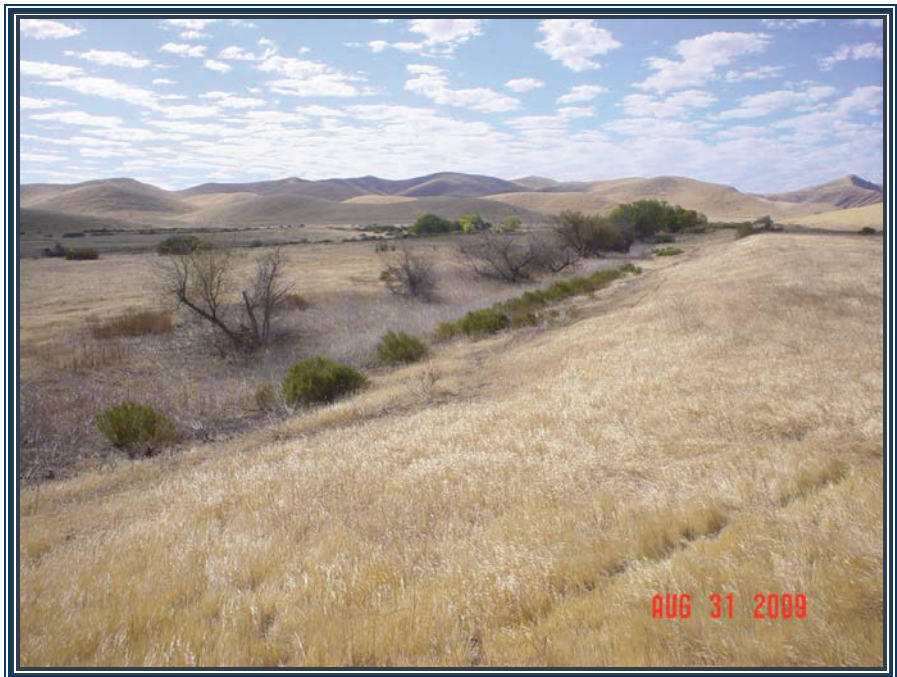
Photograph 4. Seepage wetlands occur in the lands east of the foot of the dam. These wetland features are connected via a series of ditches that help to convey the waters to O'Neill Forebay.

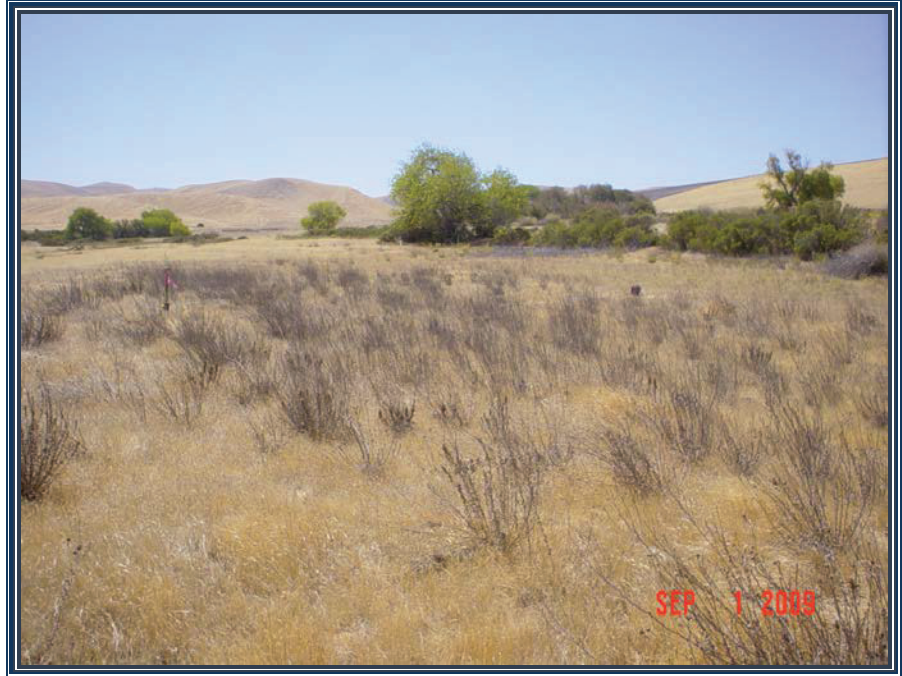
Photograph 5. A number of seasonal wetlands, such as the one in this photograph, occur east of the dam.

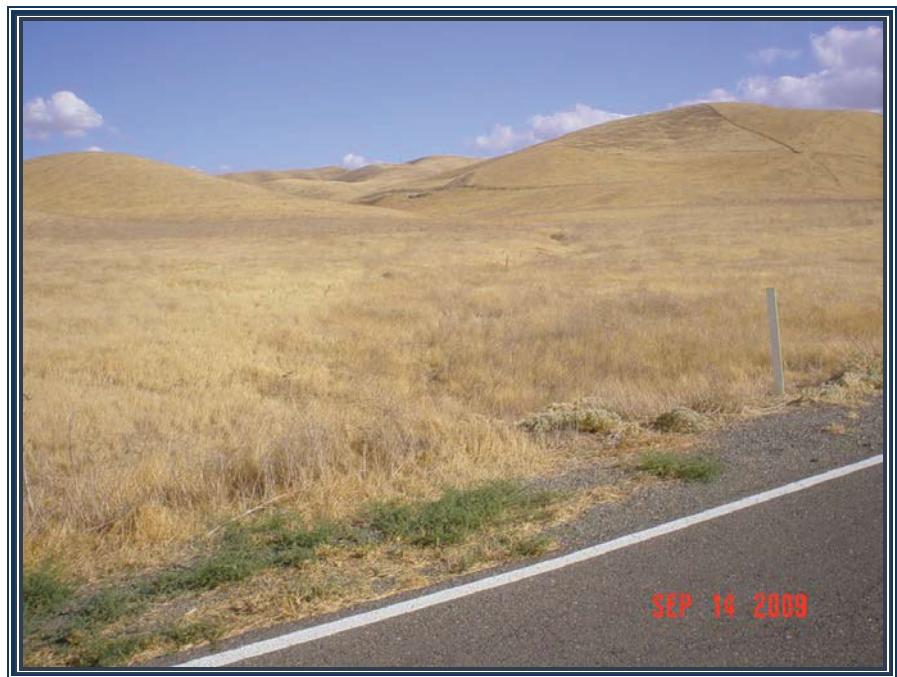
Photograph 6. Several ephemeral drainages exit the hills surrounding the project area, including this 2-foot wide ephemeral drainage.

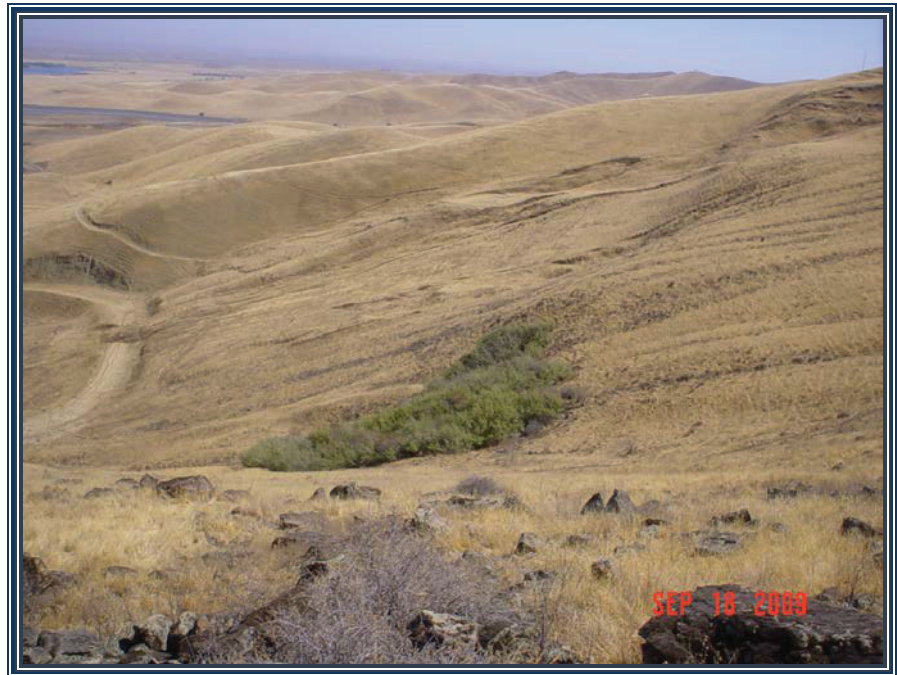
Photograph 7. This photograph shows the single “mixed chaparral” stand of silver buffaloberry.

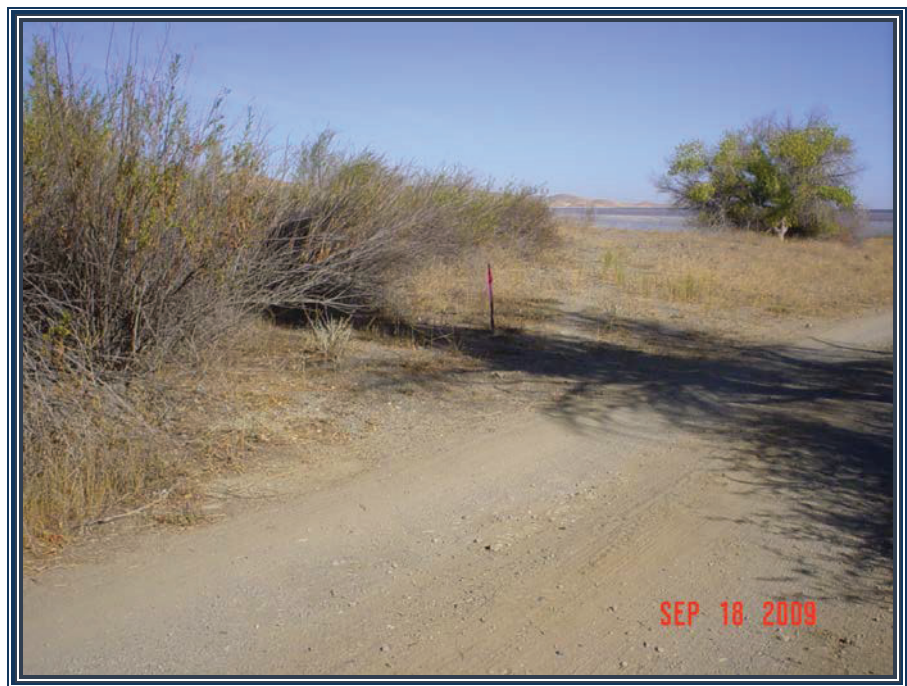
Photograph 8. This photograph shows the San Luis Reservoir below the full pool elevation. The dam can be seen in the background, and a temporary road in the foreground.
