APPENDIX A
AIR QUALITY AND GREENHOUSE GAS
EMISSIONS ASSESSMENT

SILVER DOLLAR MIXED- USE PROJECT AIR QUALITY AND GHG ASSESSMENT

Union City, California

August 29, 2018

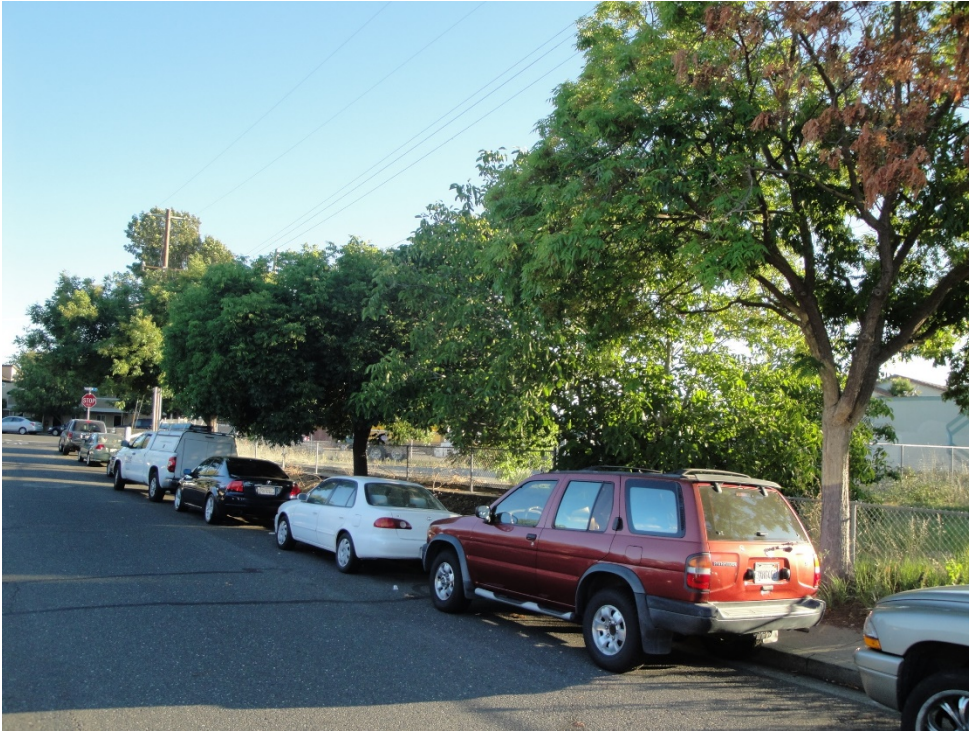
Tree #'s 1-4

- **Tree #1; Chinese Pistache, *Pistacia chinensis*:** Tree has an 11" D.B.H., diameter breast height, and a 30' drip canopy. The tree is in fair condition with a sparsely foliated canopy, with no signs of disease, infestations, biological or mechanical damages of any kind. Tree may be deficient in provided moisture and/or basic nutrients. This tree is a low to moderate preservation value city street tree.

- **Tree #2: Chinese Pistache, *Pistacia chinensis*:** Tree has a 12" D.B.H., diameter breast height, and a 35' drip canopy. The tree is in fair to good condition with a fully lush and foliated canopy, with no signs of disease, infestations, biological or mechanical damages of any kind. Tree is not deficient in moisture and/or basic nutrients. This tree has a moderate preservation value as a city street tree.

- **Tree #3; Chinese Pistache, *Pistacia chinensis*:** Tree has a 12" D.B.H., diameter breast height, and a 32' drip canopy. The tree is in fair to good condition with a fully lush and foliated canopy, with no signs of disease, infestations, biological or mechanical damages of any kind. Tree is not deficient in moisture and/or basic nutrients. This tree has a moderate preservation value as a city street tree.

- **Tree #4; *Juglans species*, Walnut:** Multiple main stems add to a cumulative D.B.H. of approximately 30", with a 25' drip canopy. This tree is in poor condition

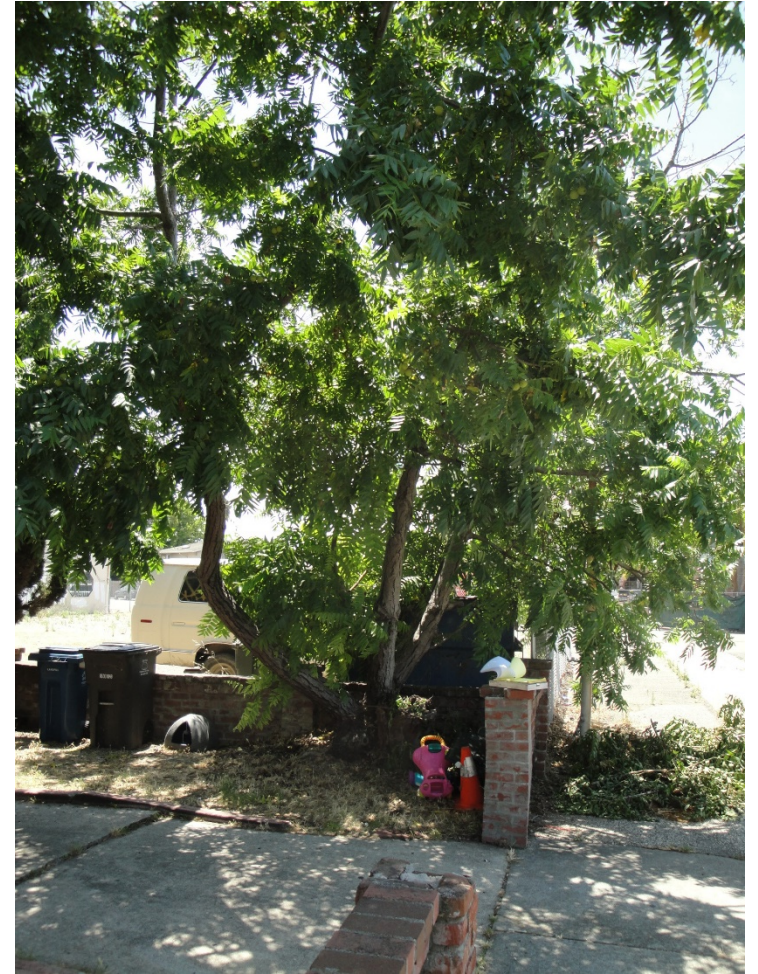
Tree #6

- **Tree # 5; *Juglans species*, Walnut:** Multiple main stems with much of the tree dead. This tree is in poor condition and has no value.
- **Tree # 6; *Juglans species*, Walnut:** Multiple main stems, totaling 32" D.B.H. Tree has been Improperly maintained and neglected, and much of this tree has dying or dead limbs and branches. This tree is in poor condition and has no value.

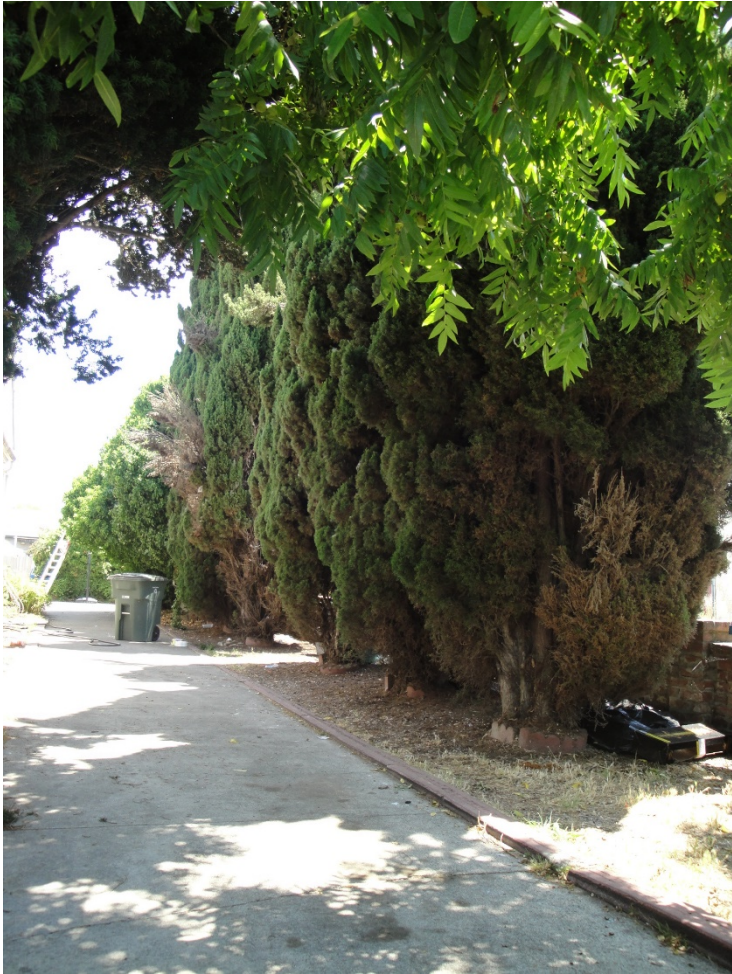
Tree #'s 7-12

- **Tree # 7; Cupressus sempervirens; Italian Cypress:** Multiple main stems, this tree has a canopy width of 7'. Foliage is dark-green, full, and lush, with no sign of diseases, or infestations. This tree is in fair condition.

- **Tree # 8; Cupressus sempervirens; Italian Cypress:** Multiple main stems, this tree has a canopy width of 6'. Foliage is dark-green, full, and lush, with no sign of diseases, or infestations. This tree is in fair condition.

- **Tree # 9; Cupressus sempervirens; Italian Cypress:** Multiple main stems, this tree has a canopy width of 6'. Foliage is dark-green, full, and lush, with no sign of diseases, or infestations. This tree is in fair condition.

- **Tree # 10; Cupressus sempervirens; Italian Cypress:** Multiple main stems, this tree has a canopy width of 6'. Foliage is -green, full, and lush, however, this tree has many dead branches up in the column canopy. This tree is in poor condition.

- **Tree # 11; Cupressus sempervirens; Italian Cypress:** Multiple main stems, this tree has a canopy width of 6'. Foliage is dark green, full, lush, with no sign of diseases, or infestations. This tree is in fair condition.

- **Tree # 12; Cupressus sempervirens; Italian Cypress:** Multiple main stems, this tree has a canopy width of 6'. Foliage is dark green, full, and lush; however, the tree is overgrown with Algerian Ivy. This tree is in poor condition.

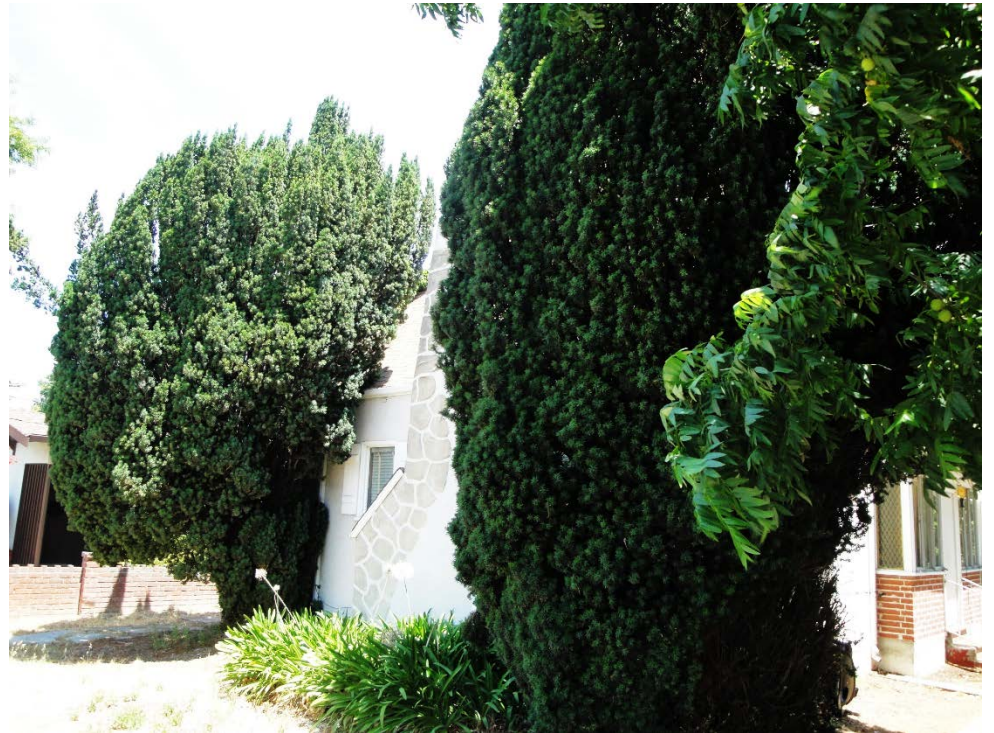
Tree #'s 13-14

- **Tree # 13; Taxus baccatta stricta:** Multiple main stems, this tree is lush, full, and dark-green, with no sign of diseases, or infestations. This tree has been improperly trimmed and pruned over the years.

- **Tree # 14; Taxus baccatta stricta:** Multiple main stems, this tree is lush, full, and dark-green, with no sign of diseases, or infestations. This tree has been improperly trimmed and pruned over the years.

TR#13	Taxus baccata	English Yew	Multi. From grade	8'	<ul style="list-style-type: none"> - Tree/shrub is in fair condition. - Leaves are dark-green, and lush that are full, thick, and vigorous. 	Some improper pruning for clearance was performed on this tree.

level.		- No sign of disease, infestation or decay of any kind is present at this time.	
TR#14	Taxus baccata	English Yew	Multi. From grade level.	8'	<ul style="list-style-type: none"> - Tree/shrub is in fair condition. - Leaves are dark-green, and lush that are full, thick, and vigorous. - No sign of disease, infestation or decay of any kind is present at this time. 	Some improper pruning for clearance was performed on this tree. value.

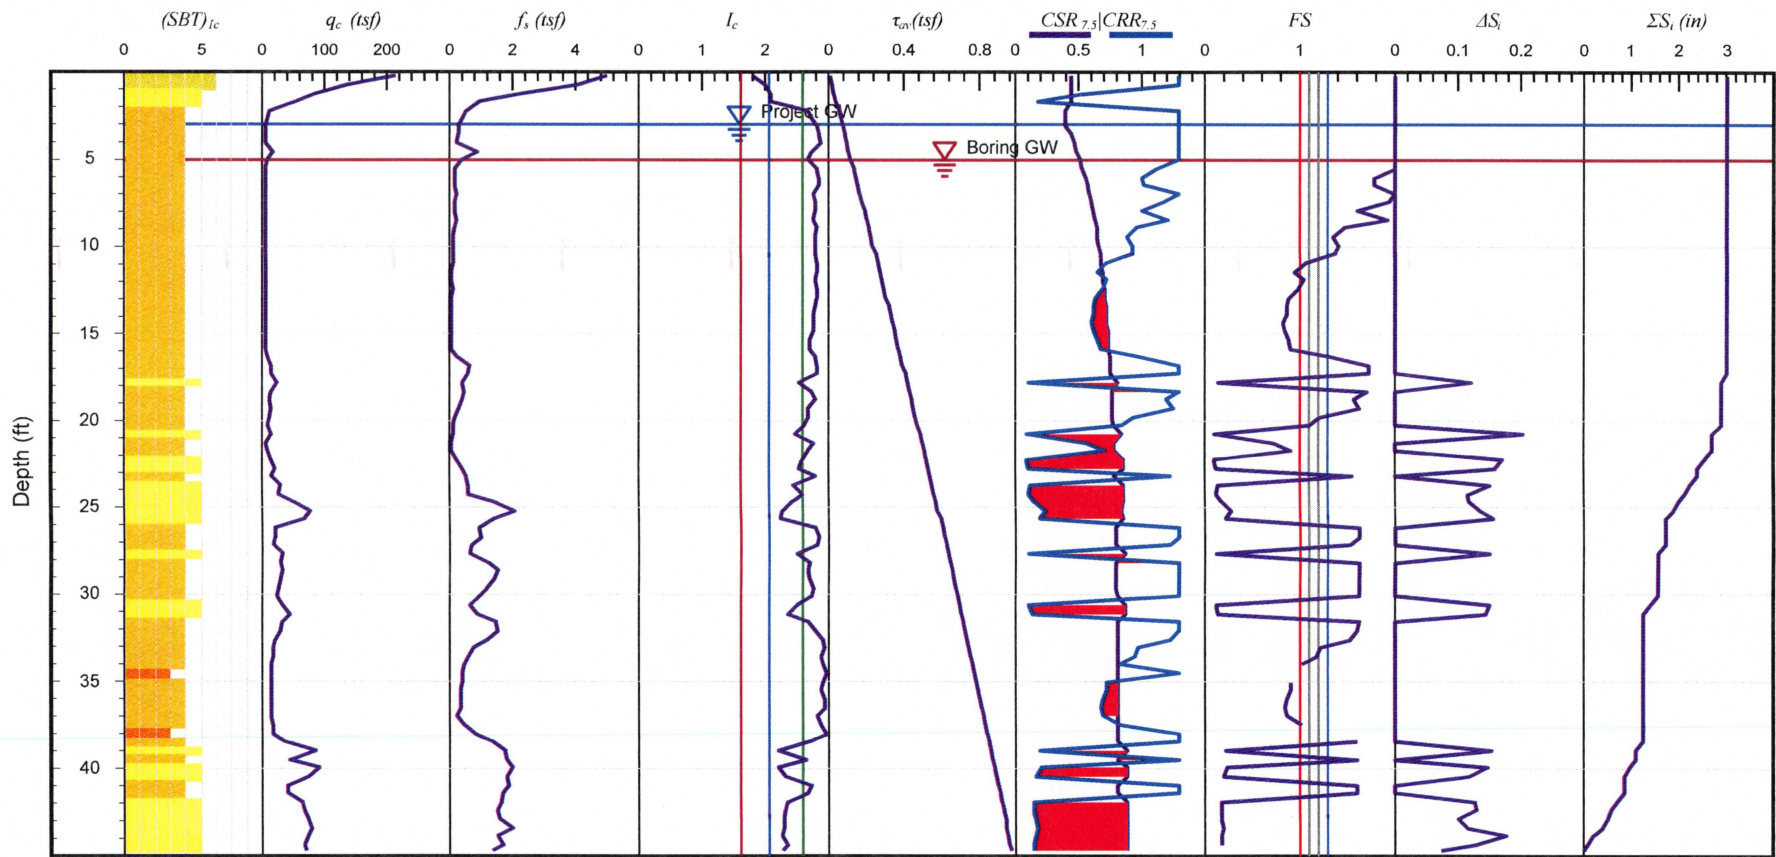
- Sensitive fine grained
- Organic soils - peats
- Clay to silty clay
- Silty clay to clayey silt
- Sandy silt to silty sand
- Silty sand to clean sand
- Dense sand to gravelly sand
- Clayey sand to very stiff sand

- Very stiff fine grained *
- * Overconsolidated or cemented

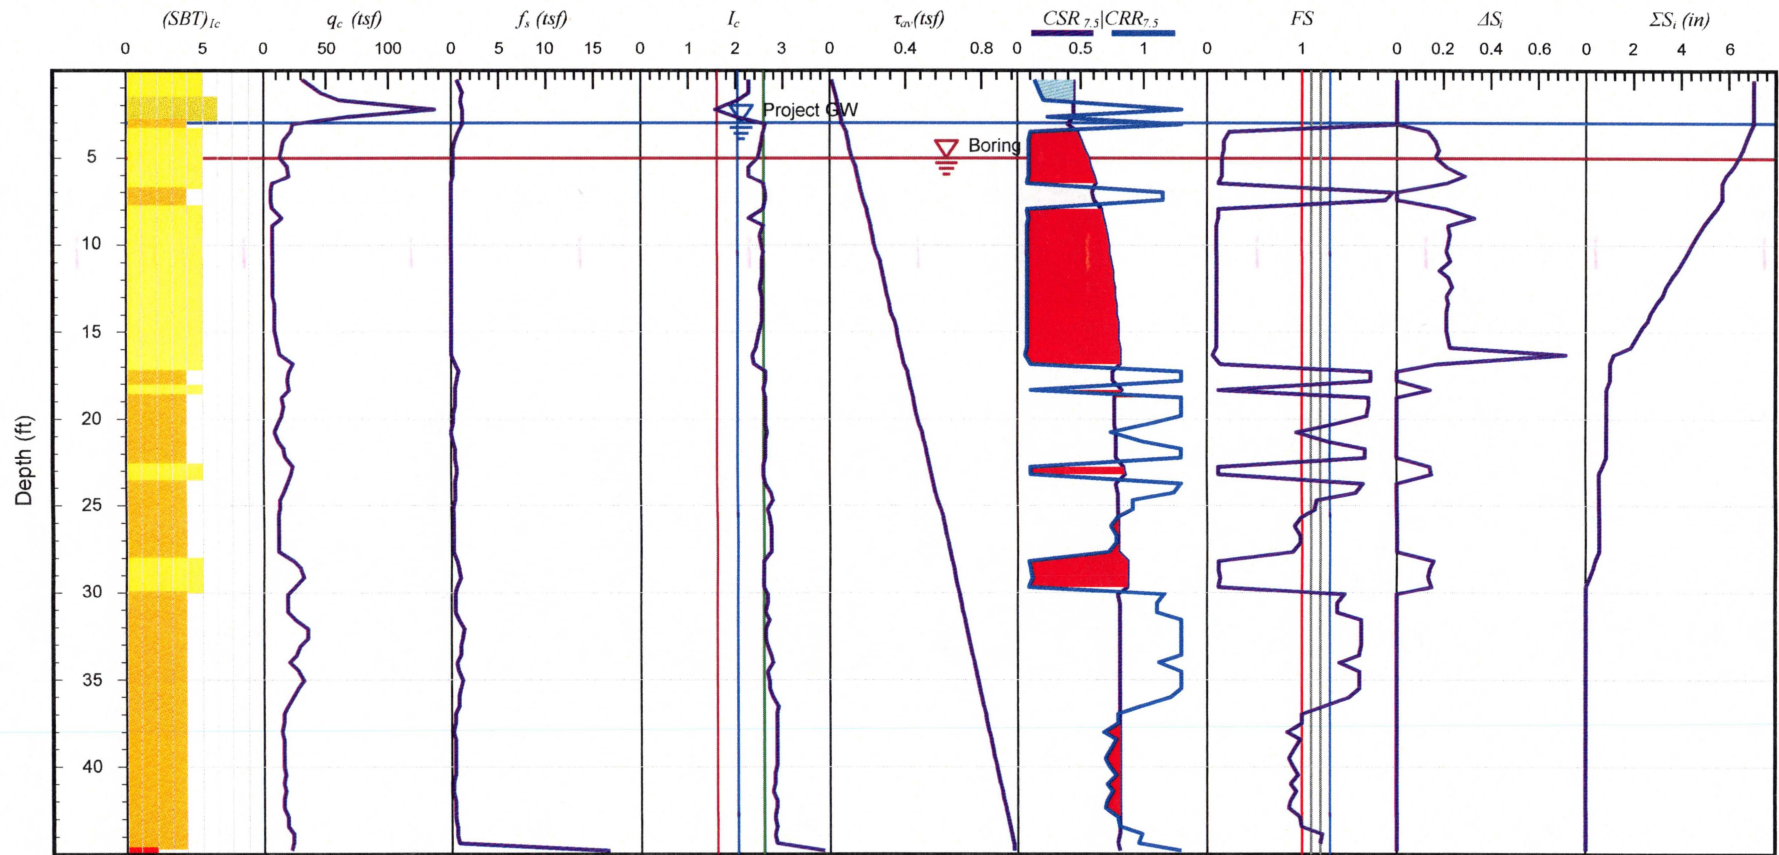
- Sensitive fine grained
- Organic soils - peats
- Clay to silty clay
- Silty clay to clayey silt
- Sandy silt to silty sand
- Silty sand to clean sand
- Dense sand to gravelly sand
- Clayey sand to very stiff sand

- Very stiff fine grained *
- * Overconsolidated or cemented
