## REVISED PHASE I ENVIRONMENTAL SITE ASSESSMENT

*1000 South Fremont Avenue  
Alhambra, California*

February 12, 2018  
Haro Environmental Project 1902-2017

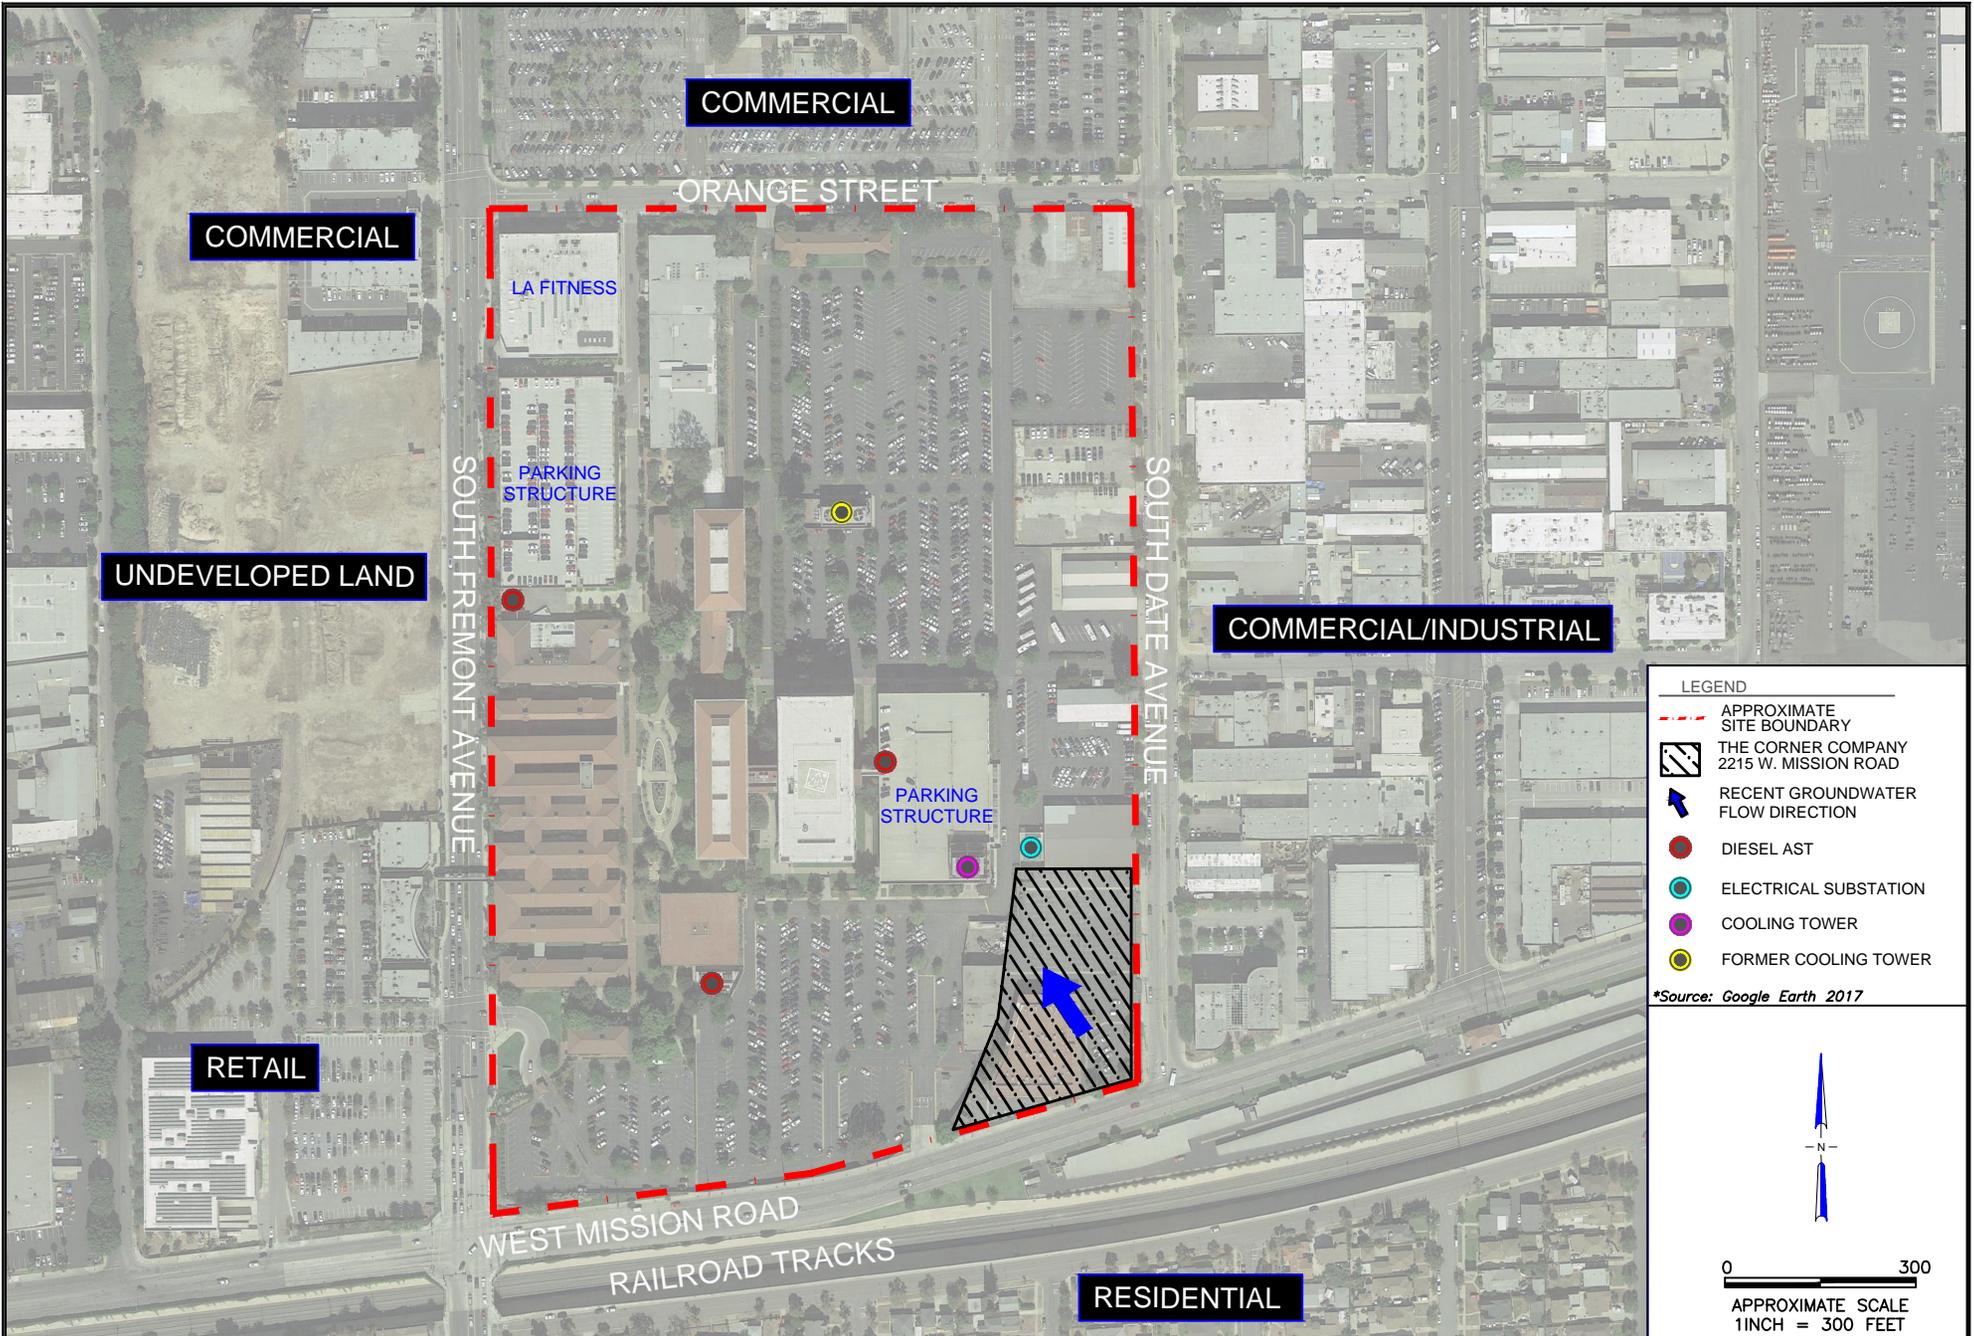
- APPROXIMATE SITE BOUNDARY
- THE CORNER COMPANY 2215 W. MISSION ROAD
- RECENT GROUNDWATER FLOW DIRECTION
- DIESEL AST
- ELECTRICAL SUBSTATION
- COOLING TOWER
- FORMER COOLING TOWER

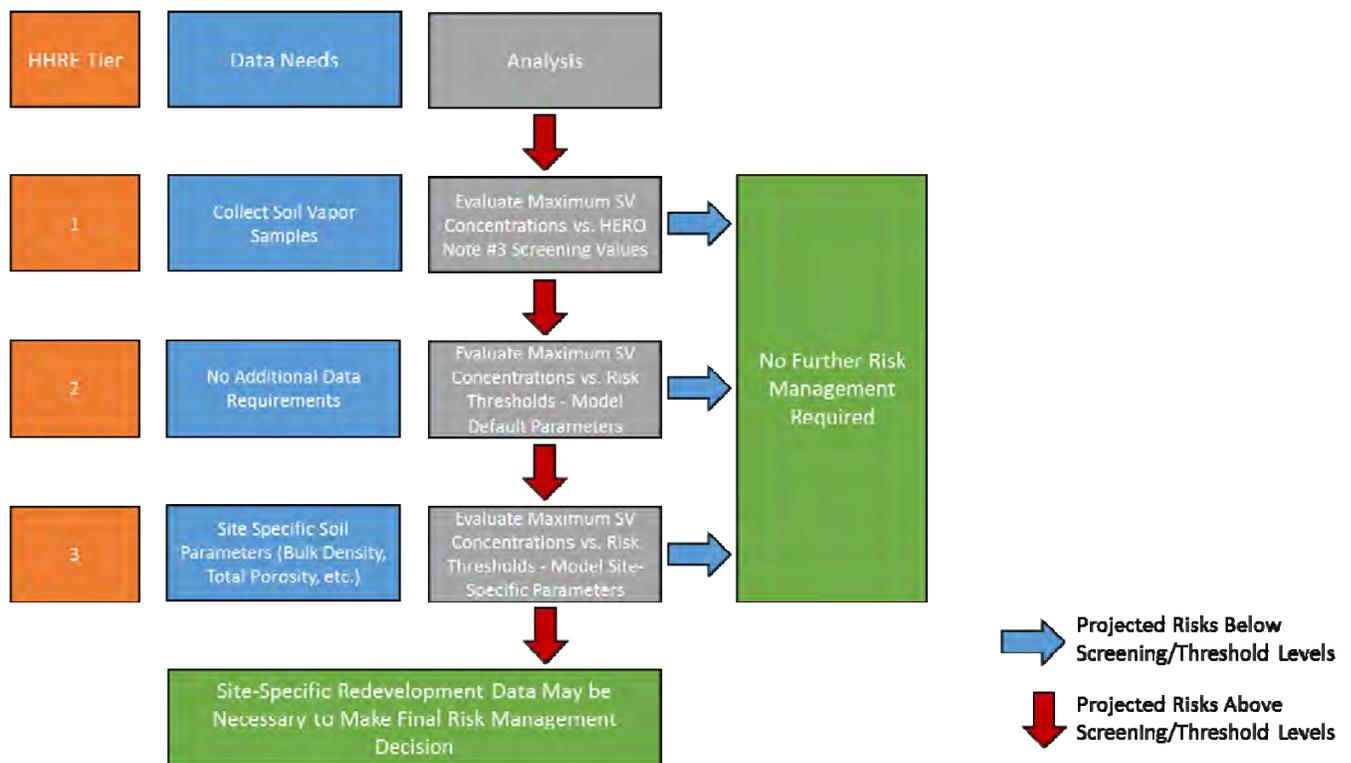
The objective of the soil vapor sampling proposed in this work plan will be to obtain and analyze soil vapor samples to allow a technically defensible position regarding the nature and extent of chemicals of potential concern in subsurface soil vapor and provide high quality data for regulatory agency decision-making regarding the long-term protection of human health. Equipoise anticipates that a multi-tier human health risk evaluation (HHRE) for the assessment of potential human health risks associated with the migration of soil vapors to indoor air at the subject Site would be beneficial. It is proposed that the structure of this multi-tiered HHRE progress from conservative regulatory screening criteria to site-specific modeling as necessary to isolate risk driving components, if any. The following flow chart summarizes the proposed multi-tier risk evaluation process.

The first tier of the analysis consists of a comparison of the maximum detected soil vapor concentrations in the 5 and 10 foot samples of each constituent for the proposed sample event to the corresponding chemical-specific Department of Toxic Substances Control (DTSC) Office of Human and Ecological Risk (HERO) Human Health Risk Assessment (HHRA) Note #3 recommended screening value for soil vapor intrusion risk screening (Cal/EPA, 2014). The soil vapor HERO Note#3 values represent concentrations in soil vapor that the Cal/EPA considers to be below thresholds of concern for risks to human health for specific land use conditions. The HERO Note #3 values are conservatively used to qualitatively screen sites for potential human health concerns associated with potential soil and/or soil vapor contamination.

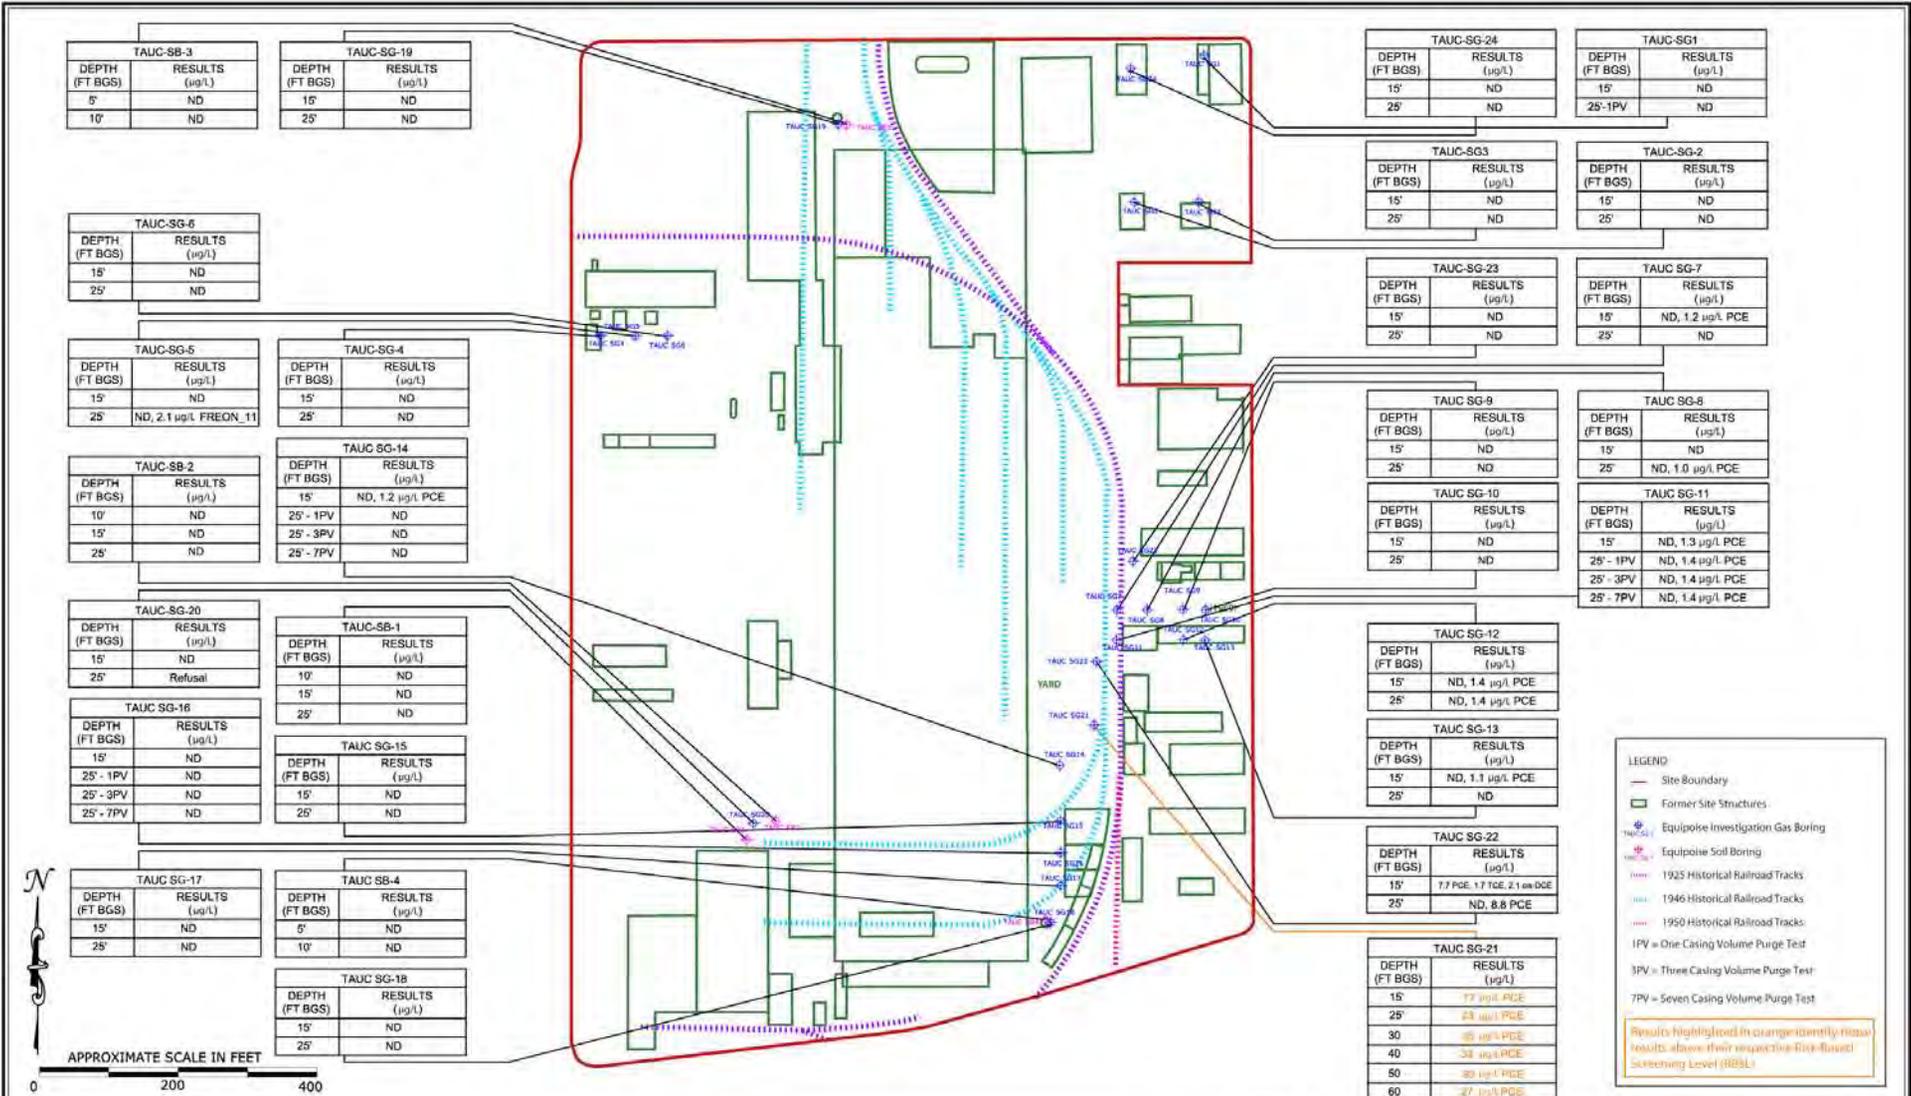
TAUC-SB-3	
DEPTH (FT BGS)	RESULTS (µg/L)
5'	ND
10'	ND

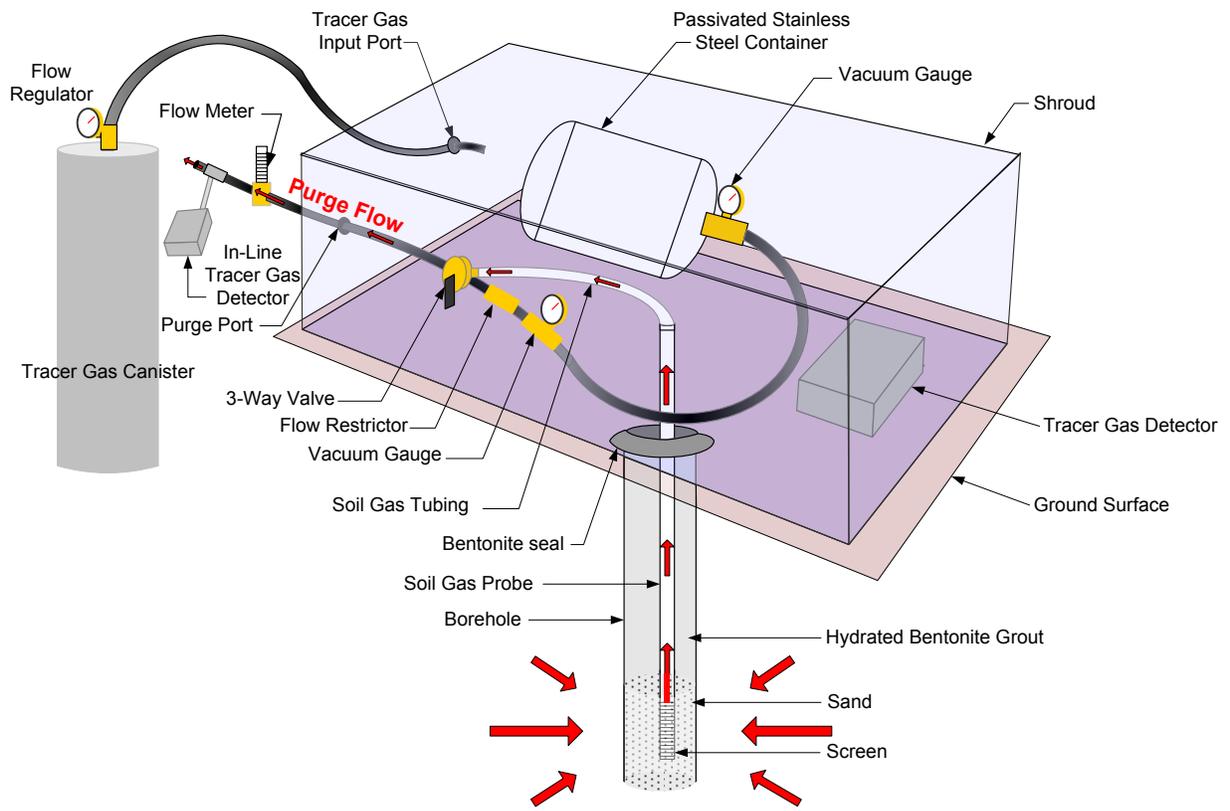
FIGURE C-2

Shroud Components – Purge Conditions

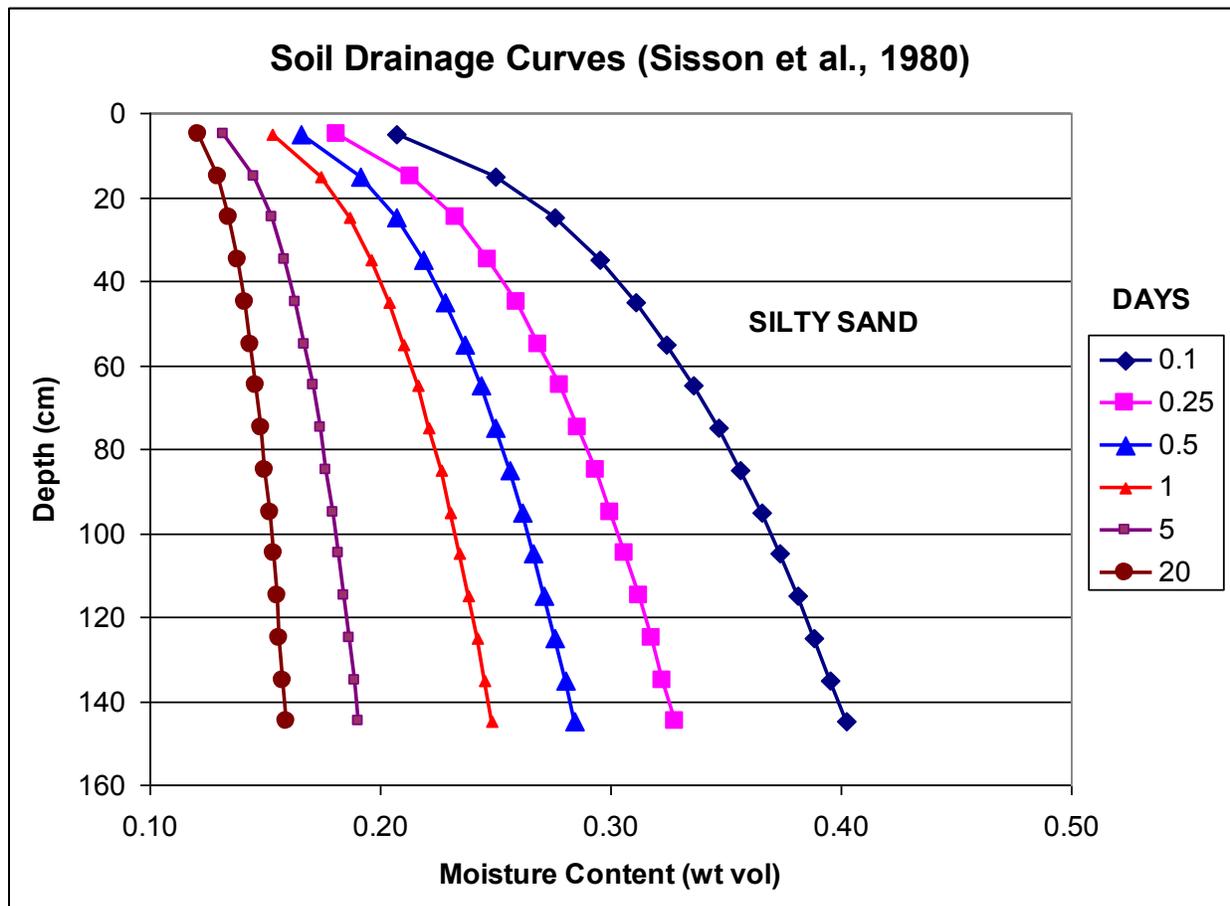
FIGURE G-2

Likewise, Sisson and others (1980) derived a one-dimensional unsaturated flow equation to evaluate water movement in the vadose zone. Soil drainage curves from Sisson and others (1980) where a unit gradient was assumed are shown in Figure G-2. The figure denotes a silty sand scenario where the initial unsaturated hydraulic conductivity was assumed to be 100 centimeters per day. The model assumed that the vadose was saturated to 0.40 and allowed to drain. Moisture profiles are shown for five different time intervals. The figure demonstrates that drainage to near ambient moisture conditions of 0.10 occurred within about five days, agreeing with the approximations by Gardner and others (1970).
