# **SOIL ASSESSMENT REPORT ADDITIONAL BORING SS-4A**

**777 NORTH FRONT STREET  
BURBANK, CALIFORNIA**

Project Number HR1305

July 22, 2016

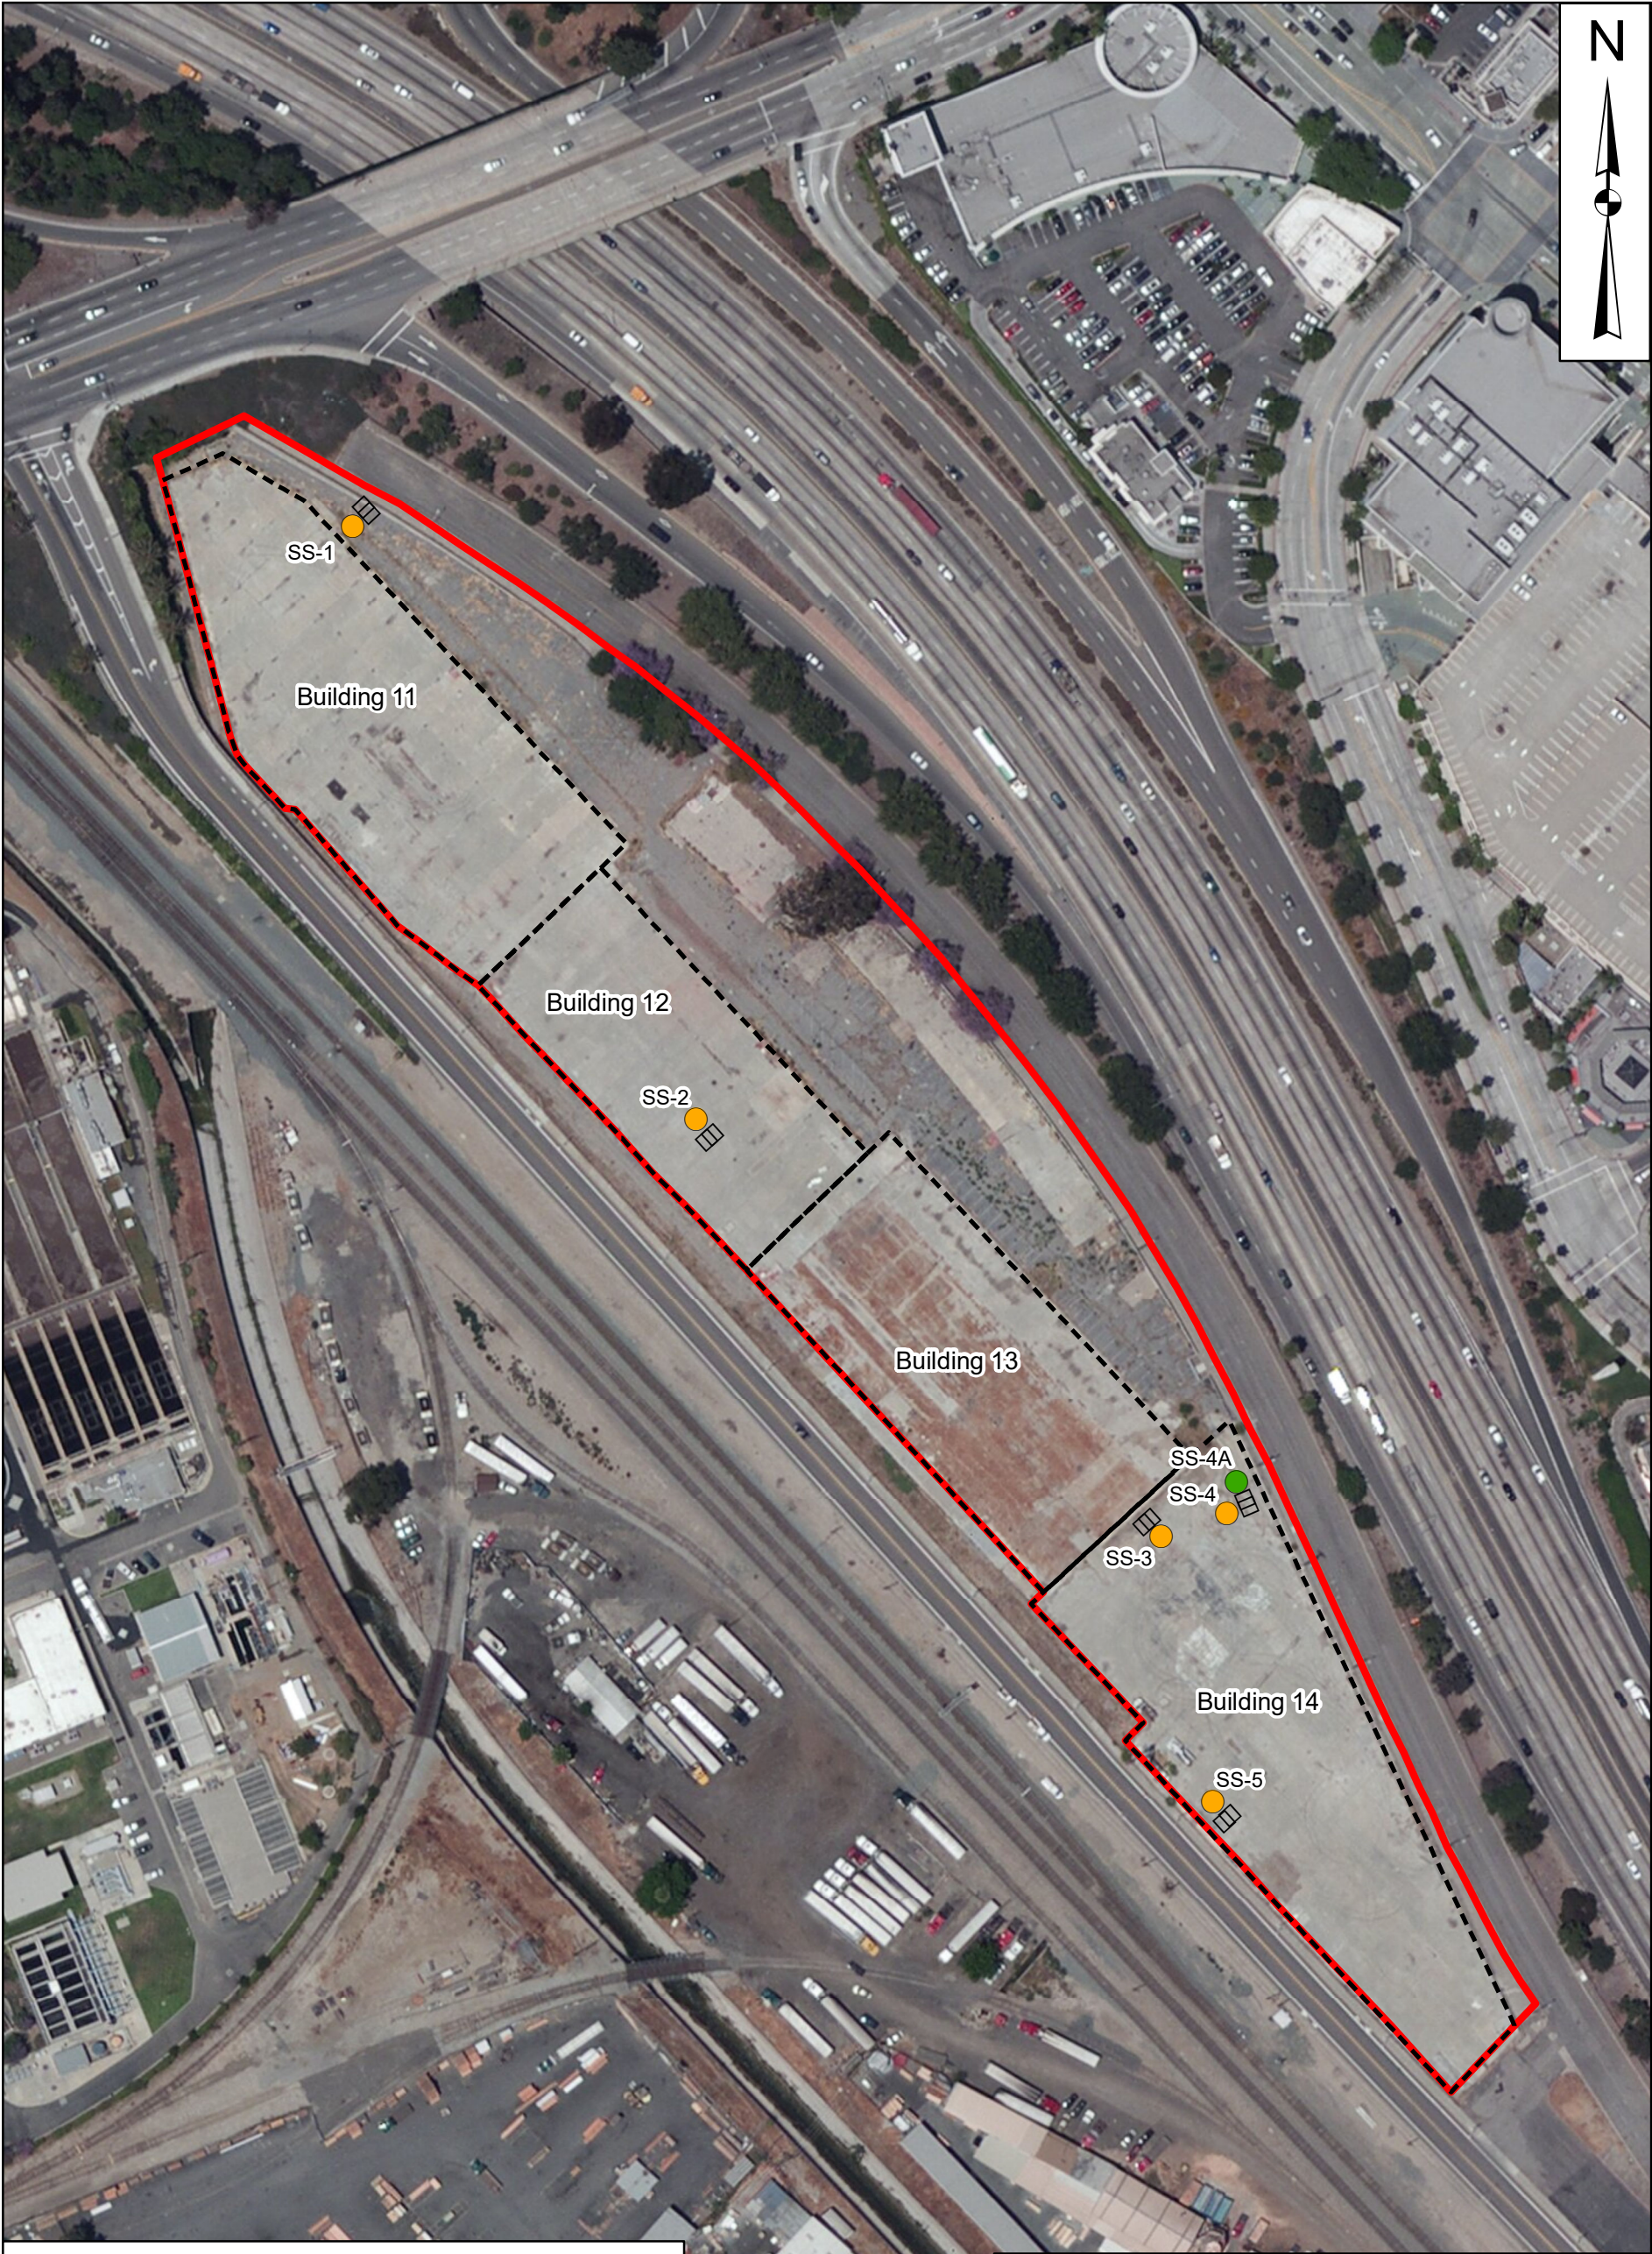
Figure  
2

Soil Boring Locations  
Former Zero Corporation  
777 North Front Street  
Burbank, California

On June 2, 2016, under the direction of Geosyntec, Gregg Drilling advanced a single boring (labeled SS-4A; Figure 2) using a hollow-stem auger rig to a depth of approximately 40 ft bgs and several depth discrete soil cores were collected using a 18-inch split-spoon sampler. Borings were visually logged for geologic lithology in accordance with the Unified Soil Classification System (USCS). The first 5 ft of the boring was completed by hand auger to reduce the potential for impairing unidentified underground utilities or pipes. Soil samples were collected from the cores at 10, 20, 25, 30, 35, and 40 ft bgs in accordance with the approved Work Plan (Appendix A) using disposable sampling equipment in order to avoid cross contamination of samples. A photographic log showing the Site soil assessment field procedures is provided in Appendix D. A total of six primary soil samples and two duplicate soil samples (labeled SS-4A-10DUP and SS-4A-20DUP) were collected in this manner.

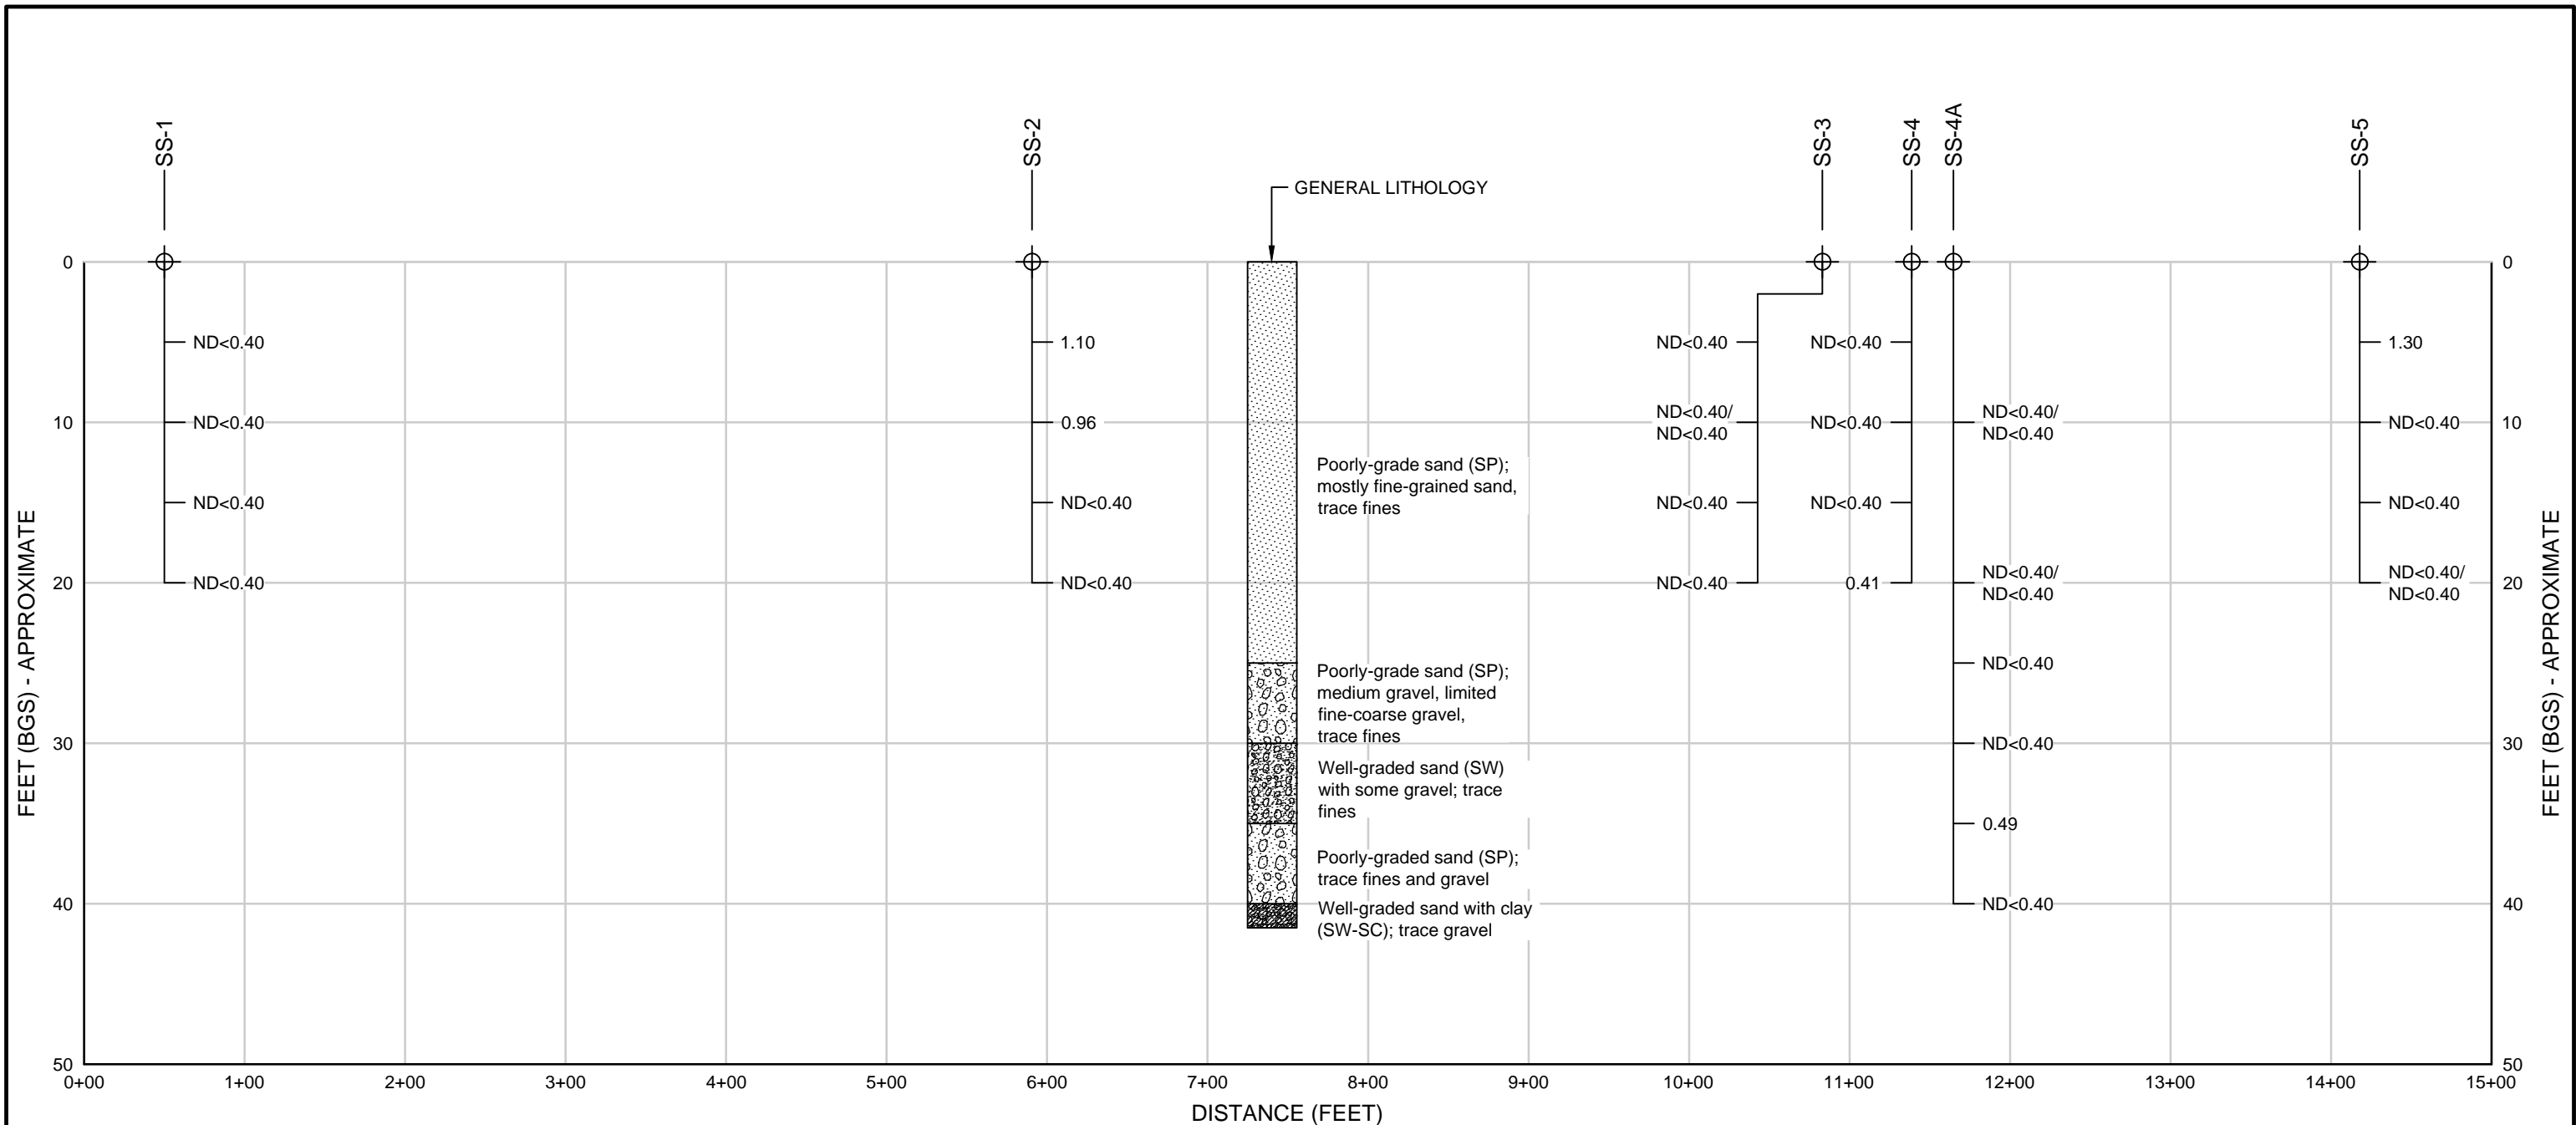
Figure  
**4**

**FENCE DIAGRAM - Cr6+ RESULTS**  
FORMER ZERO CORPORATION  
777 NORTH FRONT STREET  
BURBANK, CALIFORNIA

A total of six primary and two duplicate soil samples were collected from SS-4A and were analyzed for  $\text{Cr}^{6+}$  using EPA Method 7199. Table 1 summarizes the analytical results and provides commercial/industrial SSLs (i.e., chemical-specific soil health screening levels for commercial/industrial land use) for comparison. A plan view of boring locations from June 2012 and June 2016 is provided in Figure 3 that includes tables with soil sample depths and concentrations of  $\text{Cr}^{6+}$ . Per the request of the LARWQCB in the conditional approval letter [LARWQCB, 2016], the vertical distribution of  $\text{Cr}^{6+}$  results is also shown on Figure 4 along with a general lithologic profile.

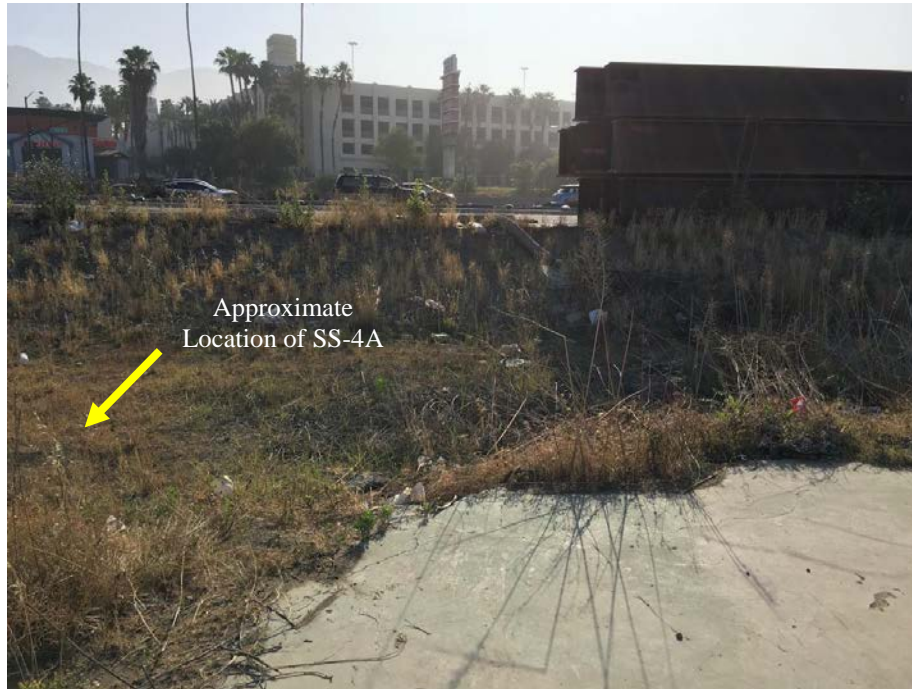
<b>Photo No.:</b>	1	<b>Date:</b>	June 2, 2016
<b>Photographer:</b>	Brian Penserini		
<b>Subject:</b>	View of Proposed Site of SS-4A		
<b>Project:</b>	777 N. Front Street, Additional Boing Investigation - 2016	<b>City/State:</b>	Burbank, CA

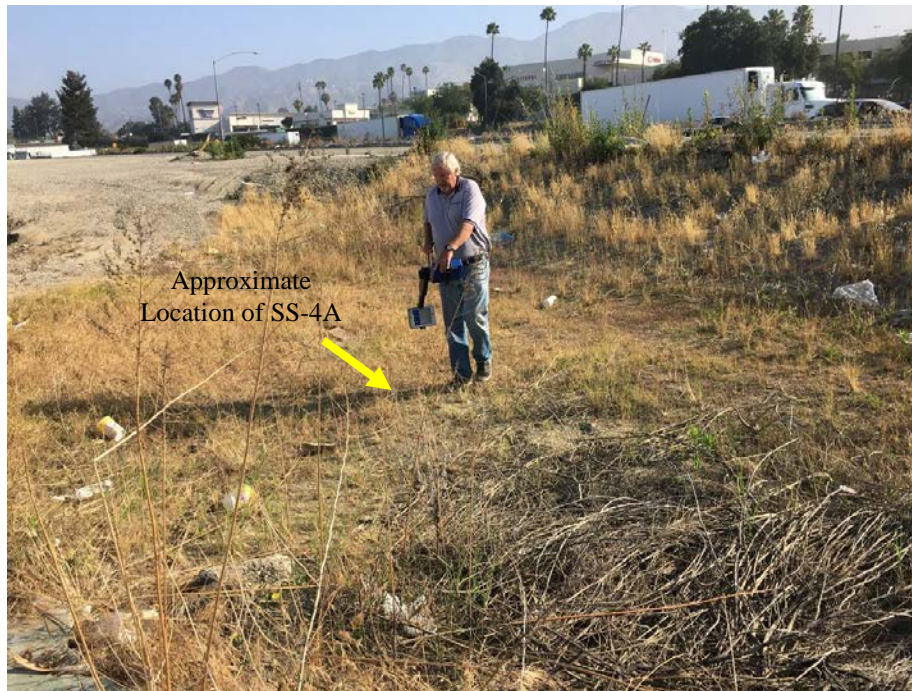
<b>Photo No.:</b>	2	<b>Date:</b>	June 2, 2016
<b>Photographer:</b>	Brian Penserini		
<b>Subject:</b>	Goldak Geophysics Performing Subsurface Survey		
<b>Project:</b>	777 N. Front Street, Additional Boing Investigation - 2016	<b>City/State:</b>	Burbank, CA

Underground Service Alert (USA) was notified more than 48 hours prior to beginning drilling activities to identify underground utilities in the vicinity of the proposed borehole location and to reduce the potential for accidentally encountering buried utility lines (USA ticket number A61341104). Once utilities were cleared, drilling of the borehole was scheduled. Geosyntec also contracted with Goldak Geophysics to conduct a subsurface geophysical survey to identify locations of potential underground utilities. Goldak identified a subsurface anomaly in the approximate location of the former clarifier

and marked the outline of the anomaly with high-visibility paint. SS-4A was then positioned approximately 5 ft north of the anomaly.

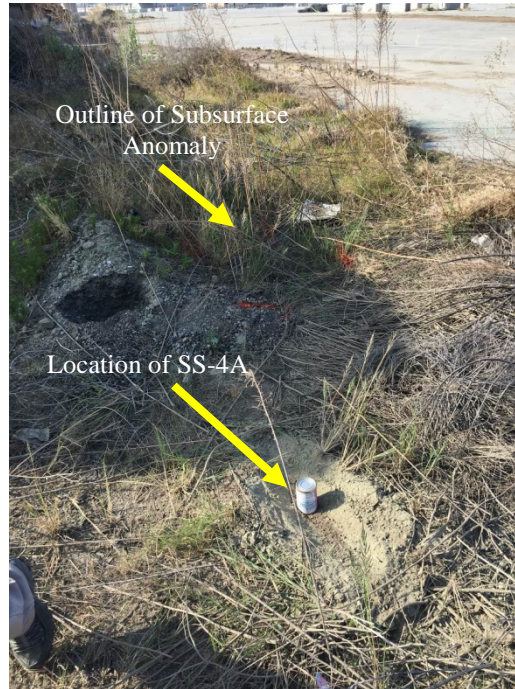
<b>Photo No.:</b>	3	<b>Date:</b>	June 2, 2016
<b>Photographer:</b>	Brian Penserini		
<b>Subject:</b>	Location of SS-4A Prior to Drilling		
<b>Project:</b>	777 N. Front Street, Additional Boing Investigation - 2016	<b>City/State:</b>	Burbank, CA

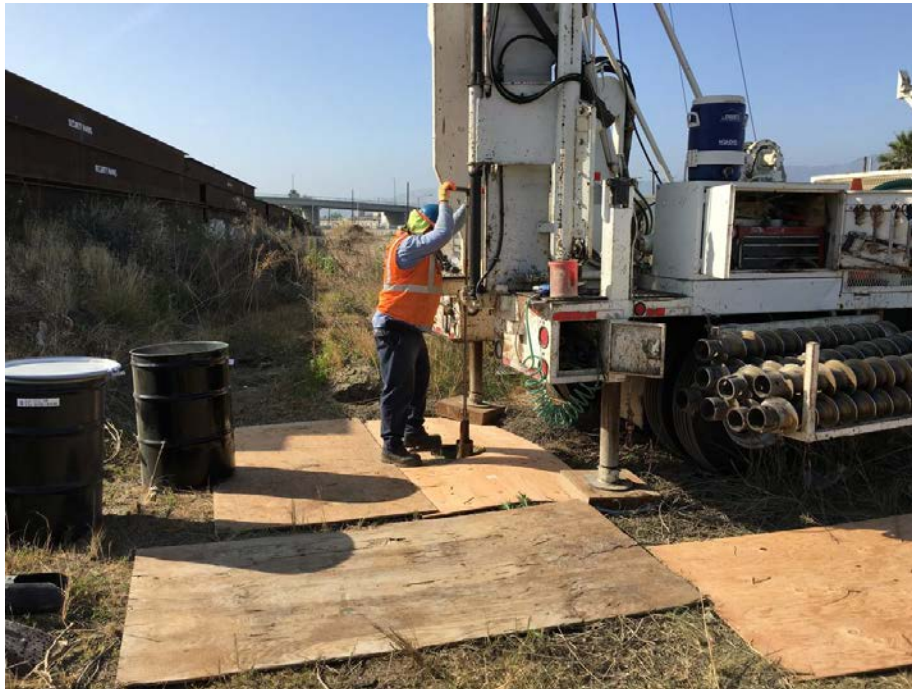
<b>Photo No.:</b>	4	<b>Date:</b>	June 2, 2016
<b>Photographer:</b>	Brian Penserini		
<b>Subject:</b>	Gregg Drilling Hand Augering at SS-4A		
<b>Project:</b>	777 N. Front Street, Additional Boing Investigation - 2016	<b>City/State:</b>	Burbank, CA

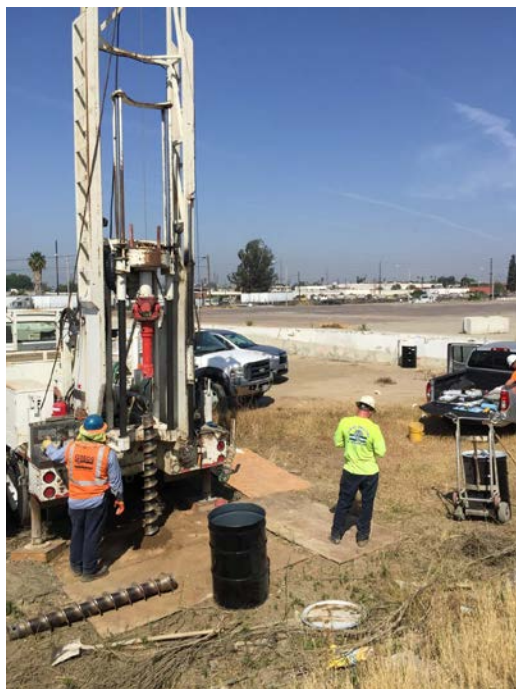
<b>Photo No.:</b>	5	<b>Date:</b>	June 2, 2016
<b>Photographer:</b>	Brian Penserini		
<b>Subject:</b>	Overview of SS-4A Site Setup During Drilling		
<b>Project:</b>	777 N. Front Street, Additional Boing Investigation - 2016	<b>City/State:</b>	Burbank, CA

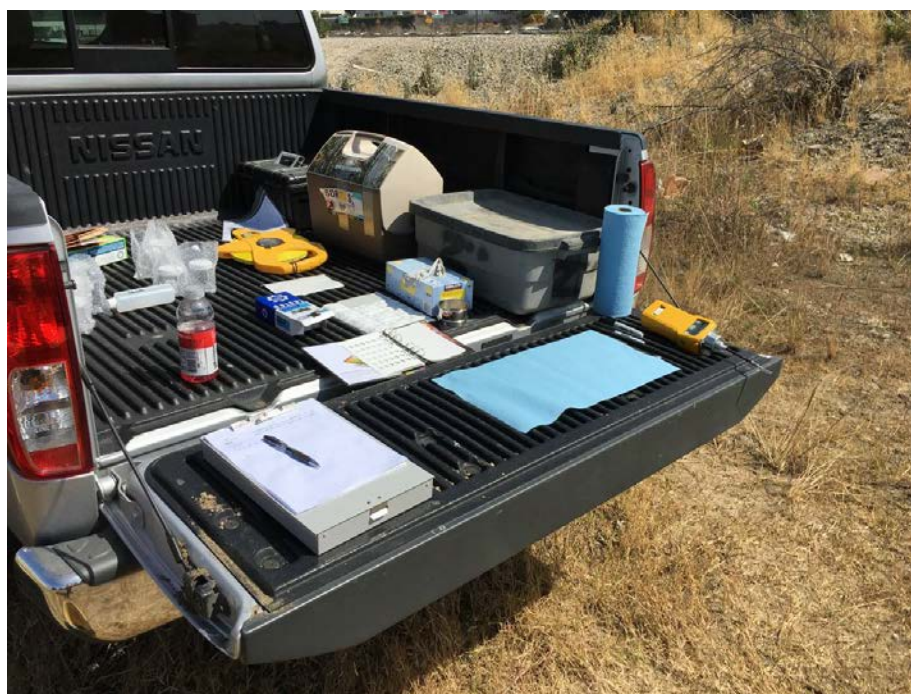
<b>Photo No.:</b>	6	<b>Date:</b>	June 2, 2016
<b>Photographer:</b>	Brian Penserini		
<b>Subject:</b>	Sampling Setup		
<b>Project:</b>	777 N. Front Street, Additional Boing Investigation - 2016	<b>City/State:</b>	Burbank, CA

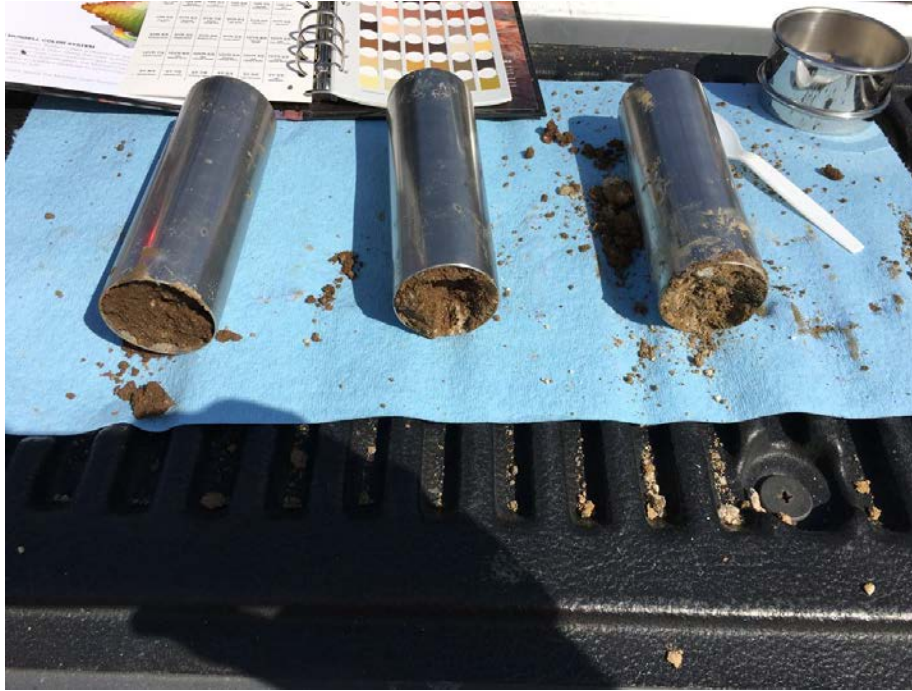
<b>Photo No.:</b>	7	<b>Date:</b>	June 2, 2016
<b>Photographer:</b>	Brian Penserini		
<b>Subject:</b>	Sample SS-4A-30 After Sample Collection		
<b>Project:</b>	777 N. Front Street, Additional Boing Investigation - 2016	<b>City/State:</b>	Burbank, CA

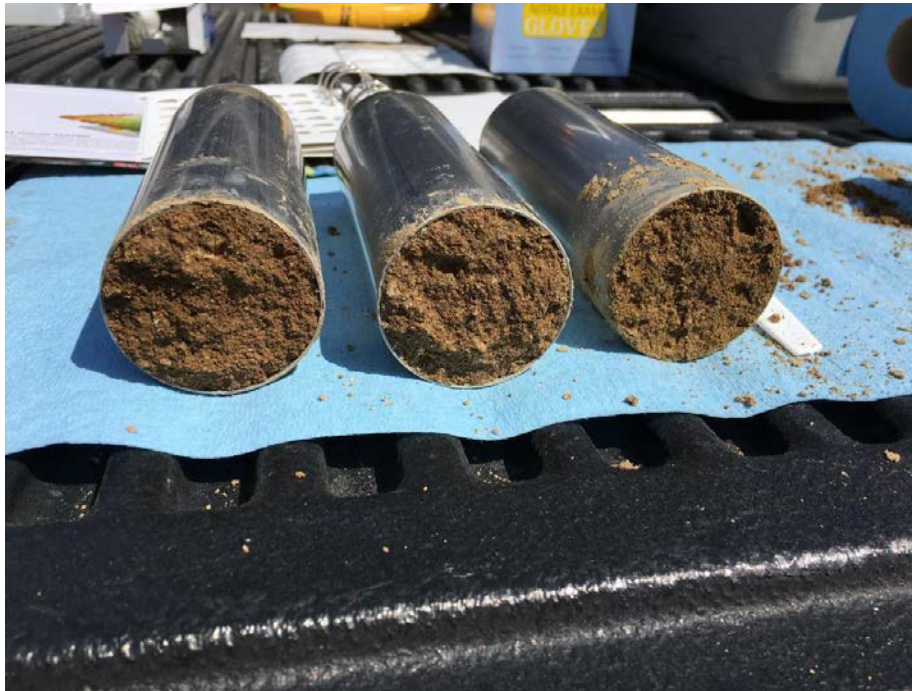
<b>Photo No.:</b>	8	<b>Date:</b>	June 2, 2016
<b>Photographer:</b>	Brian Penserini		
<b>Subject:</b>	Sample SS-4A-40 Prior to Sample Collection		
<b>Project:</b>	777 N. Front Street, Additional Boing Investigation - 2016	<b>City/State:</b>	Burbank, CA

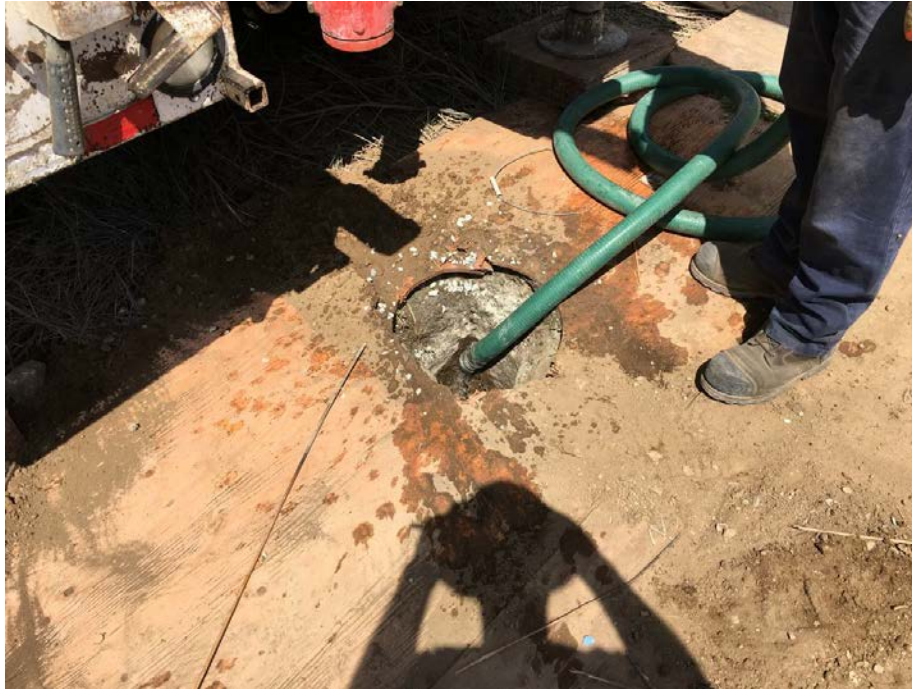
<b>Photo No.:</b>	9	<b>Date:</b>	June 2, 2016
<b>Photographer:</b>	Brian Penserini		
<b>Subject:</b>	Gregg Drilling Hydrating Bentonite Backfill		
<b>Project:</b>	777 N. Front Street, Additional Boing Investigation - 2016	<b>City/State:</b>	Burbank, CA

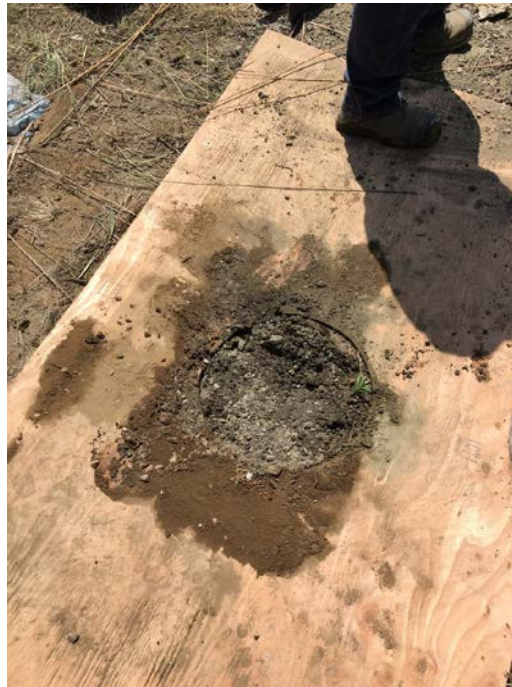
<b>Photo No.:</b>	10	<b>Date:</b>	June 2, 2016
<b>Photographer:</b>	Brian Penserini		
<b>Subject:</b>	SS-4A After Backfilling		
<b>Project:</b>	777 N. Front Street, Additional Boing Investigation - 2016	<b>City/State:</b>	Burbank, CA
