**INITIAL STUDY/
MITIGATED NEGATIVE DECLARATION**

WEST CAPITOL AVENUE ROAD REHABILITATION PROJECT

WEST SACRAMENTO, CALIFORNIA

FEDERAL PROJECT NO: HSIPL-5447 (042)

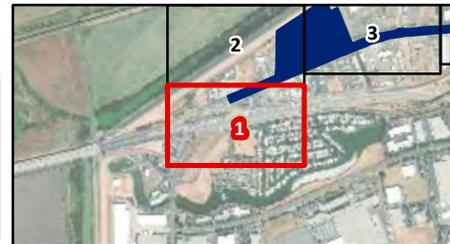
FIGURE 3
 Page 1 of 10

West Capitol Avenue Rehabilitation Project
 City of West Sacramento, Yolo County, California
 Federal Project No. HSIPL-5447(042)
 Project Area and Project Design

Other infrastructure improvements that would be part of the Project include a new water line installation (excavation depth up to 7 feet) at the intersections of West Capitol Avenue and Sutter Avenue, Houston Street, and Glide Avenue; replacement of an existing 12-inch water line from Jefferson Boulevard to Westacre Road (excavation depth up to 5 feet); installation of a new 16-inch water transmission line from Enterprise Boulevard to Northport Drive (excavation depth up to 7 feet); and fiber-optic cabling for traffic signal interconnect along West Capitol Avenue (excavation depth up to 2 feet). The preliminary design for the Project is shown on **Figure 3: Project Area and Project Design**.

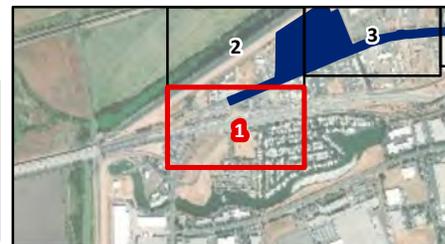
FIGURE 4
 Page 1 of 10

West Capitol Avenue Rehabilitation Project
 City of West Sacramento, Yolo County, California
 Federal Project No. HSIPL-5447(042)
 Biological Study Area and Project Design

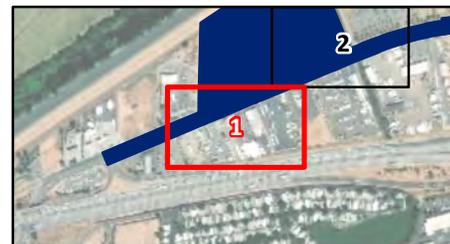
FIGURE 6
Page 1 of 3

West Capitol Avenue Rehabilitation Project
 City of West Sacramento, Yolo County, California
 Federal Project No. HSIPL-5447(042)
 Aquatic Resources within the BSA

Aquatic resources within the BSA consist of interconnected roadside ditches located both east and west of I-80 adjacent to West Capitol Avenue, totaling 0.11 ac. Runoff from West Capitol Avenue is collected in these roadside ditches which parallel the roadway on both shoulders in areas without existing sidewalks, and convey ephemeral flows during storm events. These areas are partially culverted to pass underneath existing business entrances. Vegetation within the ditches is maintained by mowing and herbicide applications. Ditches located east of I-80 appear to flow east, and likely have connectivity to the West Sacramento storm water collection system. Ditches located west of I-80 generally flow east into another unnamed canal. This unnamed canal is entirely culverted underneath West Capitol Avenue within the BSA. The unnamed canal conveys water year-round, which is pumped from Toe Drain/Prospect Slough and flows generally south through the BSA into a residential lake associated with the Valhalla Mobile Home Club and the Sacramento West RV Parks and Campground. Water from this unnamed lake then flows back into Toe Drain/Prospect Slough. Aquatic resources in the BSA are shown in Figure 6.

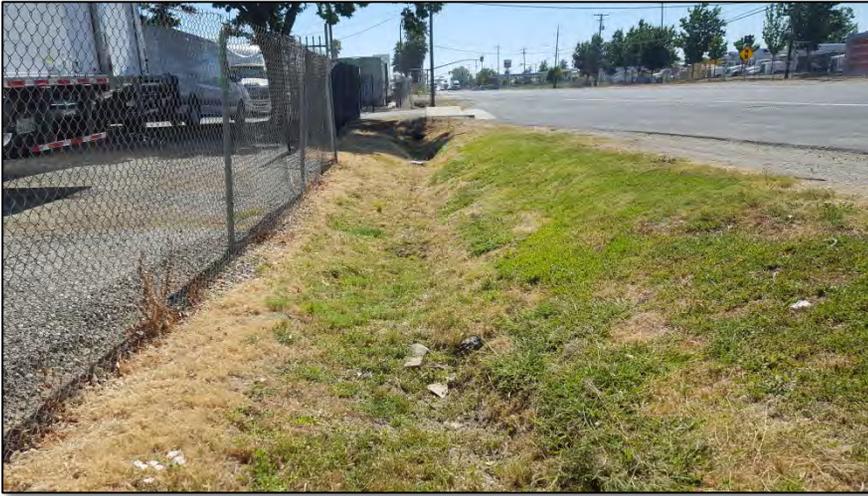
Data Point 1 – roadside ditch influenced by landscape water runoff.

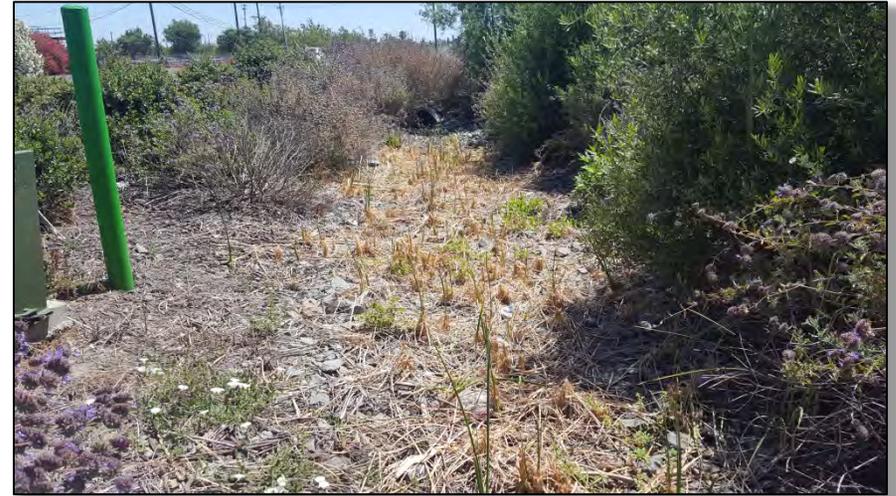
Data Point 2 – Roadside ditch showing emergent wetland vegetation.

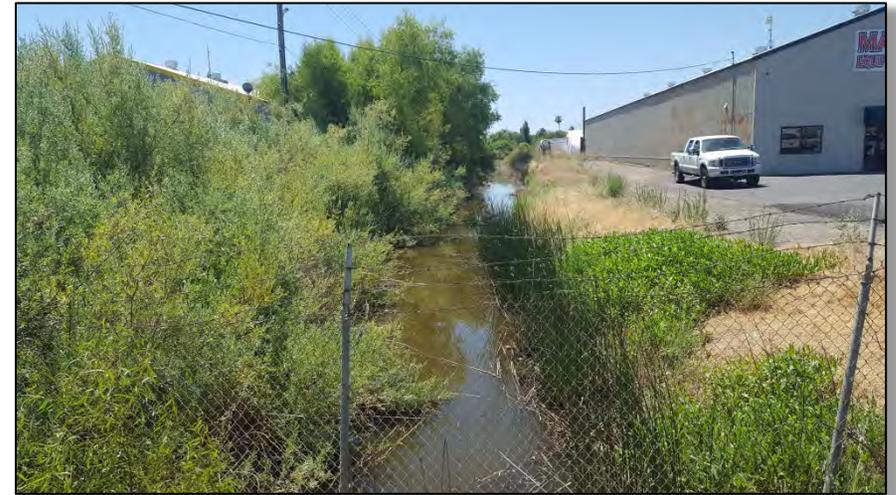
Data points 3 and 3a – Unnamed ditch looking south of the BSA. Chain link fence delineates the edge of the right-of-way.
