HISTORICAL/ARCHAEOLOGICAL RESOURCES SURVEY REPORT

FONTANA BLOCK III PROJECT

City of Fontana San Bernardino County, California

April 12, 2019 CRM TECH Contract No. 3452 Title: Historical/Archaeological Resources Survey Report: Fontana Block III

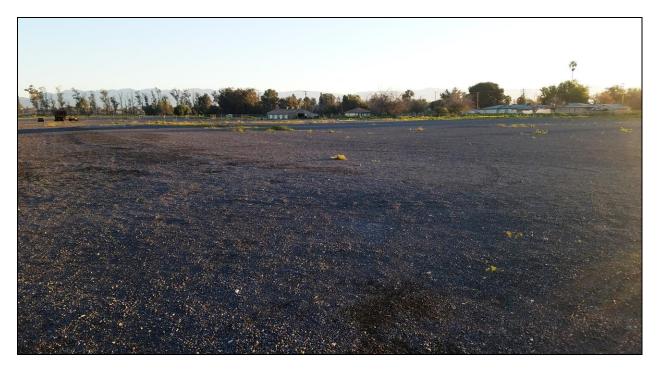
Figure 4. Overview of the project area. (Photograph taken on March 18, 2019; view to the northeast)

The terrain in the project area is relatively level (Fig. 4), with elevations ranging between 1,034 feet and 1,060 feet above mean sea level. Where visible, the surface soil consists mainly of unpacked grayish-tan silty loam. Past agricultural, construction, and demolition activities have left the ground surface throughout the project area extensively disturbed and littered with refuse. Roughly 30 percent of the project area is covered by imported gravel (Fig. 3), while a recent growth of tall grasses covers another 60 percent.

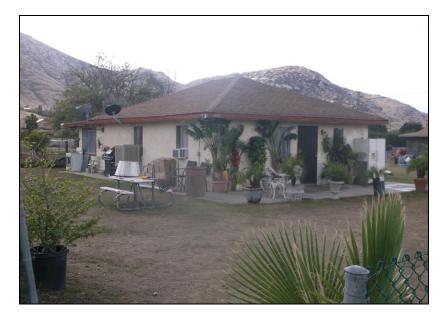
About 75 feet to the rear (west) of the residence in front is a square-shaped, one-story Minimal Traditional-style residence that faces Kraft Lane to the north. It is surmounted by a medium-pitched hip roof with narrow eaves and reddish trim that flattens in the rear over a small mass encased in off-white shiplap siding, while the rest of the building is clad in off-white stucco. The at-grade, slightly off-centered main entry is filled with a paneled wood door and secured by a steel security door. It is flanked by two narrow, aluminum-framed sliding windows. Similar windows are also found on the east and west sides, with two large ones towards the rear sporting flat wood trim painted red. A concrete walkway and landscaping plants surround the building, which is occupied and in fairly good condition. A one-story barn stands to the west of this building, its north-facing main entrance now sealed with wood panels. Four large openings on the west side contains aluminum garage doors.

Rear house at 11210 Juniper Avenue, view to the southwest

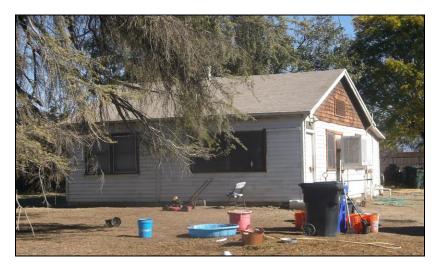
The residence to the north is a rectangular building surmounted by a medium-pitched front-gable roof covered with composition shingles. The roof ends in narrow eaves with exposed rafter tails and features narrow white fascia and vergeboards on the north, west, and south sides. The roof flattens on the west side over a lean-to that extends across roughly two-thirds of the western façade. Brownish-red wood shingles and a large louvered vent are found under the front (southern) gable peak, and narrow horizontal shiplap boards cover the rest of the exterior wall surface. The main entry is set on the western end of the main façade and is filled with a paneled wood door with a small transom above. Fenestration to the building includes wood-framed double-hungs and aluminum-framed sliding windows. A chain-link fence enclosed the two houses, which are both occupied and in fair condition.

Northerly house (11155 Cypress Avenue), view to the northeast

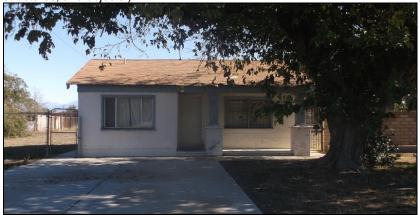
P5a. Photograph or Drawing (Photograph required for buildings, structures, and objects.)

P5b. Description of Photo: taken December 3, 2018; view to the east
