CLEAN WATER ACT PRELIMINARY JURISDICTIONAL DELINEATION

CAVALLO HIGHLANDS
HAYWARD, ALAMEDA COUNTY, CALIFORNIA

March 2017

Project No. HLC1601

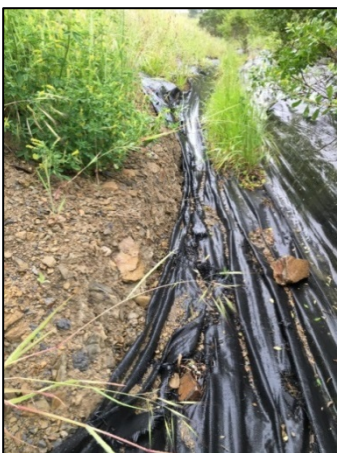
Northern Swale. A 280-foot-long swale on the north side of the Study Area conveys ephemeral to intermittent flows of the northern sub-watershed towards a storm drain gutter off site to the west. The swale is covered with a 6 to 8 foot-wide black tarp. The fabric of the tarp is disintegrating at places, giving views of an on average 1 foot-wide bed with cut banks and an OHWM, with clear evidence of concentrated flow, including recent bank erosion, destruction of terrestrial vegetation, and the presence of litter and debris (Photo 1). The swale may qualify as a jurisdictional tributary, classified as a non-relatively permanent water, intermittent riverine (Cowardin Code R4). The potential jurisdictional area of this tributary is approximately 280 square feet.

Photo 1: Northern Swale draining the watershed to the north of the central ridge in the Study Area. The swale is lined with a black tarp, which is disintegrating at places.

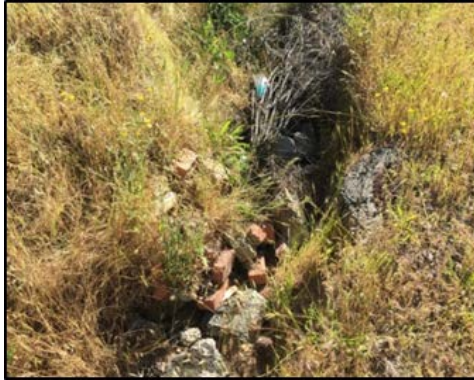
Photo 3: The downslope section of the roadside ditch. Ongoing erosion is transforming this ditch to a gully. This ditch is constructed entirely in uplands, does not drain wetlands, and is not connected to a tributary.

Roadside Ditch. A 280-foot-long artificial roadside ditch runs on the north side of the access road. Ongoing erosion is transforming this feature from a ditch to a gully (Photo 3). The ditch and gully convey intermittent flow, draining an approximate 2.5-acre watershed to the north. The ditch has an (on average) 1-foot-wide bed with eroding, undercut banks and an OHWM with evidence of concentrated flow, including sediment scour.

Bed, banks and the OHWM of the ditch end abruptly at the toe of the slope 20 feet east of the access gate (Figure 3). Flows conveyed by this ditch then appear to sheet-flow across the vegetated toe of the slope and across the paved access road towards the south and off site to culvert that travels under Carden Lane. No continuous bed, banks or OHWM connect the roadside ditch to potential jurisdictional features downstream.

The roadside ditch is entirely constructed in uplands, it is not a wetland, it does not drain a wetland, and it is not connected to a potential jurisdictional water of the U.S.

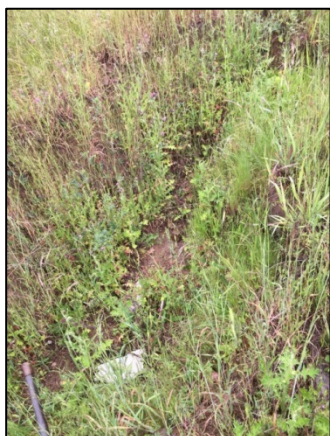
Northeast Gully. A 50-foot-long partially overgrown gully conveys ephemeral flow from parts of the west-facing slopes of the embankment of Stonebrae Country Club Drive and parts of the northeast-facing slopes of the main ridge (Photo 4). The gully has a 1-foot-wide bed and banks, but bed and banks are not continuous over the entire 50 feet. The gully ends more than 200 feet upslope from the start of the closest potential jurisdictional feature (Northern Swale).

Photo 4: Northeast Gully.
Vegetation within the gully is dominated by Italian thistle.

Where vegetation occurs within this gully and along the banks, the vegetation community is dominated by non-hydrophytic species, including Italian thistle, soft chess and ripgut brome (Sample Point 2).

This gully is a purely erosional feature entirely located in uplands, it is not a wetland, does not drain wetlands, and it is not connected to a potential jurisdictional water of the U.S.
