P3a. Descriptions (continued):

Canal Creek P-24-000090

Appendix D. MID Merced River Restoration Monitoring Plan

MERCED IRRIGATION DISTRICT'S MERCED RIVER INSTREAM AND OFF- CHANNEL REHABILITATION PROJECT

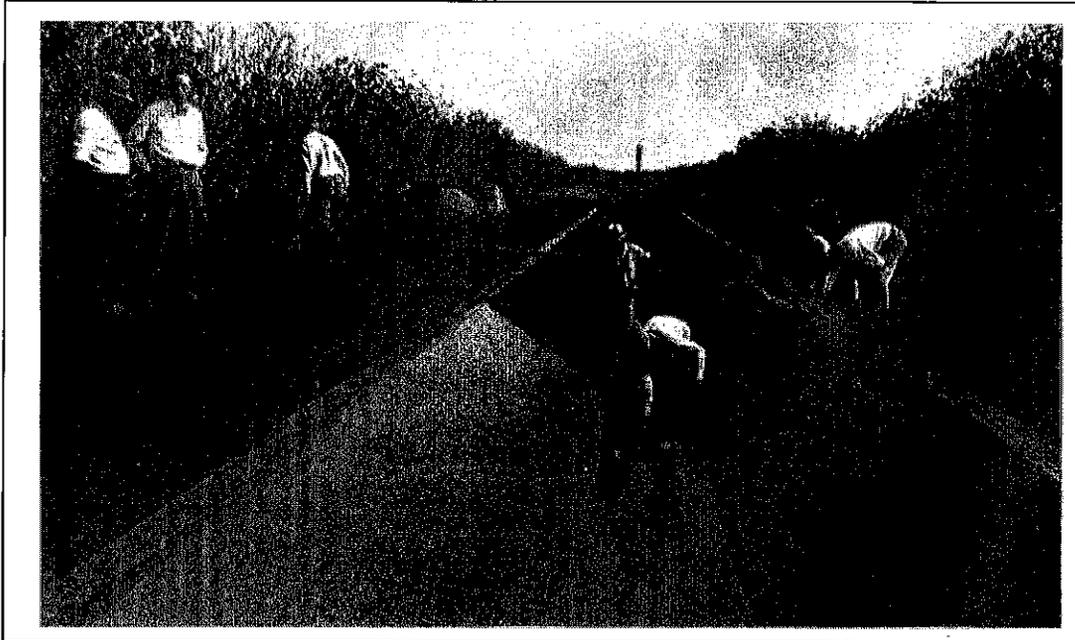
Figure 6. Arena Canal being shaped for concrete lining in 1950. (McSwain 174)

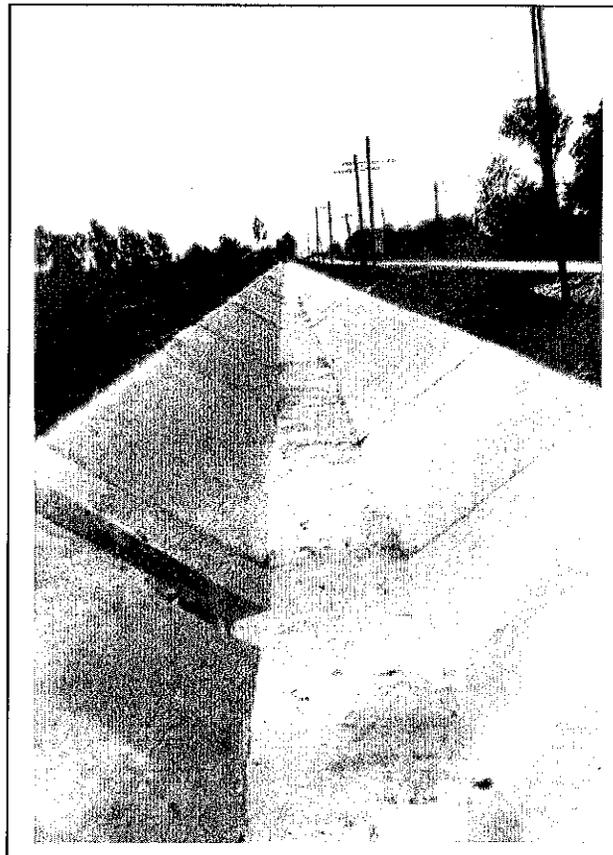
Figure 7. Concrete lining of unknown canal in 1930. (McSwain 105)

Figure 8. Newly lined McSwain Lateral in 1930.(McSwain, 102).

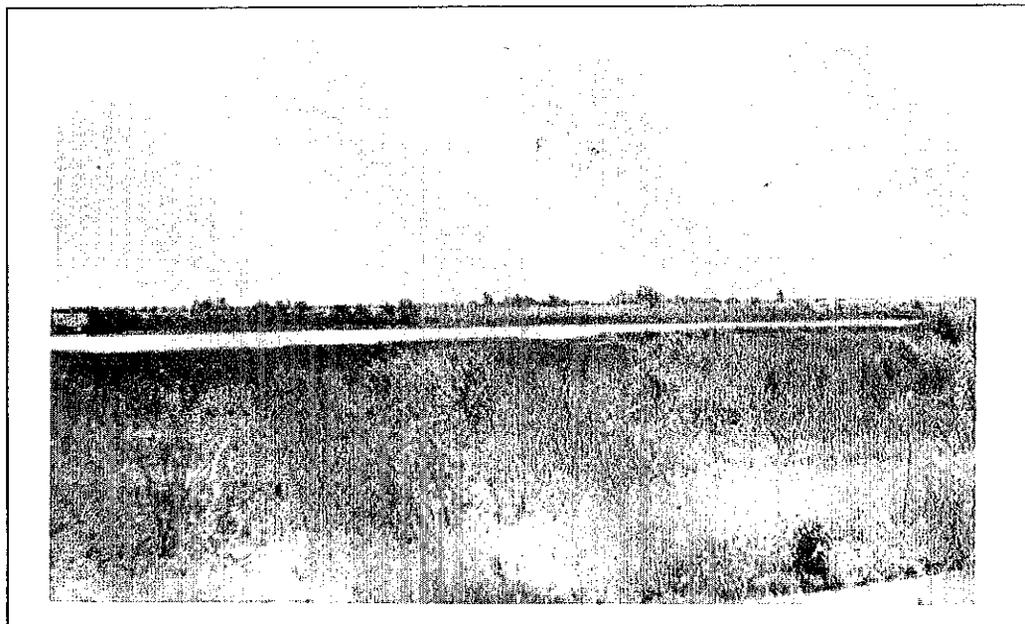
Figure 9. Photo from 1920 showing water-logged land north of Atwater. (McSwain, 33)

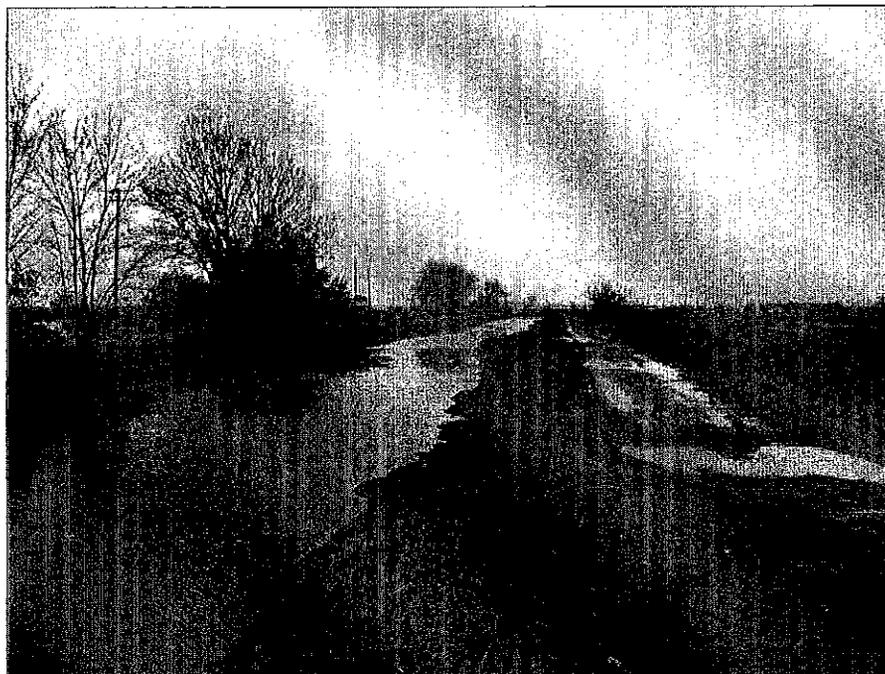
Photograph 29. Canal Creek at Fox Road (point CC1), camera facing west. 12/12/06

Canal Creek (MR1-CC) is an irrigation canal that runs approximately 16 miles north to south from its origination point in Section 29 T5S/R14E MDBM where it branches off from the MID Main Canal. It terminates in the NE ¼ of Section 20 T7S/R13E where it flows into Black Rascal Creek. Canal Creek is a natural watercourse that has had irrigation water conveyed into it from the Main Canal since 1876. Today the route follows the natural route of the creek for much of its length. Small sections of Canal Creek have been realigned into straight segments with right angles and a "man-made" appearance. At many of the points recorded on this form the channel follows a generally natural alignment, but the banks and channel bottom have been dredged, graded, shaped, and maintained (See Linear Feature Records MR1-CC and Photographs 29, 30, 32).

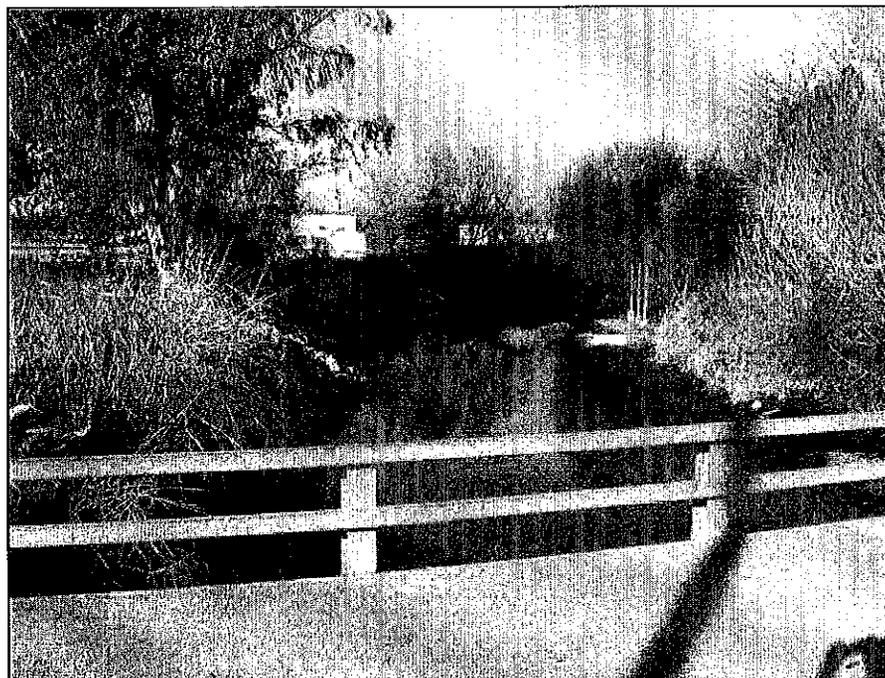
Photograph 30. Canal Creek at Ladino Road (point CC8), camera facing north. 1/22/07.

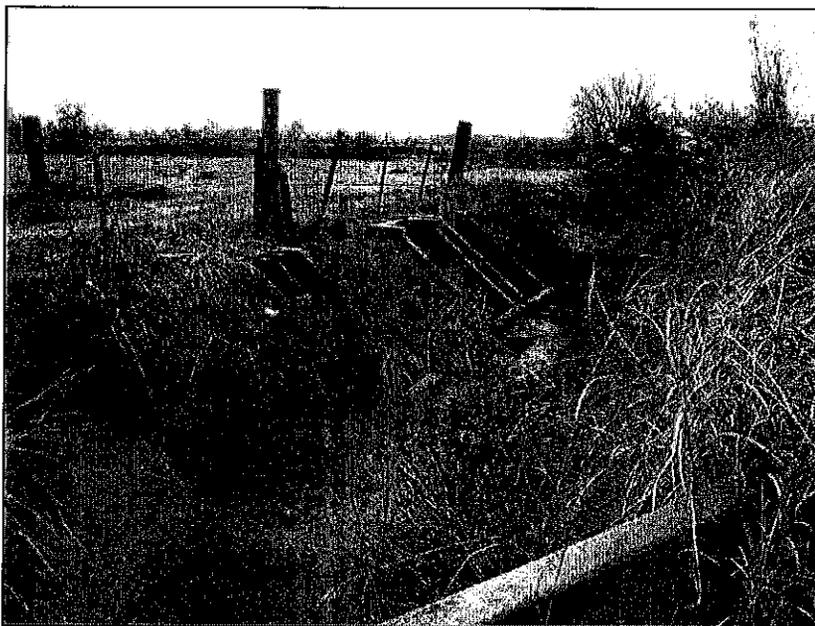
Photograph 31. Control gates on Main Ashe Lateral at point MA2, camera facing south. 12/12/06.

The Main Ashe Lateral draws water from Canal Creek at the same point as the Livingston Canal diversion. The East Ashe Lateral branches off of the Main Ashe Lateral in Section 9, T7S/R13E MDBM (See Location Map 1). These two relatively small canals are only a few miles in length and function to transport water from Canal Creek to farm fields. Prevalent along their banks are metal gates that control the flow of water into the fields. Some sections of these laterals are unlined, while others are trapezoidal in cross section and concrete lined. Along their course, they pass under roadways by means of concrete culverts (See Linear Feature Records MR1-MA and MR1-EA and Photographs 31-36).

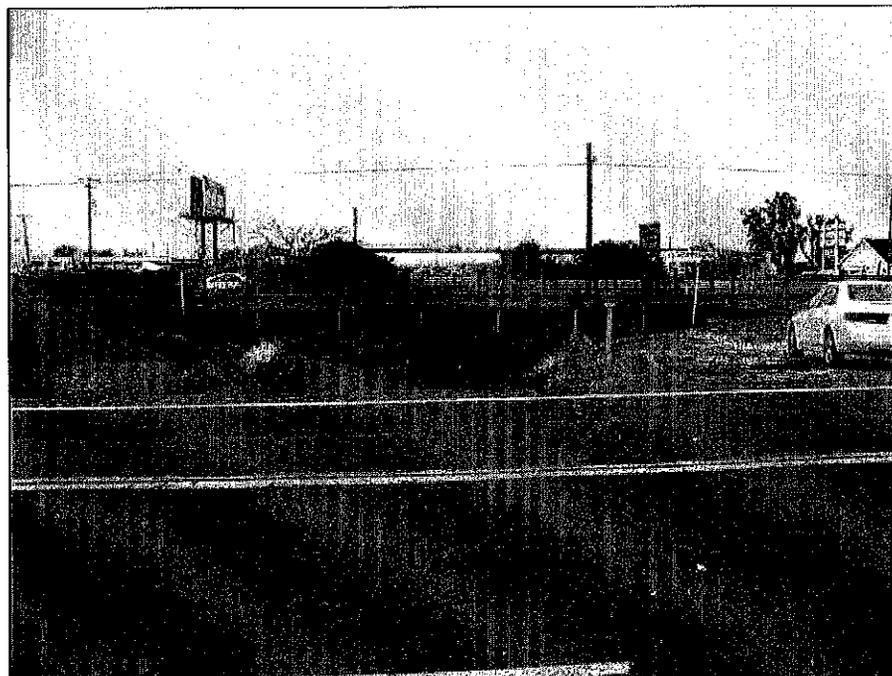
Photograph 34. Main Ashe Lateral at SP Avenue showing the canal passing under the UPRR at point MA4, camera facing north. 12/12/06.

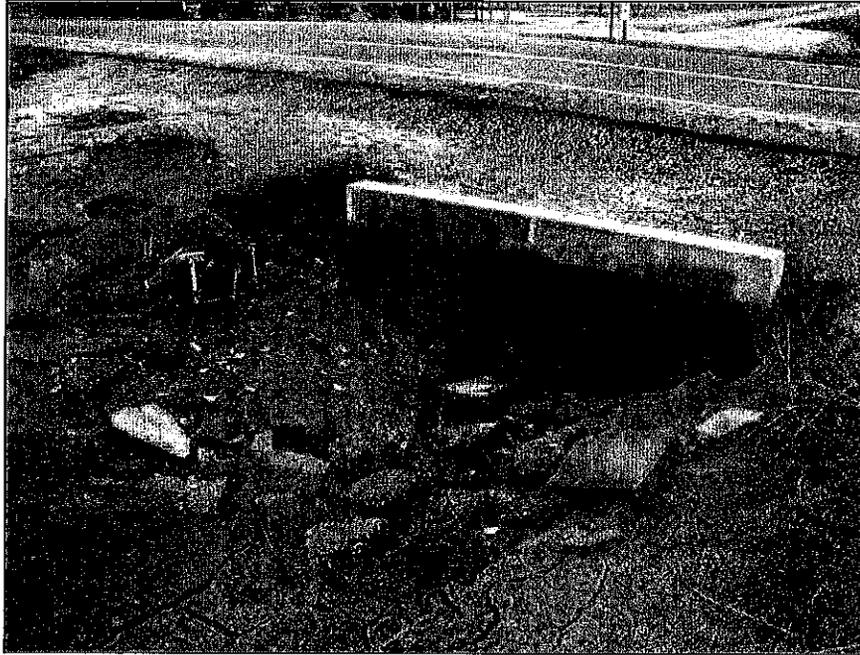
Photograph 35. Main Ashe Lateral at SP Avenue showing concrete culvert passing under SP Avenue at point MA4, camera facing southeast. 12/12/06.

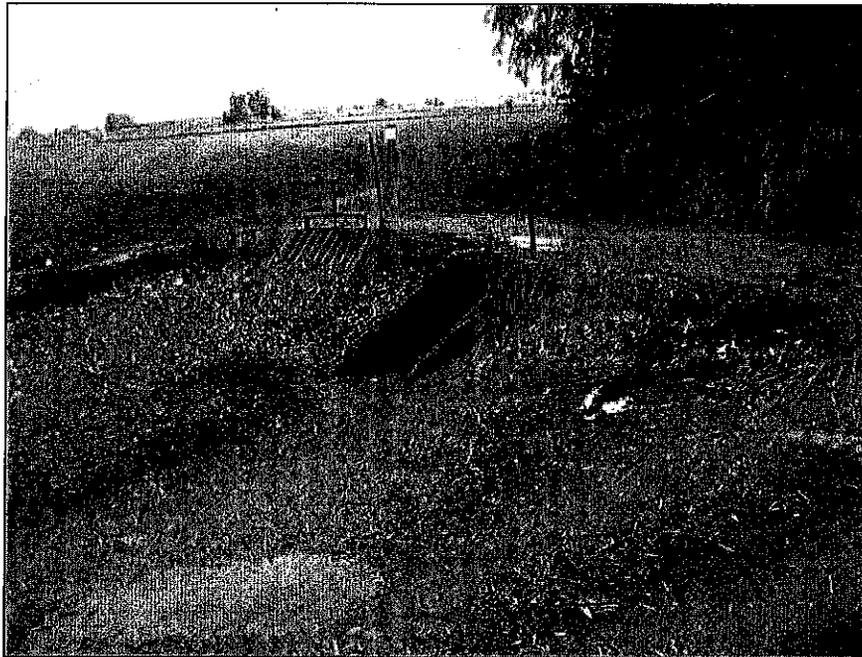
Photograph 36. East Ashe Lateral near Trinidad Road showing concrete and metal control gates at point EA6, camera facing southeast. 12/12/06

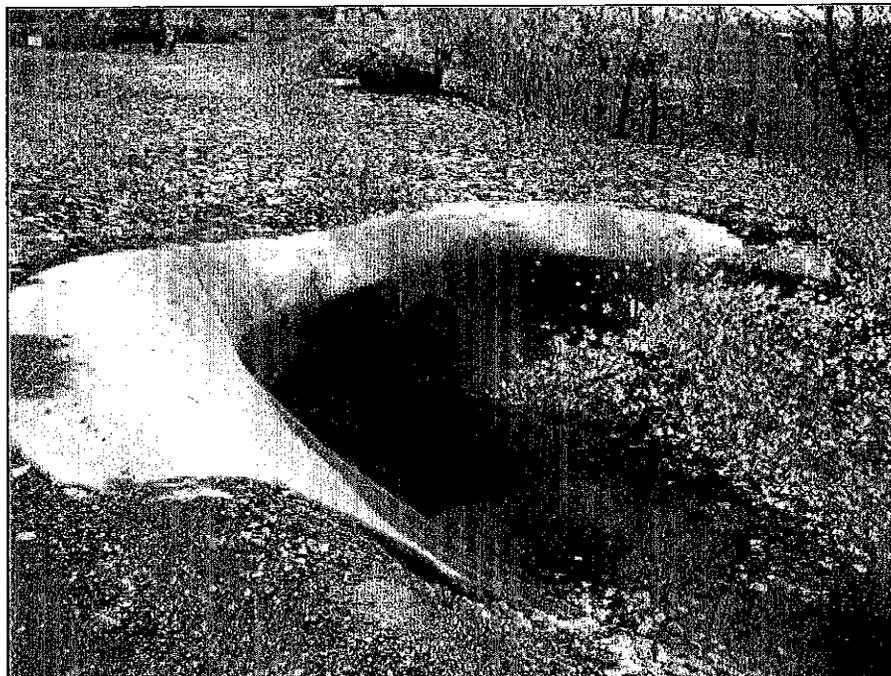
Photograph 37. Meadowbrook Lateral siphon pipes at point MB1, camera facing east. 12/12/06.

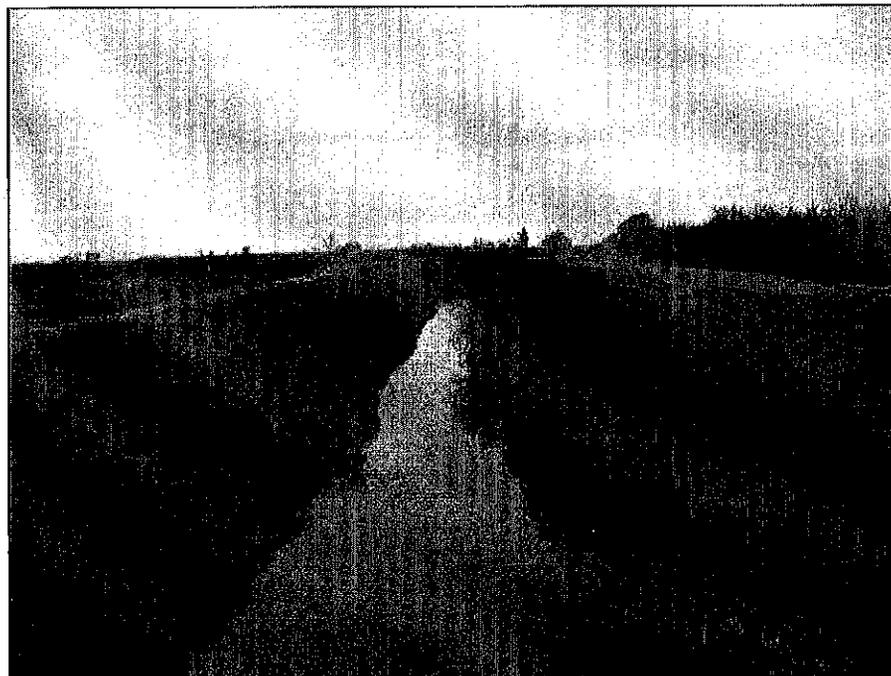
Photograph 38. Black Rascal Creek at point BR1, camera facing east. 12/12/06.

The role of this creek as a canal began around 1905 when the Crocker-Huffman Irrigation Company constructed the Livingston Canal, from which Black Rascal Creek drew water. This part of Black Rascal Creek is roughly U shaped in cross section and has vegetation growing along its unlined banks. Black Rascal Creek has a very regular, groomed appearance. Its banks have been raised above the surrounding farmland to form berms or levees and the banks have a uniform slope. The channel also appears straight and angular in alignment, within the segment addressed in this study. In this area the canal passes through agricultural land irrigating orchards, pastures, and row crops (See Linear Feature Record MR1-BR-1 and Photographs 38).

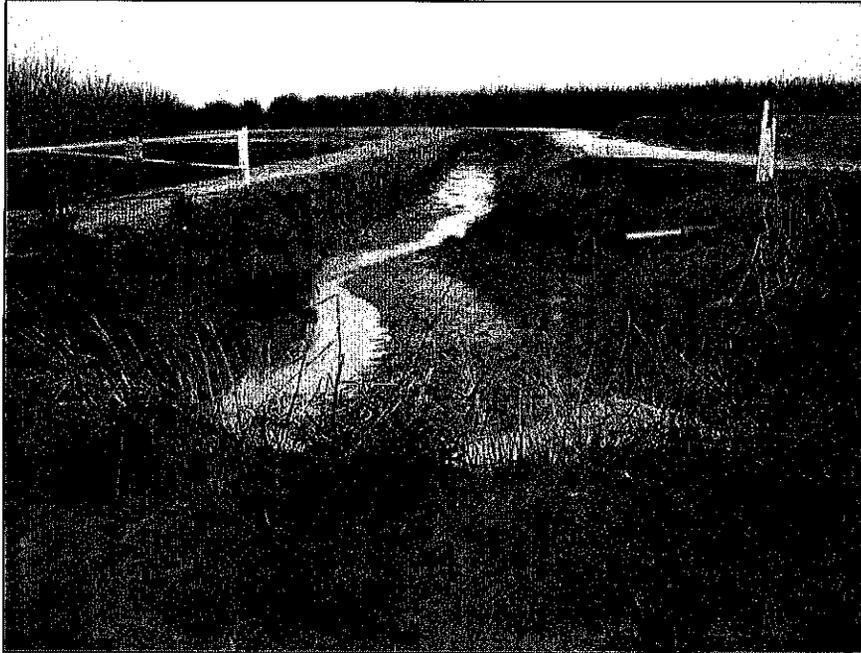
Photograph 39. Henderson Lateral at point HN1, camera facing north. 12/12/06.

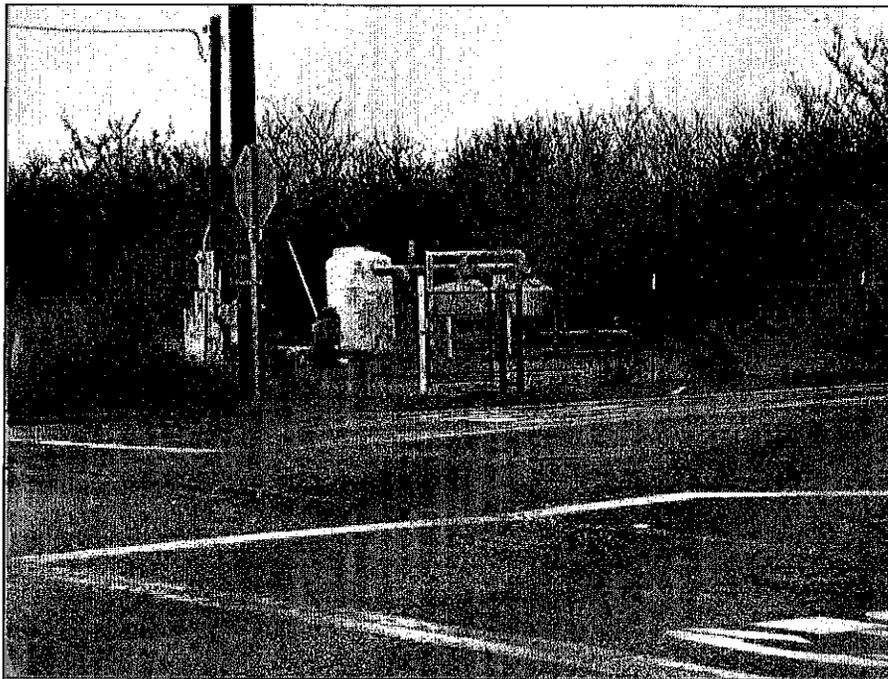
Photograph 44. Pump at point HN2, camera facing northeast. 12/12/06.

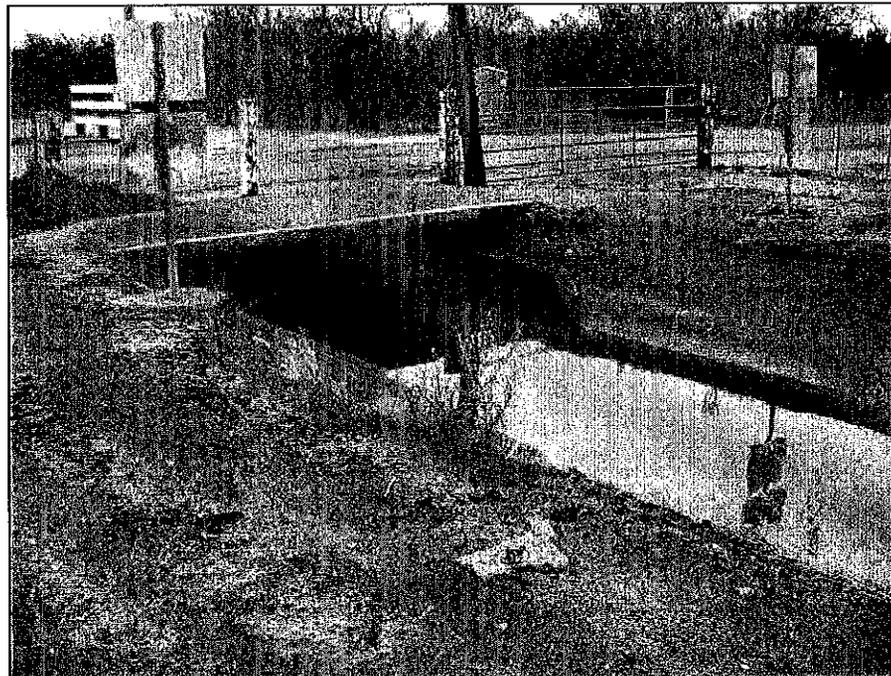
Photograph 46. Culvert under Elliot Avenue at point BH1, Buhach Lateral, camera facing northeast. 12/12/06.

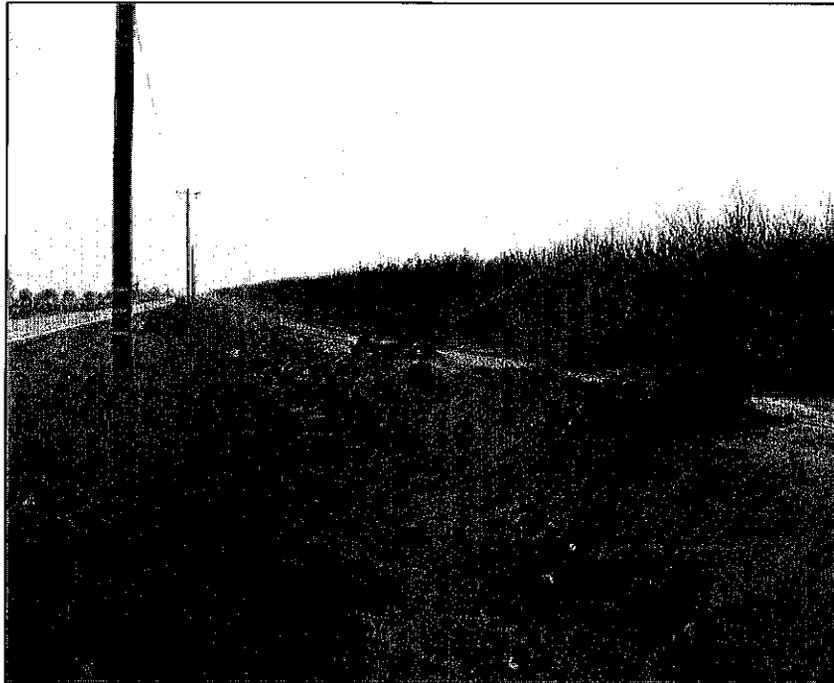
Photograph 47. Drainage Ditch at point DR1, camera facing west. 12/12/06

This drainage ditch, built between 1957 and 1960 borders farm land in Sections 25, 26, 34 and 35, T6S/13E MDBM and is about four miles in total length (Location Map 6). Ditches such as these are common in Merced County and drain irrigation water from fields. The ditch is approximately 14 feet wide at the top and four feet deep. It is unlined and has some vegetation on its banks and shows signs of erosion and of recent excavation. This form addresses that portion the ditch perpendicular and parallel to Bellevue Road. The ditch at this point runs north/south between two fields in Section 35 and east/west parallel to Bellevue Road. Maps and field observation indicate that a portion of the original ditch has been piped and covered recently. The terminus was undetermined, but generally such ditches drain into a natural waterway or canal (Linear Feature Record MR1-DR-1 and Photographs 47, 48).

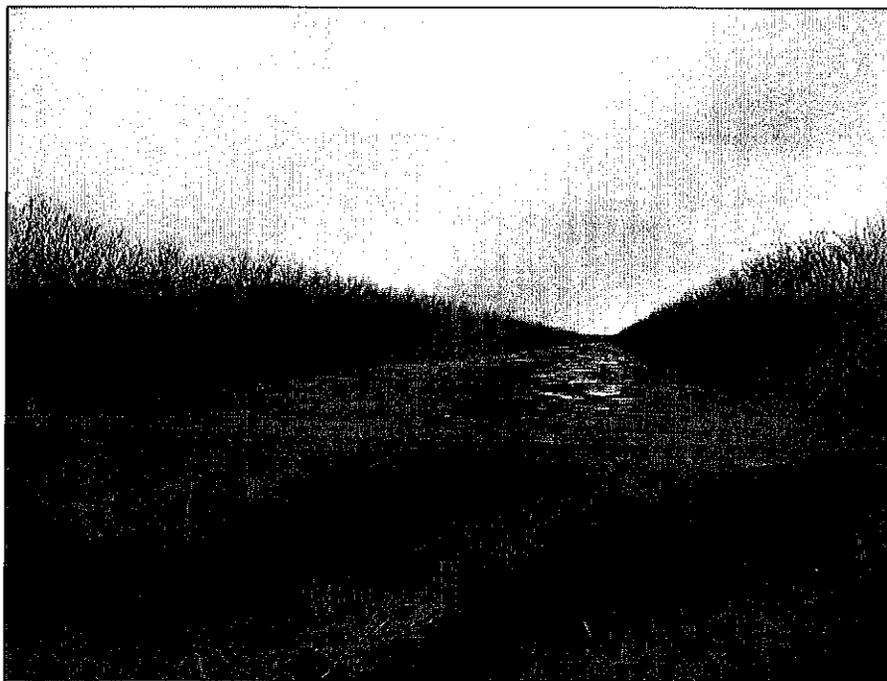
Photograph 48. Former site of an open drainage ditch that has been piped and covered (west of point DR1), camera facing north. 12/12/06.

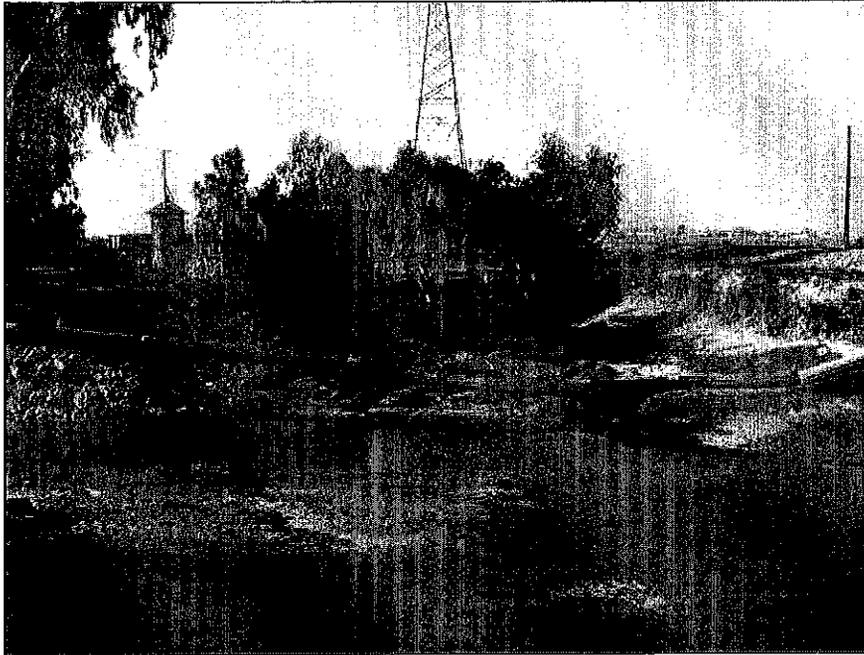
Photograph 49. Livingston Canal headgate (point LC1), Canal Creek in foreground camera facing west. 1/22/07.

There is a lateral headgate across Canal Creek at its junction with the Livingston Canal controlling the flow of Canal Creek downstream from this point. The exact construction date of the gate is unknown, although it is likely a modern structure. It consists of four vertical, rectangular, steel lift gates set in a poured concrete foundation with flaring wings. A roadway runs over the top of the structure (See MR1-CC-9).
