# **Delineation of Potential Jurisdictional Wetlands and Waters of the U.S.**

## **Erosion Protection System Maintenance at the San Antonio Road West Bridge**

**Vandenberg Air Force Base,  
Santa Barbara County, California**

# **Mitigation and Monitoring Plan for the San Antonio Road West Bridge Maintenance at Vandenberg Air Force Base, CA**

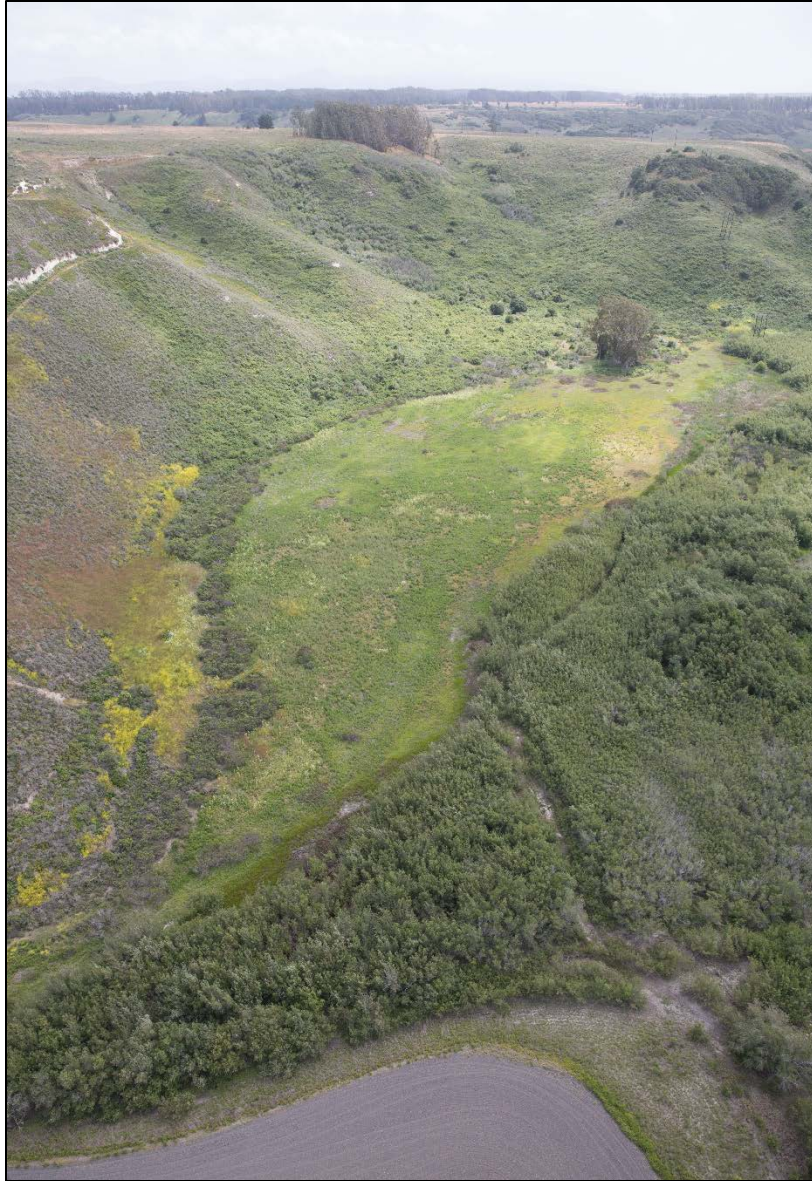
**Figure 3.** Aerial view of recommended mitigation area, showing active farm field at bottom extent.

The mitigation area is immediately adjacent to an existing willow riparian area that abuts a farm field (Figure 2 and Figure 3). Because permanent impacts cannot be mitigated at the San Antonio Road West Bridge project area, they will be mitigated through the planting of willow poles and understory species container plants, and invasive species control at the edge of the existing wetland transitional zone within the mitigation area.

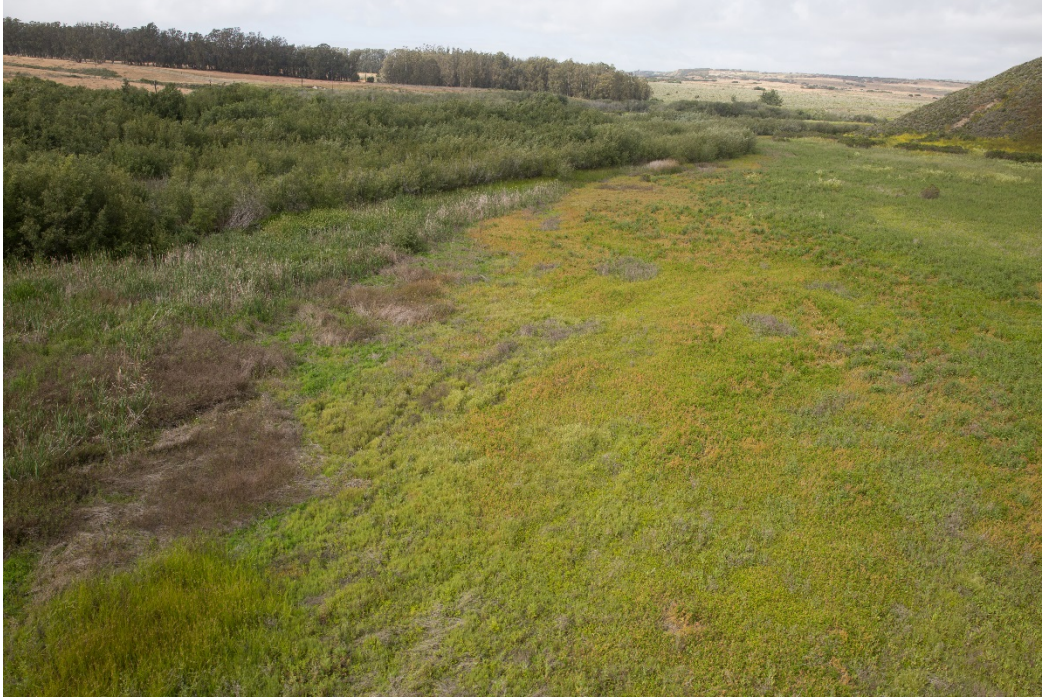
Based off VAFB GIS vegetation layers, the mitigation area is within an agricultural tract (Figure 8). However, this tract was abandoned, and the area is now inundated with a combination of non-native species including whitetop and mustard, however, willows have begun to develop on the western edge (Figure 9).

**Figure 9.** Existing willow riparian vegetation adjacent to proposed mitigation site (left extent of image).
