# COYOTE CANYON

## NATURAL RESOURCES MANAGEMENT PLAN & INTERIM ACCESS PLAN

REVISED DRAFT  
AUGUST 2019

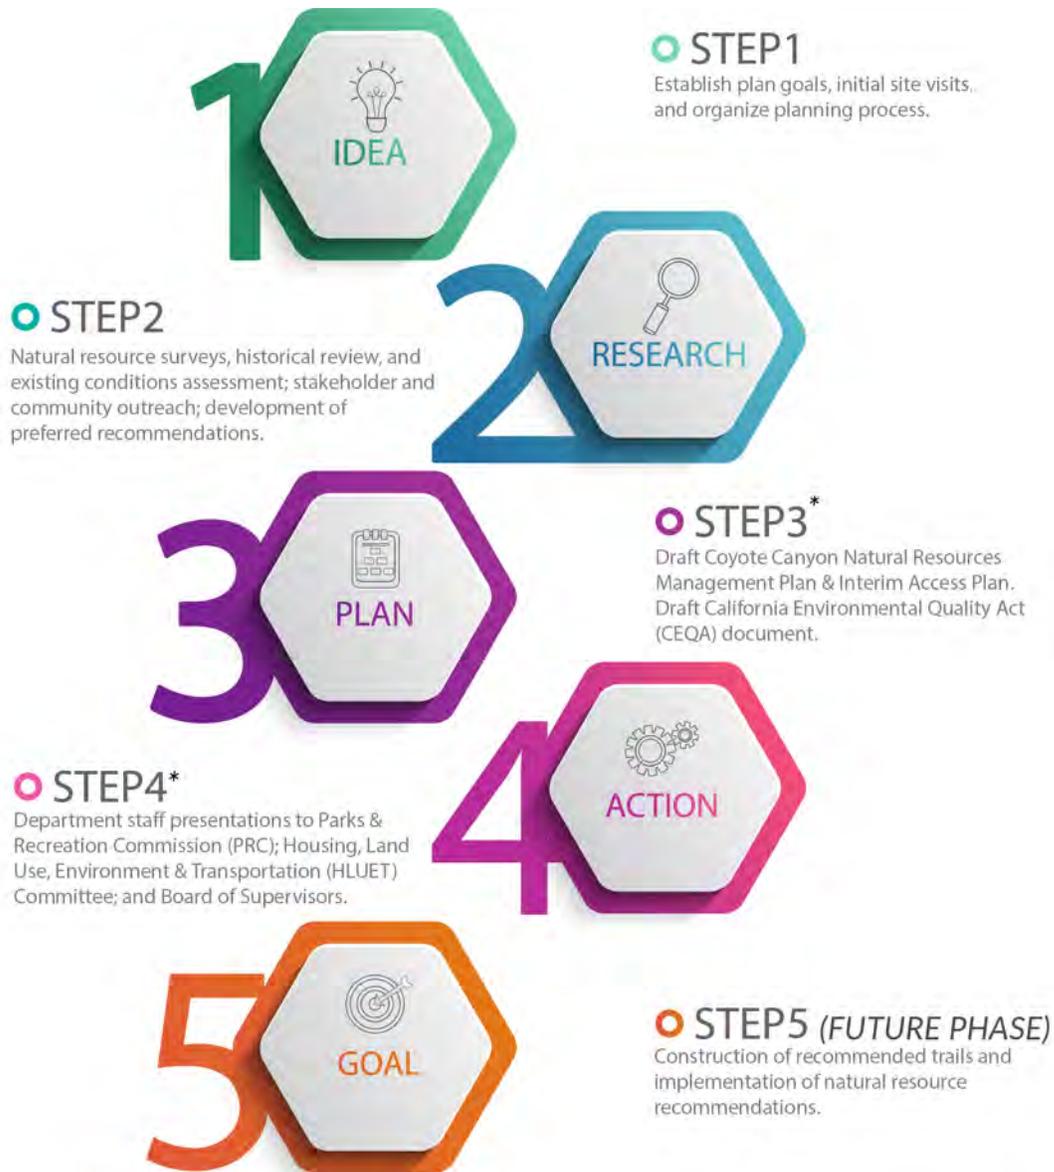
Figure 3. Coyote Canyon Planning Process

The planning process for the Plan is described below and further illustrated in Figure 3. The assessment of existing conditions through focused resource management surveys and the evaluation of preliminary trail options, provided key information for effective stakeholder and community engagement, and led to the development of the Recommended Public Access Alignment.

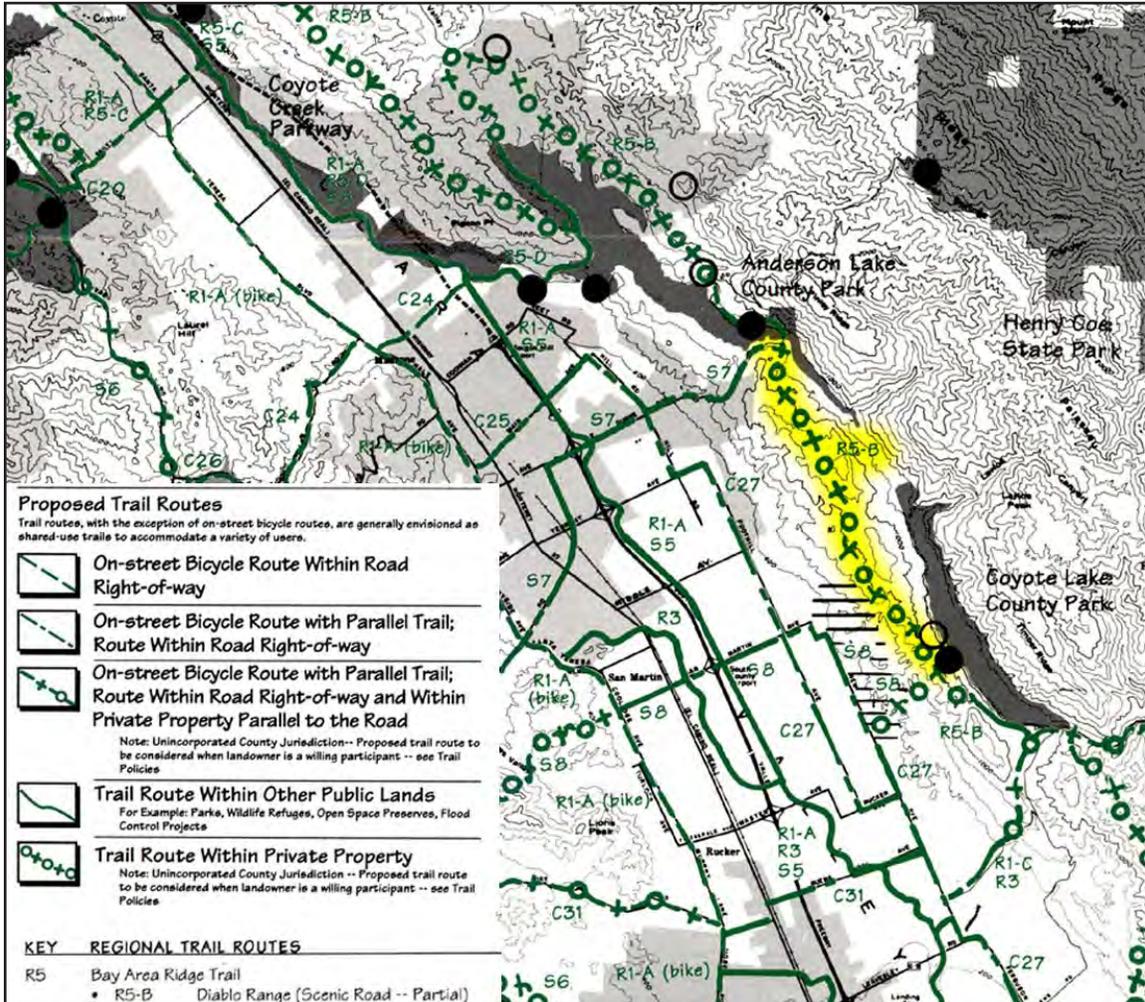
Figure 3. Countywide Trails Master Plan Update (excerpt)

Highlighted in yellow is the Diablo Range (R5-B) portion of the Ridge Trail.

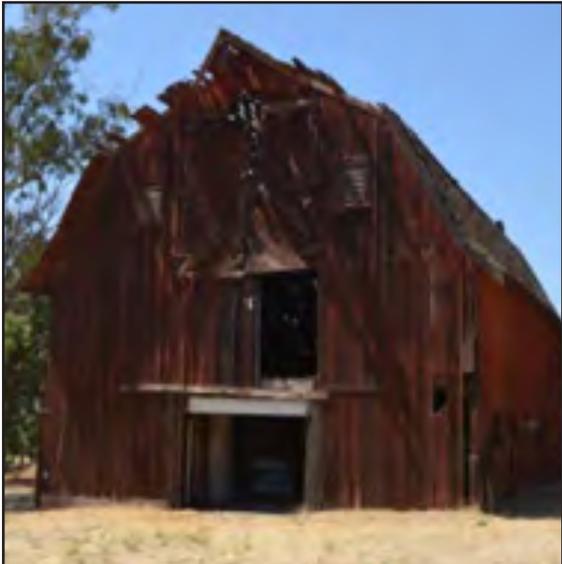
Photo 3. Achilles' barn

The two-story Achilles' barn (historically known as the Fountain Oaks Horse Barn), located off Carey Avenue, was built in 1927 and is in a state of advanced deterioration. However, it does maintain a high level of historic integrity. It has not been altered significantly and is not typical of California barns of the period (Photo 2). The barn has a gambrel roof, and stylistically is more typical of East Coast barns. Its use was discontinued after the Property was sold in 1956. Adjacent related structures were also demolished at that time, including a milk house, implement shed, cow-feeding stalls and barn, straw shed, and corrals.

<sup>4</sup> The barn maintains a high level of its historical integrity as per the National Register's seven aspects of integrity. It maintains its original location, although many of the surrounding buildings and the enclosure are gone. The building has not been altered except for one of its large entry doors. The barn retains its underlying early-20th Century residential scale and feeling.

Sign of bat presence (i.e. guano and staining) was observed inside the eastern room of the north metal Quonset at the Ranch Complex and in the southwest room in the Achilles barn. No bats or sign of bats was observed in other structures in the Property. Buildings throughout the Property may provide day-roosting or night-roosting habitat for small

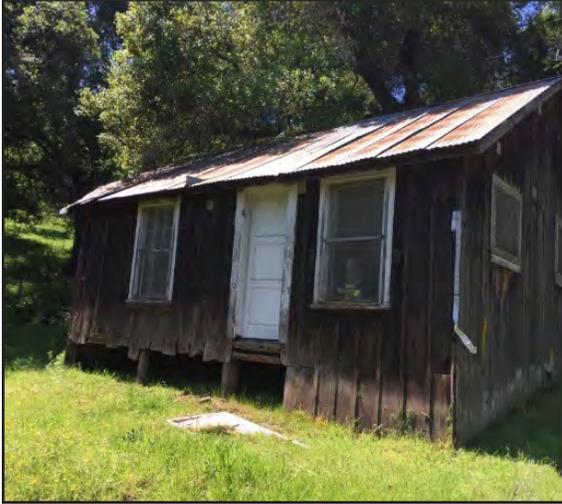
Photo 4. Otis Brown cabin

The Otis Brown cabin (Photo 3), located in the central part of the Property near Coyote Creek, was built in 1910 and is in a state of disrepair. It is not being used in conjunction with existing grazing operations and is not a part of the historic register. The area also has an outhouse, water tank and corrals. The cabin is named after Otis Brown, who lived there part-time in the 1960's and 1970's while he worked as a ranch manager for both Raymond Gilkey and the Mills family.

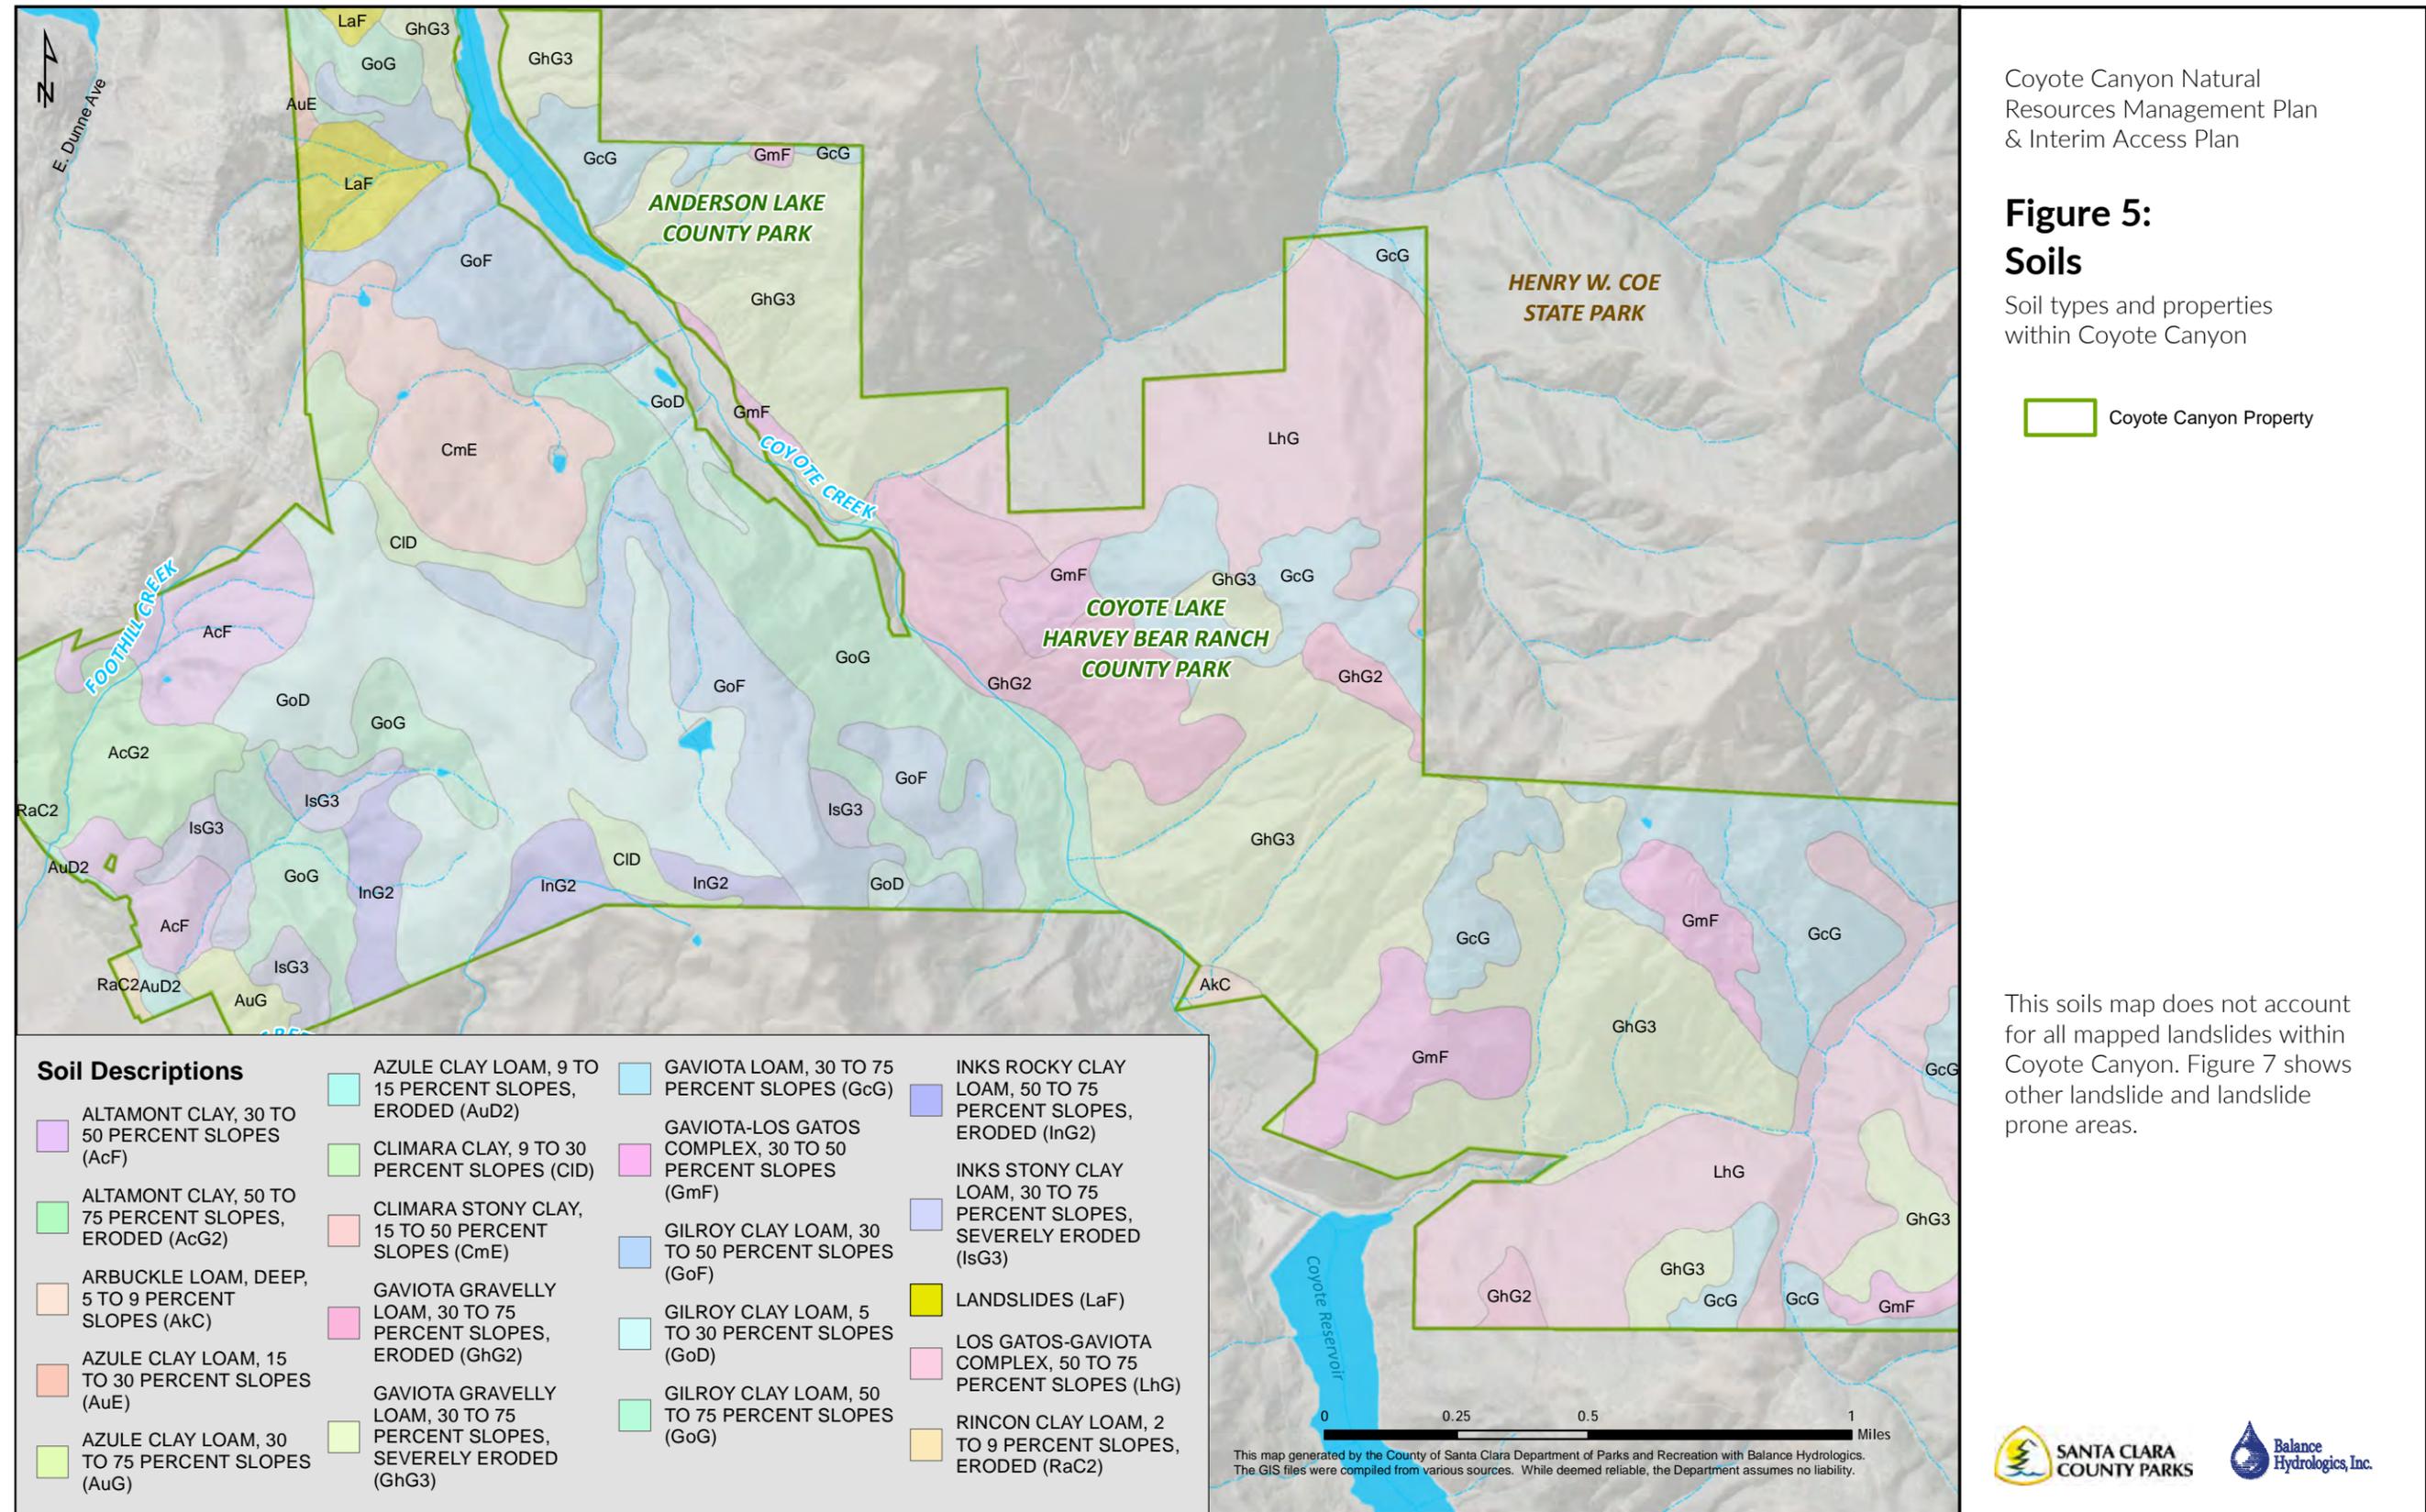
Figure 5. Soils

### Figure 5: Soils

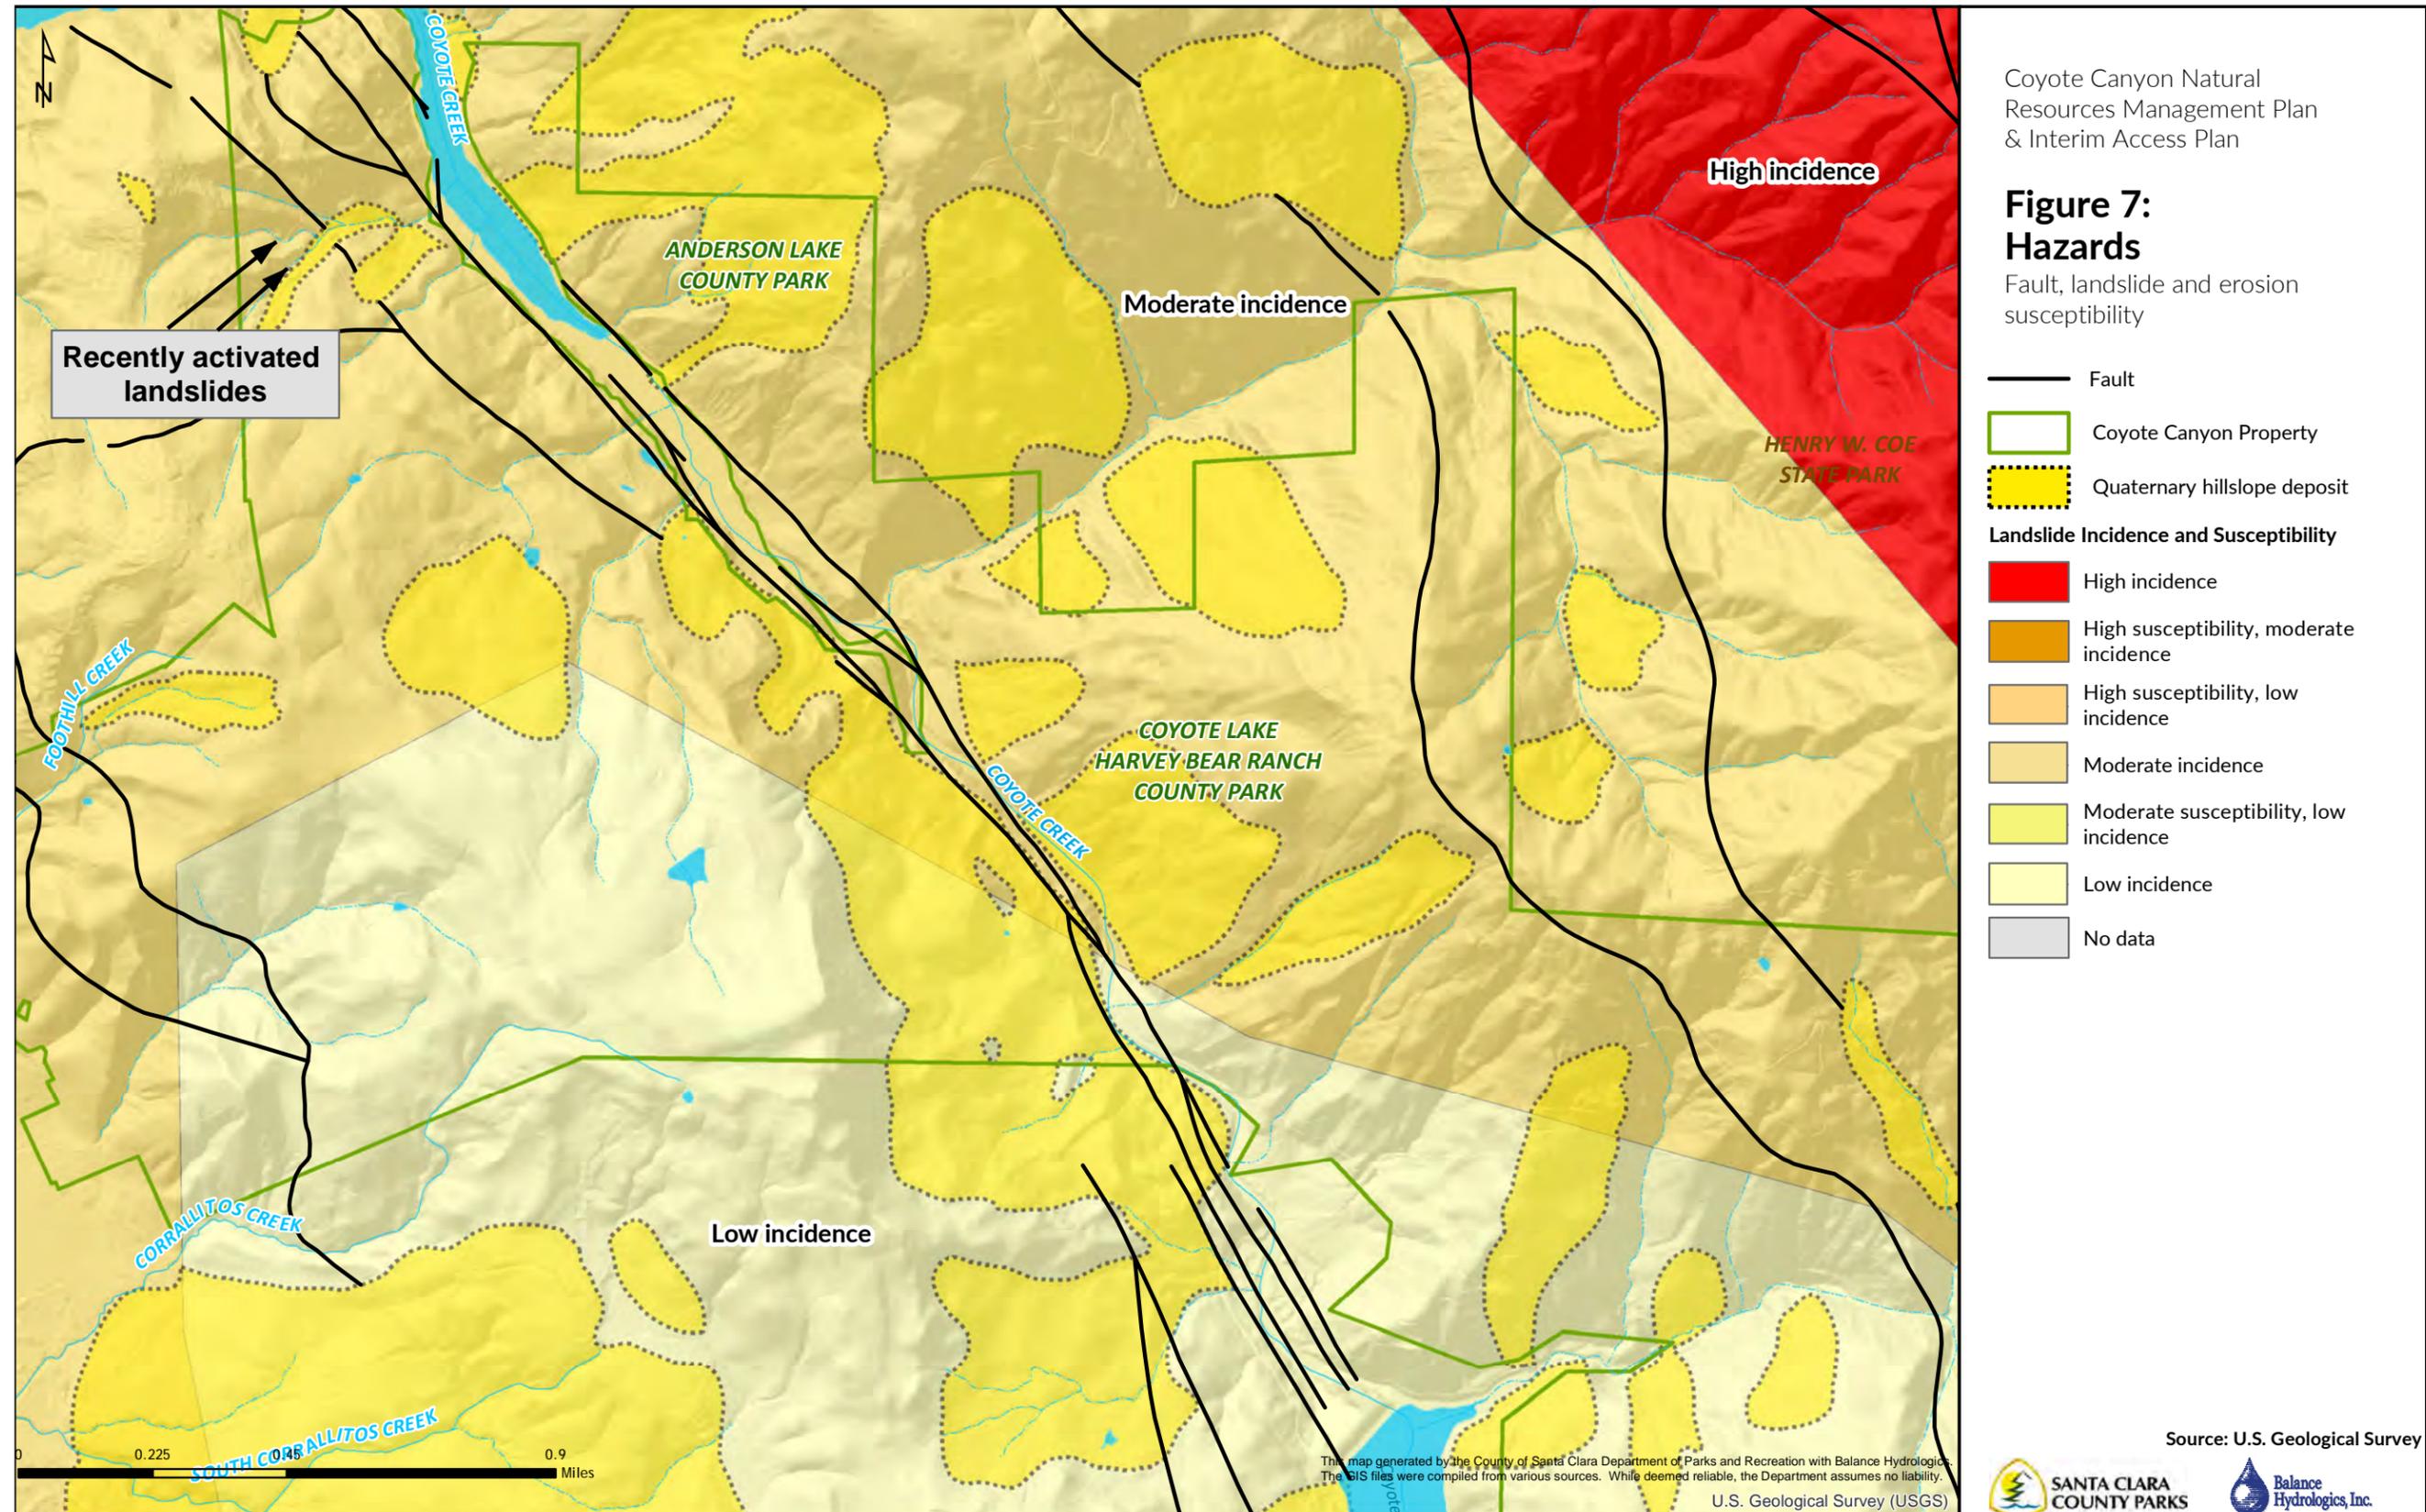
Figure 7. Hazards

The primary erosion hazards associated with the Property are those related to landslides, faults and erosion from gullies and stream channels. It may be difficult to control erosion related to landslides and faults, but gully erosion may be managed with standard treatments and strategies. These can be found in the recommendations section of this Plan. Much of the Property has moderate incidence and susceptibility of landslides. Evidence of slumping and hummocky topography was found during field visits, which are indicative of historic landslide activity. Two areas appeared to have an active landslide and erosion within the past few years, likely from the heavy rains in winter of 2017 (Figure 7). These landslide scarps are present in historic aerial photographs, and the scarps appear to have been active within the past few years. The channel downstream of these landslides exhibits signs of active channel adjustments including incised reaches, buried culvert inlets, and extensive sediment deposition at its confluence with Coyote Creek.

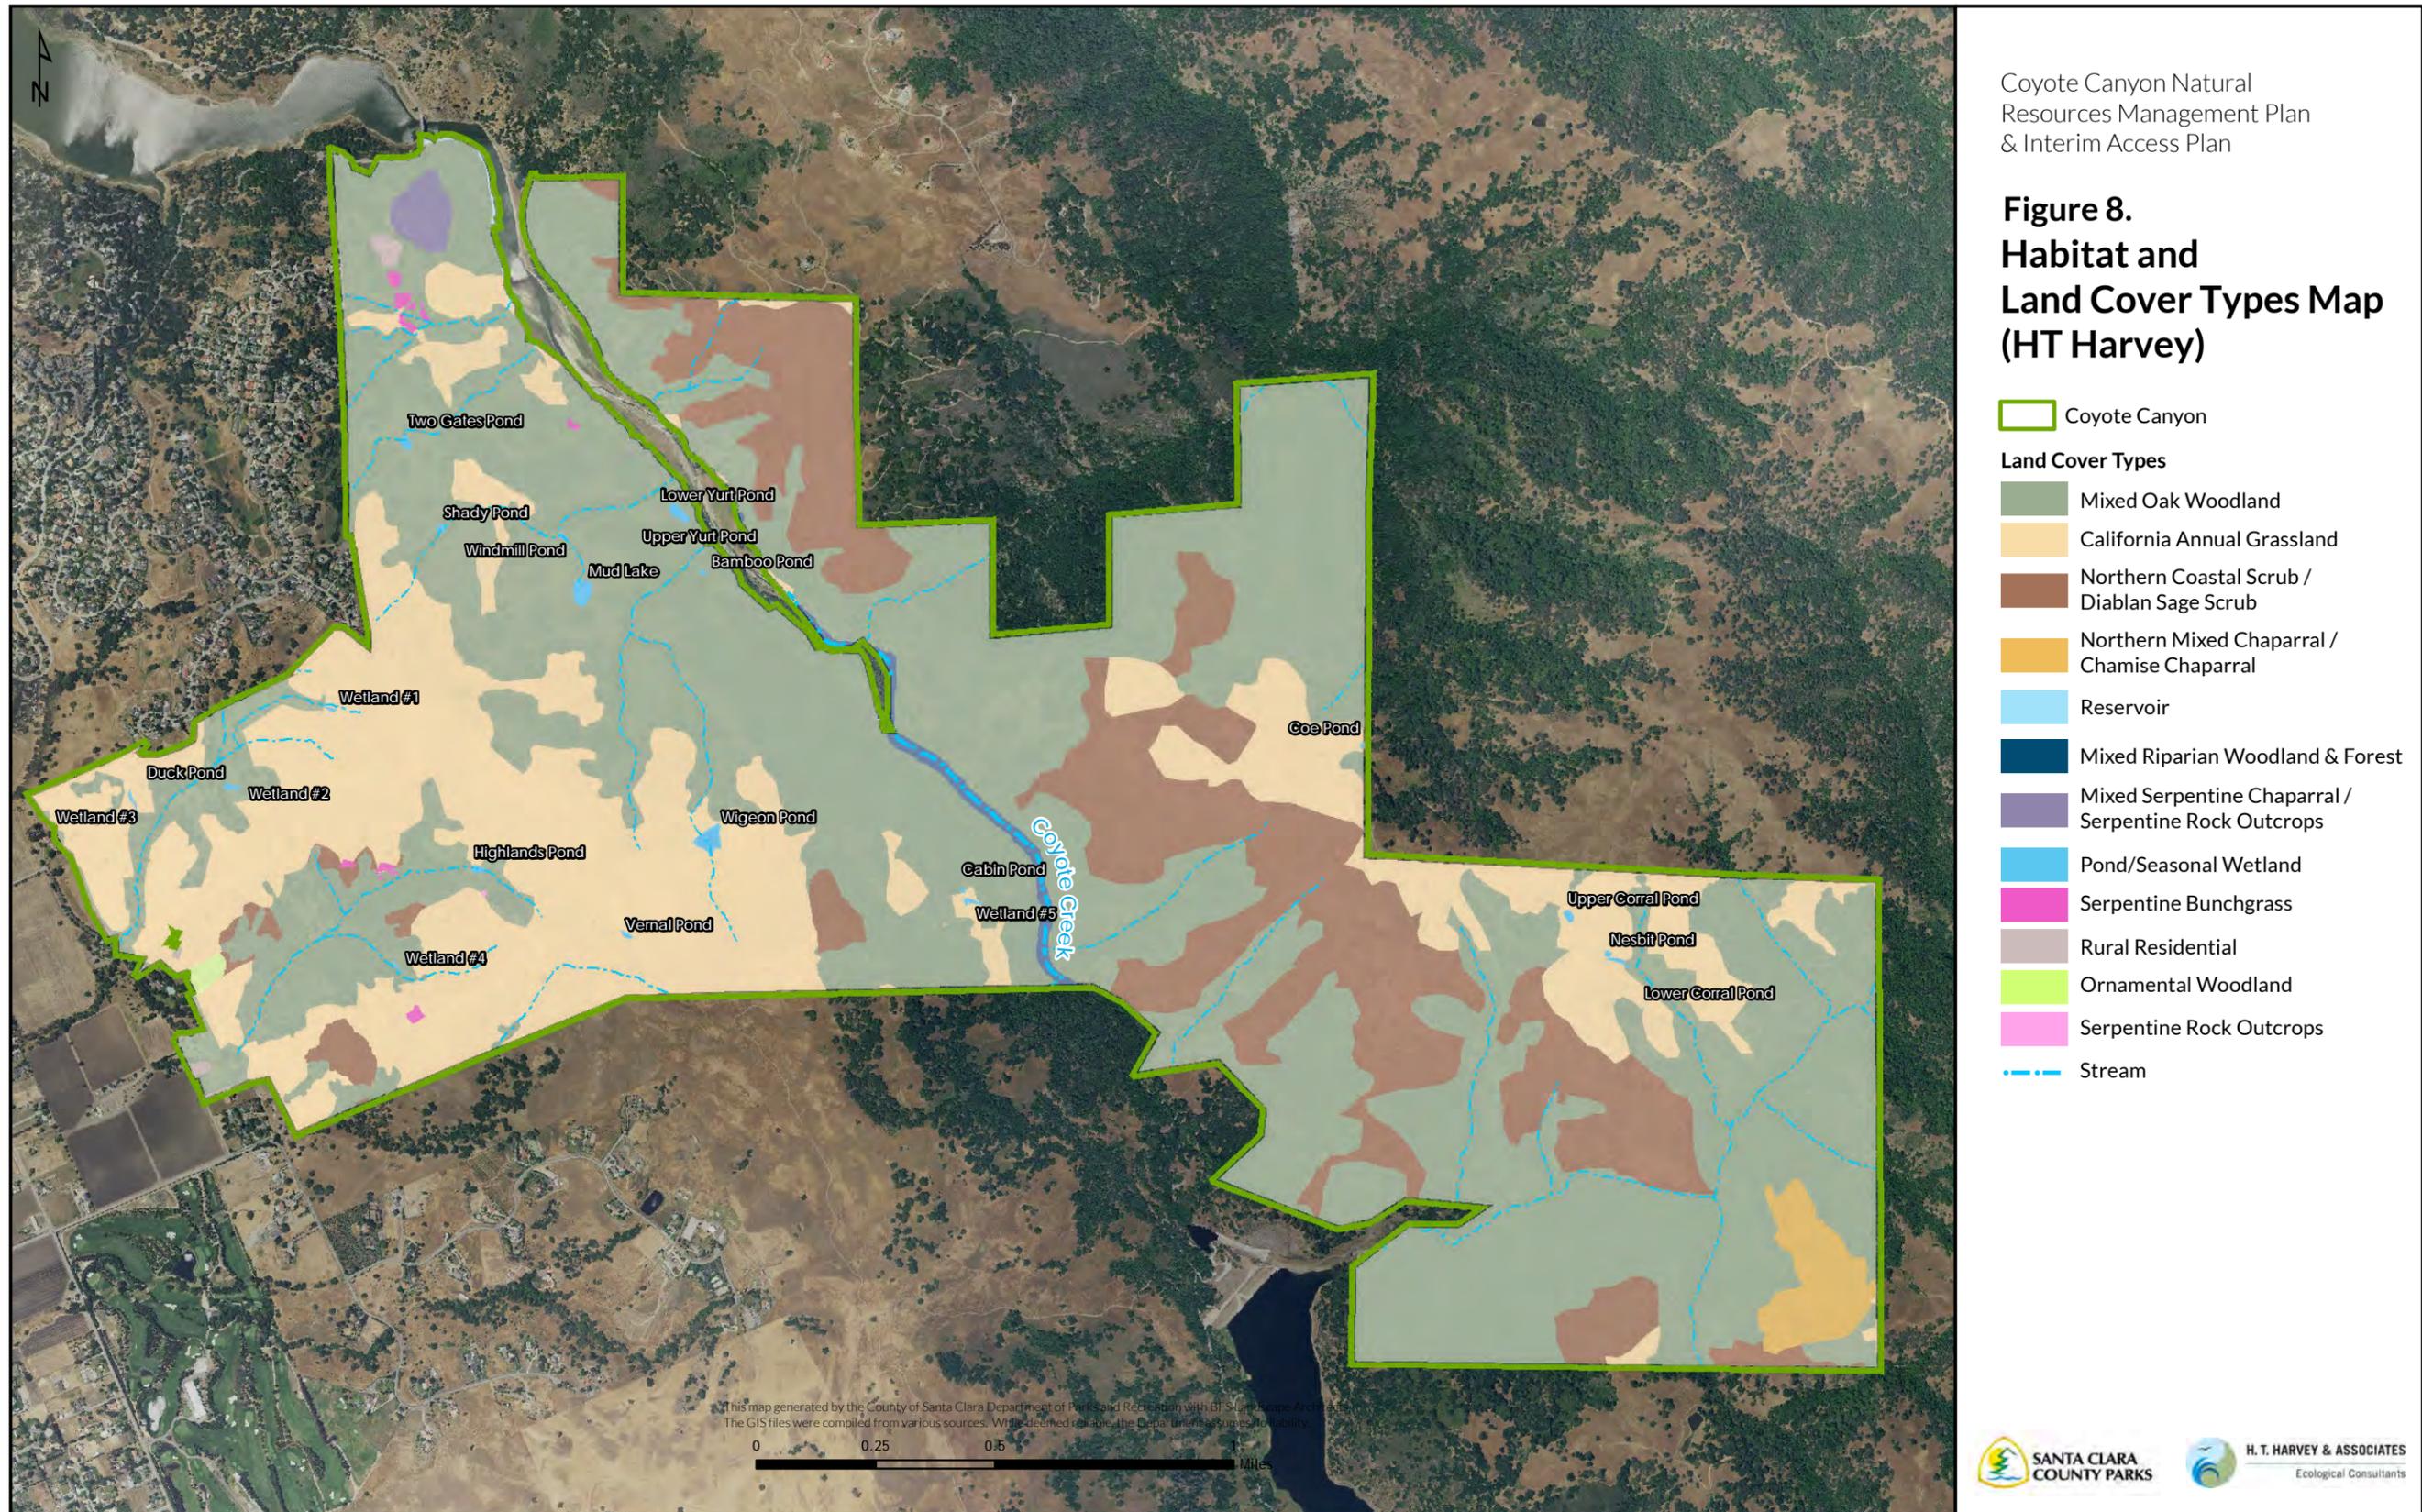
Figure 8. Habitat & Land Cover Types Map

Fourteen biotic habitats and land cover types were identified on the Property: mixed oak woodland, California annual grassland, northern coastal scrub/Diablan sage scrub, northern mixed chaparral/chamise chaparral, reservoir, mixed riparian woodland and forest, mixed serpentine chaparral/serpentine rock outcrops, pond, seasonal wetland, serpentine bunchgrass, rural residential, ornamental woodland, serpentine rock outcrops, and stream (Figure 8). Of these land cover types, aquatic features consist of reservoir, pond, seasonal wetland, and stream. These habitats and land cover types are described in detail in Appendix C.

**Figure 8. Habitat and Land Cover Types Map (HT Harvey)**

Santa Clara Valley dudleya was observed on the Property during the 2018 surveys (Photo 15). This occurrence is located in the serpentine rock outcrop land cover type just east of the Ranch Complex (Figure 8). Here, dudleya are present in crevices within rock outcrops at scattered locations all over the hilltop. No comprehensive survey of this population was performed, and it is likely that this occurrence is larger than was observed. The population appeared to be in good health on high-quality habitat, and no immediate threats to the continued existence of this population are expected from the proposed management activities.

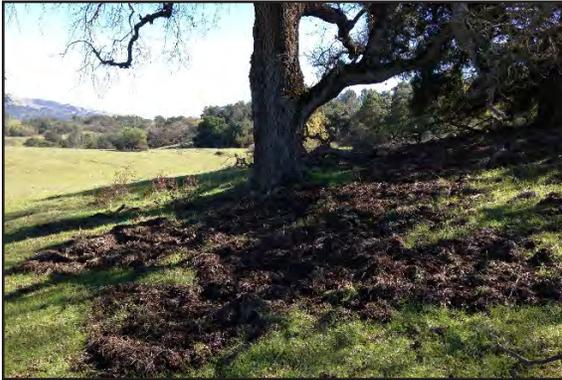
Feeding and rooting activities of feral pigs can damage ecosystems by disturbing soil, uprooting plants, and modifying physical resources. Rooting behavior can also damage fencing and other infrastructure. Feral pigs feed not only on plants, but also on other animal species, potentially impacting other wildlife populations (Jolley et al. 2010, Barrios-Garcia and Ballari 2012). Feral pigs can also present a danger to public safety by charging when they feel threatened, and may act aggressively towards dogs, although the likelihood of an attack is generally low.

Photo 27. Pig rooting in oak woodlands.

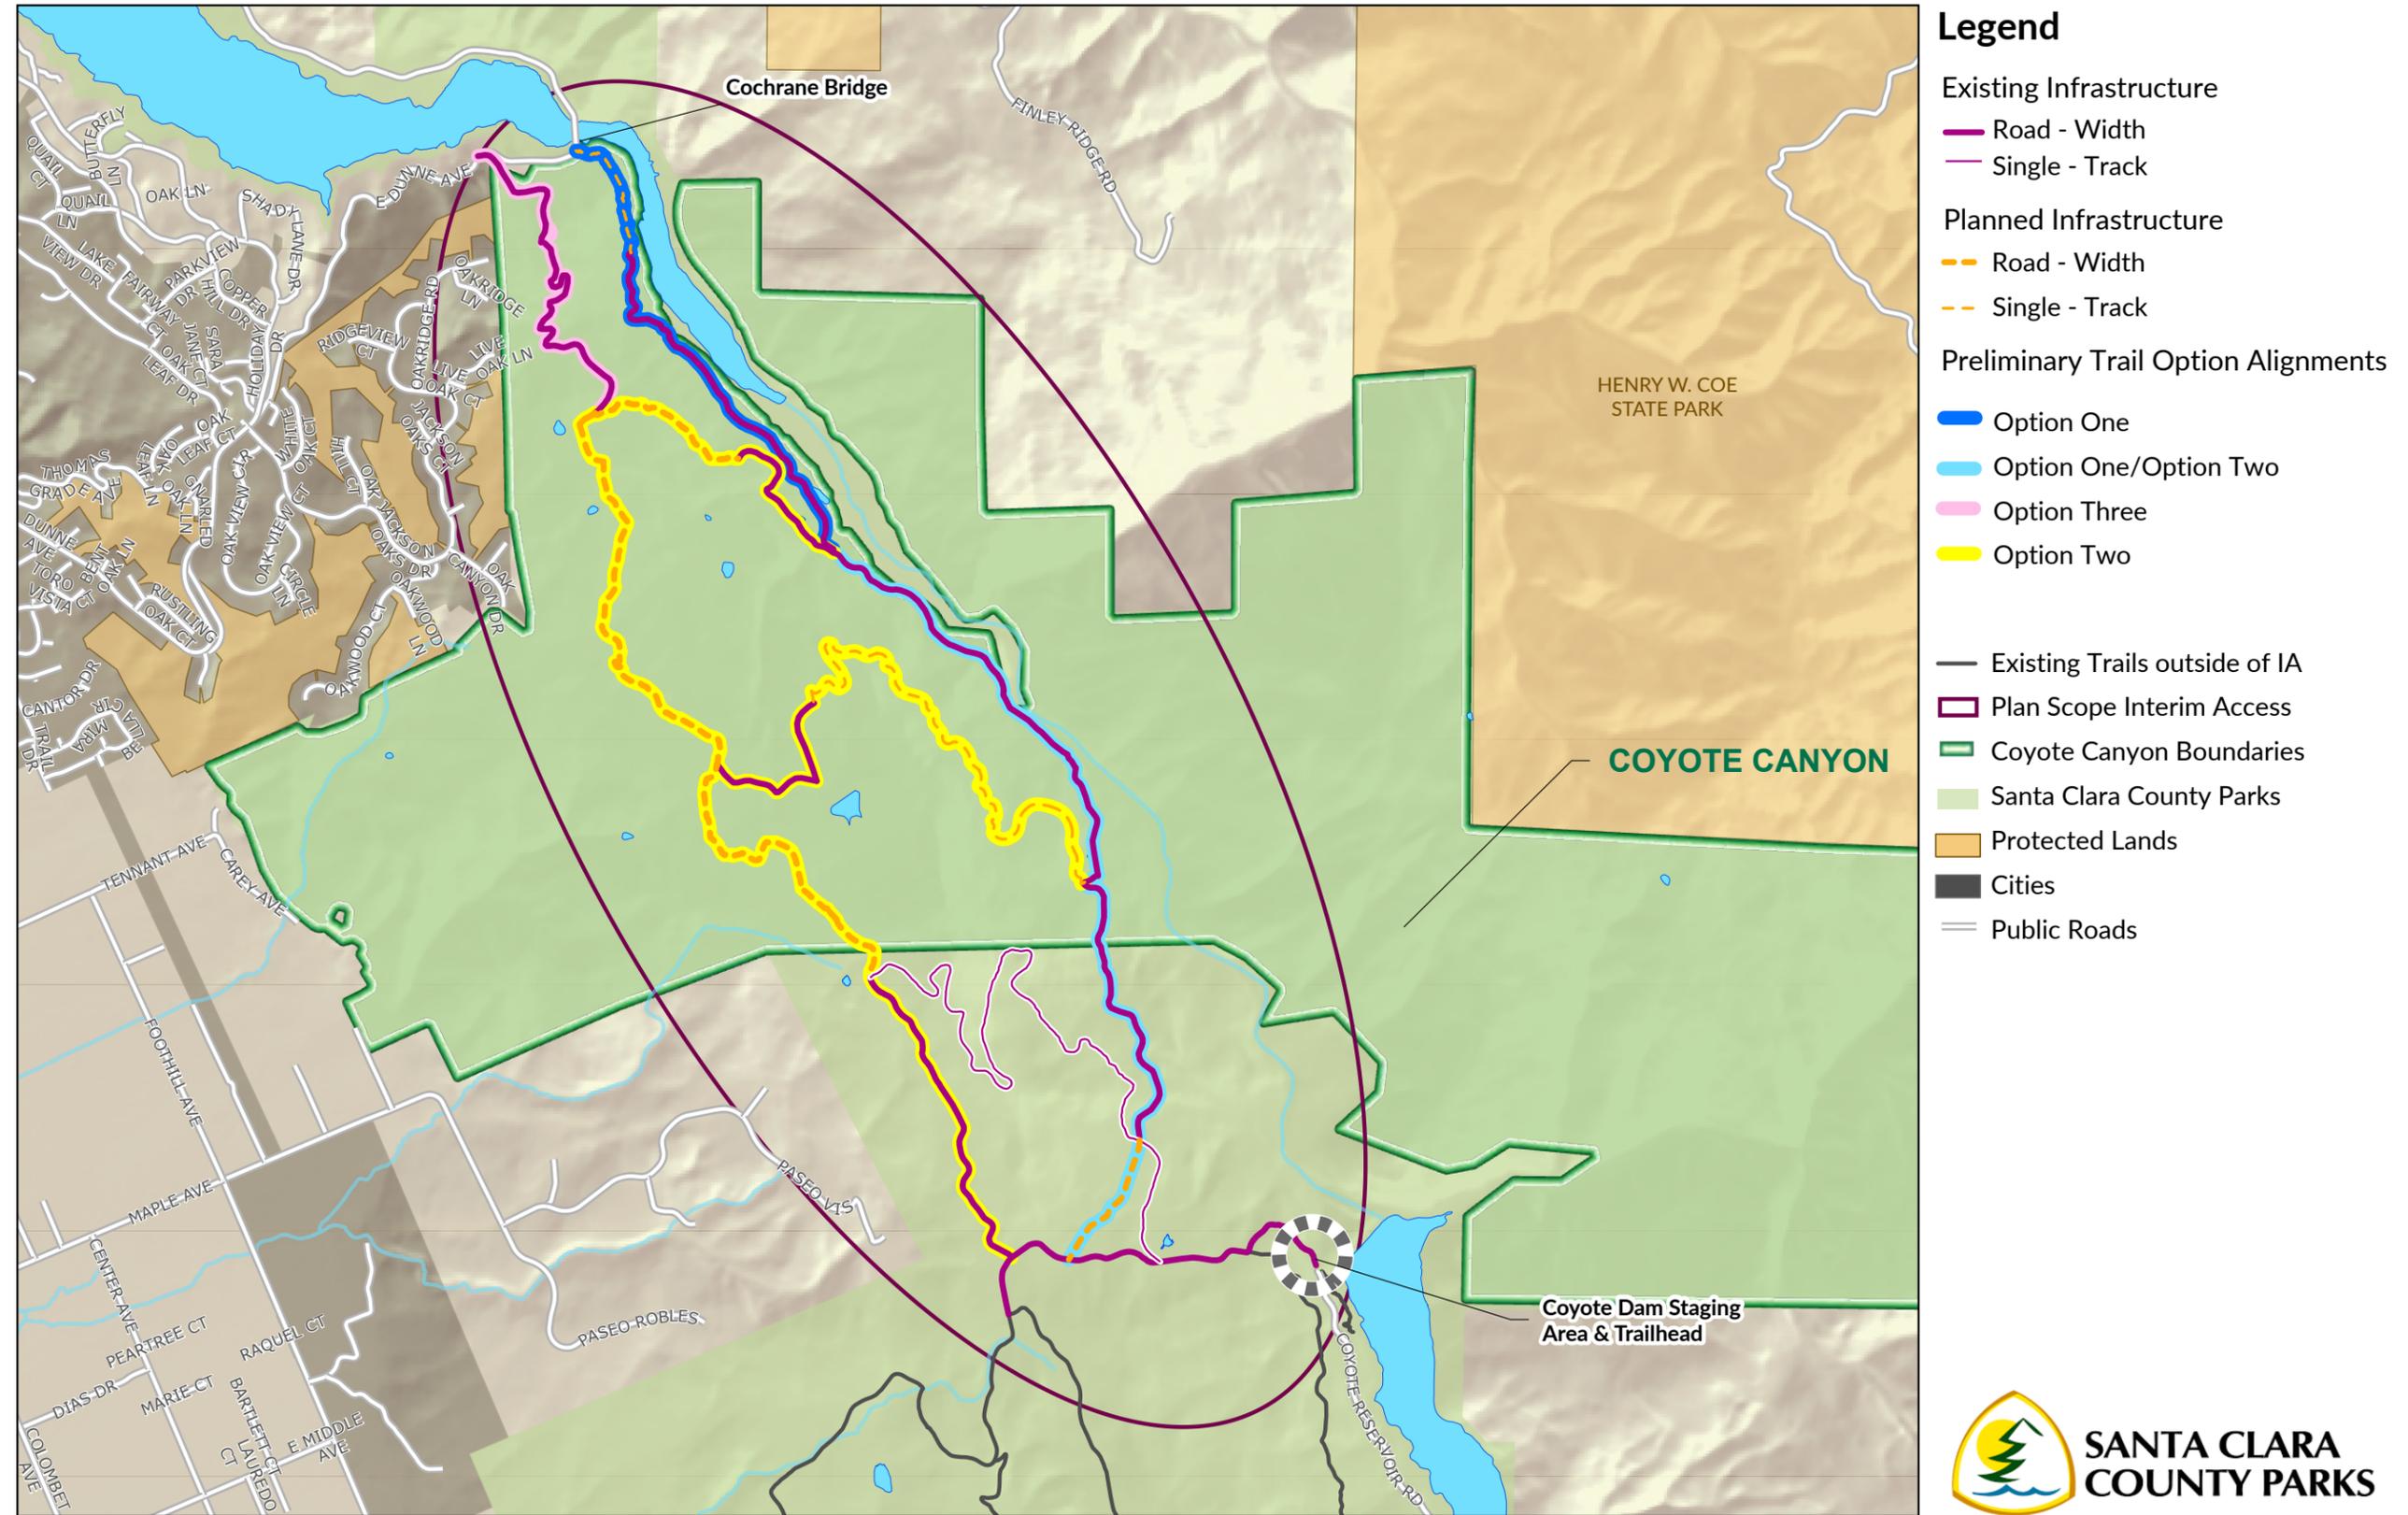
Figure 11: Preliminary Trail Options

Users would be able to access Option Two (Figure 11) from either the same converted service road as included in Option One or at the existing junction of the hiking/dogs-on-leash-only double-track segment of the Ed Willson Trail and the multi-use double-track segment of Coyote Ridge Trail in Coyote Lake–Harvey Bear Ranch County Park. Option Two would provide a moderate (5-mile) loop trail and a longer distance (6.5-mile) option within the Property. In addition to the other loops, a new 1.5-mile loop would be created in Coyote Lake–Harvey Bear Ranch County Park.

Option Three provides approximately 8.2 miles of trail including 7.5 miles of trail from Option Two. This option includes the development of a public staging area at the northern end of the Property at the existing Ranch Complex Area off East Dunne Avenue. From the staging area, a short double-track 0.7-mile trail would connect users to the trails described in Option Two (Figure 11).
