# COYOTE CANYON

## NATURAL RESOURCES MANAGEMENT PLAN & INTERIM ACCESS PLAN

REVISED DRAFT  
AUGUST 2019

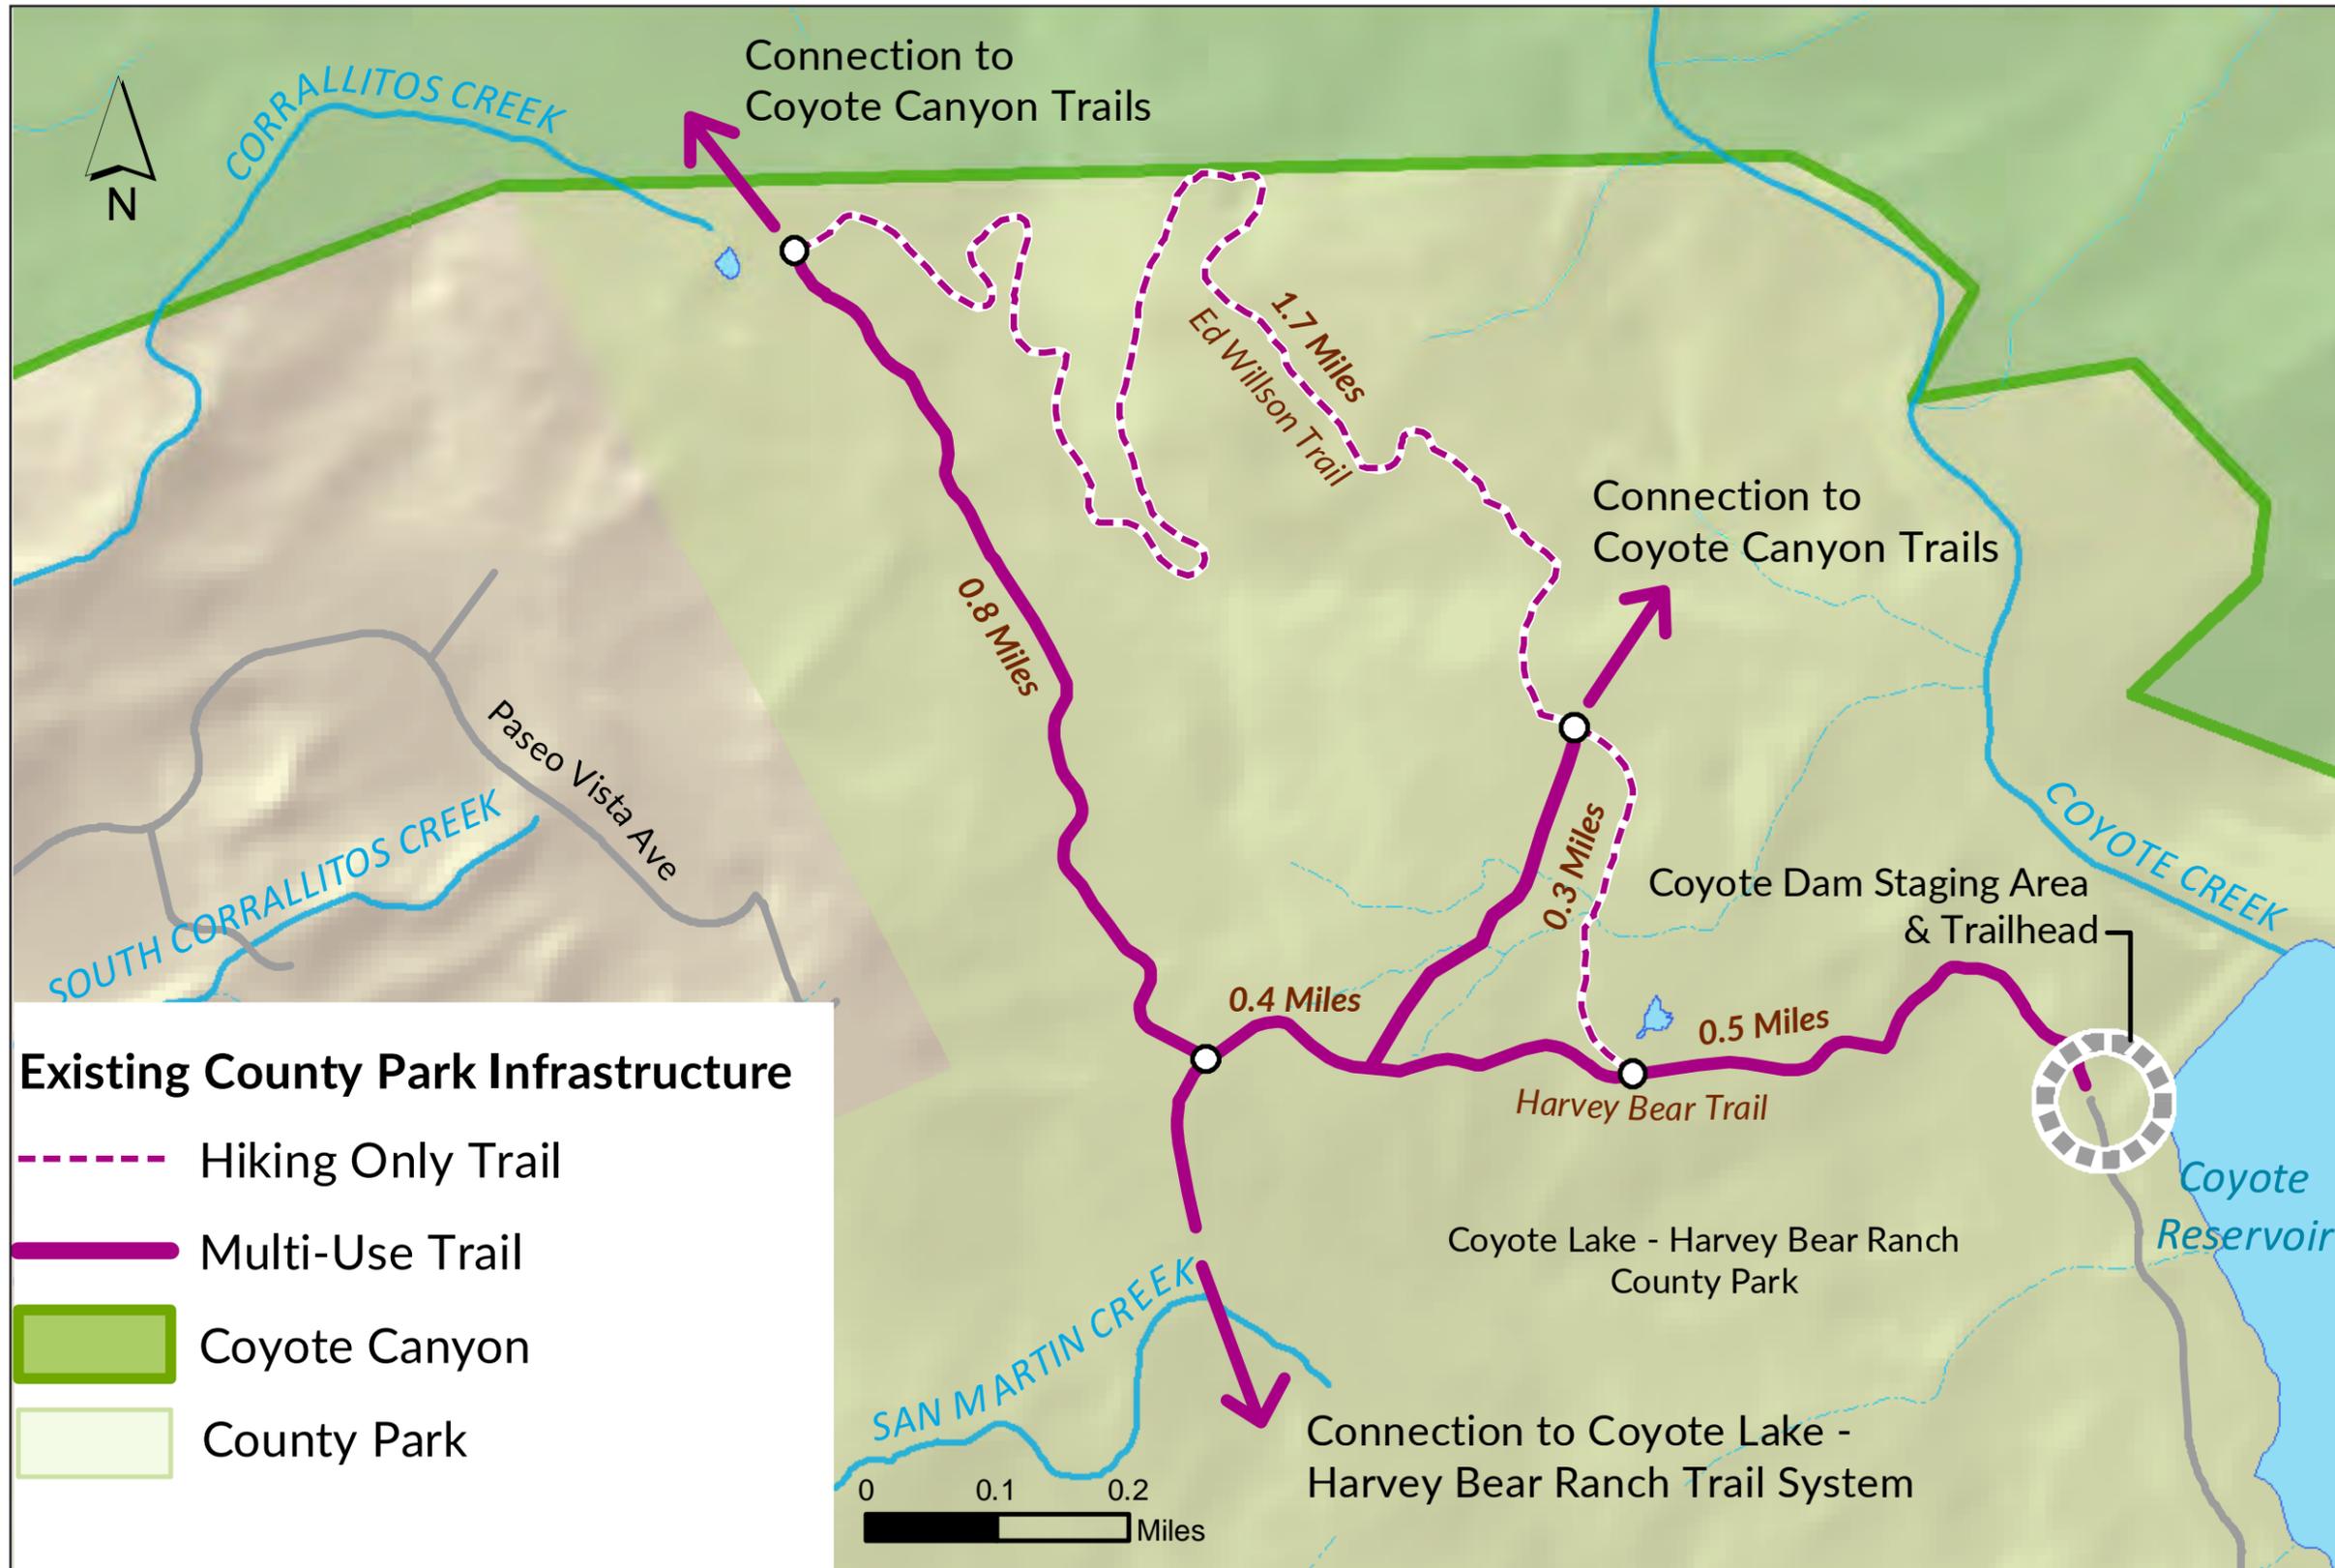
Figure 12: Existing Trails at Coyote Lake-Harvey Bear Ranch County Park

The Coyote Ridge Trail (Figure 12) is a 3.9-mile multi-use trail within Coyote Lake–Harvey Bear Ranch County Park. Built to a double-track width, it provides primary service access for Department vehicles for patrol and maintenance activities (Figure 12).

The Harvey Bear Trail (Figure 12) includes a mix of converted ranch road and new trail construction resulting in the current 4.5-mile multi-use trail. Built to double-track standards, it provides primary service access for Department vehicles from the Coyote Dam Staging Area to the Harvey Bear Staging Area located on the west side of the Park. The trail features views of Coyote Creek, the surrounding foothills as well as more distant ridgelines. The name commemorates the previous landowners who sold the land to the Department to be incorporated into the then-existing Coyote Lake County Park.

The Ed Willson Trail (Figure 12) is comprised of a mix of new trail and converted ranch road and allows hiking/dogs on-leash-only single-track segments and double-track segments. The Ed Willson Trail commemorates a former ranch hand that died on the Bear Ranch while working at the property.

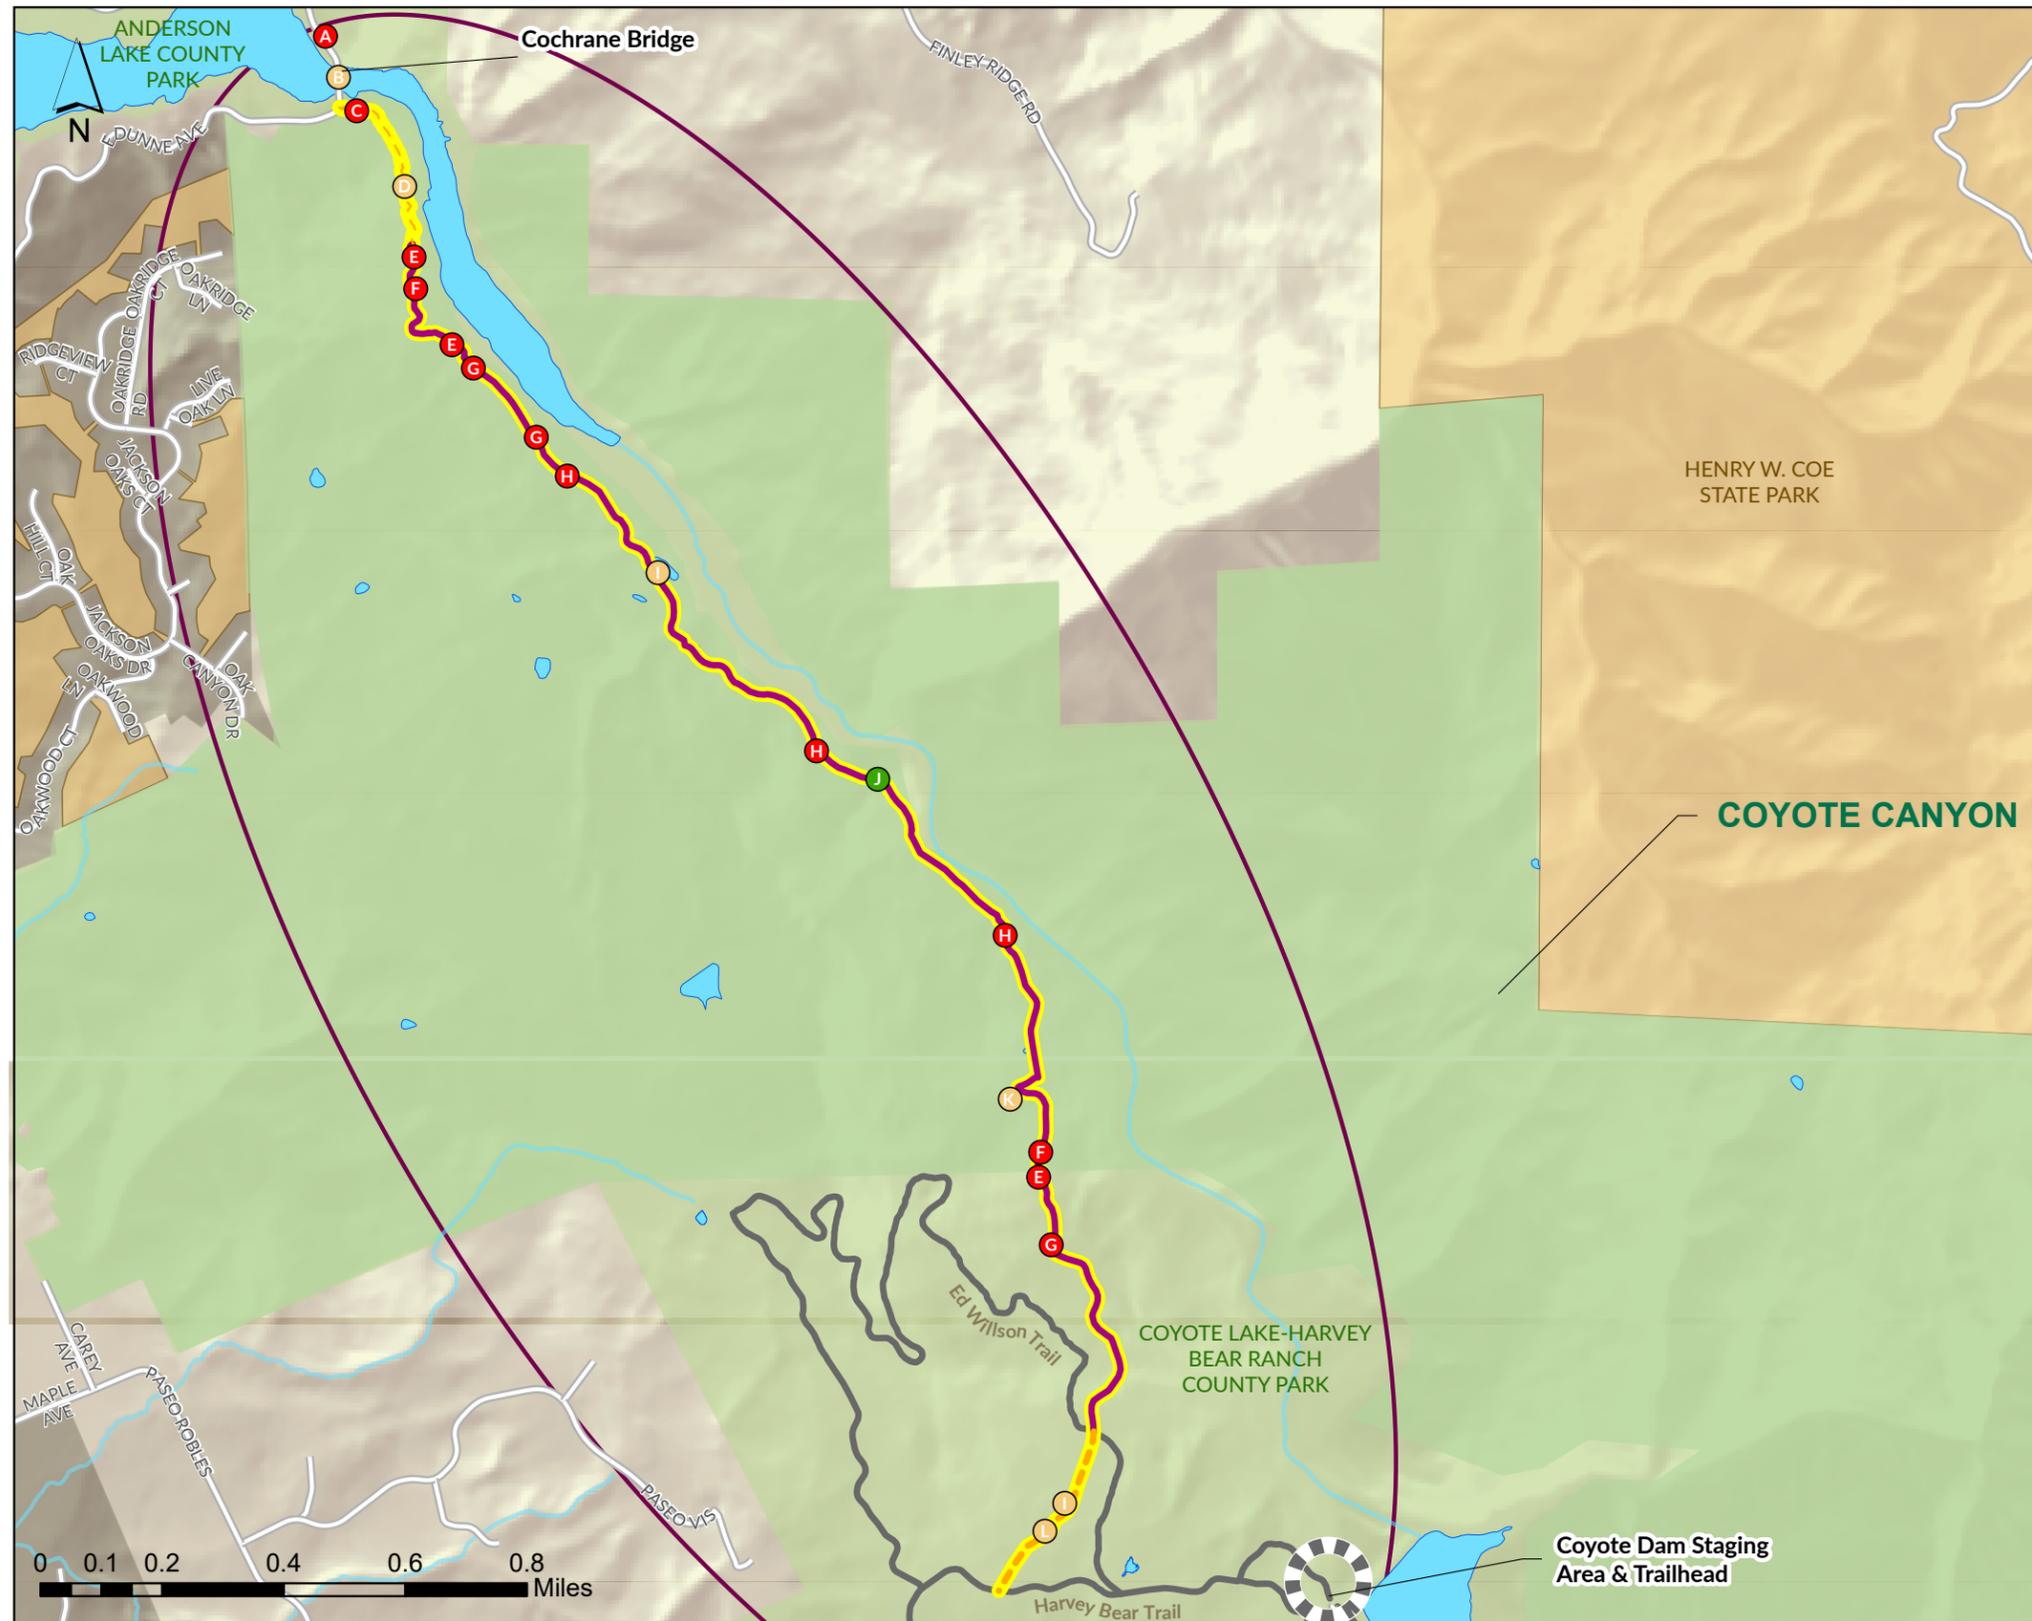
Figure 13: Trail Option One Opportunities & Constraints

OPTION ONE - CREEK TRAIL ALIGNMENT FROM ED WILLSON TRAIL TO COCHRANE BRIDGE			
ITEM	DESCRIPTION	OPPORTUNITY	CONSTRAINT
A	Narrow road with cliff on east side		No designated walking lane from Cochrane Bridge to Woodchopper’s Flat parking area; Existing conditions limit potential to add width to shoulder
B	Existing Cochrane Bridge	Roadway may be striped and signed for trail / bike use	Existing bridge provides no opportunity to widen to improve safety for other users.
C	Lack of trailhead		Trail ends abruptly on East Dunne Avenue with no trailhead or parking; Limited shoulder space to construct a new staging area along roadway
D	New trail segment	Provides northern connection to East Dunne Avenue and bypasses Ranch Complex Area; Provides regional connection for Bay Area Ridge Trail	Serious concerns at the northern end of the trail for potential of visitors falling into reservoir due to steepness of cross-slopes; landing of land or water from that steepness would be problematic

E	Trail crosses existing fence		Self-closing pedestrian gate needed to keep cattle fenced
F	Erosion; culvert or restoration needed		Erosion is actively occurring on trail; Trail construction will require grading and drainage improvements to create stable trail
G	Drainage crossing		Trail crosses existing natural drainage; Install culverts or other means to stabilize trail needed
H	Shaded segment of trail; seasonally wet	When dry, the segment offers shaded areas for users	Potential for damage to trail if not allowed to dry before use; May require base rock reinforcement; Trail may be seasonally closed

The trail in Option One includes single-track and double-track segments and terminates at East Dunne Avenue and the Cochrane Bridge. East Dunne Avenue is a narrow two-lane road with no bike lanes and constrained by Anderson Reservoir to the east and steep mountain slopes to the west (Figure 13 and Figure 14). Currently, various parking restrictions are designated for the roadway including a no parking restriction. The closest parking area is located at Woodchopper’s Flat Staging Area, a half-mile away in Anderson Lake County Park. To connect to Woodchopper’s Flat, users would walk, bike, or take their horse across Cochrane Bridge and along the shoulder of East Dunne Avenue. The lack of staging at the trail junction with East Dunne Avenue and the inadequate road width to Woodchopper’s Flat Staging Area present significant safety concerns.

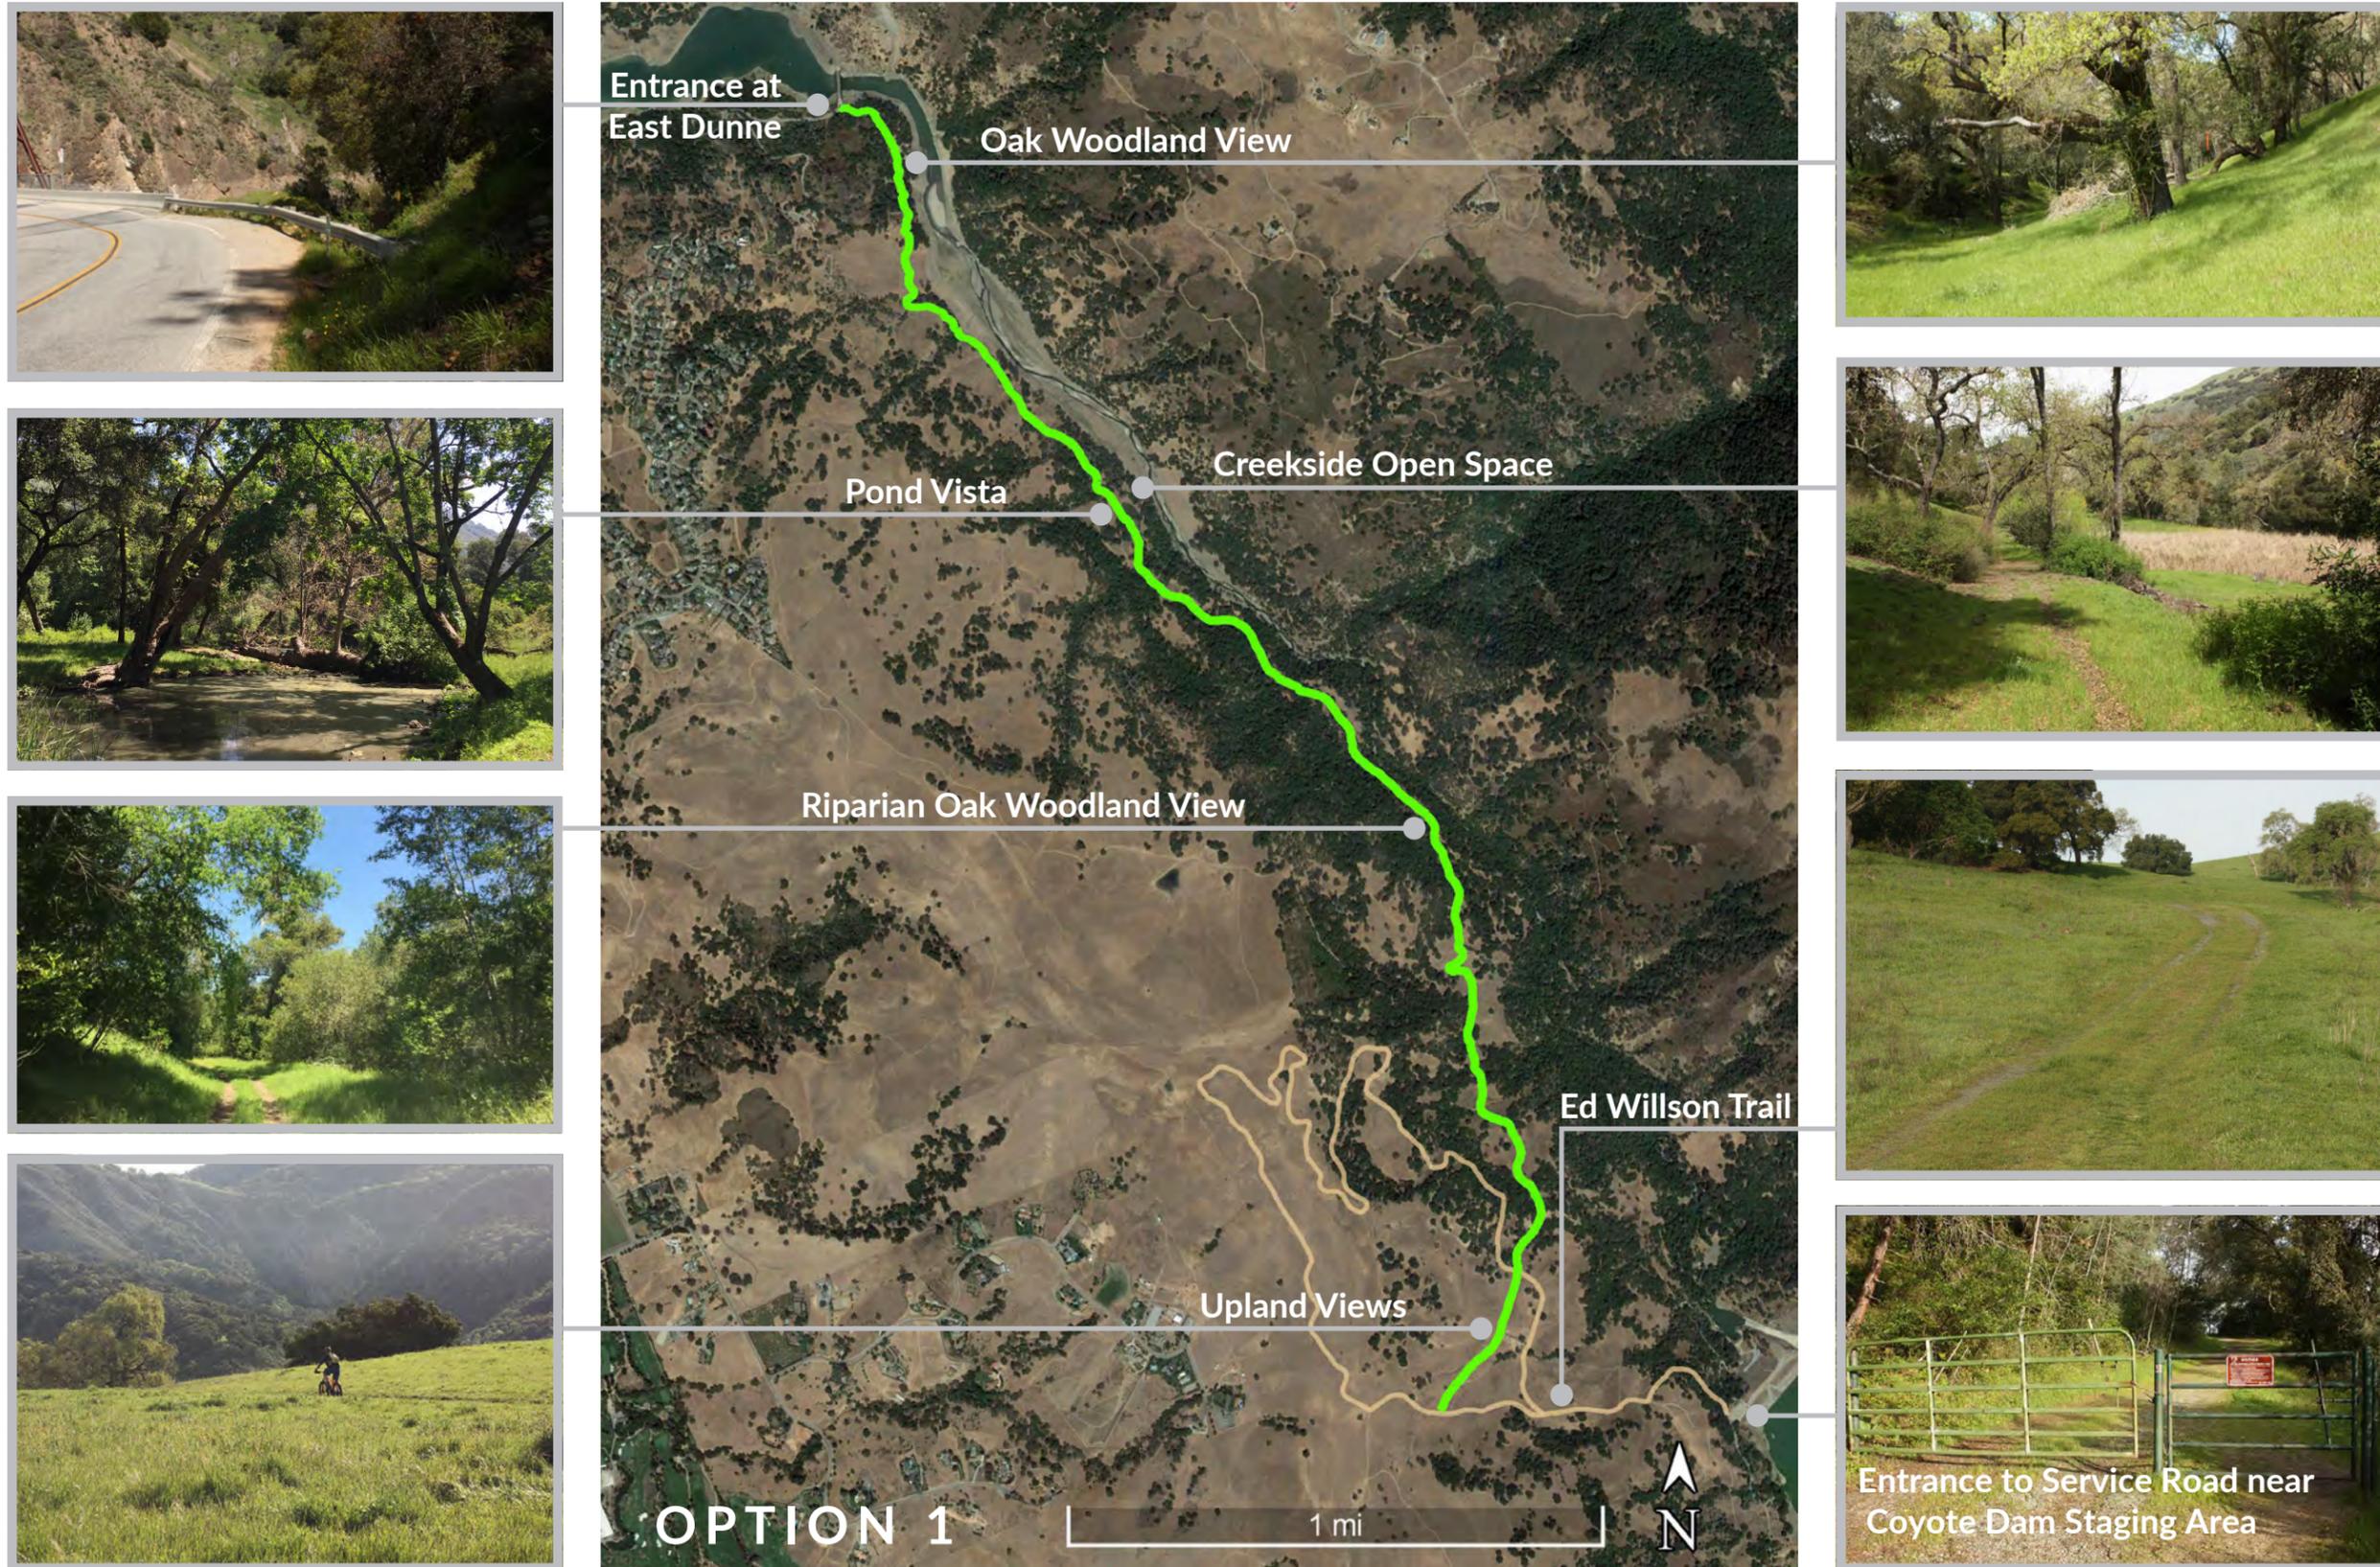
Figure 14: Trail Option One

OPTION ONE - CREEK TRAIL ALIGNMENT FROM ED WILLSON TRAIL TO COCHRANE BRIDGE CONT.			
ITEM	DESCRIPTION	OPPORTUNITY	CONSTRAINT
I	Pond / Wetland	Interpretive signage opportunity; Bench; Point of interest along trail to see potential habitat of sensitive species	Potential habitat for sensitive species; May require assessment of impacts; Potential issues with water source reliability, a water infrastructure assessment needs to be completed
J	Vista point	Vegetation and topography create opportunity for vista point; Possible bench location	
K	Trail segment on existing ranch road	Use of existing ranch road for trail eliminates need for new construction	Road surface and drainage improvements needed to accommodate public trail use; Unstable slopes

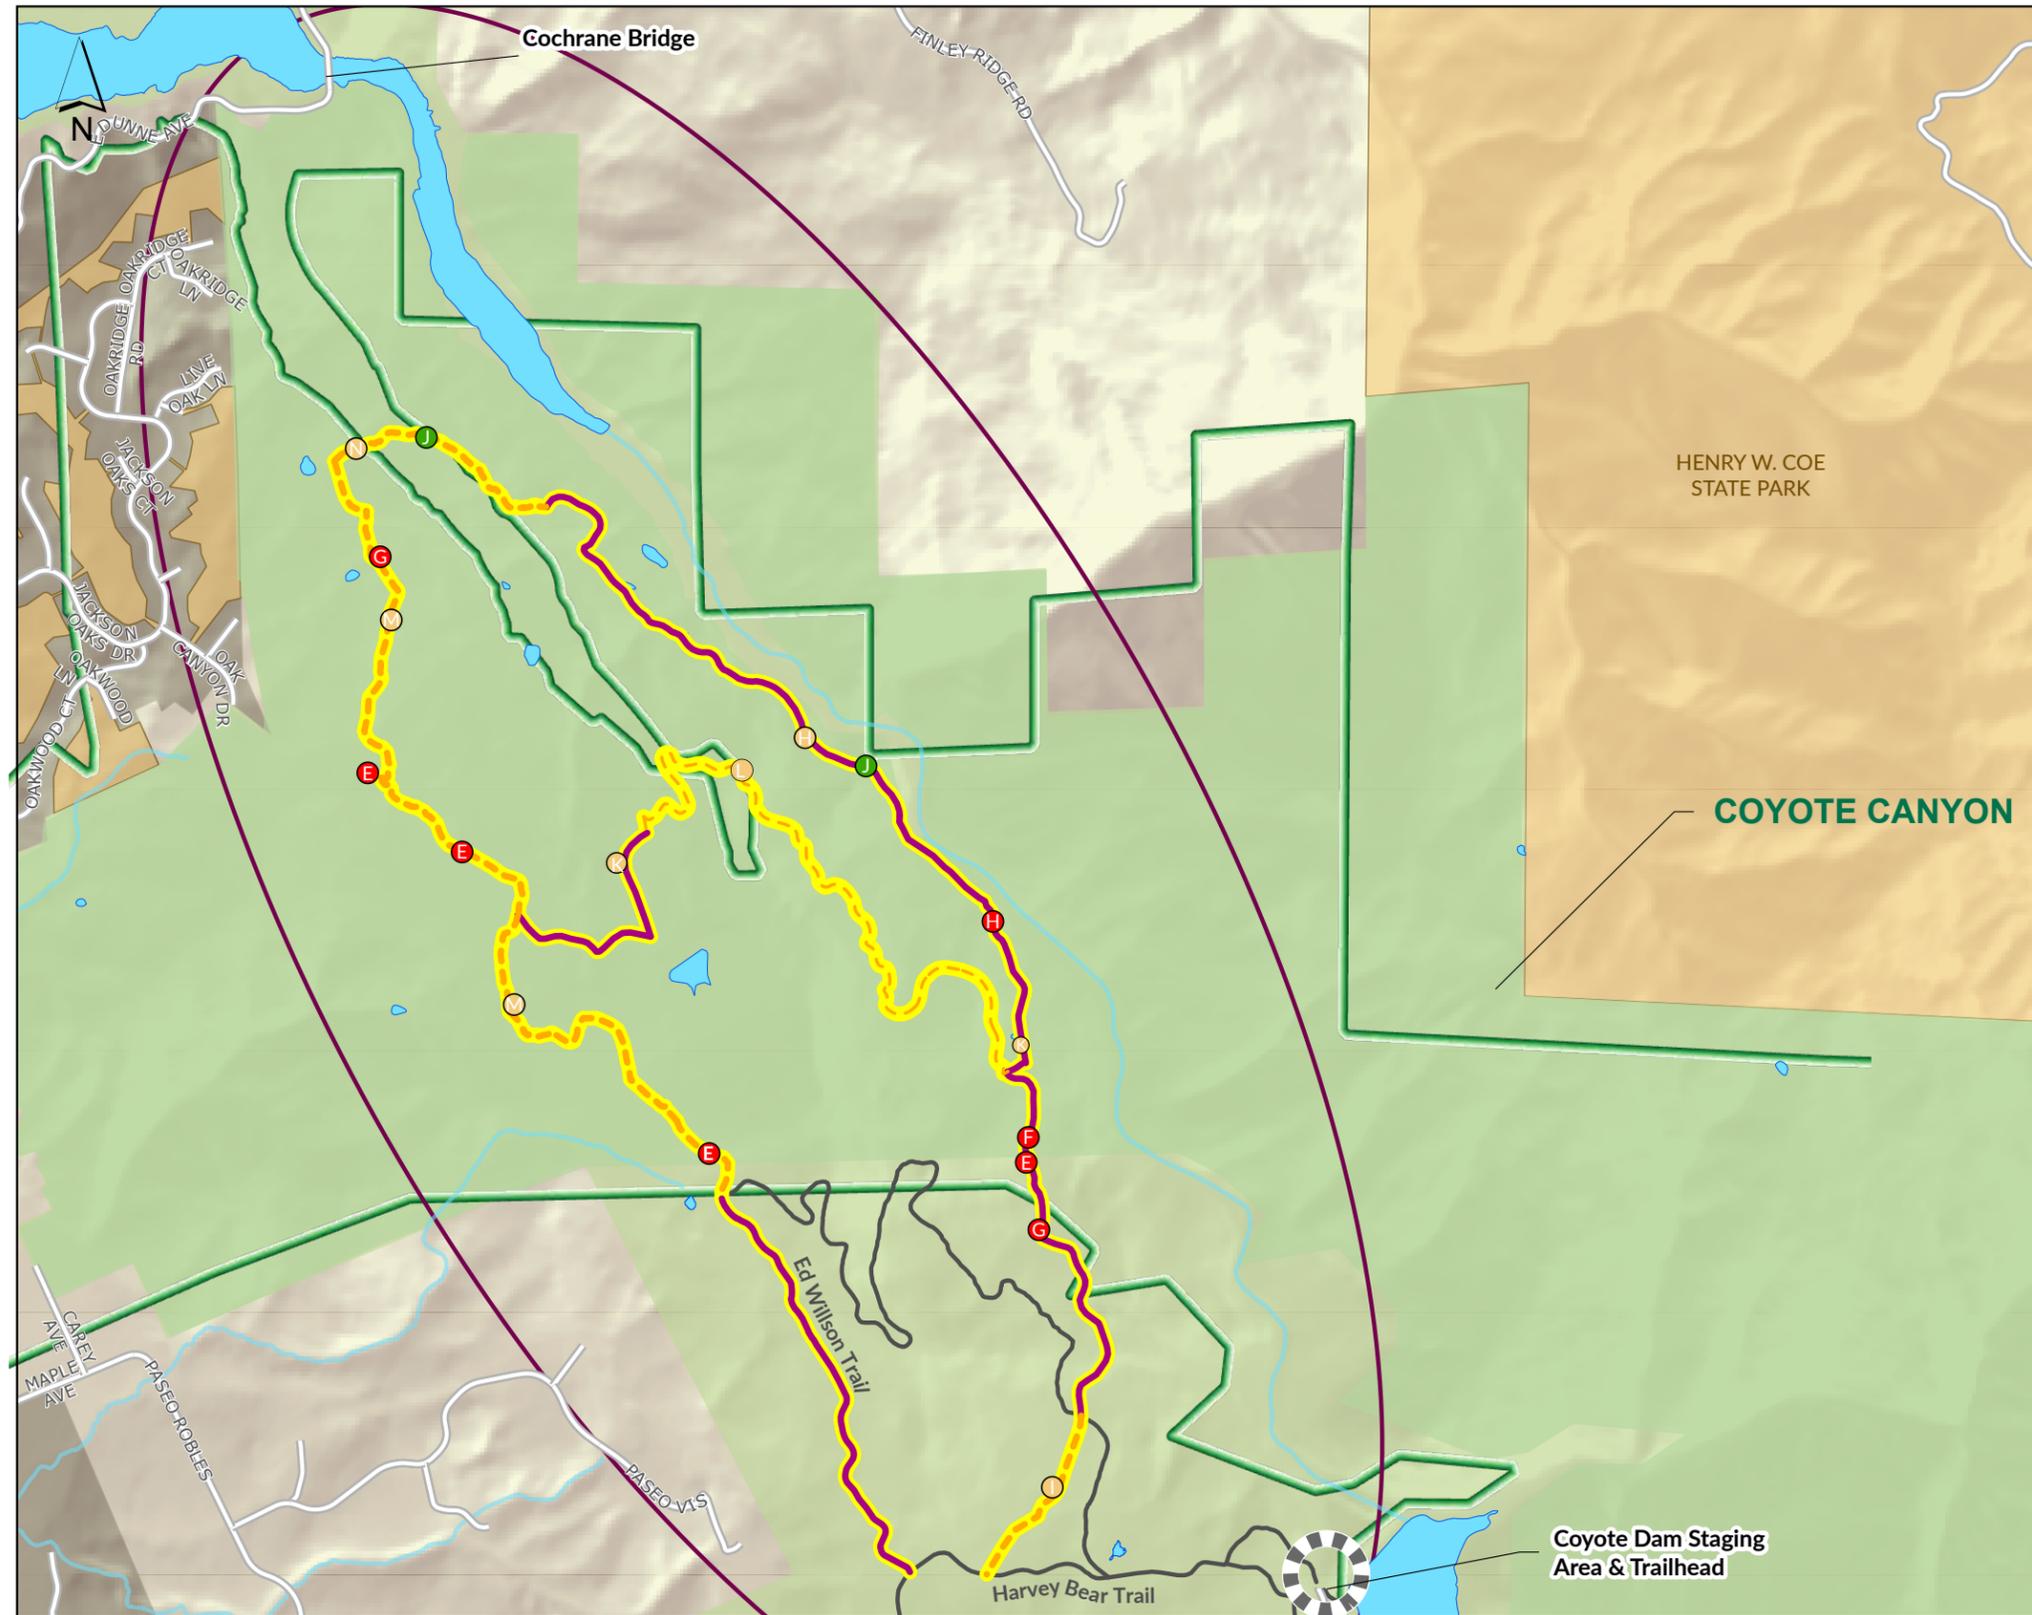
Figure 15: Trail Option Two Opportunities & Constraints

OPTION TWO - LOOP TRAIL FROM HARVEY BEAR TRAIL TO ED WILLSON TRAIL			
ITEM	DESCRIPTION	OPPORTUNITY	CONSTRAINT
E	Trail crosses existing fence		Self-closing pedestrian gate needed to keep cattle fenced
F	Erosion; culvert or restoration needed		Erosion is actively occurring on trail; Trail construction will require grading and drainage improvements to create stable trail
G	Drainage crossing		Trail crosses existing natural drainage; Culvert or other means to stabilize trail needed
H	Shaded segment of trail; seasonally wet	When dry, the segment offers shaded areas for users	Potential for damage to trail if not allowed to dry before use; May require base rock reinforcement; Trail may be seasonally closed
I	Pond / Wetland	Interpretive signage opportunity; Bench; Point of interest along trail to see potential habitat of sensitive species	Potential habitat for sensitive species; May require assessment of impacts; Potential issues with water source reliability, a water infrastructure assessment needs to be completed

J	Vista point	Vegetation and topography create opportunity for vista point; possible bench location	
K	Trail segment on existing ranch road	Use of existing ranch road for trail eliminates need for new construction	Existing double-track segment may cause conflicting interactions between users and with staff and emergency vehicles; Road surface and drainage improvements needed to accommodate public trail use; Unstable slopes
L	New single-track trail segment	Trail blends into surrounding environment; Provides a more immersive natural experience for users; More challenging ride for bicyclists; Provides views of wetland	New construction of trail; May require assessment of impacts to natural resources
M	New double-track trail segment	Wider width provides infrastructure and emergency access for vehicles and multi trail use	New construction of road; May require assessment of impacts to natural resources; Less immersive natural experience for users; More difficult to maintain; Lack of shade

N	Connection to existing service road	Provide north service road access from Ranch Complex Area; improvements to service roads	Signage improvements needed; Serpentine outcropping along existing service roads

As stated above, to select a recommended public access alignment, the Project Team evaluated opportunities and constraints of each potential option. The Opportunities and Constraints Maps (Figures 13, 15, and 17) show the physical layout of each option and a condensed summary of specific points along the trail that would present either an opportunity or constraint. In some cases, the element could be viewed as both an opportunity and a constraint, either from the natural resource or the public use perspective. Table 1 below details general considerations that were taken into account for each potential trail option.

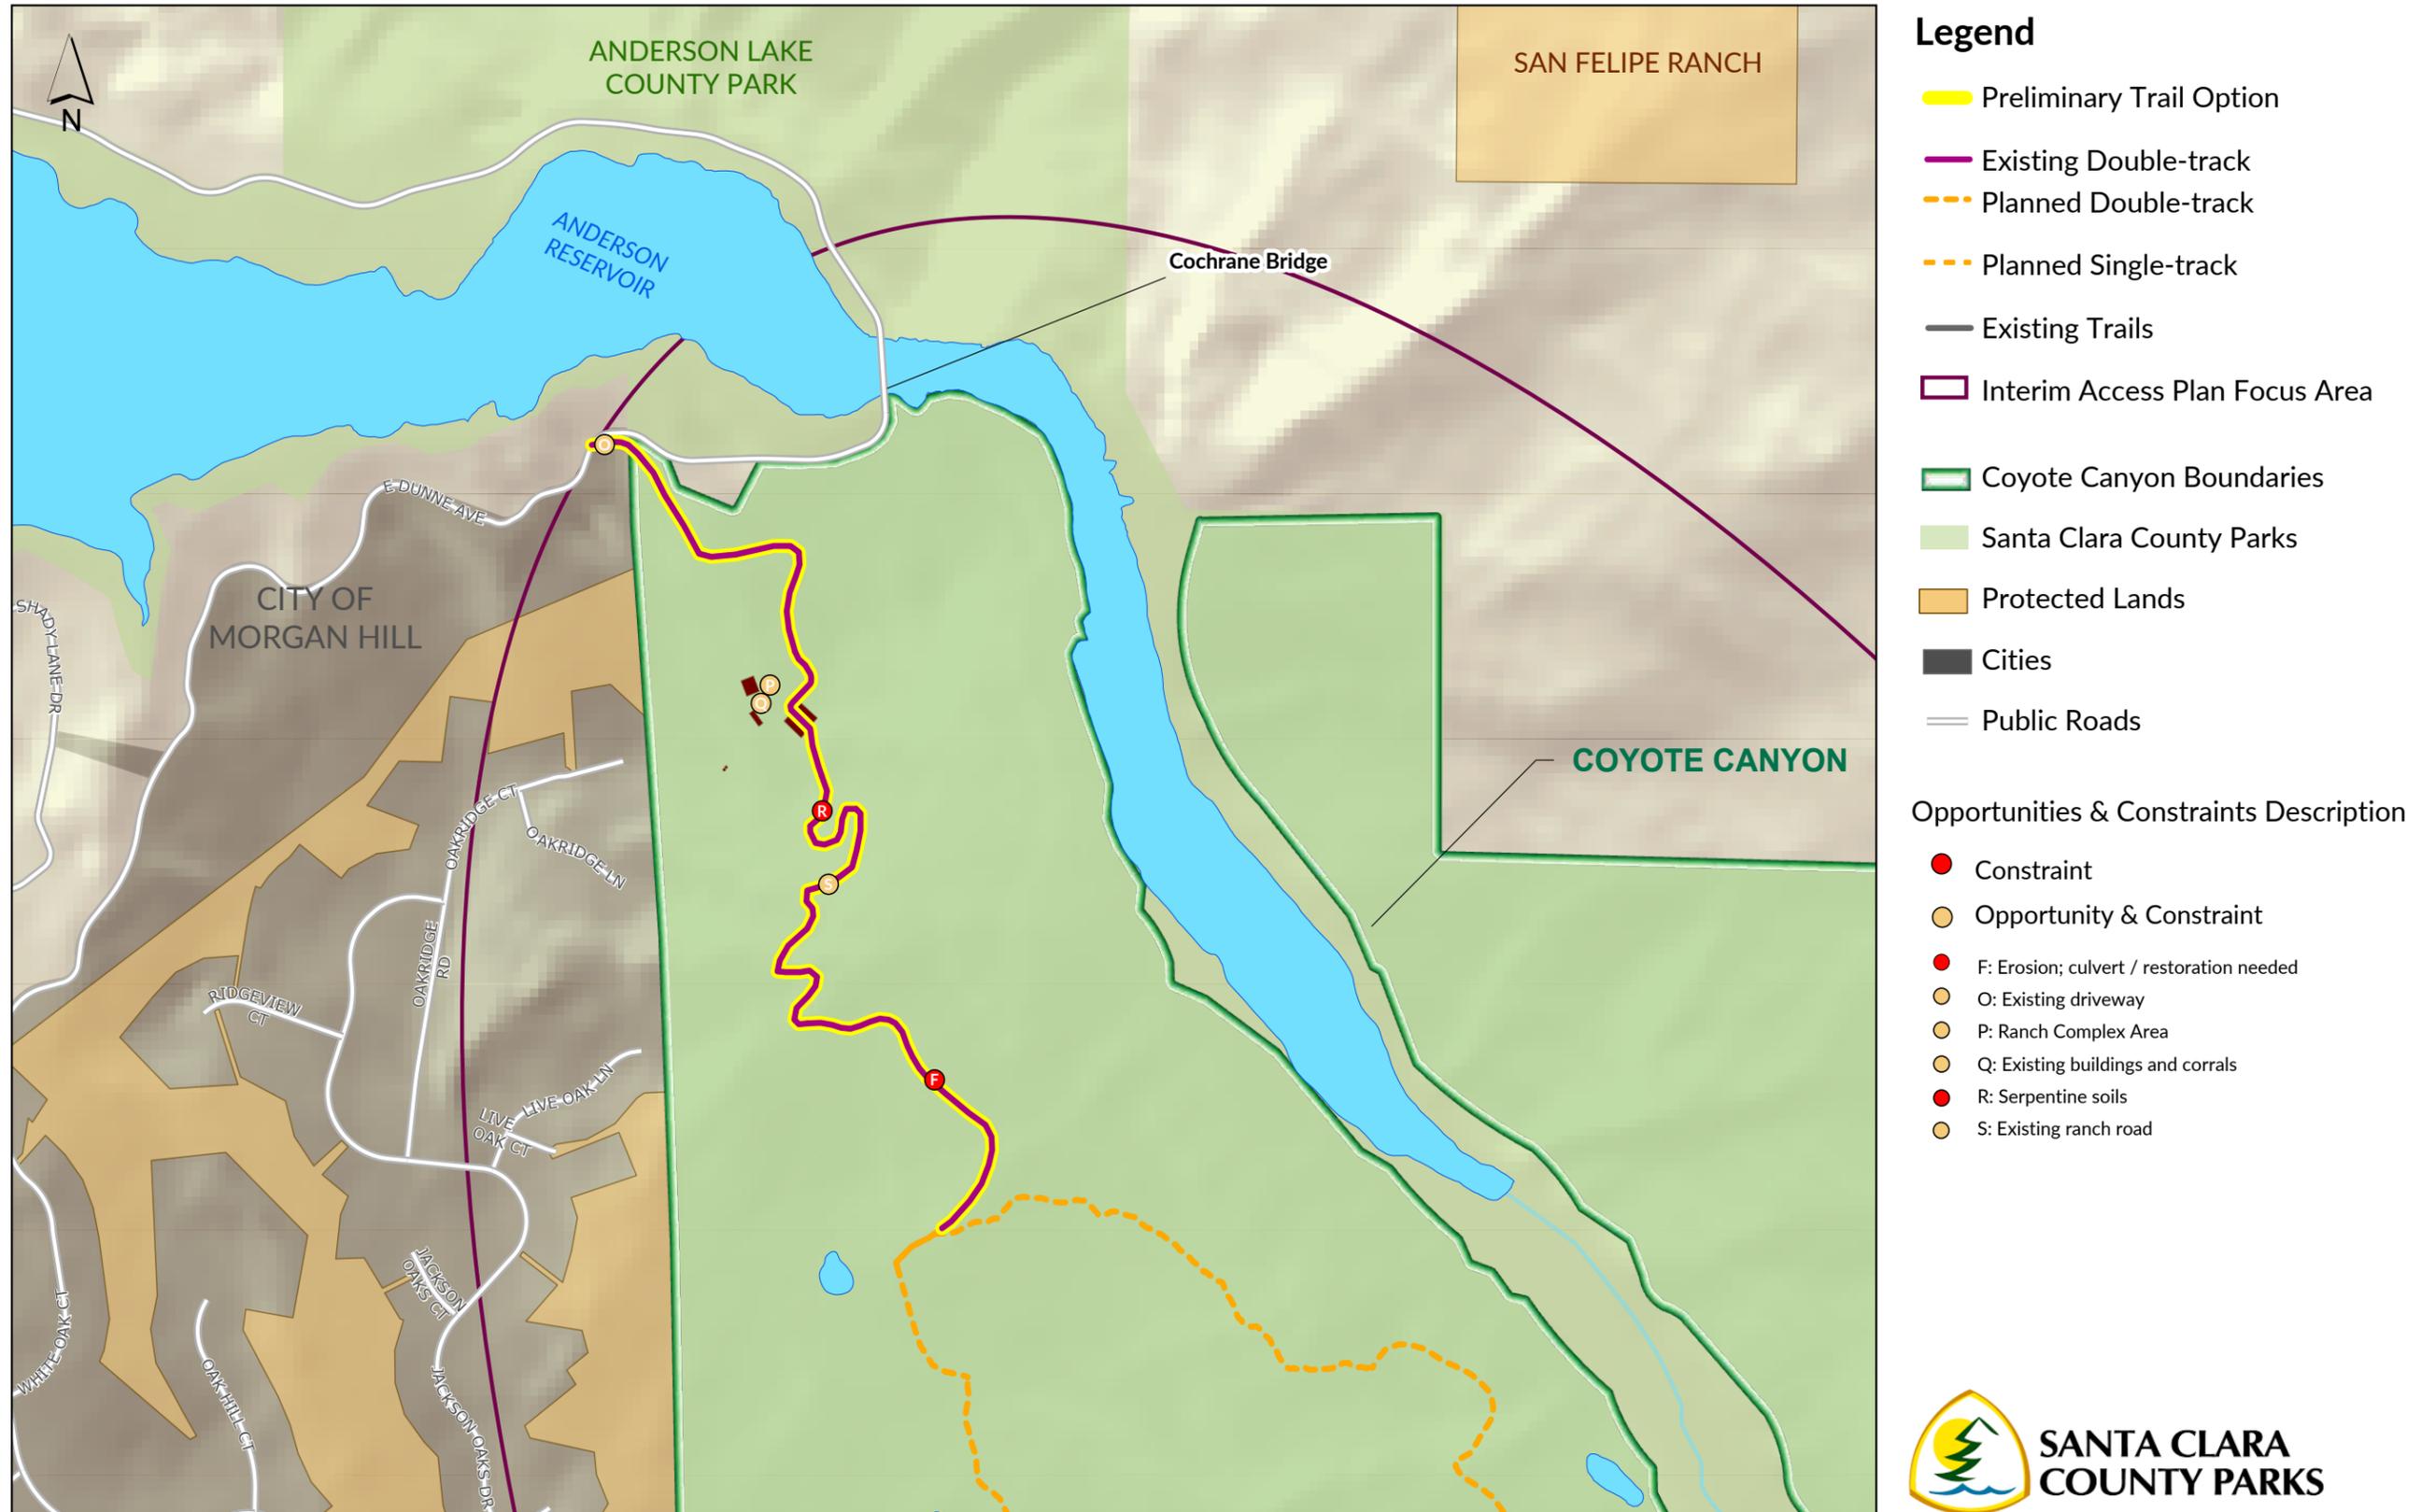
Figure 17: Trail Option Three Opportunities & Constraints

Q	Existing buildings and corrals	Potential interpretive or event opportunities; Potential equestrian staging area, with existing corrals used for turnout or warm-up; Storage for County vehicles and equipment; ADA restroom	Water system currently not suitable for public use; No fire suppression; Significant improvements to existing buildings may be required; May require more assessment of impacts to natural resources
R	Serpentine soils		May require surveys and potential assessments of impacts to natural resources
S	Existing ranch road	Provides connection from trailhead to Option Two trail alignment; Use of existing road for trail eliminates need for new construction	Road surface and drainage improvements needed to accommodate public trail use; Unstable slopes

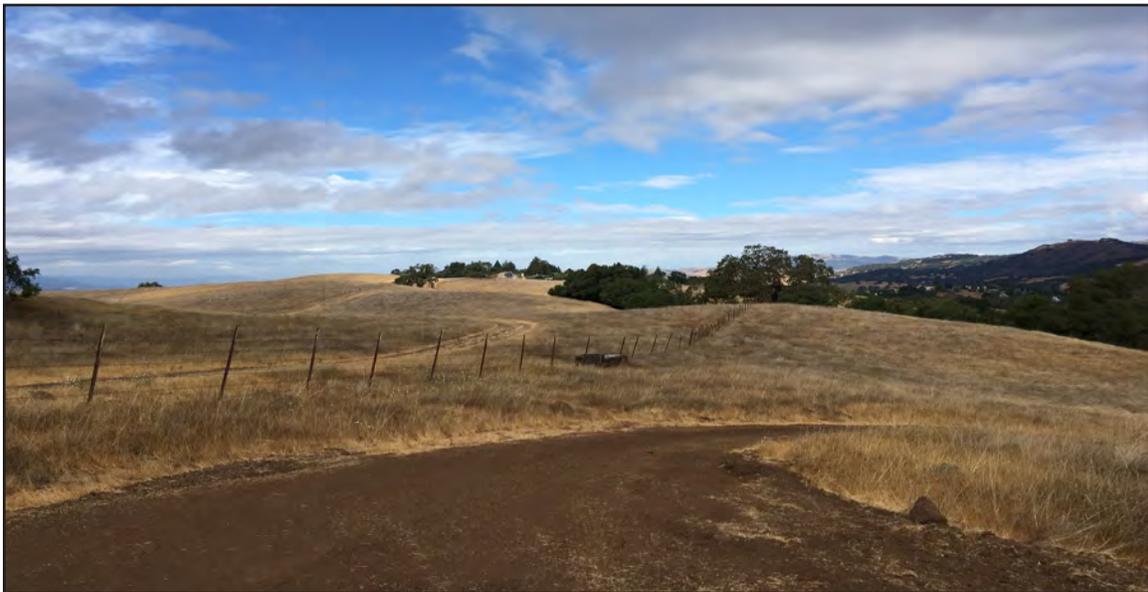
*Photo 31. View of Existing Segment of the Recommended Trail Alignment facing northwest in the direction of the Jackson Oaks Residential Development.*

The results concluded that the alignments range from 1,000-feet to 1,595-feet away from the adjacent Jackson Oaks neighborhood (approximately three football fields). The neighborhood itself is visible from an existing ranch road 0.39 miles away (approximately six football fields) (Photo 31). Building new segments and converting existing ranch roads will not change the overall aesthetic character of the Property. To provide additional security along the perimeter of the Property, areas are fenced with 5-strand barbed wire fencing and gates.
