# COYOTE CANYON

## NATURAL RESOURCES MANAGEMENT PLAN & INTERIM ACCESS PLAN

REVISED DRAFT  
AUGUST 2019

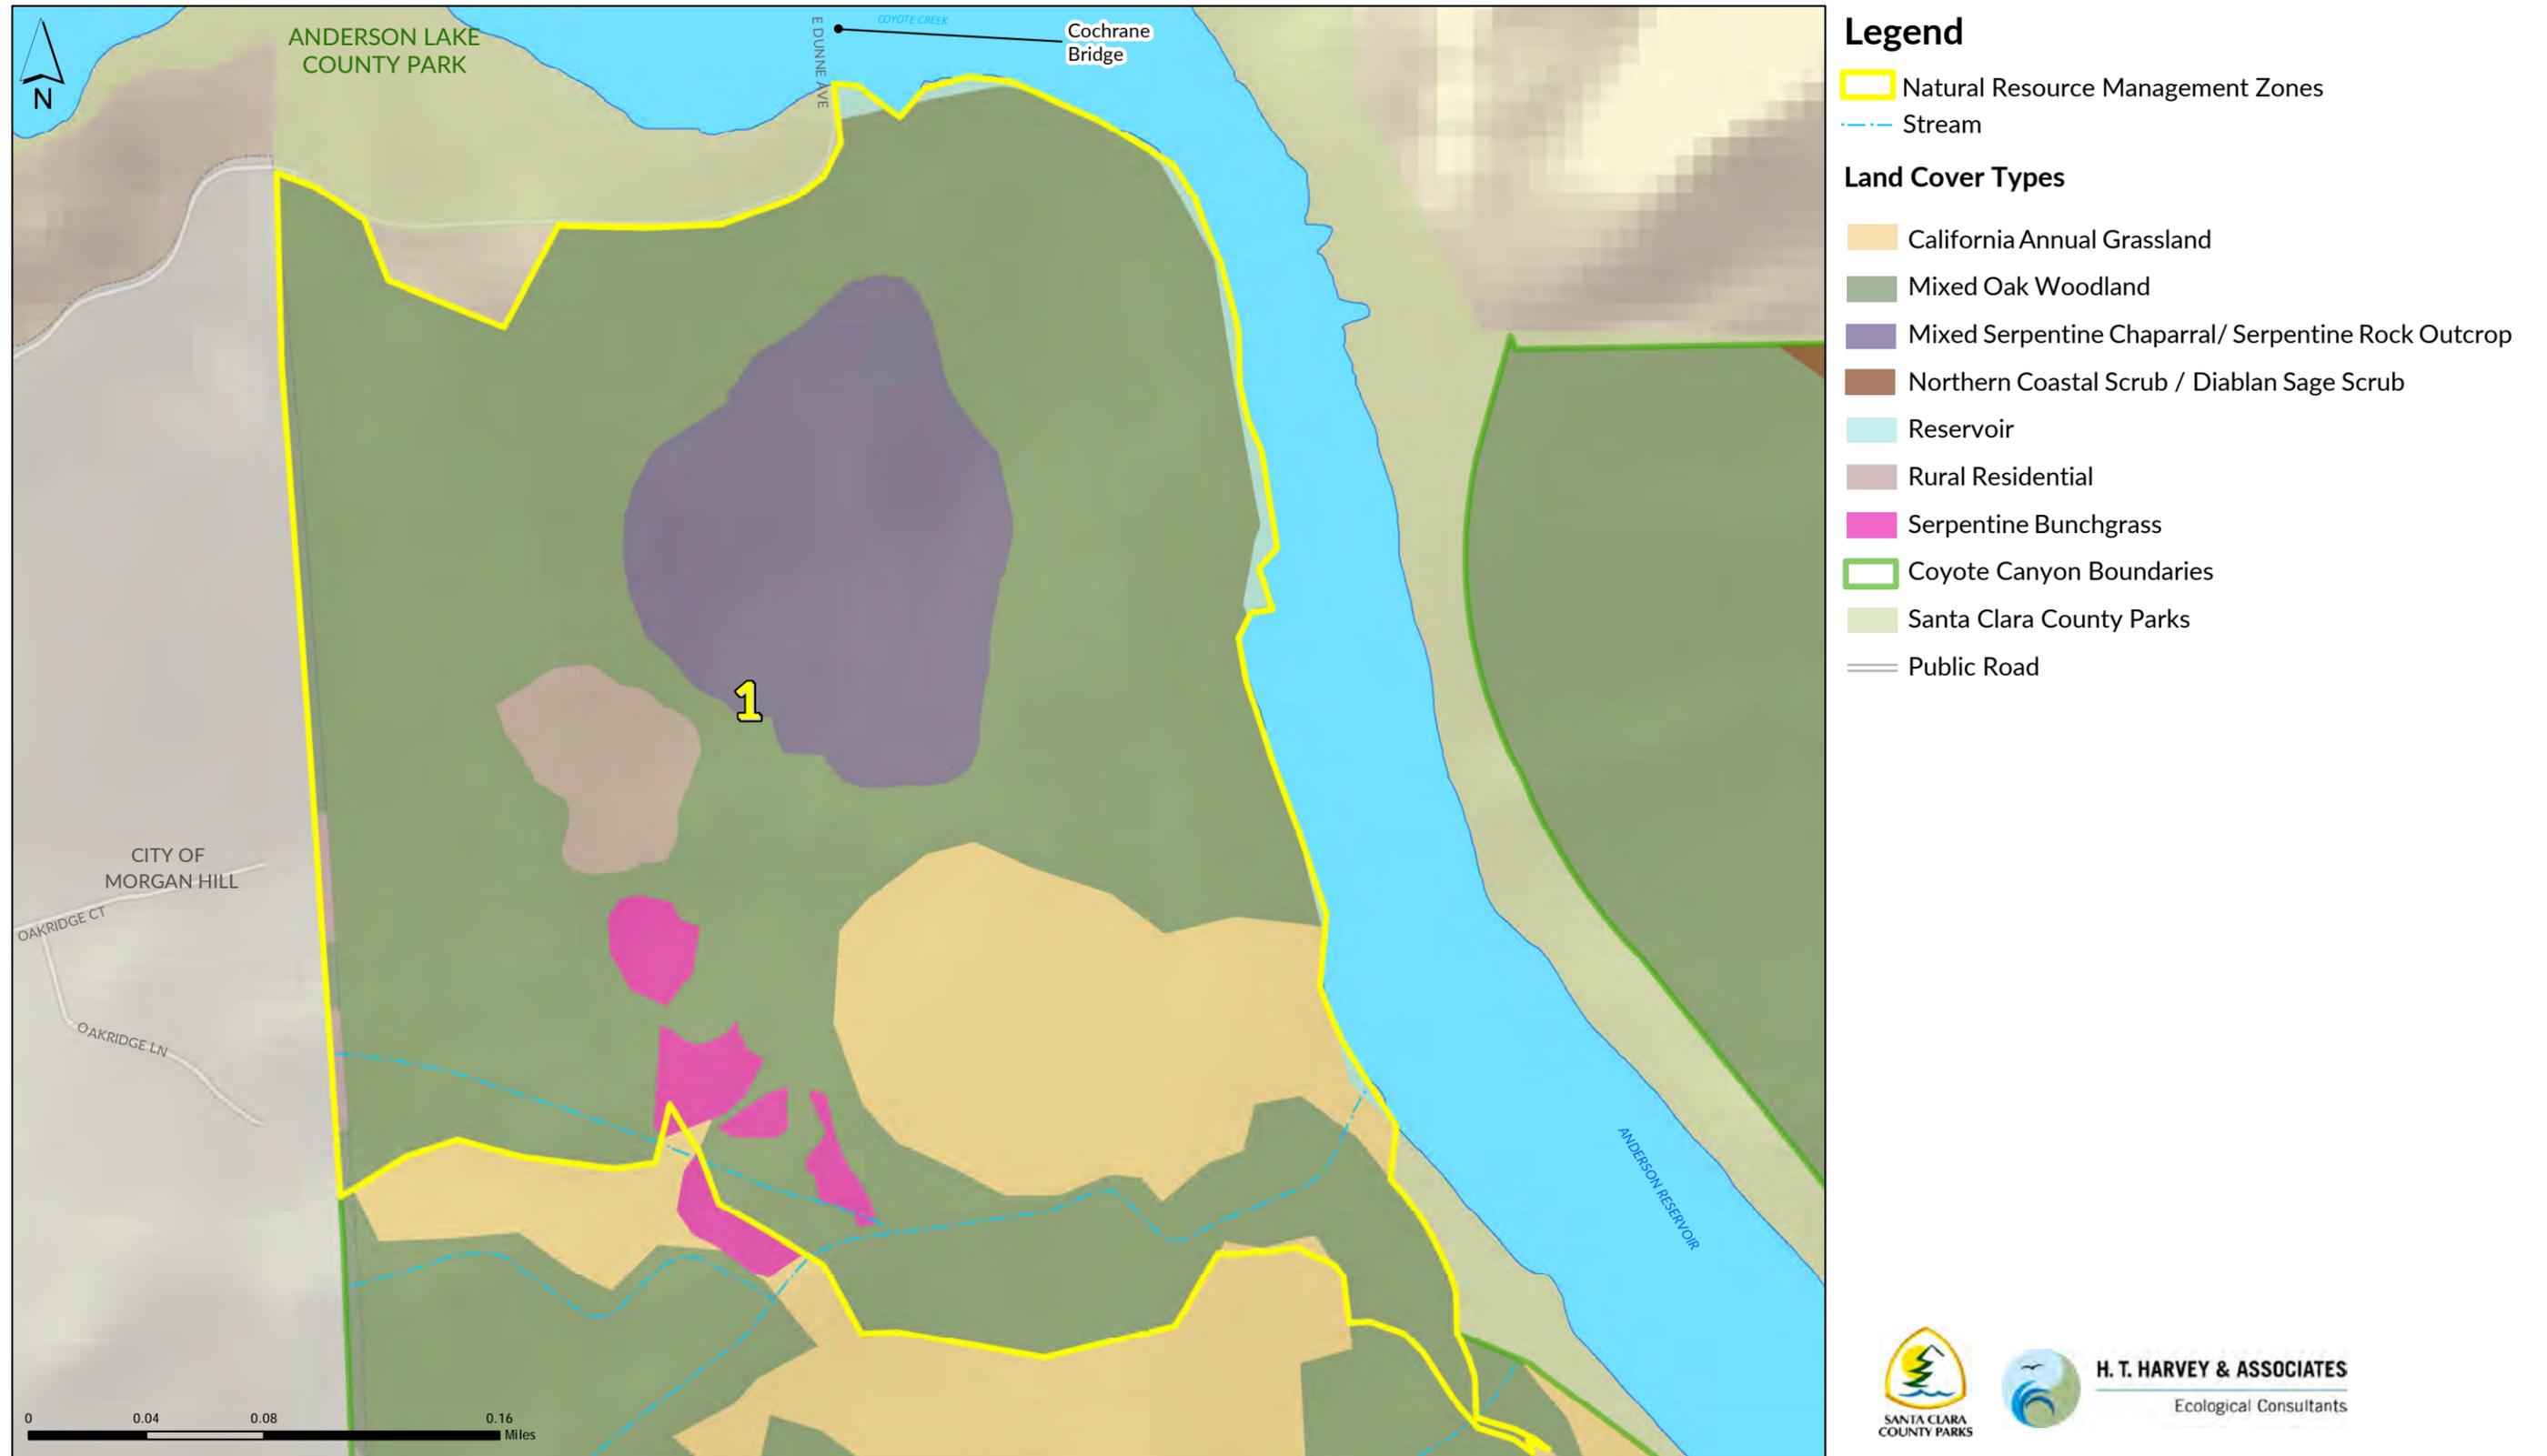
Figure 23. Natural Resource Management Zone 1

Zone 1 (Figure 23) includes the existing Ranch Complex Area and potential trail alignment extending to East Dunne Avenue (which will not be constructed under the Plan) and is primarily dominated by mixed oak woodland habitat. A portion of Zone 1 is located within House Pasture and is grazed by cattle. Because no public access is proposed within Zone 1 under the Plan and grazing in this zone is limited to a small area, potential protections for natural resources within this zone are limited.

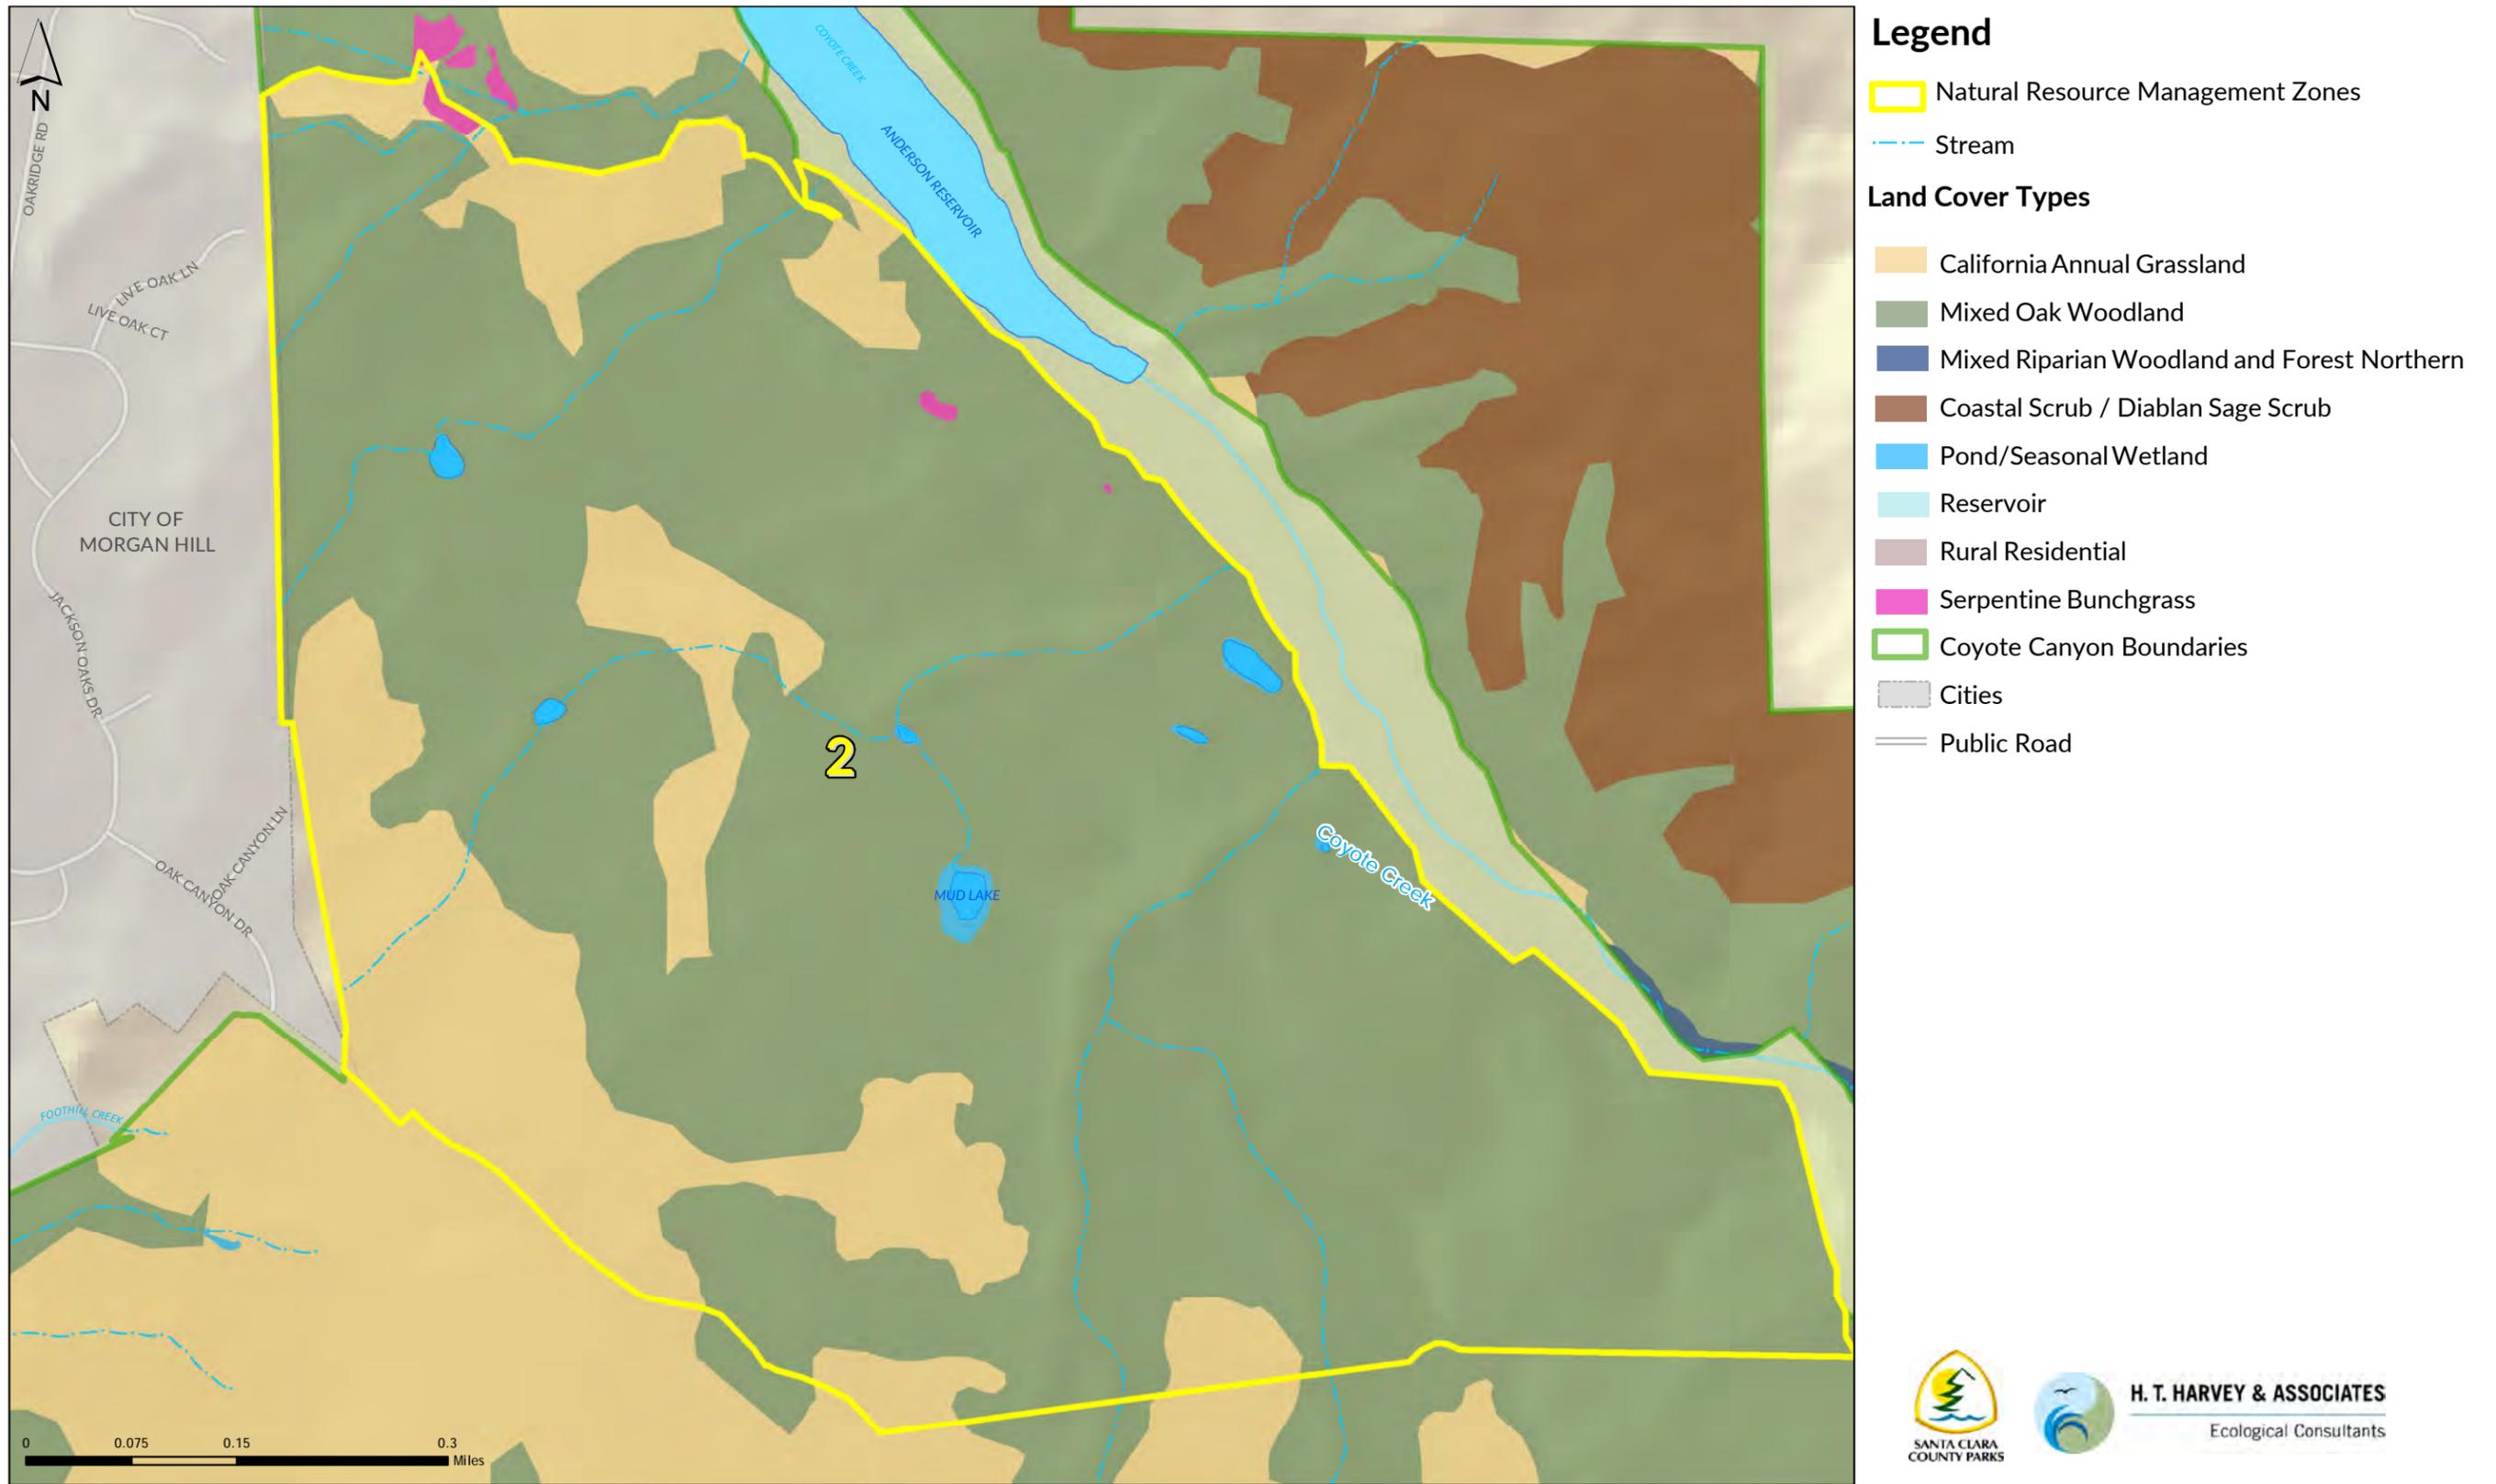
Figure 24. Natural Resource Management Zone 2

Zone 2 (Figure 24) encompasses the central portion of the Property southwest of Anderson Reservoir. This zone is dominated by mixed oak woodland habitat and includes a large section of the existing and proposed trails under the Plan. Because public access is proposed throughout much of Zone 2 and grazing also occurs throughout this zone, the protection of natural resources near trails and in cattle use areas is a priority.

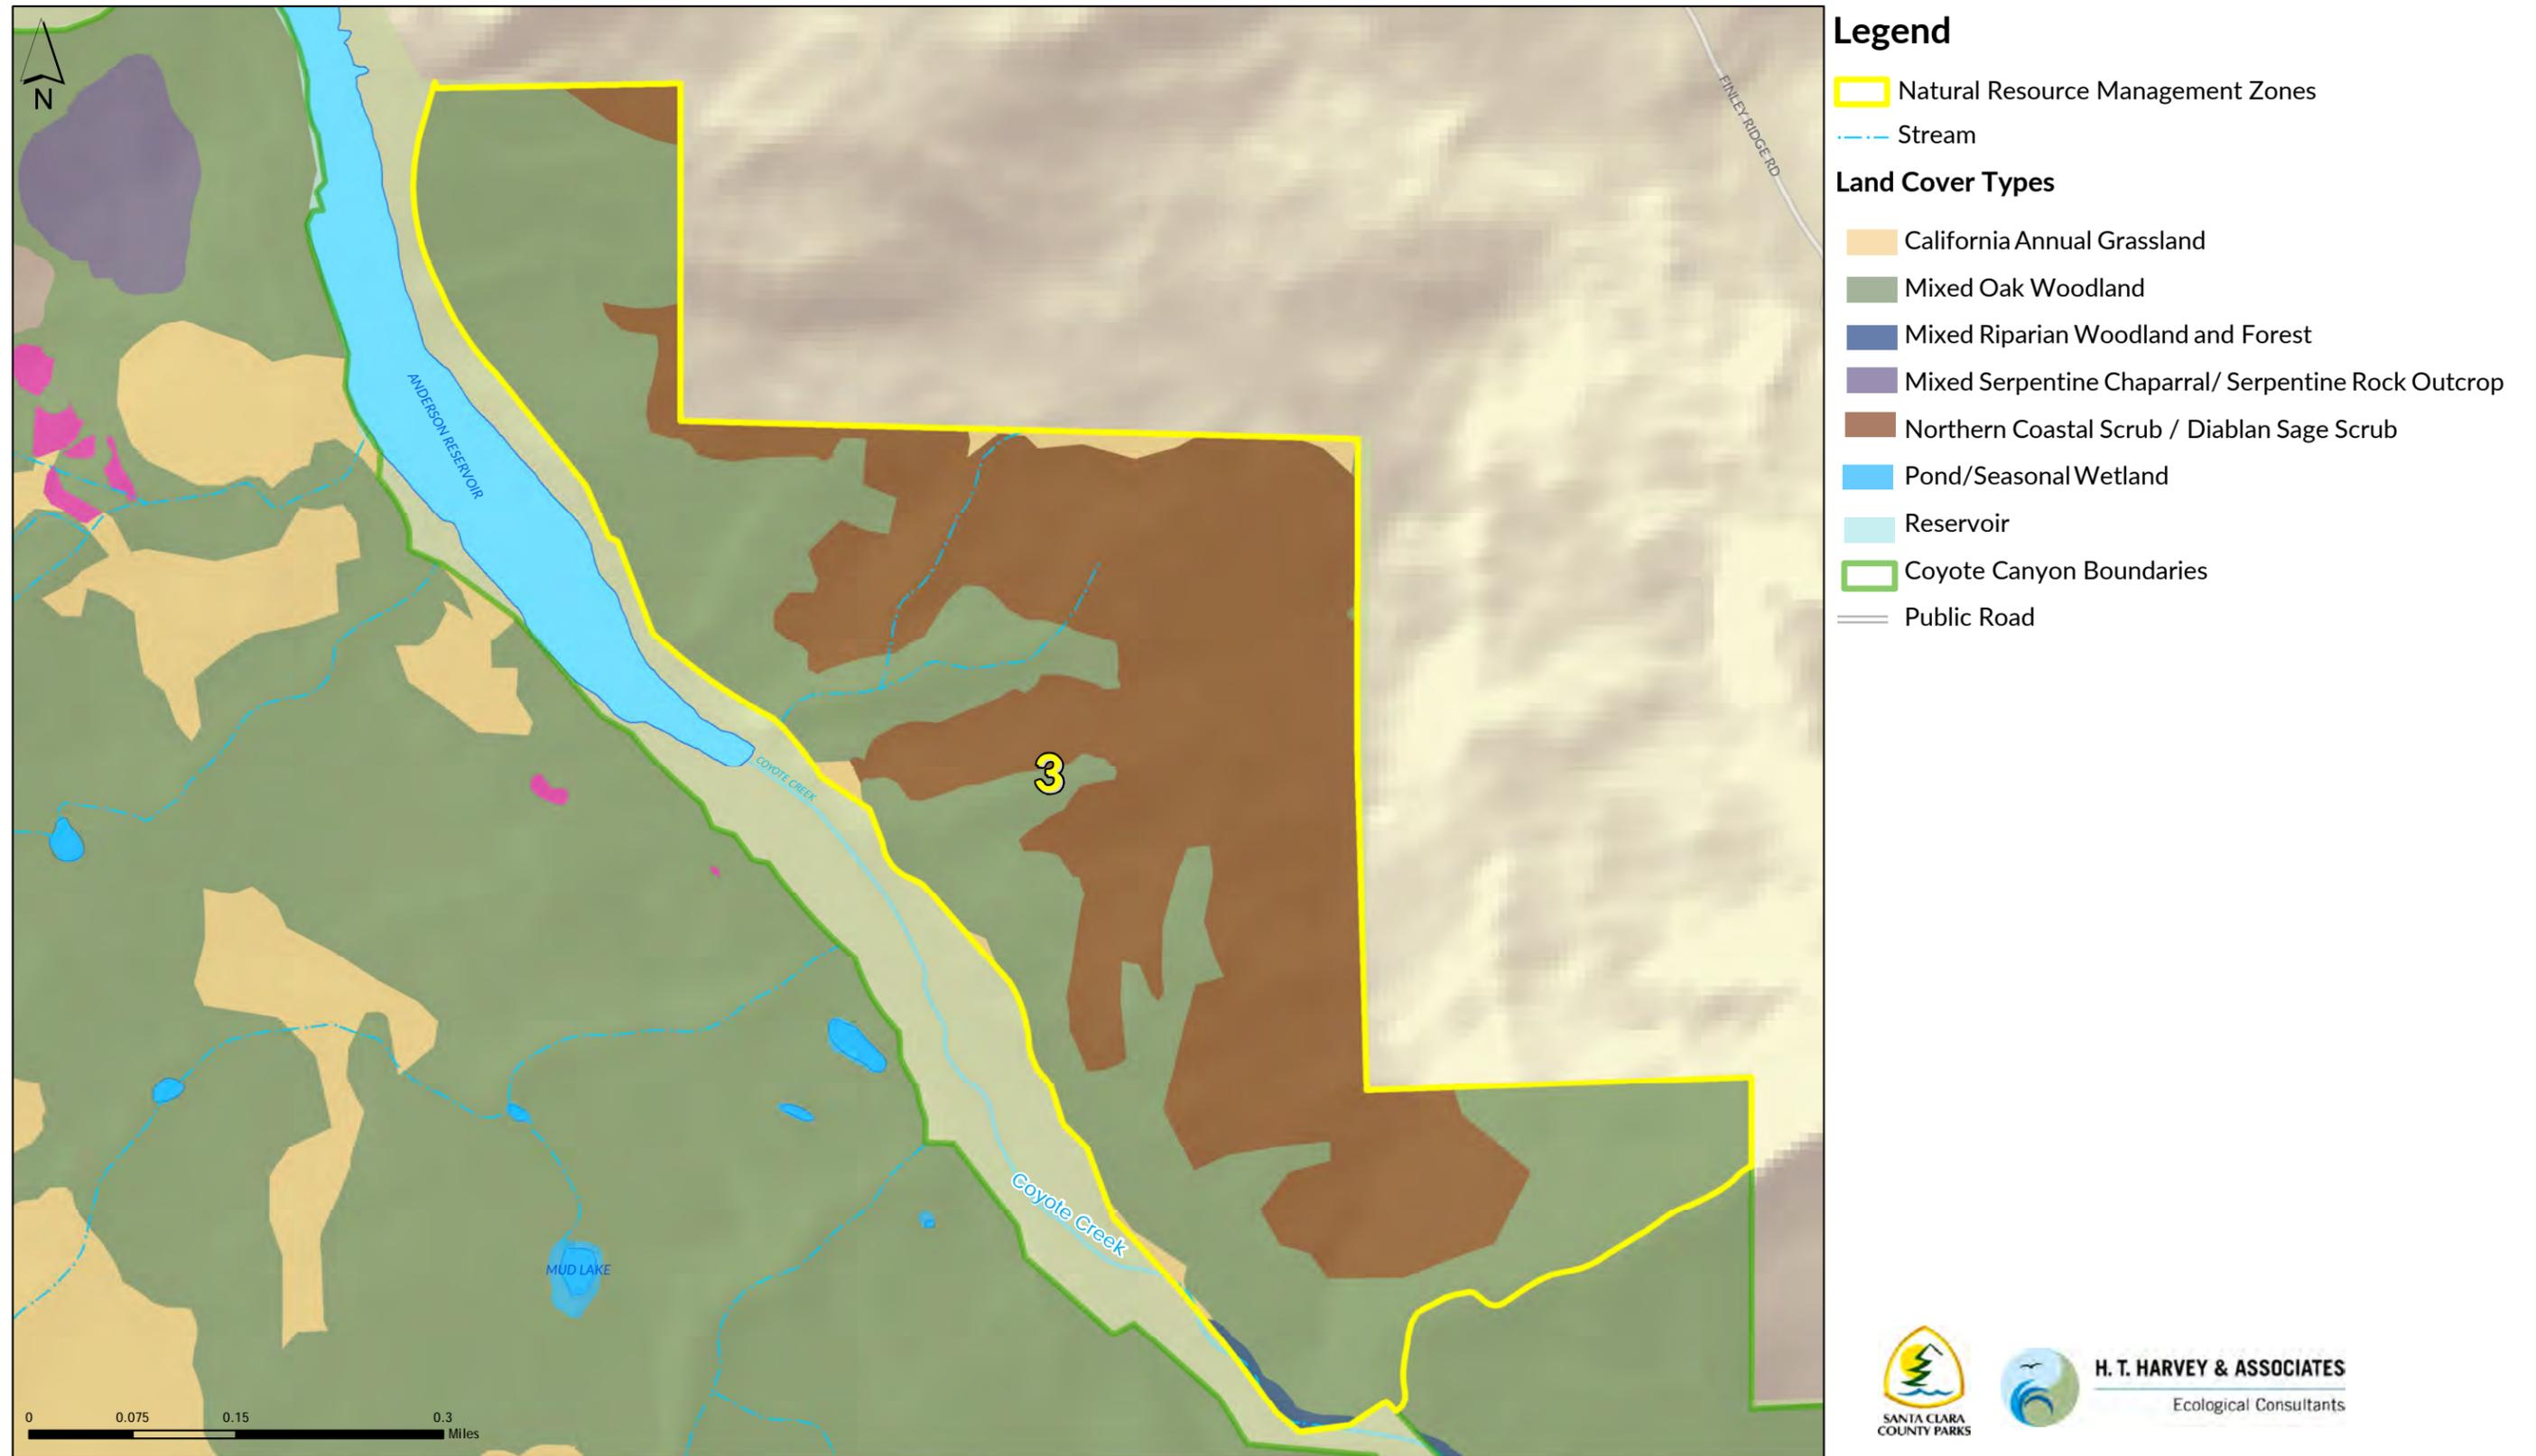
Figure 25. Natural Resource Management Zone 3

Zone 3 (Figure 25) is located northeast of Anderson Reservoir in an area with extremely steep slopes that is difficult to access. This zone is primarily dominated by oak woodland habitat and northern coastal scrub/Diablan sage scrub. The only sensitive natural resources in Zone 3 are intermittent and ephemeral streams, but Zone 3 is also located immediately adjacent to Anderson Reservoir and Coyote Creek. No trail creation, cattle grazing, or public access is proposed within Zone 3 in the near-term.

Recommended management and monitoring objectives, tasks, and priorities for Zone 3, summarized in Table 11, include protection and management of aquatic and riparian habitat along Anderson Reservoir and Coyote Creek. In addition, once access is established, focused surveys are recommended to refine the assessment of natural resource conditions within Zone 3 and determine any appropriate additional management objectives and priorities.

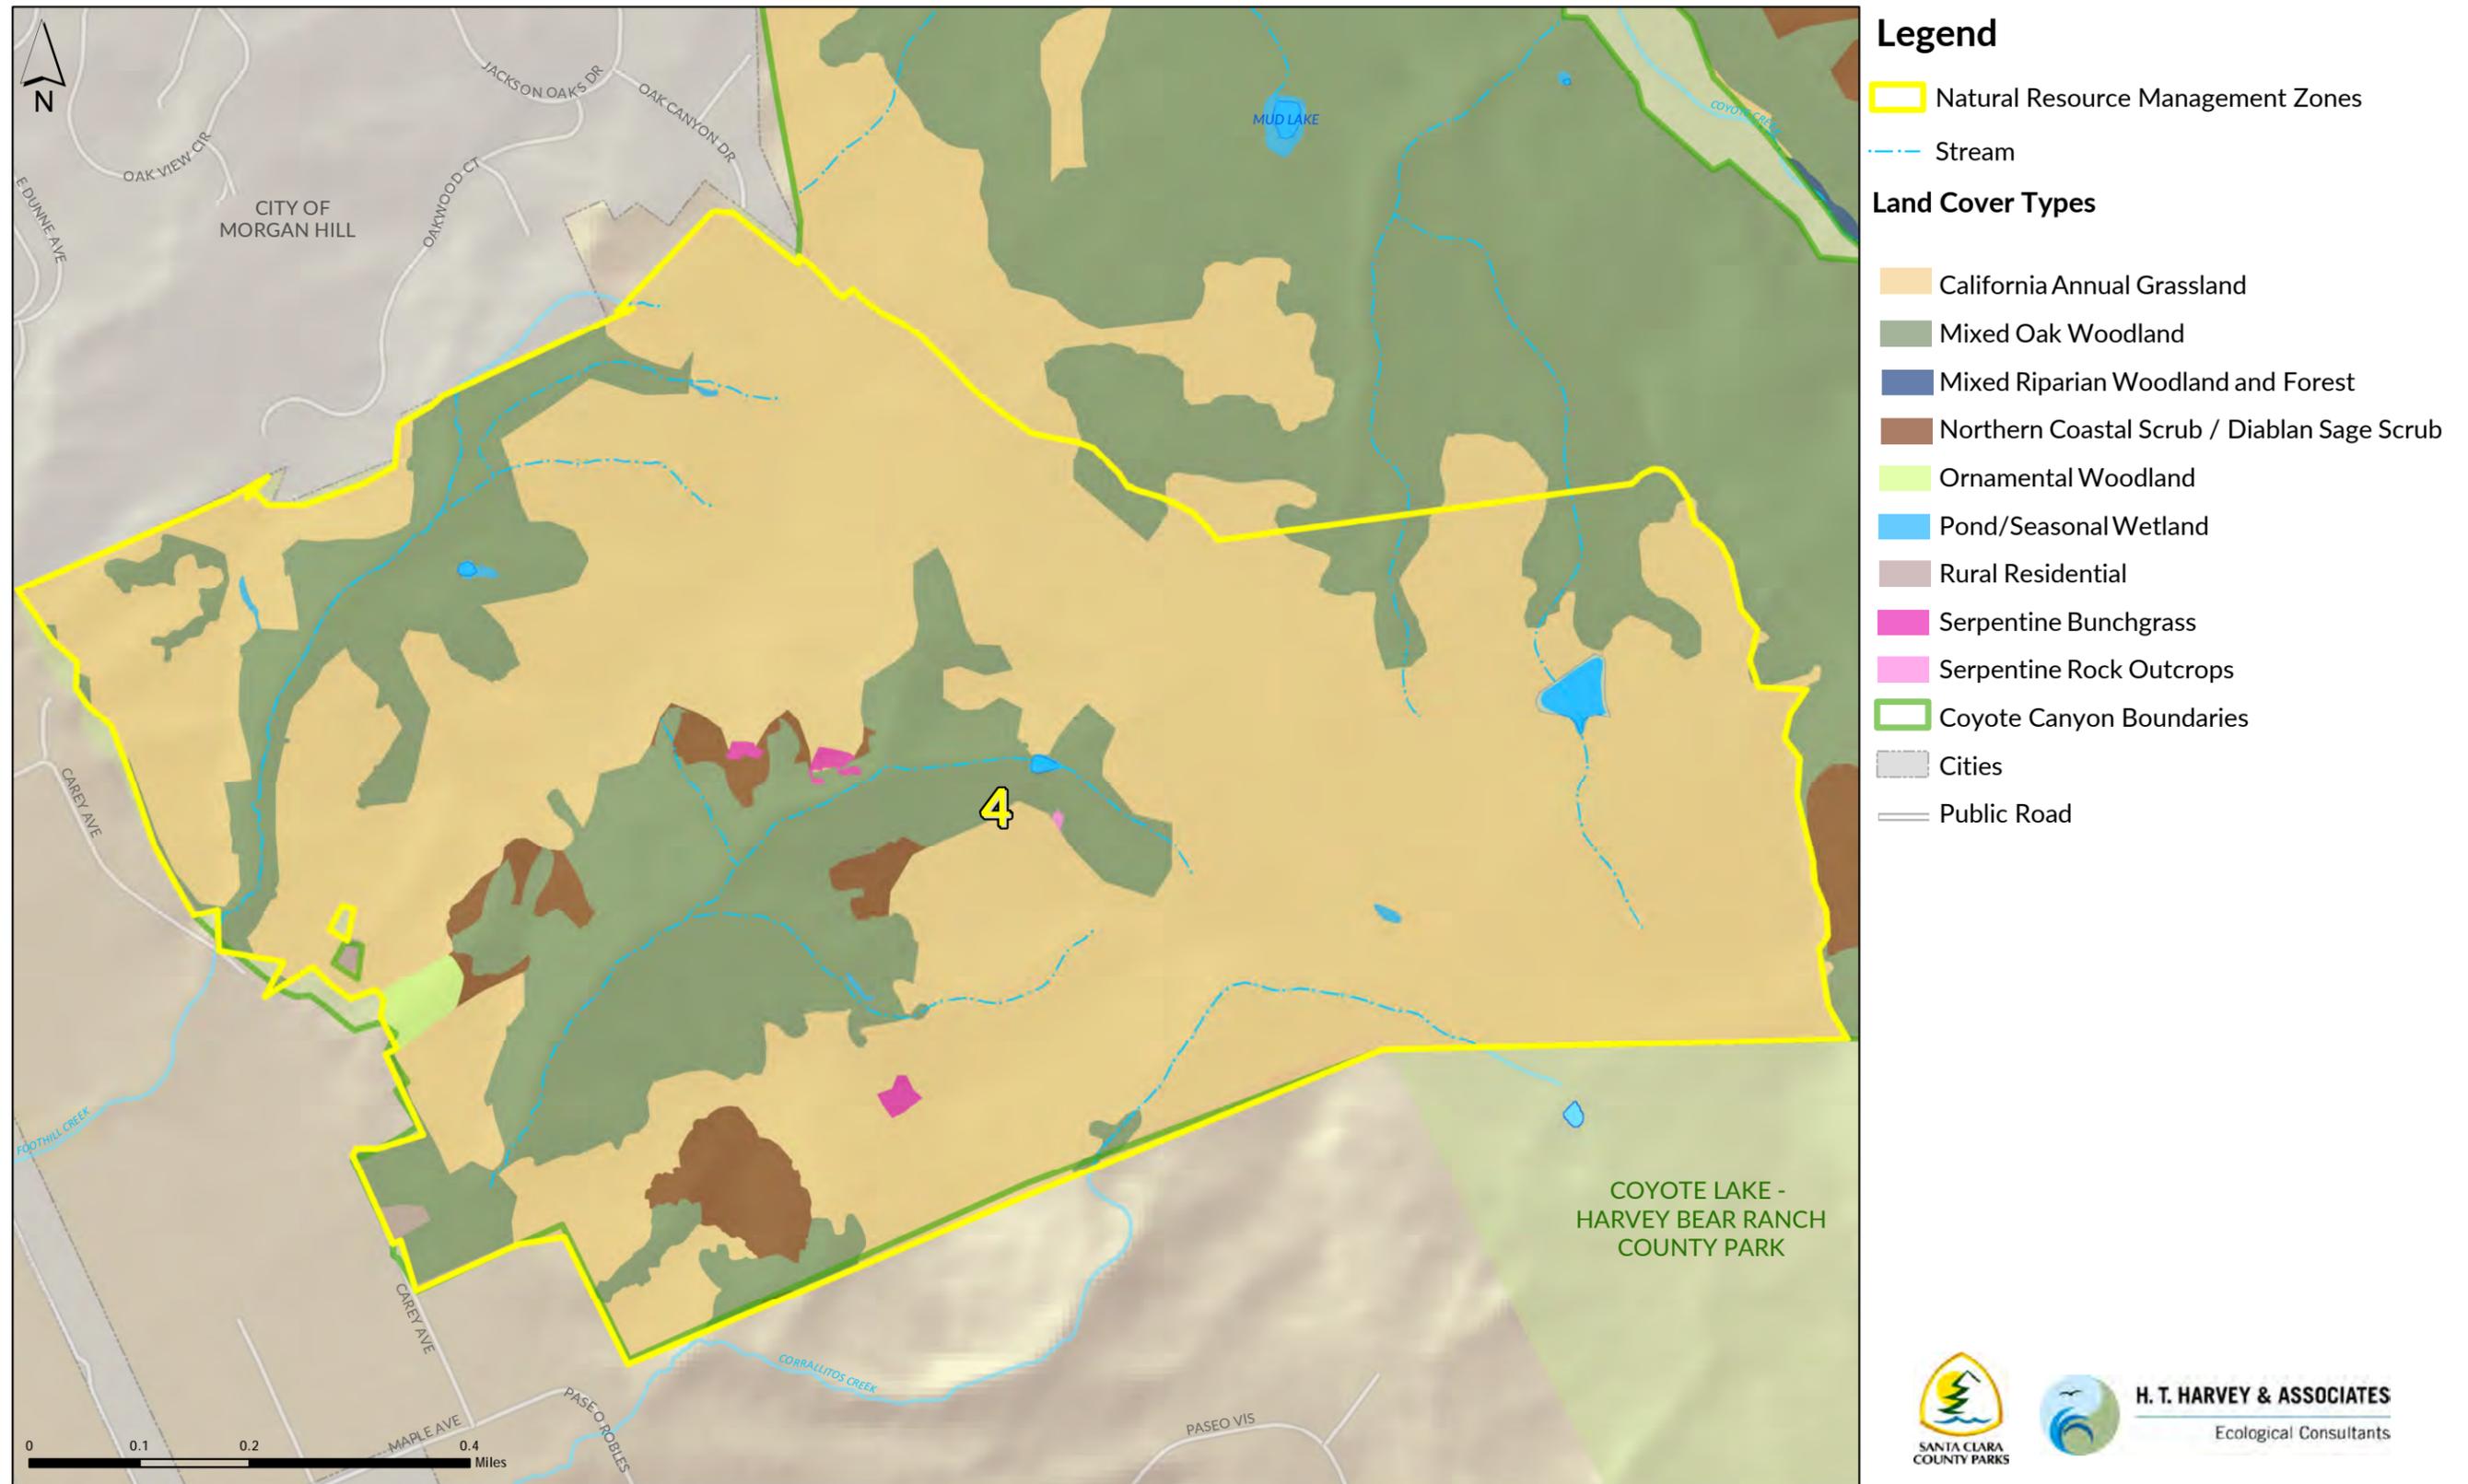
Figure 26. Natural Resource Management Zone 4

Zone 4 (Figure 26) includes the entire western slope of the Property and a portion of the area to the east, which is dominated by California annual grassland habitat. Proposed trails under the Plan will cross the western ridgeline in the eastern portion of this zone, but no trails are proposed west of the ridgeline. Several sensitive natural resources are present in this zone. Because public access is proposed in the eastern portion of Zone 4 and grazing occurs throughout this zone, the protection of natural resources near trails and in cattle use areas is a priority.

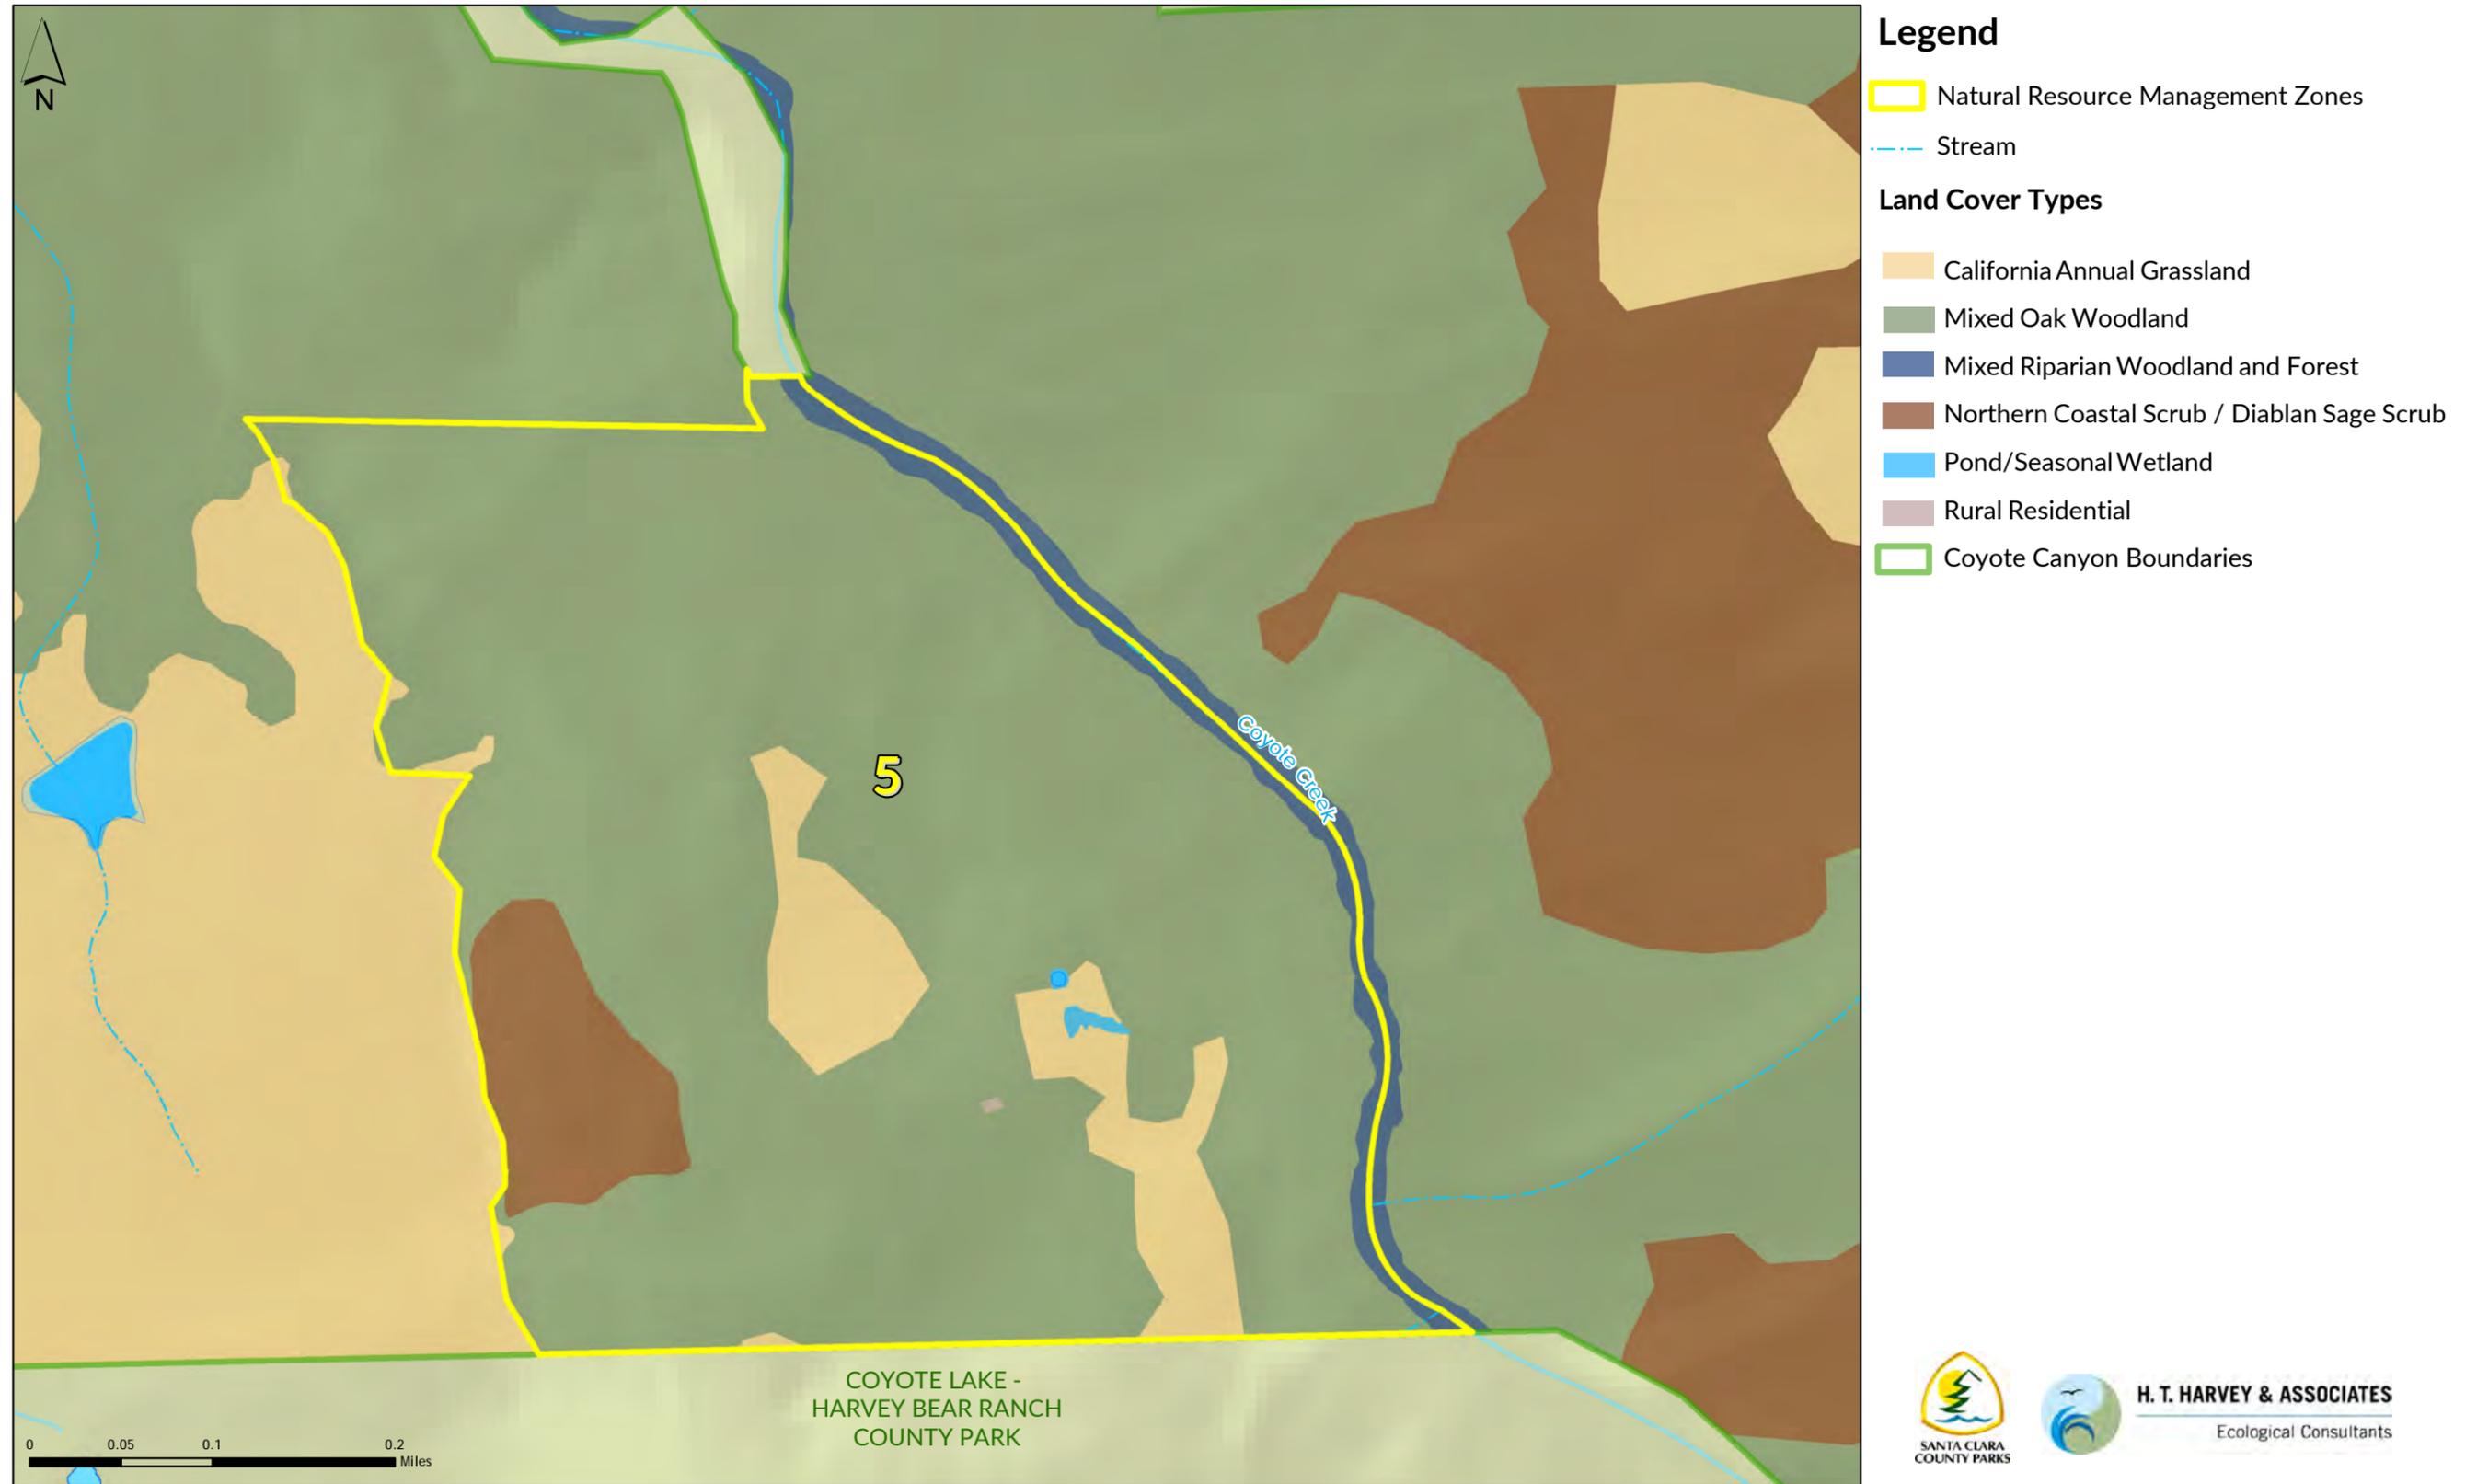
Figure 27. Natural Resource Management Zone 5

Zone 5 (Figure 27) is dominated by mixed oak woodland habitat and is located adjacent to Coyote Creek. New public trails are proposed within Zone 5 connecting with Zone 2 to the north and Coyote Lake-Harvey Bear Ranch County Park to the south. Because public access is proposed within Zone 5 and grazing occurs throughout this zone, the protection of natural resources near trails and in cattle use areas is a priority. However, no zone-specific grazing management or monitoring actions, apart from general site-wide grazing management and monitoring, are necessary in this zone.

Recommended management and monitoring objectives, tasks, and priorities for Zone 5, summarized in Table 13, include protection and management of sensitive aquatic and riparian habitats along Coyote Creek and protection of Cabin Pond and any sensitive wildlife species that use this pond.
