# COYOTE CANYON

## NATURAL RESOURCES MANAGEMENT PLAN & INTERIM ACCESS PLAN

REVISED DRAFT  
AUGUST 2019

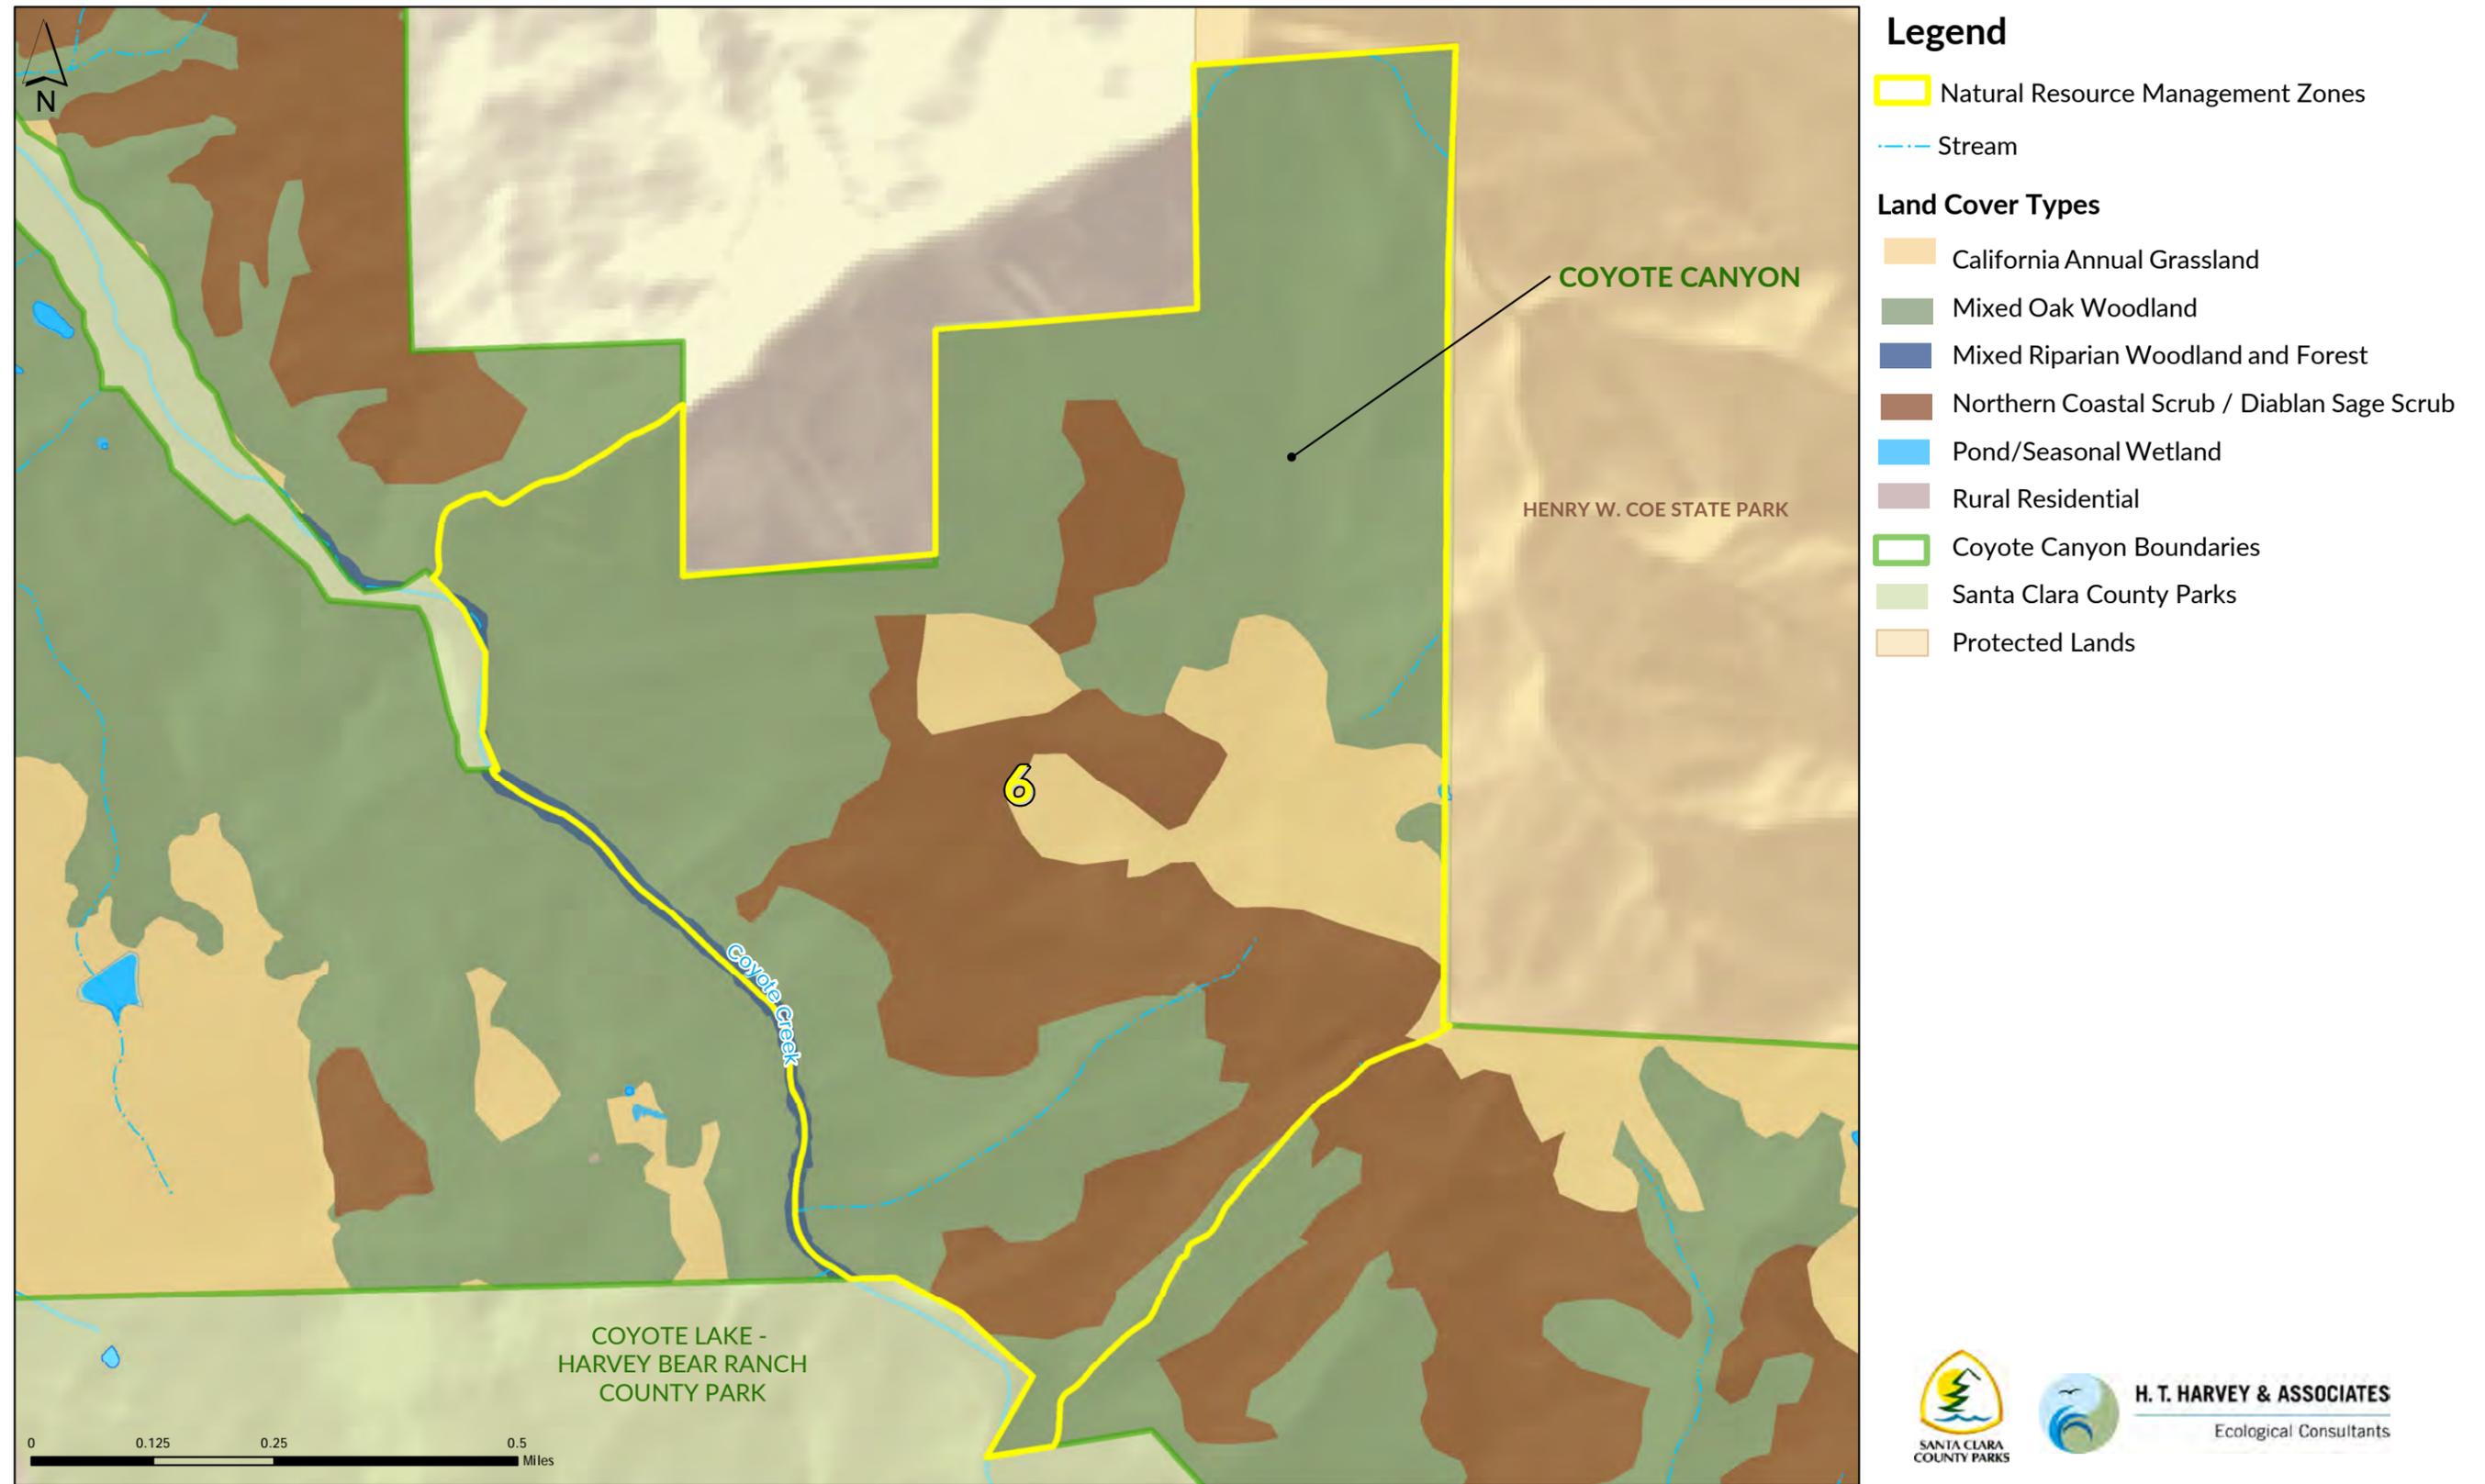
Figure 28. Natural Resource Management Zone 6

Zone 6 (Figure 28) is located northeast of Coyote Creek in an area with extremely steep slopes. This zone is dominated by mixed oak woodland habitat and is periodically grazed by cattle. Sensitive resources in Zone 6 are a pair of nesting golden eagles, intermittent and perennial streams, Coe Pond, and the sensitive habitats along Coyote Creek. No trail creation, cattle grazing, or public access is proposed within Zone 6 in the near-term.

Recommended management and monitoring objectives, tasks, and priorities for Zone 6, summarized in Table 14, include protection and management of aquatic and riparian habitat along Coyote Creek; protection of a pair of nesting golden eagles; and protection of Coe Pond and any sensitive wildlife species that may use this pond. Grazing management would include installation of new fencing and/or repair of existing fencing along the Property boundary to facilitate targeted grazing management. In addition, once access is established, focused surveys are recommended to refine the assessment of natural resource conditions within Zone 6 and determine any appropriate additional management objectives and priorities.

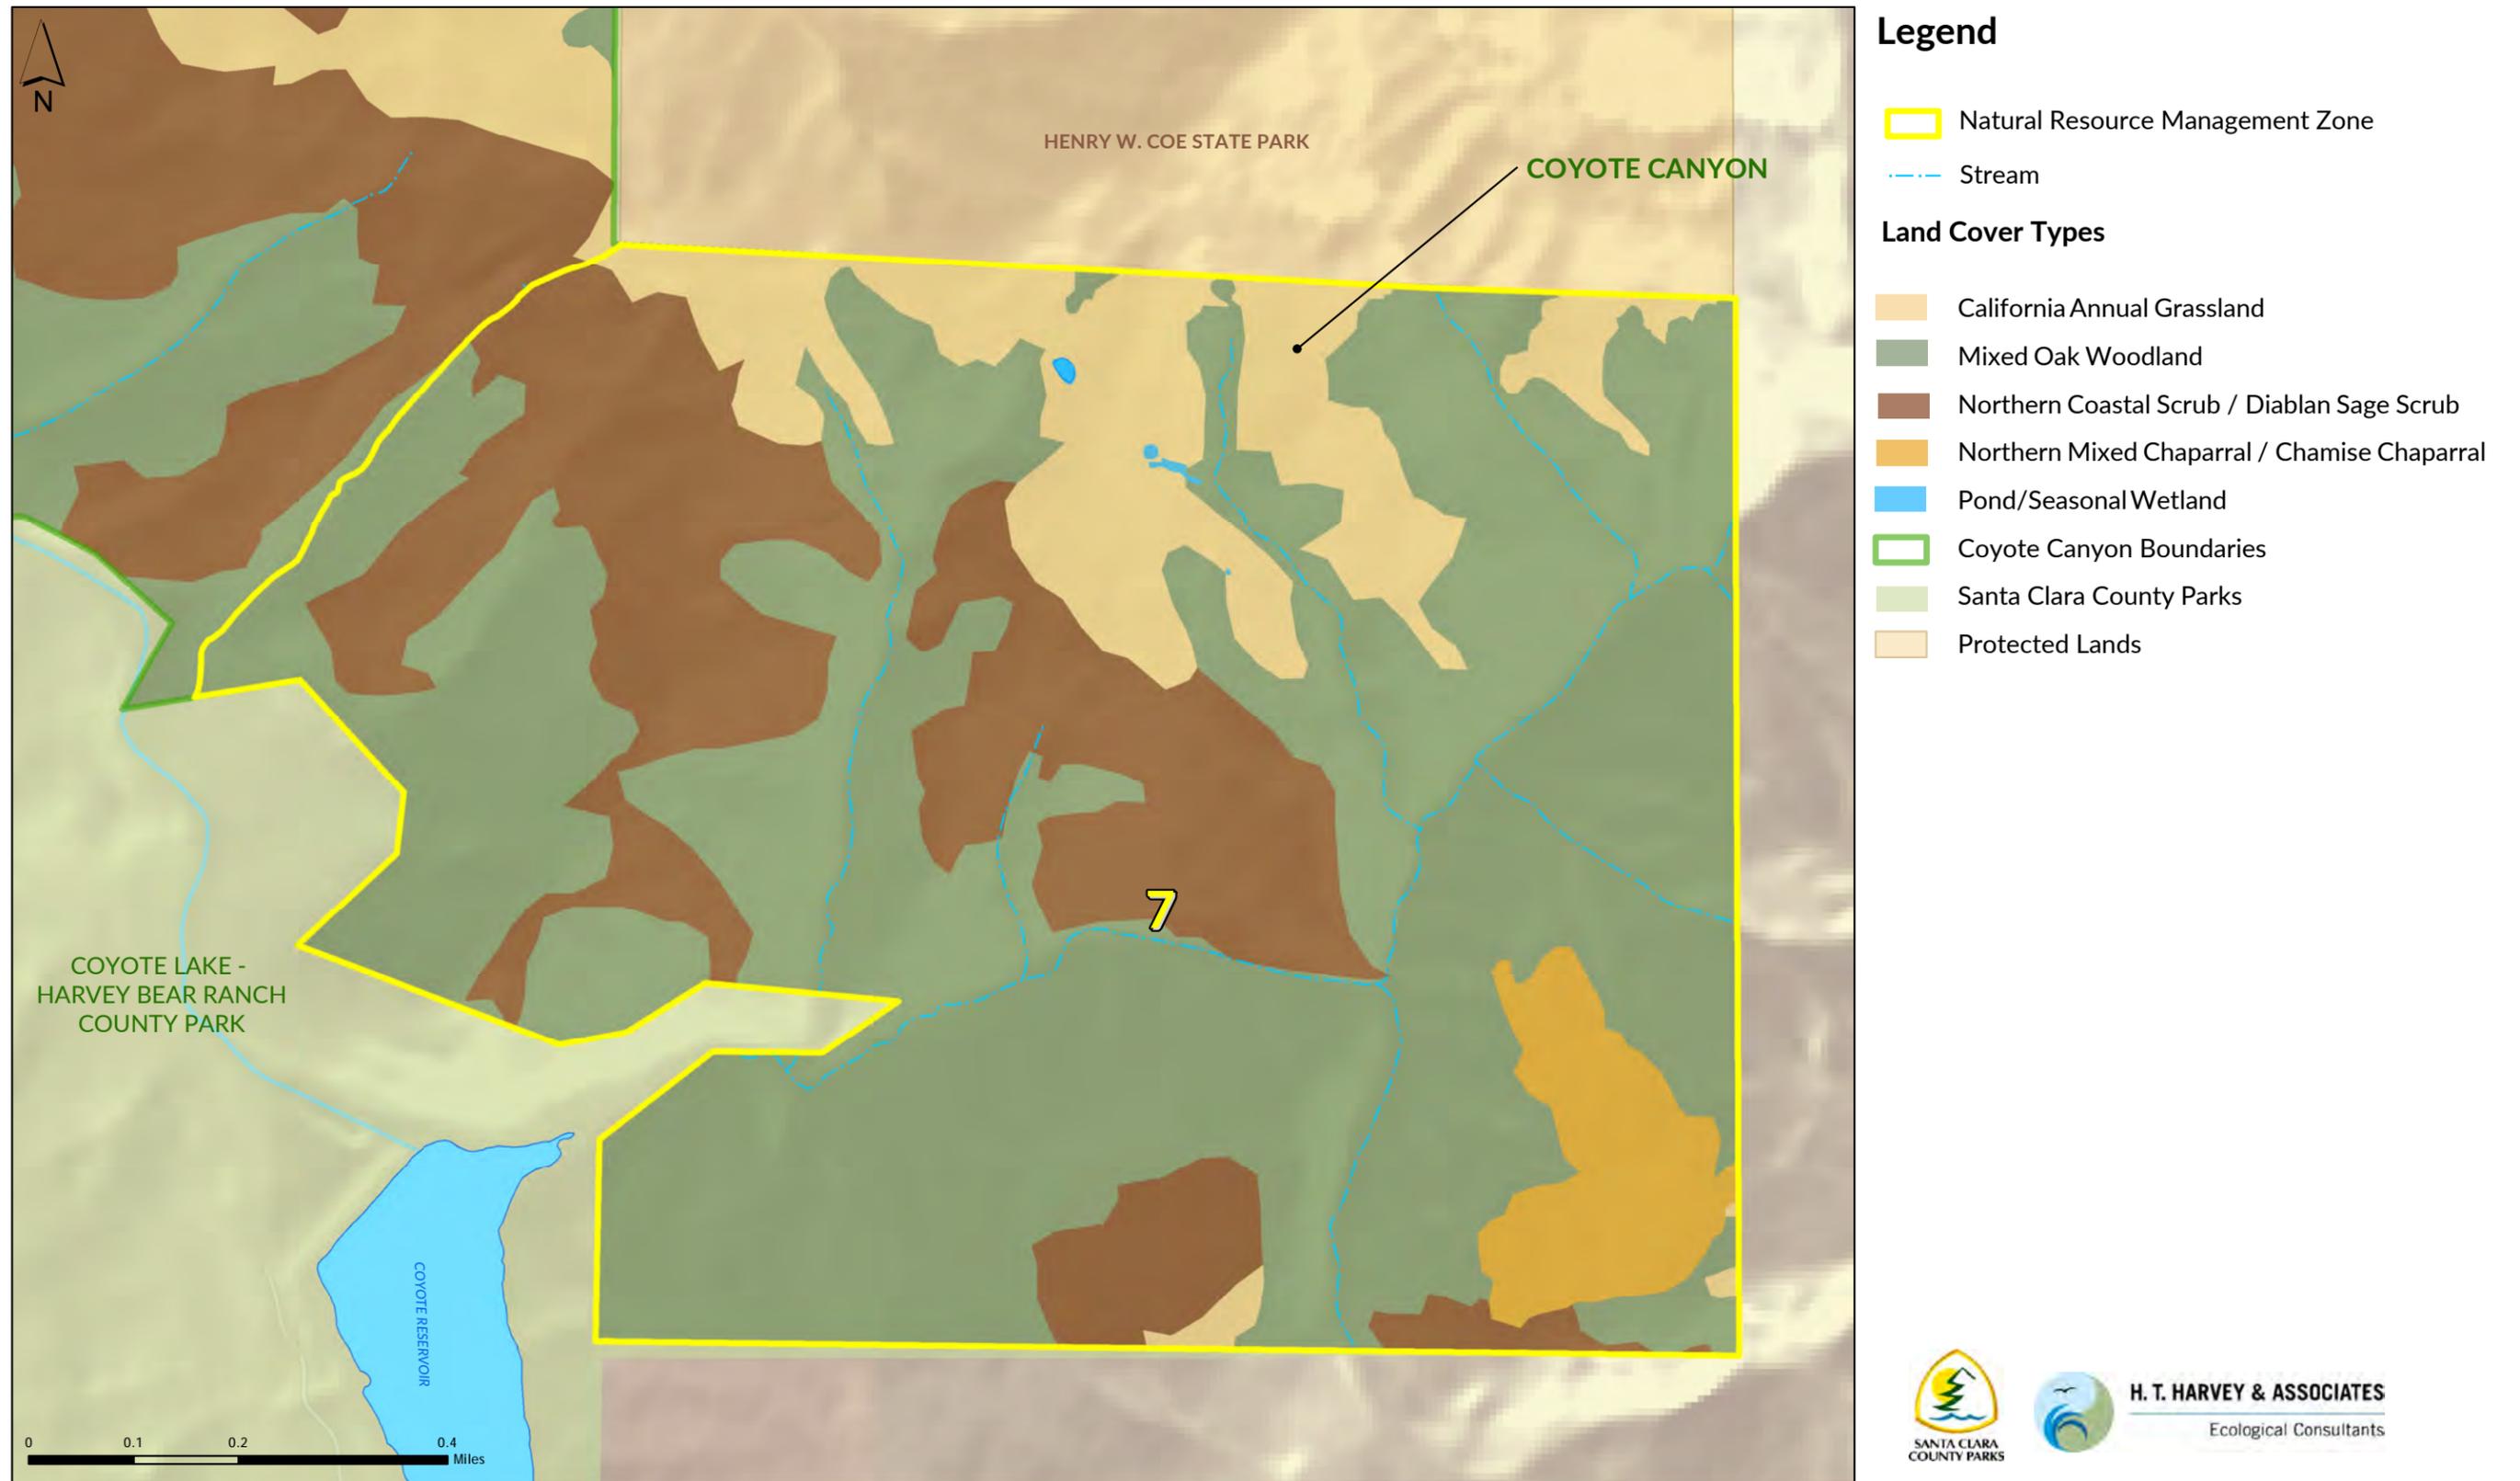
Figure 29. Natural Resource Management Zone 7

Zone 7 (Figure 29) is located in an area with extremely steep slopes that is difficult to access. This zone is dominated by mixed oak woodland habitat. Sensitive natural resources in Zone 7 are several ponds (at least one of which provides suitable breeding habitat for California red-legged frogs) and intermittent and ephemeral streams. No trail creation, cattle grazing, or public access is proposed within Zone 7 in the near-term.

Recommended management and monitoring objectives, tasks, and priorities for Zone 7, summarized in Table 15, include protection and management of several ponds and the sensitive wildlife species that use them, which historically included California red-legged frogs in Corral Pond. Grazing management would include installation of new fencing and/or repair of existing fencing along the Property boundary to facilitate targeted grazing management. In addition, once access is established, focused surveys are recommended to refine the assessment of natural resource conditions within Zone 7 and determine any appropriate additional management objectives and priorities.

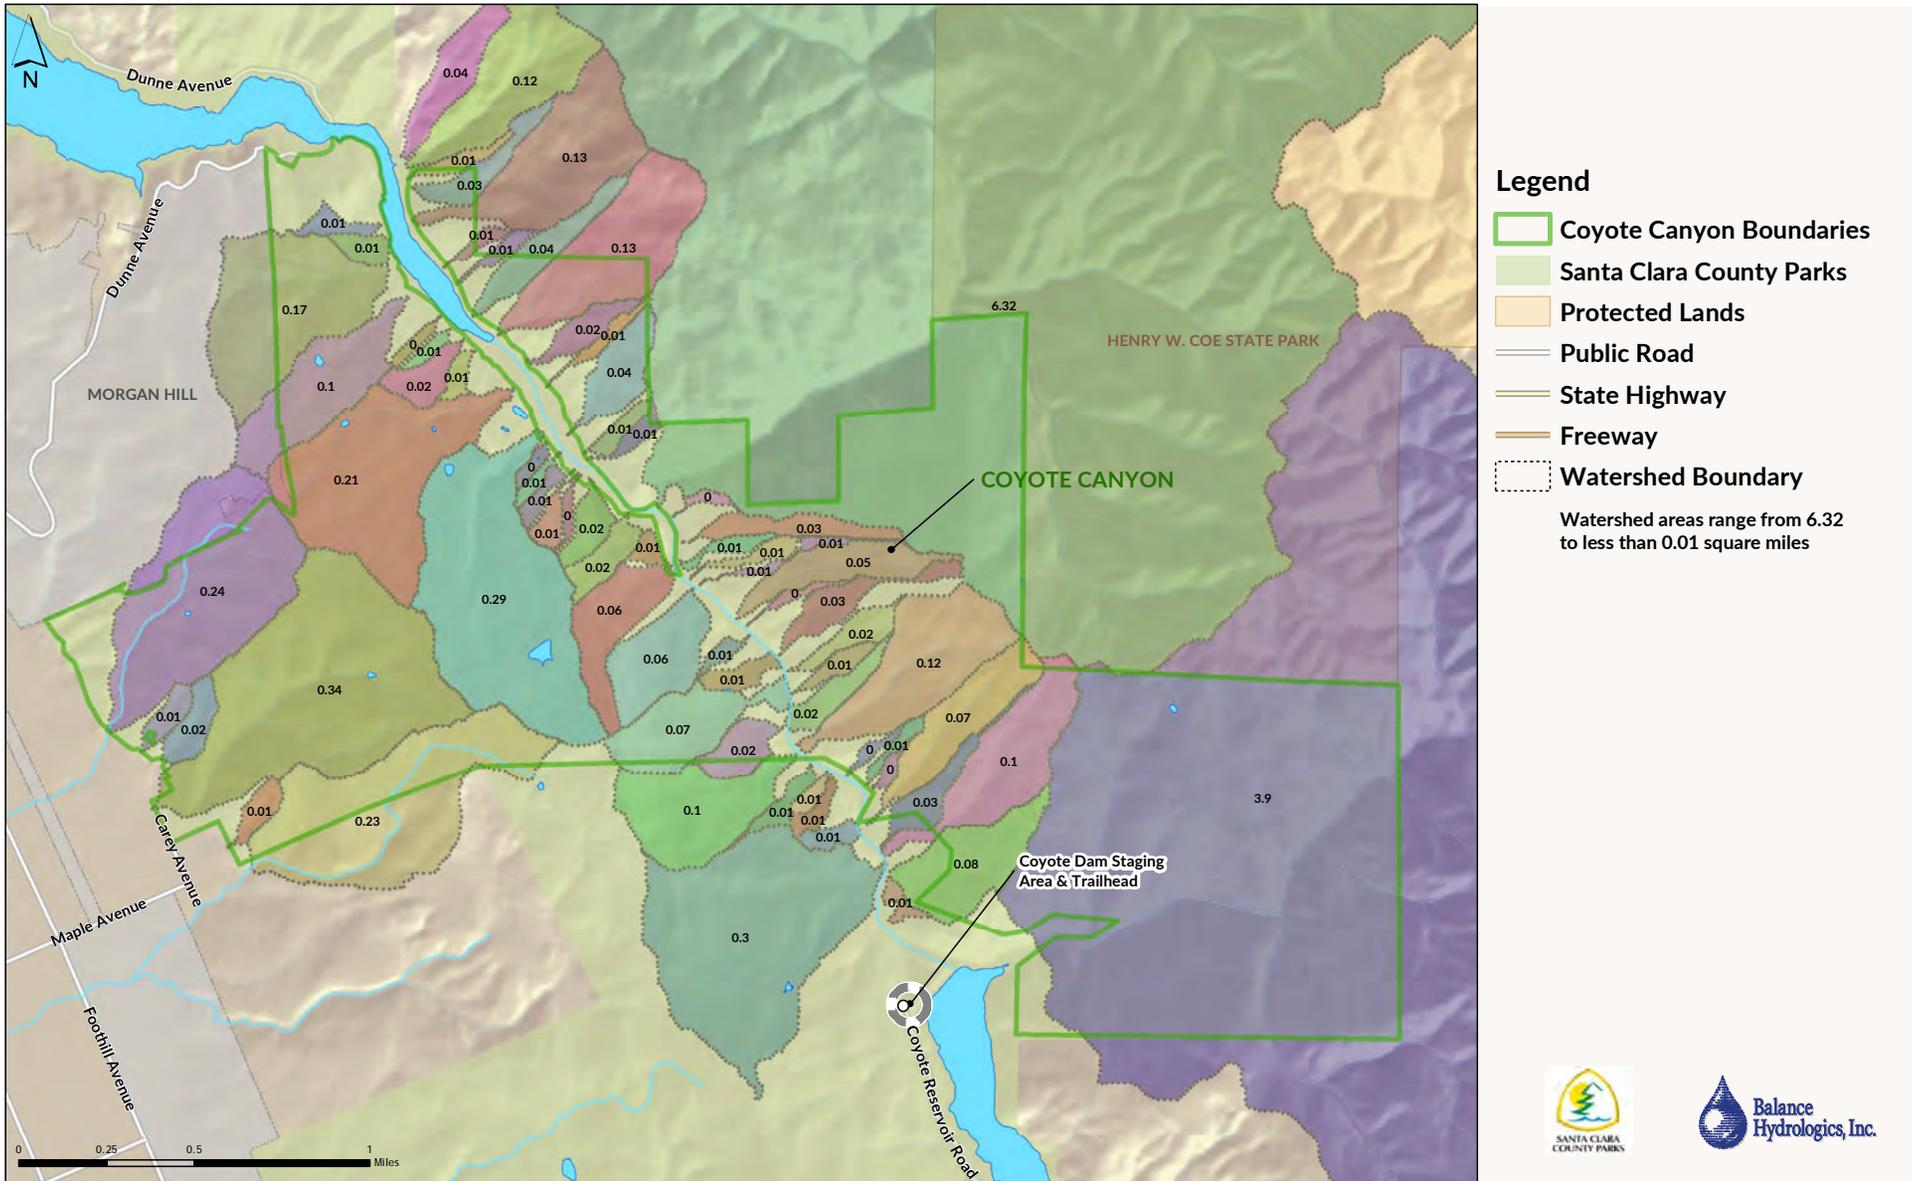
Figure B1: Watershed Areas

The main watershed areas within the property and sub-watersheds for 16 ponds were delineated using the Hydrology toolset in ArcGIS v 10.3 (Figure B1). The delineations were calculated from a USDA/NRCS 3m DEM (digital elevation model). Pond watershed areas were also delineated and verified in the field where possible (Figure B2).

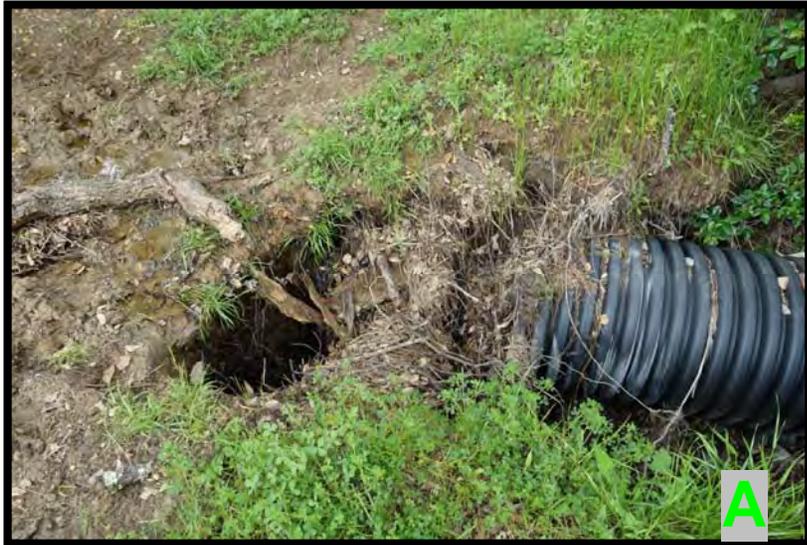
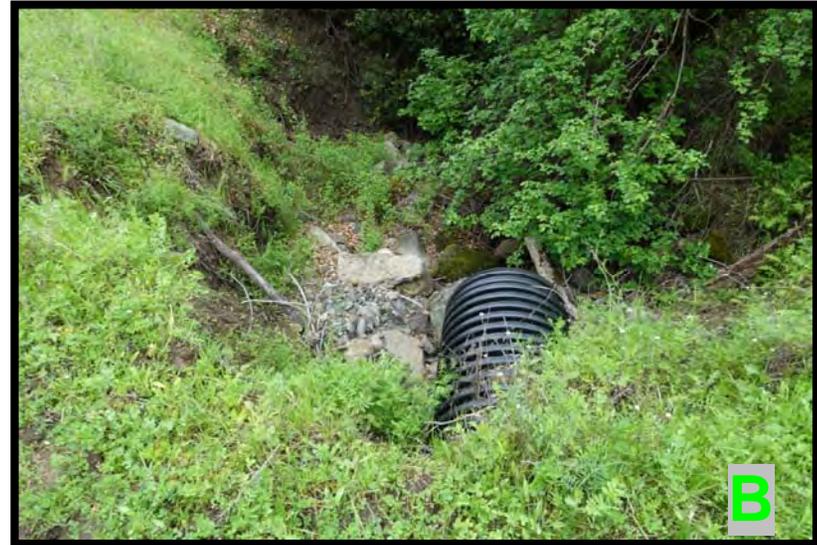
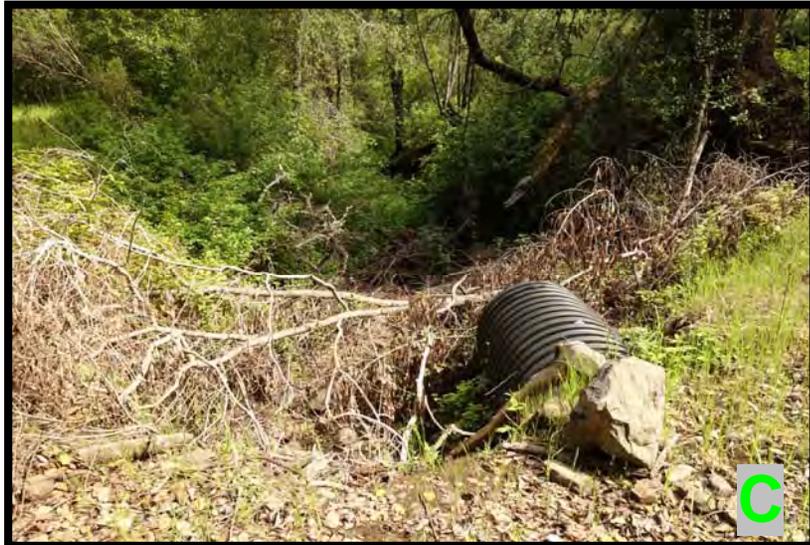
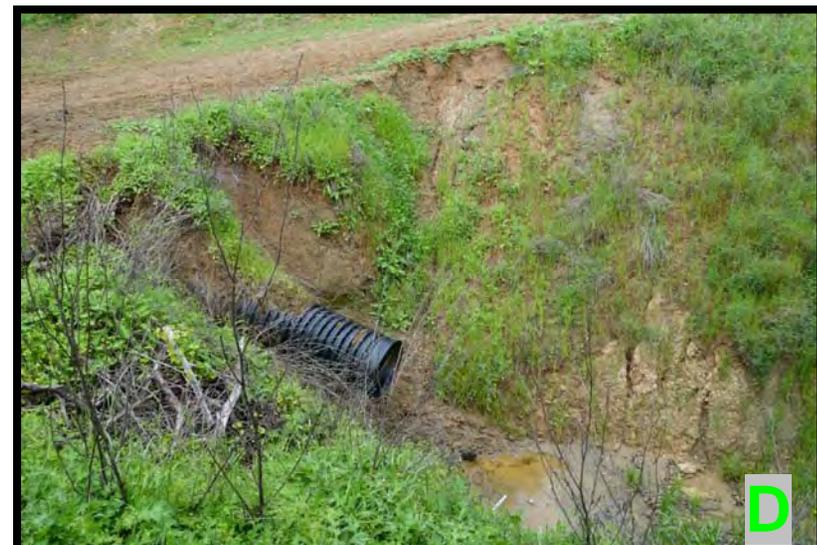
Many of the streams are incised at road crossings, particularly downstream of the crossings. Some of the culverts appear to be under-sized and clogged with sediment, with obvious signs of water moving across the road rather than through the culvert. In many locations, the water movement across the road is causing the road to erode. Figure B3 and B4 show images of buried culvert inlets and erosion and incision at stream crossings. The location of the photo points can be seen in Figure B5. Field Hydrologists observed multiple partially-buried culvert inlets, which may be the result of the culvert not being placed at a low enough elevation, the culvert not having enough slope to convey sediment, or the culvert being too small. The Coyote Canyon property is situated in a dynamic landscape and stream crossings should be planned accordingly. Channel segments that appear stable are likely to experience episodes of sedimentation and incision over the next decades. Proposed trail alignments in general, and stream crossings in particular, should consider terrain and hydrologic processes during the planning process.

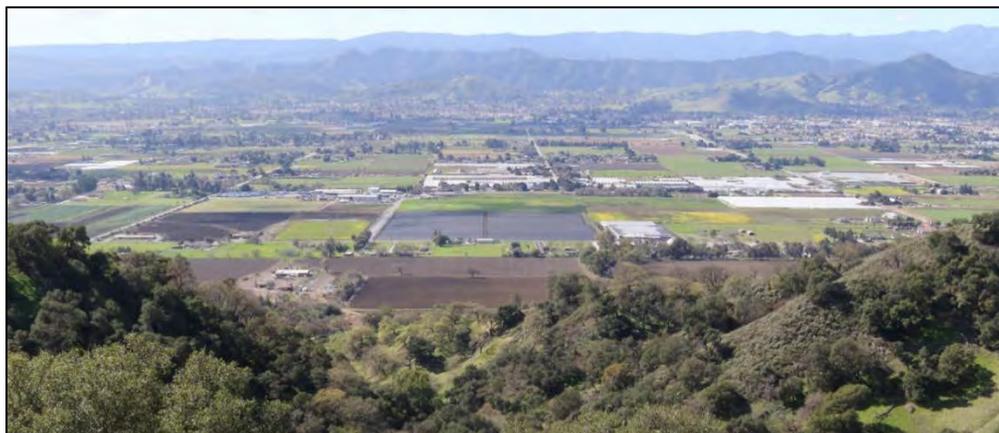
Photo 1. Agricultural and residential lands in the valley adjacent to the Property.

Land use in the valley to the west is primarily agricultural and residential (Photo 1). Small ranches, homes, and open space are the primary land use in the foothills and mountains. Private residences within the Jackson Oaks residential development are located along the northwestern boundary of the Property along East Dunne Avenue, and low-density residential development and agricultural properties are located west/southwest of the Property.

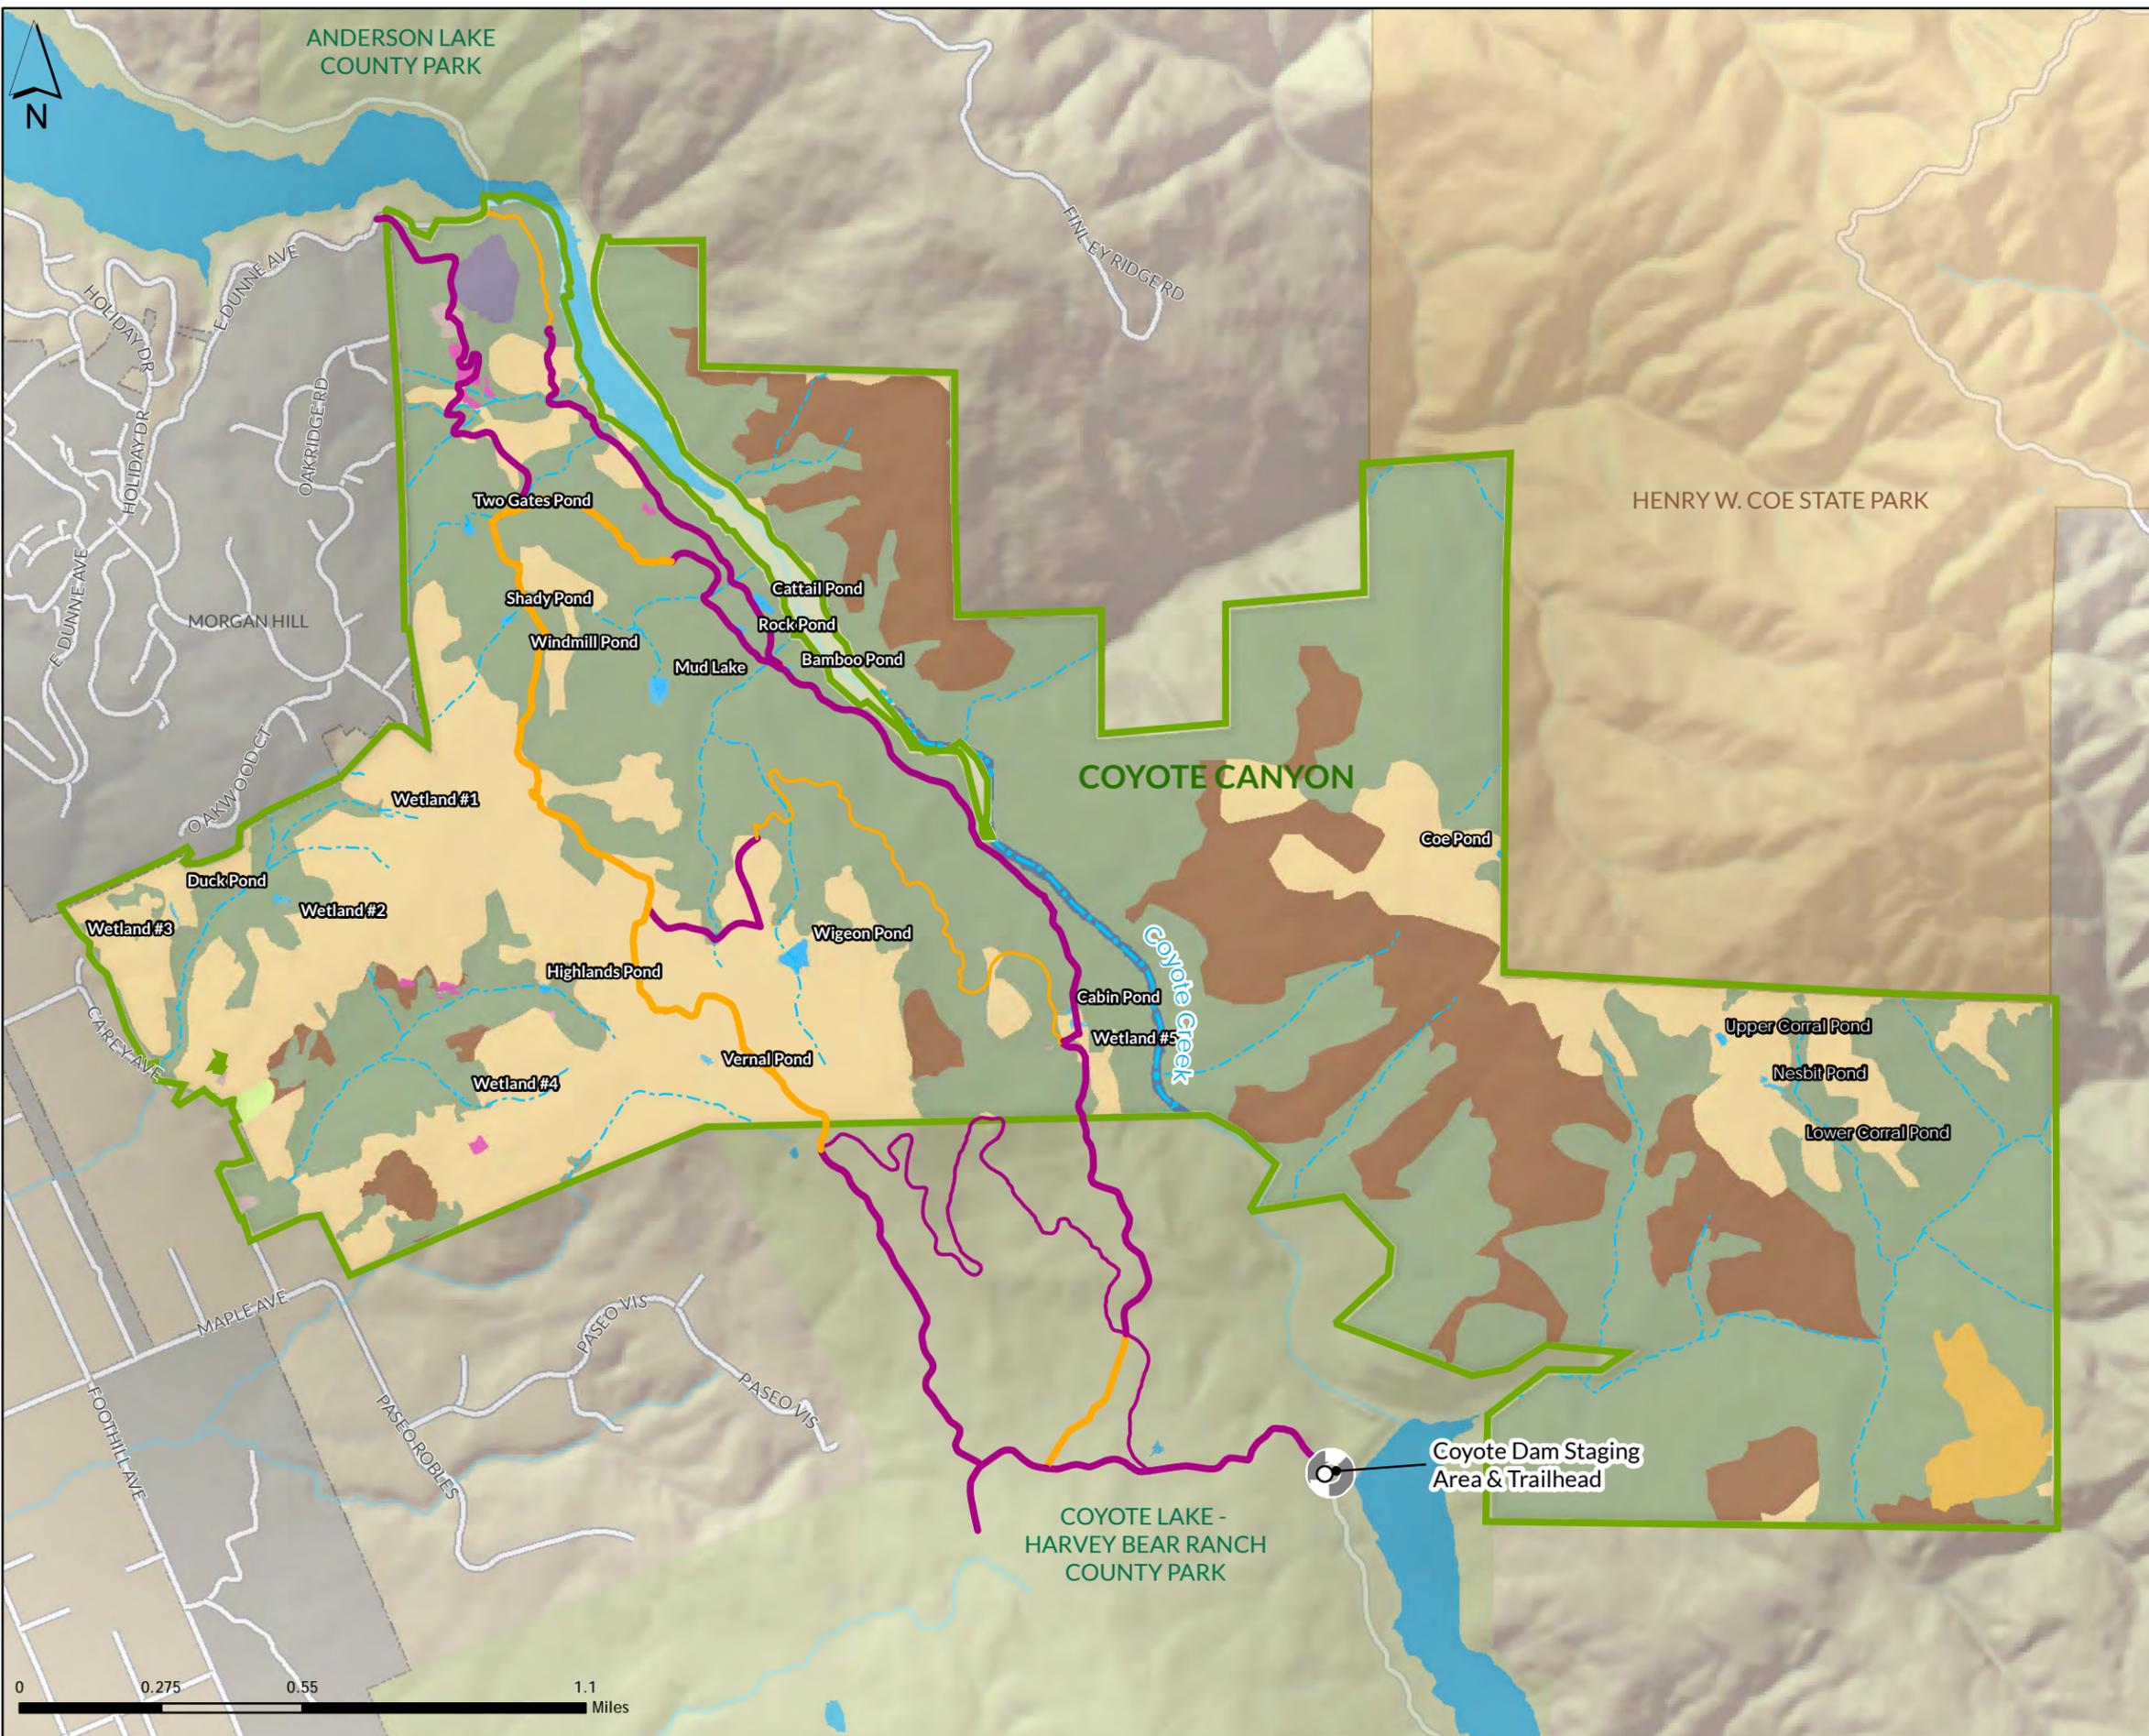
- Coyote Canyon Boundaries
- Santa Clara County Parks
- Protected Lands
- Roads
- Existing Infrastructure**
- Road - Width
- Single - Track
- Planned Infrastructure**
- Road - Width
- Single - Track
- Land Cover**
- California Annual Grassland
- Mixed Oak Woodland
- Mixed Riparian Woodland and Forest
- Mixed Serpentine Chaparral/ Serpentine Rock Outcrop
- Northern Coastal Scrub / Diablan Sage Scrub
- Northern Mixed Chaparral / Chamise Chaparral
- Ornamental Woodland
- Pond/Seasonal Wetland
- Reservoir
- Rural Residential
- Serpentine Bunchgrass
- Serpentine Rock Outcrops

As noted above, vegetation surveys focused primarily on areas within 200 feet of proposed roads and trails on the Property (i.e., the vegetation survey area), as shown on the Habitat and Land Cover Types figure (Figure 3). Vegetation surveys of the Property were conducted by H. T. Harvey & Associates plant ecologist Matthew Mosher, B.S., on February 27, March 6 and 8, and May 1, 2, 3, and 10, 2018. Surveys were timed based on the flowering periods of most plants covered by the Santa Clara Valley Habitat Plan (Habitat Plan), as feasible<sup>2</sup>. The purpose of the surveys was to (1) ground-truth available Habitat Plan land cover mapping to verify existing conditions and refine this land cover mapping as necessary, (2) look for and map infestations of nonnative/invasive plant species, and (3) identify the locations of sensitive communities and vegetation types (e.g., serpentine-based communities, valley oak woodland, blue oak woodland, native grassland, freshwater wetlands, and riparian woodland and scrub) and sensitive plant species. In addition, M. Mosher examined the Habitat Plan-mapped serpentine areas within 200 feet of the proposed trail alignments to determine (a) if the plant community expressed in the field is actually that of a serpentine plant community, and (b) whether rare serpentine-associated plant species are present. Land cover types were also mapped in the area within and immediately surrounding Anderson Reservoir that bisects the Property, for the sake of continuity, and along an existing road that extends south into Coyote Lake-Harvey Bear County Park.

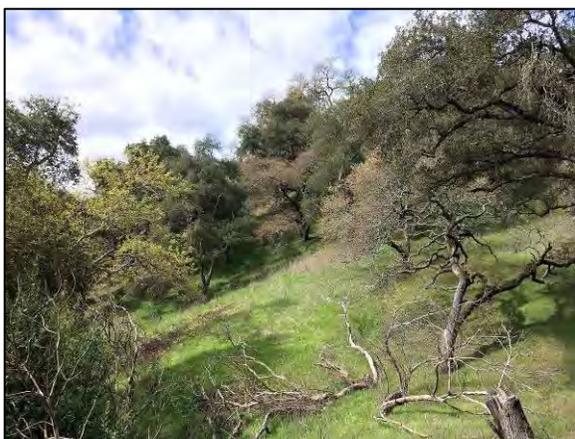
Photo 2. Mixed oak woodland habitat.

The mixed oak woodland land cover type contains different oak species in varying levels of dominance. Within the focal vegetation survey area, the canopy ranges from closed to open and is dominated by coast live oak (*Quercus agrifolia*), valley oak (*Quercus lobata*), and blue oak (*Quercus douglasii*), as well as scattered grey pine (*Pinus sabiniana*) (Photo 2). Concentration of blue oaks are present in some areas; however, the blue oaks are still intermixed with other oak species and do not constitute more than 25% of the canopy in any particular area (Photo 3). Therefore, these areas were not mapped specifically as blue oak woodland within the survey area, and instead fall under the mixed oak woodland land cover type. In most locations where mixed oak woodland and forest adjoins California annual grassland, the understory contains species typical of the California annual grassland land cover type. Where mixed oak woodland and forest is surrounded by coyote brush scrub or northern mixed chaparral/chamise chaparral and northern coastal scrub/Diablan sage scrub, the understory species from those land cover types occur at the borders of these habitats.

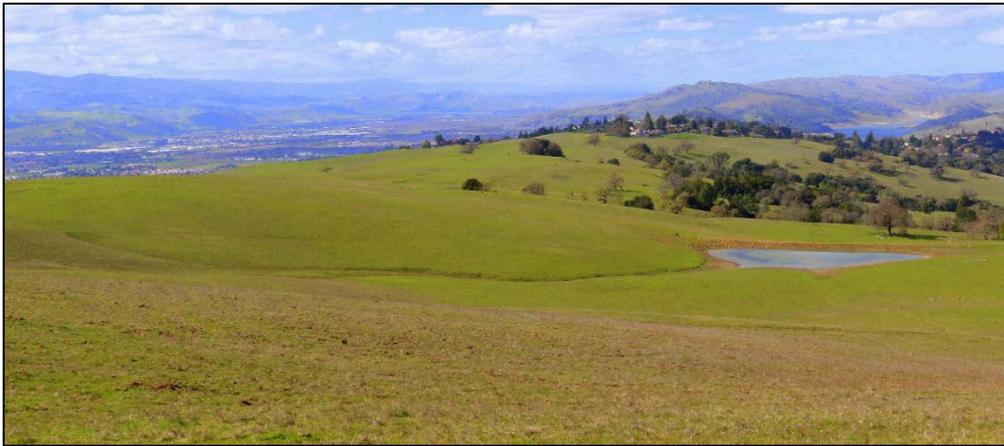
Photo 6. California annual grassland habitat on the Property.

The California annual grassland habitat is an herbaceous plant community that is dominated by nonnative annual grasses (Photo 6). Dominant species consist of nonnative grasses such wild oats (*Avena* sp.), foxtail barley (*Hordeum murinum*), ripgut brome (*Bromus diandrus*) and Italian rye grass (*Festuca perennis*). Common nonnative and native forbs include clovers (*Trifolium* spp.), filarees (*Erodium* spp.), bicolored lupine (*Lupinus bicolor*), and California poppy (*Eschscholzia californica*). Several noxious weeds are also common in this habitat, including medusa head (*Elymus caput-medusae*), yellow star-thistle (*Centaurea solstitialis*), Italian thistle (*Carduus pycnocephalus*), and milk thistle (*Silybum marianum*).

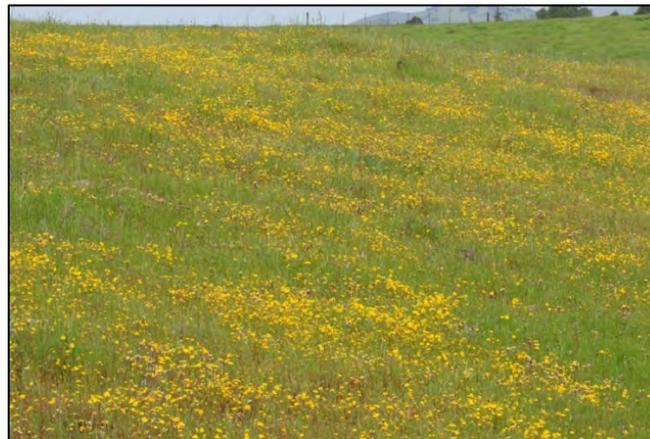
Photo 7. A portion of California annual grassland habitat dominated by native forbs.

Despite the abundance of nonnative plants in many areas, some areas of California annual grassland, particularly along the western ridgeline, support large stands of native forbs, including goldfields (*Lasthenia* sp.), purple owl's clover (*Castilleja exserta* ssp. *exserta*), miniature lupine (*Lupinus bicolor*), variable leptosiphon (*Leptosiphon parviflorus*), coast larkspur (*Delphinium decorum* ssp. *decorum*), and johnnytuck (*Triphysaria eriantha*) (Photo 7).

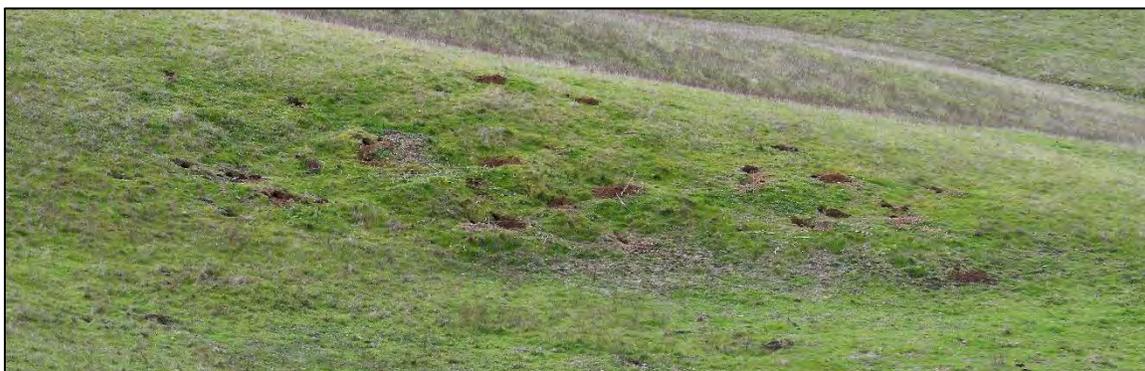
Photo 8. Burrows of California ground squirrels in rocky areas of California annual grassland habitat on the Property.

California ground squirrels (*Otospermophilus beecheyi*) are patchily distributed, particularly in rocky areas and under oaks in the annual grassland habitat; numbers are lower in expanses of annual grasslands that are not rocky, though some concentrations are present (Photo 8). Botta's pocket gophers (*Thomomys bottae*) are fairly widespread in the Property's California annual grassland, and deer mice are likely common throughout this habitat. Black-tailed deer are common browsers throughout the survey area, and other large mammals (e.g., coyotes and bobcats [*Lynx rufus*]) occasionally forage in grasslands throughout the site.

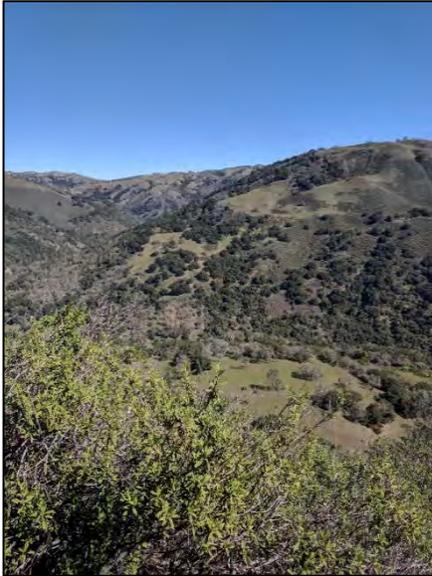
Photo 9. Northern coastal scrub/Diablan sage scrub habitat shown in the foreground and on the far slope intermixed with mixed oak woodland.

Northern coastal scrub/Diablan sage scrub (Photo 9) occupies a large portion of the Property, but the majority of this habitat is located on the steep slopes northeast of Coyote Creek, outside of the focal survey area. A small portion of this habitat is located within the focal survey area near the southern boundary of the Property adjacent to Coyote Lake-Harvey Bear County Park. The vegetation and wildlife that characterize the portion of this habitat within the survey area are discussed below.

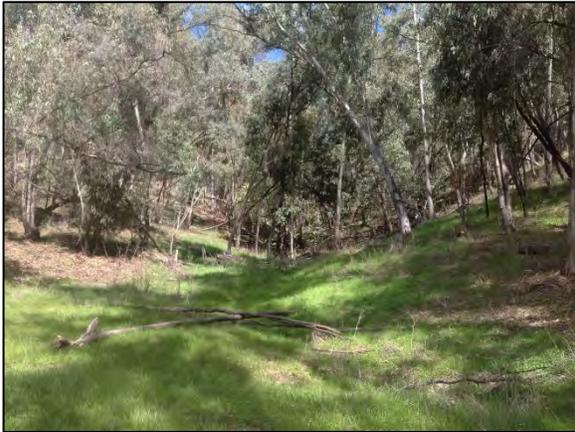
Photo 15. Eucalyptus-dominated ornamental woodland habitat in the western part of the Property.

The ornamental woodland land cover type occurs on the western edge of the Property, adjacent to residential structures along Carey Way and well outside the focal survey area. The vegetation here consists solely of large blue gum (*Eucalyptus globulus*) trees, relatively evenly spaced with a semi-closed canopy (Photo 15).

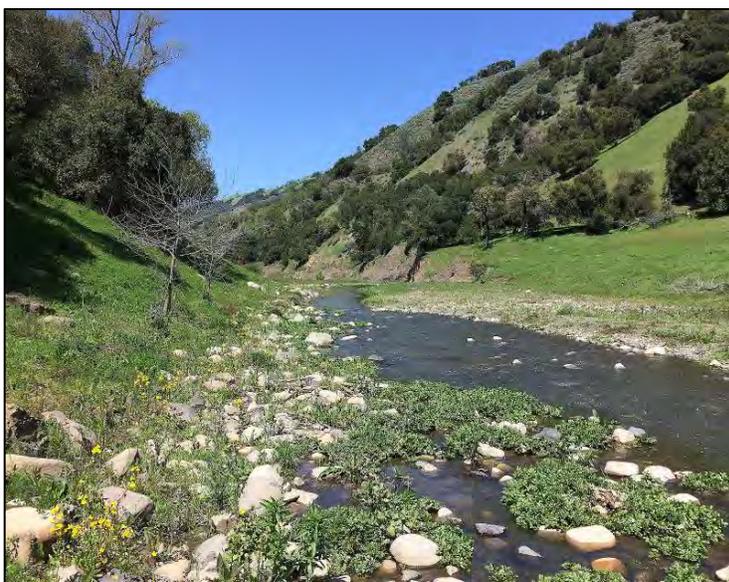
Photo 16. Coyote Creek.

One perennial stream, Coyote Creek, runs through the center of the Property and forms the major geographic divide between its western and eastern halves (Photo 16). Coyote Creek originates to the southeast in the Diablo Range, where it enters Santa Clara Valley at Coyote Reservoir. From Coyote Reservoir, Coyote Creek flows to the northwest, through the Property, and into Anderson Reservoir. From there, Coyote Creek continues to flow northwest through the Santa Clara Valley, before entering the San Francisco Bay at Alviso. Additionally, numerous intermittent (Photo 17) and ephemeral streams occur throughout the Property. These vary from grassy swales with minimal incision and attendant riparian canopy which only run with water during rain events, to intermittent streams which flow consistently during the wet season and support an attendant riparian canopy consisting coast live oak, California sycamore (*Platanus racemosa*), and other trees.

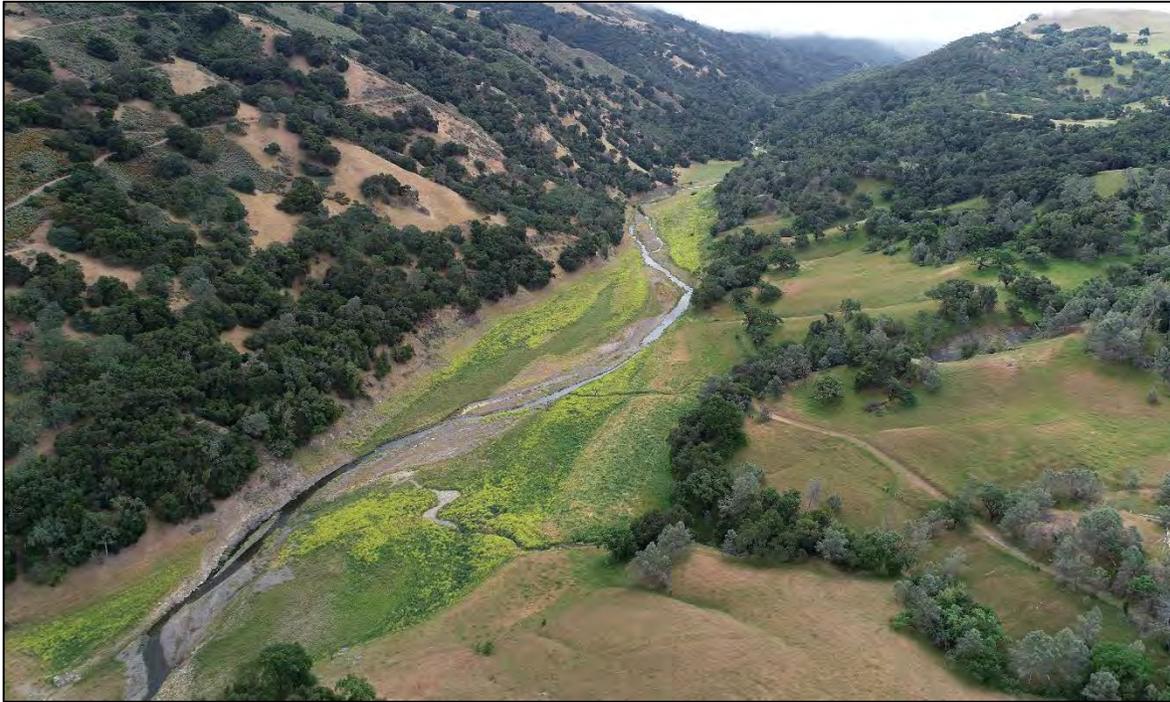
Photo 18. The south end of Anderson Reservoir, in its drawn-down stage, adjacent to the Property.

In its current drawdown stage, the portion of the reservoir adjacent to the Property contains little to no ponded water; rather, this area consists of the Coyote Creek channel flowing through alluvial materials that have been deposited in the floodplain/reservoir during higher flows. These alluvial materials support a variety of grasses and forbs (Photo 18). In its current condition, this area provides habitat for the same animal species that are present along Coyote Creek, as described in the preceding section.

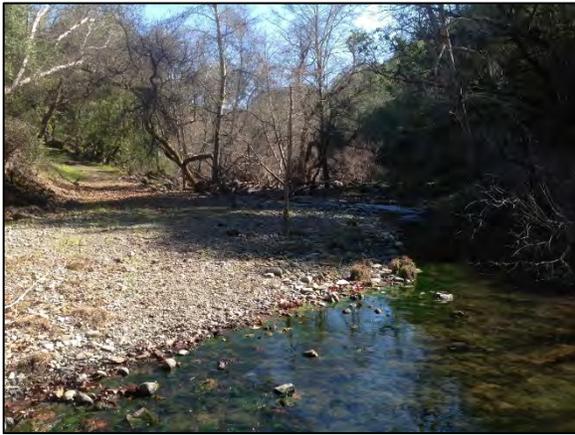
Photo 19. Mixed riparian woodland and forest habitat along Coyote Creek.

Mixed riparian woodland and forest on the Property occurs predominantly along Coyote Creek (Figure 3, Photos 19 and 20). Here, the vegetation consists of a mix of various overstory species, including coast live oak, big leaf maple (*Acer macrophyllum*), California sycamore, and red willow (*Salix laevigata*). Common understory species in the riparian corridor include common snowberry (*Symphoricarpos mollis*) and California blackberry (*Rubus ursinus*). All areas of mixed riparian forest and woodland along Coyote Creek on the Property (i.e., within and outside of the focal vegetation survey area) were mapped via interpretation of aerial imagery using the obvious vegetation signature of red willow and California sycamore versus the surrounding oak woodland. Mixed riparian woodland and forest also occurs along some of the intermittent streams on the Property. However, due to the very narrow nature of riparian habitat occurring along intermittent streams and the large scale of the habitat mapping, these areas are not depicted as riparian on the Habitat and Land Cover Types map and were not mapped in the field.
