# COYOTE CANYON

## NATURAL RESOURCES MANAGEMENT PLAN & INTERIM ACCESS PLAN

REVISED DRAFT  
AUGUST 2019

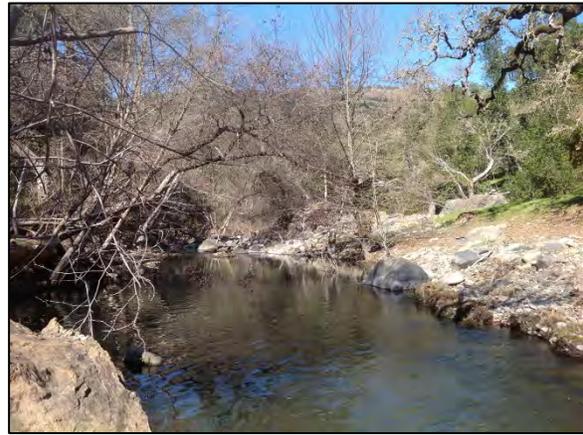
Photo 20. A pool section of Coyote Creek with associated mixed riparian woodland and forest.

Mixed riparian woodland and forest on the Property occurs predominantly along Coyote Creek (Figure 3, Photos 19 and 20). Here, the vegetation consists of a mix of various overstory species, including coast live oak, big leaf maple (*Acer macrophyllum*), California sycamore, and red willow (*Salix laevigata*). Common understory species in the riparian corridor include common snowberry (*Symphoricarpos mollis*) and California blackberry (*Rubus ursinus*). All areas of mixed riparian forest and woodland along Coyote Creek on the Property (i.e., within and outside of the focal vegetation survey area) were mapped via interpretation of aerial imagery using the obvious vegetation signature of red willow and California sycamore versus the surrounding oak woodland. Mixed riparian woodland and forest also occurs along some of the intermittent streams on the Property. However, due to the very narrow nature of riparian habitat occurring along intermittent streams and the large scale of the habitat mapping, these areas are not depicted as riparian on the Habitat and Land Cover Types map and were not mapped in the field.

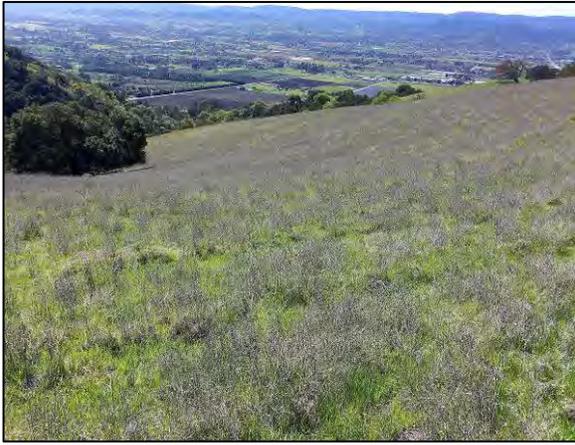
**Photo 58. An extensive infestation of yellow star thistle in the western part of the Property.**

This species' occurrence certainly extends beyond the boundary of the vegetation survey area on the Property, and should be expected in areas of California annual grassland habitat throughout the Property. In particular, large infestations were incidentally noted outside the survey area within the western part of the Property (Photo 58), but these areas were not mapped due to their large extent and because they were outside the focal survey area.

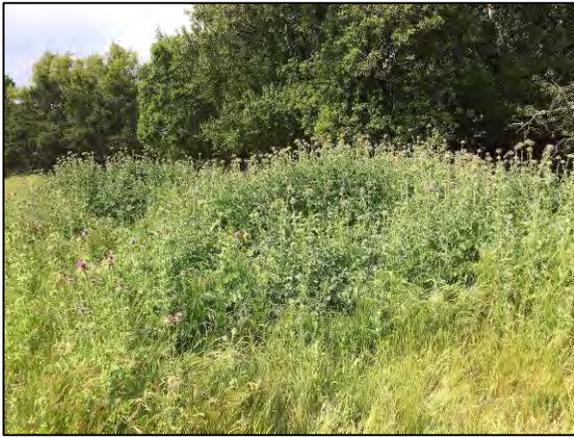
Photo 59. Italian thistle in an area that was previously disturbed by cattle.

Italian thistle is extremely common both regionally and locally on the Property, often occurring in areas that have been disturbed by cattle, such as beneath scattered oaks that offer shade to cattle (Photo 59; Figure 6). Due to its ubiquitous nature, only the largest infestations were mapped during the survey. Additionally, this species is likely present in California annual grassland and mixed oak woodland habitats outside of the survey area within the rest of the Property.

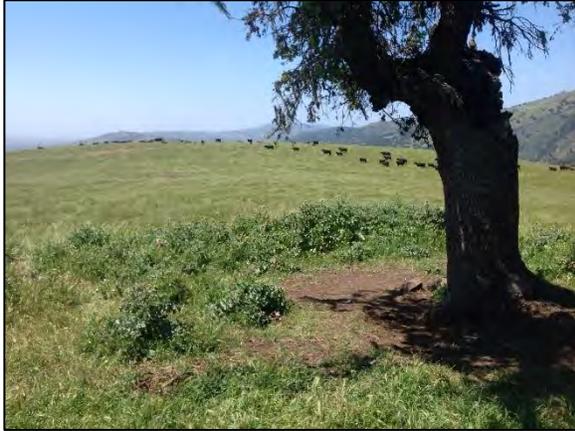
Photo 60. Milk thistle infestation associated with cattle disturbance under a coast live oak tree.

Milk thistle is common on the Property, often occurring in areas that have been disturbed by cattle, such as beneath scattered oaks that offer shade to cattle (Photo 60; Figure 6). Due to its ubiquitous nature, only large infestations which completely excluded native vegetation were mapped during the survey. Additionally, this species is likely present in California annual grassland and oak woodland outside of the survey area within the rest of the Property.

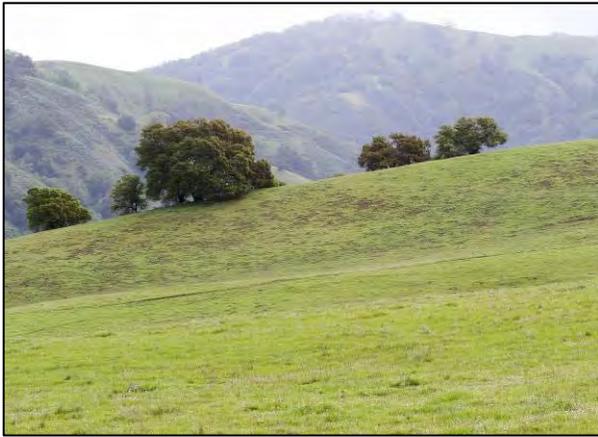
Photo 61. Pig rooting in California annual grasslands.

Feral pigs are common on the Property, and pig rooting is extensive in California annual grasslands and in the understory of mixed oak woodlands (Photos 61 and 62). This species was seen during a number of 2018 survey visits, with family groups of up to 20 at a time being observed (Photos 63 and 64). This exotic species is the ancestor of European wild boars and domestic pigs, with which they freely hybridize (Frederick 1998); was intentionally introduced to North America for hunting; and is now the most abundant wild-living introduced ungulate in the United States (Mayer and Brisbin 1991). Feral pigs are highly adaptable, can inhabit a wide range of environments, are omnivorous and can survive on a great variety of food resources, and are capable of rapid increases in population (Baskin and Dannell 2003). Feral pigs can cause substantial environmental damage (Cushman et al. 2004) and present health, and safety concerns to humans, livestock, and wildlife in California (Kreith 2007, Barrios-Garcia and Ballari 2012, Brown et al. 2018).

Feeding and rooting activities of feral pigs can damage ecosystems by disturbing soil, uprooting plants, and modifying physical characteristics and resources. Soil disturbance by pigs facilitates invasion by exotic plant species, increases exotic plant species diversity, and can reduce vegetative soil cover (Cushman et al. 2004). In addition to damaging pastures and causing disturbance in riparian areas (Barrios-Garcia and Ballari 2012), rooting behavior and movements can damage fencing, gates, water troughs, and other infrastructure. Feral pigs feed not only on plants, but also on other animal species, potentially impacting other wildlife populations (Jolley et al. 2010, Barrios-Garcia and Ballari 2012). On the Property, feral pig “wallows” at the edges of some ponds, such as Wigeon Pond and Two Gates Pond, have degraded emergent vegetation. Feral pigs can also present a danger to public safety by charging when they feel threatened, and may act aggressively towards dogs, although the likelihood of an attack is generally low.

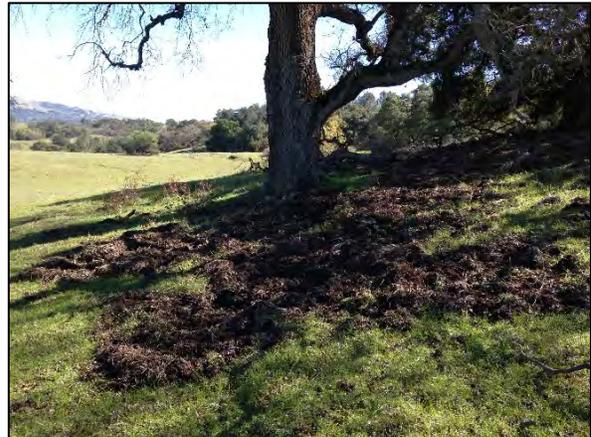
Photo 62. Pig rooting in oak woodlands.

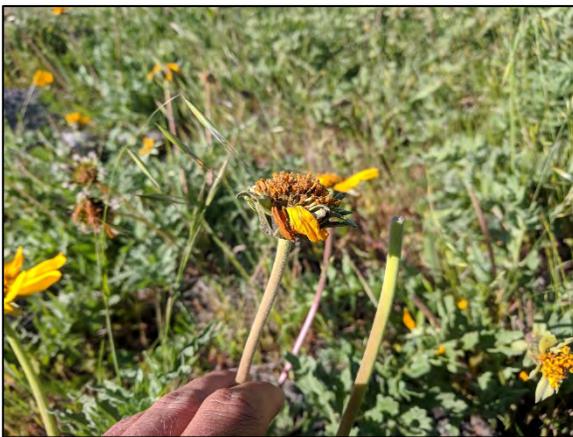
Photo 65. Cattle grazing observed on big-scale balsamroot individuals.

heads had been eaten by cattle grazing nearby (Photo 65). The large size and apparent robustness of the population, despite the long duration of cattle grazing here (at least eight consecutive years, with decades of prior grazing at some level), suggest that cattle grazing is not having a deleterious effect on this species' populations on the Property. Nevertheless, monitoring of the health of this population over time is recommended to determine whether grazing is having an adverse effect.

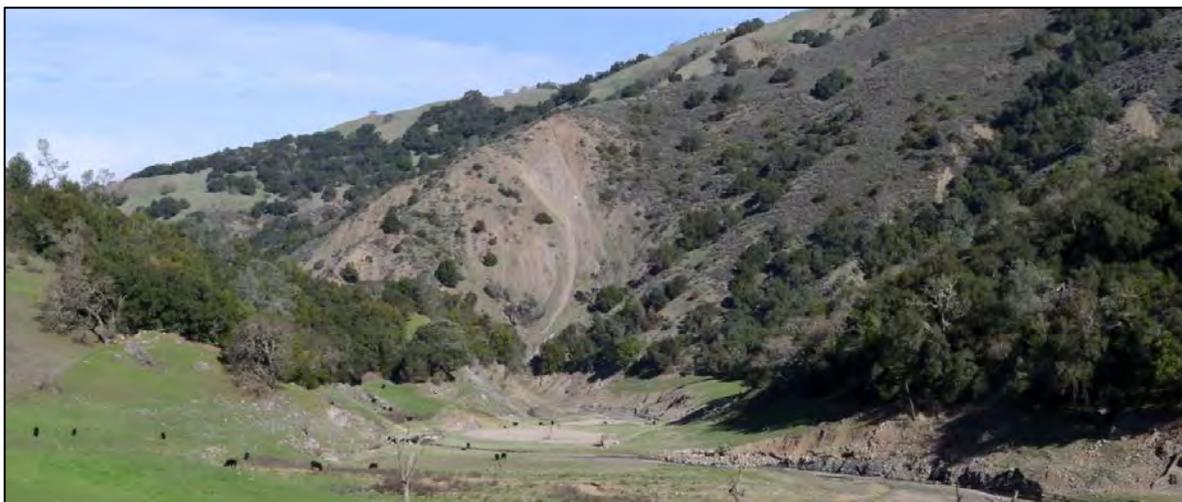
Photo 66. Cattle grazing along Coyote Creek in the upper portion of drawn-down Anderson Reservoir.

Cattle were observed grazing within the riparian habitat along Coyote Creek during the 2018 surveys (Photo 66). Existing fencing is present along the southwest side of the creek, but this fencing is in disrepair. To maintain high-quality riparian habitat along Coyote Creek, it is recommended that cattle be excluded from the riparian habitat except if needed to control nonnative invasive weeds or travel to pastures located to the northeast. Thus, it is recommended that existing fencing along the southwest side of Coyote Creek be repaired to effectively exclude cattle from this area. In addition, if East Coyote Canyon Pasture will be used for grazing,

the existing fencing located along the northeast side of Coyote Creek should also be repaired to effectively exclude cattle from the creek. The fencing on both sides of the creek would include one or more gates that can be opened to allow passage by cattle as needed.

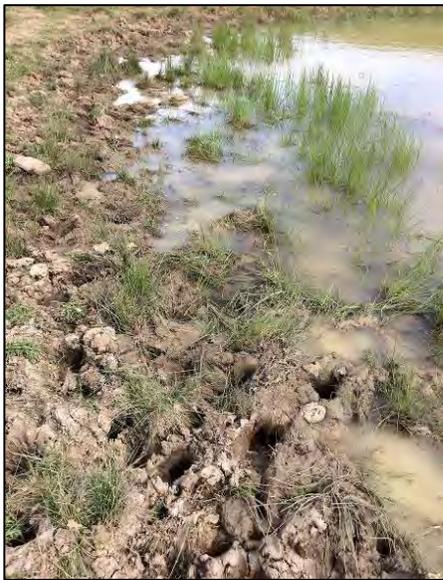
**Photo 67. Cattle impacts on emergent vegetation at Wigeon Pond.**

All of the ponds on the Property are located in areas that are grazed by cattle, which affects vegetation height, distribution, and composition (Photo 67). These ponds are focal points for cattle to forage and drink during much of the year. Intensive cattle use currently degrades many of the ponds by reducing plant height and density, compacting wetland soils, and increasing nutrient levels through fecal matter. Cattle exclusion fencing can be installed to protect and restore wetland vegetation in portions of the pond areas. Cattle exclusion would facilitate the increased growth and recruitment of wetland vegetation, which would provide breeding and foraging habitat for California red-legged frogs (eggs, larvae, and adults); increased height and density of wetland vegetation, thereby improving habitat quality for wetland-associated wildlife; increased species richness of native wetland vegetation; increased aboveground primary production typical of high-quality wetlands; and improved filtration of suspended sediments, nutrients, and organic matter, thereby improving water quality. The initial

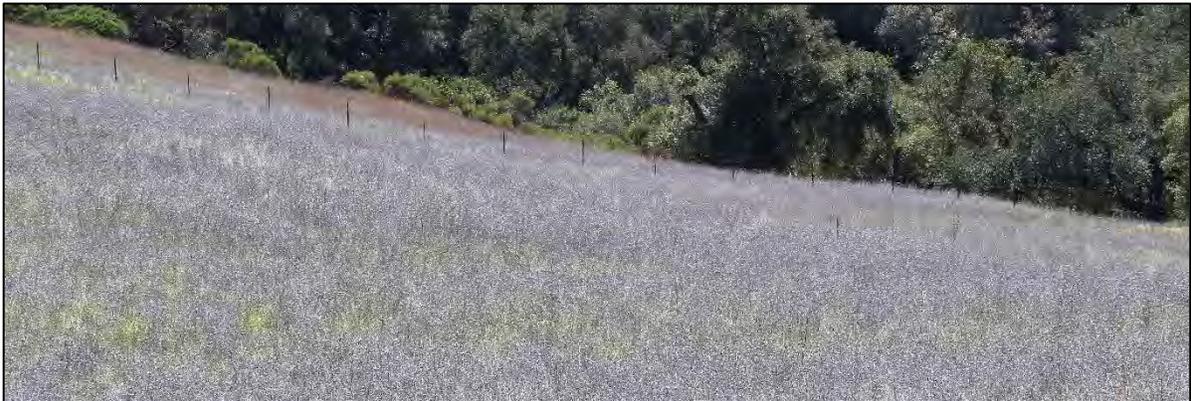
Photo 71. Extensive yellow star thistle infestation on Front Pasture in the western part of the Property.

Large infestations of yellow star thistle observed in Windmill Pasture were thought to have resulted from ground disturbance by feral pigs, whereas extensive yellow star thistle in the western part of the Property was present in areas that had been lightly grazed and had little pig damage (Photo 71). Oak recruitment is occurring along the Coyote Creek riparian corridor and in lowland areas, but very little to none is present in upland grasslands, where grazing and animal impacts are most intensive. Grazing intensity is low to moderate in most riparian areas and woodlands, although pegging (i.e., disturbance of soil where cattle hooves have cut into and sheered soft soils) is extensive due to deep, soft, friable soils with thick litter layers under canopies. However, RDM levels were moderate to high in most wooded and riparian areas. Soils are generally heavily impacted by livestock and feral pigs in California annual grasslands (e.g., due to pegging, compaction and forming of trails, bare and disturbed soils, and evidence of erosion), particularly around water resources such as the constructed ponds.

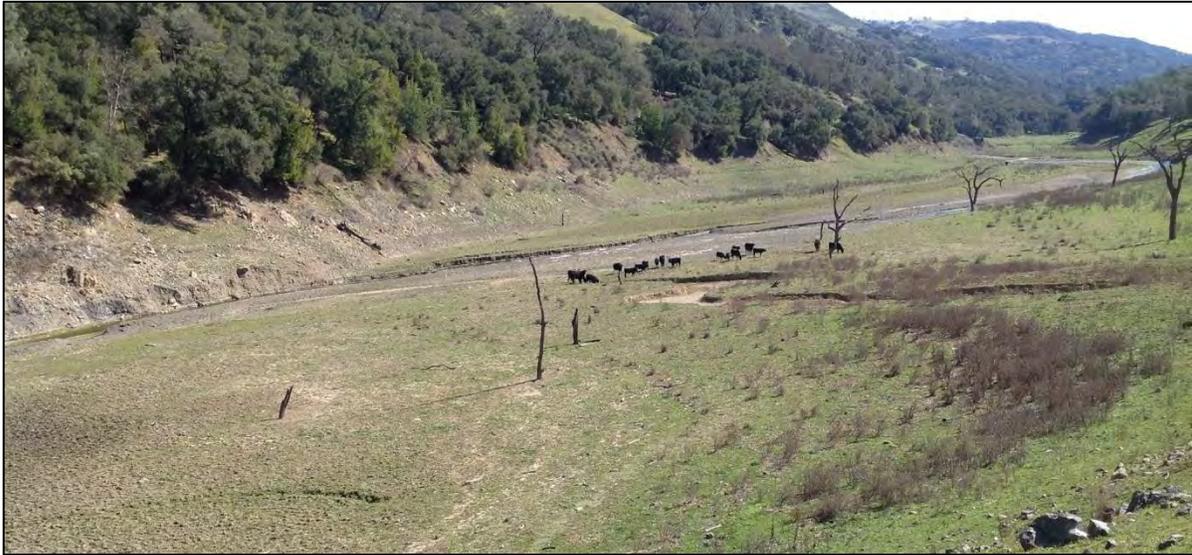
**Photo 72. Cattle loafing along Coyote Creek create compacted soils, promote infestations of thistles in disturbed areas, and increase erosion.**

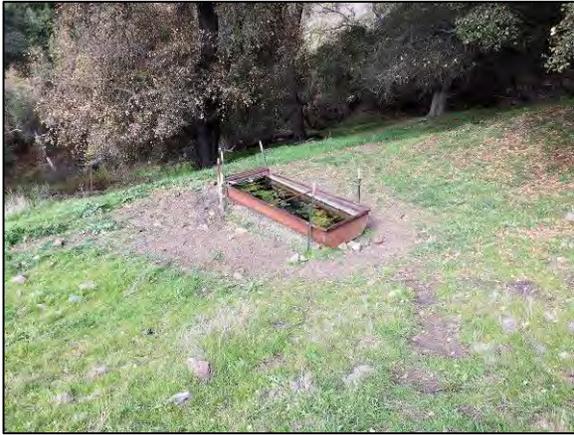
Photo 73. An existing water trough in the western part of the Property.
