VISUAL IMPACT ASSESSMENT
Buckman Springs Road Bridge
Widening Project
(for Minor Level VIA)

California Department of Transportation
District 11-SD-Buckman Springs Road Bridge (57C-0270)
Unincorporated Community of Campo, San Diego County
BRLS-5957 (084)
PI 1100020114

Buckman Springs Road Bridge Widening Project

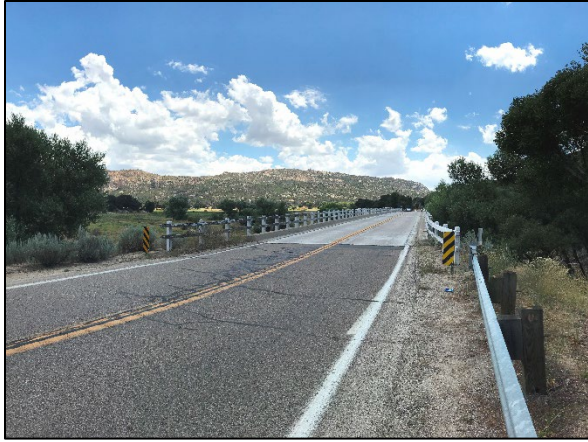
Figure 5: View of Bridge and Surroundings from North

As described above, the existing Buckman Springs Road Bridge is a two-lane roadway crossing of Cottonwood Creek. The roadway traverses the creek in a general northwest to southeast direction. The concrete bridge is approximately 450 feet in length and is constructed with nine piers. The roadway along the bridge is 27 feet wide, and is flanked by wooden railings painted in white. The paint is worn and chipped on both sides of the roadway.

Buckman Springs Road is a north-south road, but curves to the east as the roadway approaches the bridge from the north. At the northern end of the bridge, an approximately 350-foot dirt pullout provides visibility along this curve. The project site is therefore visible from the northern approach along Buckman Springs Road for approximately 450 feet, near the intersection with Morena Stokes Valley Road. The southern approach toward the bridge is a straight path providing views of the project site from approximately 900 feet to the southeast. Figures 5 and 6 show the bridge and surrounding area from the northern and southern approaches, respectively.

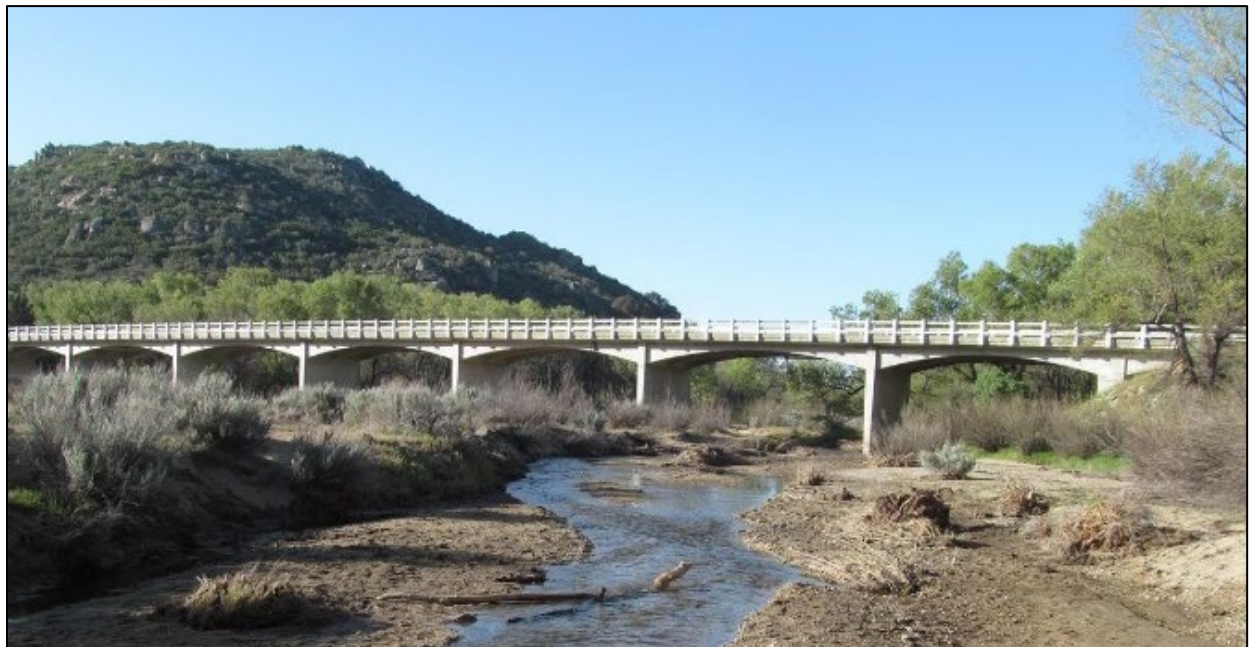
Figure 9: View of Bridge from North at Cottonwood Creek

The bridge itself represents a visual landmark that can be used as orientation by PCT trail users. The bridge is a visually interesting structure within an area that is primarily undeveloped and fairly uniform in setting. Views of the bridge are available from portions of PCT to the north, but are generally obscured by surrounding trees and vegetation when approaching the bridge from the south. Figure 11 shows the view from PCT at the point where it extends from a more densely vegetated area to the unvegetated Cottonwood Creek channel, north of the bridge. Where the trail extends directly adjacent to the northern side of the bridge, the bridge represents a strong visual element that is dominant over adjacent natural elements. Figure 12 shows the view from the north side of the bridge, where the concrete piers and overhangs are seen as dominant visual elements.
