Biological Technical Report for the Torrey Pines Golf Course Storm Drain Repair Project

July 23, 2019

City of San Diego
1222 First Avenue
San Diego, CA 92101

Alden Environmental, Inc.
3245 University Avenue, #1188
San Diego, CA 92104

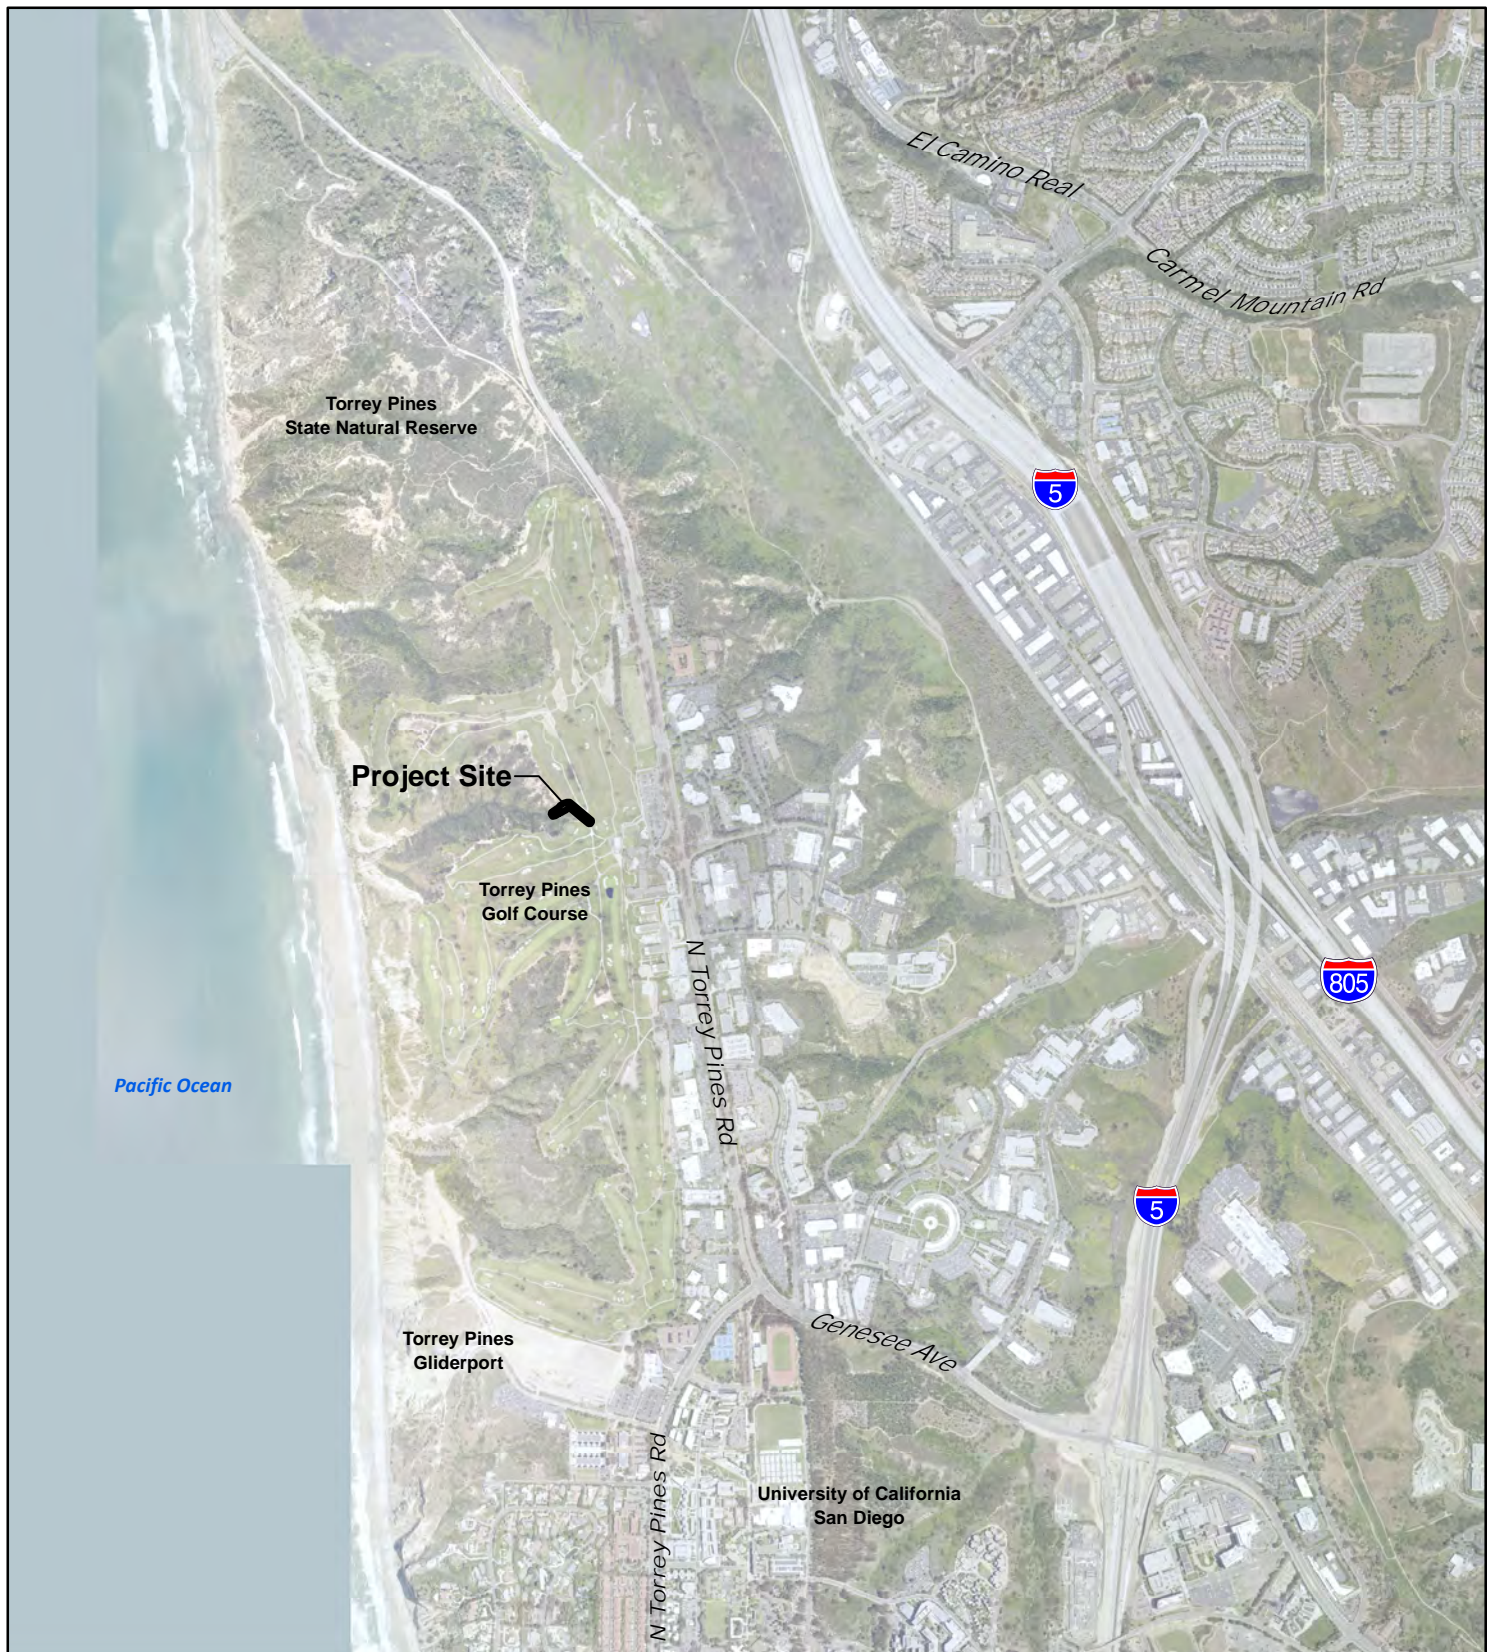
Figure 2

Project Location

The study area for the project is located at the Torrey Pines Golf Course, 11480 North Torrey Pines Road, in the City west of the northbound Interstates 5 and 805 merge (Figures 1 and 2). The study area includes the project impact footprint where it occurs on undeveloped land and a portion of where the footprint occurs on developed golf course (the remainder of the project impact footprint is entirely on developed golf course so it is not addressed herein). The study area also includes a mapped buffer in order to address potential indirect effects to sensitive biological resources adjacent to the project. The study area is not within or adjacent to the City's preserve, the Multi-habitat Planning Area (MHPA). The study area is located in unsectioned land in Township 15S, Range 4W on the U.S Geological Survey (USGS) Del Mar quadrangle.

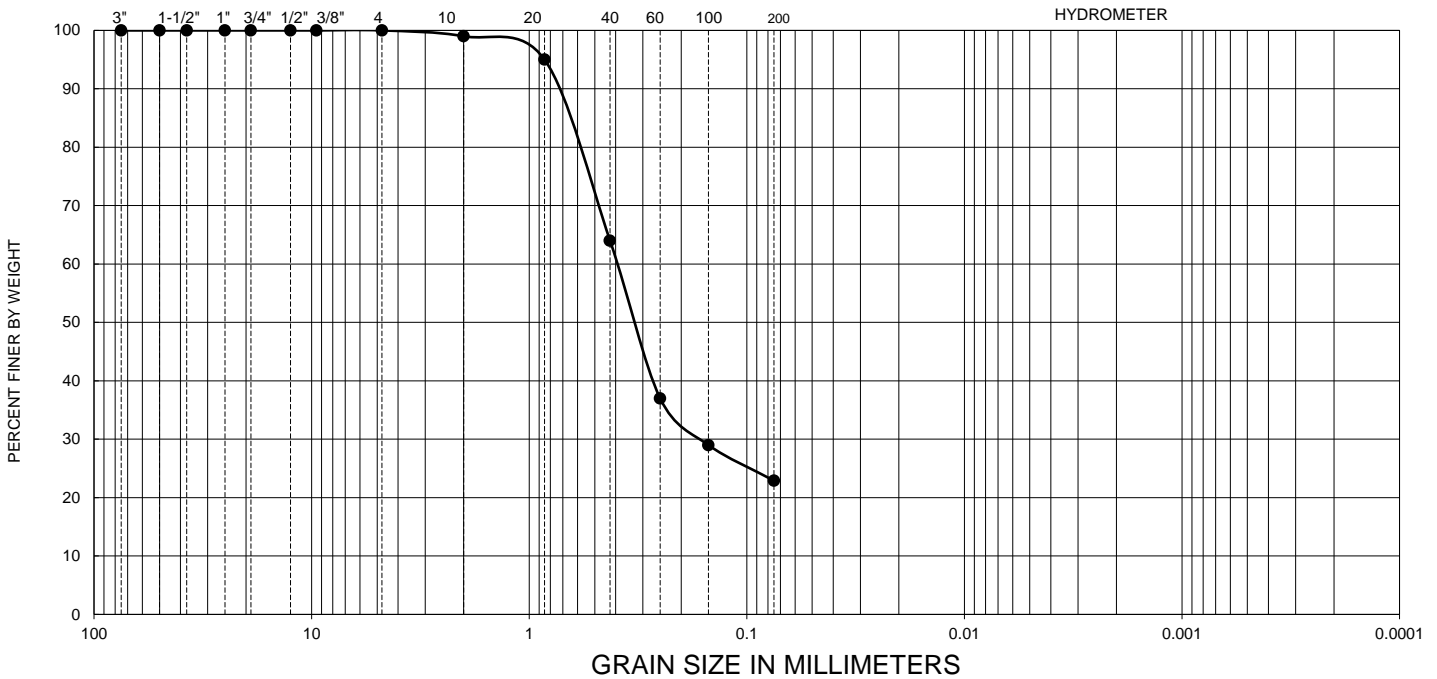
Boring No.	Sample No.	Depth (ft)	Passing 200 (%)	USCS Classification
B1	S2	5.5-6	22.9	SM

Sample Description	Silty sand
--------------------	------------

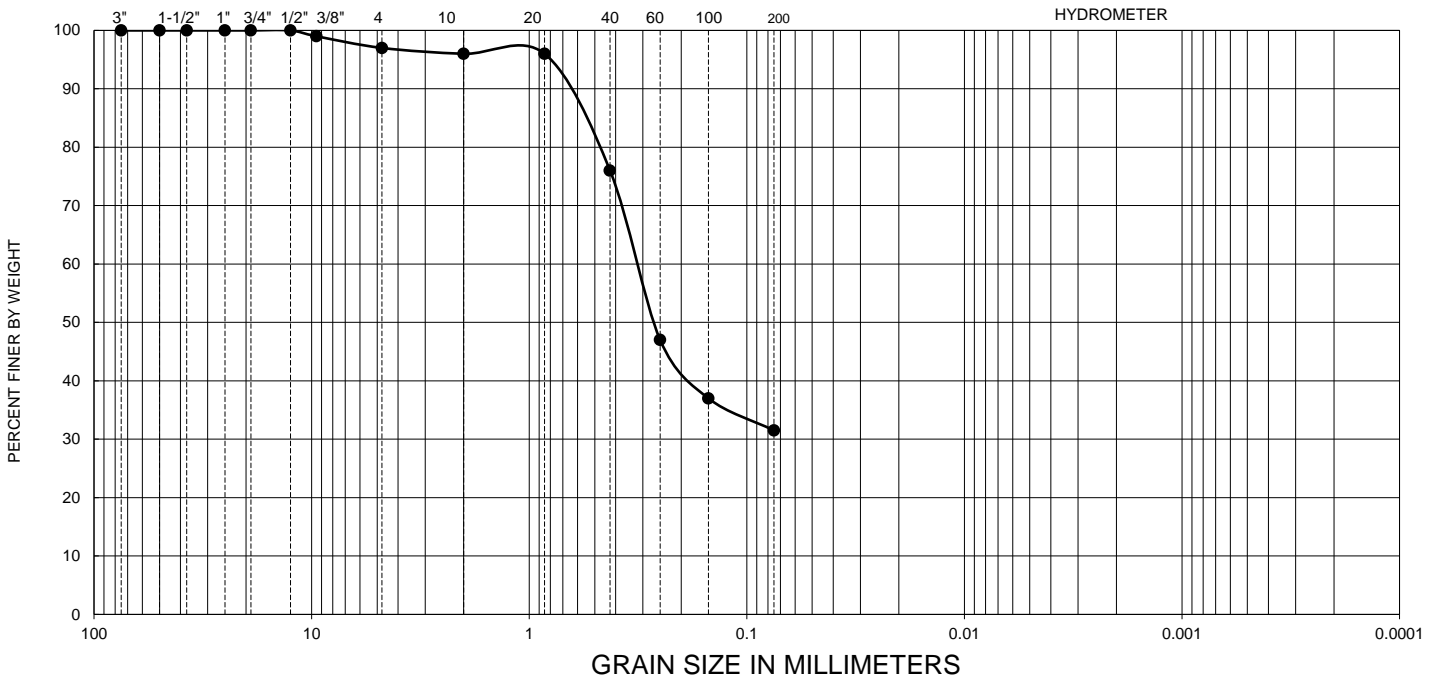
Boring No.	Sample No.	Depth (ft)	Passing 200 (%)	USCS Classification
B2	S1	0.5-4	31.5	SM

Sample Description	Silty sand
--------------------	------------

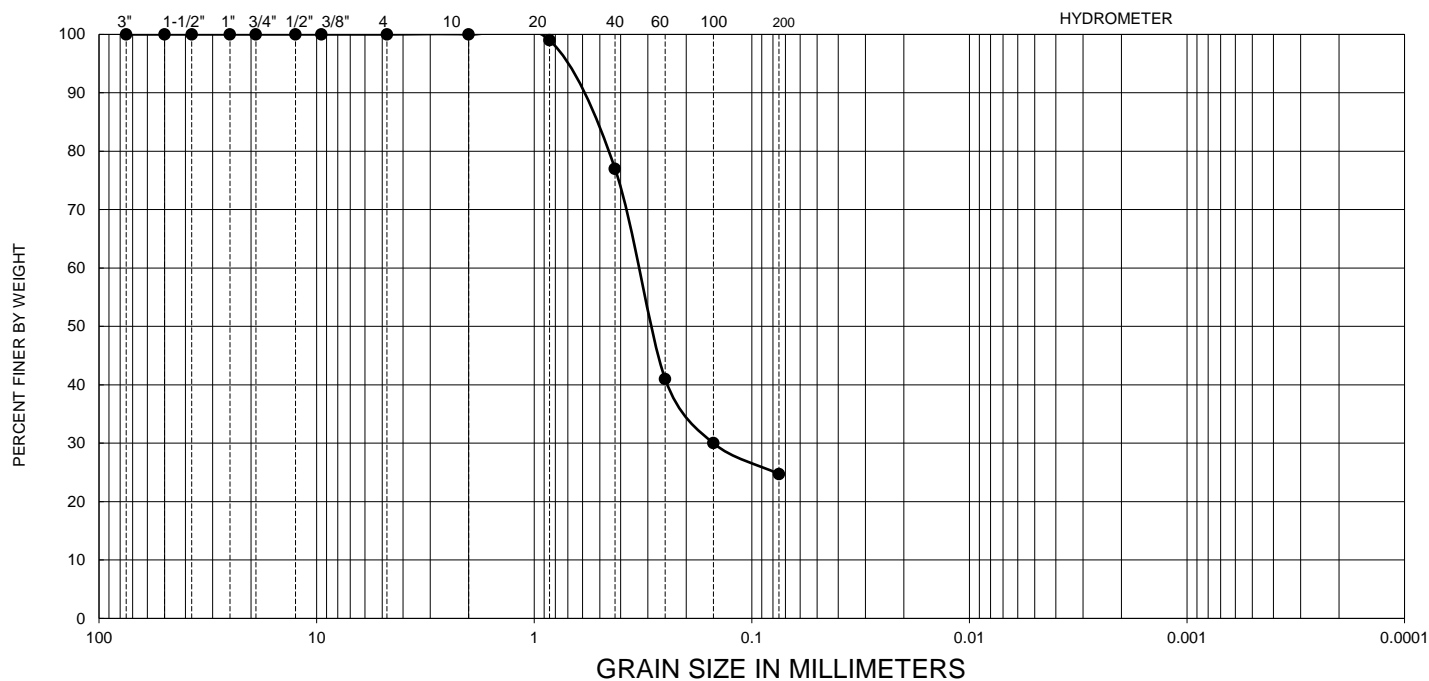
Boring No.	Sample No.	Depth (ft)	Passing 200 (%)	USCS Classification
B2	S3	10.5-11	24.7	SM

Sample Description	Silty sand
--------------------	------------

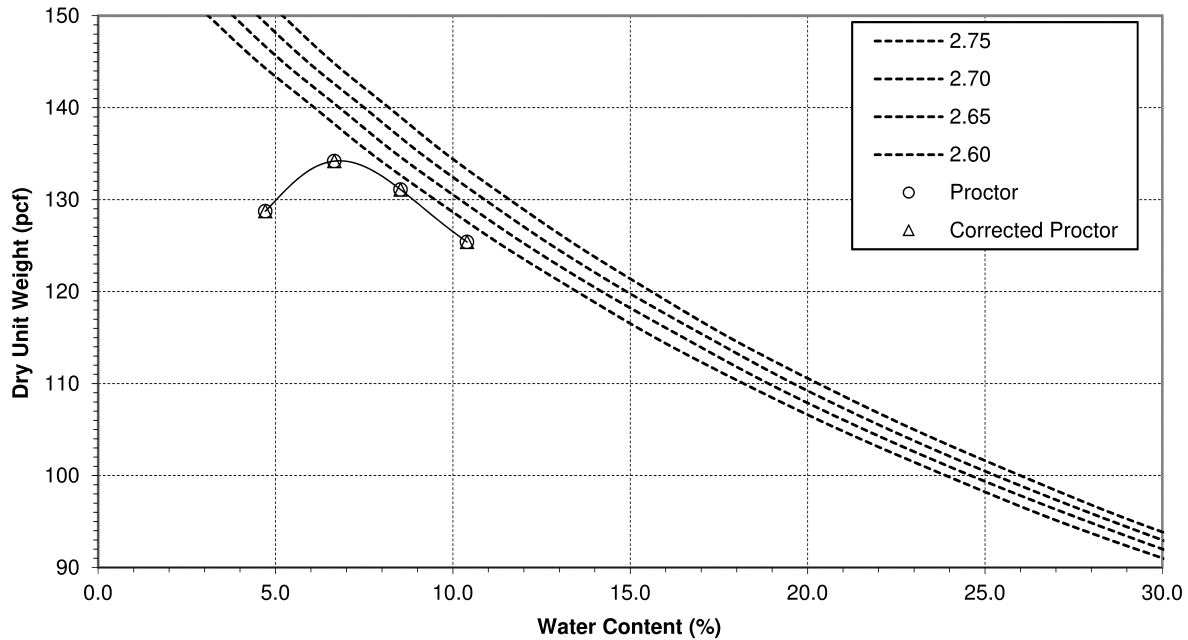
Tested on **4/16/2019** by **U. Panuncialman**
Material Description: **Brown silty clayey sand**
Location: **B2/S1 depth 0.5'-4'**

Test Method: ASTM D1557 B	Uncorrected	Corrected
Maximum Dry Unit Weight (pcf)	134.2	na
Optimum Water Content (%)	6.8	na
Oversize Fraction, retained on (%)		<5
Bulk Specific Gravity of Oversize Fraction		na

Rammer Type: Mechanical
Specimen Preparation: Moist
