Initial Study/Mitigated Negative Declaration

Via Verdi Slope Stabilization Project Richmond, CA

October 2019

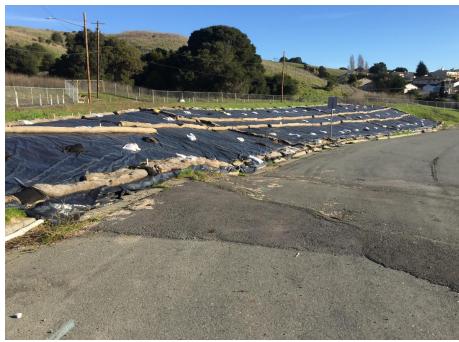
Photograph 14. Uneven condition of the existing Via Verdi roadway. Photo taken in January 2019.

As shown in the photos, the landslide was observable within the roadway as undulations/settlement with some cracking in the asphalt pavement and concrete sidewalk, with a vertical offset at the developing scarp¹ (**Appendix A**, Photos 9 and 10). In addition, there was damage to water, stormwater, and sewer utilities that required temporary repairs. By late March, the landslide scarp had become more pronounced and the pavement had settled up to several feet, with the pavement requiring frequent patching by the City to maintain the roadway driving surface.

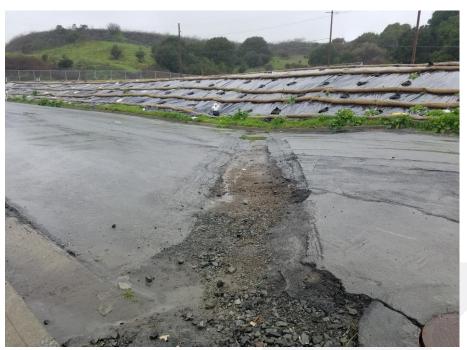
Photograph 15. Detail of existing Via Verdi and landslide conditions. Photo taken in January 2019.

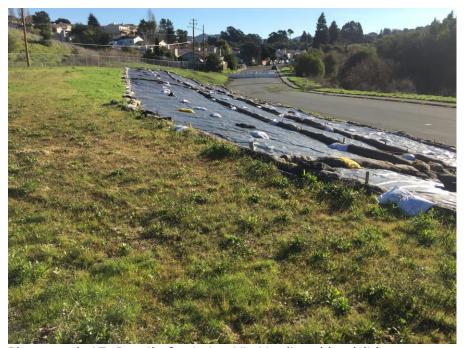
Photograph 16. Uneven condition of the existing Via Verdi roadway. Photo taken in January 2018.

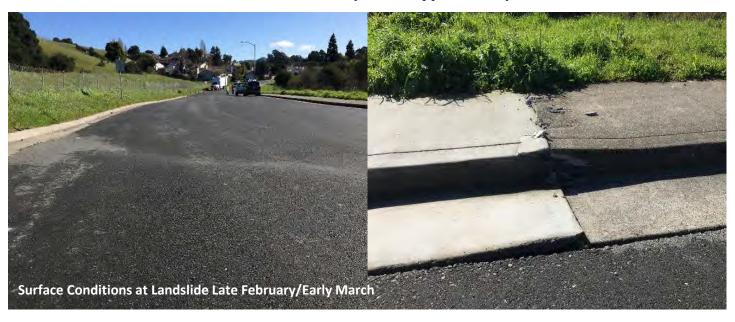
The landslide is within the Via Verdi roadway fill embankment with the top of the head scarp north or above Via Verdi extending in an arcuate shape from down through Via Verdi and into the creek bank. The landslide currently affects approximately 250 feet of the Via

Verdi roadway with the extent of the scarp approximately shown on the **Plate 1**, **Site Plan**. In late February the landslide was observable as undulations/settlement with some cracking in the asphalt pavement and concrete sidewalk as shown in the photos above with
