# **Redwood National and State Park Visitor Center and Restoration Project**

Initial Study/Proposed Mitigated Negative Declaration

11187543 | December 2019

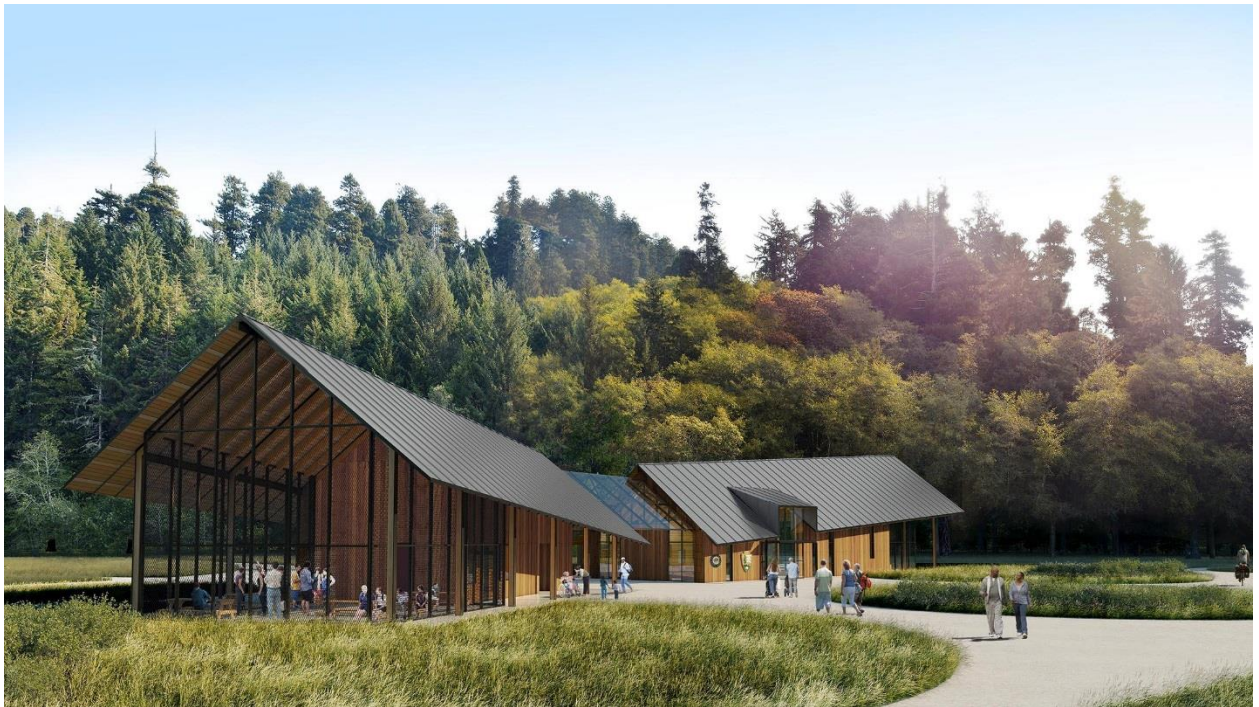
**Image 4.1-1: A digital representation of the Visitor Center (Save the Redwoods League 2018).**

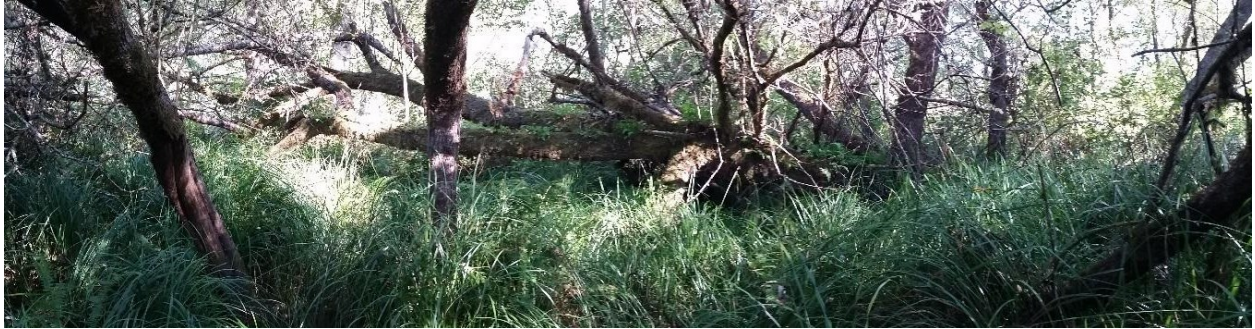
Figure 2a. Willow with slough sedge understory near the confluence of Prairie creek with Skunk Cabbage creek.

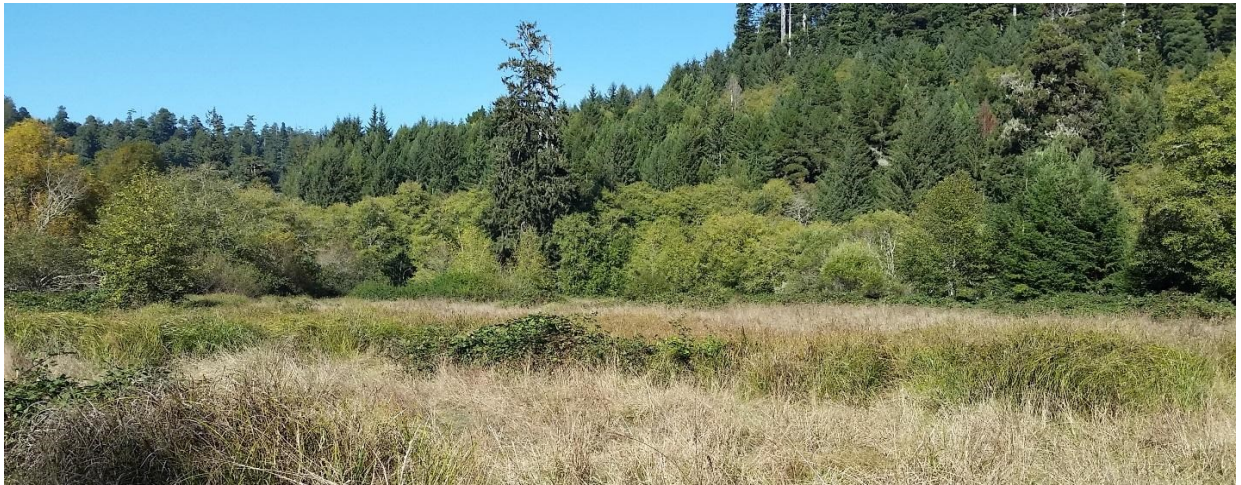
Figure 2b. North pasture-wetland complex: tall fescue in foreground, slough sedge wetland and a Sitka spruce, alder and willow forested wetland with a skunk cabbage and slough sedge understory.

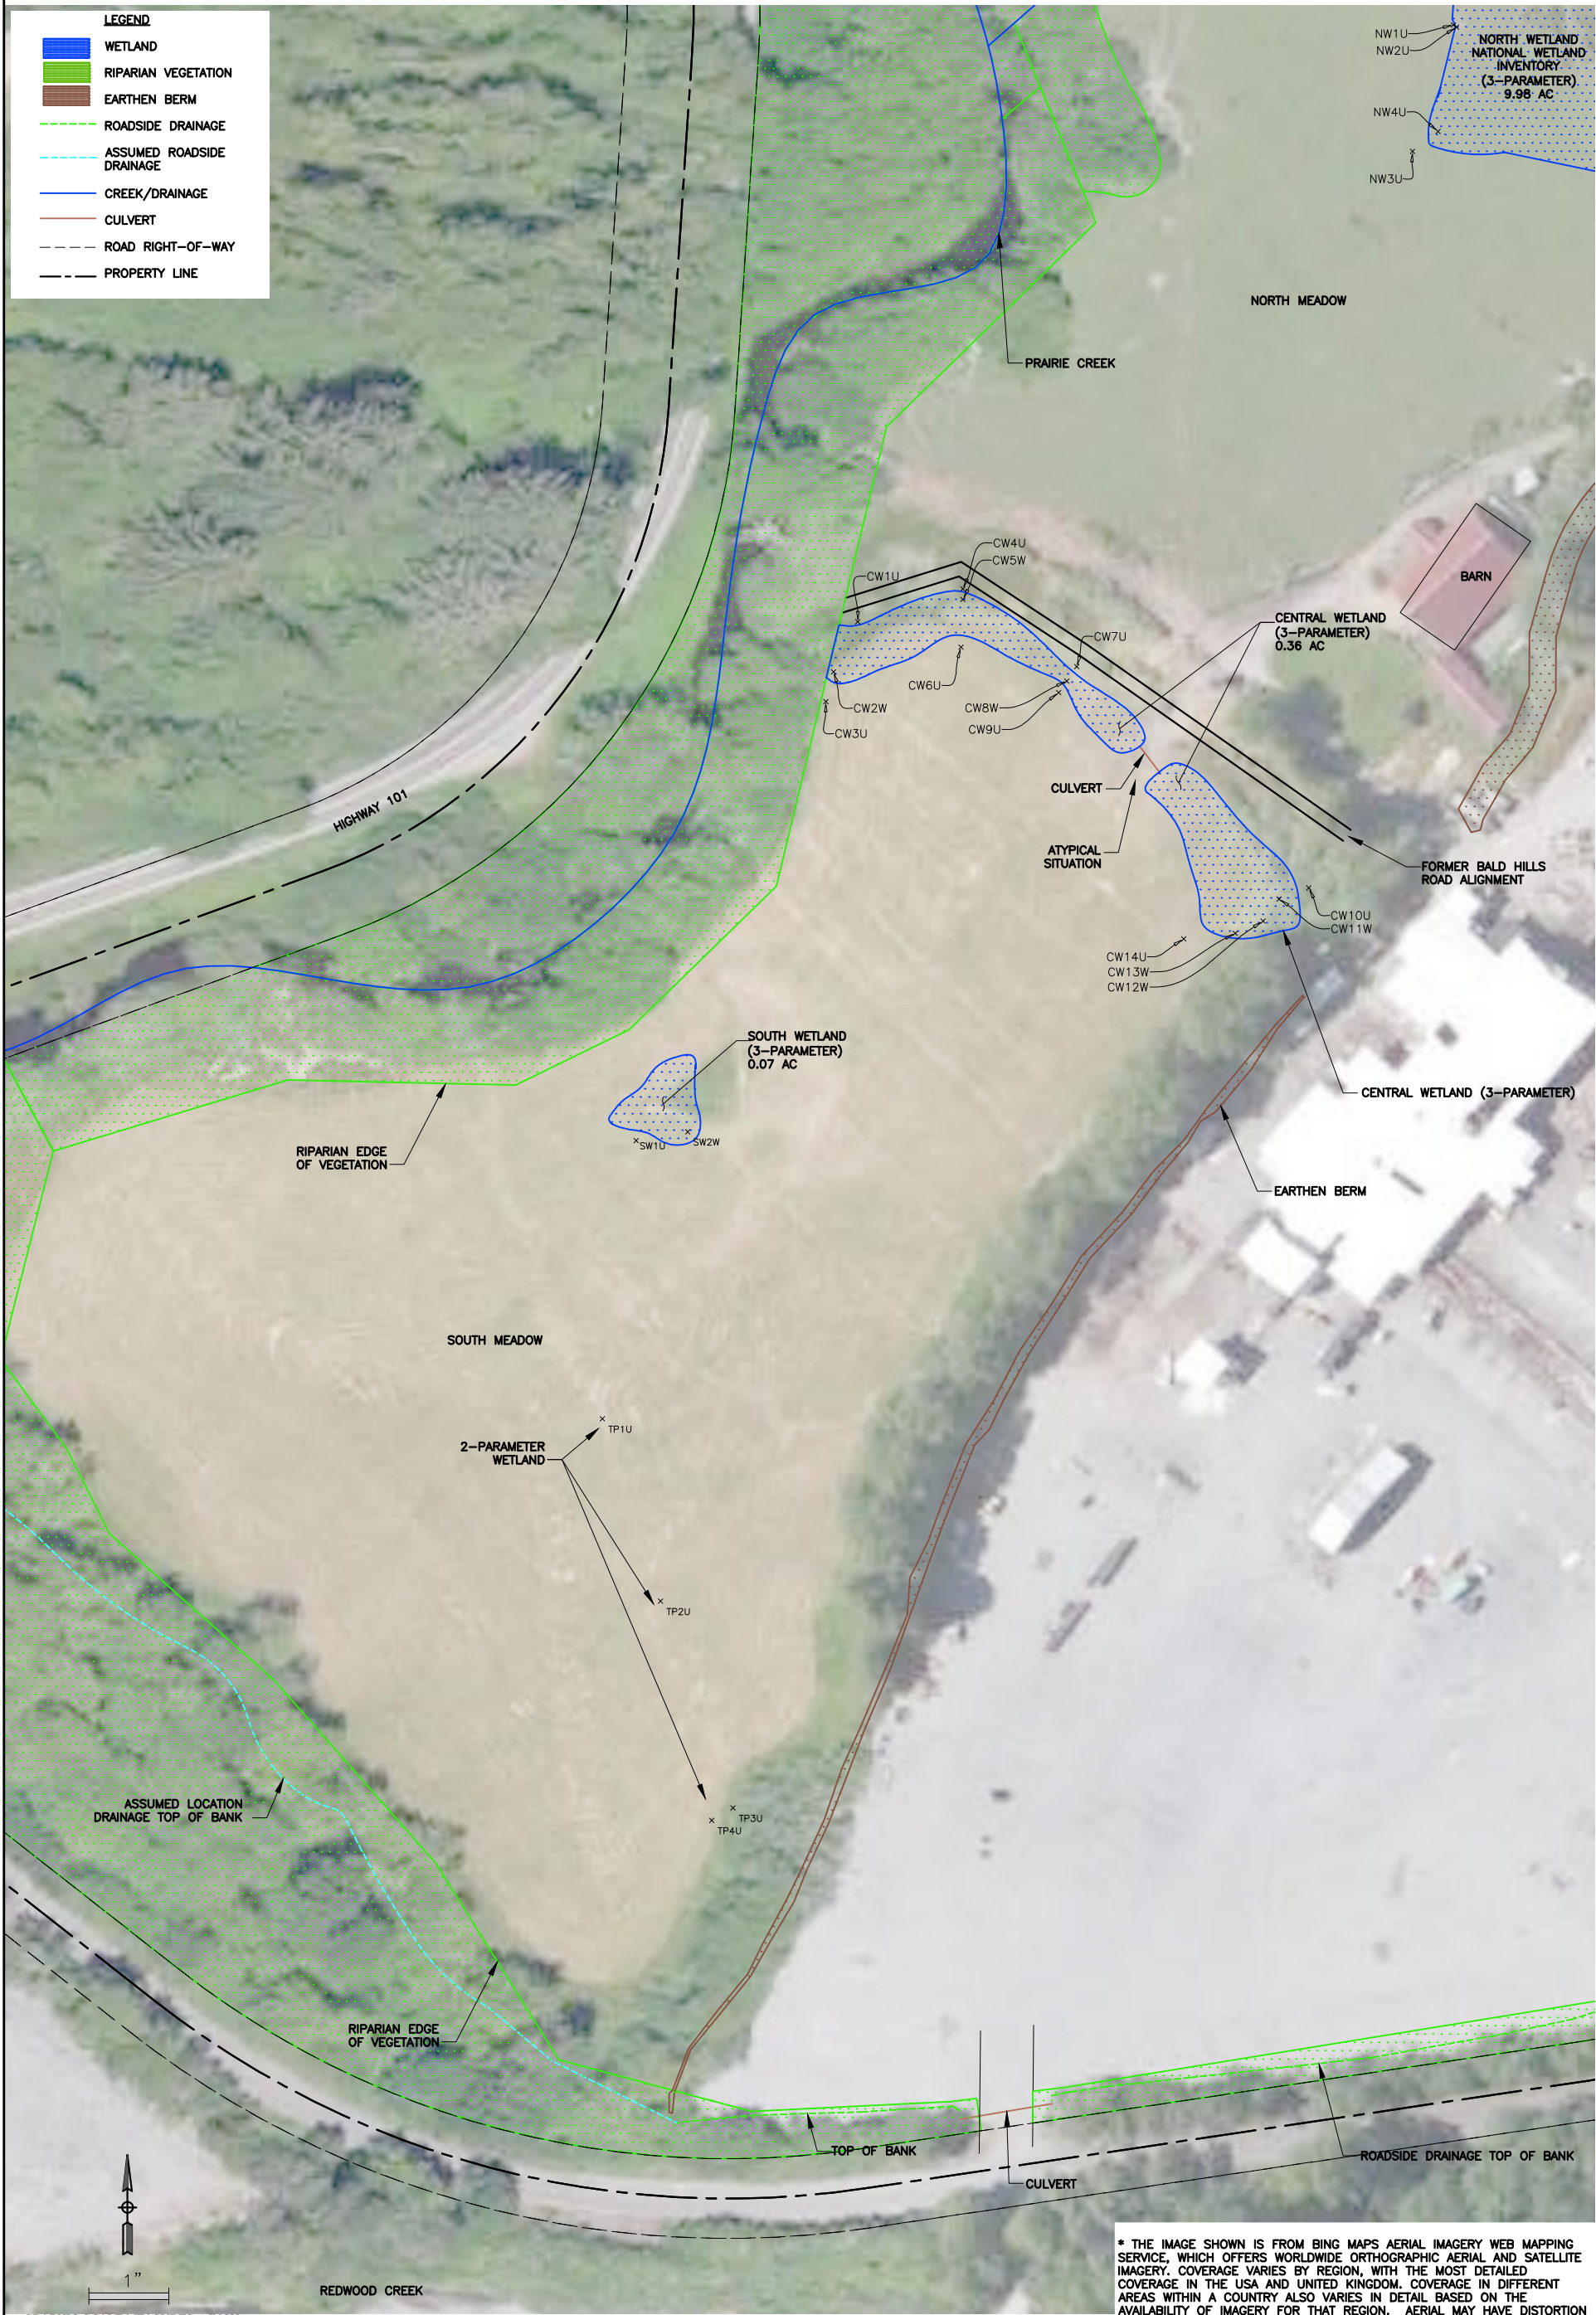
SCALE	1"=60'
DRAWN	JB
CHECK	MDN
APPVD	
DATE	03/27/12
JOB NO.	7291.08
FIGURE	5

**WETLAND DELINEATION REPORT**  
WETLAND PLOT MAP

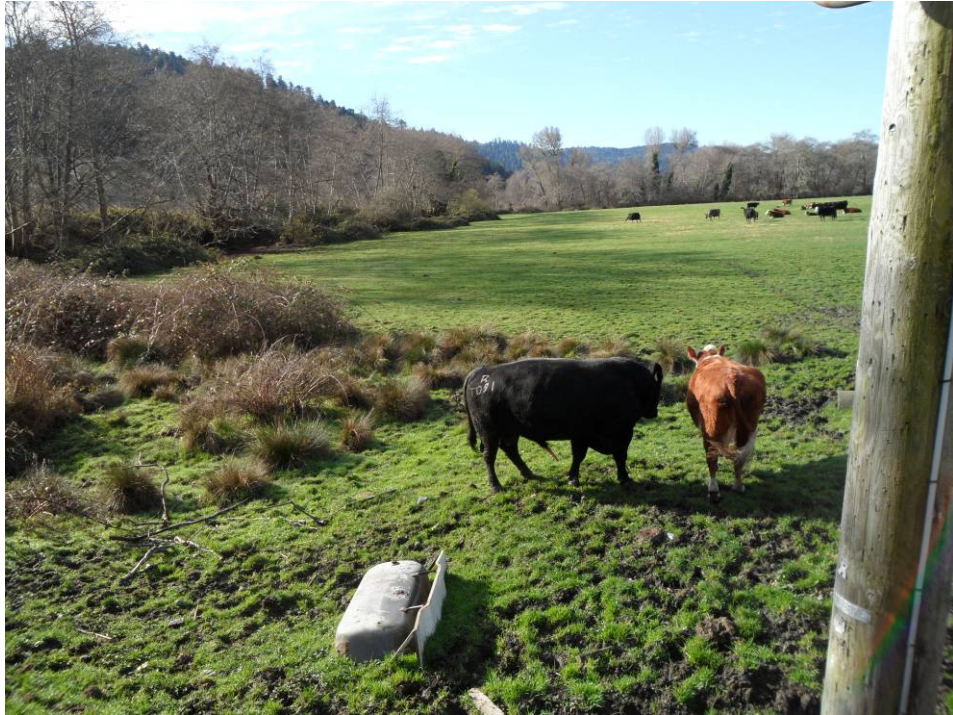
**Photo 3 - South entrance to grazing area. Note atypical situation due to cattle grazing and wetlands to the left.**

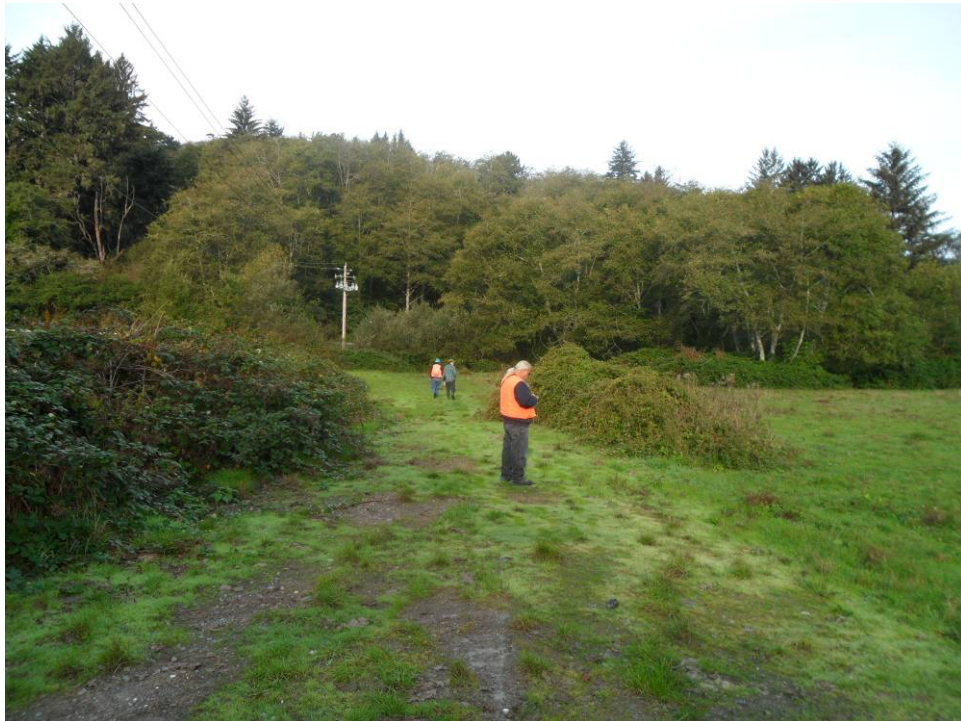
**Photo 4 - Remnants of old Bald Hills Road which washed out during the 1964 flood.**

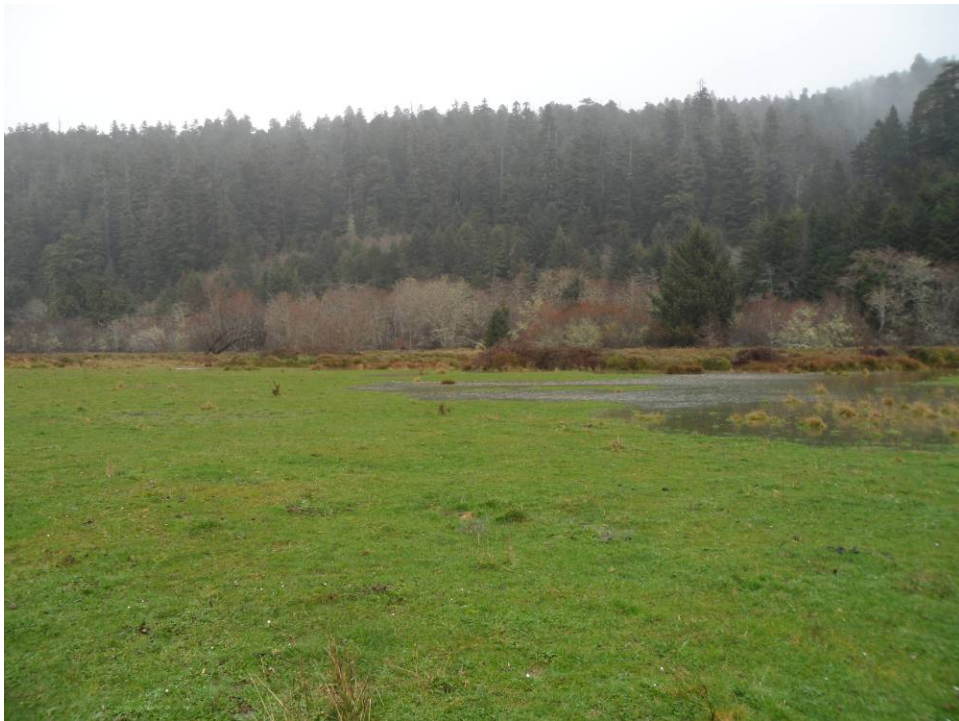
**Photo 8 – North Meadow after storm event of January 19, 2012**

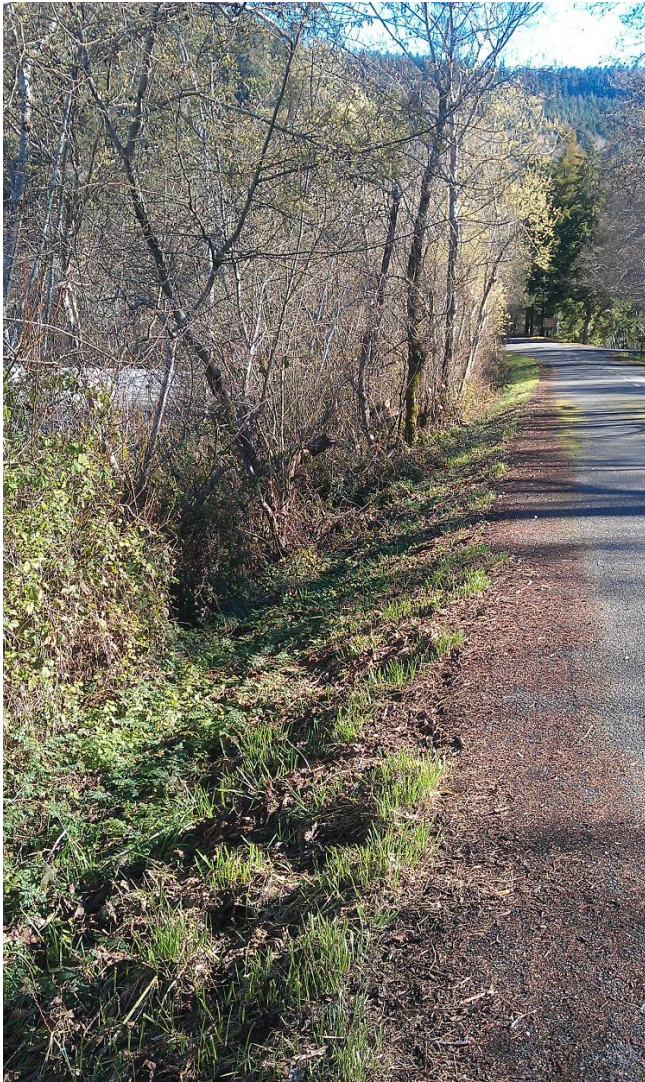
**Photo 9 - Drainage ditch along Bald Hills Road  
(Riparian)**

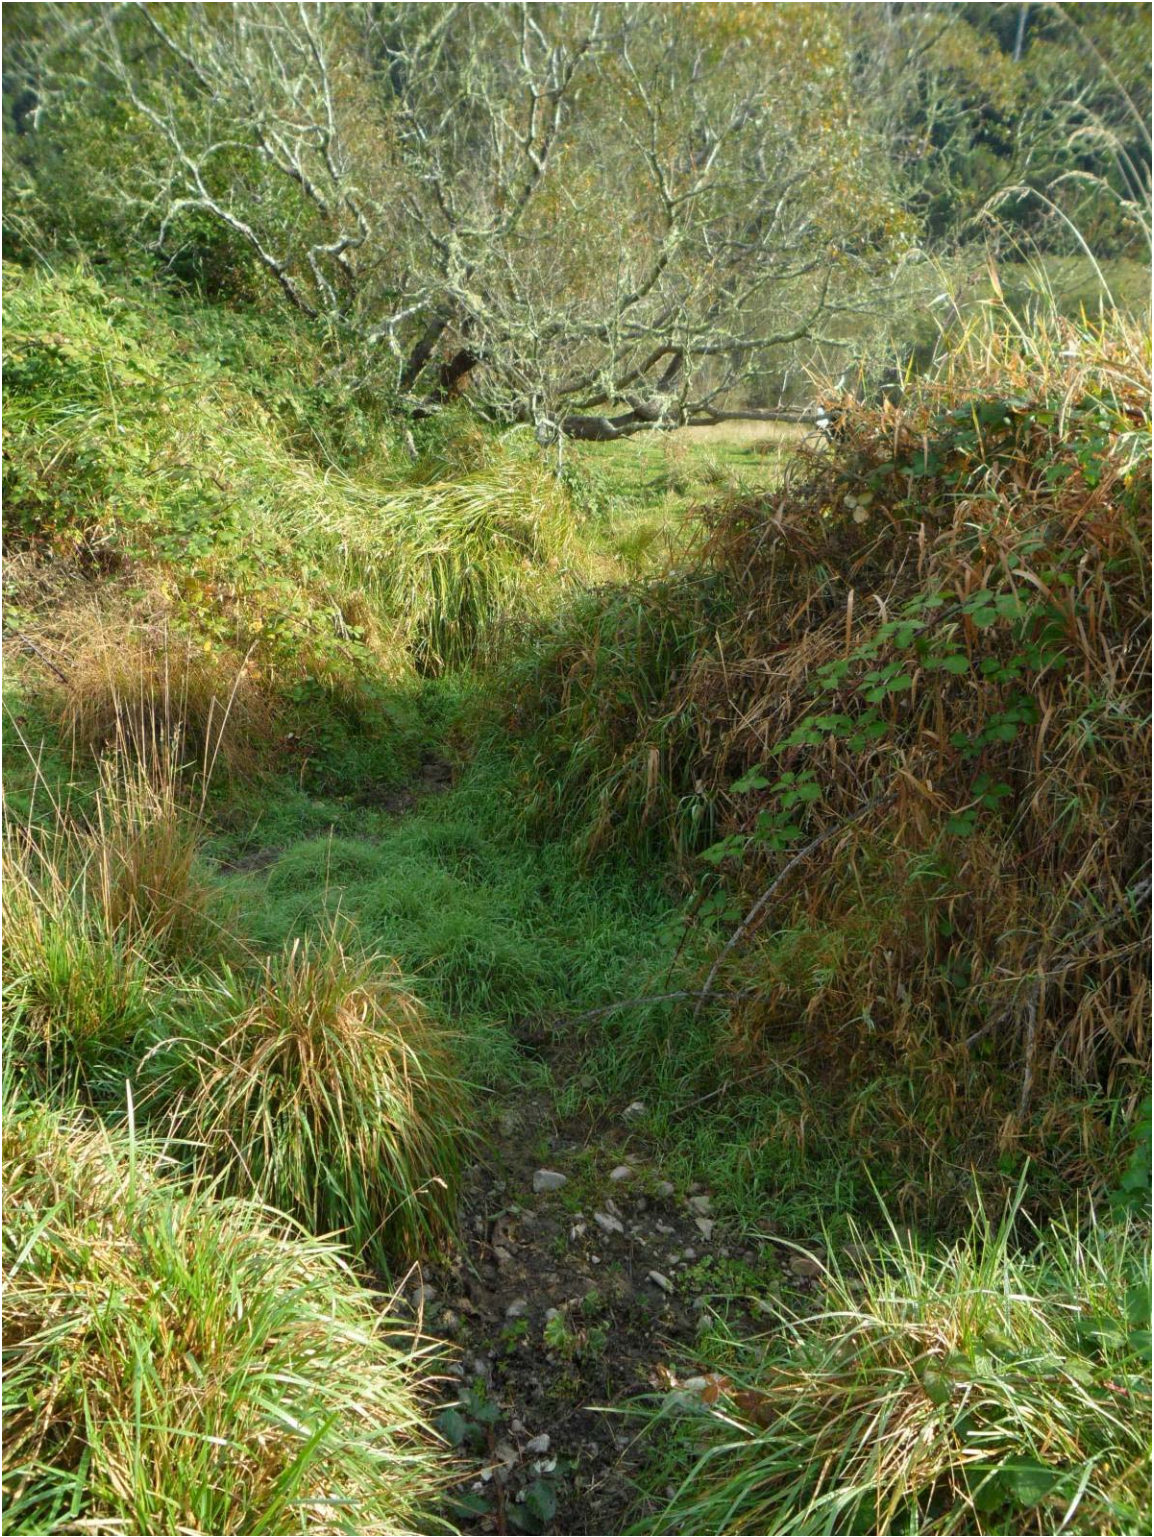
**Photo 11 - Typical 3-Parameter Wetland in North Meadow**

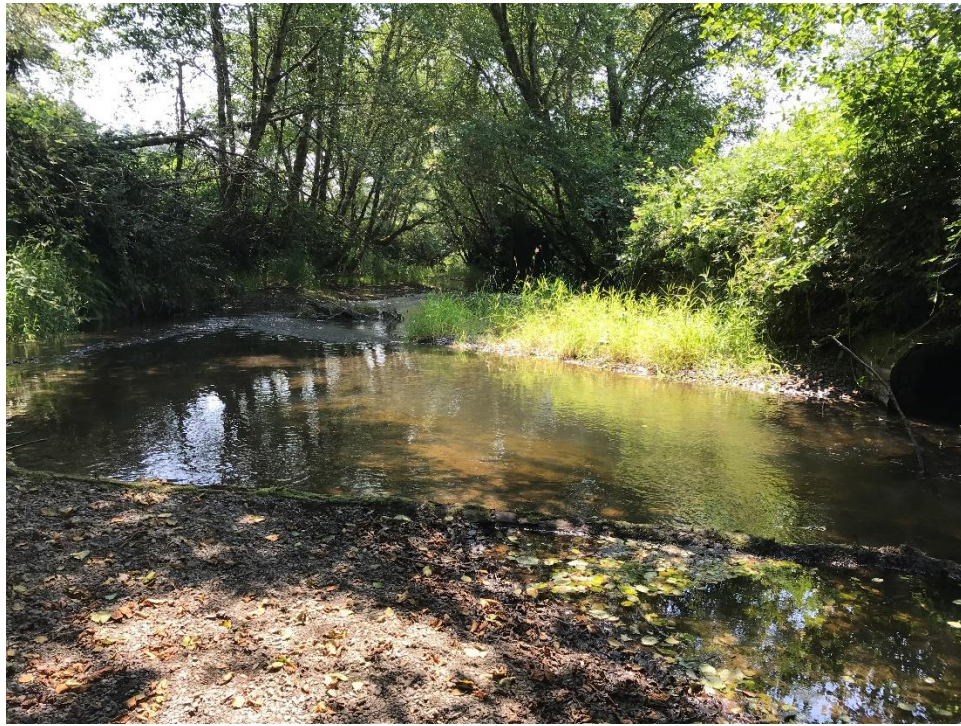
Figure 3. Point bar at RS 55+82.

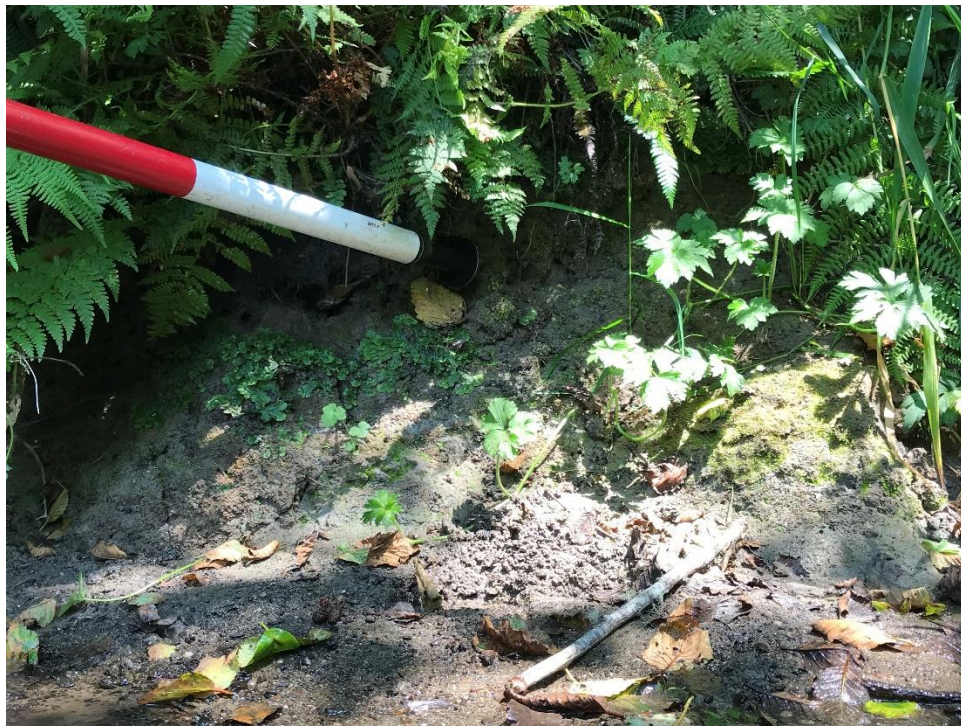
Figure 4. Change in vegetation on river left at RS 55+82.

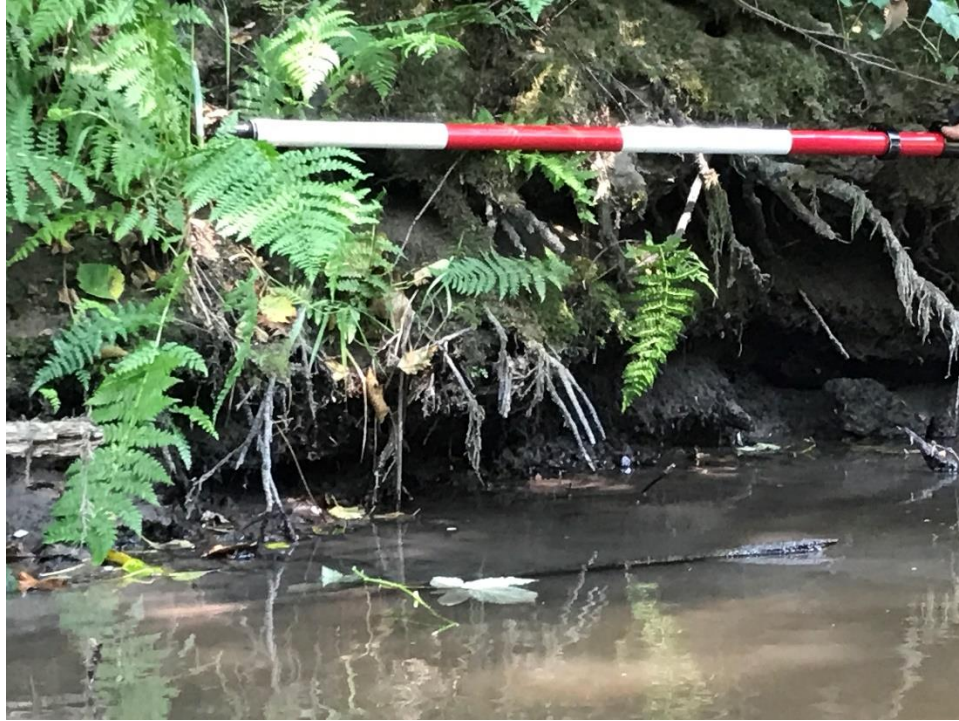
Figure 5. Exposed root hairs and on river left at RS 28+00.

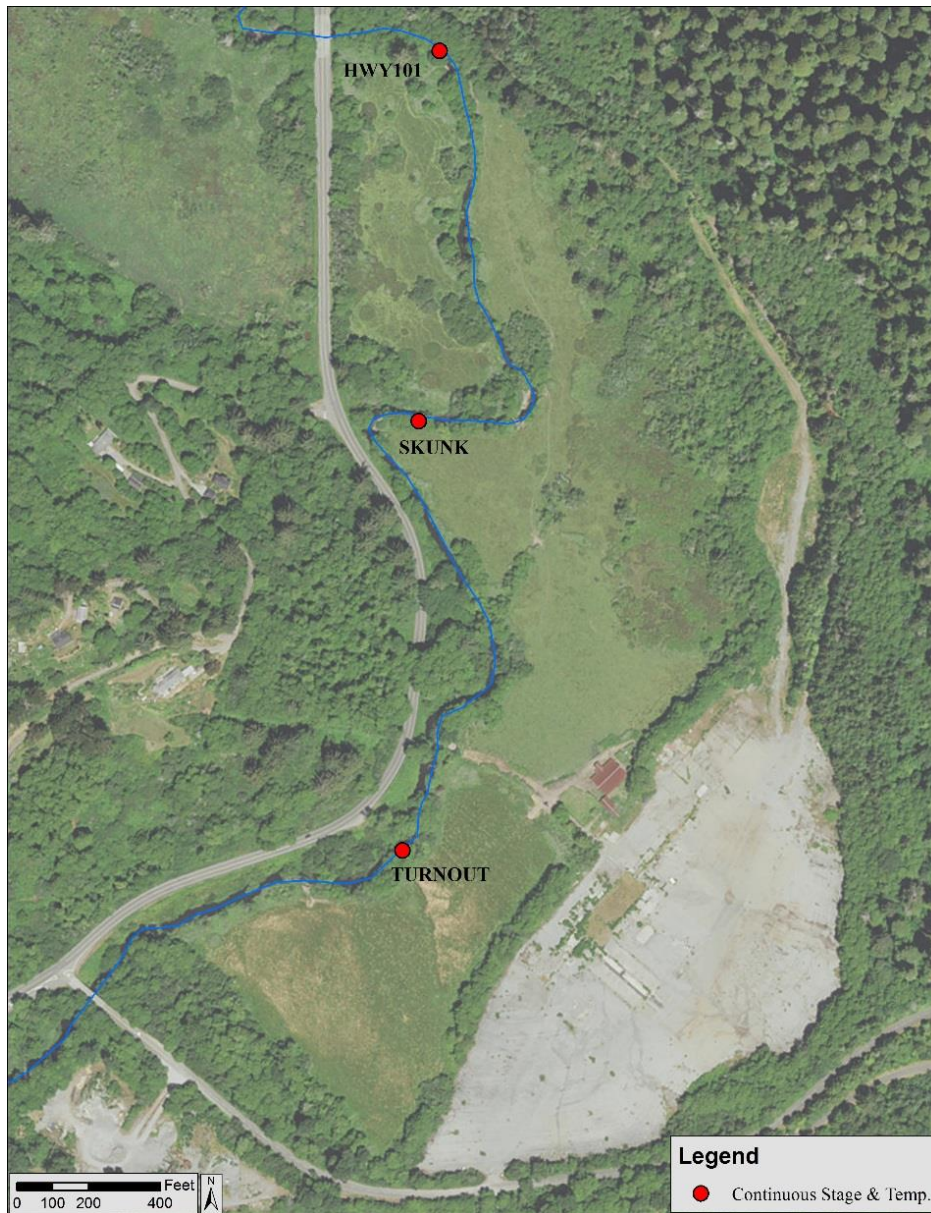
**Figure 10. Location of continuous water level loggers.**

Although NPS and others have collected streamflow data on the upper mainstem Prairie Creek and various tributaries for decades, flow data for lower Prairie Creek at or near the Project area were not collected historically (Vicki Ozaki, personal communication). NHE has collected water level information at three locations (HWY101, SKUNK and TURNOUT) on Prairie Creek within the Project area (Figure 10) since February 2015. Continuous water level data is collected at 15-minute intervals at all three sites. Discharge was measured at the upstream site (HWY101) to develop a stage-discharge rating that translates the water level record to a 15-minute discharge record. Additional depth, velocity and discharge measurements were collected within the Project area to better characterize site flow conditions and calibrate numerical models.

As part of the NHE sampling efforts, continuous water temperature has been collected at 15-minute intervals at HWY101, SKUNK and TURNOUT sites (Figure 10) since February 2015. This temperature information provides three continuous WYs of water temperatures and four years of summer MWAT and MWMT values at each sampling site within the Project area. The continuous water temperature data at all three sampling sites is summarized in Table 8, and the continuous mean weekly average temperatures at each site is shown in Figure 25. The maximum value each year in Figure 25 would be the MWAT value.

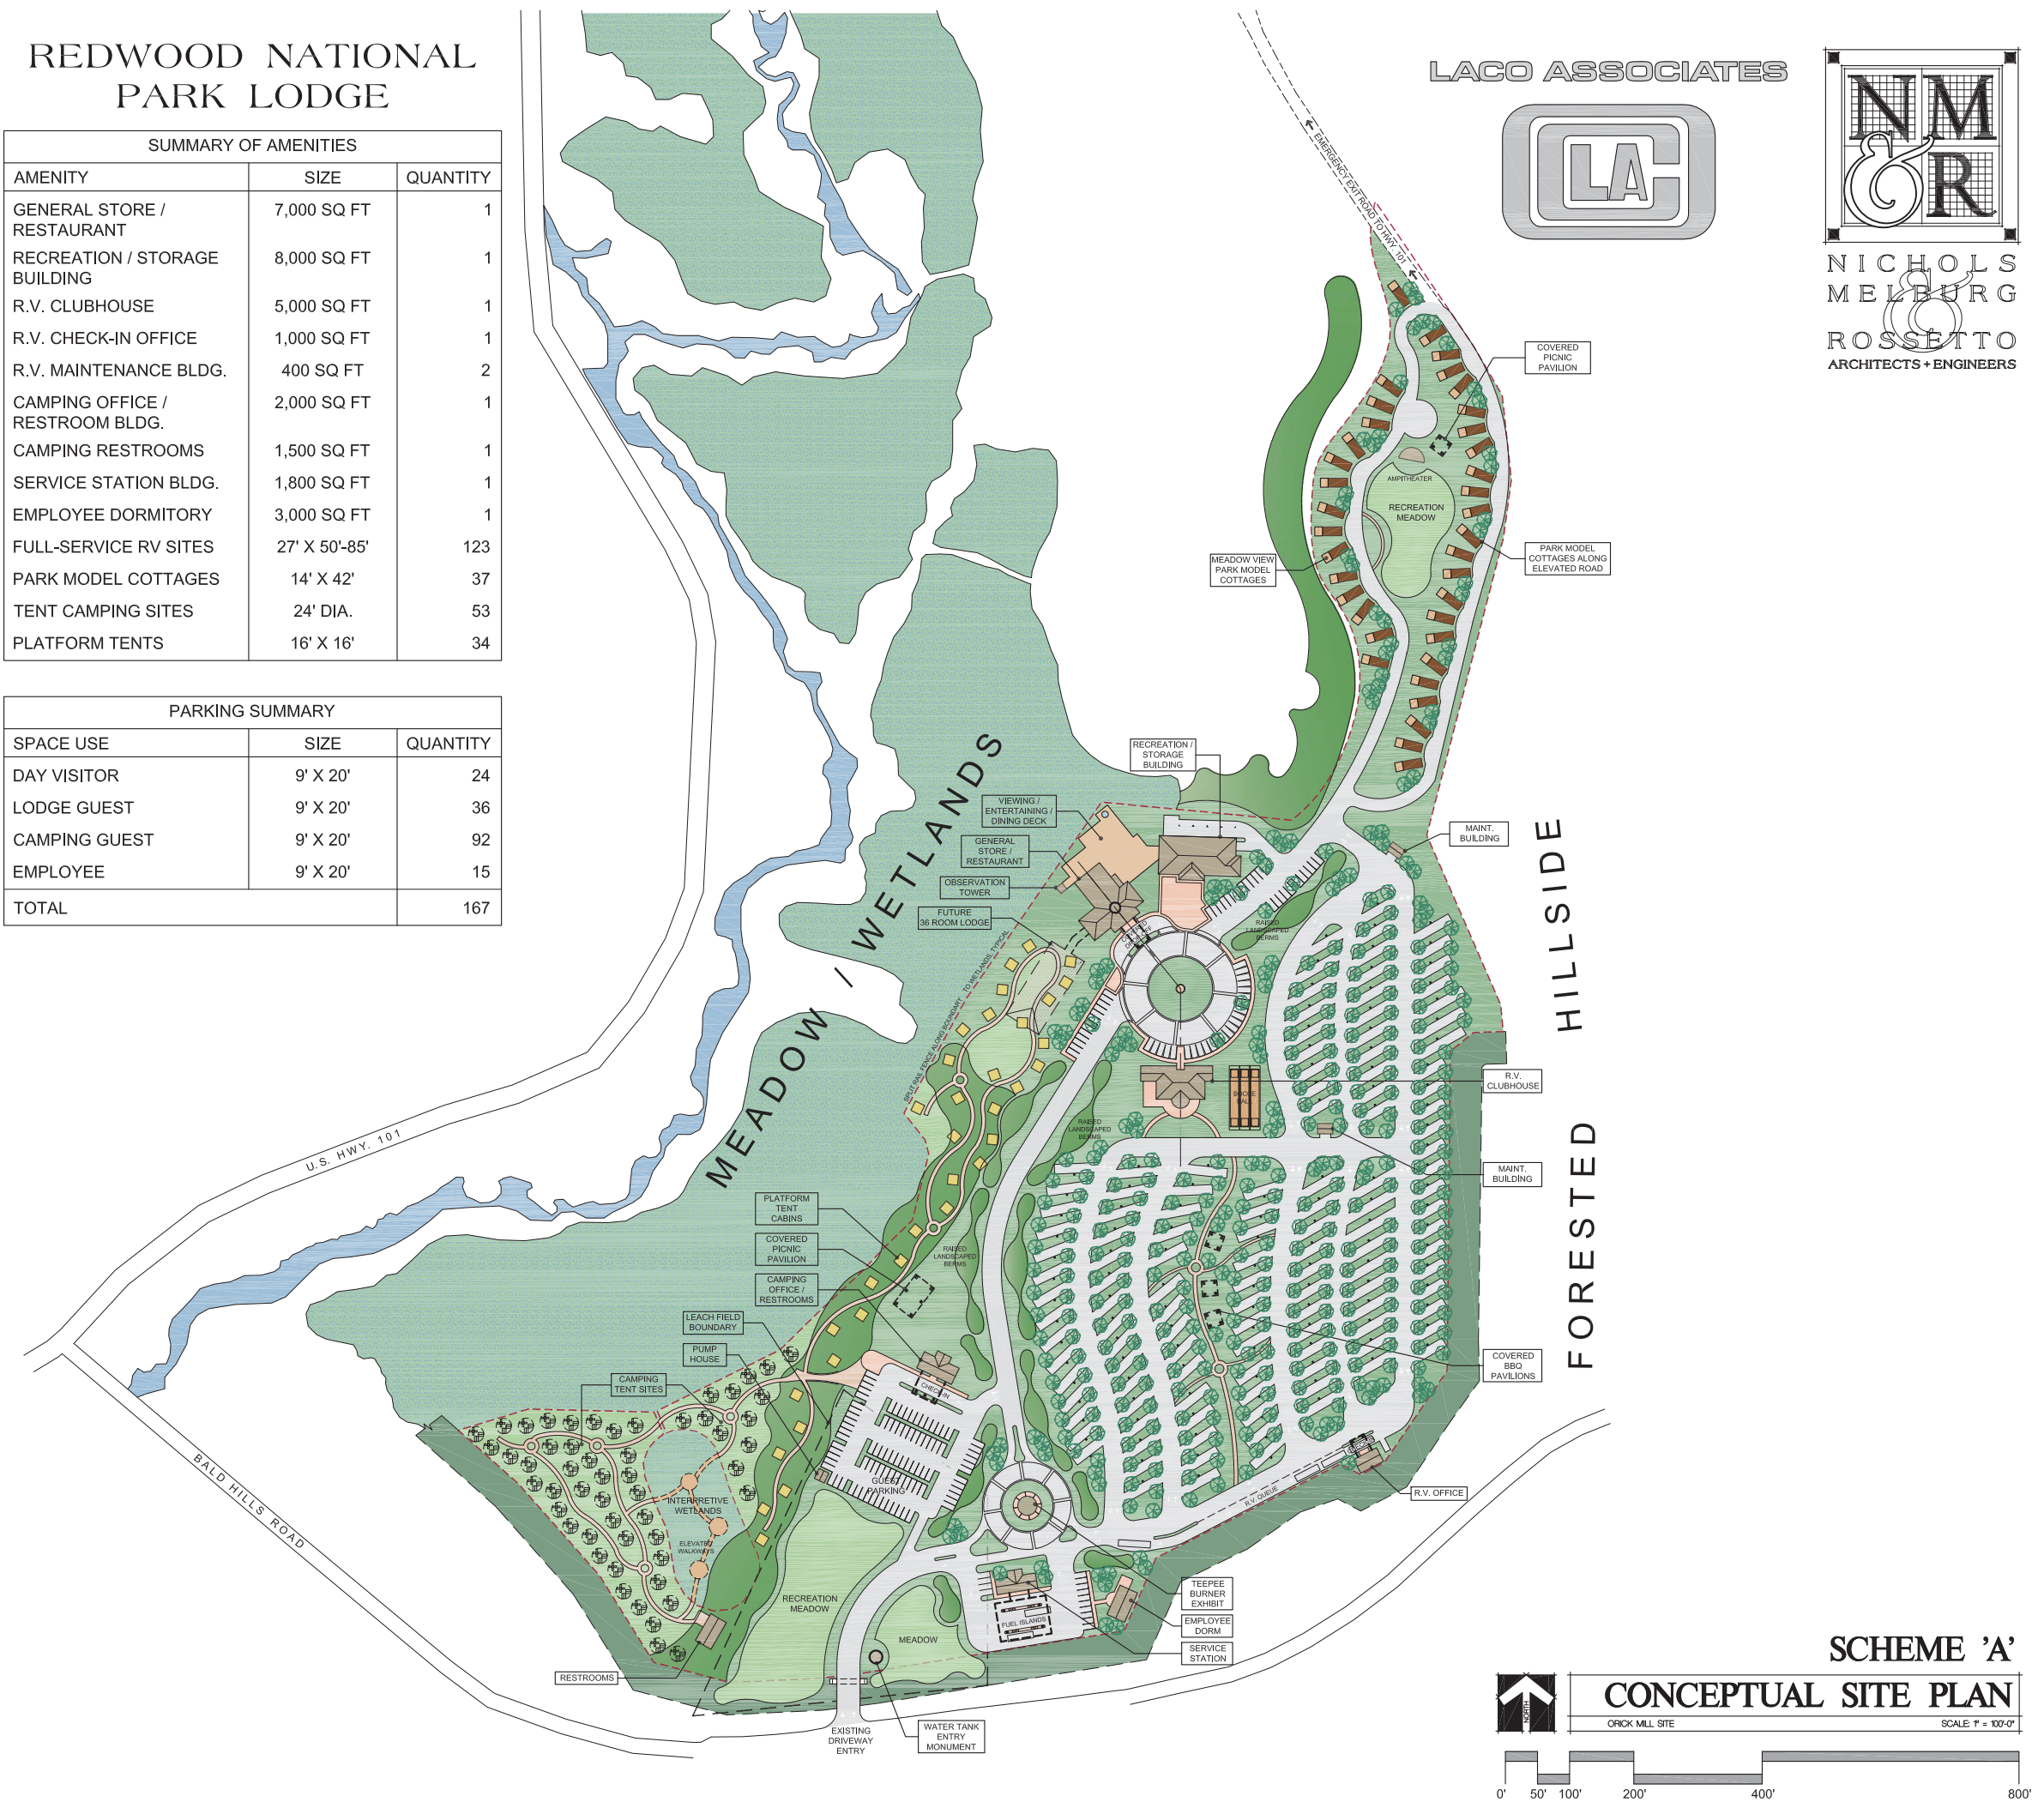
SUMMARY OF AMENITIES		
AMENITY	SIZE	QUANTITY
GENERAL STORE / RESTAURANT	7,000 SQ FT	1
RECREATION / STORAGE BUILDING	8,000 SQ FT	1
R.V. CLUBHOUSE	5,000 SQ FT	1
R.V. CHECK-IN OFFICE	1,000 SQ FT	1
R.V. MAINTENANCE BLDG.	400 SQ FT	2
CAMPING OFFICE / RESTROOM BLDG.	2,000 SQ FT	1
CAMPING RESTROOMS	1,500 SQ FT	1
SERVICE STATION BLDG.	1,800 SQ FT	1
EMPLOYEE DORMITORY	3,000 SQ FT	1
FULL-SERVICE RV SITES	27' X 50'-85'	123
PARK MODEL COTTAGES	14' X 42'	37
TENT CAMPING SITES	24' DIA.	53
PLATFORM TENTS	16' X 16'	34

PARKING SUMMARY		
SPACE USE	SIZE	QUANTITY
DAY VISITOR	9' X 20'	24
LODGE GUEST	9' X 20'	36
CAMPING GUEST	9' X 20'	92
EMPLOYEE	9' X 20'	15
TOTAL		167

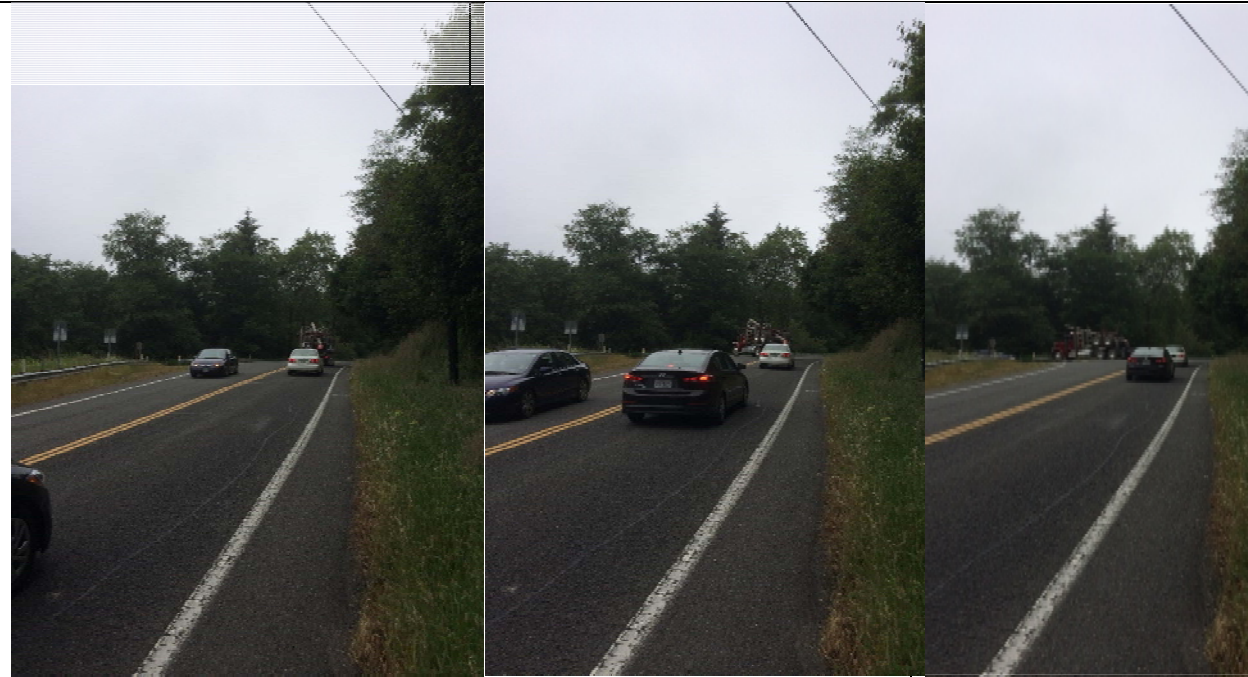
1-A truck stopped at the intersection to make a left turn to Bald Hills RD. Then a car had to stop behind it waiting for the truck.

2- Another car approached and stopped in the highway

- Short term: Reducing the speed in the affected area, installing warning sign informing drivers of possible stopped or slowed vehicles in the southbound 101.
- Long term: Left-turn channelization in southbound highway 101

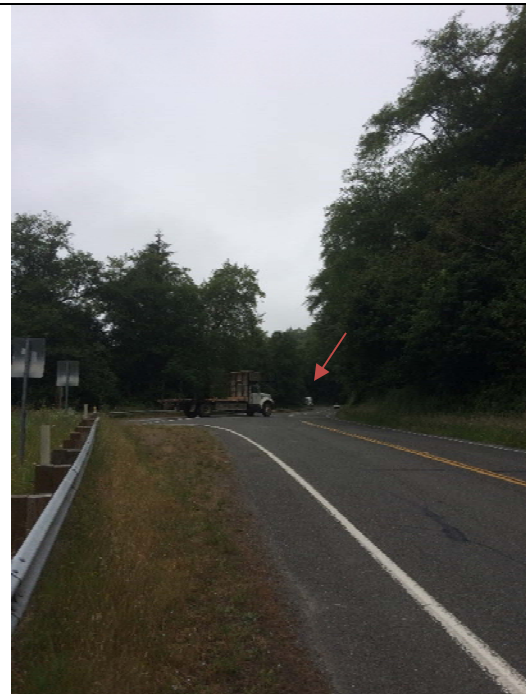
Drivers does not have enough sight distance to predict the available gap time and should go up the slope.

- Improve the sight distance visibility in northbound highway 101 to reach to the recommended values.

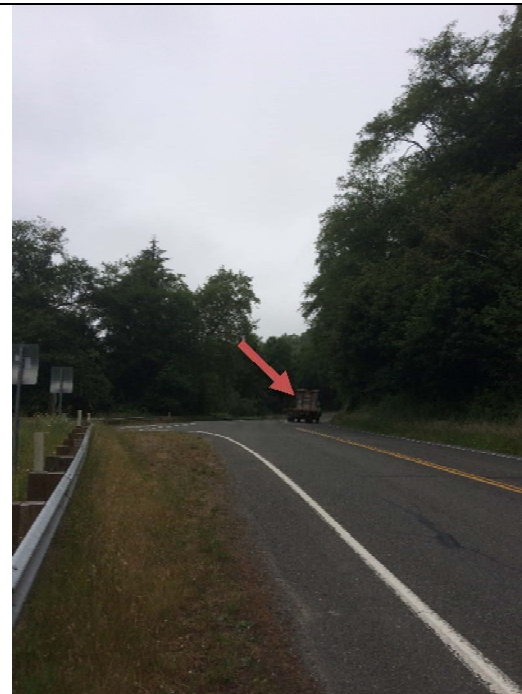
The northbound truck is almost reaching the turning truck when the turn is fully done.

View looking south through Highway 101 to study intersection

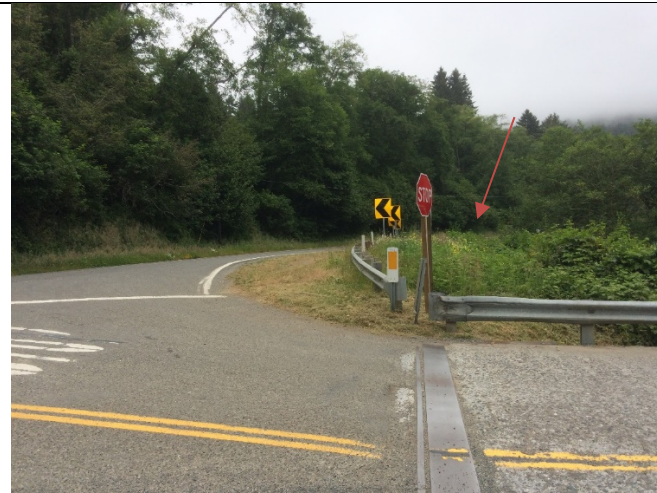
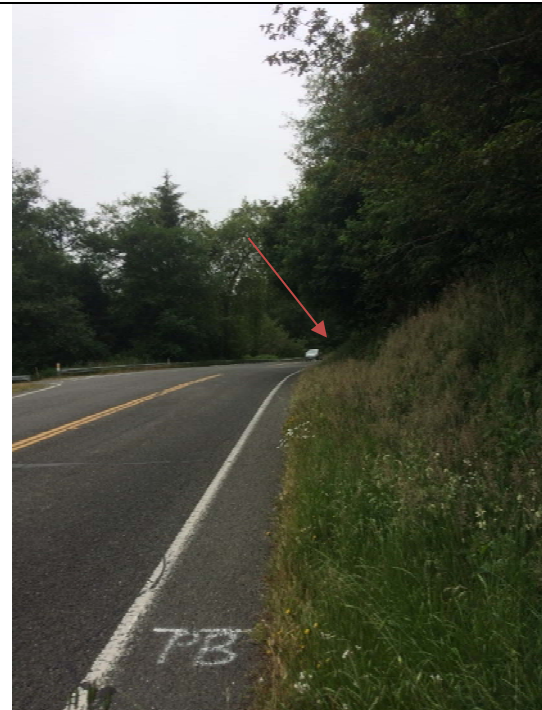
Fast growing vegetation in combination with the road slope and curve effect degrade the existing sight distance in northbound and southbound 101.

View looking north from Bald Hills Road

- Improve the sight distance visibility by trimming/removing vegetation.

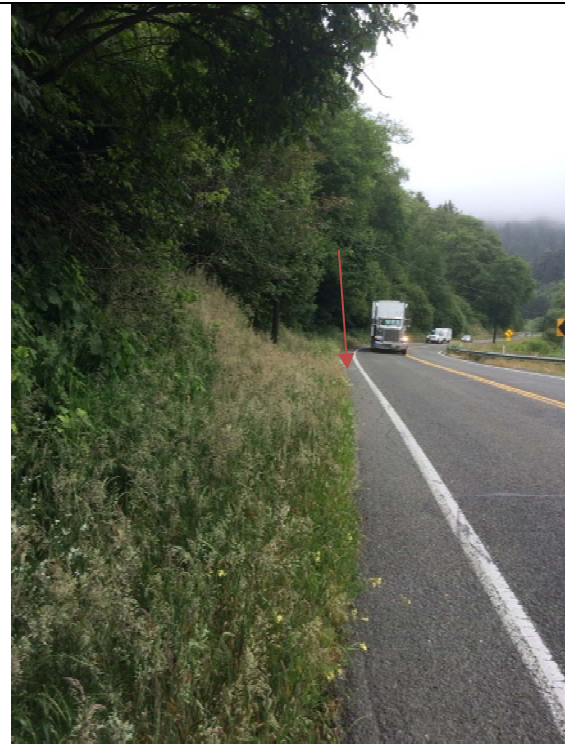
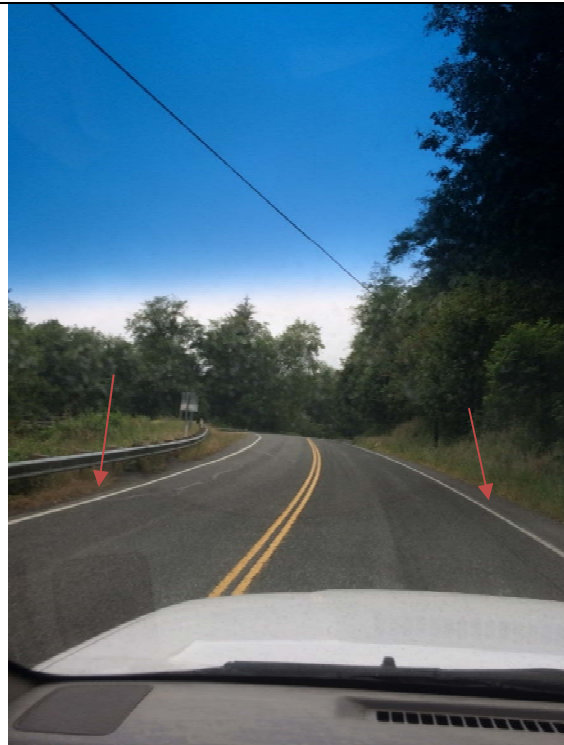
Narrow shoulders –pedestrian safety Intersection visibility

View looking north through Highway 101

- Shoulder widening to meet the minimum requirements.
