**CITY OF MALIBU  
NOTICE OF INTENT TO ADOPT  
A MITIGATED NEGATIVE DECLARATION**

**Project Title** Malibu Jewish Center & Synagogue

**Application Nos.** Initial Study No. 18-001, Mitigated Negative Declaration No. 18-001, Coastal Development Permit No. 14-069, Conditional Use Permit No. 16-005, Variance Nos. 14-050, 14-051 and 16-009, Site Plan Review No. 14-050, and Sign Permit No. 16-006

**Project Description:** An application to remove four modular buildings and redevelop the site with a two-story, 16,410 square foot classroom/administration building with two subterranean levels, one for 28 parking spaces and the second for storage, construct a new synagogue building with 2,013 square foot of above-ground floor area and a basement, redevelop the existing surface parking lot to improve internal circulation and parking, habitat restoration program for Puerco Canyon Creek to be integrated with ongoing fuel modification activities and remove two protected native trees (western sycamore trees), including a conditional use permit for the expansion of the existing religious facility, variances for the required parking spaces and parking space dimensions, construction within the Env

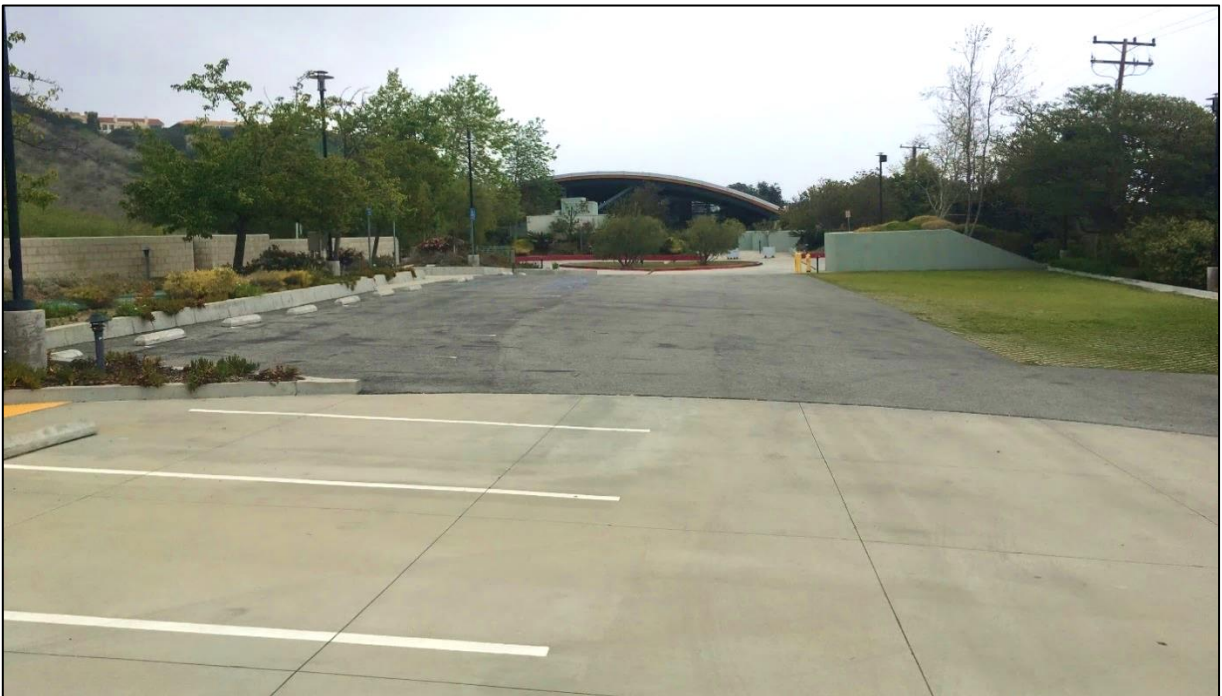
**Photo 2.** A surface parking lot lies south of the modular buildings fronting PCH. A 28-foot-tall temple/event building and two support structures are located at the east side of the site. This building features an arched roof that dips to the north and south, and covers a central interior area flanked by two patios.

The existing temple/event building and two support structures at the east side of the level graded hilltop encompass approximately 5,305 sf of floor area. The existing temple/event building features a central, glass-walled interior flanked by two outdoor patios to the west and east. The building and patios are under an arched roof that dips lower on the north and south. A small amphitheater with bench seating is adjacent to the east patio. A landscaped berm, glass walls, and support buildings wrap around the north and east sides of the building and patios. Outdoor speakers at the patios are directed downward to minimize noise carrying to nearby properties.

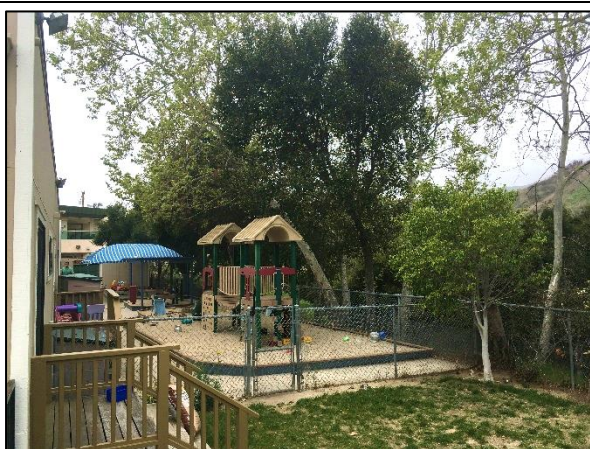
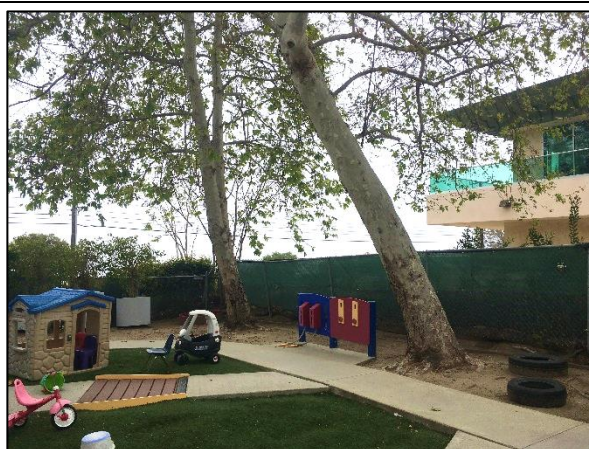
**Photos 3 & 4.** An estimated 21 protected trees species, including California Black Walnut, Coast Live Oaks, and Western Sycamores are planted within and adjacent to existing development, including trees that overhang a playground that would be retained by the project (pictured left). Two protected Western Sycamores (pictured right) would be removed to accommodate the proposed two-story building.

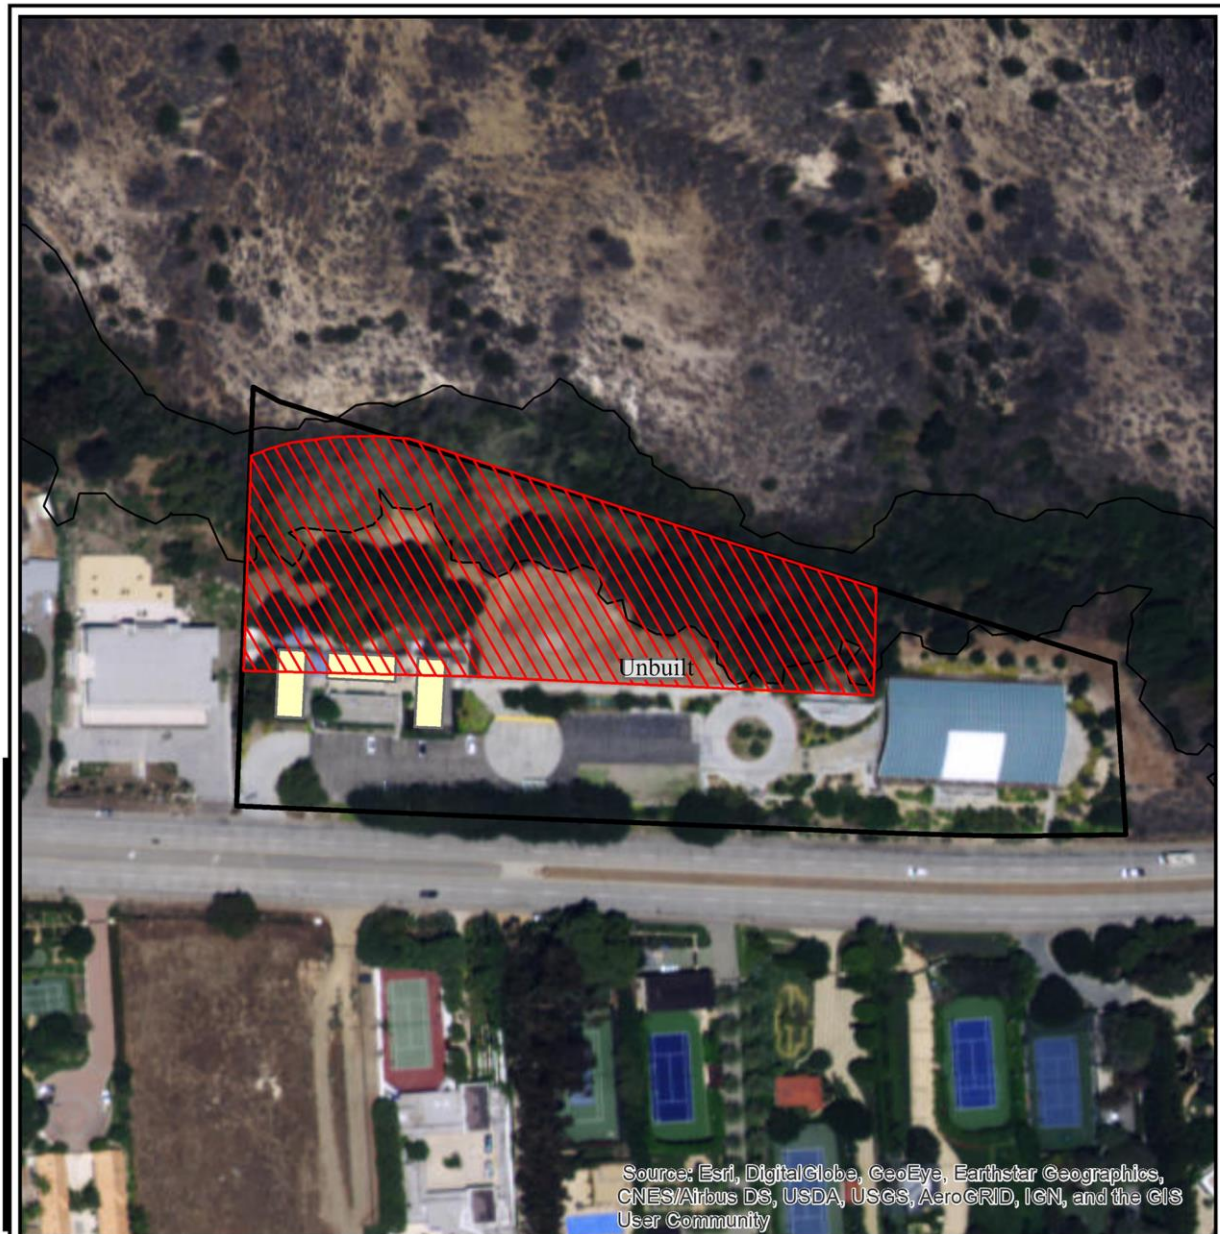
**Figure 2 – Project Site and Project Footprint**

**Project Site and Building Footprint**

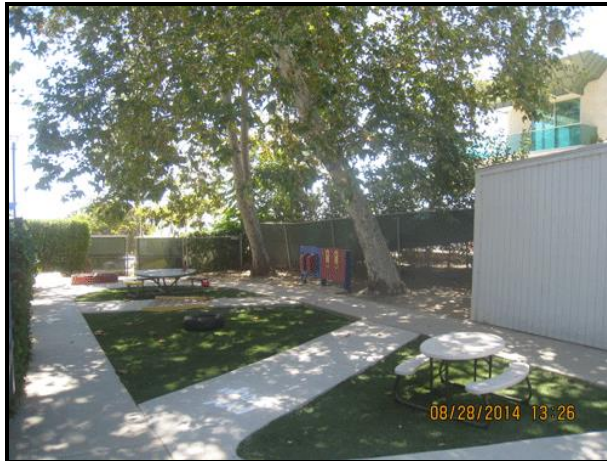
*Photo 1 (left): Trees 1 & 2, Western Sycamore (Platanus racemosa) existing in the toddler playground on the west edge of the property, required for removal.*

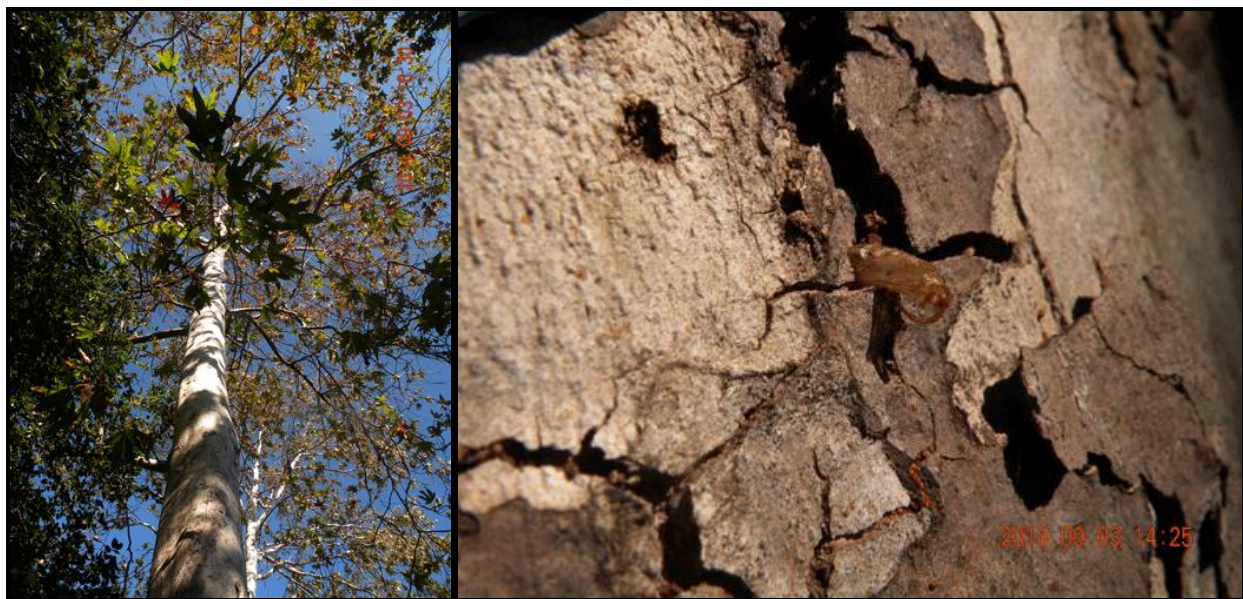
*Photo 5 (left): Tree #13, Western Sycamore (Platanus racemosa), in generally good condition with sound trunk but somewhat sparse canopy.*

*Photo 6 (right): Tree #2, Western Sycamore (Platanus racemosa), bark borer insect molt and some frass visible on the trunk..*

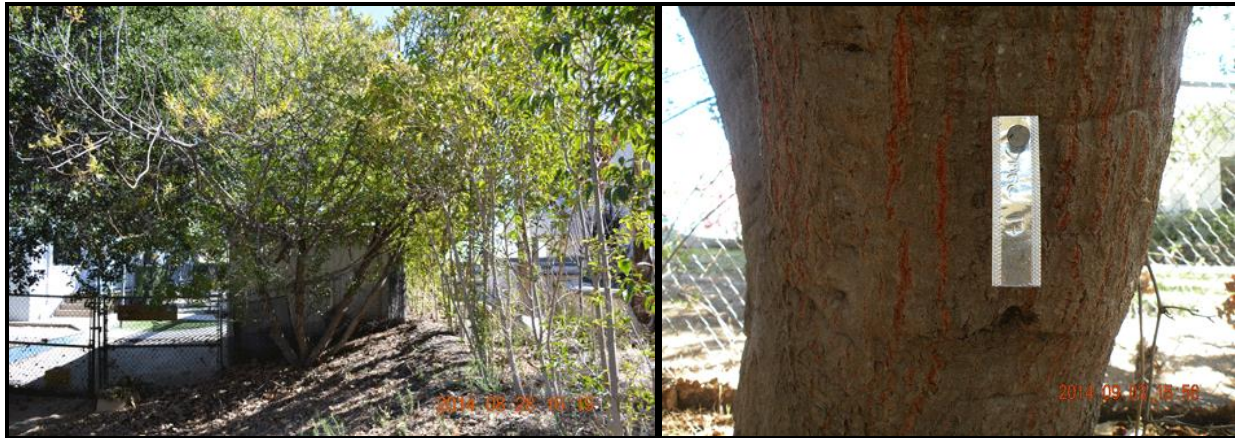
*Photo 7 (left): Tree #3, Southern California Black Walnut (Juglans californica), in generally good condition near the northwest corner of the proposed project footprint.*

*Photo 8 (right): Tree #17, Coast Live Oak (Quercus agrifolia), DMEC assigned number tag and trunk with significant new growth visible.*

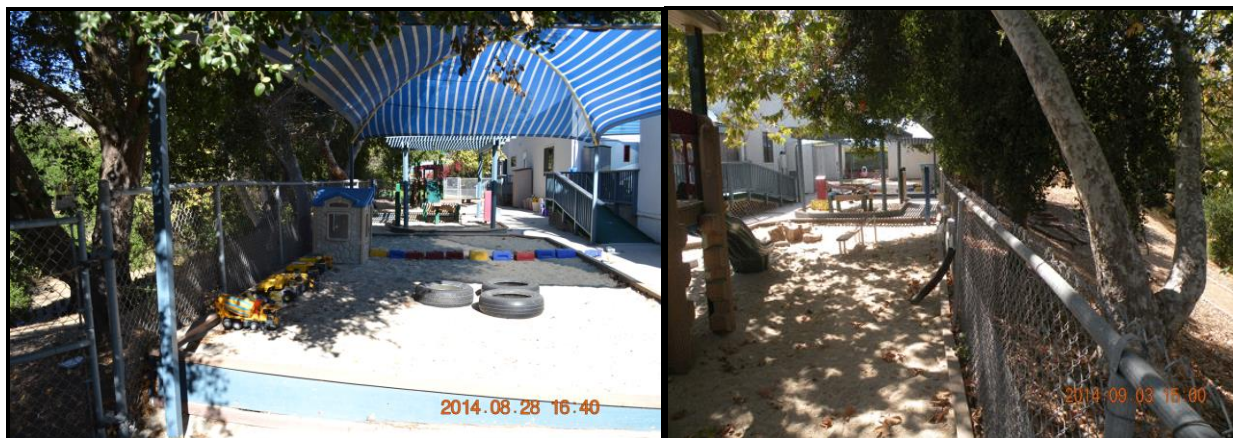
*Photo 9(left): View east from near the northwest corner of the proposed project footprint of playground and sandbox area to be preserved. Photo 10(right): View west from north of the proposed project footprint of playground and sandbox area to be preserved.*

Mark Meyer of David Lawrence Gray Architects indicated that the playground area, lawn, and sandboxed north of the current facilities are to remain in place during construction of the proposed project (Photos # 9 & 10). Retention of these features should provide protection against significant impacts to the remaining sixteen (16) trees existing north of the proposed project footprint. Significant impacts to these trees are only expected if substantial alteration of the surface occurs within the TPZ. These trees are well adapted to their current location and the current extent of impervious surfaces and compacted soils that exist within the playground, lawn, and sandbox areas north of the current facilities.

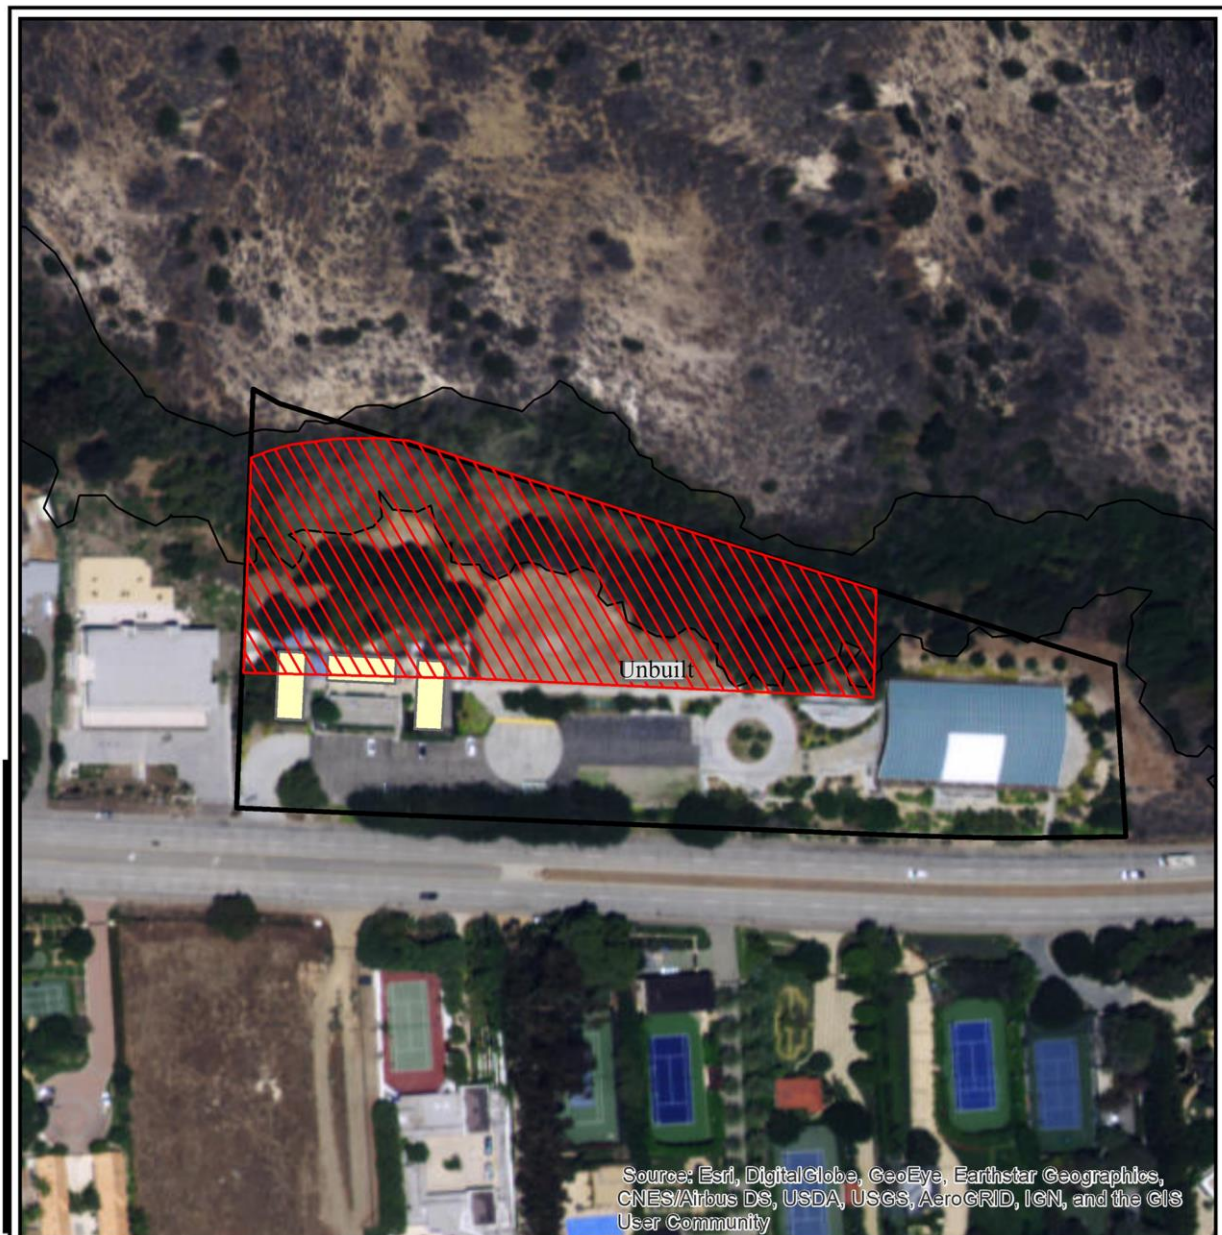
**Figure 2 – Aerial Photograph of the Malibu Jewish Center Property**

### Project Site and Building Footprint

- Existing Buildings
- Malibu Jewish Center & Synagogue Parcel

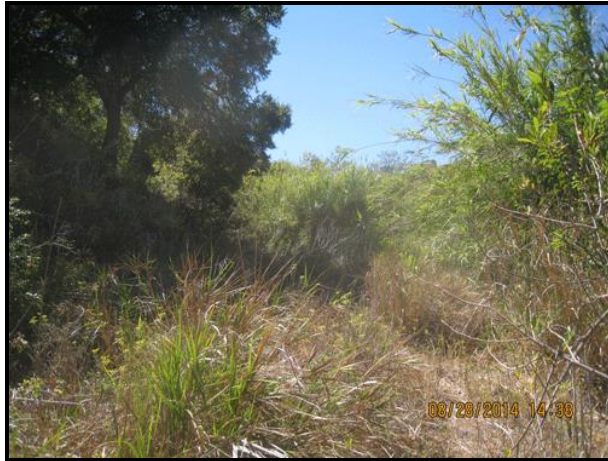
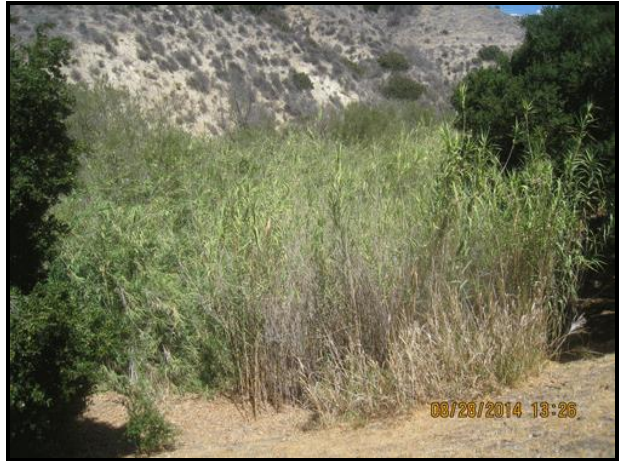
Left: View northwest of mitigation area along Puerco Canyon. *Arundo donax* dominates a significant portion of the ESHA riparian habitat. Right: View northward of *Arundo donax* dominating Puerco Canyon Creek. This area to be cleared of invasive exotic plants and planted with native riparian species.

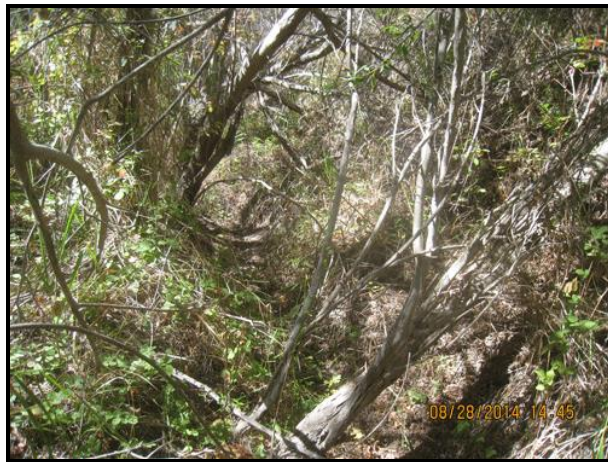
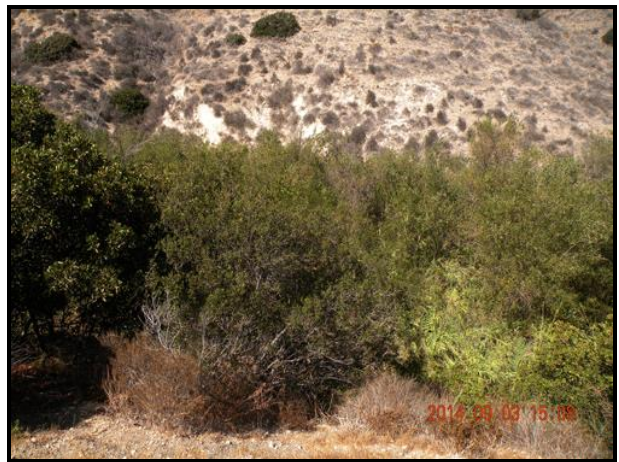
Left: Riparian ESHA onsite dominated by native species. Right: View northward of riparian ESHA from near proposed mikvah building site.

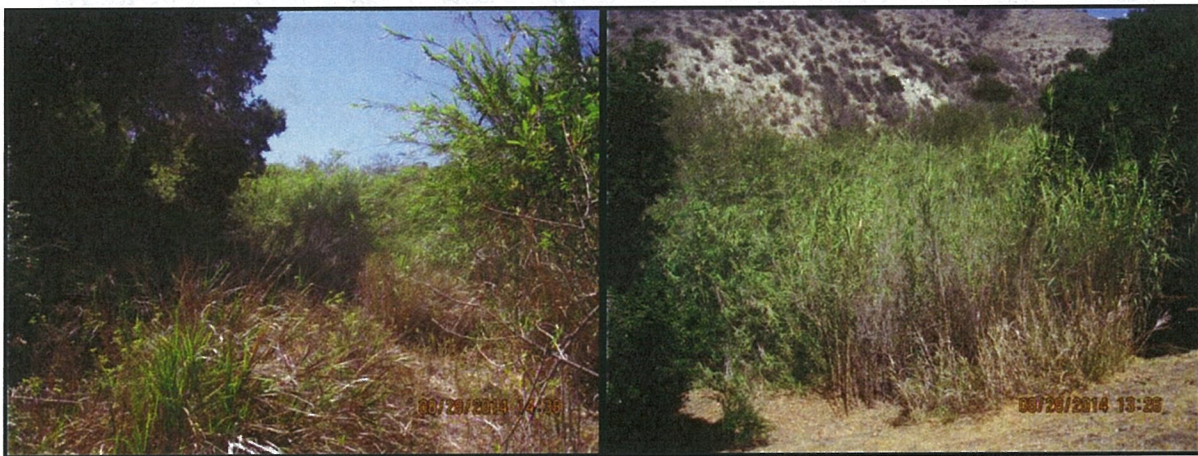
Photo 1 (left). View westward of riparian community (*Arundo donax*) below hillside mixed Oak-Walnut Woodland.  
Photo 2 (right). View northward of dense *Arundo donax* stand in Puerco Canyon Creek.

*Arundo donax* forms a nearly impenetrably dense stand on the project site. Several individuals of *Salix lasiolepis* exist within the stands of *A. donax*; however, *S. lasiolepis* is the dominant riparian species in areas not containing *A. donax*. This stand dominates the creek bed on the northwest corner of the project parcel and exists in the adjacent parcels to the north and west. This stand of *A. donax* appears to be the only significant stand within Puerco Canyon Creek drainage. Areas on the project site dominated by *A. donax* are mapped as “Arundo Stand”. The project site contains approximately 0.35 acre of *A. donax*.

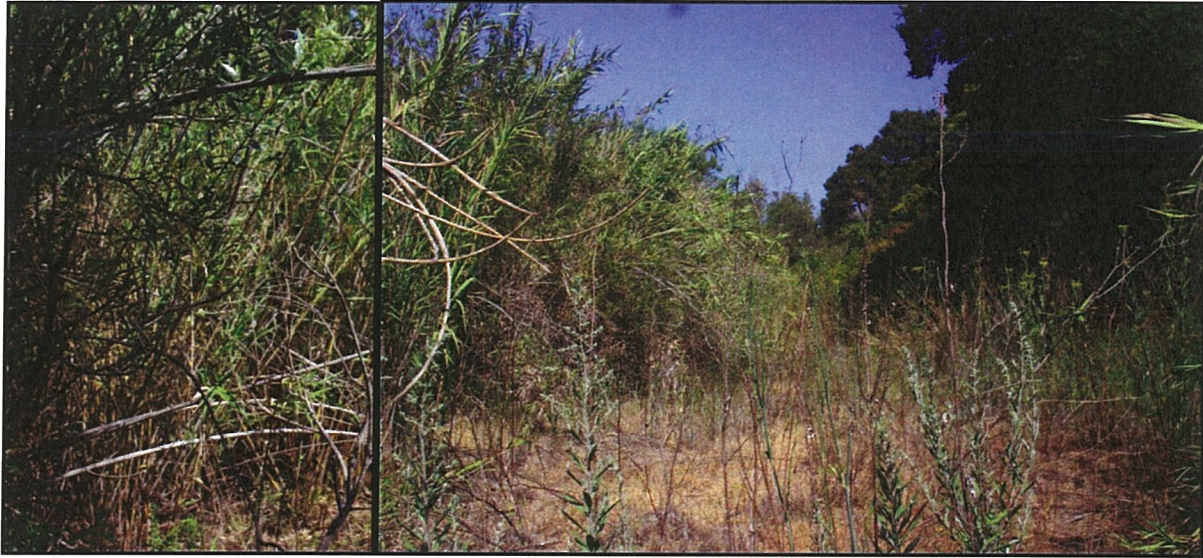
Photo 3 (left). View of dense *Arundo donax* dominating Puerco Canyon Creek in June 2018, not significantly changed from 2014. Photo 4 (right). View eastward/downstream adjacent to dense *Arundo donax* showing open herbaceous vegetation just outside of jurisdictional wetlands.

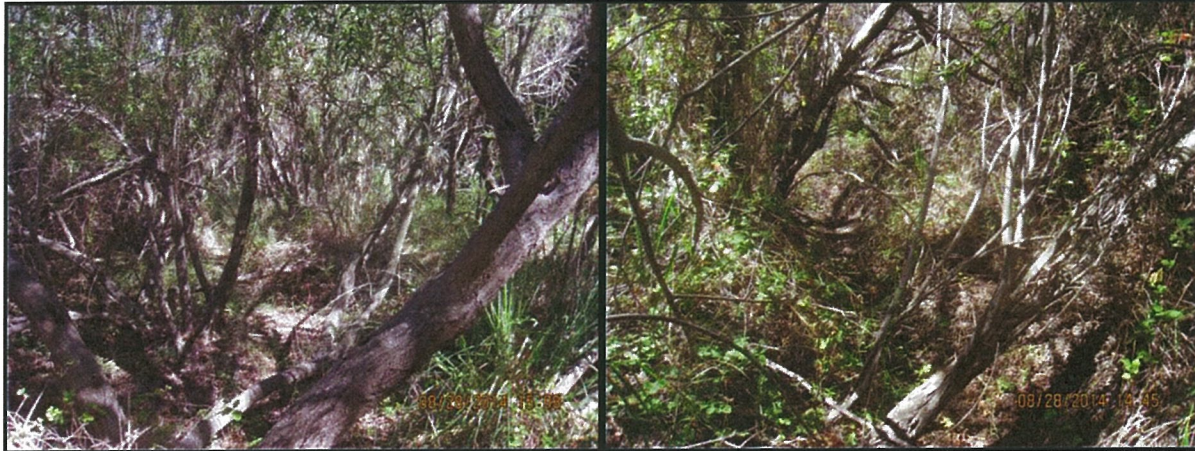
*Photo 5 (left). View eastward (downstream) of creek bed and Arroyo Willow Thicket with understory.  
Photo 6 (right). View westward (upstream) of creek bed and Arroyo Willow Thicket with understory.*

*Salix lasiolepis* Shrubland Alliance dominates the streambed on the project site in areas where *Arundo donax* does not occur. *Salix lasiolepis* and *A. donax* do occur together, but in areas where *A. donax* forms dense stands, *S. lasiolepis* is forced out. Areas of the project site dominated by *S. lasiolepis* are mapped as “Willow Thicket”. The project site contains approximately 0.29 acre of Arroyo Willow Thicket.

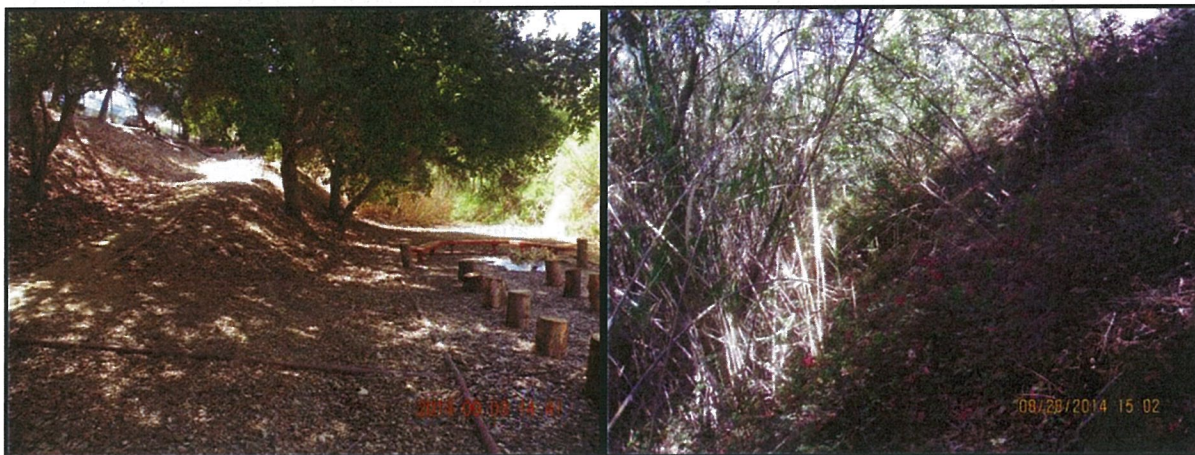
*Photo 9 (left). View westward of mixed Oak-Sycamore Woodland with modified (ruderal) understory.  
Photo 10 (right). View eastward of mixed Oak-Walnut Woodland natural understory adjacent to Arundo donax.  
These photos show habitats outside of jurisdictional wetlands.*

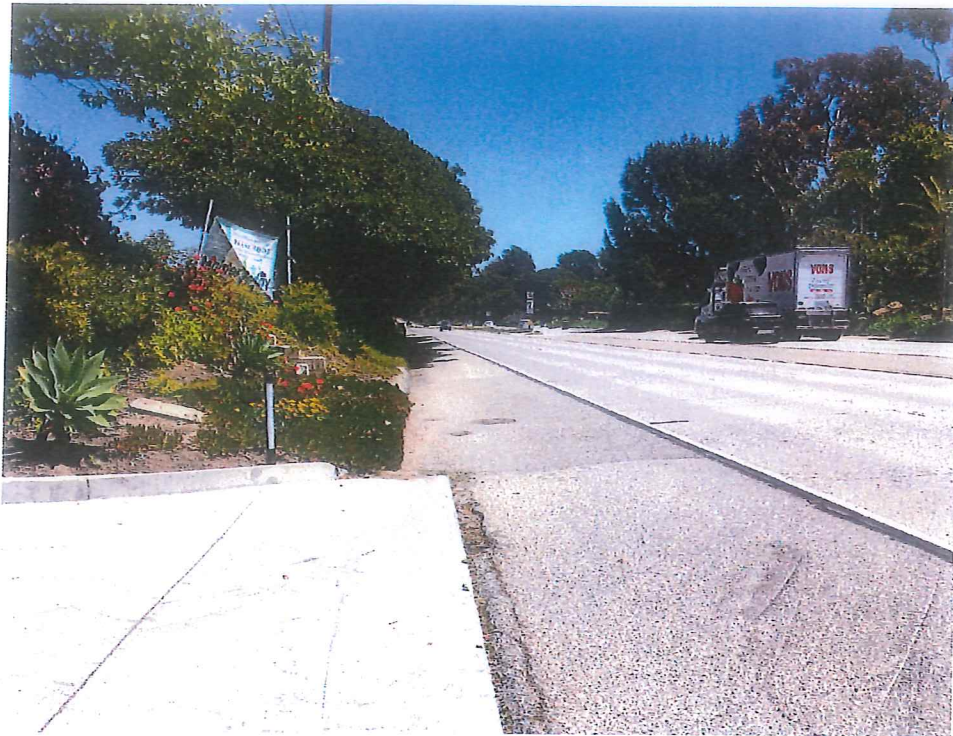
DRIVEWAY SIGHT DISTANCE TO EAST: 1,030 FEET

Drivers of vehicles turning from the Project driveway should have unobstructed view along PCH sufficient in length to anticipate and avoid potential collisions. PCH is posted with 50 MPH signs in the vicinity of Project site. Floating vehicle speeds surveys found that vehicles travel at 50-60 MPH adjacent to driveway. The Caltrans minimum corner sight distance standard for public roads with 60 MPH speeds is 660 feet and the minimum stopping sight distance for private driveways is 580 feet. Figure 8 shows the sight distances looking to the east and west along PCH from Project driveway. As shown, the sight distance looking to the east is about 1,030 feet and is limited by a horizontal curve in the roadway alignment. The sight distance looking to the west is about 1,600 feet and is limited by a vertical curve in the roadway alignment. These sight distances exceed the Caltrans 580-foot to 660-foot minimum requirement for roads with 60 MPH speeds. As noted previously, on-street parking is allowed on the shoulder of PCH adjacent to the site. Although there is adequate sightline distance and impacts would be less than significant, driveway operations and sightline distances looking west from the driveway could be further enhanced by restricting parking along the Project frontage adjacent to the driveway (see Recommended Improvements section for more detail).

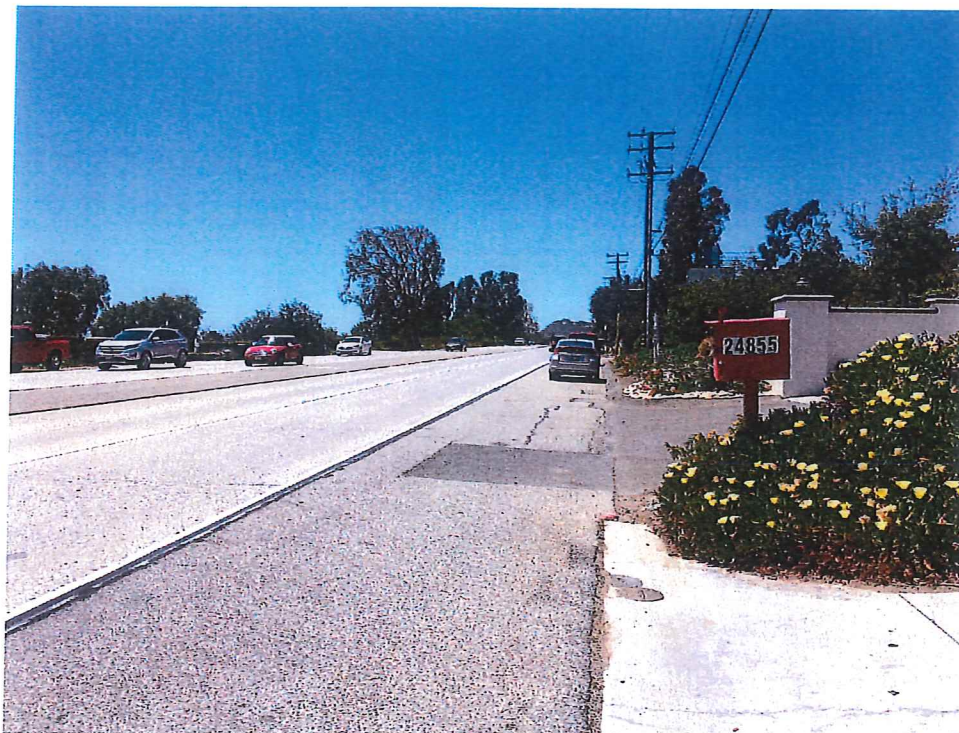
DRIVEWAY SIGHT DISTANCE TO WEST: 1,600 FEET

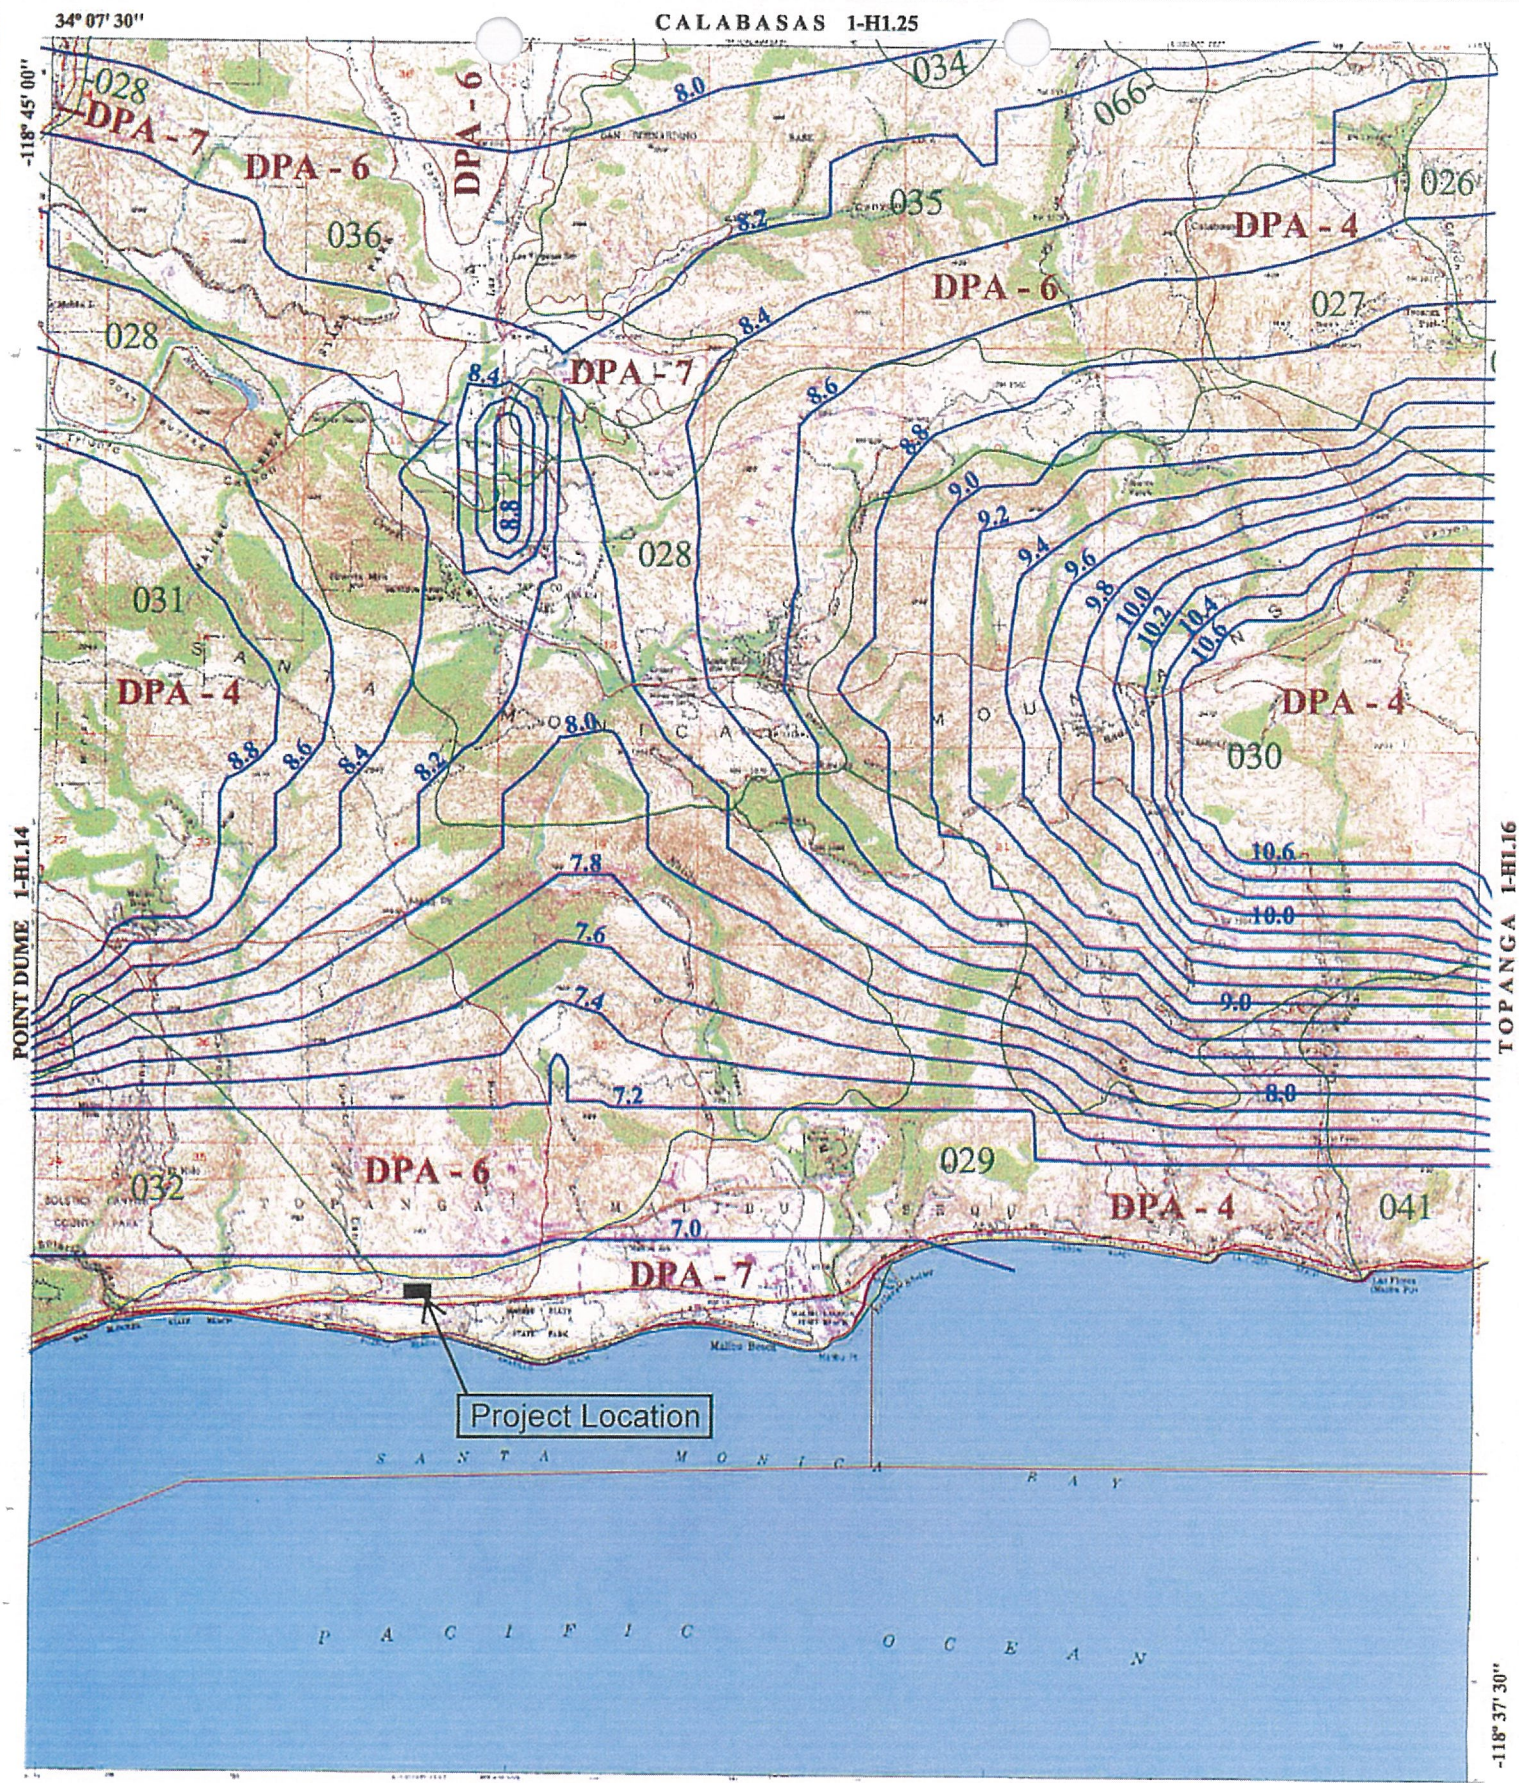
**016**  
SOIL CLASSIFICATION AREA

**7.2**  
INCHES OF RAINFALL

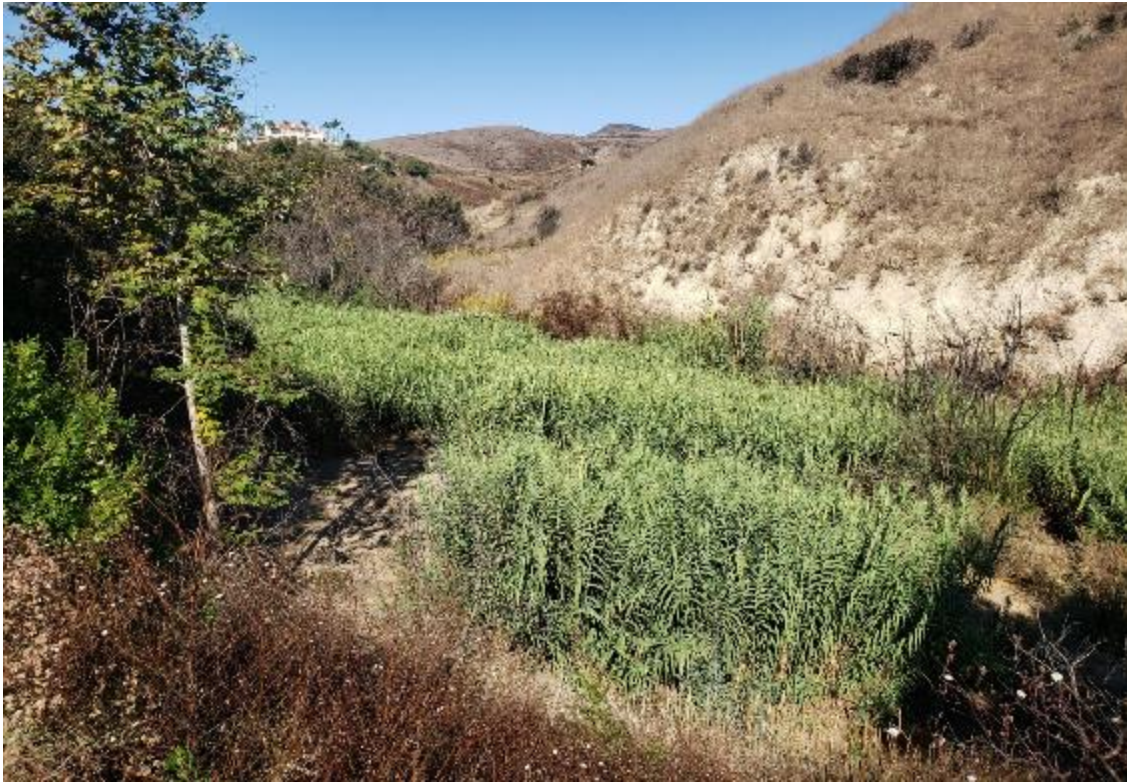
Photo 1. View facing northwest of the *Arundo donax* stand in the bottom of Puerco Canyon Creek.

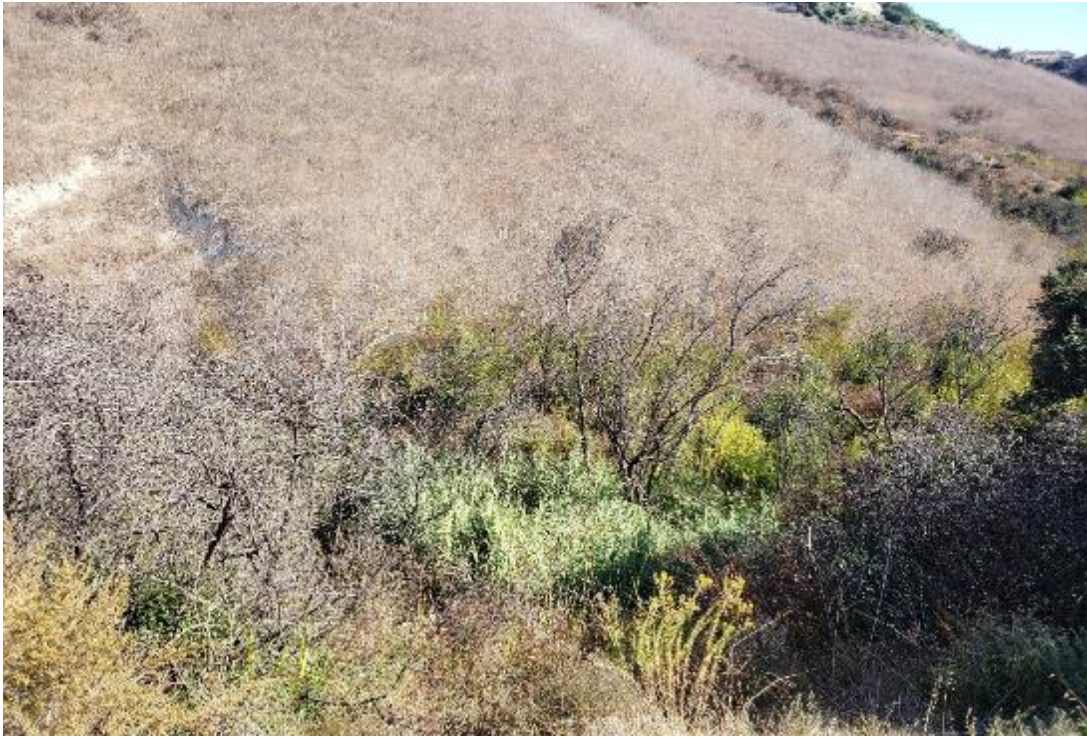
Photo 3. View facing northeast of the burned willow riparian area. *Arundo donax* can be observed in the foreground with some willows and other unknown greenery in the background.

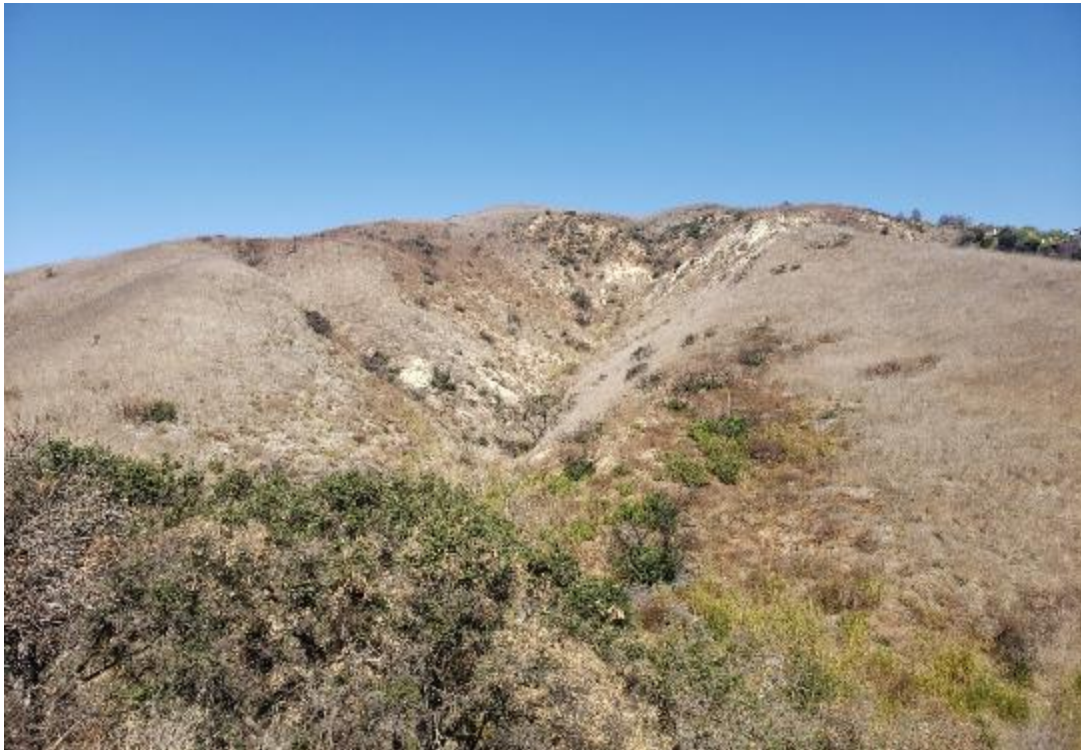
Photo 4. View facing northeast of the ruderal grassland that has replaced the coastal sage scrub on the south-facing slope of Puerco Canyon across from the temple.

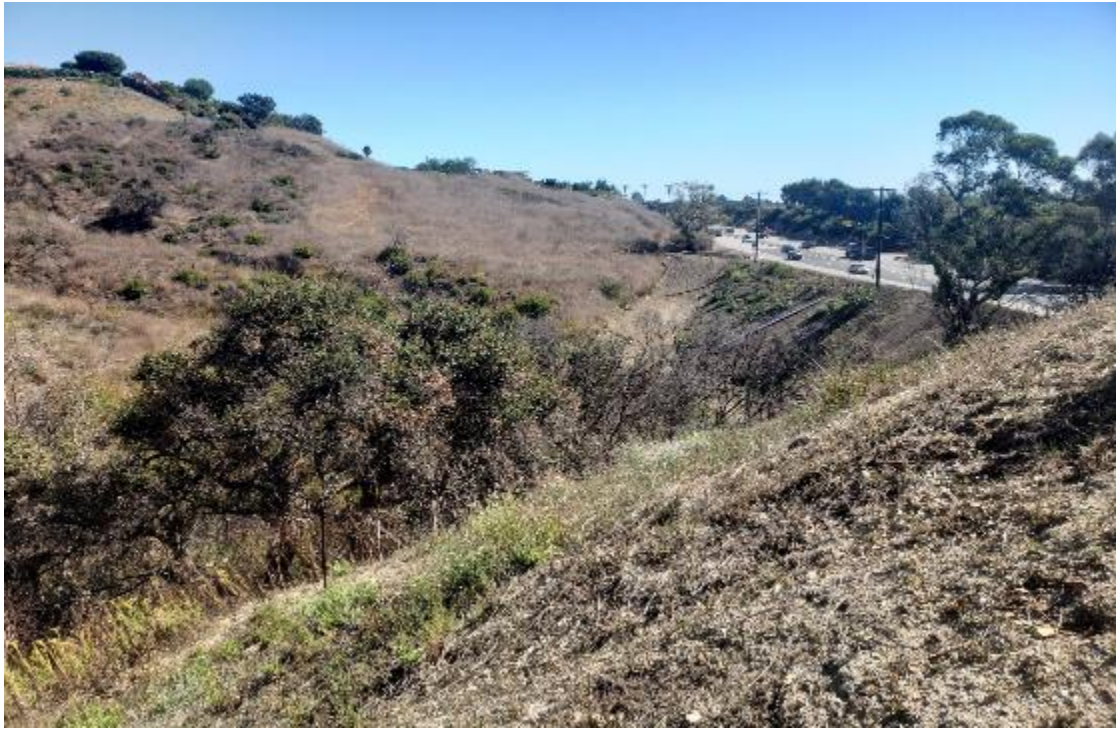
Photo 5. View facing southeast of the oak-walnut woodland on the slope just north of the temple.

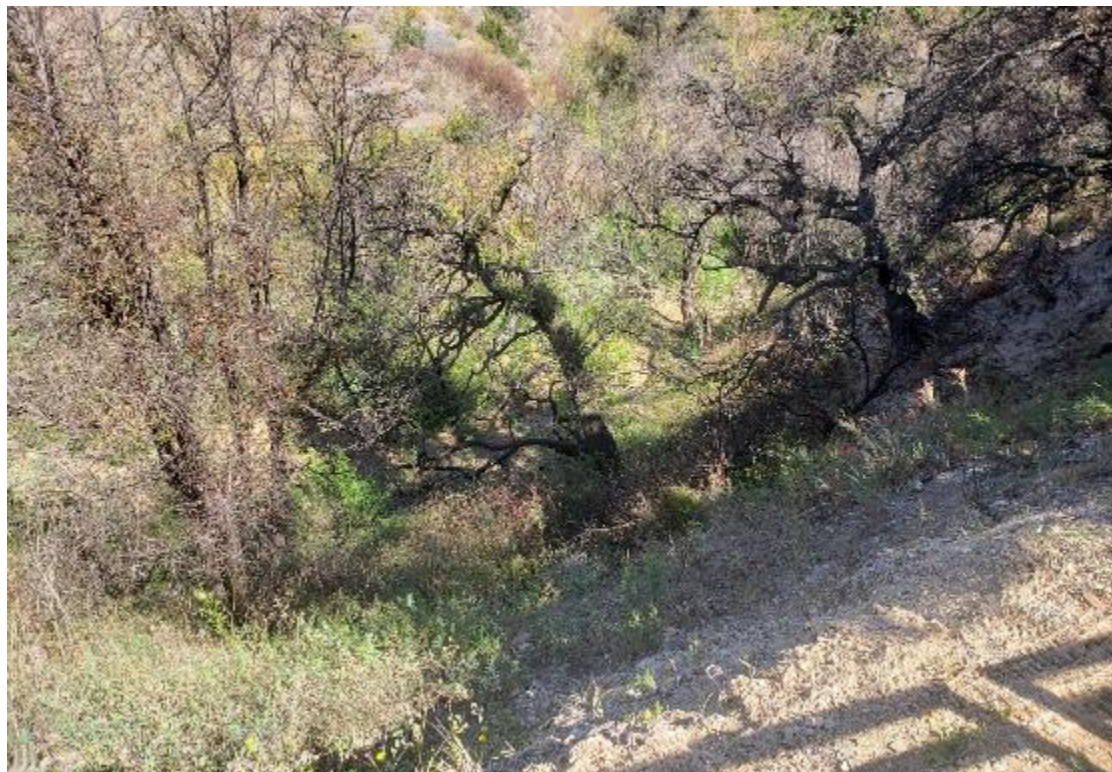
Photo 6. View looking downslope into the bottom of Puerco Canyon Creek at portions of burned oak-walnut woodland and willow riparian.

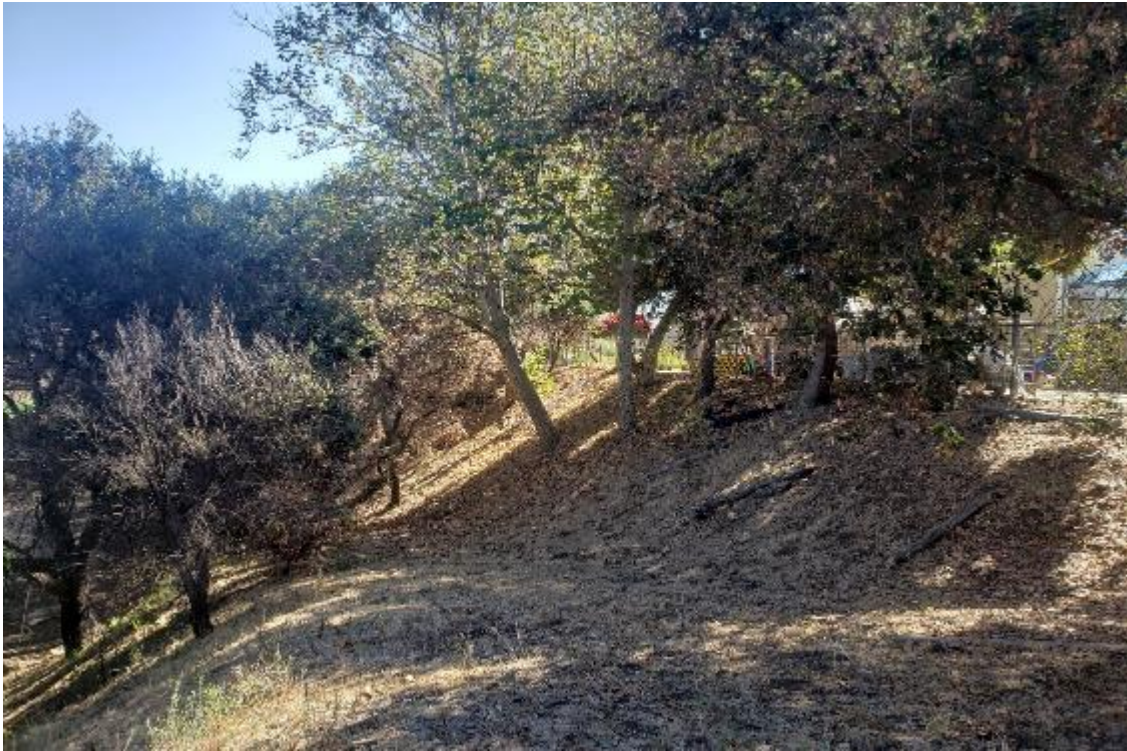
Photo 7. View facing east of the oak-sycamore woodland that survived the Woolsey Fire.

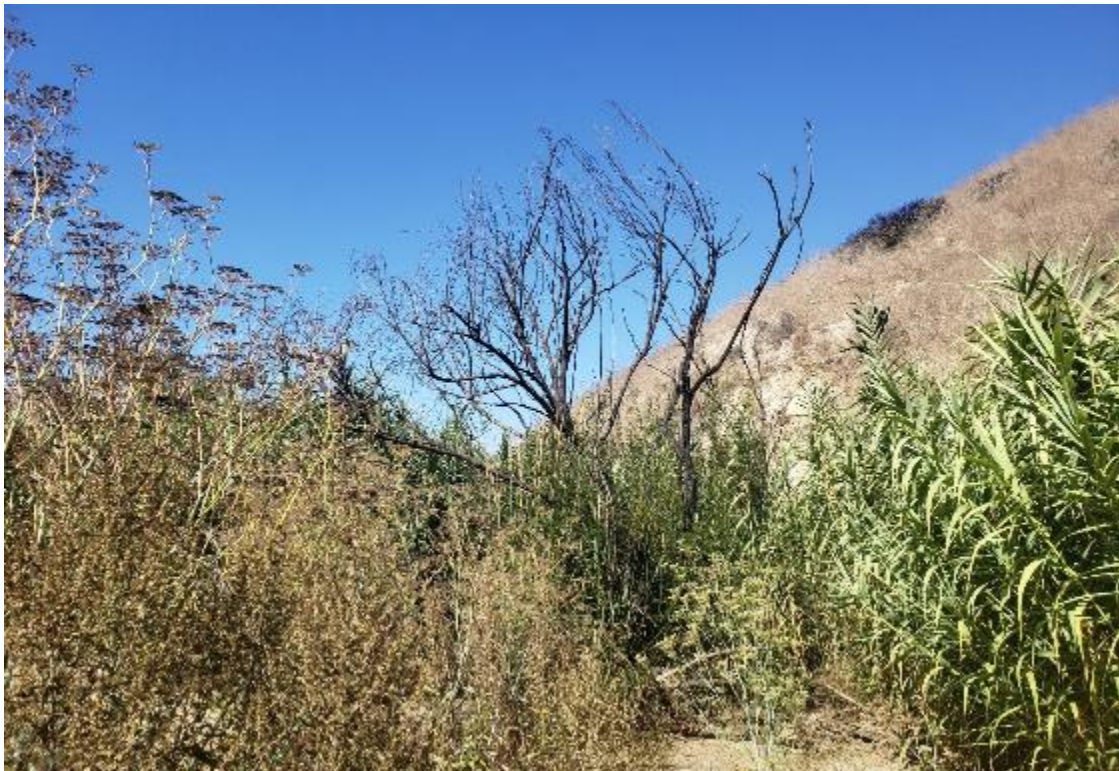
Photo 8. View facing northwest from the bottom of Puerco Canyon Creek of the burned willow riparian and heavy *Arundo donax* coverage, as well as fennel and other non-native invasive species.
