# **Appendix D      Biological Resources Assessment and MSHCP Consistency Analysis**

## General Biological Resources Assessment

Agua Mansa Commerce Park Project Site  
Jurupa Valley, Riverside County, California

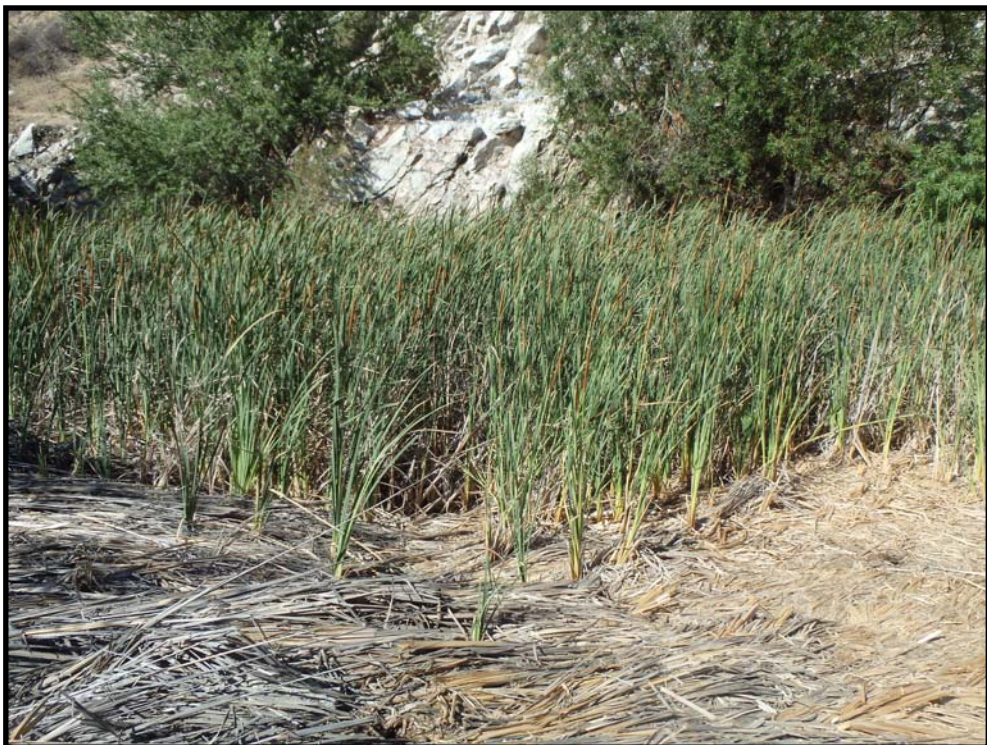
PHOTOGRAPH 10 - Cattails are found in the most mesic and low-lying areas of the Proposed Open Space portion of the Project Site.

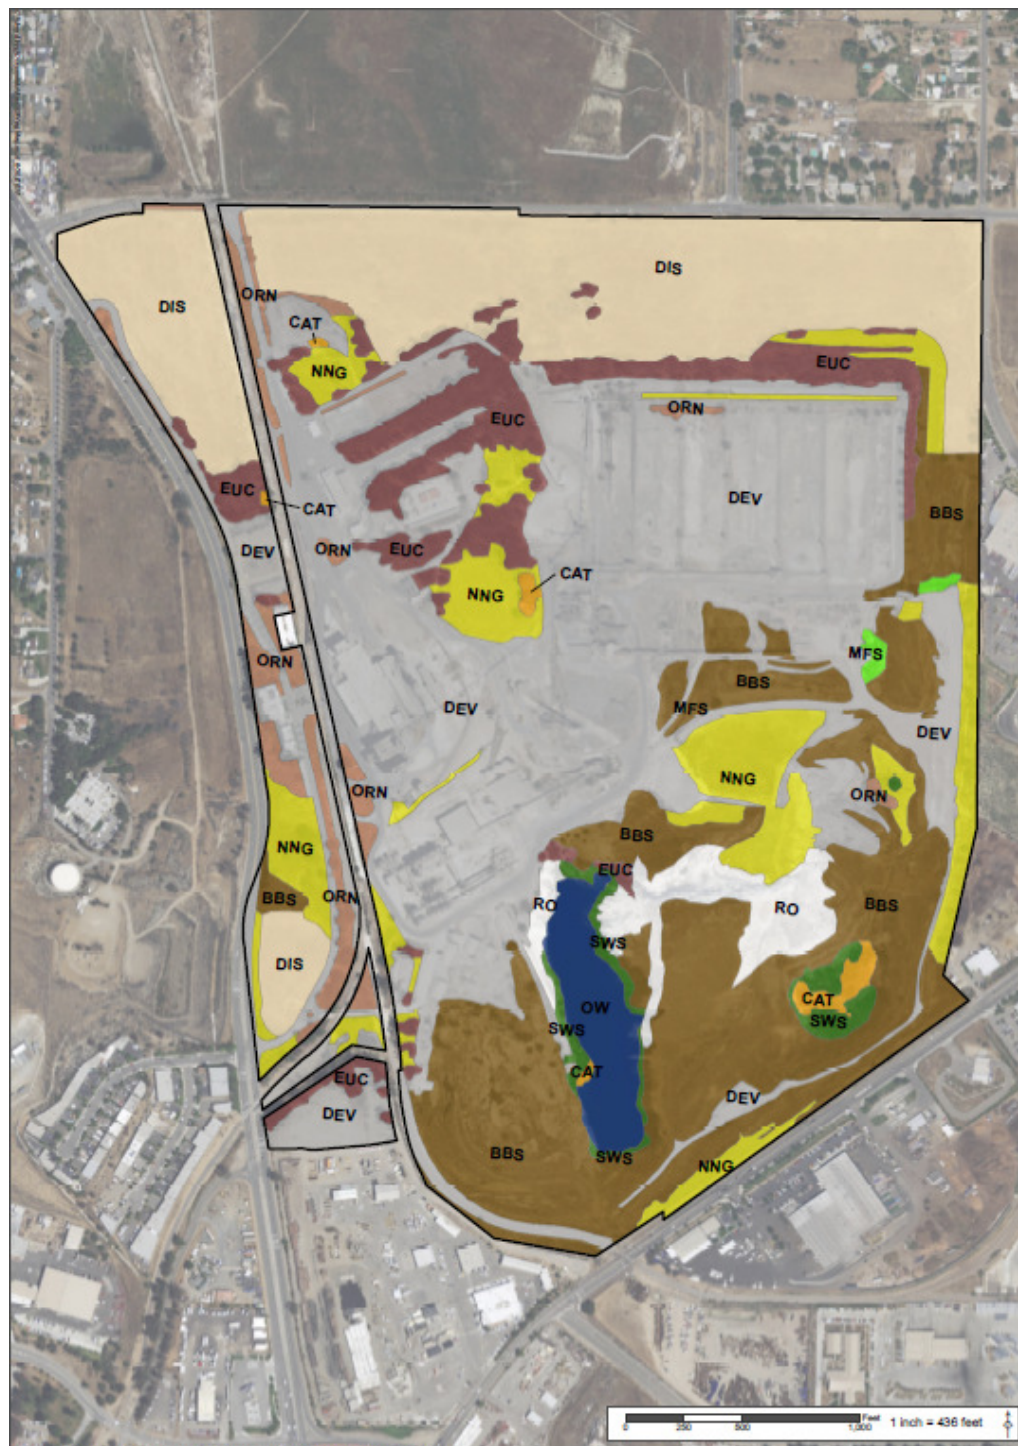
Figure 2. Vegetation Map of the project site.

Vegetation Community	
Developed (DEV): 115.89 ac	Rock Outcrop (RO): 7.80 ac
Disturbed (DIS): 53.70 ac	Ornamental (ORN): 7.33 ac
Brittlebush Scrub (BBS): 56.92 ac	Open Water (OW): 6.30 ac
Non-Native Grassland (NNG): 24.42 ac	Southern Willow Scrub (SWS): 3.29 ac
Eucalyptus Grove (EUC): 18.92 ac	Cattails (CAT): 1.52 ac
	Mulefat Stand (MFS): 0.60 ac

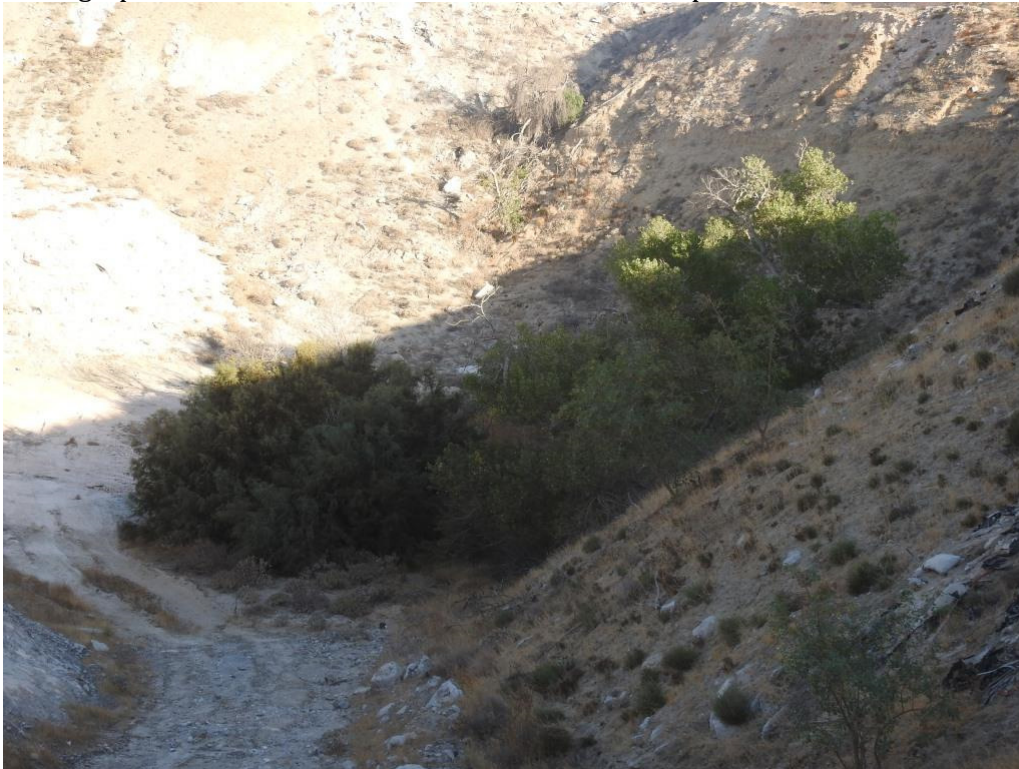
Photograph 3. Southern Willow Scrub in the larger depression southeast of the quarry.

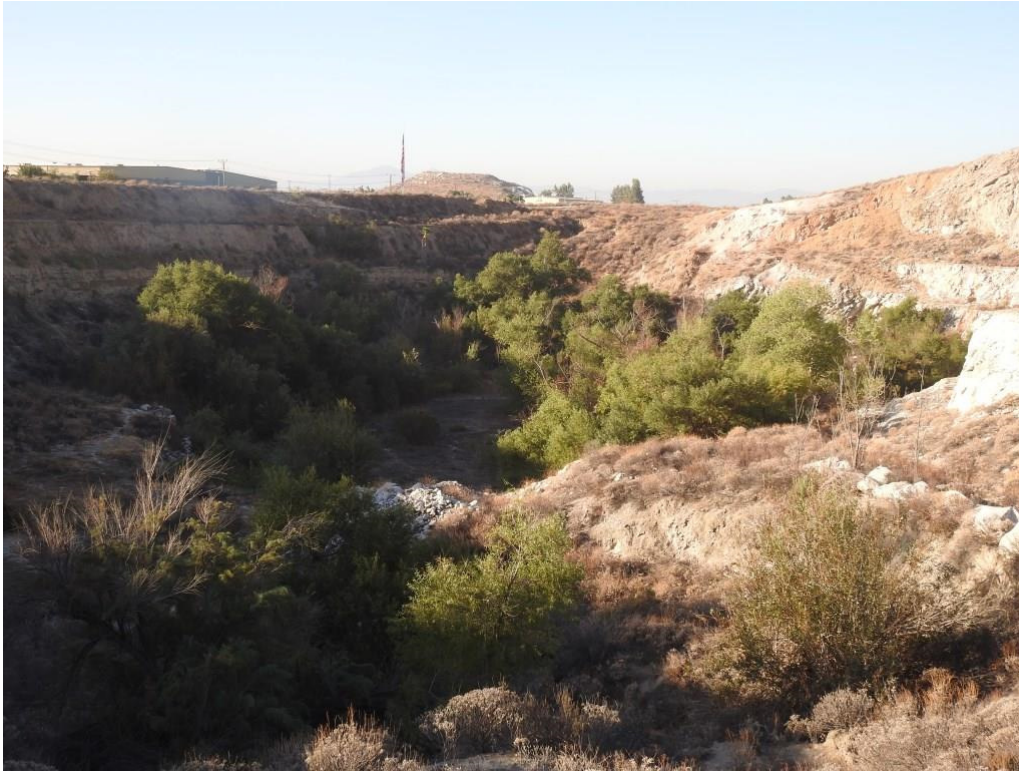
Photograph 4. Southern Willow Scrub in the larger depression southeast of the quarry.

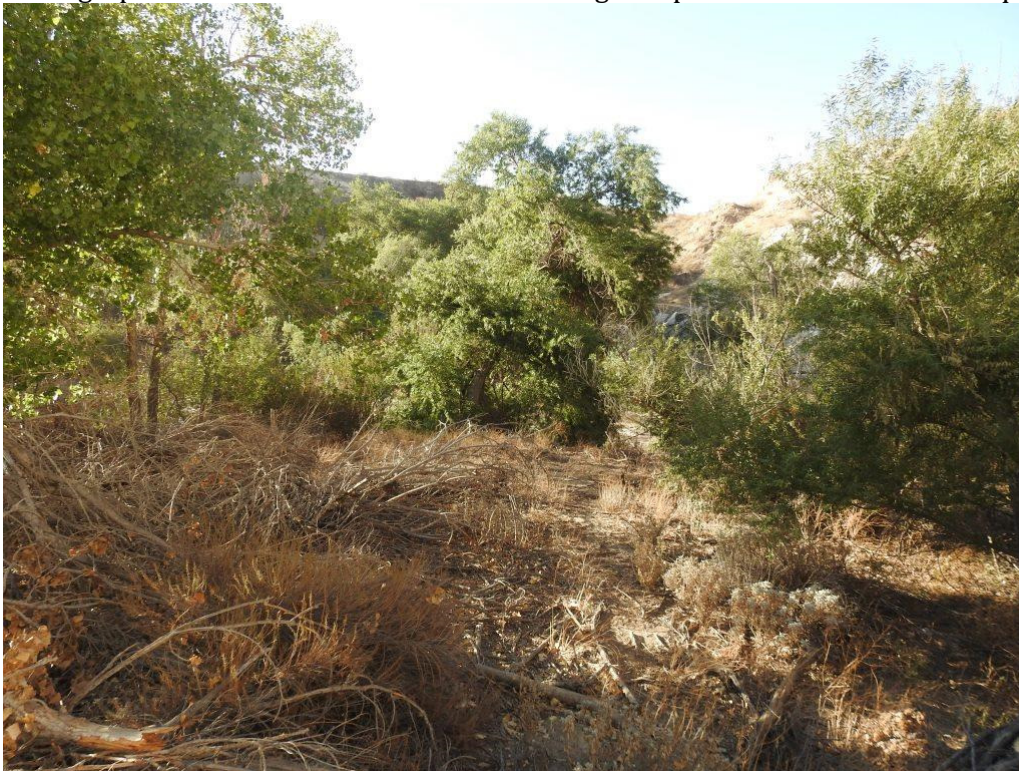
Photograph 5. Southern Willow Scrub along the east shore of Crestmore Lake.

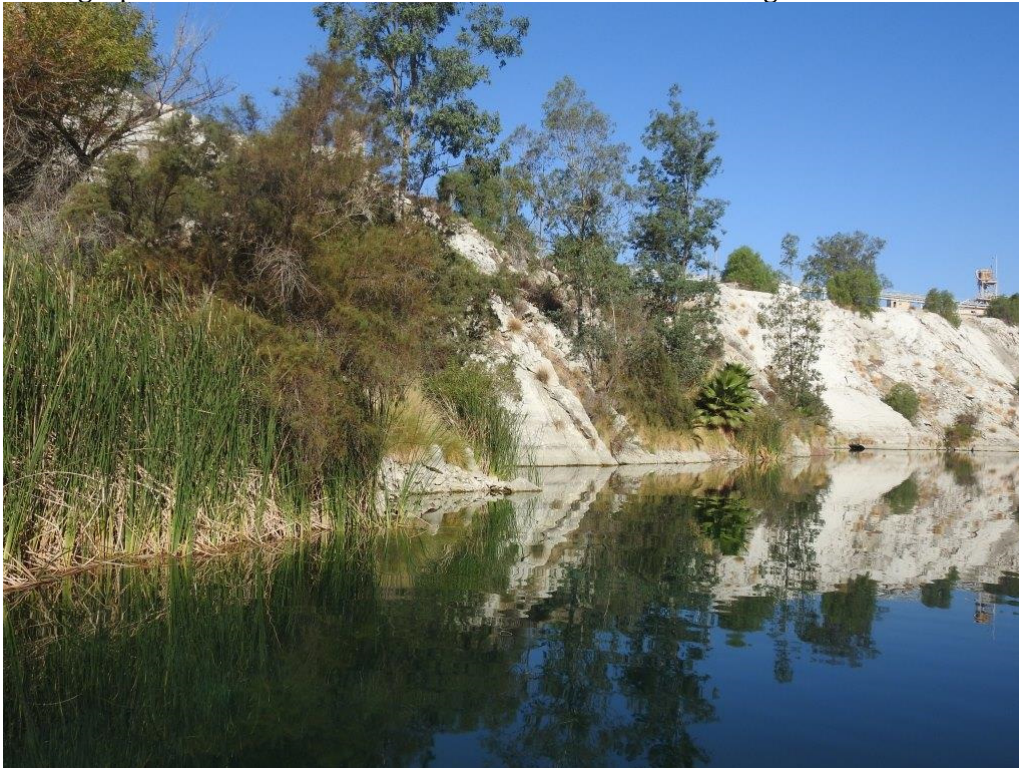
Photograph 7. Southern Willow Scrub and Cattail Marsh along the west and north shore of Crestmore Lake.

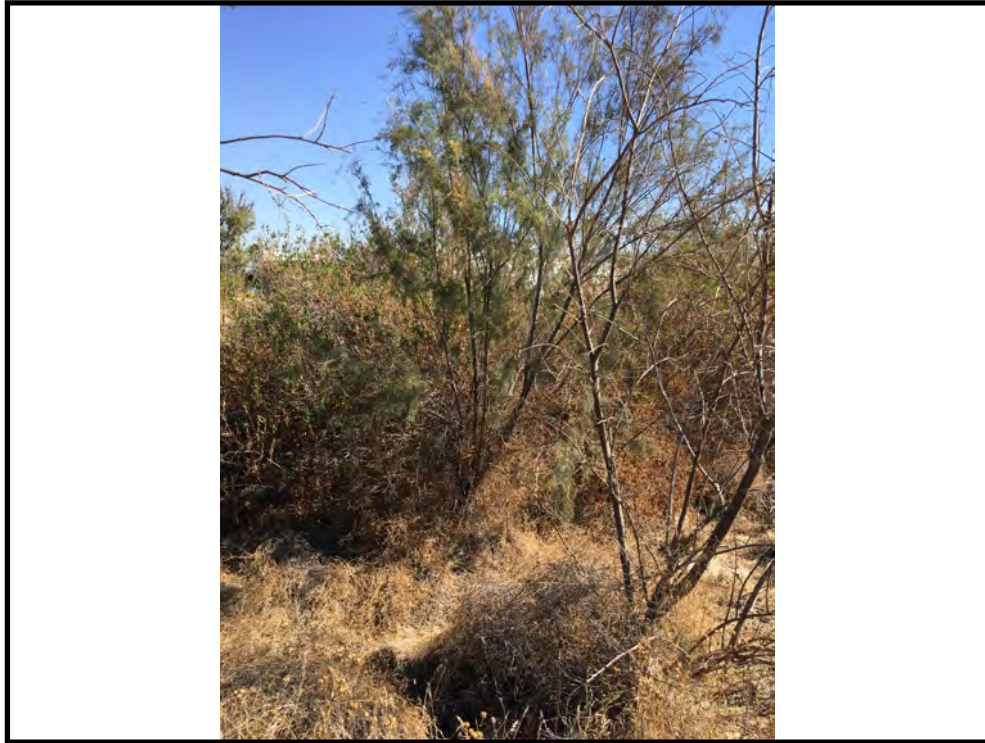
PHOTOGRAPH 1 - View of sample point CDFW1 in a mulefat-tamarisk in borrow area. No primary/secondary hydrology indicators observed and soils are disturbed/denuded from quarry operations.

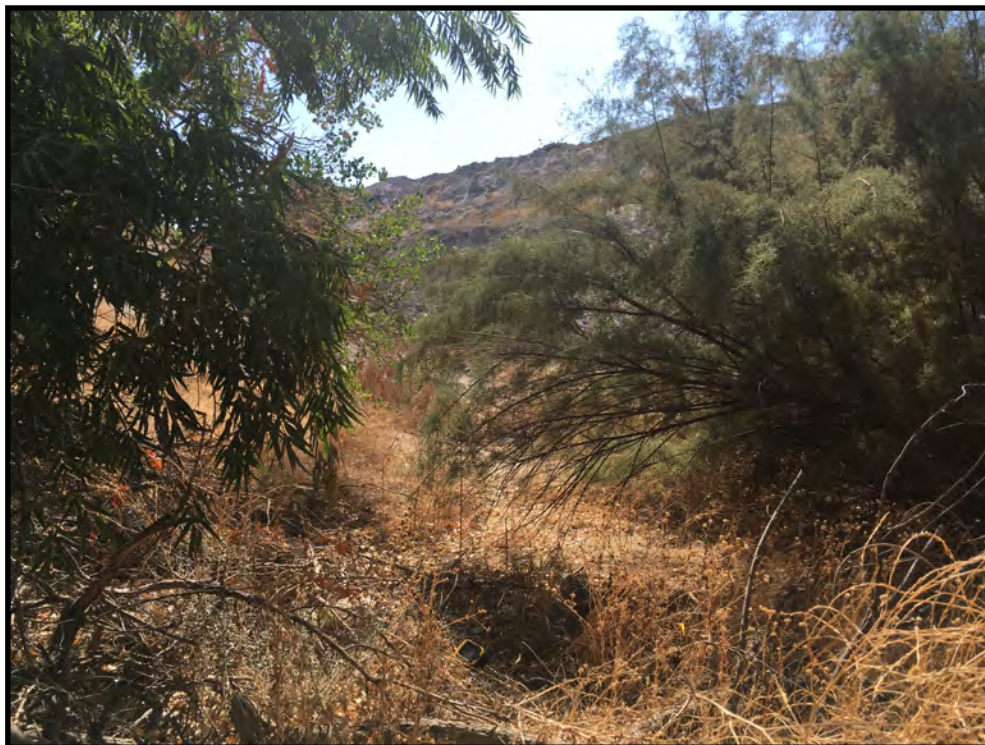
PHOTOGRAPH 2 - View of sample point CDFW2 in a quarry pit with non-wetland riparian community. No primary/secondary hydrology indicators observed and soils did not exhibit and redox or other hydric indicators.

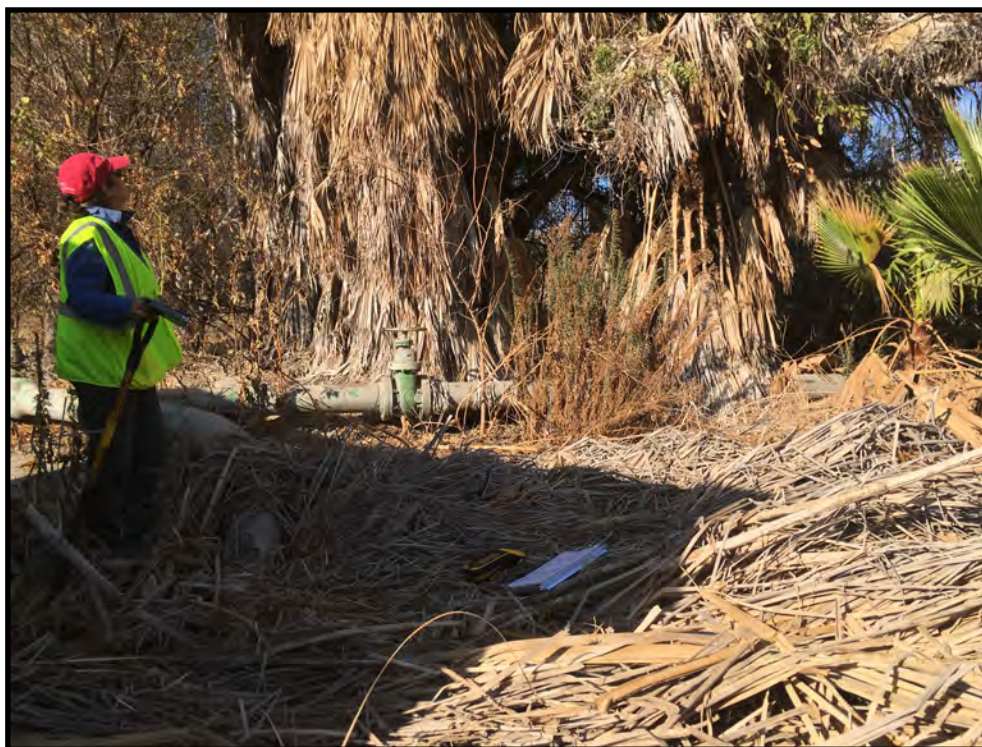
PHOTOGRAPH 6 - View of sample point WL4 located adjacent to broken water pipe within the refinery processing area.
