# PHASE I ENVIRONMENTAL SITE ASSESSMENT

Henderson Road  
Shasta County, California  
Assessor's Parcel Nos.

107-400-008, 107-430-059, 107-500-017, -018, -019, -020, -023, -024 and -025

**Dignity Health**

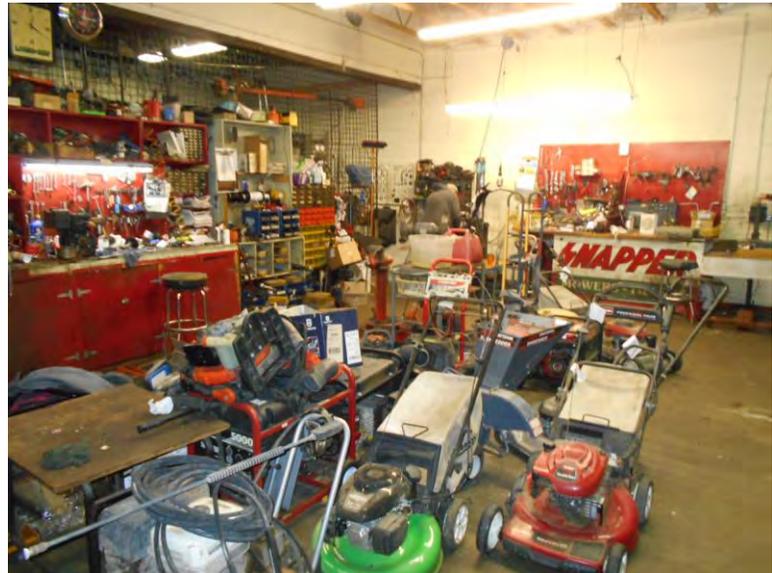
Photo 8. Interior view of 2456 Henderson Road, currently occupied by Augie's Lawnmower Repair.

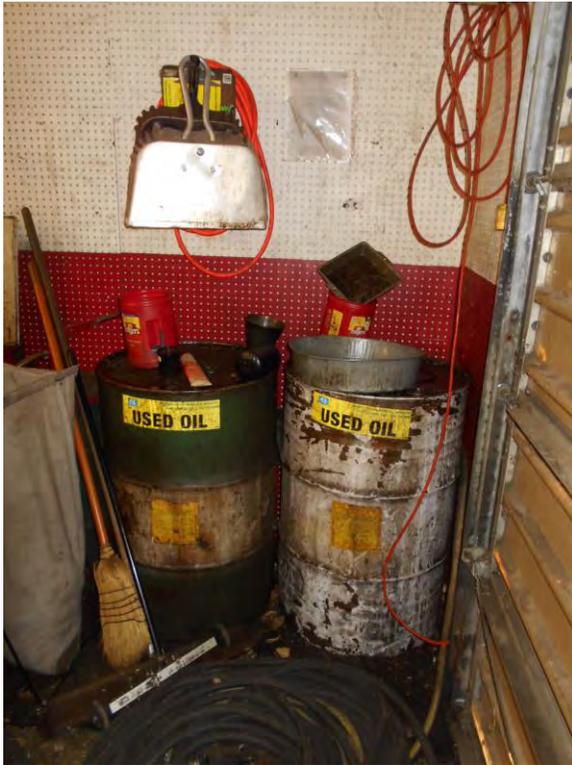
Regulated quantities of hazardous materials observed on the property were limited to two 55-gallon drums of used oil in Augie's Lawnmower Repair. Asbury Environmental Services reportedly removes waste oil from the property as needed. A sharps container for medical waste is located in Pet Care Naturally. No x-ray equipment was observed on the property.

Photo 9. 55-gallon drums of used oil located in 2456 Henderson Road.

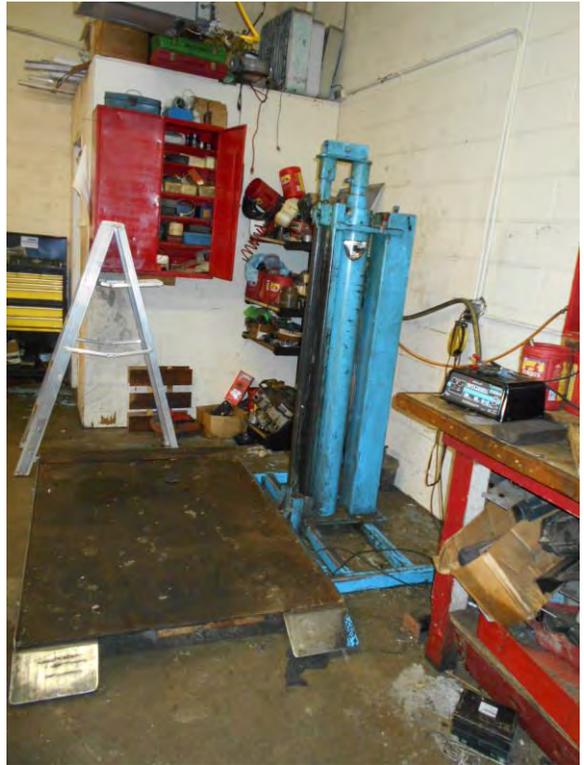
- Unit 2442 is currently vacant. It was previously occupied by a church for approximately 20 years.
- Unit 2446 is currently used by Ms. Jeri Campbell as a private dance studio.
- Unit 2448 is currently occupied by Natural Health Care, a chiropractic clinic.
- Unit 2450 is currently occupied by Pet Care Naturally, an out-patient veterinary clinic and pet food store. Pet Care Naturally has occupied this unit for approximately 9 years. This unit was previously occupied by an auto trim detail shop.
- Unit 2456 is currently occupied by Augie's Lawnmower Repair. Augie's has occupied this unit for approximately 6 years. This unit was previously occupied by D&L Automotive. No underground hoists or lifts were observed in this unit. Augie's currently has three aboveground lifts.

Photo 10. Aboveground hoist located in 2456 Henderson Road.

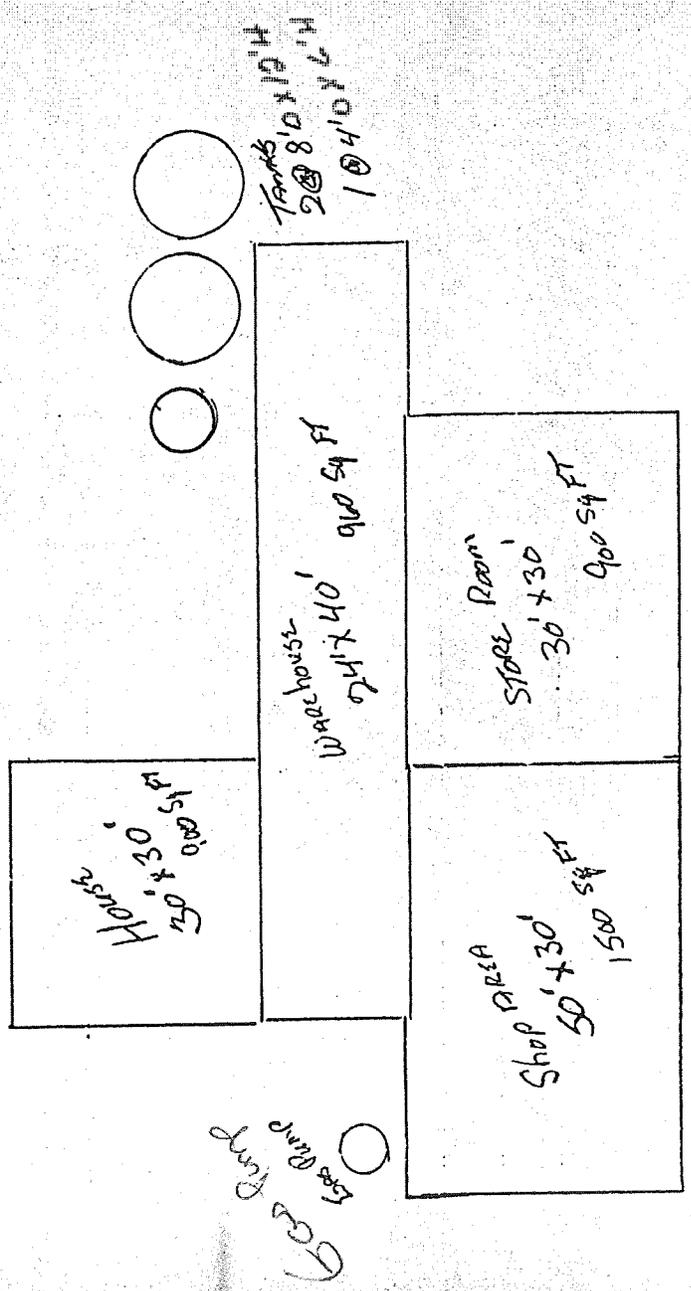
RIDDING TRANSIT MIX  
Permit # 107-SD-14  
2511 HANCOCK ROAD

1997

1. A UST, associated piping, and fuel dispenser were formerly located on the property at the historic Redding Transit Mix facility at 2511 Henderson Road. The fuel dispenser is no longer located on the property. The UST and piping may have been removed, but no records were found to indicate that the soil/groundwater was properly tested at the time of removal. A 1997 plot plan is included in Appendix B, which depicts the location of the former gas pump. It is assumed that the UST is/was located in the vicinity of the former gas pump. ENPLAN recommends further investigation to confirm that the UST has been removed and to obtain and analyze soil samples (and water samples, if groundwater is encountered) from the UST site.
