The Junipers Project
Environmental Impact Report

Phase I Environmental Site Assessment, Vacant Land, Unassigned Address

PHASE I ENVIRONMENTAL SITE ASSESSMENT

Vacant Land, Unassigned Address:
APN: 313-011-10-00, 313-011-06-00, 313-060-01-00
San Diego, CA 92129

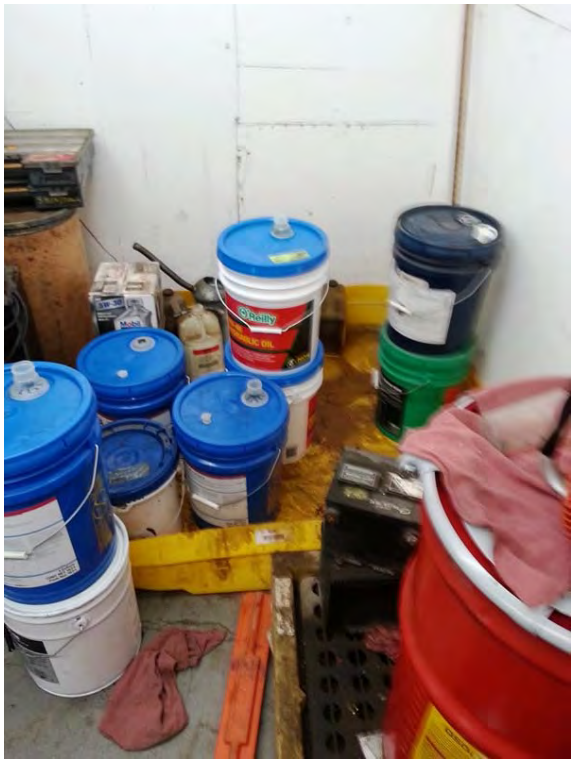
Gasoline, diesel, oil, waste oil, anti-freeze, used oil filters, pesticides, fungicides, rodent killer, paint, and lead-acid batteries were observed in the maintenance areas at the subject site. Gasoline, diesel, oil, waste oil, and anti-freeze were observed to be stored in properly labeled containers in secondary containment (Photos 12 through 14 – Appendix B). Pesticides, fungicides, rodent killer, and paint were observed to be stored in portable storage trailers and sheds at the subject site (Photos 10, 17, 18, 23, and 24 – Appendix B). Used oil filters are stored in a 55-gallon drum in secondary containment in the maintenance building in the central portion of the Site (Photo 14 – Appendix B).

Photo 14: View of secondary containment for oil storage in the maintenance area in the central portion of the Site.

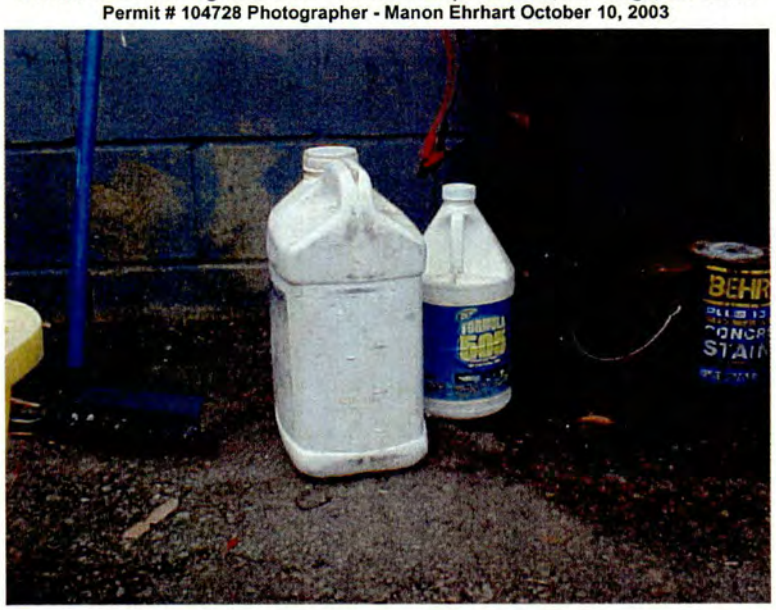
This is an unknown unlabeled container in the Landscape/Grounds Maintenance area.

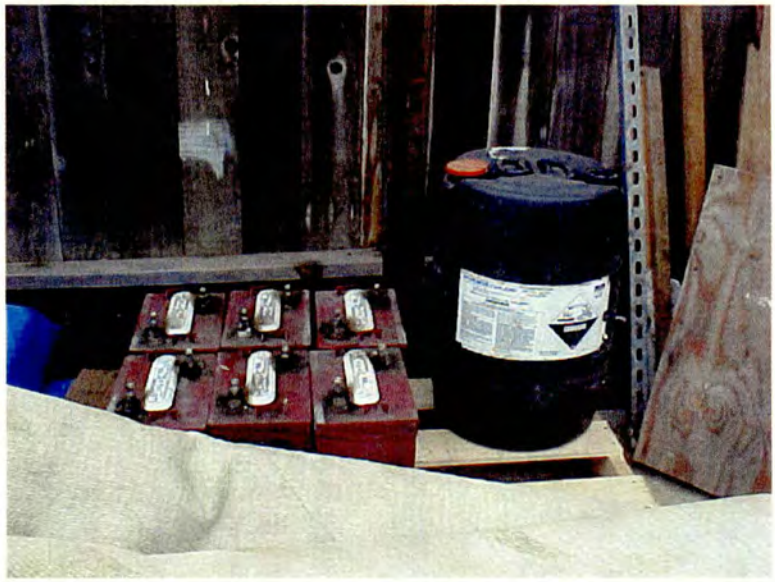
6 used cart batteries and an empty tub of corrosive material in the Facility's Maintenance Area.

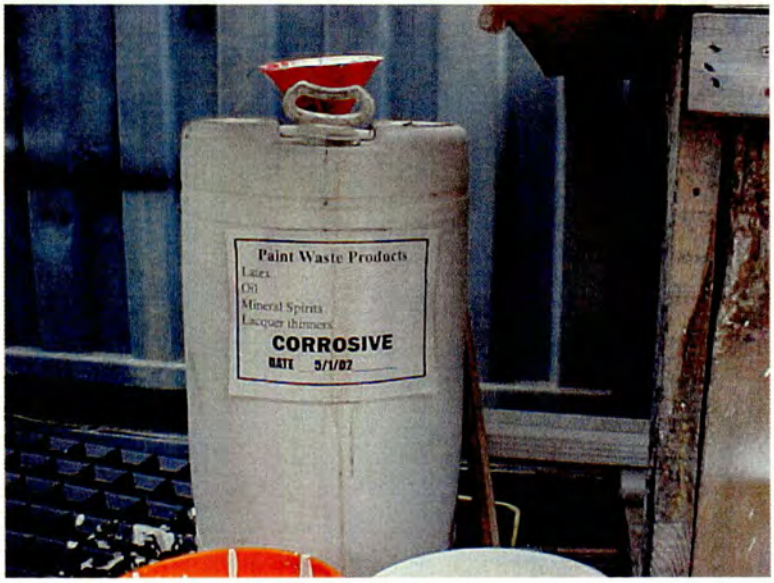
This is the 30-gallon drum labeled "Corrosive" waste paint in the Facility's Maintenance Area.
