Revised Appendix Q

Existing Building Evaluation

Los Angeles County Museum of Art Building Evaluation

September 16, 2014

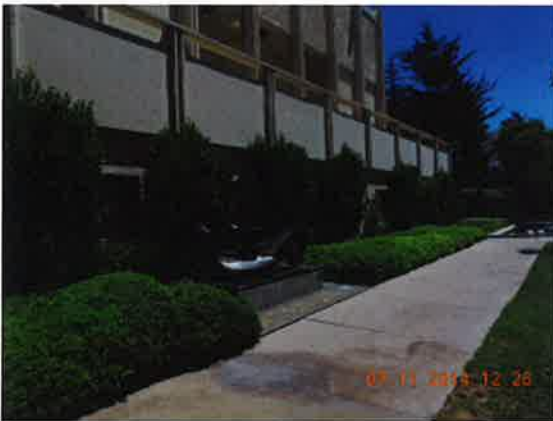
General Balcony A-007

Typical Balcony Rails

Picture of the typical balcony rails at the podium level.

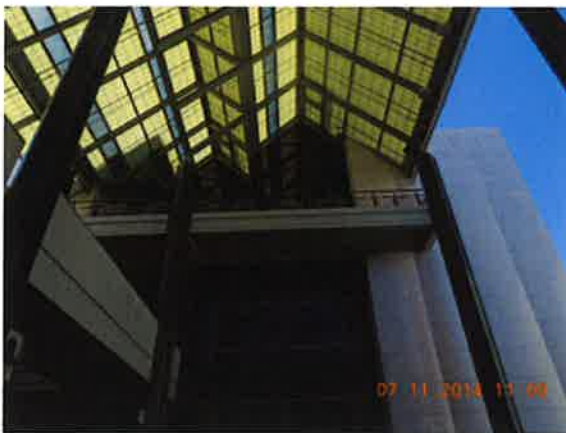
General - Skylights A-008

Typical skylights

Picture of the typical skylight system install over the patio area.

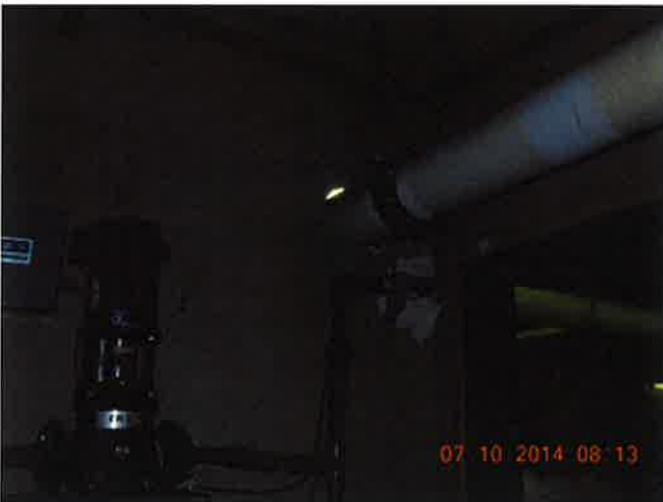
A-010

Pipe penetrations at fire rated walls

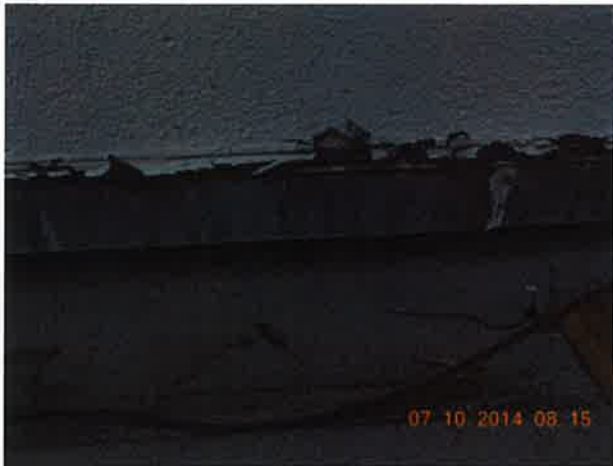
A-015

Roof Flashing

Roofing flashing and water proofing are in poor condition

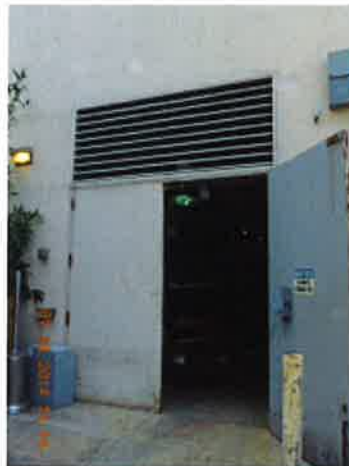
A-016

Loading dock doors

Loading dock metal doors are in poor condition

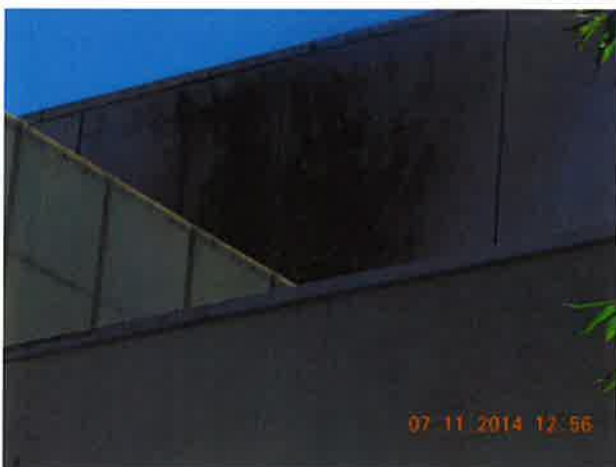
A-017

Exterior Walls

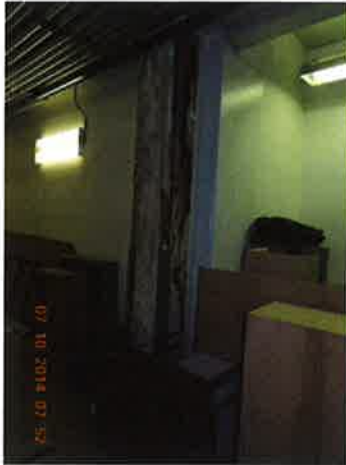
Water intrusion and rust damage A-018

Extensive water intrusion and rust damage has been a continuing problem from the plaza level.

Level 2 Plaza pavers and water proofing are in poor condition. This situation has caused significant damages to the lower level.

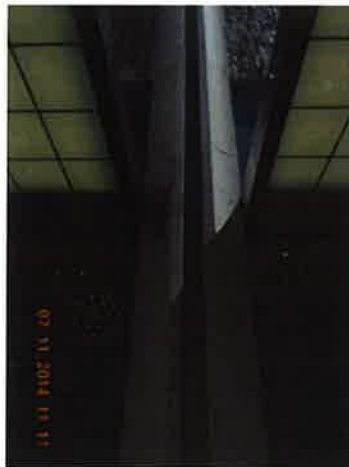
Concrete columns A-020

Concrete column encasements are cracked and spalling.

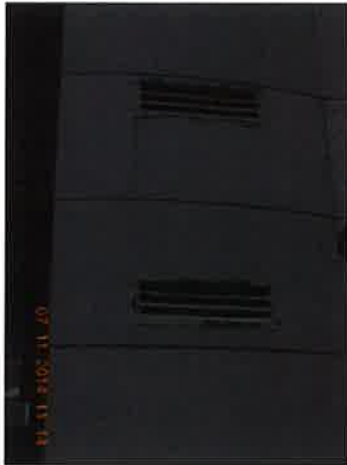
Roof Flashing A-021

Mechanical louvers located above the gift shop are damaged and need to be replaced.

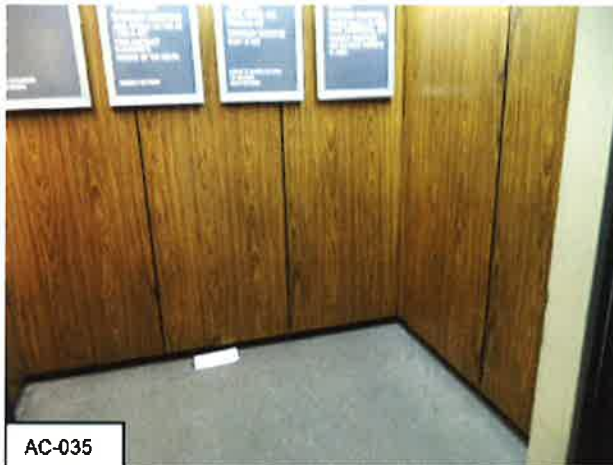
Loading dock doors A-022

Elevator doors, cabs, controls, corridor carpeting, paint and finishes are old in fair condition and require refurbishment throughout.

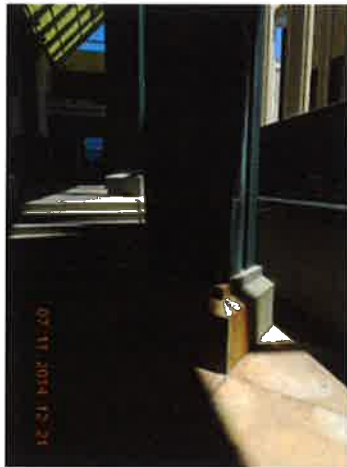
Column Base –
stains and cracking A-024

Wilshire Boulevard main entrance canopy column concrete bases including ceramic tiles cladding have developed numerous cracks and rust stain marks.

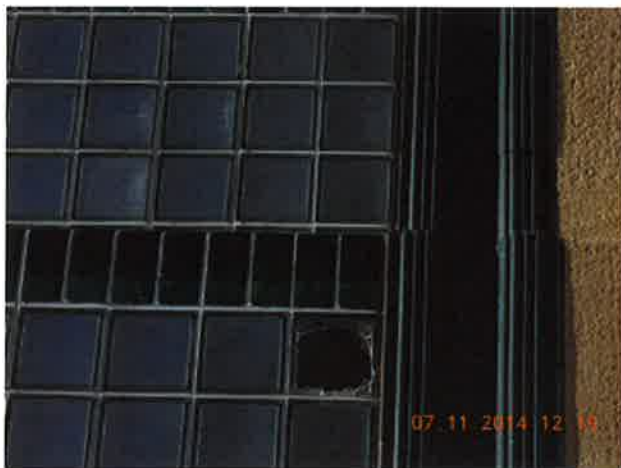
Water Fountain A-026

Walls glass blocks are broken and cracked at several locations.

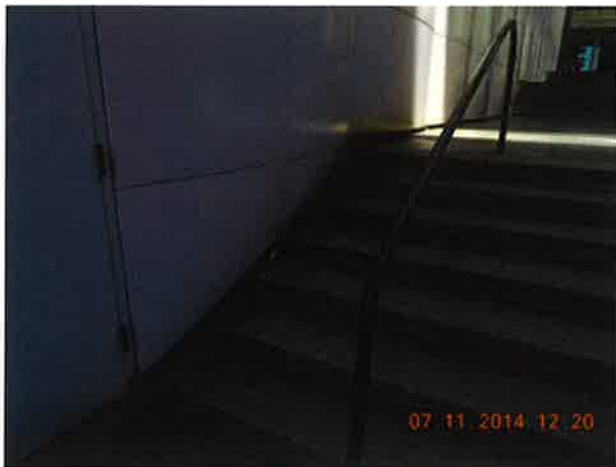
A-027

Porcelain/metal panels

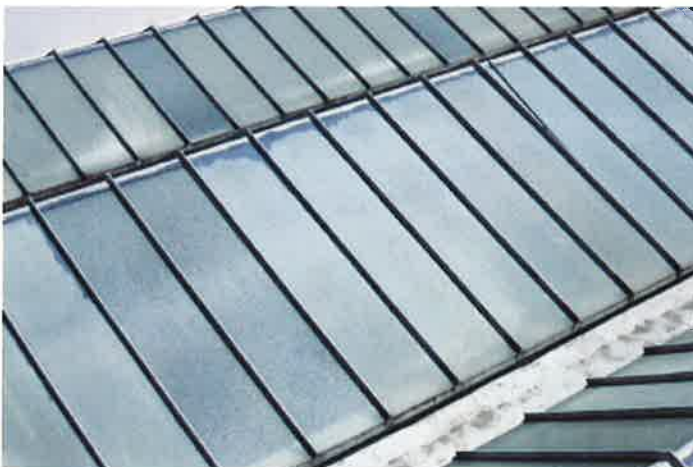
A-029

Skylight panels

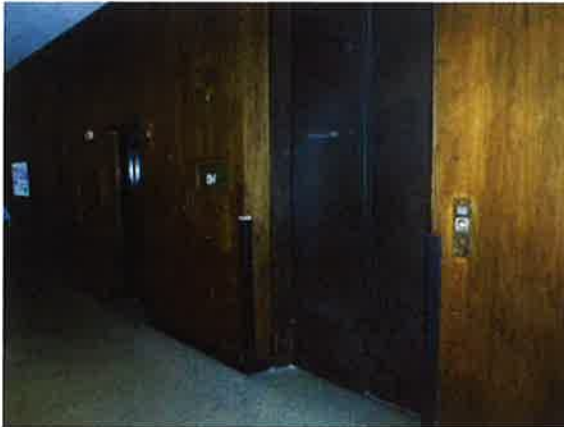
A-30

Original Equipment Elevators

Ahmanson Building Elevator

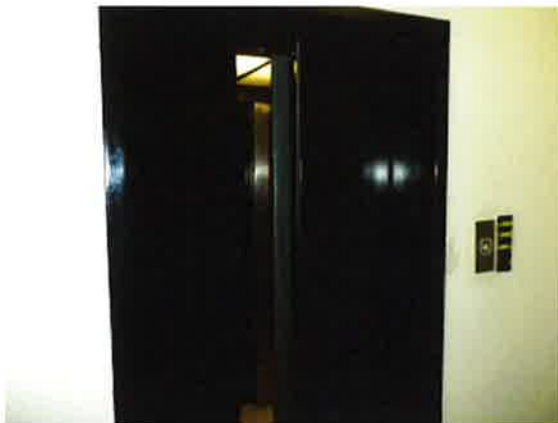
A-031

Original Equipment Elevators

Hammer Building Elevator

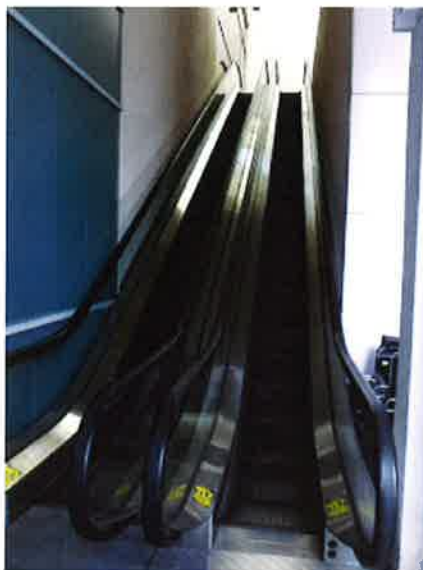
A-032

Original Equipment Escalators

Hammer Building Escalators

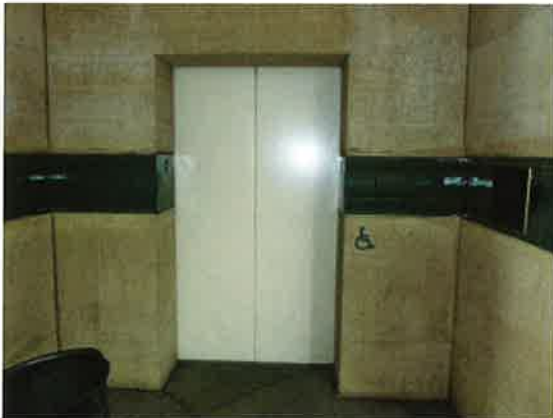
A-033

Bing Center Elevator

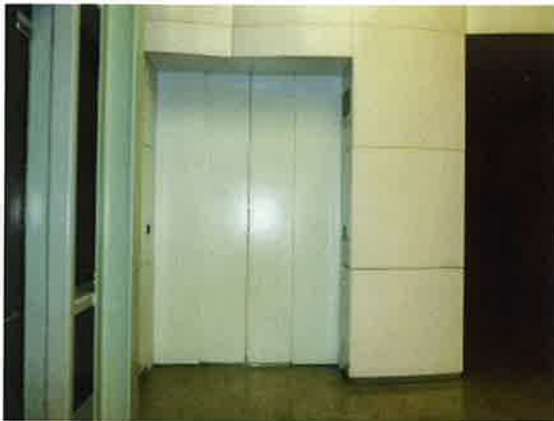
A-034

Original Equipment Elevator

Art of the Americas Elevator

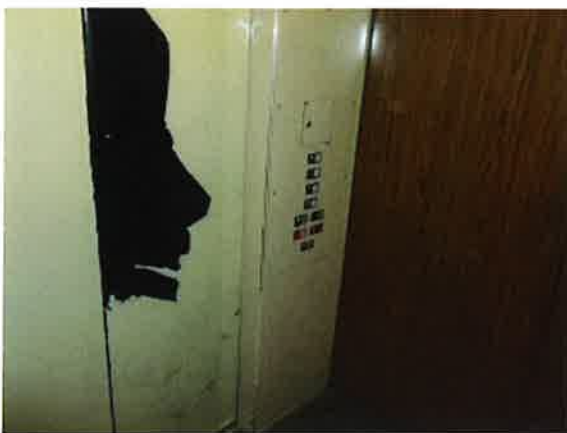
A-035

Original Equipment Freight Elevator

Ahmanson Building Elevator Cab

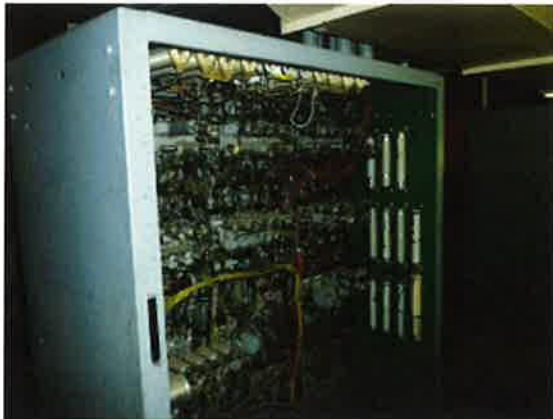
A-036

Obsolete Relay-Logic Elevator Controls

Ahmanson Building

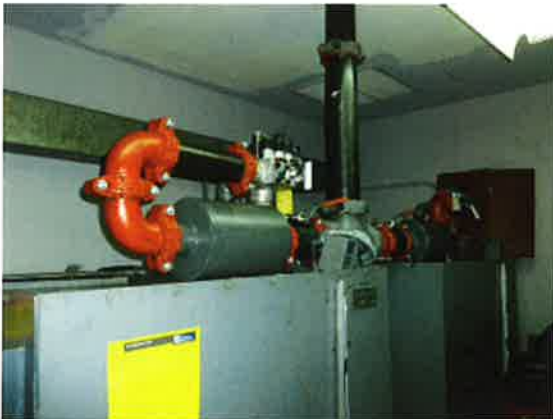
A-037

Upgraded Hydraulic Controls

Art of the Americas Elevator Hydraulics

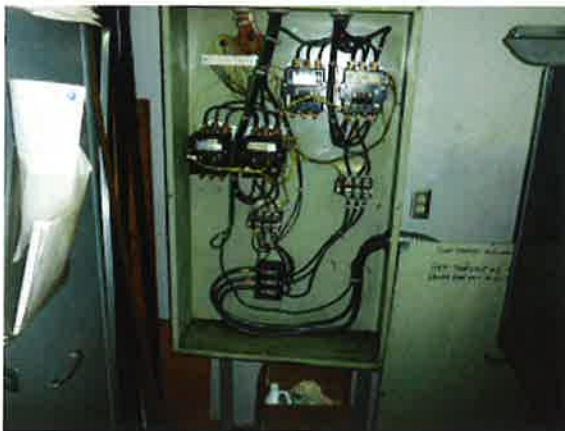
A-038

Obsolete Relay-Logic Elevator Controls

Art of the Americas

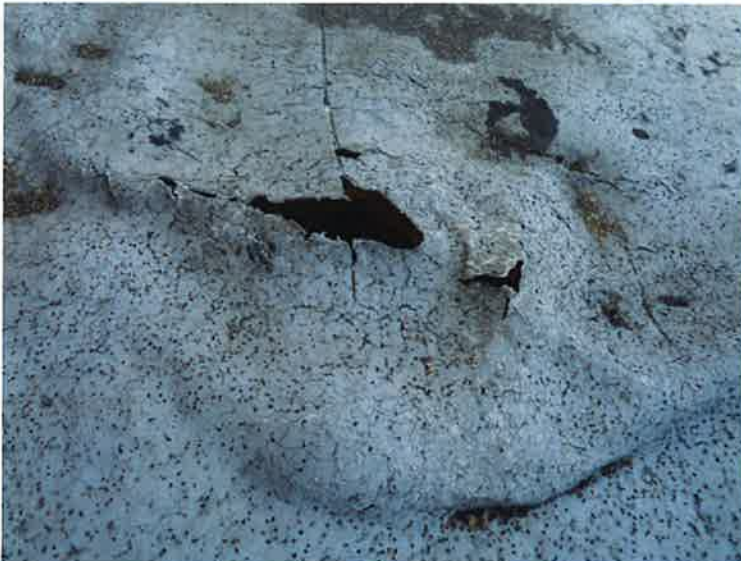
WI-002

This picture shows a close up of one of numerous large blisters in foam, split and fractured blisters, degraded coating. Ahmanson Bldg Penthouse

This is a Sprayed Polyurethane Foam with Coating.

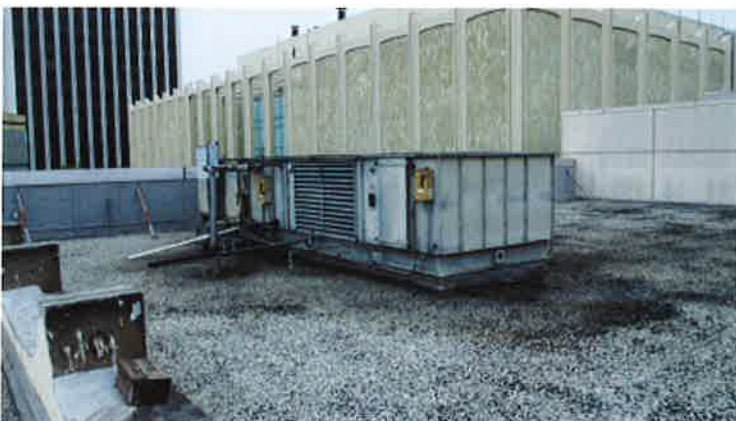
This picture shows the building roof system which is a cold-tar pitch system and is no longer in standard use.

Roofing, flashing and waterproofing are in poor condition and at the end of expected life.

Roofing should be replaced on all buildings in the near term.

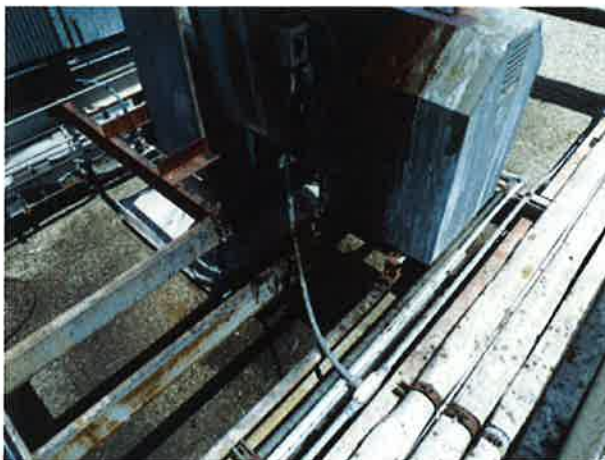
WI-004

Severe grease contamination on roof system over cafe

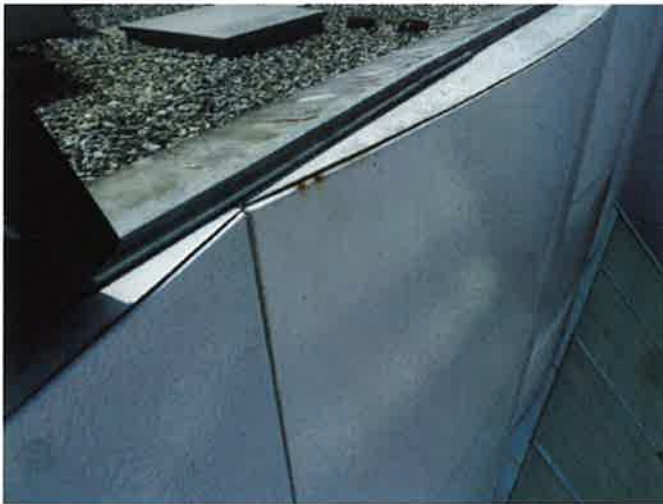
WI-007

Degraded sealant in wall cladding - both concrete/stone and metal panels

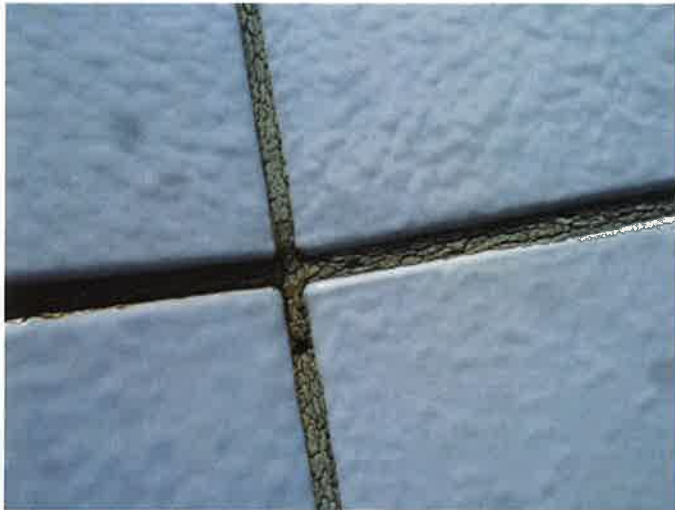
WI-008

Degraded sealant in wall cladding - both concrete/stone and metal panels

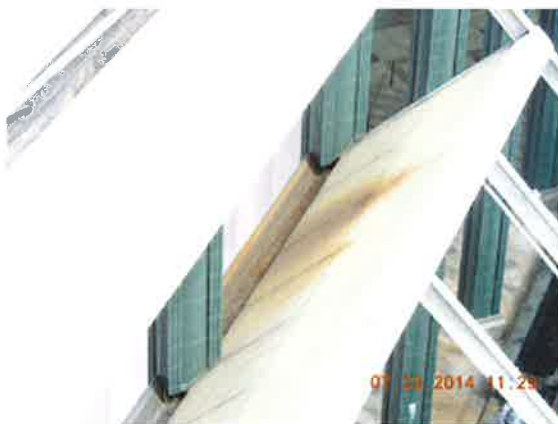
WI-011

Translucent polycarbonate panels with internal grids.

Rust at areas below gutters on steel framing and columns. Rust on wall panels at joint below some of the gutter sections.

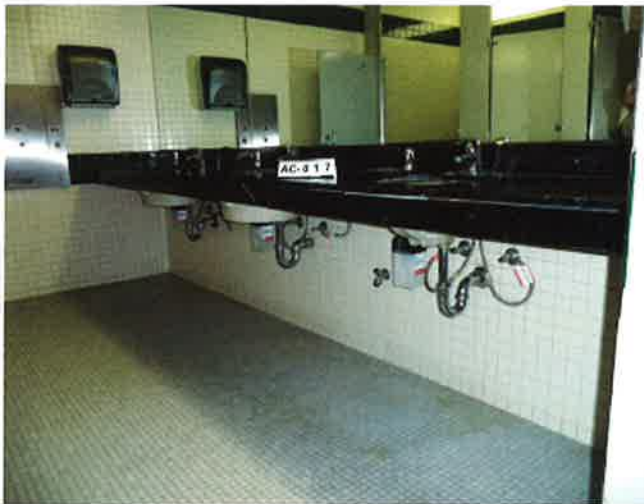
AC-001

This picture shows counter heights that are not accessible.

Corrections are needed to some fixtures and dispensers. Corrections are needed to some elements including additional ambulatory stall, grab bar heights, accessories heights and type, clear knee space, toilet location in respect to adjacent wall, counter heights, partition door arrangement, door hardware, and other similar items.

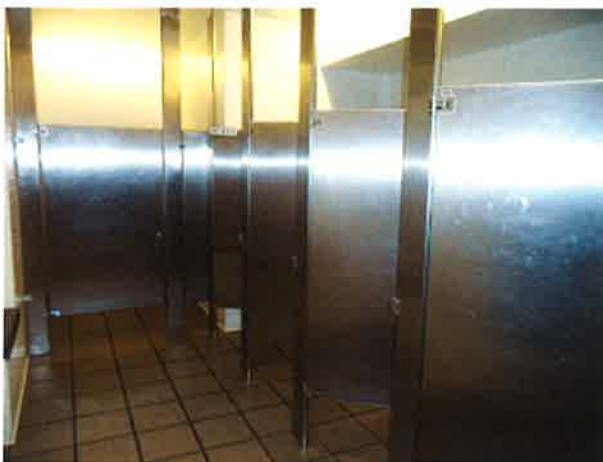
AC-002

This picture shows partition panels side stiles are 6" when 4" max is specified.

Modification to the partition panels required to provide side stiles at the accessible stall which are 4" max in width.

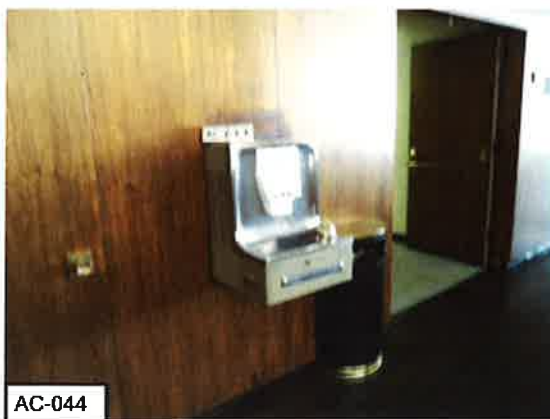
AC-003

Drinking fountains at several locations are not code complaint. Modification require including adding signage and barrier rails, replace existing units with Hi/Lo ADA units for facility update.

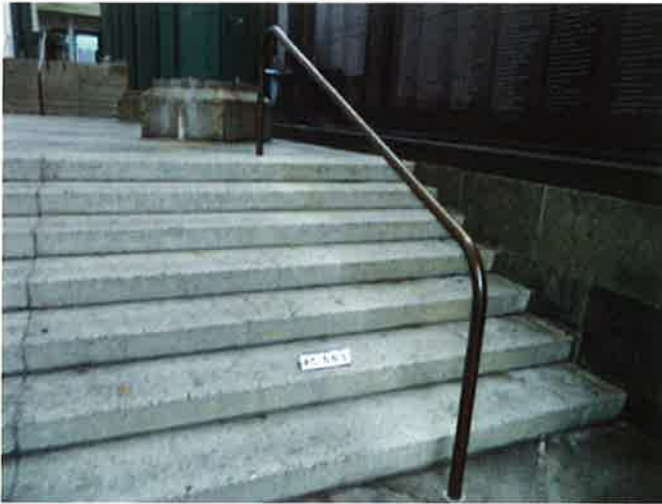
AC-004

This picture shows handrails do not provide the required level extensions at the top and bottom.

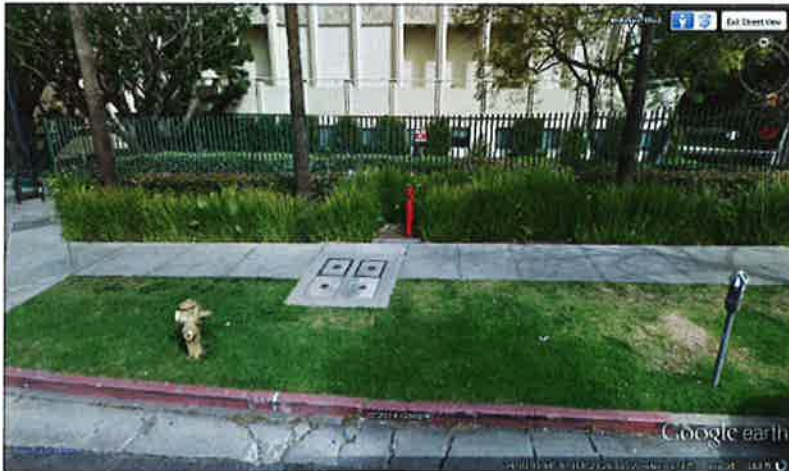
C-001

The current backflow preventers are either buried or do not exist and most likely do not meet current requirements.

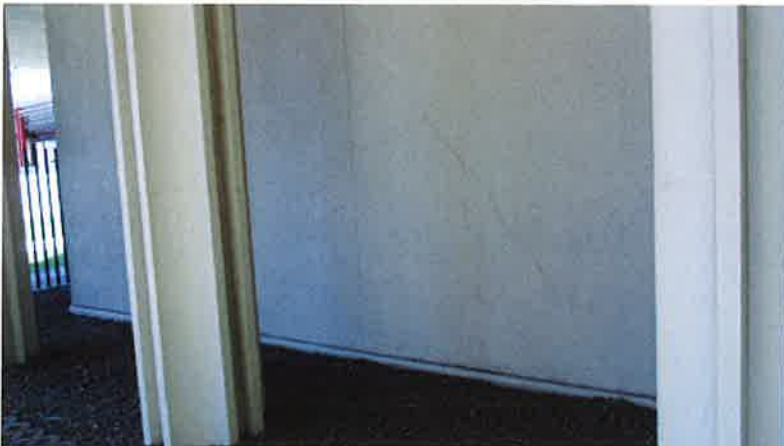
S-003

Shear Wall Crack Repairs, 1st Floor Ahmanson

Several diagonal cracks and repairs were observed in the walls at the corner of the Ahmanson Building 1st Floor.

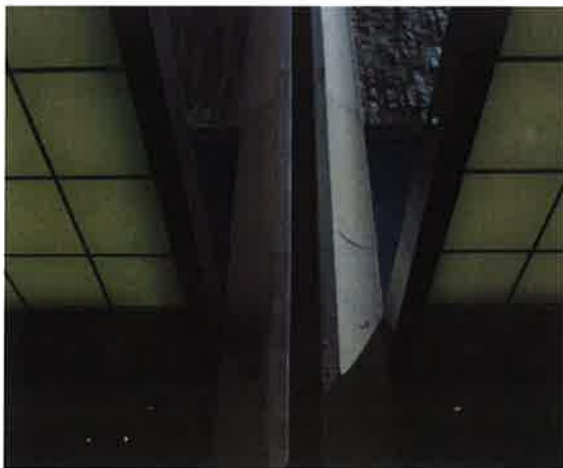
S-006

Cracked Column Cladding, Hammer

Several cracks were observed in the column cladding of the Hammer building.

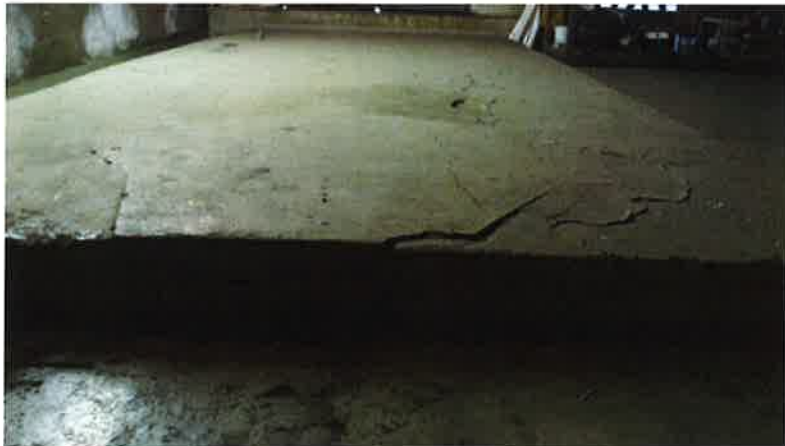
S-009

Roof Slab Cracking

Cracks were observe in the pads and slab at the main roof of the Ahmanson building.

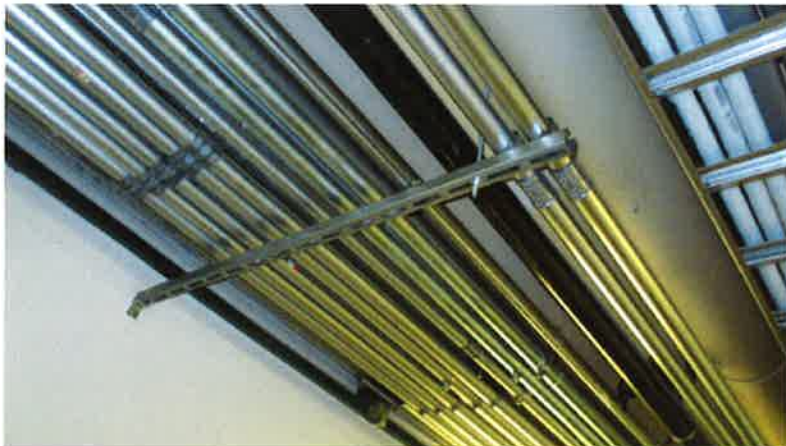
S-012

Several utility pipes, ducts, and raceways were observed without lateral bracing.

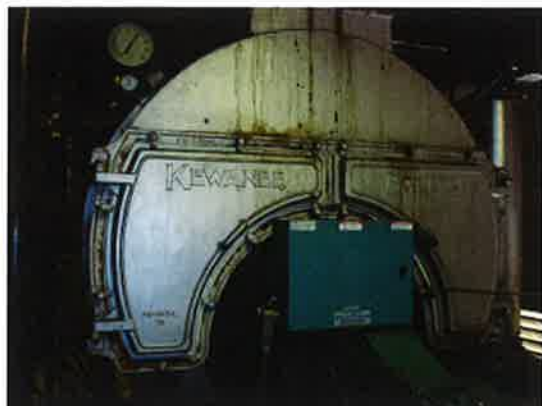
M-001

Steam Boilers: These have been retrofitted to meet current AQMD air quality requirements.

However, further retrofit will not be possible to meet more stringent AQMD requirements expected in 5 years.

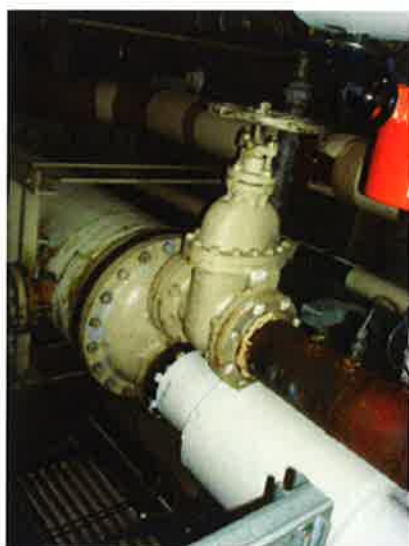
M-002

These are in fair condition.

There is not a way to remove the heating bundle, without removing the entire heat exchanger.

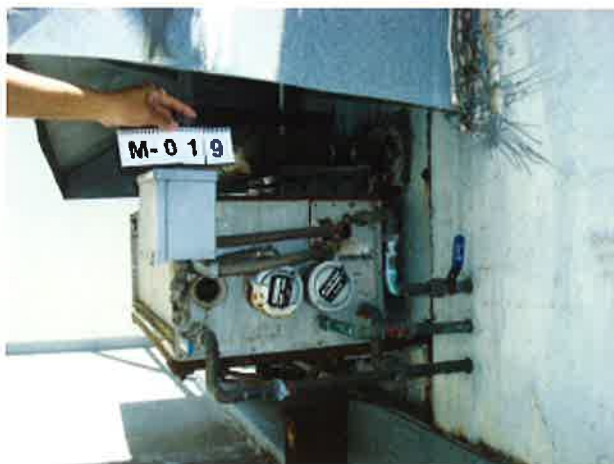
M-003

This picture shows an electric humidifier shut off and non-operational.

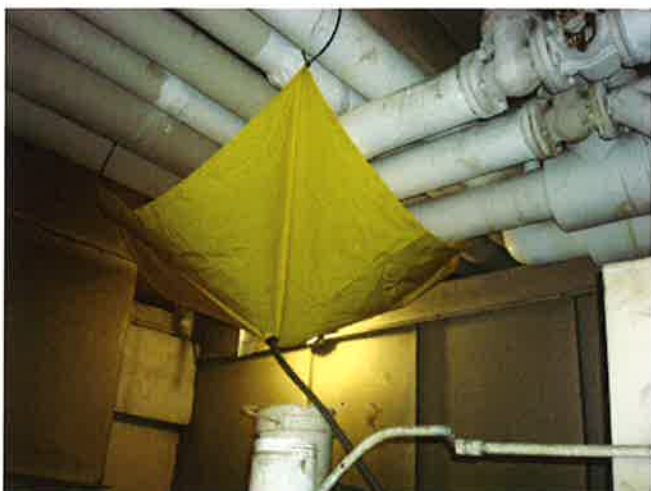
M-006

HHW Piping: Water leaking from HHW water piping.

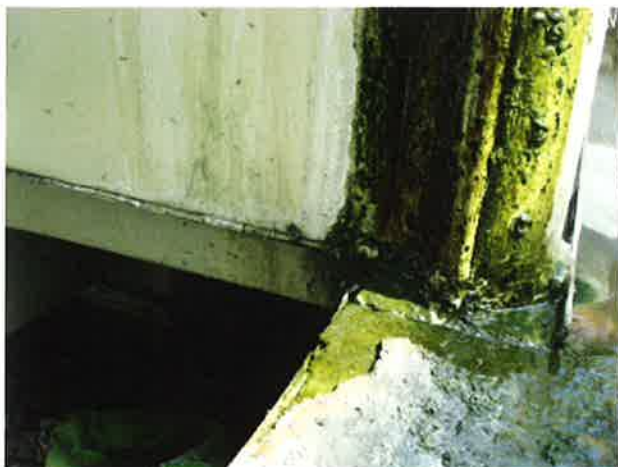
M-011

Cooling Towers: Algae build up on and in the tower basin.

There was a lot of standing water on the roof around the towers

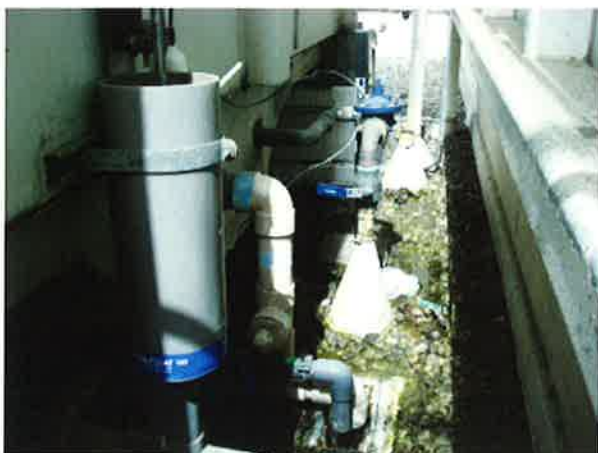
M-012

Cooling Towers: This picture shows that there is a lot of standing water on the roof around the cooling tower due to poor drains and drain lines.

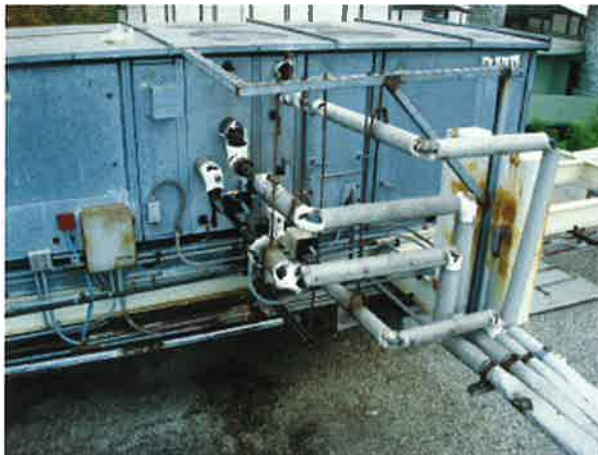
M-013

Air Handling Units: The existing air handling systems are old and obsolete - in age, condition, and technology. All air handling units (AHUs) are in poor condition and are past their expected useful lives.

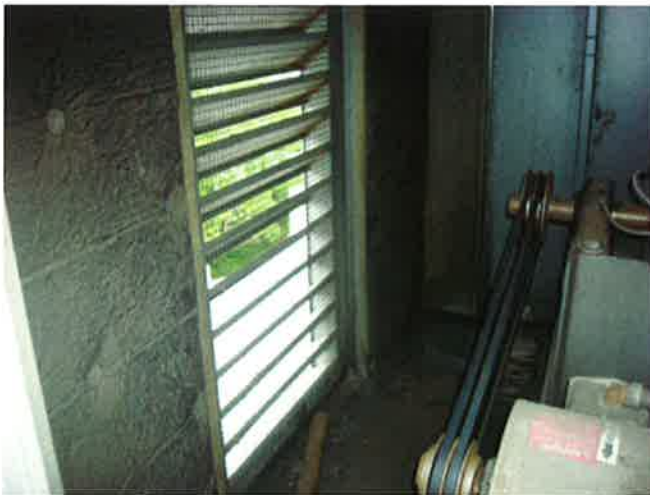
M-016

Air Handler Units: Return fan motor and fan wheel are not aligned and is not operational.

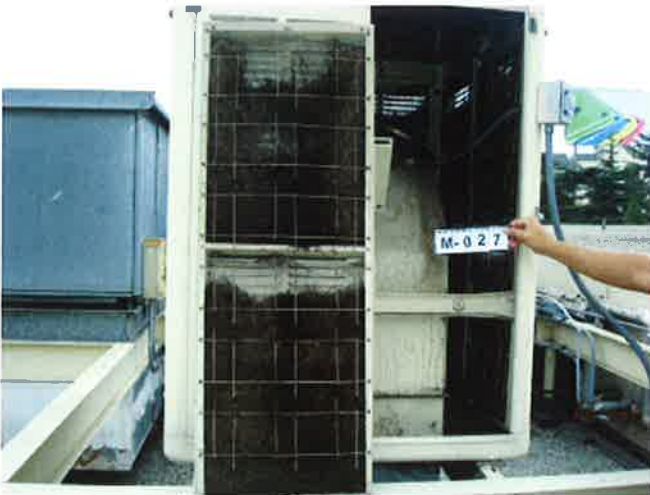
M-017

This picture shows a non-operational evaporator cooler.

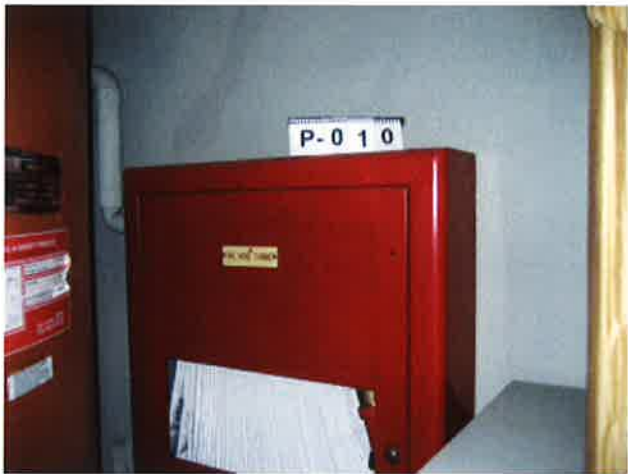
FP-002

This picture shows a fire hose cabinet that is in fair good condition.

There are several Fire Hose Cabinets that need to relocate because they do not have clear access path to it.

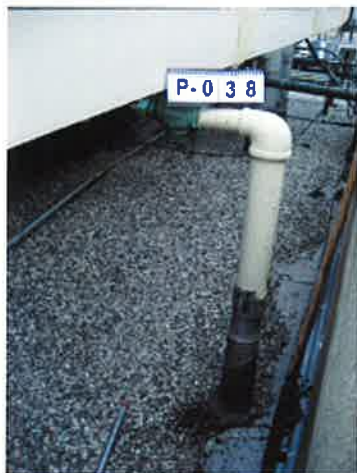
FP-006

Hose connection
standpipe

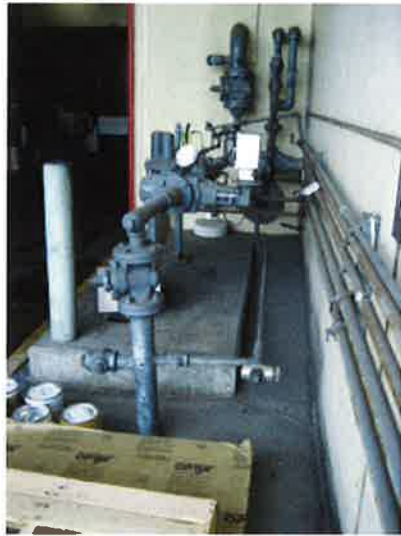
P-001

Main gas service

The main gas meter is at the loading dock of the Ahmanson Bldg loading dock

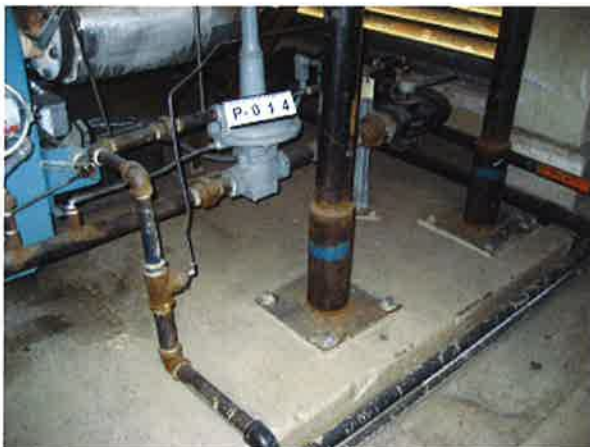
P-002

Medium pressure gas piping

Medium pressure gas supply to existing boilers are in good condition

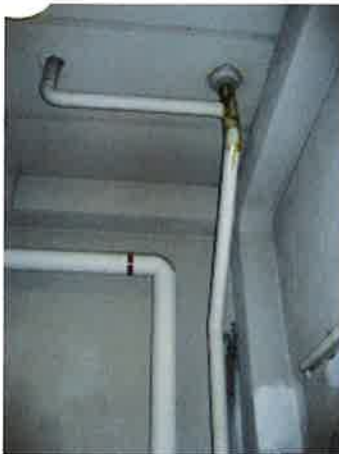
P-004

This drain pipe is leaking

Drain pipe

Existing floor sink need to be replaced and the drain pipe from this floor sink needs to be fixed and un-clogged.

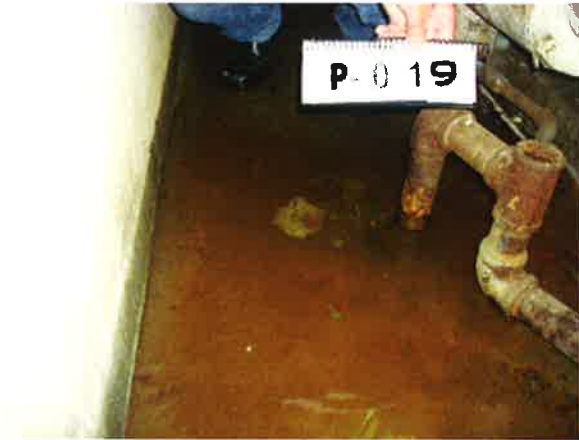
P-005

Clogged Floor Sink Drain

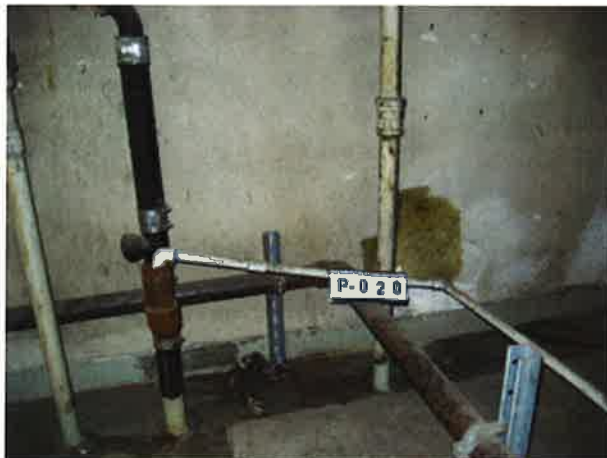
P-006

Condensate pipe sloping in the wrong direction.

Condensate piping

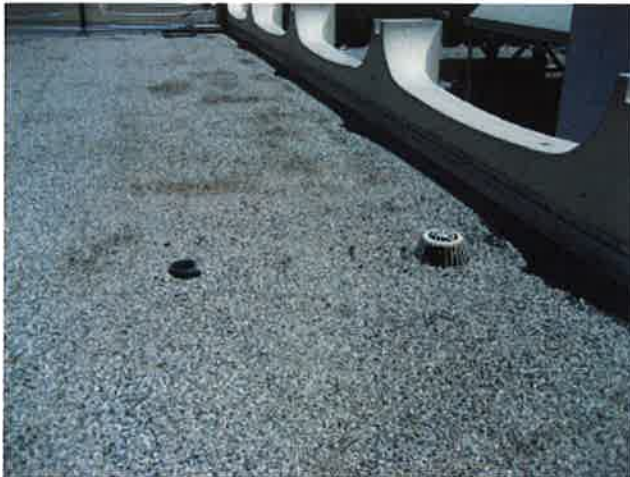
P-007

An existing roof drain dome is broken and need to replace with new on Building A
New overflow storm drain with 2" water
dame need to install right at above of all
existing overflow storm drain pipes.

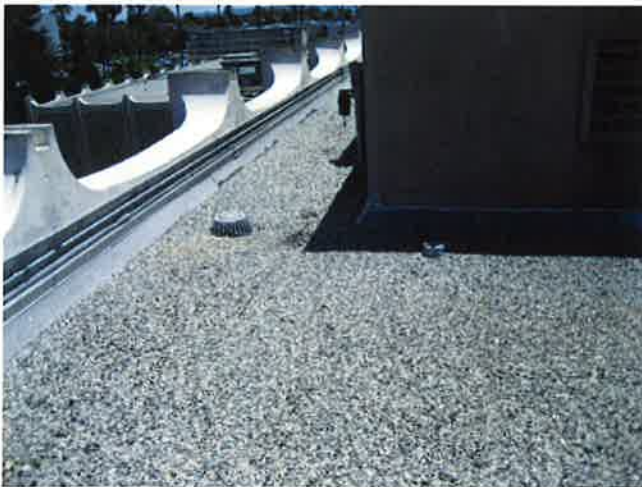
P-008

Over flow storm drains need to be installed
2" above finished roof right at the existing
drain pipes. Building B.

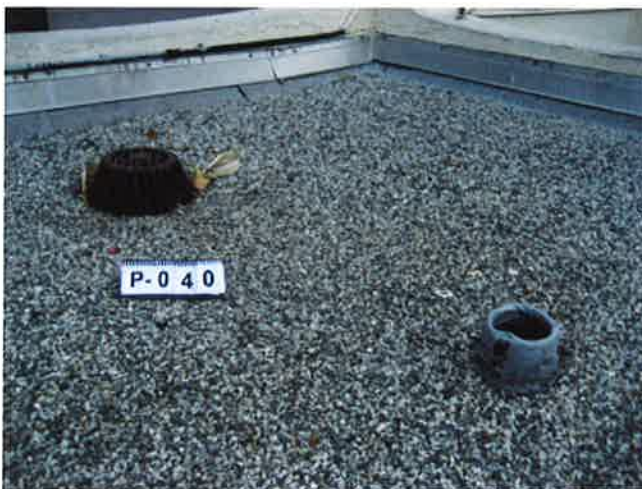
P-009

The existing storm drains on roof of Building
C are in good condition. However, a new
overflow storm drain with 2" water dome
need to install right at above of all existing
overflow storm drain pipes up 2" above
finish roof

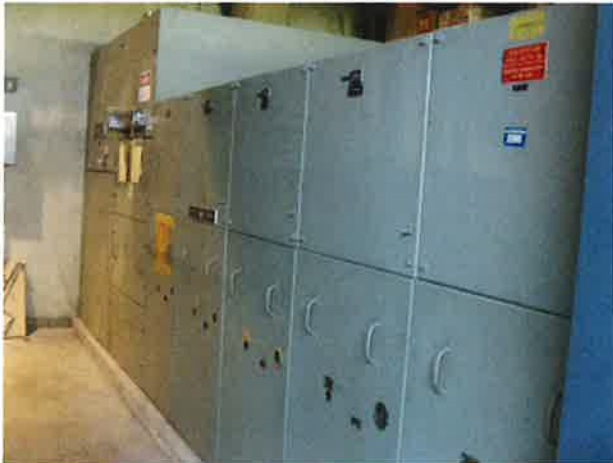
E-001

The primary electrical service supplied to the building is by LADWP, via a 12Kv utility vault located adjacent to the electrical room on the first floor.

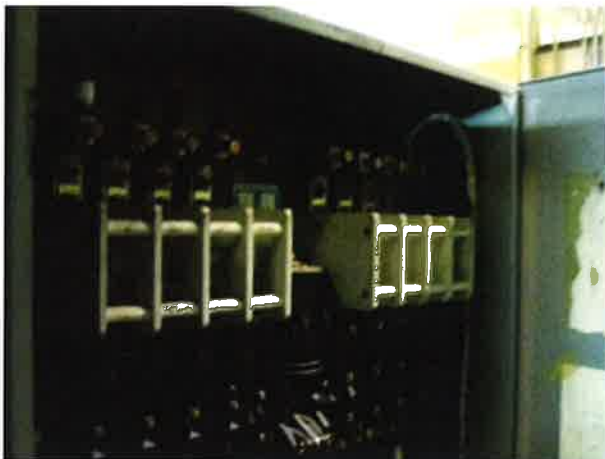
E-002

Sub-stations: The substations are 50 years old. Replacement parts are no longer available and need be replaced with new as recommended.

Various transformers have overheated and recently been replaced. Some are running high above their temperature rating and being cooled by fans. Many unit substations and distributions in the electrical rooms are violating the working clearance per the electrical code and emergency access doors.

This picture shows a 500KVA, 4160V.-120/208v, 3 phase indoor unit substation "T-1" in the Ahmanson Building

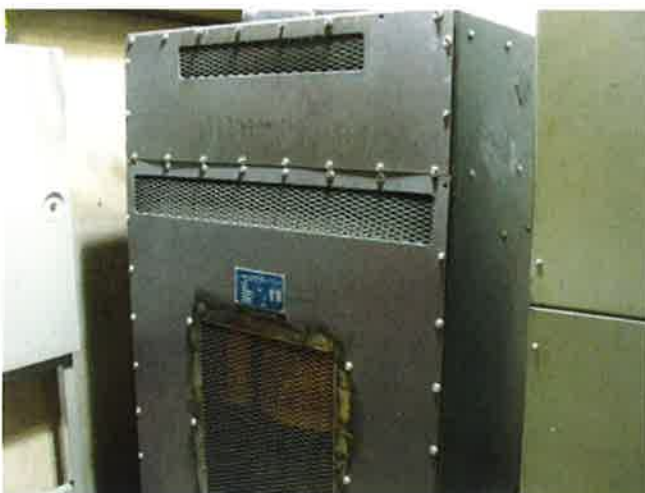
E-003

This picture also shows the limited safe working space between the equipment.

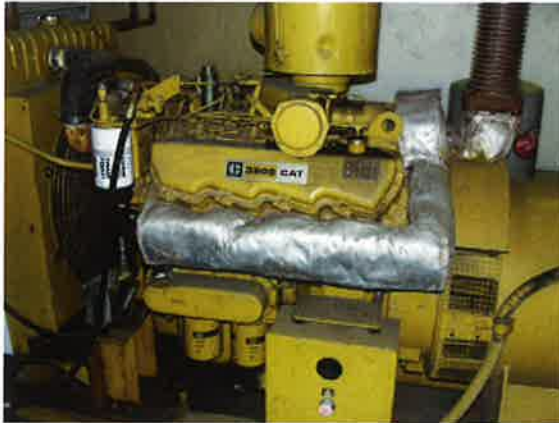
Indoor Emergency Generator – Building D E-010

This picture shows emergency Generator G-3, 150 kw.

Replace with system re-design in near term to provide reliable emergency power system for the buildings.

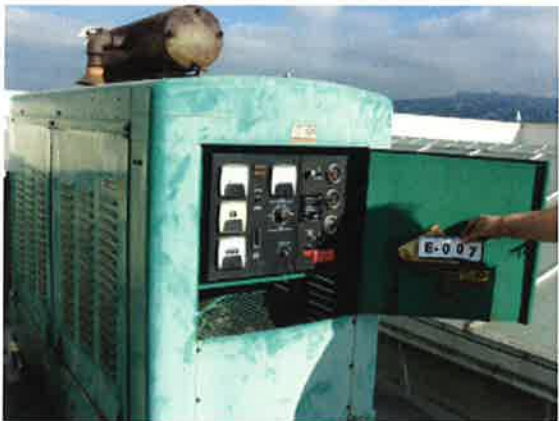
Outdoor Emergency Generator – Ahmanson addition E-012

This emergency generator set and transfer switch including all associated distribution panels and remote annunciator control panels are 30 years old and there is no future expansion power capacity.

This picture show the emergency generator G-2, 50 kw.

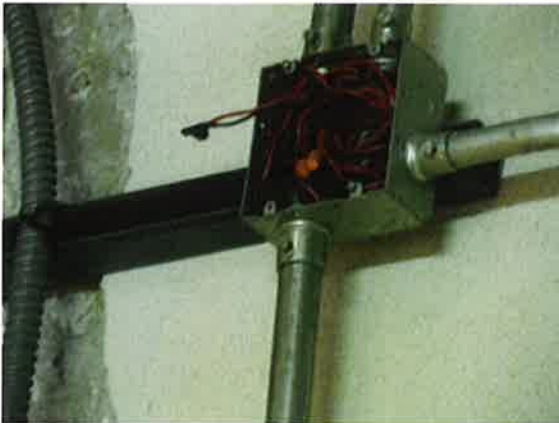
E-013

Many power outlets, especially in the kitchen, electrical and mechanical rooms, are smoked indicating evidence of short circuits.

Also, as shown in this picture, many outlets do not have cover plates with exposed wires.

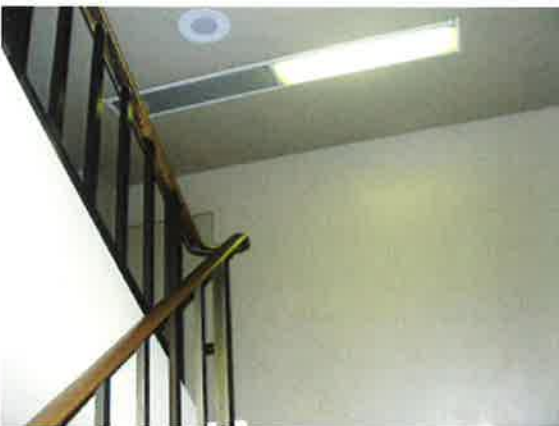
E-014

Various stairwell and path of egress lighting do not have adequate lighting levels and illuminated exit signs throughout the building.

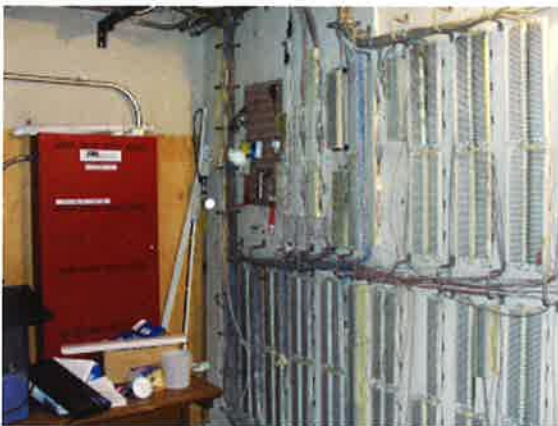
E-017

This picture shows old telephone PBX systems which are old and not current.

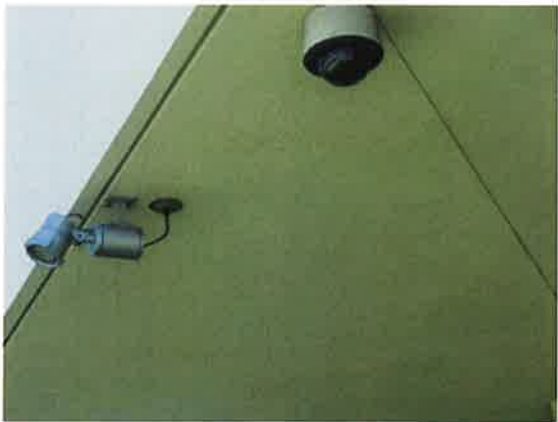
E-018

Security systems were installed nearly 7 years ago. Fire alarm and public address systems were installed in June of 2013. There are no deficiencies reported (by the main director of central security personnel).

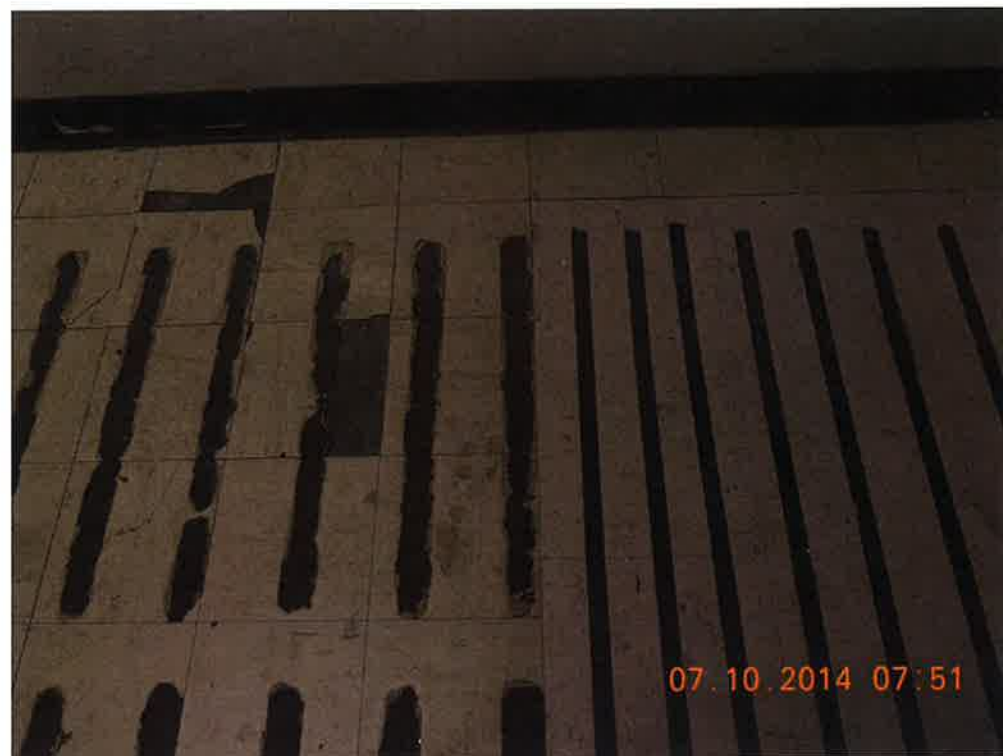
Comment #: A1101

A/E Comment No.	System	Floor	Building	Title	Item	Condition	Recommendation	Priority 1 (Immediate)	Priority 2 (2-5 years)	Priority 3 (5-10 Years)	Priority 4 (10+ Years)
1101	Architectural	1	A	Exit corridor asbestos floor tiles	Asbestos floor tiles	Poor condition	Remove and replace			X	
1102	Architectural	1	A	Exit corridor	Not code complaint	Trip hazard	Demolish and remove		X		
1103	Architectural	1	A	Exit corridor column	Water leak and rust damage	Poor condition	Repair, replace and paint			X	
1103	Architectural	1	A	Exit corridor column	Water leak and rust damage	Poor condition	Repair, replace and paint			X	
1103	Architectural	1	A	Exit corridor column	Water leak and rust damage	Poor condition	Repair, replace and paint			X	
1103	Architectural	1	A	Exit corridor walls	Water leak and rust damage	Poor condition	Repair, replace and paint			X	
1104	Architectural	1	A	Exit corridor rated walls	Mechanical piping penetrations	Not code complaint, CBC 2013	Apply fire caulking	X

Picture 1: Comment# A1101
Drawing #: Group 1 Level 1
Bldg:
Item: Exit corridor asbestos floor tiles
Discipline: A Building

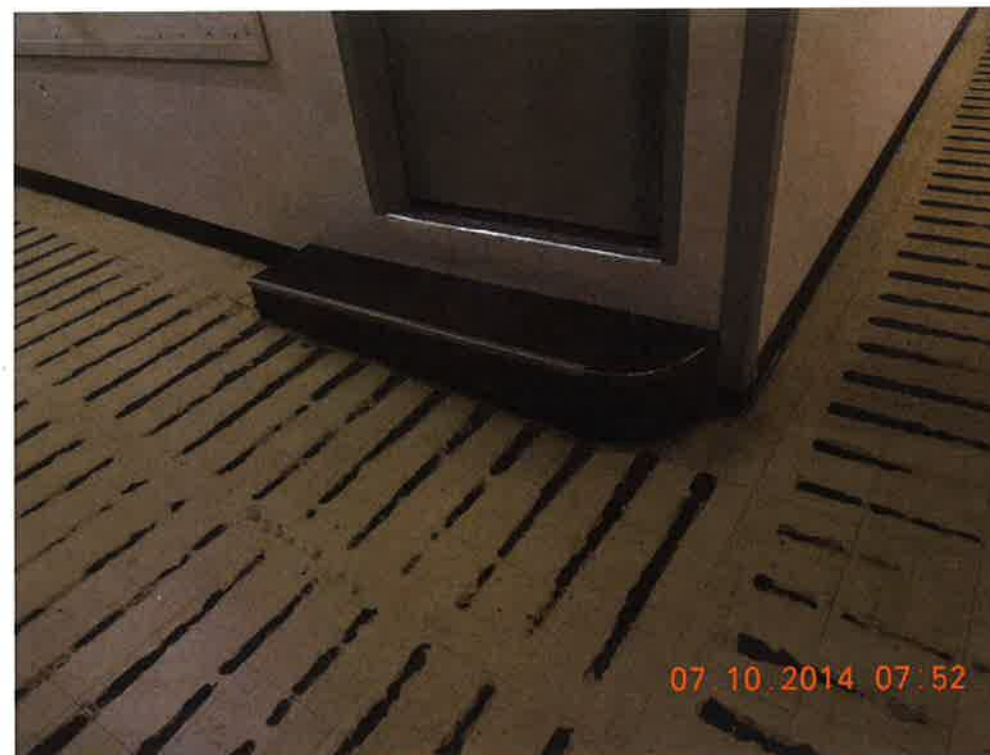
Comment #: A1102

Picture 2: Comment# A1102
Bldg:
Drawing #: Group 1 Level 1
Discipline: A Building
Item: Exit corridor

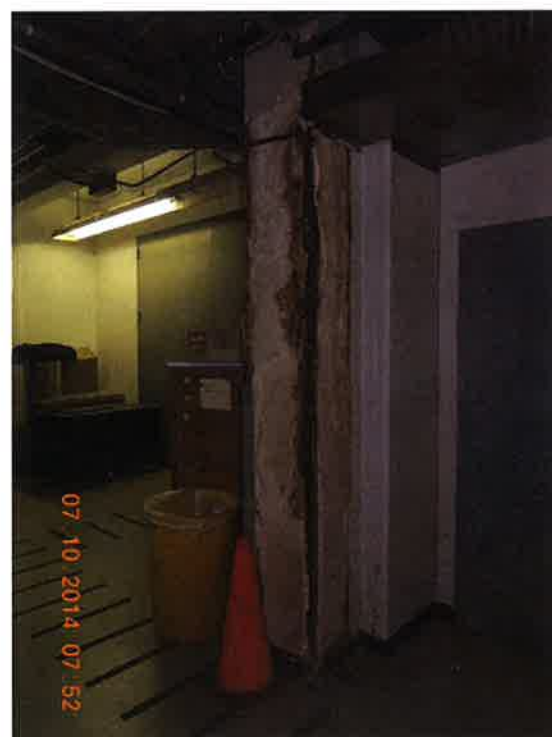
Comment #: A1103.1

Picture 3: Comment# A1103.1
Bldg:
Drawing #: Group 1 Level 1
Discipline: A Building
Item: Exit corridor column

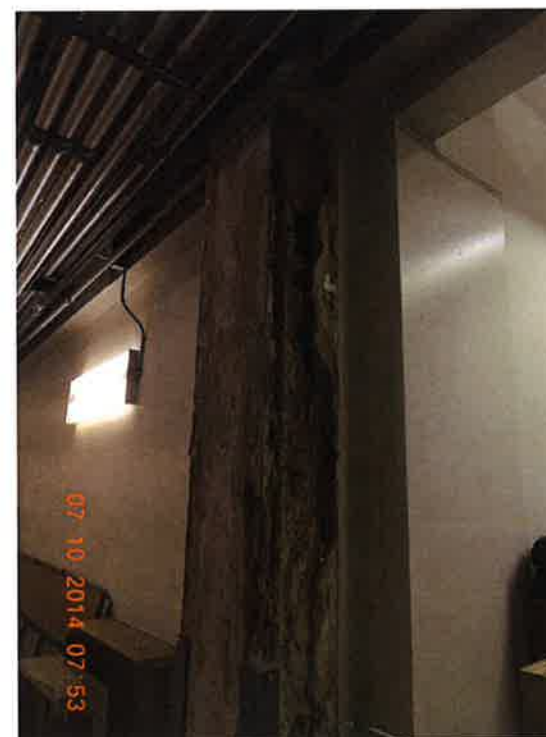
Comment #: A1103.2

Picture 4: Comment# A1103.2
Bldg:
Drawing #: Group 1 Level 1
Discipline: A Building
Item: Exit corridor column
