Revised Appendix Q

Existing Building Evaluation

Los Angeles County Museum of Art Building Evaluation

September 16, 2014

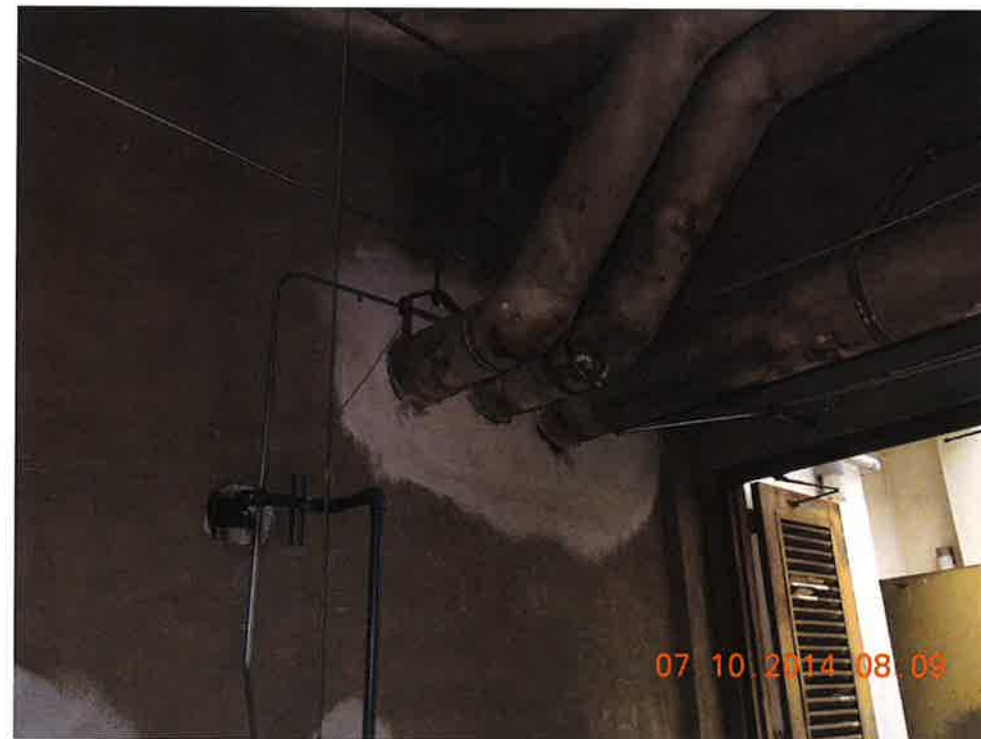
Comment #: A1104

Picture 3: Comment# A1104
Bldg:
Drawing #: Group 1 Level 1
Discipline: A Building
Item: Exit corridor rated walls

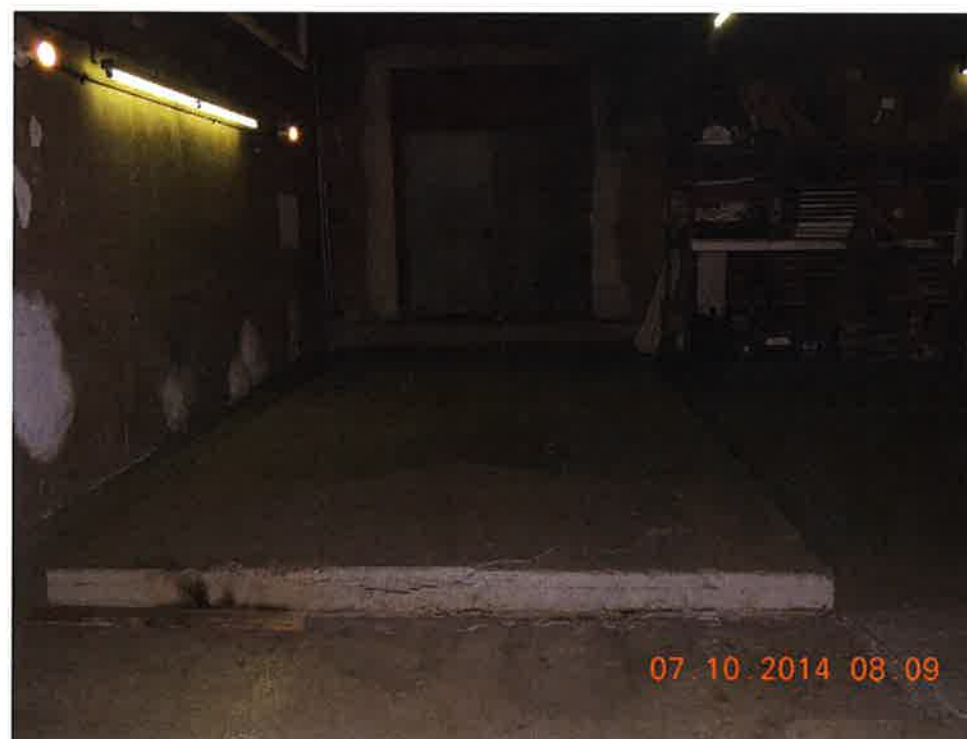
Comment #: A1105

1105	Architectural	1	A	Concrete house keeping pad	Concrete pad	Poor condition	Repair and paint		X		
1106	Architectural	1	A	Exit corridor rated walls	Mechanical piping penetrations	Not code complaint, CBC 2013	Apply fire caulking	X			
1106	Architectural	1	A	Exit corridor rated walls	Mechanical piping penetrations	Not code complaint, CBC 2013	Apply fire caulking	X			
1106	Architectural	1	A	Exit corridor rated walls	Mechanical piping penetrations	Not code complaint, CBC 2013	Apply fire caulking	X			
1106	Architectural	1	A	Exit corridor rated walls	Openings	Not code complaint, CBC 2013	Repair and paint	X			
1107.0	Architectural	1	A	Exit corridor suspended ceiling tiles	Asbestos ceiling tiles	Not code complaint, CBC 2013	Replace entire suspended ceiling system with acoustical tiles and install new light fixtures			X	
1108.0	Architectural	1	A	Water damage from adjacent walls	Water leak and damage	Poor condition	Demolish and remove partial wall to repair and waterproof			X

Picture 4: Comment# A1105
Bldg:
Drawing #: Group 1 Level 1
Discipline: A Building
Item: Concrete house keeping pad

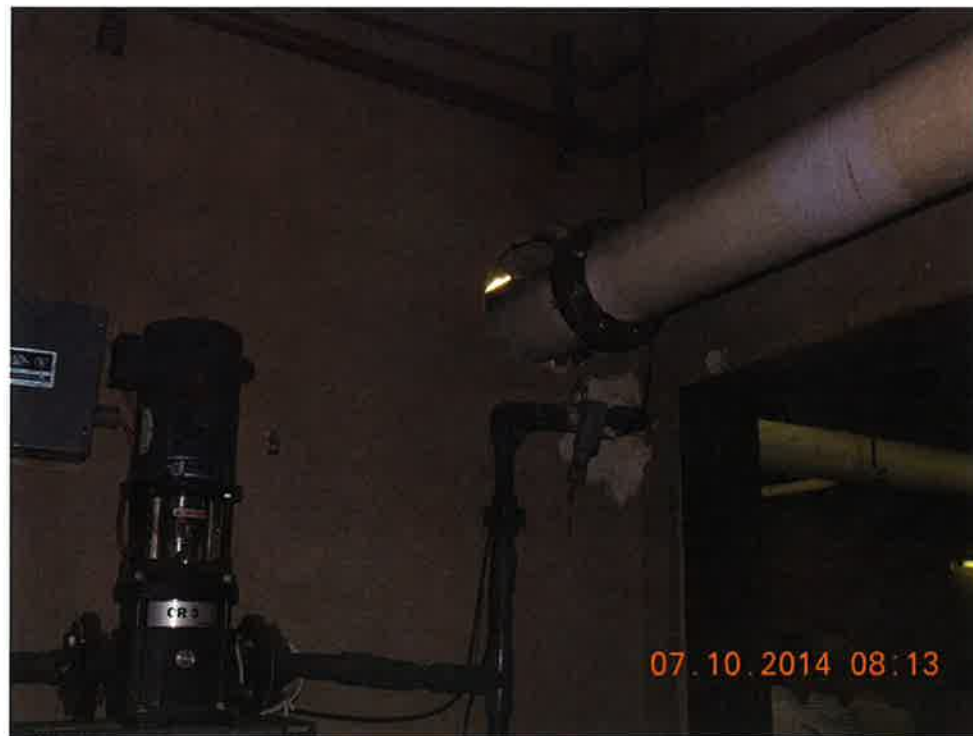
Comment #: A1106.3

Picture 3: Comment# A1106.3
Bldg:
Drawing #: Group 1 Level 1
Discipline: A Building
Item: Exit corridor rated walls

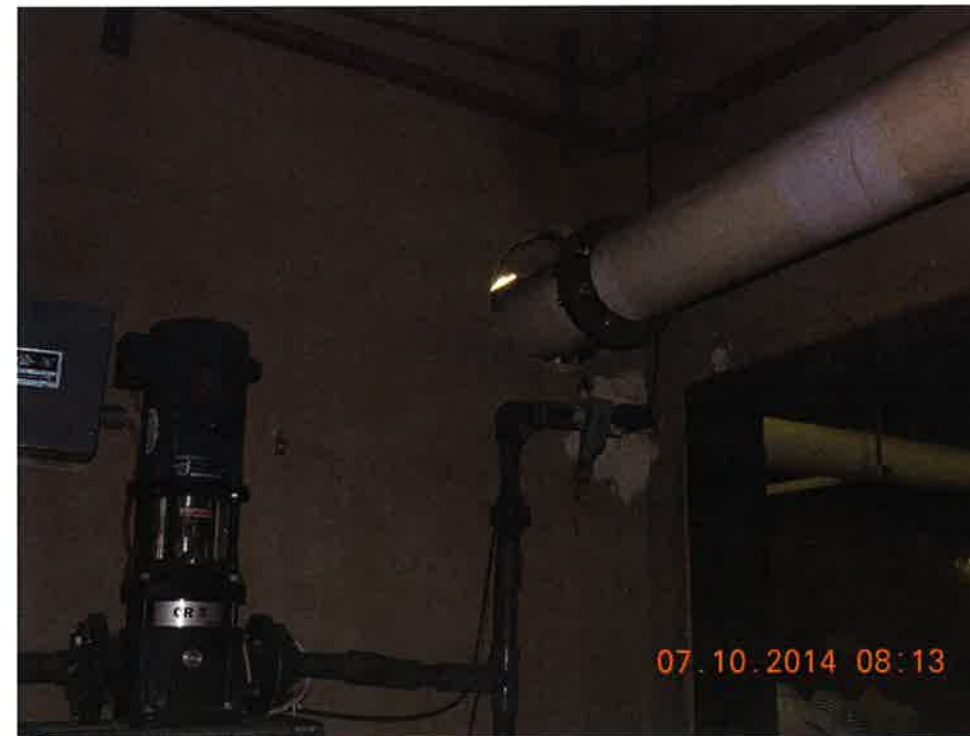
Comment #: A1106.4

Picture 4: Comment# A1106.4
Bldg:
Drawing #: Group 1 Level 1
Discipline: A Building
Item: Exit corridor rated walls

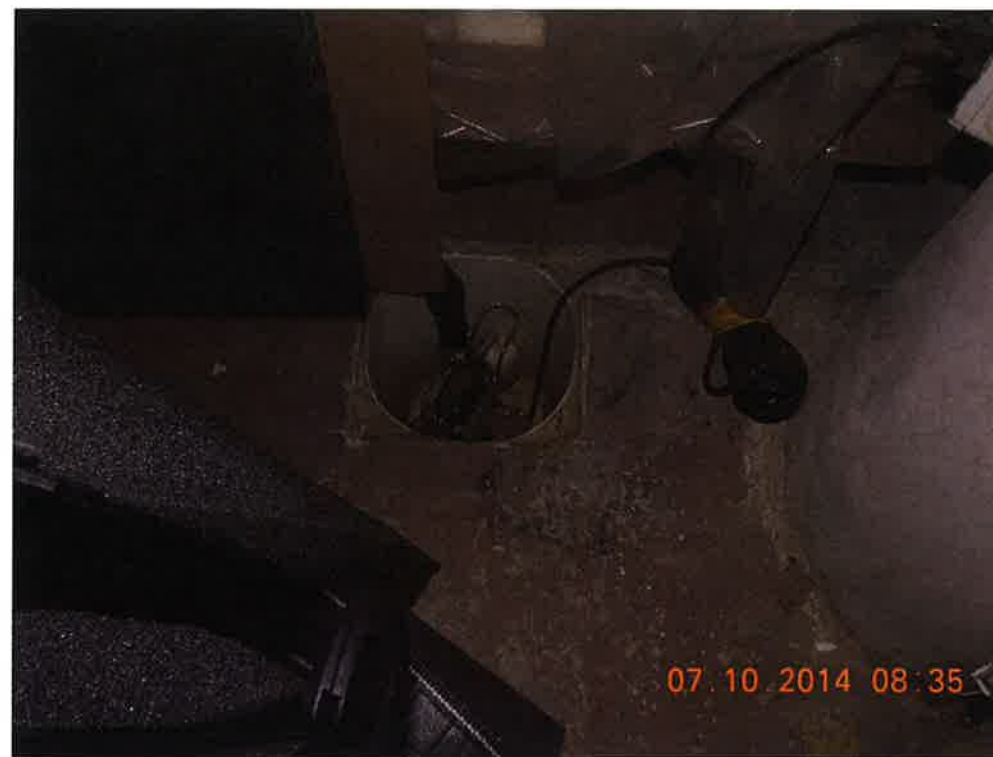
Comment #: A1108

Picture 2: Comment# A1108
Bldg:
Drawing #: Group 1 Level 1
Discipline: A Building
Item: Water damage from adjacent \

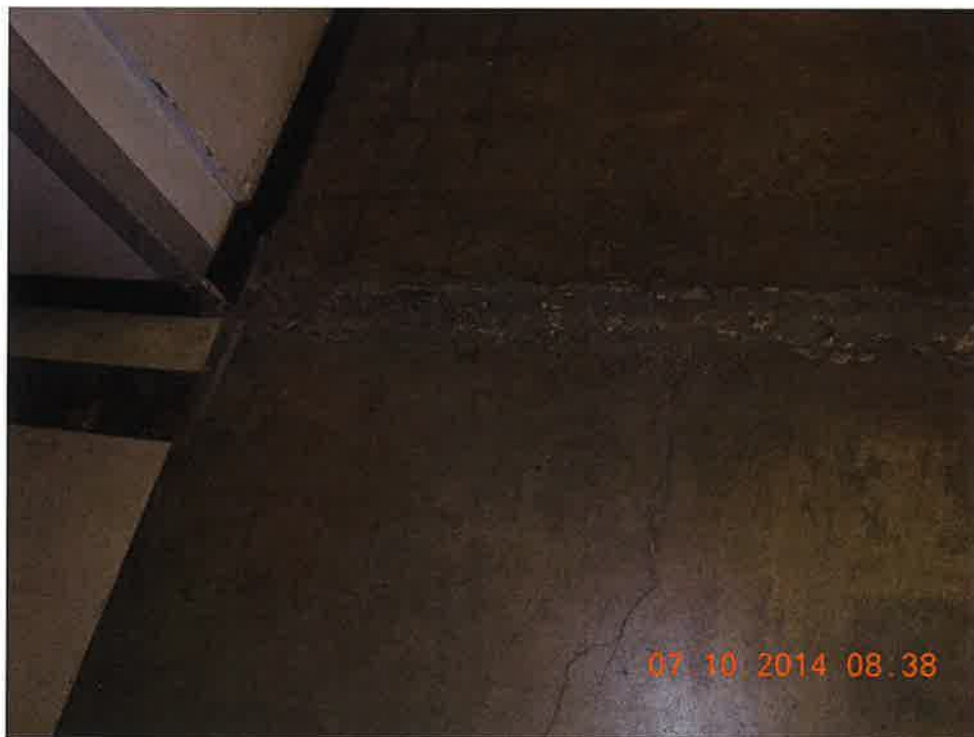
Comment #: A1109

1109.0	Architectural	1	A	Exit corridor floor concrete slab	Concrete slab	Poor condition	Repair and seal		X		
1110.1	Architectural	1	A	Exit corridor rated walls	Openings	Not code complaint, CBC 2013	Repair and paint	X			
1110.2	Architectural	1	A	Exit corridor rated walls	Openings	Not code complaint, CBC 2013	Repair and paint	X			
1111.0	Architectural	1	A	Exit corridor suspended ceiling	Framing, tiles and light fixture	Poor condition	Replace entire suspended ceiling system with acoustical tiles and install new light fixtures		X		
1112.0	Architectural	1	A	Men's Restroom	Plumbing fixtures	Not code complaint, CBC 2013	Replace restroom entire plumbing fixture per ADA code, CBC 2013		X		
1113	Architectural	1	A	Exit doors	Finish Hardware	Not code complaint, CBC 2013	Modify finish hardware		X

Picture 3: Comment# A1109
Bldg:
Drawing #: Group 1 Level 1
Discipline: A Building
Item: Exit corridor floor concrete slat

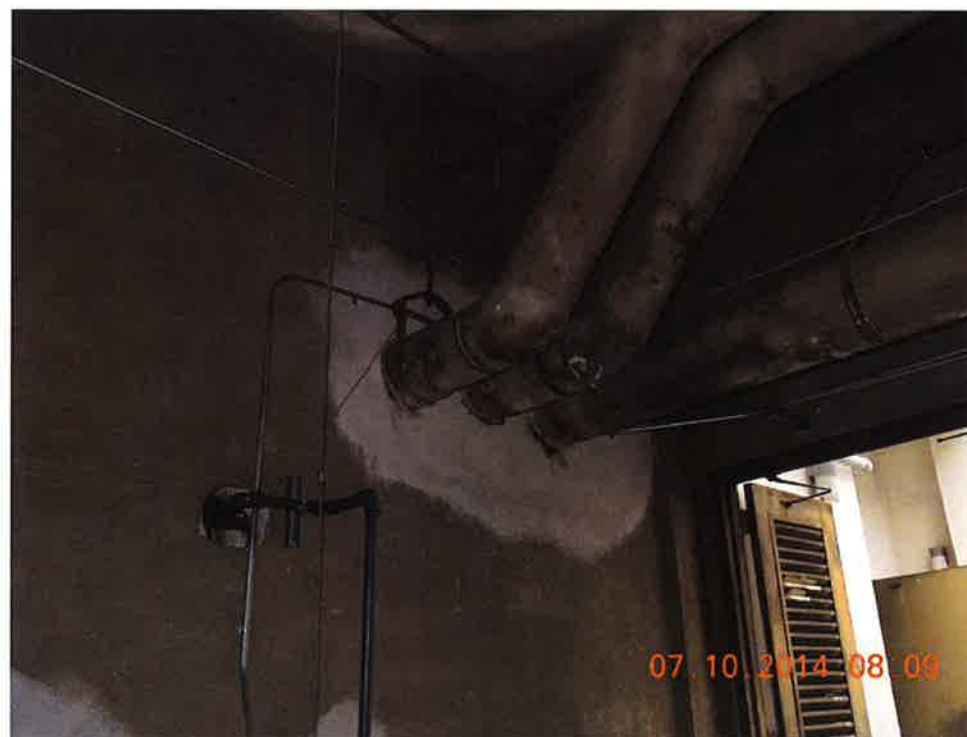
Comment #: A1110.1

Picture 4: Comment# A1110.1
Bldg:
Drawing #: Group 1 Level 1
Discipline: A Building
Item: Exit corridor rated walls

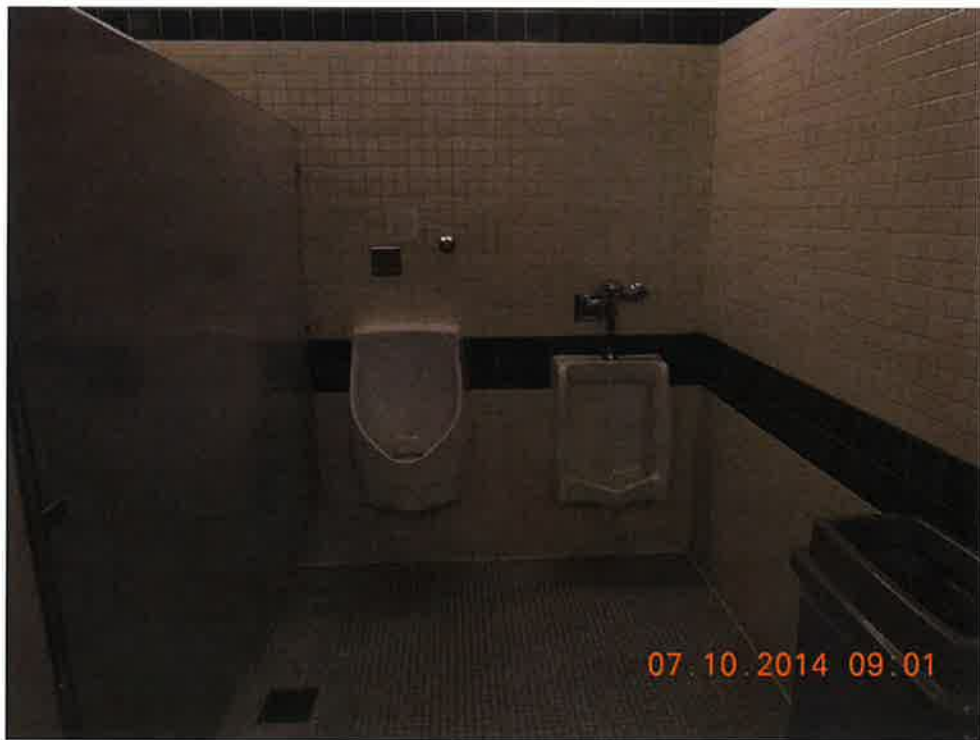
Comment #: A1112

Picture 3: Comment# A1112
Bldg:
Drawing #: Group 1 Level 1
Discipline: A Building
Item: Men's Restroom

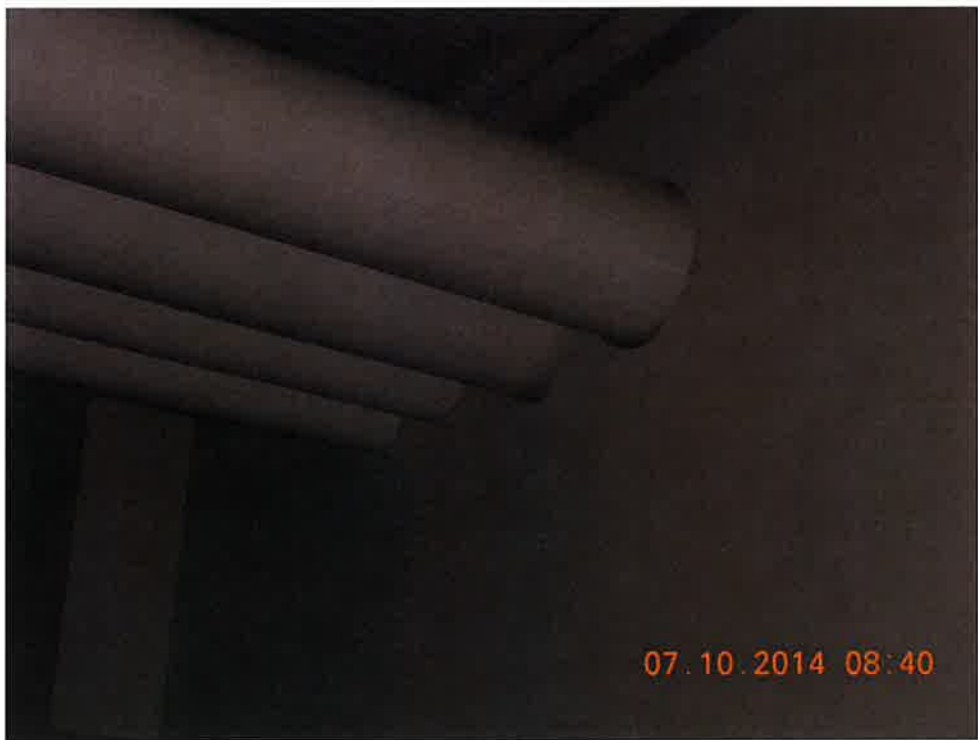
Comment #: A1113

Picture 4: Comment# A1113
Bldg:
Drawing #: Group 1 Level 1
Discipline: A Building
Item: Exit doors

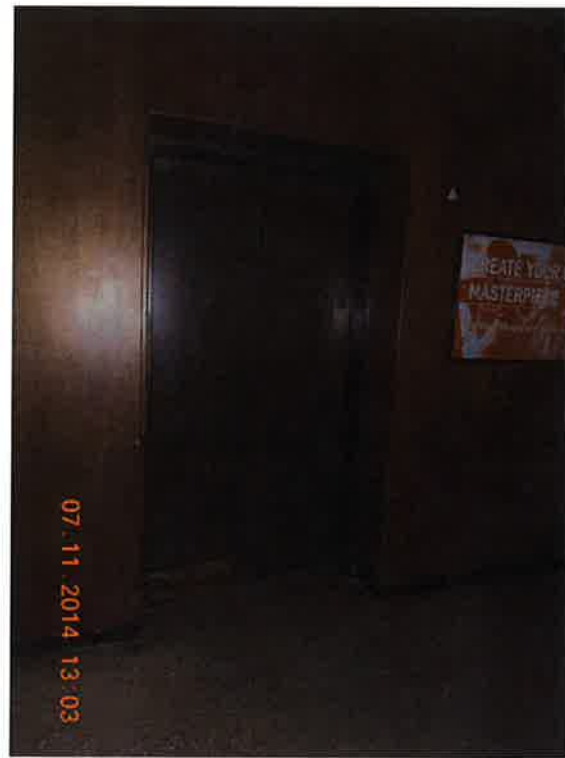
Comment #: A1114

Picture 1: Comment# A1114
Drawing #: Group 1 Level 2
Bldg:
Item: Passenger Elevator
Discipline: A Building

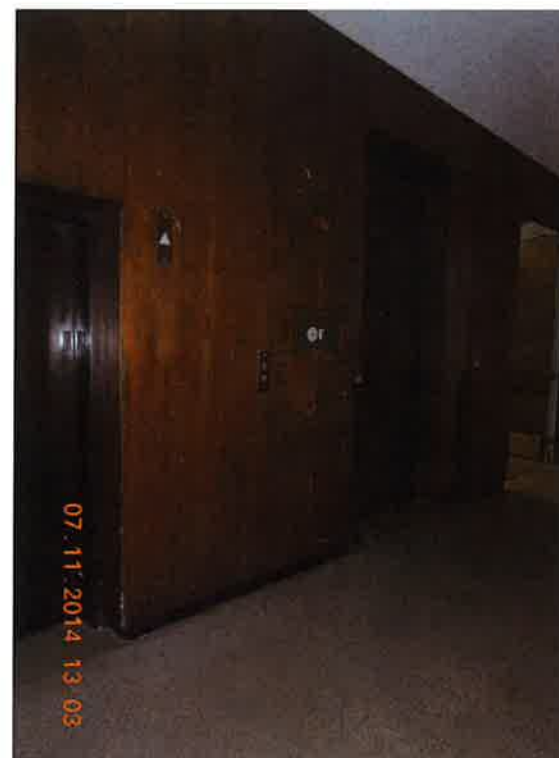
Comment #: A1115

Picture 2: Comment# A1115
Bldg:
Drawing #: Group 1 Level 2
Discipline: A Building
Item: Exit corridor

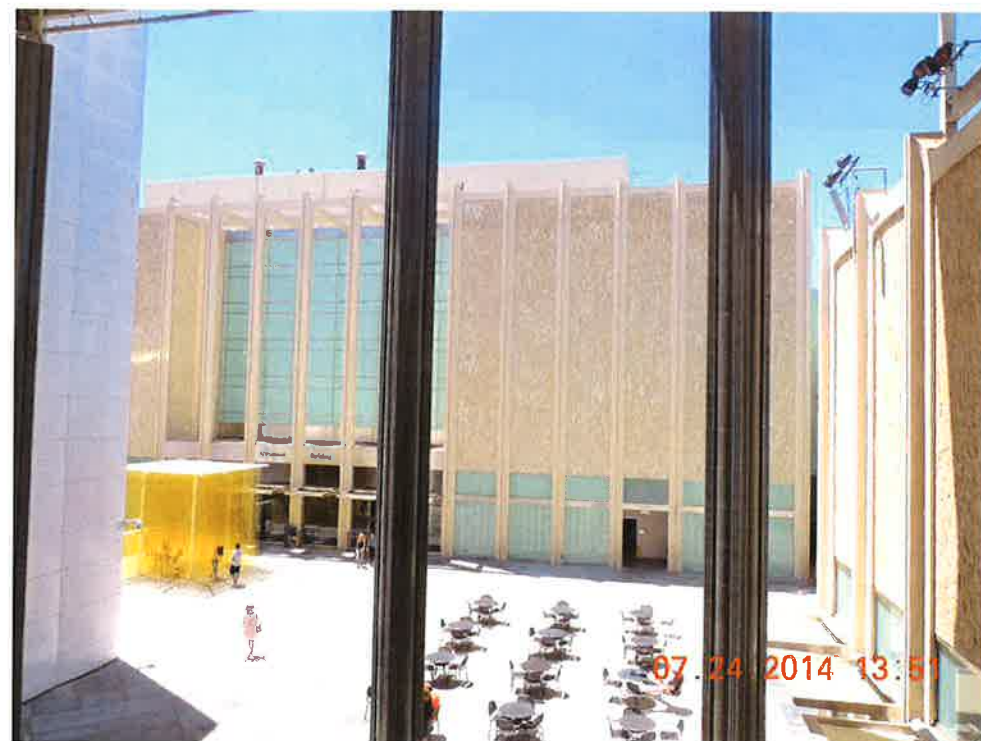
Comment #: A1201

Picture 3: Comment# A1201
Bldg:
Drawing #: Group 1 Level 2
Discipline: A Building
Item: Ext. east elevation

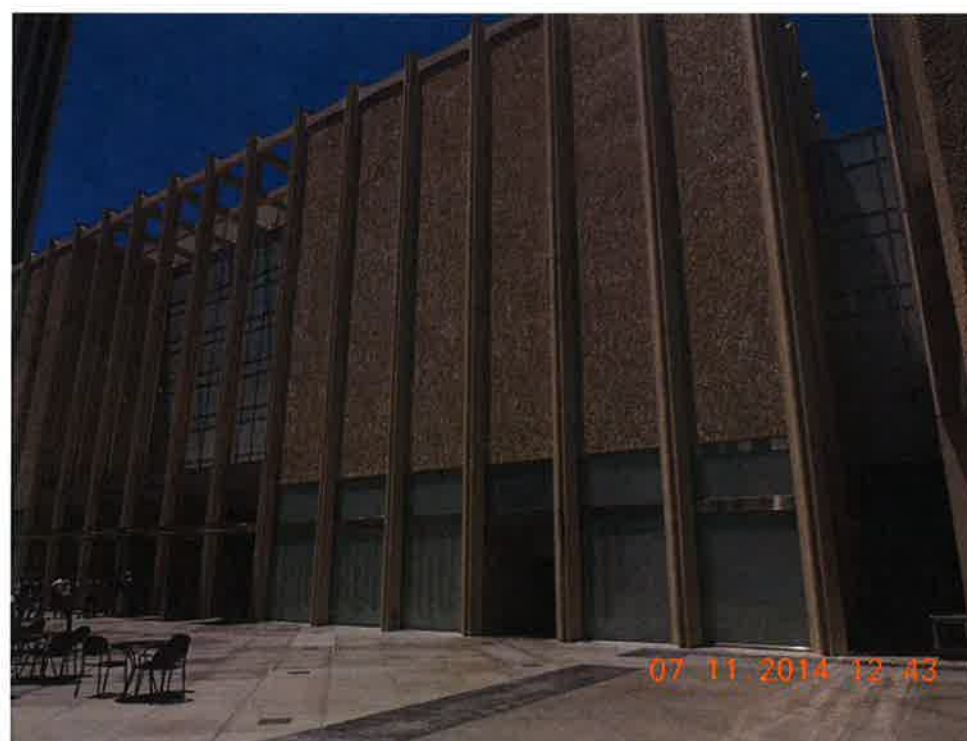
Comment #: A1202

Picture 4: Comment# A1202
Bldg:
Drawing #: Group 1 Level 2
Discipline: A Building
Item: Ext. east elevation

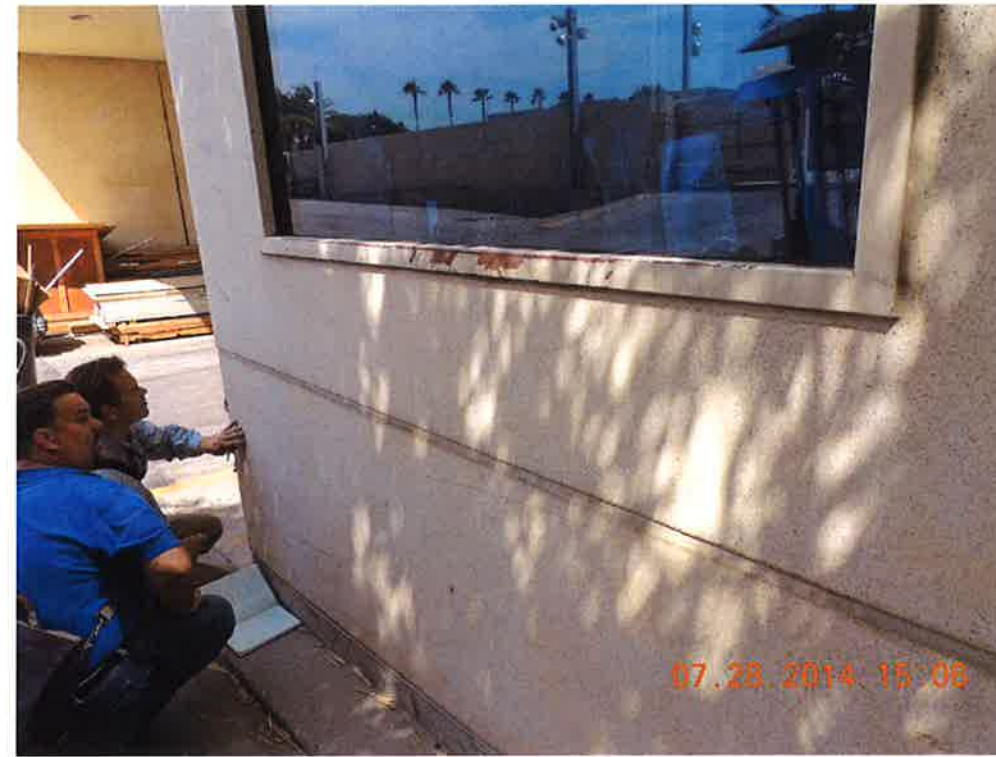
Picture 2 Comment #: A1204

1204	Architectural		A	Ext. south elevation	Cement plaster and sealant	Fair condition	Repair, clean and seal			X	
1205	Architectural	1	A	Ext. west elevation	Hollow metal doors and louvers	Poor condition	Replace, seal and paint		X	X	
1206	Architectural	2	A	Plaza concrete pavers	Concrete pavers and waterproofing	Plaza concrete pavers are cracked and leak water in several locations	Demolish and remove concrete pavers to repair waterproofing and cast in place concrete pavers		X		
1207	Architectural	3	A	Ext. north elevation	Cement plaster mold	Poor condition	Clean, seal and paint		X		
1208	Architectural	1	A	Ext. north elevation	Cement plaster cracks	Fair condition	Repair and paint	X (Repair)	X		
1209	Architectural	2	A	Ext. elevation	Stone veneer	Ext. walls stone veneer has settled and moved slightly	Check stone veneer in every section to repair and secure properly	X (Repair)	X		
1209	Architectural	2	A	Ext. elevation	Stone veneer	Ext. walls stone veneer has settled and moved slightly	Check stone veneer in every section to repair and secure properly		X

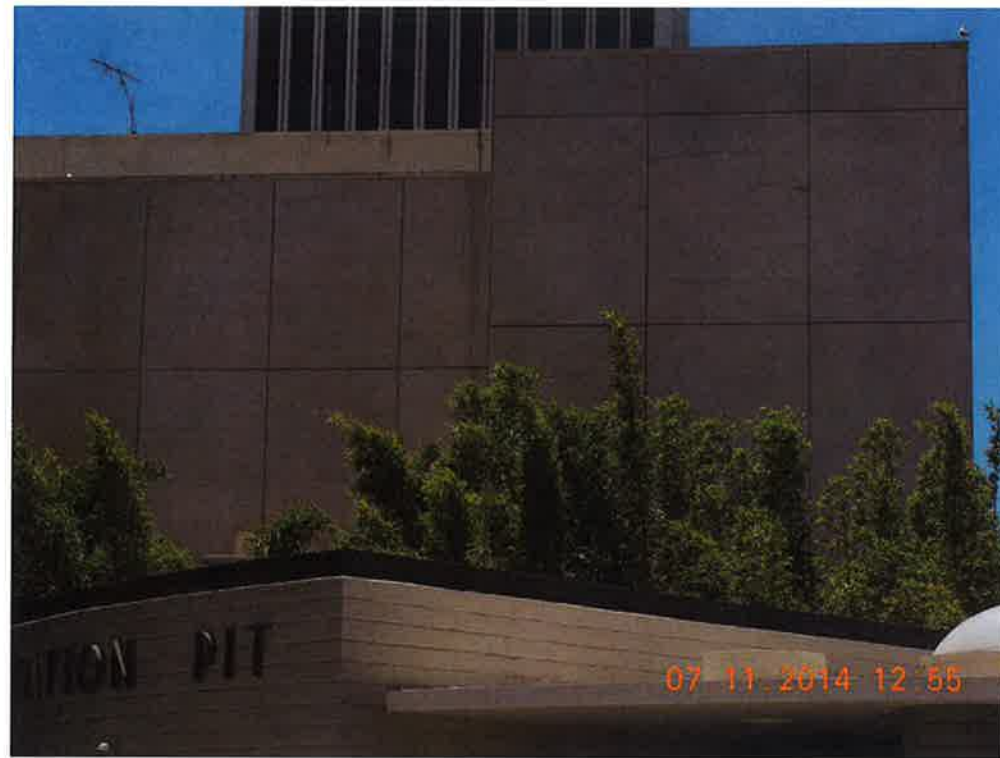
Comment #: A1213

1213	Architectural	1	A	Ext. north elevation	Cement plaster cracks	Fair condition	Repair and paint		X		
1214	Architectural	2	A	Ext. exit doors path of egress	Path of egress	Not code complaint, CBC 2013	Repair and surface concrete slab		X		
1214	Architectural	2	A	Ext. exit doors path of egress	Path of egress	Not code complaint, CBC 2013	Repair and surface concrete slab		X		
1401	Architectural	5	A	Roofing, sheet metal flashing and waterproofing	Roofing, sheet metal flashing and waterproofing	Roofing, sheet metal flashing with waterproofing are old and in a poor condition	Replace roofing, sheet metal flashing and waterproofing		X		
1402	Architectural	5	A	Roofing, sheet metal flashing and waterproofing	Roofing, sheet metal flashing and waterproofing	Roofing, sheet metal flashing with waterproofing are old and in a poor condition	Replace roofing, sheet metal flashing and waterproofing		X		
1501	Architectural	1	A	Loading dock ramp railings	Railings	Not code complaint, CBC 2013	Modify handrails		X

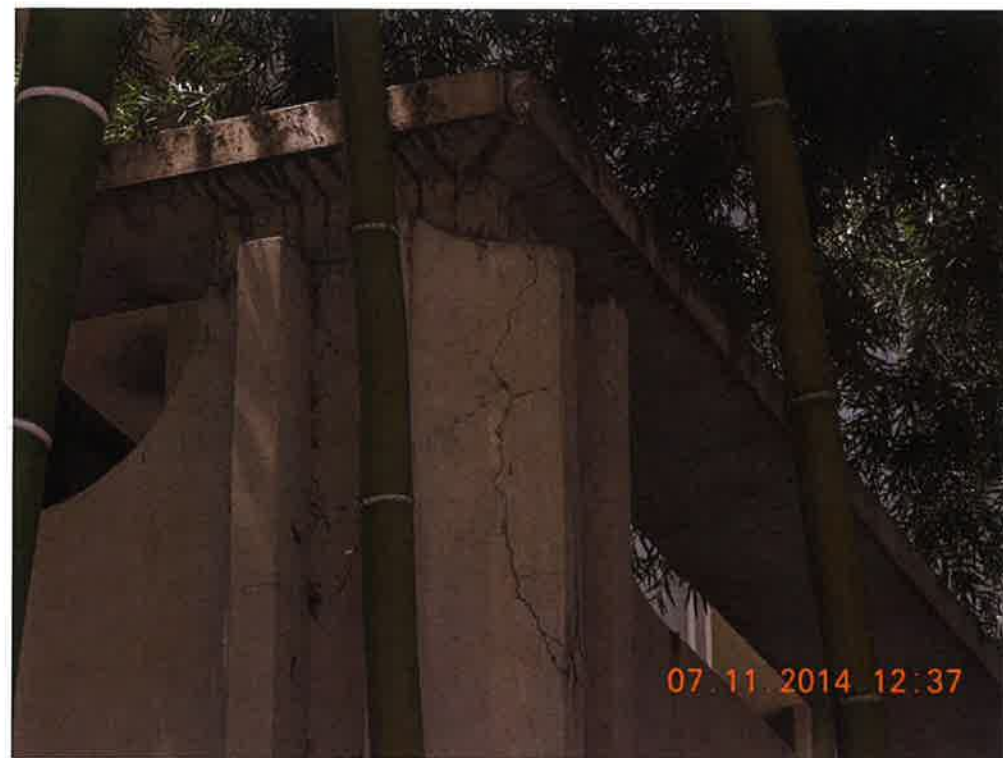
Comment #: A1223

1223	Architectural	1	B	Ext. south elevation	Concrete columns	Poor condition	Repair and paint		X		
1224	Architectural	3	B	Ext. concrete column	Cracks and spalling	Poor condition	Repair and paint		X		
1225	Architectural	3	B	Ext. concrete balcony	Cracks and spalling	Fair condition	Repair and paint		X		
1226	Architectural	3	B	Ext. plaster soffit	Cracks and maintenance	Poor condition	Repair and paint		X		
1227	Architectural	1	B	Ext. north elevation	Cracks and spalling	Poor condition	Repair and paint		X

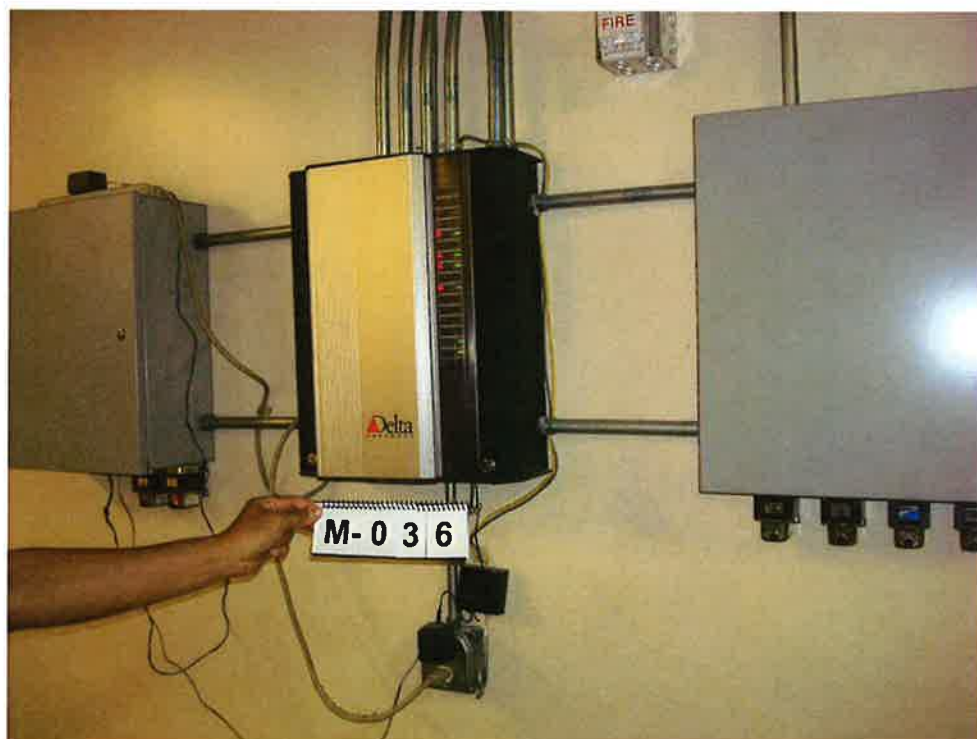
Picture 3: Comment# D6133
Bldg:
Drawing #: Group 2 Level 1
Discipline: D AOA
Item: Control Panel for AH-3

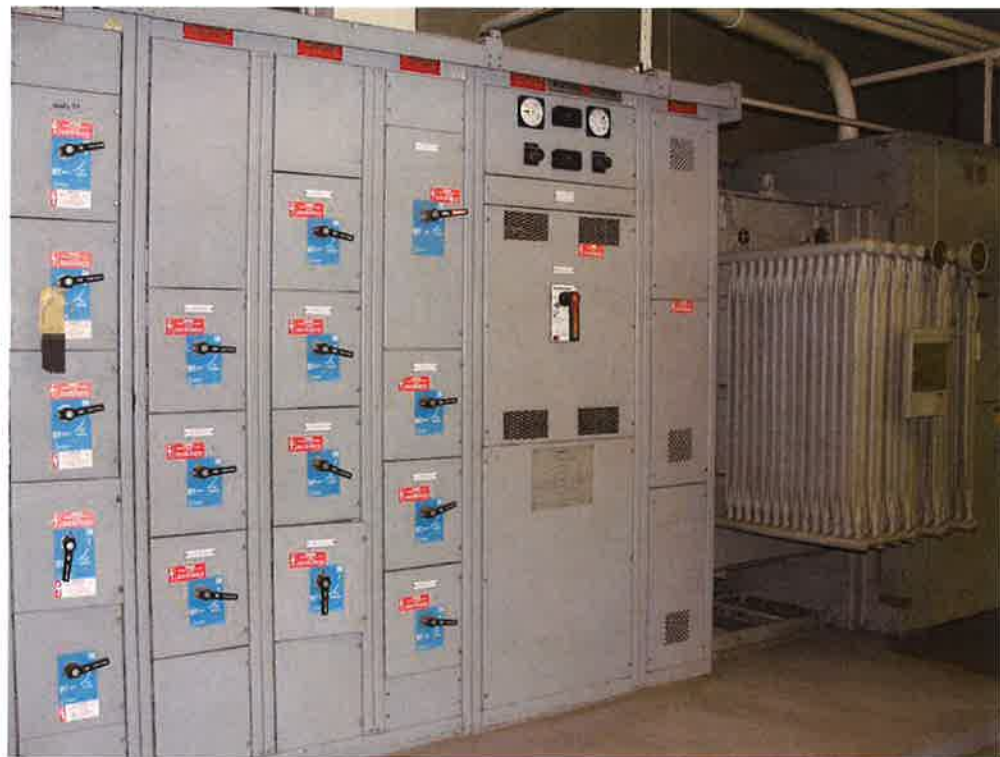
Picture 1: Comment# D9015
Drawing #: Group 2 Level 1
Bldg:
Item: Switchboards & Distribution
Discipline: D AOA

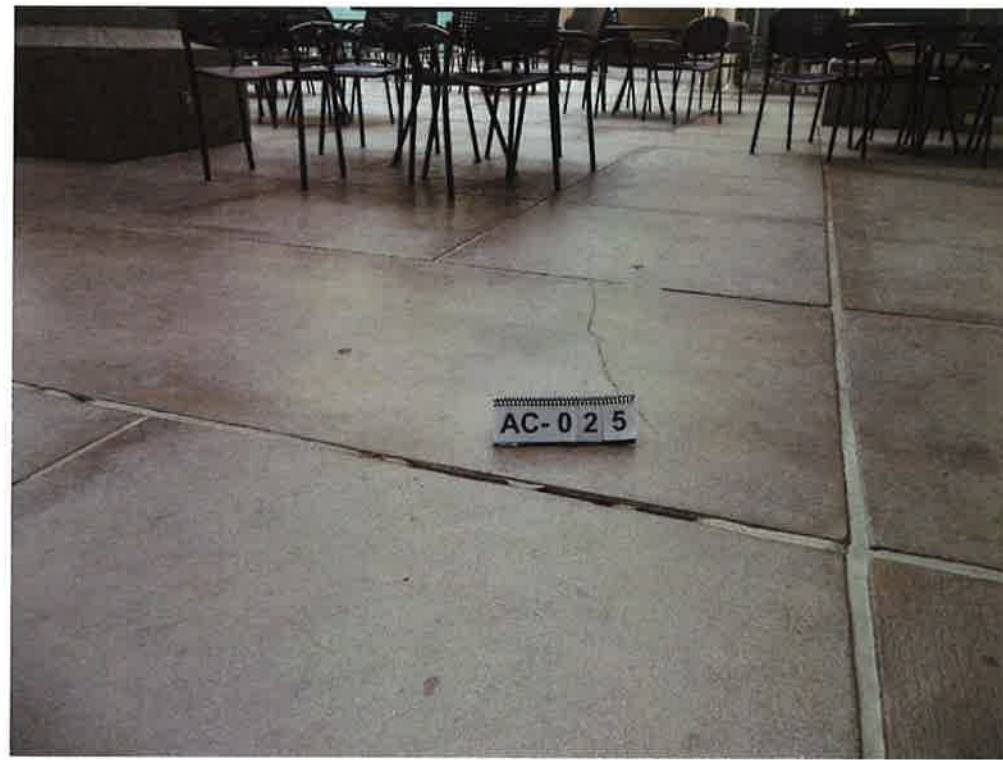
Picture 1

Picture 1: Comment# G2001
Drawing #: Group 1 Level 1
Bldg:
Item: Central courtyard
Discipline: G Common

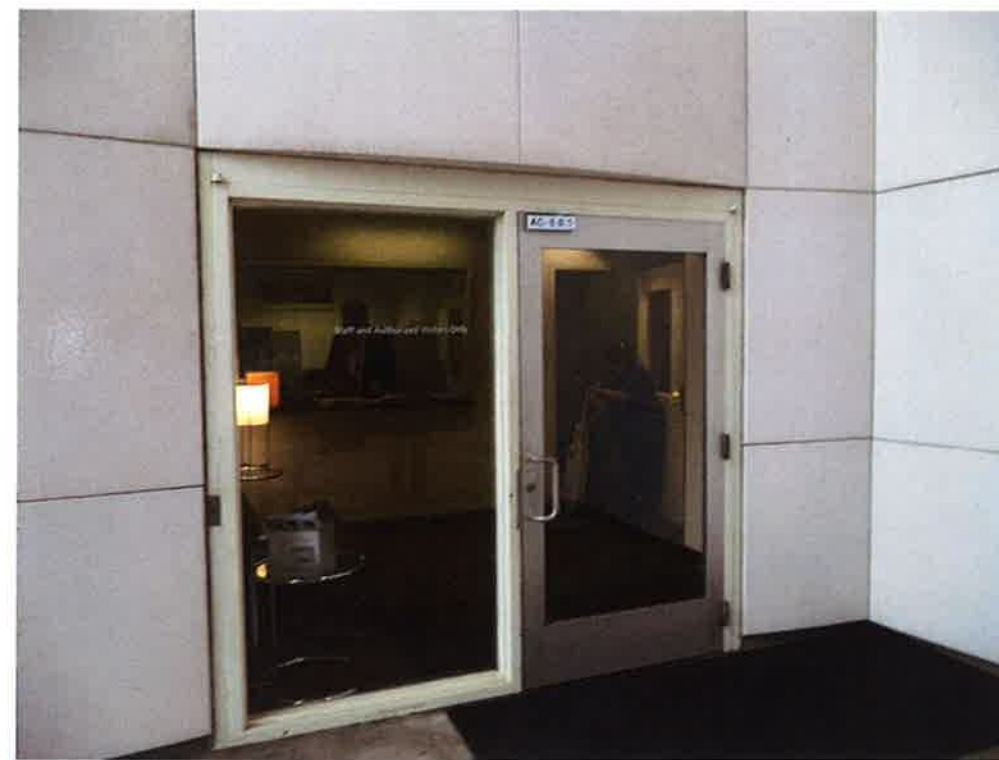
Picture 2

Picture 2: Comment# G2101
Bldg:
Drawing #: Group 1 Level 1
Discipline: G Common
Item: Permanent Room I.D. Signs

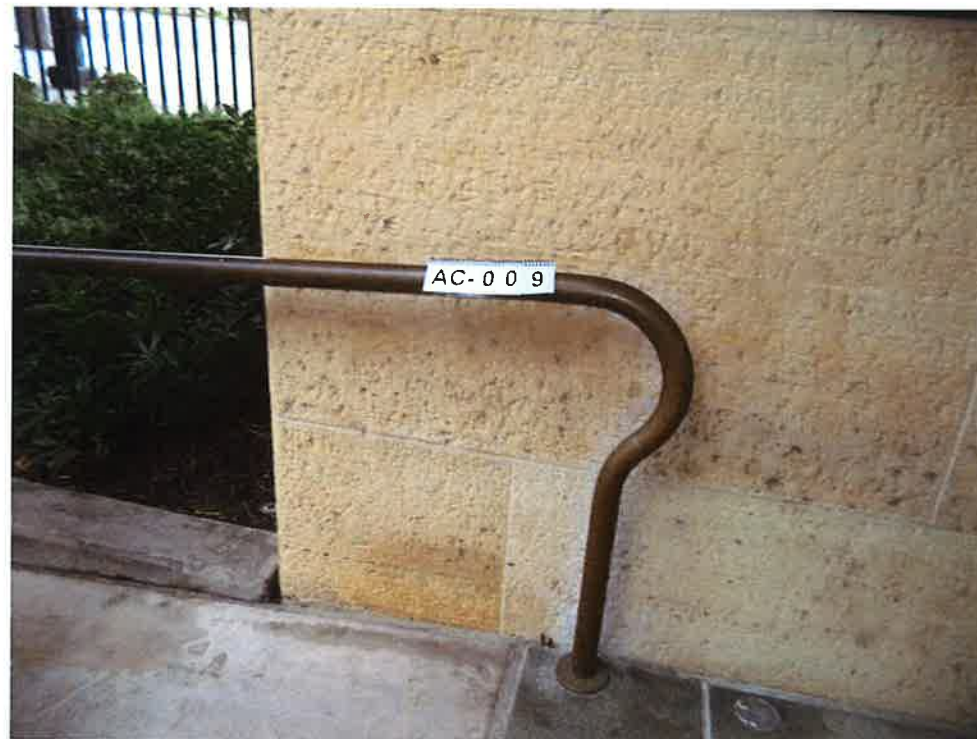
Picture 3 Comment #: G2301

Picture 3: Comment# G2301
Bldg:
Drawing #: Group 1 Level 1
Discipline: G Common
Item: Ramp Handrails

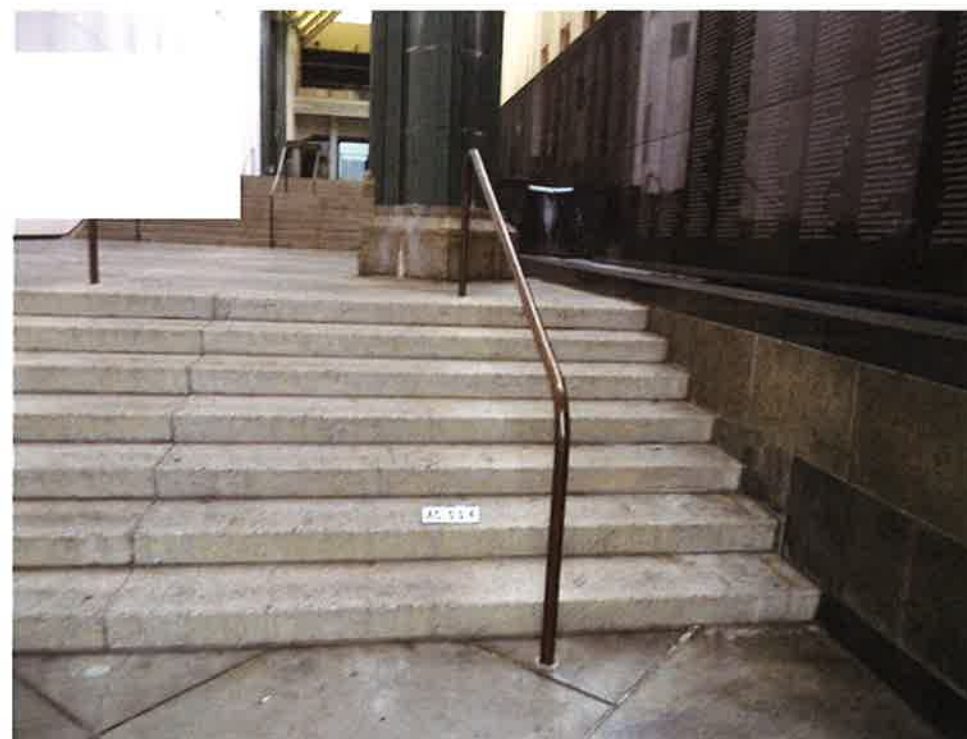
Picture 4: Comment #: G2401

Picture 4: Comment# G2401
Bldg:
Drawing #: Group 1 Level 1
Discipline: G Common
Item: Visual Warning Stripes

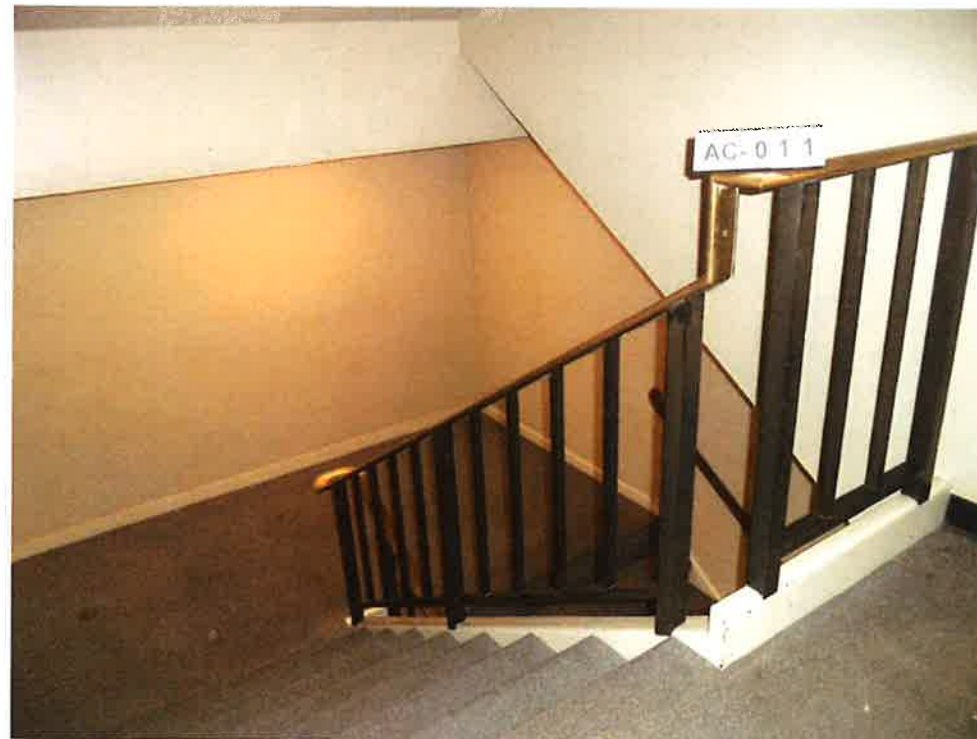
Picture 3 Comment #: G2404

Picture 3: Comment# G2404
Bldg:
Drawing #: Group 1 Level 1
Discipline: G Common
Item: All Stairwells

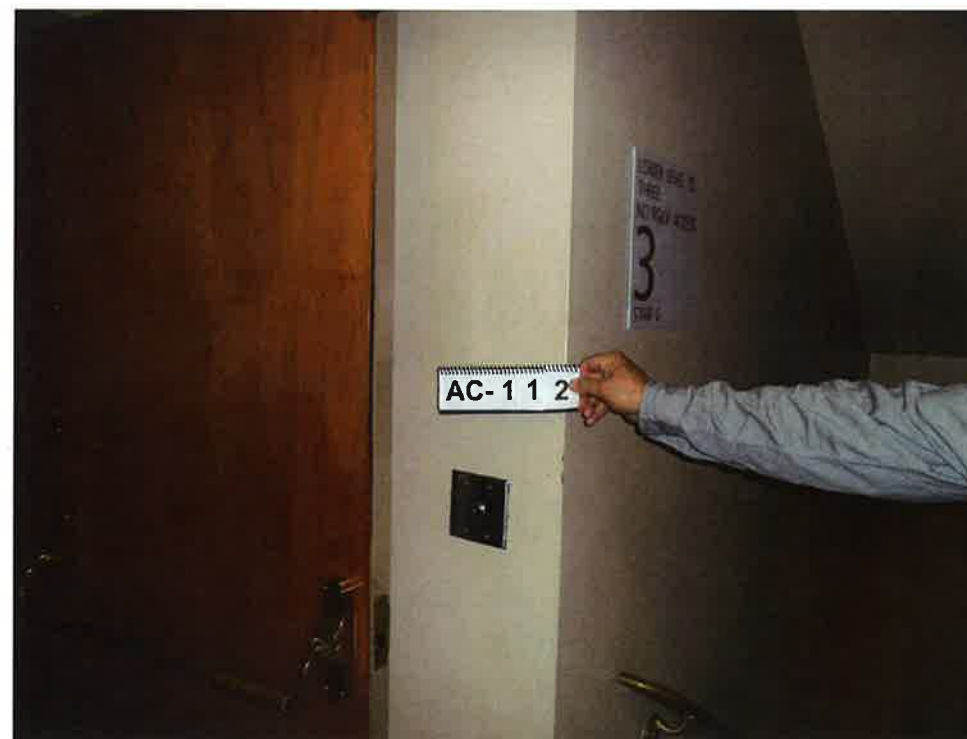
Picture 4 Comment #: G2405

Picture 4: Comment# G2405
Bldg:
Drawing #: Group 1 Level 1
Discipline: G Common
Item: All Stairwells

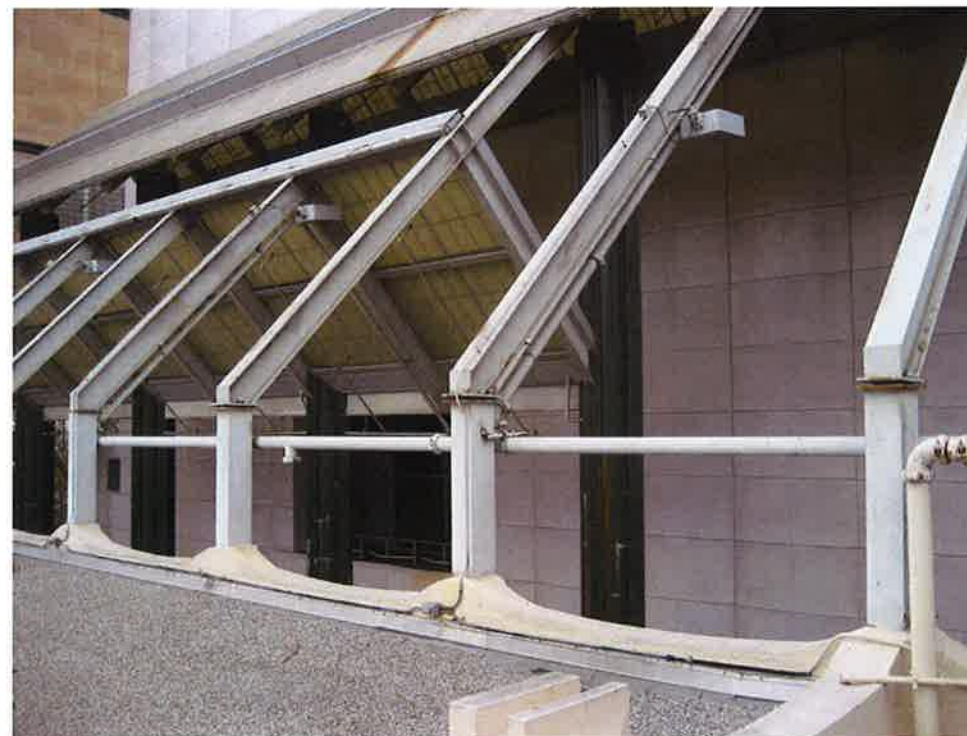
Picture 3: Comment #: G8216

Picture 3: Comment# G8216
Bldg:
Drawing #: Group 2 Level 1
Discipline: G Common
Item: Fire Sprinkler

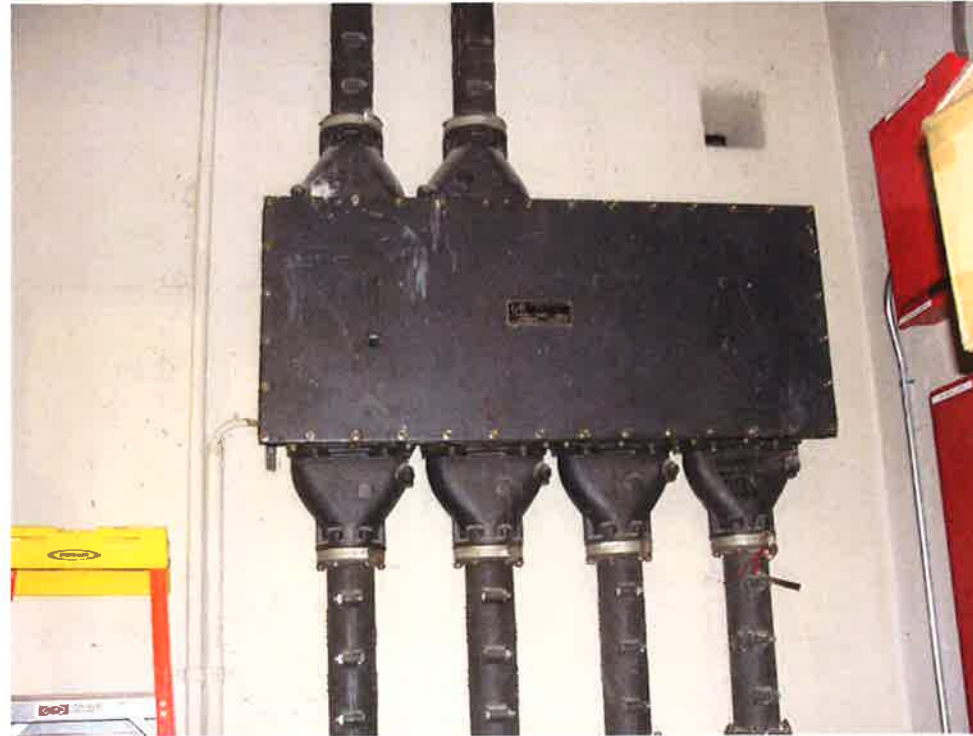
Picture 4 Comment #: G9103

Picture 4: Comment# G9103
Bldg:
Drawing #: Group 2 Level 1
Discipline: G Common
Item: Power receptacle outlets

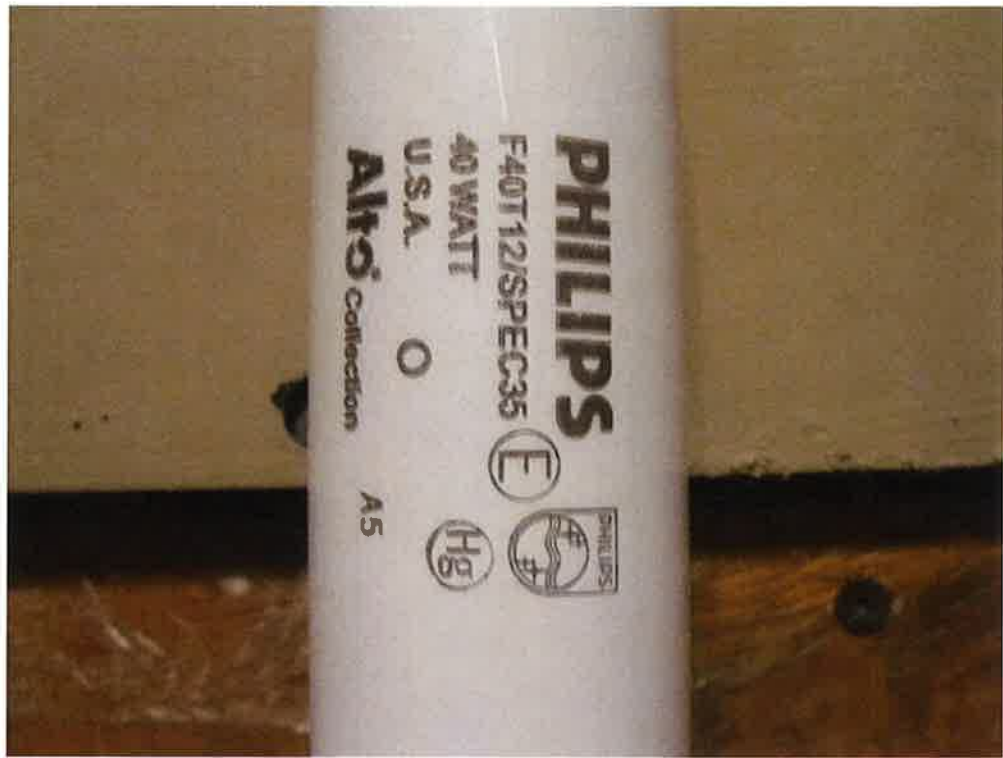
Comment #: G9202

Picture 1: Comment# G9202
Drawing #: Group 2 Level 1
Bldg:
Item: Lighting
Discipline: G Common

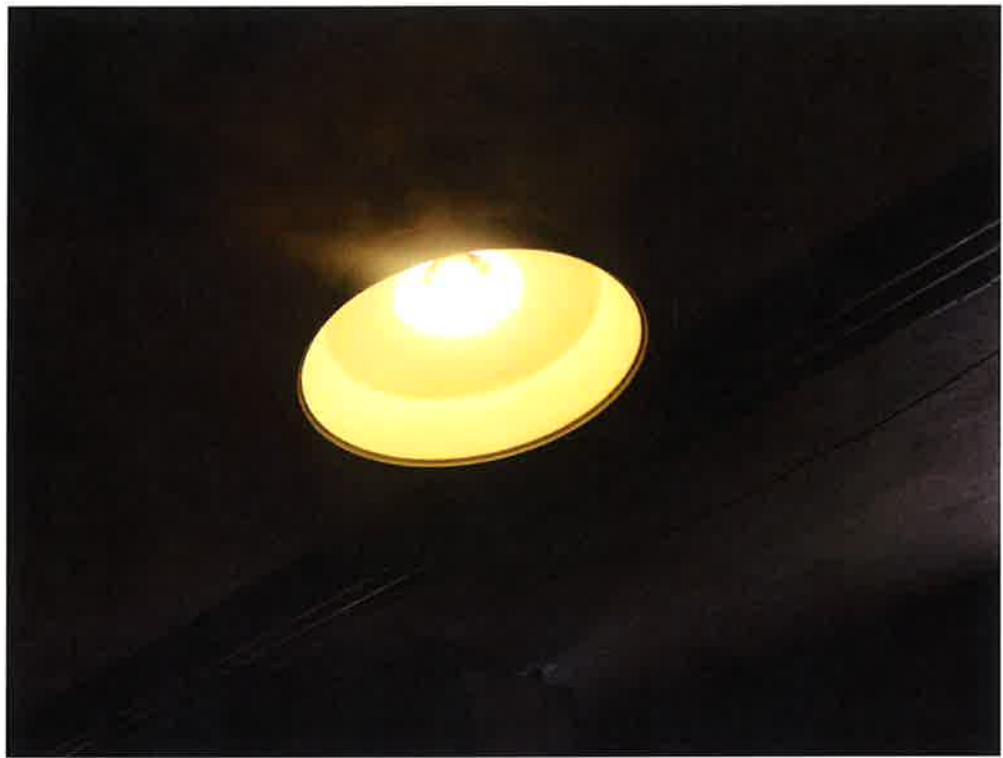
Comment #: G9301

Picture 2: Comment# G9301
Bldg:
Drawing #: Group 2 Level 1
Discipline: G Common
Item: Lighting

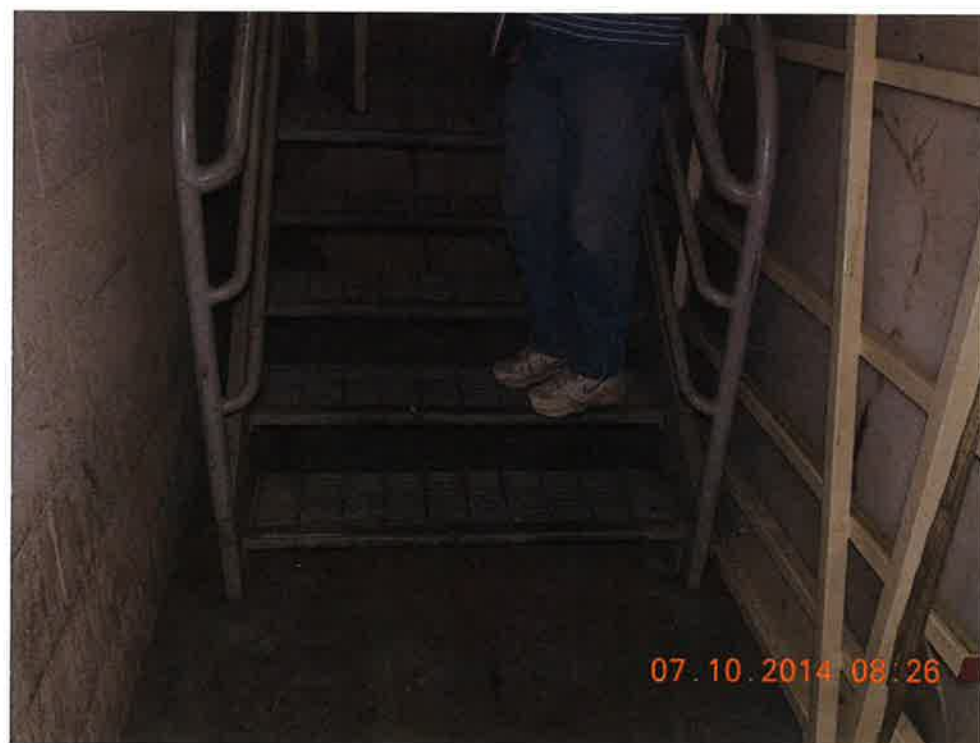
Comment #: A1503

Picture 3: Comment# A1503
Bldg:
Drawing #: Group 1 Level 1
Discipline: A Building
Item: Interior metal stairs railings
