Revised Appendix Q

Existing Building Evaluation

Los Angeles County Museum of Art Building Evaluation

September 16, 2014

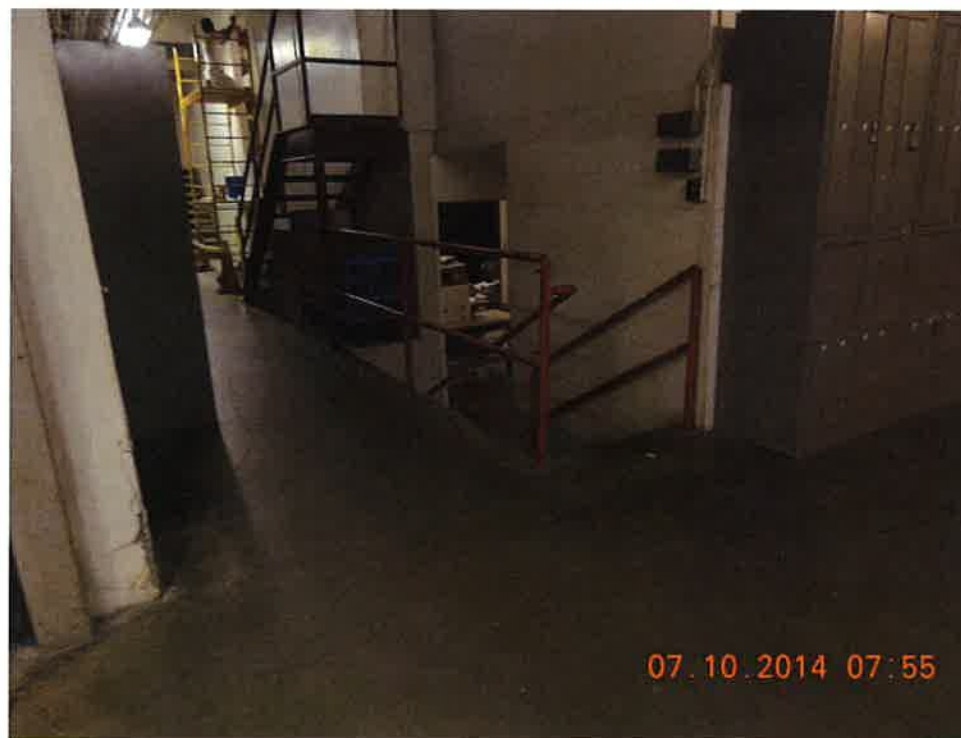
Comment #: A1504

Picture 4: Comment# A1504
Bldg:
Drawing #: Group 1 Level 1
Discipline: A Building
Item: Exit corridor stair railings

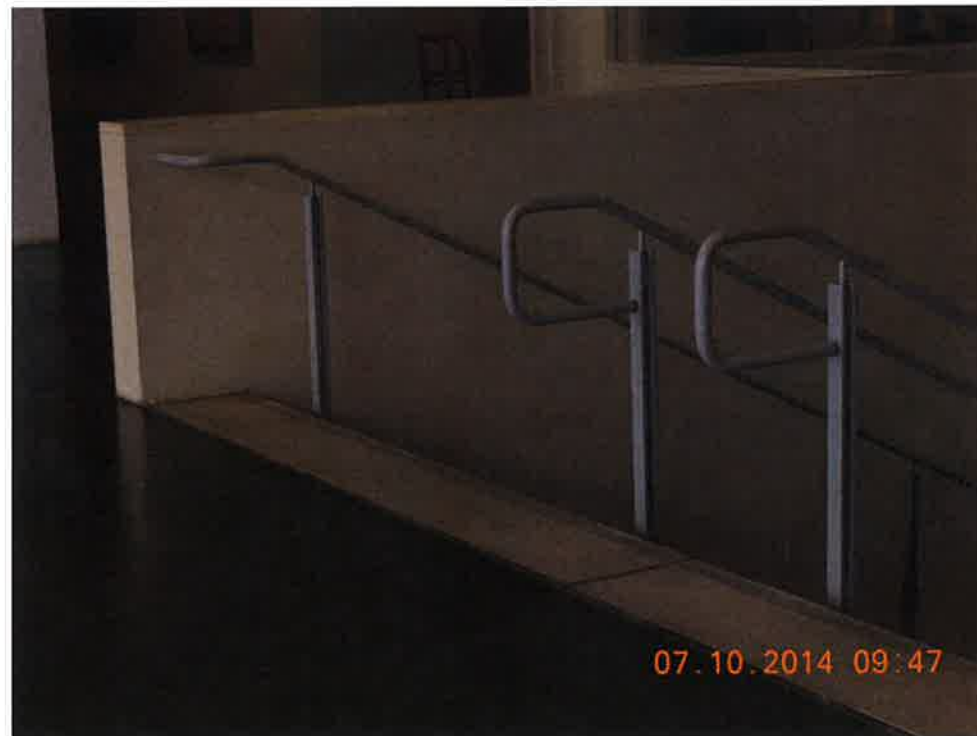
Comment #: A1507

Picture 3: Comment# A1507
Bldg:
Drawing #: Group 1 Level 1
Discipline: A Building
Item: Main stair railings

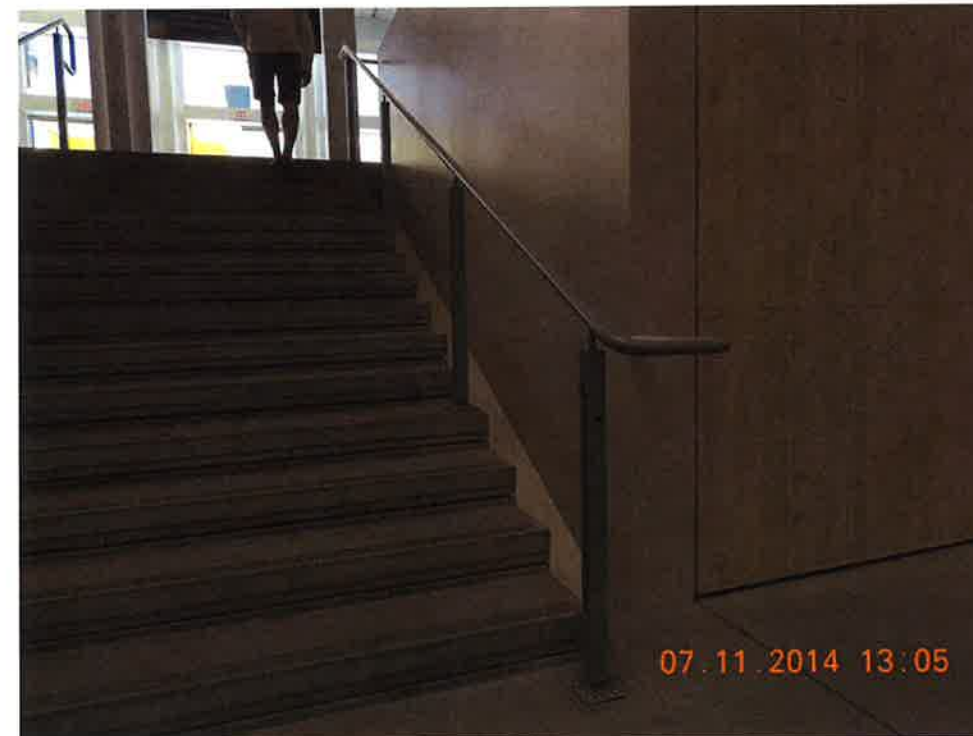
Comment #: A1508.1

Picture 4: Comment# A1508.1
Bldg:
Drawing #: Group 1 Level 1
Discipline: A Building
Item: Main stair railings

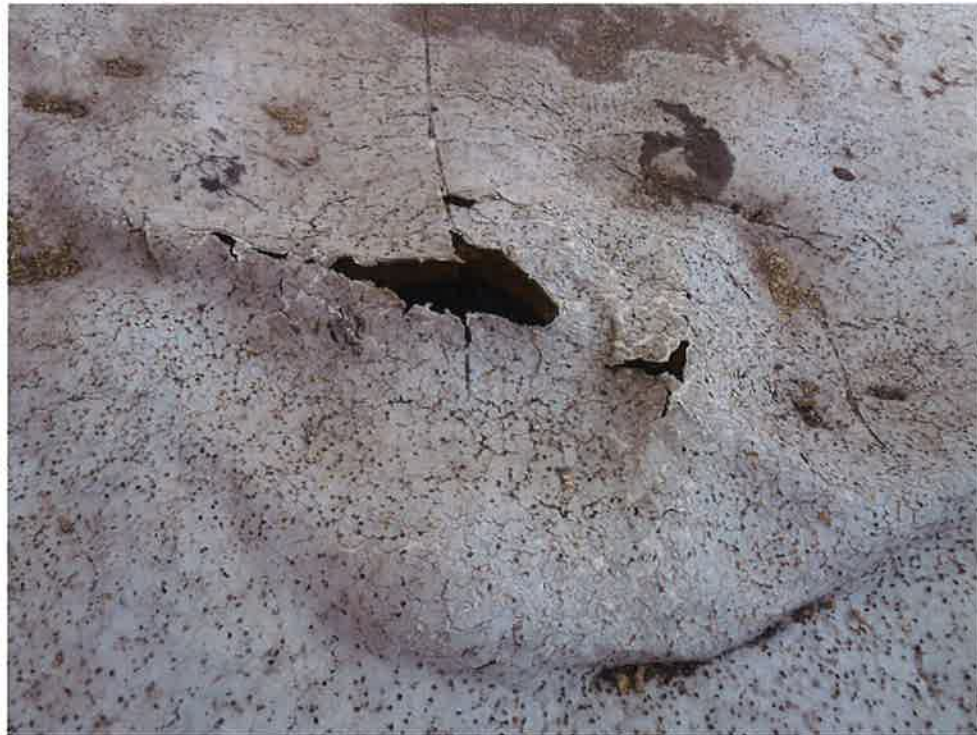
Comment #: A1825

Picture 3: Comment# A1825
Bldg:
Drawing #: Group 2 Roof
Discipline: A Building
Item: Upper roof on the Ahmanson

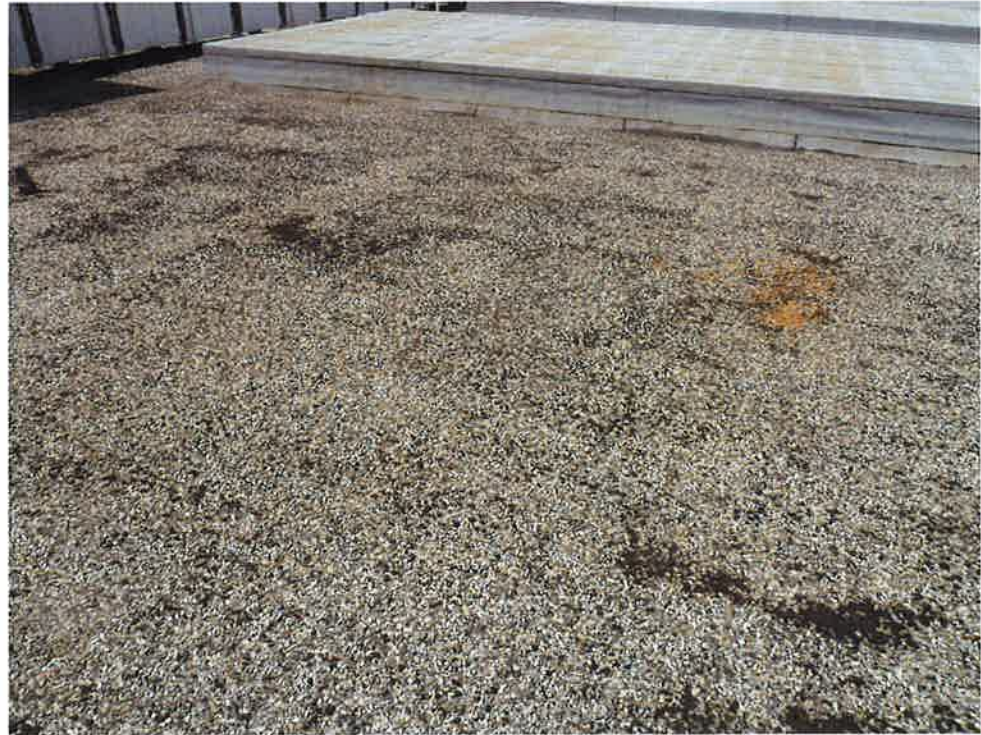
Comment #: A1826

Picture 4: Comment# A1826
Bldg:
Drawing #: Group 2 Roof
Discipline: A Building
Item: Roof on the Ahmanson North

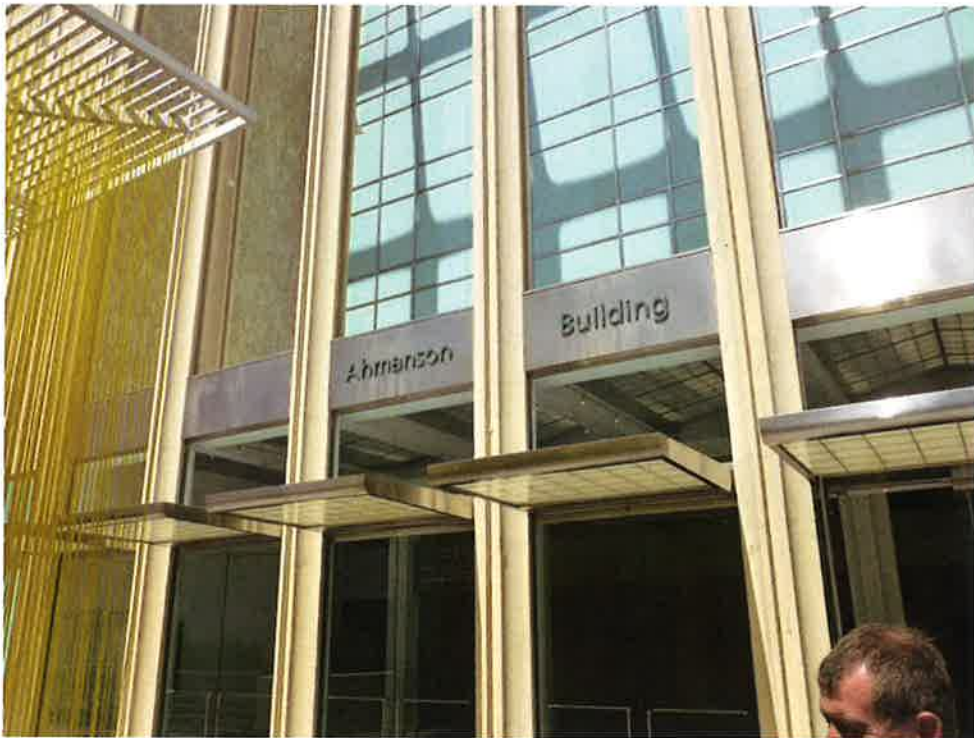
Picture 3 Comment #: A1917

Picture 3: Comment# A1917
Bldg:
Drawing #: Group 2 Level 2
Discipline: A Building
Item: curtain wall system

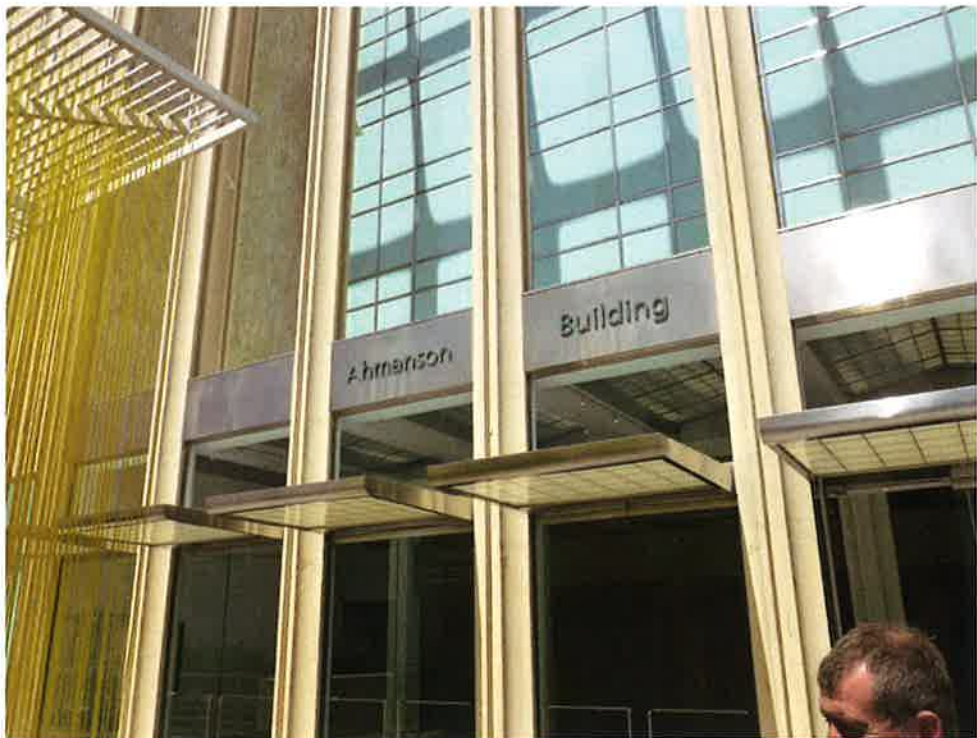
Picture 4 Comment #: A1918

Picture 4: Comment# A1918
Bldg:
Drawing #: Group 2 Level 1
Discipline: A Building
Item: storefront system

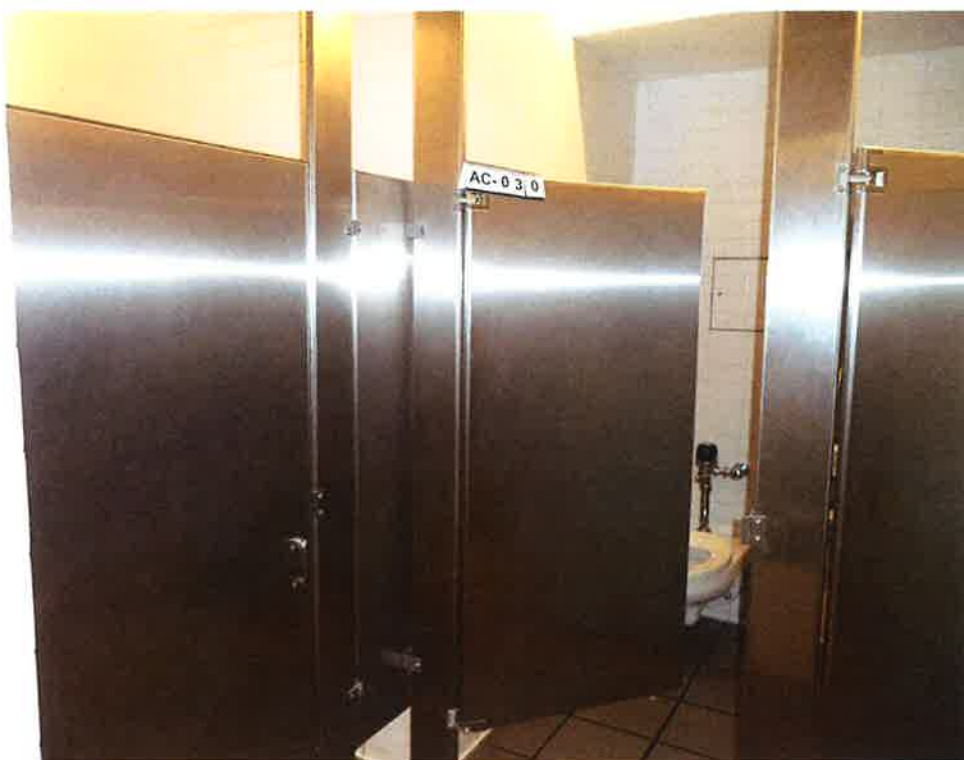
Comment #: A2209

Picture 1: Comment# A2209
Drawing #: Group 1 Level 1
Bldg:
Item: AHM Restrooms
Discipline: A Building

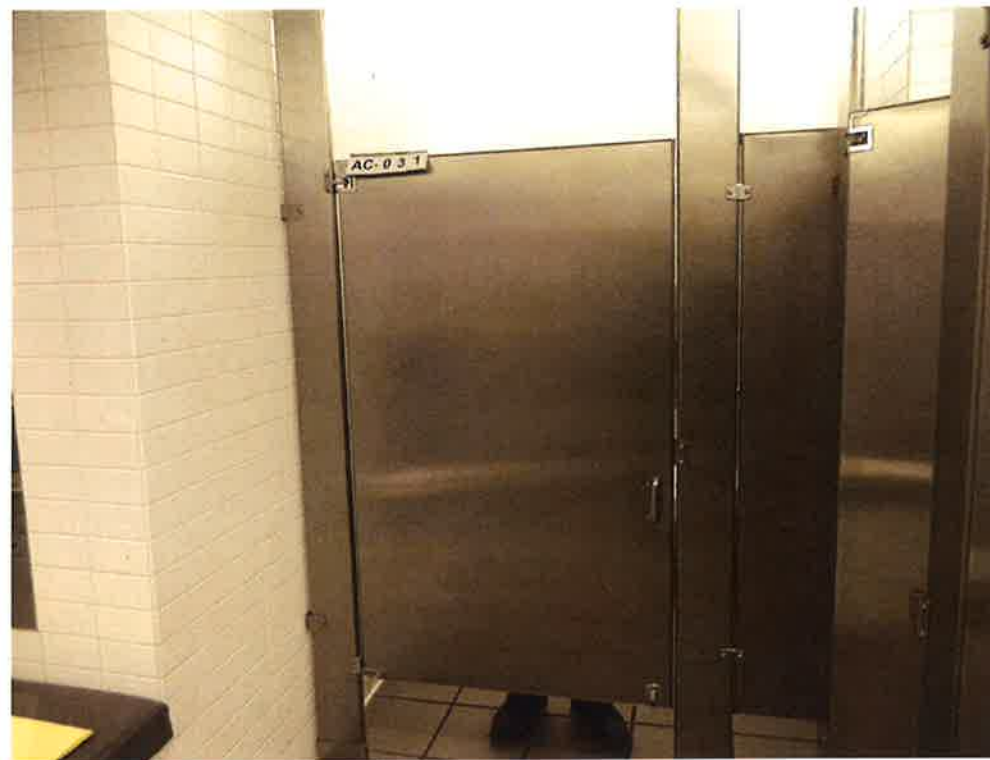
Comment #: A2210

Picture 2: Comment# A2210
Bldg:
Drawing #: Group 1 Level 1
Discipline: A Building
Item: AHM Restrooms

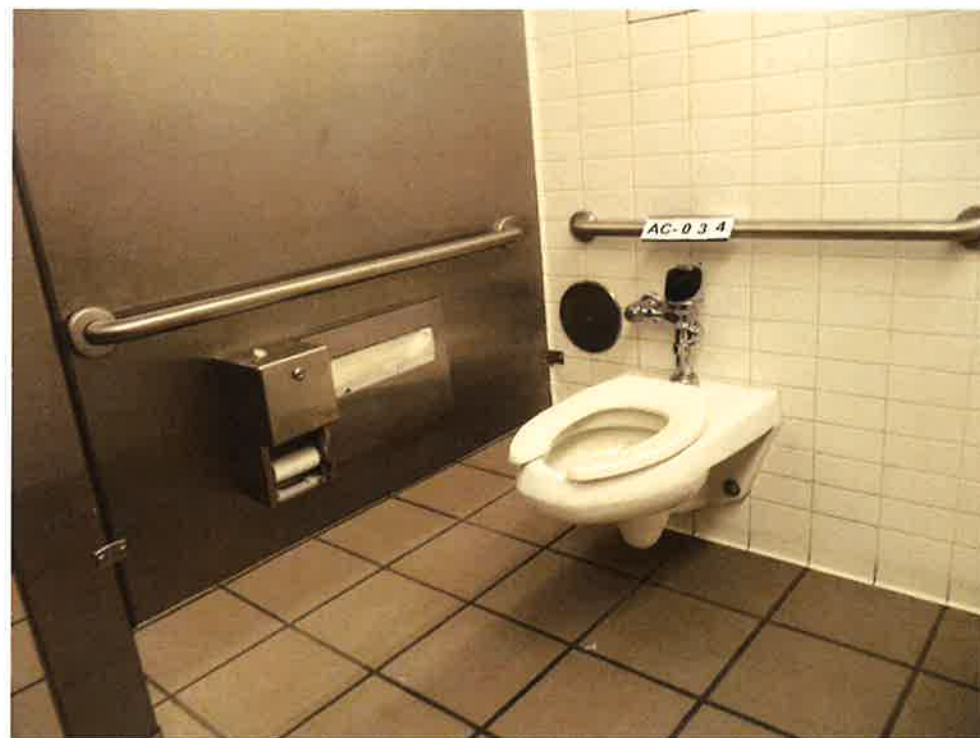
Comment #: A2213

Picture 3: Comment# A2213
Bldg:
Drawing #: Group 1 Level 1
Discipline: A Building
Item: Men's Restroom - AHM

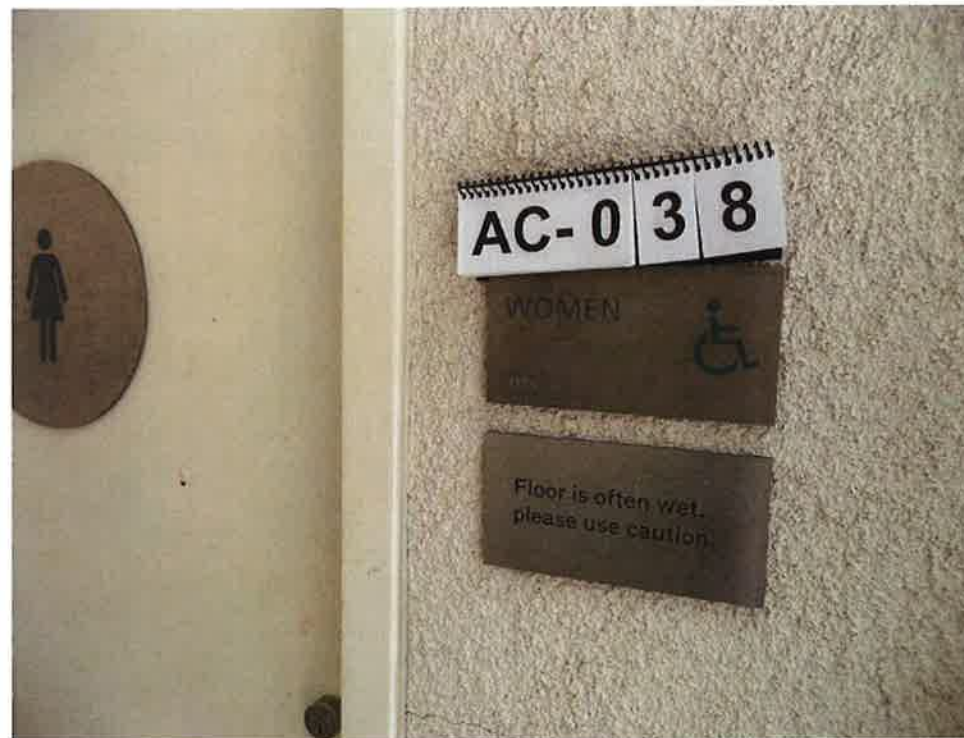
Comment #: A2214

Picture 4: Comment# A2214
Bldg:
Drawing #: Group 1 Level 1
Discipline: A Building
Item: AHM - Restroom Signage

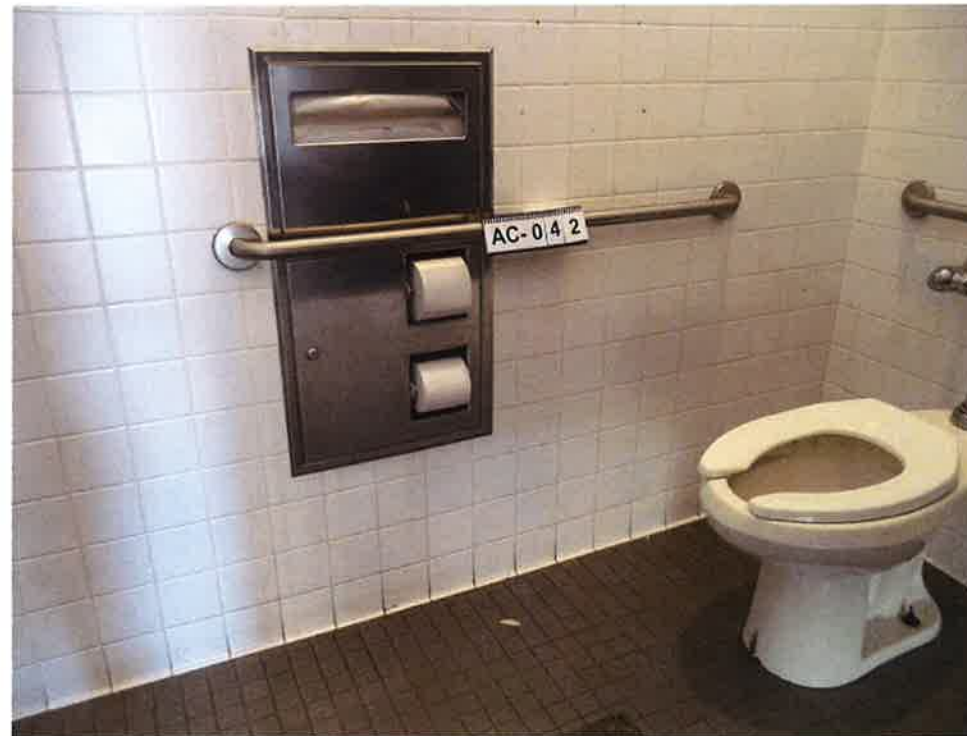
Picture 3 Comment #: A2217

Picture 3: Comment# A2217
Bldg:
Drawing #: Group 1 Level 1
Discipline: A Building
Item: AHM - Men's Restroom

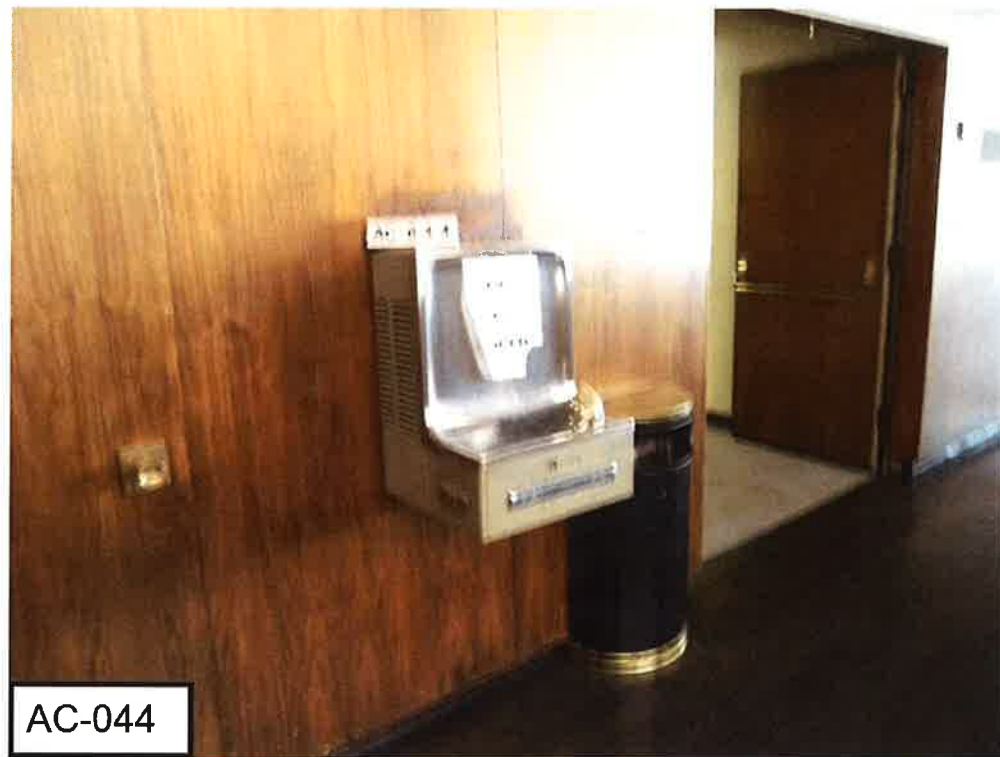
Comment #: A2706

Picture 1: Comment# A2706
Drawing #: Group 1 Level 1
Bldg:
Item: AHM - Drinking Fountain
Discipline: A Building

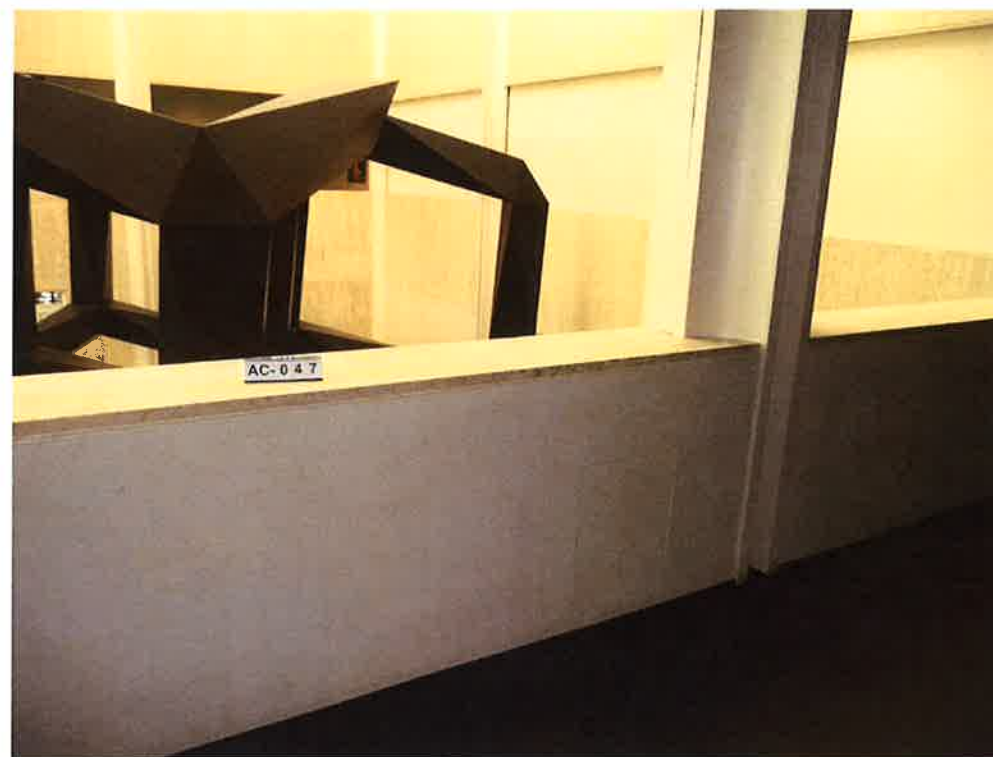
Comment #: A2707

Picture 2: Comment# A2707
Bldg:
Drawing #: Group 1 Level 1
Discipline: A Building
Item: AHM - Atrium Guard Wall

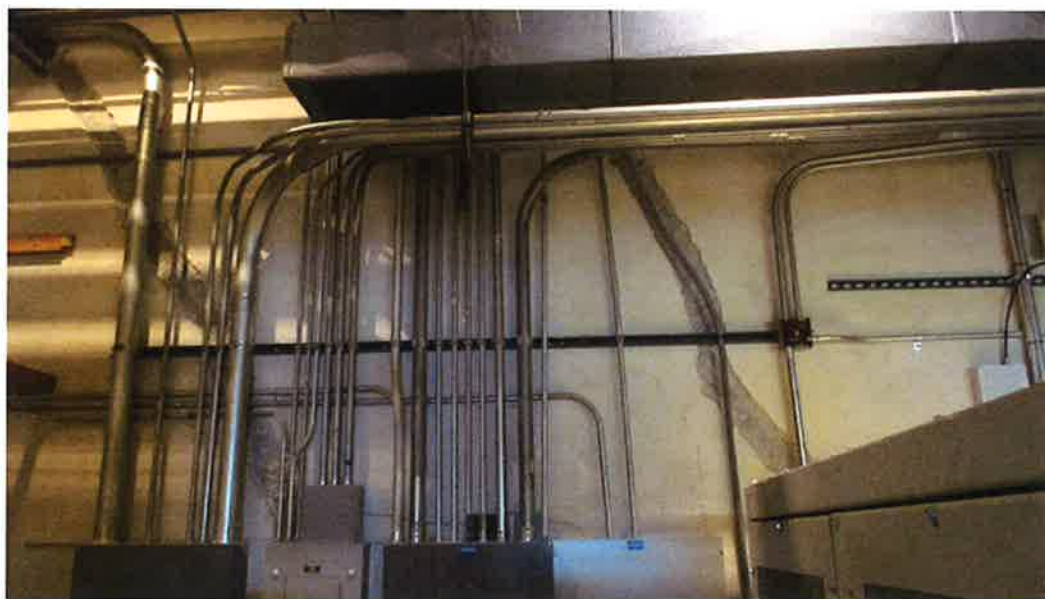
Comment #: A5201

Picture 3: Comment# A5201
Bldg:
Drawing #: Group 1 Level 1
Discipline: A Building
Item: Seismic Crack Repair

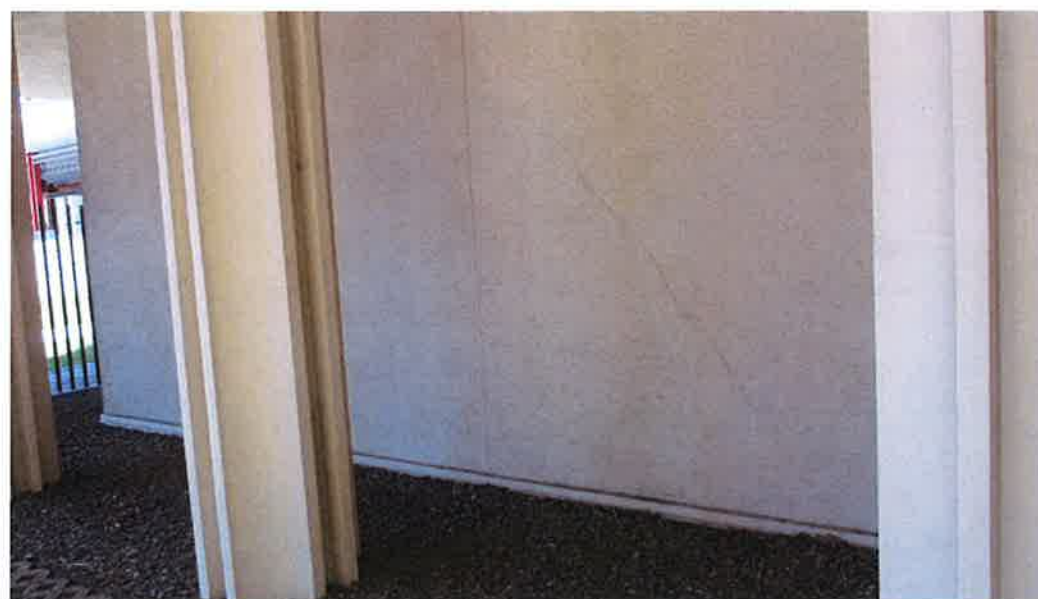
Comment #: A5202

Picture 4: Comment# A5202
Bldg:
Drawing #: Group 1 Level 1
Discipline: A Building
Item: Seismic Crack Repair

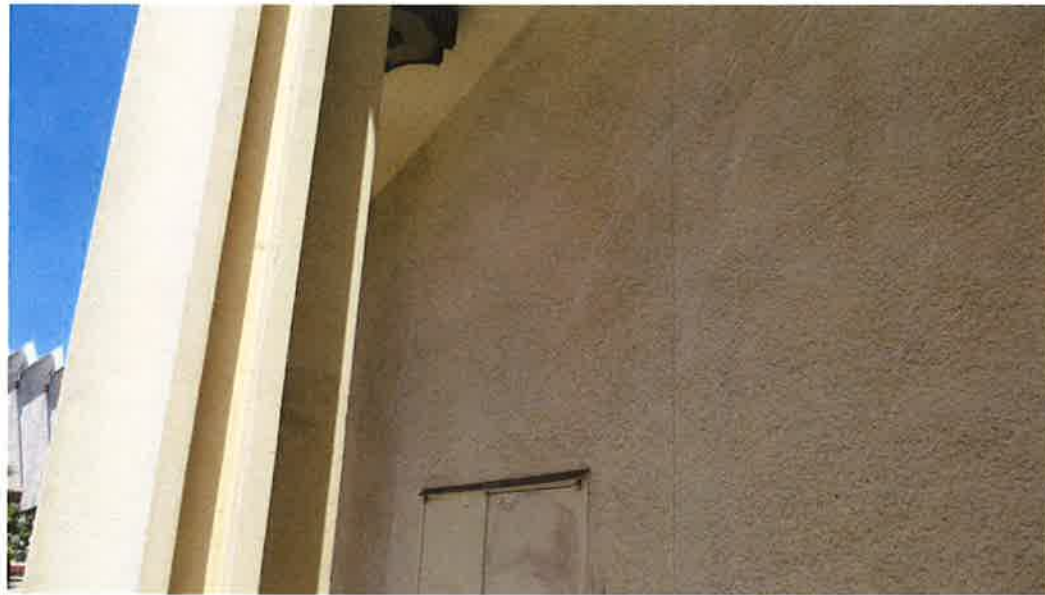
Picture 1 Comment #: A5203

Picture 1: Comment# A5203
Drawing #: Group 1 Level 2
Bldg:
Item: Shear wall crack repairs
Discipline: A Building

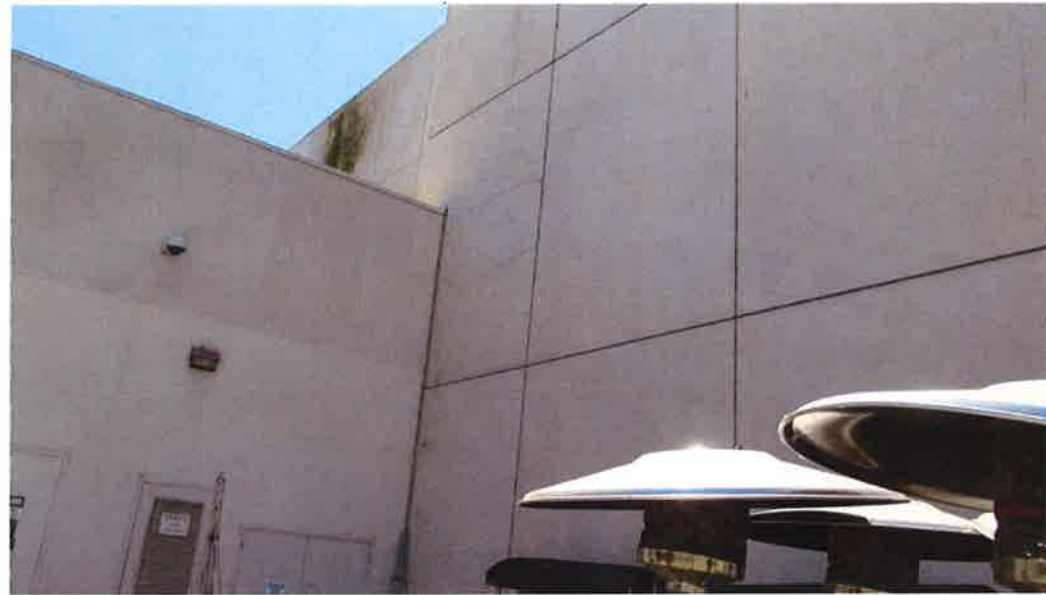
Picture 2 Comment #: A5204

Picture 2: Comment# A5204
Bldg:
Drawing #: Group 1 Level 2
Discipline: A Building
Item: External shell cracks

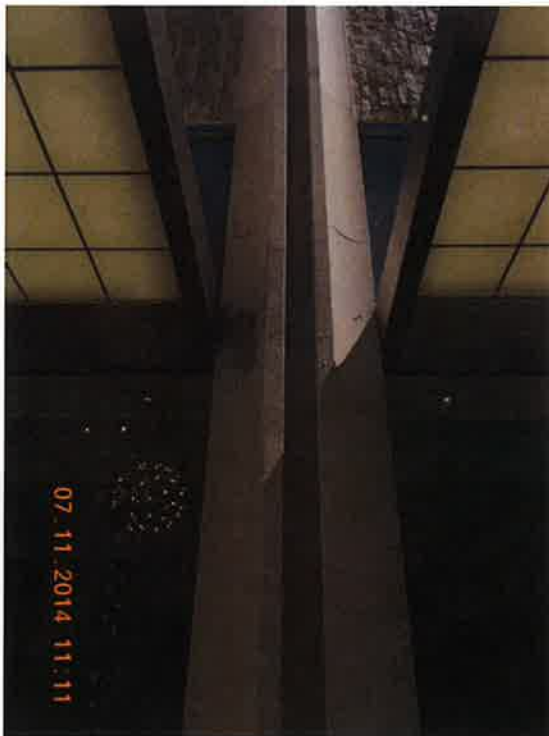
Picture 3: Comment #: A5205

Picture 3: Comment# A5205
Bldg:
Drawing #: Group 1 Level 2
Discipline: A Building
Item: Column cladding cracks

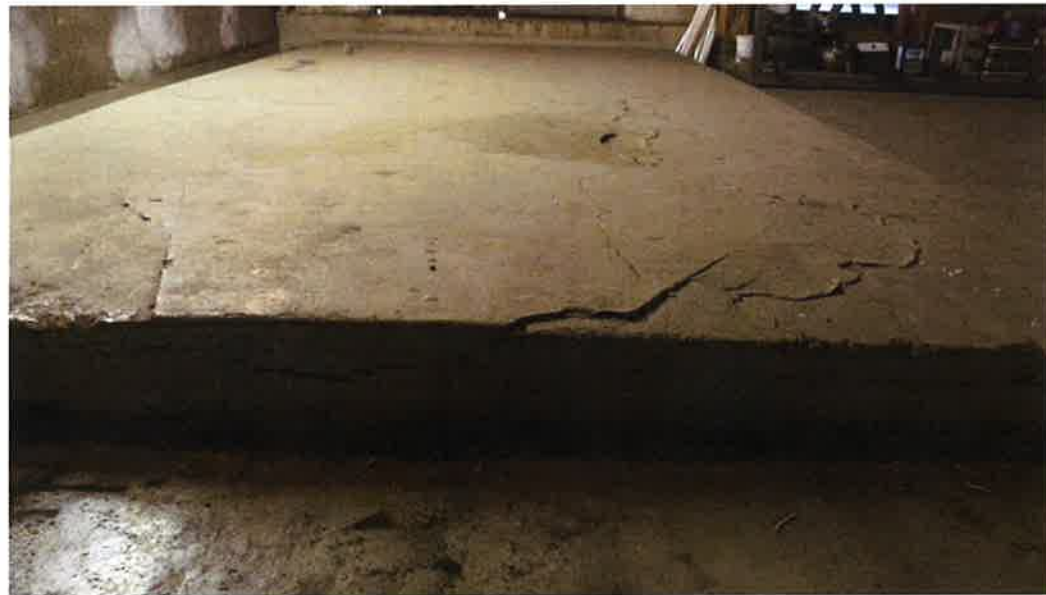
Picture 4 Comment #: A5211

Picture 4: Comment# A5211
Bldg:
Drawing #: Group 1 Roof
Discipline: A Building
Item: Roof Slab cracking

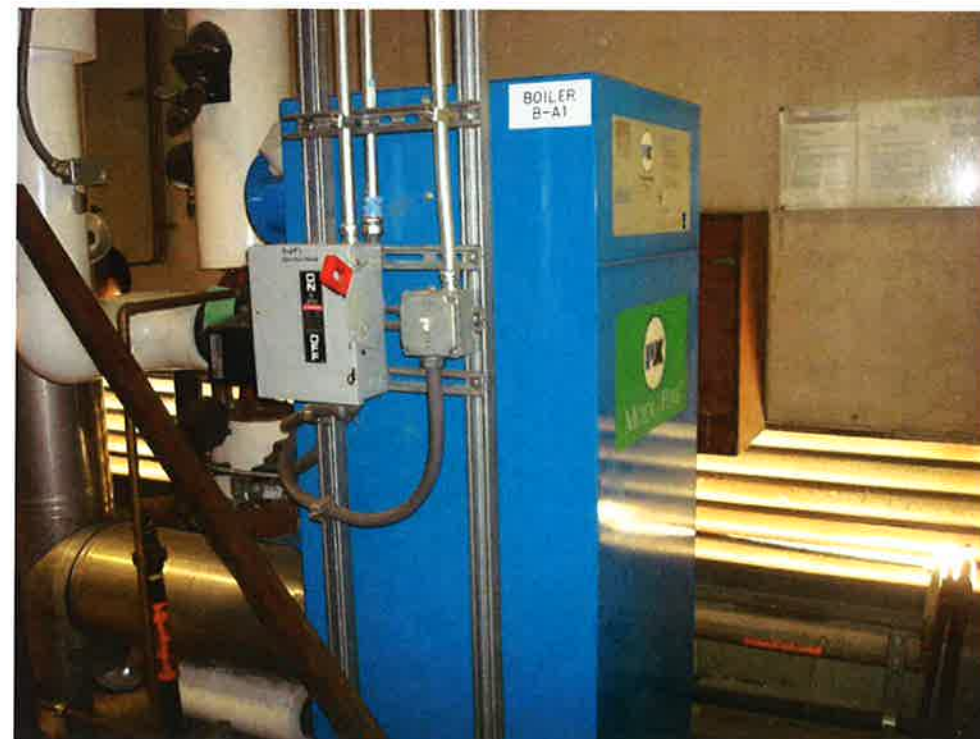
Comment #: A6108

Picture 3: Comment# A6108
Bldg:
Drawing #: Group 2 Level 1
Discipline: A Building
Item: Boiler Room

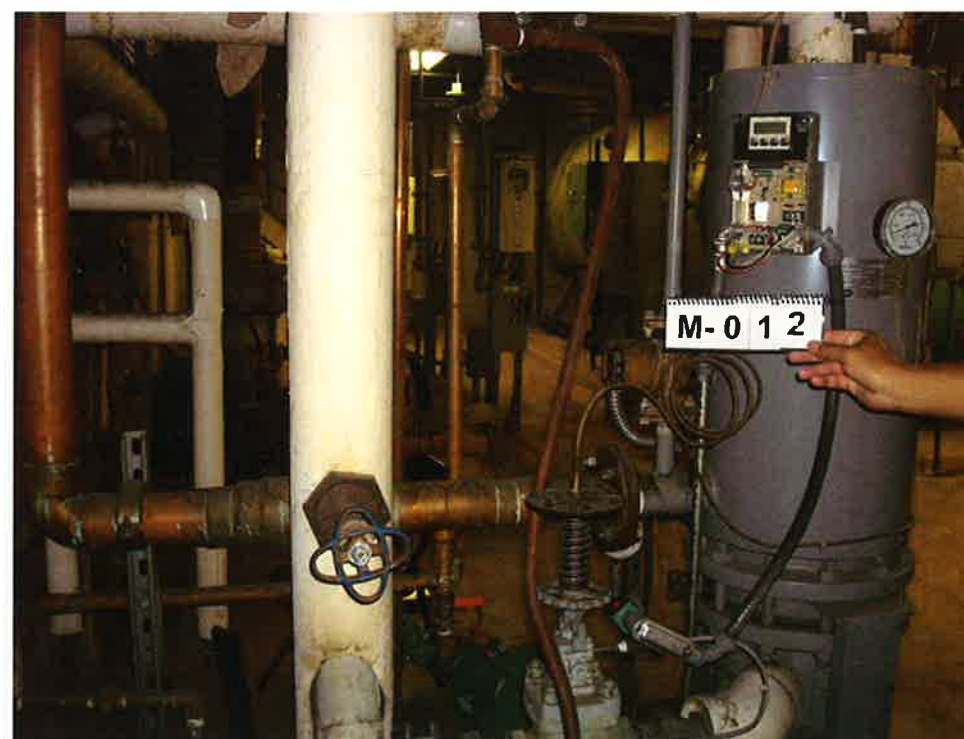
Comment #: A6109

Picture 4: Comment# A6109
Bldg:
Drawing #: Group 2 Level 1
Discipline: A Building
Item: Boiler Room

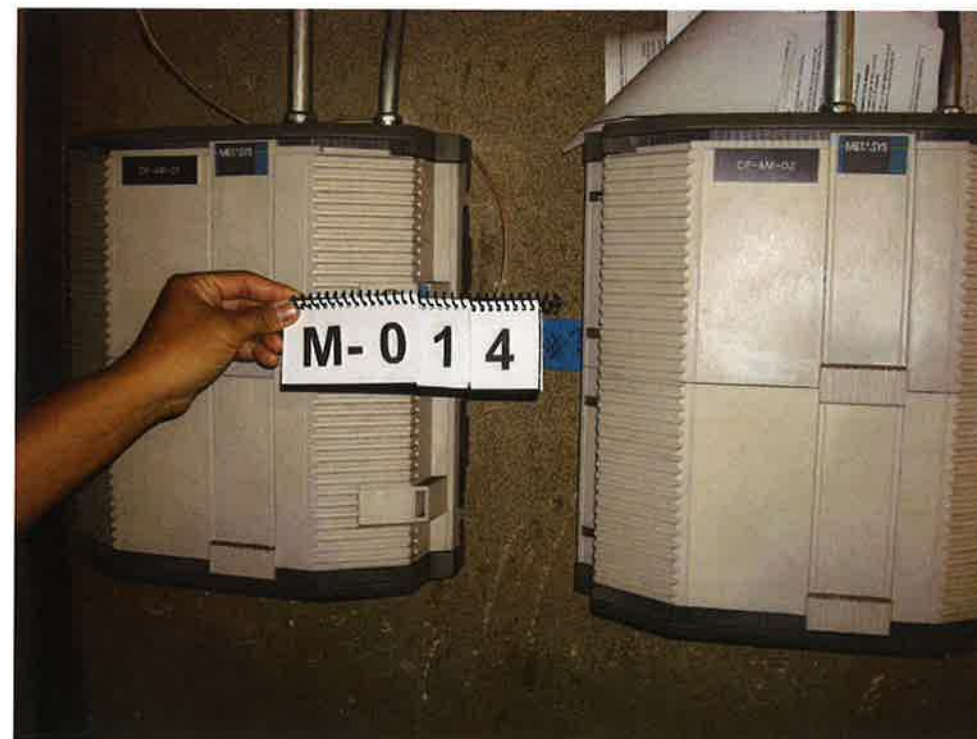
Comment #: A6112

Picture 3: Comment# A6112
Bldg:
Drawing #: Group 2 Level 1
Discipline: A Building
Item: Boiler Room

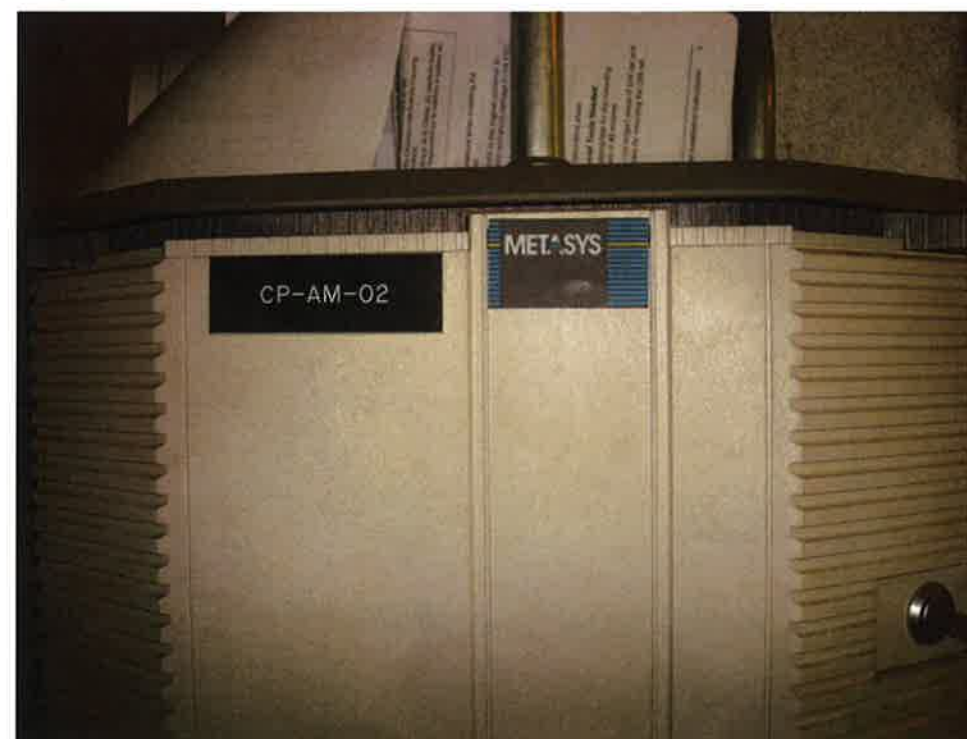
Comment #: A6113

Picture 4: Comment# A6113
Bldg:
Drawing #: Group 2 Level 1
Discipline: A Building
Item: Boiler Room

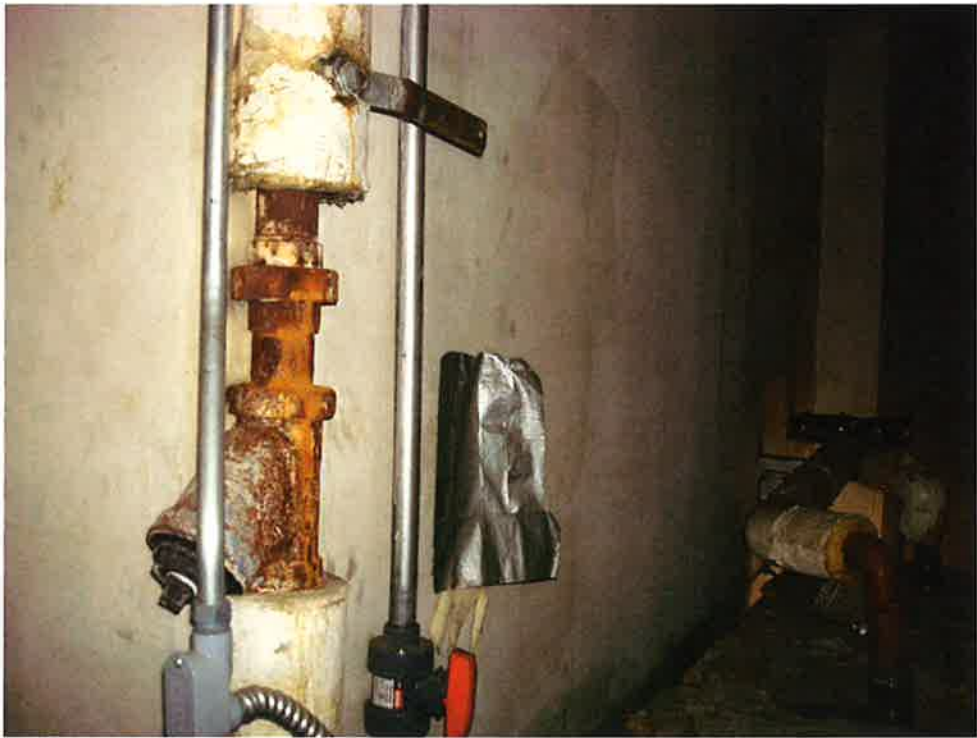
Picture 3
Comment #: A6116

Picture 3: Comment# A6116
Bldg:
Drawing #: Group 2 Roof
Discipline: A Building
Item: Air Handling Room at Penthou

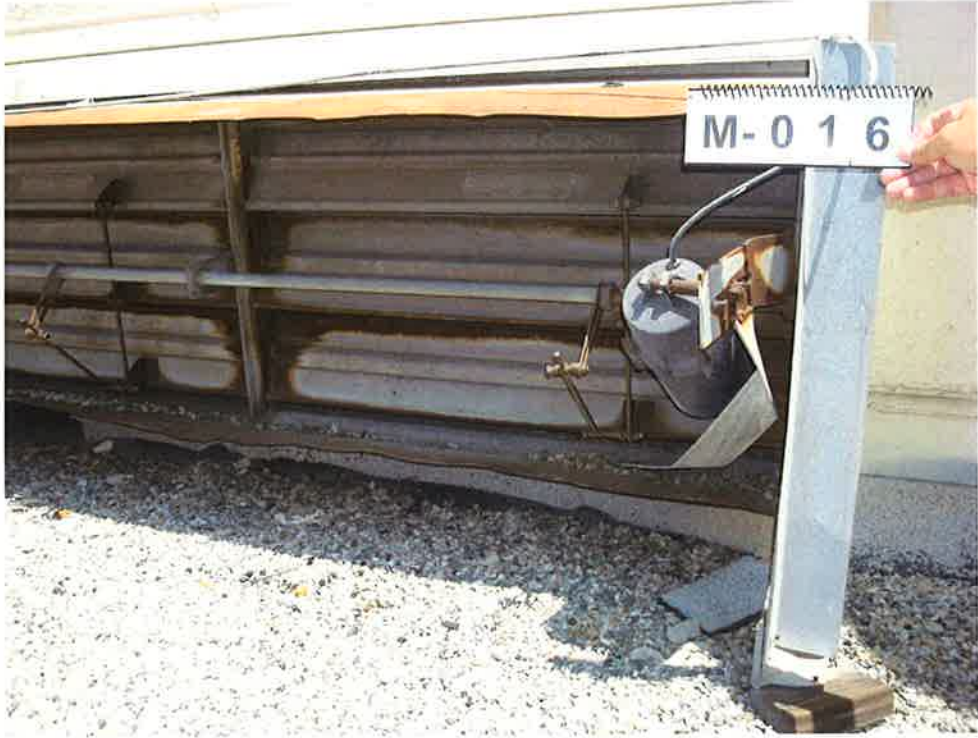
Picture 4
Comment #: A6117

Picture 4: Comment# A6117
Bldg:
Drawing #: Group 2 Roof
Discipline: A Building
Item: Out side air damper on roof

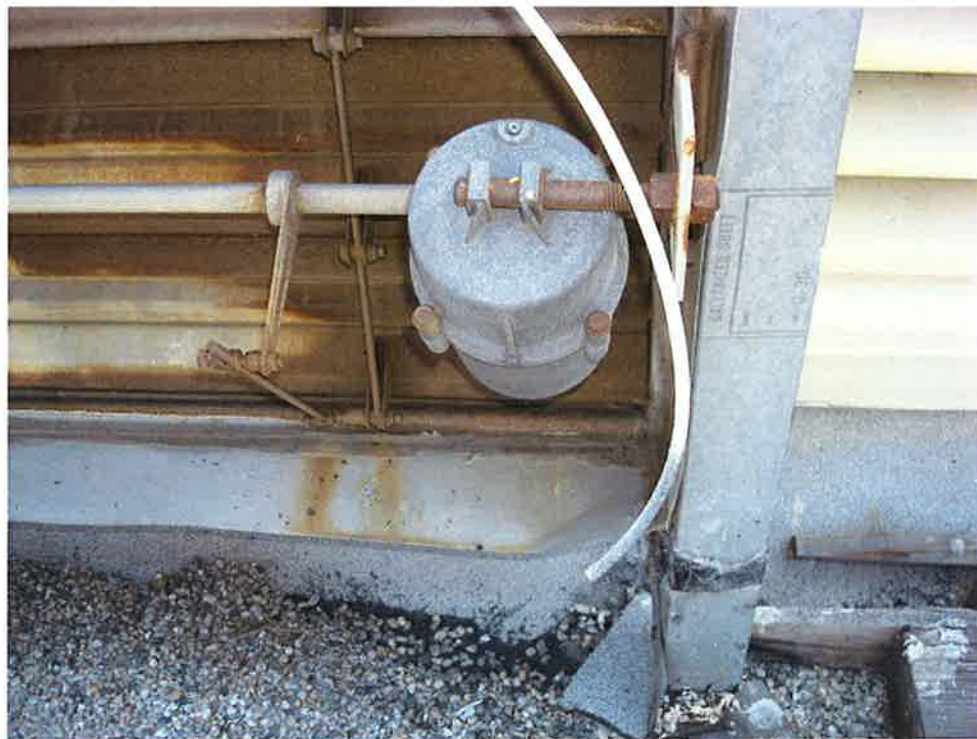
Comment #: A6120

Picture 3: Comment# A6120
Bldg:
Drawing #: Group 2 Roof
Discipline: A Building
Item: Out side air damper on roof

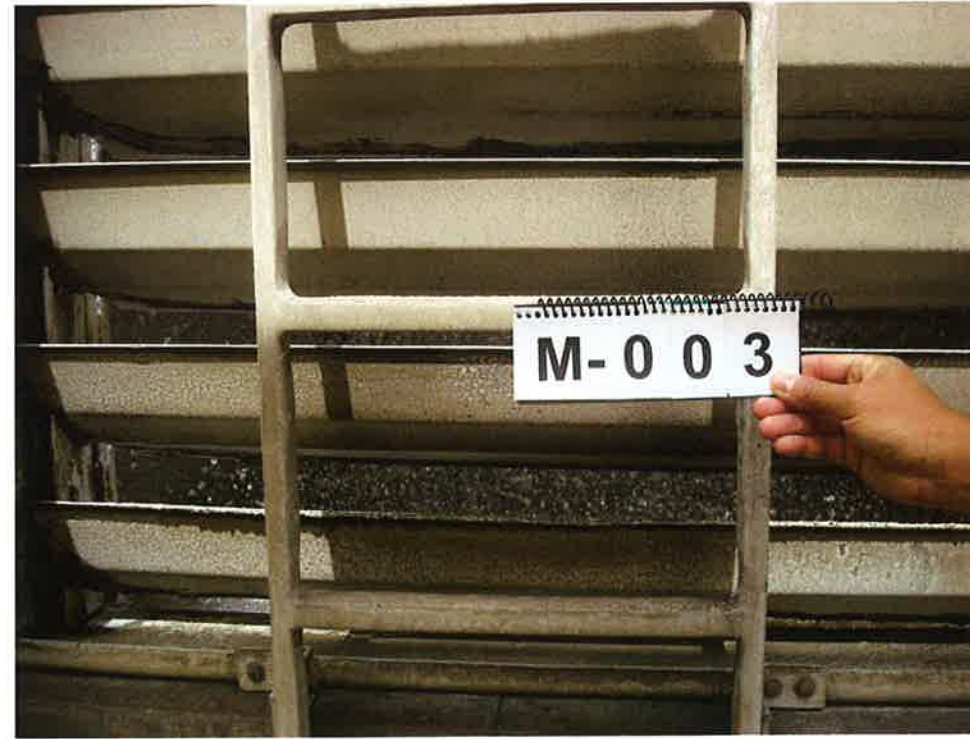
Comment #: A6201

Picture 4: Comment# A6201
Bldg:
Drawing #: Group 2 Roof
Discipline: A Building
Item: Cooling Towers on Roof

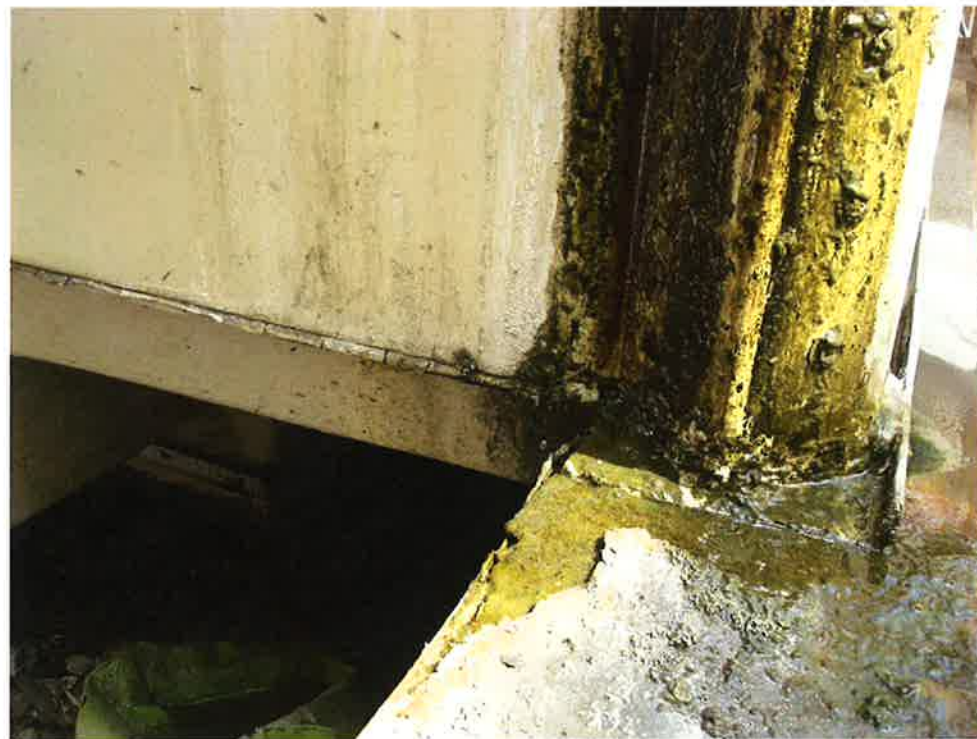
Comment #: A6204

Picture 3: Comment# A6204
Bldg:
Drawing #: Group 2 Roof
Discipline: A Building
Item: Cooling Towers on Roof

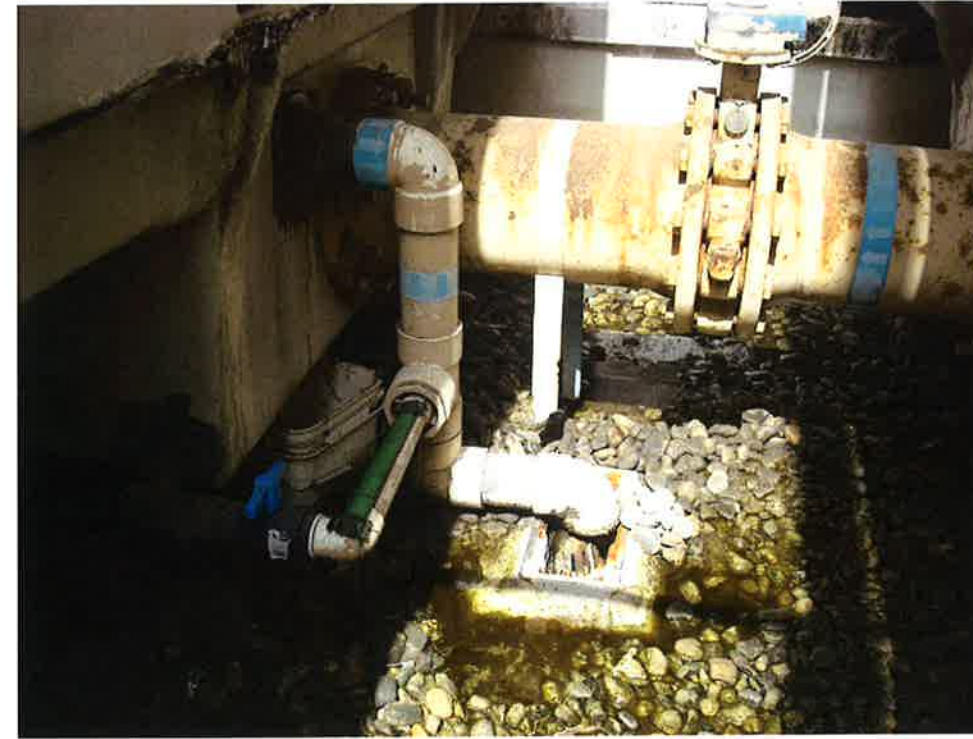
Comment #: A6205

Picture 4: Comment# A6205
Bldg:
Drawing #: Group 2 Roof
Discipline: A Building
Item: Cooling Towers on Roof

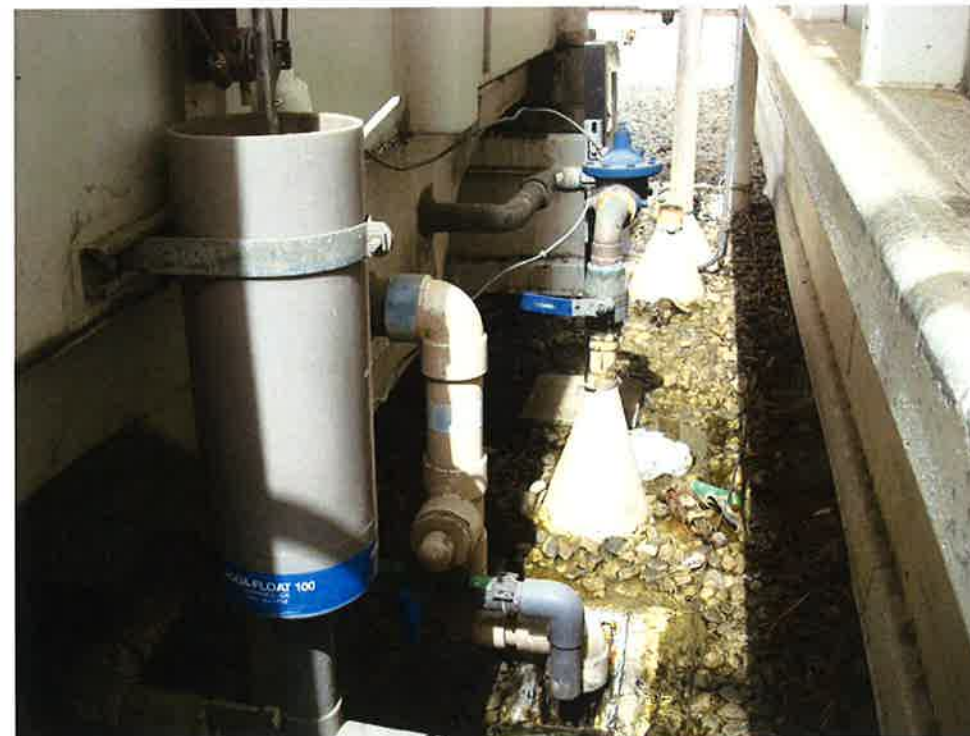
Picture 3: Comment #: A6208

Picture 3: Comment# A6208
Bldg:
Drawing #: Group 2 Roof
Discipline: A Building
Item: Cooling Towers on Roof
