Revised Appendix Q

Existing Building Evaluation

Los Angeles County Museum of Art Building Evaluation

September 16, 2014

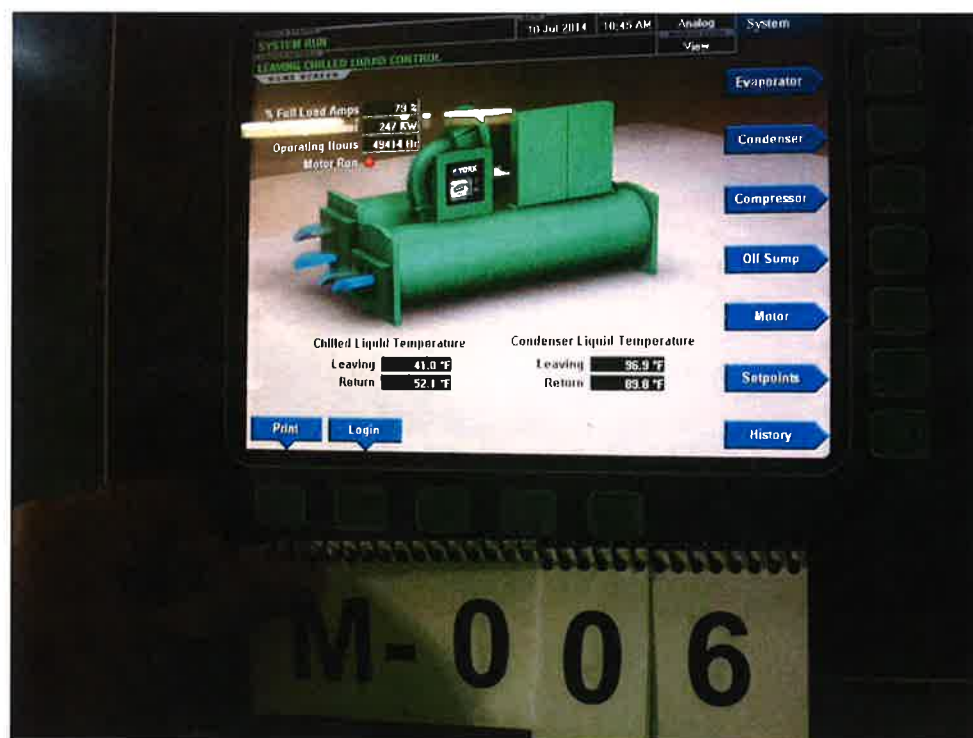
Picture 3

Picture 3: Comment# A6216
Bldg:
Drawing #: Group 2 Roof
Discipline: A Building
Item: Chiller Room

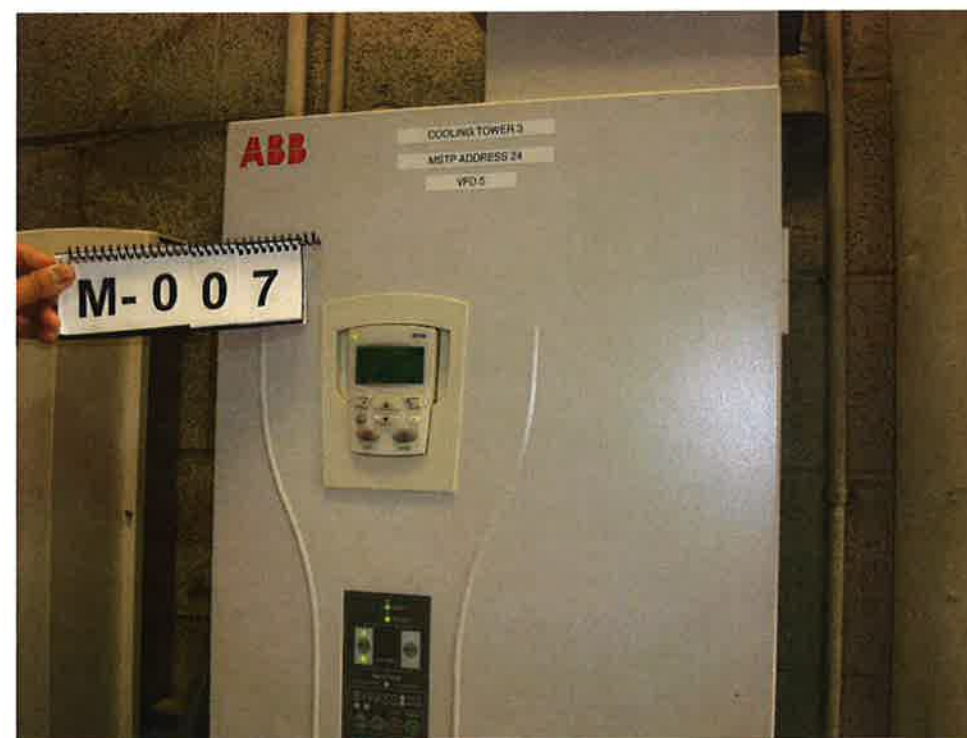
Picture 4

Picture 4: Comment# A6217
Bldg:
Drawing #: Group 2 Roof
Discipline: A Building
Item: Chiller Room

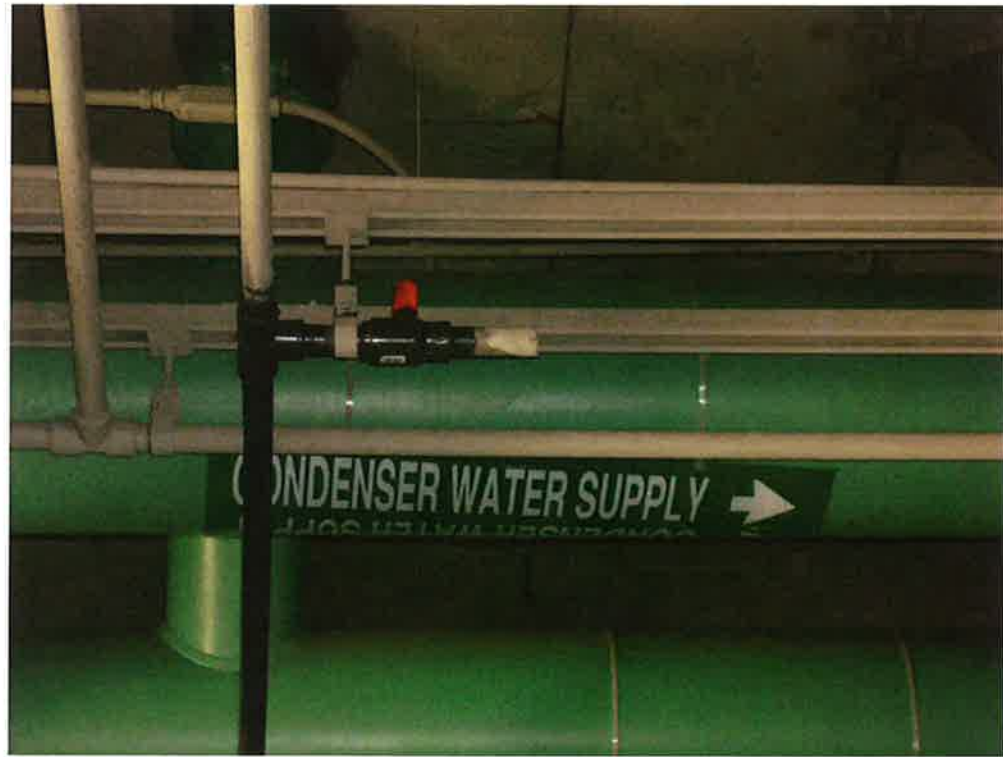
Comment #: A6222

Picture 1: Comment# A6222
Drawing #: Group 2 Roof
Bldg:
Item: Chiller Room
Discipline: A Building

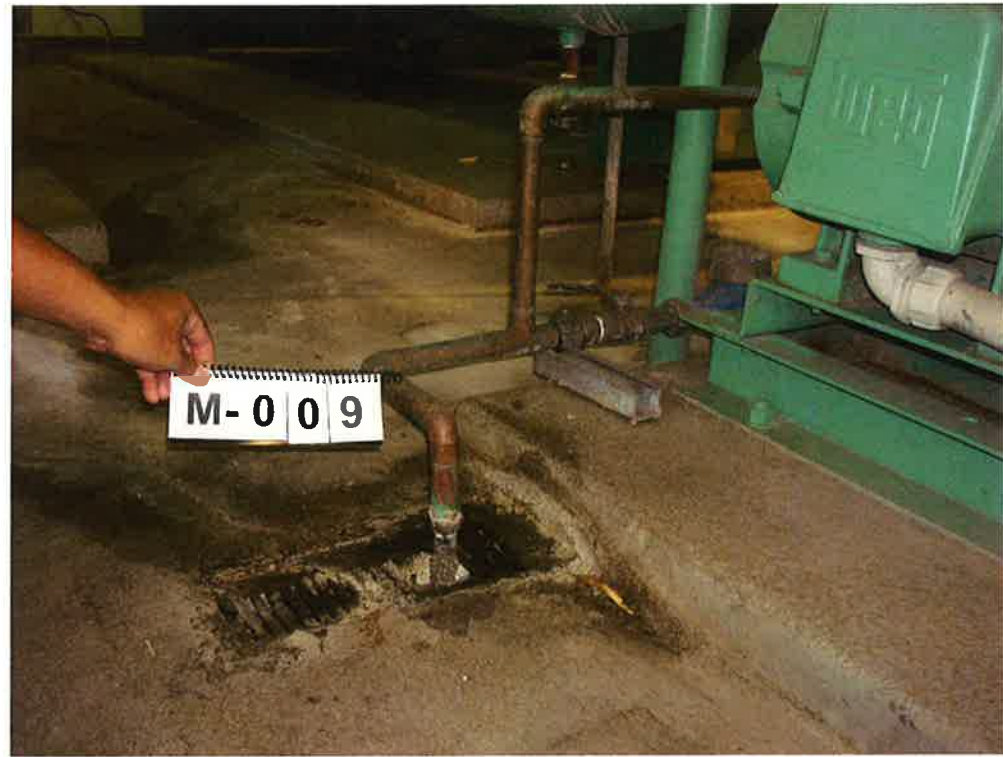
Comment #: A6223

Picture 2: Comment# A6223
Bldg:
Drawing #: Group 2 Roof
Discipline: A Building
Item: Chiller Room

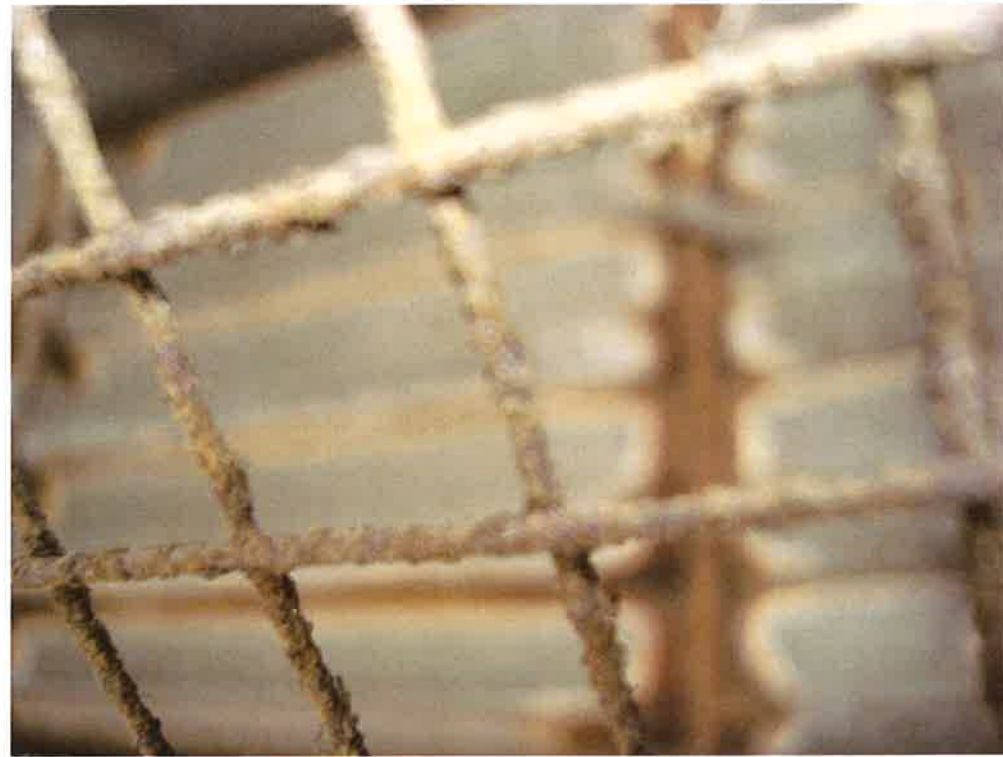
Comment #: A6302

Picture 1: Comment# A6302
Drawing #: Group 2 Roof
Bldg:
Item: Louver on roof
Discipline: A Building

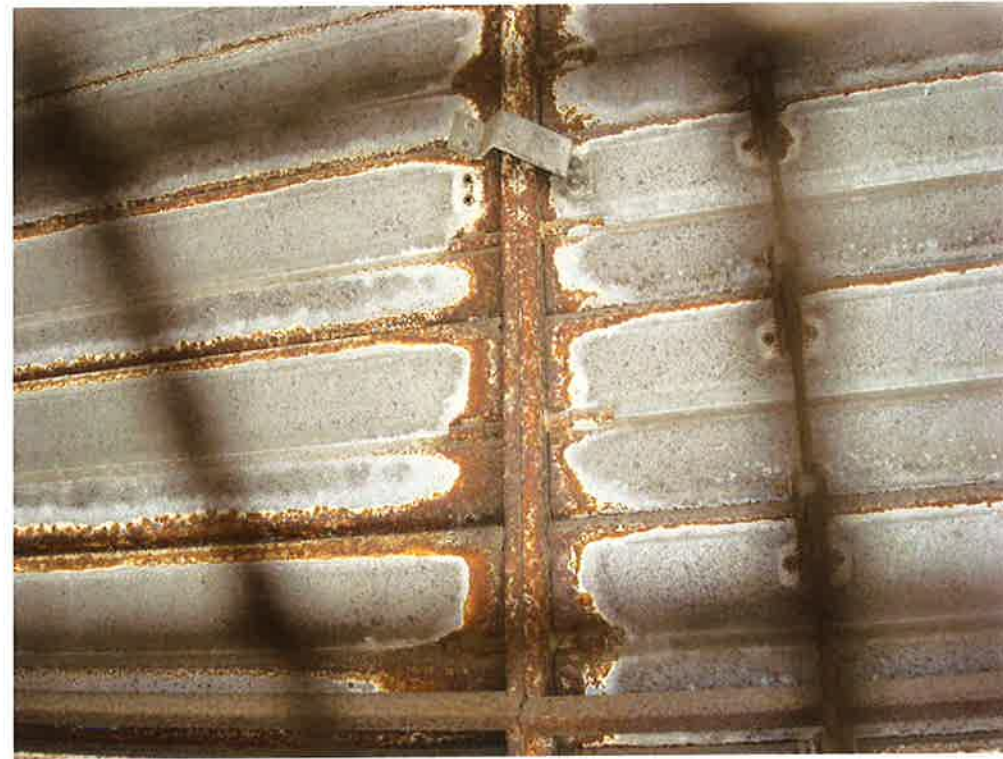
Comment #: A6303

Picture 2: Comment# A6303
Bldg:
Drawing #: Group 2 Roof
Discipline: A Building
Item: Louver on roof

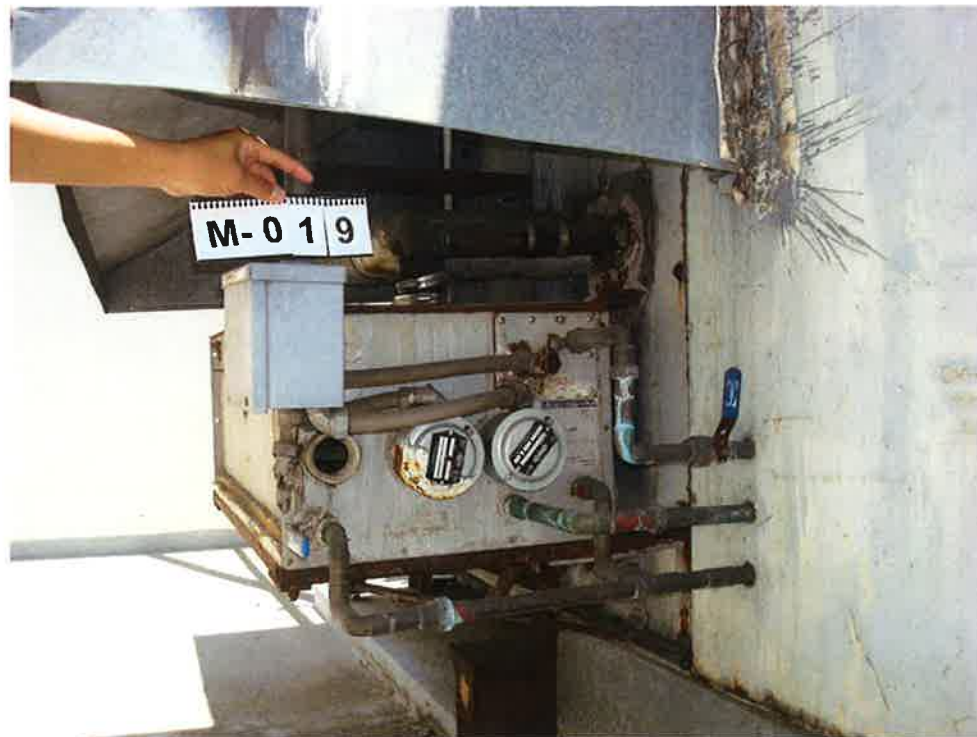
Comment #: A6304

Picture 3: Comment# A6304
Bldg:
Drawing #: Group 2 Roof
Discipline: A Building
Item: Steam Humidifier on Roof

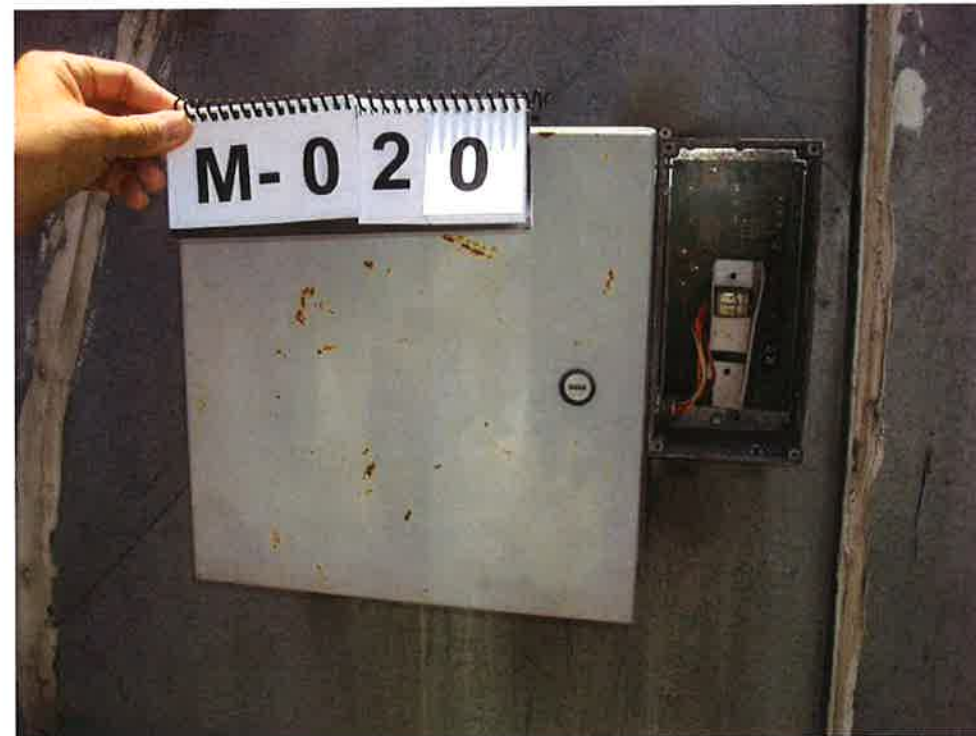
Comment #: A6305

Picture 4: Comment# A6305
Bldg:
Drawing #: Group 2 Roof
Discipline: A Building
Item: Fire Smoke Detector for S-16

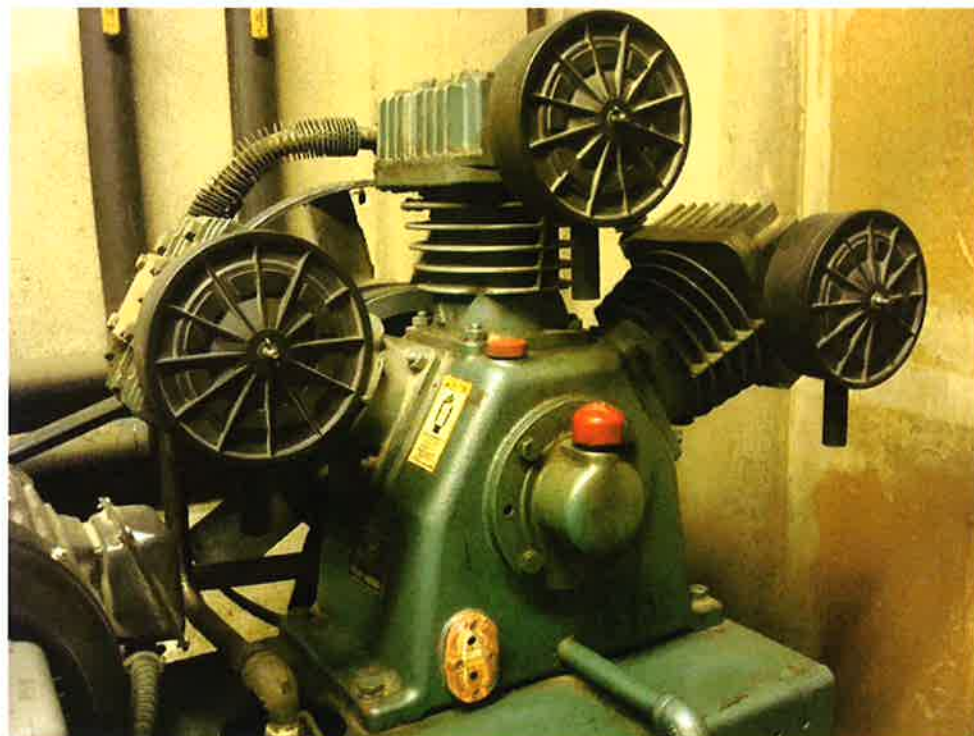
Comment #: A6702

Picture 3: Comment# A6702
Bldg:
Drawing #: Group 2 Roof
Discipline: A Building
Item: Control Air Compressor in

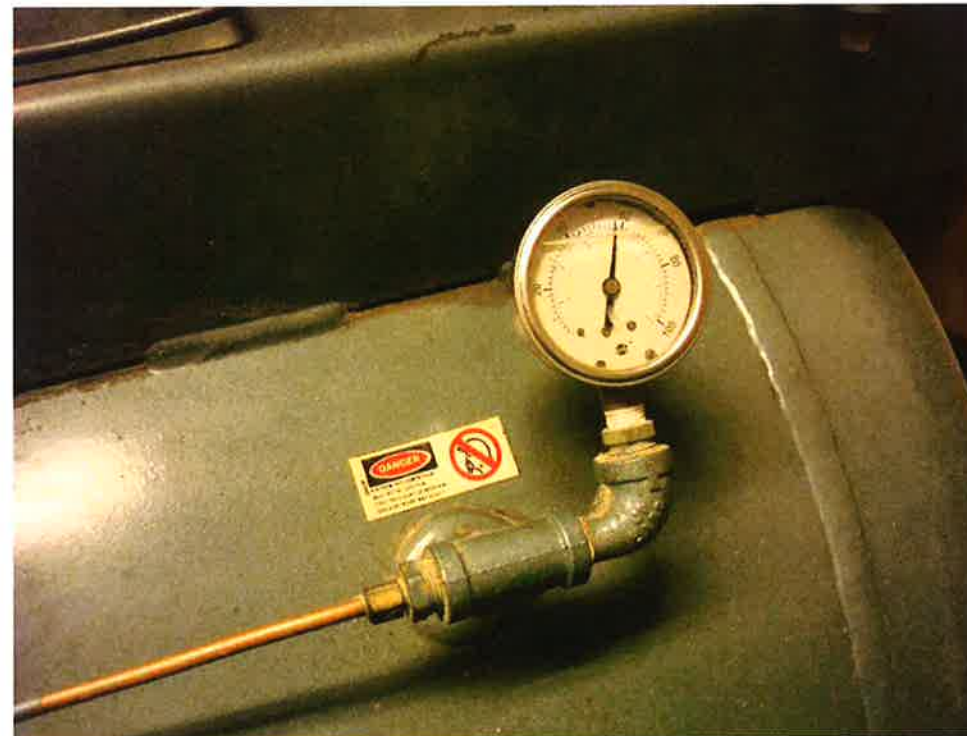
Comment #: A6703

Picture 4: Comment# A6703
Bldg:
Drawing #: Group 2 Roof
Discipline: A Building
Item: Control Air Compressor in

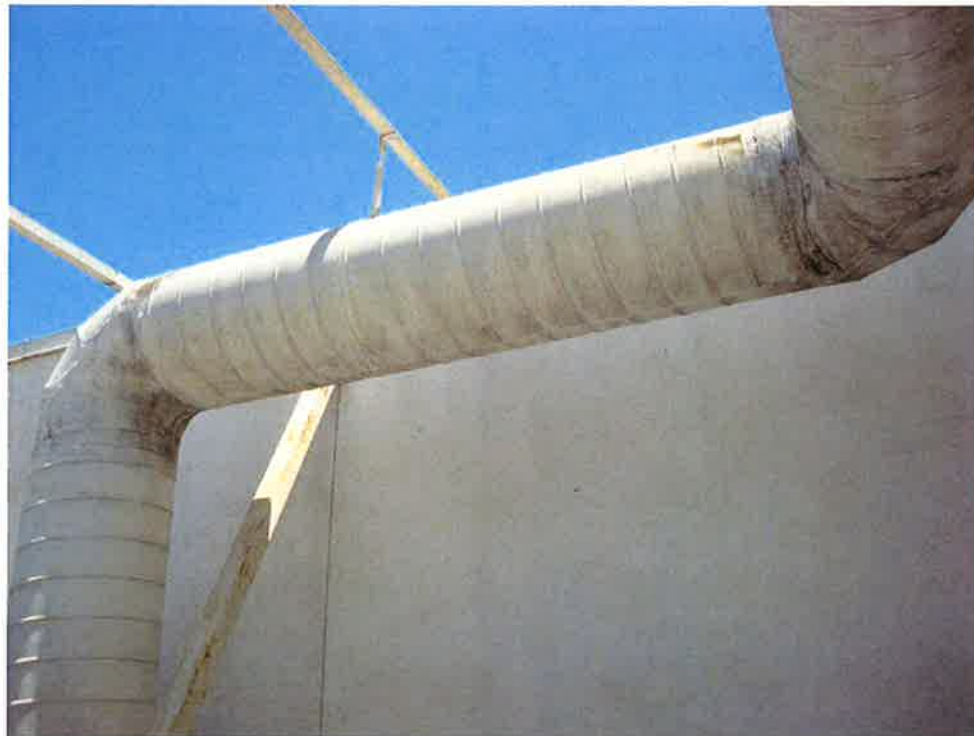
Comment #: A6706

Picture 3: Comment# A6706
Bldg:
Drawing #: Group 2 Roof
Discipline: A Building
Item: 18

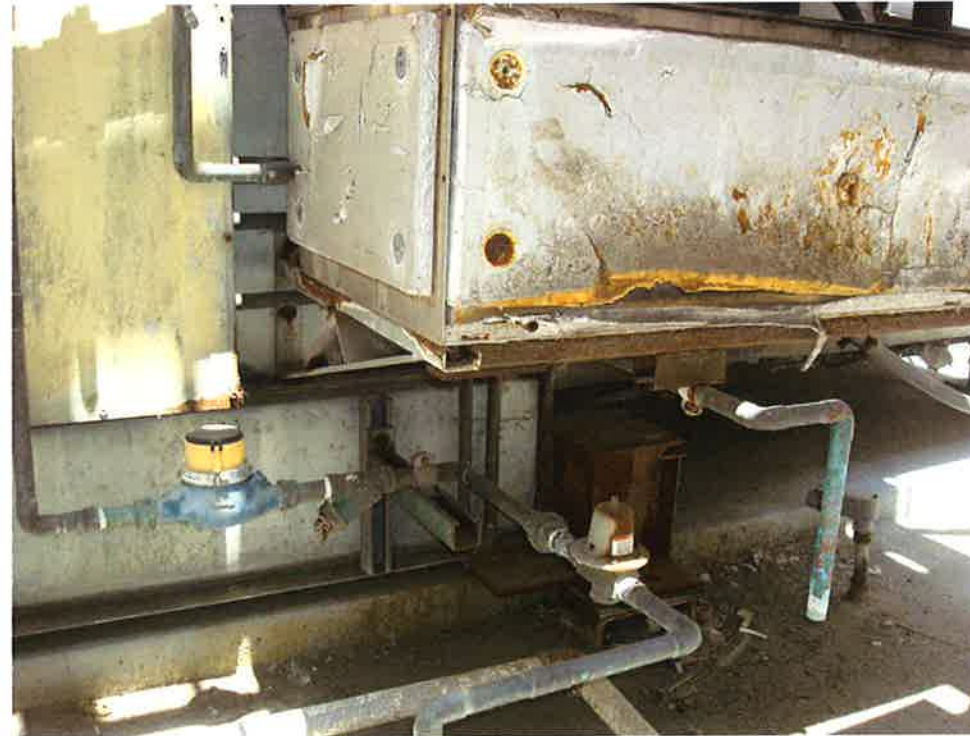
Comment #: A6801

Picture 4: Comment# A6801
Bldg:
Drawing #: Group 2 Roof
Discipline: A Building
Item: Electric humidifier on roof

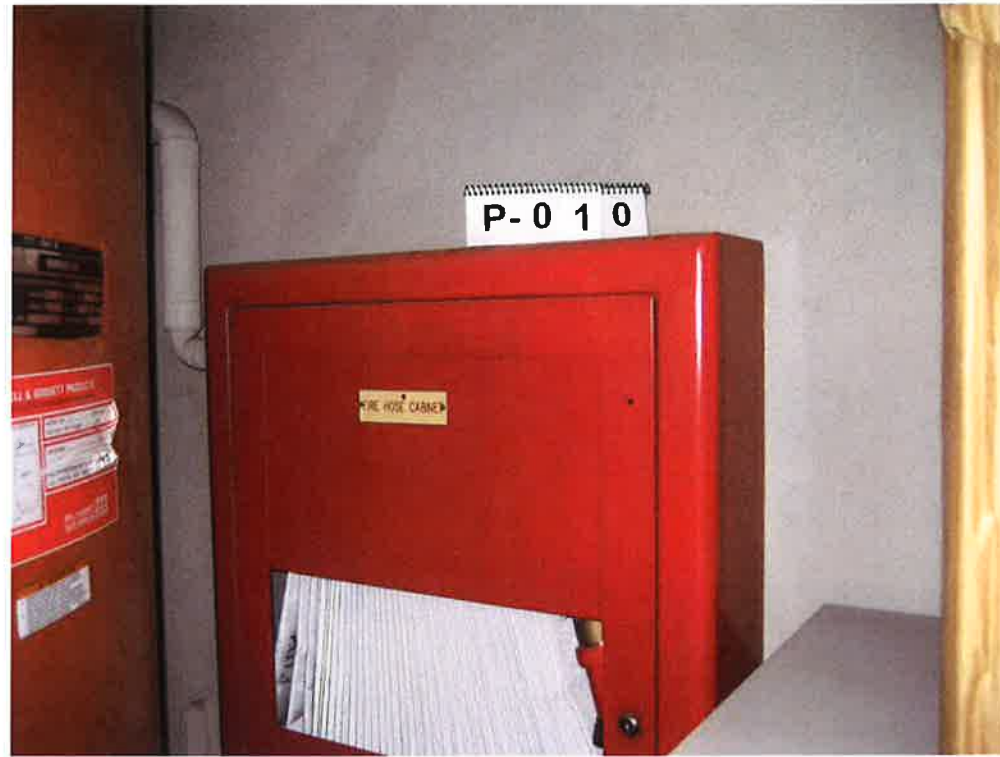
Picture 1: Comment #: A8202

Picture 1: Comment# A8202
Drawing #: Group 2 Level 1
Bldg:
Item: Fire Hose Cabinet
Discipline: A Building

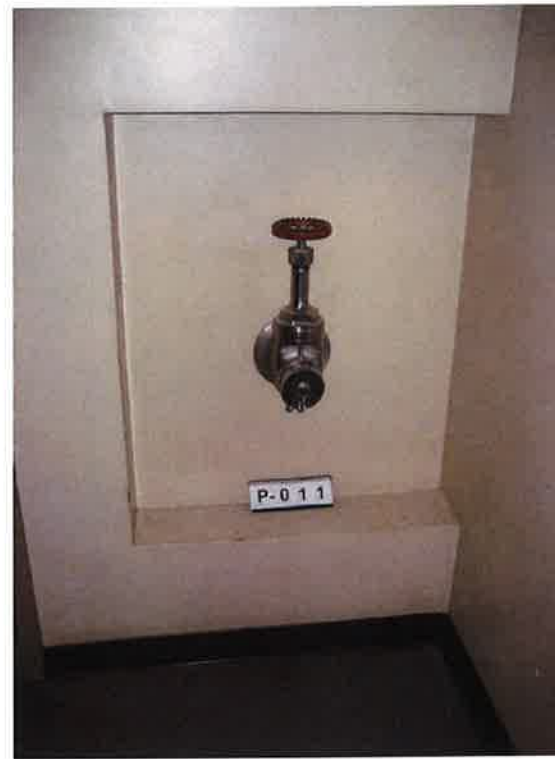
Picture 2: Comment #: A8203

Picture 2: Comment# A8203
Bldg:
Drawing #: Group 2 Level 1
Discipline: A Building
Item: Fire Hose Connection

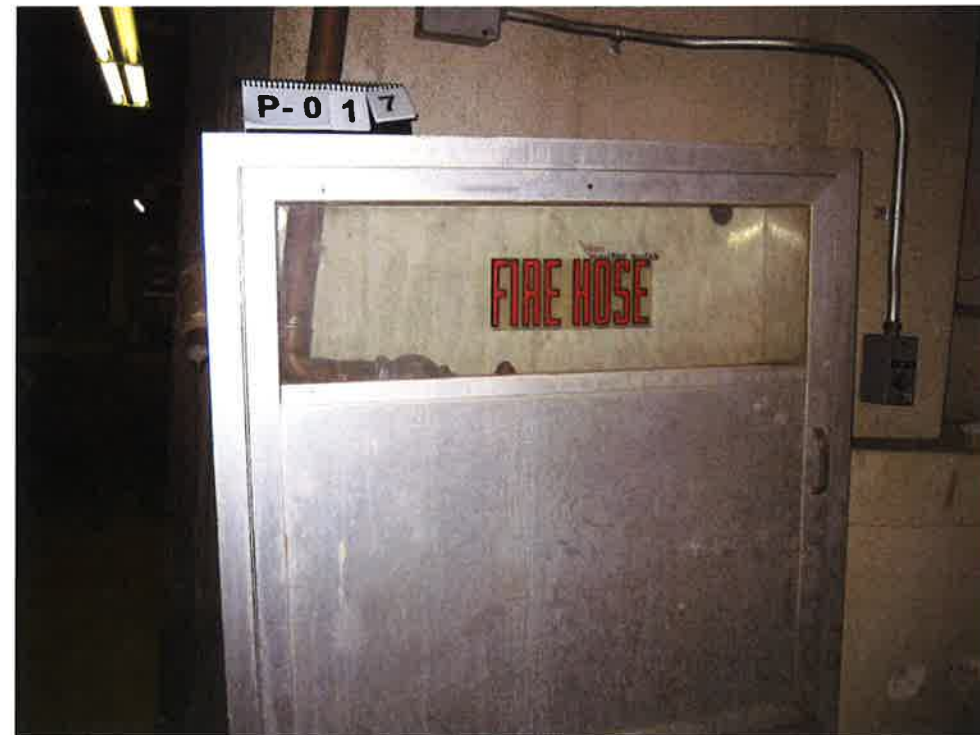
Picture 3: Comment #: A8204

Picture 3: Comment# A8204
Bldg:
Drawing #: Group 2 Level 1
Discipline: A Building
Item: Fire Hose Cabinet

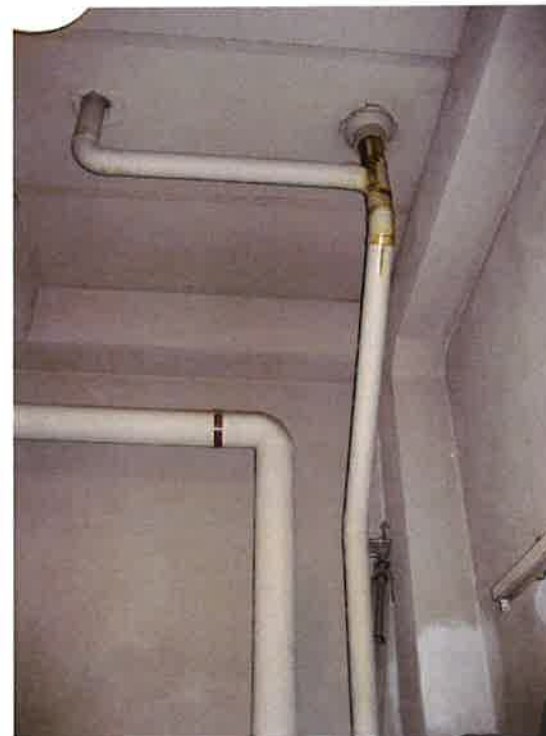
Picture 3

Picture 3: Comment# A8208
Bldg:
Drawing #: Group 2 Level 1
Discipline: A Building
Item: General

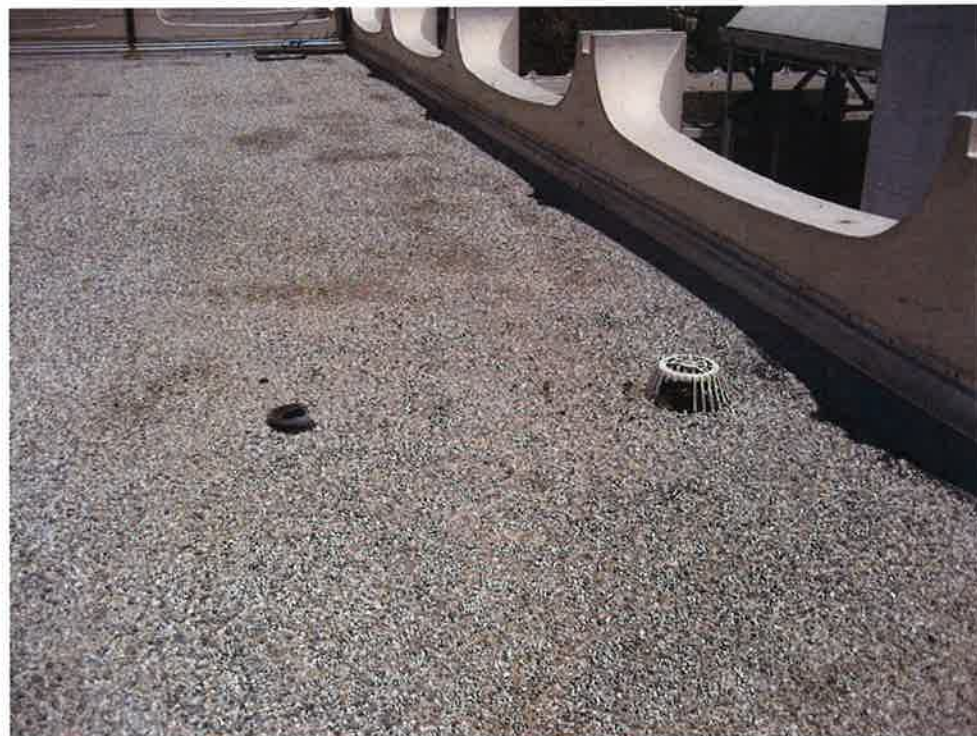
Picture 3 Comment #: A8403

Picture 3: Comment# A8403
Bldg:
Drawing #: Group 2 Level 1
Discipline: A Building
Item: Storm Drain

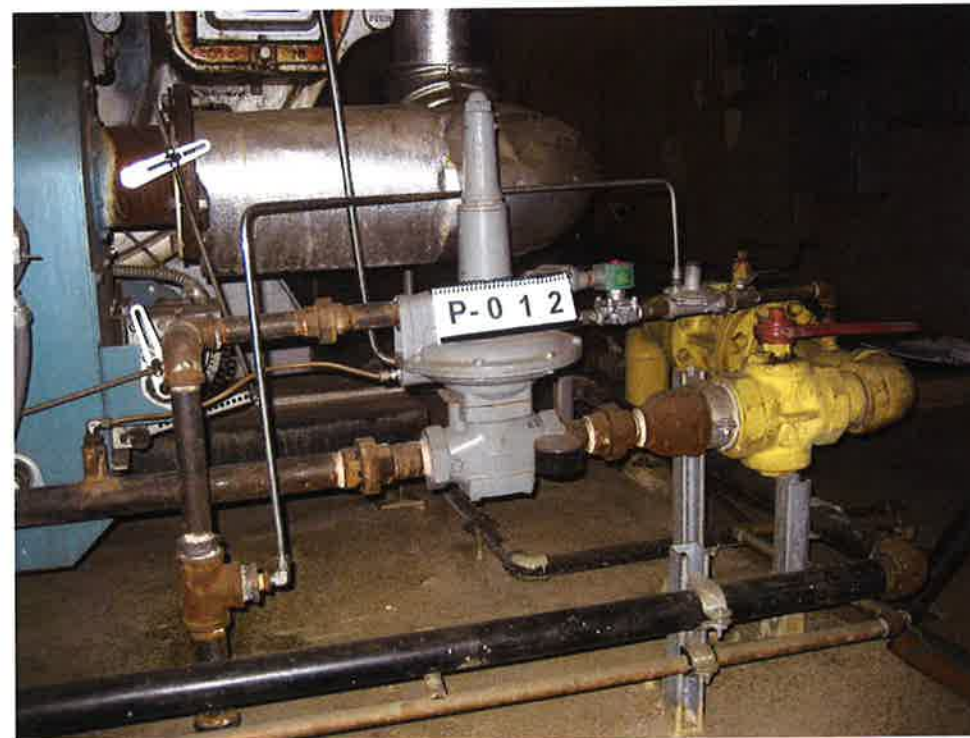
Picture 4 Comment #: A8501

Picture 4: Comment# A8501
Bldg:
Drawing #: Group 2 Level 1
Discipline: A Building
Item: Gas supply to Boilers

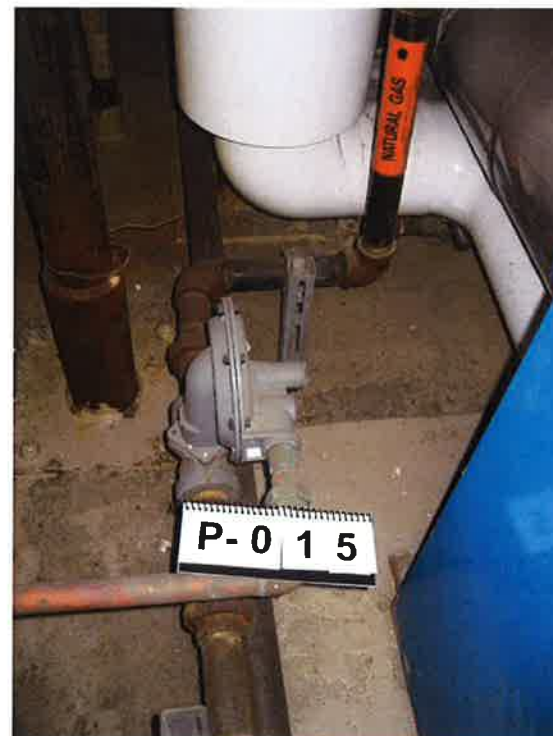
Picture 3 Comment #: A8506

Picture 3: Comment# A8506
Bldg:
Drawing #: Group 2 Level 1
Discipline: A Building
Item: Gas supply to Boilers

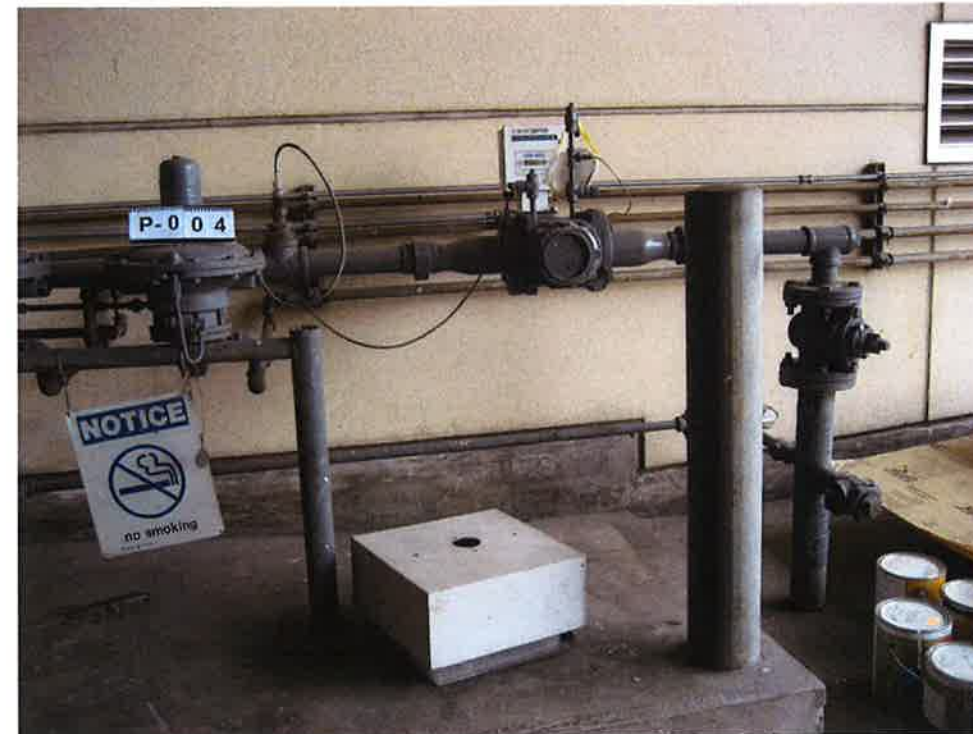
Picture 4 Comment #: A8601

Picture 4: Comment# A8601
Bldg:
Drawing #: Group 2 Level 1
Discipline: A Building
Item: Main Gas Meter location

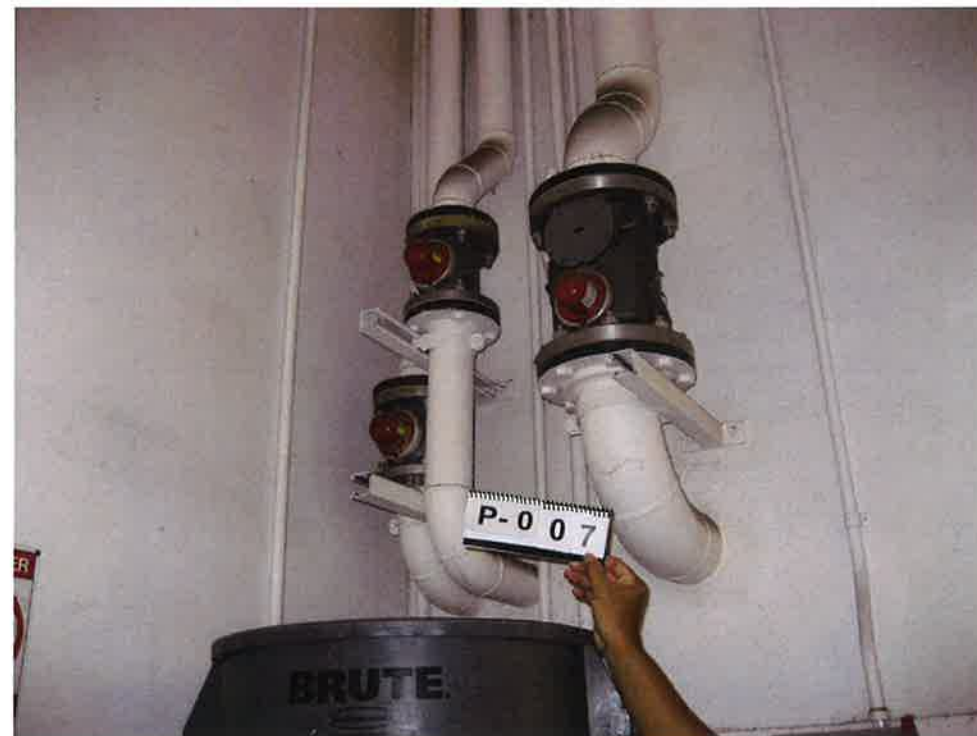
Picture 3: Comment #: A8604

Picture 3: Comment# A8604
Bldg:
Drawing #: Group 2 Level 1
Discipline: A Building
Item: Line size earthquake shut-off

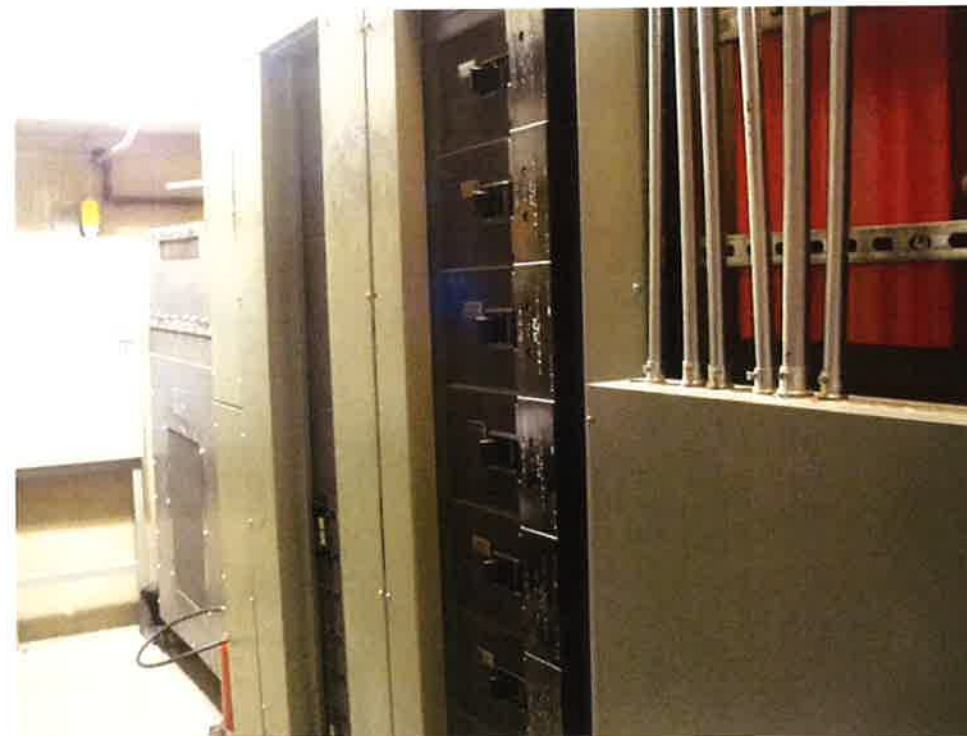
Picture 4 Comment #: A9002

Picture 4: Comment# A9002
Bldg:
Drawing #: Group 2 Level 1
Discipline: A Building
Item: Unit Substation

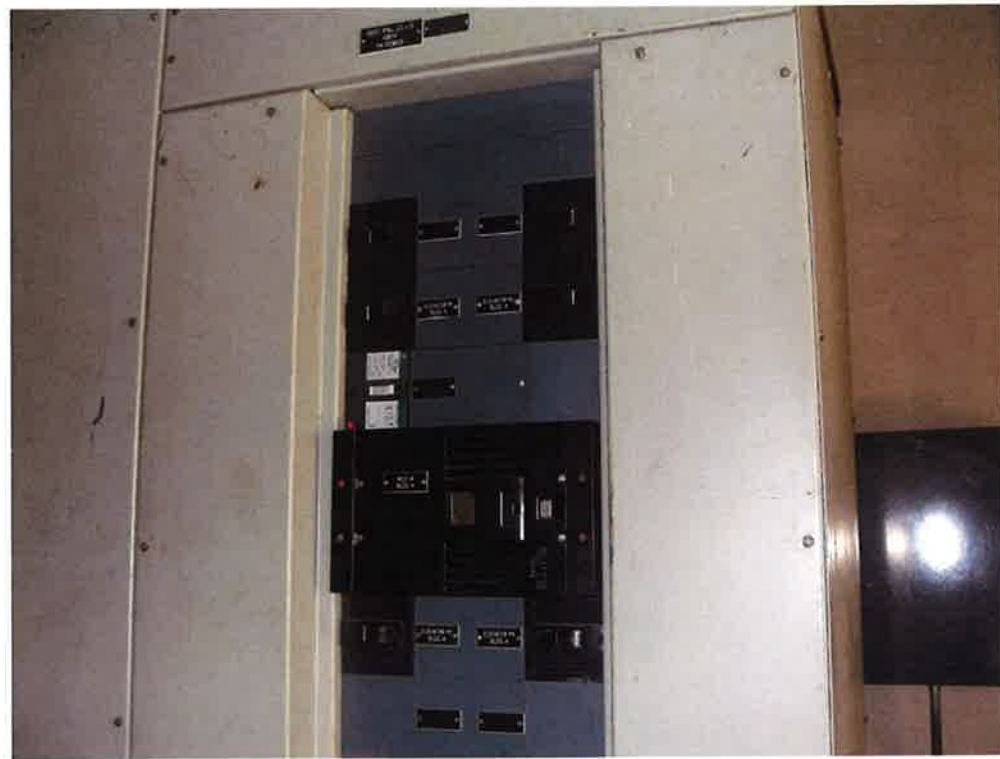
Picture 1
Comment #: A9003

9003	Electrical	3	A	Unit Substation	Substation T-2	This type of substation should be replaced every 20 years, this is currently 50 years old and passed its useful life and reported over heating.	Replace this substation T-2, with new including all associated distribution boards.		X		
9004	Electrical	5	A	Unit Substation	Substation T-3 & T-3A	This type of substation should be replaced every 20 years, this is currently 50 years old and passed its useful life and reported over heating.	Replace this substation T-3, with new including all associated distribution boards. Do not replace T-3A		X

Picture 1: Comment# A9003
Drawing #: Group 2 Level 3
Bldg:
Item: Unit Substation
Discipline: A Building

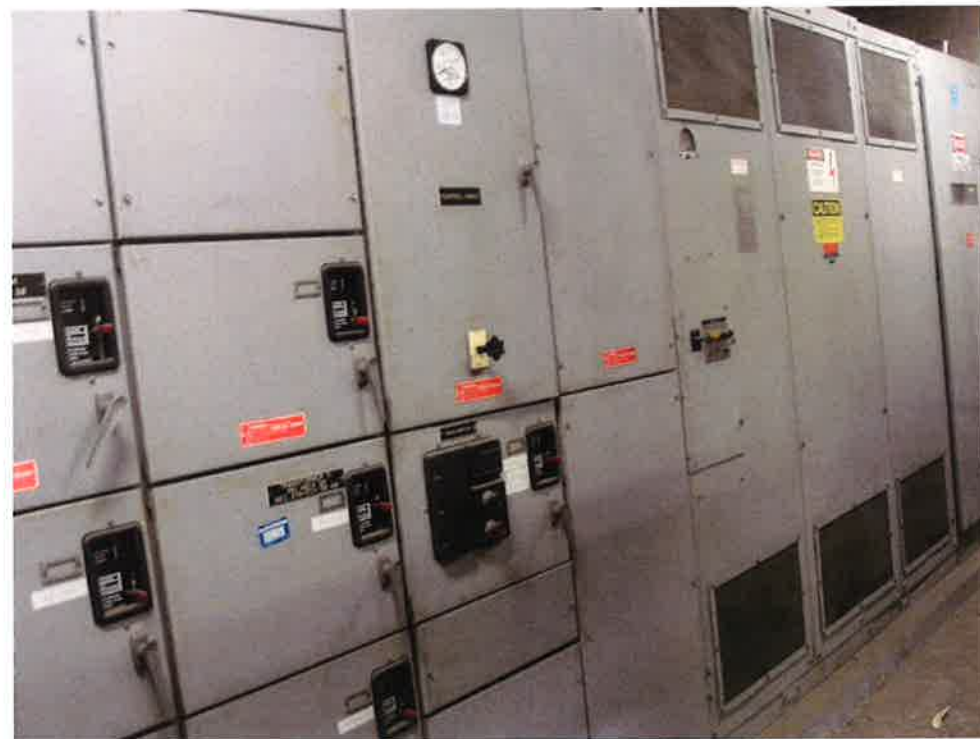
Picture 3
Comment #: A9006

Picture 3: Comment# A9006
Bldg:
Drawing #: Group 2 Level 1
Discipline: A Building
Item: Generator

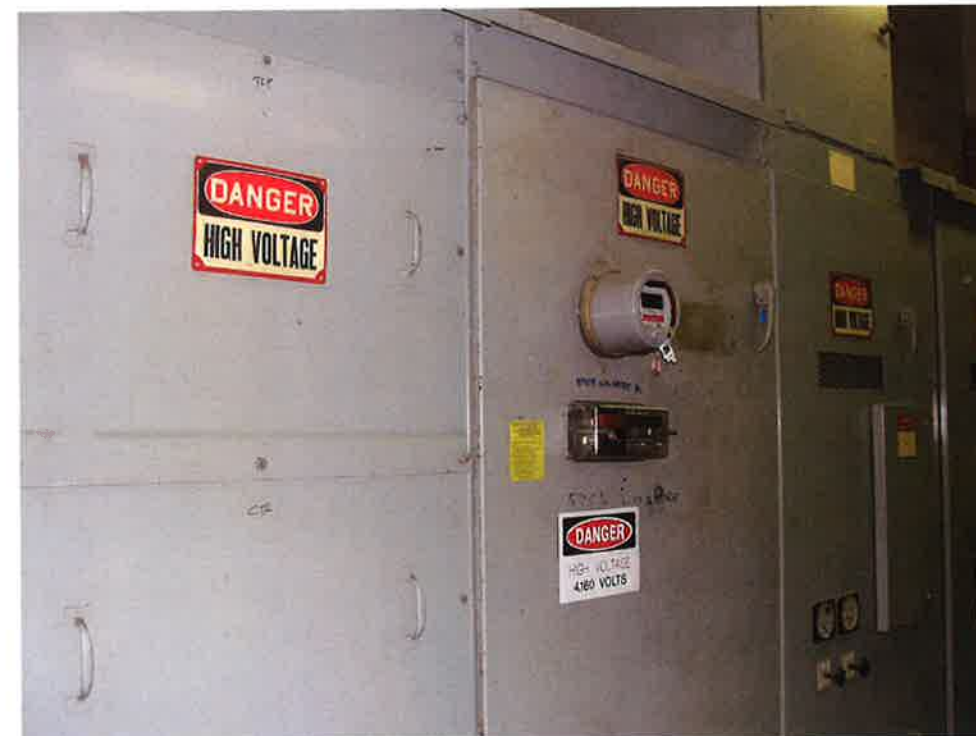
Picture 4
Comment #: A9007

Picture 4: Comment# A9007
Bldg:
Drawing #: Group 2 Level 1
Discipline: A Building
Item: Unit Substation

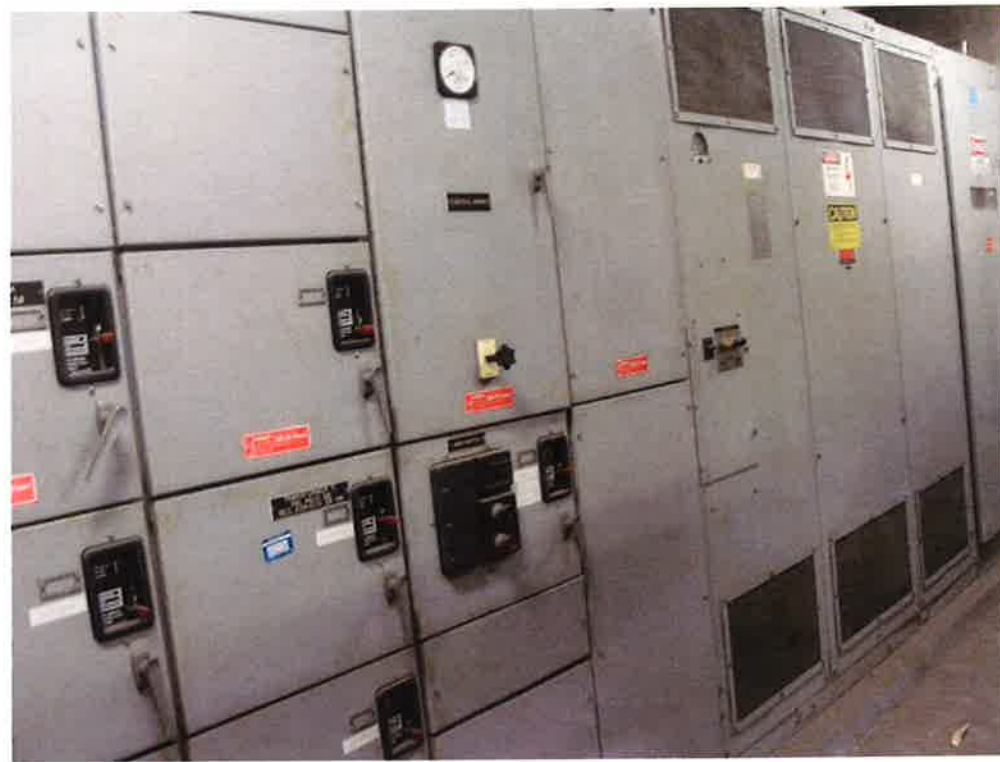
Picture 1

9008	Electrical	5	A	Unit Substation	Substation TTR-2 & MCC-A	This type of substation should be replaced every 20 years, this is currently 30 years old and passed its useful life. Also reported over	Replace this substation TTR-2, with new including all associated distribution boards and MCC-A		X		
9009	Electrical	5	A	Generator	Emergency Generator G-2, 50 kw and Auto- Transfer Sw.	This generator is reported in poor working condition, and it is 30 years old, including ATS & Distribution board	Generator set shall be replaced with new G-2, including ATS& Distribution Board		X		
9010	Electrical	1	B	Unit Substation	Substation T-4 and T-5	This type of substation should be replaced every 20 years, this is currently 50 years old and passed its useful life and reported over heating.	Replace this substation T-4 and T-5, with new including all associated distribution boards.		X		
9011	Electrical	3	B	Unit Substation	Substation T-6 and Motor Control Center MCC-D	This type of substation should be replaced every 20 years, this is currently 50 years old and passed its useful life and reported over heating.	Replace this substation T-6 with new including all associated distribution boards. MCC-D to remain as is.		X

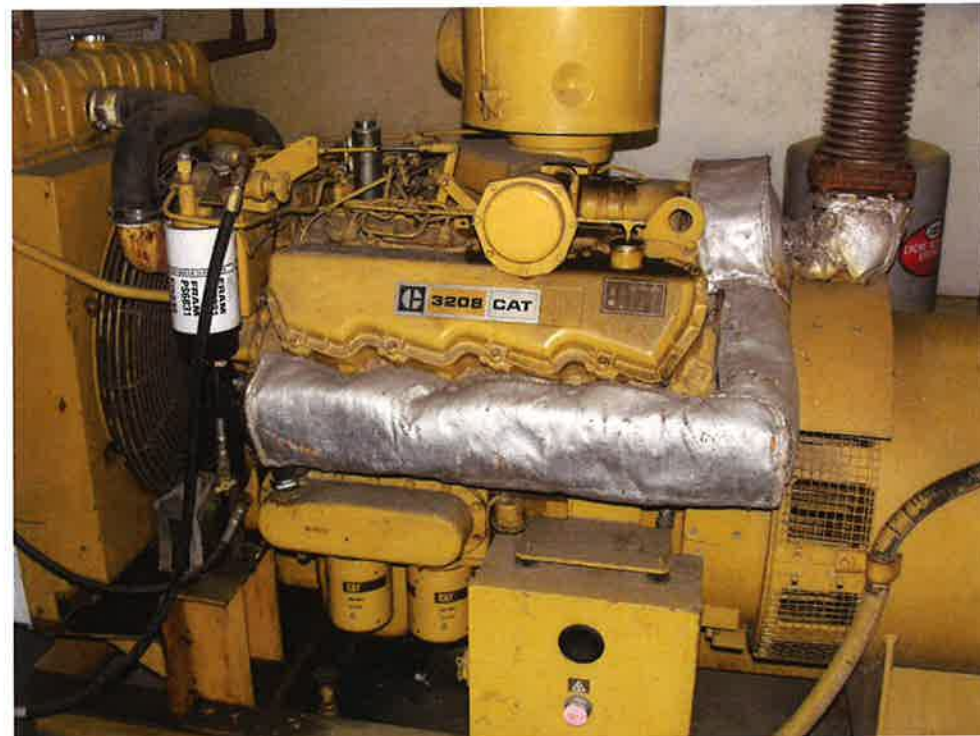
Picture 3:

9101	Electrical	1	A	Generator	Emergency Generator G-3, 150 kw and Auto- Transfer Sw.	This generator is reported in Goods working condition and is 30 years old including ATS.	Generator set G-3, including ATS shall remain as is, with routine maintenance.		X		
9103	Electrical	All	G	Power receptacle outlets	Power receptacle outlets	The Power receptacle outlets are in average condition. Some areas and in the kitchen especially show signs of smoke damage	The faceplates should be removed to check for further damage, if damage is found the outlets should be replaced.		X		
9202	Electrical	All	G	Lighting	Interior & exterior lighting - general office areas, men's/women's, lobbies,	Consist of incandescent, fluorescent & wall lights, including controls are inefficient, and do not meet the current codes requirements.	All lighting in these areas shall be replaced with new LED"S as required, including the controls		X

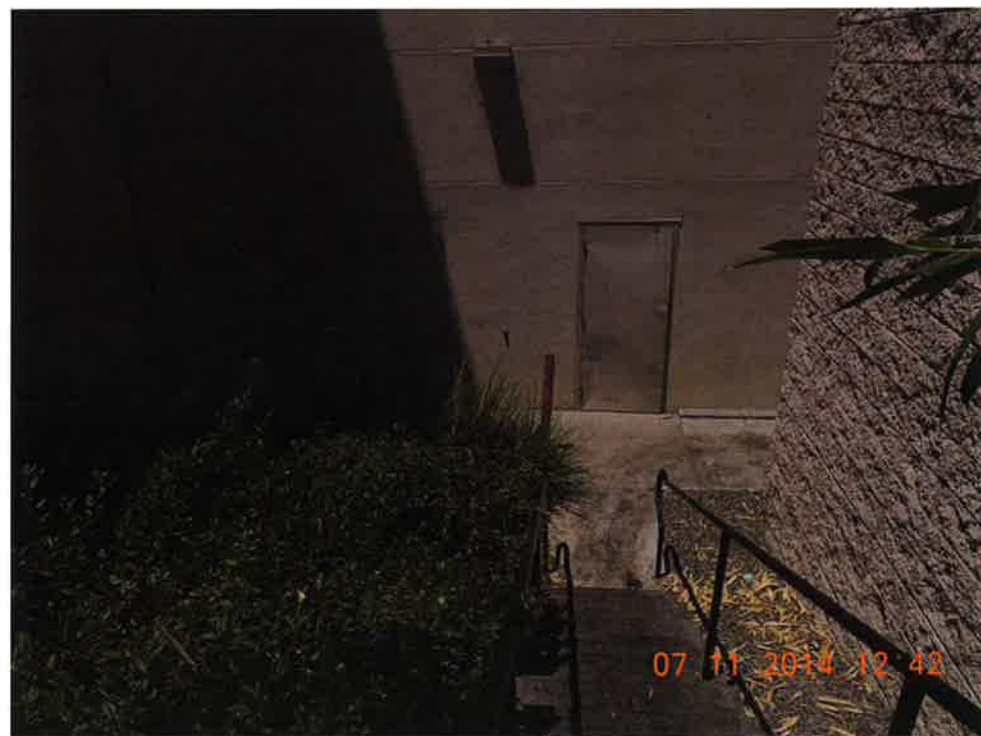
Picture 3: Comment# B1510.2
Bldg:
Drawing #: Group 1 Level 1
Discipline: B Hammer
Item: Ext. concrete stairs and railing

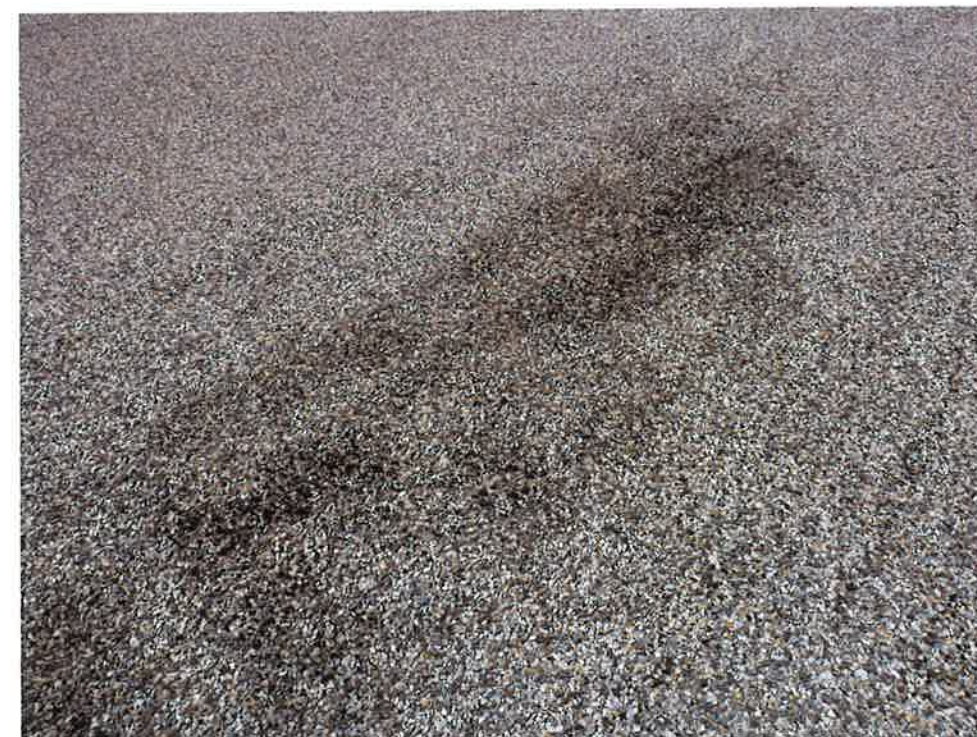
Picture 4

Picture 4: Comment# B1822
Bldg:
Drawing #: Group 2 Level 4
Discipline: B Hammer
Item: Roof on the Hammer building

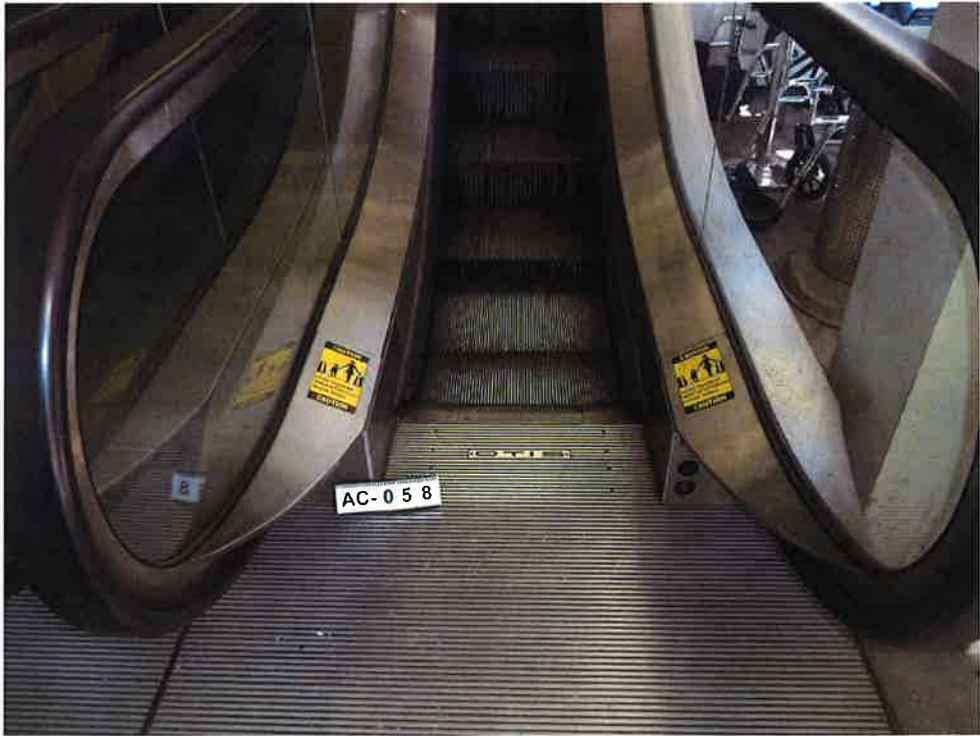
Picture 3 Comment #: B2710

Picture 3: Comment# B2710
Bldg:
Drawing #: Group 1 Level 1
Discipline: B Hammer
Item: Hammer - Escalator
