Revised Appendix Q

Existing Building Evaluation

Los Angeles County Museum of Art Building Evaluation

September 16, 2014

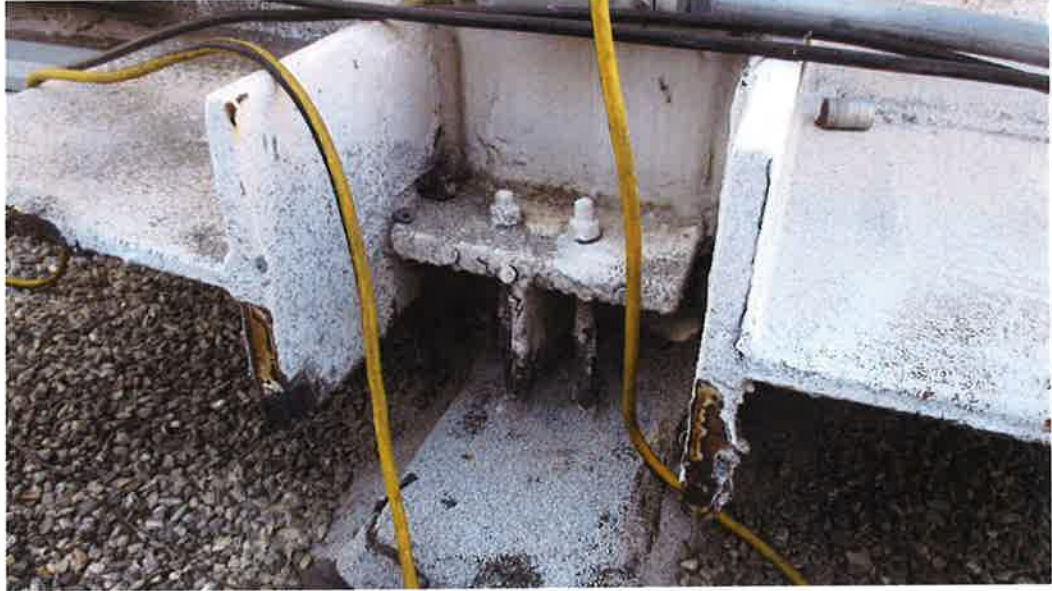
Picture 4 Comment #: B5210

Picture 4: Comment# B5210
Bldg:
Drawing #: Group 1 Level 4
Discipline: B Hammer
Item: Displaced canopy connection

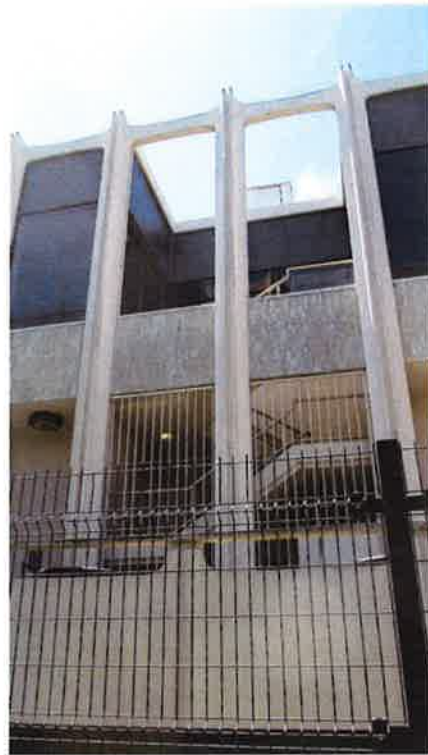
Picture 1 Comment #: B5301

Picture 1: Comment# B5301
Drawing #: Group 1 Level 3
Bldg:
Item: Spalling Columns
Discipline: B Hammer

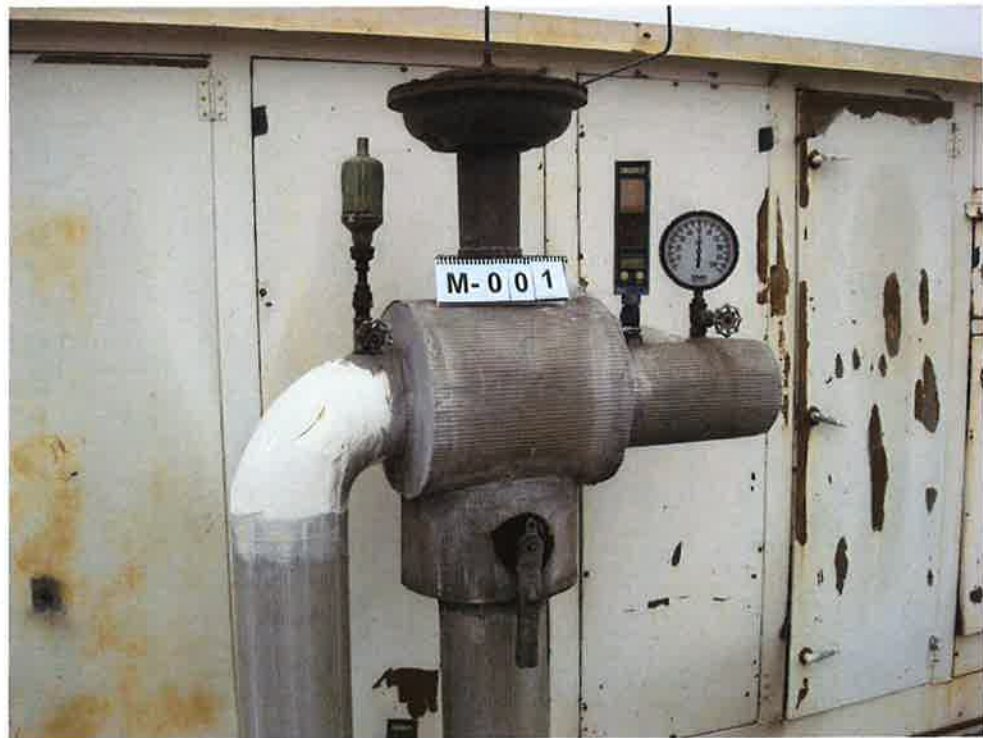
Picture 3 Comment #: B6101

Picture 3: Comment# B6101
Bldg:
Drawing #: Group 2 Roof
Discipline: B Hammer
Item: AH-1 on Roof Level

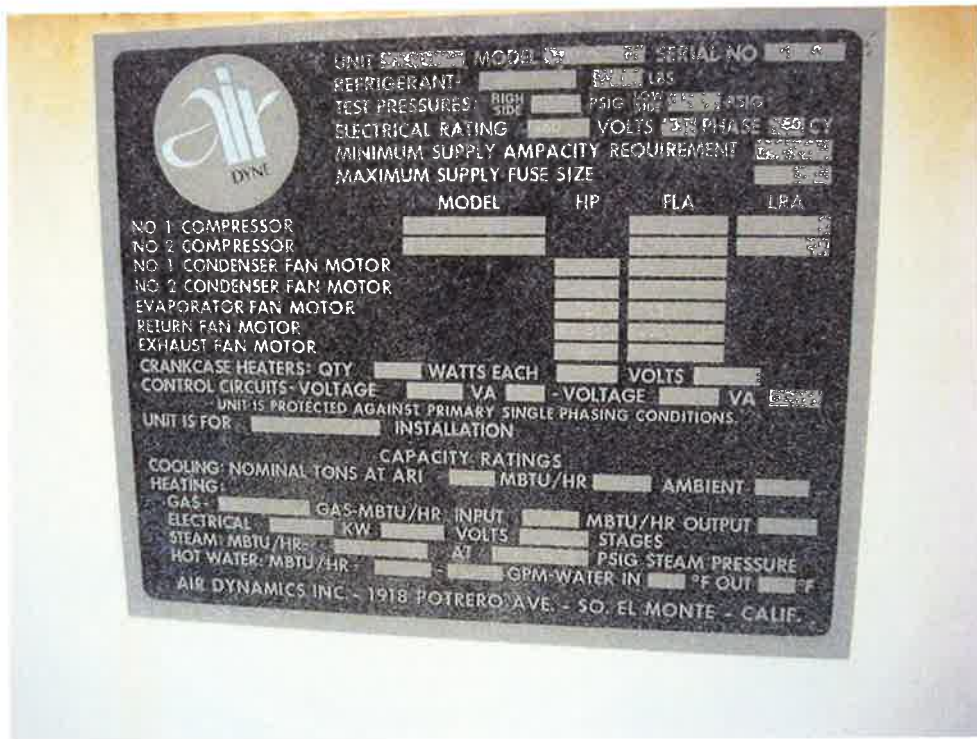
Picture 4 Comment #: B6102

Picture 4: Comment# B6102
Bldg:
Drawing #: Group 2 Roof
Discipline: B Hammer
Item: AH-1 on Roof Level

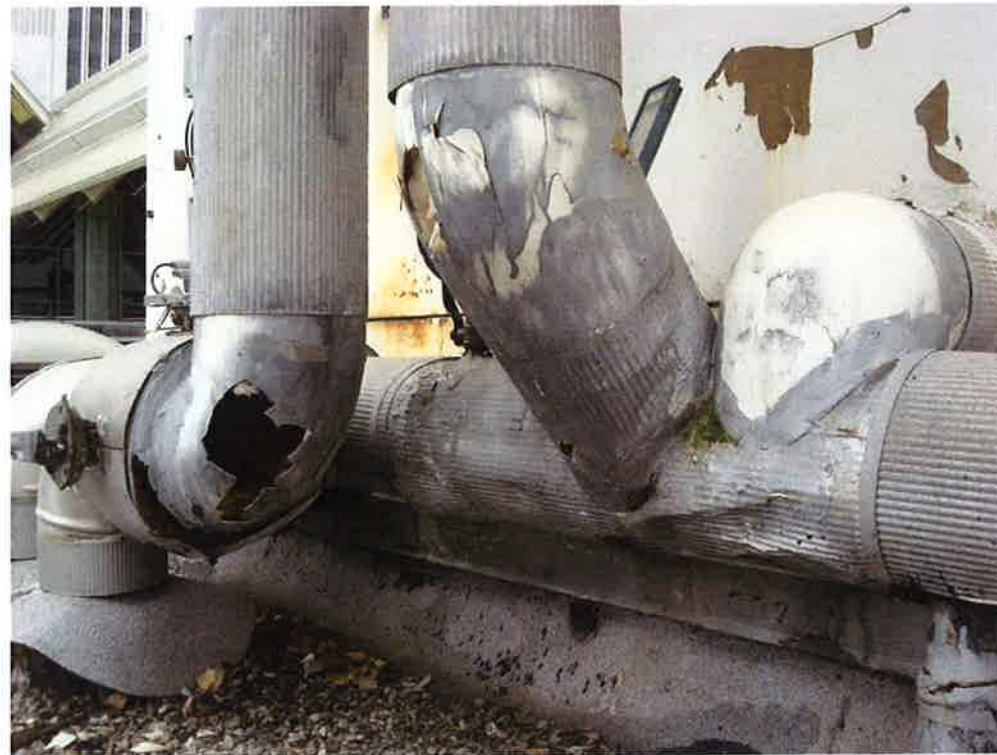
Comment #: B6103

Picture 1: Comment# B6103
Drawing #: Group 2 Roof
Bldg:
Item: AH-1 on Roof Level
Discipline: B Hammer

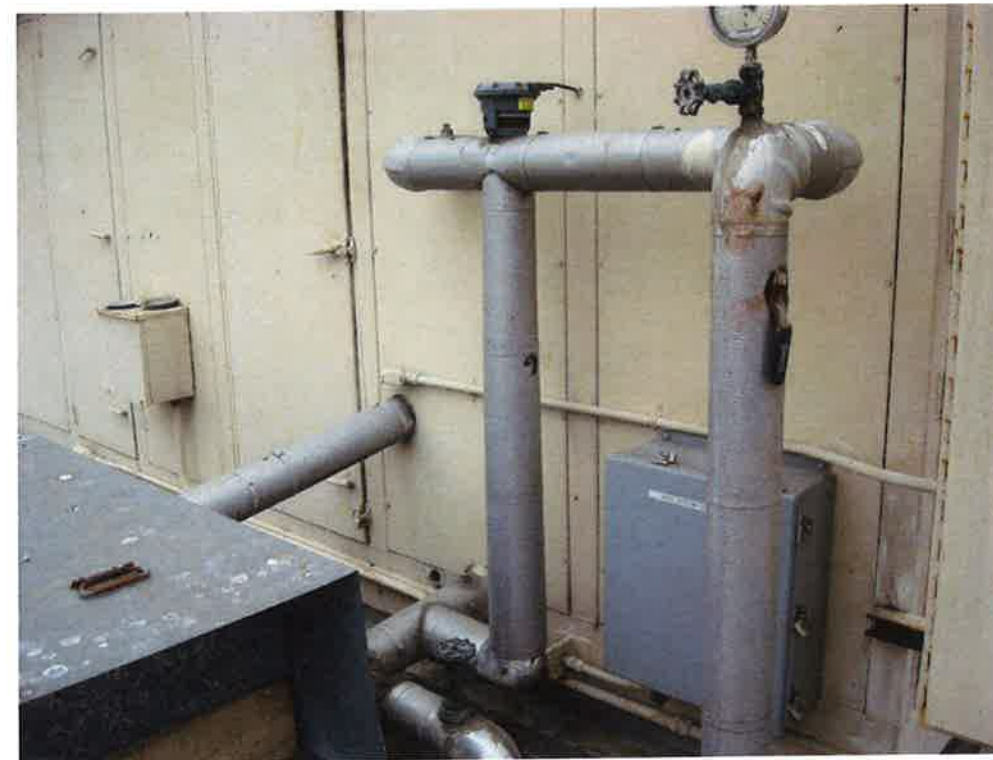
Comment #: B6104

Picture 2: Comment# B6104
Bldg:
Drawing #: Group 2 Roof
Discipline: B Hammer
Item: AH-1 on Roof Level

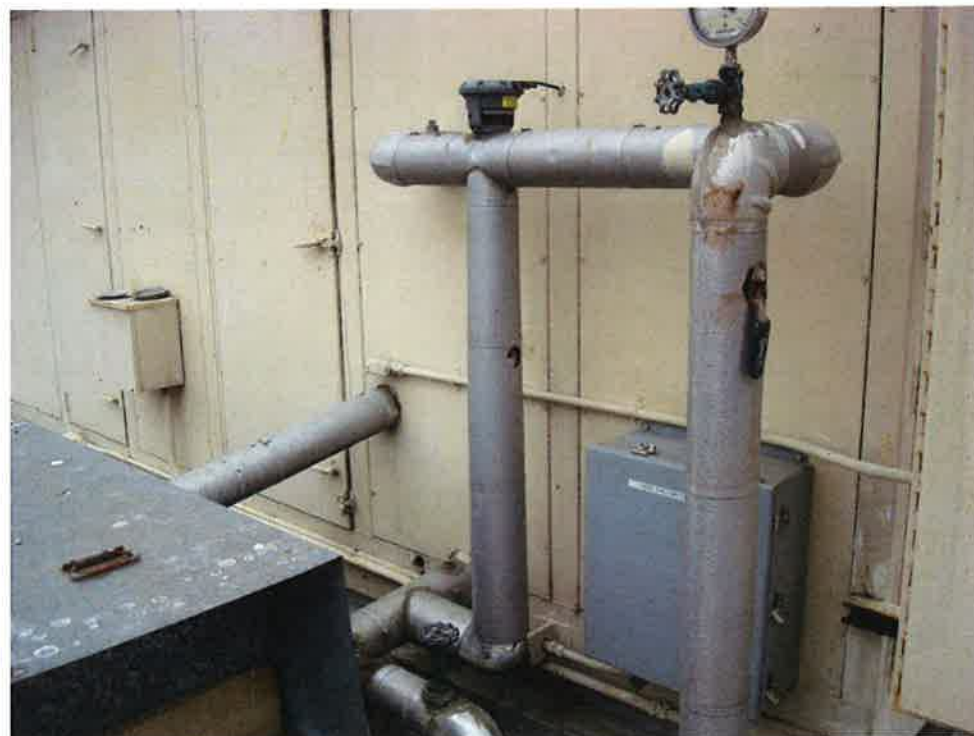
Comment #: B6105

Picture 3: Comment# B6105
Bldg:
Drawing #: Group 2 Roof
Discipline: B Hammer
Item: AH-1 on Roof Level

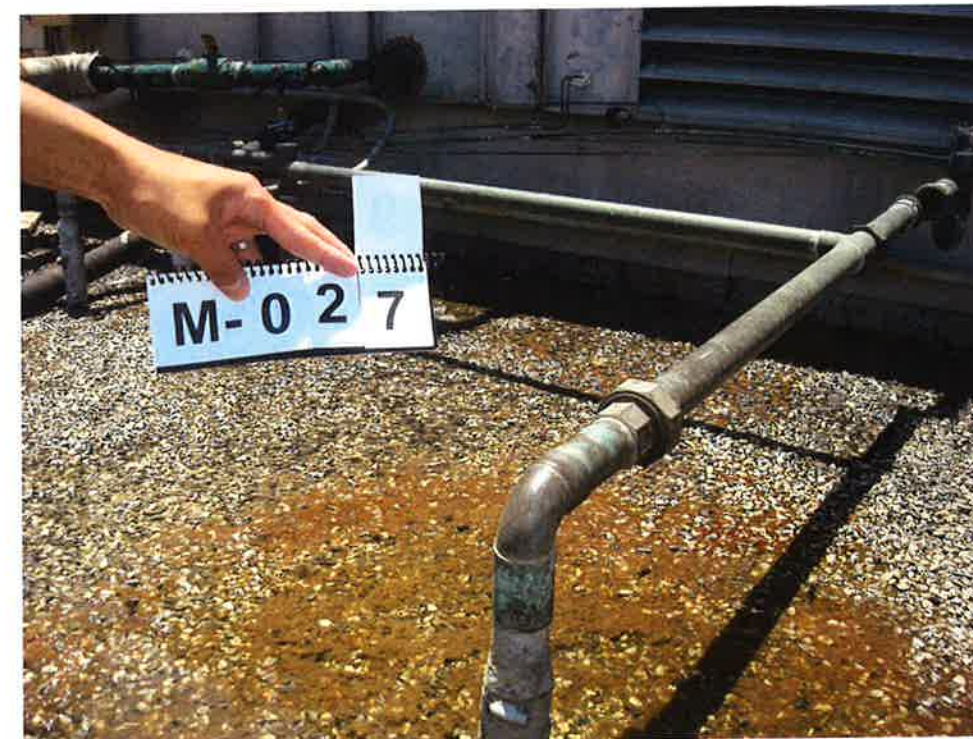
Comment #: B6121

Picture 4: Comment# B6121
Bldg:
Drawing #: Group 2 Level 4
Discipline: B Hammer
Item: AH-1 on Roof Level

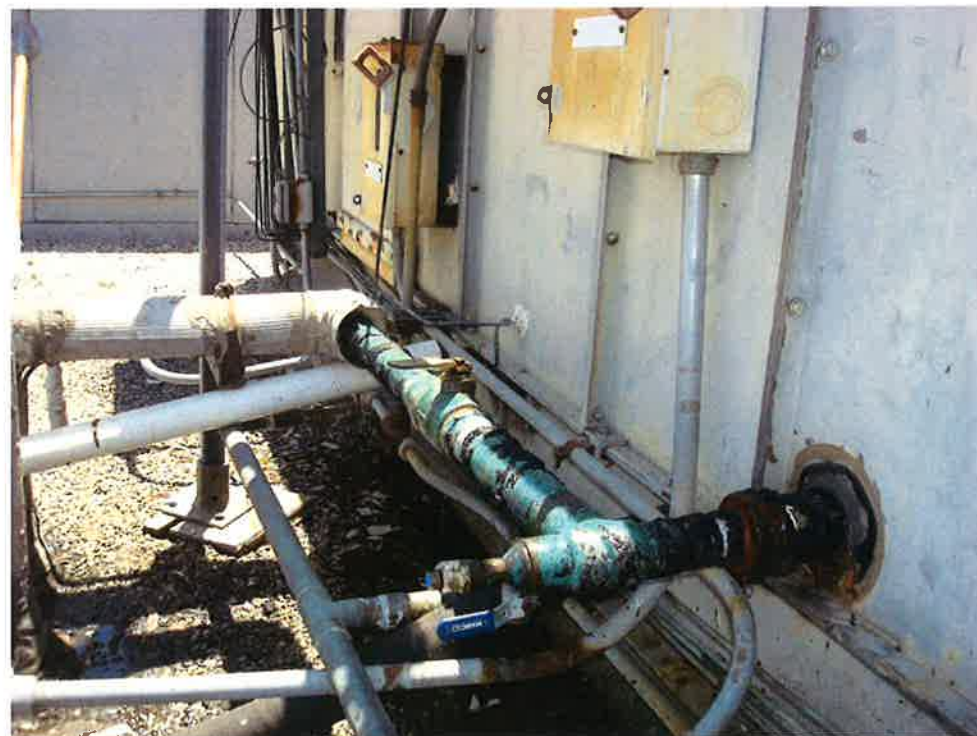
Comment #: B6124

Picture 3: Comment# B6124
Bldg:
Drawing #: Group 2 Level 4
Discipline: B Hammer
Item: AH-2 on Roof Level

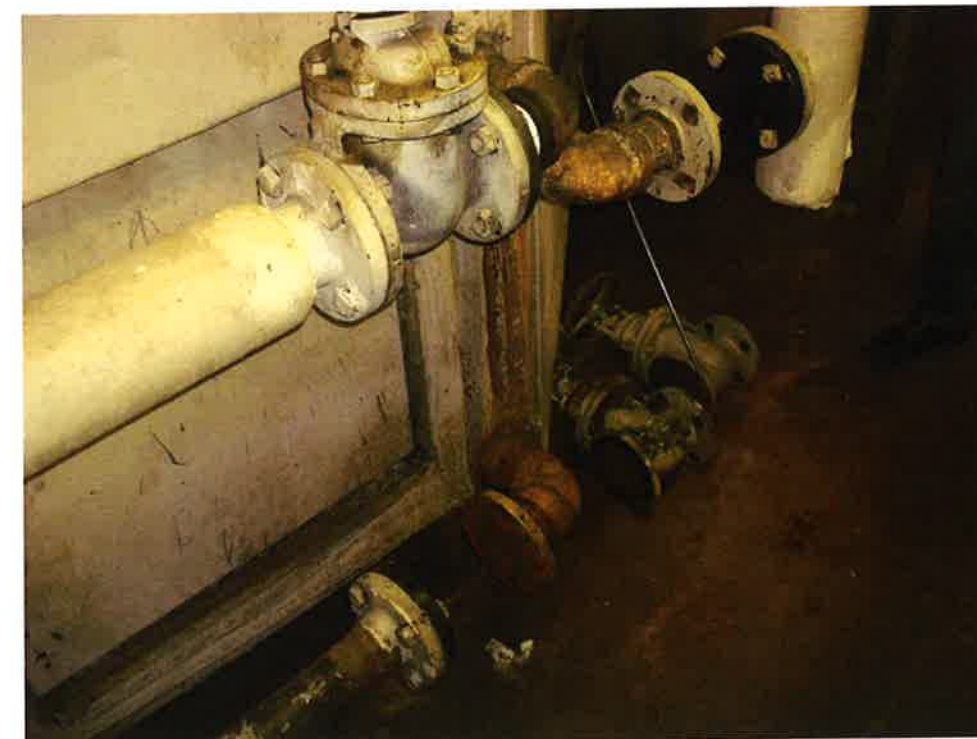
Comment #: B6306

Picture 4: Comment# B6306
Bldg:
Drawing #: Group 2 Roof
Discipline: B Hammer
Item: HHW Pipe for S-8

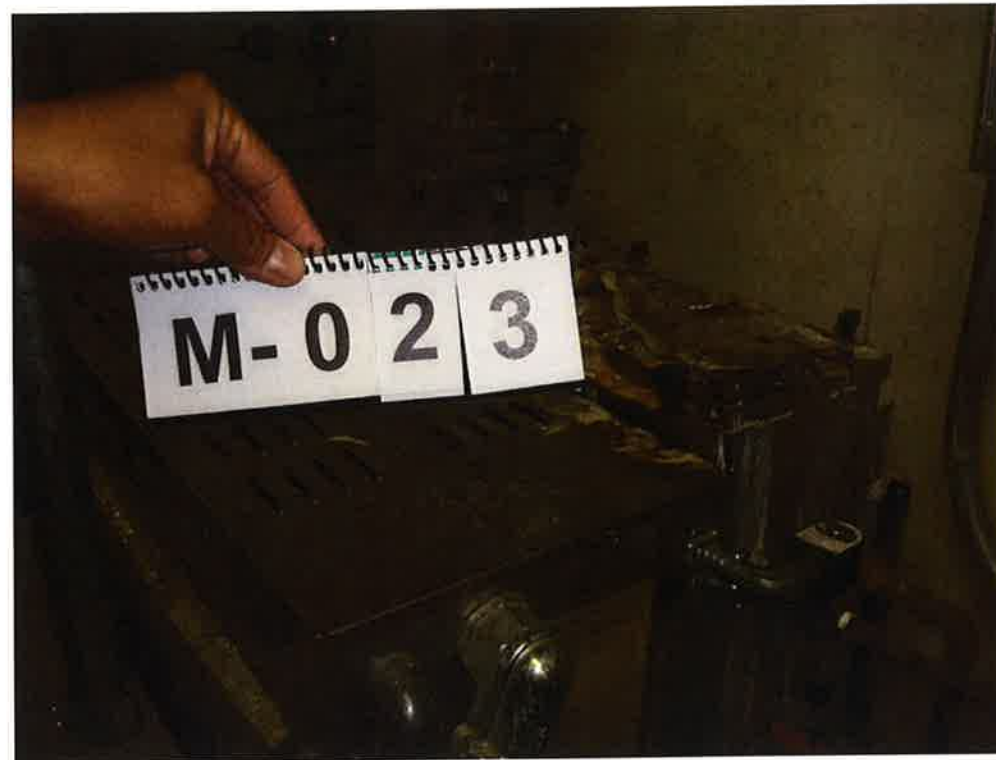
Comment #: B6309

Picture 2: Comment# B6309
Bldg:
Drawing #: Group 2 Roof
Discipline: B Hammer
Item: Humidifier for S-8

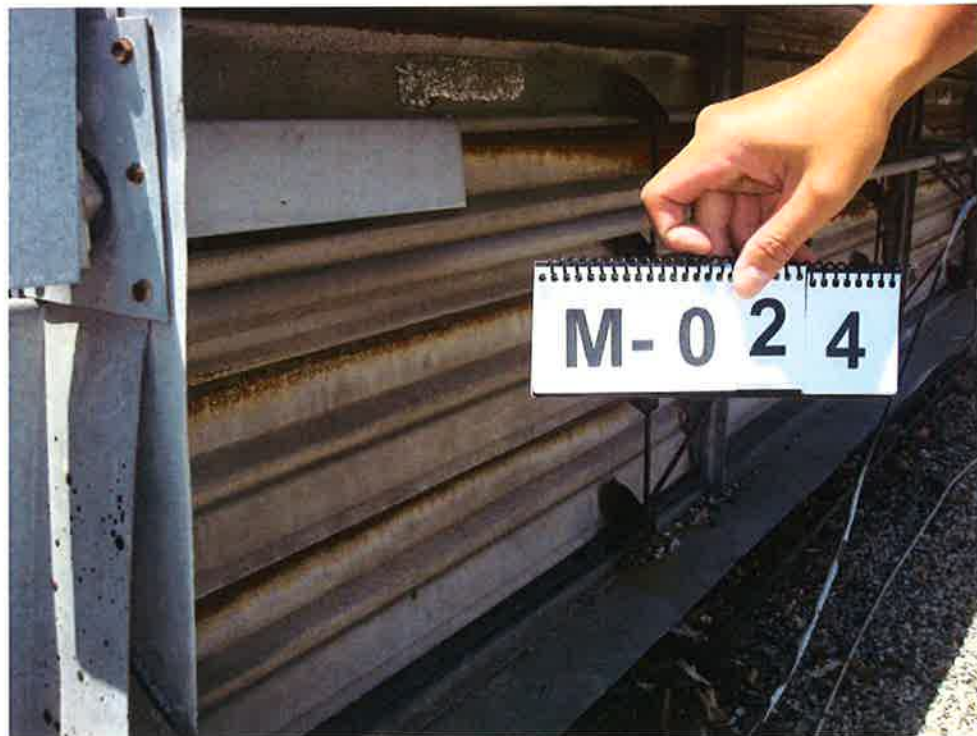
Comment #: B6310

Picture 3: Comment# B6310
Bldg:
Drawing #: Group 2 Roof
Discipline: B Hammer
Item: OSA Damper for S-8

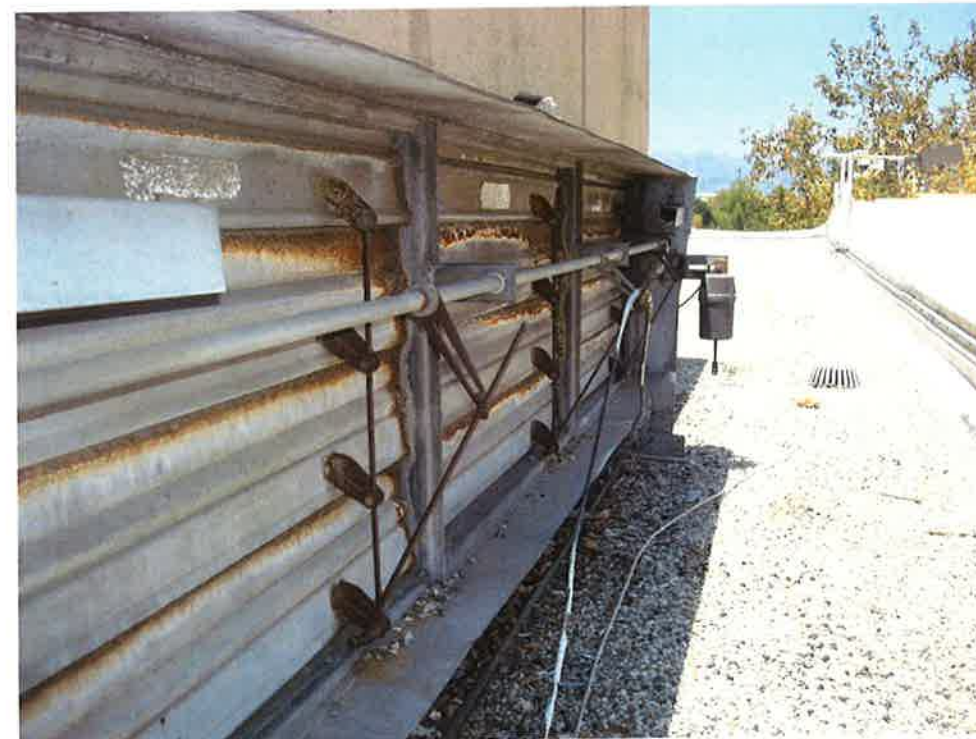
Comment #: B6311

Picture 4: Comment# B6311
Bldg:
Drawing #: Group 2 Roof
Discipline: B Hammer
Item: OSA Damper for S-8

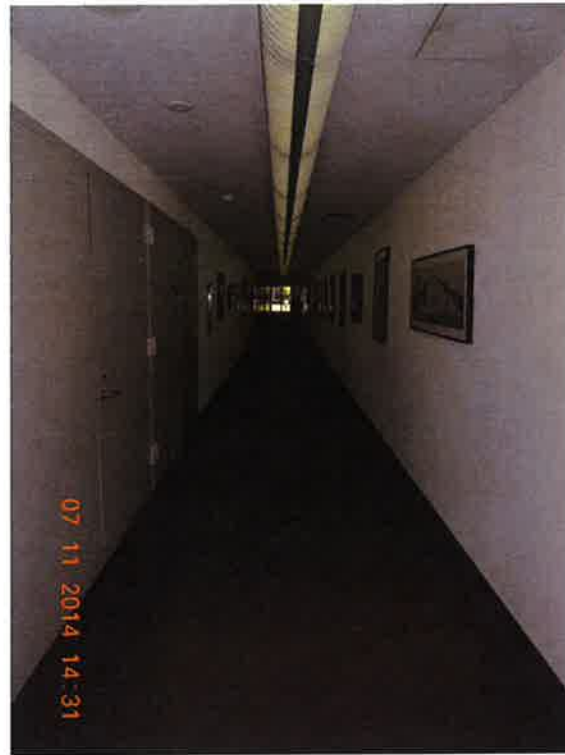
Comment #: C1116

Picture 1: Comment# C1116
Drawing #: Group 1 Level 1
Bldg:
Item: Exit corridor suspended ceiling
Discipline: C Bing

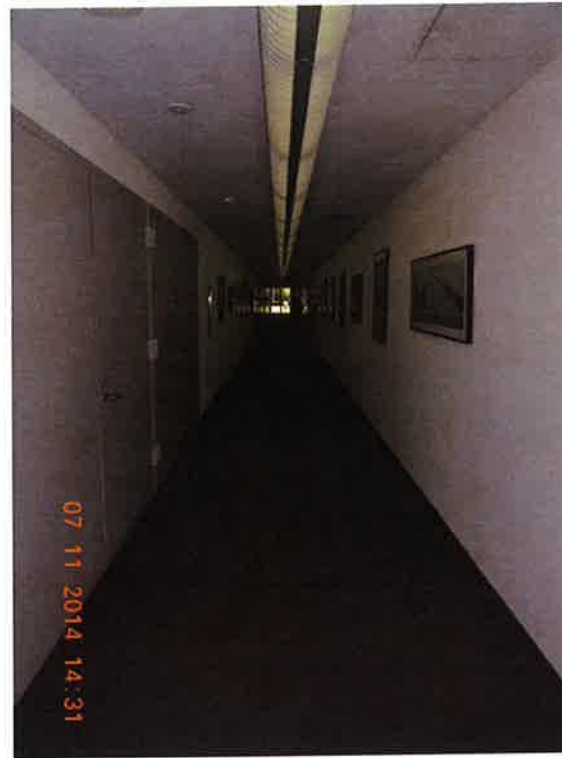
Comment #: C1117

Picture 2: Comment# C1117
Bldg:
Drawing #: Group 1 Level 1
Discipline: C Bing
Item: Exit corridor carpet and paint

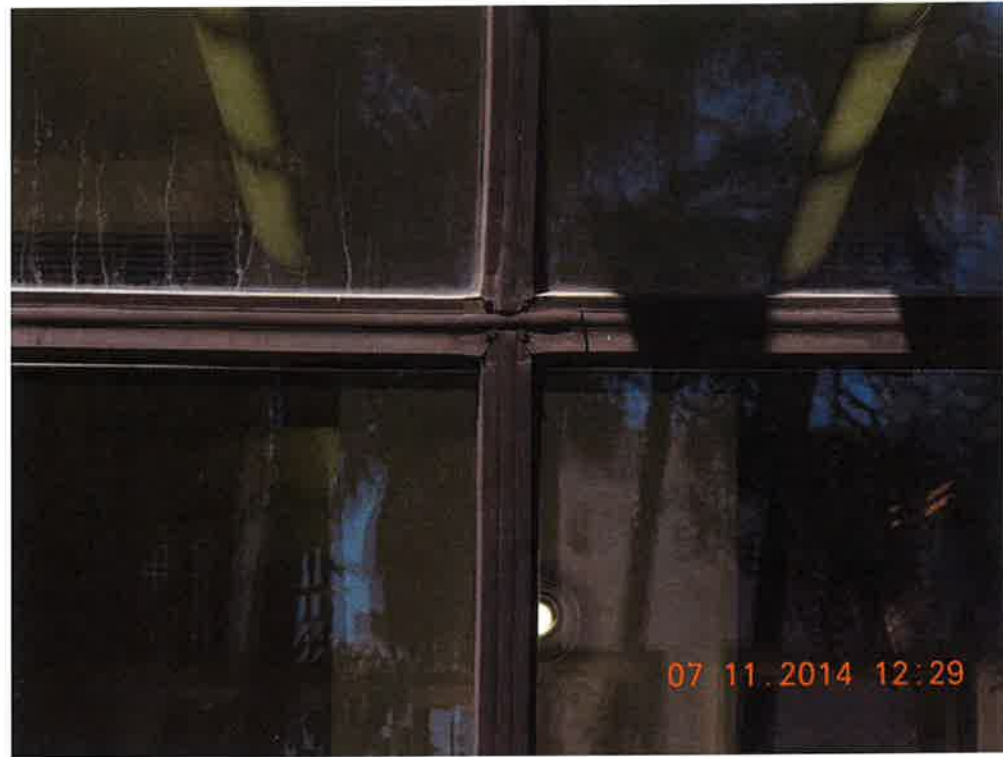
Picture 1 Comment #: C1232.1

Picture 1: Comment# C1232.1
Drawing #: Group 1 Level 1
Bldg:
Item: Ext. aluminum storefront glazing
Discipline: C Bing

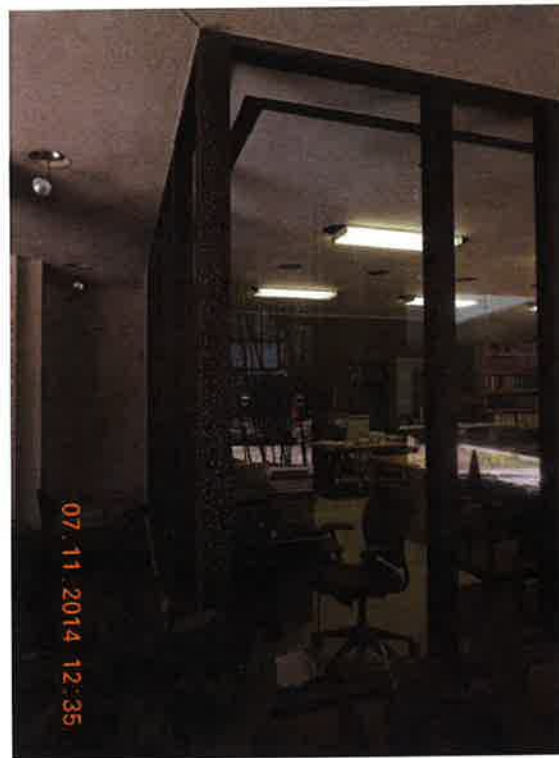
Picture 2 Comment #: C1232.2

Picture 2: Comment# C1232.2
Bldg:
Drawing #: Group 1 Level 1
Discipline: C Bing
Item: Ext. aluminum storefront glazing

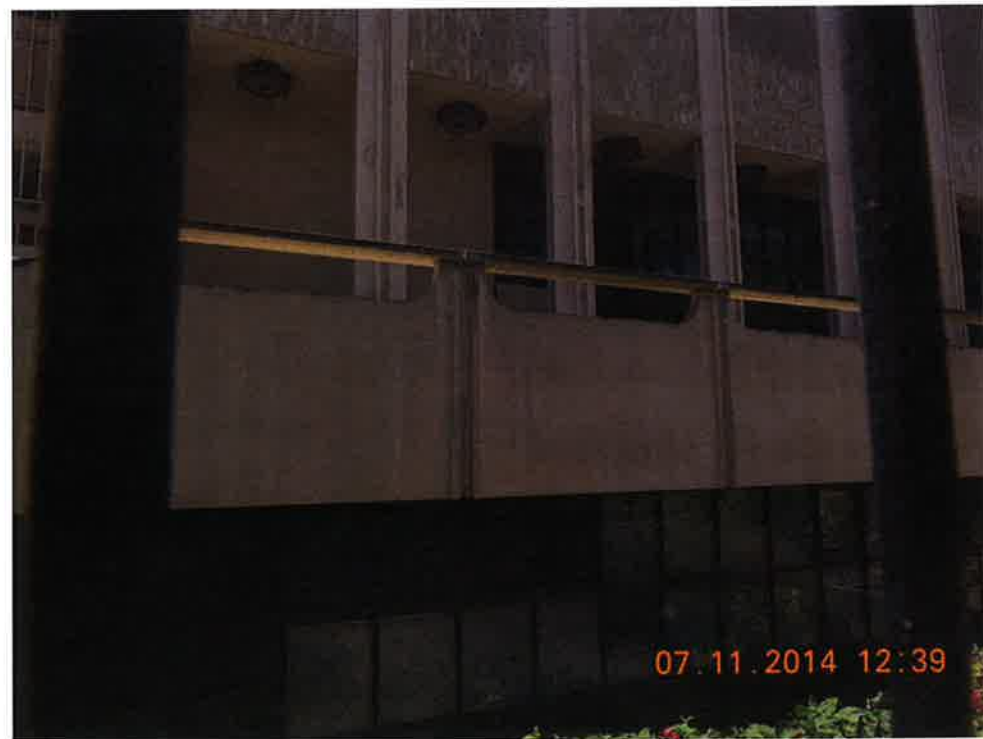
Picture 3 Comment #: C1233

Picture 3: Comment# C1233
Bldg:
Drawing #: Group 1 Level 1
Discipline: C Bing
Item: Ext. aluminum louvers

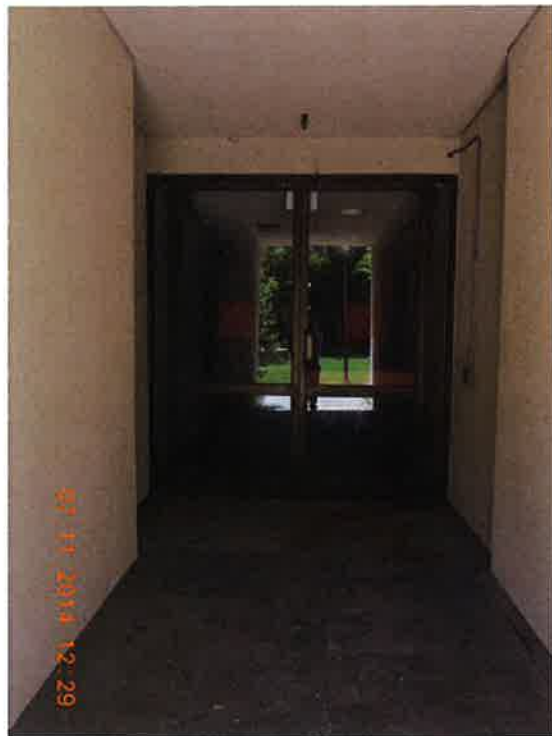
Comment #: C1239

Picture 3: Comment# C1239
Bldg:
Drawing #: Group 1 Level 1
Discipline: C Bing
Item: Exit doors finish hardware and

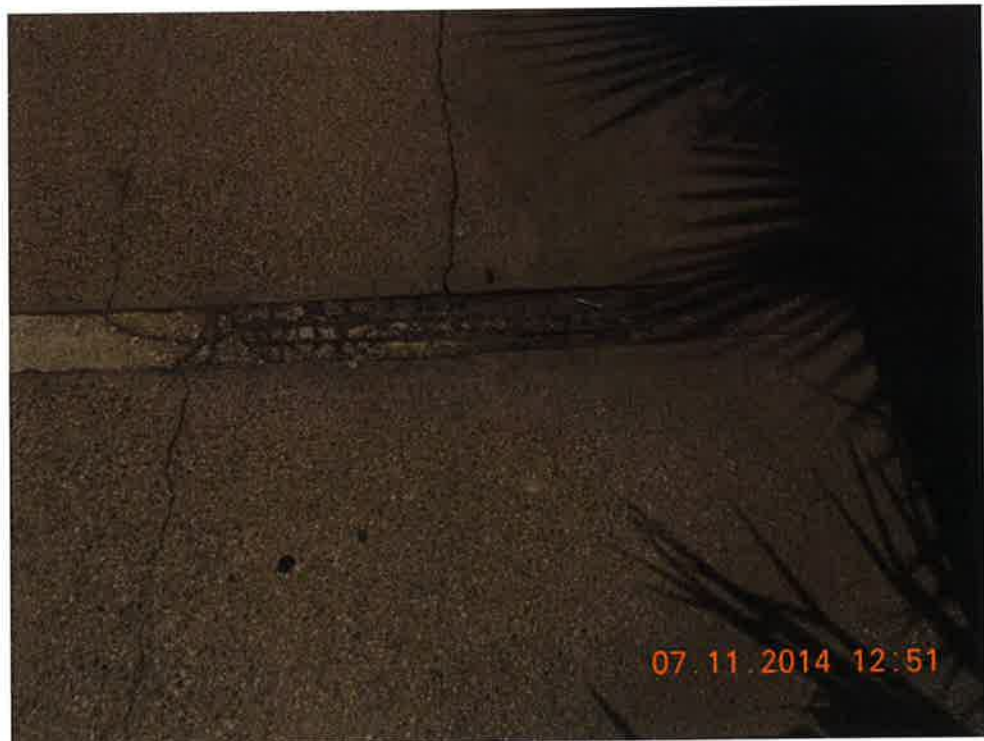
Comment #: C1240.1

Picture 4: Comment# C1240.1
Bldg:
Drawing #: Group 1 Level 2
Discipline: C Bing
Item: Ext. concrete balcony

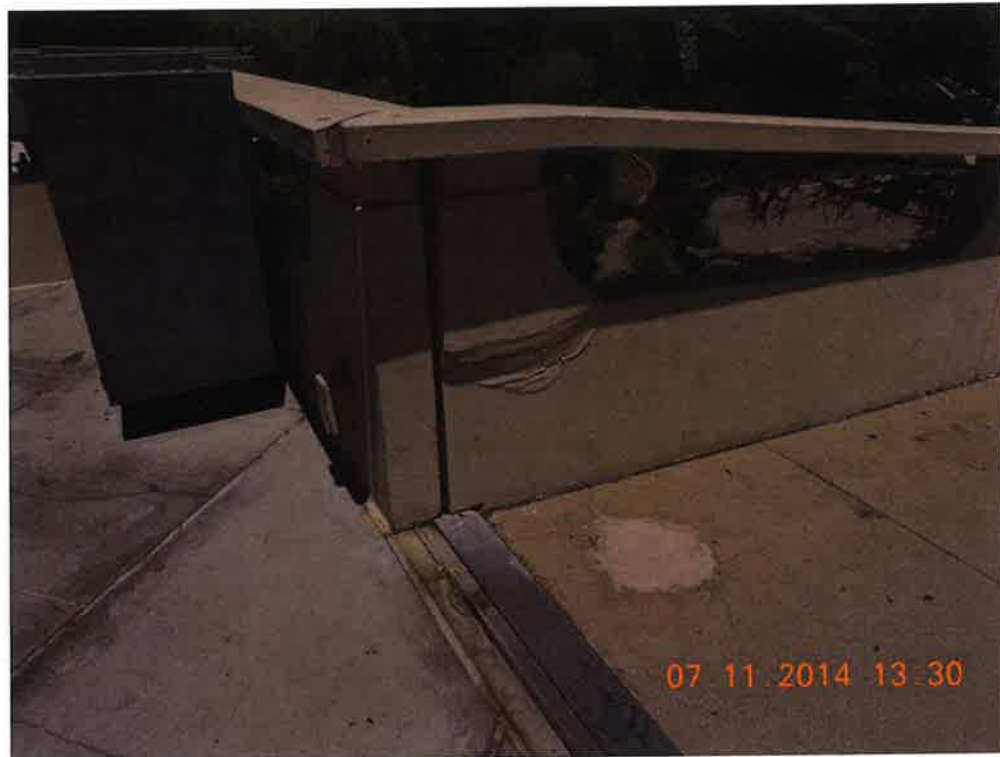
Comment #: C1240.2

Picture 1: Comment# C1240.2
Drawing #: Group 1 Level 2
Bldg:
Item: Ext. concrete balcony
Discipline: C Bing

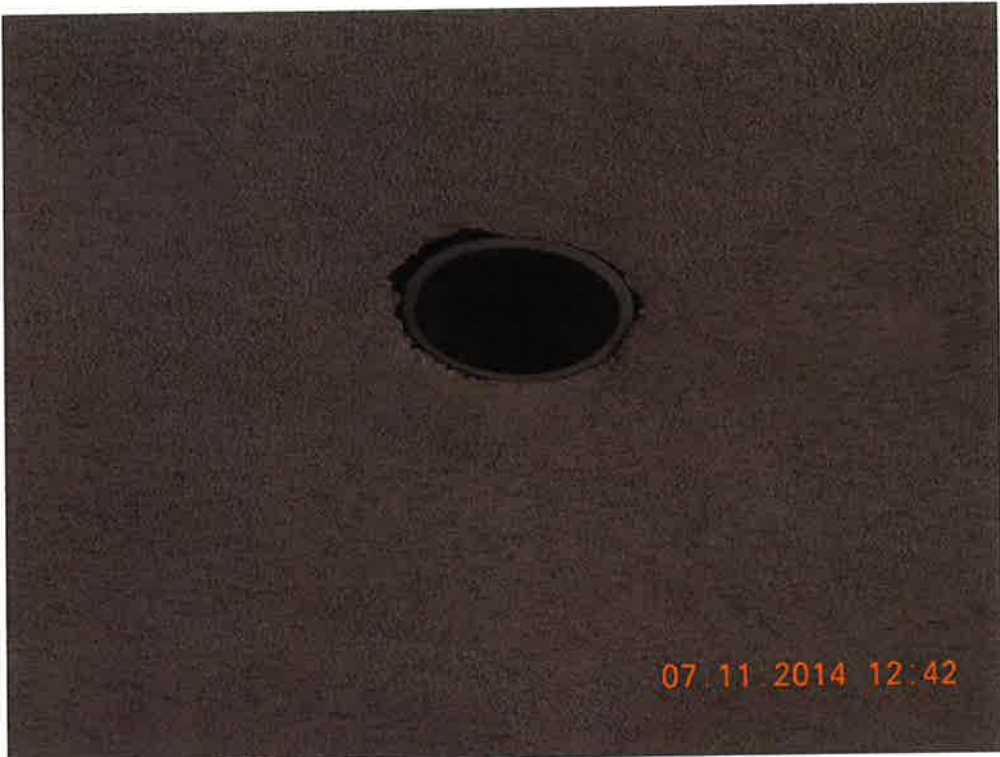
Comment #: C1241

Picture 2: Comment# C1241
Bldg:
Drawing #: Group 1 Level 2
Discipline: C Bing
Item: Ext. plaster soffit recessed ligh

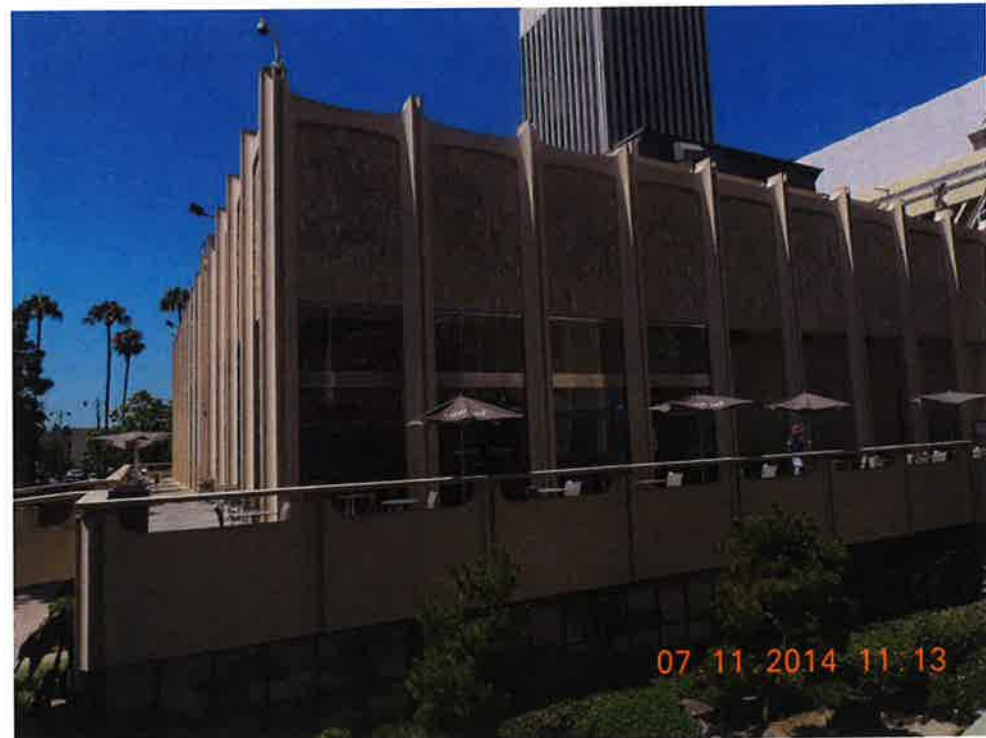
Comment #: C1242.1

Picture 3: Comment# C1242.1
Bldg:
Drawing #: Group 1 Level 2
Discipline: C Bing
Item: Ext. north elevation

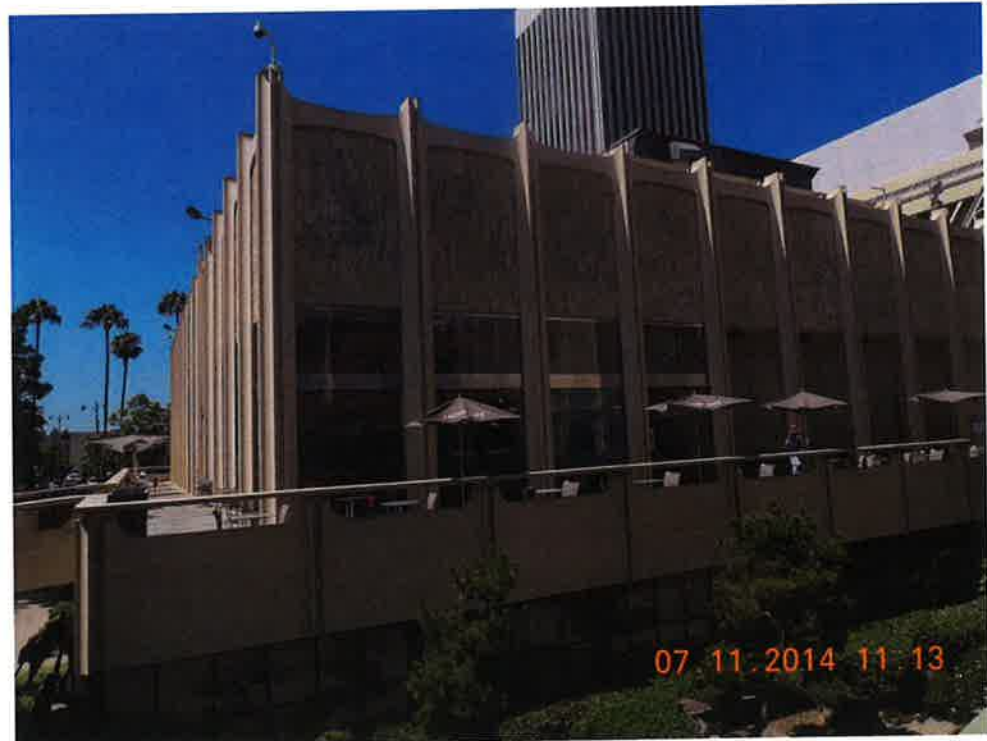
Comment #: C1242.2

Picture 4: Comment# C1242.2
Bldg:
Drawing #: Group 1 Level 2
Discipline: C Bing
Item: Ext. north elevation

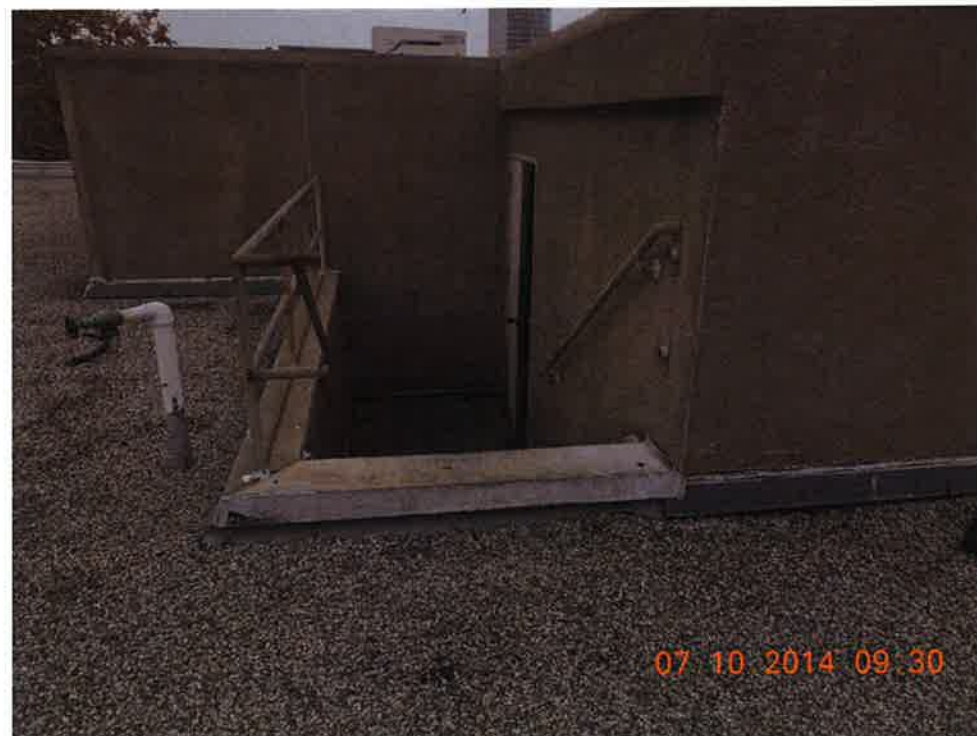
Comment #: C1512

Picture 3: Comment# C1512
Bldg:
Drawing #: Group 1 Roof
Discipline: C Bing
Item: Rooftop exit stairs

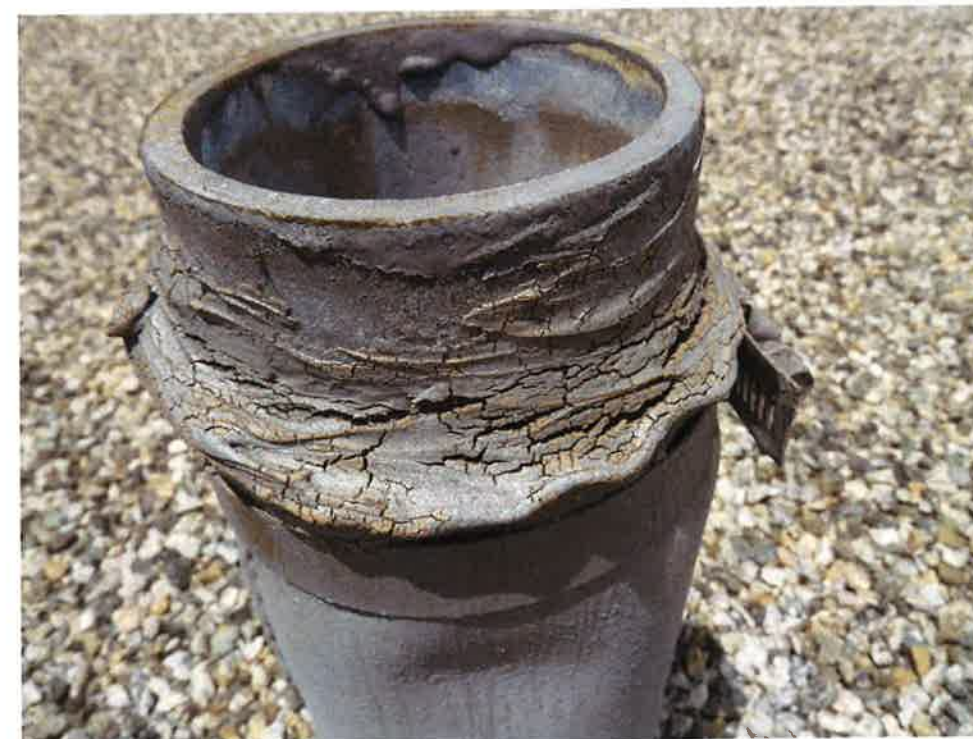
Comment #: C1801

Picture 4: Comment# C1801
Bldg:
Drawing #: Group 2 Level 4
Discipline: C Bing
Item: Roofing on the Bing building

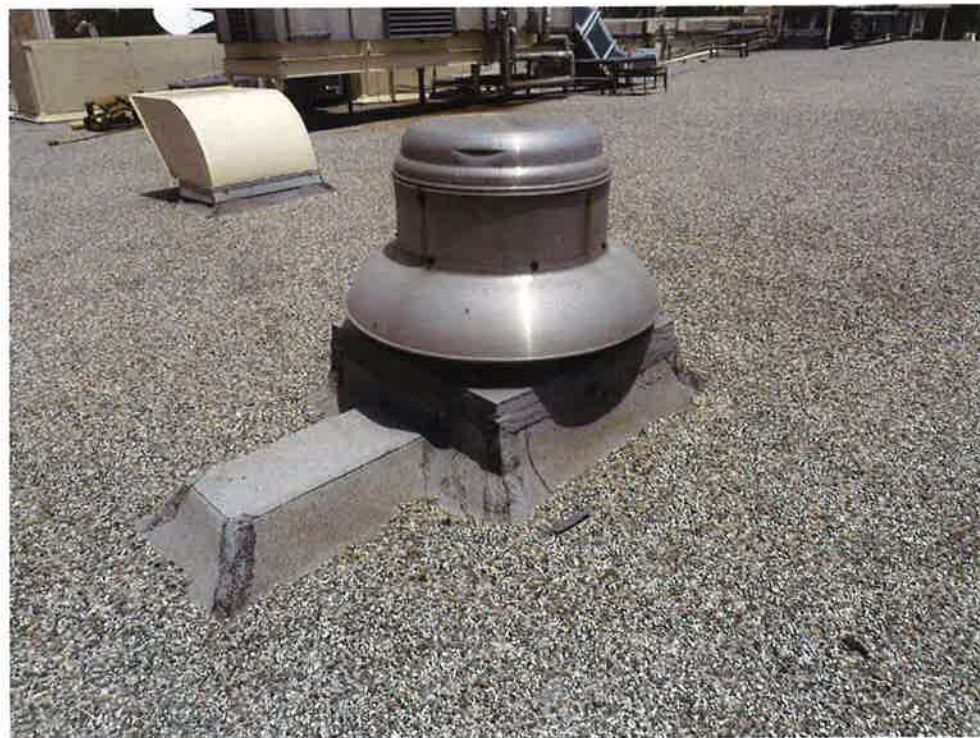
Picture 3: Comment #: C1804

Picture 3: Comment# C1804
Bldg:
Drawing #: Group 2 Level 4
Discipline: C Bing
Item: Roofing on the Bing building

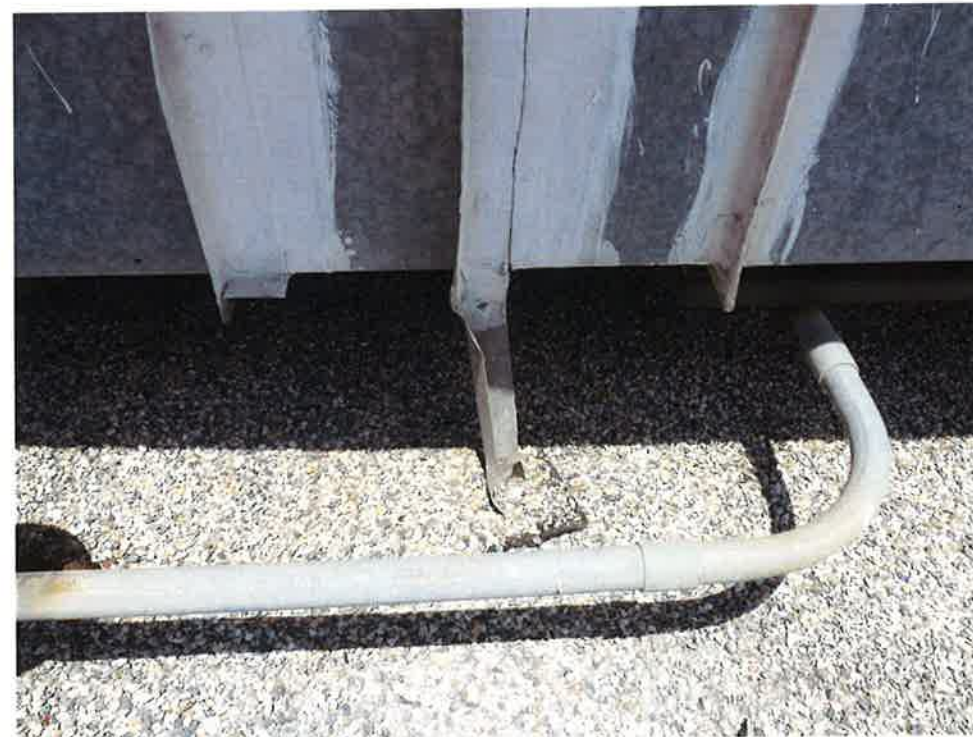
Picture 4 Comment #: C1805

Picture 4: Comment# C1805
Bldg:
Drawing #: Group 2 Level 4
Discipline: C Bing
Item: Roofing on the Bing building

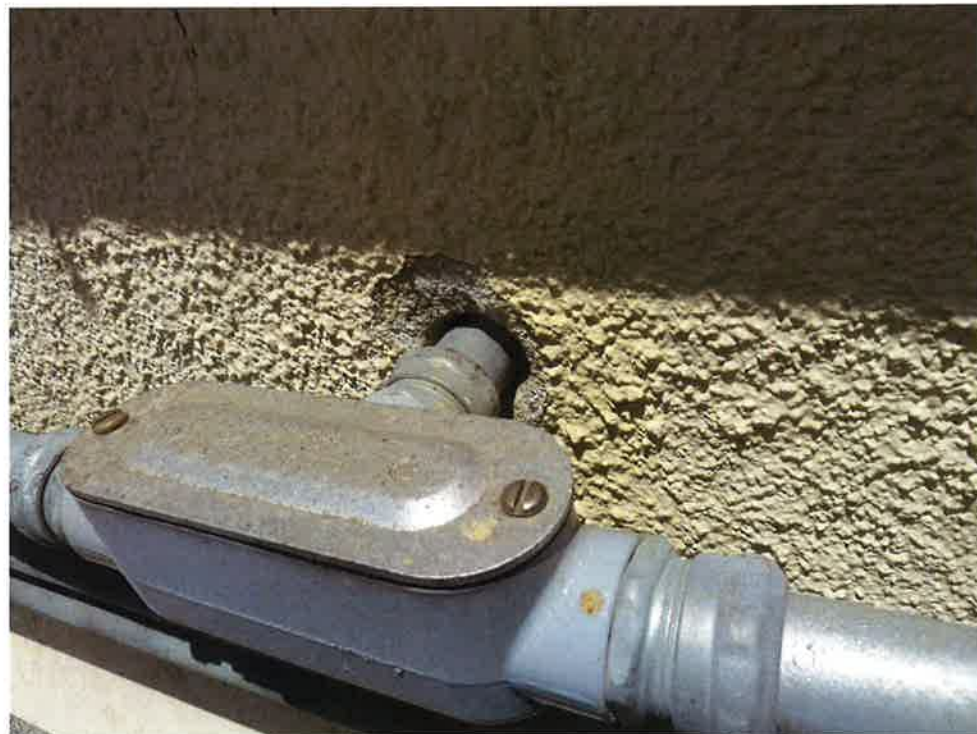
Picture 3: Comment #: C1808

Picture 3: Comment# C1808
Bldg:
Drawing #: Group 2 Level 4
Discipline: C Bing
Item: Roofing on the Bing building

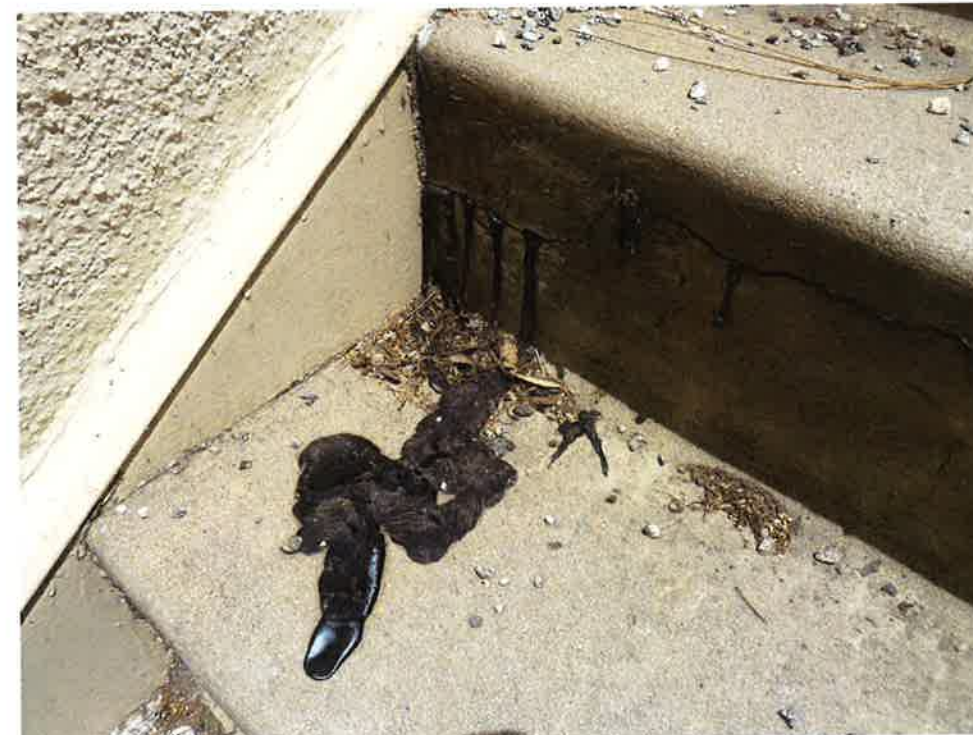
Picture 4 Comment #: C1809

Picture 4: Comment# C1809
Bldg:
Drawing #: Group 2 Level 4
Discipline: C Bing
Item: Roofing on the Bing building

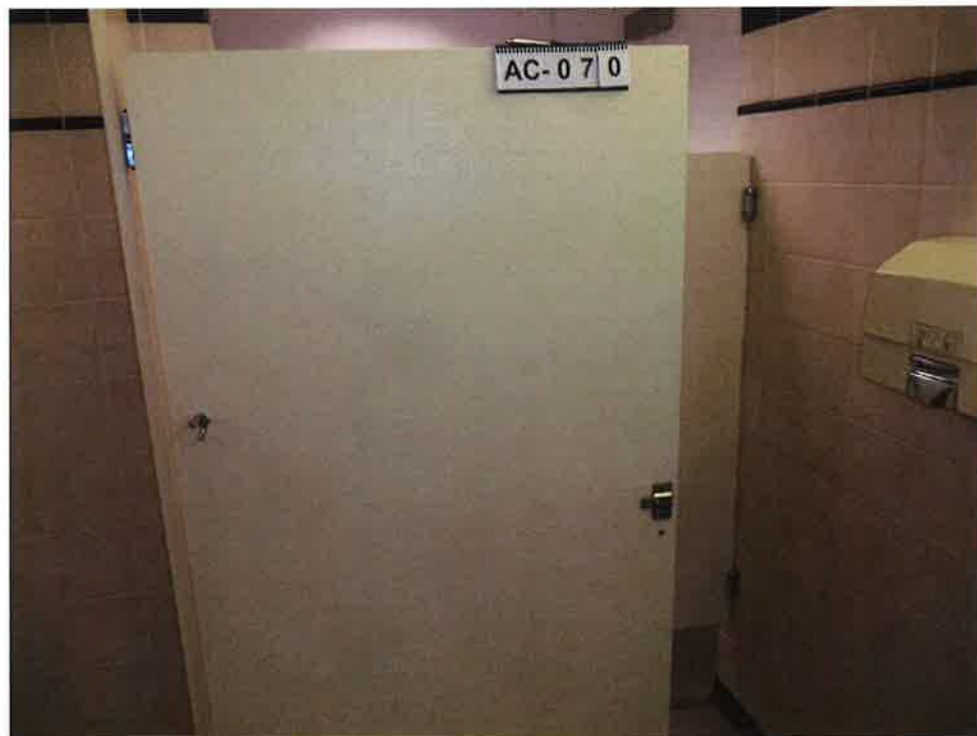
Picture 3 Comment #: C2223

Picture 3: Comment# C2223
Bldg:
Drawing #: Group 1 Level 1
Discipline: C Bing
Item: Bing - Lwr Level Women's

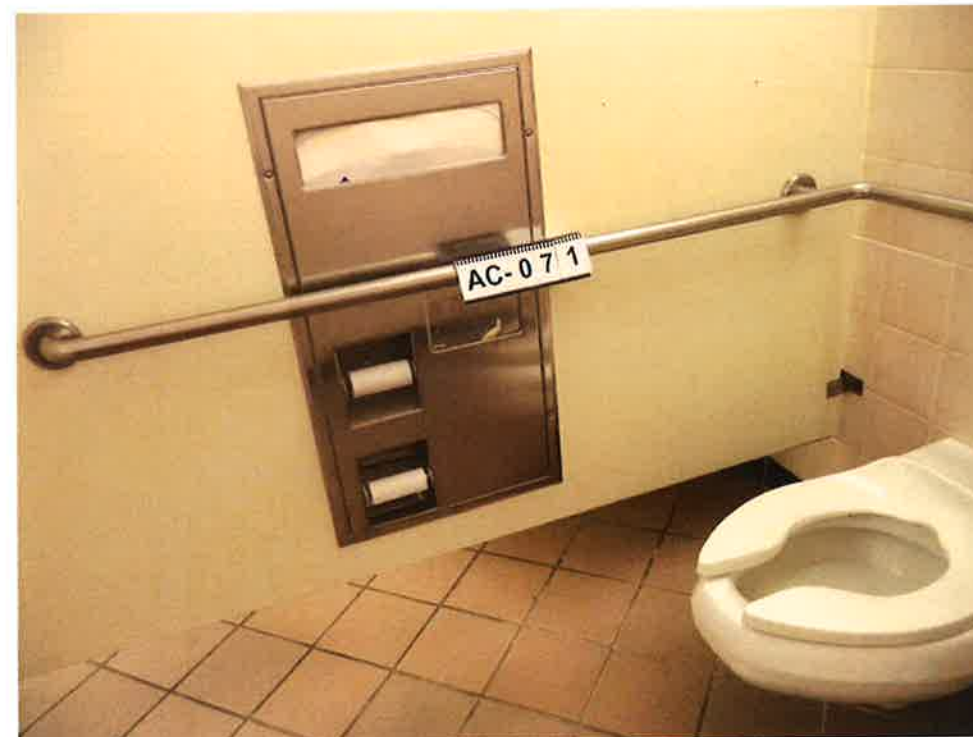
Picture 4: Comment #: C2224

Picture 4: Comment# C2224
Bldg:
Drawing #: Group 1 Level 1
Discipline: C Bing
Item: Bing - Lwr Level Women's
