Revised Appendix Q

Existing Building Evaluation

Los Angeles County Museum of Art Building Evaluation

September 16, 2014

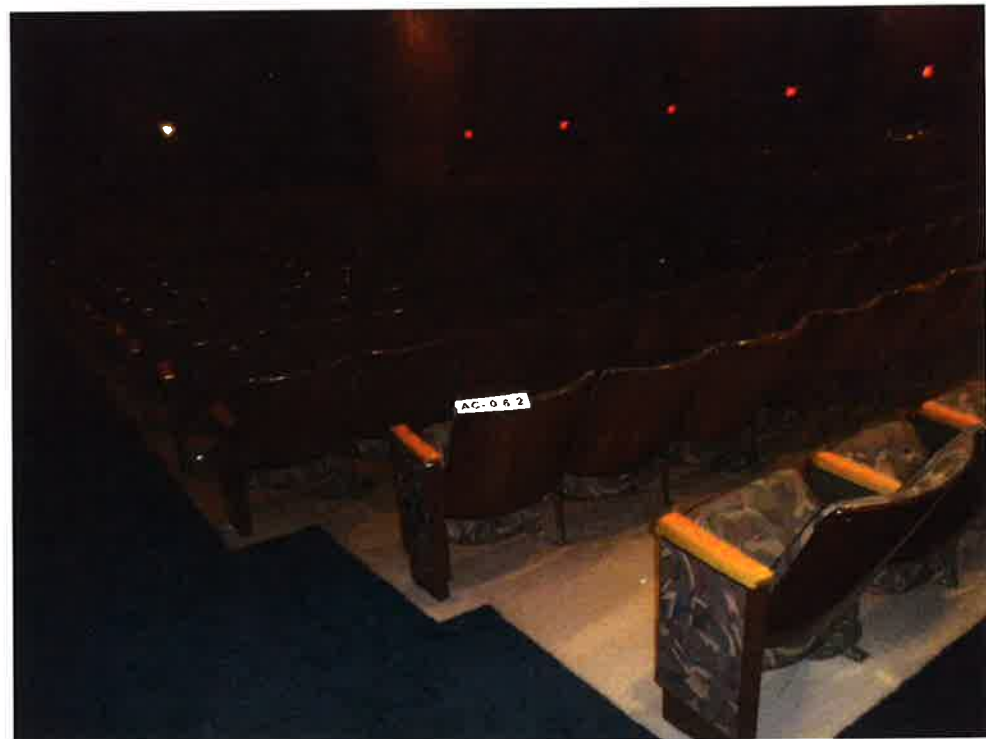
Picture 3 Comment #: C2711

Picture 3: Comment# C2711
Bldg:
Drawing #: Group 1 Level 1
Discipline: C Bing
Item: Bing - Theater

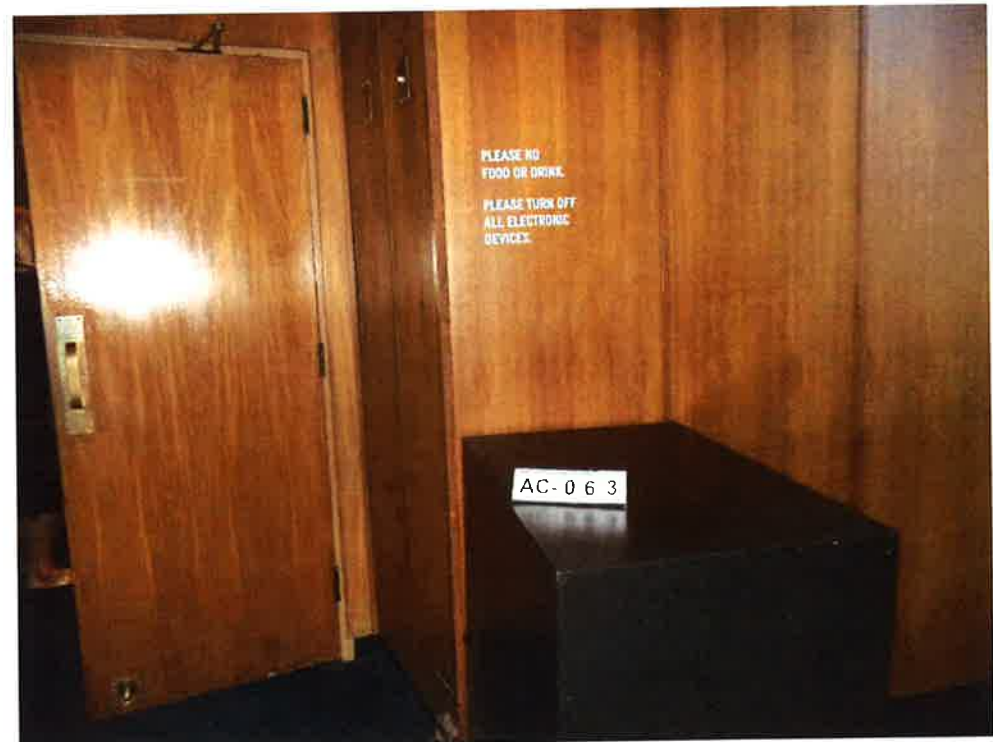
Picture 4 : Comment #: C2712

Picture 4: Comment# C2712
Bldg:
Drawing #: Group 1 Level 1
Discipline: C Bing
Item: Bing - Theater

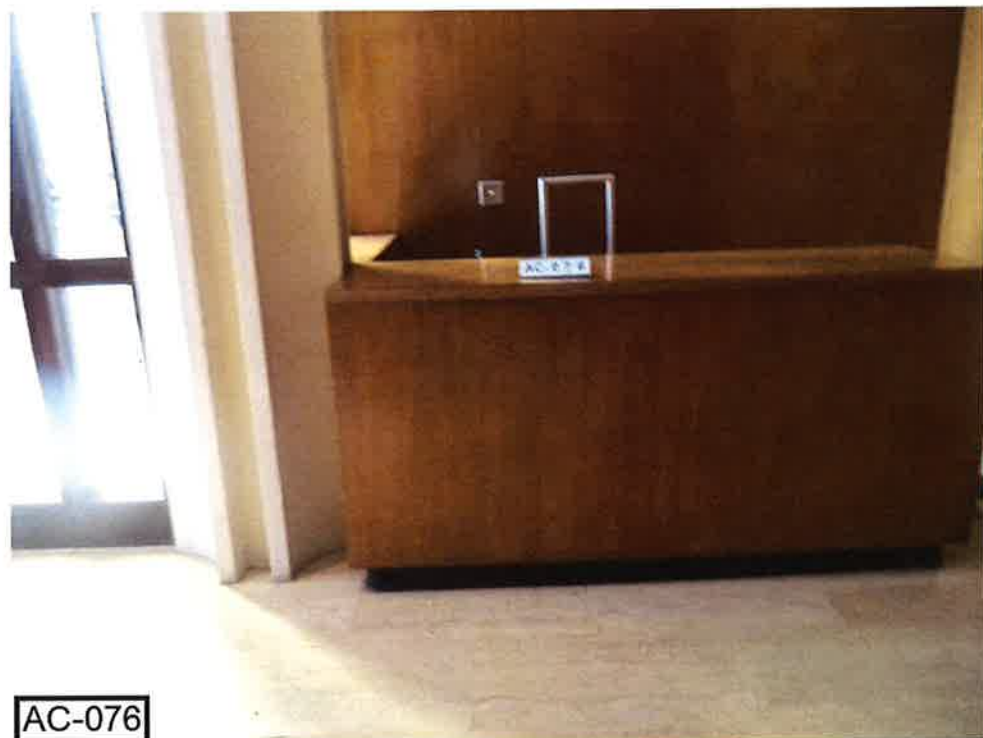
Picture 3: Comment #: C2715

Picture 3: Comment# C2715
Bldg:
Drawing #: Group 1 Level 1
Discipline: C Bing
Item: Bing - Lobby

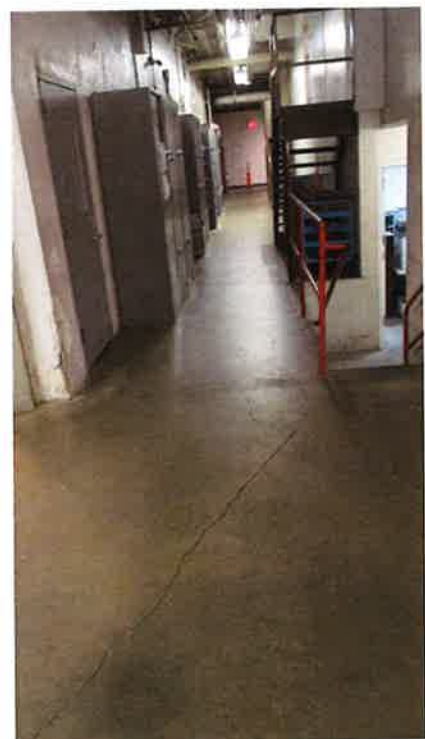
Picture 4: Comment #: C5001

Picture 4: Comment# C5001
Bldg: ALL
Drawing #: Group 1 Level 1
Discipline: C Bing
Item: Footing cracks

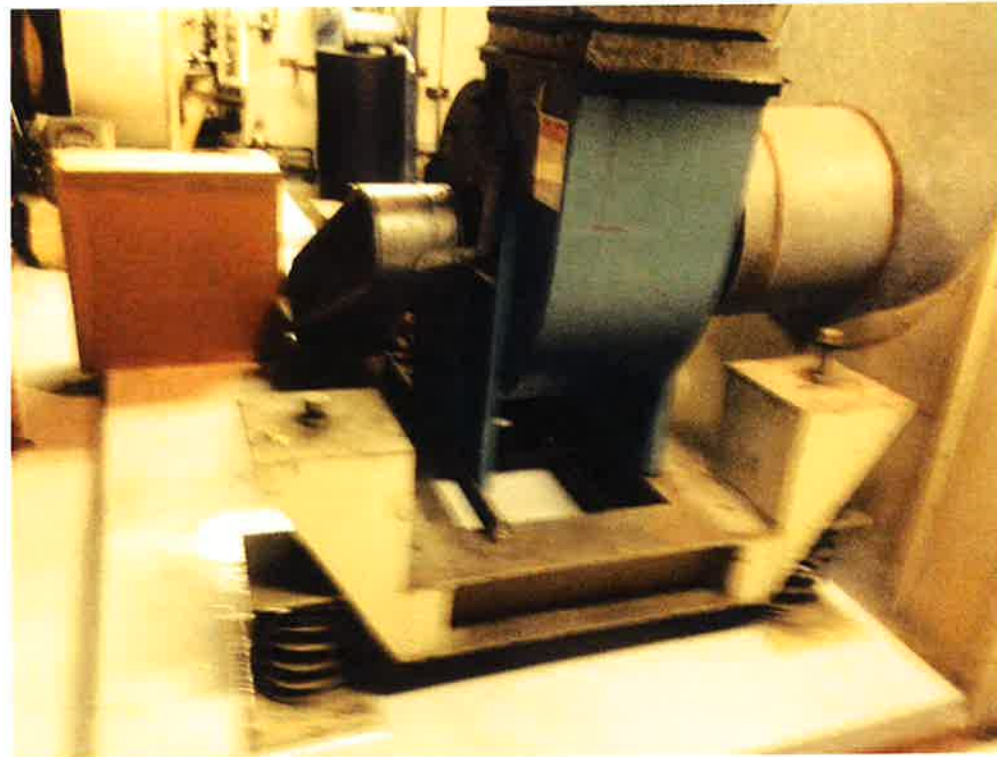
Picture 1 Comment #: C5401

Picture 1: Comment# C5401
Drawing #: Group 1 Level 3
Bldg:
Item: Equipment restraint deficiency
Discipline: C Bing

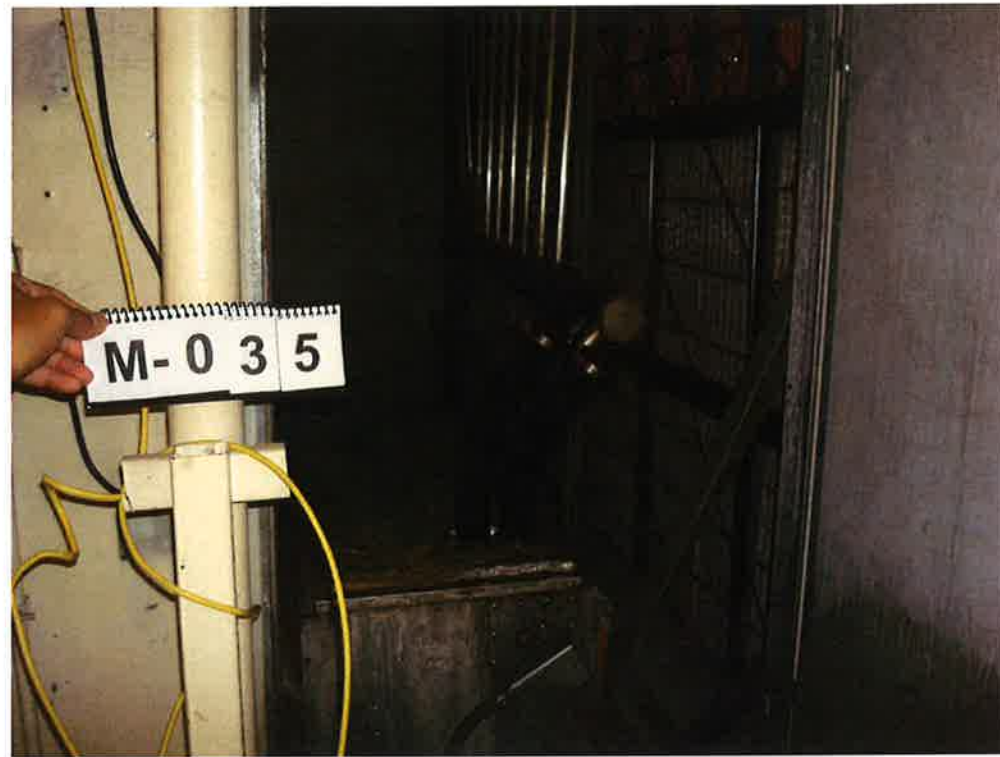
Comment #: C6128

Picture 1: Comment# C6128
Drawing #: Group 2 Level 1
Bldg:
Item: Humidifier for AH-3 serves low
Discipline: C Bing

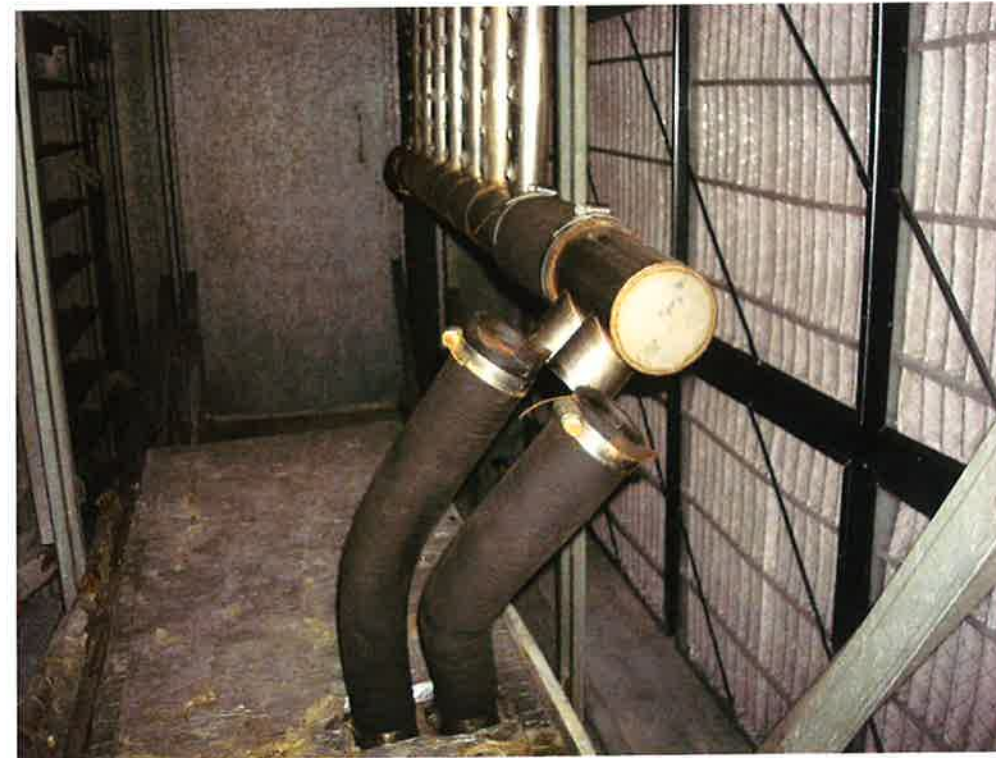
: Comment #: C6129

Picture 2: Comment# C6129
Bldg:
Drawing #: Group 2 Level 1
Discipline: C Bing
Item: Humidifier for AH-3 serves low

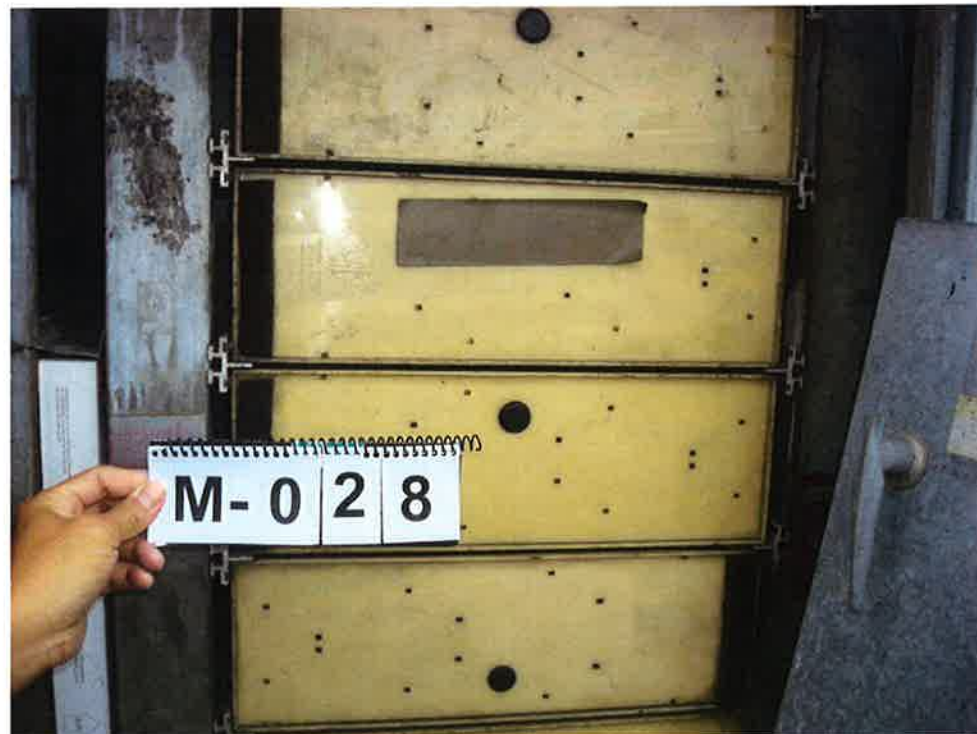
Comment #: C6314

Picture 3: Comment# C6314
Bldg:
Drawing #: Group 2 Roof
Discipline: C Bing
Item: OSA Filters of S-2&4 on roof

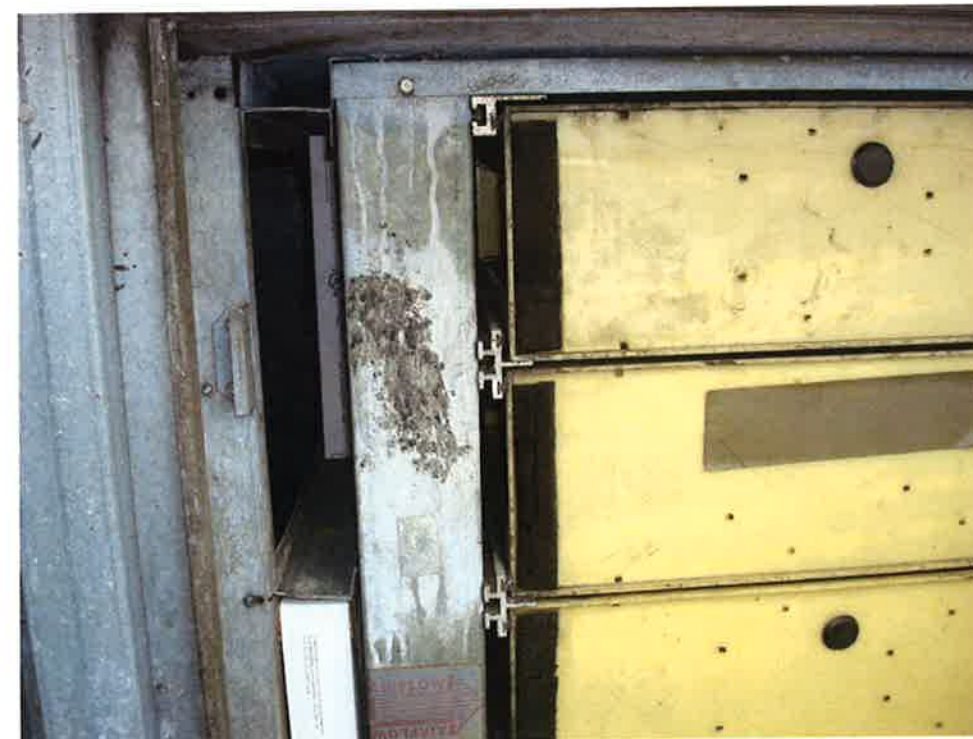
Comment #: C6315

Picture 4: Comment# C6315
Bldg:
Drawing #: Group 2 Roof
Discipline: C Bing
Item: OSA Filters of S-2&4 on roof

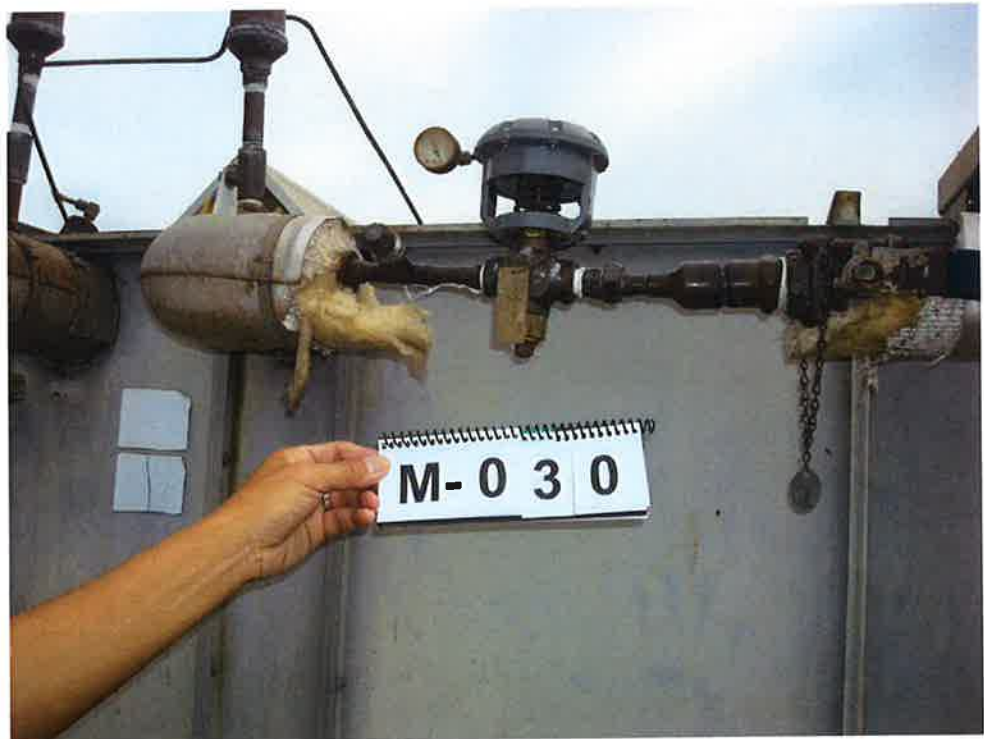
Comment #: C6319

Picture 4: Comment# C6319
Bldg:
Drawing #: Group 2 Level 4
Discipline: C Bing
Item: 2 way control valve for S-1&4

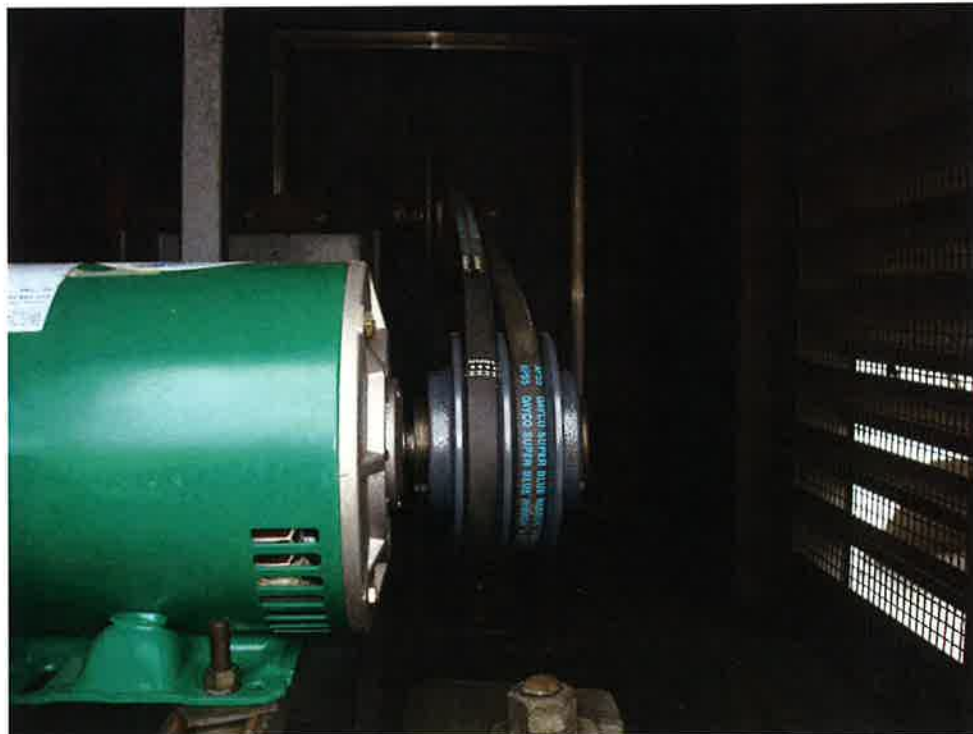
Comment #: C6322

Picture 3: Comment# C6322
Bldg:
Drawing #: Group 2 Level 4
Discipline: C Bing
Item: Return fan for S-1

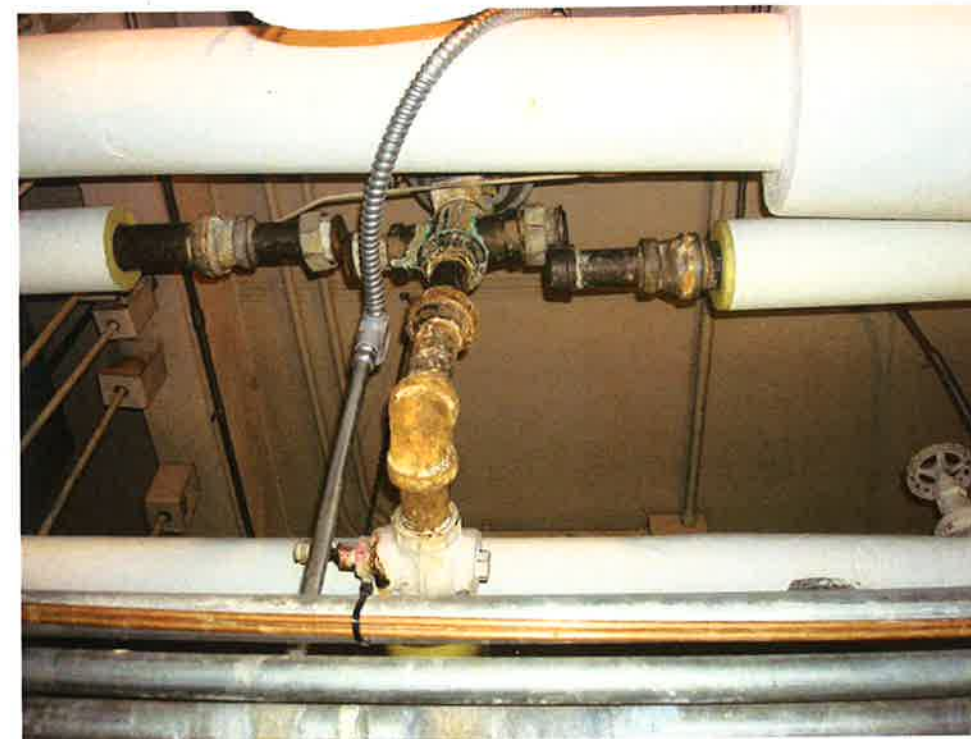
Comment #: C6323

Picture 4: Comment# C6323
Bldg:
Drawing #: Group 2 Level 4
Discipline: C Bing
Item: HHW Pipes

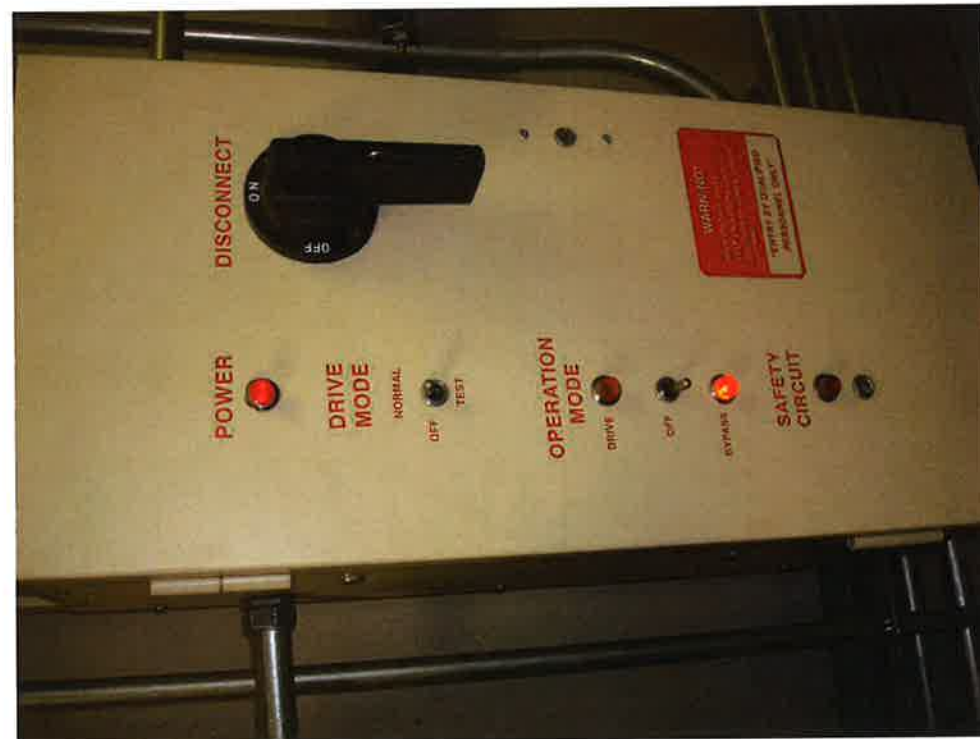
Comment #: C6708

Picture 3: Comment# C6708
Bldg:
Drawing #: Group 2 Level 4
Discipline: C Bing
Item: Controls Panel for Units on roc

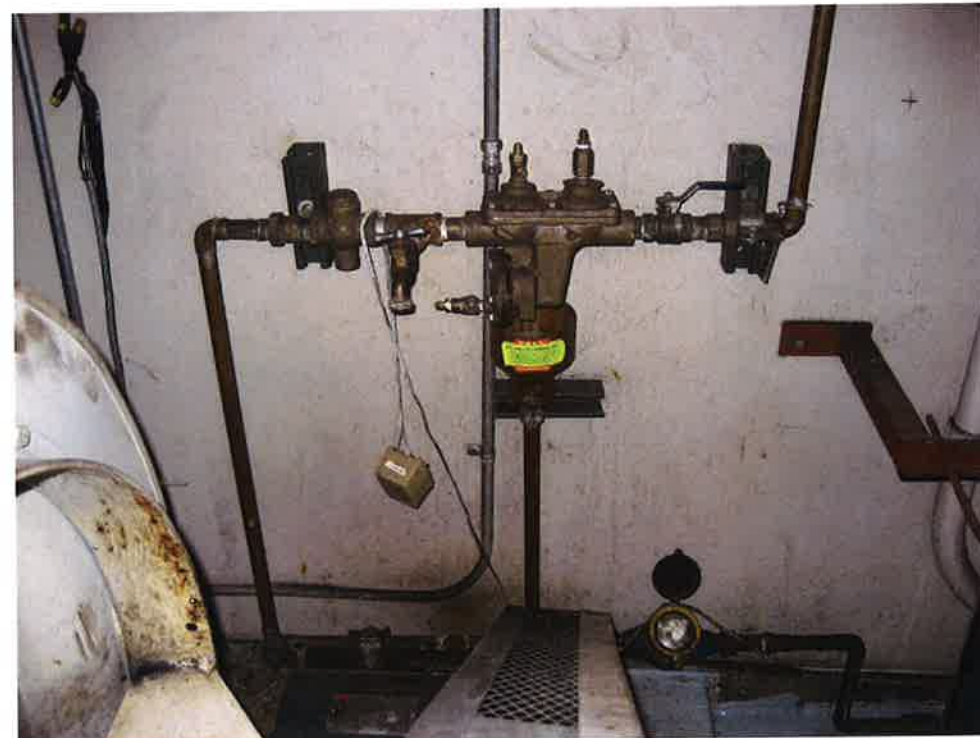
Comment #: C8004

Picture 4: Comment# C8004
Bldg:
Drawing #: Group 2 Level 1
Discipline: C Bing
Item: Water supply to Softener tank

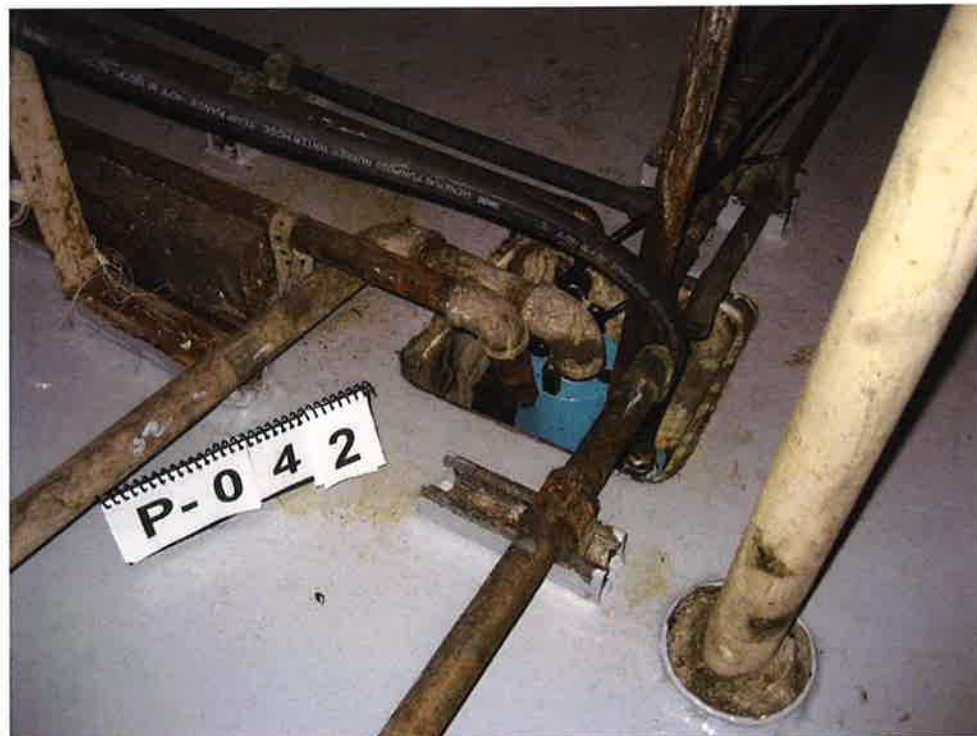
Picture 3 Comment #: C8302

Picture 3: Comment# C8302
Bldg:
Drawing #: Group 2 Level 1
Discipline: C Bing
Item: Fire water

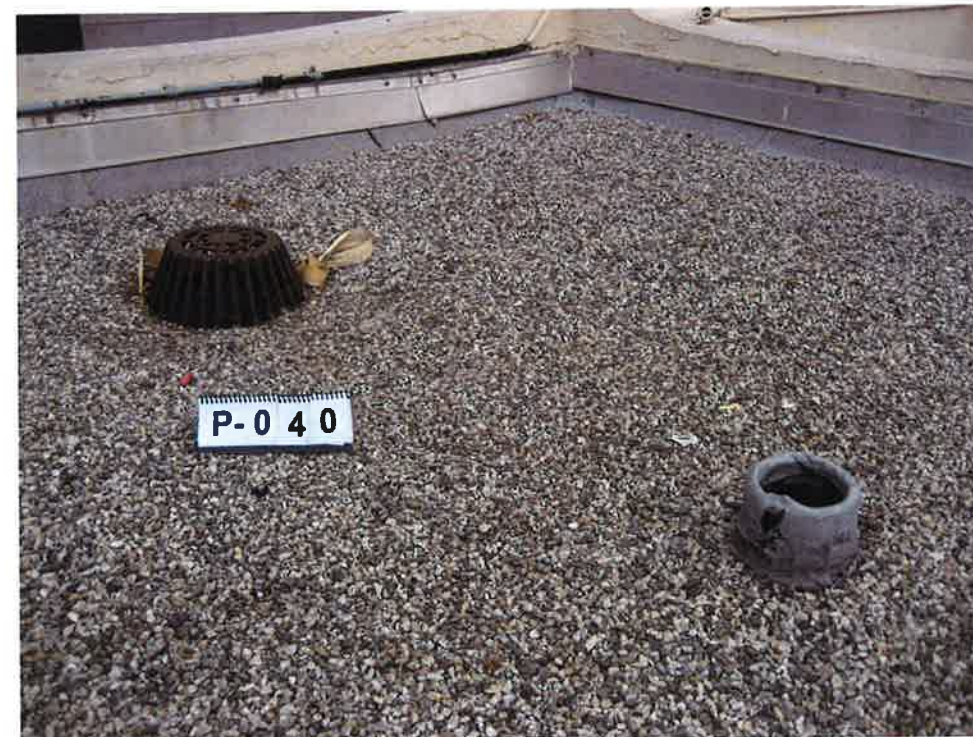
Picture 4 : Comment #: C8405

Picture 4: Comment# C8405
Bldg:
Drawing #: Group 2 Level 1
Discipline: C Bing
Item: Storm Drain

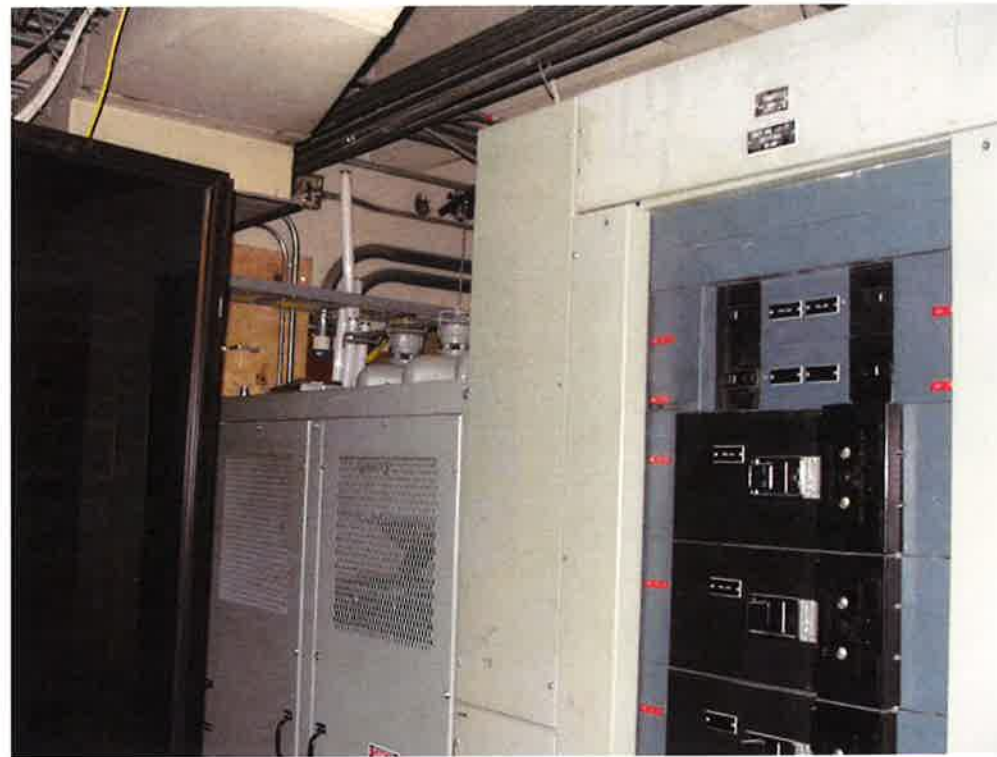
Comment #: C9012

9012	Electrical	1	C	Unit Substation	Substation T-7	This type of substation should be replaced every 20 years, this is currently 50 years old and passed its useful life. Reported over heating.	Replace this substation T-7 with new including all associated distribution boards.		X		
9013	Electrical	3	C	Unit Substation	Substation T-8 and Motor Control Center MCC-C	This substation is only 4 years old and good condition. MCC-C is currently 50 years old and passed its useful life.	This substation T-8 is in good condition and to remain as is. Replace MCC-C with new.		X		
9014	Electrical	5	D	Unit Substation	Substation T-A & T-B ,Motor Control Center MCC-A & MCC-E	This oil type of substation should be replaced every 20 years, this is currently 30 years old and passed its useful life.	Replace only the oil type Transformers T-A & T-B with new. MCC-A & MCC-E, to remain as is.		X		
9015	Electrical	1	D	Switchboards & Distribution Boards	Switchboards S & SS & Distribution Boards	This Switchboards currently are 30 years old, reported in good condition.	These Switchboards are to remain as is.		X

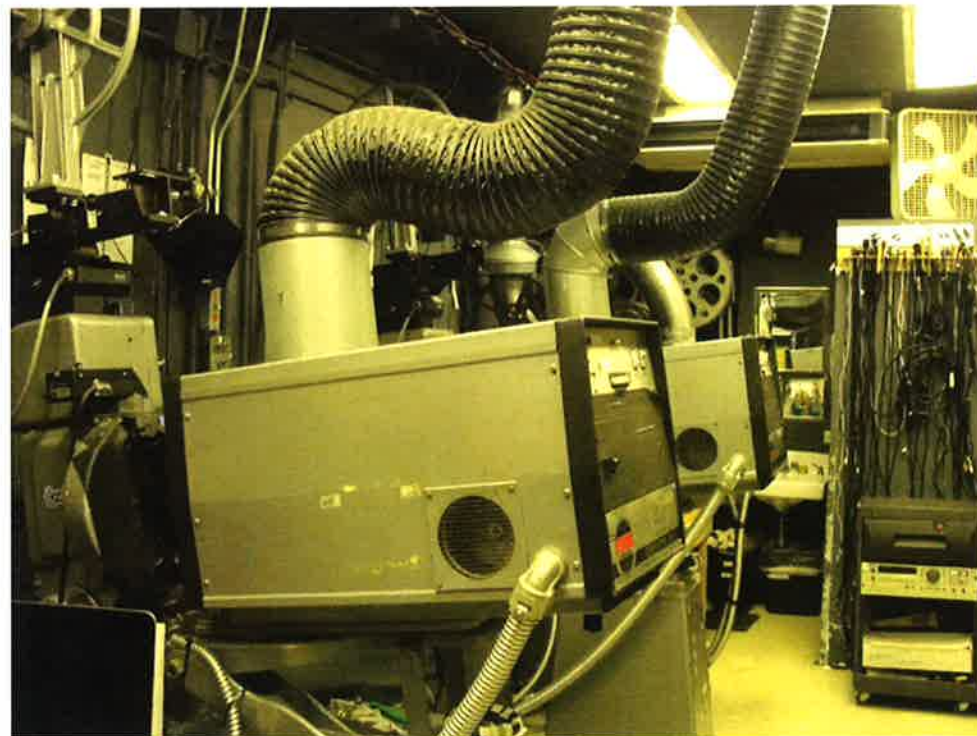
Comment #: C9503

9503	Electrical	1	C	Audio Visual Systems	Audio Visual Systems	There are (3) ventage 35mm&70mm Projectors in this room, including a 4th one for 6mm. Also an Audio Dolby sound systems equipment.	Replace the (3) old ventage projectors with new Digital Visual systems, also with new HI-TECH (Audio)Systems including new speakers and			X	
9504	Electrical	1	C	Audio Visual Systems (Brown Auditorium)	Audio Visual Systems	All Audio/Visual systems, speakers and Microphones are out dated.	Replace All Audio/Visual systems, speakers and Microphones with new Audio/Visual systems.			X	
9505	Electrical	1	C	Audio Visual Systems (Research Library)	Audio Visual Systems	All Audio/Visual systems, speakers and Microphones are installed at Feb. 2014	Audio/Visual systems are current and to remain as is.			X

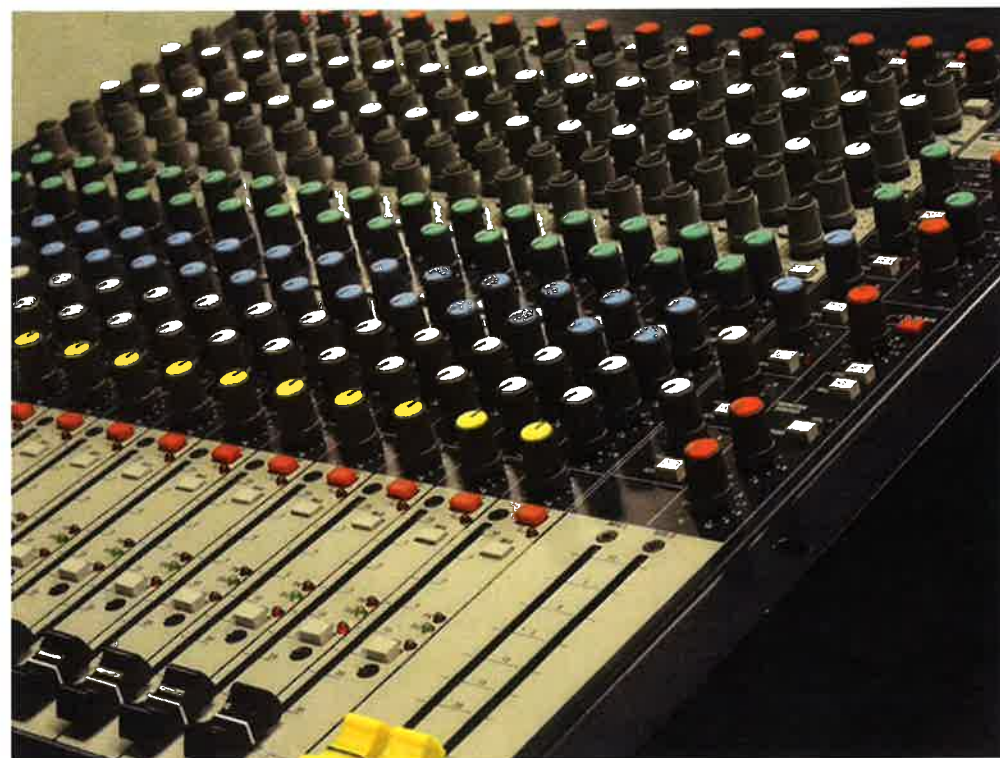
Comment #: C9505

Picture 1: Comment# C9505
Drawing #: Group 2 Level 1
Bldg:
Item: Audio Visual Systems
Discipline: C Bing

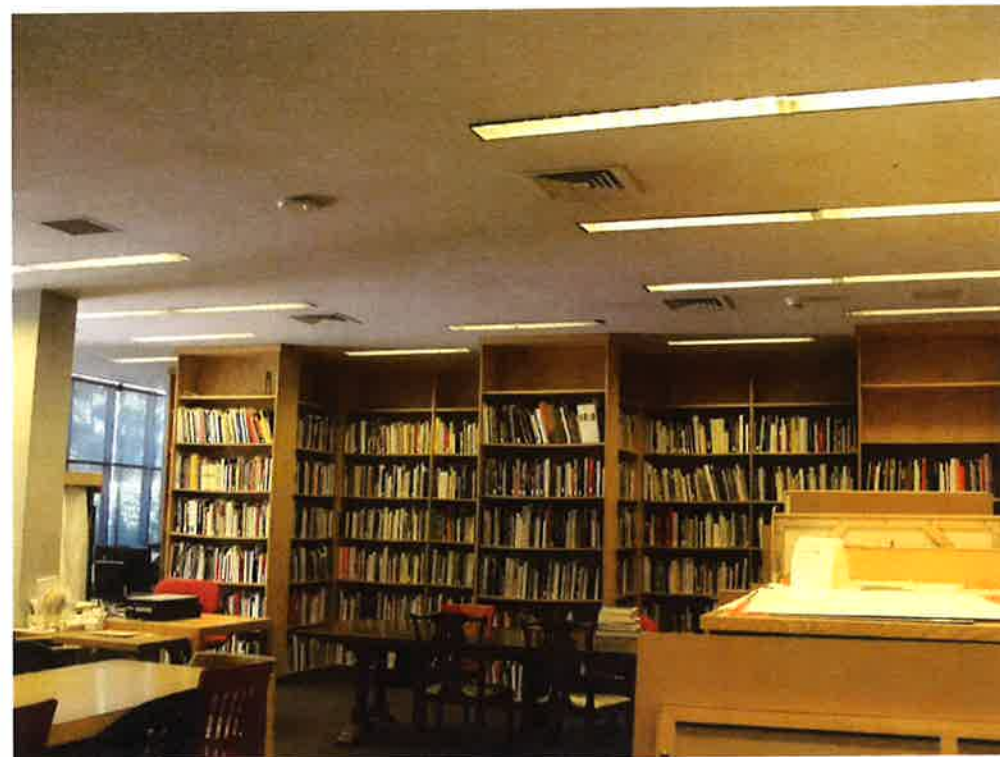
Comment #: C9506

A/E Comment No.	System	Floor	Building	Title	Item	Condition	Recommendation	Priority 1 (Immediate)	Priority 2 (2-5 years)	Priority 3 (5-10 Years)	Priority 4 (10+ Years)
9506	Electrical	1	C	Audio Visual Systems (German Rifkind Library)	Audio Visual Systems	There are no Audio/ Visual systems in this Library.	Provide new Audio/Visual systems similar to exiting one located in Research Library.			X

Picture 2: Comment# C9506
Bldg:
Drawing #: Group 2 Level 1
Discipline: C Bing
Item: Audio Visual Systems (Germ)

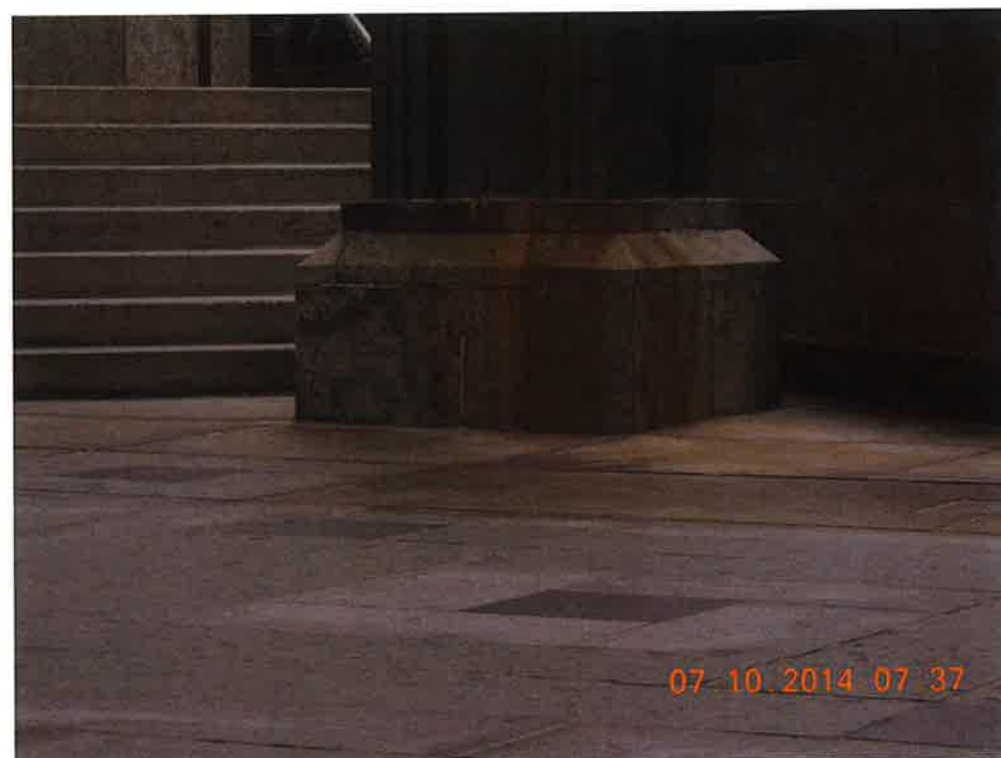
Picture 1: Comment #: D1246

Picture 1: Comment# D1246
Drawing #: Group 1 Level 1
Bldg:
Item: Ext. column Stone Base
Discipline: D AOA

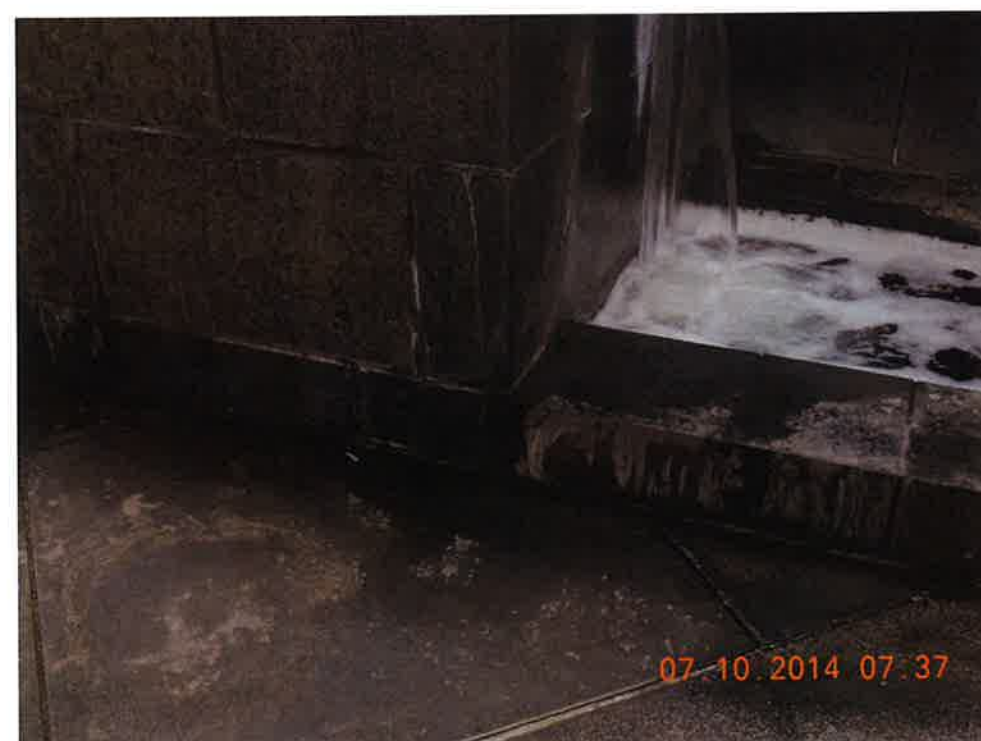
Picture 2: Comment# D1247.1
Bldg:
Drawing #: Group 1 Level 1
Discipline: D AOA
Item: Main entry Fountain

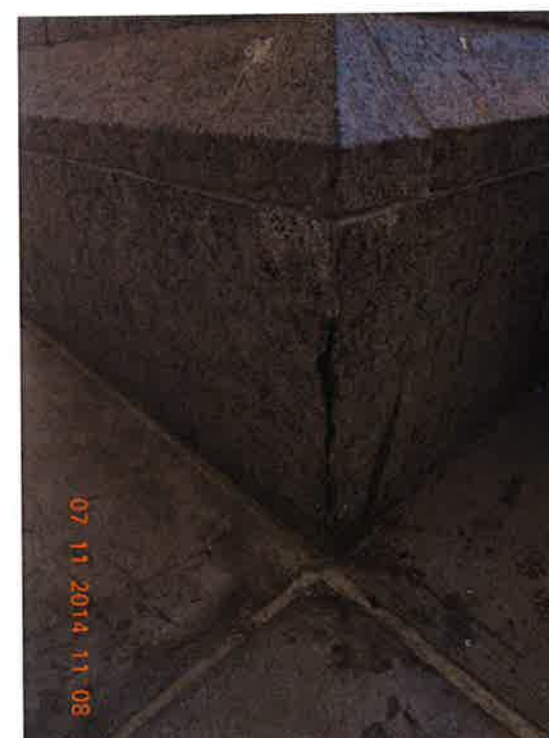
Picture 3: Comment #: D1247.2

Picture 3: Comment# D1247.2
Bldg:
Drawing #: Group 1 Level 1
Discipline: D AOA
Item: Main entry Fountain

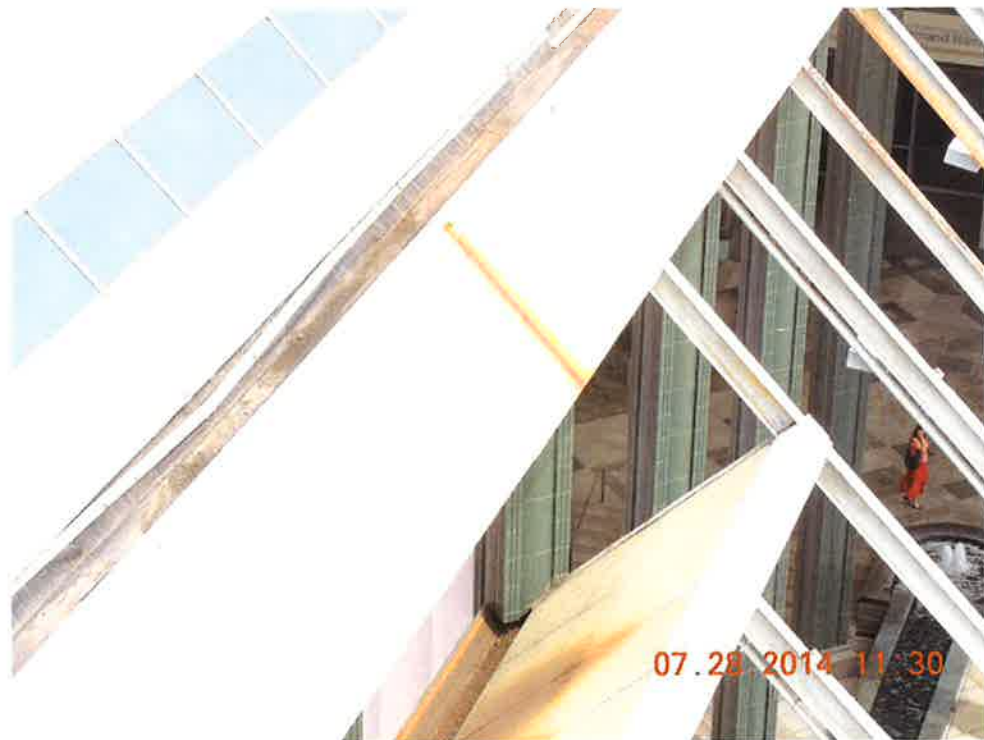
Comment #: D1254.4

Picture 3: Comment# D1254.4
Bldg:
Drawing #: Group 1 Level 4
Discipline: D AOA
Item: Ext. metal canopy and Kalwall

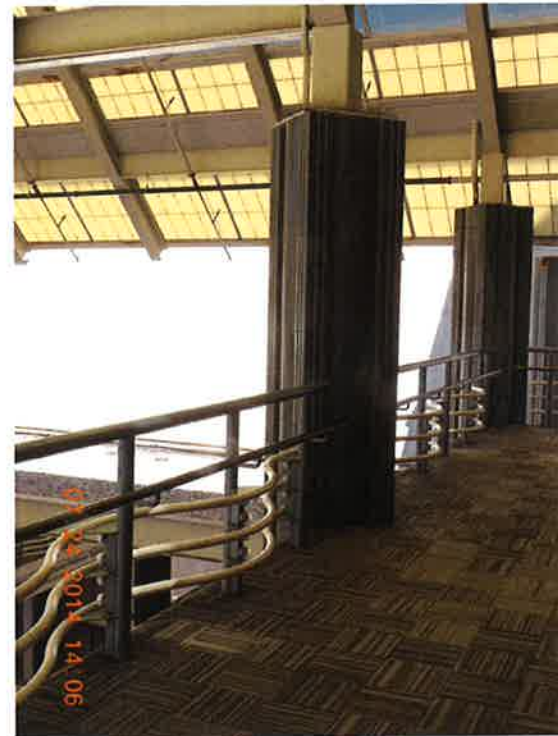
Comment #: D1255

Picture 4: Comment# D1255
Bldg:
Drawing #: Group 1 Level 3
Discipline: D AOA
Item: Ext. balcony and bridge

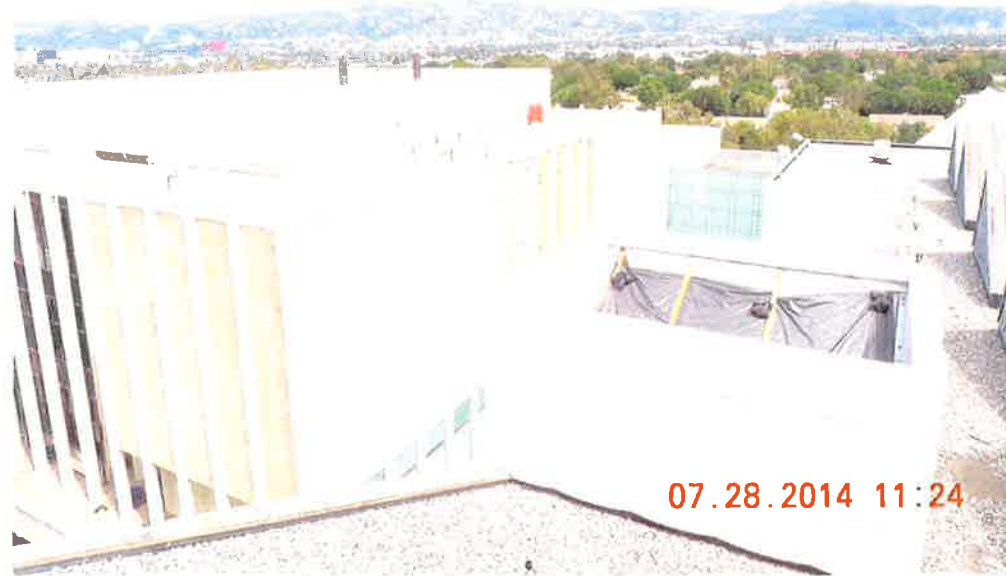
Comment #: D1406.1

Picture 1: Comment# D1406.1
Drawing #: Group 1 Roof
Bldg:
Item: Rooftop skylight
Discipline: D AOA

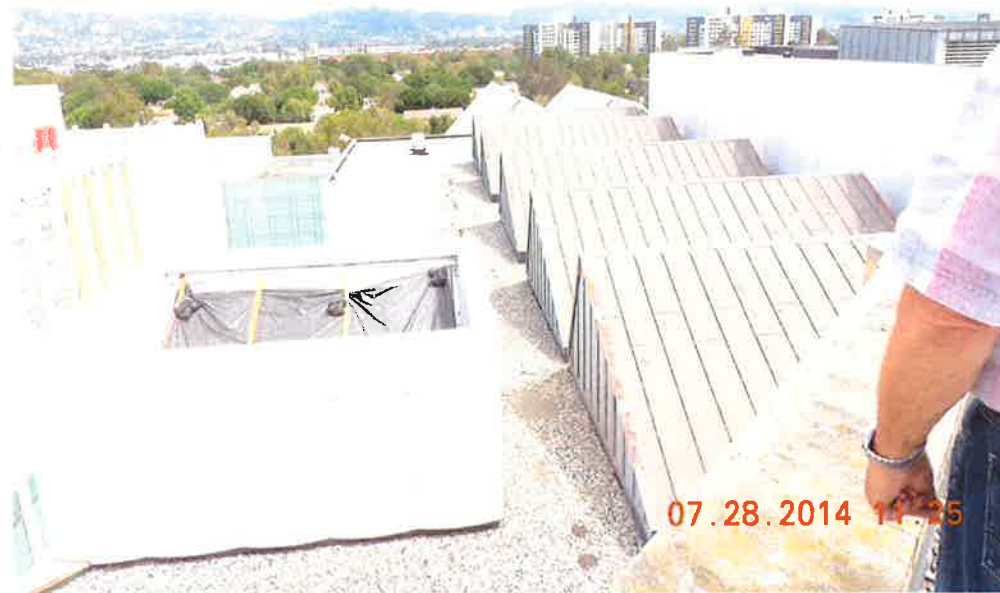
Comment #: D1406.2

Picture 2: Comment# D1406.2
Bldg:
Drawing #: Group 1 Roof
Discipline: D AOA
Item: Rooftop skylight

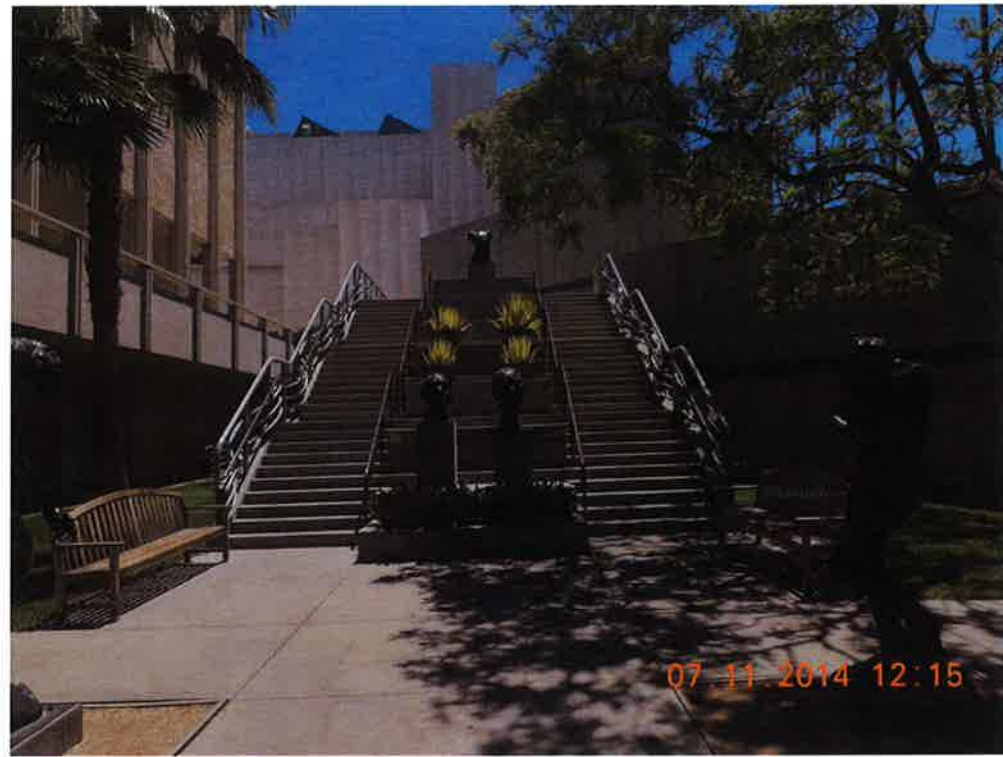
Comment #: D1513.3

Picture 1: Comment# D1513.3
Drawing #: Group 1 Level 1
Bldg:
Item: Ext. exit concrete stairs
Discipline: D AOA

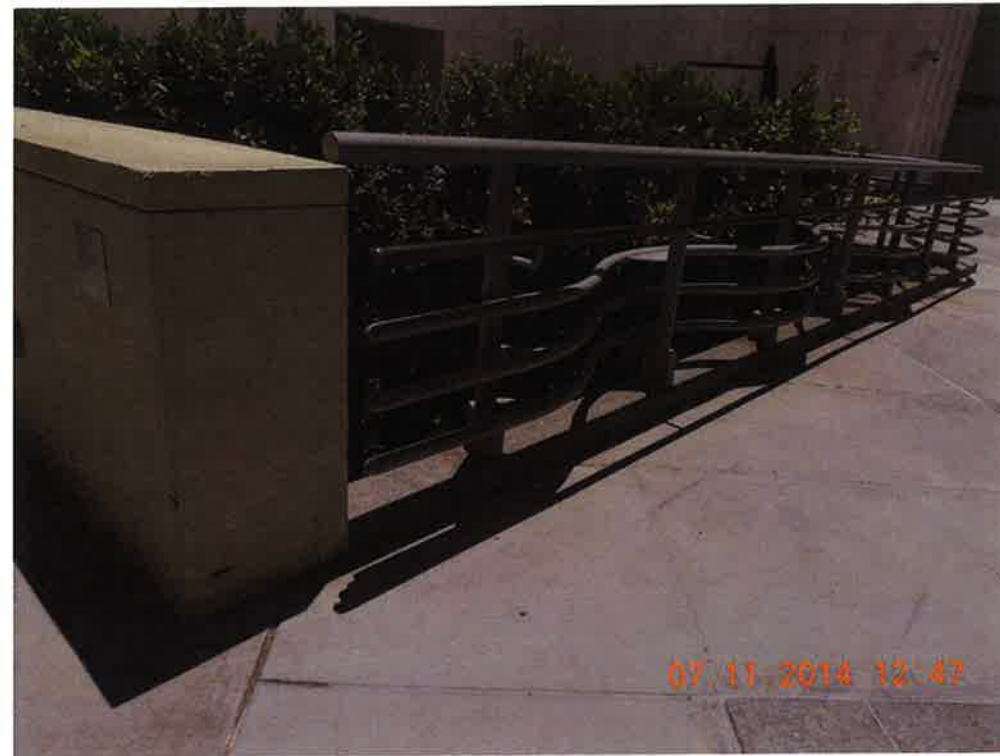
Comment #: D1514

Picture 2: Comment# D1514
Bldg:
Drawing #: Group 1 Level 2
Discipline: D AOA
Item: Plaza planter guardrails

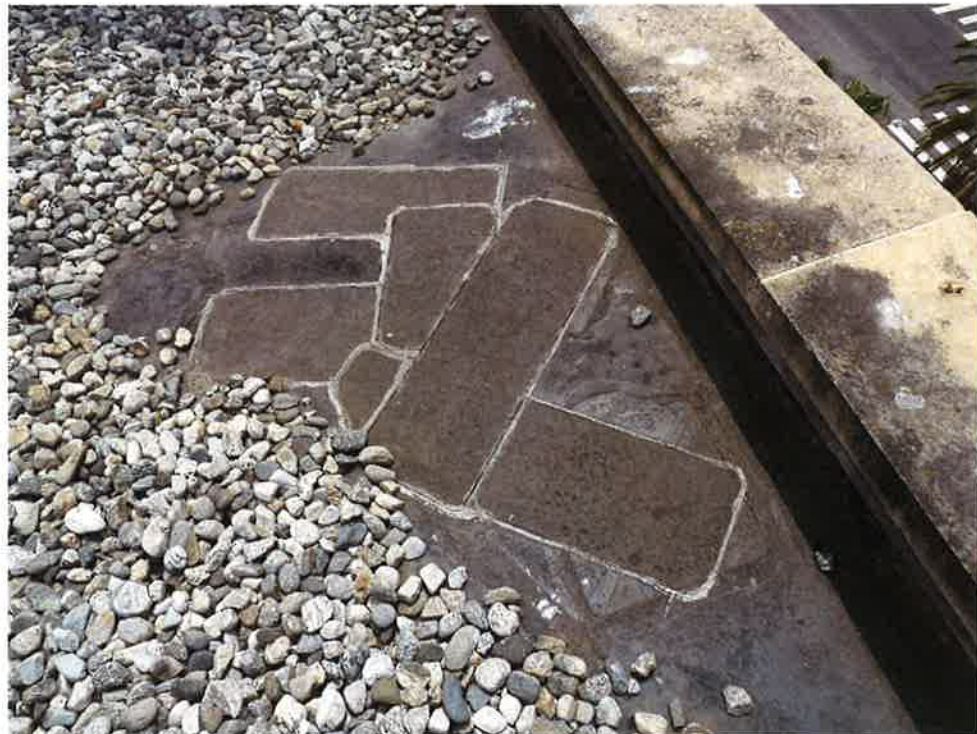
Picture 3 Comment #: D1814

Picture 3: Comment# D1814
 Bldg:
 Drawing #: Group 2 Roof
 Discipline: D AOA
 Item: Roofing on the Art of America's

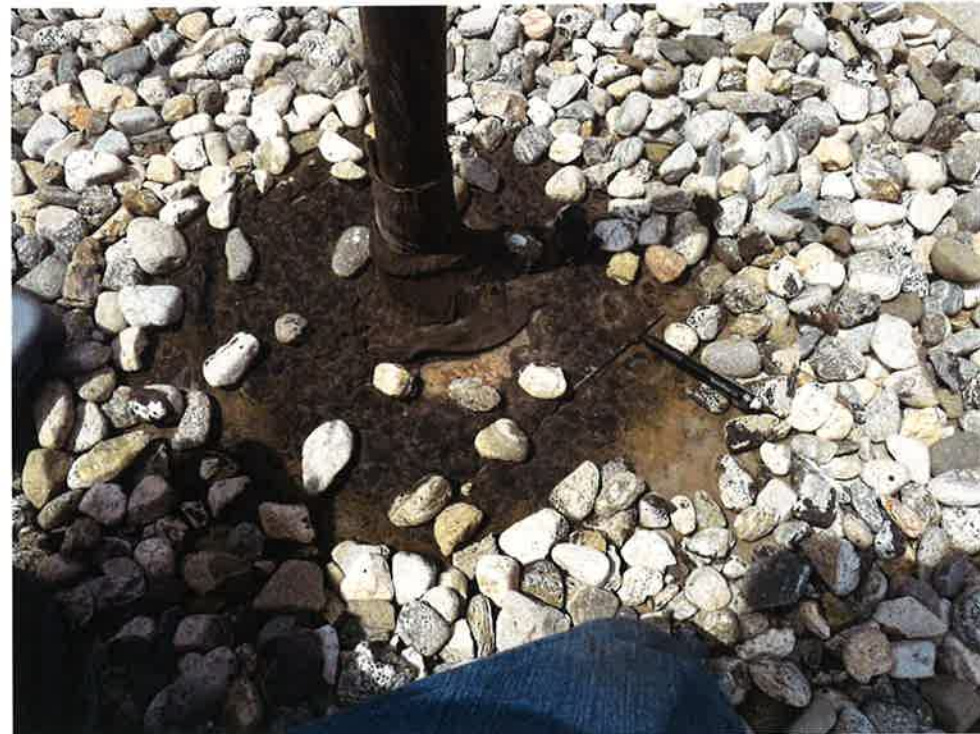
Picture 4: Comment #: D1815

Picture 4: Comment# D1815
 Bldg:
 Drawing #: Group 2 Roof
 Discipline: D AOA
 Item: Roofing on the Art of America's
