Revised Appendix Q

Existing Building Evaluation

Los Angeles County Museum of Art Building Evaluation

September 16, 2014

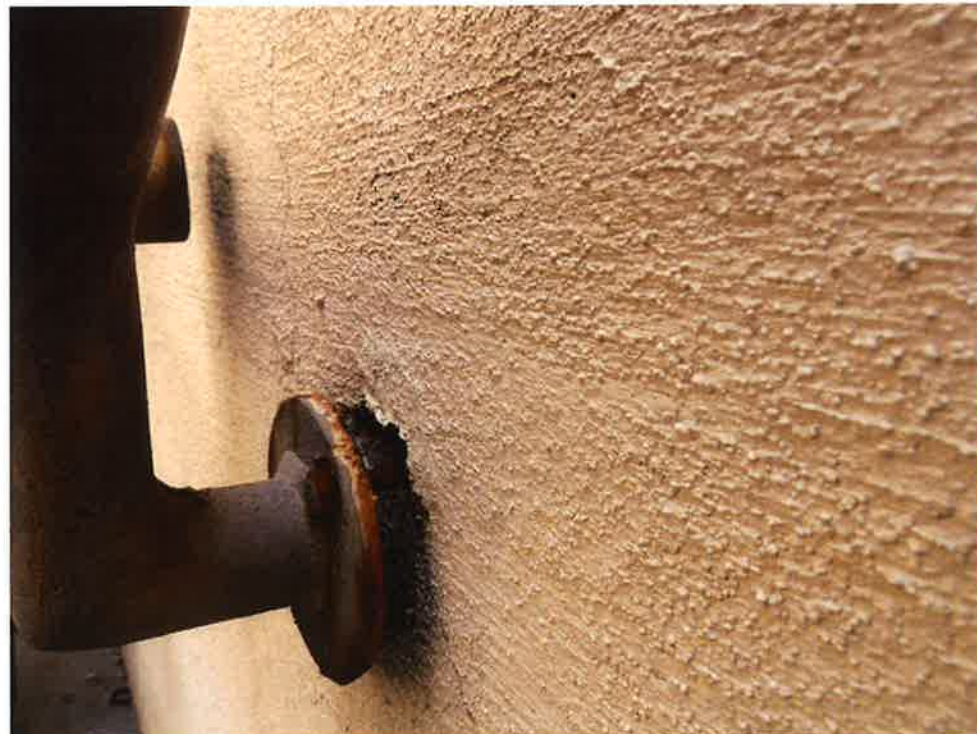
Picture 3 Comment #: D1818

Picture 3: Comment# D1818
Bldg:
Drawing #: Group 2 Roof
Discipline: D AOA
Item: Roof stairwell on the Art of

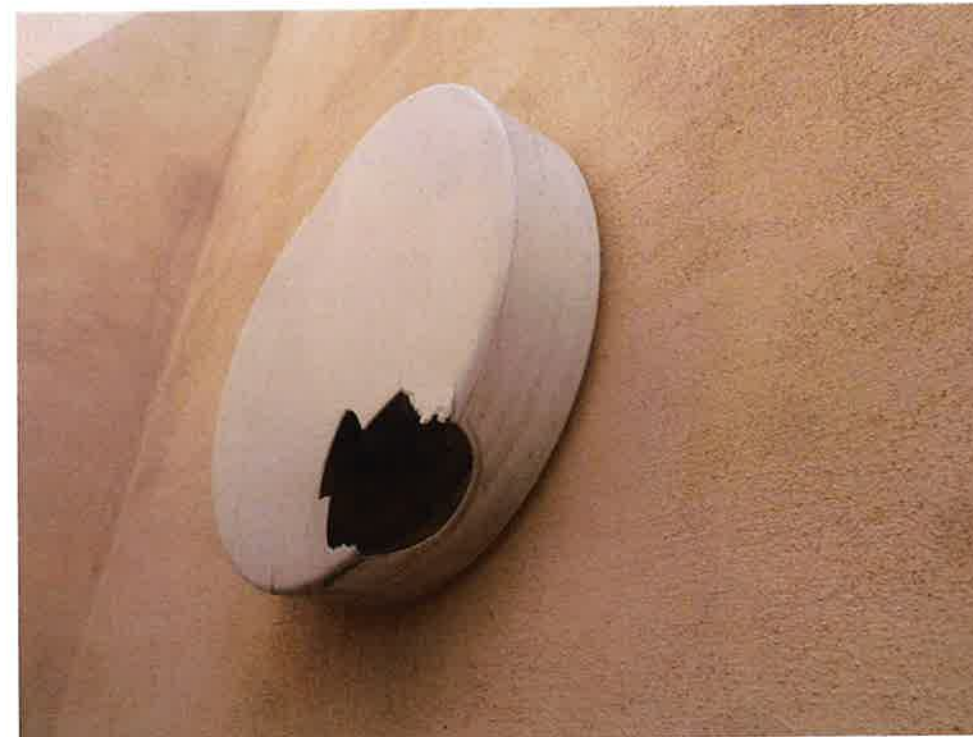
Picture 4 Comment #: D1819

Picture 4: Comment# D1819
Bldg:
Drawing #: Group 2 Roof
Discipline: D AOA
Item: Roof stairwell on the Art of
