Storm Drainage Maintenance Plan

City of Monterey

Storm Drainage Maintenance Plan (SDMP)

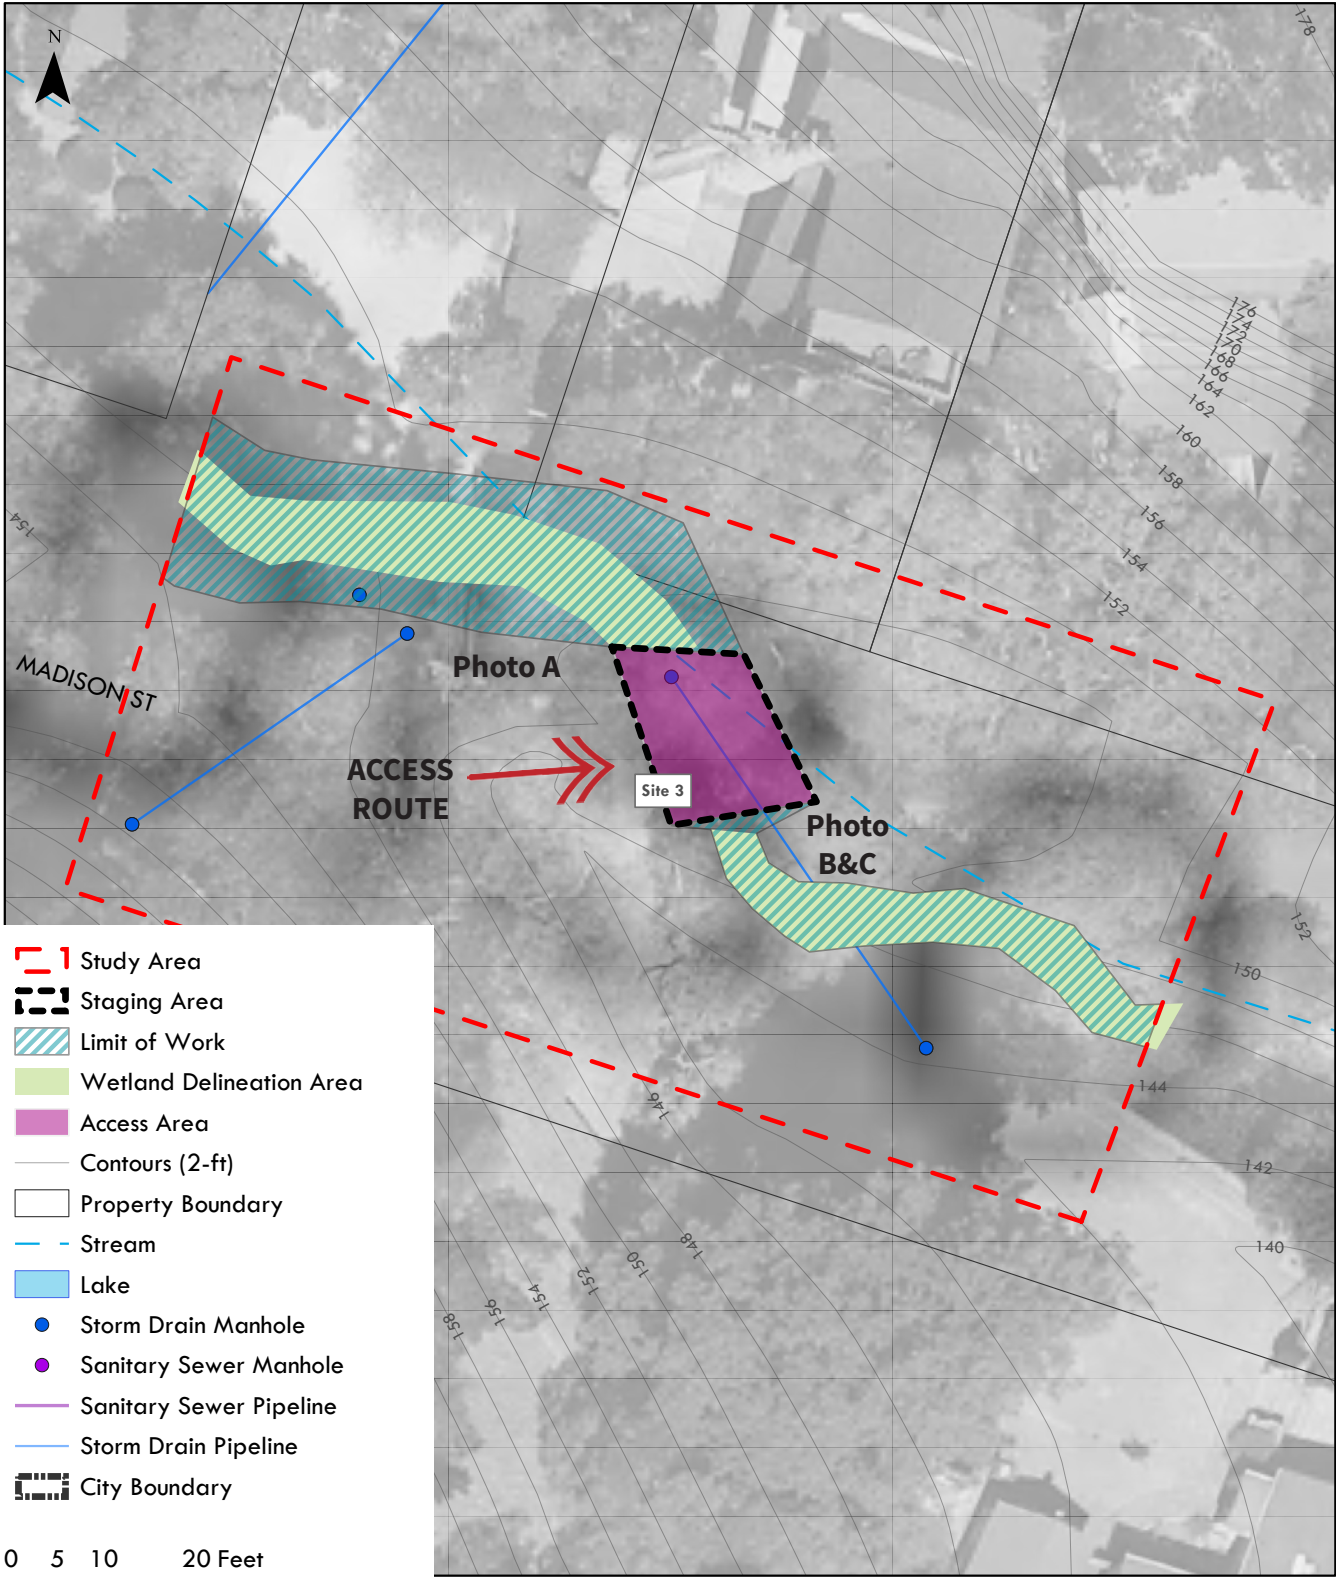
CROSS STREETS: Madison Street
CITY DRAINAGE BASIN: Hartnell Drainage

Inspected on September 13, 2017. Site includes an earthen channel flowing between residential properties and Madison Street. The channel is approximately 4-ft wide at its base, with near vertical banks extending up to an open channel width of approximately 8-ft. Vegetation is mostly grass and berries with more than 80% vegetative cover upstream of Madison Street where the channel is overgrown with brambles and approximately 30% downstream of Madison Street. No significant rock or accumulated sediment was observed along the channel bottom. Within the limit of work, there were no significant fallen trees or tree limbs and none of the existing infrastructure is known to be undersized. Vegetation around the culvert outlet was short, allowing adequate access and visibility; the inlet was obstructed by overgrown vegetation.

The growth of vegetation in the channel is a maintenance concern, along with the close proximity of the channel to residential structures. The loose condition of the channel and bank material will potentially limit access and the types of tools used to perform maintenance activities.

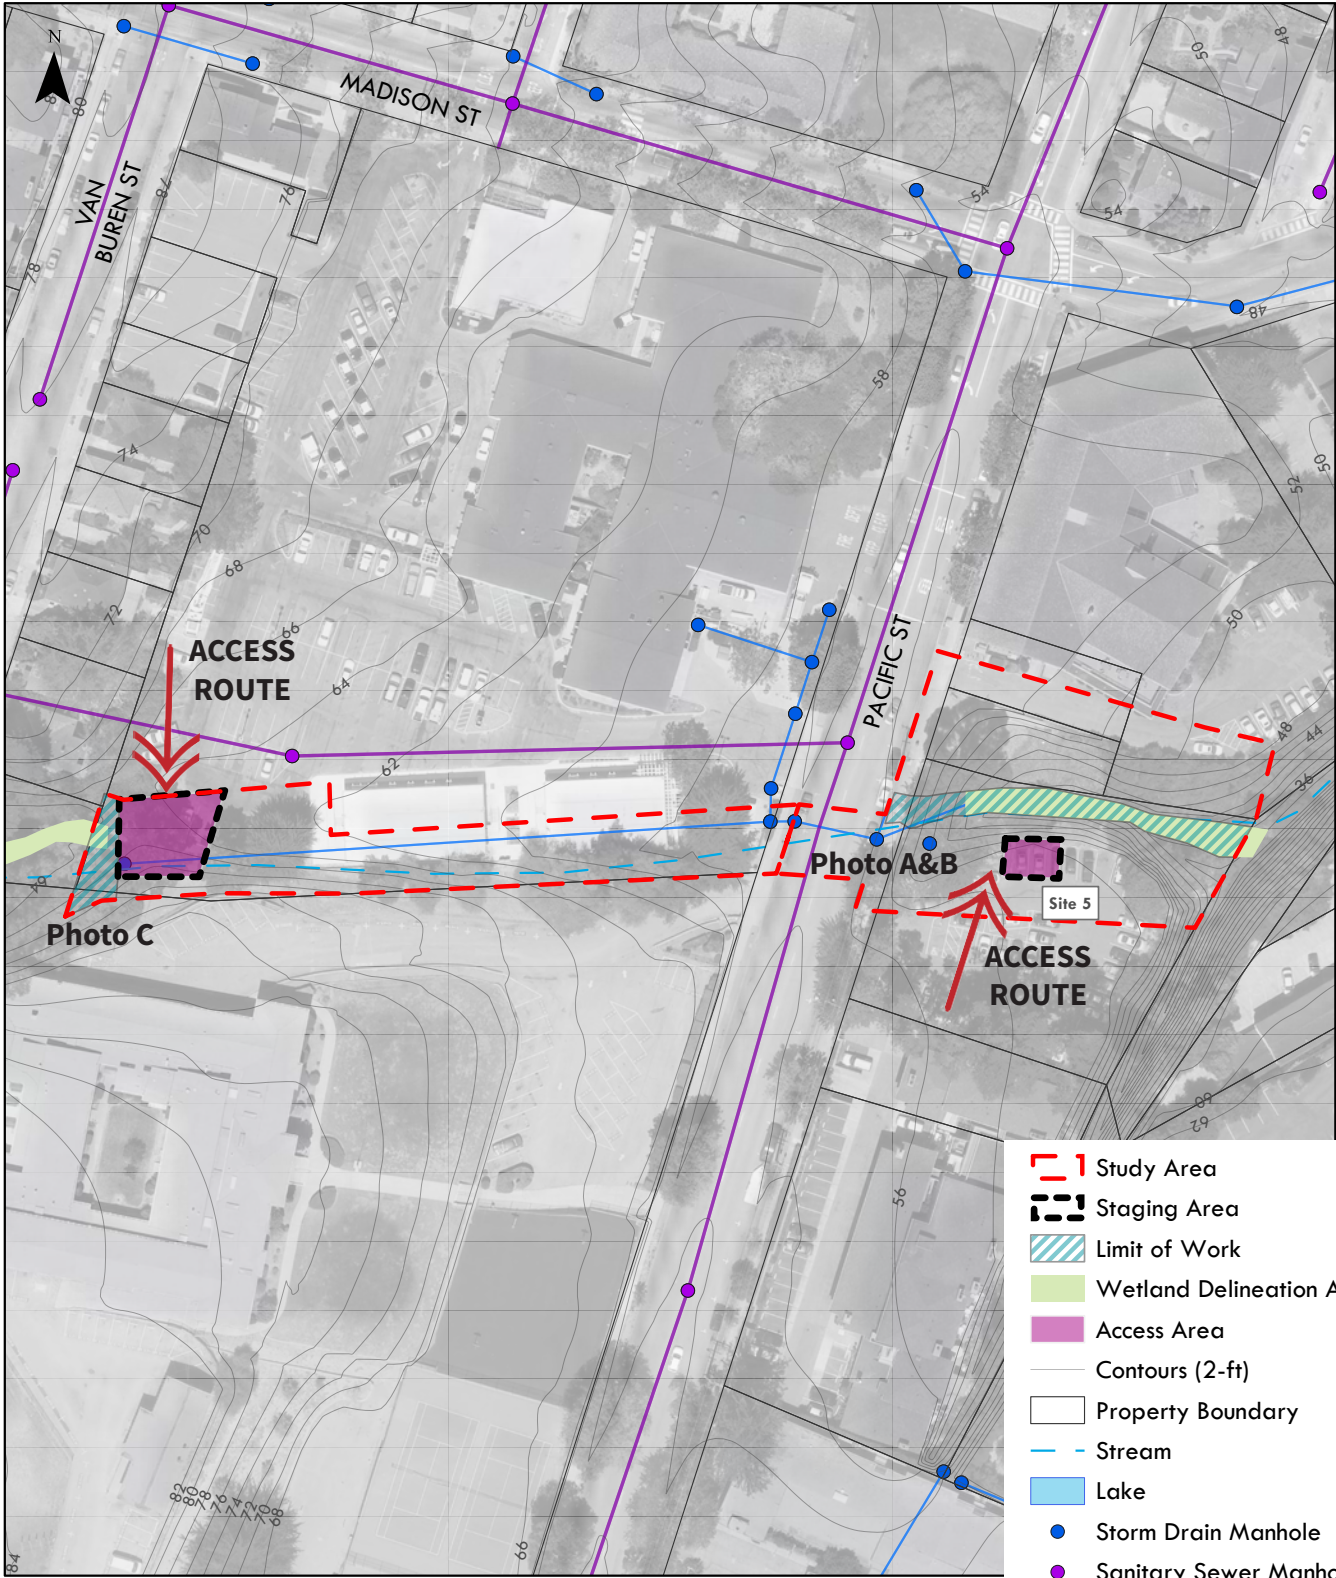
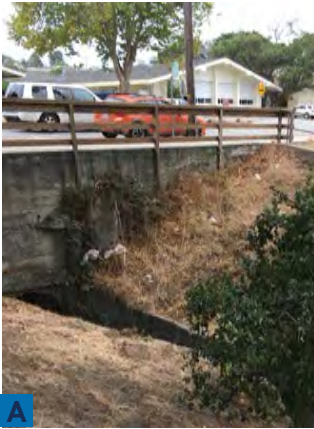
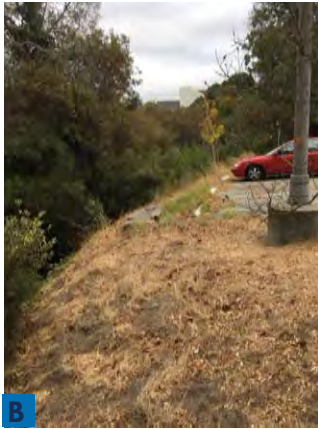
Inspected on September 13, 2017. Site includes an earthen channel flowing west to east between Van Buren Street and Pacific Street. The western most section proposed for maintenance activities is accessed from the Police Station Parking lot; the eastern most section, east of Pacific Street is accessed through the library parking lot. A trash rack is located across the culvert inlet (Photo C) with evidence of sediment and debris accumulation. The channel is approximately 5-ft wide at its base, with near vertical banks extending up to a bankfull channel width of approximately 6-ft. Vegetation includes trees and low brush with 75% vegetative cover observed on banks. East of Pacific Street the channel is incised and approximately 15 feet lower than the parking lot elevation. Within the limit of work, there were no significant fallen trees or tree limbs and none of the existing infrastructure is known to be undersized.

To maintain stormwater conveyance and capacity in the channel, accumulated sediment, debris, and vegetation along the channel bottom will be removed annually. The site will be accessed from the adjacent parking lot areas. Work will be focused within the limits of the channel banks. Chain saws and hand tools (i.e., picks, shovels, rakes, loppers, etc.) will be used to clear and/or limb vegetation overhanging into the channel within the 6-ft bankfull width. A backhoe will be used to remove debris from the trash rack, if big material is identified in the channel, or in the event of an emergency. Sediment, trash, and green waste generated from the proposed activities would be disposed of properly at the Monterey Peninsula Landfill in Marina.

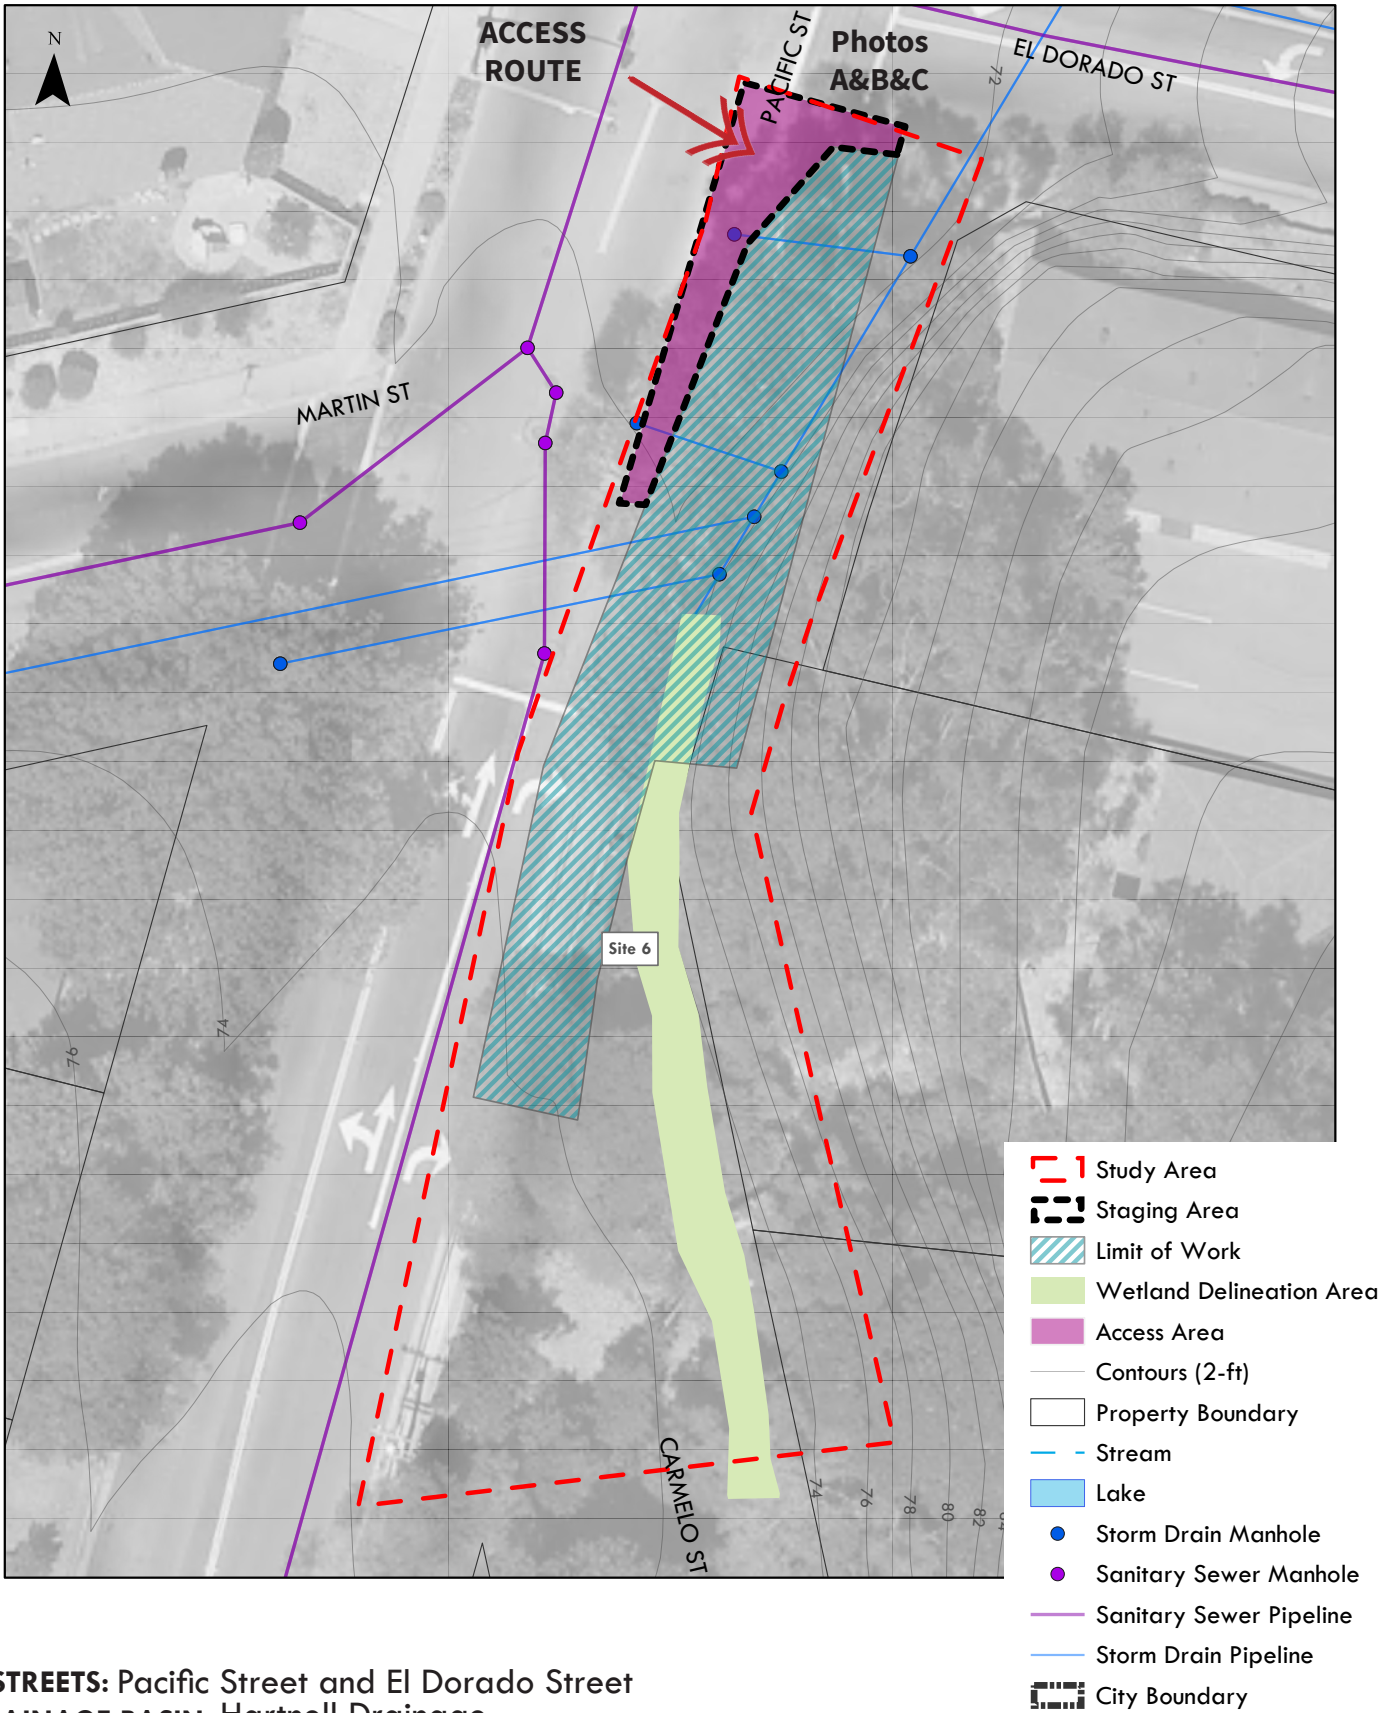
Inspected on September 13, 2017. Site includes an earthen channel flowing parallel to Pacific Street. The channel is approximately 5-ft wide at its base, with near vertical banks extending up to an open channel width of approximately 8-ft. Vegetation is mostly trees and brush with over 80% vegetative cover observed on banks. No significant rock or accumulated sediment was observed along the channel bottom. Within the limit of work, there were no significant fallen trees or tree limbs and none of the existing infrastructure is known to be undersized. Vegetation around the culvert inlet was dense, limiting access and visibility.

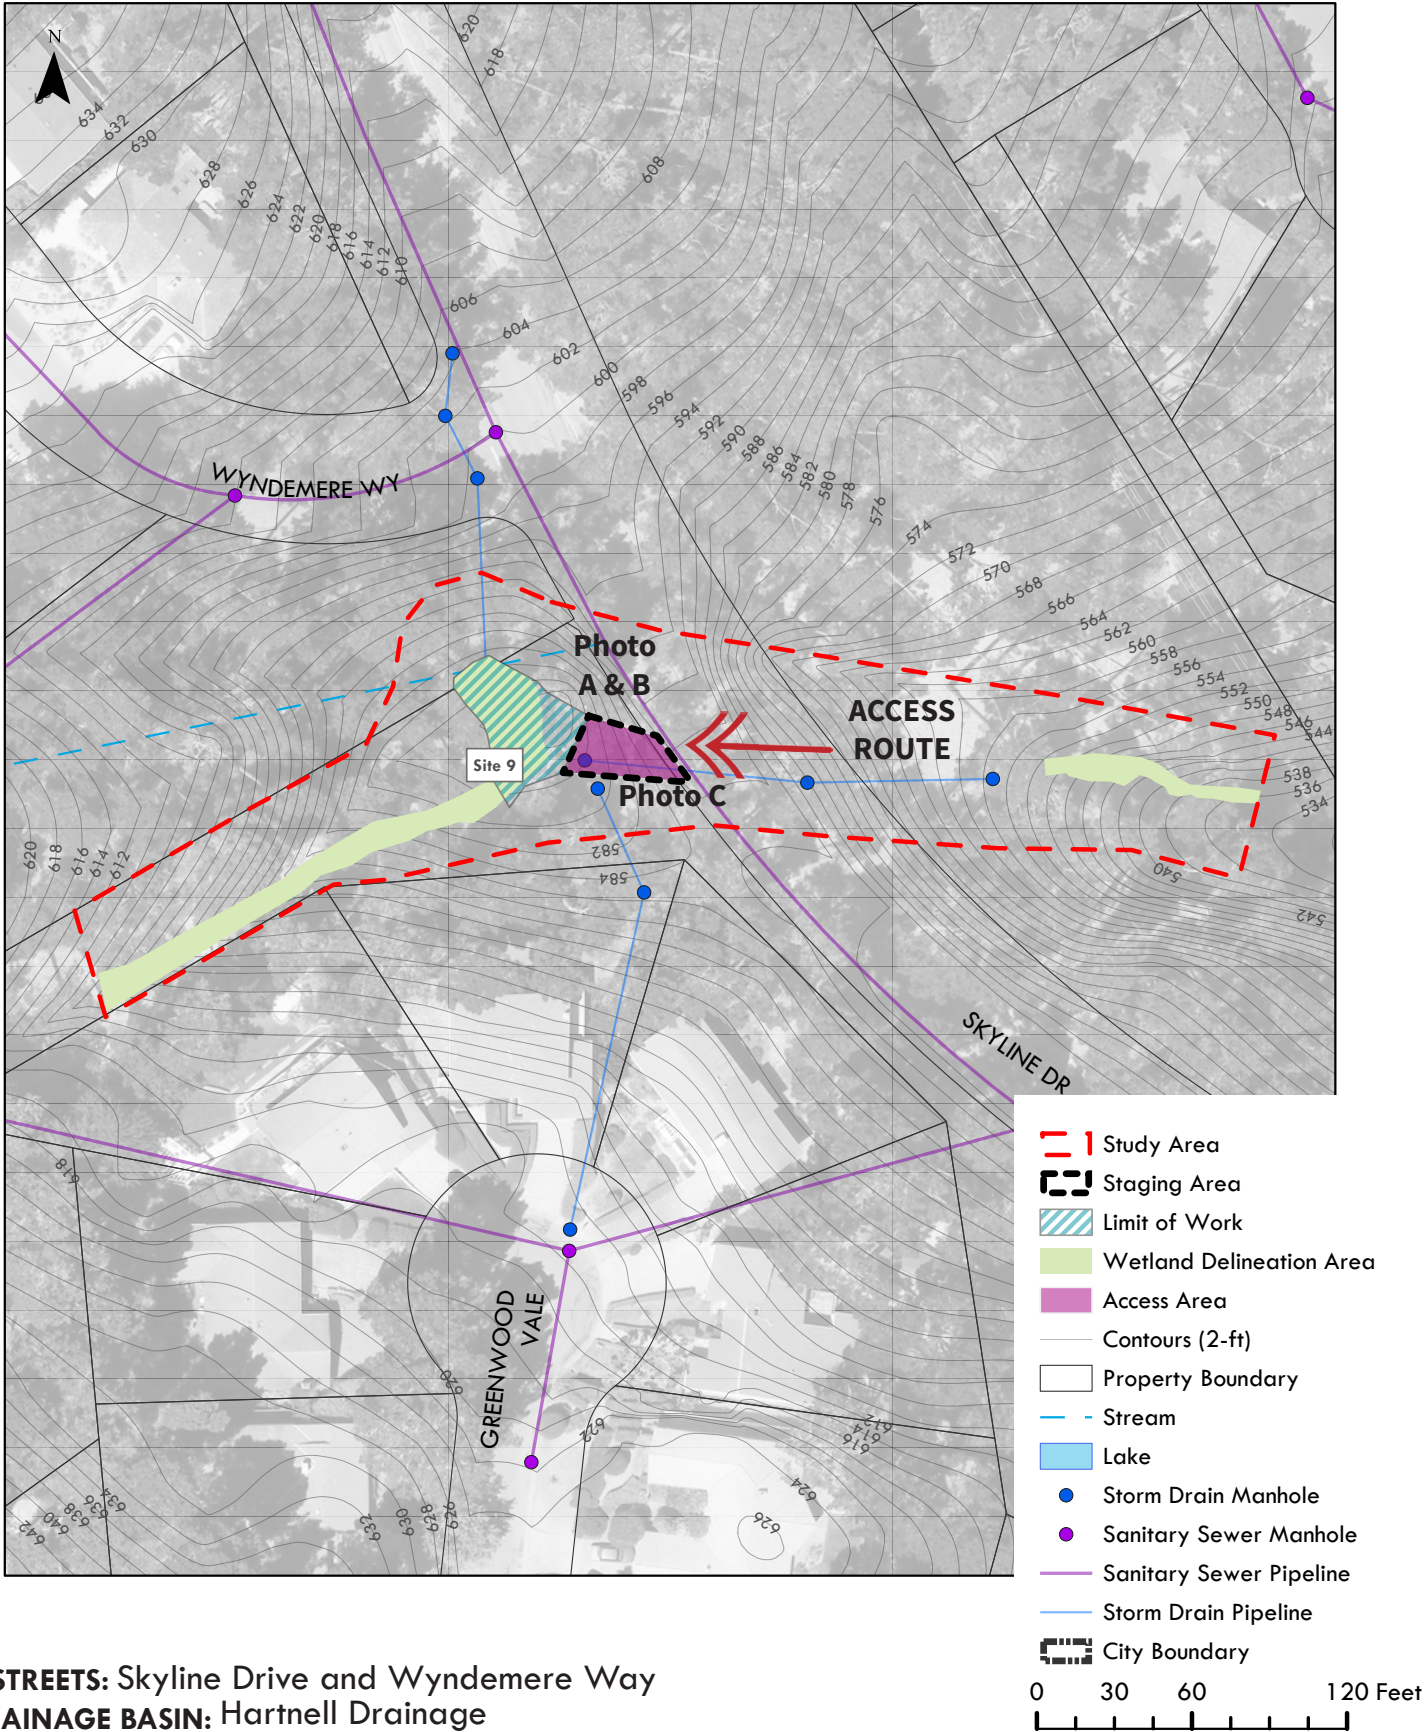
Inspected on September 11, 2017. Site includes an earthen channel flowing in a gully between residential developments and roadways. A series of log drop structures have been installed in the upper (western) portion of the channel. Maintenance of those structures is not included in the annual maintenance SDMP limit of work, which is focused on the sediment basin at the base of the structures and upstream of Skyline Drive. The basin is approximately 30-ft wide at its base, with outlet through a 21-inch culvert beneath Skyline Drive. Vegetation is light brush and weeds with some trees. Accumulated vegetation and sediment was observed along the channel bottom and in front of the culvert. There were no significant fallen trees or tree limbs and the existing culvert beneath Skyline is considered to be undersized resulting in a backwater effect and localized flooding.

The growth of vegetation in the basin was not preventing access to evaluate condition and maintain facilities. Sediment and vegetation accumulation in the basin are maintenance concerns.

To maintain stormwater conveyance and capacity in the basin, accumulated sediment and vegetation along the basin bottom and in front of the culvert will be removed annually. The site will be accessed from an open space off of Skyline Drive. Work will be focused within the limits of the channel banks. Chain saws and hand tools (i.e., picks, shovels, rakes, loppers, etc.) will be used to clear and/or limb vegetation overhanging into the basin. A backhoe and dump trucks will be used if large quantities of material are identified in the basin or in the event of an emergency. Sediment, trash, and green waste generated from the proposed activities would be disposed of properly at the Monterey Peninsula Landfill in Marina.

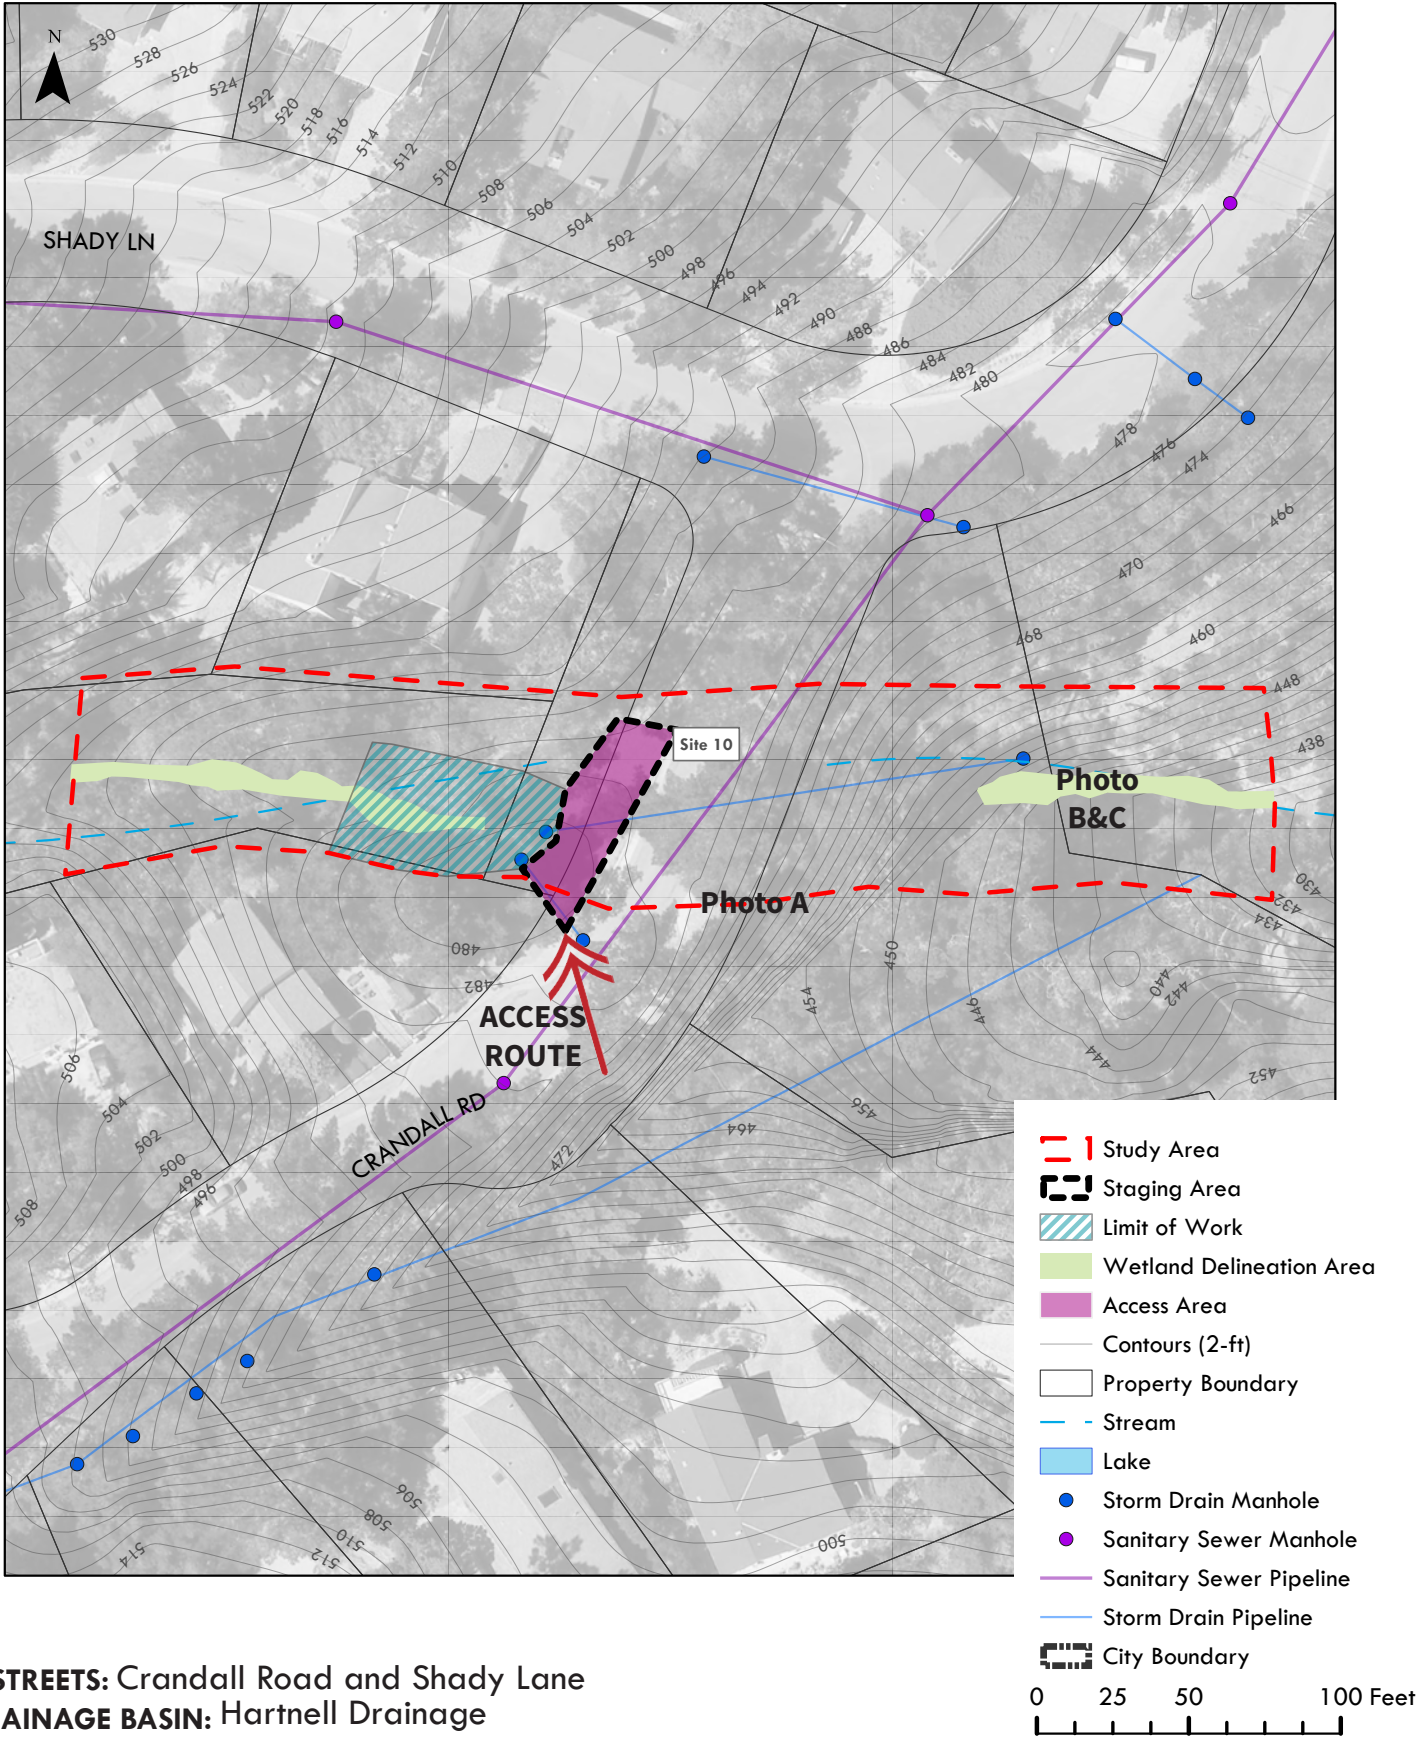
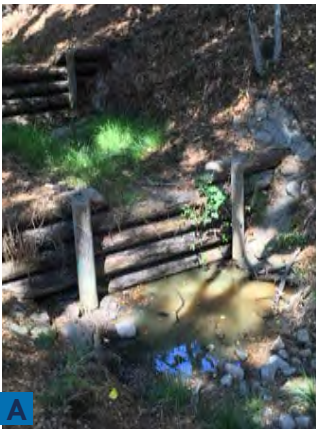
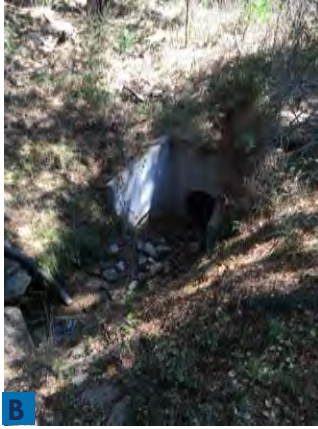
Inspected on September 11, 2017. Site includes an earthen channel flowing in a gully between single family residences and roadways. A series of log drop structures have been installed in the upper (western) portion of the channel. Annual maintenance activities are expected to include the bottom two structures, a distance of approximately 40-ft upstream of the culvert inlet under Crandell Road. The channel is approximately 2-3-ft wide at its base, extending up to an open channel width of approximately 10-ft. Vegetation is mostly grass, weeds, poison oak with trees and approximately 30% vegetative cover observed on banks. Accumulated vegetation, rock, and sediment was observed along the channel bottom and in front of the culvert. Fallen trees and tree limbs in and around the channel were observed. None of the existing infrastructure is known to be undersized.

The growth of vegetation in the channel was not preventing access to evaluate the facility condition. Some young pine trees are located in the access path and will need to be removed to allow maintenance activities to occur. Sediment, loose rock from the upstream armoring, and vegetation accumulation in the channel are maintenance concerns.

To maintain stormwater conveyance and capacity in the channel accumulated sediment and vegetation along the channel bottom and in front of the culvert will be removed annually. The site will be accessed from an open space off of Crandall Road. Work will be focused within the limits of the channel banks. Chain saws and hand tools (i.e., picks, shovels, rakes, loppers, etc.) will be used to clear and/or limb vegetation overhanging into the active channel width. A backhoe and dump trucks will be used if large quantities of material are identified in the channel or in the event of an emergency. Sediment, trash, and green waste generated from the proposed activities would be disposed of properly at the Monterey Peninsula Landfill in Marina.

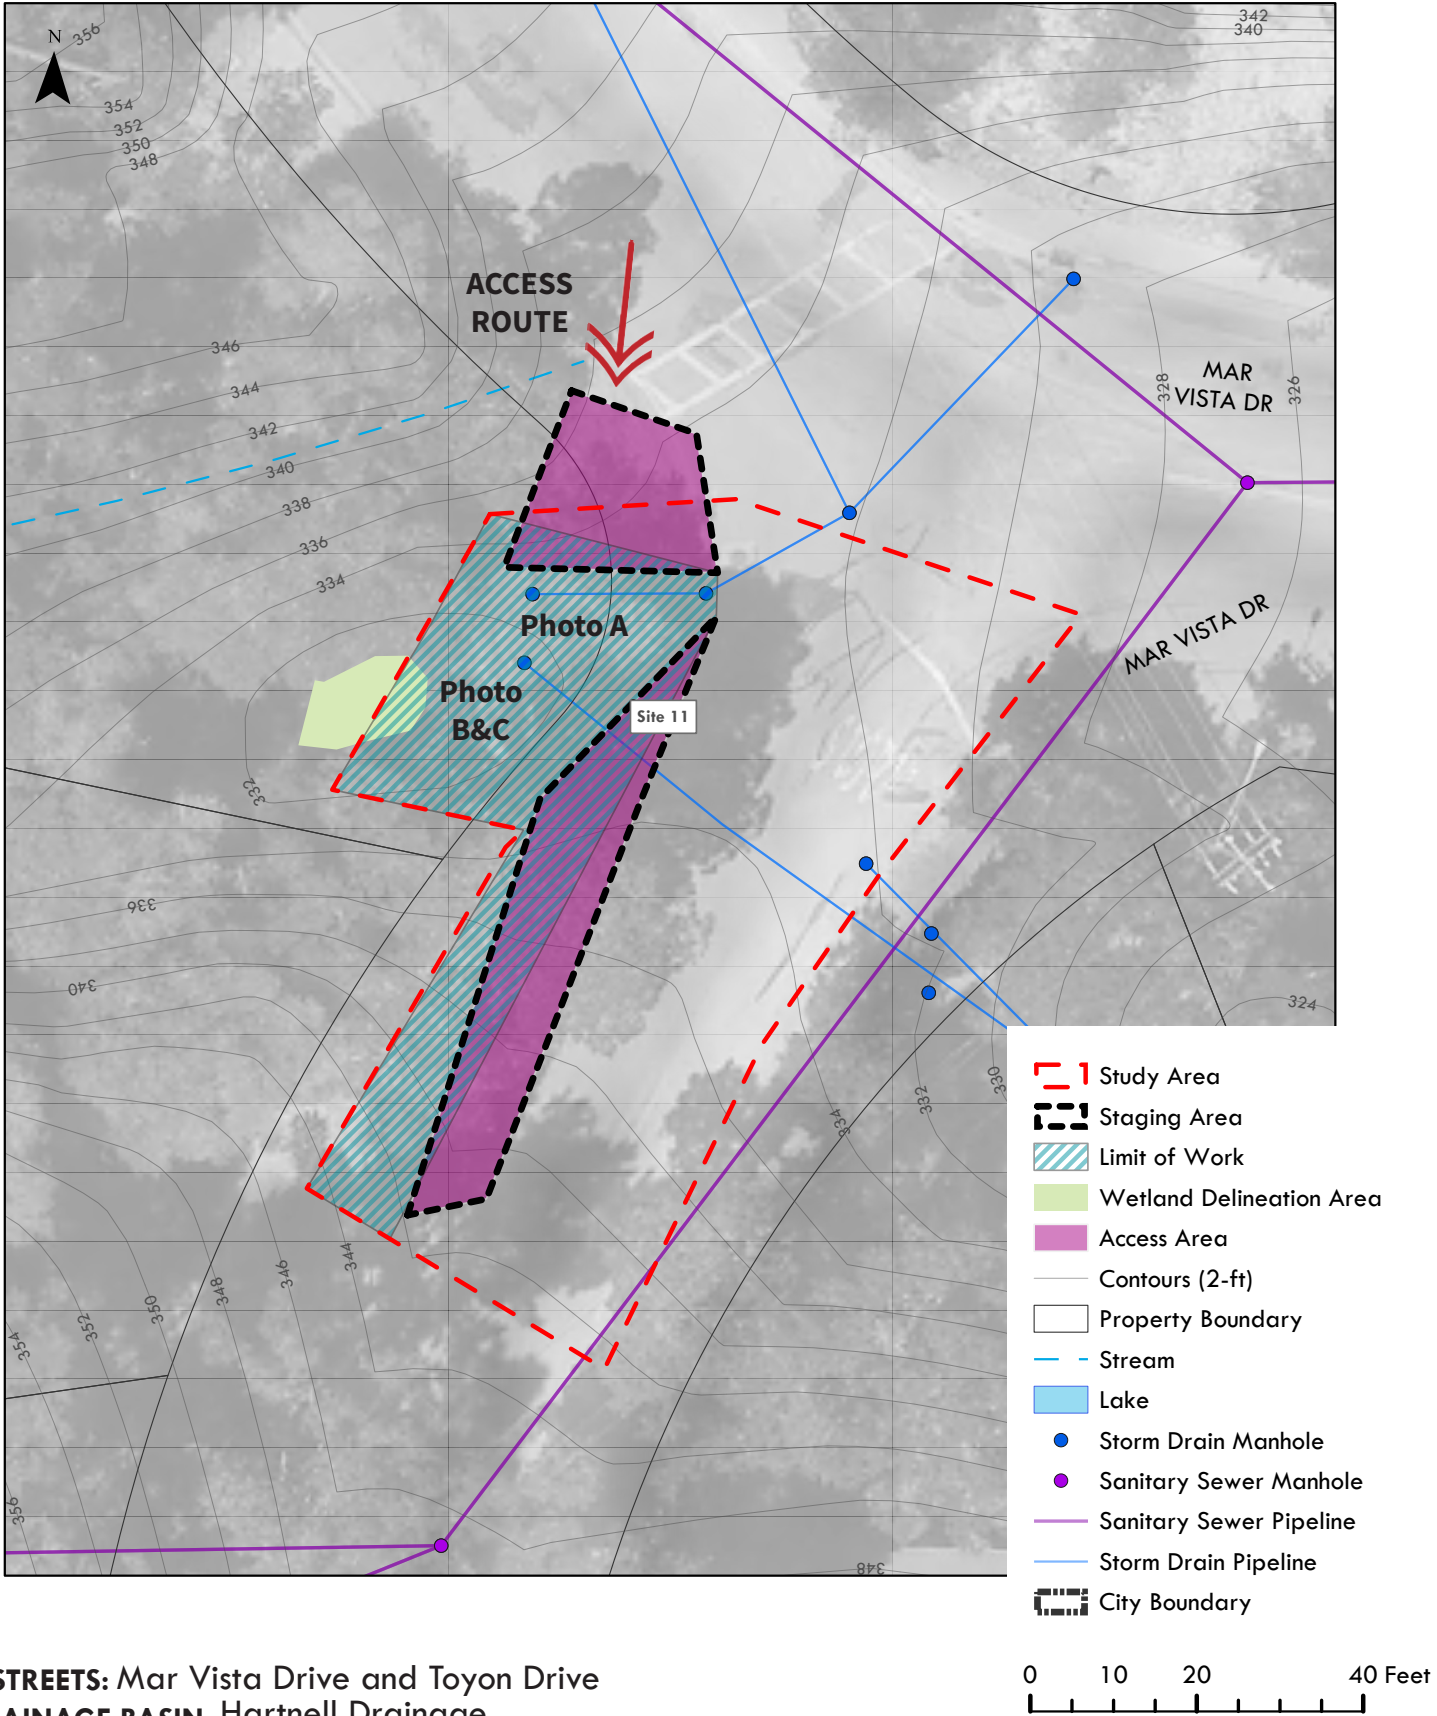
Inspected on September 11, 2017. Site includes an earthen channel near Mar Vista Drive. The channel is approximately 2-ft wide at its base, extending up to an open channel width of approximately 8-ft, with outlet through a trash rack and culvert. Vegetation is mostly dense brush with some trees with 95% vegetative cover observed on banks. Some rock and accumulated sediment was observed along the channel bottom. The adjacent land use includes single family residences and roadways. There were no significant fallen trees or tree limbs and none of the existing infrastructure is known to be undersized. No flood or erosion threats were observed. Vegetation around the culvert inlet was short, allowing adequate access and visibility.

The growth of vegetation in the inlet channels was not preventing access to evaluate condition and maintain facilities nor is it currently reducing the capacity of the system. Sediment accumulation in the channel and vegetation accumulation on the trash rack are maintenance concerns.

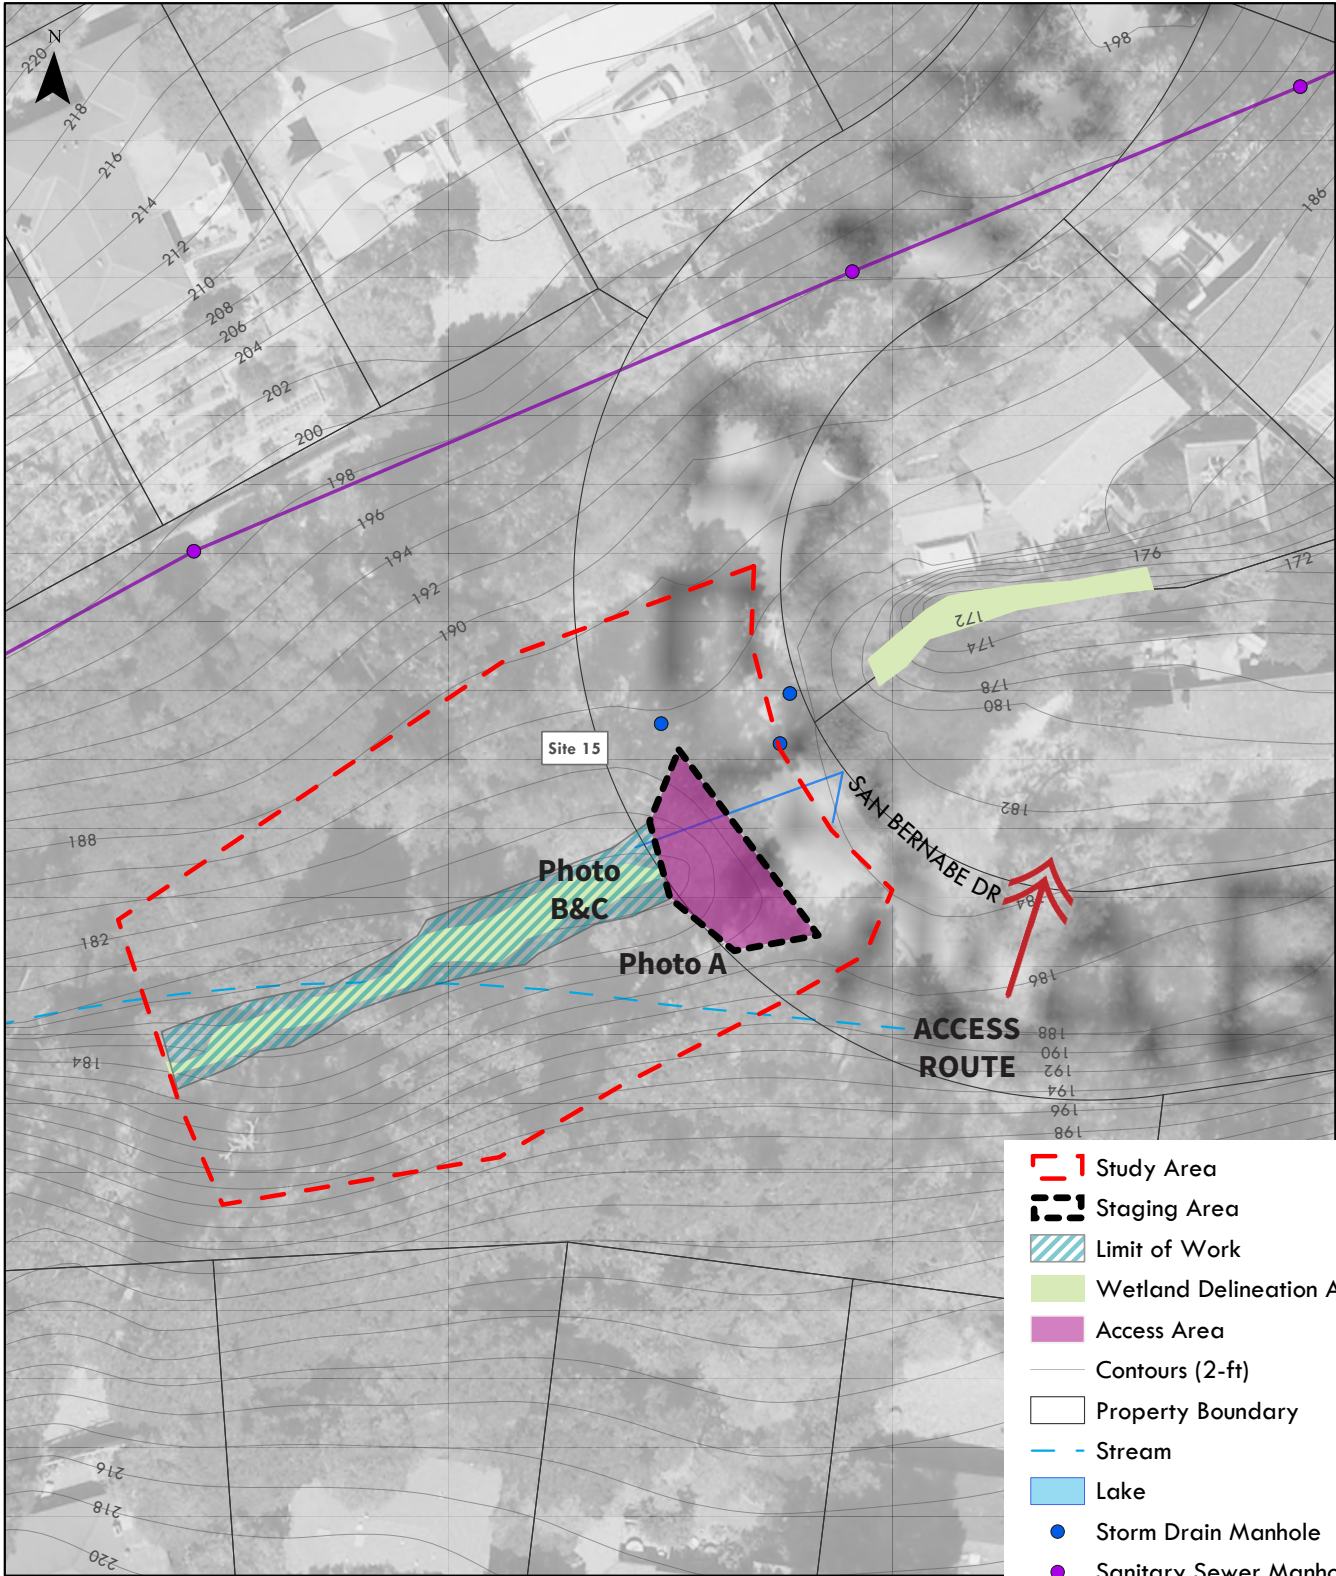
CROSS STREETS: San Bernabe Drive near
CITY DRAINAGE BASIN: Hartnell Drainage

Inspected on September 11, 2017. Site includes an earthen channel flowing through undeveloped land and between residential properties towards San Bernabe Drive. The channel is approximately 2-ft wide at its base extending up to an open channel width of approximately 5-ft. Vegetation is mostly light brush with weeds with 100% vegetative cover observed on banks. No significant rock or accumulated sediment was observed along the channel bottom. Within the limit of work, there were no significant fallen trees or tree limbs and none of the existing infrastructure is known to be undersized. Vegetation around the culvert inlet was limiting access and visibility.

To maintain stormwater conveyance and capacity in the channel, accumulated sediment and vegetation along the channel bottom will be removed annually. The site will be accessed from San Bernabe Drive. Work will be focused within the limits of the channel banks. Chain saws and hand tools (i.e., picks, shovels, rakes, loppers, etc.) will be used to clear and/or limb vegetation overhanging into the channel within the 2-ft bankfull width. A backhoe will be used if big material is identified in the channel or in the event of an emergency. Sediment, trash, and green waste generated from the proposed activities would be disposed of properly at the Monterey Peninsula Landfill in Marina.

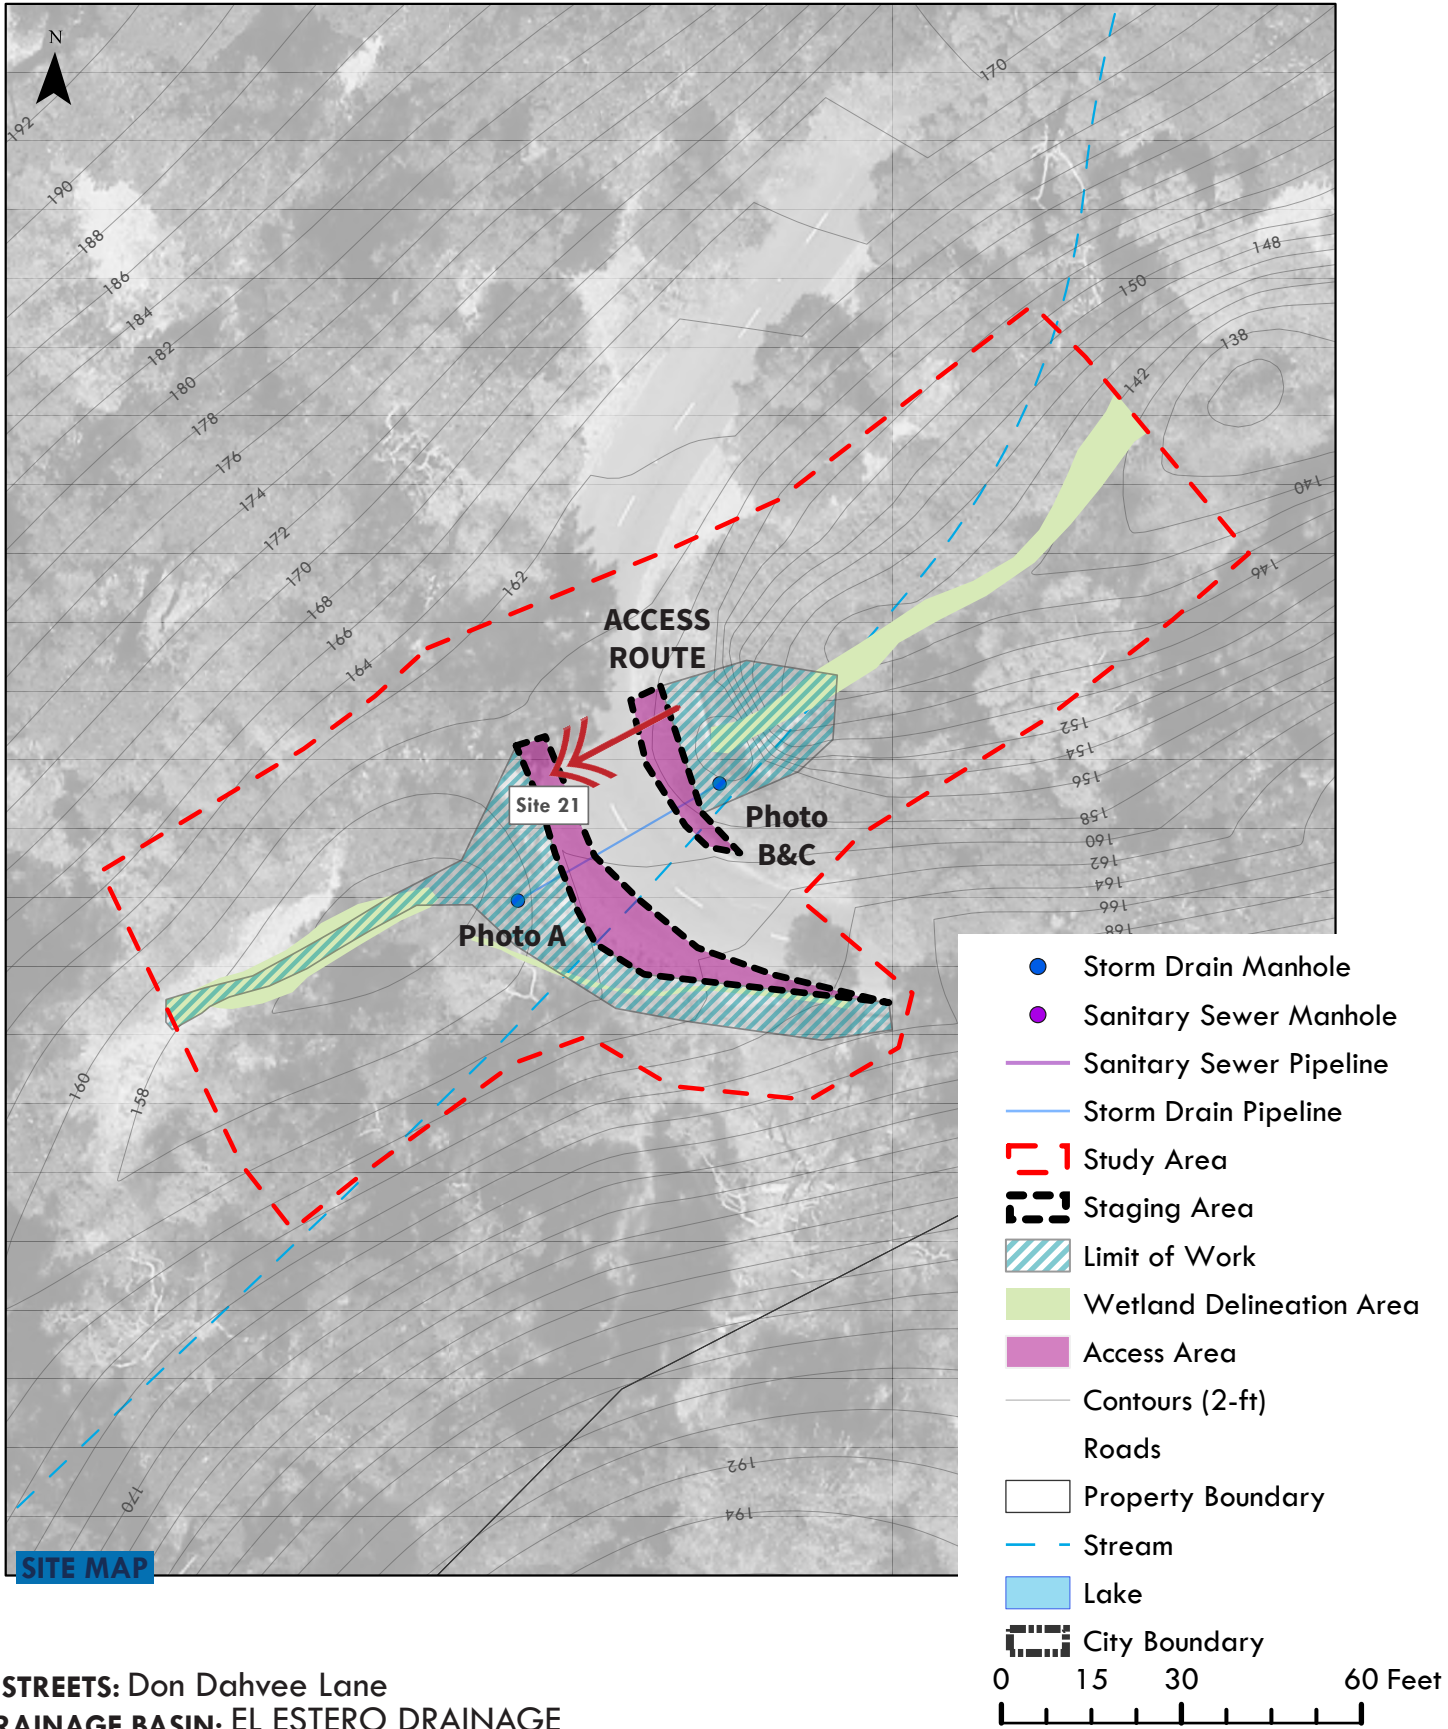
Inspected on September 12, 2017. The adjacent land use includes open space (Don Dahvee Park), roadways, and single family residences. Vegetation is 3-6-ft tall with approximately 90% vegetation cover on the banks. The dense brush on the upstream side especially, prevented inspection of existing infrastructure. There was a 24" diameter tree down across the upstream channel. None of the existing infrastructure is known to be undersized. No flood or erosion threats were observed though vegetation on the northern site obscured an evaluation of the facility condition. The downstream channel has a steep drop from the culvert outlet and roadway into a rock spillway (Photo C).

To maintain stormwater conveyance and capacity, trees within the limit of work will be limbed to maintain access to the channel corridor. Accumulated sediment and debris within the bankfull channel will be removed. To maintain inlet function and capacity, vegetation along the inlet channels and adjacent banks will be removed annually. Access would occur from Don Dahvee Lane. Equipment that would be used to maintain the site include a backhoe, dump trucks, chain saws, and hand tools (i.e., picks, shovels, rakes, loppers, etc.). Sediment, trash, and green waste generated from the proposed activities would be disposed of properly at the Monterey Peninsula Landfill in Marina.
