Storm Drainage Maintenance Plan

City of Monterey

Storm Drainage Maintenance Plan (SDMP)

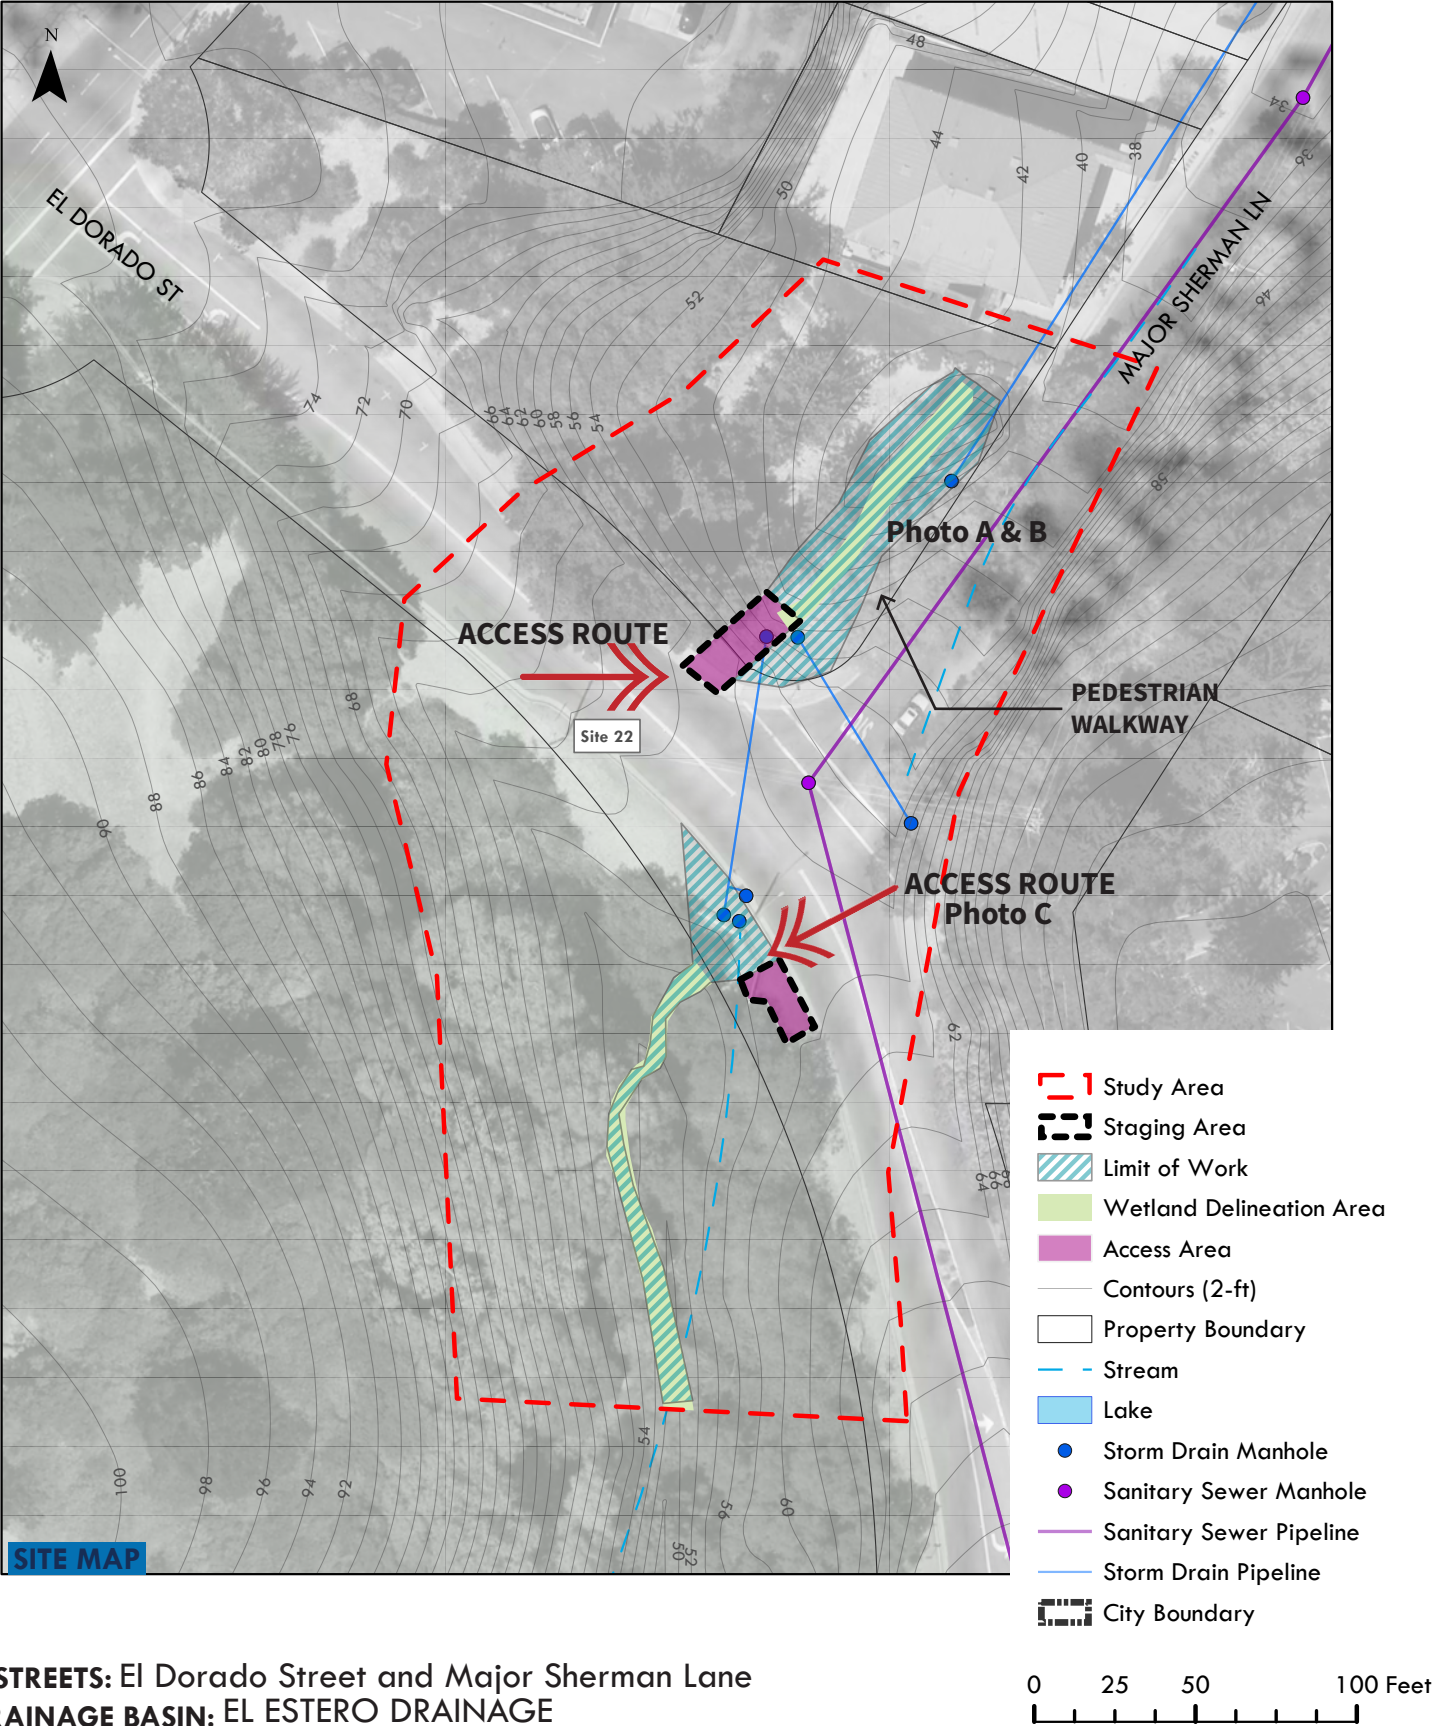
Inspected on September 13, 2017. The channel bankfull width is approximately 12-ft upstream of El Dorado Street and a trash rack on the upstream culvert inlet was clear of debris though an 8-ft long 18-inch diameter downed tree was crossing the channel upstream of the trash rack. The downstream channel section has incised approximately 5-ft below the invert of the culvert outlet and bank erosion was observed. Dense brush and trees were established along the channel banks in both the upstream and downstream sections. The adjacent land use includes professional buildings, Don Dahvee Park, single family residences, and roadways. None of the existing infrastructure is known to be undersized and no flood threats were observed. Vegetation around the culvert inlet was short, allowing adequate access and visibility, though on the downstream side overgrown vegetation limited visibility of the culvert outlets.

On the upstream side, the site will be accessed via an existing gate off of El Dorado Street (Photo C). On the downstream side, access will need to occur from El Dorado Street or the northern side of the adjacent private property or for work with hand tools, down the banks next to the pedestrian walkway parallel to Major Sherman Lane. Work will be focused within the limits of the channel banks. Chain saws and hand tools (i.e., picks, shovels, rakes, loppers, etc.) will be used to clear and/or limb vegetation overhanging into the channel bankfull width. A backhoe and dump truck would be used to clear overgrown vegetation and accumulated material in the trash rack vicinity. Sediment, trash, and green waste generated from the proposed activities would be disposed of properly at the Monterey Peninsula Landfill in Marina.

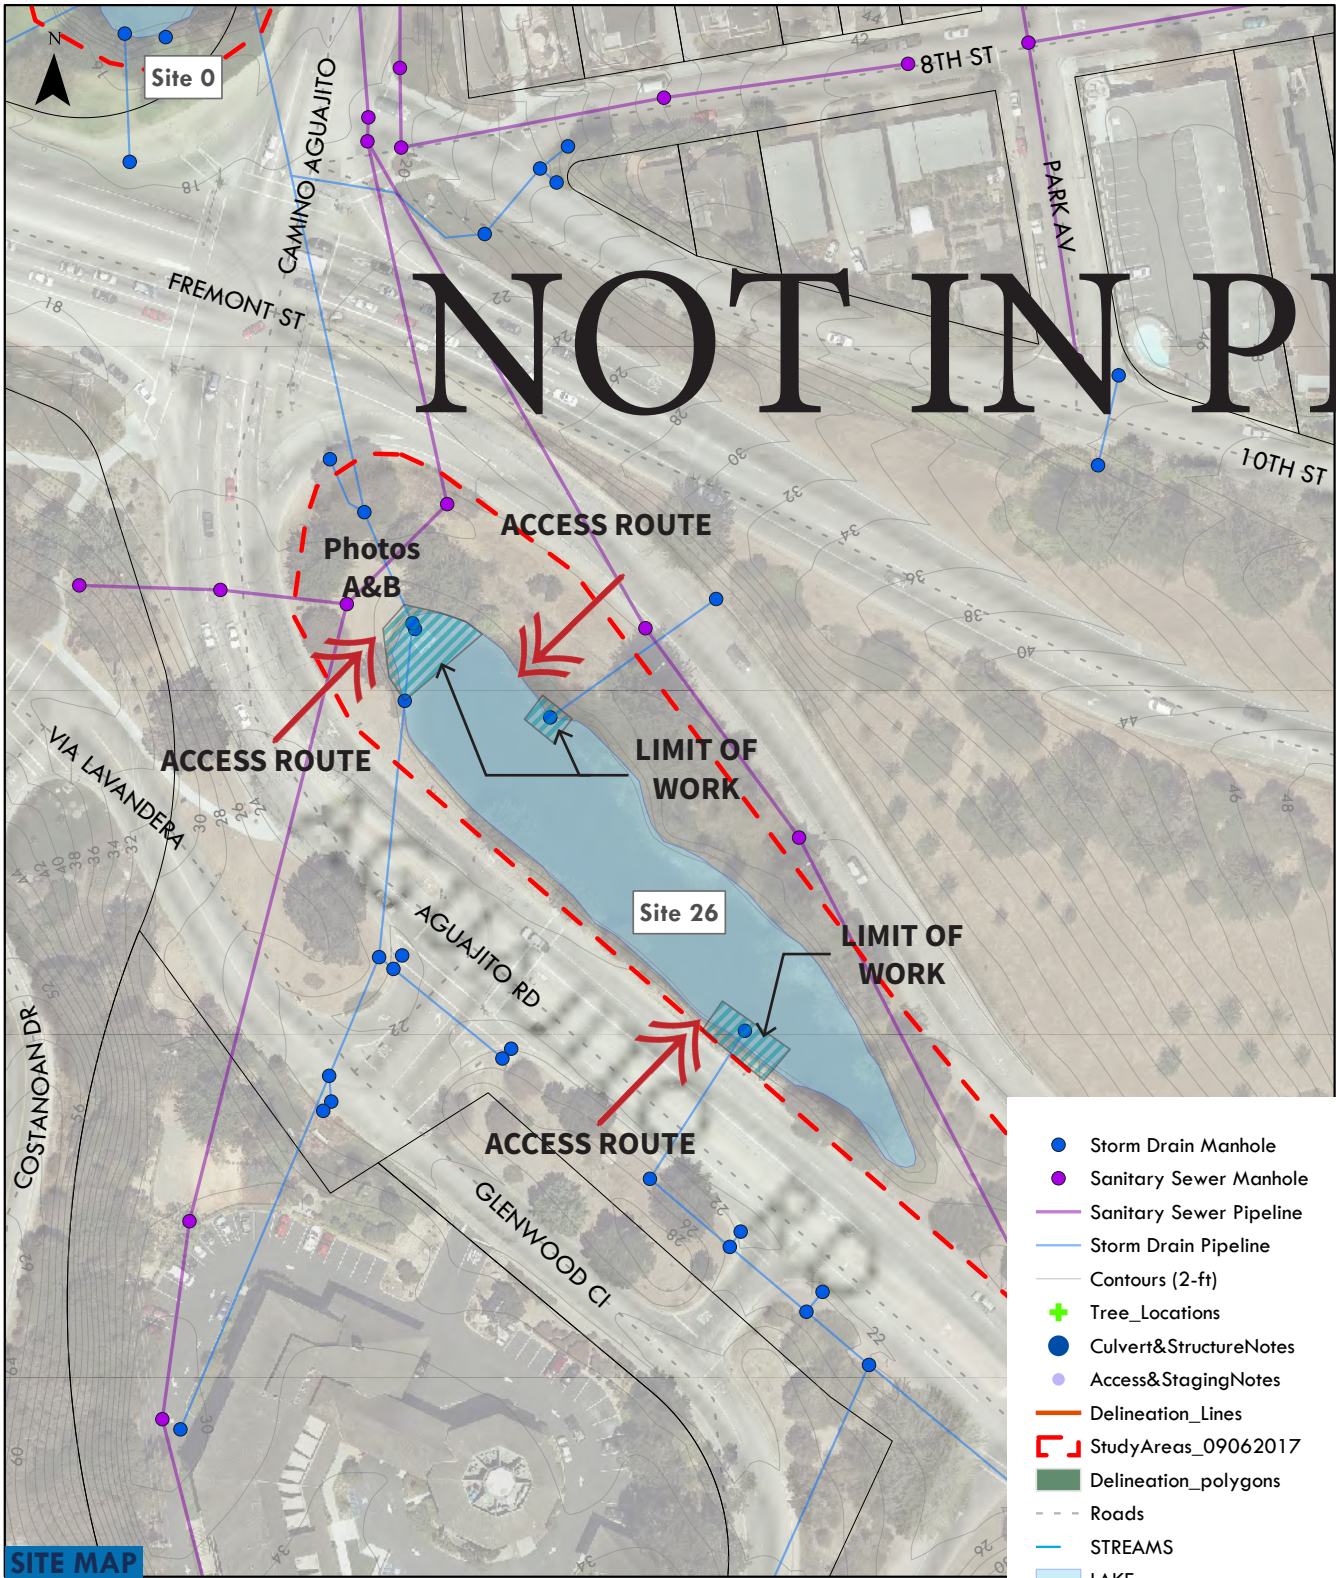
Inspected on September 12, 2017. Dense vegetation, 10-12-ft in height, extends from the pond perimeter towards the center of the pond, becoming less dense towards with distance from the pond bank. Light brush and weeds provides 100% coverage along the pond banks. The adjacent land use is predominantly roadways and medians. No significant fallen trees or tree limbs were observed and none of the existing infrastructure is known to be undersized. No flood or erosion threats were observed, though visibility was limited due to the extent and density of vegetation. Vegetation around the pond outlet and trash rack was dense and overgrown, preventing adequate access and visibility to maintain the structure.

To maintain stormwater conveyance and capacity in the pond, accumulated sediment and vegetation in the vicinity of the inlets and outlet will be removed annually. The site will be accessed from three locations; two from Aguajito Road and a third from Fremont Street. Equipment that would be used to maintain the site include a backhoe, dump trucks, chain saws, and hand tools (i.e., picks, shovels, rakes, loppers, etc.). Sediment, trash, and green waste generated from the proposed activities would be disposed of properly at the Monterey Peninsula Landfill in Marina.

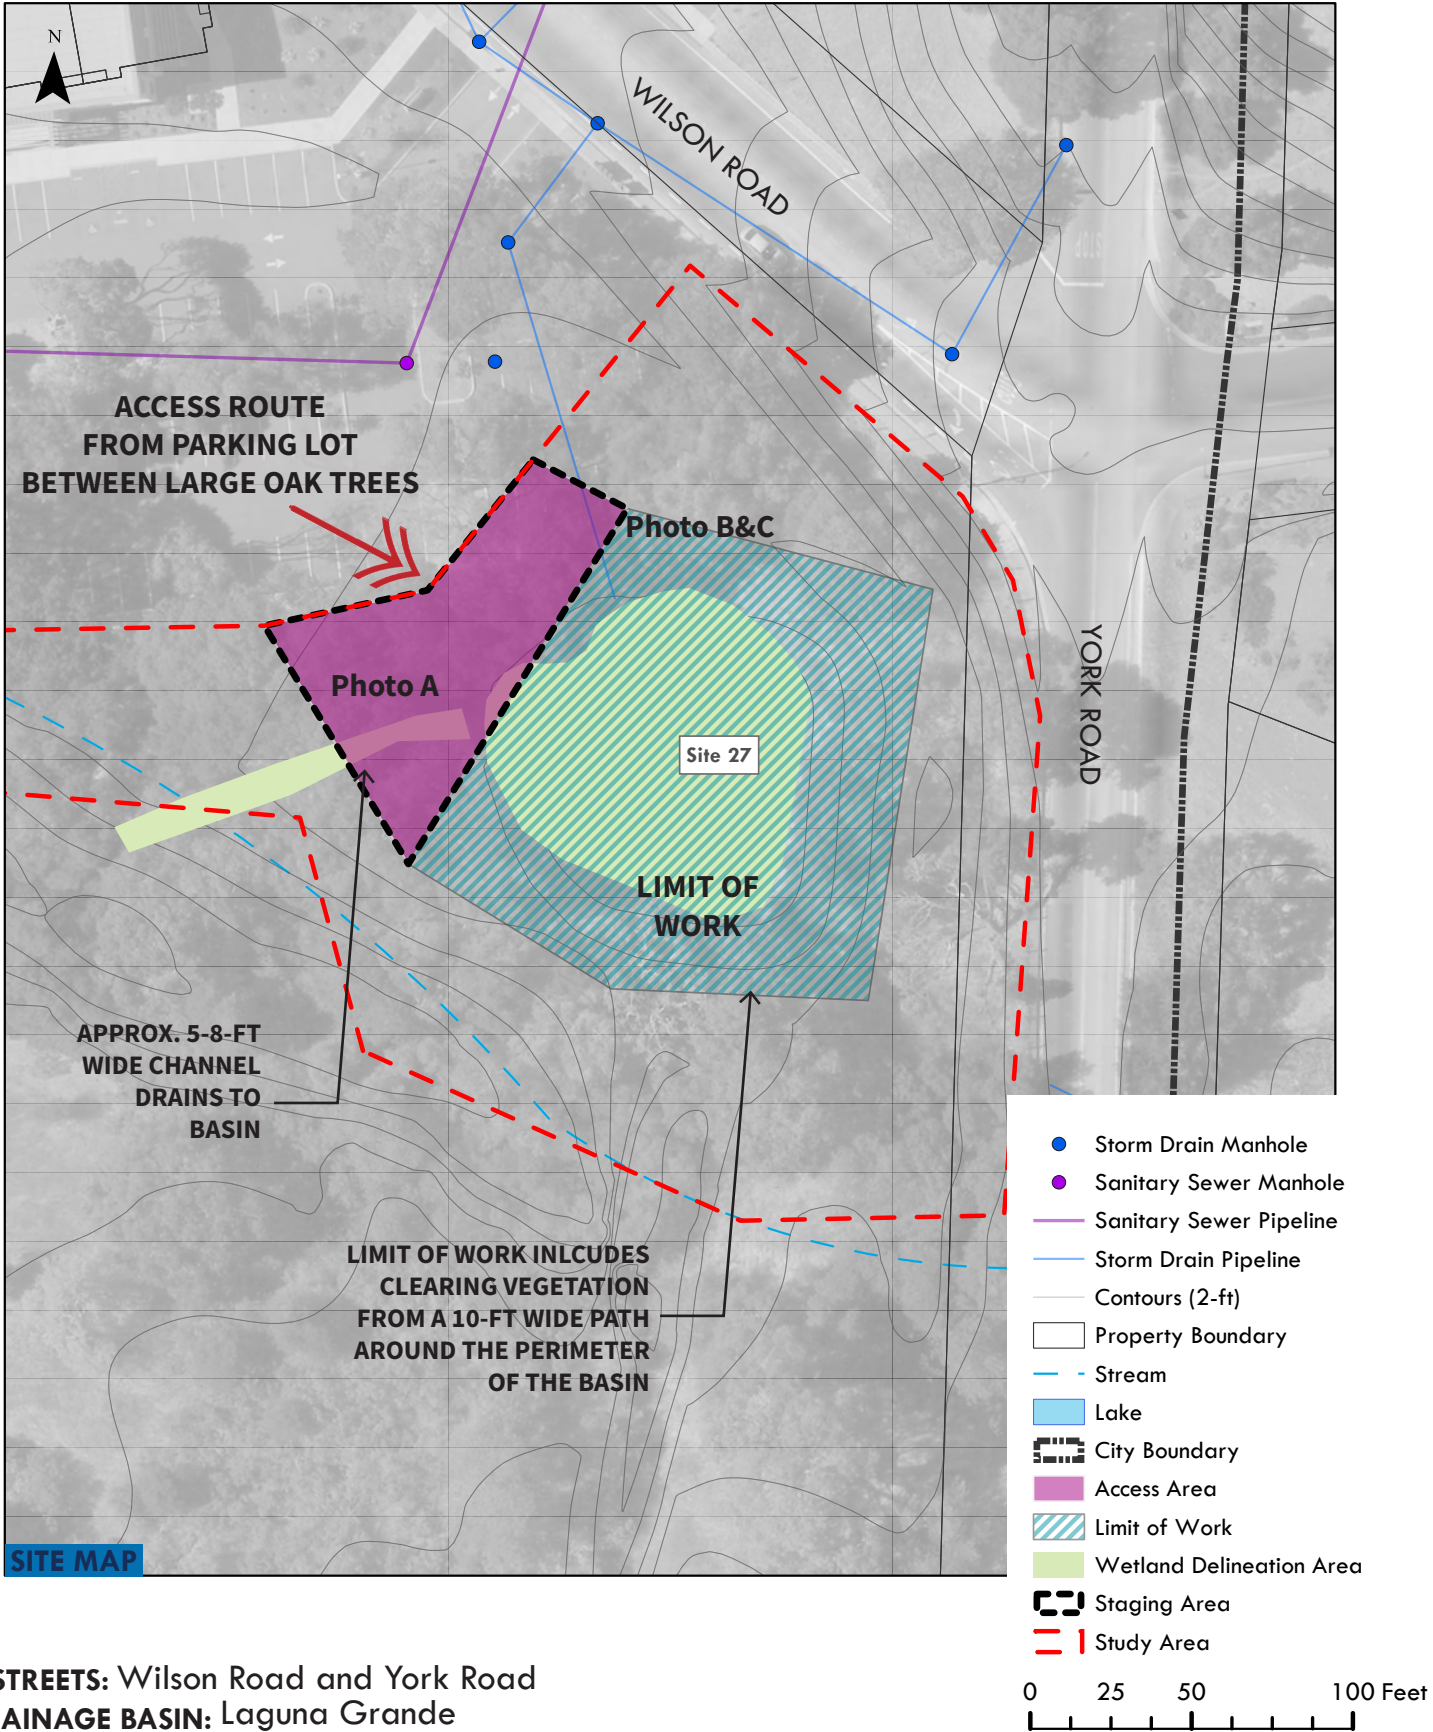
Inspected on September 12, 2017. Site vegetation is light density brush and weeds with 3-4 ft tall shrub and grasses (french broom) in the basin bottom and banks with approximately 60% vegetation cover on the banks. The adjacent land use includes Highway 68 and the Ryan Ranch Industrial Park and the area is zoned as Industrial in the City's General Plan. The area in the immediate vicinity of the detention basin is a parking lot for medical offices. There were no significant fallen trees or tree limbs and none of the existing basin infrastructure is known to be undersized. No flood or erosion threats were observed. A 5 to 8-ft wide channel drains to the basin from the west.

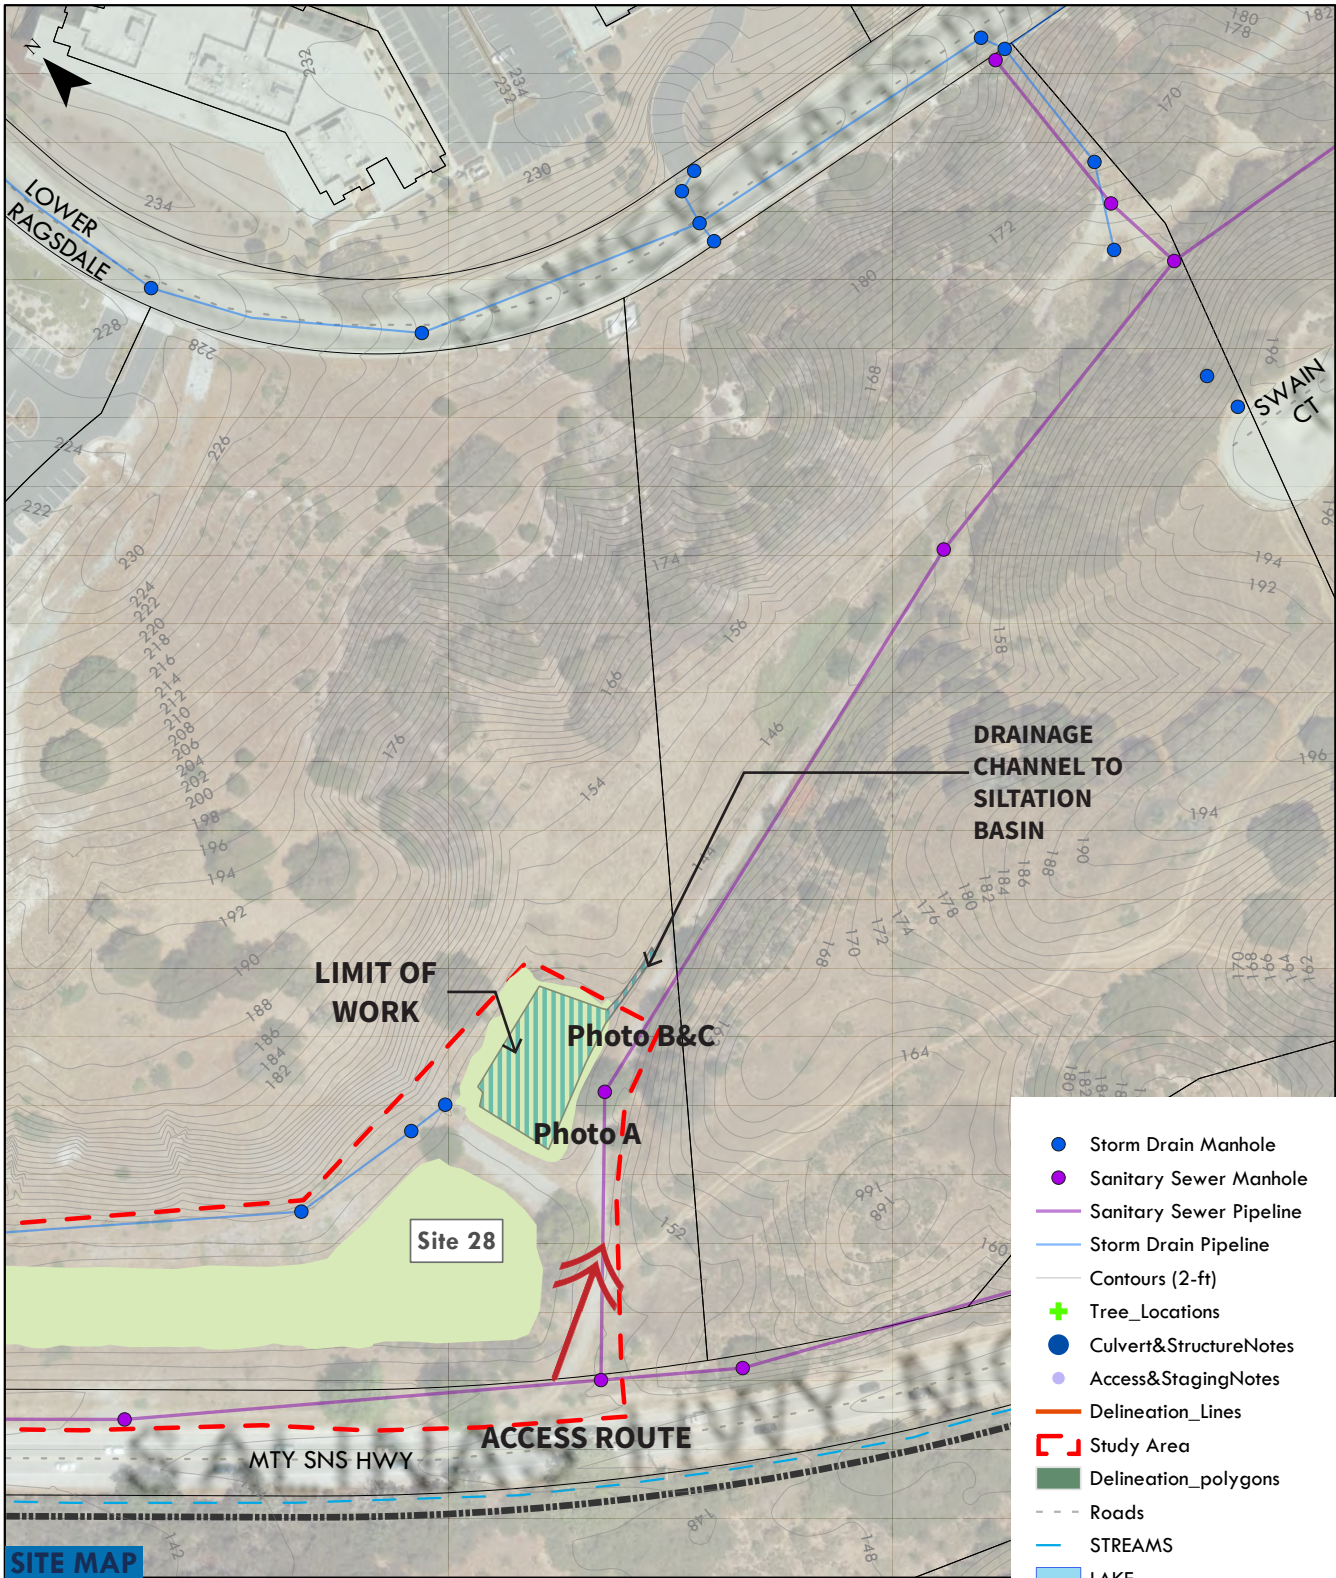
LOCATION & SITE DESCRIPTION

Inspected on September 12, 2017. Site vegetation is light density brush and weeds with 10-12 ft tall willows with approximately 60% vegetation cover on the banks. The adjacent land use includes Highway 68 and the Ryan Ranch Industrial Park and the area is zoned as Industrial in the City’s General Plan. The area in the immediate vicinity of basin is open space. There were no significant fallen trees or tree limbs and none of the existing basin infrastructure is known to be undersized. Areas of sedimentation and erosion were observed related to a slope failure/landslide on the north/north-east slope above the Basin.

Capacity and function of the basin is reduced by the presence of vegetation and accrual of sediment. The sediment and debris from the slope failure has overwhelmed the Basin and the incoming drainage channel that enters from the east. As a result of the channel being choked with sediment from the slope failure, storm flows will be forced into the adjacent sewer easement road; potentially causing erosion along the roadway and risking exposure of the sewer line. The Study Area does not include the extents of the slope failure, and the proposed maintenance activities described in the project description do not include restoration of the flow path/drainage channel into the siltation basin.

To maintain the function and capacity of the siltation basin the City proposes to remove accumulated sediment and vegetation from within the bottom of the detention basin and in the drainage channel entering from the east, 1-2 times per year. The site would be accessed from Highway 68 onto an access road that parallels a sewer easement. Equipment that would be used to maintain the site include a backhoe, dump trucks, chain saws, and hand tools (i.e., picks, shovels, rakes, loppers, etc.). Sediment, trash, and green waste generated from the proposed activities would be disposed of properly at the Monterey Peninsula Landfill in Marina.

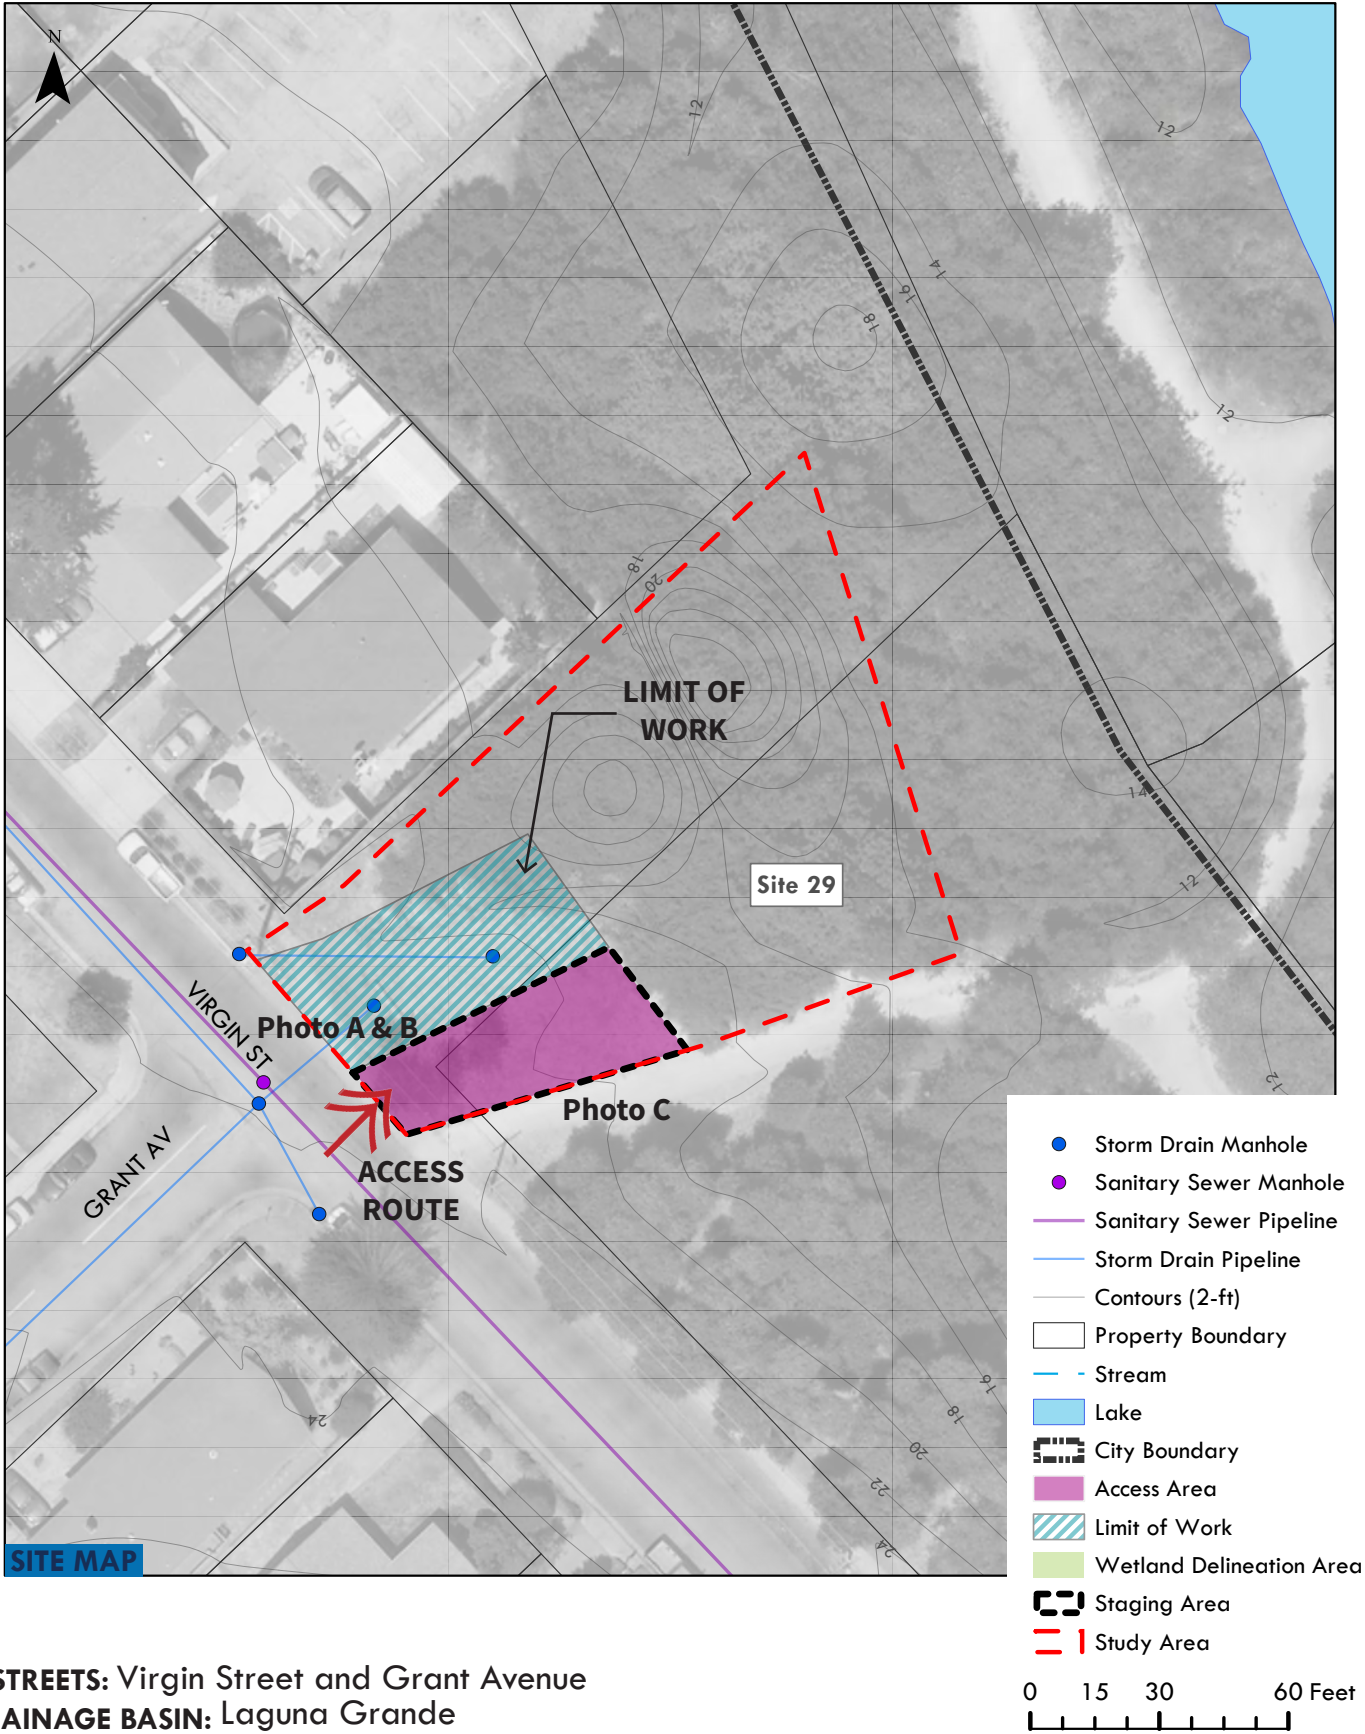
LOCATION & SITE DESCRIPTION

Inspected on September 12, 2017. Site includes a low density stormwater swale that drains from east to west towards dense riparian vegetation extending around the border of Laguna Grande. Vegetation in the stormwater swale is approximately 2-ft tall, whereas the riparian vegation is 8-10-ft tall willow. In both cases approximately 60% vegetation cover on the banks was observed. The adjacent land use includes single family residences and public park land. There were no significant fallen trees or tree limbs and none of the existing infrastructure is known to be undersized. No flood or erosion threats were observed. Vegetation around the inlet to the stormwater swale was short, allowing access and visibility to the storm water inlet and channel.

The growth of vegetation in the inlet channel was not preventing access to evaluate condition and maintain facilities nor is it currently reducing the capacity of the system. Sediment accumulation does not appear to be as significant of a maintenance concern compared to overgrown vegetation. The observed condition is how the City proposes to maintain the swale in future as part of the annual maintenance practices.

To maintain stormwater swale function and capacity, vegetation along the inlet channel and adjacent banks will be removed annually. The site will be accessed from Virgin Street, along the southern bank of the swale. Work will not extend east of the existing taller riparian vegetation. Equipment that will be used to maintain the site include a backhoe, dump trucks, chain saws, and hand tools (i.e., picks, shovels, rakes, loppers, etc.). Sediment, trash, and green waste generated from the proposed activities would be disposed of properly at the Monterey Peninsula Landfill in Marina.

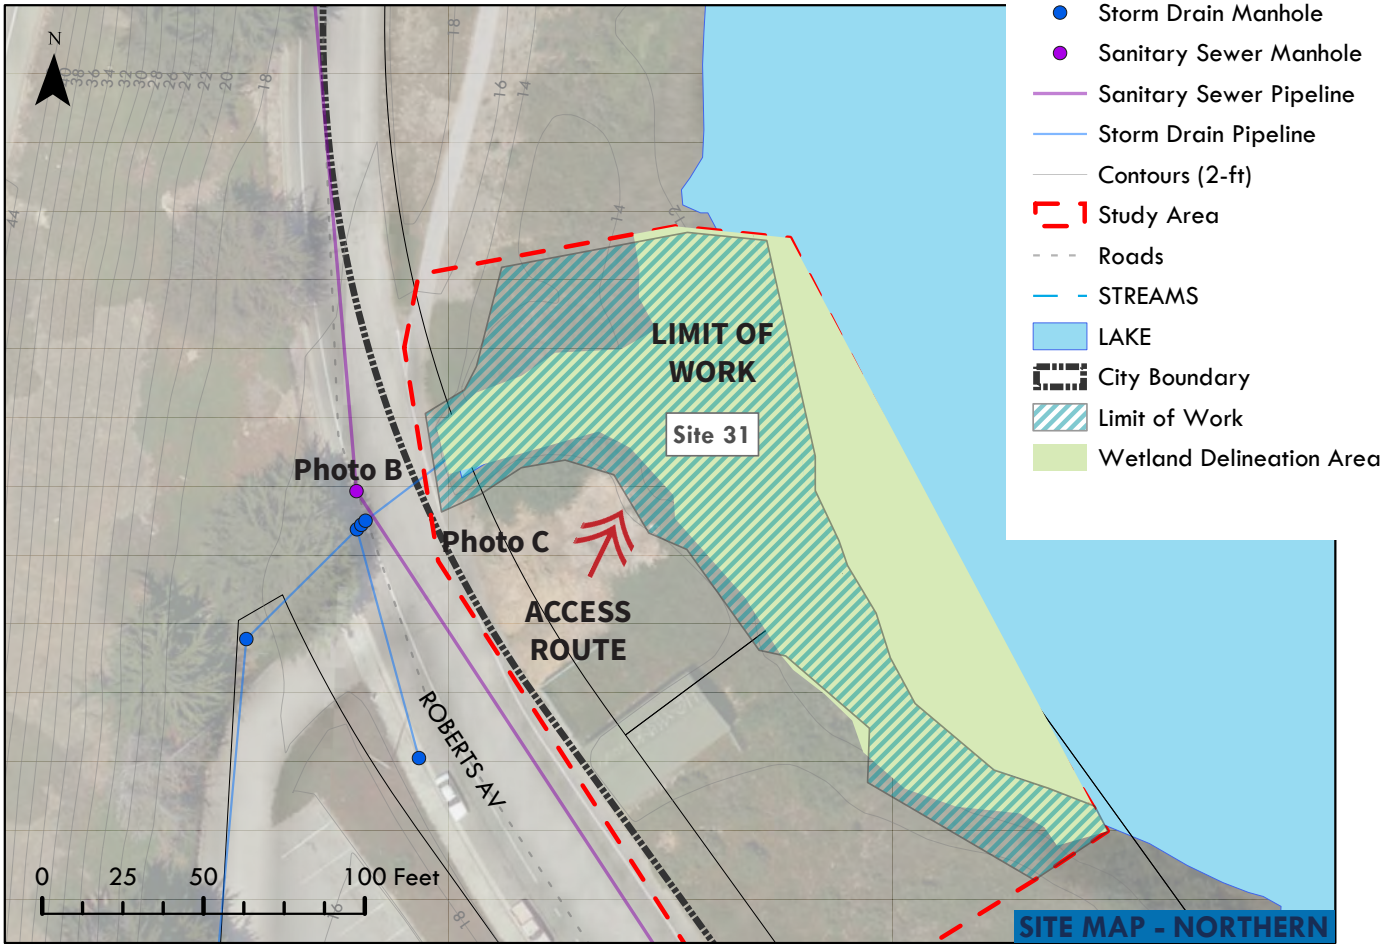
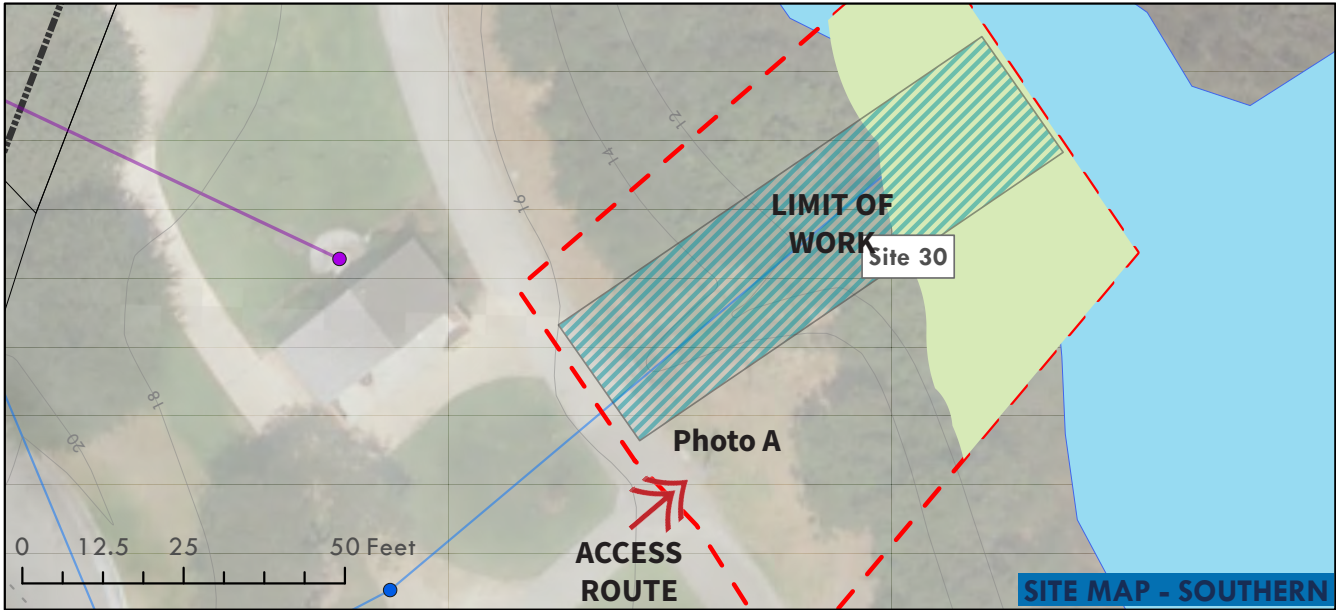
LOCATION & SITE DESCRIPTION

The growth of vegetation in the inlet channels is preventing access to evaluate condition and maintain facilities and is reducing the capacity of the system. Sediment accumulation does not appear to be as significant of a maintenance concern at either location, compared to overgrown vegetation.

To maintain inlet function and capacity, vegetation along the inlet channel and adjacent banks will be removed annually. The northern site would be accessed from Roberts Avenue and the southern site from Virgin Avenue. At the northern site, work would extend from the top of bank to the edge of open water and equipment that would be used to maintain the site include a backhoe, dump trucks, chain saws, and hand tools (i.e., picks, shovels, rakes, loppers, etc.). At the southern site hand tools and chain saws would be used to limb trees and increase visibility to the existing infrastructure. Sediment, trash, and green waste generated from the proposed activities would be disposed of properly at the Monterey Peninsula Landfill in Marina.

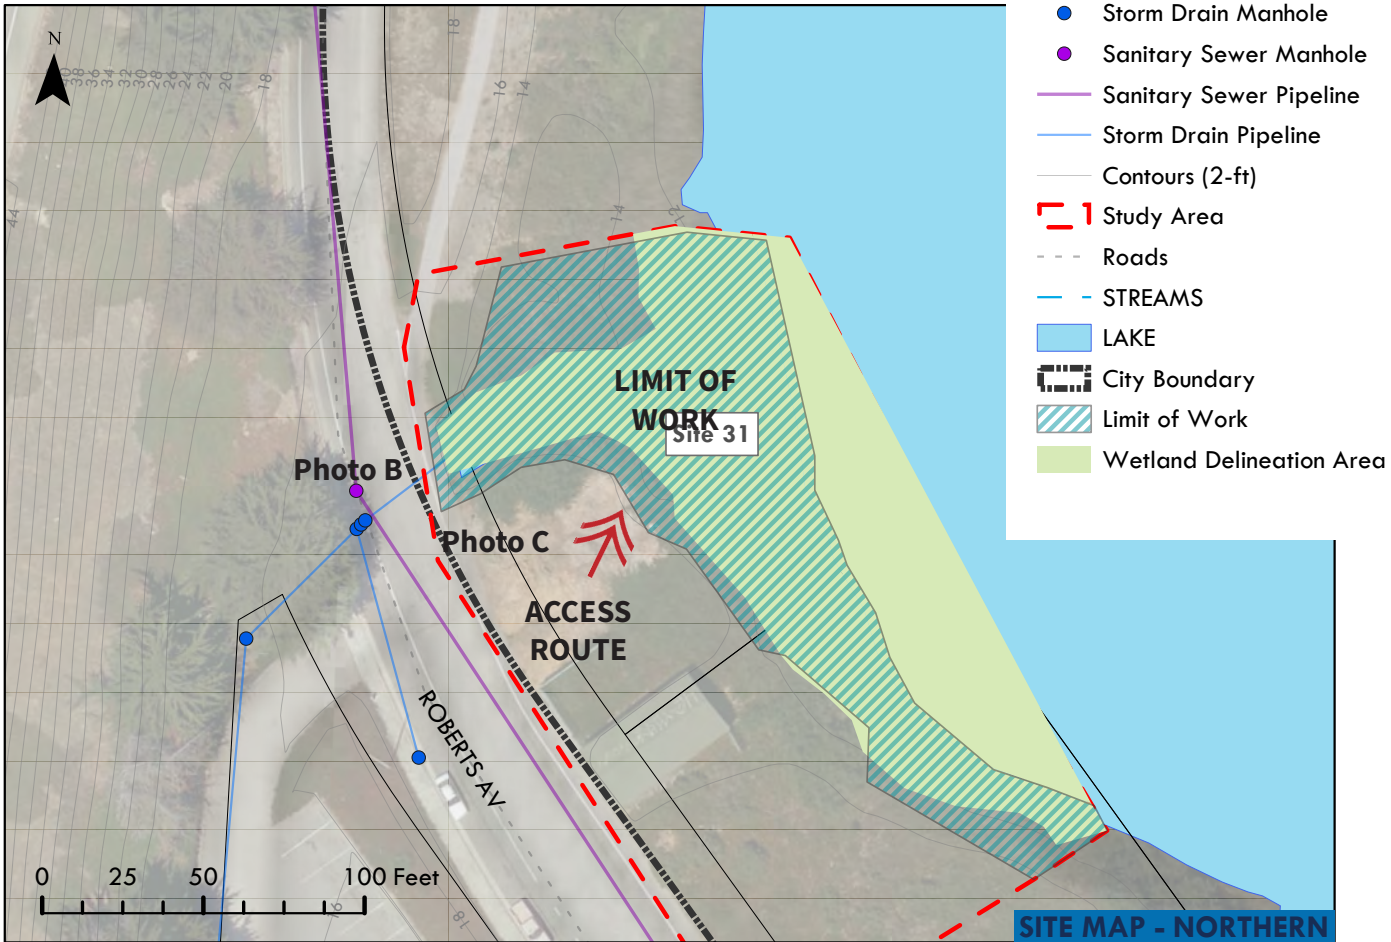
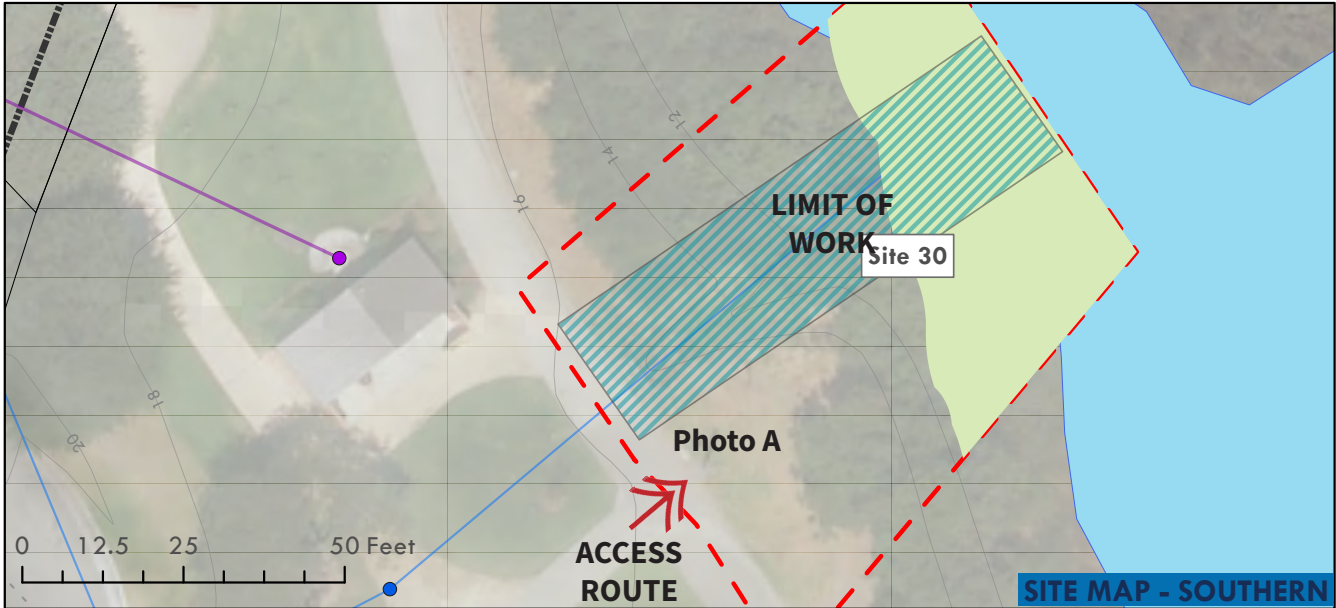
LOCATION & SITE DESCRIPTION

The growth of vegetation in the inlet channels is preventing access to evaluate condition and maintain facilities and is reducing the capacity of the system. Sediment accumulation does not appear to be as significant of a maintenance concern at either location, compared to overgrown vegetation.

To maintain inlet function and capacity, vegetation along the inlet channel and adjacent banks will be removed annually. The northern site would be accessed from Roberts Avenue and the southern site from Virgin Avenue. At the northern site, work would extend from the top of bank to the edge of open water and equipment that would be used to maintain the site include a backhoe, dump trucks, chain saws, and hand tools (i.e., picks, shovels, rakes, loppers, etc.). At the southern site hand tools and chain saws would be used to limb trees and increase visibility to the existing infrastructure. Sediment, trash, and green waste generated from the proposed activities would be disposed of properly at the Monterey Peninsula Landfill in Marina.

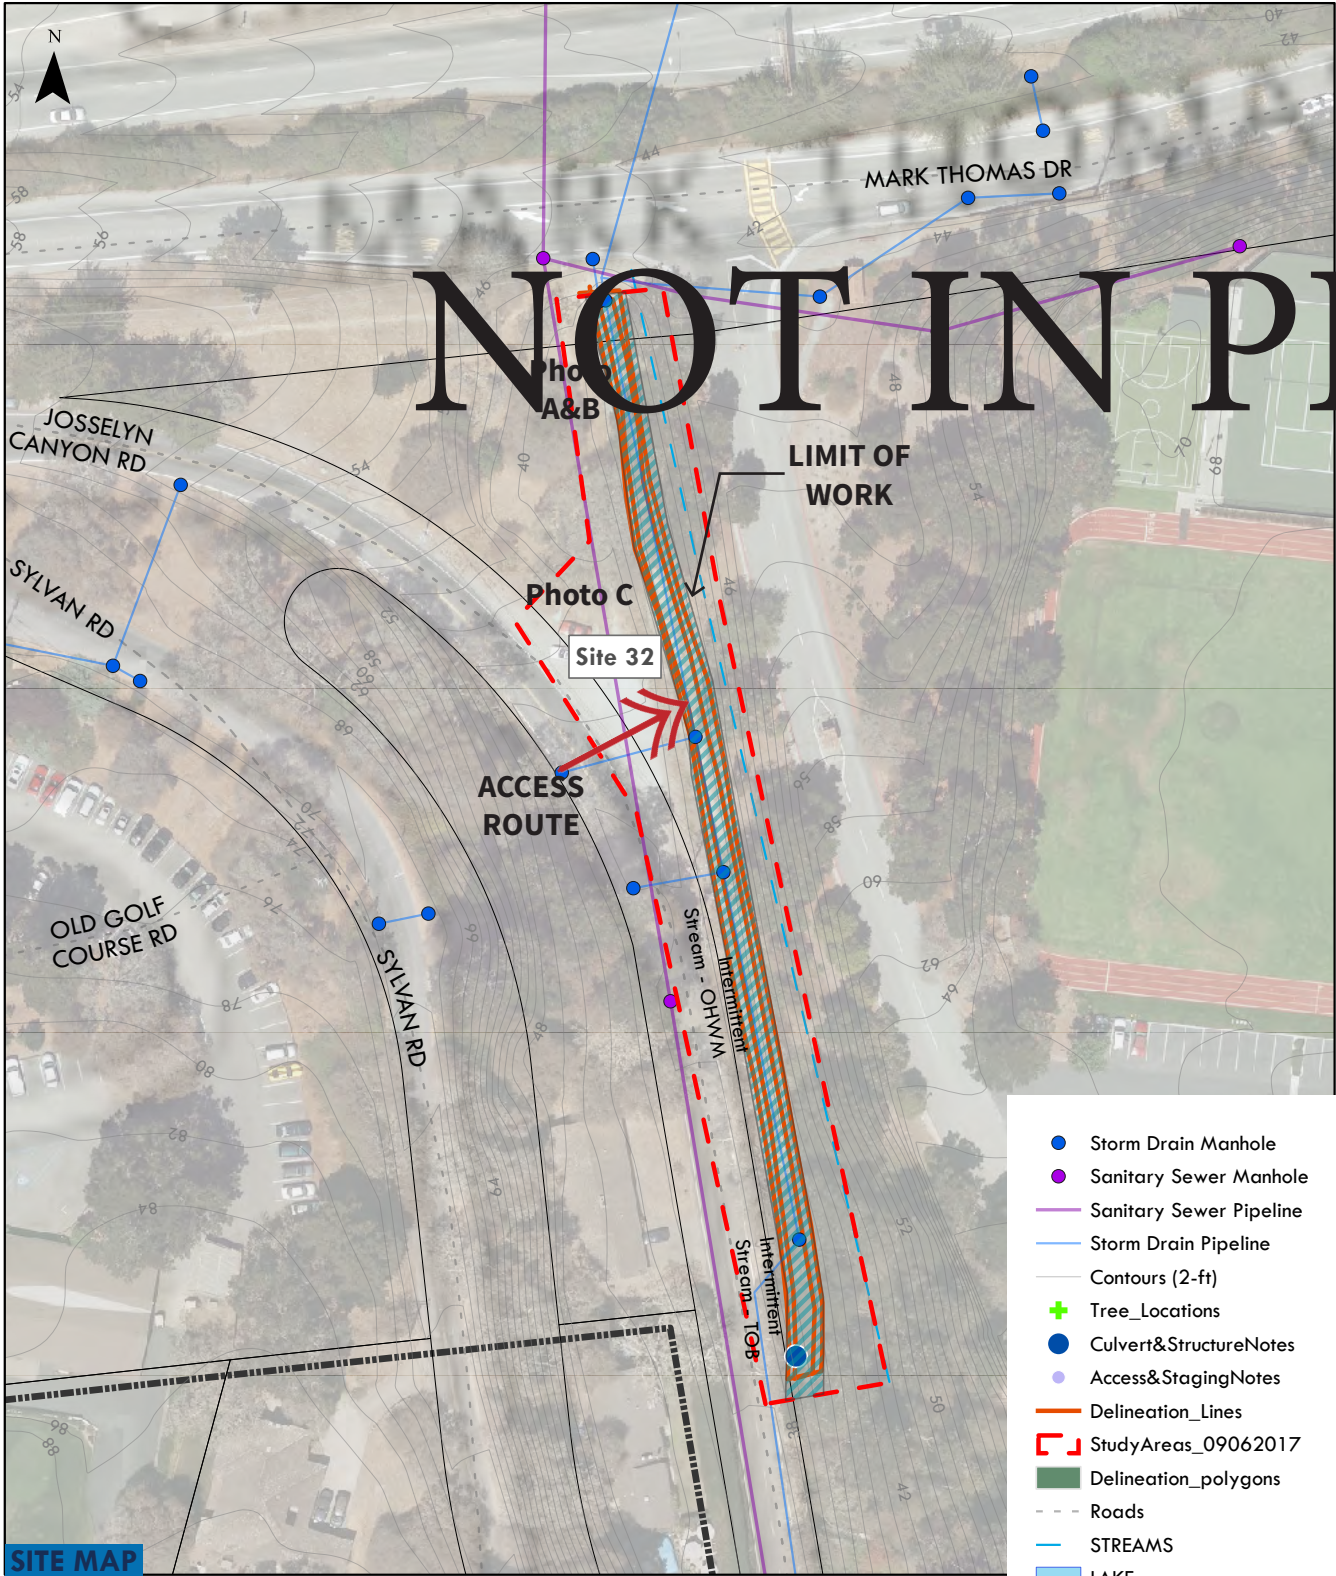
LOCATION & SITE DESCRIPTION

The growth of vegetation in the inlet channels was not preventing access to evaluate condition and maintain facilities nor is it currently reducing the capacity of the system. Sediment accumulation in the channel is a maintenance concern.

To maintain stormwater conveyance and capacity in the concrete channel, accumulated sediment along the channel bottom will be removed annually. The site will be accessed from Josselyn Canyon Road, along the western channel bank. Work will be focused within the limits of the concrete channel banks. A bobcat within the channel will push channel sediment and vegetation to a single location where it can be accessed and removed by a backhoe and placed in a dump truck. Chain saws and hand tools (i.e., picks, shovels, rakes, loppers, etc.) will be used to clear and/or limb vegetation overhanging into the channel within the 4-ft bankfull width. Sediment, trash, and green waste generated from the proposed activities would be disposed of properly at the Monterey Peninsula Landfill in Marina.
