Storm Drainage Maintenance Plan

City of Monterey

Storm Drainage Maintenance Plan (SDMP)

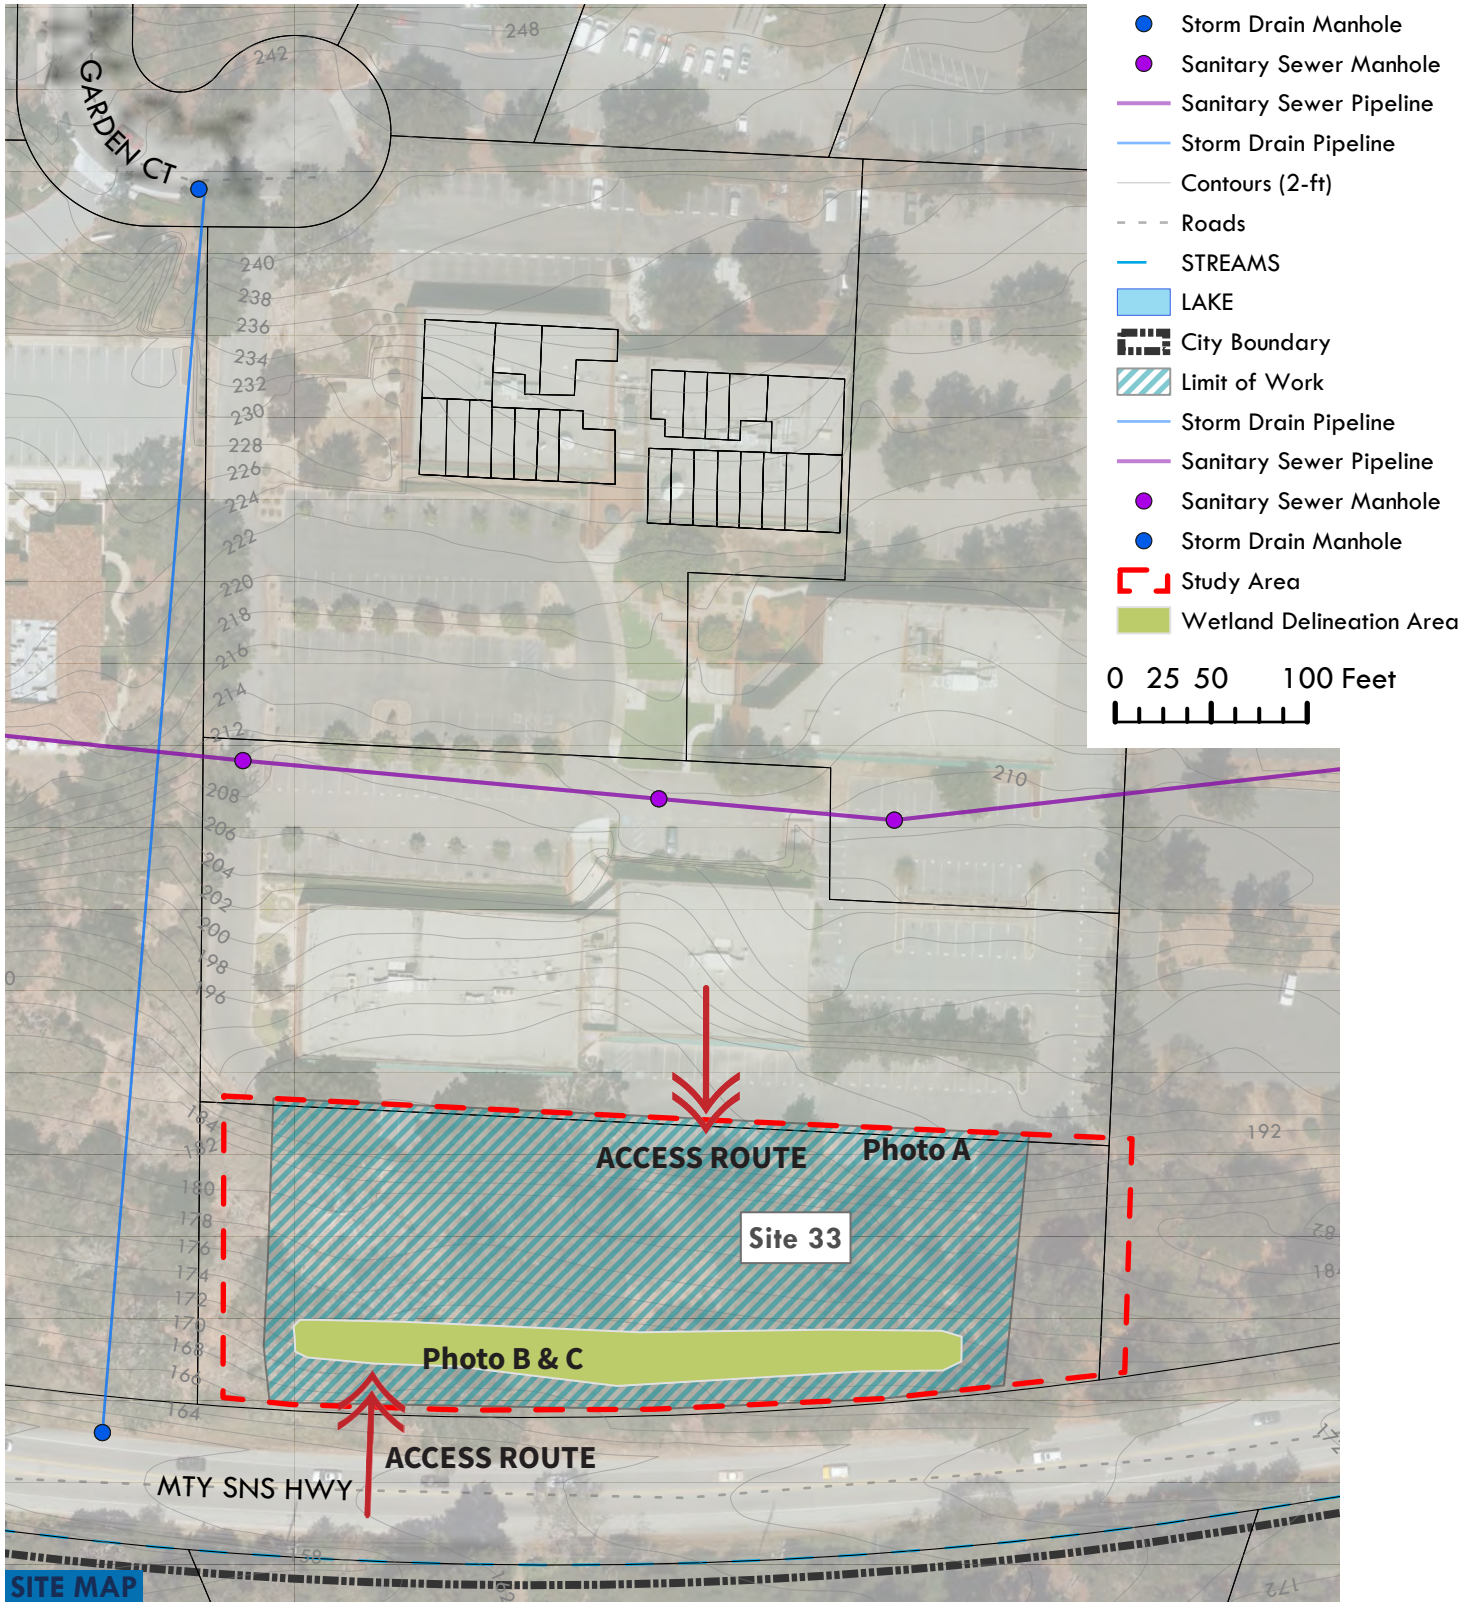
LOCATION & SITE DESCRIPTION

Erosion was observed in the vicinity of the basin overflow structure. To maintain stormwater conveyance and capacity, fallen limbs and trees will be removed and trees within the limit of work will be selectively limbed to maintain access and return the feature to design capacity. Failure of the concrete around an inlet catchbasin in the parking lot (Photo A) was observed and should be repaired in coordination with the neighboring property owner of the commercial complex.

To the north, the site will be accessed via the commercial building complex, and from the south from Highway 68. Work will be focused within the limits of the basin. Chain saws and hand tools (i.e., picks, shovels, rakes, loppers, etc.) will be used to clear and/or limb vegetation overhanging into or crossing the basin. Sediment, trash, and green waste generated from the proposed activities would be disposed of properly at the Monterey Peninsula Landfill in Marina.

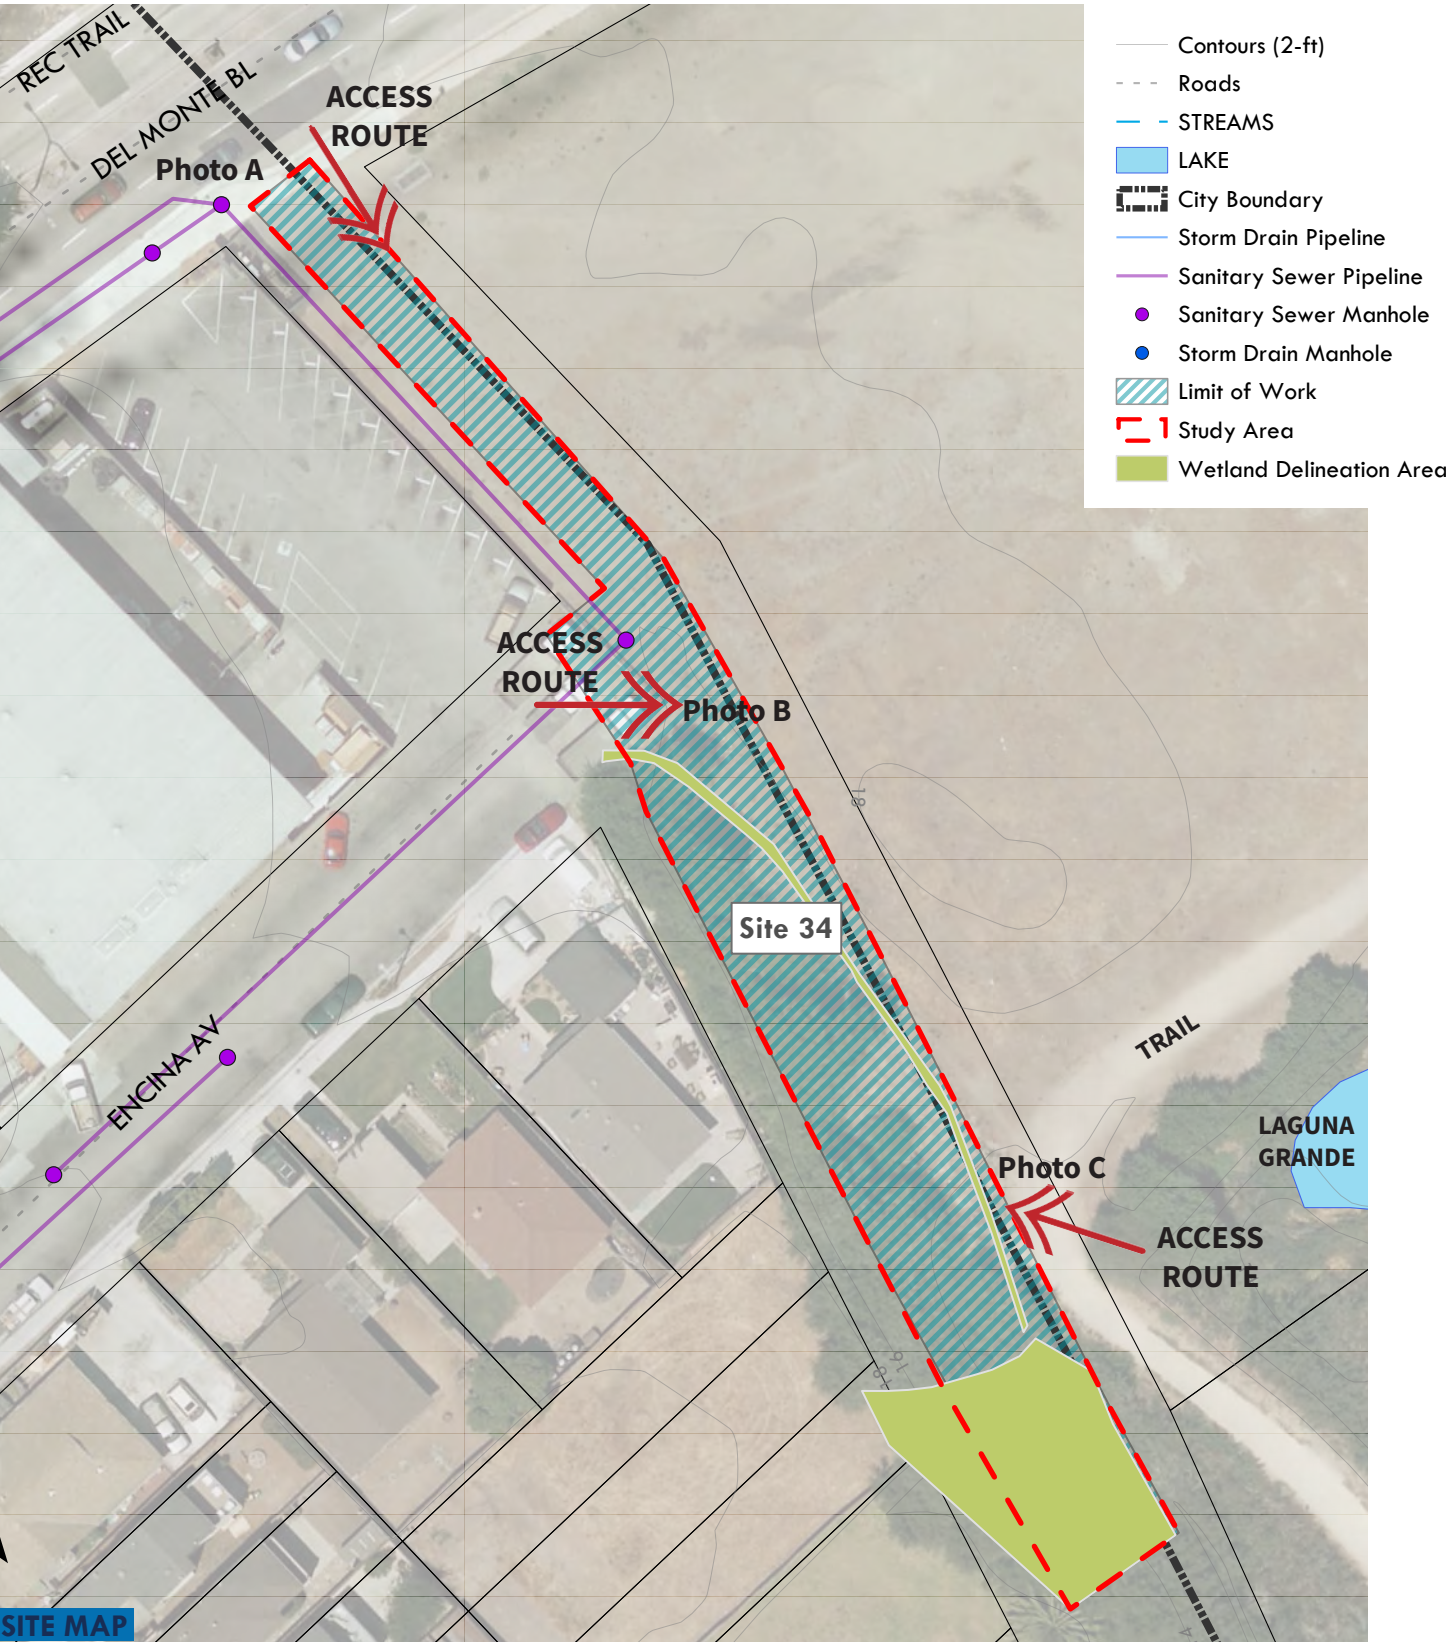
LOCATION & SITE DESCRIPTION

Inspected on November 7, 2017. The proposed maintenance area includes a grass swale that drains northwest to southeast between commercial and residential properties toward a trail and eventual outlet into Laguna Grande Lake. Vegetation in the stormwater swale is mowed grass, whereas the riparian vegetation includes mature trees and shrubs. In both cases approximately 60% vegetation cover on the banks was observed. The adjacent land use includes single family residences and public park land. There were no significant fallen trees or tree limbs and none of the existing infrastructure is known to be undersized. No flood or erosion threats were observed.

The growth of vegetation in the inlet channel was not preventing access to evaluate condition and maintain facilities nor is it currently reducing the capacity of the system. Sediment accumulation does not appear to be as significant of a maintenance concern compared to overgrown vegetation. The observed condition is how the City proposes to maintain the swale in future as part of the annual maintenance practices.

To maintain stormwater swale function and capacity, vegetation along the inlet channel and adjacent banks will be mowed annually. The site will be accessed from Encina Avenue, Del Monte Boulevard, or the Laguna Grande trail. Equipment that will be used to maintain the site include a backhoe, dump trucks, chain saws, and hand tools (i.e., picks, shovels, rakes, loppers, etc.). Sediment, trash, and green waste generated from the proposed activities would be disposed of properly at the Monterey Peninsula Landfill in Marina.

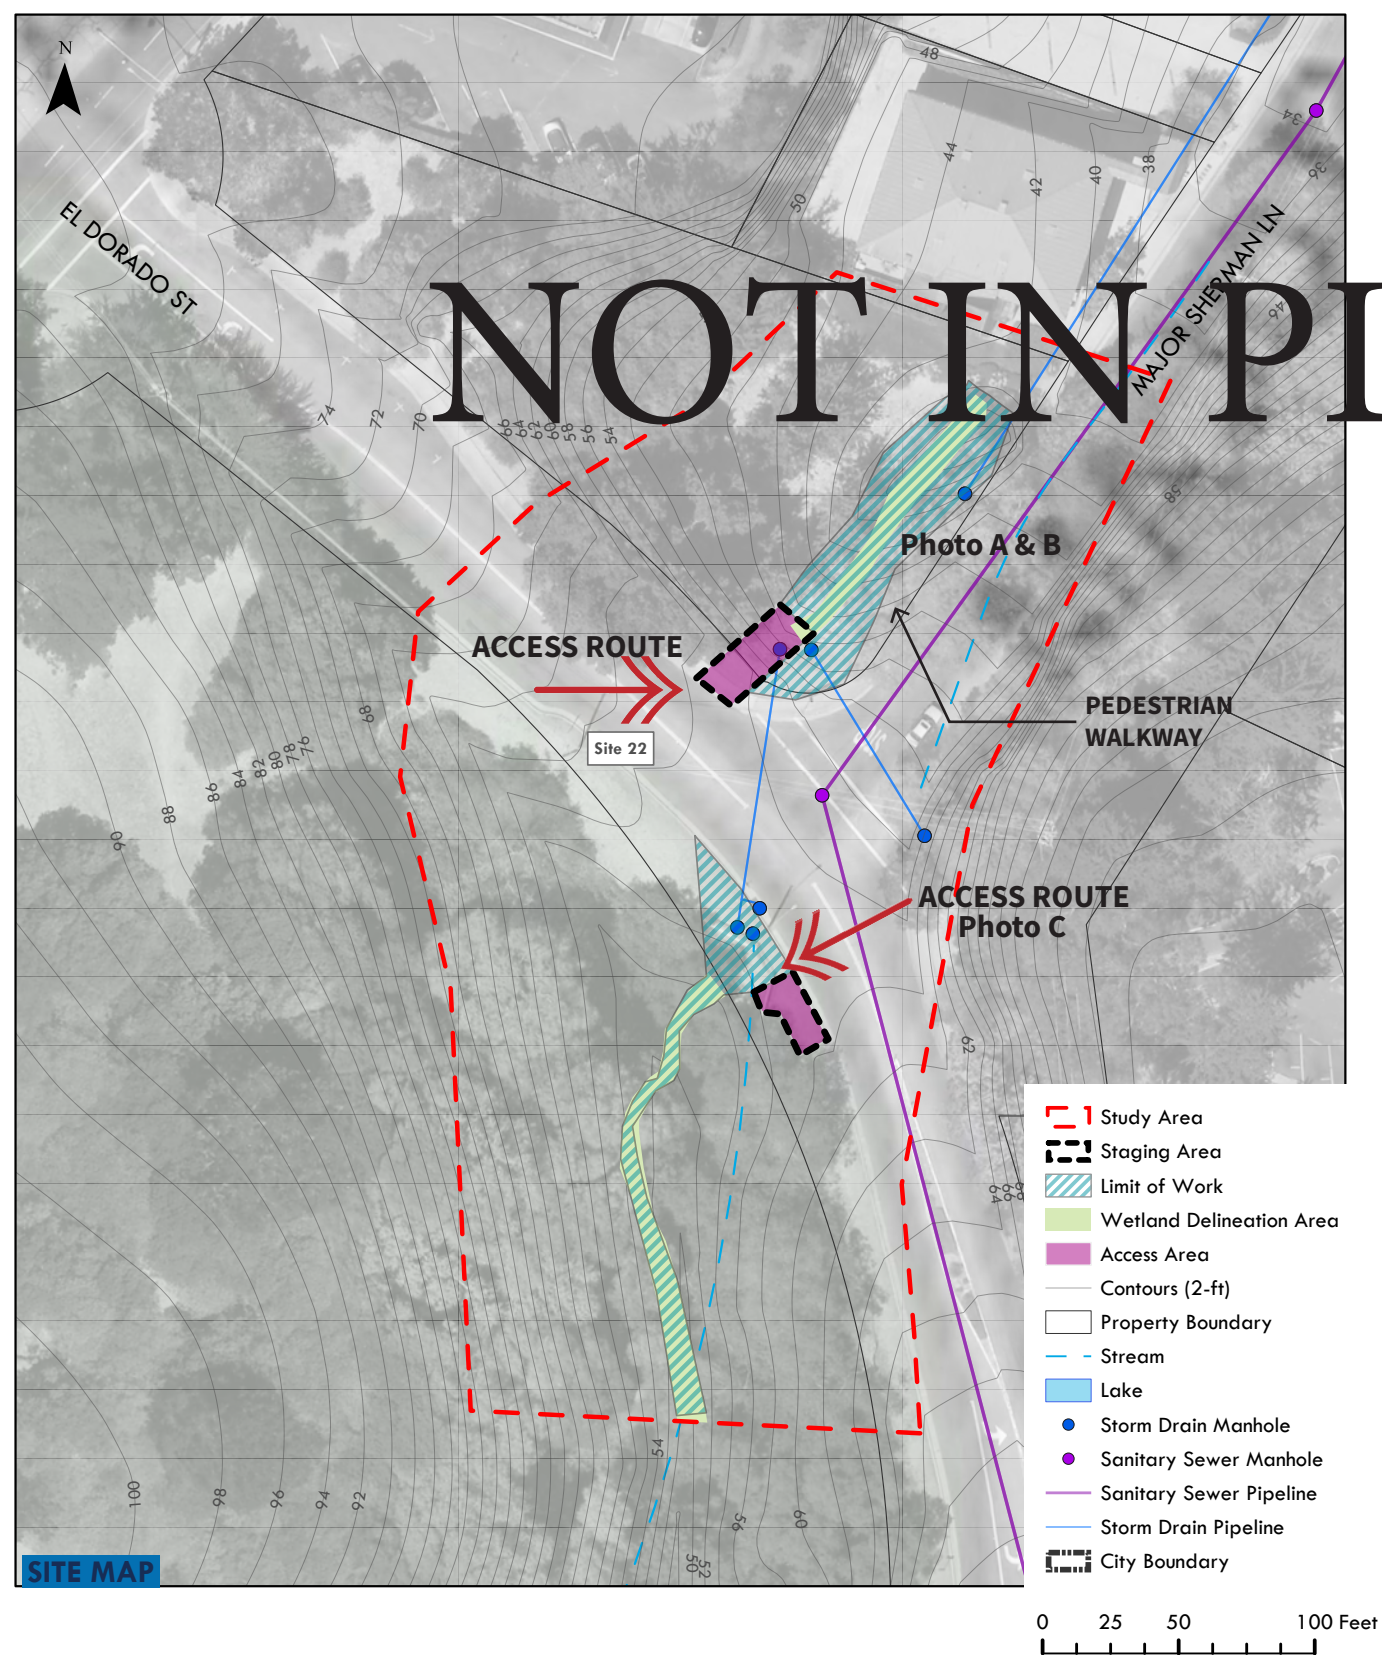
LOCATION & SITE DESCRIPTION

Inspected on September 13, 2017. The channel bankfull width is approximately 12-ft upstream of El Dorado Street and a trash rack on the upstream culvert inlet was clear of debris though an 8-ft long 18-inch diameter downed tree was crossing the channel upstream of the trash rack. The downstream channel section has incised approximately 5-ft below the invert of the culvert outlet and bank erosion was observed. Dense brush and trees were established along the channel banks in both the upstream and downstream sections. The adjacent land use includes professional buildings, Don Dahvee Park, single family residences, and roadways. None of the existing infrastructure is known to be undersized and no flood threats were observed. Vegetation around the culvert inlet was short, allowing adequate access and visibility, though on the downstream side overgrown vegetation limited visibility of the culvert outlets.

On the upstream side, the site will be accessed via an existing gate off of El Dorado Street (Photo C). On the downstream side, access will need to occur from El Dorado Street or the northern side of the adjacent private property or for work with hand tools, down the banks next to the pedestrian walkway parallel to Major Sherman Lane. Work will be focused within the limits of the channel banks. Chain saws and hand tools (i.e., picks, shovels, rakes, loppers, etc.) will be used to clear and/or limb vegetation overhanging into the channel bankfull width. A backhoe and dump truck would be used to clear overgrown vegetation and accumulated material in the trash rack vicinity. Sediment, trash, and green waste generated from the proposed activities would be disposed of properly at the Monterey Peninsula Landfill in Marina.

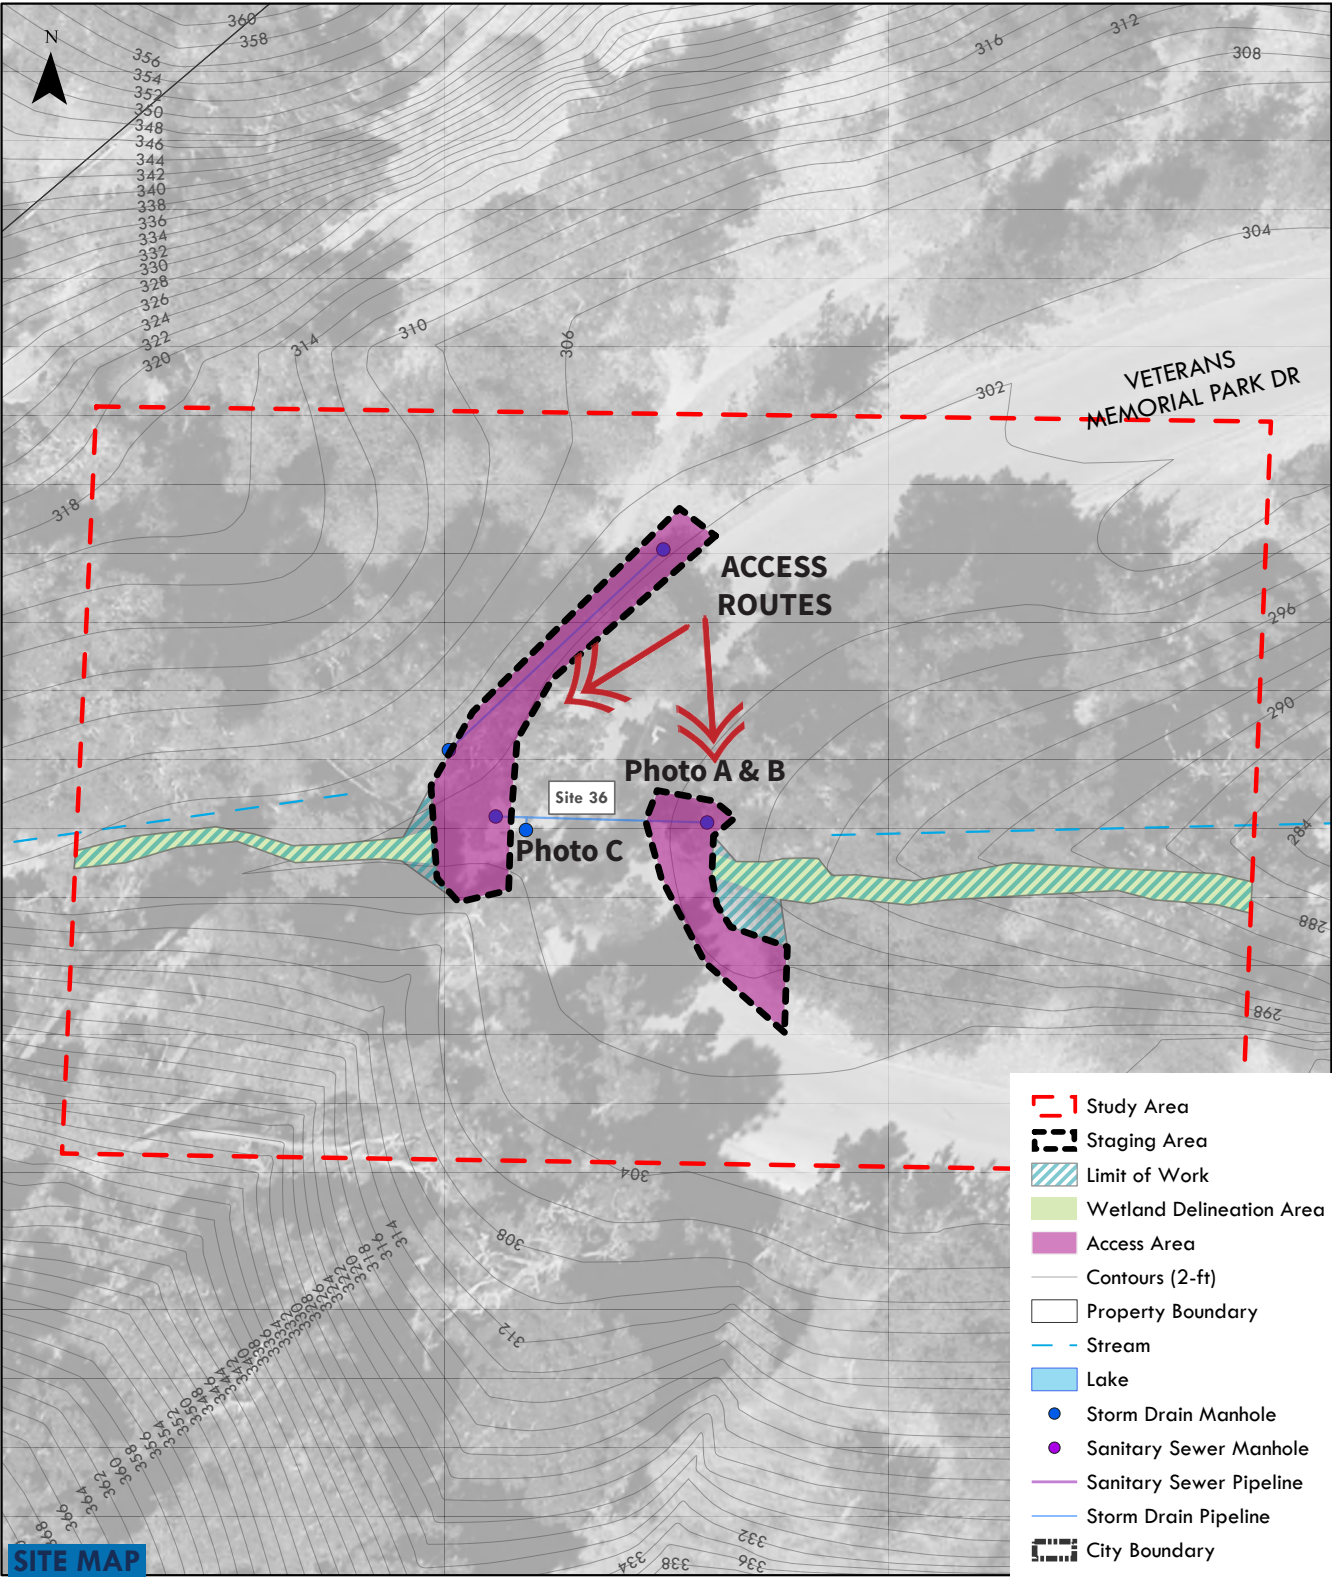
LOCATION & SITE DESCRIPTION

Inspected on September 13, 2017. The adjacent land use includes open space (Veterans Memorial Park), roadways, and the Presidio of Monterey. Vegetation is 10-ft tall with approximately 90% vegetation cover on the banks. The dense brush on the upstream (Photo C) and downstream side (Photo A) prevented inspection of existing infrastructure. There were two approximately 24” diameter trees down across the upstream channel. None of the existing infrastructure is known to be undersized. Erosion was observed where surface runoff from Veterans Memorial Park Drive enters the downstream channel (Photo B).

The growth of vegetation in the vicinity of the culvert inlet and outlet are preventing access to evaluate condition and maintain facilities. Sediment accumulation does not appear to be as significant of a maintenance concern compared to overgrown vegetation.

To maintain stormwater conveyance and capacity, trees within the limit of work will be limbed to maintain access to the channel corridor. Accumulated sediment and debris within the bankfull channel will be removed. To maintain inlet function and capacity, vegetation along the inlet channels and adjacent banks will be removed annually. Access would occur from Veterans Memorial Park Drive. Equipment that would be used to maintain the site include a backhoe, dump trucks, chain saws, and hand tools (i.e., picks, shovels, rakes, loppers, etc.). Sediment, trash, and green waste generated from the proposed activities would be disposed of properly at the Monterey Peninsula Landfill in Marina.

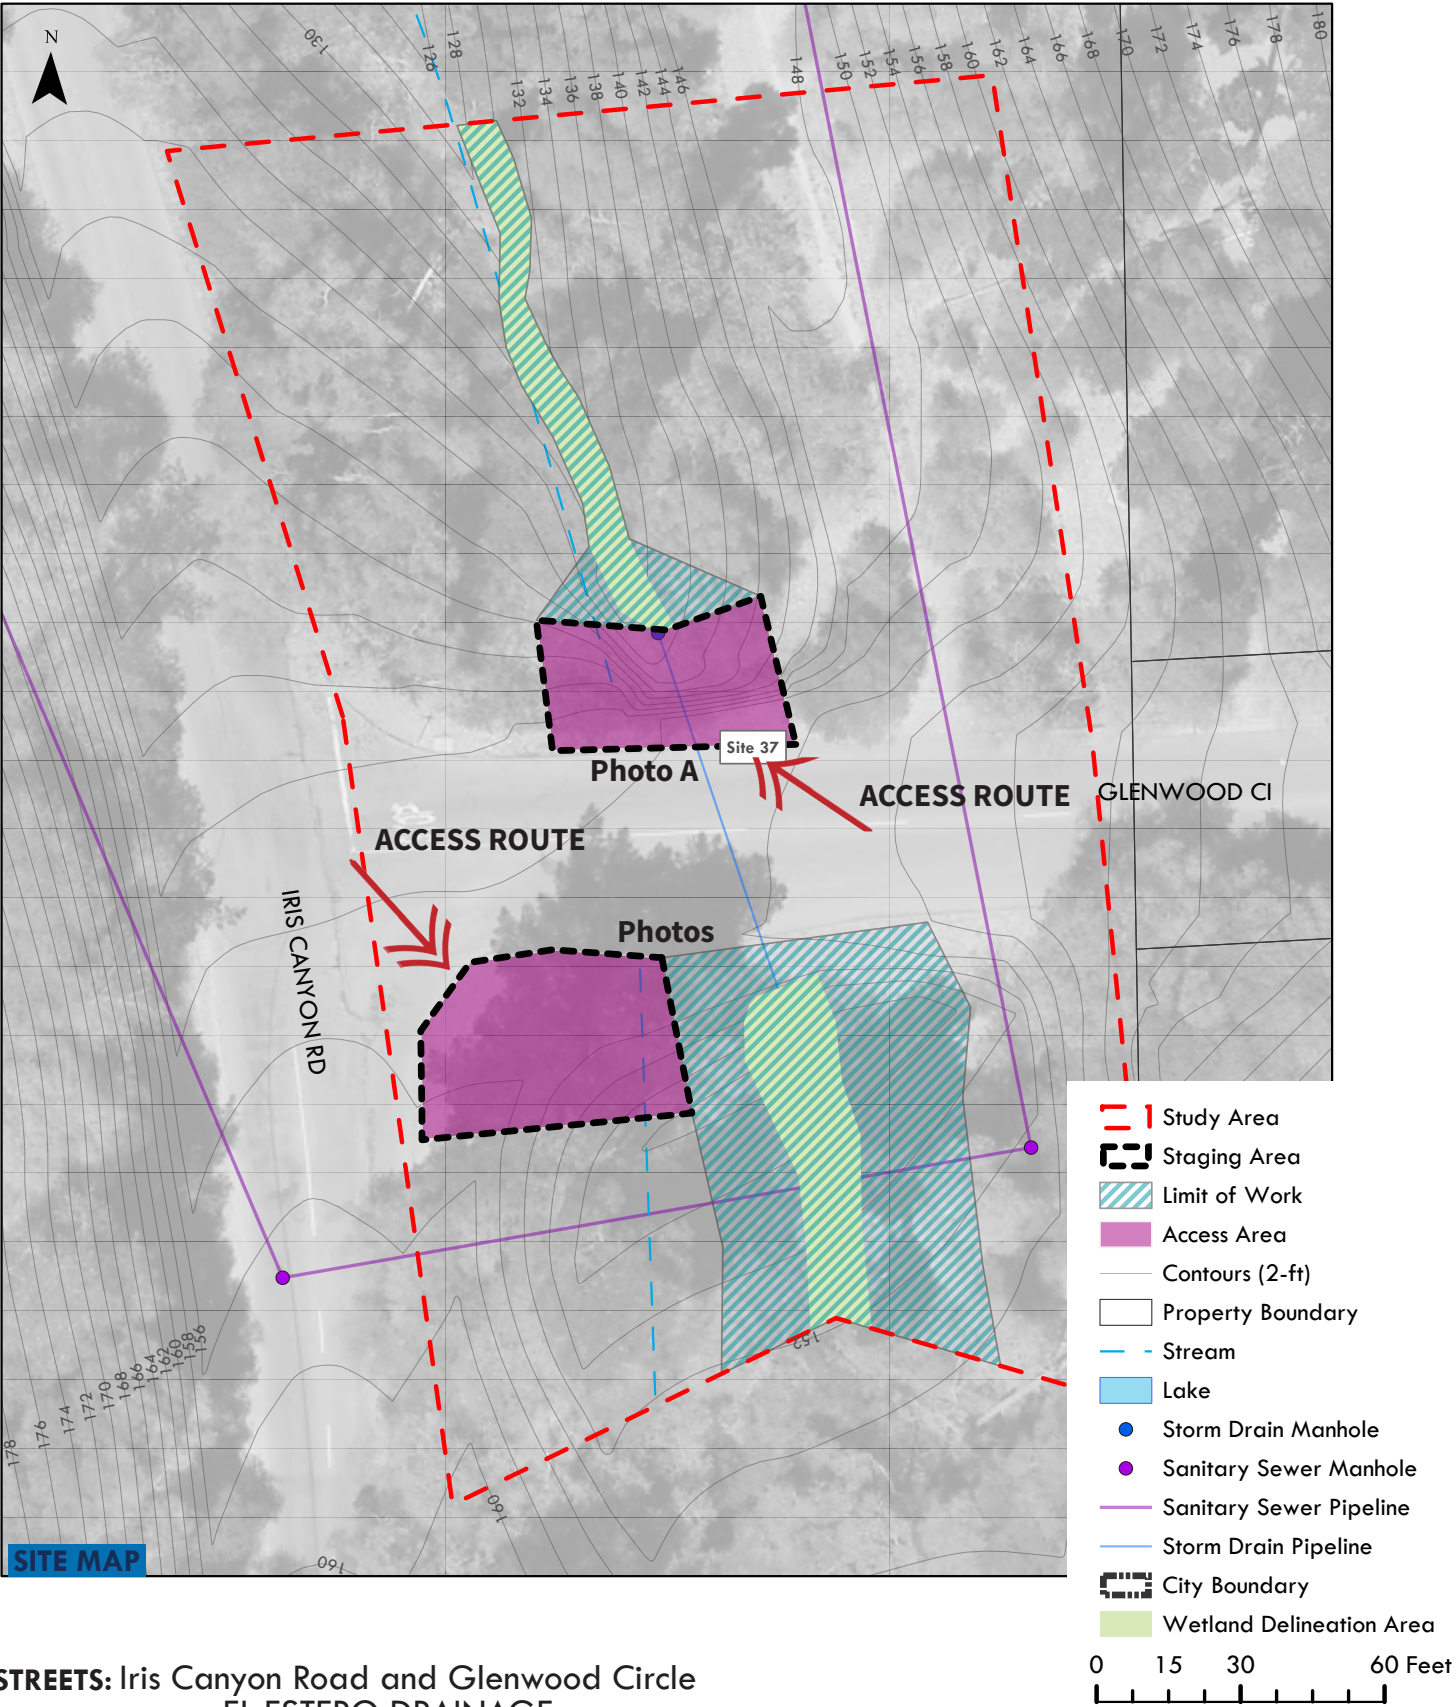
LOCATION & SITE DESCRIPTION

Inspected on September 13, 2017. Site includes an earthen channel flowing between open space, roadways, and multi-family apartments. Vegetation and accumulated sediment prevented access and evaluation of the channel and associated conveyance infrastructure. Vegetation is berries, pampas grass, and poison oak with 90% vegetative cover observed on banks. No significant fallen trees or tree limbs were observed and none of the existing infrastructure is known to be undersized. Vegetation in the vicinity of Glenwood Circle was dense and overgrown, preventing adequate access and visibility to maintain the structures.

To maintain stormwater conveyance and capacity in the channel, accumulated sediment and vegetation along the channel bottom will be removed annually. The site will be accessed from Glenwood Circle and work will be focused within the limits of the channel banks. Chain saws and hand tools (i.e., picks, shovels, rakes, loppers, etc.) will be used to clear and/or limb vegetation overhanging into the channel within the bankfull width. A backhoe will be used if big material is identified in the channel or in the event of an emergency. Sediment, trash, and green waste generated from the proposed activities would be disposed of properly at the Monterey Peninsula Landfill in Marina.

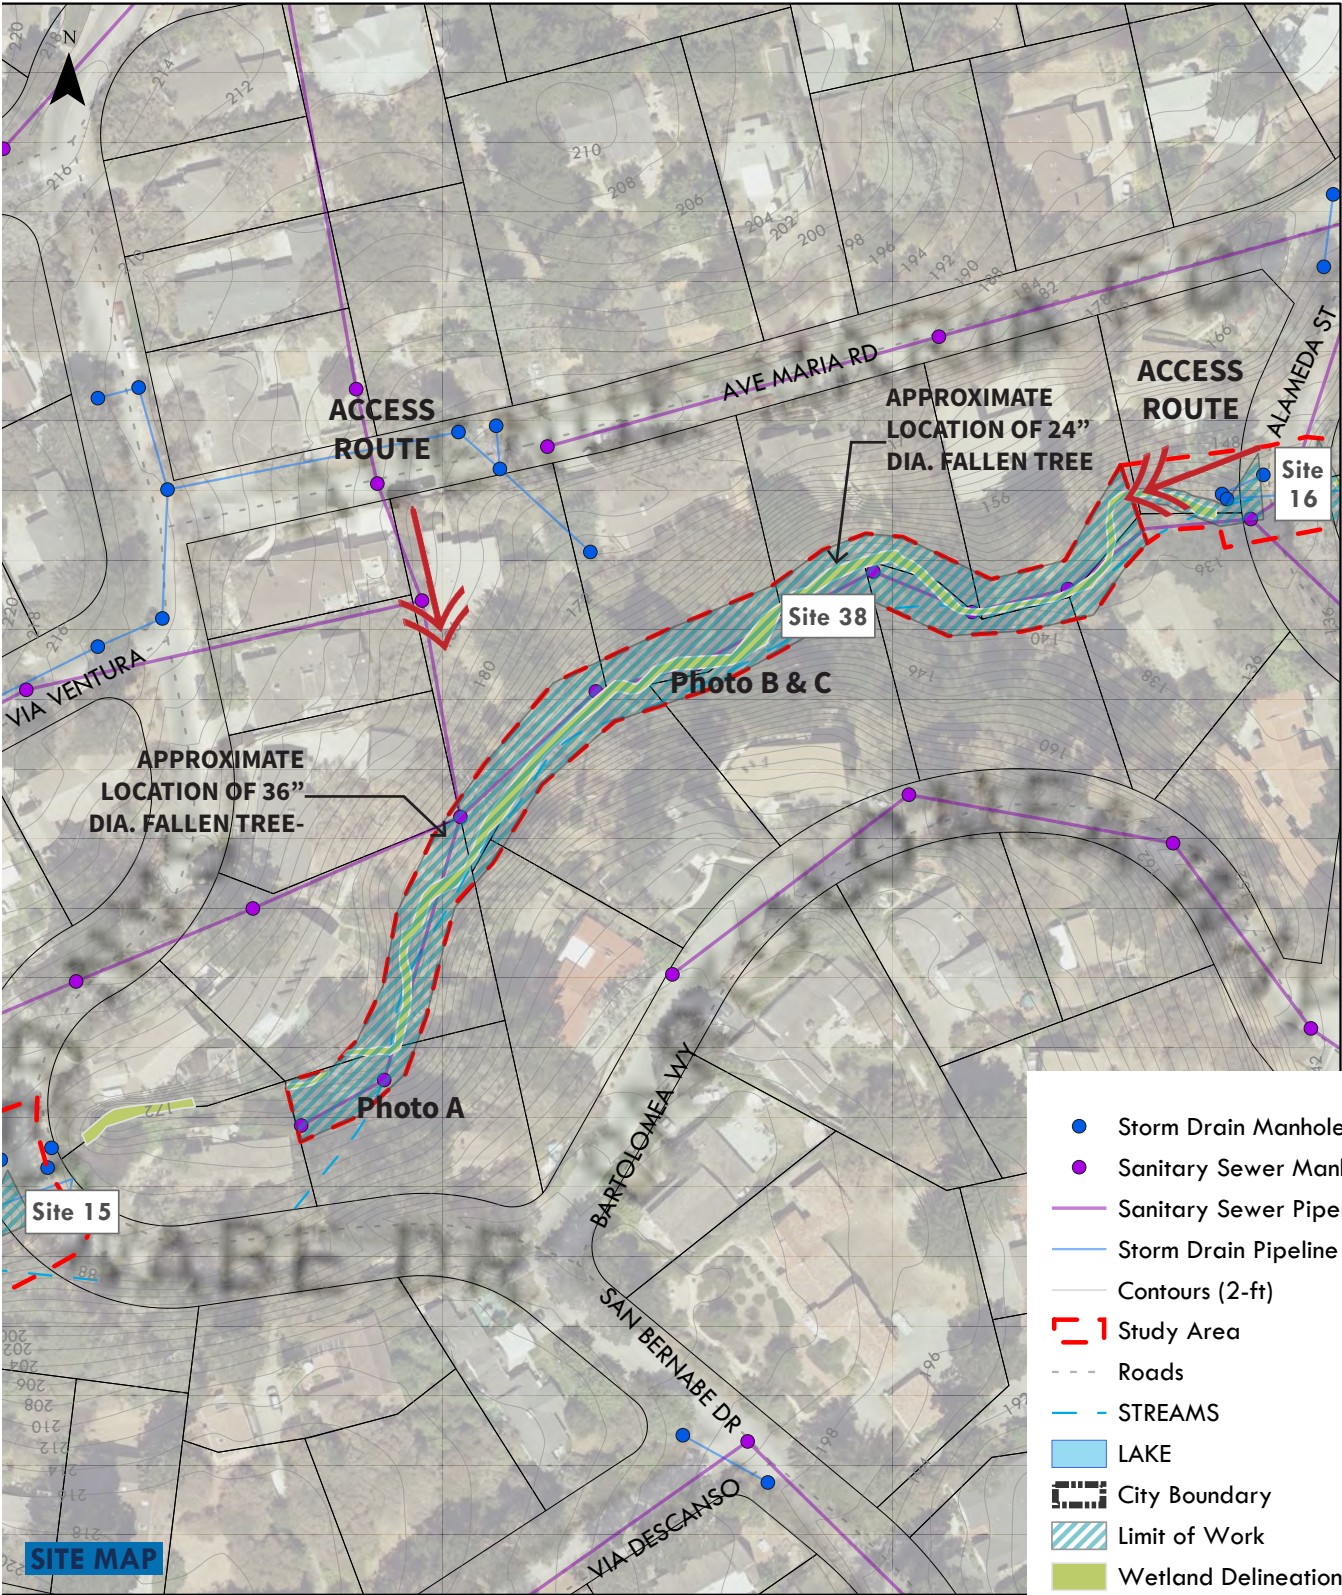
LOCATION & SITE DESCRIPTION

Inspected on November 7, 2017. Site includes an earthen channel flowing between residential properties along a sewer easement (photo A) from San Bernabe Drive northeast towards Alameda Street. The channel is approximately 2-3-ft wide at its base, extending up to an open channel width of approximately 7-ft, with outlet through a box culvert beneath Alameda Street (see Site 16 description). Vegetation is mostly ivy and brambles, with some trees and 90% vegetative cover on banks. Some rock and accumulated sediment was observed along the channel bottom. There were two fallen trees identified at the time of survey (24" and 36" DBH, photo B) crossing the stream channel. Locations were observed where erosion was occurring, bank material was loose, and vegetation loss had occurred.

Accumulated rocks and sediments from bank erosion were observed within the channel. Existing facilities were not noticeable damaged. Access to the sewer assessment was possible only by foot, which presents a maintenance and emergency response concern. Landscape material, including large tree stumps (as shown in Photo C), had been dumped along the right channel bank and along the sewer easement.
