**PHASE I  
ENVIRONMENTAL SITE ASSESSMENT \***

**Undeveloped Property  
8600 Prospect Avenue  
Santee, California**

Project C415-01

September 28, 2016

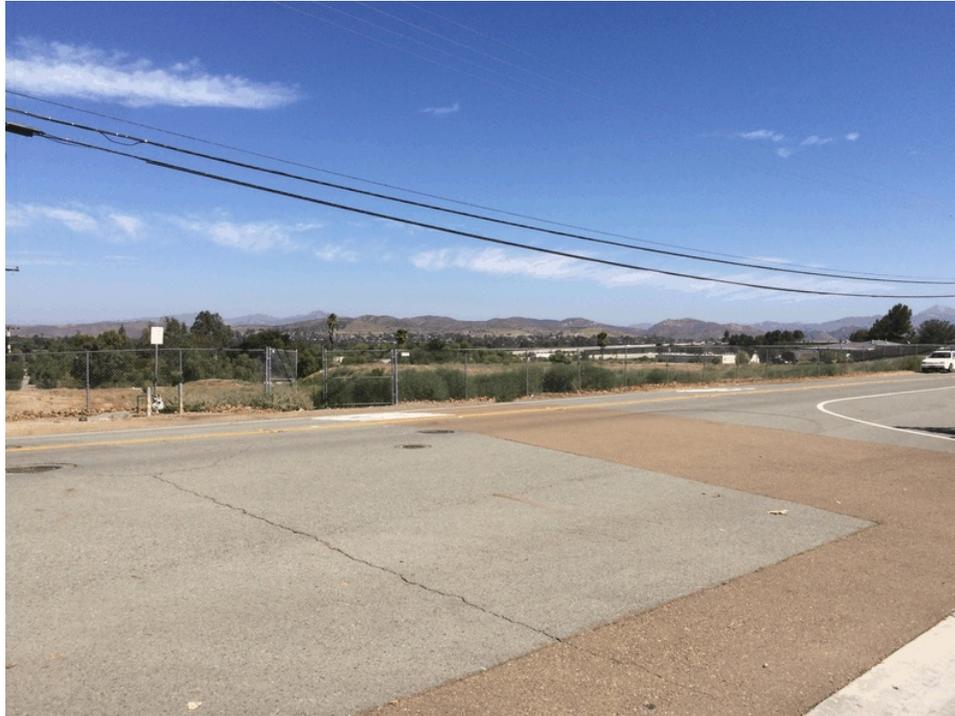
Photograph 1: View of the Property looking northeastward from across Prospect Avenue

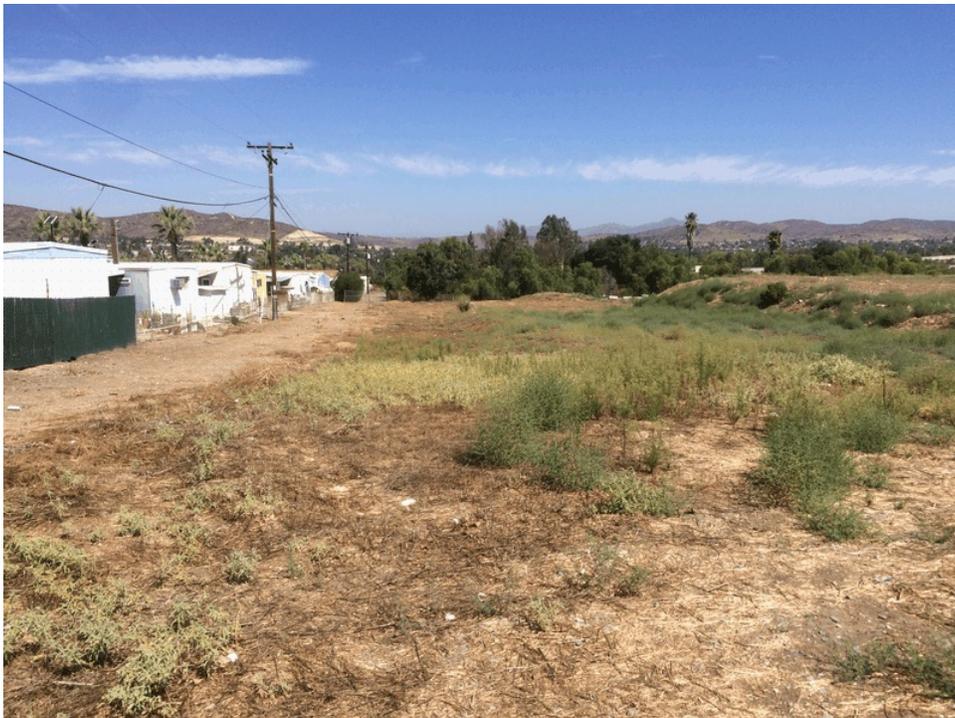
Photograph 2: View of the western portion of the Property looking northward from near the southwesternmost Property corner

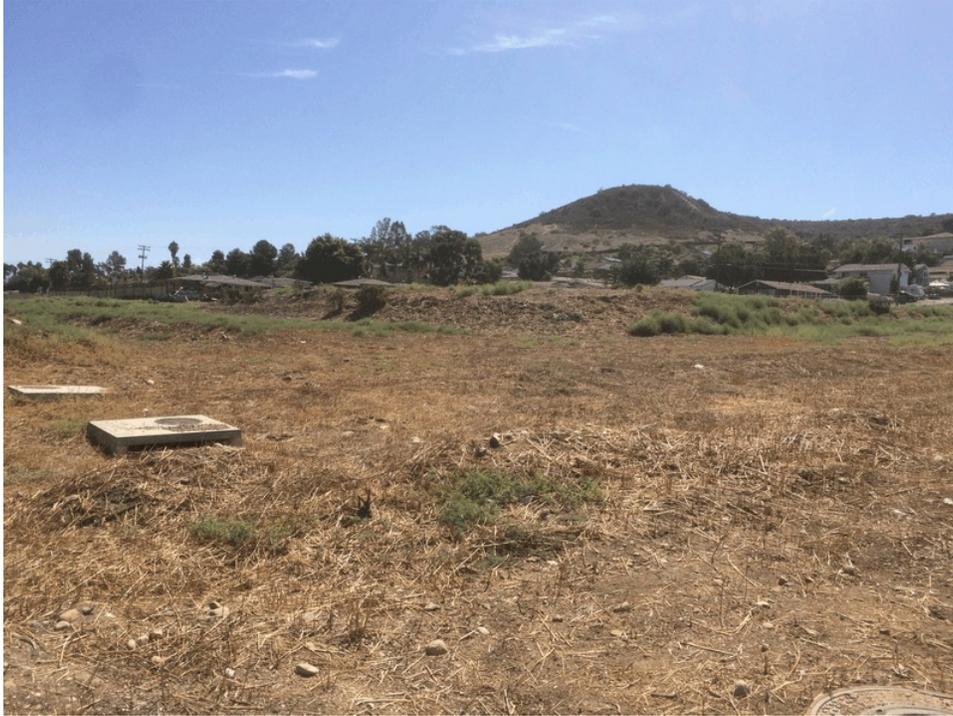
Photograph 3: View of the Property looking southeastward from near the northwestern Property corner

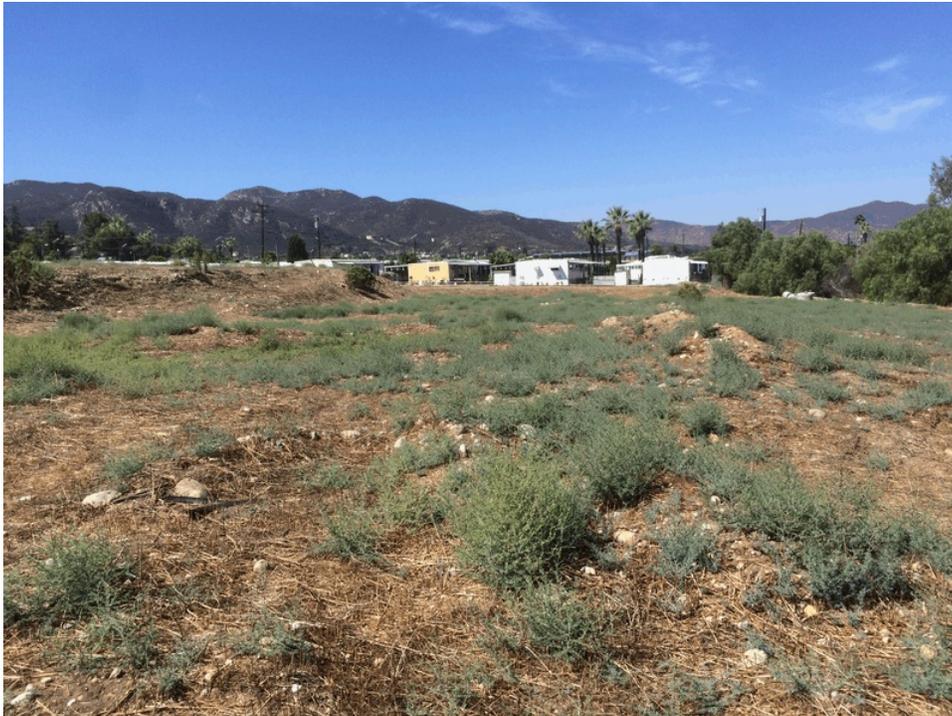
Photograph 4: View of the northern portion of the Property looking westward from near the northeasternmost Property corner

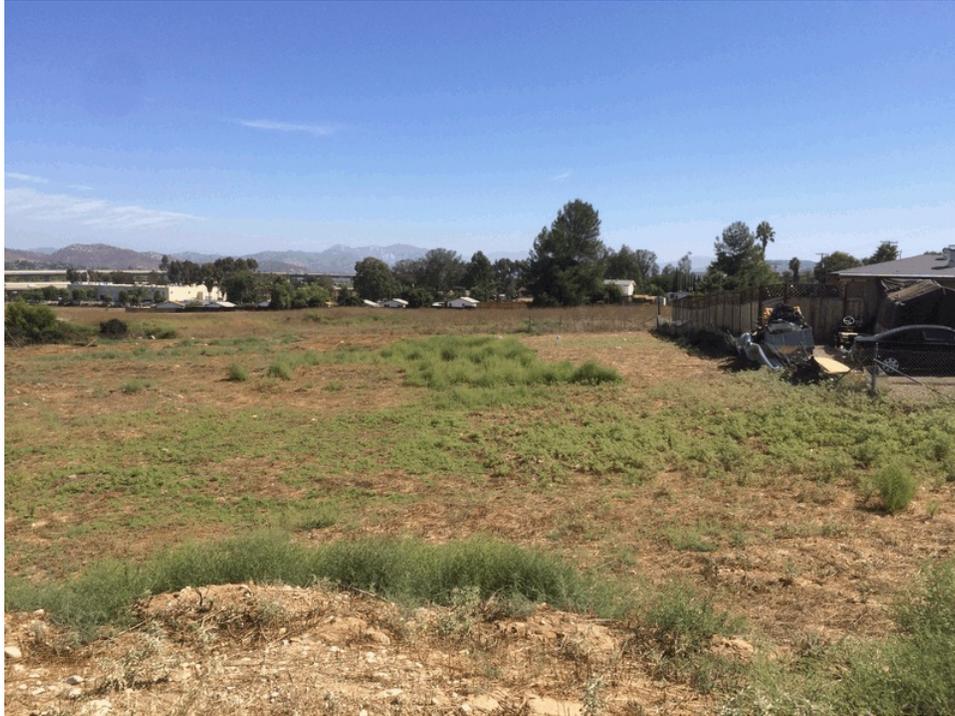
Photograph 5: View of the northeastern portion of the Property looking eastward

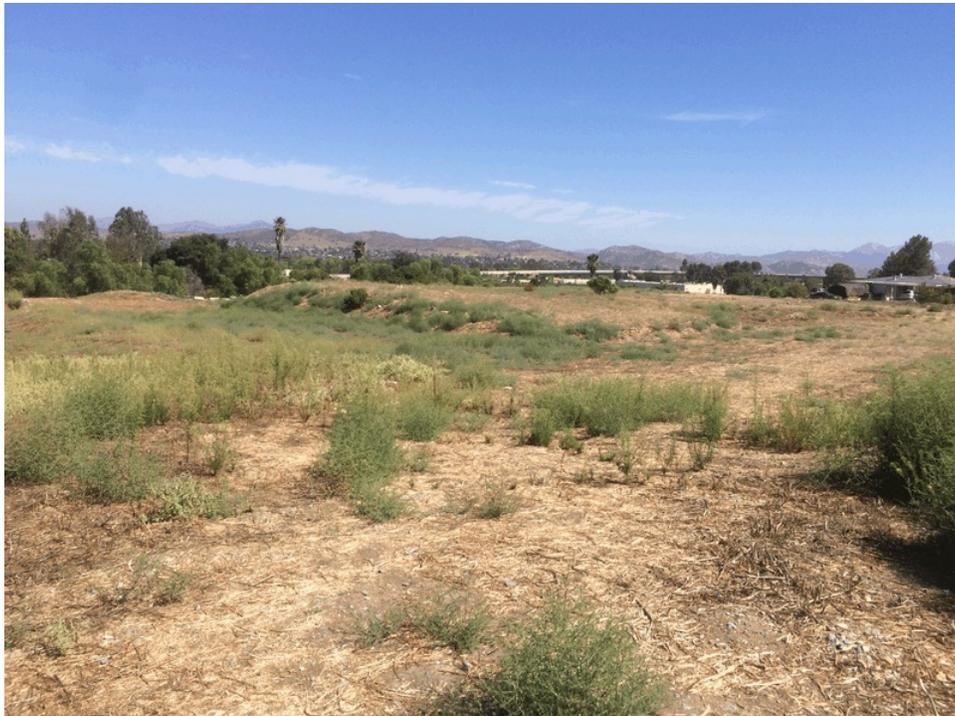
Photograph 6: View of the Property looking northeastward from near the southwesternmost Property corner

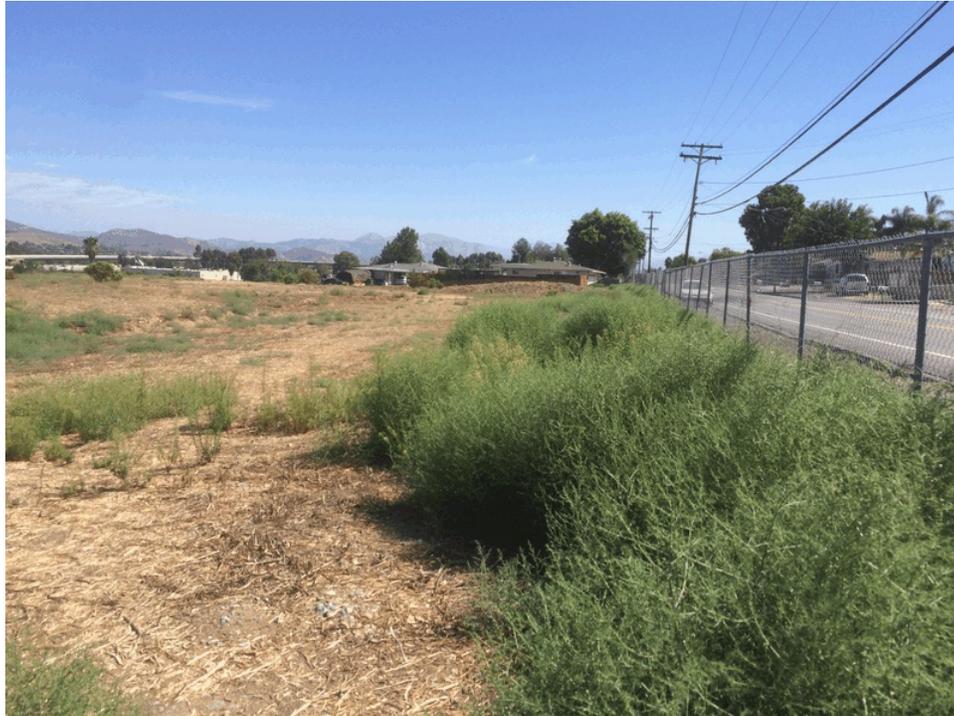
Photograph 7: View of the southern border area of the Property looking eastward from near the southwesternmost Property corner

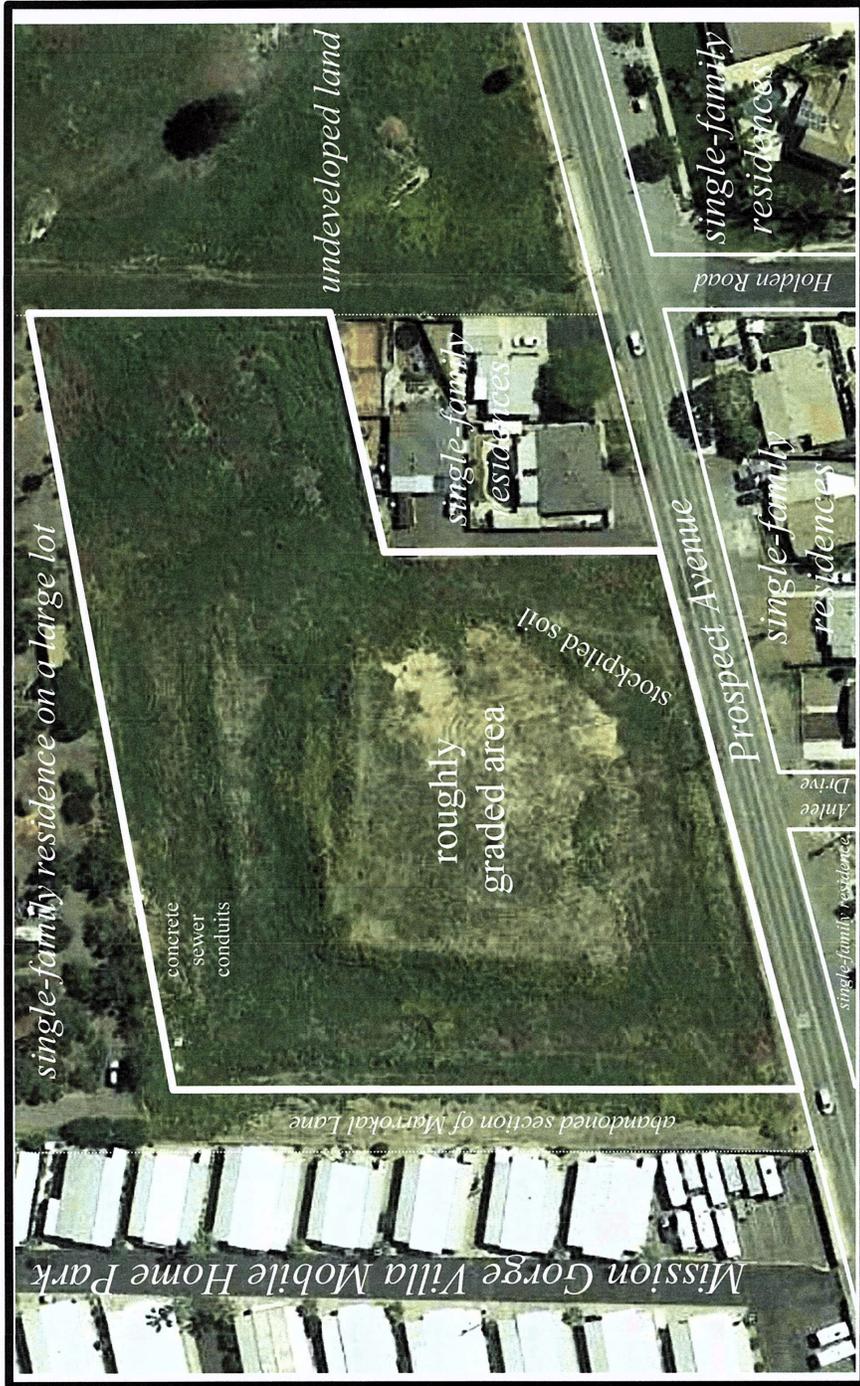
**FIGURE 2**

The reported 3.54-acre undeveloped Property is mostly overgrown with grasses and weeds. A roughly graded area was observed in the approximate center of the Property. This area did not appear to have been graded recently. Stockpiled soil was located in the southeast portion of the Property, near Prospect Avenue. Concrete conduits and what appeared to three storm drains were observed near the northwestern Property corner. Refer to Figure 2 and Photographs 1 through 10 in Section 7.0 - Property Photographs (E 1527-13, Section 9).
