**PRELIMINARY GEOTECHNICAL
ENGINEERING INVESTIGATION**

**Proposed 13-Story Hotel Expansion
Over Partial One Level Subgrade Parking
&
22-Story Residential Building
Over 3-4 Levels Subgrade Parking**

**1246 S. Hope Street
&
427 W. Pico Boulevard
Los Angeles, California**

Project 5076

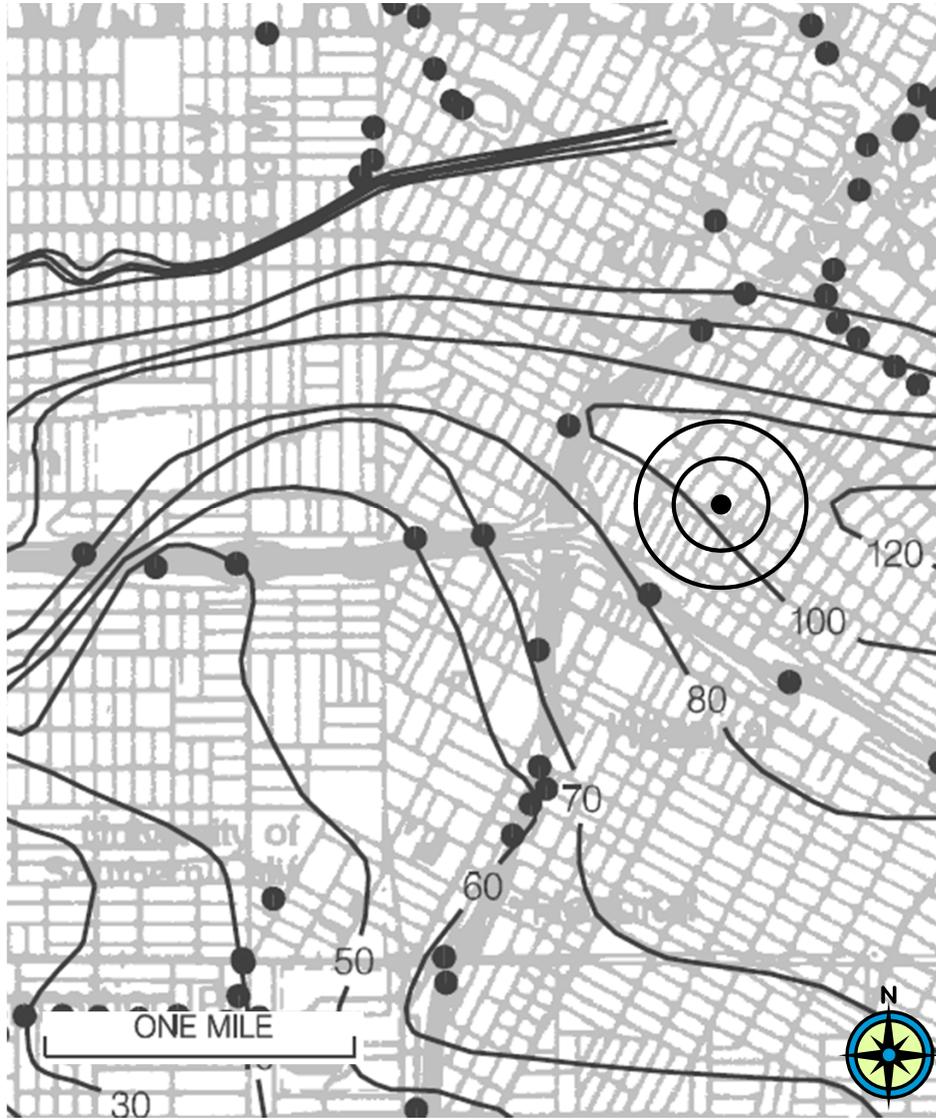
● Borehole Site

— 30 — Depth to ground water in feet

State of California Seismic Hazard Report, Hollywood Quadrangle

No active surface groundwater seeps or springs were observed on the subject site. The subsurface exploration did encounter groundwater seepage at a depth of 157.5 & 187.5 feet. The depth to seeps/perched water groundwater, when encountered in the explorations, is only valid for the date of exploration. Based on the Seismic Hazard Zone Report by the California Geological Survey (formerly Division of Mines and Geology), the depth to historical high groundwater level is greater than 100 feet below the surface. Seasonal fluctuations of groundwater levels may occur by varying amounts of rainfall, irrigation and recharge.

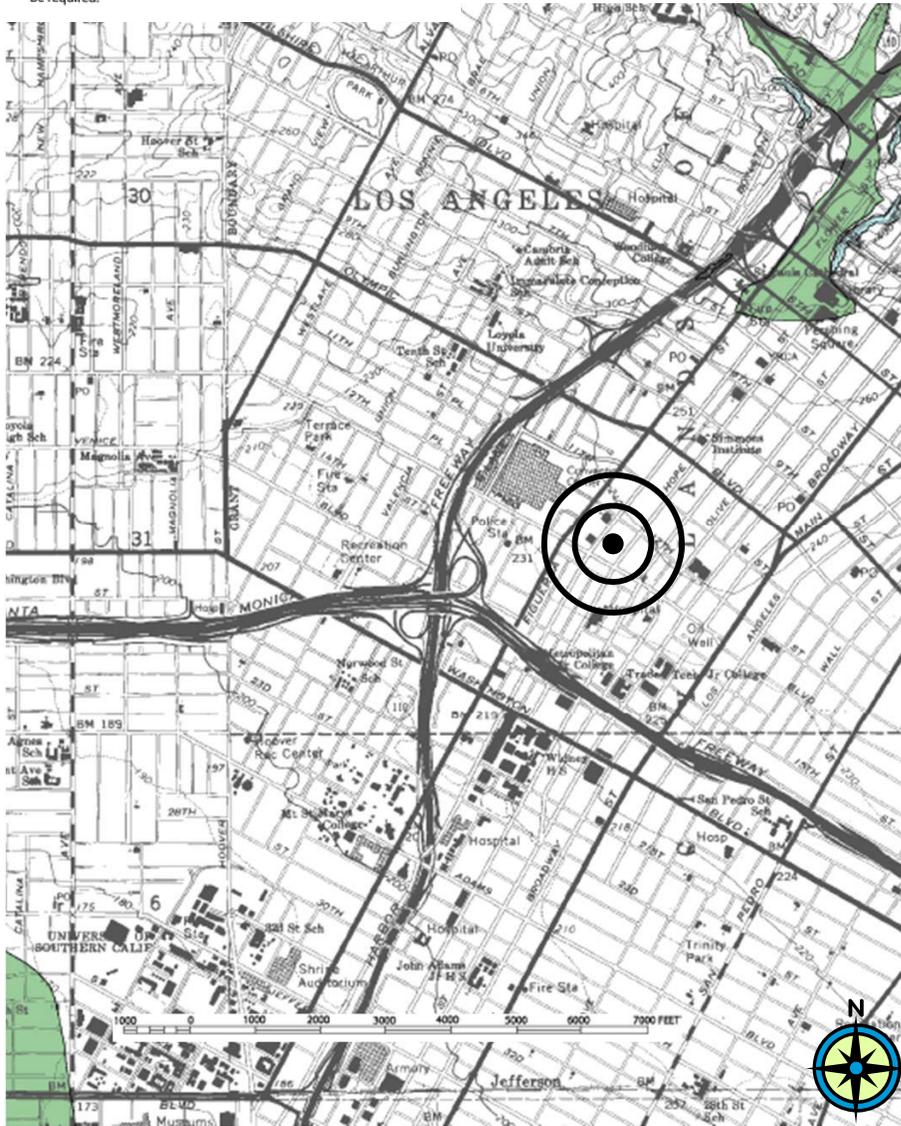
Liquefaction

Areas where historic occurrence of liquefaction, or local geological, geotechnical and groundwater conditions indicate a potential for permanent ground displacements such that mitigation as defined in Public Resources Code Section 2693(c) would be required.

Reference: State of California, Seismic Hazard Map of the Hollywood Quadrangle Scale: As Shown
