Geotechnical Investigation

5150 El Camino Real Los Altos, CALIFORNIA

PRELIMINARY GEOTECHNICAL EXPLORATION

PROJECT NO. 14723.000.000

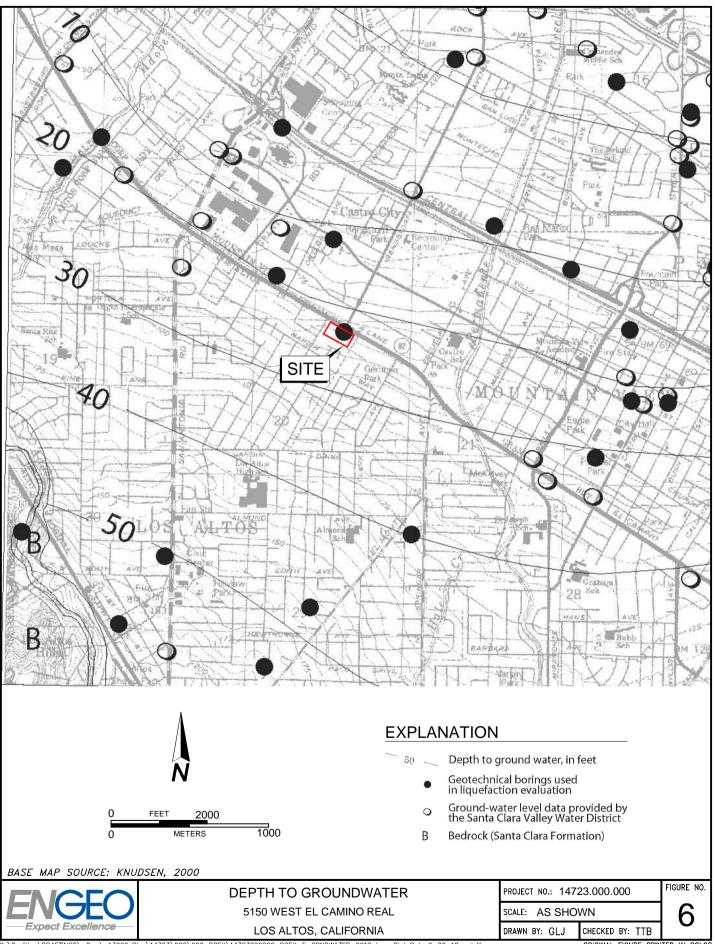
G:\Drafting\DRAFTING2_Dwg_13000 Plus\14723\000\000-PGEX\14723000000-PGEX-5-GRNDWATER-0218.dwg Plot Date:2-20-18 gjaffe

Groundwater was not observed nor measured due to the method of exploration used. Groundwater mapping in the Seismic Hazard Zone Report for the Mountain View 7.5-Minute Quadrangle, Santa Clara, Alameda, and San Mateo Counties, CA (CGS, 2006) indicates groundwater may be encountered at approximately 20 to 25 feet bgs at the site.

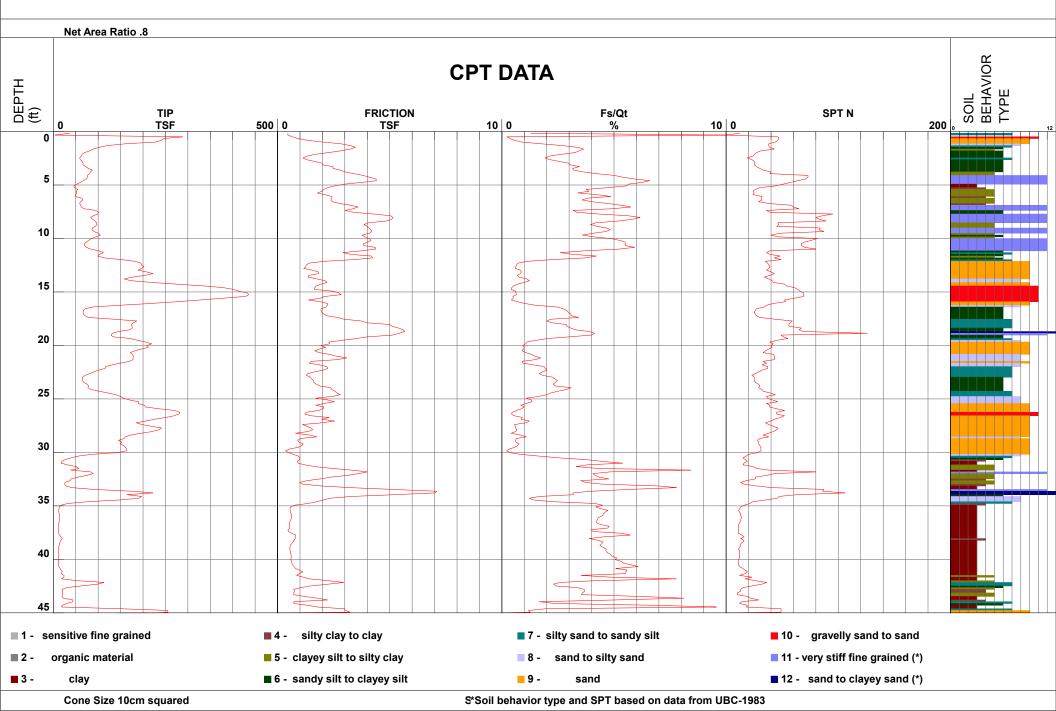
Middle Earth	Project	5150 El Camino Real	Operator	BH-RB-JO	Filename	SDF(060).cpt
GEO TESTING INC.	Job Number	14723.000.000	Cone Number	DDG1418	GPS	
	Hole Number	1-CPT1	Date and Time	2/15/2018 12:16:14 PM	Maximum Depth	45.44 ft
	EST GW Depth During Test		34.00 ft

The CPT data processing provides interpretations of the subsurface conditions based on empirical correlations with the cone tip and sleeve friction resistance. In general, the CPT data interpretations indicated that roughly the upper 20 feet of the site is underlain by clay and silty clay with relatively thin intermittent layers of sand and silty sand. The site is further underlain with interbedded layers of medium dense to dense sand, and stiff clay to the bottom of our explorations at approximately 45 feet bgs. Interpretations of CPT-05 indicated a soil profile of predominantly sand and gravel to the bottom of the exploration where refusal was met at approximately 35 feet bgs. Additional exploration should be performed to further characterize the variations in the subsurface prior to final project design.

The Site Plan (Figure 2) and CPT data (Appendix A) provide subsurface interpretations at each exploration location. The CPT data graphically depict the subsurface conditions encountered at the time of the exploration.

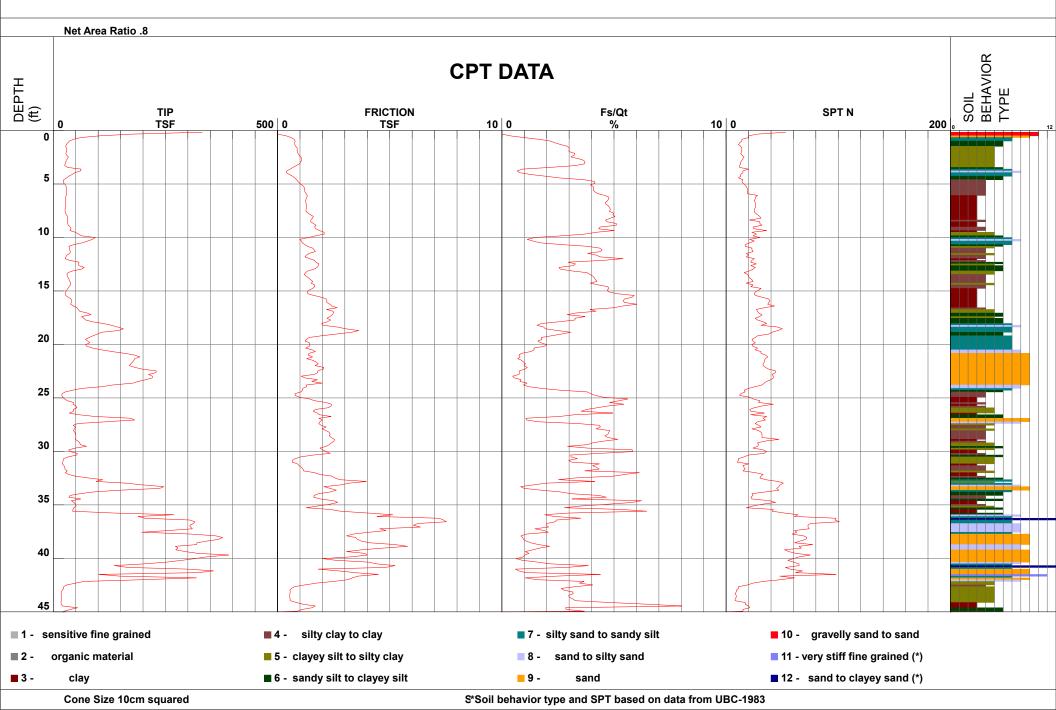
Middle Earth	Project	5150 El Camino Real	Operator	BH-RB-JO	Filename	SDF(063).cpt
ded restricting.	Job Number	14723.000.000	Cone Number	DDG1418	GPS	
	Hole Number	1-CPT2	Date and Time	2/15/2018 2:17:59 PM	Maximum Depth	45.44 ft
	EST GW Depth During Test		32.00 ft

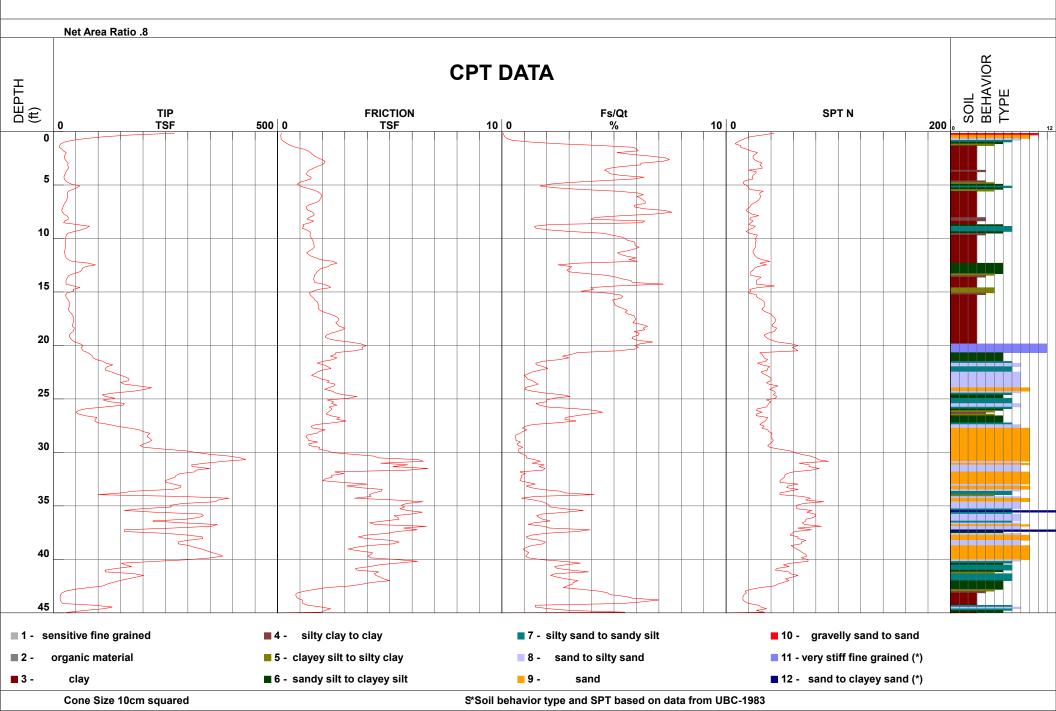
GEO TESTING INC.	Project Job Number	5150 El Camino Real 14723.000.000	Operator Cone Number	BH-RB-JO DDG1418	Filename GPS	SDF(062).cpt
	Hole Number	1-CPT3	Date and Time	2/15/2018 1:37:02 PM	Maximum Depth	45.44 ft
	EST GW Depth During Test		34.00 ft		· · -

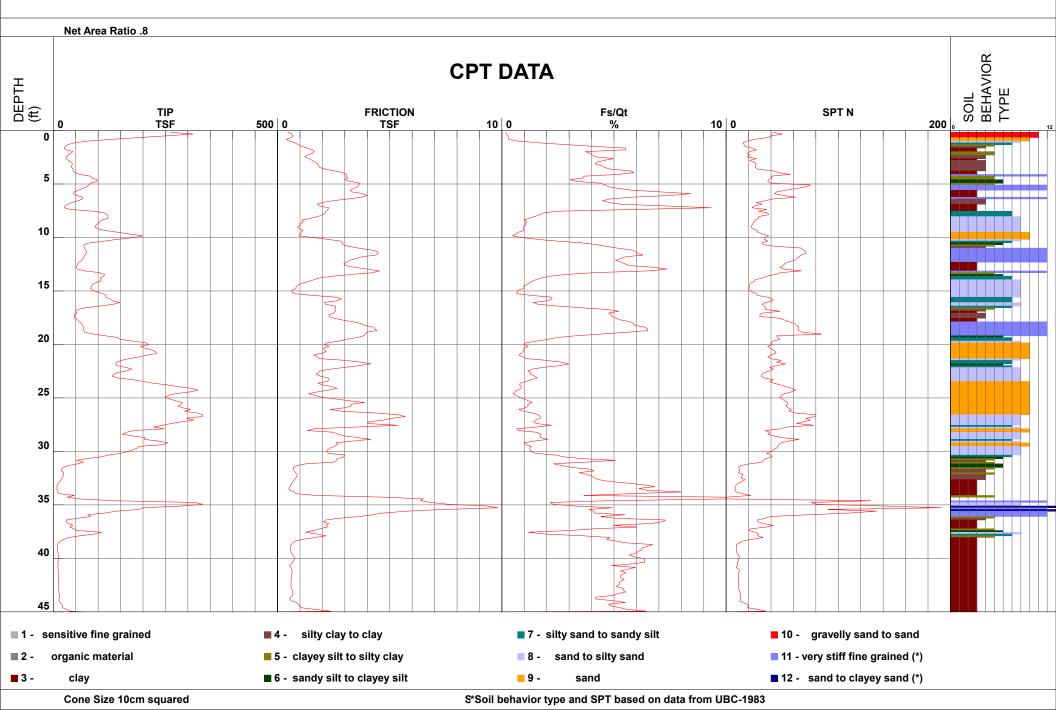
Middle Earth	Project	5150 El Camino Real	Operator	BH-RB-JO	Filename	SDF(064).cpt
GEOTESTINGINC	Job Number	14723.000.000	Cone Number	DDG1418	GPS	
	Hole Number	1-CPT4	Date and Time	2/15/2018 3:04:40 PM	Maximum Depth	45.44 ft
	EST GW Depth During Test		31.00 ft

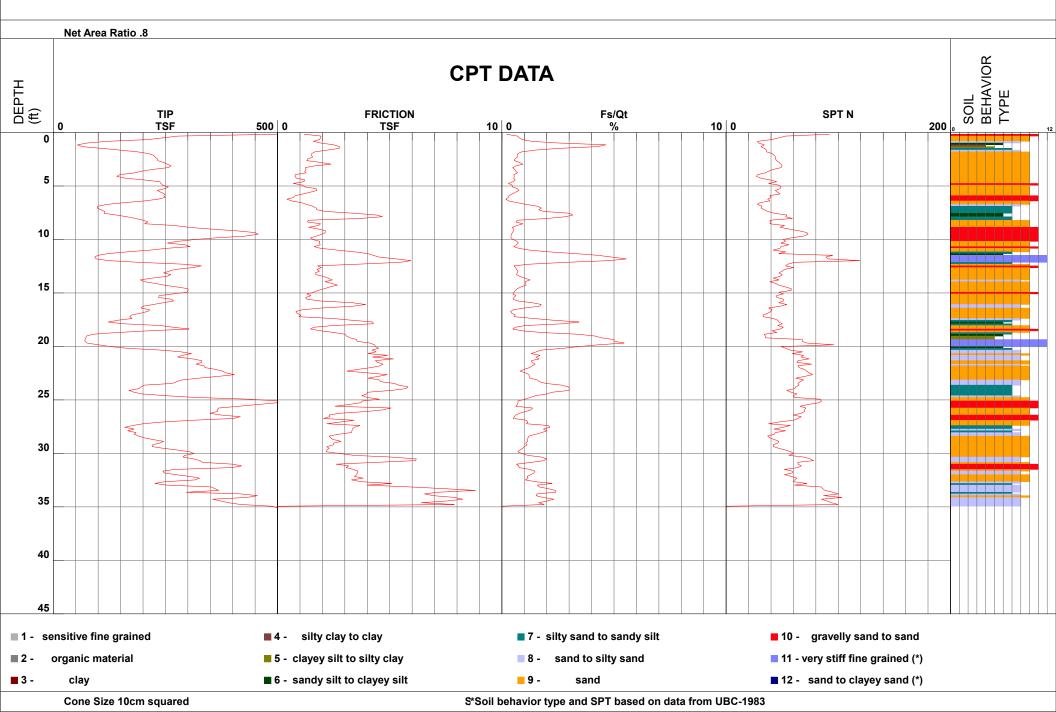
GEO TESTING INC.	Project Job Number	5150 El Camino Real 14723.000.000	_ Operator Cone Number	BH-RB-JO DDG1418	Filename GPS	SDF(061).cpt
	Hole Number	1-CPT5	Date and Time	2/15/2018 1:01:18 PM	Maximum Depth	35.27 ft
	EST GW Depth During Test		34.00 ft		· · · · · · · · · · · · · · · · · · ·

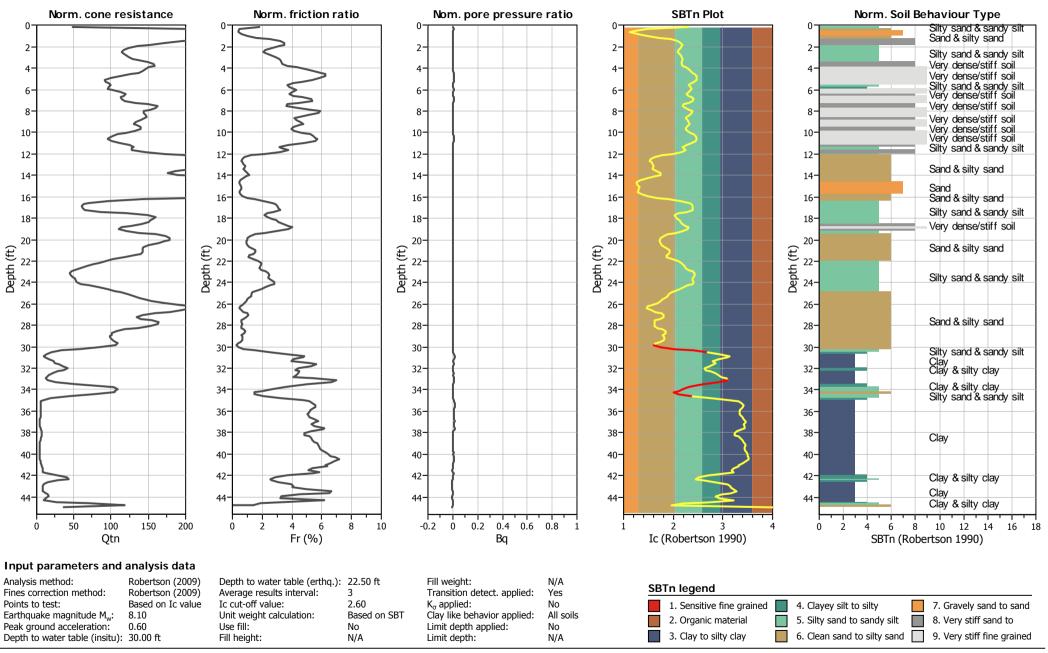
CPT basic interpretation plots (normalized)

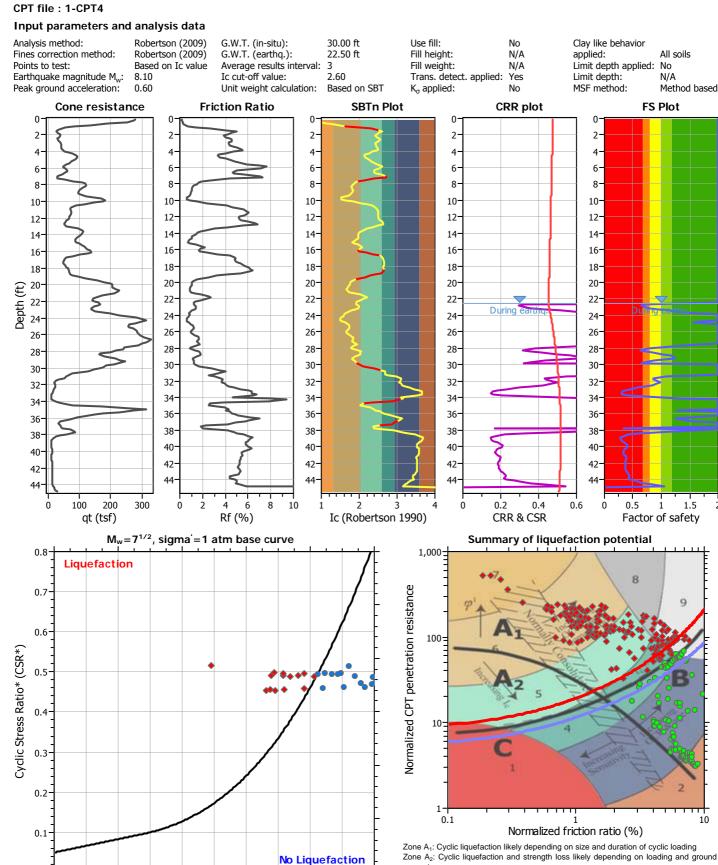
geometry Zone B: Liquefaction and post-earthquake strength loss unlikely, check cyclic softening Zone C: Cyclic liquefaction and strength loss possible depending on soil plasticity, brittleness/sensitivity, strain to peak undrained strength and ground geometry
