Geotechnical Investigation

**Updated Geotechnical Feasibility Report
Proposed High-Rise Hotel Development
1718 Vine Street
Hollywood District
Los Angeles, California**

**July 28, 2016
GDC Project No. LA-1289**

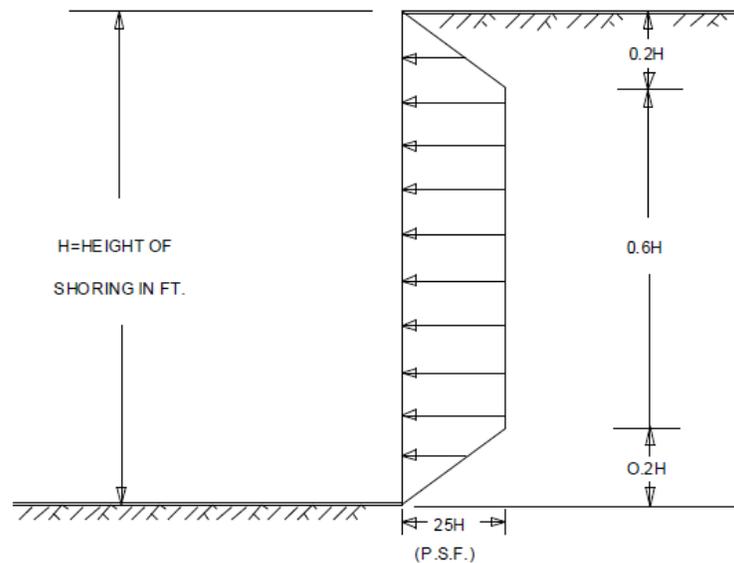
For the design of temporary tied-back or braced shoring, we recommend the use of a trapezoidal distribution of earth pressure. For preliminary design, the pressure distribution, for the case where the grade is level behind the shoring, is illustrated in the following diagram with the maximum pressure equal to $25H$ in pounds per square foot, where H is the height of the shoring in feet.

The recommended earth pressure provided above is a preliminary value. The final earth pressure for design of soldier piles and anchors will be provided during the design-level geotechnical investigation. Surcharge loads from equipment or stockpiled material should be kept behind the top of the temporary excavations a horizontal distance of at least twice the depth of the excavation, or the shoring should be designed for the additional pressure. Foundation and traffic loads from adjacent areas should also be added to the lateral earth pressures. If traffic loading can occur near the top of the shoring, the design height of the shoring should be increased by 2 feet to account for the traffic surcharge. Surface drainage should be controlled and prevented from running down the temporary excavations or down the face of the shoring. Ponding water should not be allowed within the excavation.

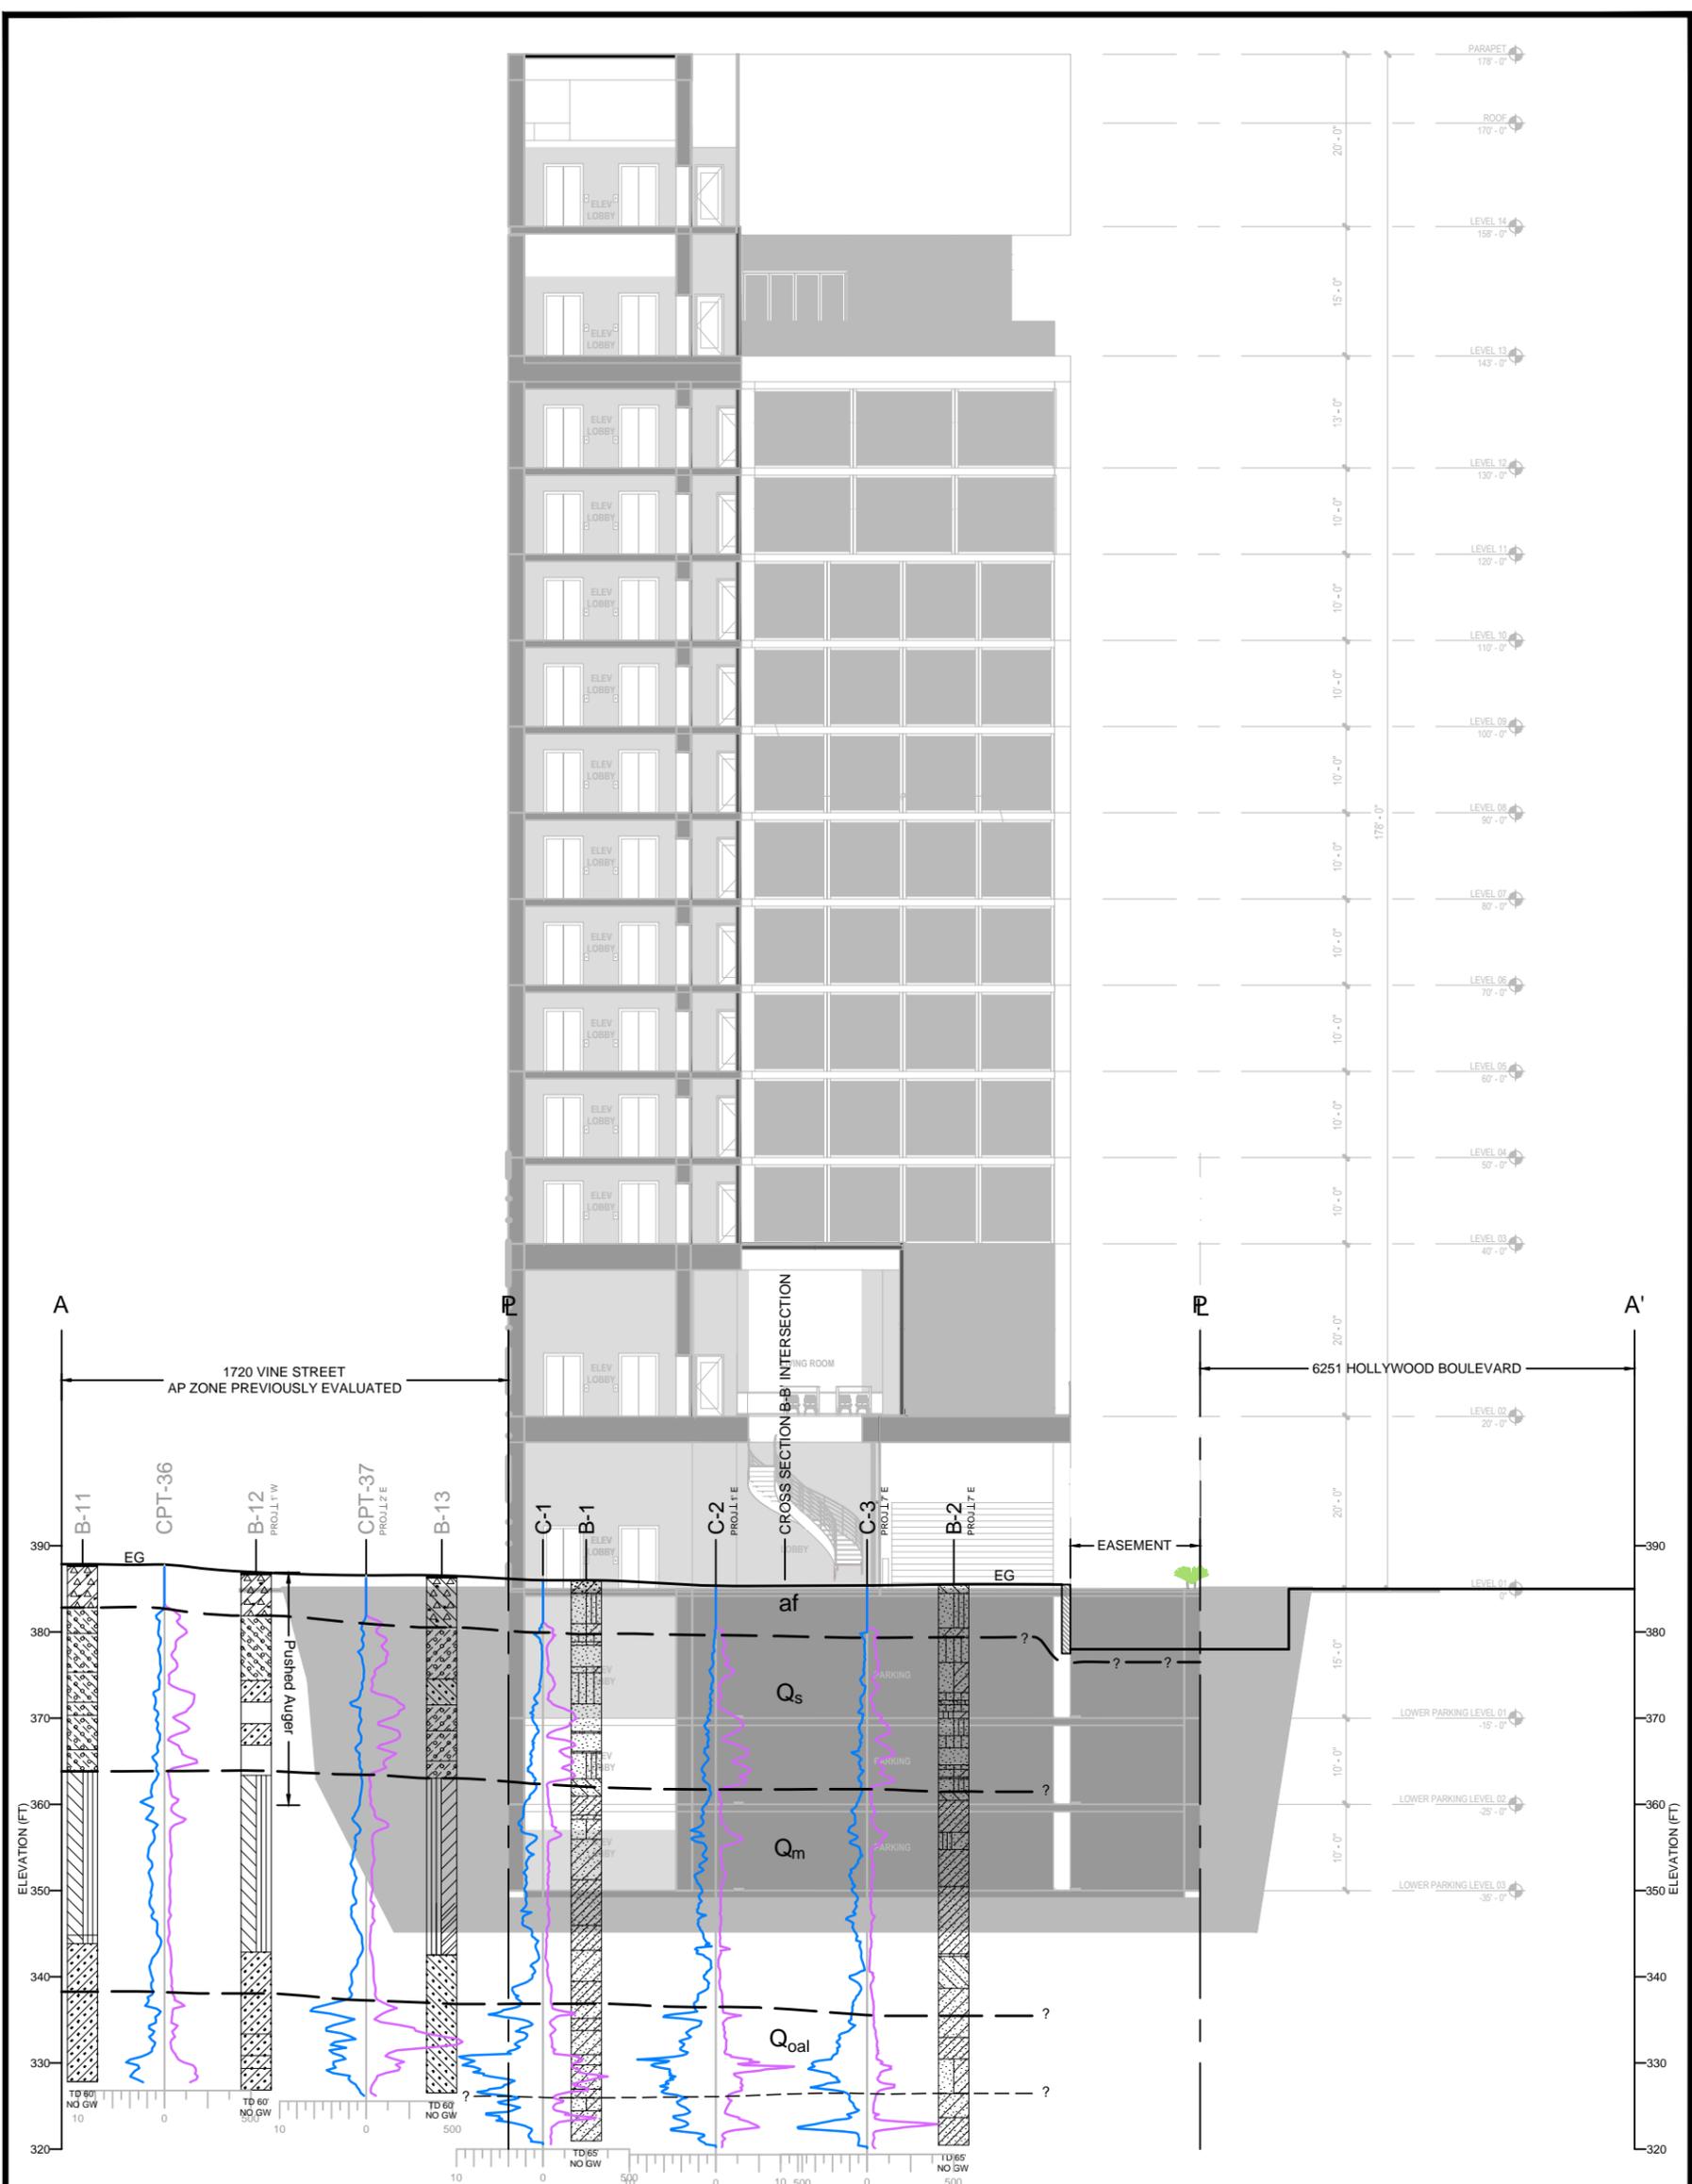
DATE: 7/11/2016	DRAWN BY: JMT	GROUP DELTA CONSULTANTS, INC 370 Amapola Ave. Suite 212 Torrance, CA. 90501	CROSS SECTION A-A' CitizenM HOTELS 1718 VINE ST., LOS ANGELES, CA	PROJECT NUMBER: LA-1289
REVIEW: JB	APPROVED BY:			SCALE: AS SHOWN
PREPARED BY: MS				FIGURE NUMBER: 3.1

- af** ARTIFICIAL FILL
- Q_s** YOUNGER ALLUVIAL FAN DEPOSITS, LOOSE POORLY GRADED SANDS WITH SILT, FEW INTERBEDDED SILTS AND CLAYS
- Q_m** MUD FLOWS, POROUS CLAYEY SAND AND SANDY CLAY
- Q_{oal}** OLDER ALLUVIAL FAN DEPOSITS, CONSOLIDATED CLAYEY SAND AND SANDY CLAY
- ? APPROXIMATE GEOLOGIC UNIT CONTACT, QUERIED WHERE NOT CONFINED

Artificial fill materials up to about 6 feet thick were encountered in the rear parking area along the east portion of the site. Deeper fill associated with the retaining walls along the east and west boundaries of the site and the restaurant interceptors is anticipated locally. The fill material consists of clayey sand and poorly graded sand with silt. Underlying the fill material is variably interbedded loose silty sand, poorly graded sand with clay, and few thin layers of stiff silty clay to depth of about 22 feet. At about 22 feet depth the native material is massive clayey sand and sandy clay. At a depth of about 53 feet the material becomes dense and hard to the maximum depth explored onsite, 65 feet. Figures 3.1 and 3.2 illustrate the subsurface profile at the site.

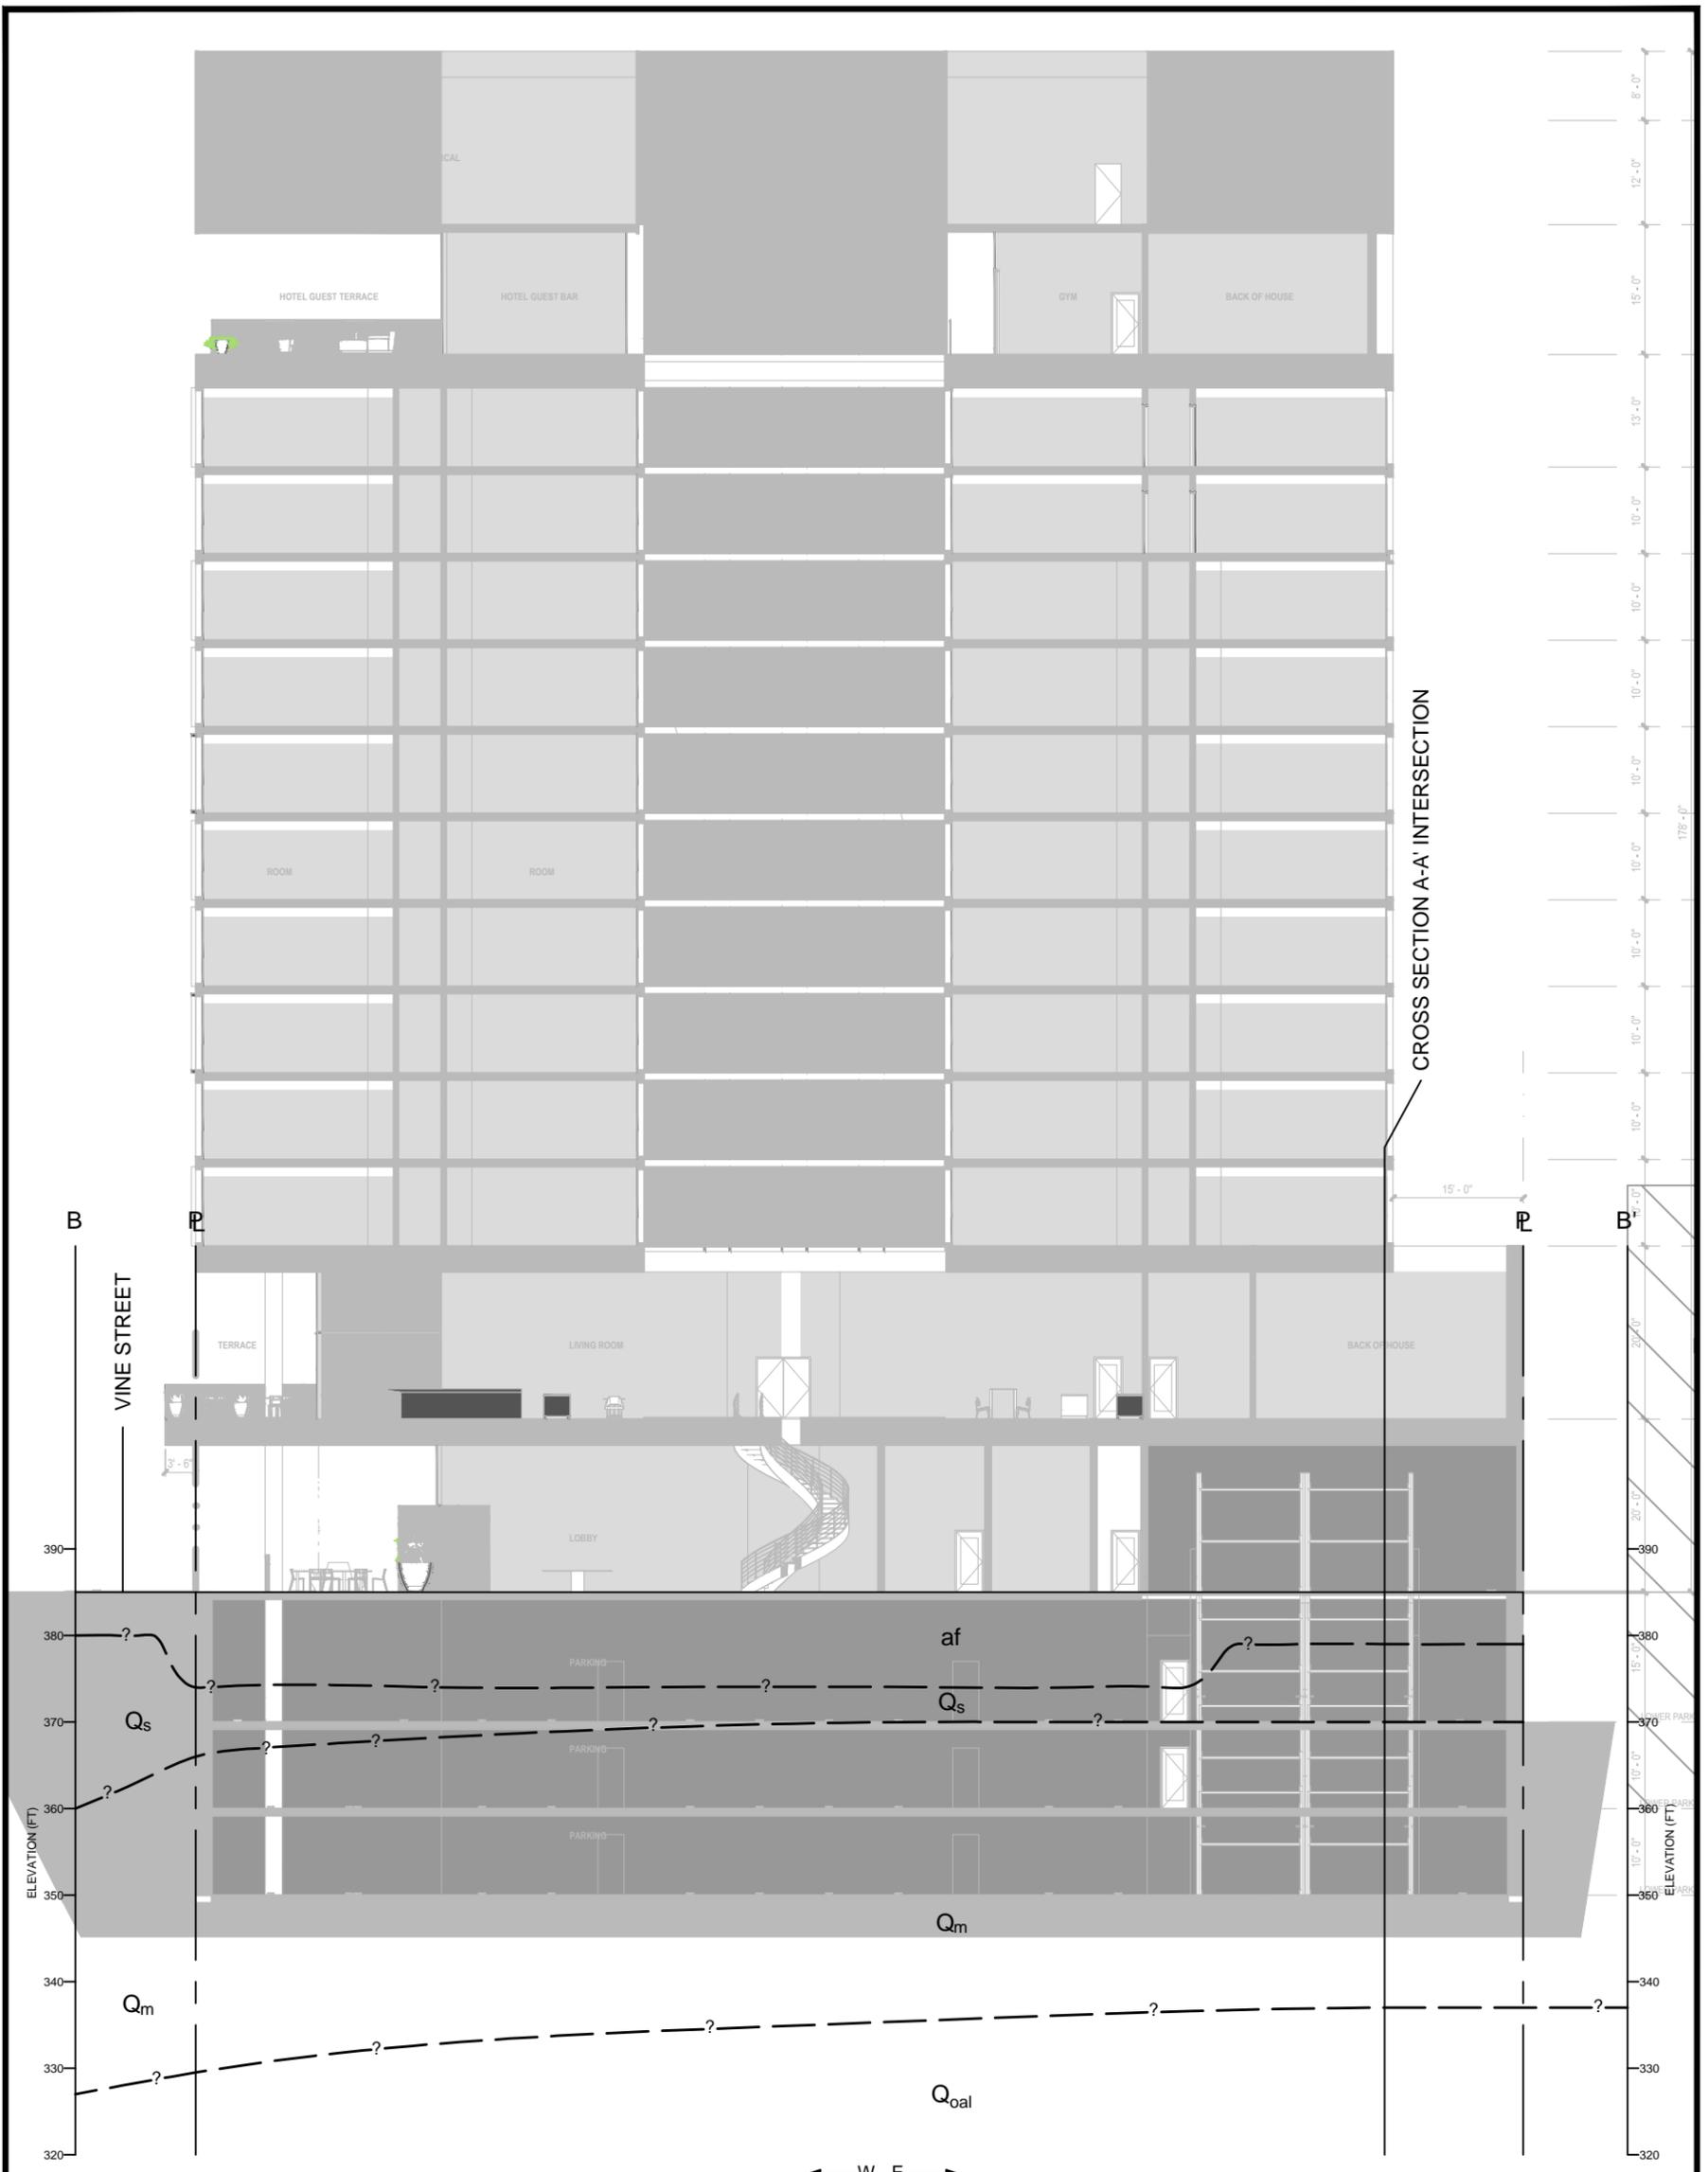
GROUP DELTA CONSULTANTS, INC 370 Amapola Ave. Suite 212 Torrance, CA. 90501	CROSS SECTION B-B' CitizenM HOTELS 1718 VINE ST., LOS ANGELES, CA	PROJECT NUMBER: LA-1289
REVIEW: JB	APPROVED BY:			SCALE: AS SHOWN
PREPARED BY: MS				FIGURE NUMBER: 3.2

- af** ARTIFICIAL FILL
- Q_s** YOUNGER ALLUVIAL FAN DEPOSITS, LOOSE POORLY GRADED SANDS WITH SILT, FEW INTERBEDDED SILTS AND CLAYS
- Q_m** MUD FLOWS, POROUS CLAYEY SAND AND SANDY CLAY
- Q_{oal}** OLDER ALLUVIAL FAN DEPOSITS, CONSOLIDATED CLAYEY SAND AND SANDY CLAY
- — ? APPROXIMATE GEOLOGIC UNIT CONTACT, QUERIED WHERE NOT CONFINED

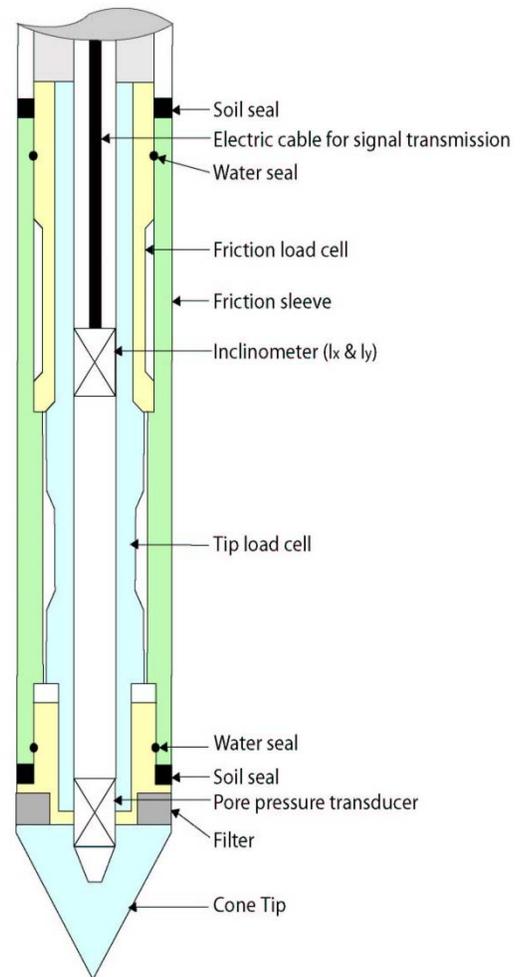
Figure CPT

The 5mm thick porous plastic filter element is located directly behind the cone tip in the u_2 location. A new saturated filter element is used on each sounding to measure both penetration pore pressures as well as measurements during a dissipation test (*PPDT*). Prior to each test, the filter element is fully saturated with oil under vacuum pressure to improve accuracy.

Gregg 15cm² Standard Cone Specifications

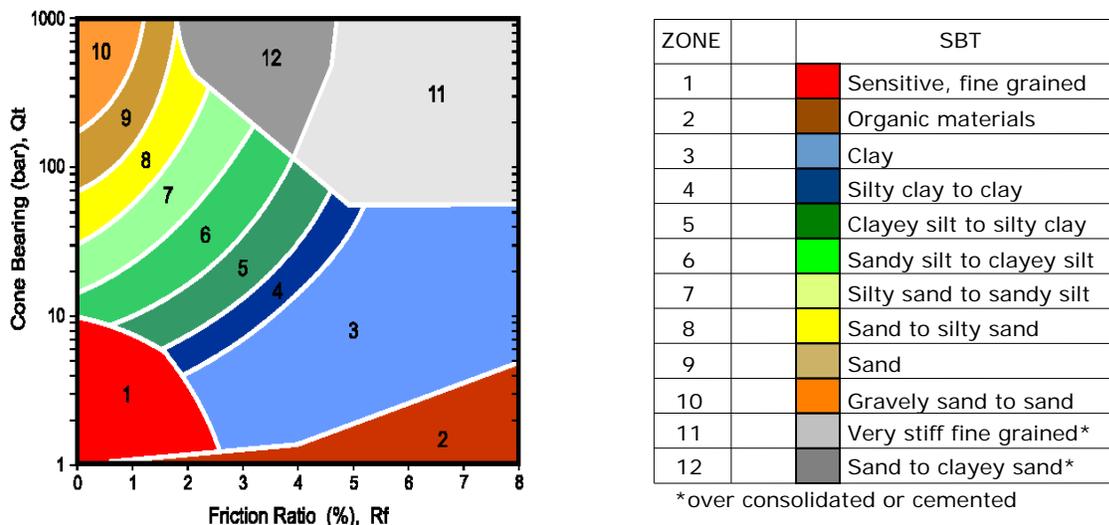
Figure SBT (After Robertson et al., 1986) – Note: Colors may vary slightly compared to plots

Note that it is not always possible to clearly identify a soil type based solely on q_t , f_s , and u_2 . In these situations, experience, judgment, and an assessment of the pore pressure dissipation data should be used to infer the correct soil behavior type.

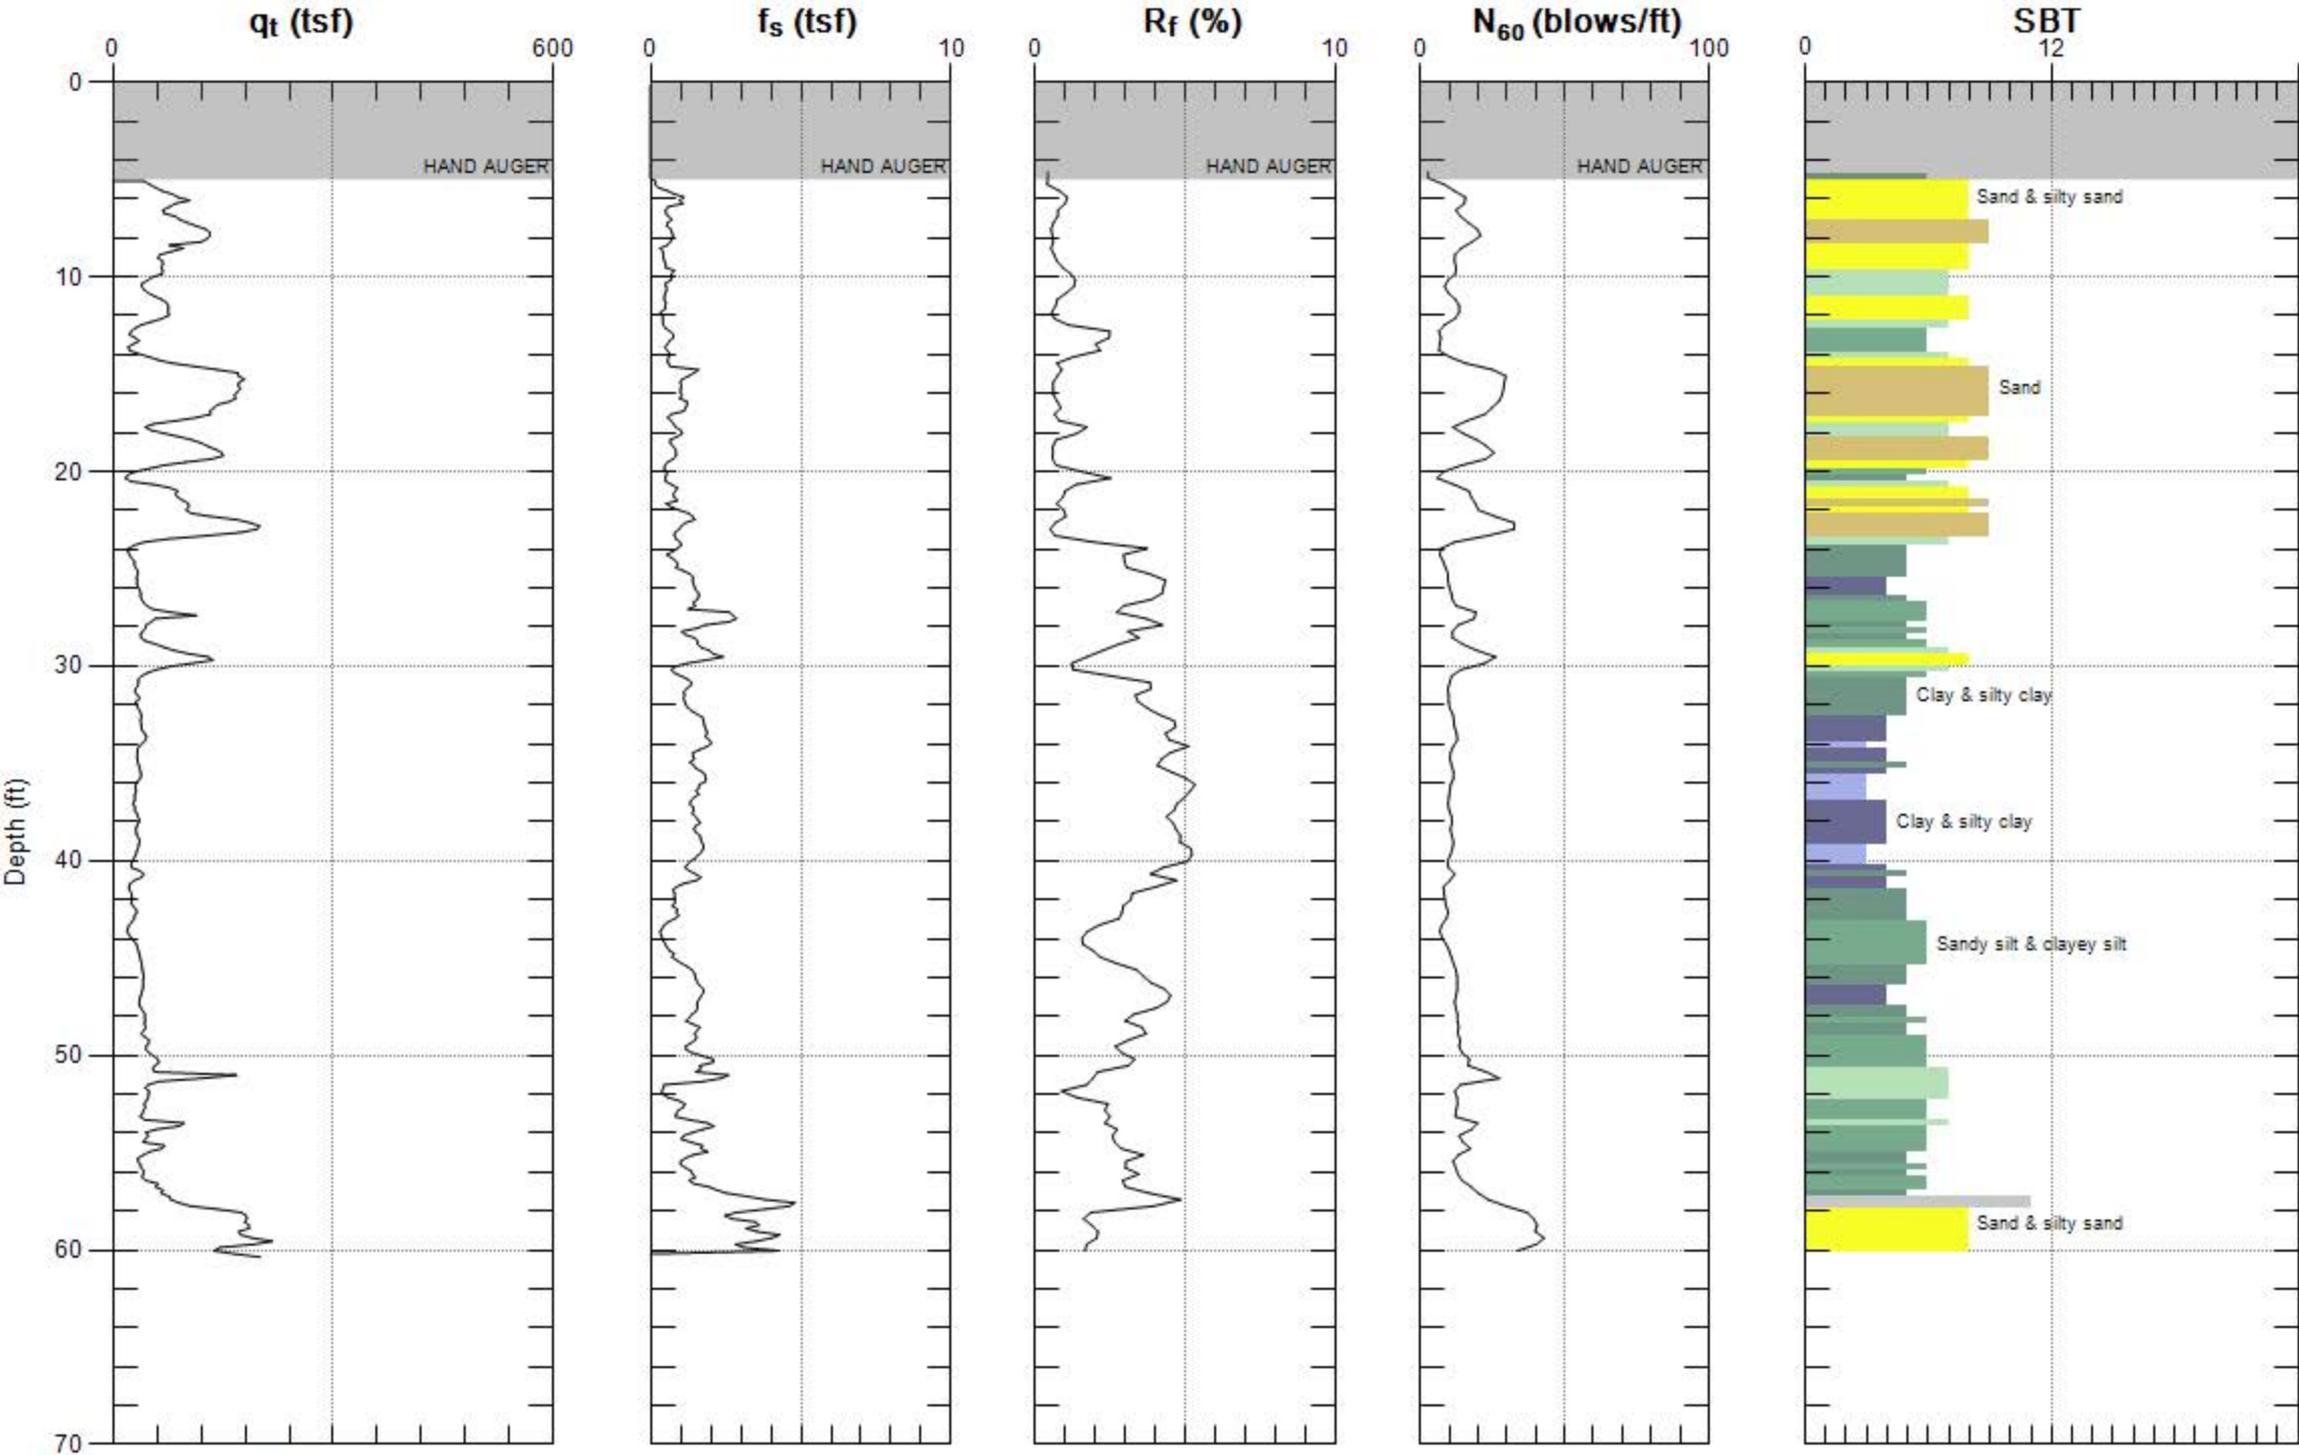
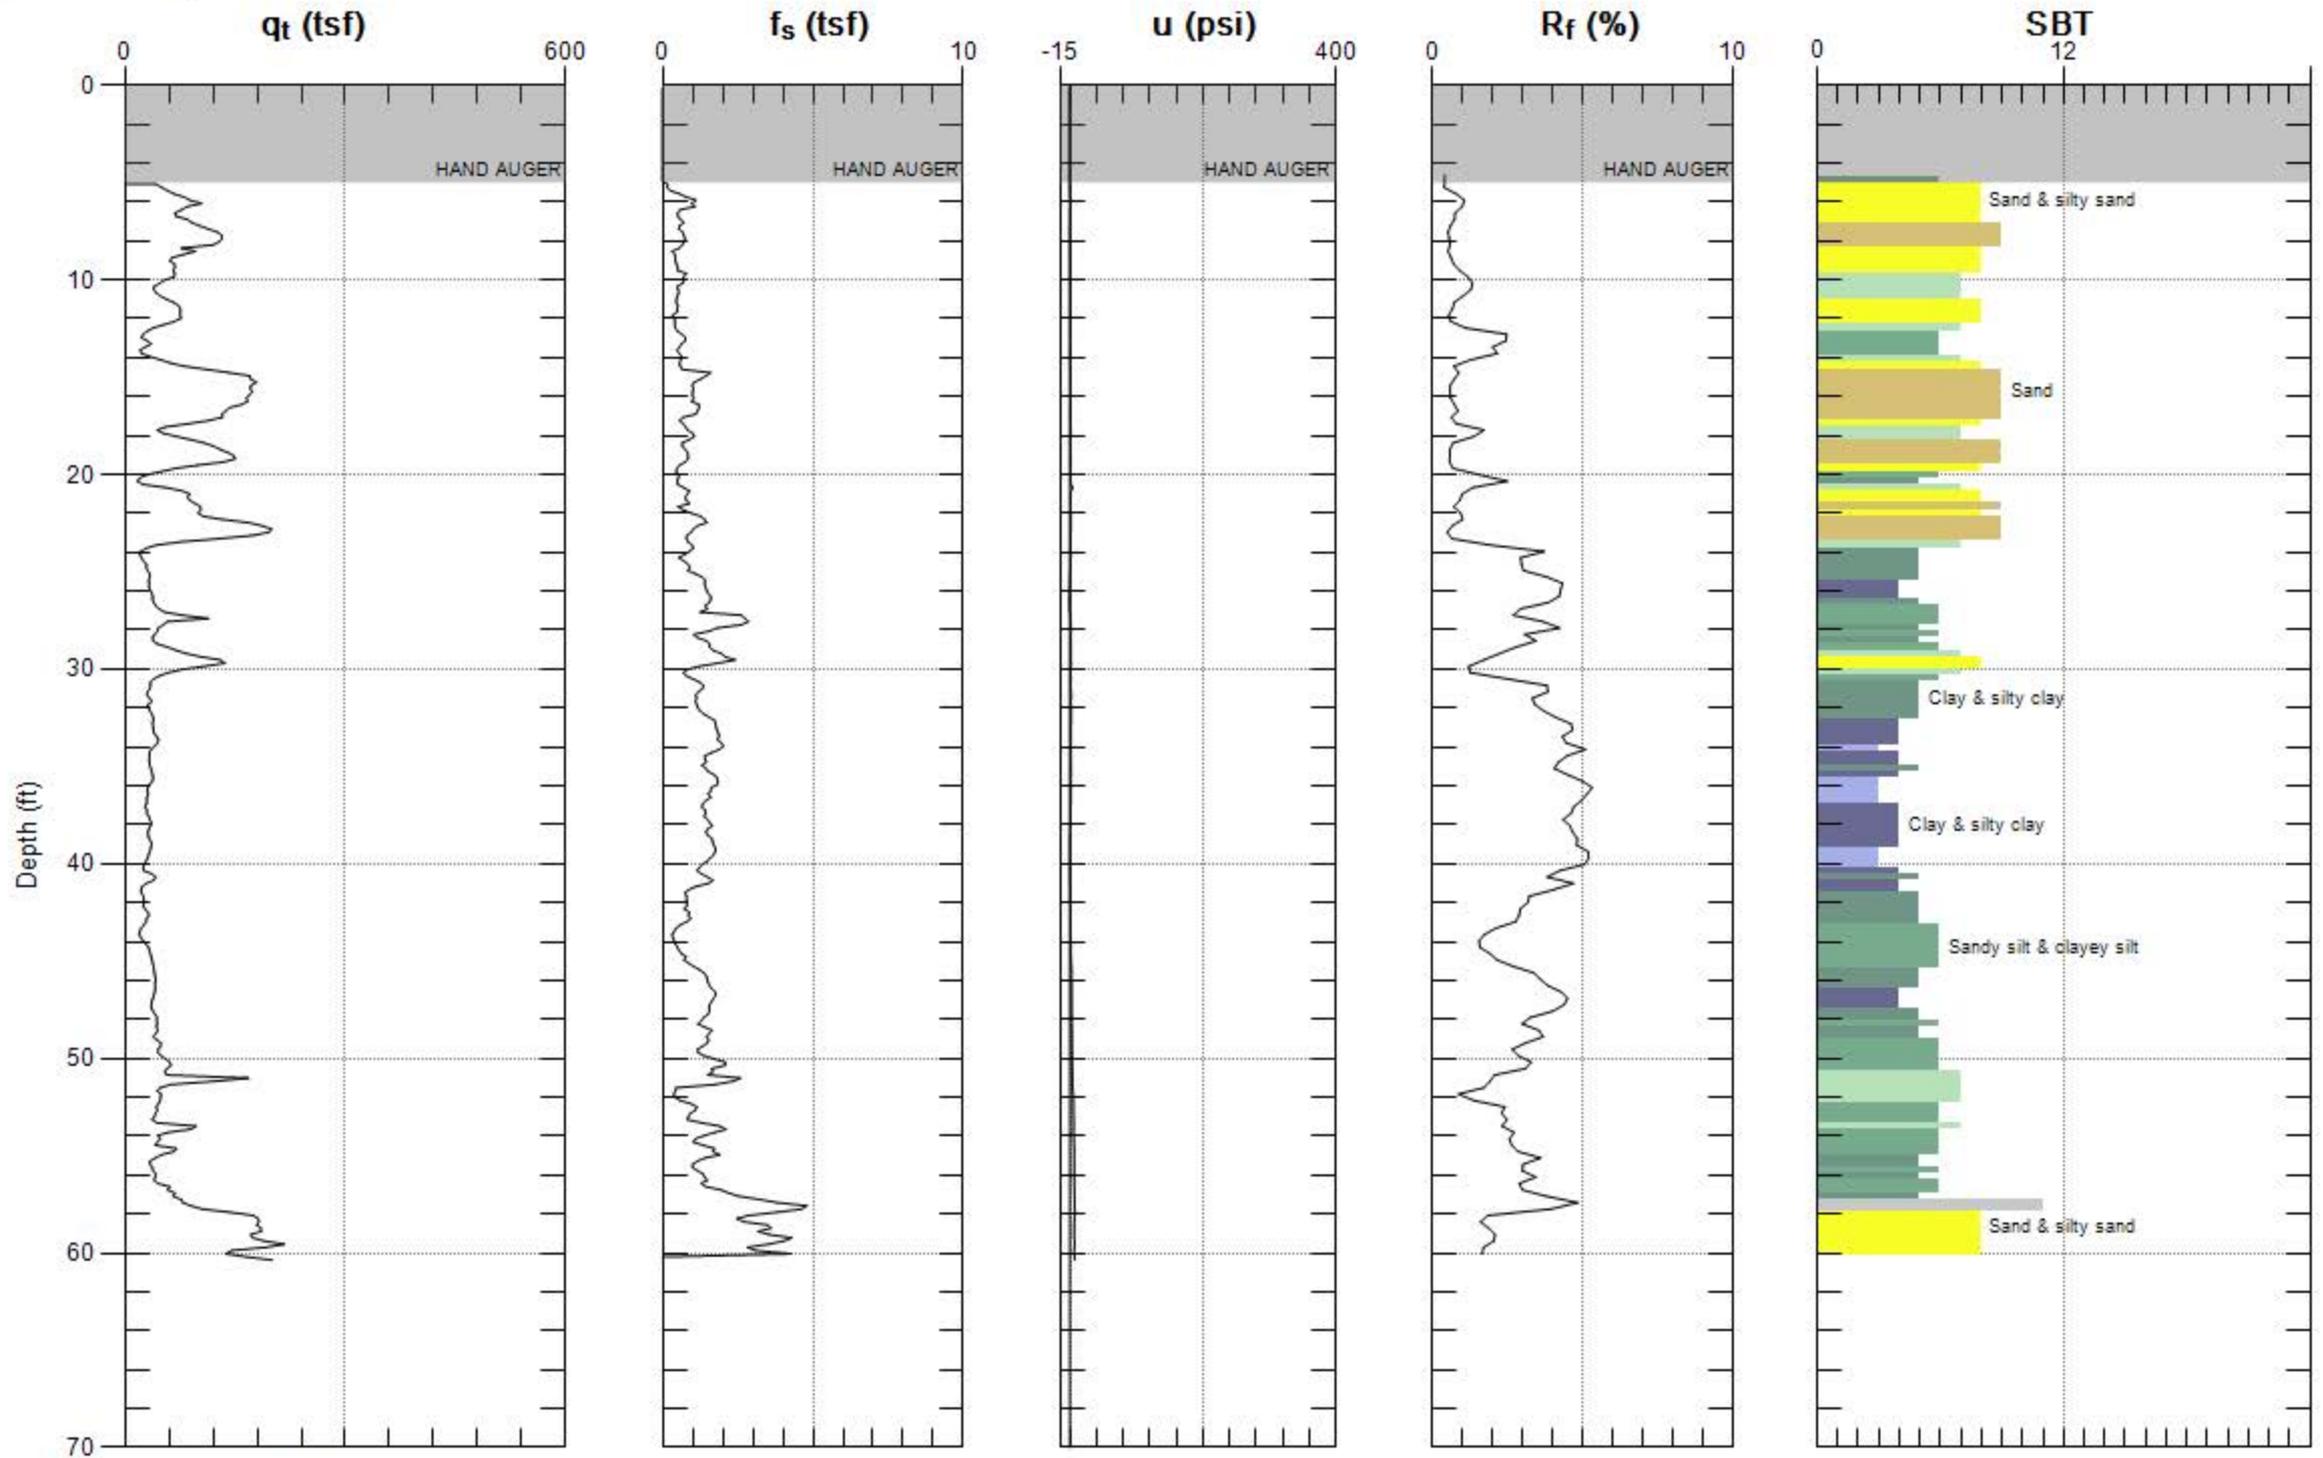
Sounding: CPT-36

Max. Depth: 60.367 (ft)
Avg. Interval: 0.328 (ft)
