Geotechnical Investigation

**Updated Geotechnical Feasibility Report
Proposed High-Rise Hotel Development
1718 Vine Street
Hollywood District
Los Angeles, California**

**July 28, 2016
GDC Project No. LA-1289**

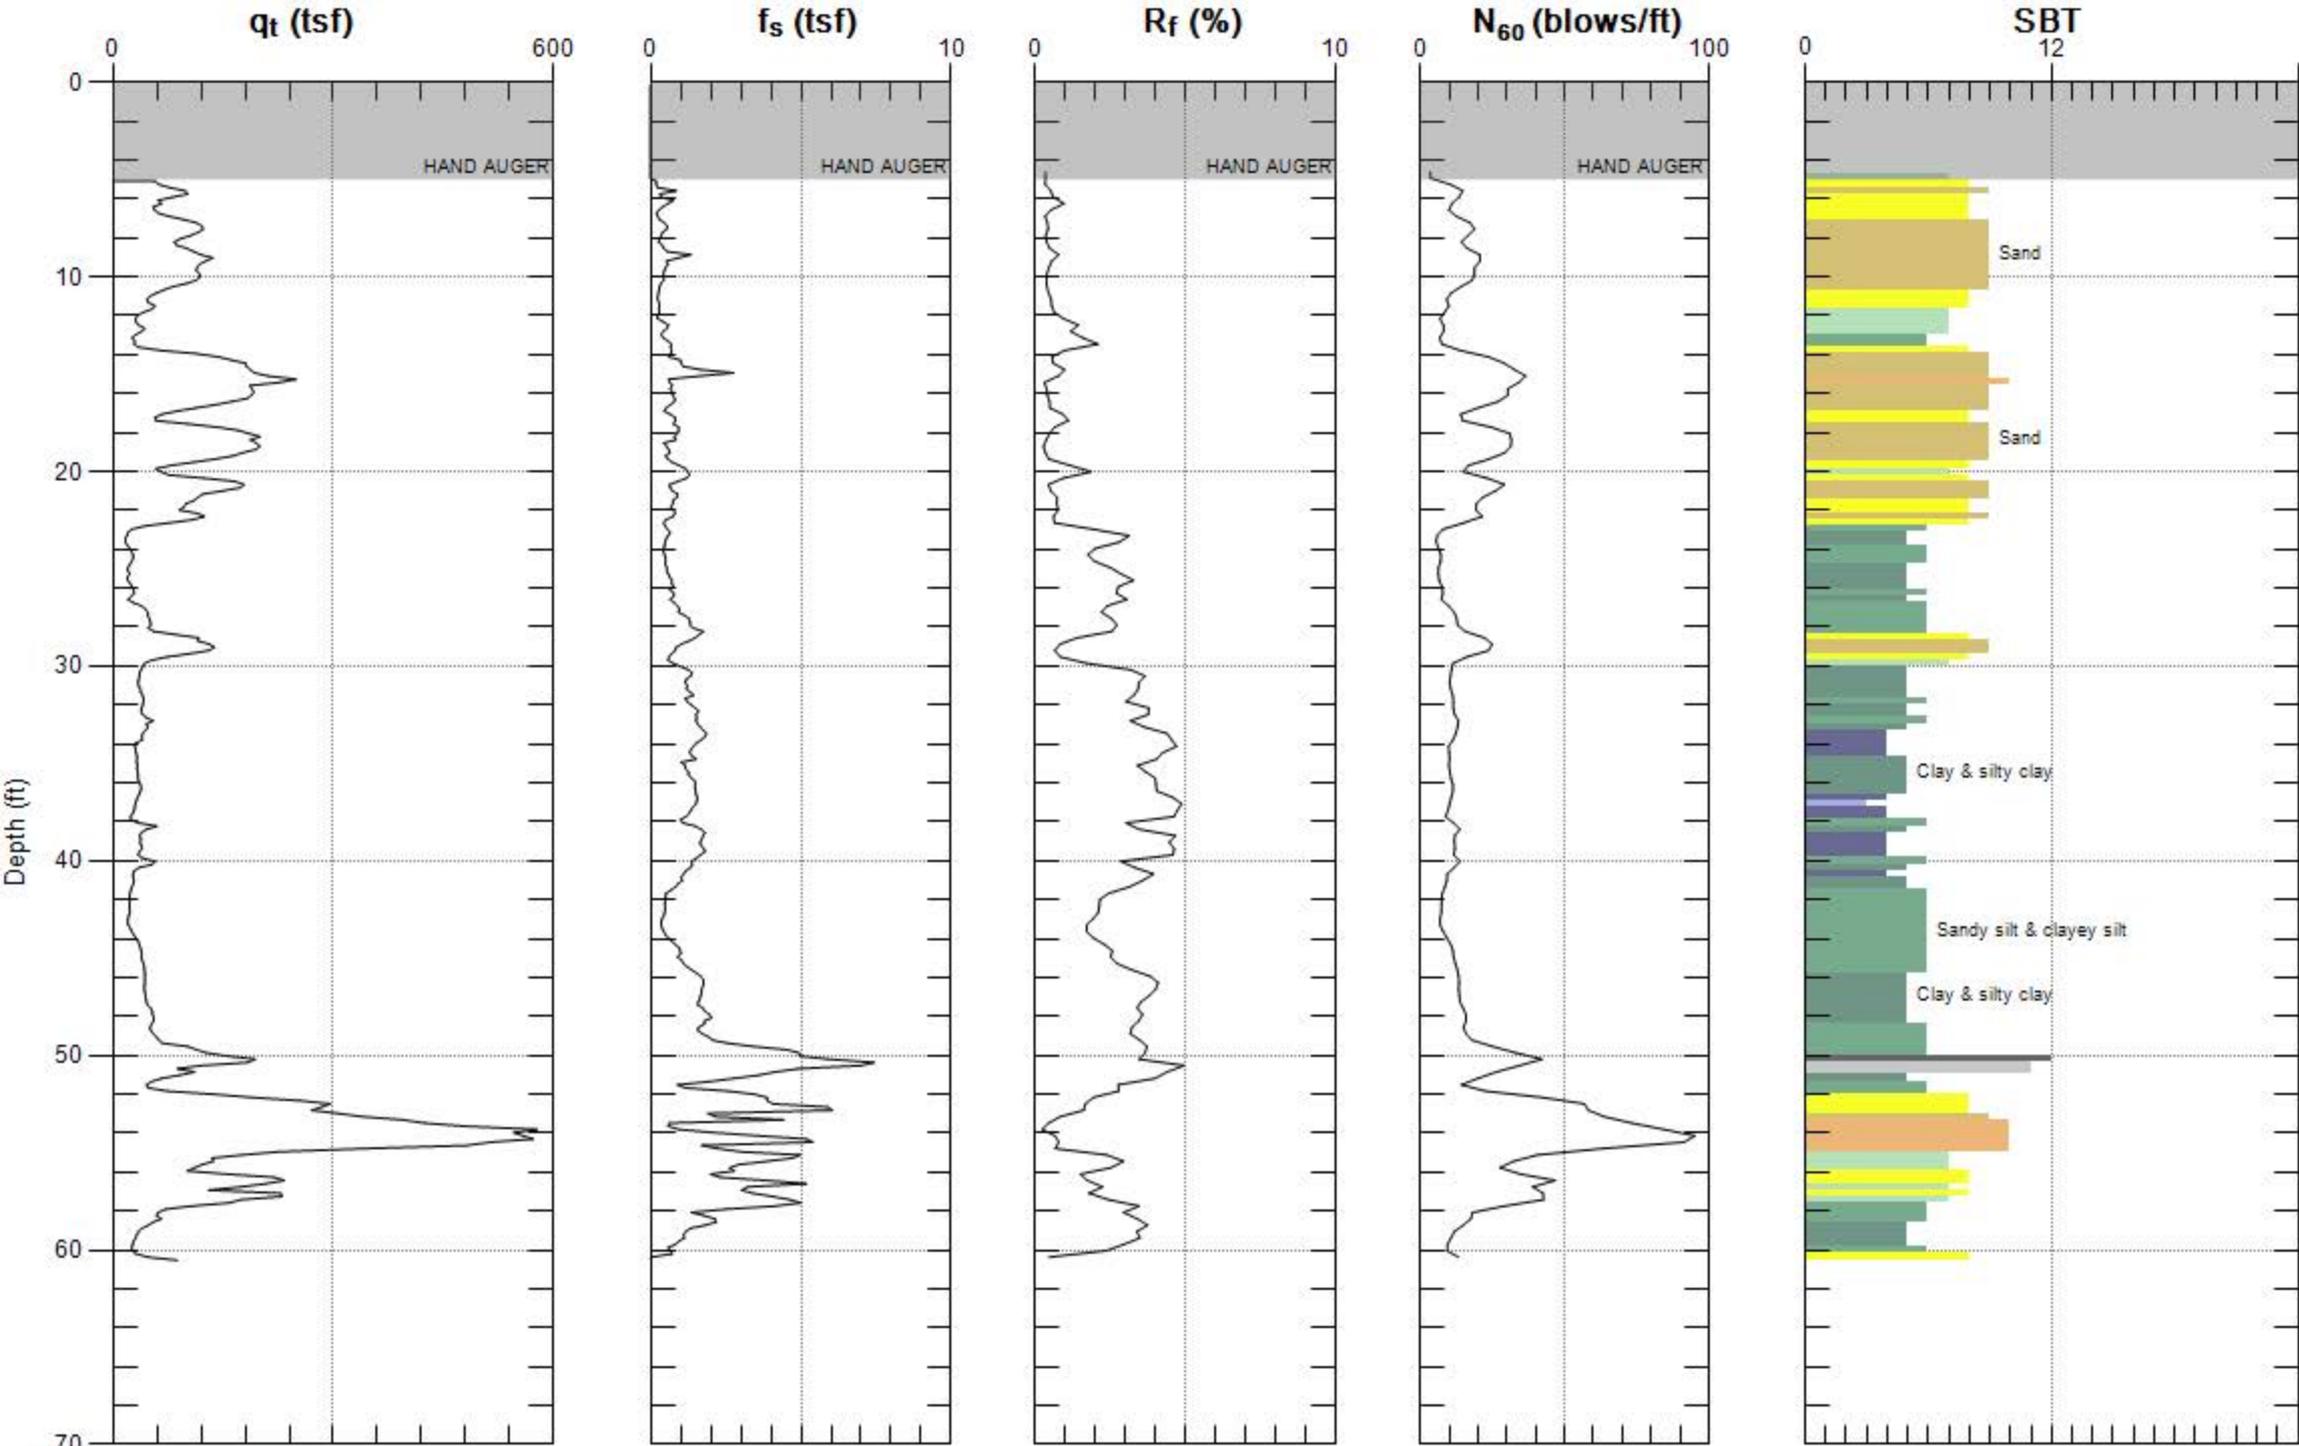
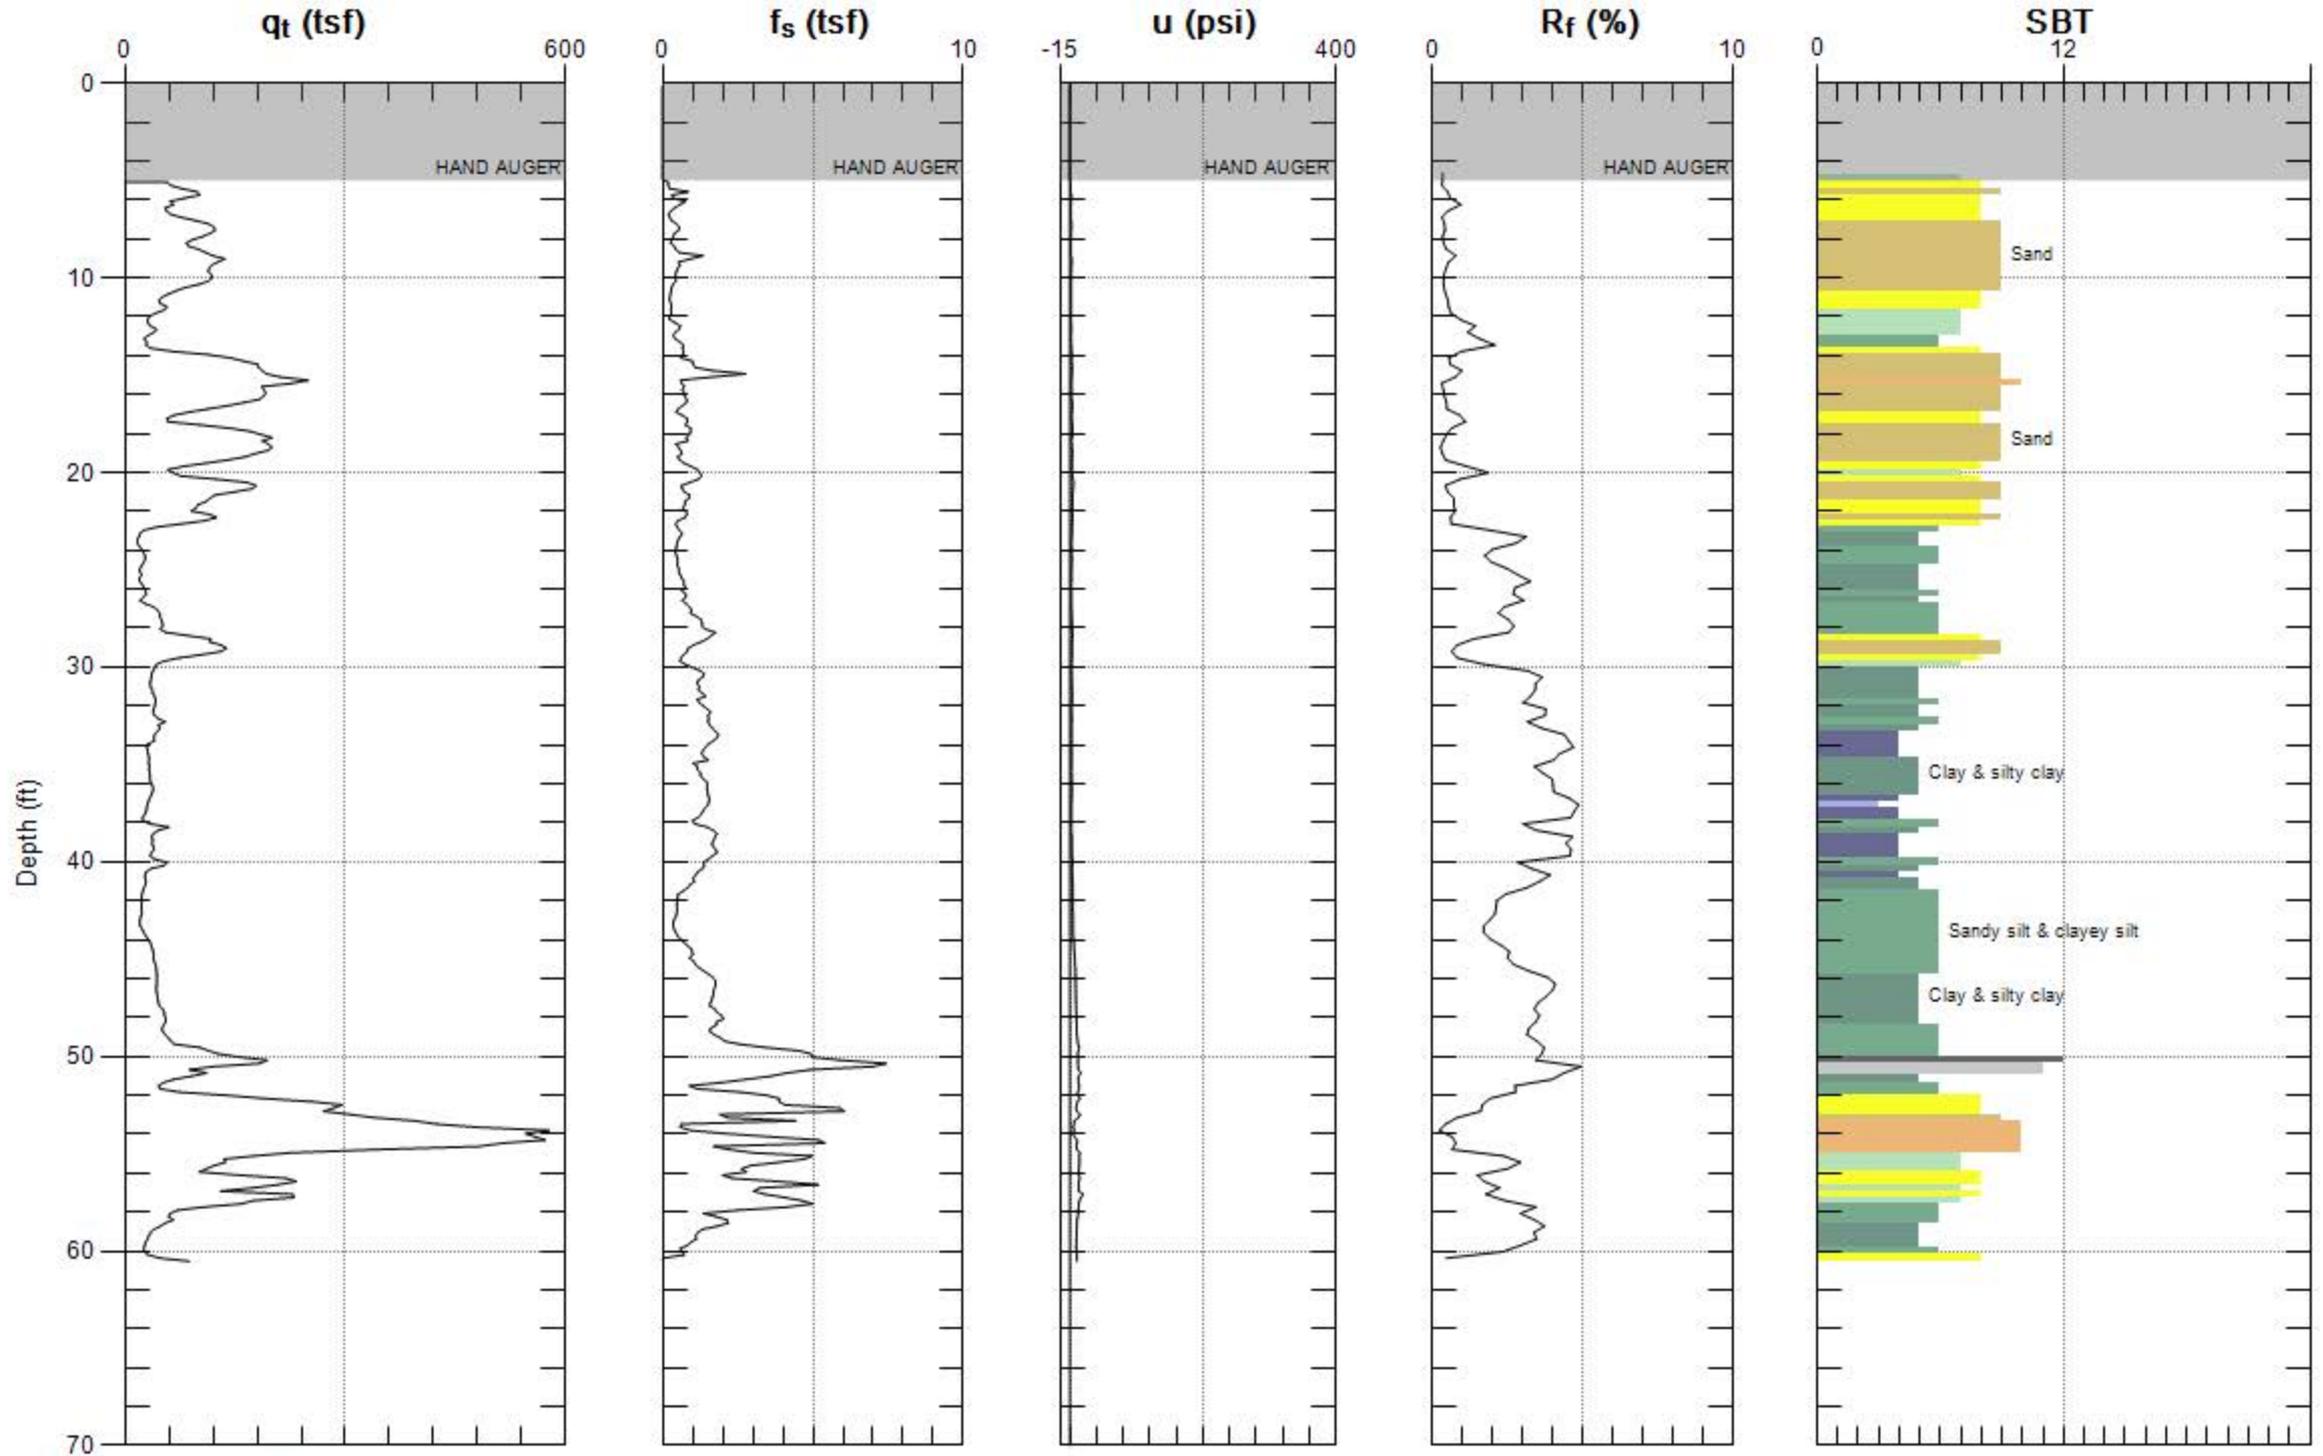
Site: PARKING LOT S
Sounding: CPT-37

Max. Depth: 60.531 (ft)
Avg. Interval: 0.328 (ft)

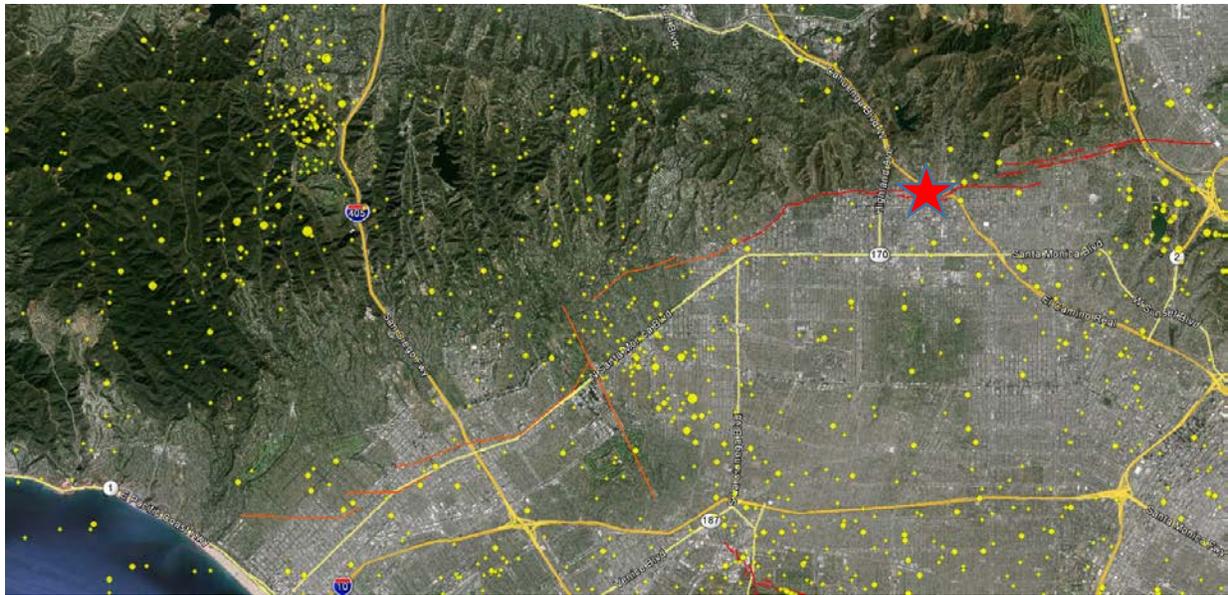
Note: Yellow dots represent recent earthquake epicenter location and magnitude the red lineaments represent the mapped Hollywood fault, and the orange lineaments represent the Santa Monica fault and Newport Inglewood lineament (USGS, 2014).

The Hollywood fault is estimated to be capable of a 6.7 Mw earthquake. However, it has not been a source of significant seismic activity in historical time. The USGS Earthquake Catalog indicates a few small magnitude earthquakes in the fault zone as illustrated below; however, the seismicity has not been directly attributed to the Hollywood fault (USGS 2016). Surface rupture data on this fault indicates the most recent surface rupture is likely between 7,000 to 9,500 years ago (Dolan, 2000).

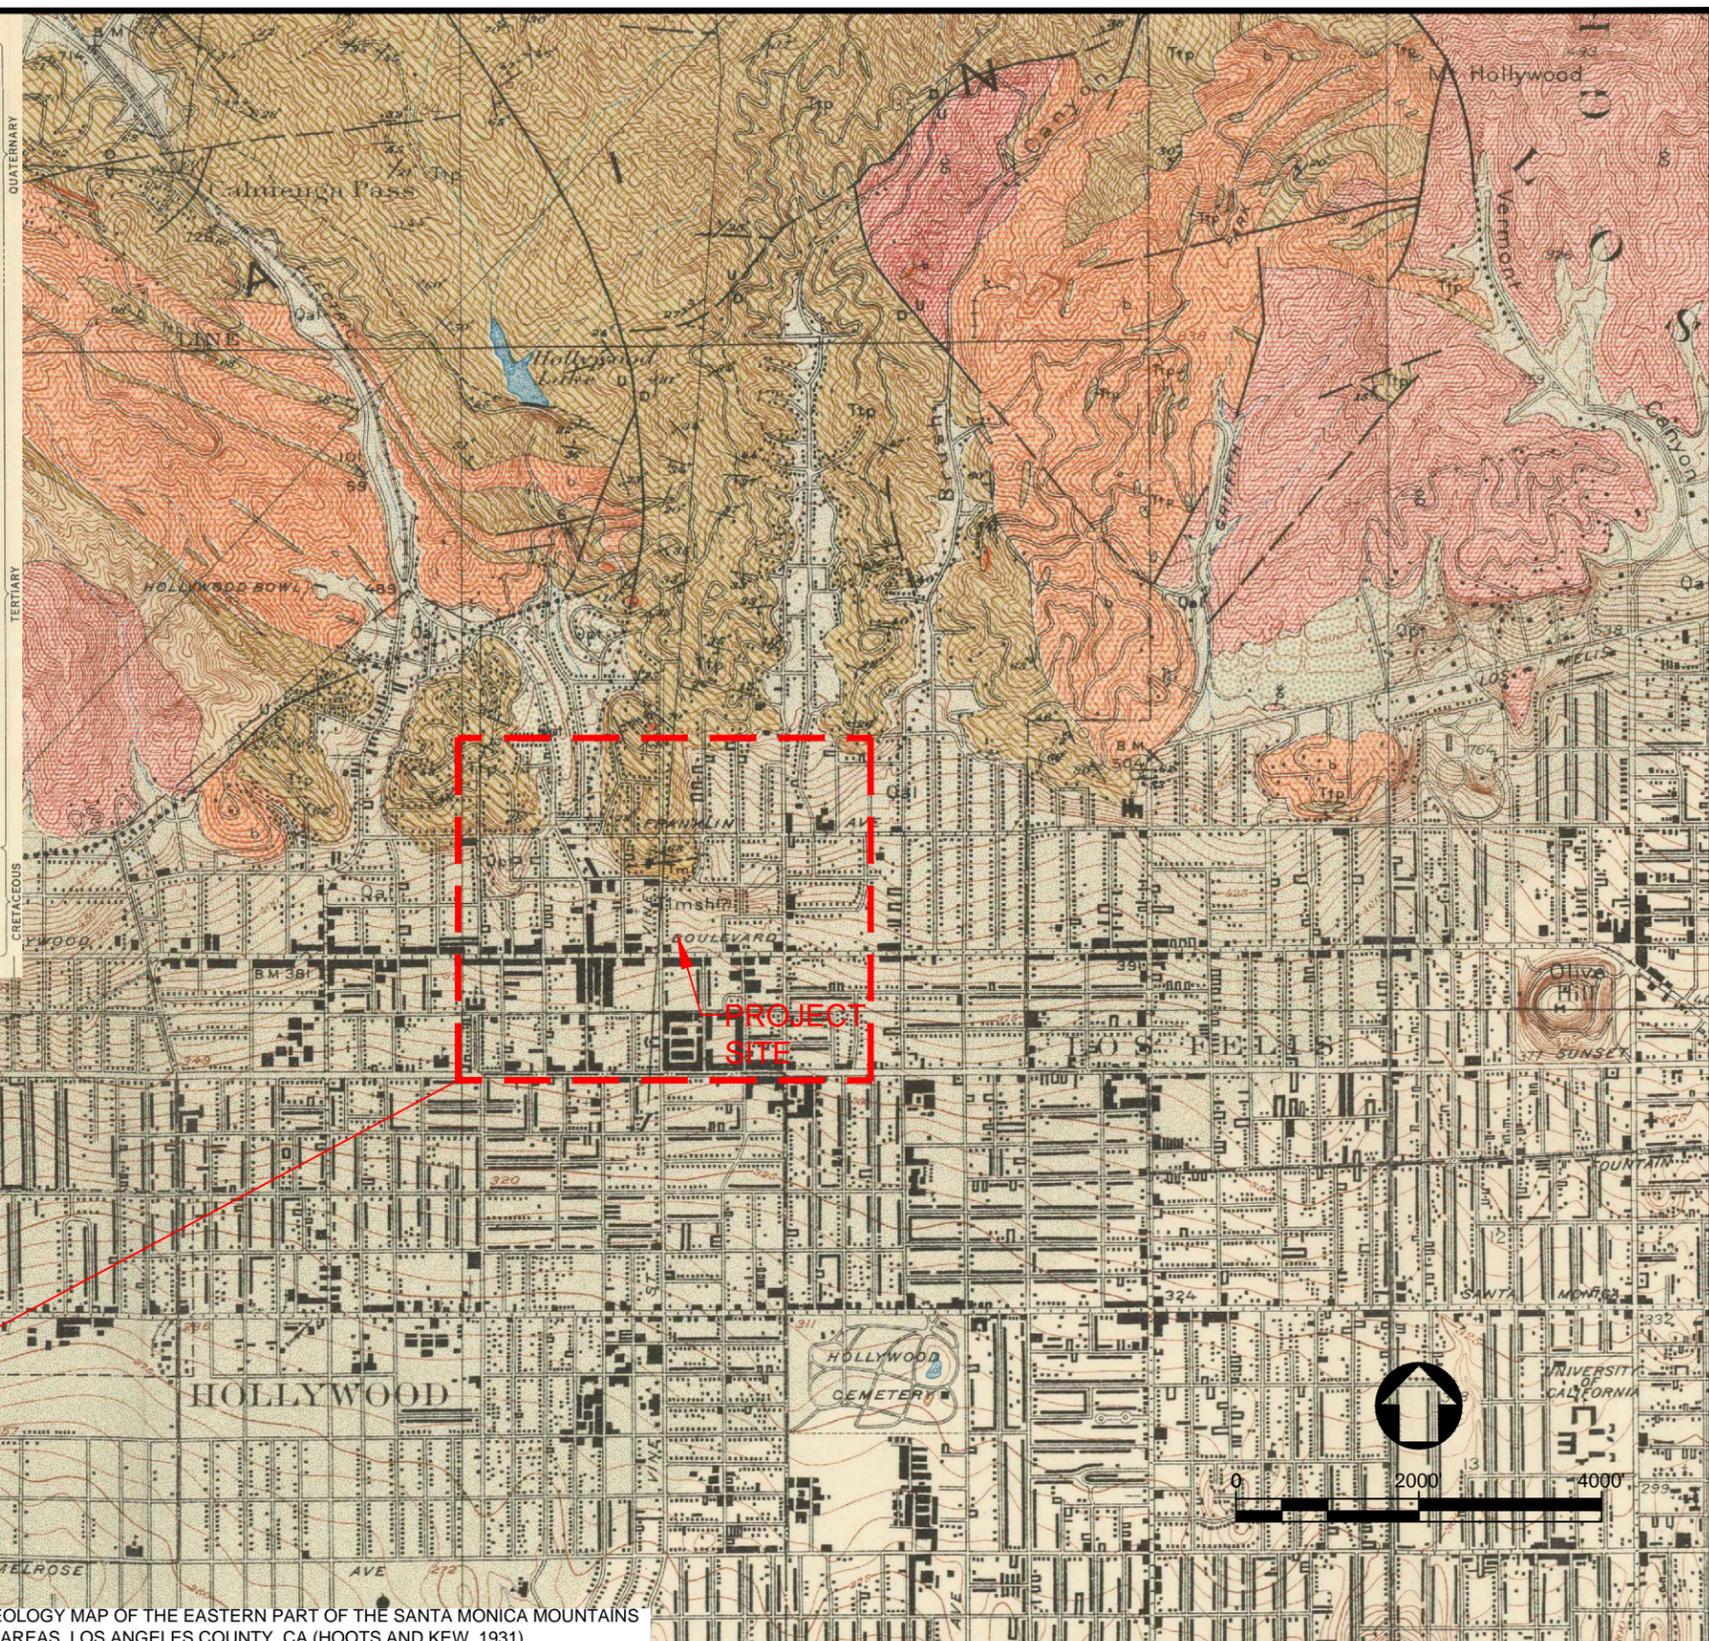
REFERENCE: GEOLOGY MAP OF THE EASTERN PART OF THE SANTA MONICA MOUNTAINS AND ADJACENT AREAS, LOS ANGELES COUNTY, CA (HOOTS AND KEW, 1931)

Our interpretation is based on historical topography and geology presented in Figure 3, exploration data presented in Figure 4 and Appendix A, and background data discussed in this report. An illustration of our interpretation is presented in Figure 5.1 and Figure 5.2. A discussion is presented below.

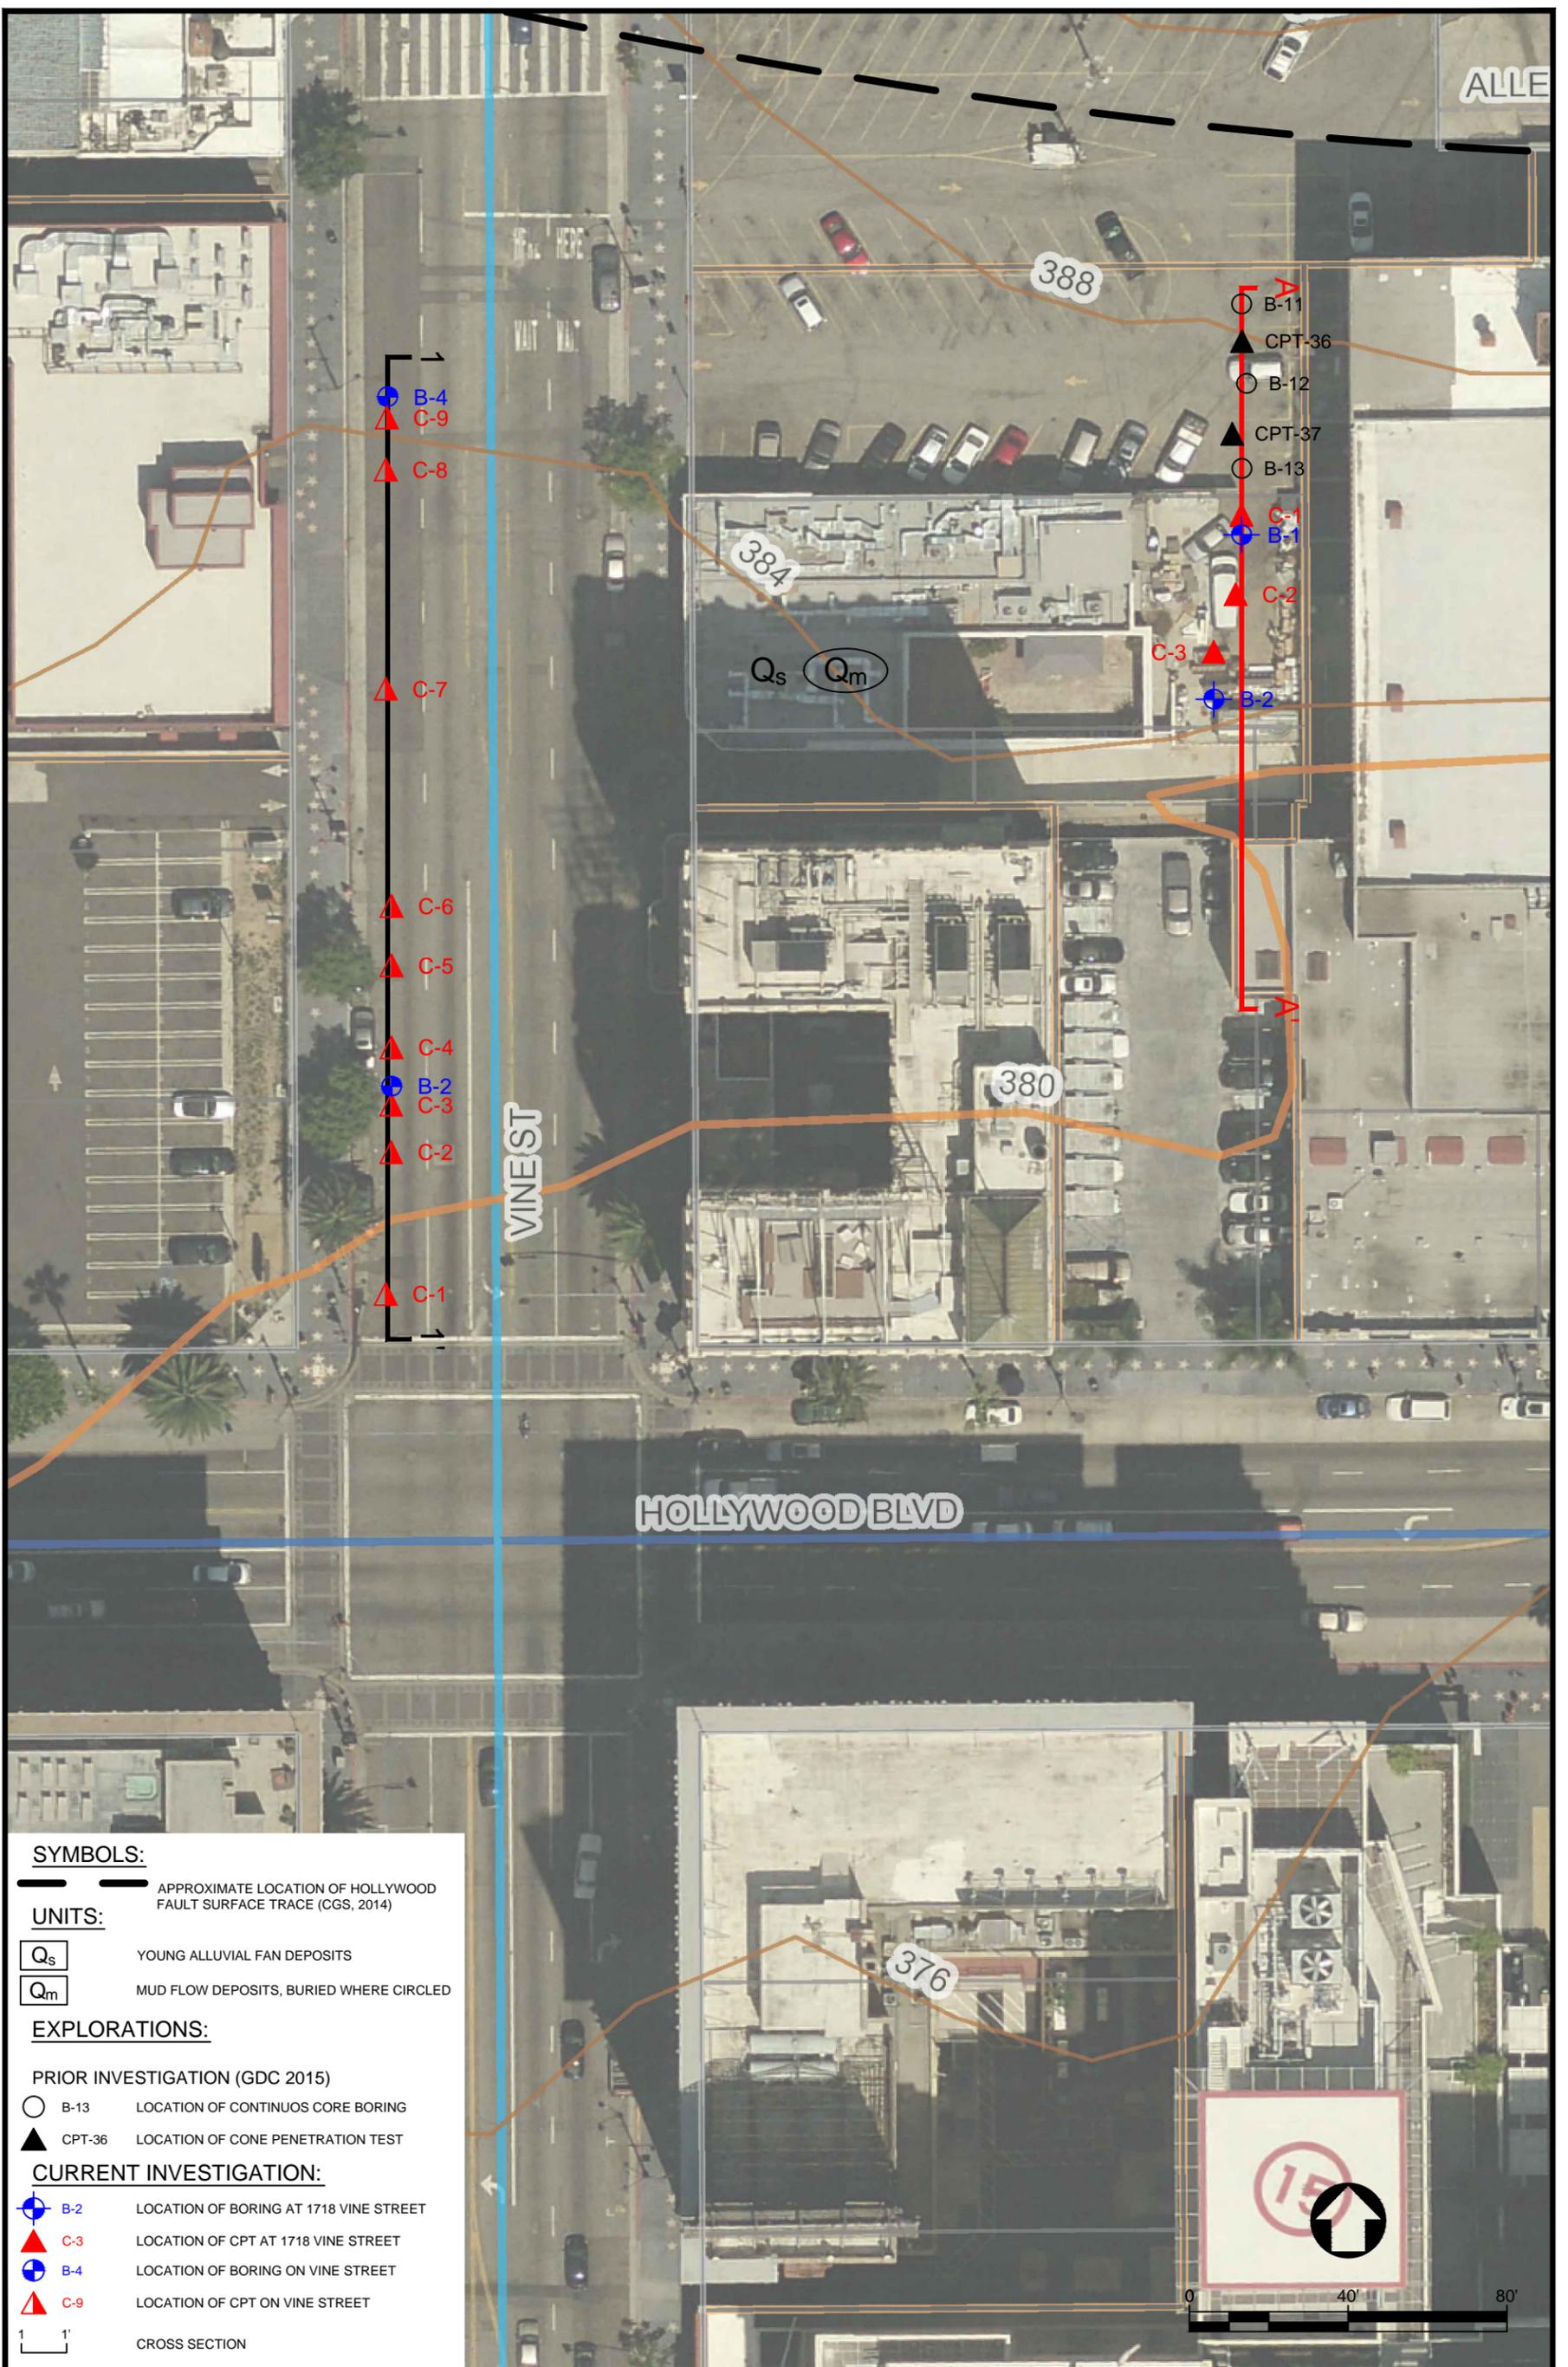
DATE: 7/28/2016	DRAWN BY: JMT	 GROUP DELTA CONSULTANTS, INC 370 Amapola Ave. Suite 212 Torrance, CA. 90501	EXPLORATION PLAN CitizenM HOTELS 1718 VINE ST., LOS ANGELES, CA	PROJECT NUMBER: LA-1289
REVIEW: MR	APPROVED BY: MS			SCALE: AS SHOWN
PREPARED BY: MS	FINAL			FIGURE NUMBER: 4

SYMBOLS:
 APPROXIMATE LOCATION OF HOLLYWOOD FAULT SURFACE TRACE (CGS, 2014)

UNITS:
 YOUNG ALLUVIAL FAN DEPOSITS
 MUD FLOW DEPOSITS, BURIED WHERE CIRCLED

We evaluated the accessible areas of the Site and a 50-foot perimeter south for the field exploration, see Figure 4. The eastern portion of the Site is open space, however due to the narrowness of the area, the active adjacent developments, and the depth to pre-Holocene deposition, trenching was not considered feasible. The eastern portion of the Site is accessible to drilling and CPT equipment, which allows a transect of closely spaced explorations to be performed. Within alluvial fan environments, deposition stratigraphy is often complex and not considered linearly relatable; however, prior investigations in the Site vicinity (as described below) indicate sheet flow depositional episodes are preserved, which can be correlated across explorations.

Our field investigation for the Site and an area 50 feet south utilized the method of CPT and core transects to collect data for evaluation of evidence for active faulting at the Site. The location of exploration transects is illustrated in Figure 4. The transect stretches across the Site oriented near perpendicular to the mapped fault trace to intersect all potential breaks in stratigraphy across the Site. Prior investigations performed by GDC (2015) (as described above) were used to extend the evaluation north 50 feet from the northern property line. Exploration along Vine Street was used to extend the evaluation south 50 feet from the Site's southern property line. Existing structures, sidewalks, and utilities were considered inaccessible areas.

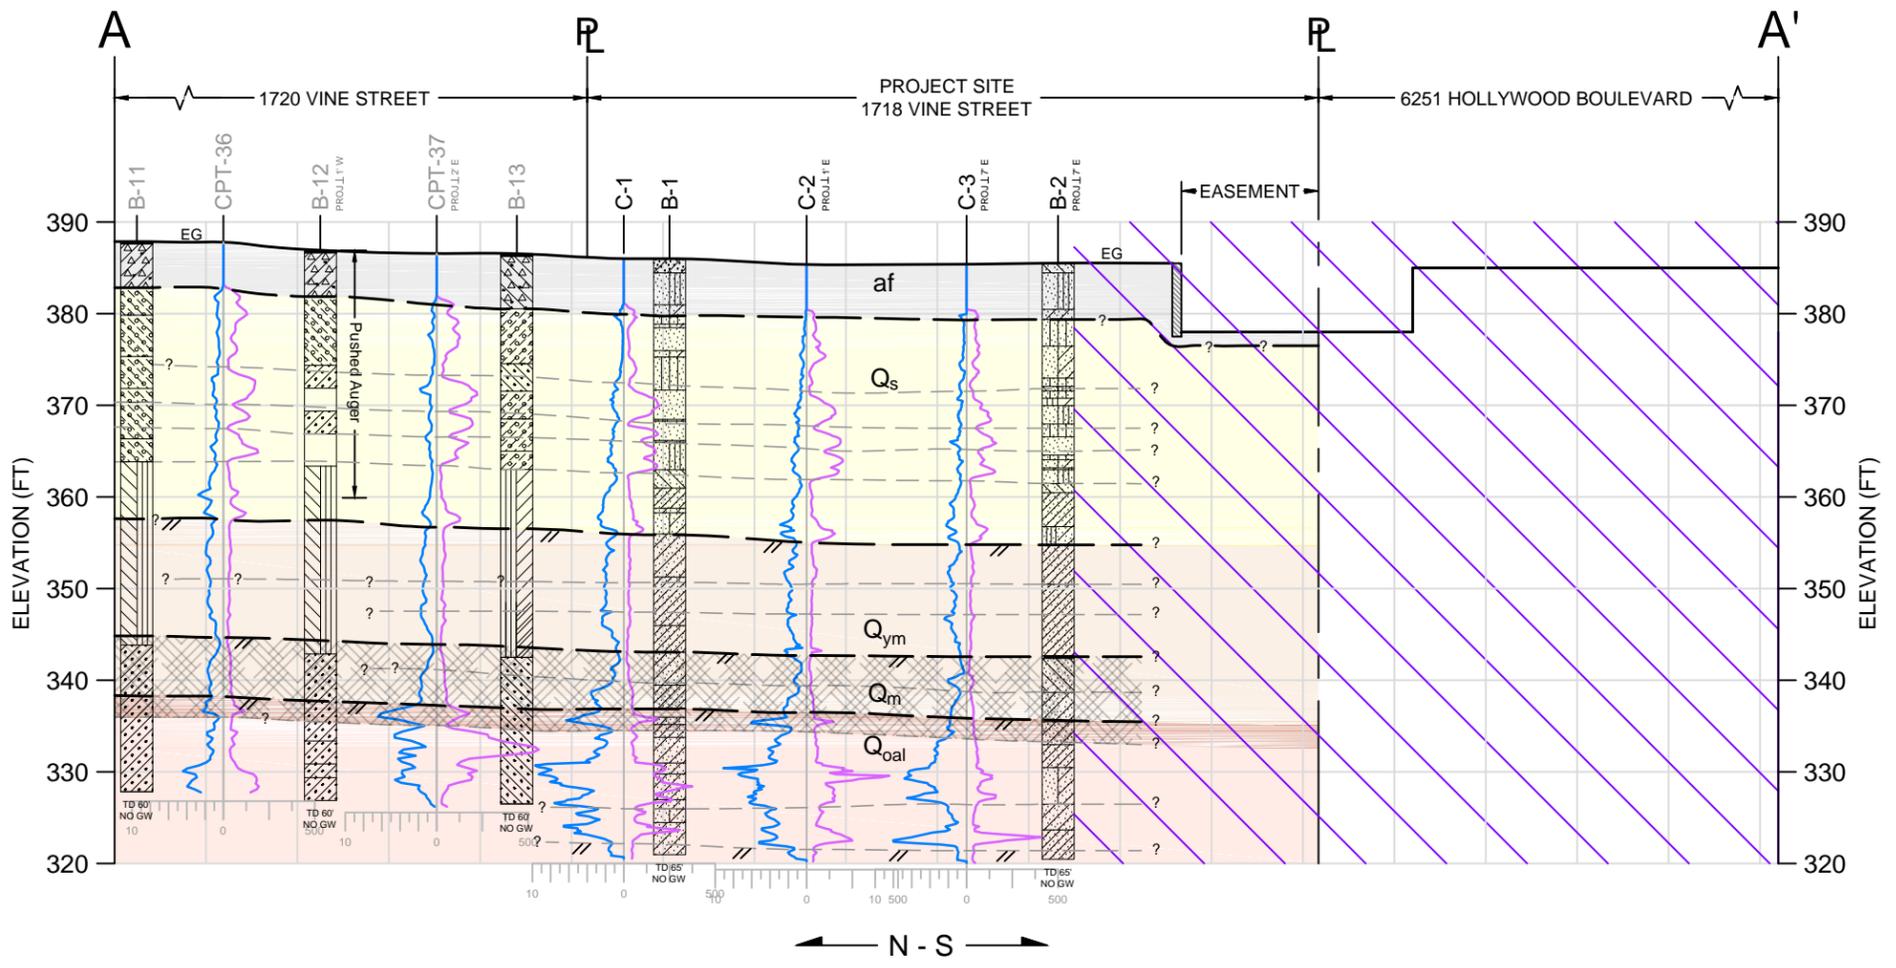
- HOLOCENE
 - ARTIFICIAL FILL
 - YOUNG ALLUVIAL FAN DEPOSITS - POORLY GRADED SAND WITH VARIABLE CLAY AND SILT, FEW GRAVEL, DISTINCTIVE INTERBEDDED THIN FINE GRAINED LAYERING (10 YR)
- PLEISTOCENE
 - YOUNGER MUD FLOWS - DISTINCTIVE COLOR SHIFT TO 7.5 YR, SANDY CLAY
 - MUD FLOW - VERY DARK BROWN TO DARK BROWN 7.5YR, PLATY PED DEVELOPMENT WITH ARGILLIC FACES (t)
 - Btg - SOIL HORIZON - GLEYED MOTTLING (g), SLIGHTLY INDURATED, WELL DEVELOPED PLATY PED STRUCTURE WITH ARGILLIC FACES (t), REMNANT ROOTLETS
 - OLDER ALLUVIAL FAN DEPOSITS - DISTINCTIVE UPPER CONTACT, COLOR SHIFT TO STRONG 7.5YR AND 5YR, CONSOLIDATED CLAYEY SAND

The explorations are located within an alluvial fan, outside the main drainage path of the source canyons, and relatively proximal-medial to the mouth of the canyons. The ridge separating the source canyons slopes up to the north and bedrock of the Topanga Formation (Ttp) is exposed at the surface several hundred feet north of the Site. Bedrock of the Modelo Formation (Tm) underlies the site at depth (GDC, 2015). Surficial deposits, below the Site, include artificial fill over alluvial fan sediments, including younger alluvial fan deposits (Qs), mud flows (Qym and Qm), and older alluvial fan deposits (Qoal). A discussion of these geologic units, the nature of their contacts, and estimated age of deposition is presented below. An illustration of the correlated stratigraphy below the Site is presented in Figure 5.1 Profile A-A' and Figure 5.2 Profile 1-1', and

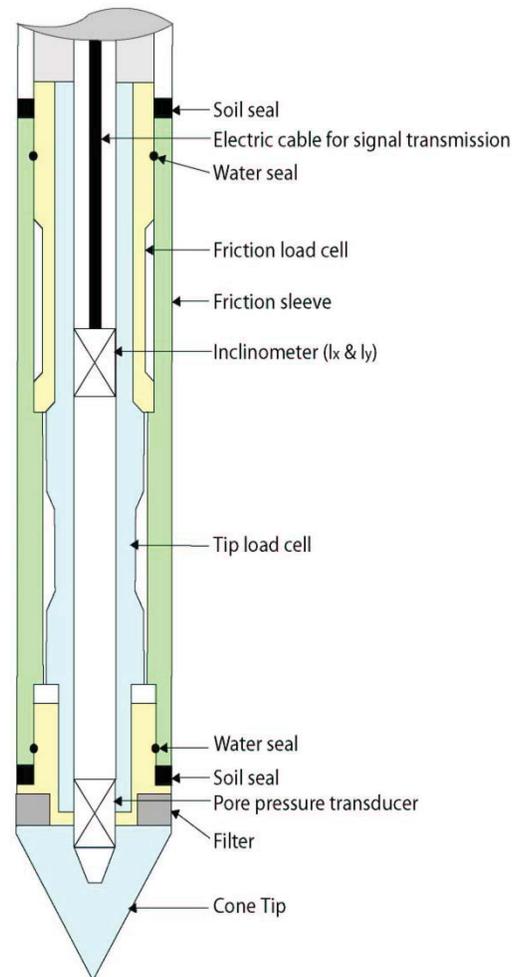
Figure CPT

The 5mm thick porous plastic filter element is located directly behind the cone tip in the u_2 location. A new saturated filter element is used on each sounding to measure both penetration pore pressures as well as measurements during a dissipation test (PPDT). Prior to each test, the filter element is fully saturated with oil under vacuum pressure to improve accuracy.

Gregg 15cm² Standard Cone Specifications

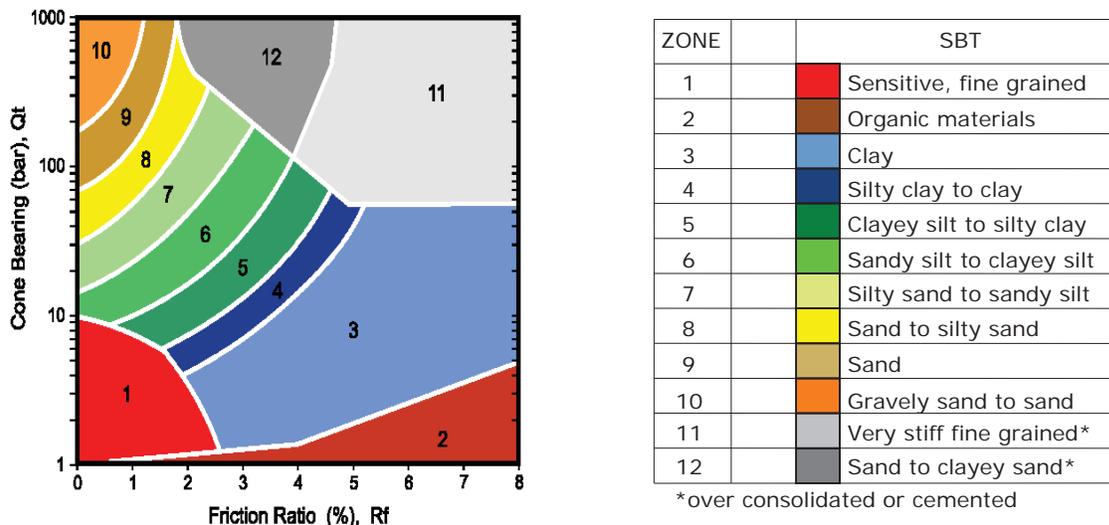
Note that it is not always possible to clearly identify a soil type based solely on q_t , f_s , and u_2 . In these situations, experience, judgment, and an assessment of the pore pressure dissipation data should be used to infer the correct soil behavior type.

Figure SBT (After Robertson et al., 1986) – Note: Colors may vary slightly compared to plots

The Cone Penetration Test (CPT) data collected are presented in graphical and electronic form in the report. The plots include interpreted Soil Behavior Type (SBT) based on the charts described by Robertson (1990). Typical plots display SBT based on the non-normalized charts of Robertson et al (1986). For CPT soundings deeper than 30m, we recommend the use of the normalized charts of Robertson (1990) which can be displayed as SBT_n, upon request. The report also includes spreadsheet output of computer calculations of basic interpretation in terms of SBT and SBT_n and various geotechnical parameters using current published correlations based on the comprehensive review by Lunne, Robertson and Powell (1997), as well as recent updates by Professor Robertson (Guide to Cone Penetration Testing, 2015). The interpretations are presented only as a guide for geotechnical use and should be carefully reviewed. Gregg Drilling & Testing Inc. does not warranty the correctness or the applicability of any of the geotechnical parameters interpreted by the software and does not assume any liability for use of the results in any design or review. The user should be fully aware of the techniques and limitations of any method used in the software. Some interpretation methods require input of the groundwater level to calculate vertical effective stress. An estimate of the in-situ groundwater level has been made based on field observations and/or CPT results, but should be verified by the user.
