Geotechnical Investigation

**Updated Geotechnical Feasibility Report
Proposed High-Rise Hotel Development
1718 Vine Street
Hollywood District
Los Angeles, California**

**July 28, 2016
GDC Project No. LA-1289**

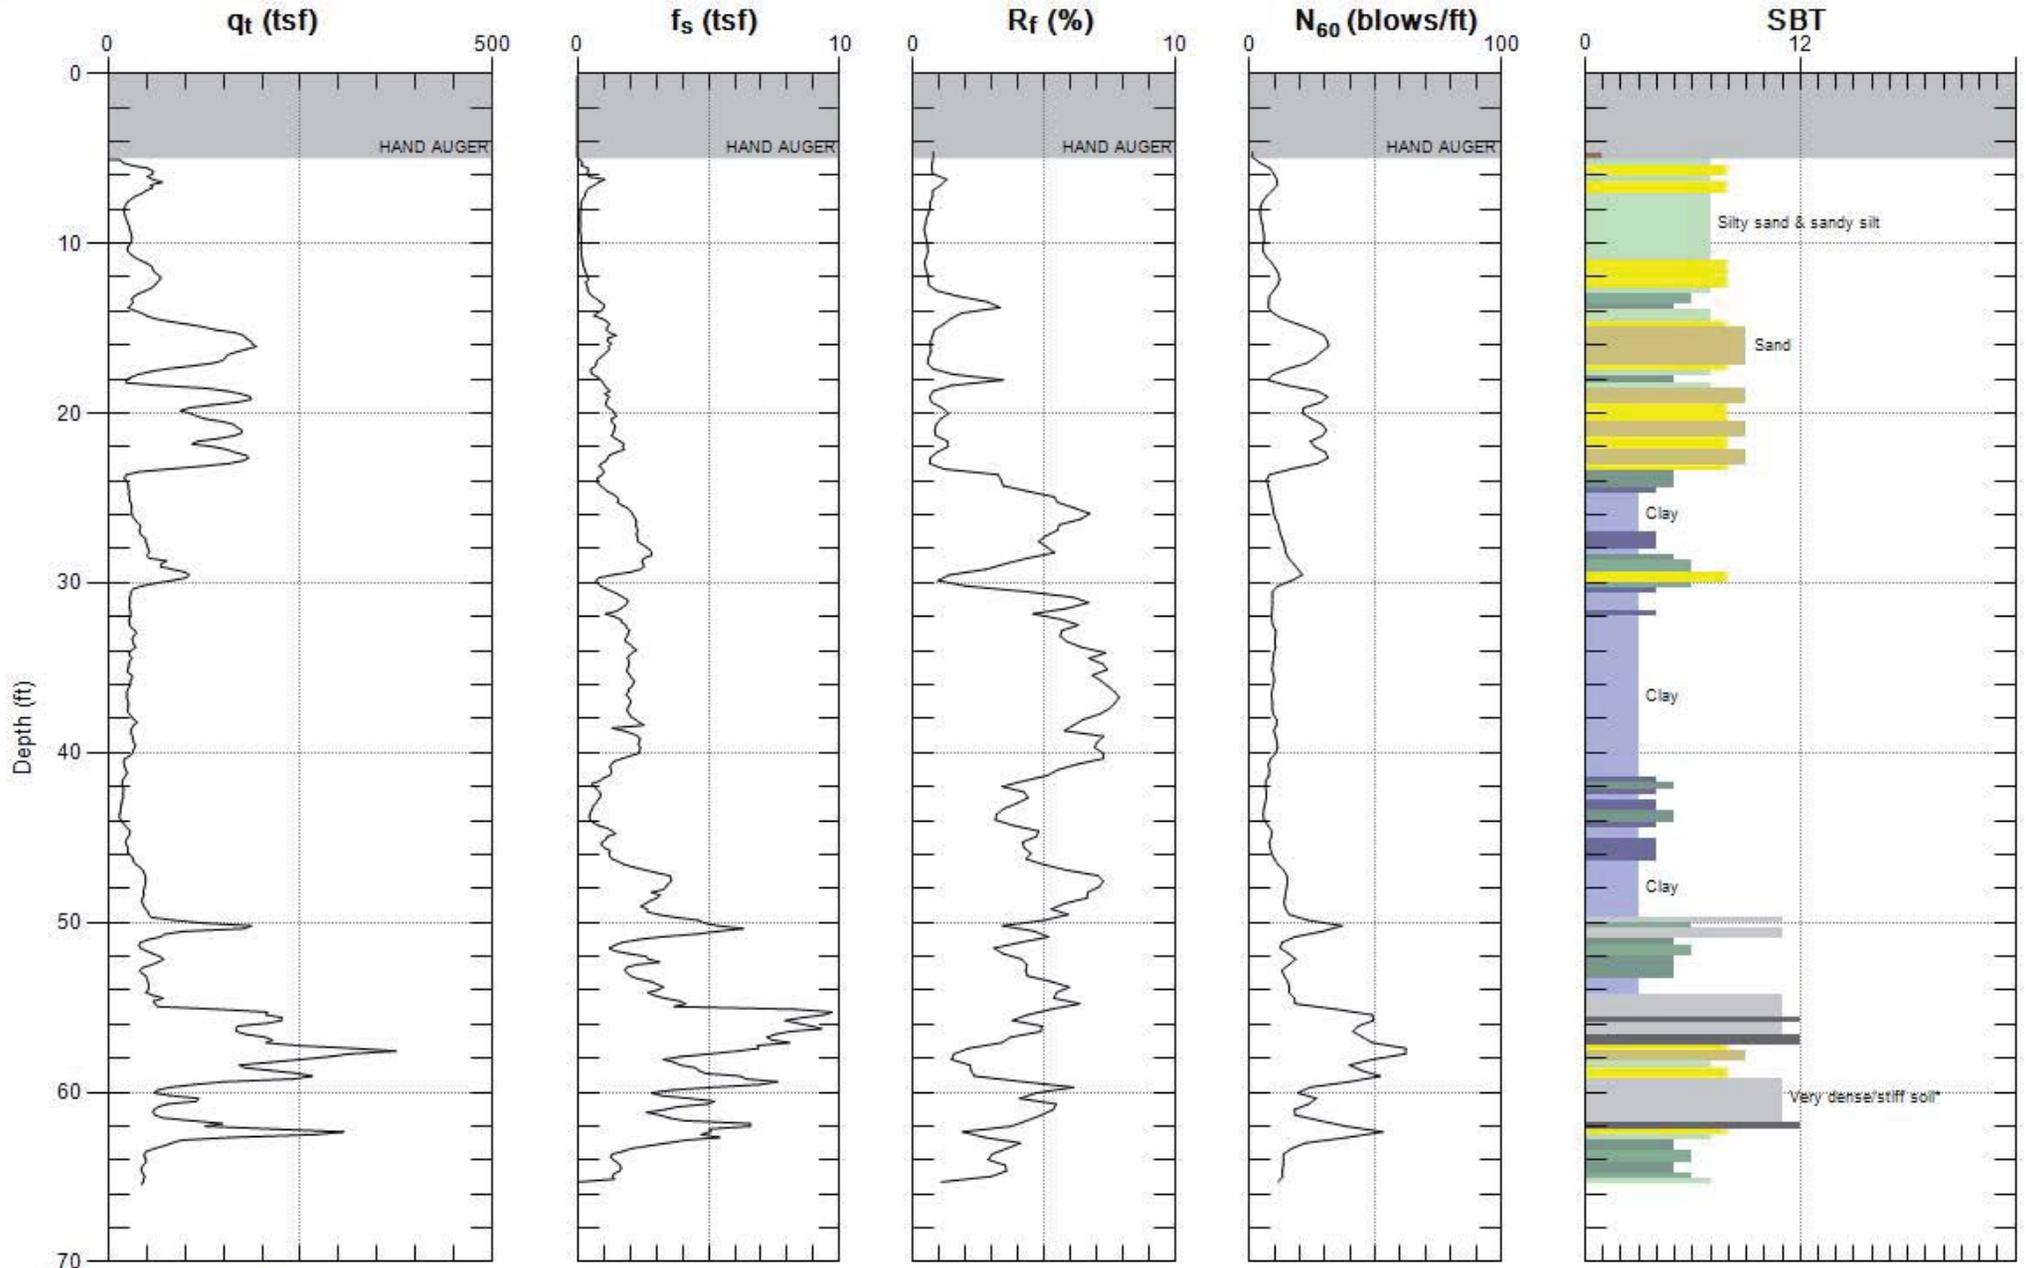
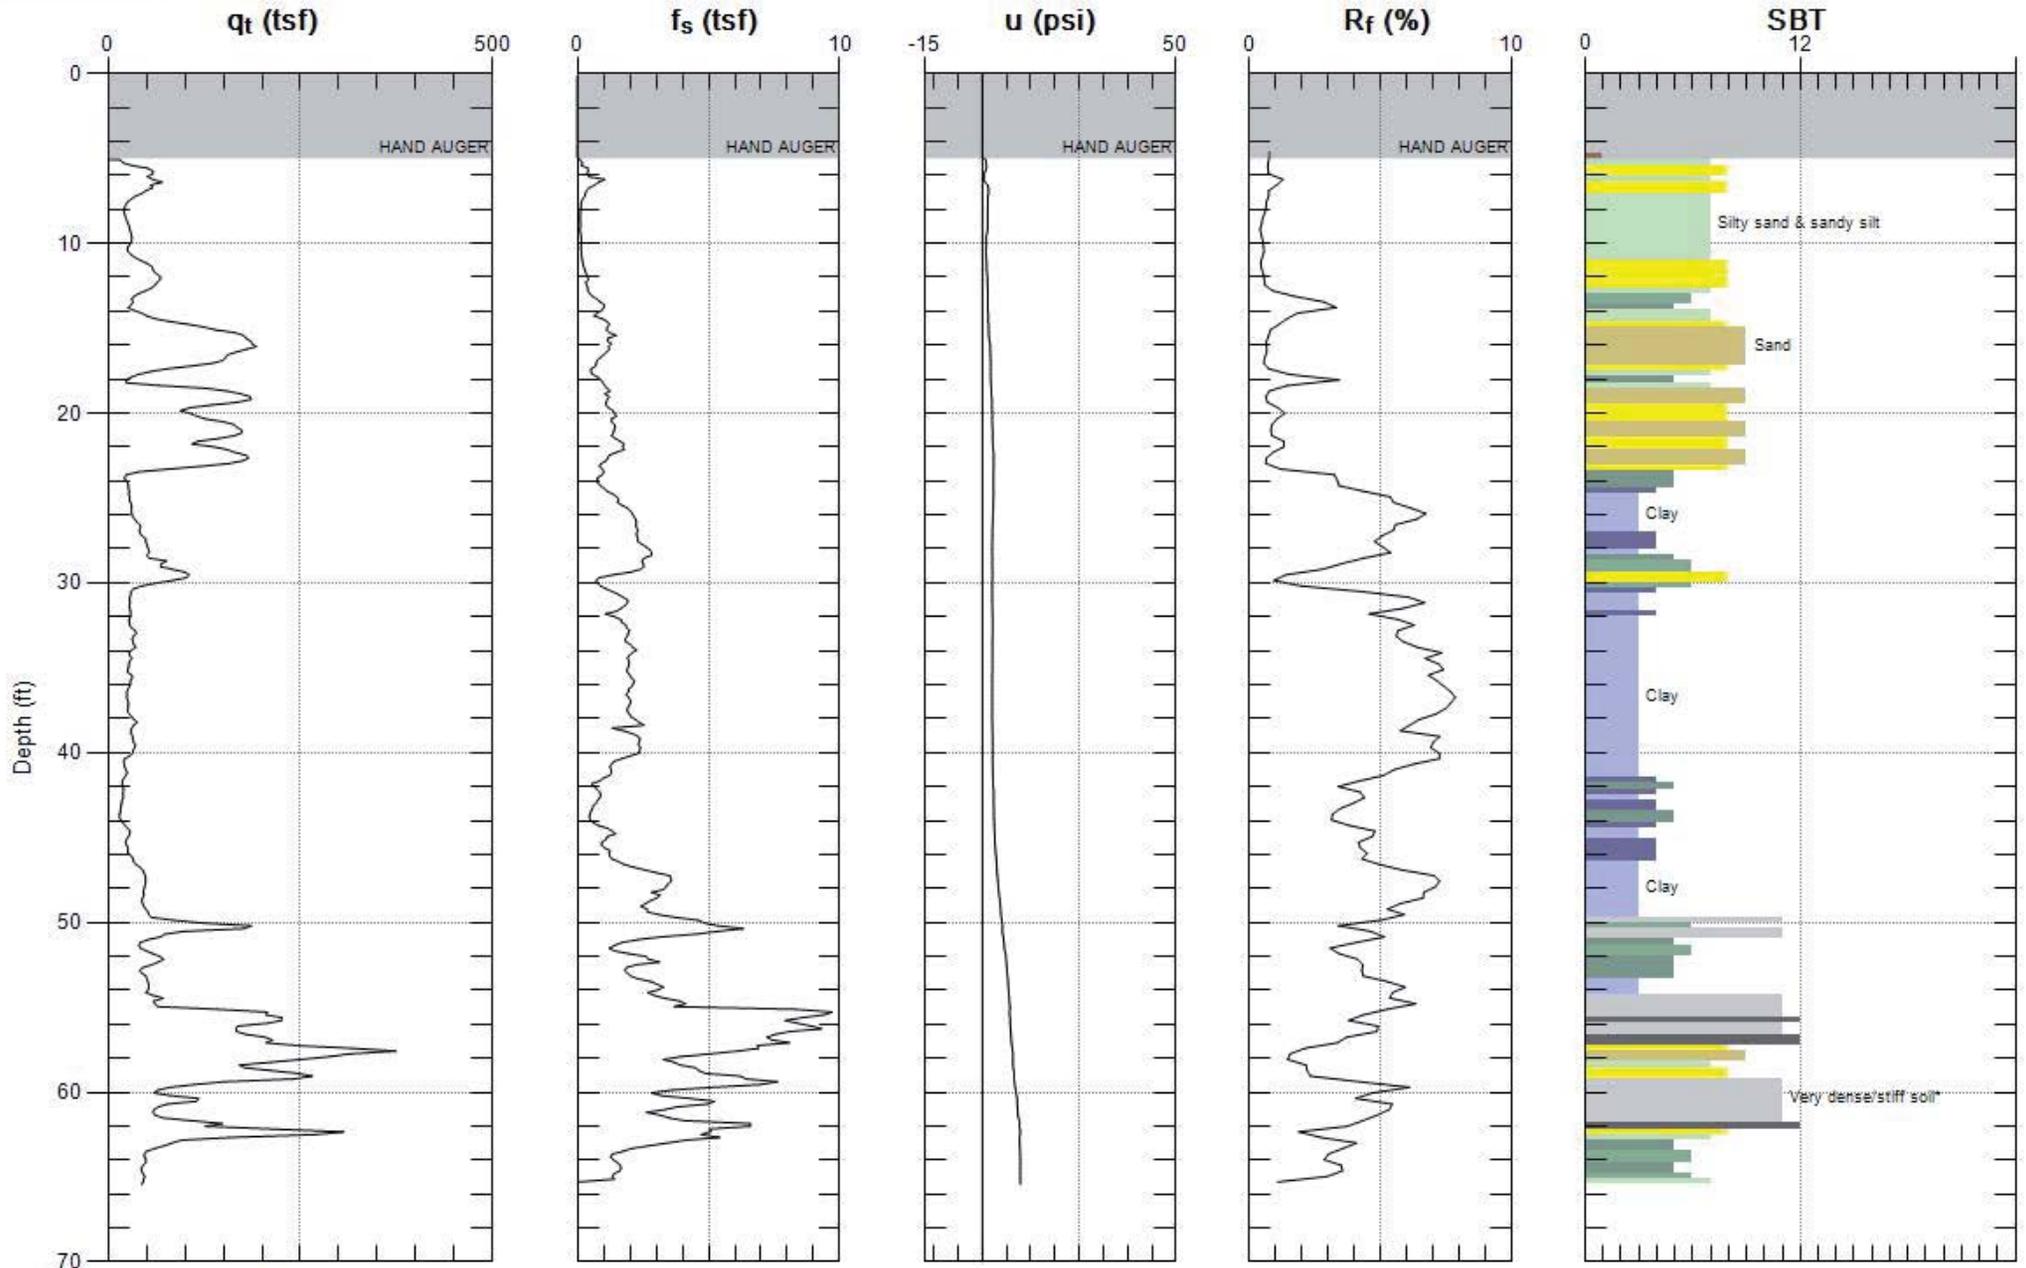
Site: 1718 VINE ST.
Sounding: C -1

Max. Depth: 65.453 (ft)
Avg. Interval: 0.328 (ft)

SBT: Soil Behavior Type (Robertson 1990)

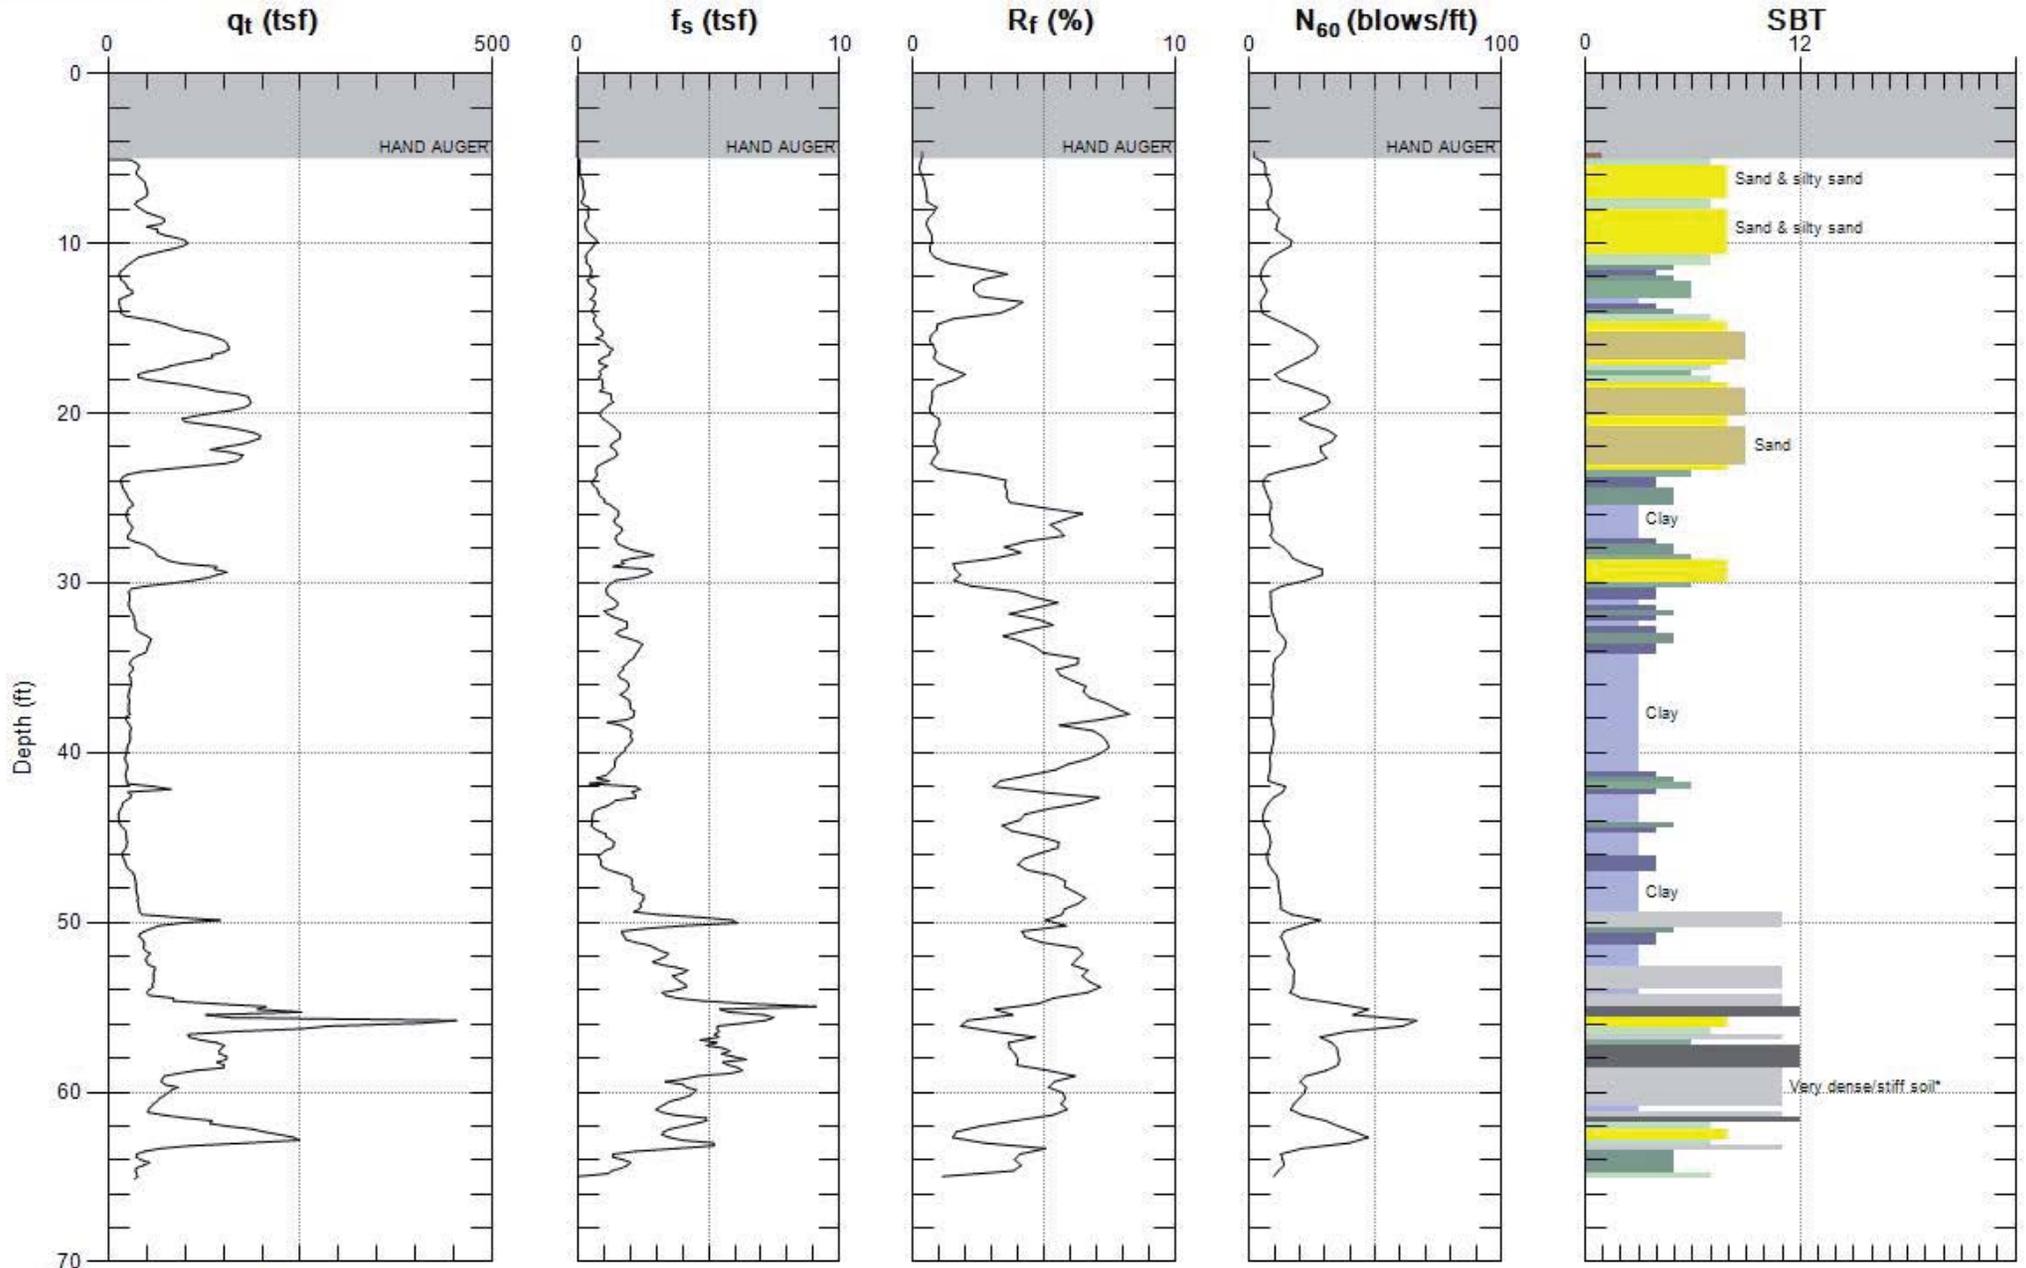
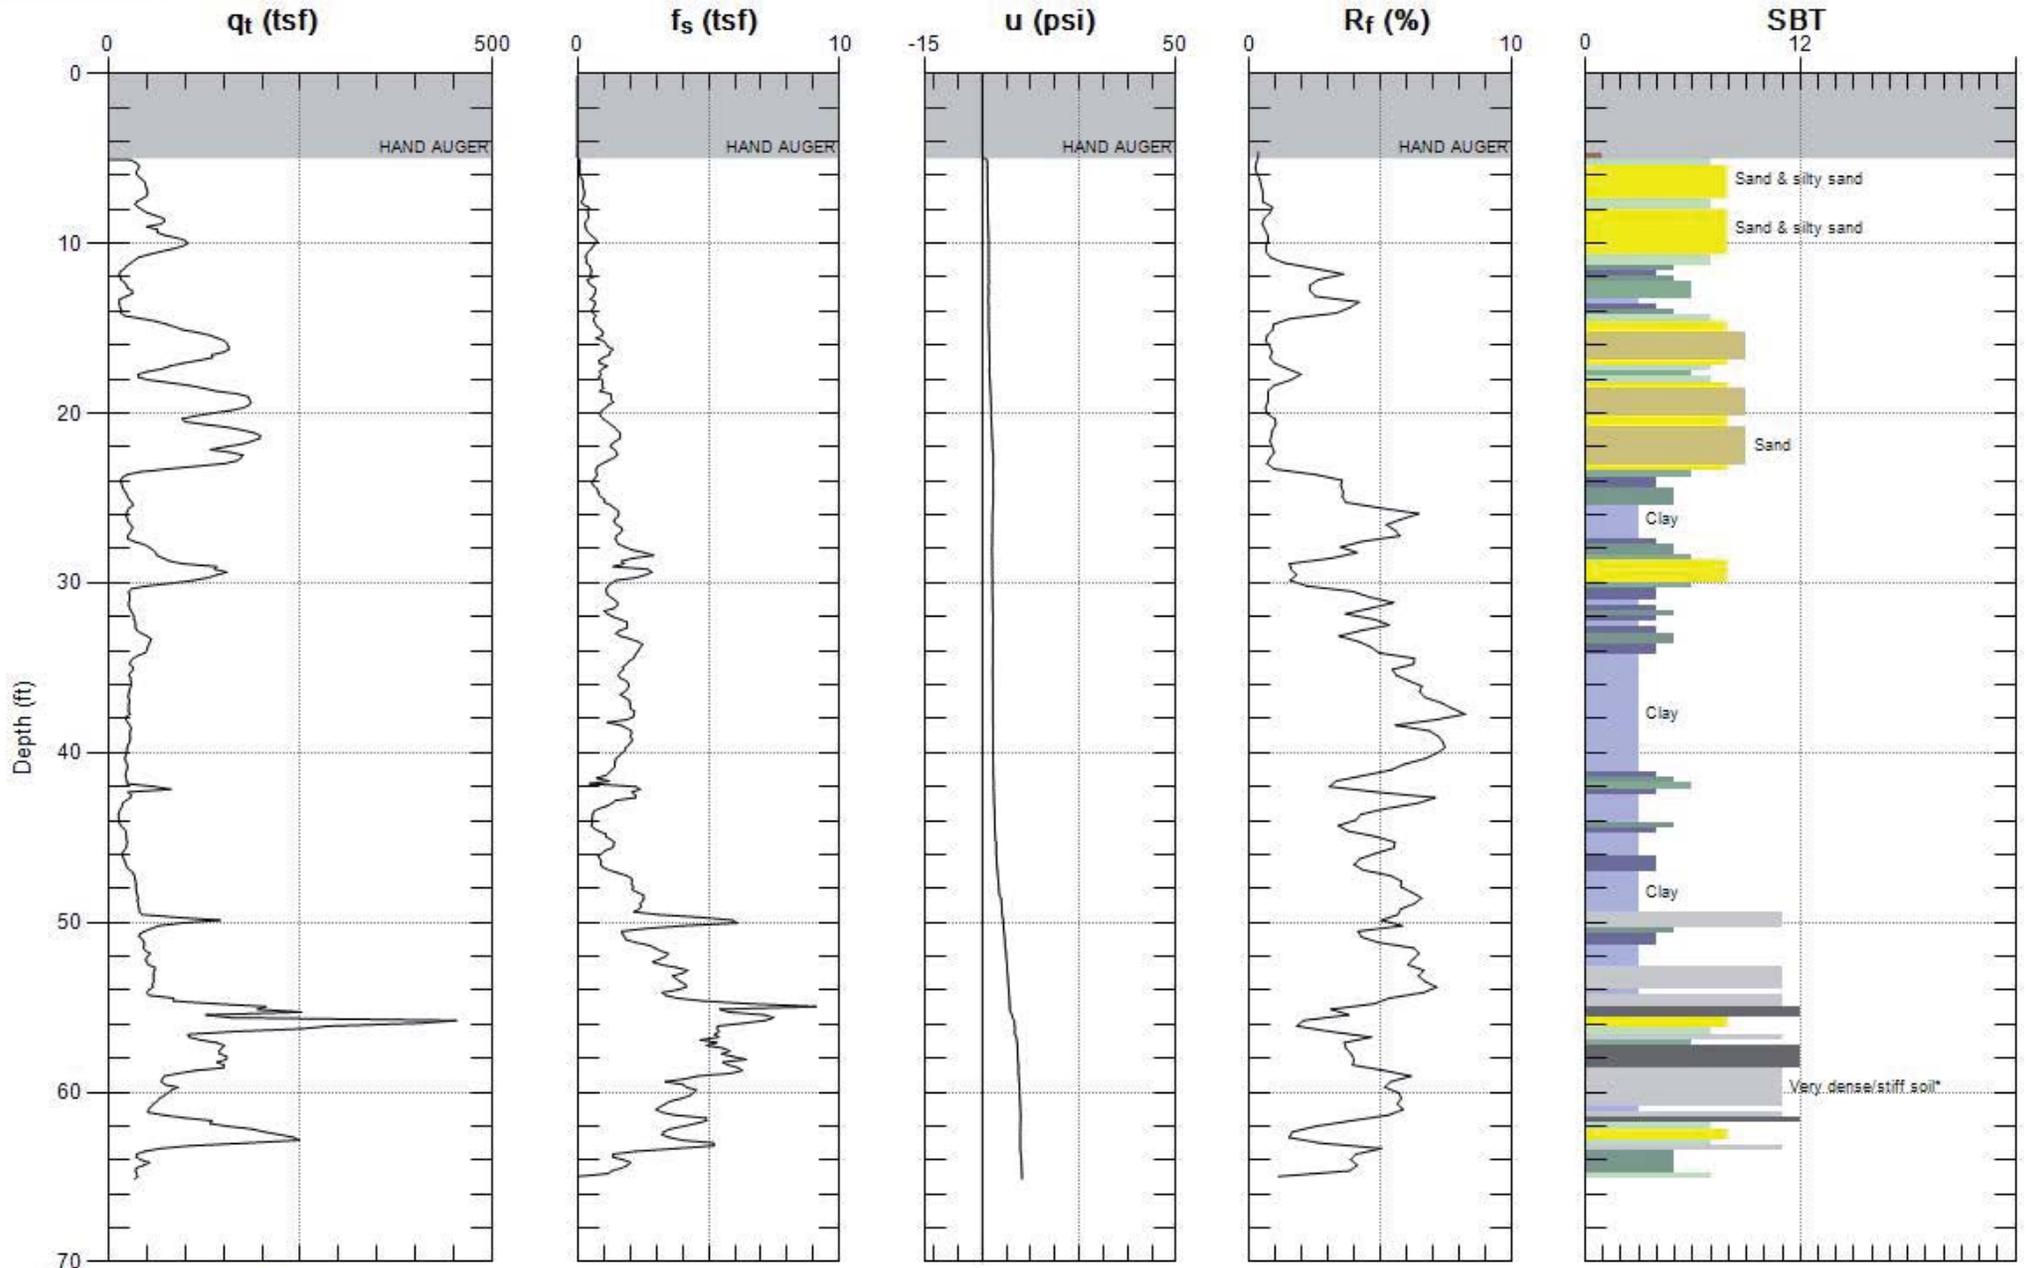
Site: 1718 VINE ST.
Sounding: C -2

Max. Depth: 65.125 (ft)
Avg. Interval: 0.328 (ft)

SBT: Soil Behavior Type (Robertson 1990)

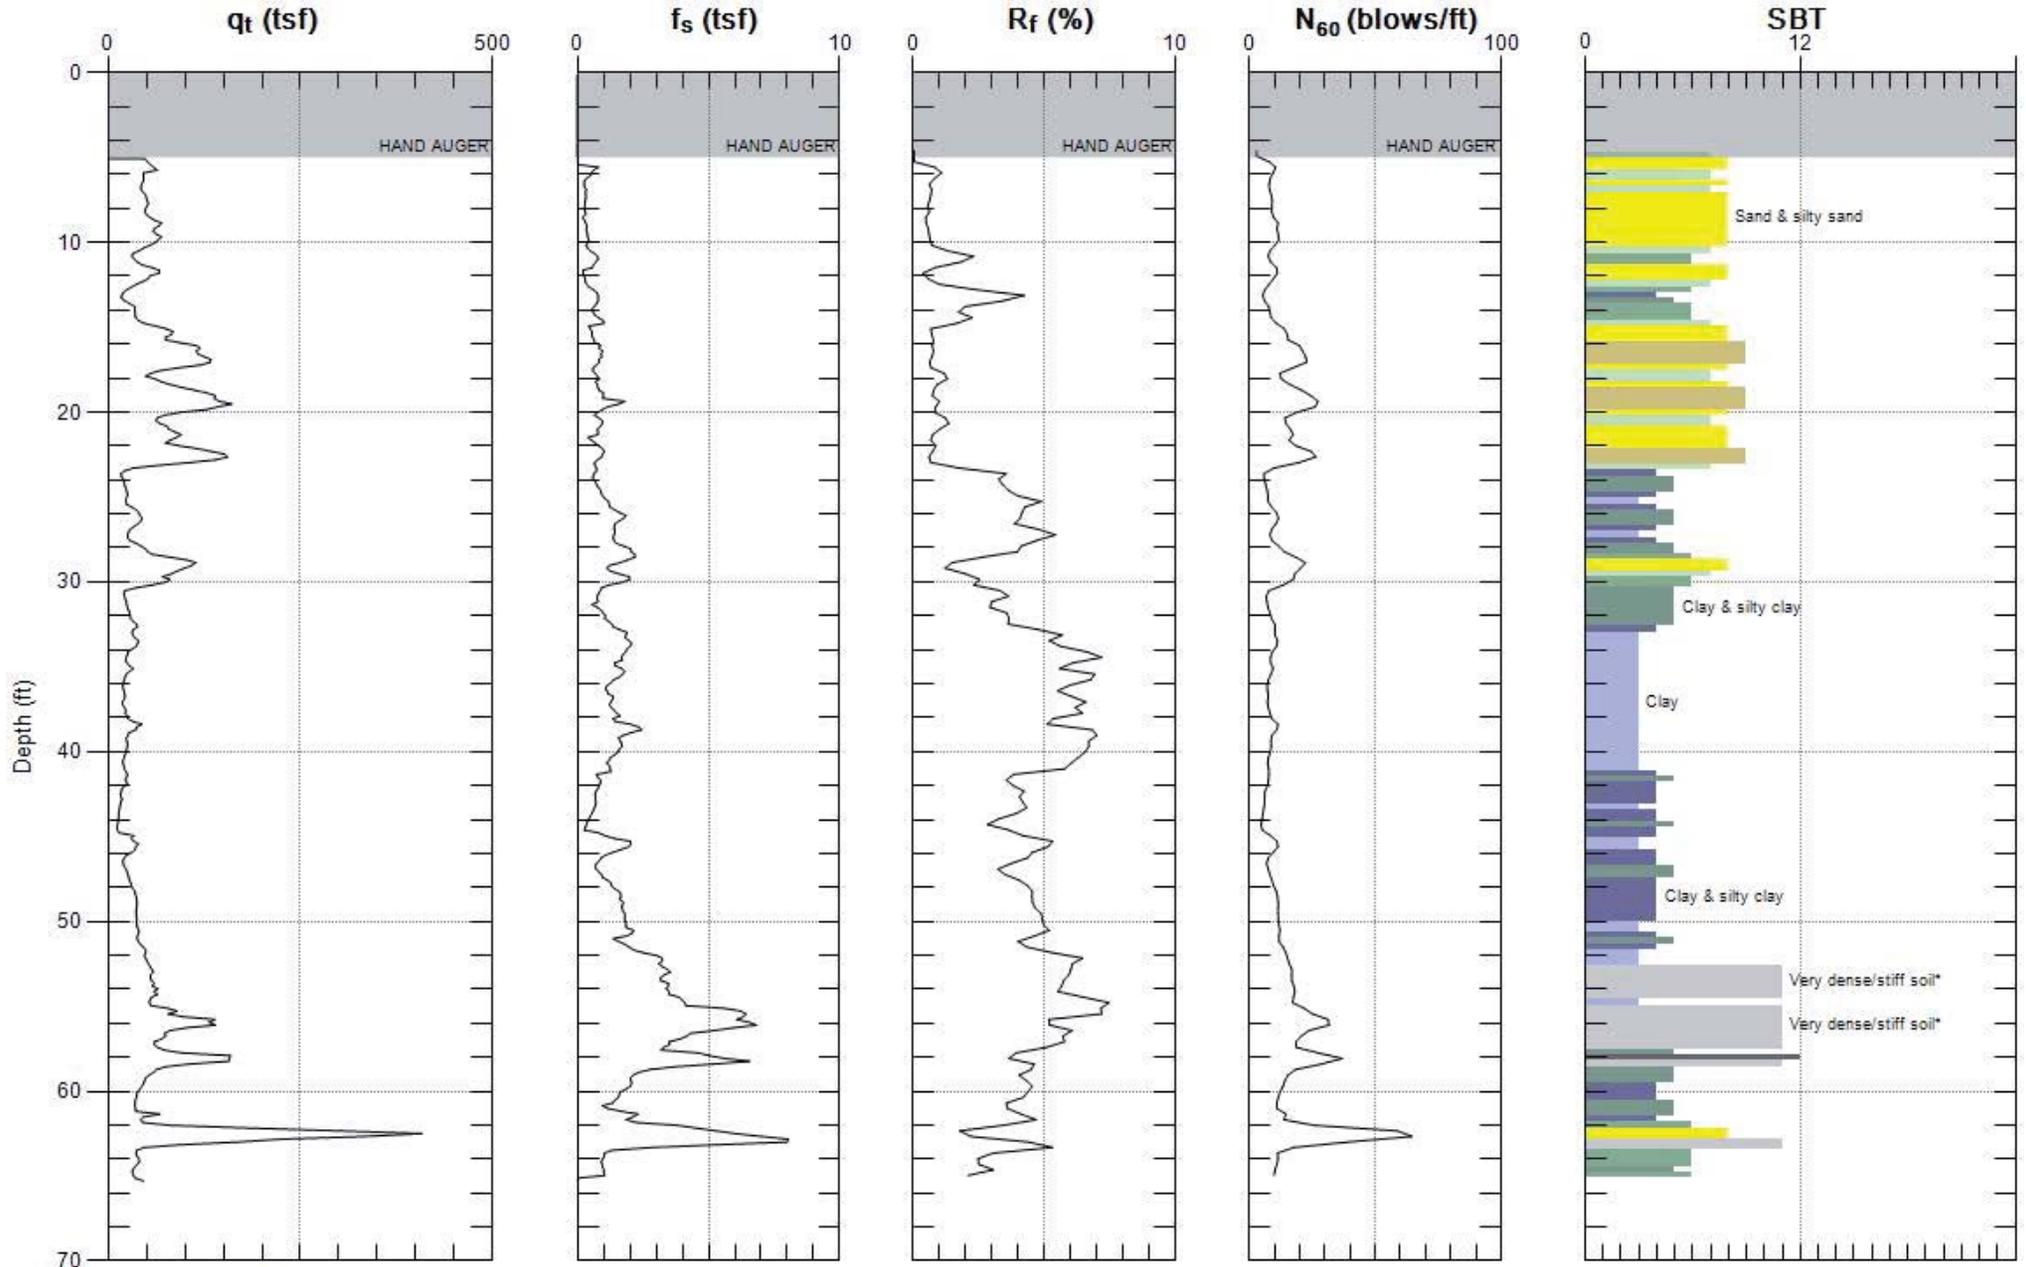
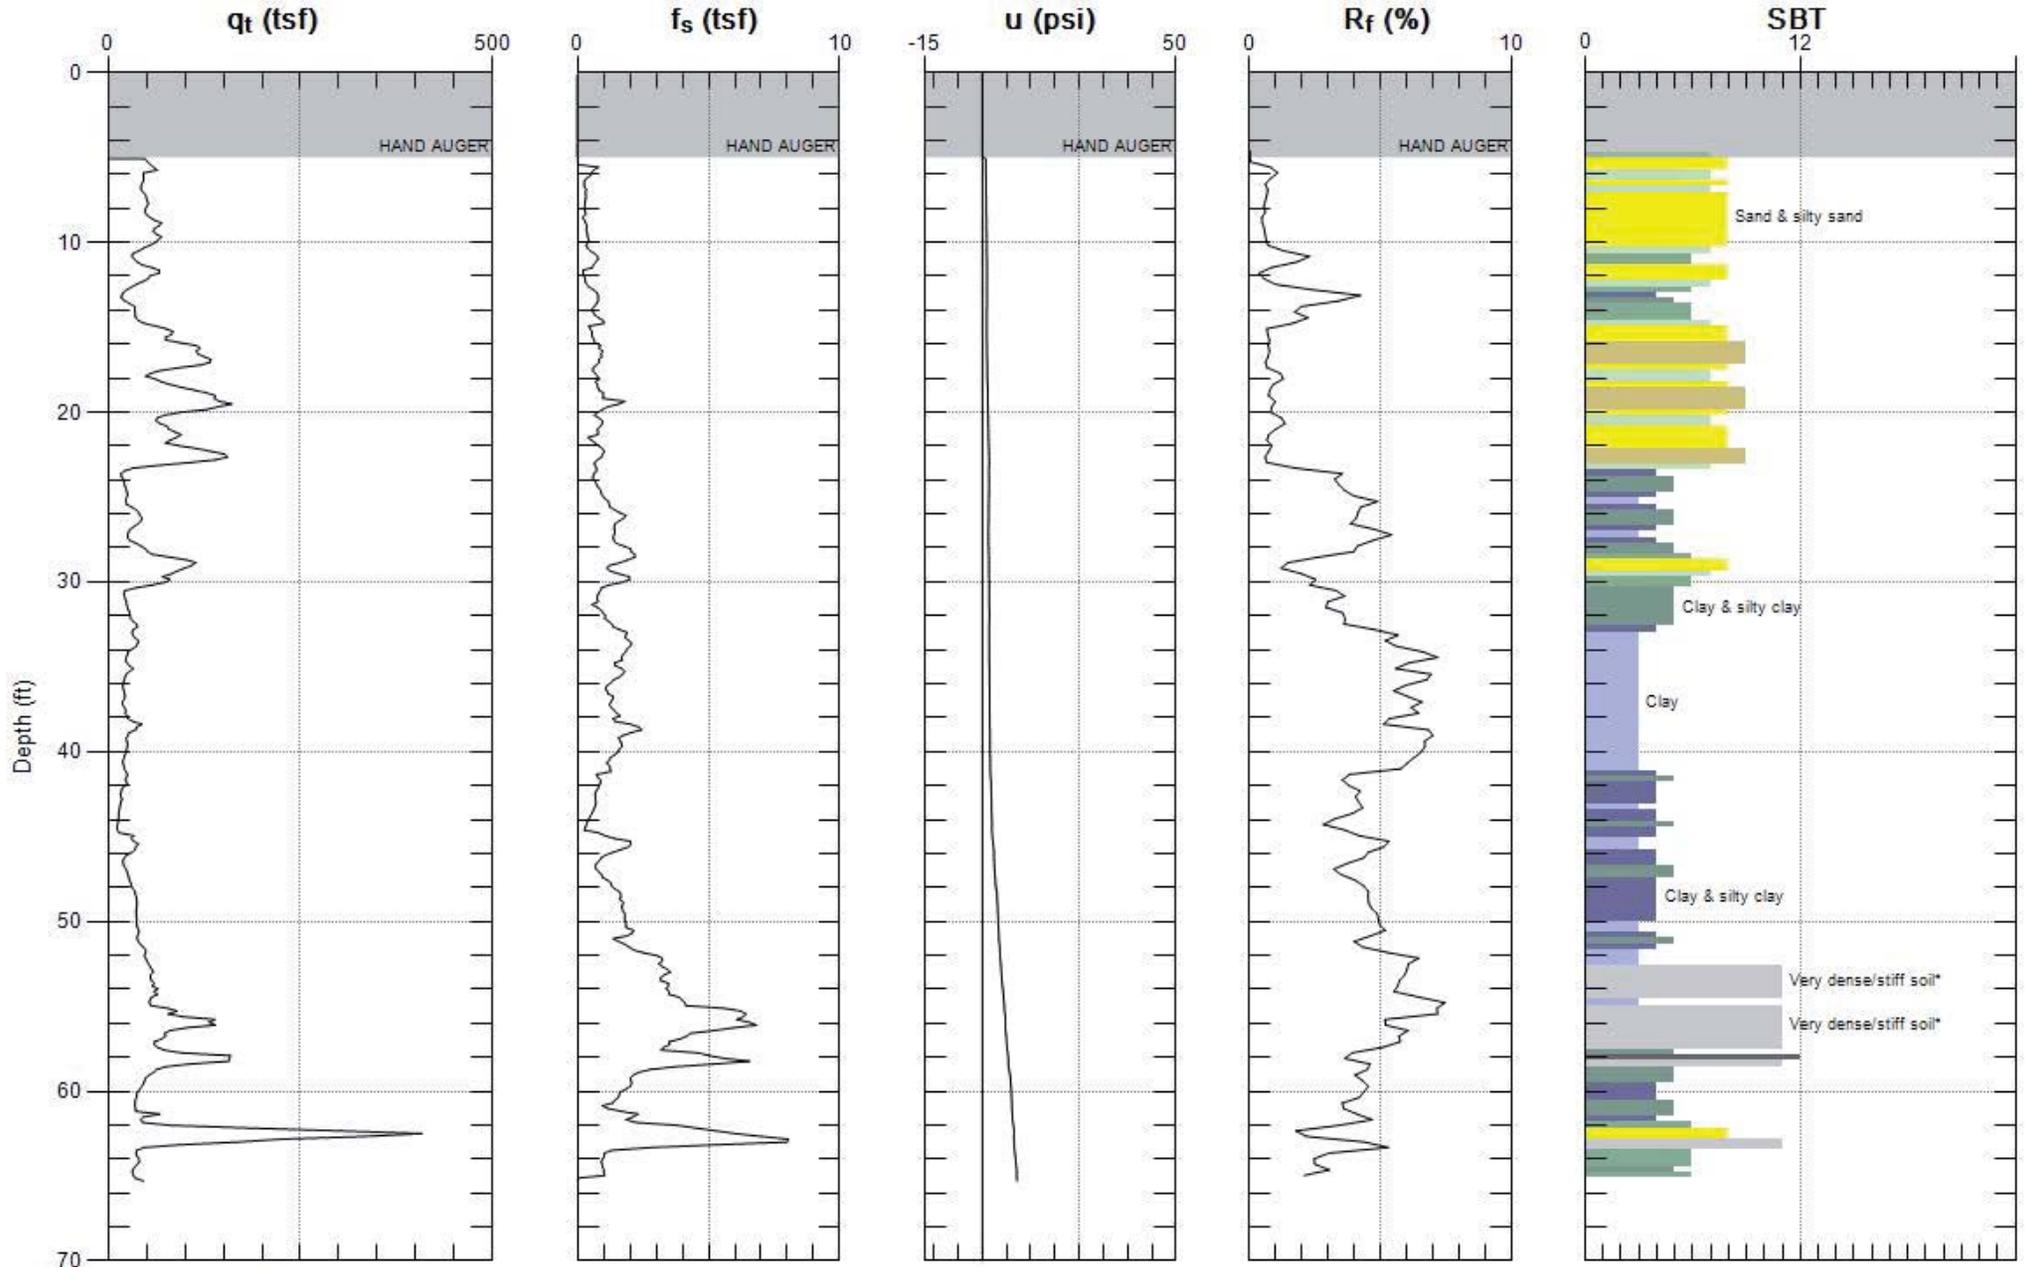
Site: 1718 VINE ST.
Sounding: C -3

Max. Depth: 65.289 (ft)
Avg. Interval: 0.328 (ft)

SBT: Soil Behavior Type (Robertson 1990)

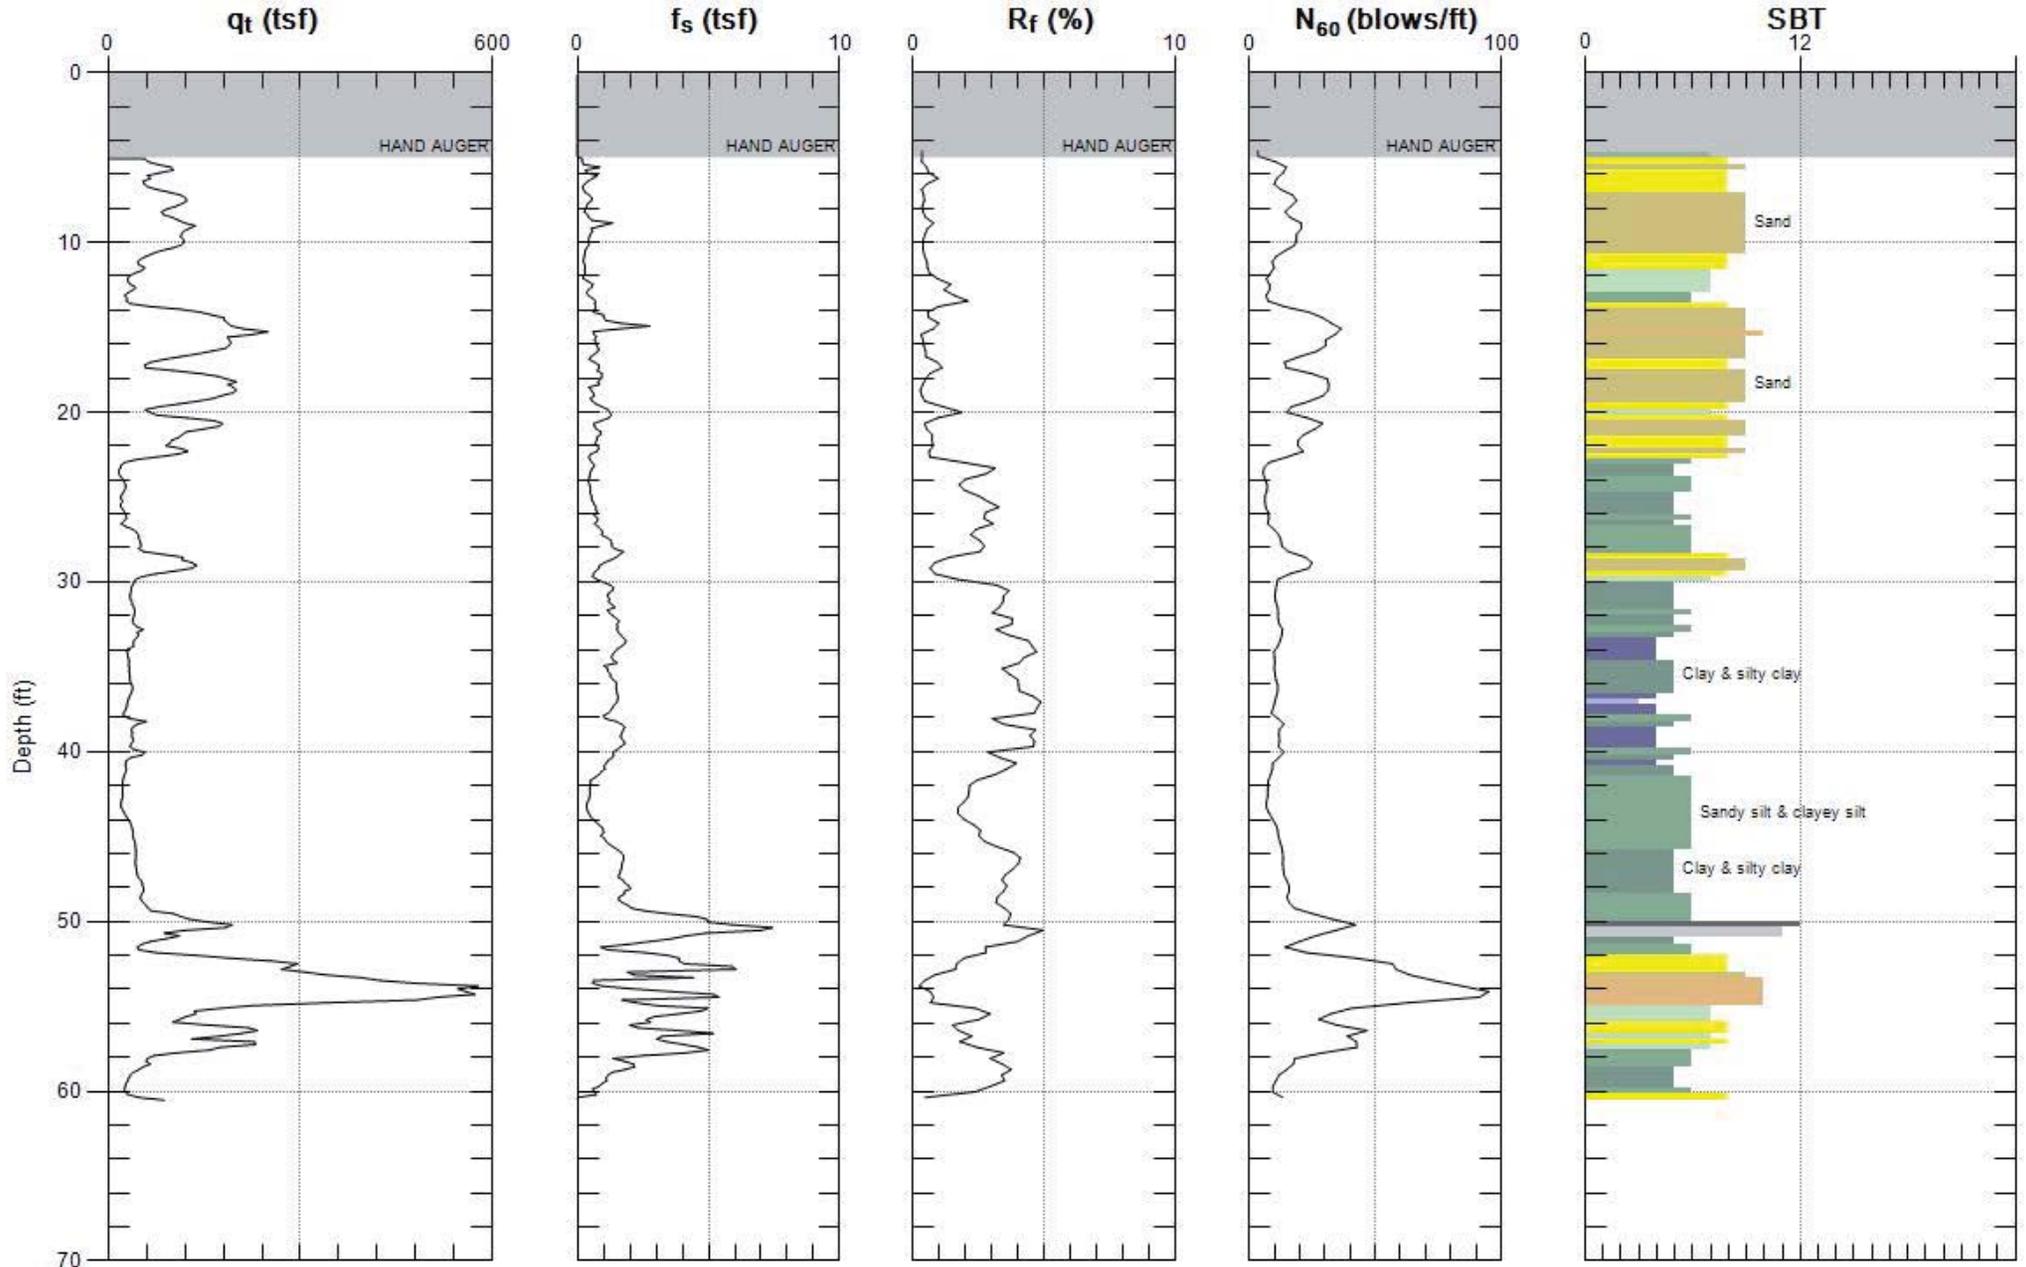
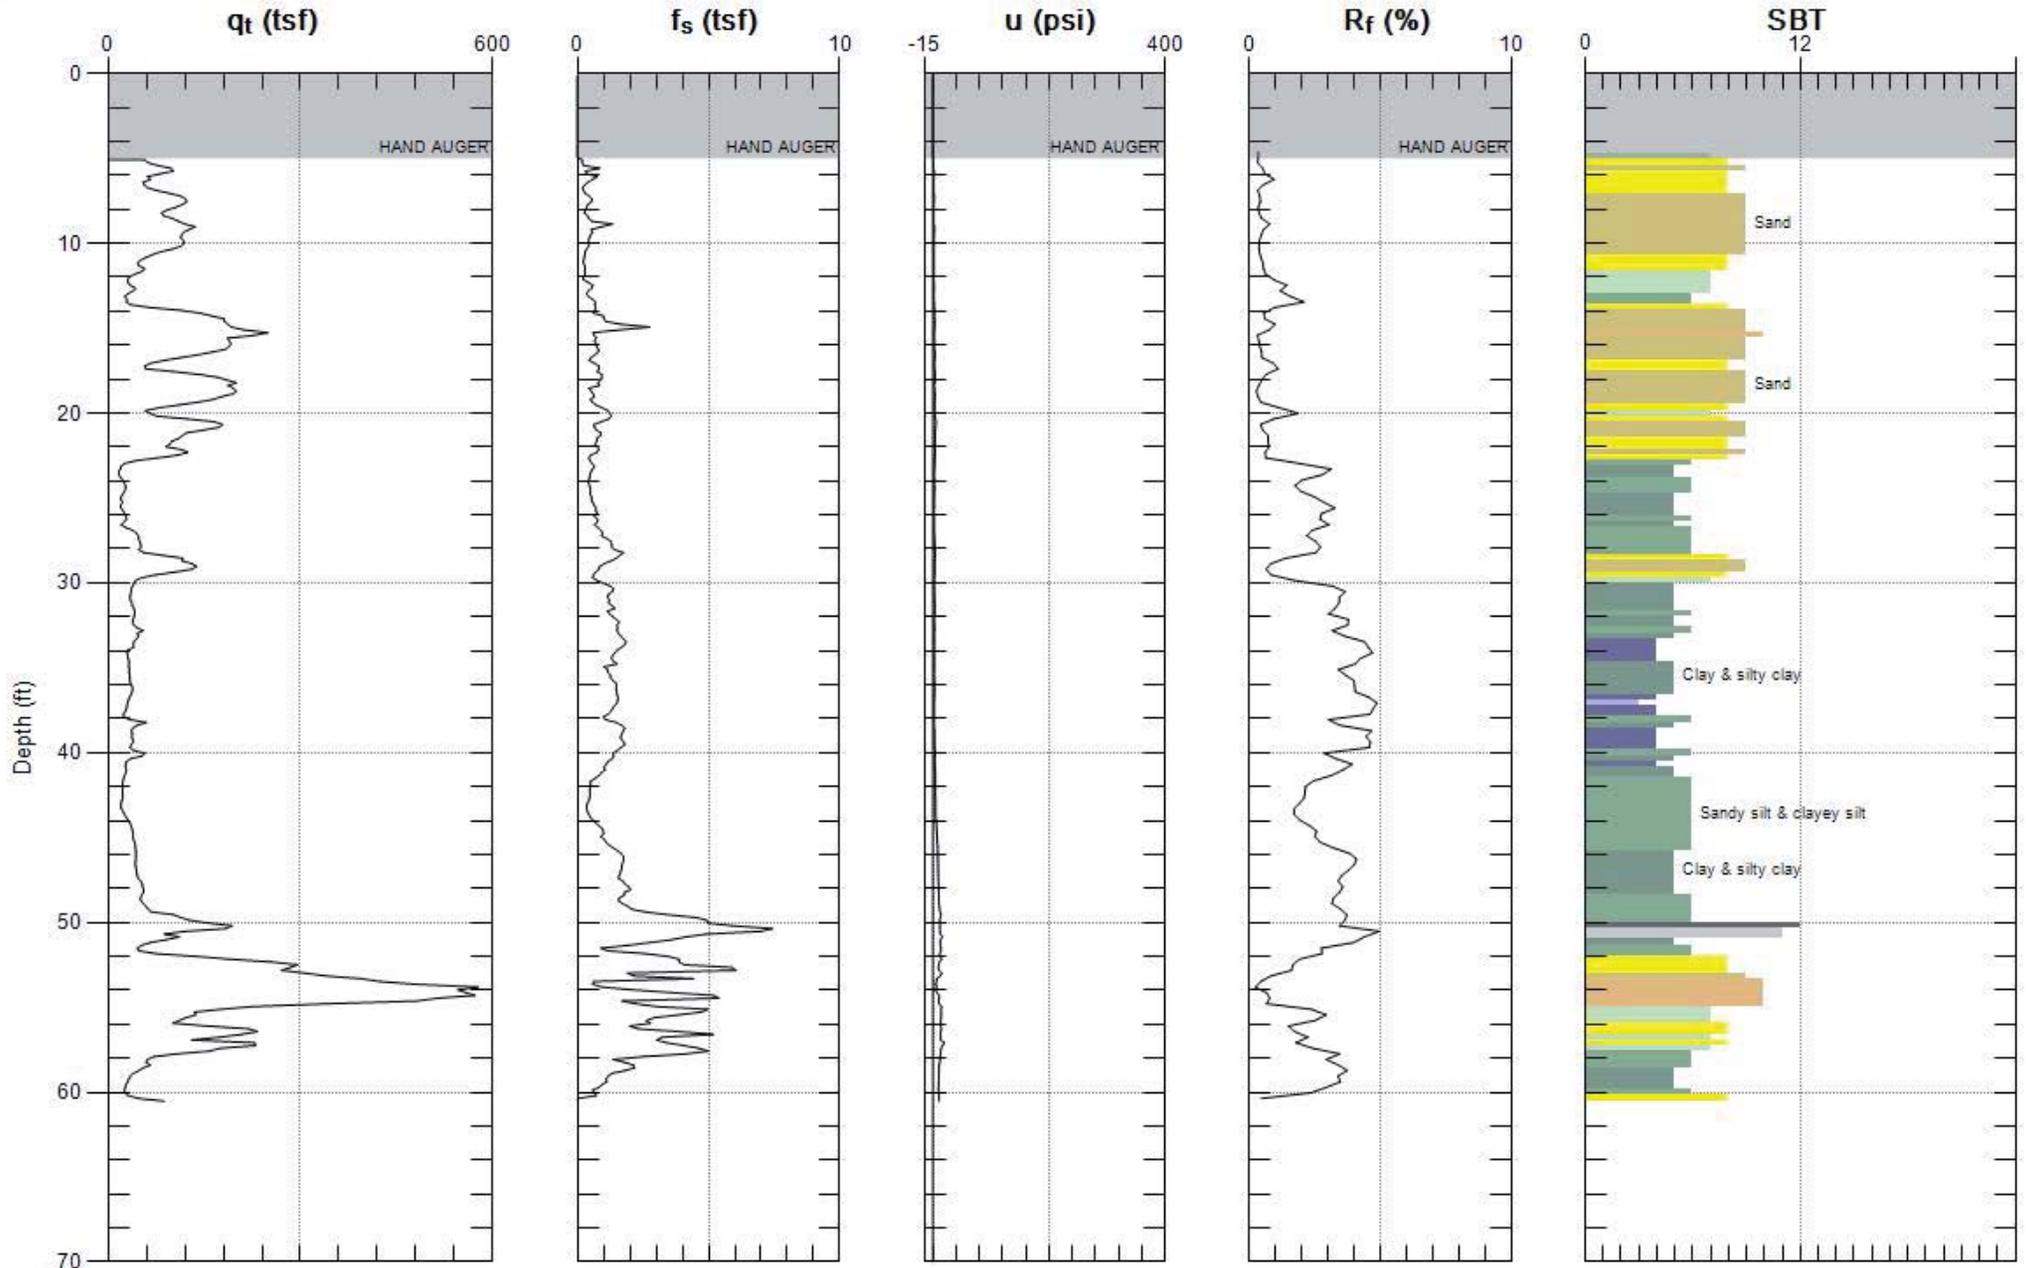
Site: PARKING LOT S
Sounding: CPT-37

Max. Depth: 60.531 (ft)
Avg. Interval: 0.328 (ft)

SBT: Soil Behavior Type (Robertson 1990)
